CANADA CENTRE FOR INLAND WATERS (CCIW)

Burlington, Ontario

LEVEL 2 (Life Cycle)
BUILDING CONDITION REPORT
September 2009

**Environment Canada
Canada Centre for Inland Waters (CCIW)
NWRI BUILDING**

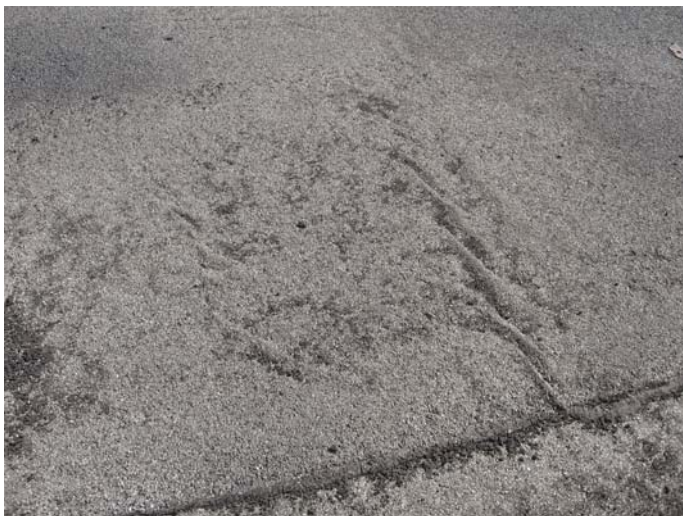
AR-037 – Wrinkling/distortion of SBS membrane.

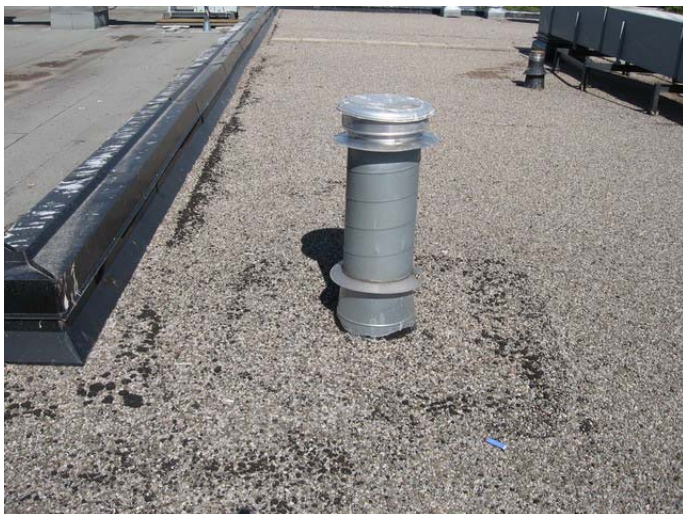
AR-041 – Asphalt bleed-through along/around flashings on BUR.

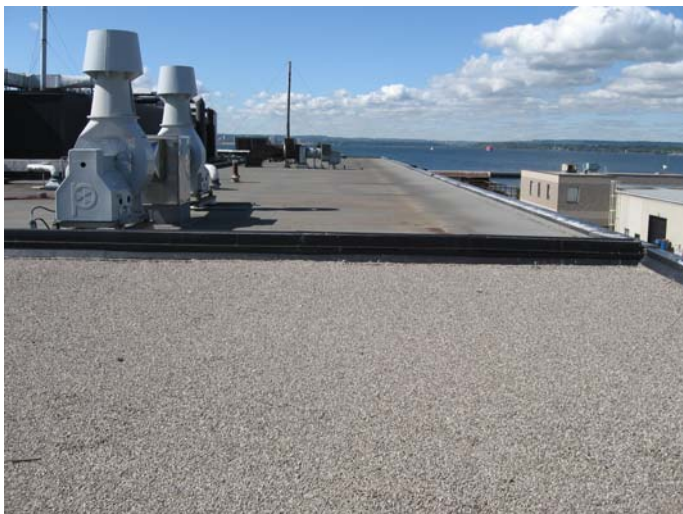
AR-045 – Discoloured SBS membrane from standing water - view looking west.

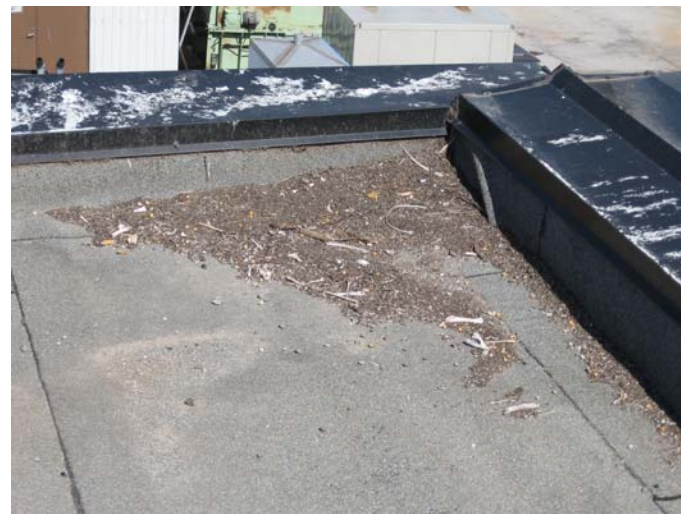
AR-046 – Accumulation of debris in corners of SBS roofing.

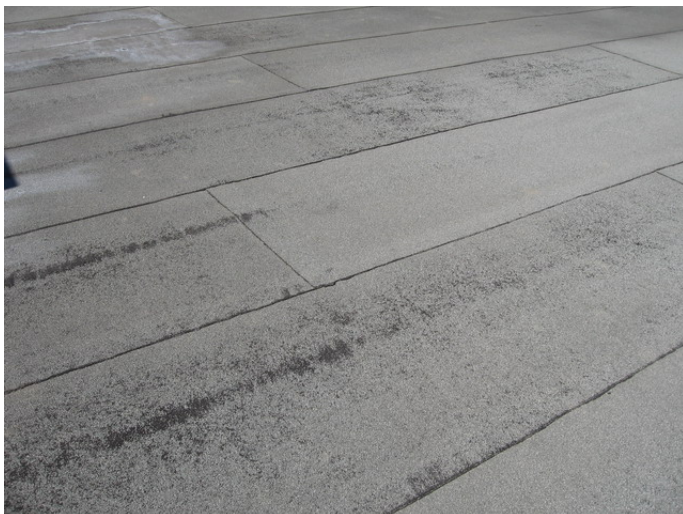
AR-049 – Ridging throughout SBS membrane at insulation joint locations.

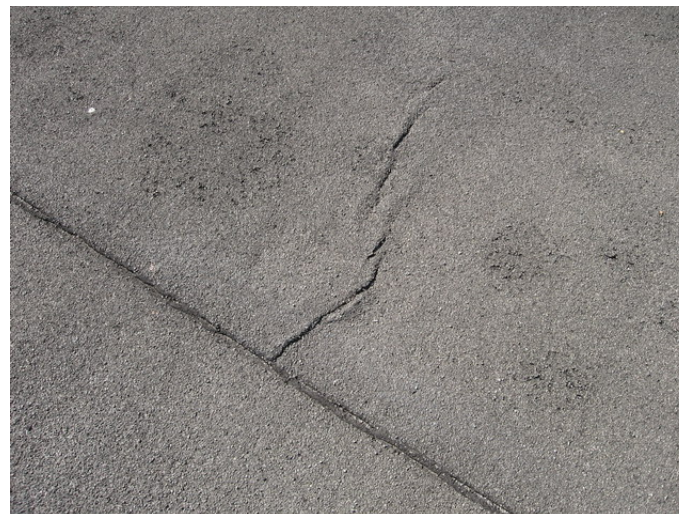
AR-050 – Fracture of SBS membrane.

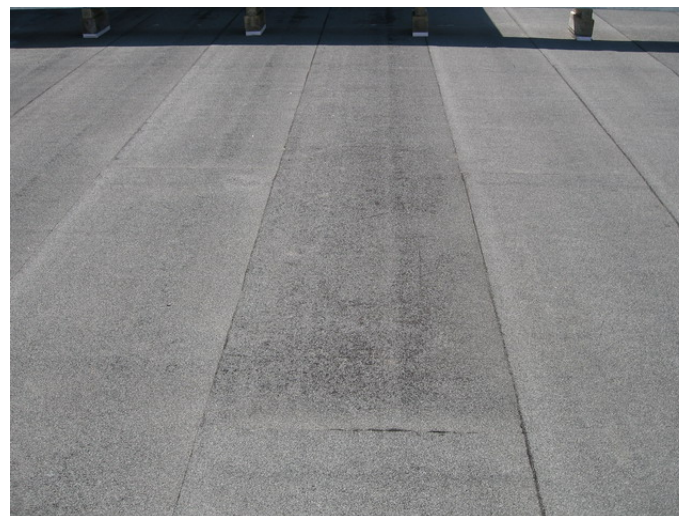
AR-052 – Loss of granular surfacing of SBS membrane roll in field.

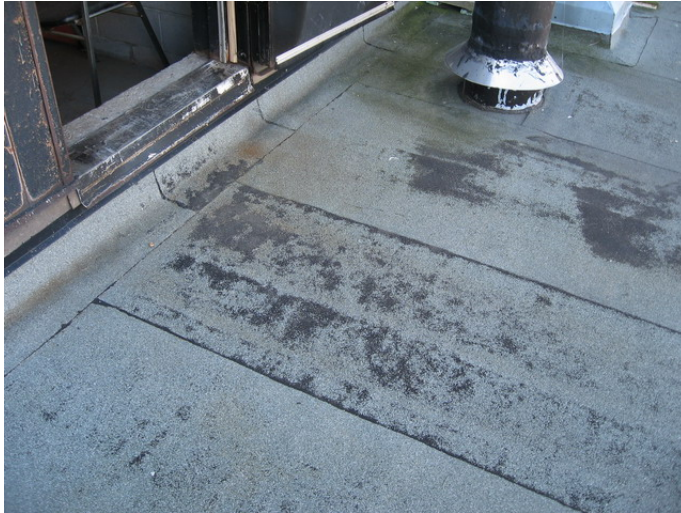
AR-053 – Loss of granular surfacing at SBS membrane roll at access door location.

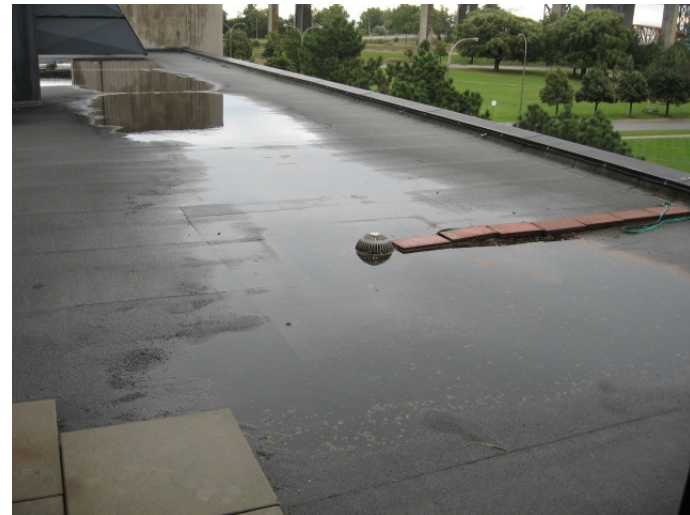
AR-056 – Ponding and blocked drain at main roof.

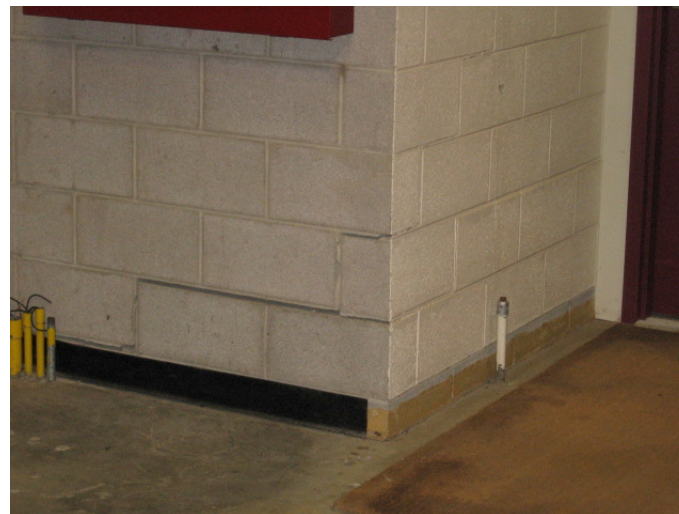
AR-058 – Open block joints at wall in high-bay area.

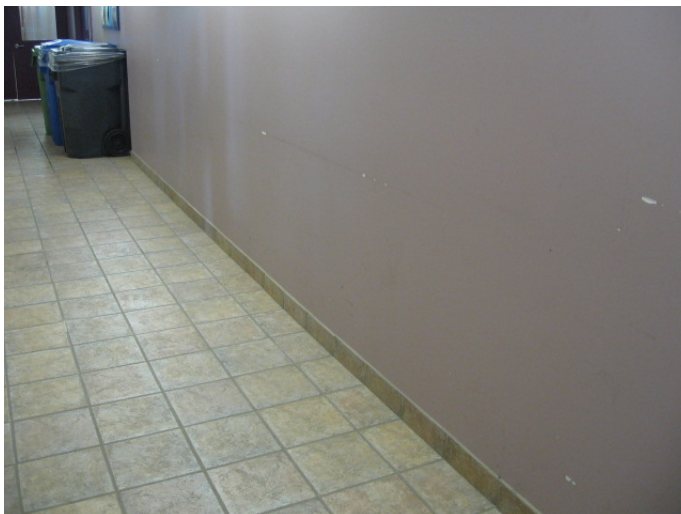
AR-061 – Damaged wall surfaces in 1st floor corridor.

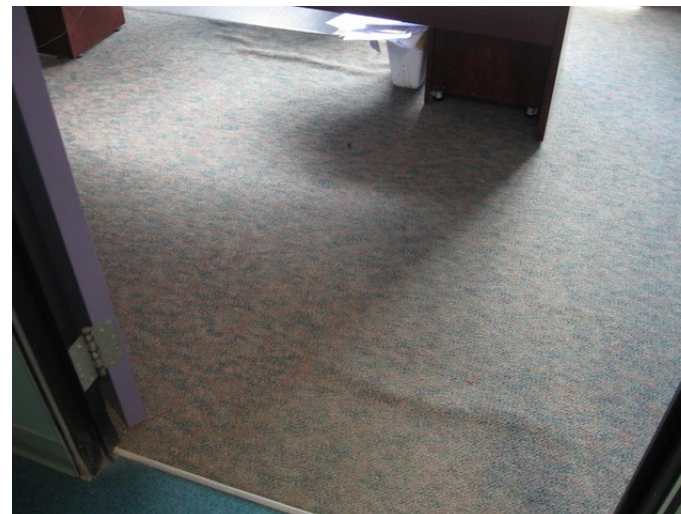
AR-062 – Wrinkling of carpet flooring in office.

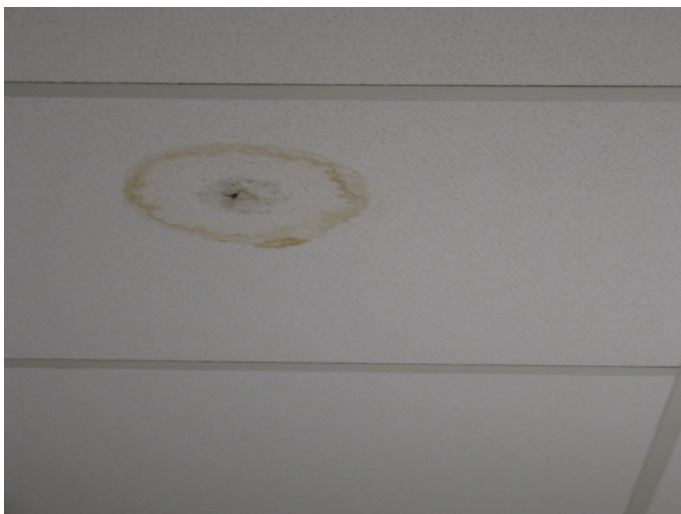
AR-063 – Water damaged/stained acoustic ceiling tile.

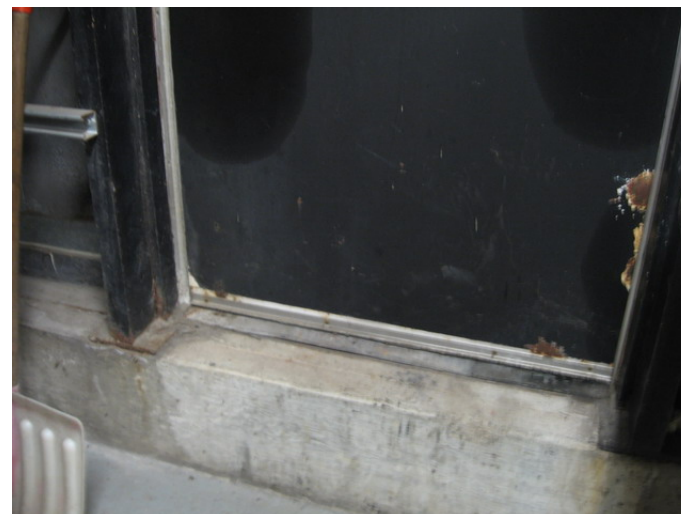
AR-064 – Deteriorating paint finish and rusting metal surfaces at PH/rooftop access door and frame.

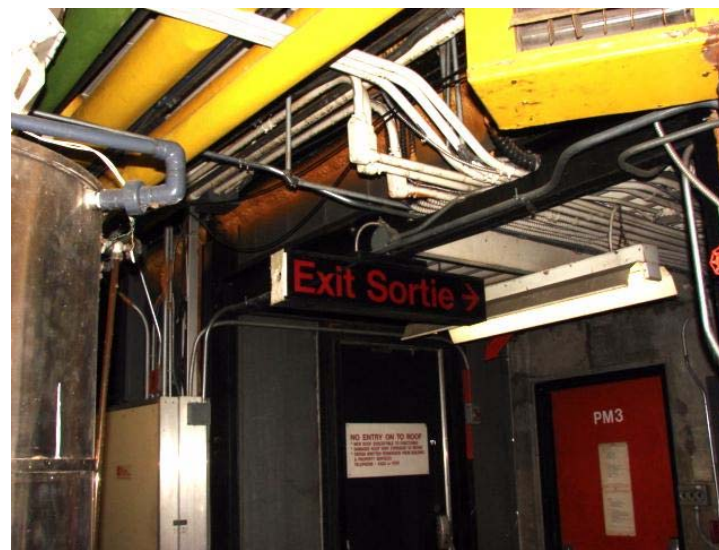
ELE-012 – Sample of exit signage.

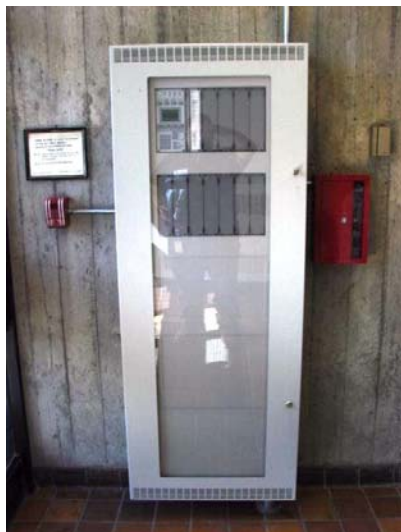
ELE-013 – Main Fire Alarm Panel in WTC.

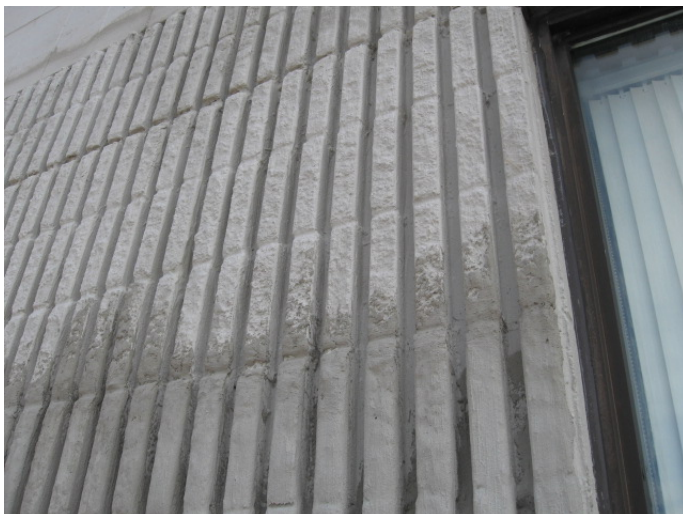
AR-005 – Cementitious coating on.

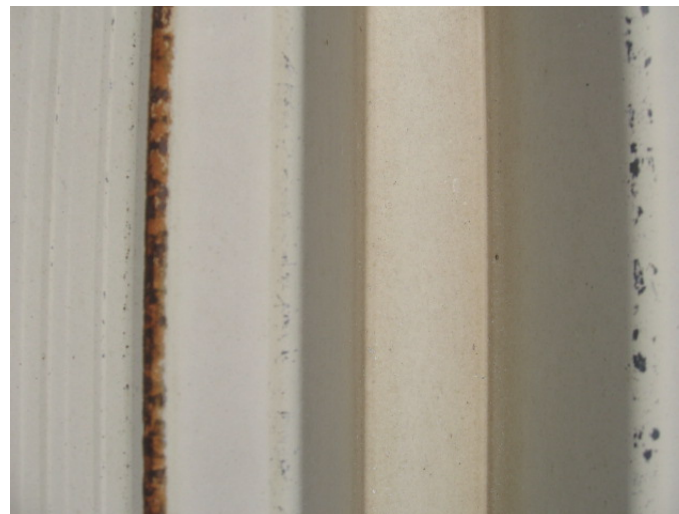
AR-006 – Deteriorating paint finish (flaking and rusting) at metal siding.

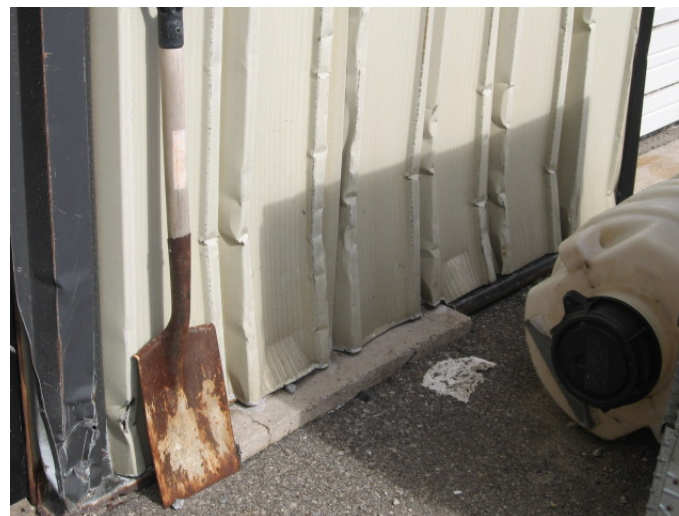
AR-008 – Damaged metal siding at south elevation.

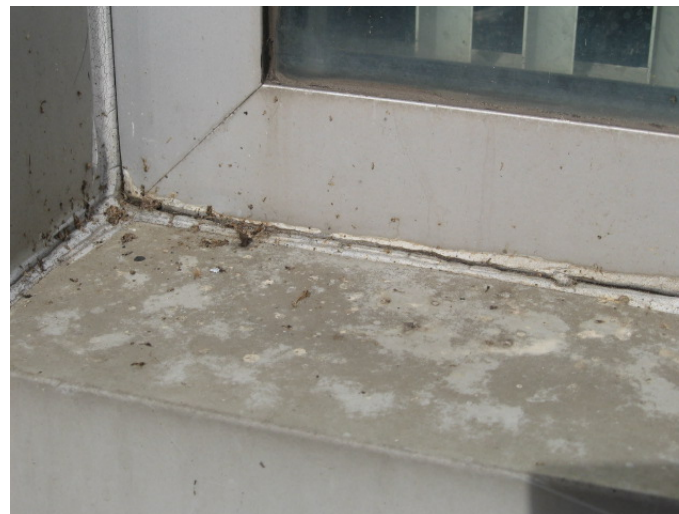
AR-010 – Deteriorated sealant at window.

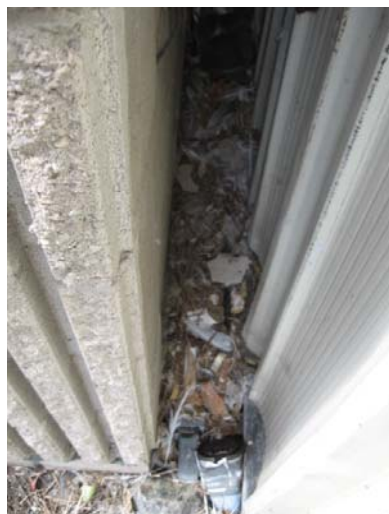
AR-011 – Open space at south elevation between warehouse and office structures.

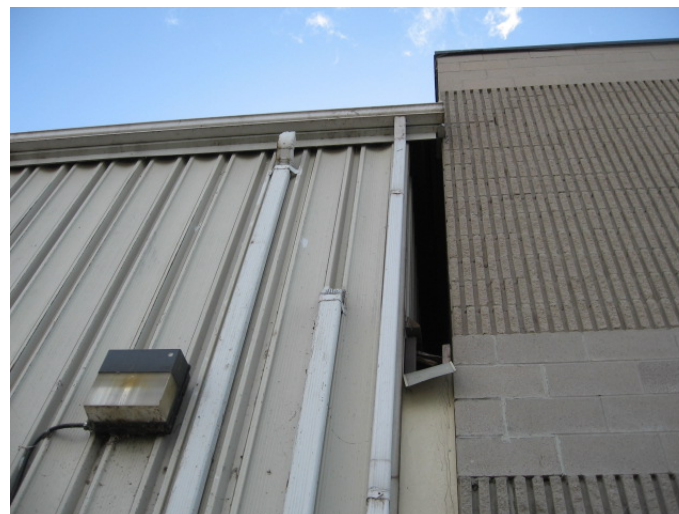
AR-012 – Open space at north elevation between warehouse and office structures.

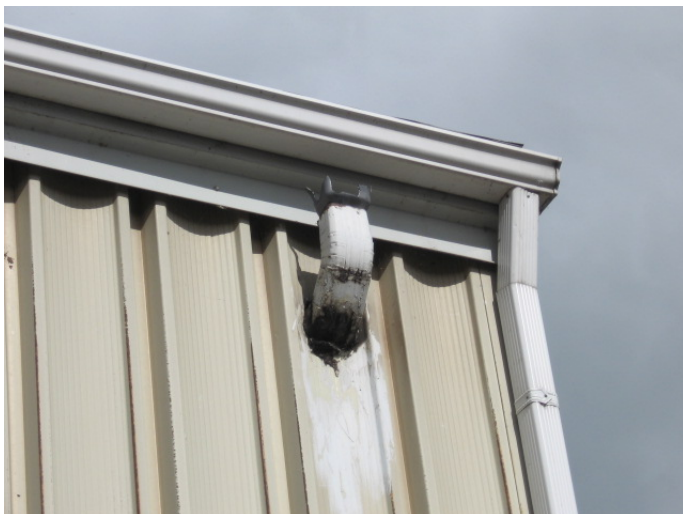
AR-013 – Poorly sealed wall penetration at now abandoned downspout.

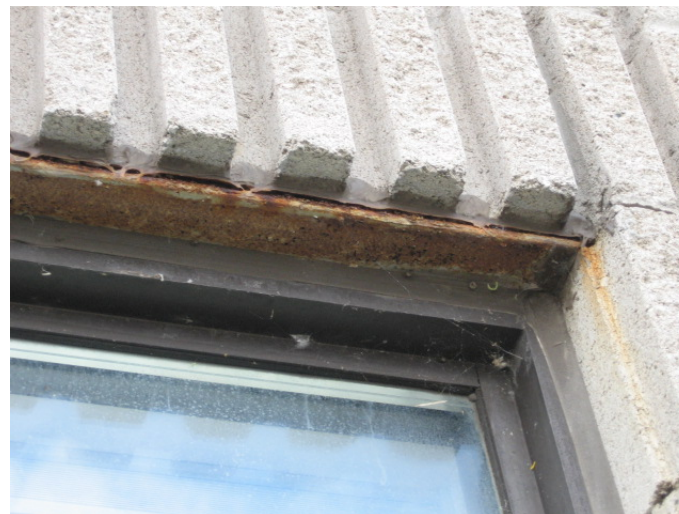
AR-014 – Rusting metal lintel at window opening.

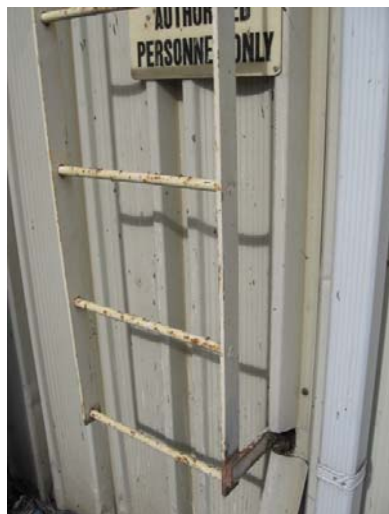
AR-015 – Deteriorating paint finish and rusting metal surfaces at roof access ladder.

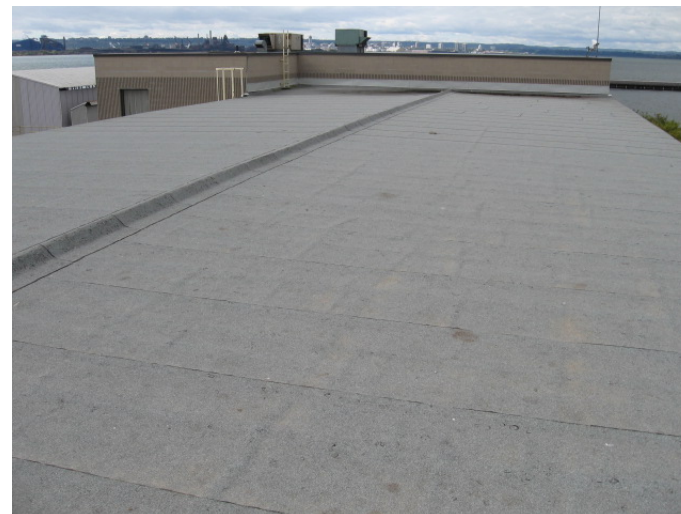
AR-018 – Ridging of membrane throughout warehouse area roof.

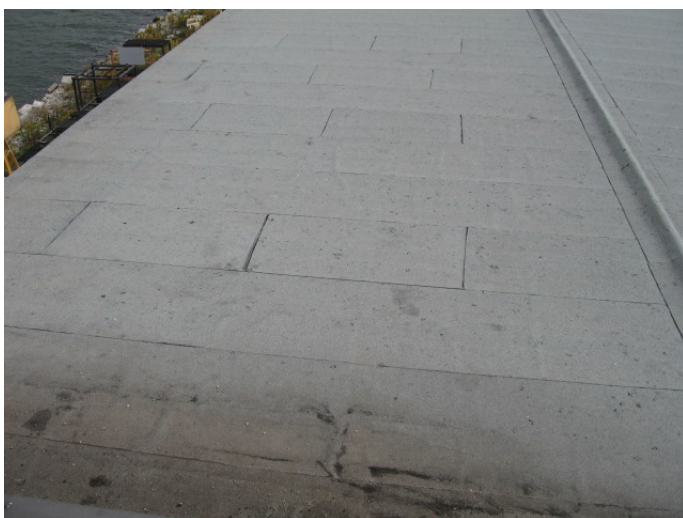
AR-019 – Roofing at northwest corner of warehouse completed with 'end cuts'.

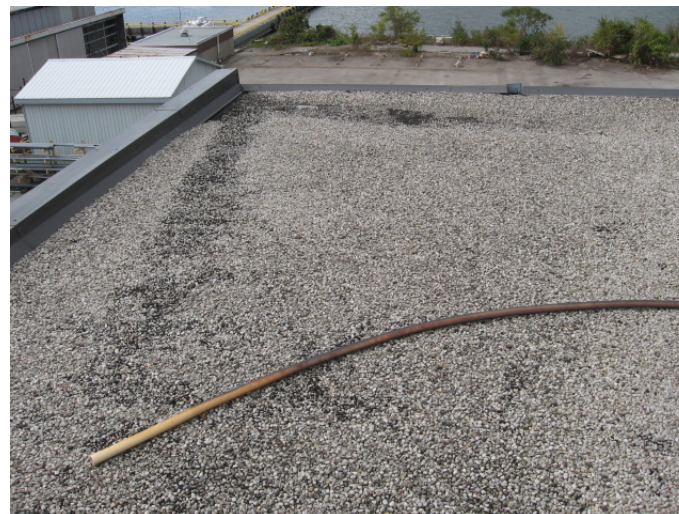
AR-022 – Areas of asphalt bleed-through and exposed bitumen at BUR.

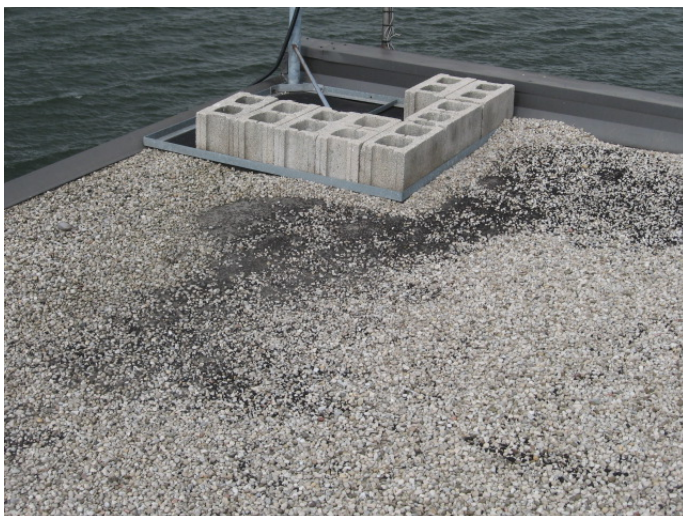
AR-023 – Exposed bitumen/membrane at BUR corner.

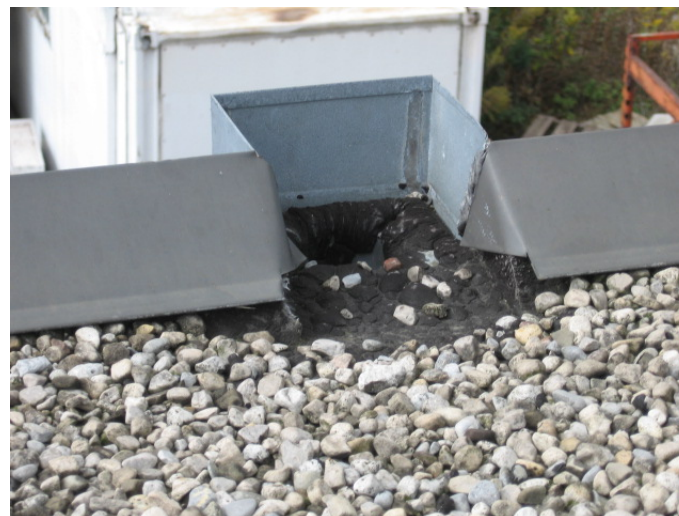
AR-024 – Exposed bitumen/membrane at BUR scupper drain.

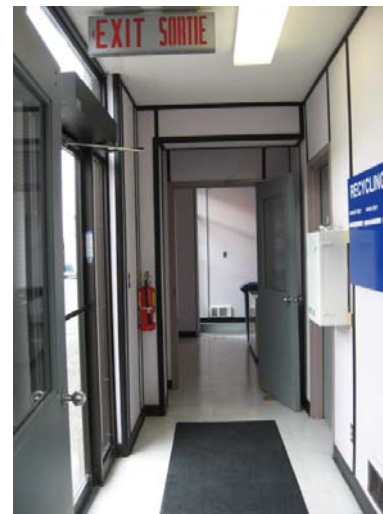
AR-026 – Fire door wedged in open position at 1st floor entrance lobby.

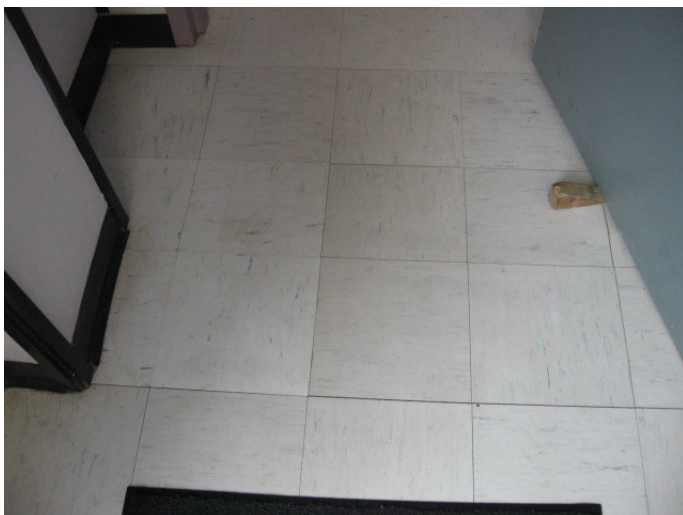
AR-027 – Open tile joints (from shrinkage) at 1st floor entrance lobby.

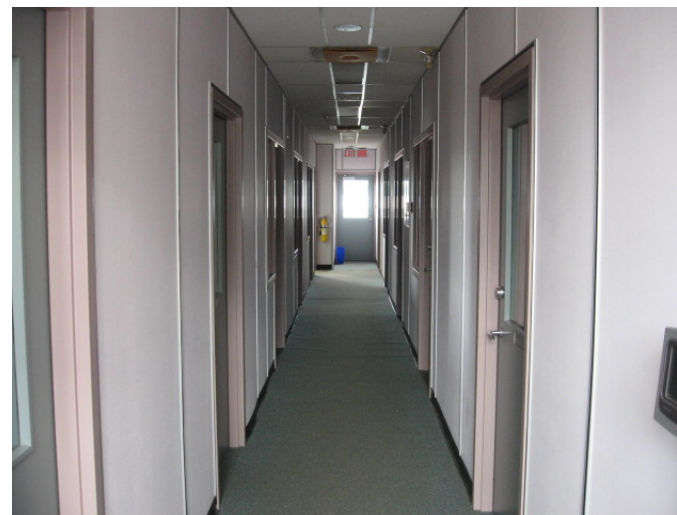
AR-028 – Wrinkled and stained carpet flooring throughout length of 1st floor corridor.

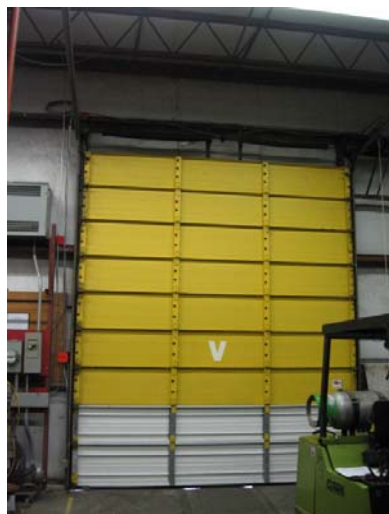
AR-031 – Uneven surface at bottom of overhead door, with daylight at several spots.

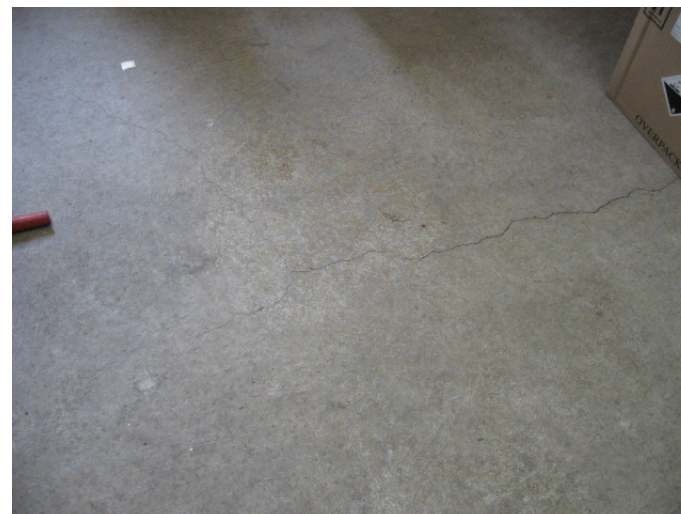
AR-032 – Cracked concrete floor slab in warehouse area office.
