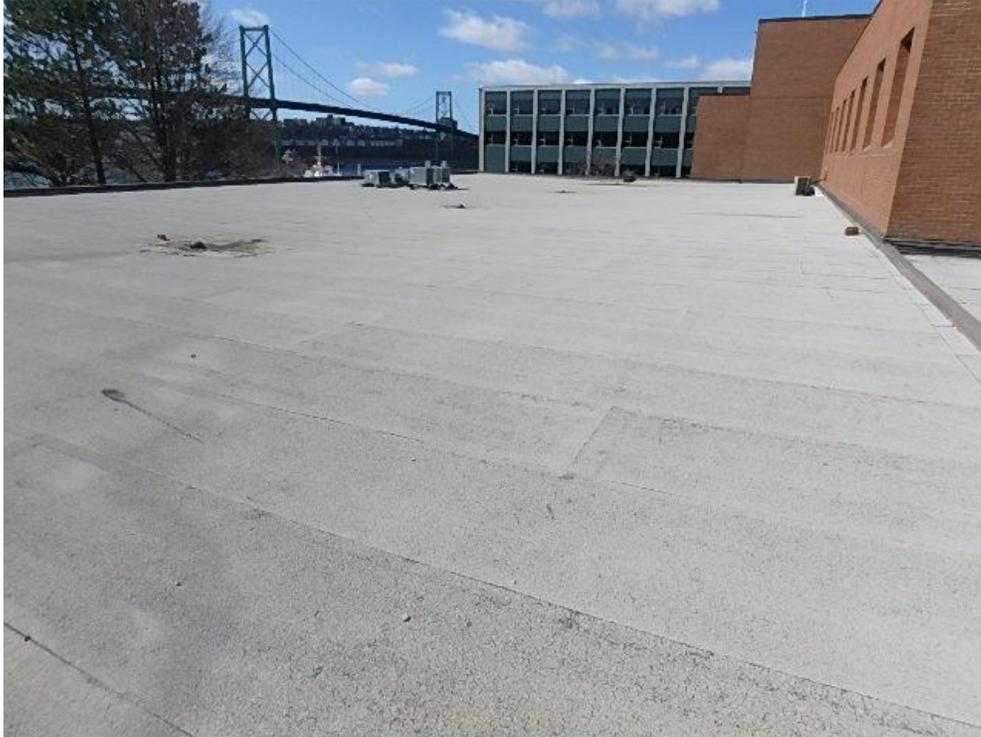
**Photograph 1:** Overall view of Murray building Roof Area 1.1 looking south towards Halifax. This is a 2 ply modified bitumen roof that is approximately 15 years old

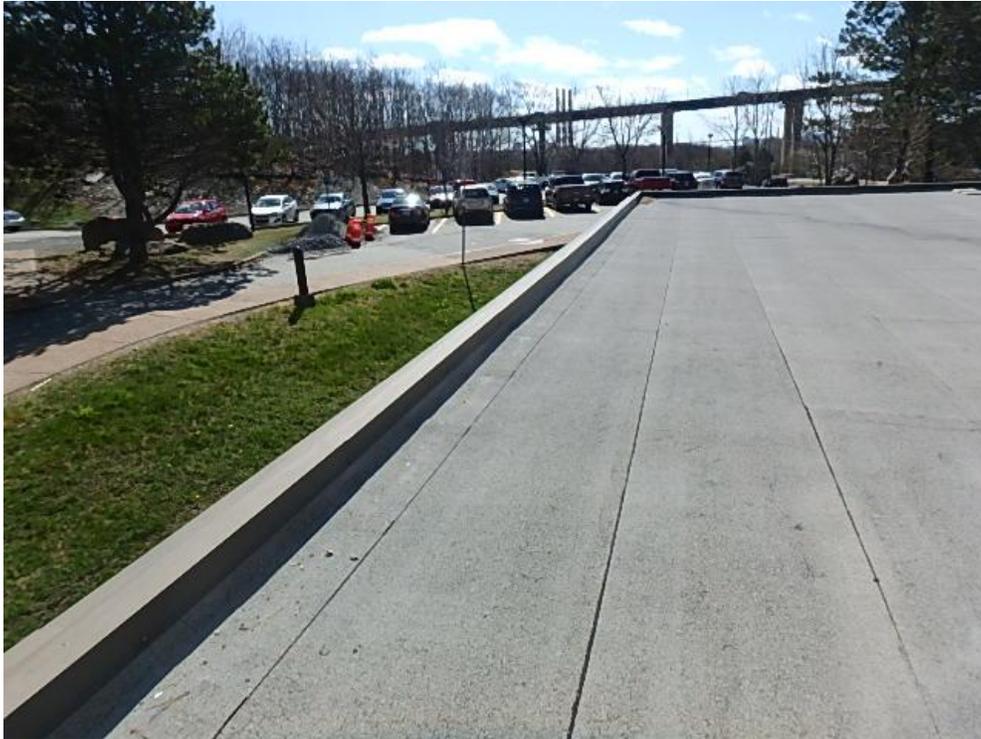
**Photograph 3:** Roof area 1.1 View of typical parapet along roof edge.

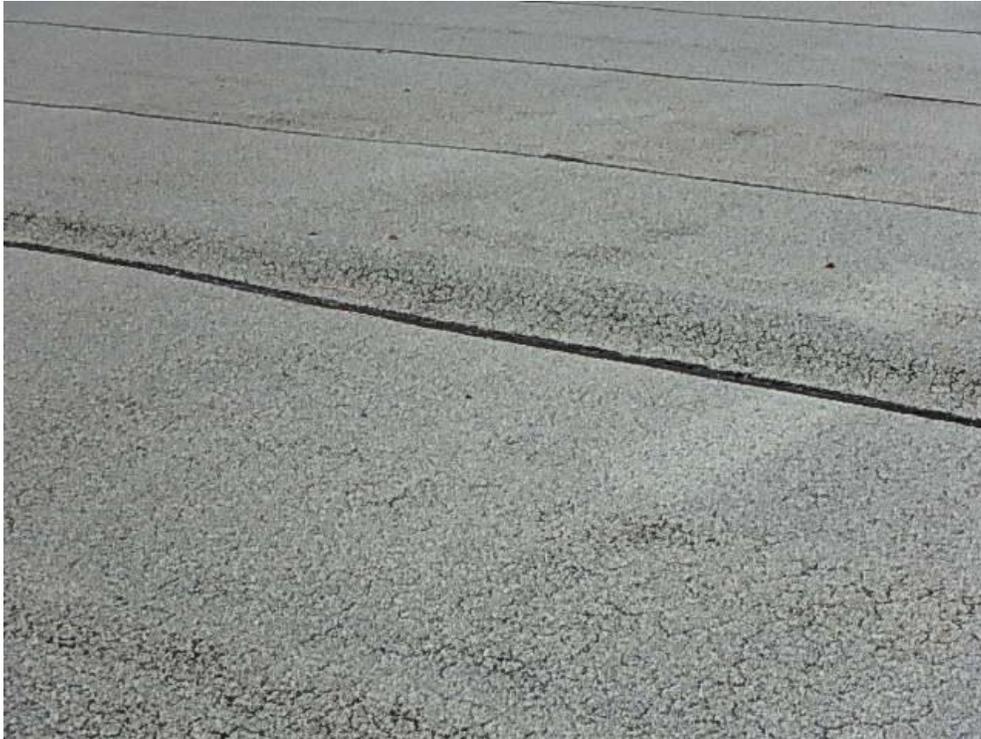
**Photograph 5:** Roof Area 1.1 –.Ridging of membrane at seam.

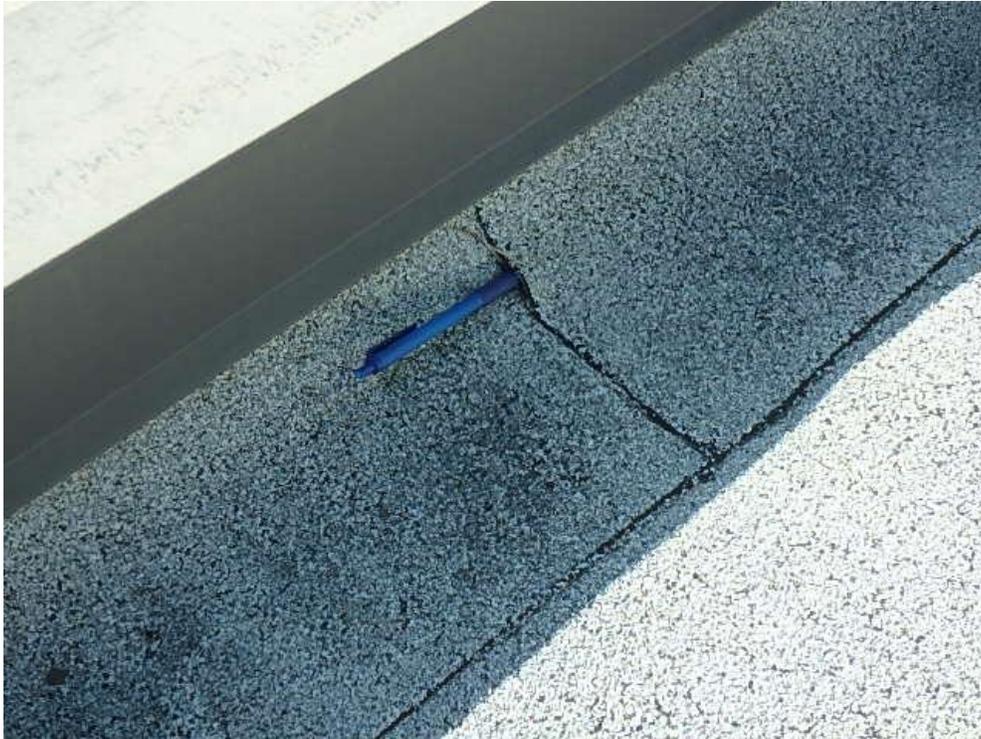
**Photograph 9:** Roof Area 1.1 – delamination of membrane cap sheet flashing that occurs in multiple locations along south east parapet.

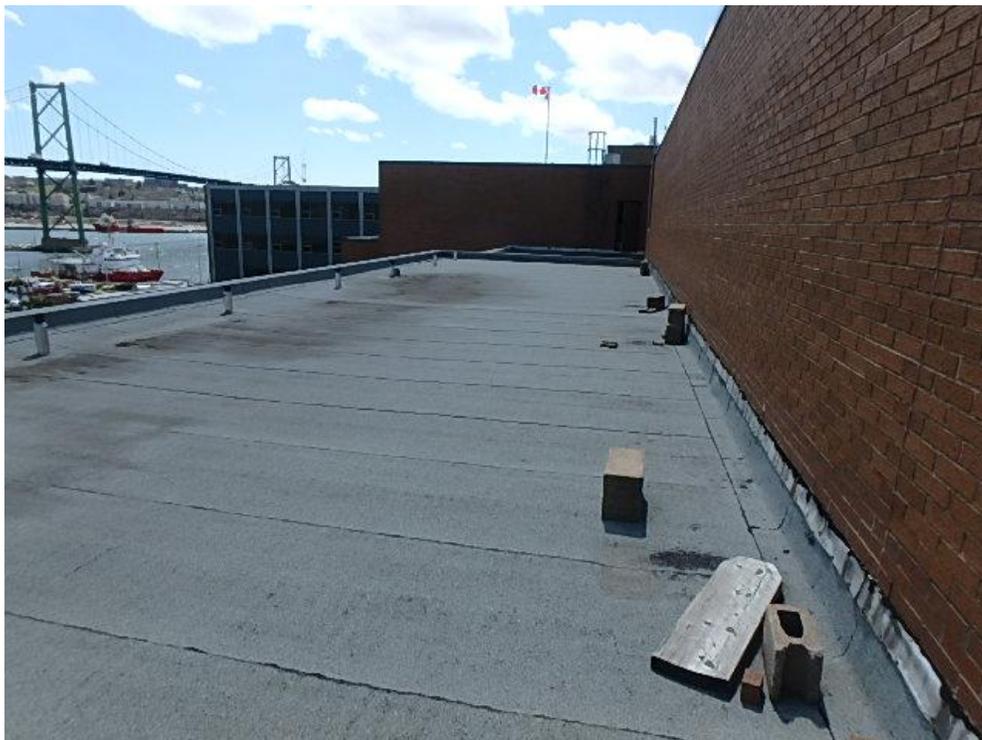
**Photograph 26:** Roof Area 2.1 – Overall view facing south west showing debris along wall, poorly sealed reglet detail, and ridging and blistering on roofing membrane.

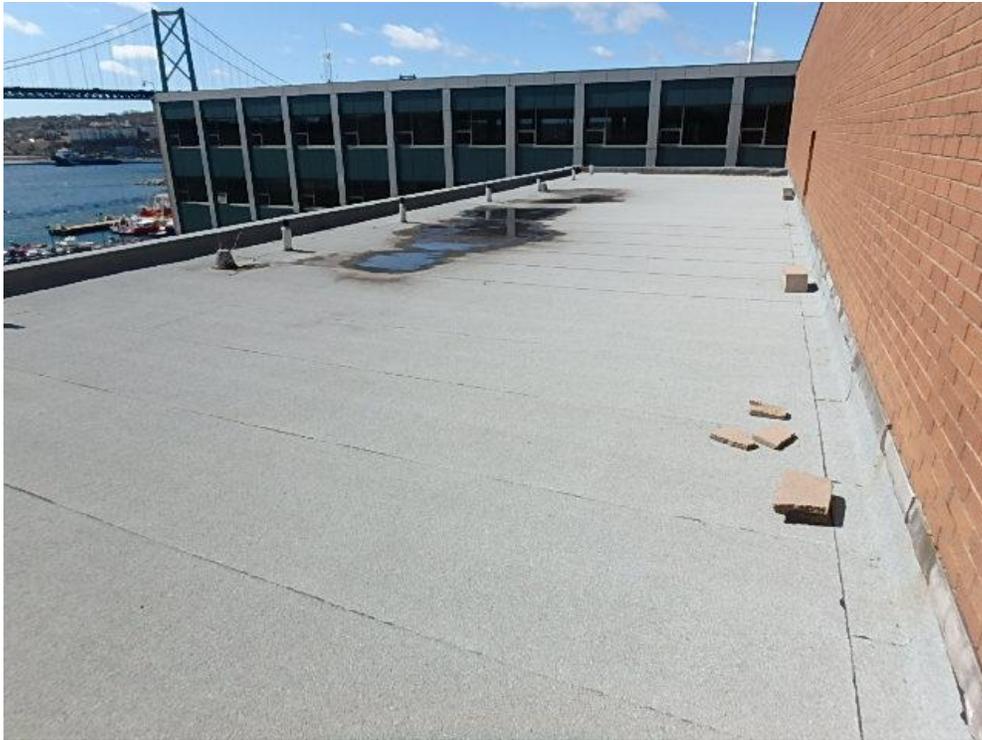
**Photograph 37:** Roof Area 2.3 – Overall view of roof area 2.3 facing south.

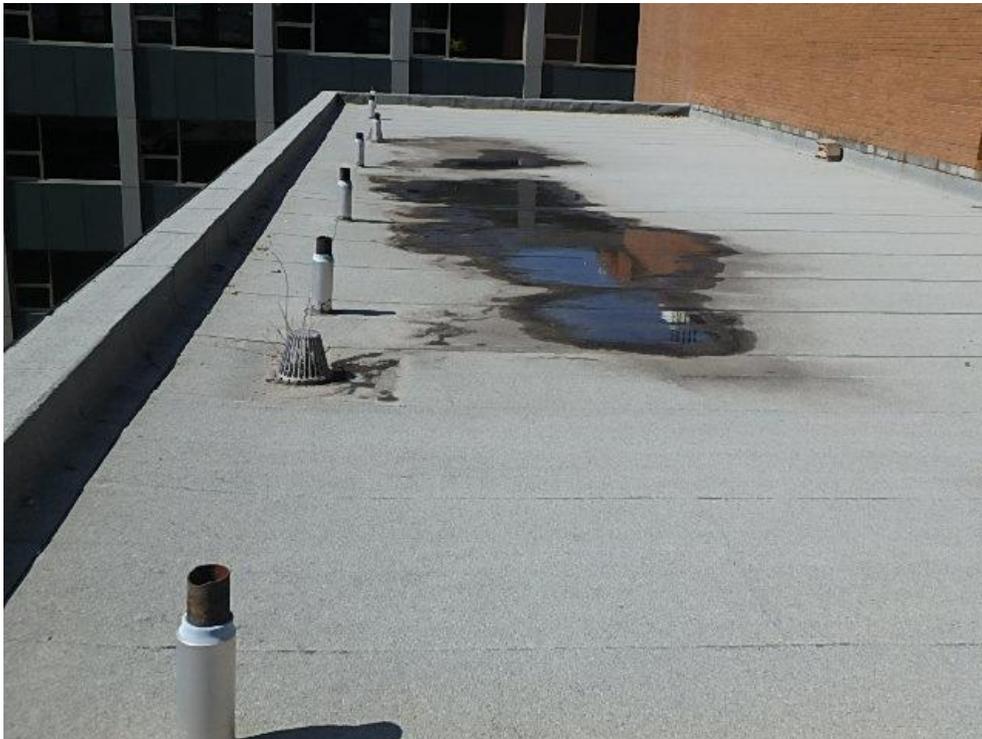
**Photograph 38:** Roof Area 2.3 – Showing typical, unprotected parapet membrane and ponding.

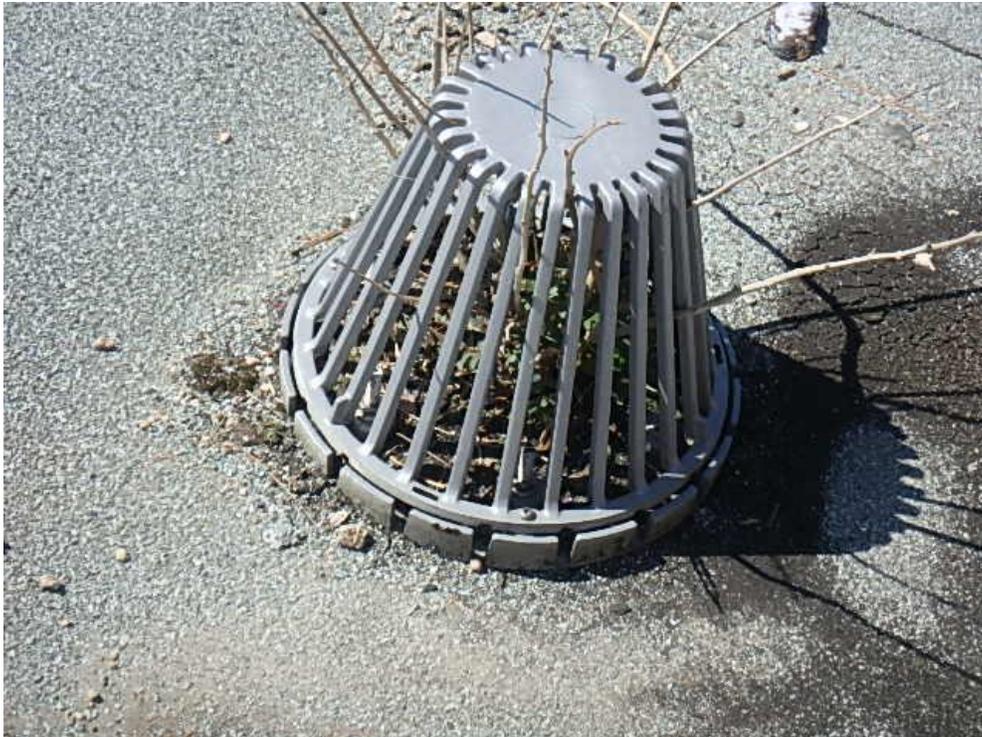
**Photograph 39:** Roof Area 2.3 – Roof drain blocked by vegetation growth.

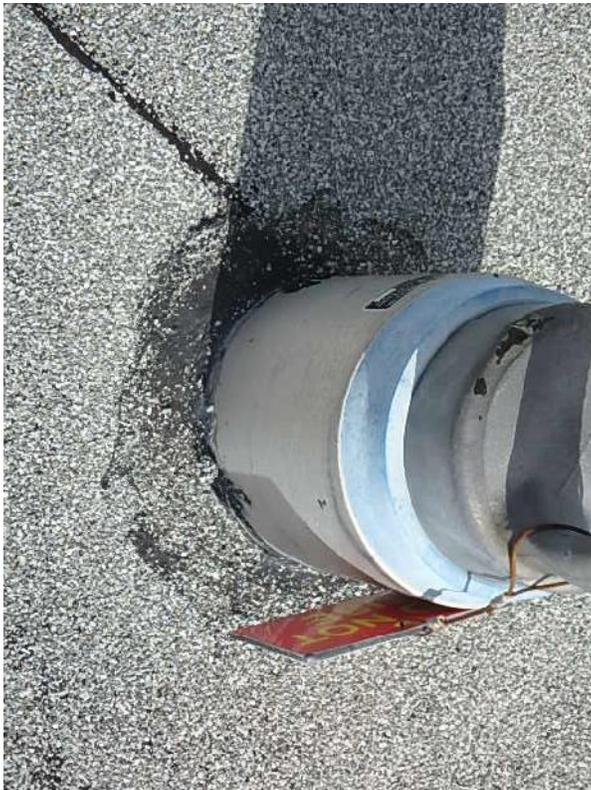
**Photograph 48:** Roof Area 3.1 – Typical roof anchor to be removed due to load testing failure. Poor flashing around anchor base is also typical.

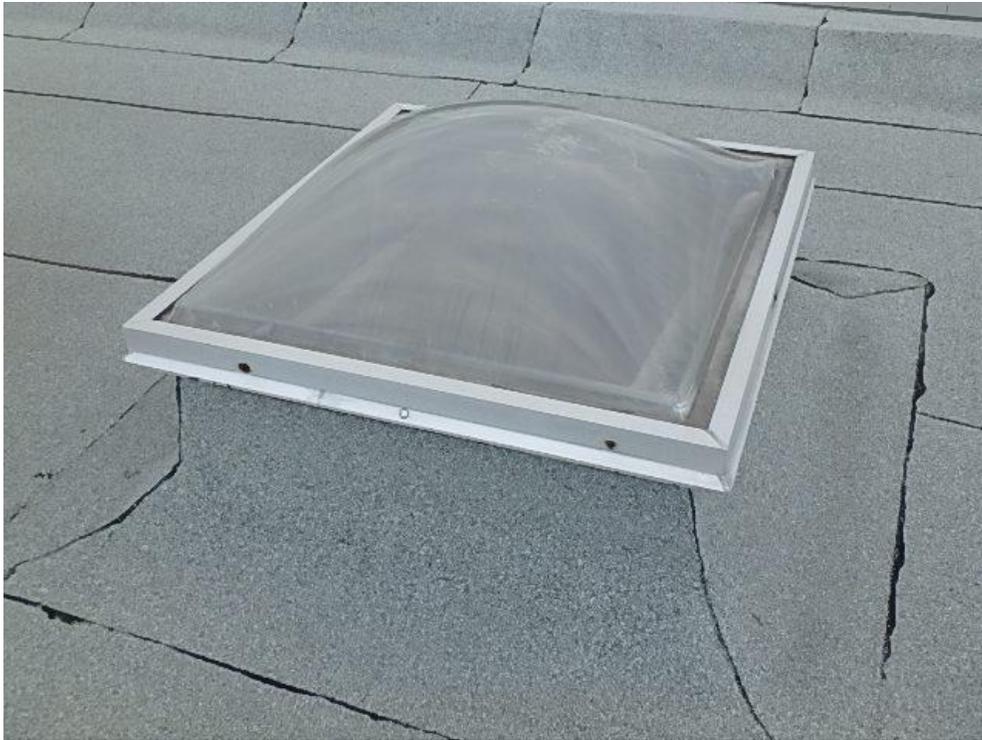
**Photograph 51:** Roof Area 3.1 – Skylight in good condition.

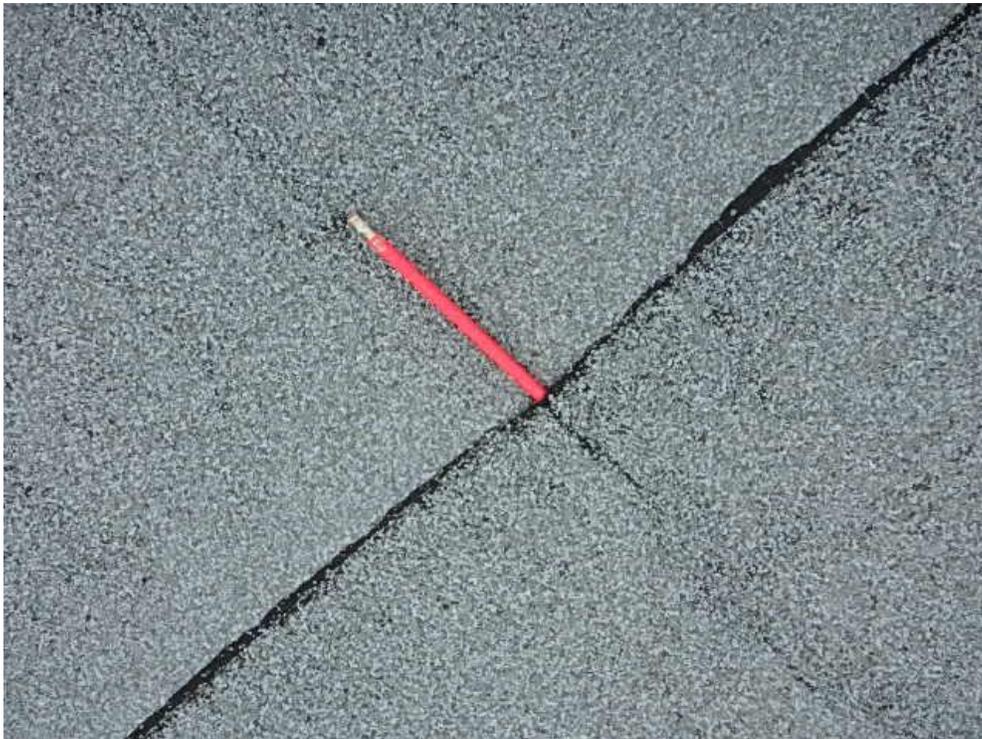
**Photograph 66:** Roof Area 3.3 – Debonding of membrane flashing is evident in multiple locations.

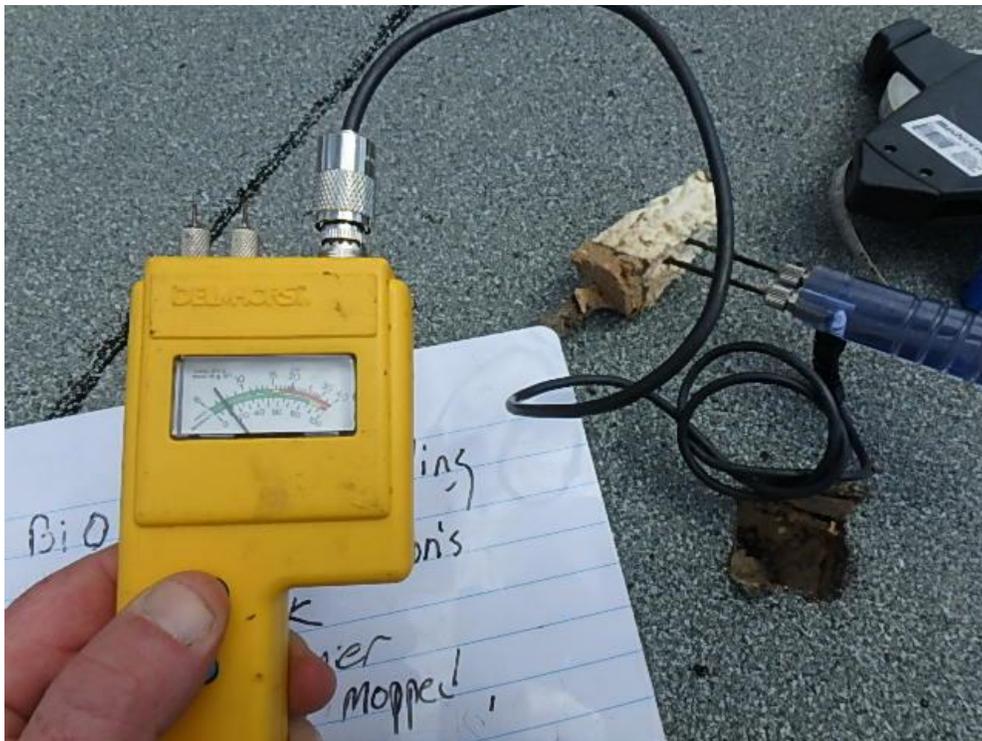
**Photograph 68:** Roof Area 1.1 – Roof insulation moisture test showing low levels of moisture.

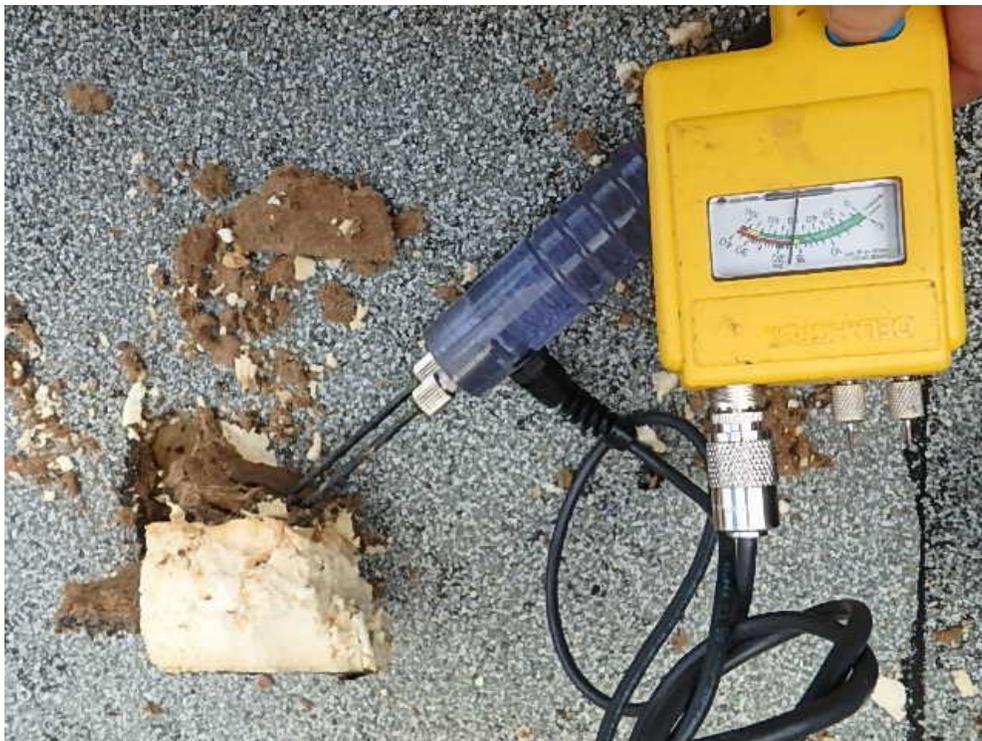
**Photograph 70:** Roof Area 2.1 – Roof insulation moisture test showing high levels of moisture.

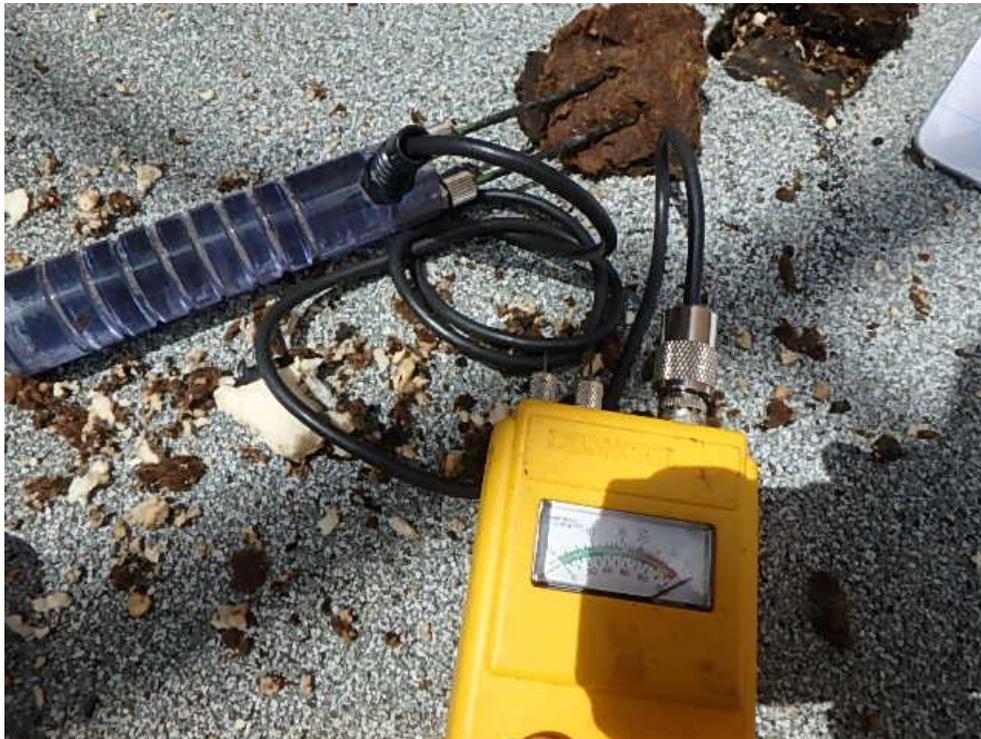
Photograph 72: Roof Area 2.2 –.Roof insulation moisture test showing a completely saturated roofing system.

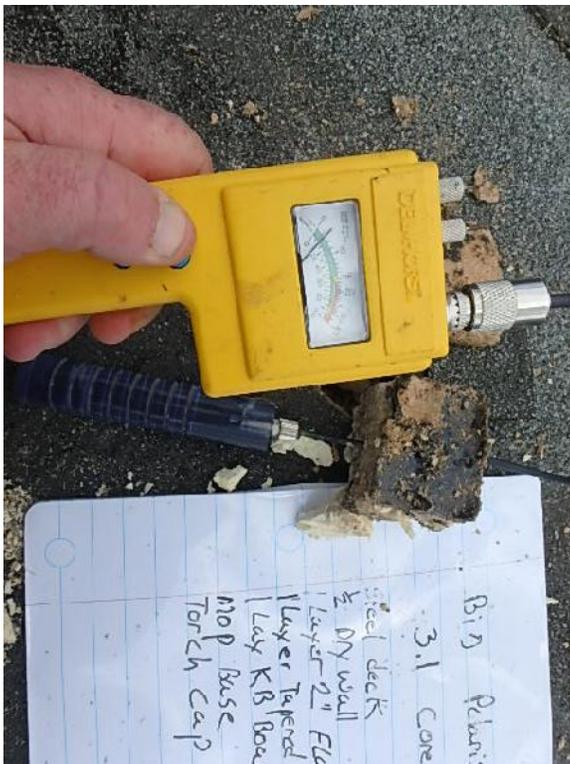
Photograph 76: Roof Area 3.1 –Roof insulation moisture test showing low levels of moisture.

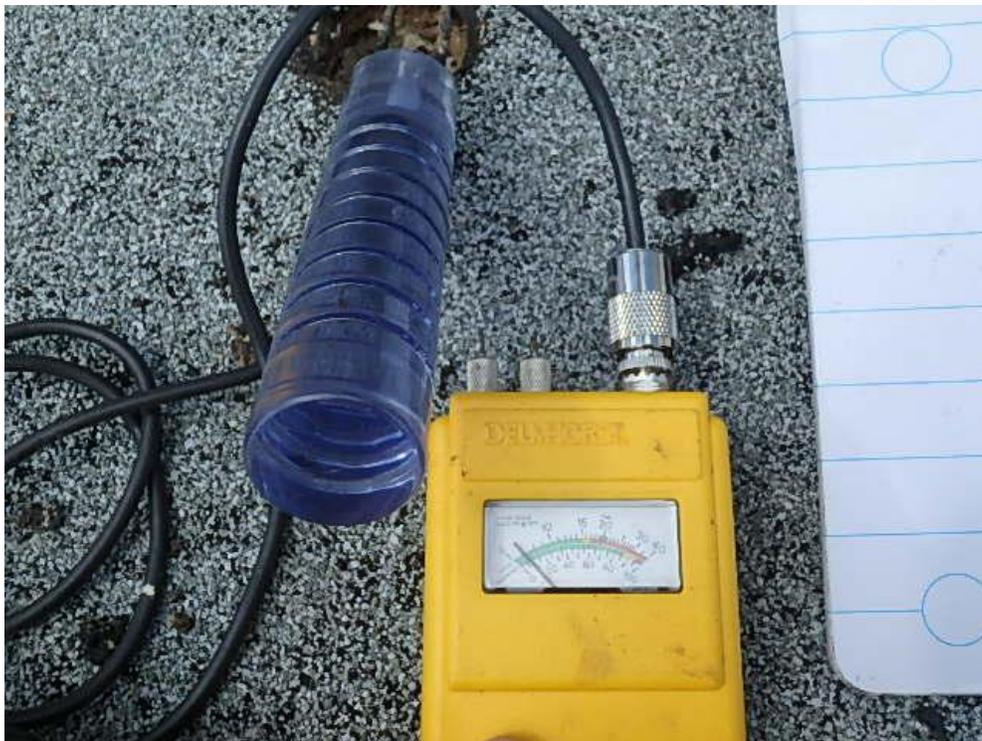
**Photograph 78:** Roof Area 3.3 –.Roof insulation moisture test showing low levels of moisture.
