Appendix C – Building Capability Report EC + DFO – Co-Location at FWI

For:
Environment Canada & Department of Oceans and Fisheries
Fresh Water Institute (FWI)
Winnipeg, Manitoba
Project No. R.075255

Prepared by:
Coupland Kraemer Architecture + Interior Design Inc.

February 13, 2017

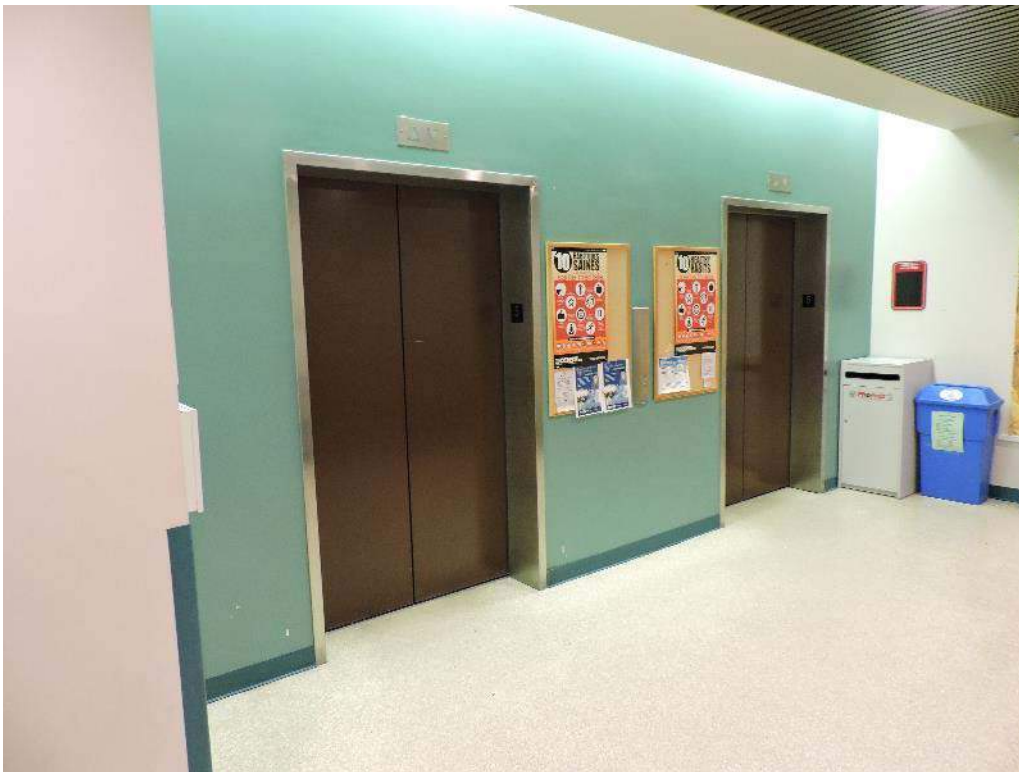
- The exits have guardrails that do not conform to current building code requirements – however, they most likely conformed to the code when the building was built. Upgrading the guardrails is recommended. This is typical for ALL stairs in the building.
- Upgrade the wall and floor finishes in the corridor to provide a uniform appearance and replace original materials that are at the end of their lifecycle
- Upgrade the elevator cabs to conform with current Barrier Free requirements

Figure 7 Elevators in Lab Block Main Corridor

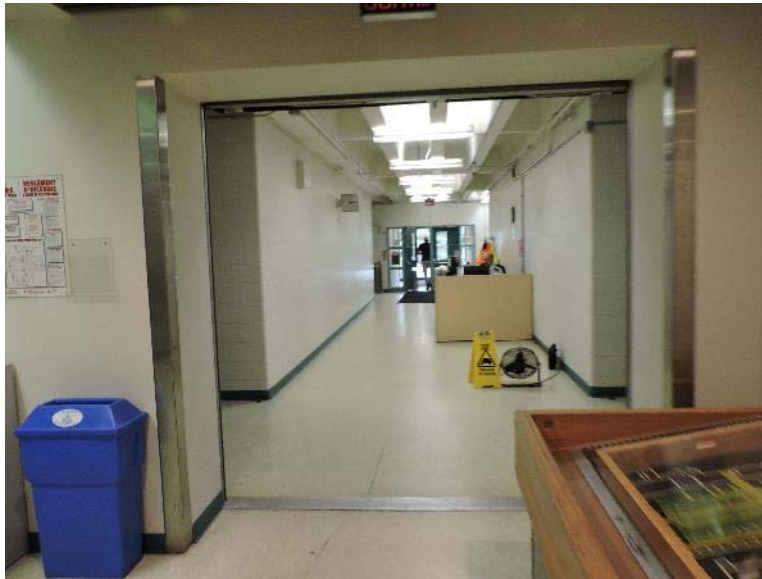
Figure 10 Service Entrance provides access to staff.

- .4 Located on the west side of the building, the service entrance lobby appears to be in good condition. Finishes are robust and in good condition. The lobby provides access by DFO Officers to Fleet vehicles located in the parking areas on the south side. The lobby provides access to office staff.
- .5 An existing reception desk is located in the area that is currently staffed by a Commissionaire. This desk monitors and controls access of people and material into the building.

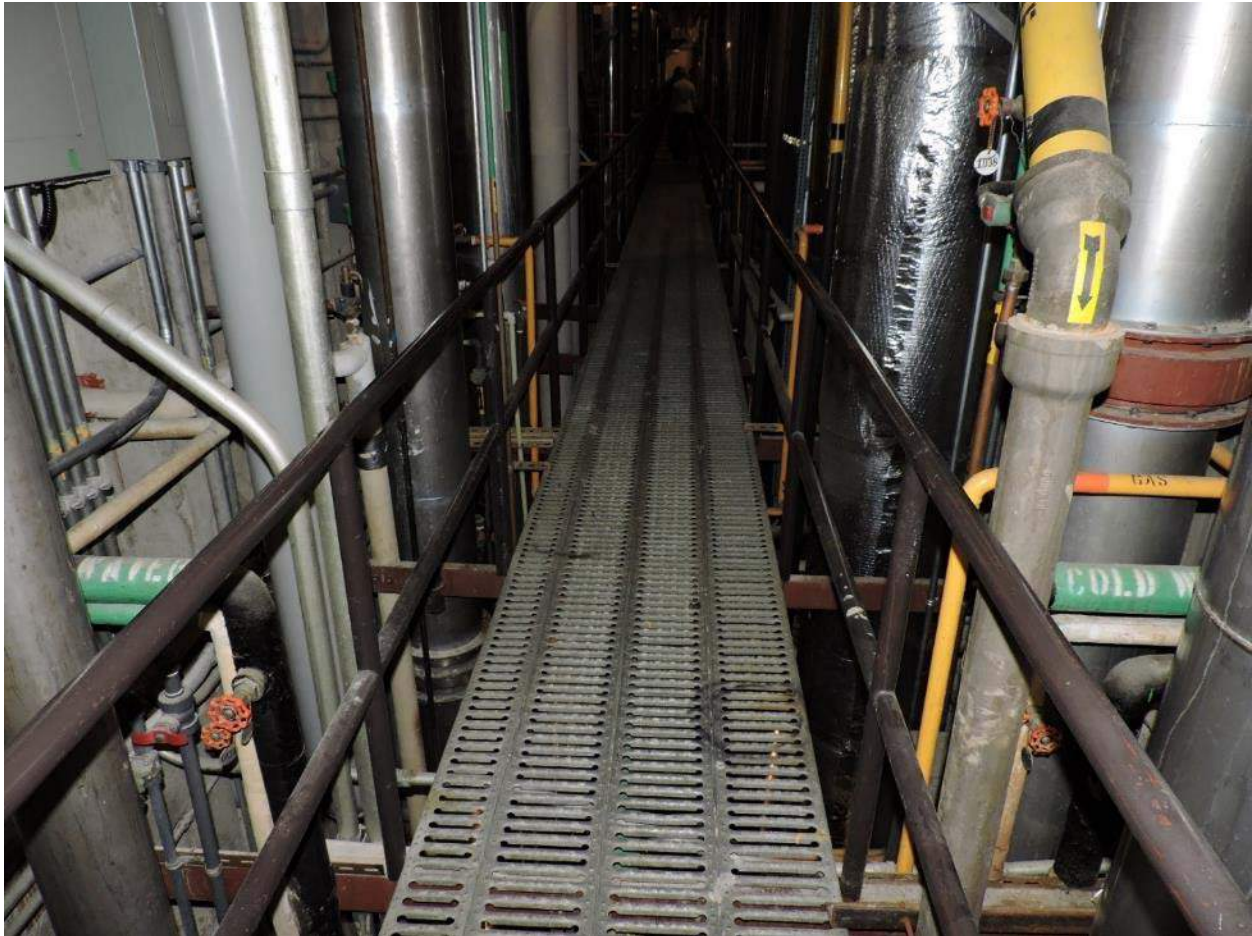
- .1 The Service Shaft appears to be in good condition and can support the Co-Location project.
- .2 Located as a spine to the Lab Block, this vertical service shaft provides flexible access from the 1st to 5th floor. This shaft will provide ease of mechanical and electrical installations on all floors.

Figure 11 The central service shaft in the Lab Block from the 1st to 5th floors.

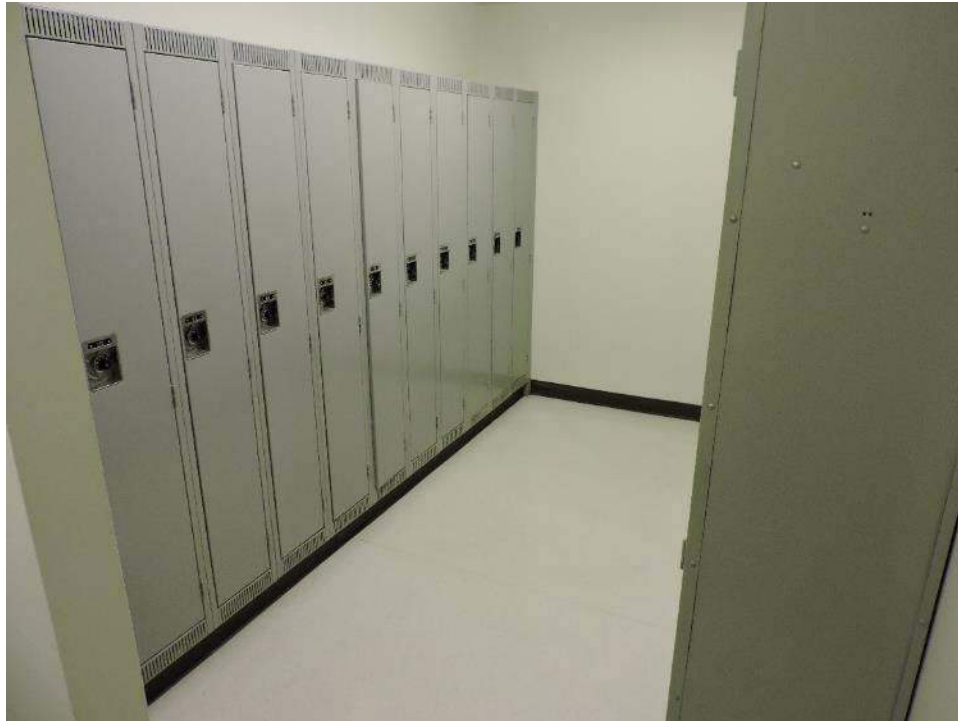
- .1 The Locker Rooms are not required for the Co-Location project and can be re-purposed.
- .2 The Lab Block has locker rooms on each floor. Currently, the existing washrooms do not provide adequate facilities for the project. Lockers are not a Workplace 2.0 compliant amenity in an office space. Where required, Lockers should be converted to Washrooms or other functional program space.

Figure 14 Existing Locker room.

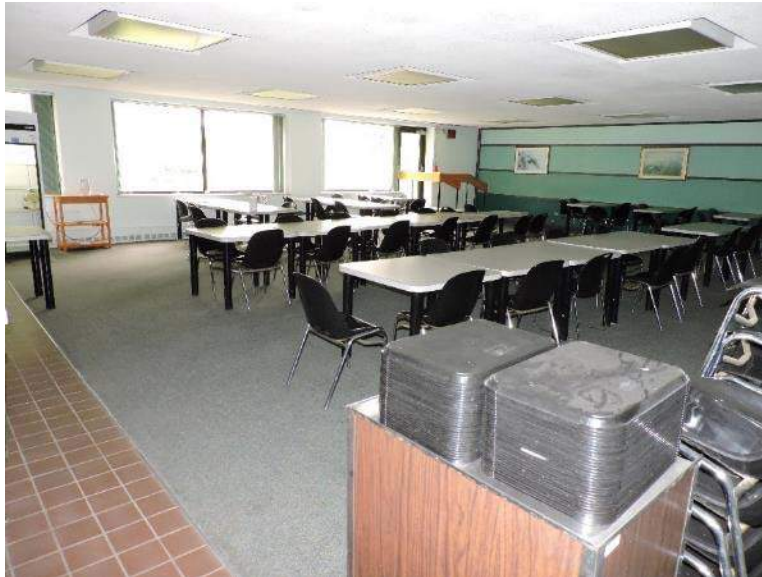
- .1 The Cafeteria is not required for the Co-Location Project and should remain out of scope.
- .2 Located on the 1st floor on the north east corner of the Admin block, a cafeteria provided food services to the building at one time. The cafeteria is currently not functioning. However, with increased occupancy levels in the building, the viability of a cafeteria re-opening is a possibility.

Figure 15 Existing cafeteria is currently not in use.

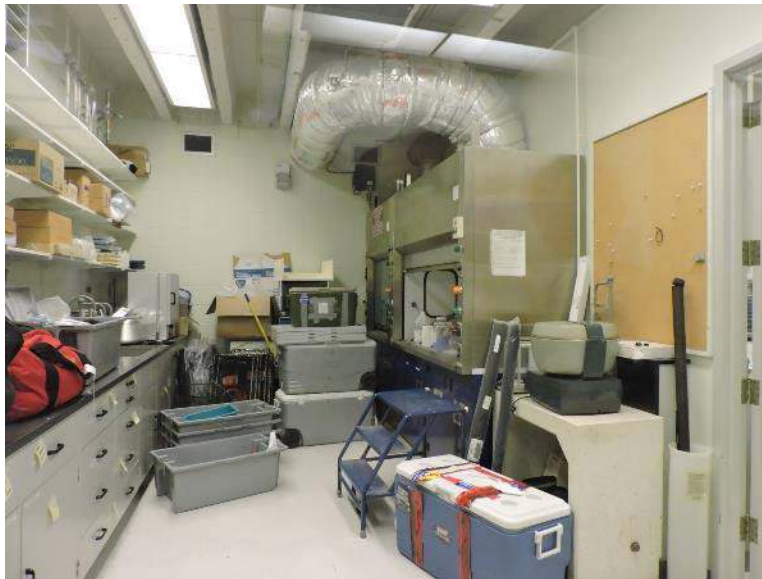
Figure 17 Typical lab.

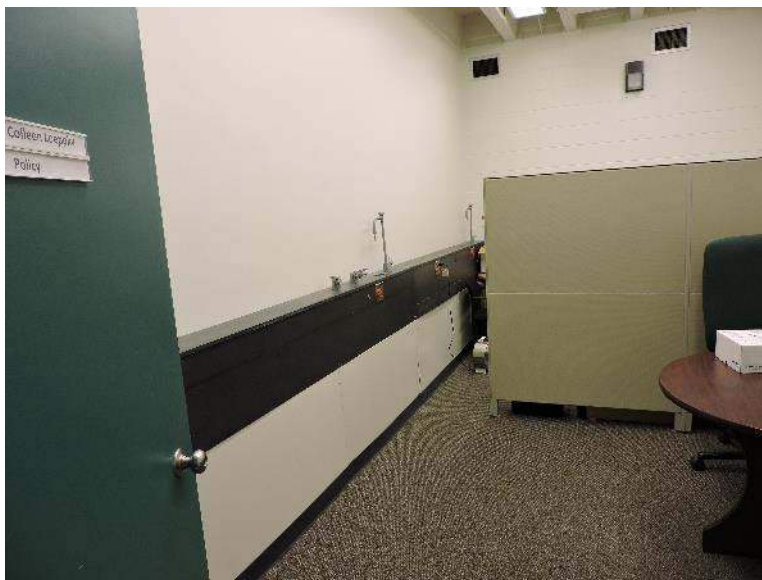
Figure 18 Typical lab converted into office space.

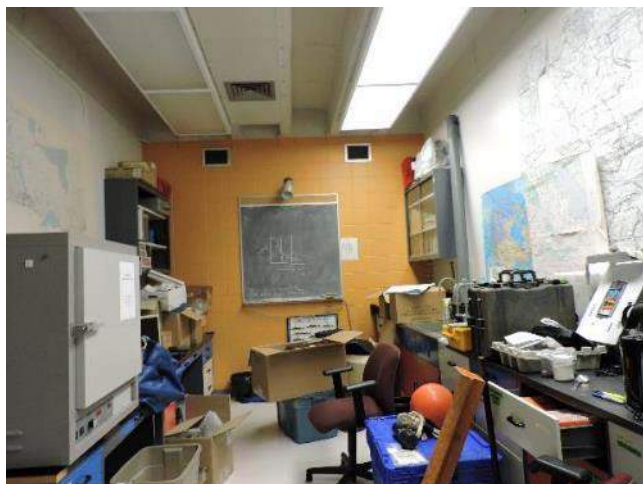
- .1 The Labs appear to be in good condition and can support the Co-Location project.
- .2 Labs are located throughout the lab block. The existing labs are in good condition.
- .3 As noted by DFO in a 2009 Space Utilization Report, many of the labs are under utilized and are not required.
- .4 Through site observations, many labs were re-purposed into office space and storage areas.
- .5 Assessments of lab use are being evaluated internally by DFO. Potential strategies for relocation and co-location of labs to meet DFO's needs is also being conducted internally.

Figure 19 Typical under-utilized Lab.

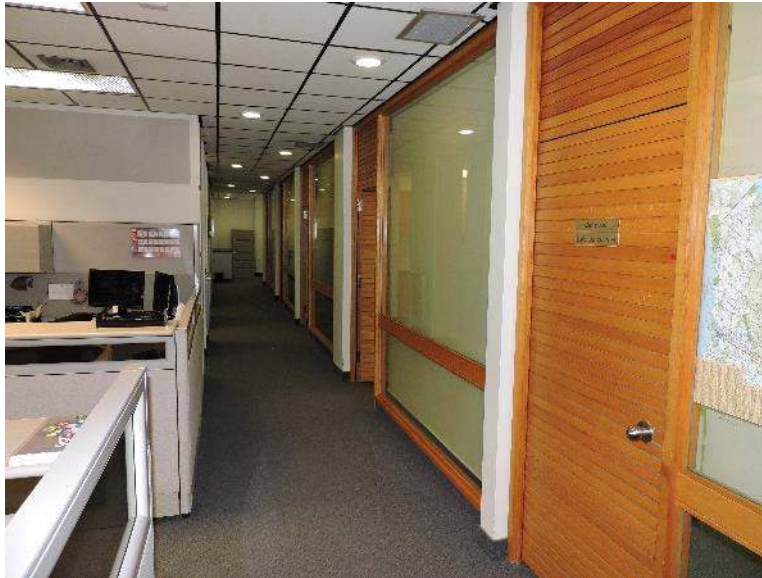
- .1 The Offices do not comply with WP2.0 and will be demolished in the Co-Location project.
- .2 Offices are located on Levels 1 and 2 of the Admin Block.
- .3 Offices are also located on Levels 1 to 5 at the perimeter of the Lab Block.
- .4 Offices do not conform to Workplace 2.0.

Figure 21 Enclosed and Open Office Areas in the Admin Block.

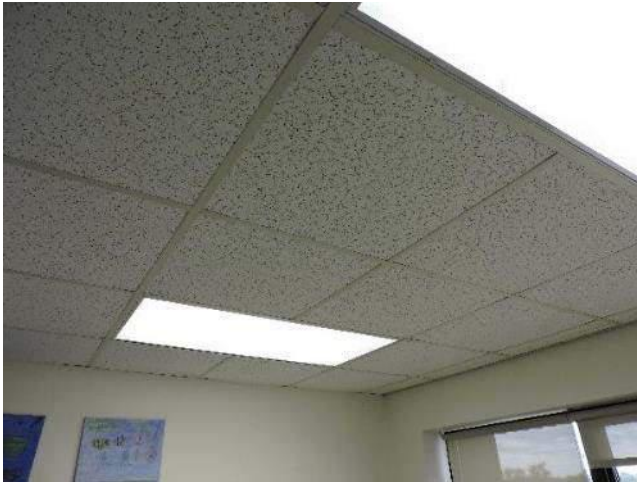
Figure 25 Typical ACT ceiling

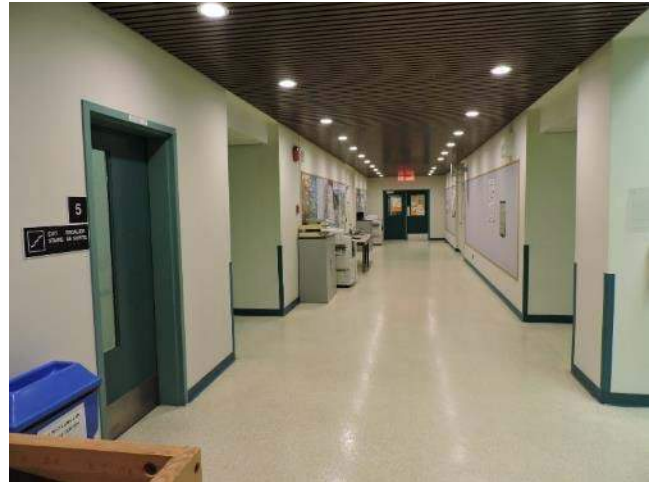
Figure 26 Typical Metal Linear Ceiling in Main Corridor

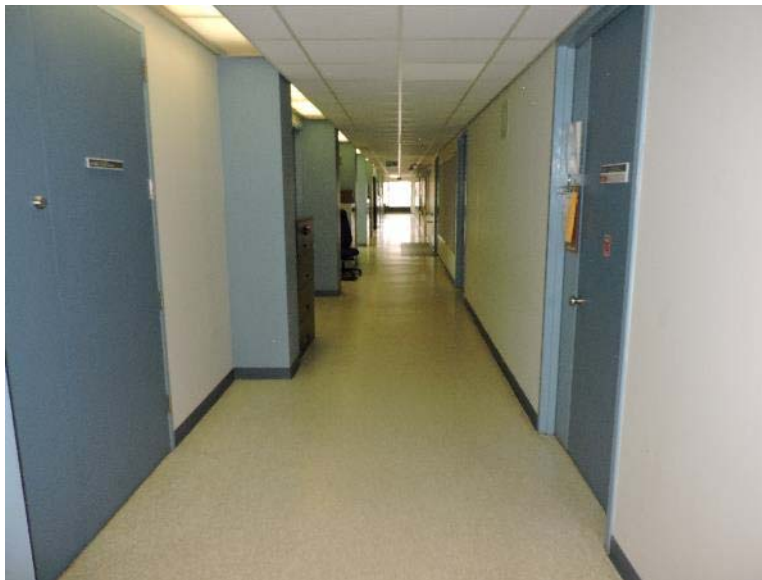
Figure 27 Typical office corridor with GB partitions both sides

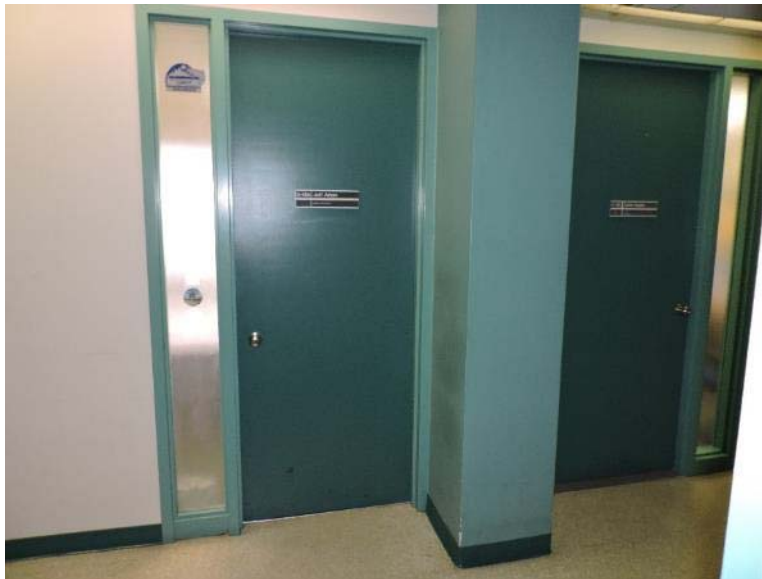
Figure 28 Typical Interior Door

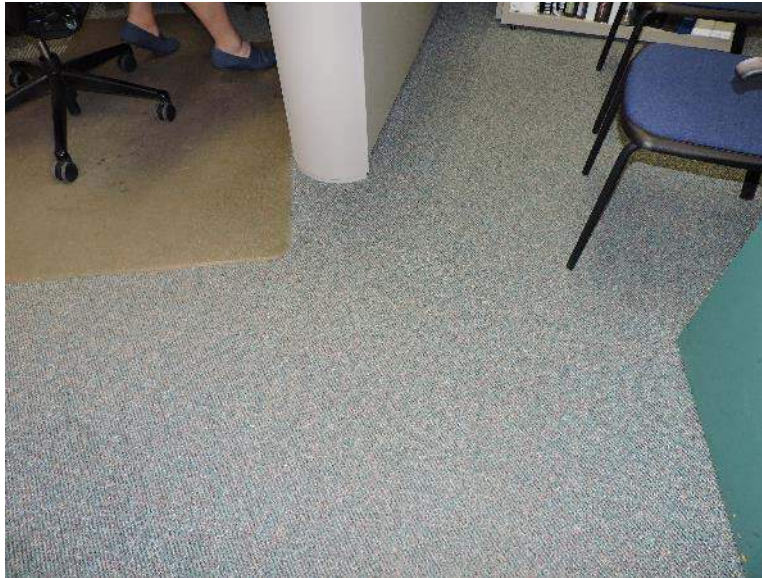
Figure 29 Typical floor with sheet flooring and carpet finish

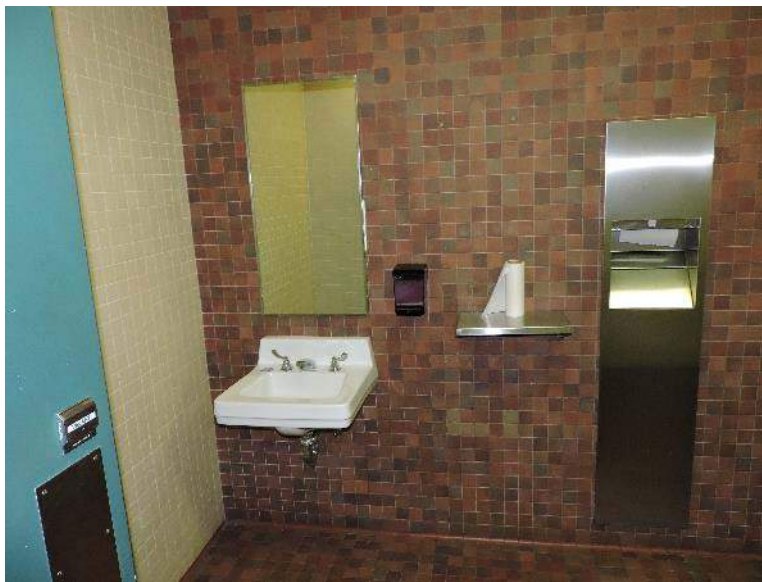
Figure 30 Typical ceramic tile in washrooms.

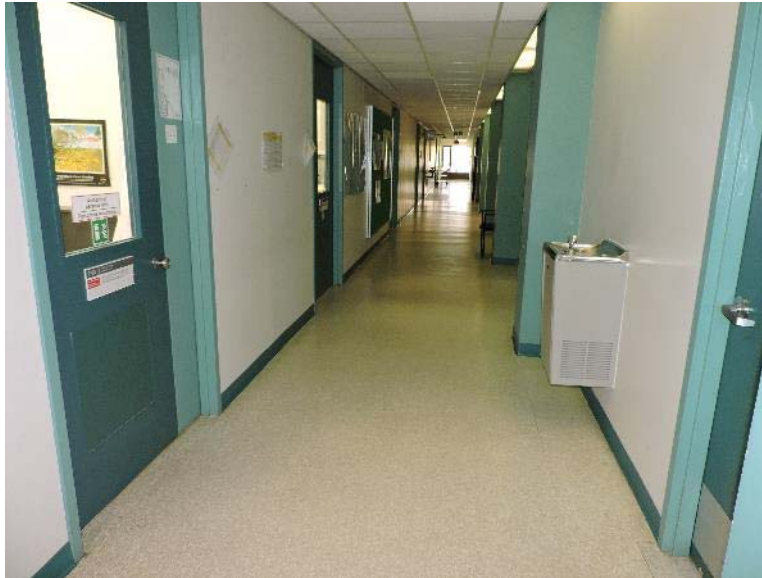
Figure 31 Typical wall paint throughout the Lab and Admin Blocks.

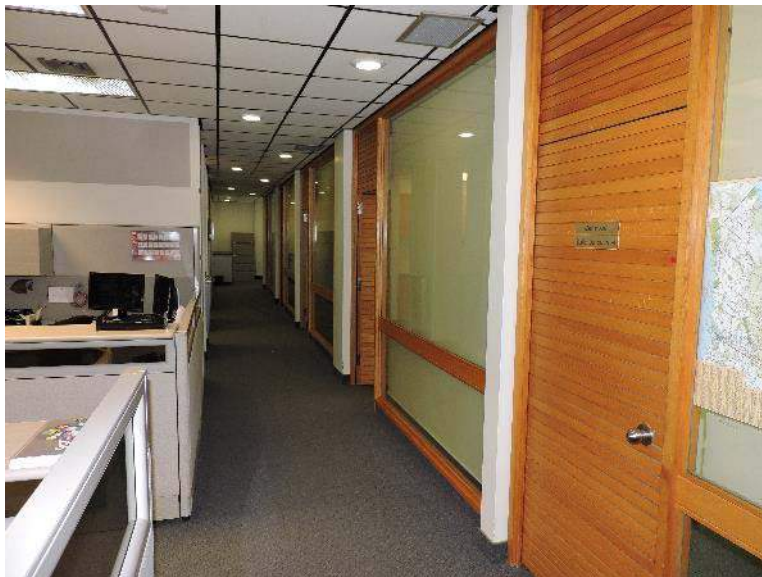
Figure 32 Typical wood finish in the Admin Block.

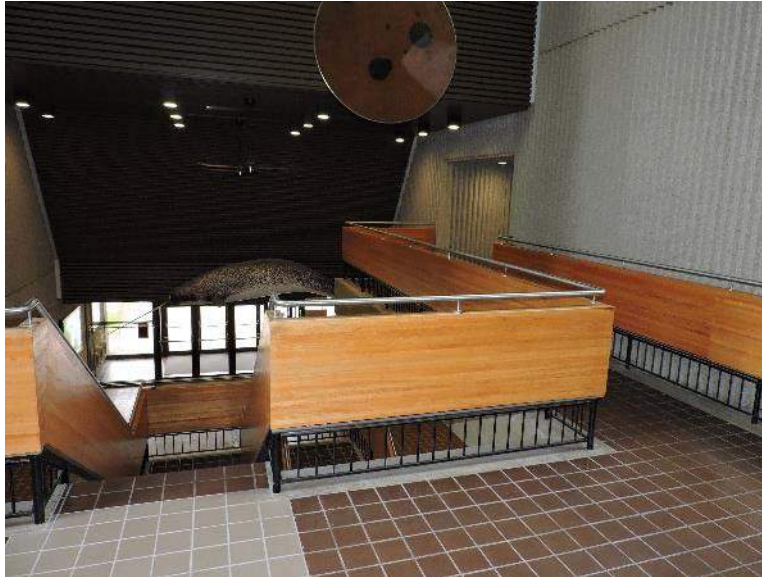
Figure 33 Fluted concrete finish in the Main Entrance Lobby.

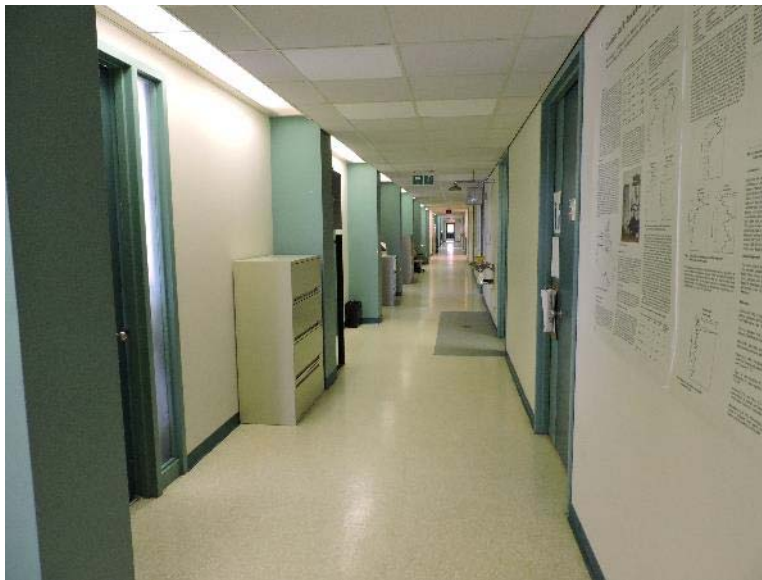
Figure 34 Original Vinyl flooring throughout the Lab Block.

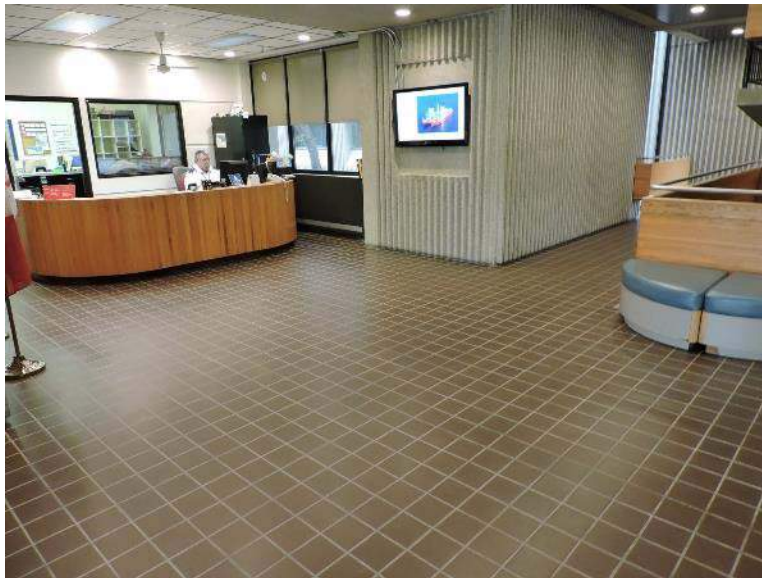
Figure 35 Quarry tile in the Main Entrance Lobby.

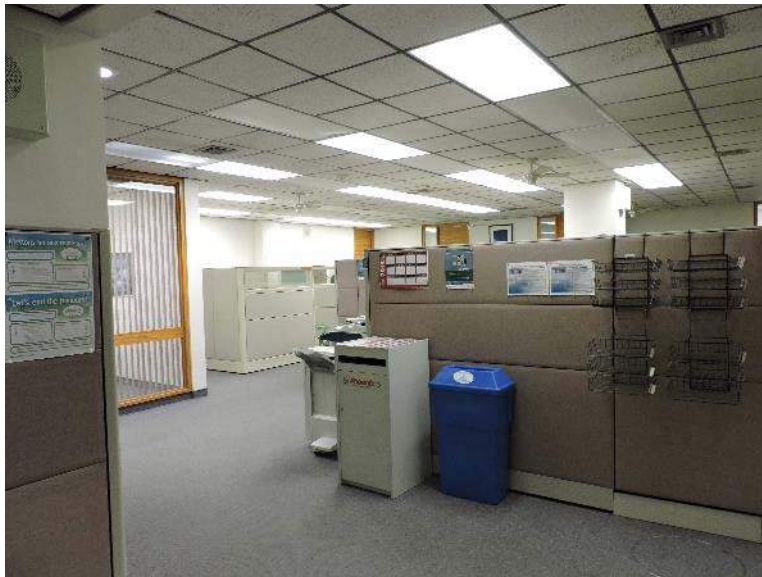
Figure 36 Typical ACT throughout the Admin and Lab Blocks.

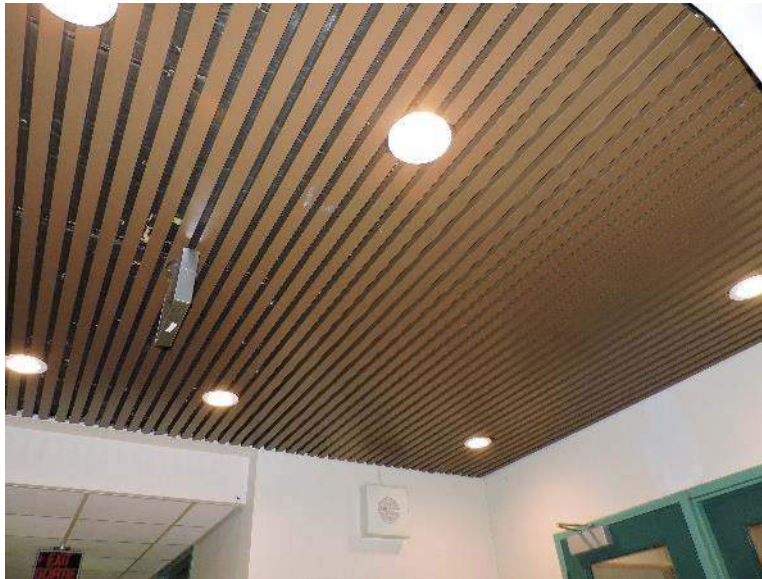
Figure 37 MLCS in Main Entrance Lobby and Admin Block Main Corridor.

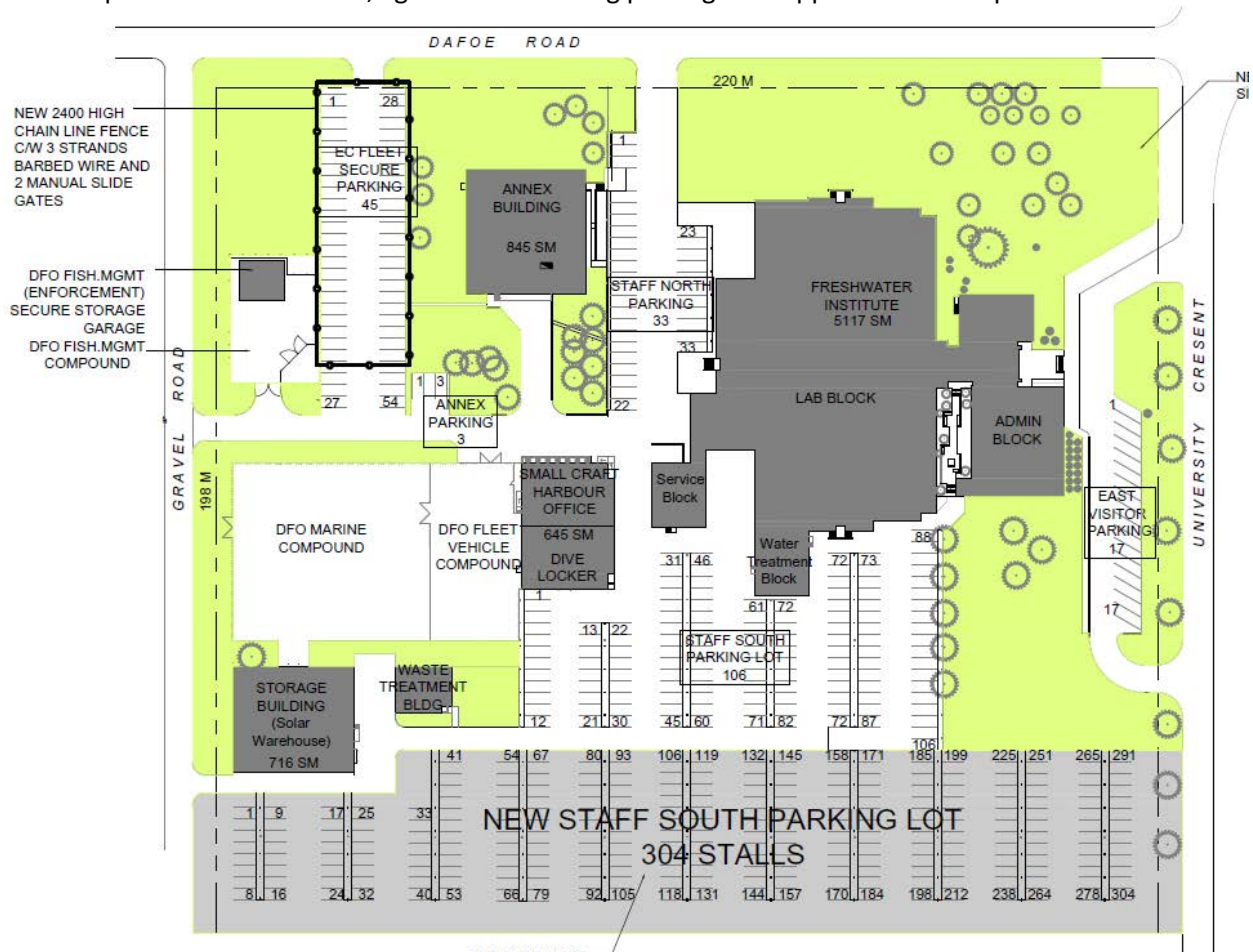
- .1 The Parking area and components appear to be in good condition and can support the Co-Location project.
- .2 However, the parking area capacity will not be sufficient based upon current parking requirements. The parking area will need to be expanded to accommodate the maximum number of additional stalls that are required for the Co-Location project. Parking area expansion will be limited by approvals and agreements with the University of Manitoba. Expansion could also be limited by the project's budget.
- .3 There are three paved main parking lots, all of which have paved asphalt and accommodate approximately 200 stalls.
- .4 Components such as curbs, lights of the existing parking area appear to be adequate.

Figure 39 Parking areas at FWI.

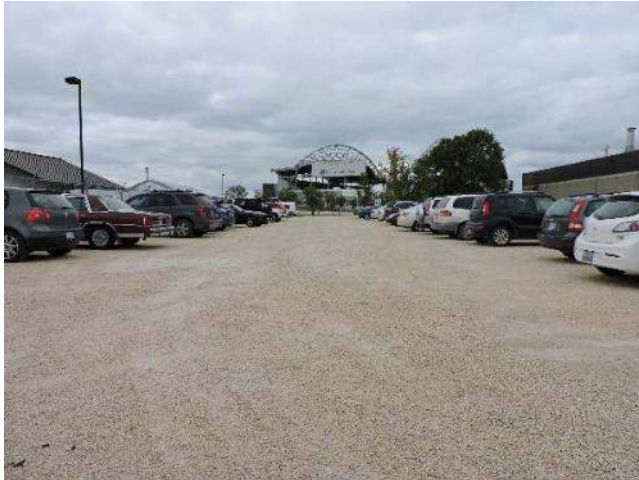
Figure 40 North West overflow gravel parking area.

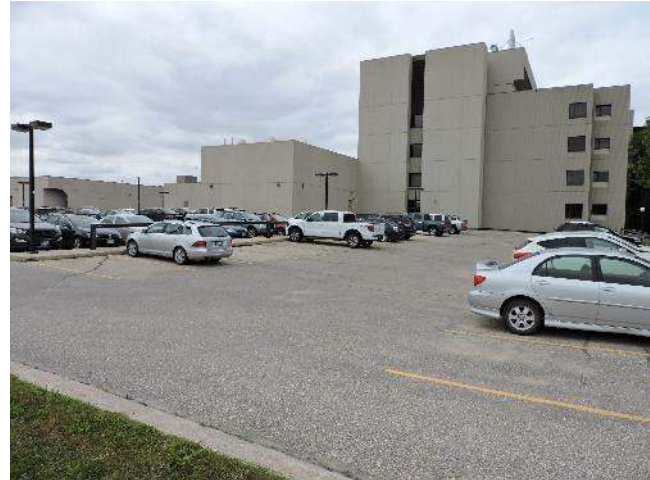
Figure 41 Staff south paved parking area.

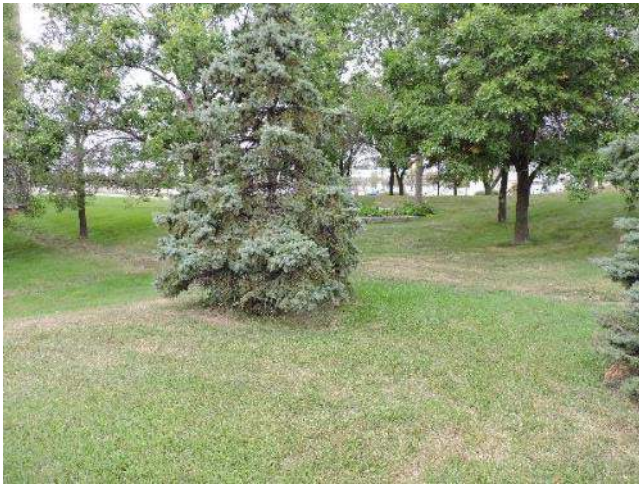
Figure 43 Typical mature trees and open grass areas throughout.

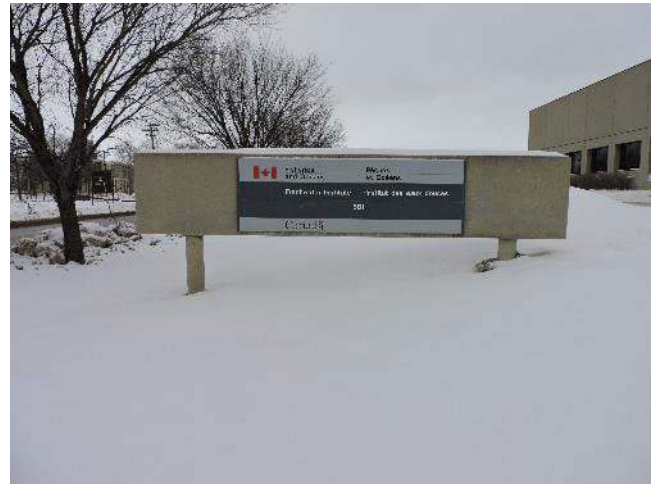
Figure 44 Building sign will need to be updated.

- Replace the freestanding building signage.

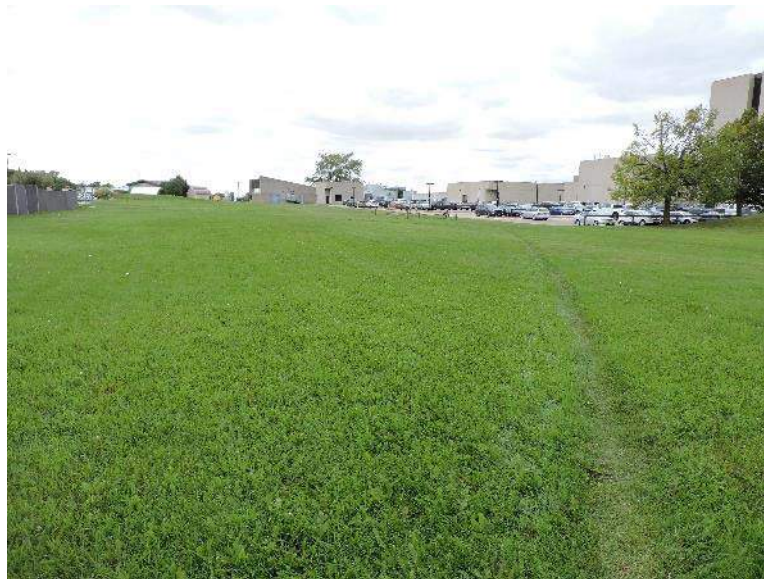
Figure 45 Existing soft landscape - potential area for parking expansion.

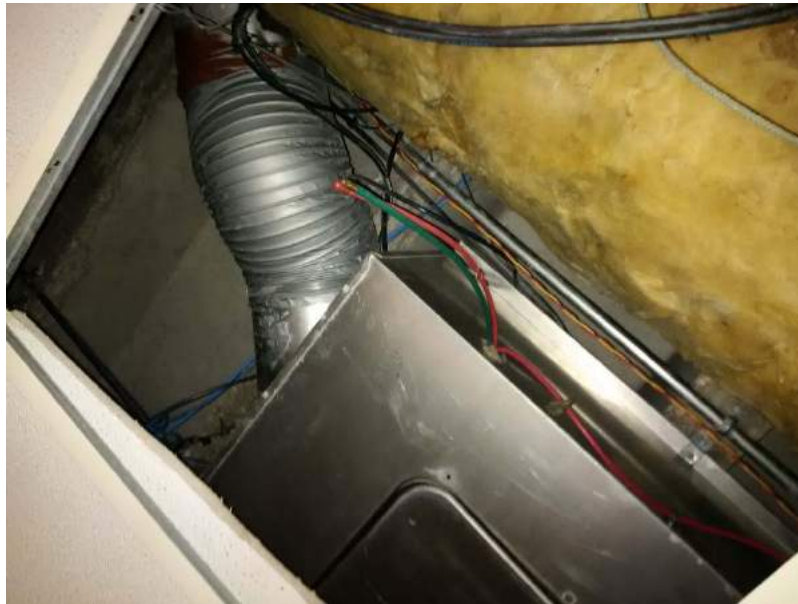
Typical Blending Box

- .8 Therefore, the main items of immediate concern are those pieces of equipment in the proposed renovation area namely, the mixing boxes and any other actuating devices. These items should be replaced with new in any of the renovation options.
- .9 Air supply devices such as grilles, registers and diffusers (GRDs) should be replaced to best accommodate the new architectural and interior design.
- .10 All systems rendered redundant due to the repurposing of spaces should be removed, eg. laboratory exhaust fans, ductwork, piping, controls, etc.
- .11 Insulation on heating and cooling piping fittings was observed that could possibly contain asbestos. This should be thoroughly assessed prior to any renovations.

- Replace the mixing boxes, actuating devices and GRDs within the areas of renovation to accommodate the Co-Location project.
- Retain the services of Hazardous Materials Consultant to review the extent of asbestos and assess the removal.
- Removal of all systems rendered redundant due to the repurposing of spaces.

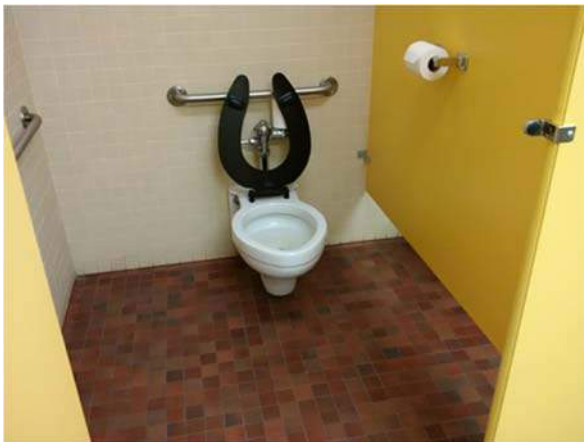
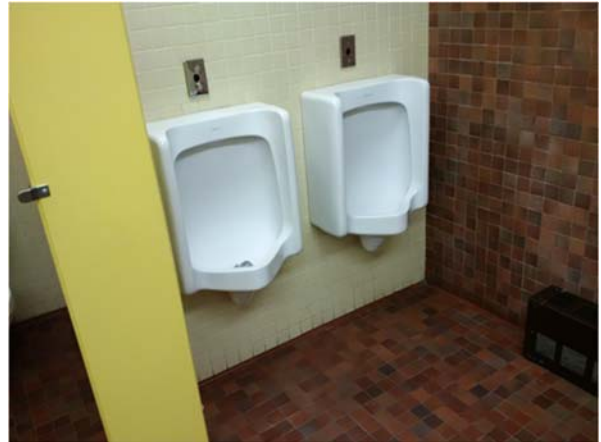
- .8 The plumbing fixtures throughout the building are older but are in good working condition. The existing toilets are all wall hung, flush valve. The lavatory sinks are all wall hung. None of the fixtures incorporate water saving features.

Typical Toilet

Typical Urinals

- Replace the existing sanitary fixtures to accommodate the Co-location project.

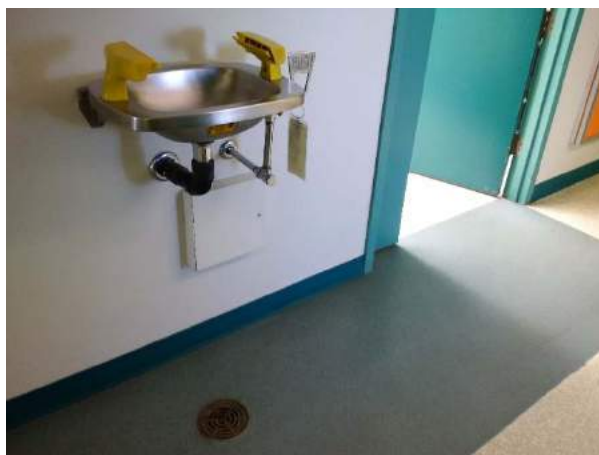
Eyewash

- .9 The washrooms would need to be reviewed by the architect for quantity, location and barrier free requirements.
- .10 Some washrooms were observed to not contain floor drains.
- .11 Safety fixtures such as eyewash stations are present and appeared to be in good condition.
- .12 Gas piping to work stations is installed with the proper controls and indication. No problems associated with this piping were reported.

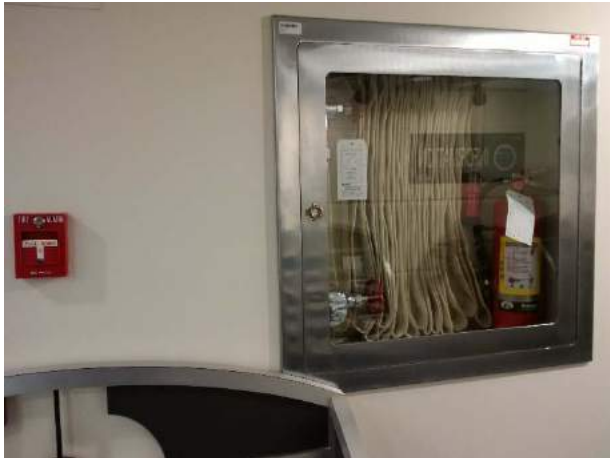
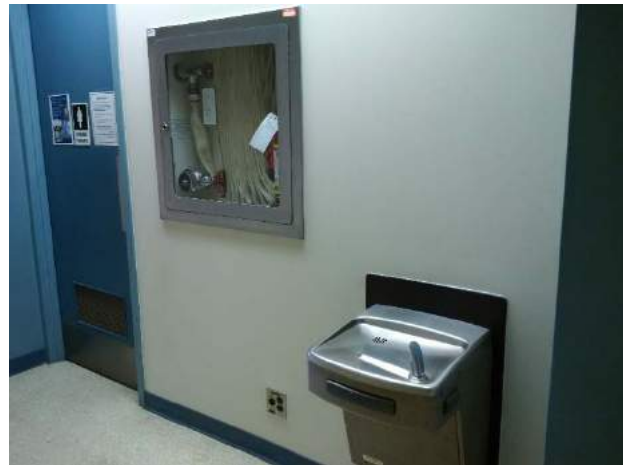
- .1 The Fire Protection systems are deficient with respect to present day codes and would need further review before it could be concluded if they could support the Co-Location project.

Typical Fire Hose Cabinet

- The building will most likely need to be sprinklered because:
 - The change in the intensity of use of the building will increase – more occupants will be using the building
 - Many low-occupant-load Labs will be replaced with a higher density office areas.
 - The existing building, while meeting the fire protection requirements of the building code at the time it was built, does not meet the current building codes.
 - The sprinkler system is the main fire protection system that has been identified in this building capability report that should be added.

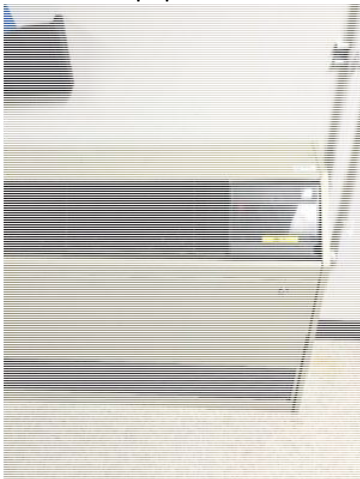
- .1 The Server room appear to be in good condition and can support the Co-Location project. Although not in total conformance with WP2.0.
- .2 The server room is located on the 3rd floor.
- .3 The Server room has a dedicated cooling system, UPS and distribution panel and suppression system. There are several racks, approximately 6, many with spare space for additional equipment.

Figure 1 Dedicated cooling unit.

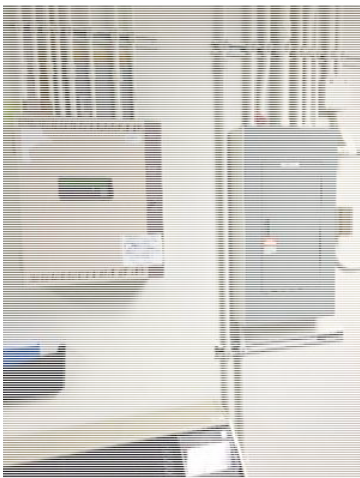
Figure 3 Server room suppression panel

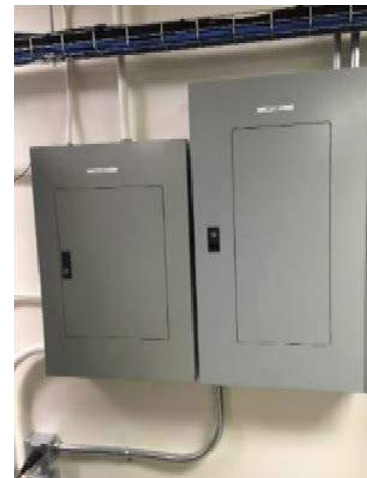
Figure 4 UPS Panels.

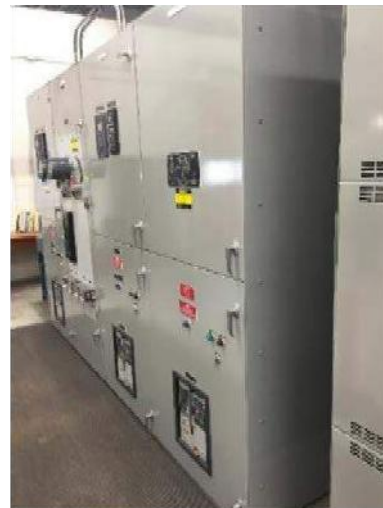
Figure 6 Normal power distribution equipment.

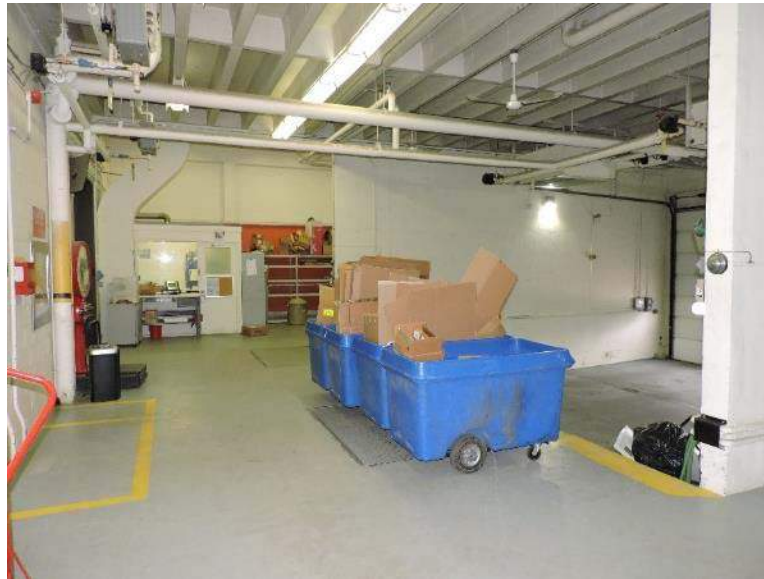
Figure 8 Loading area lighting

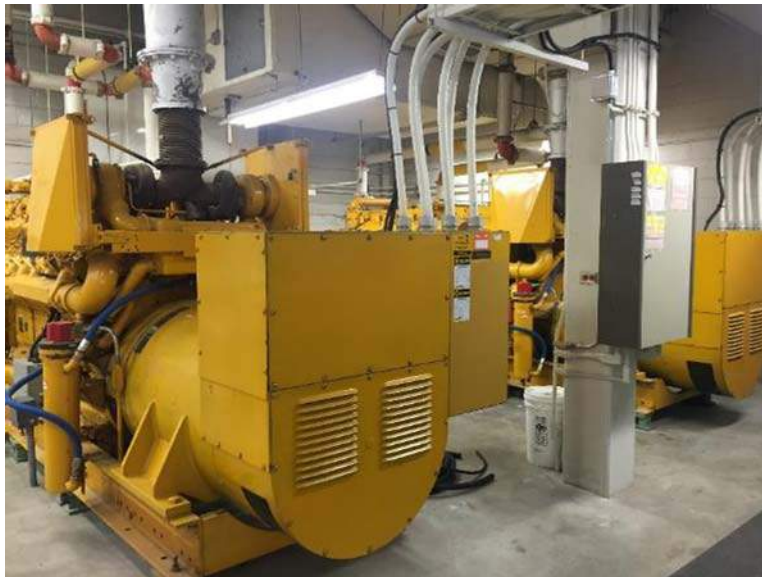
- .4 The existing transfer switch system do not conform to current electrical code CEC 46-108 (5). Current code would require separate transfer switches for life-safety systems and non life-safety systems. However, the current configuration would be considered to be grandfathered.

- .5 The generator are now 40 years old and maintenance may become more difficult and replacement part obsolete. In discussion with building maintenance, the system is fully functional and tested regularly.

Figure 15 Emergency generators

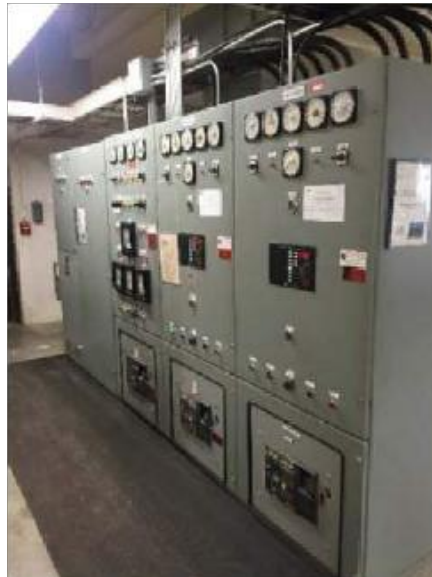
Figure 16 Synchronizing control panel
