Asset Performance Report

DFO-FWI - Main Lab-Administration Building

September 2013

PWGSC – A&E CoE
Winnipeg, Manitoba
Edmonton, Alberta
Project - R.060627.001

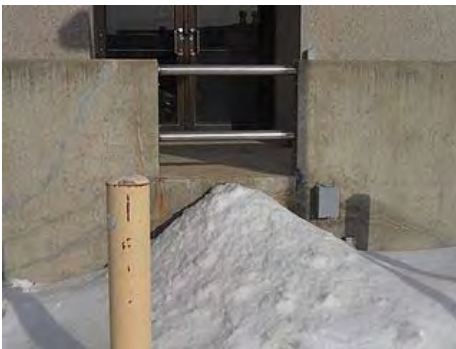
Typical exterior steel/concrete bollard with marred/rusted finish and dull/faded colour.

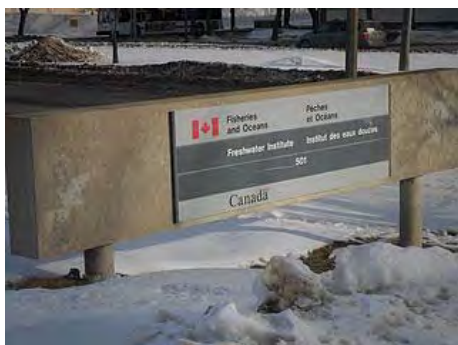
Freestanding Building Signage. Signage worn, missing information.

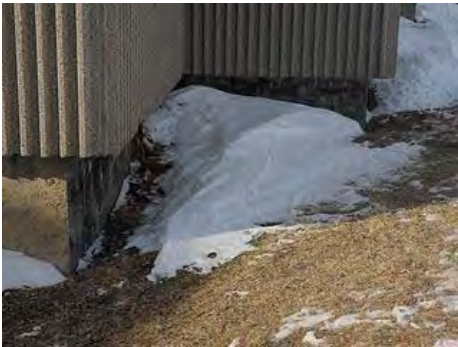
Settlement of Grade at Exterior wall.

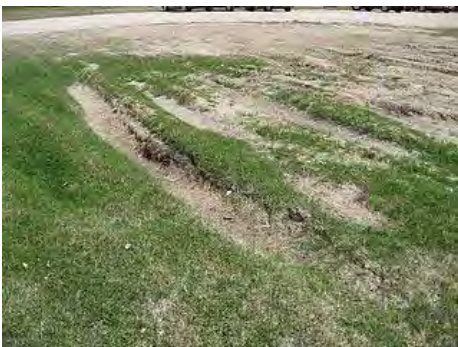
Vehicle damage in unpaved parking area.

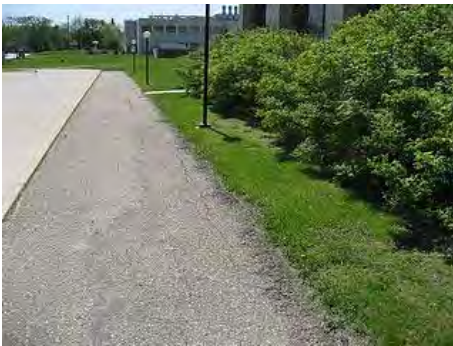
Asphalt walkway showing moderate cracking and uneven surface.

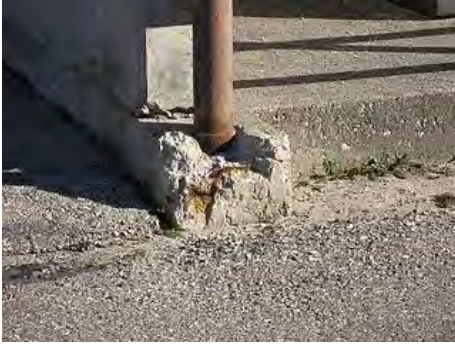
Damaged concrete curb (typical).

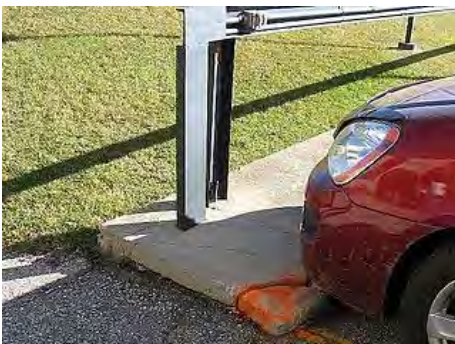
Damaged concrete walkway in parking lot.

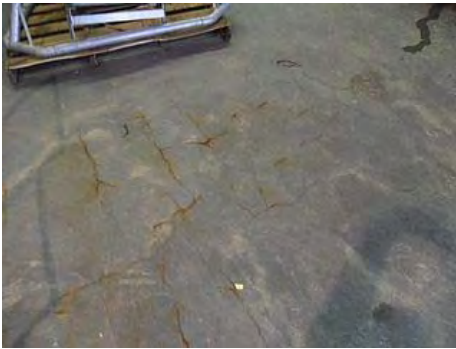
Loading dock slab: Excessive cracking and spalling.

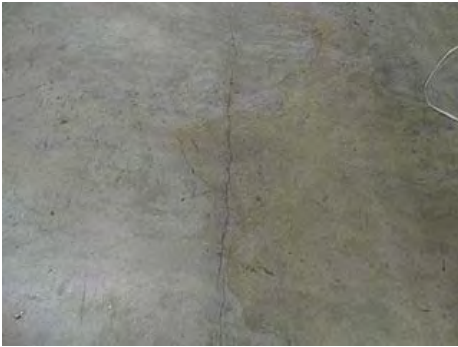
Hairline cracking in concrete slab (storage room).

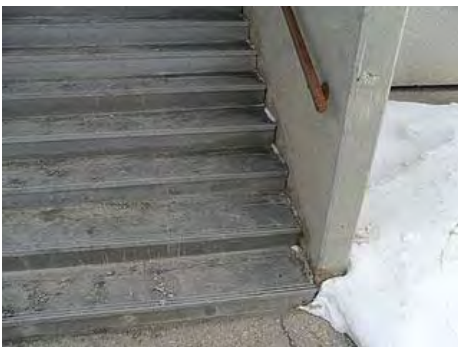
Exterior Stair - West Entry. Handrail extensions required.

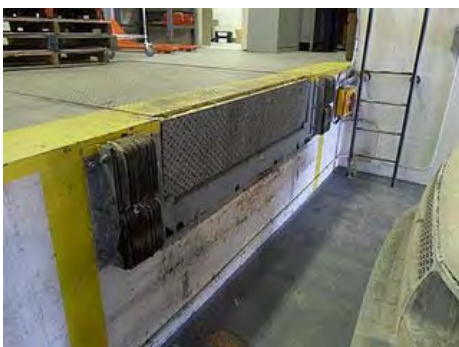
Access ladder to loading bay from loading dock is considered unsafe.

Loading dock ladder is dangerous. Maintenance staff report falls at this location.

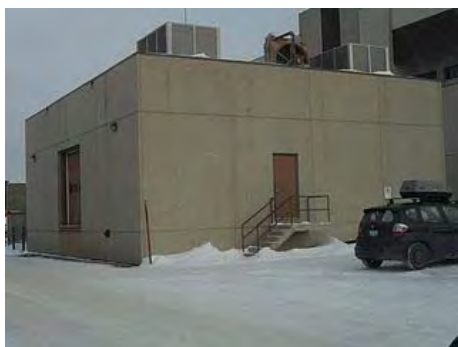
Scratches and general wear.

Typical exterior metal door.

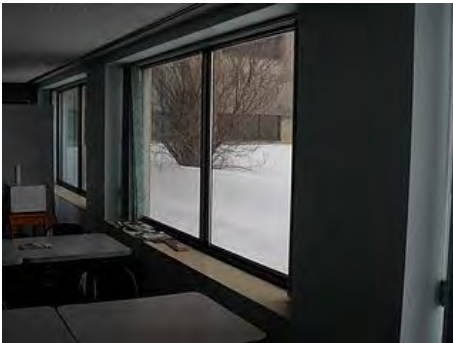
Blinds on windows facing west are not effective.

Vertical louvre - fabric blinds.

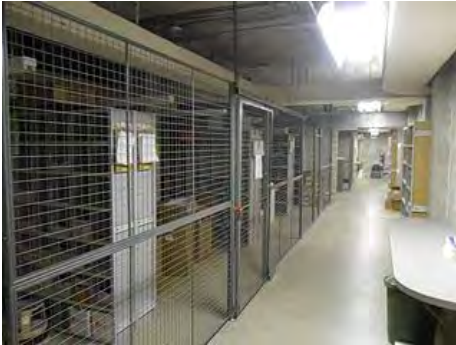
Wire mesh partition in basement storage area.

By the indicated year, chain-link partitions may require replacement due to corrosion and not having the ability to provide proper security.

Replace all chain-link partitions and hardware.

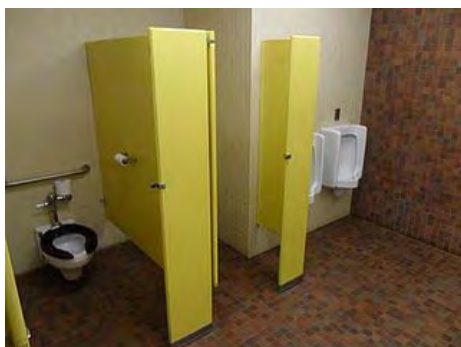
Washroom partitions are in average condition for age. Yellow colour is dated looking. Refinishing is warranted in seven years or 2020. Replacement may be required in 15 years after that, or 2035.

Typical toilet partition.

Partition repairs and painting will eliminate the dated appearance.

Replace all toilet partitions.

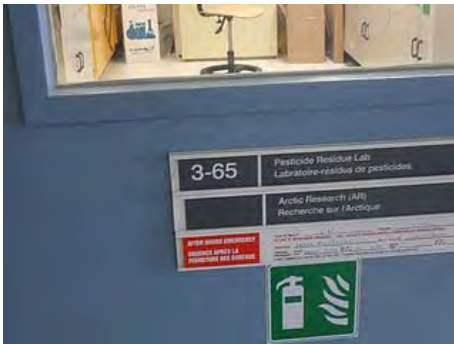
Interior wood doors are considered in average condition. Since all doors would not require replacement at the same time, starting in 2022, budget for 25 doors to be replaced every 5 years.

Typical lab door with upper lite.

Where required, replace 25 interior wood doors and reuse related hardware where possible.

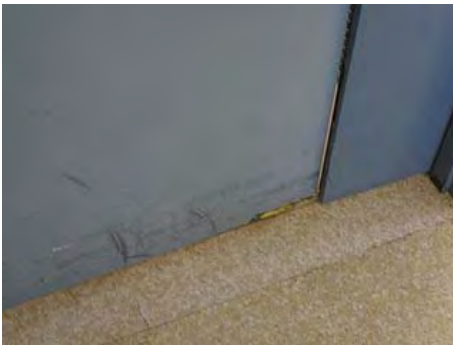
Refer to report section "01.5-060C15 Paint" for refinishing. Some lab doors are impact damaged at base - provide kick-plates in 2014.

Impact damage at base of lab door.

Provide kickplates at doors (10-20 doors) with impact damage.

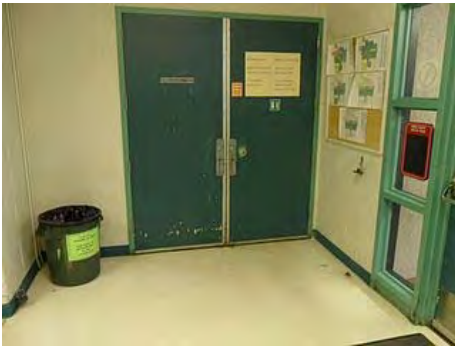
Refer to report section "01.5-060C15 Paint" for refinishing. Doors to loading area are impact damage and should have vision lites for safety. This task should be implemented in 2015.

Loading dock doors damaged and also lack vision panels for safety. Replacement is warranted to promote proper function.

Painted metal doors to loading area showing cart traffic damage and lack of vision lite and power operator.

Replace metal door assemblies to loading area.

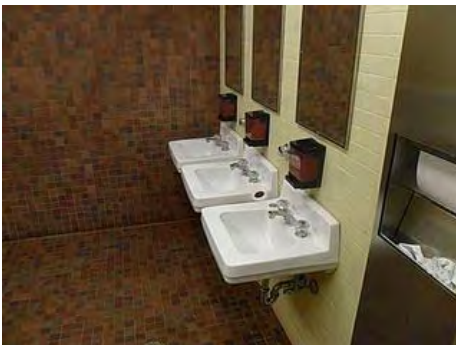
Even though the tile colours are dated, they are in average condition. Another 20 service years is granted before replacement in 2033.

Original ceramic wall and floor tile in washroom (typical).

Due to age, appearance and damaged tiles, replacement will be warranted.

Replace ceramic wall and floor tiles in all washrooms.

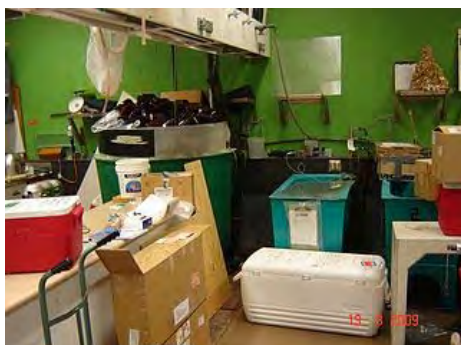
Paint on walls, doors and frames generally average condition. Since all surfaces would not require painting at the same time, starting in 2017 budget 25% (2,500m2) every 4 years, wherever required.

Lab 2-75. Original wall paint (40 years old).

Cycling repainting program of walls, doors, frames and all other noted surfaces identified in this report. Repainting cycle will repeat every 16 years.

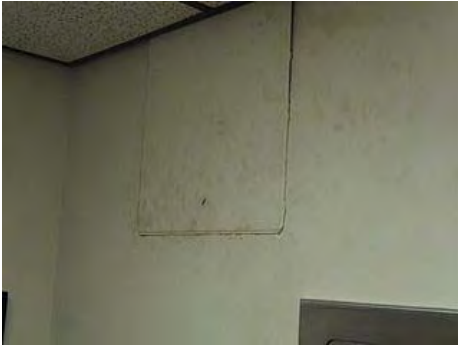
Dirt and stains on wall (typical).

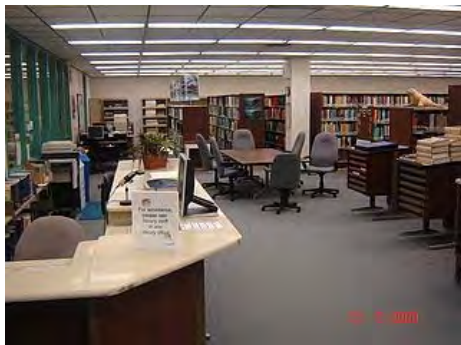
Carpet in average or better condition except as follows:

Carpet in library.

Replace approximately 1,100m² of carpet, wherever required. Initial areas would include ones in fair condition (high traffic).

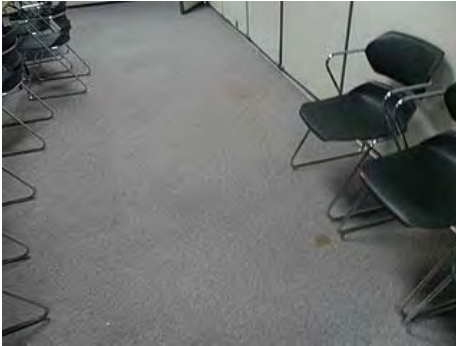
Administration Block: Main Floor: Office Area, seminar rooms (fair condition).

Carpet in seminar room, worn and stained.

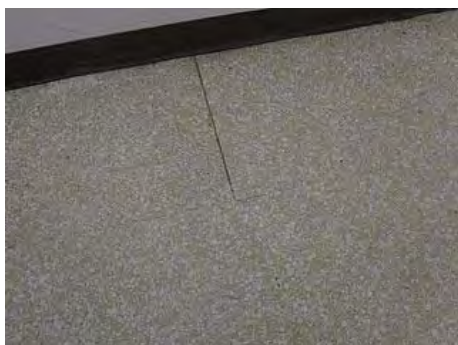
Event delay would risk increased damage and tripping hazards may occur.

Poor sheet vinyl seam in corridor.

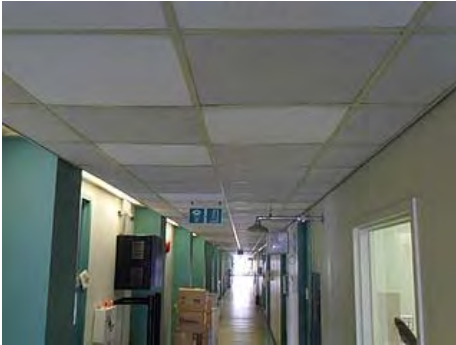
T-bar ceiling system in hallway with different vintage tiles.

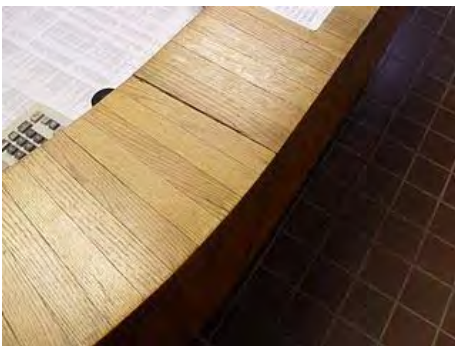
Crack in Main reception desk's wood counter.

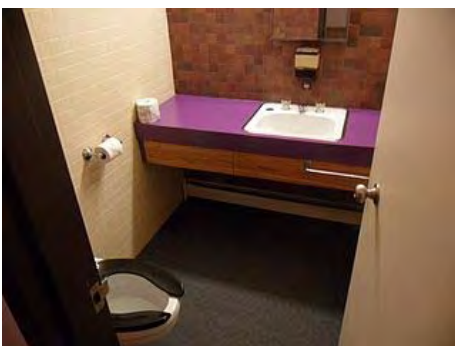
Dated looking laminate in washroom.

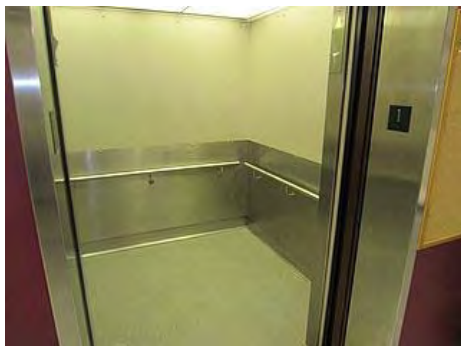
The elevator cabs both appear to be in average condition. One is lined with a protective blanket to cover the walls to protect from damage while moving freight. Considering an upgrade in 1992, the elevator cabs should not require any work until at least 2020.

Note - elevator control panels do not meet accessibility standard. Panels should be replaced in 2014.

Passenger elevator interior

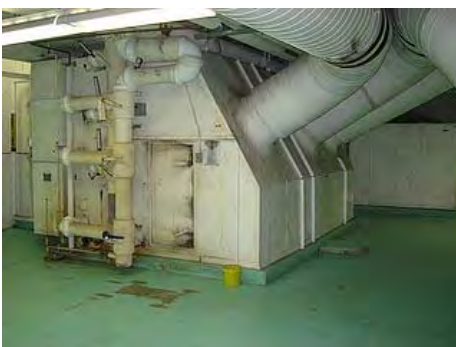
AH1 - Original 1977 Equipment

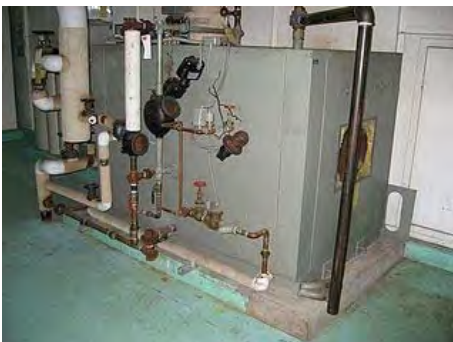
Rust and corrosion

Disabled Steam Humidification Boiler

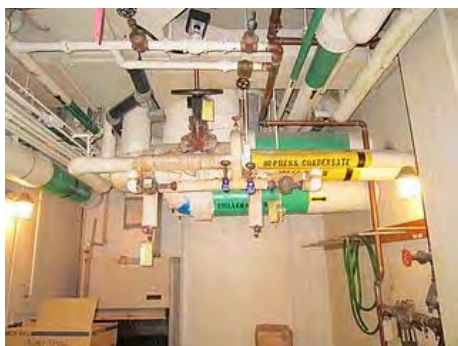
Typical heating and cooling piping in a service room

The heating and cooling piping is presently in average condition and does not require replacement in the near future. The timing of the replacement shall be re-assessed at the time of the next BCR in 2017.

This event includes replacement of the heating and cooling piping systems from the mechanical room in the basement and to the heating/cooling coils, perimeter radiation, and unit heaters.

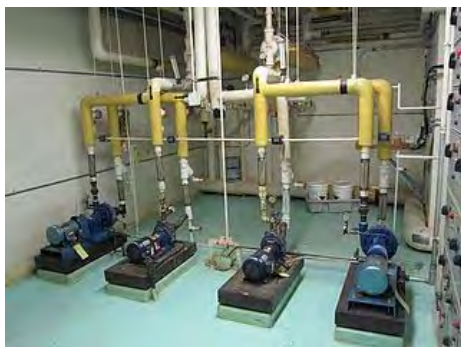
Generally, the pumps appear to be in average condition. Assuming these to be original 1977 equipment, they should have been due for replacement in 2012 but this has been pushed out to 2019 to allow another assessment at the next BCR.

Perimeter water heating system pumps in basement mechanical room

This event is for the combined life cycle replacement of the HVAC system pumps.

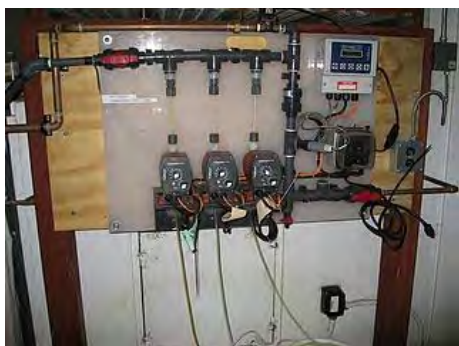
The pot feeders were installed at different times. All appear to be in the same average condition, with no reported problems. The estimated lifespan has been extended to end in 2024.

Chemical feed system added to Process Cooling Tower in Penthouse in 2007

This event is the life cycle replacement of the chemical feed system for the process, hot water and cooling tower loops.

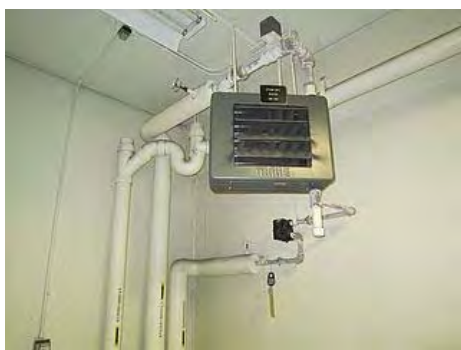
The terminal units appear to be in average condition given their age with no reported problems. Based on this, 2021 is the projected replacement year.

Typical Steam Unit Heater in Water Treatment Area in basement mechanical room

This event is for the life cycle replacement of the terminal units found throughout the facility.

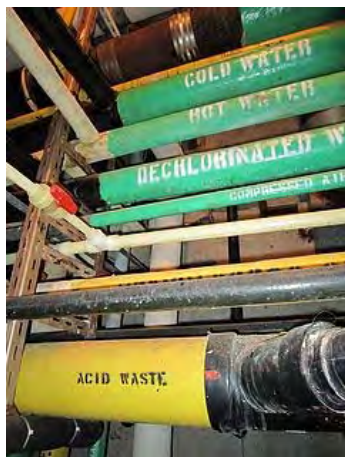
The gas piping is in good condition and should not require replacement even though it's currently 35 years old which is the projected anticipated life. A further assessment can be done at the next BCR in 5 years time.

Natural gas line (top yellow pipe) in service corridor for laboratory use only

This event is for the life cycle replacement of the natural gas piping system servicing the laboratory spaces only.

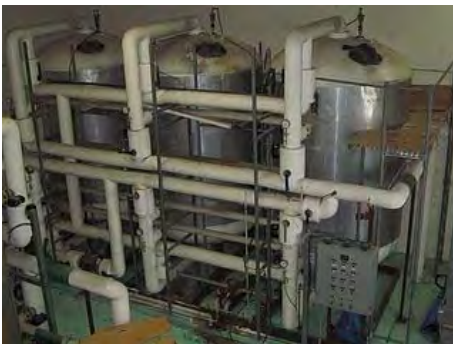
Large carbon filter media tanks, grossly oversized equipment based on present system requirements

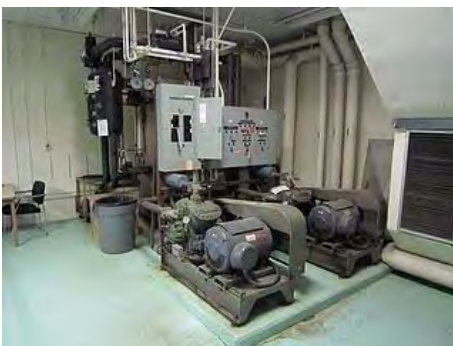
Decommissioned cooling plant for dechlorinated water loop. Ambient temperature of DCW often exceeds client requirements during summer months.

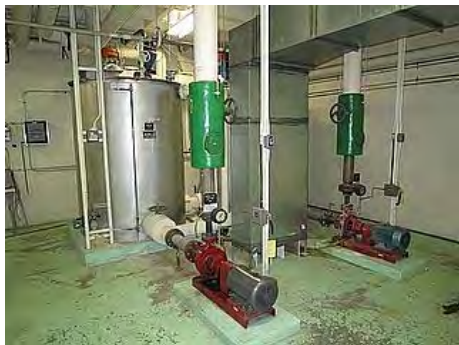
Ozone treatment tanks, no longer aerated with ozone, now using purified compressed air. Piping very fragile at this location, perhaps from ozone exposure over time.

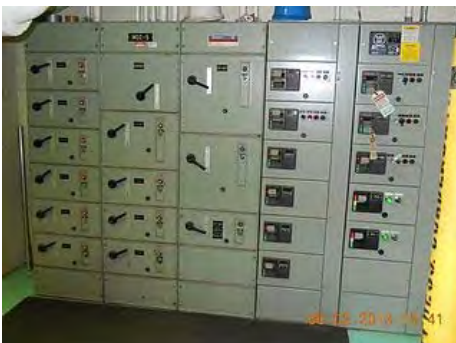
Typical Westinghouse 1972 MCC. Two new sections added.

Even now, the availability of parts may be a concern and the longer the units are kept in use, the risk will increase.

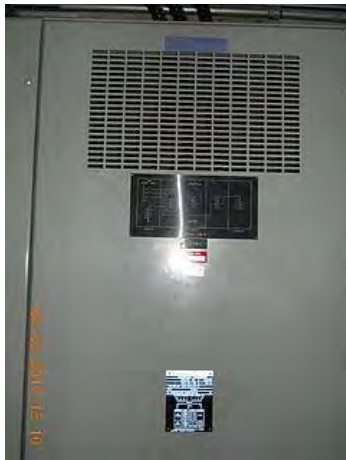
Cleaning and retorquing is required.

Typical enclosed free standing distribution with integral transformer.

If the transformers are not replaced or re-evaluated, there is a very high chance of a major outage.

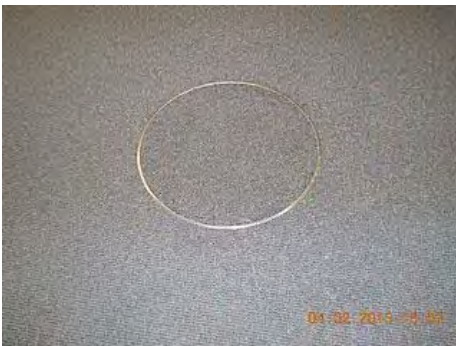
Abandoned under floor ducts.

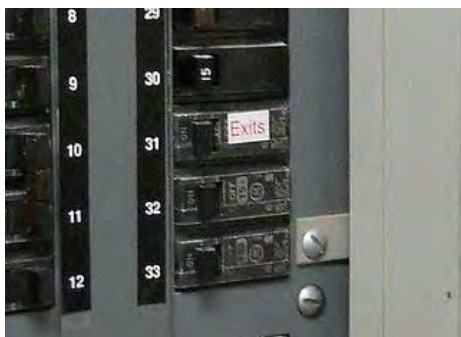
Typical breaker requiring a lock "on" device.

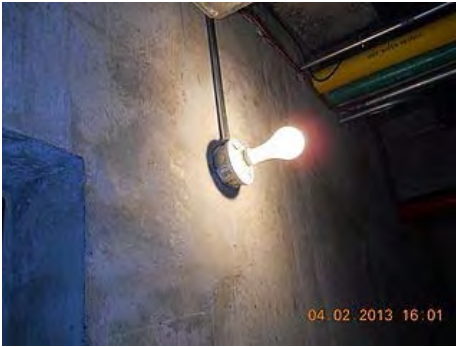
Keyless to change to Compact Fluorescent.

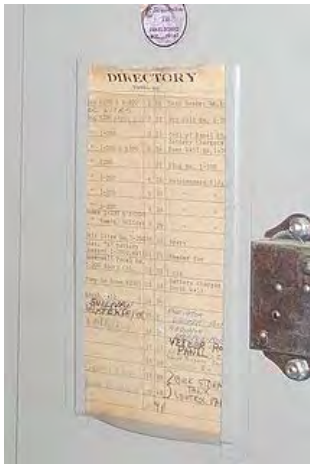
Typical directory to update.

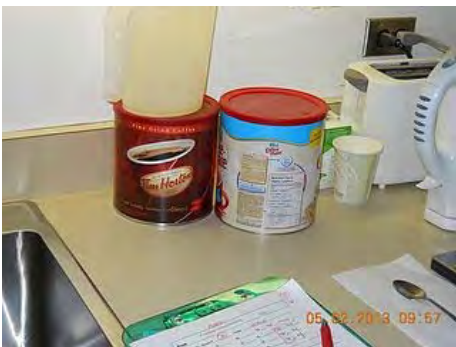
Receptacle near sink.

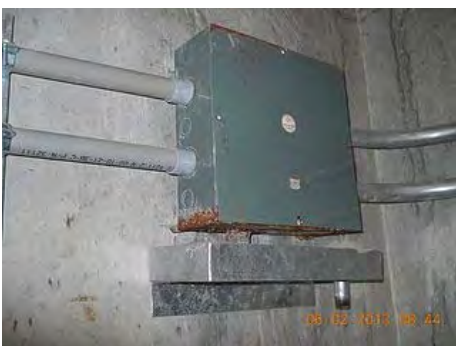
Rusting pull boxes. Typical for two.

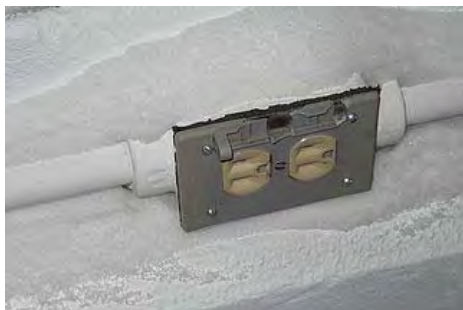
Broken receptacle.

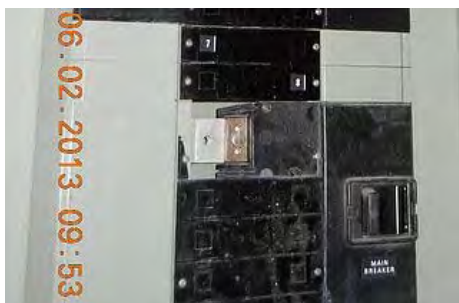
Typical filler missing.

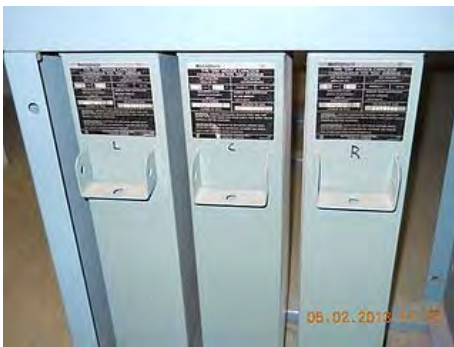
Newer capacitor units, date not established.

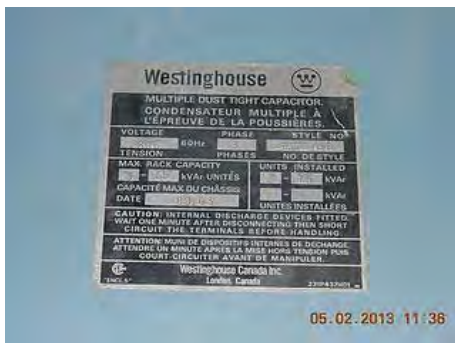
The risk of an inoperative power factor system could be elevated utility costs.

1989 capacitor units.

Replace 1989 capacitors and ensure power correction capacitors are operational.

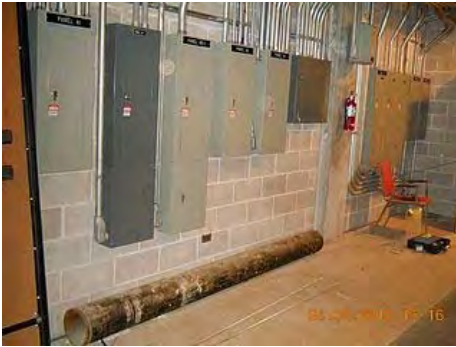
The original 1972 panels, about 328 units are 41 years old and in fair condition.

Fillers missing.

Inadequate labeling

Panel directories need updating.

Typical panelboards.

Replace 1972 panelboards and CDP panels.

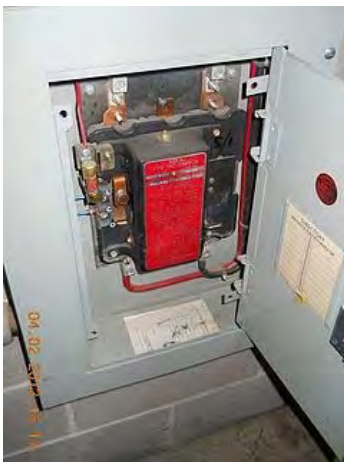
Typical panel contactor for lighting control.

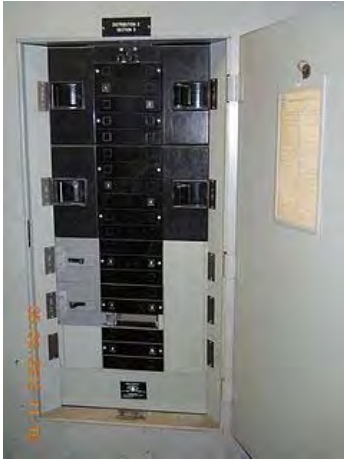
Westinghouse CDP in distribution enclosure.

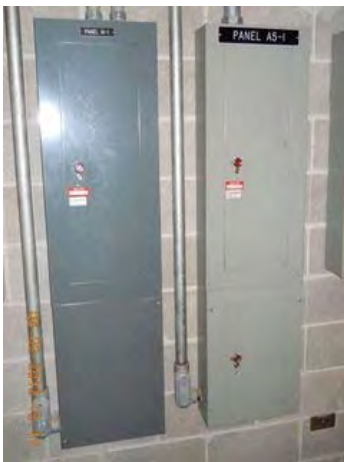
Panel A5-1 c/w lighting control contactor in lower section.

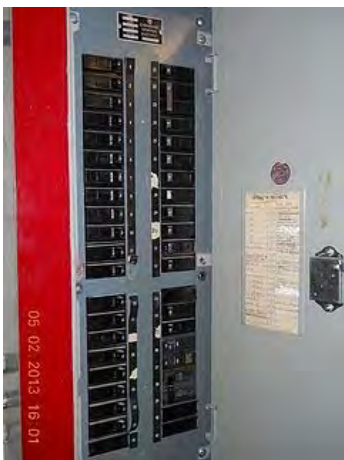
1972 CGE panelboard, painted red for emergency.

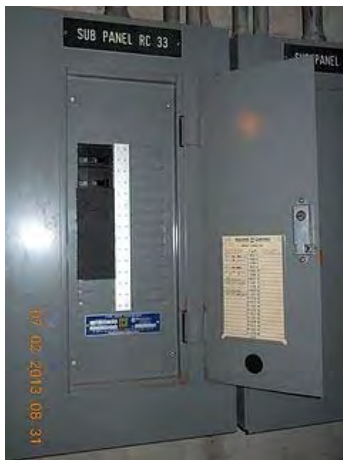
The panelboards will be older than 35 years at this point and close to their general life expectancy. Lifespan can be re-evaluated at this time or replaced in 2035.

Typical Square D panel installed for refrigeration upgrade.

Replace year 2000 panelboards.

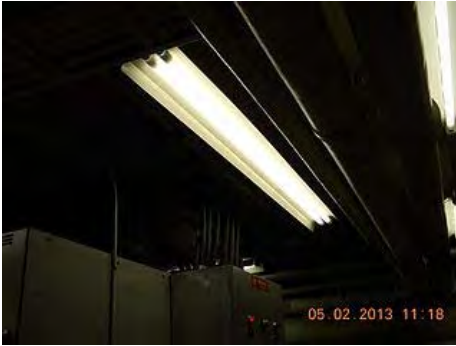
T12 lamps are obsolete.

There is high risk in operation if fluorescent fixtures are not replaced as lamps are no longer produced.

T12 lamp fluorescent fixture.

Replace about 60% of the existing fluorescent fixtures to bring all the lighting up to T8 lamps as well as replace all the incandescent fixtures.
 60% of 2957 = 1775 plus 569 incandescent.

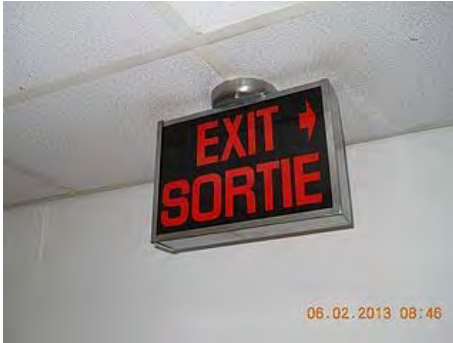
Most of the exit signs are from the 1972 installation and do not meet Government standards and are therefore classed as poor even though operational. These need to be replaced in 2014.

Lettering does not meet Government standard.

Typical exit fixture.

Replace exit signs with bilingual or international symbol type.

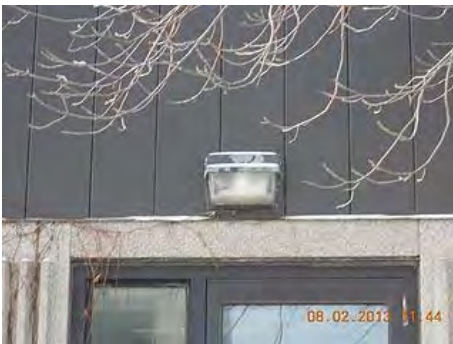
The exterior lighting is showing signs of age and although operational appear in only fair condition and should be scheduled for replacement in 5 years in 2018.

Some lamps inoperable.

Typical wall pack around the site.

Replace exterior fixtures on the side of the building, the landscape and parking lot lighting.

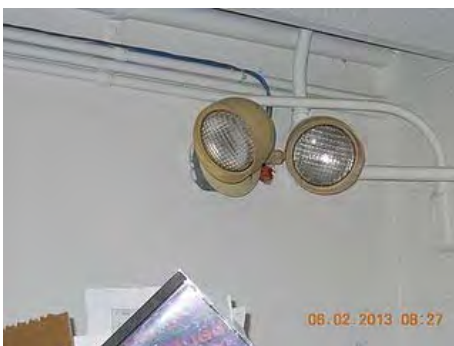
The existing emergency battery packs have been maintained over the years and this should continue. However, the old remote heads are not efficient and in fair condition and should be replaced in 2015.

Typical remote heads.

The remote heads have not been replaced since 1972 and are not efficient.

Replace remote head.

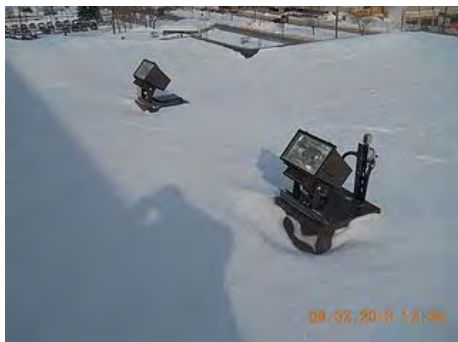
The fixtures for the Wordmark sign are in good condition and should last another 10 years so that replacement should be about 2020.

Wordmark sign fixtures on third floor roof.

Replace Wordmark flood lights.

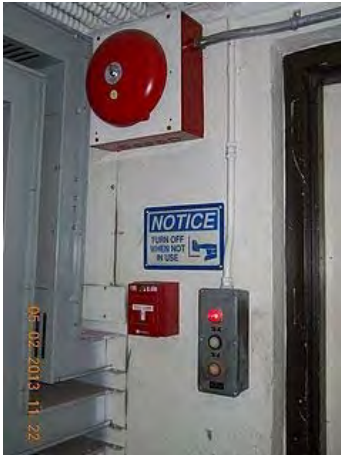
The fire alarm system appears to have been upgraded last in about 1998, and is missing any visual signal devices. This would make the system in fair condition overall. Although operational and stable, the fire alarm should be scheduled for replaced by 2018. If replacement is going to be delayed until then, visual devices should be considered in 2014.

Visual signals are a code requirement and mandatory for safety.

Typical 2 stage pull station and alarm bell. (no visual devices)

Upgrade or replace fire alarm to new technology as required.

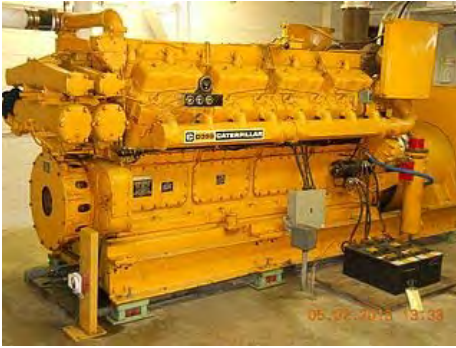
The generators and associated controls are now 40 years old and maintenance is becoming a concern. The condition of the equipment is identified as fair and replacement is inevitable and should be in the next 5 years, 2018.

One of the two diesel generators.

Replace the two generators, the synchronizing control panel and all associated equipment.

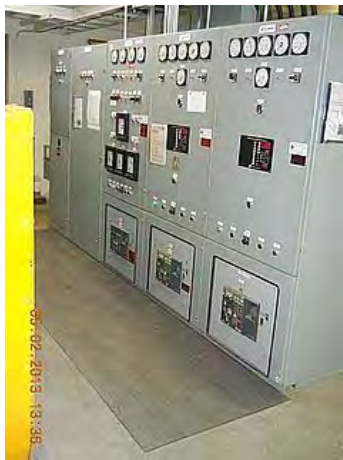
Synchronizing control panel.

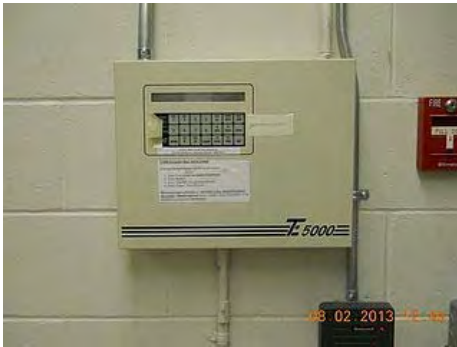
Sub panel.

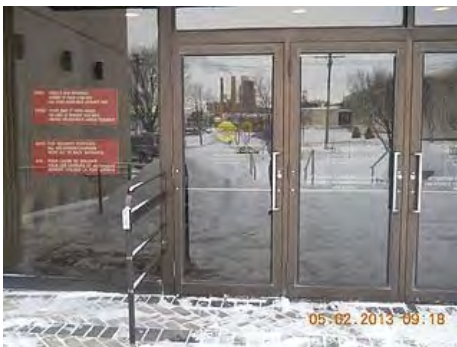
The door operators seem to be in good condition and with continued operational maintenance should not need replacement until about 2021.

Main entrance door operator.

Replace the double door operators.

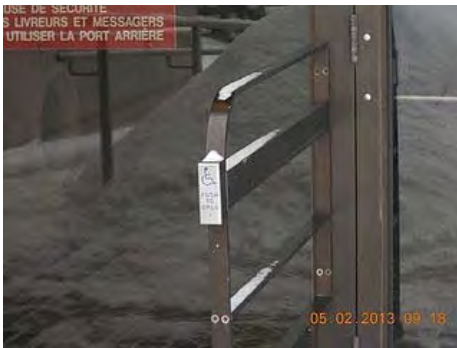
Entrance push button for door operator.

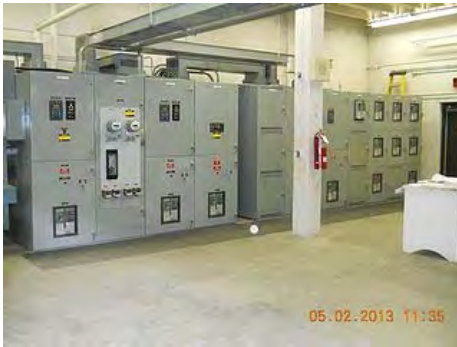
Once the existing components are labeled, no further action would be necessary unless there are utility system changes. All new equipment added after the study will have to be labeled individually. The process has not been done as of yet and is therefore considered to be in poor condition. Study should be done immediately in 2013.

Main Switchboard in Service Building.

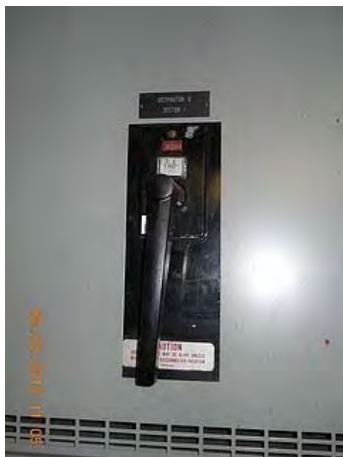
To avoid the implementation of Arc Flash labeling would be to contravene code and put lives at risk during maintenance tasks.

Air Circuit breaker not labeled.

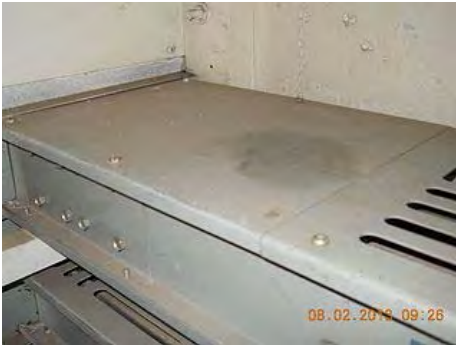
The equipment is identified as average condition as the majority of the equipment has had little preventive maintenance over the years. Cleaning and torquing should be done every 5 years and start in 2013.

Horizontal bus duct needing cleaning.

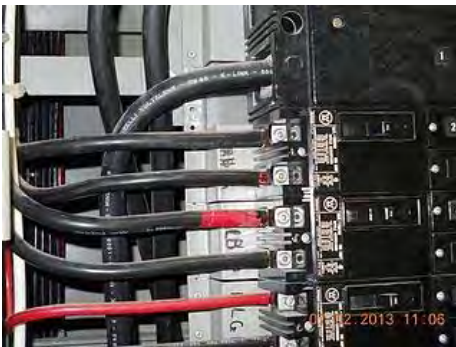
Currently, the electrical components are in average condition. The next scan would be completed in 2013.

Visual view of feeder breaker in CDP Distribution Panel EE.

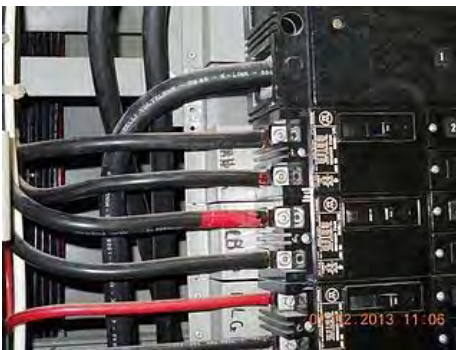
Visual view of breaker in Distribution EE. See thermographic view below.

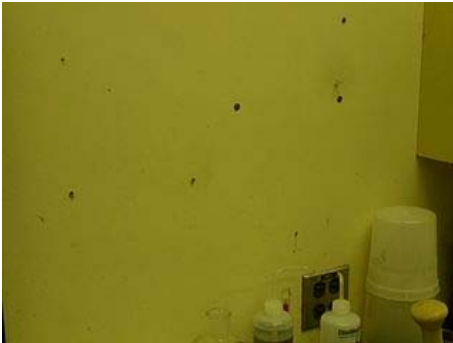
Fading Colours

Wall in lab. Paint faded, abandoned wall plugs etc. (typical).

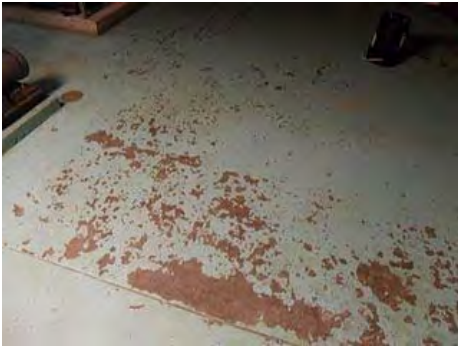
Deteriorated paint on concrete floor in Mechanical room.

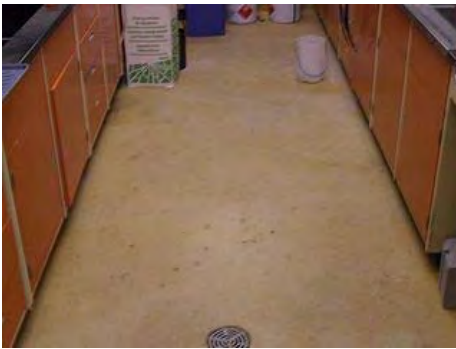
Excessive wear

Epoxy coating stained and discoloured in lab.

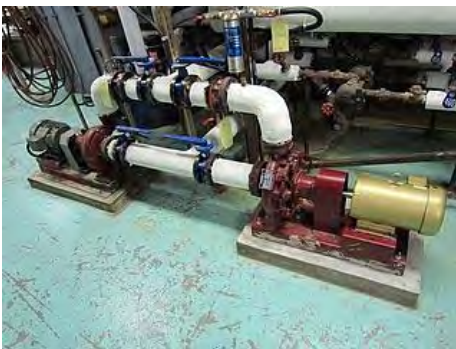
Hot water pumps - note newer right pump

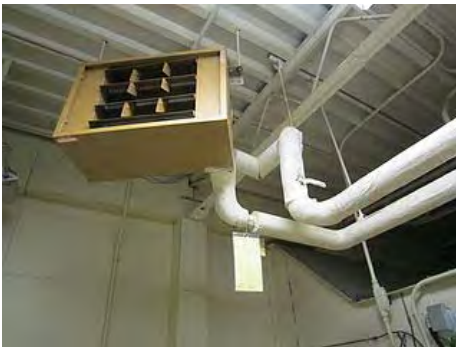
Sample Unit Heater in Penthouse Mezzanine

This event is for the life cycle replacement of the 4 terminal units.

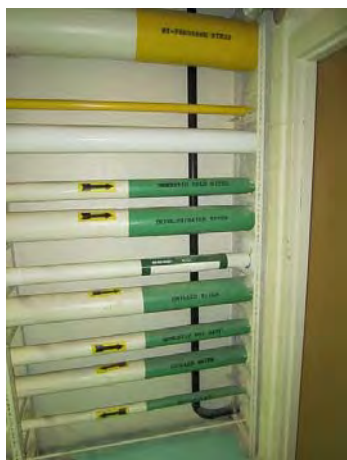
Natural gas and other services passing through tunnel wall into Annex basement Mechanical Room

The gas piping is in good condition with no reported problems and there should be no reason to consider replacement any sooner than the end of its estimated 35 year life in 2020.

If this event is deferred, and the natural gas piping is degrading, then there is a risk of a gas leak. The potential safety risk to the building and occupants should outweigh financial costs for this project.

This event is for the life cycle replacement of the natural gas piping system.

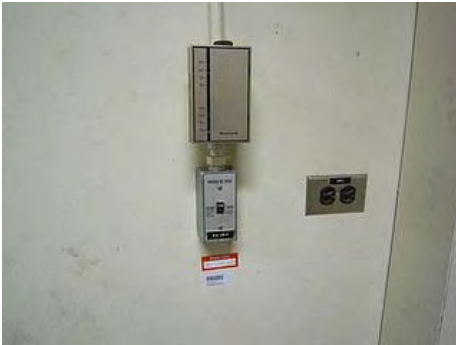
There were no reported problems with any of these components. Typically, any problems should be dealt with on a case by case basis, as part of an Operations & Maintenance program. A projected replacement date of 2018 has been set, that should be reevaluated during the next BCR in 2017.

Sample electric thermostat

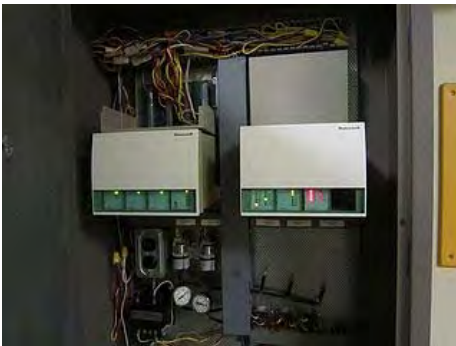
DDC system is in average condition, most of the hardware was updated ~2000. It is well maintained via a Honeywell service contract, programming and graphical interface updates are on-going. The anticipated replacement date has been set at 2020 based on a 20 year expected life. Components for this system are readily available and service needs are met with the Honeywell office.

DDC interface with pneumatic devices

This event is for the life cycle replacement of the estimated 120 points making up DDC components including panels and controllers.

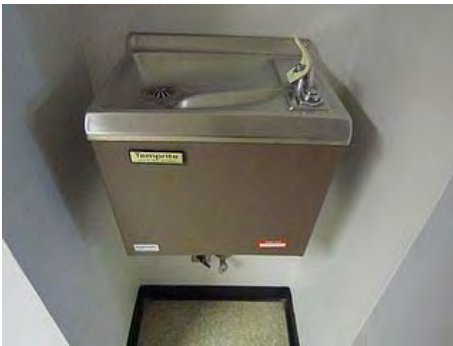
The drinking fountain appeared to be in poor condition and because it uses R12 refrigerant, it should be replaced immediately (2013) (if not done so already in 2012/13).

Unit uses R12 refrigerant - an ODS.

R-12 drinking fountain in basement

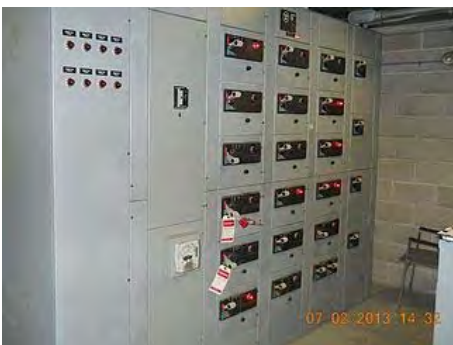
Incoming service to the Annex into the MCC.

If the Automatic Transfer Switch is not replaced or at least evaluated and seen to be stable, the power to the Annex could be jeopardized.

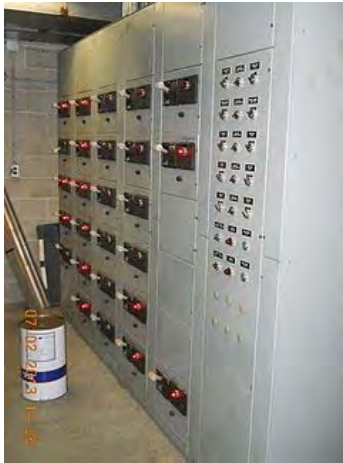
Backside of Motor Control Centre.

The risk is, the whole service or portions could be compromised if the MCC is not maintained.

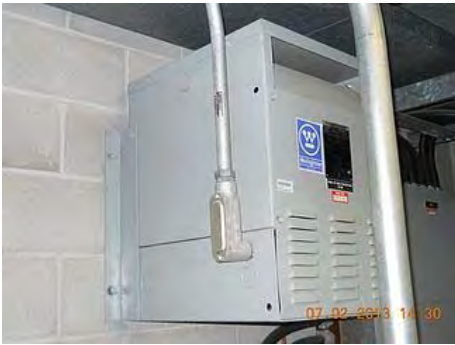
One of 5 transformers feeding the Annex building.

If the transformers are not maintained or replaced as needed, the building system would be compromised. Unreliable power may become an issue.

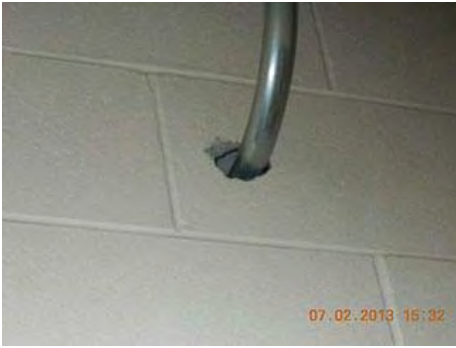
If this code work is not done, safety is a concern.

Fire stop missing on wall penetration.

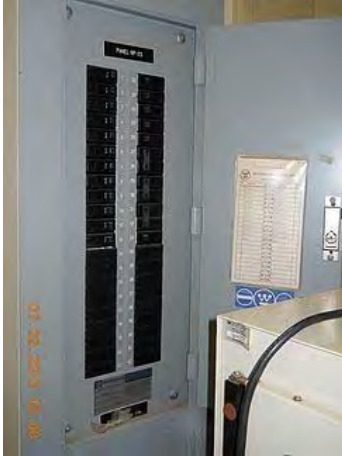
Panel access restricted by lab equipment.

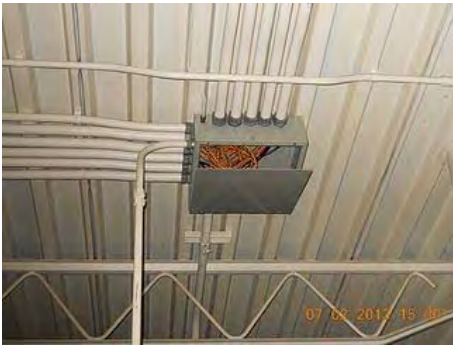
Open cover plate.

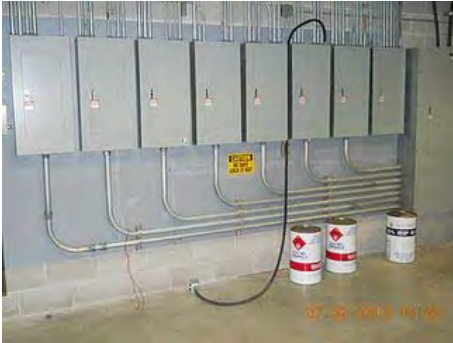
Some directories have changes identified to be confirmed and typed.

Panels located in basement electrical room.

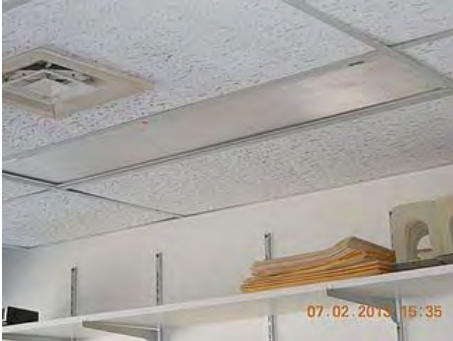
T12 lamps are obsolete.

Typical lab light fixture.

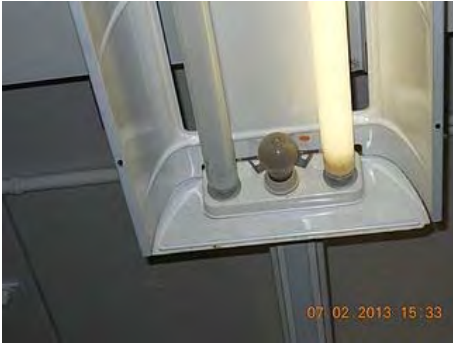
The risk of not doing the upgrade is that lamps will not be available. Note, even if they are found the lamps will be very costly from a lack of supply.

T12 lab lighting and A-line incandescent.

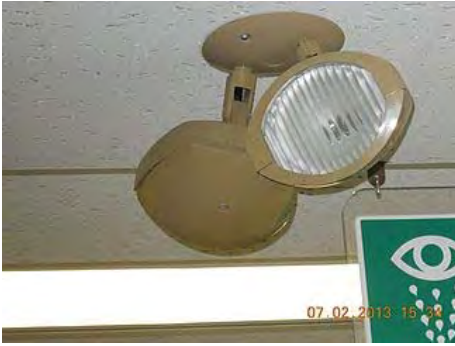
If remote heads are not replaced, the integrity of the emergency lighting could cause a safety concern during an emergency situation.

Typical remote heads.

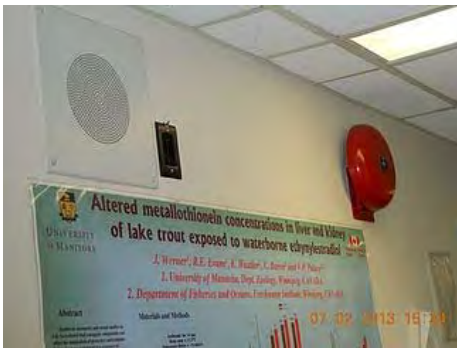
Visual signal devices add value to the building and maintain safety.

No visual signal devices.

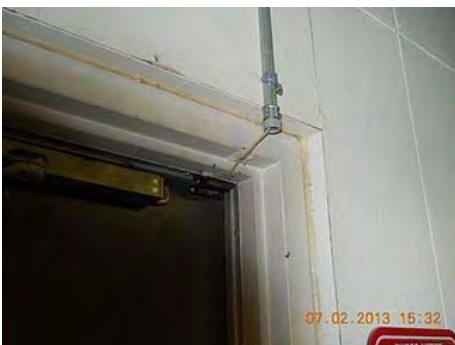
Security door contact.

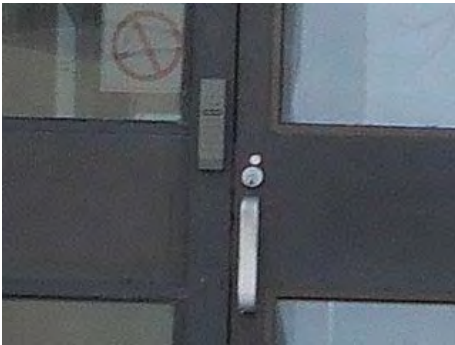
Access reader in door mullion - main entrance.

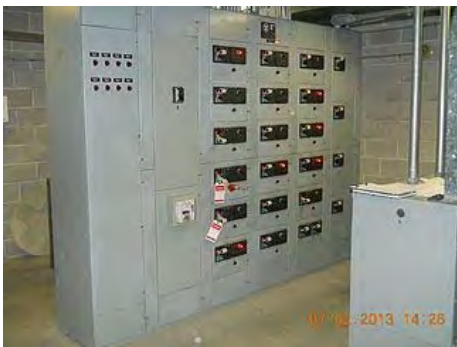
Once the existing components are labeled, no further action would be necessary unless there are utility system changes. All new equipment added after the study will have to be labeled individually. The process has not been done as of yet and is therefore considered to be in poor condition. Study should be done immediately in 2013.

Main Service breakers for Annex in MCC.

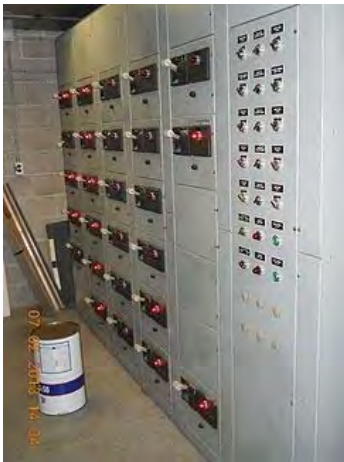
Backside of MCC.

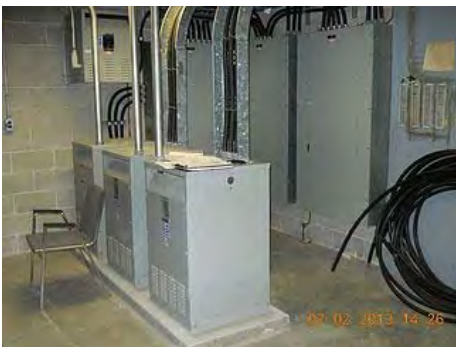
The equipment is in average condition but has had little preventive maintenance over the years. Cleaning and torquing should be done every 5 years and start in 2013.

Distribution panels and transformers.

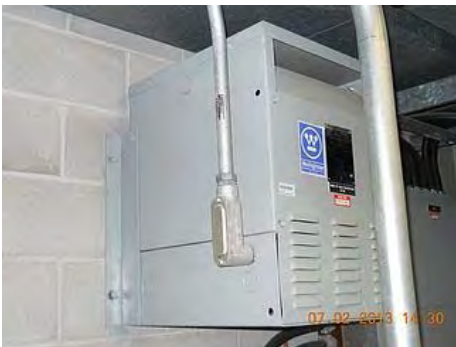
One transformer to clean and torque (typical).

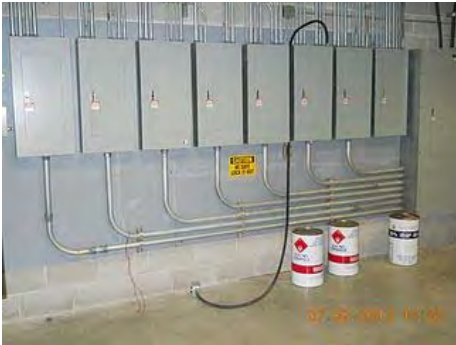
Currently, the electrical components are in good condition. The next scan would be completed in 2013.

Typical panels to be thermal scanned.

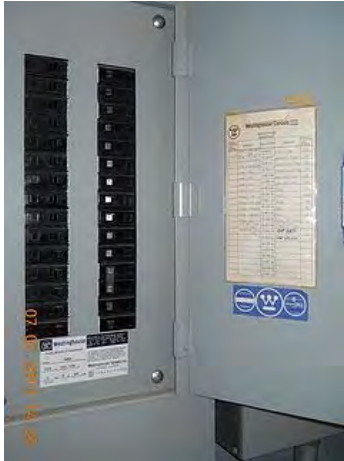
Panel and other equipment to be scanned.

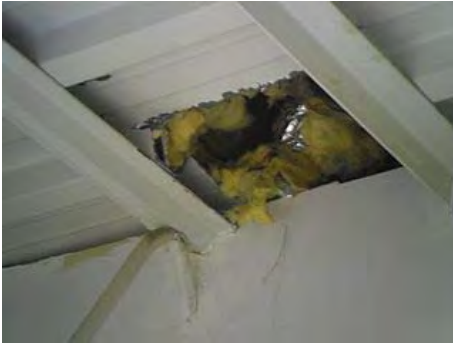
Small hole in metal decking with insulation falling out.

Opening in steel roof deck with exposed roof insulation.

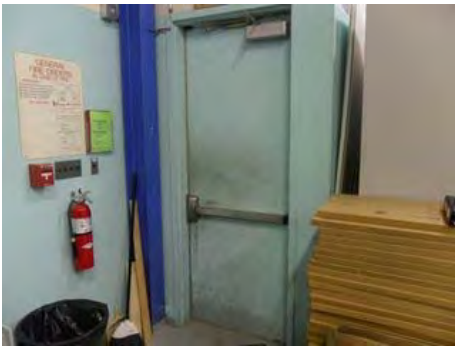
Paint badly faded.

Exterior steel door (entry door to dive locker storage area). Door requires repainting.

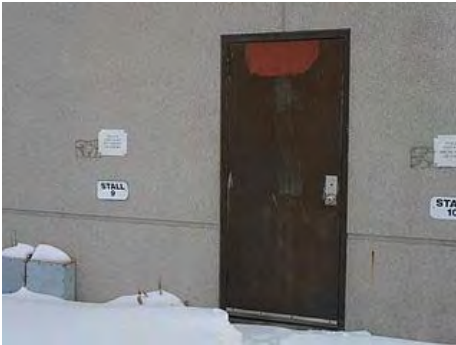
Exterior door. Deteriorated paint and makeshift cover plate at lockset.

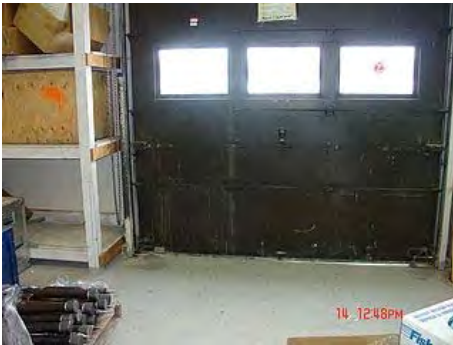
General scrapes and fading.

Interior view of overhead door, showing excessive wear. Bottom seal not tight to slab.

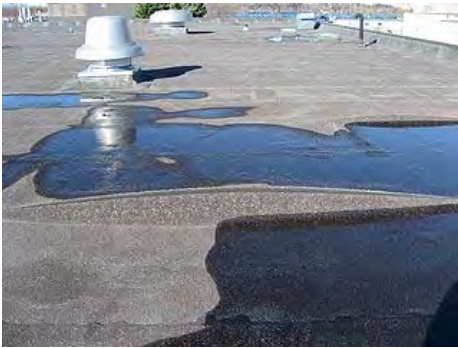
Blisters have occurred in recent years.

Blister of Modified bitumen roofing. Repaired in 2012.

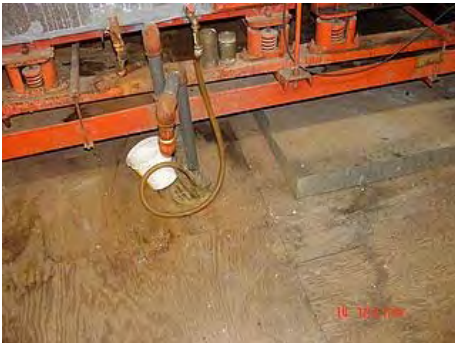
Select areas are water stained.

Water stained plywood flooring in mechanical mezzanine.

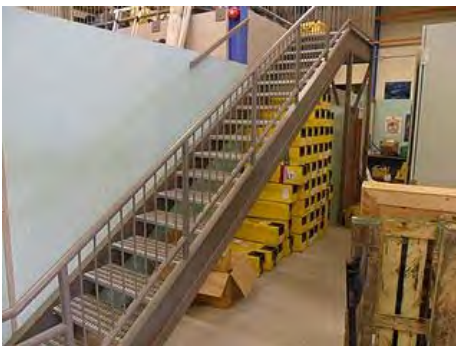
Scraped painted surfaces.

Steel stair to mezzanine - expanded metal treads, open riser.

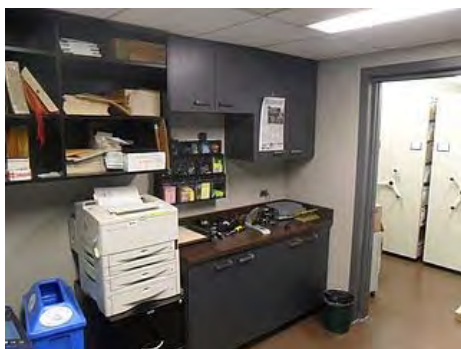
Default Yes
Catches are not operating.

Work surface and cabinets in office equipment room.

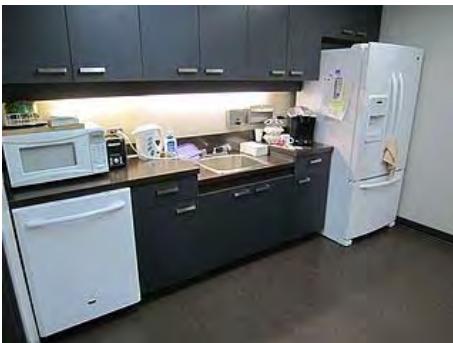
Kitchen sink and appliances

Replace all washroom and kitchen sinks throughout the building.

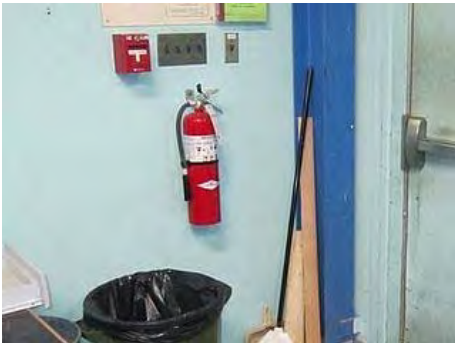
The fire extinguishers were mostly replaced between 2008-2010 and are in excellent condition. Based on maintenance and mandatory testing results, the minimum lifespan is 12 years. So, budgeting cyclical replacement of one unit every 3 years is the preferred approach. This cycle is scheduled to start in 2022.

ABC Fire extinguisher (1 of 6)

Budget to replace one portable fire extinguisher every three years, wherever required.

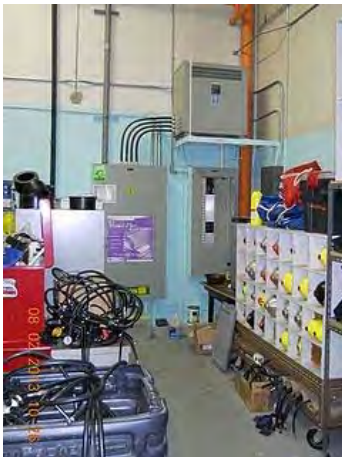
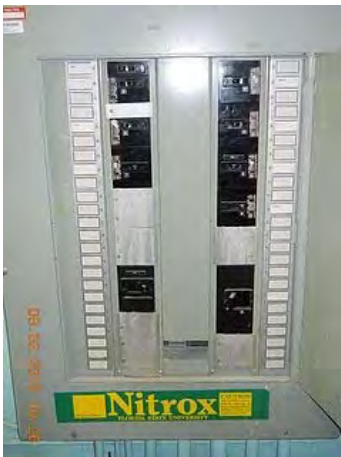
The building service CDP is in good condition and with maintenance should be replaced or reevaluated in 2022.

Warehouse area where service is located.

Service CDP.

Replace the service CDP.
