Asset Performance Report

DFO-FWI - Main Lab-Administration Building

September 2013

PWGSC – A&E CoE
Winnipeg, Manitoba
Edmonton, Alberta
Project - R.060627.001

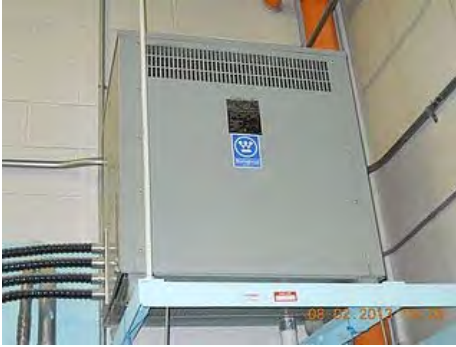
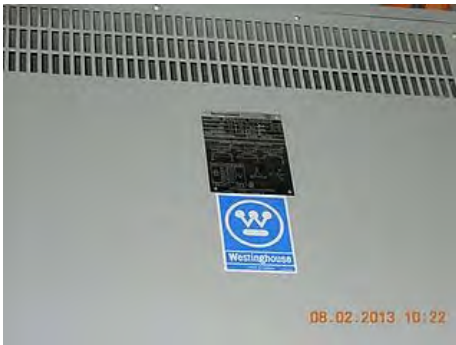
The 150 kVA transformer is in good condition and with maintenance will last at least until 2027.

Transformer above CDP in warehouse.

Westinghouse specification for dry type transformer.

Replace transformer.

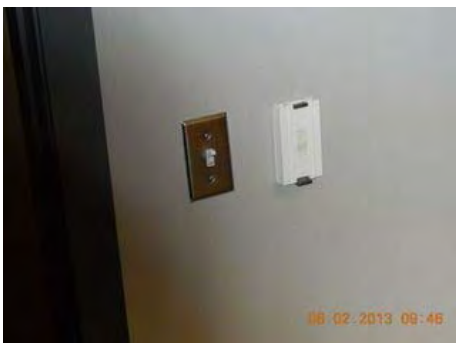
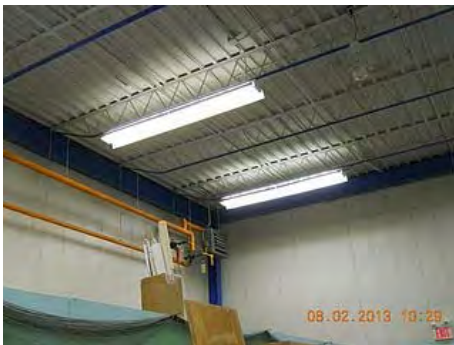
The office renovation and the distribution were installed in 1992 but the warehouse is the original 1972 construction. The two 1972 panelboards and the devices in the warehouse are in fair condition and should be replaced by 2018 and the office area distribution around 2032.

PRI lighting control switch.

Wiring in warehouse.

Replace devices and wiring in the warehouse area.

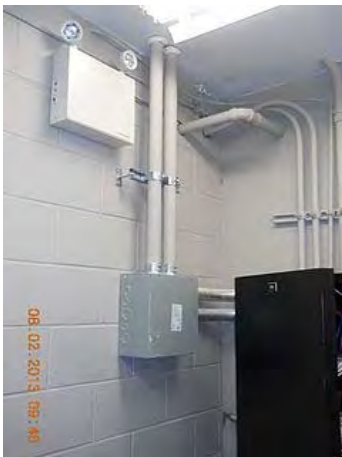
EMT conduit and wiring.

Replace wiring and devices of the 1992 office area.

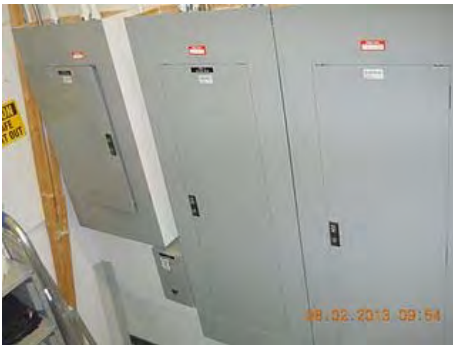
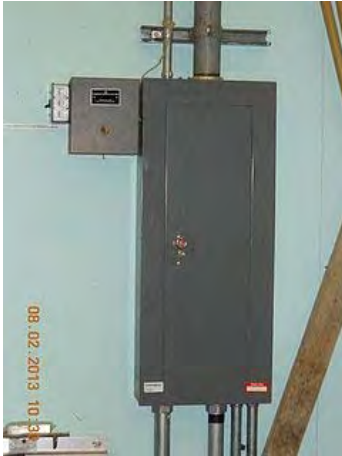
The panels are installed in two different years, 1972 when the structure was built and in 1992 with the front office renovation. The 1972 panels are in fair condition and should be replaced in 2018 and the others scheduled for 2032.

Distribution panels in office utility area.

1972 distribution panel.

Replace the two 1972 panelboards and one CDP(service entry).

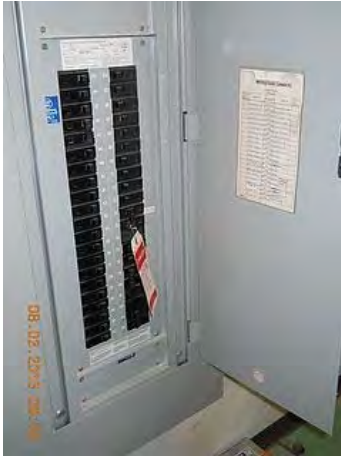
1992 distribution panel.

Replace the 1992 panelboards.

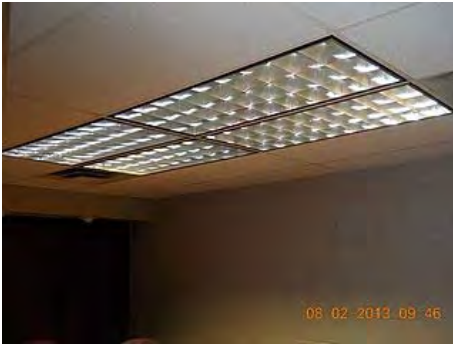
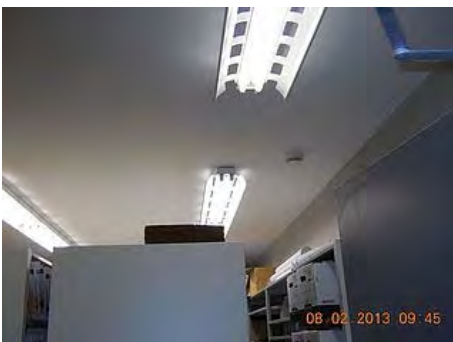
Because of the 1992 renovation, there are two generations of installation. The fixtures have T12 lamps and are considered in fair condition. All should be replaced in the next couple of years about 2015.

Lighting fixtures in office area.

Interior office deep cell fluorescent.

T12 lamps of fixtures to be upgraded.

Replace or refit fluorescent fixtures to T8 lamps.

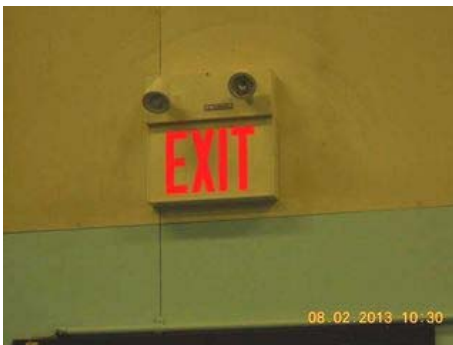
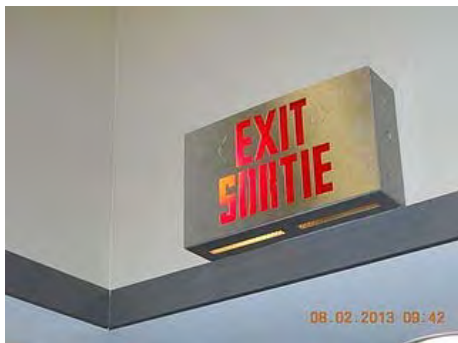
The exit signs do not meet government standard and are considered poor. Units should be replaced in 2015.

Exit signs do not meet government standard.

Warehouse self contained exit/emergency lighting.

Bilingual office exit signs - non-standard letter size.

Replace exit signs with bilingual signs having the approved dimensions.

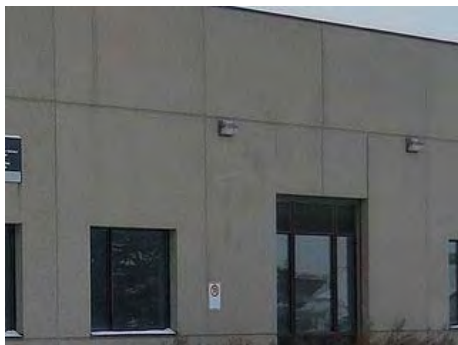
The exterior fixtures are in fair condition and beyond their life expectancy. Replacement is warranted in 2018.

Standard wall pack lighting on Small Craft building.

Replace exterior fixtures.

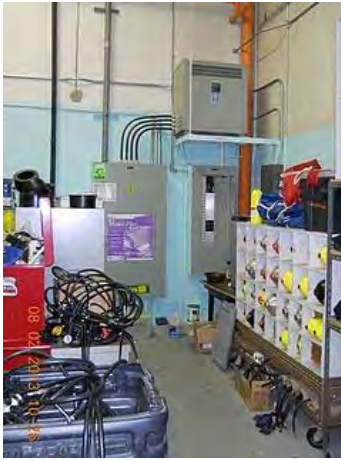
The grounding would appear to be in good condition but should be replaced when the associated distribution is in 2022.

Location of service ground.

Replace the grounding when the distribution is also completed.

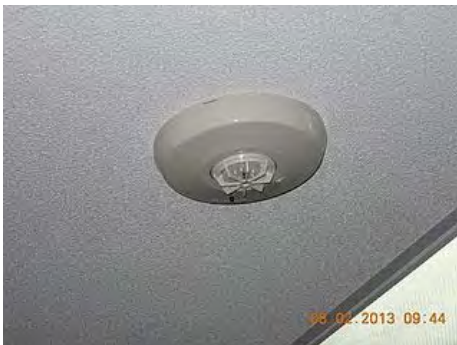
The fire alarm was installed a few years before the last major change to the main building system. The devices appear to be in average condition but at the same time should be upgraded at the same time as any upgrade of the main system which is in 2018.

Two stage pull station.

Ionization detector.

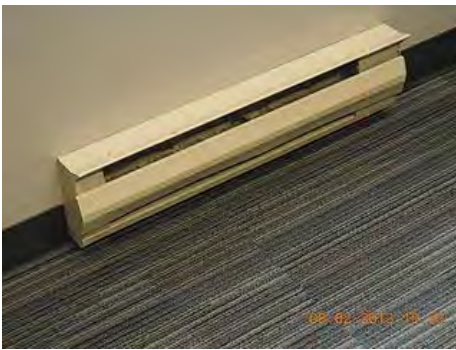
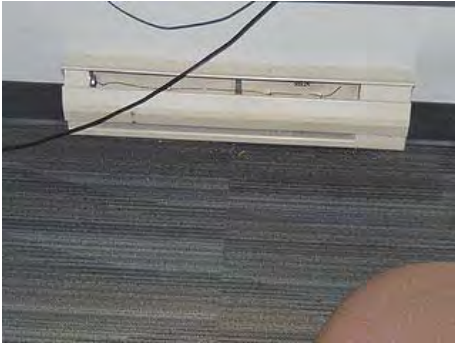
Typical electrical baseboard - old vintage.

Electric baseboard heater.

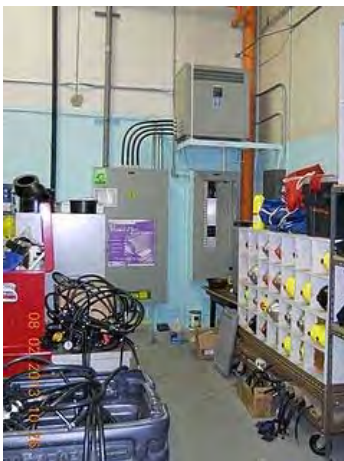
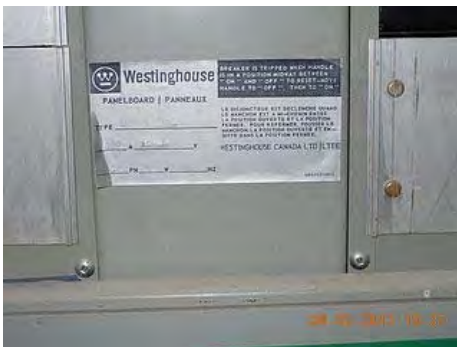
Once the existing components are labeled, no further action would be necessary unless there are utility system changes. All new equipment added after the study will have to be labeled individually. The process has not been done as of yet and is therefore considered to be in poor condition. Study should be done immediately in 2013.

Main service with two CDPs and transformer.

CDP nameplate.

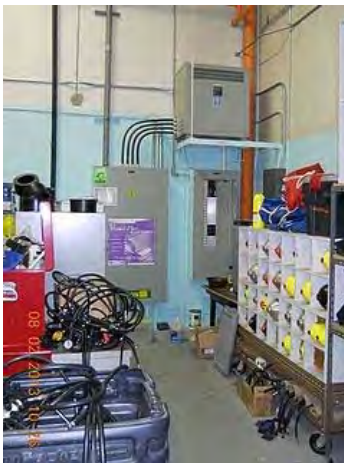
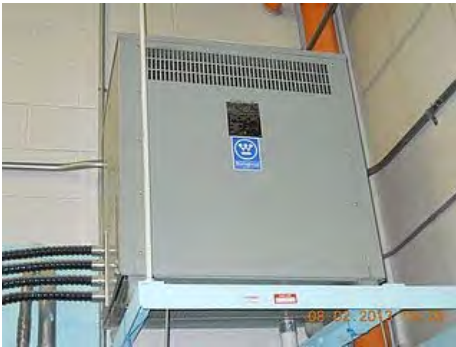
The system is in average condition but has not had any preventive maintenance done for some time. The cleaning and torquing should be done every 5 years and start in 2013.

Distribution in storage area of Craft building.

Clean and torque transformer and all electrical connections.

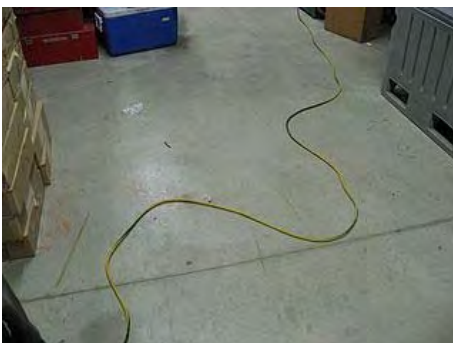
Average condition. No cracks or differential settlement is evident. The concrete is unpainted. The replacement date for this element is far beyond this BCR 30 year timeline. Therefore, no event is included.

Unpainted concrete slab.

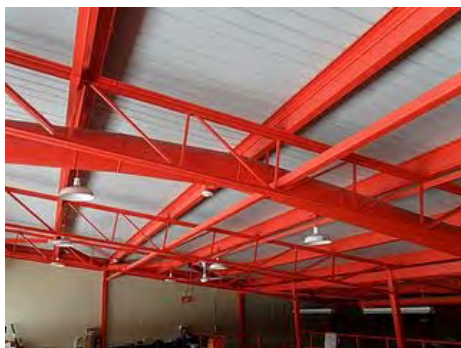
The asset's supporting structural elements are consisted in average condition. The replacement date for these elements is far beyond this BCR 30 year timeline. Therefore, no event is included. Refer to report section 01.4-060C15 Paint for repainting.

Painted steel roof structure (colour orange).

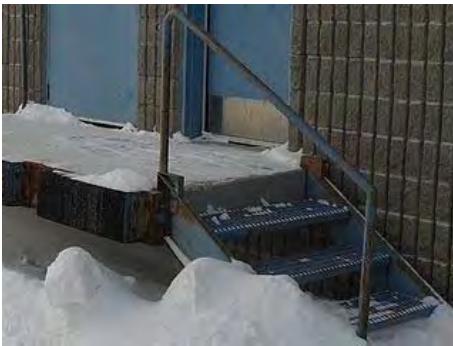
The exterior loading dock stairs have numerous unpainted sections. They are structurally functional and considered in average condition. They may need replacement in 10 years or 2023.

Loading dock serving Solvent and Chemical Storage Rooms. Dock Bumpers in fair condition. Faded paint on doors, panels and metal stairs.

Replace exterior stair assembly associated with the loading dock. This event includes the railing.

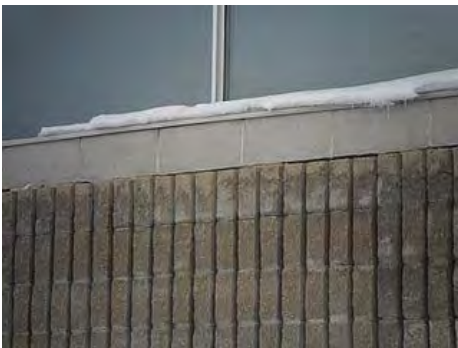
Horizontal mortar joints are deteriorated near the top of the wall. It is because the mortar which follows the profile of the ribbed block is subjected to additional weathering than a typical mortar joint. This mortar failure is due to weathering and not due to structural stress. An event is included for 2015 to address this issue.

The 1998 BCR indicated that masonry on the wall was exhibiting signs of water damage, caused by ineffective sill flashing where the metal siding meets the masonry. The sill flashing slopes back toward the building, resulting in standing water on the flashing as well as likely some ingress to the wall assembly. An event is included for 2015 to address this issue.

Mortar deterioration near top of wall.

Single wythe of block beneath windows. Mortar joint deteriorated.

Mortar joint refurbishment will prevent accelerated deterioration.

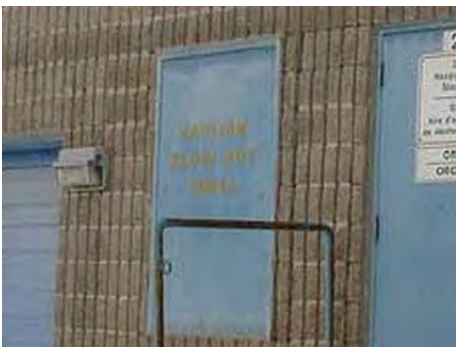
Blowout panel, east elevation, at hazardous materials area and loading dock.

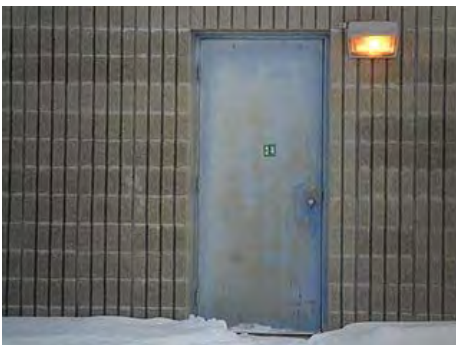
Faded paint finish.

Typical exterior door with major paint fading.

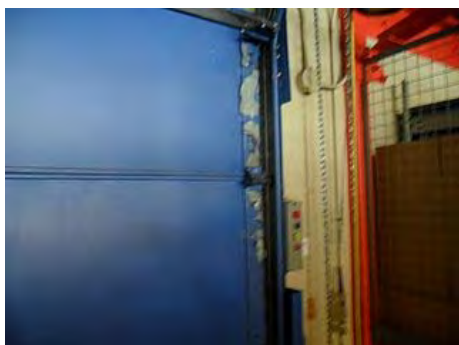
Overhead door on north side. Paint flaking off door.

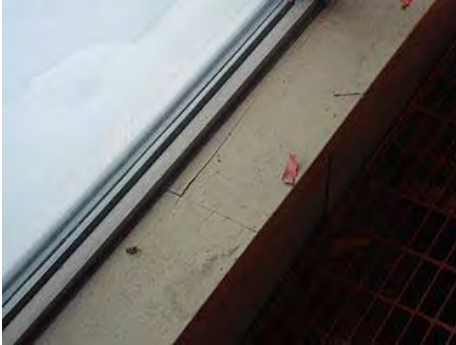
Deteriorated wood sill at windows.

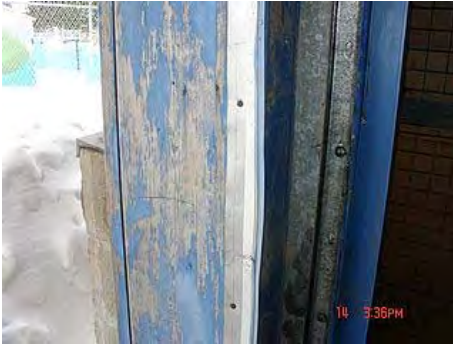
Paint flaked off at overhead wood door jamb.

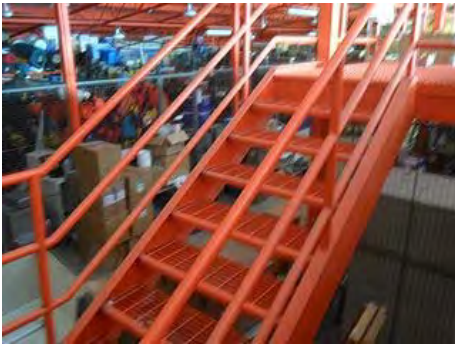
Minor worn painted surfaces.

One of two interior stairs to mezzanine.

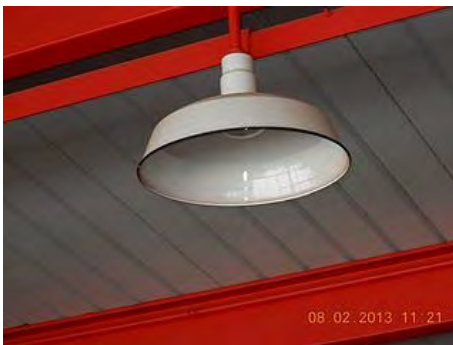
The T12 lamps are not readily available.

RML dome incandescent fixture.

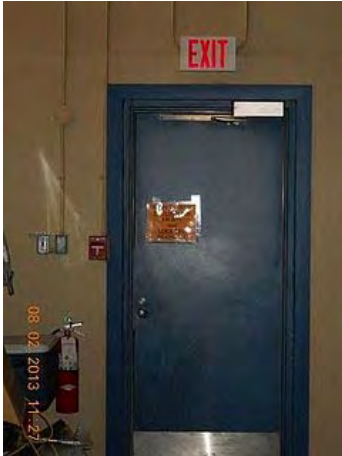
Except for an electrical issue, all other discipline site inspections revealed no apparent code violations. The electrical code issue deals with non-bilingual exit lighting. Refer to report section "04.3A-020 Exit Lighting" for details and the recommended event.

Fixtures do not meet government standards.

Exit sign.

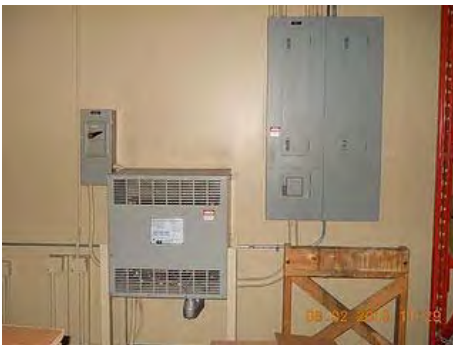
Grounding below transformer.

Replace the grounding when the distribution is also completed.

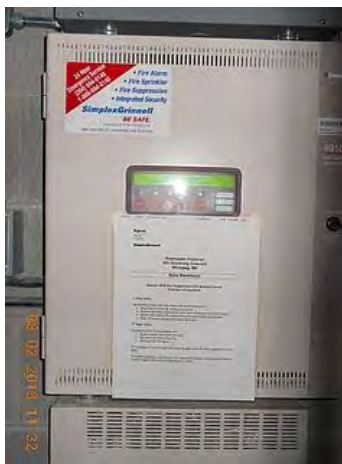
The fire alarm system in average condition and is tied to the main building system. Upgrading should be coordinated with the upgrade tentatively scheduled for 2018.

Expansion panel for local Fire Alarm system.

Replace or upgrade the fire alarm system when the main system is.

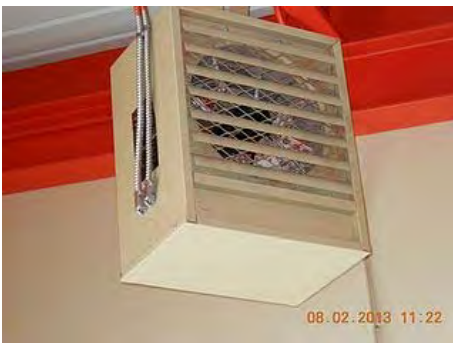
The unit heaters are in average condition and because they have limited use should not need replacement or reevaluation until 2018.

Electric Unit heater.

Replace the electrical unit heaters.

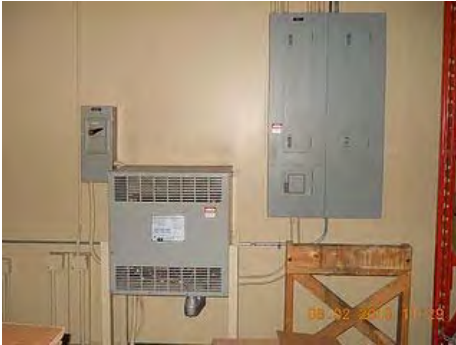
Once the existing components are labeled, no further action would be necessary unless there are utility system changes. All new equipment added after the study will have to be labeled individually. The process has not been done as of yet and is therefore considered to be in poor condition. Study should be done immediately in 2013.

Distribution for storage building.

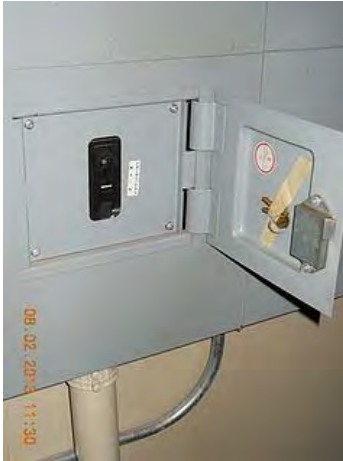
Main breaker in distribution panel.

The equipment is in average condition but has had little preventive maintenance over the years. Cleaning and torquing should be done every 5 years and start in 2013.

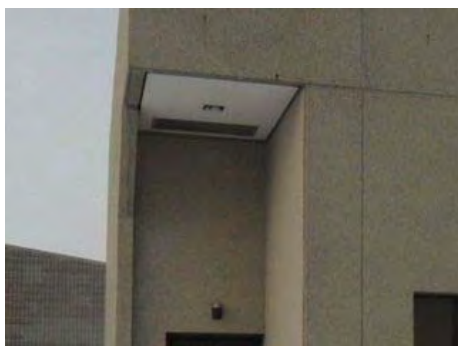
Event delay may promote falling plaster. Safety may be an issue.

Plaster soffit over main entrance. Also note, iron spotting on concrete panels.

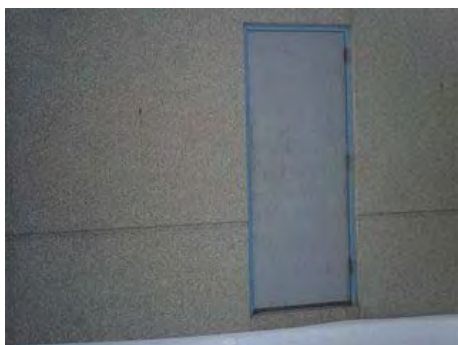
Dents, scratches and faded exterior paint.

Exterior metal door with dents, scratches and faded surface.

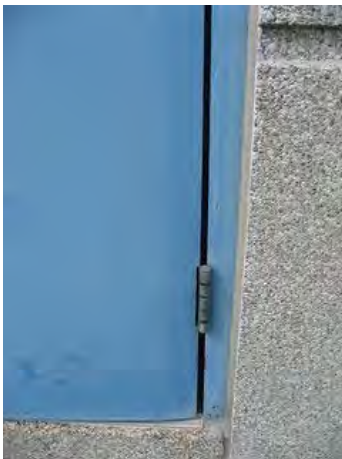
Damaged hinge at east door.

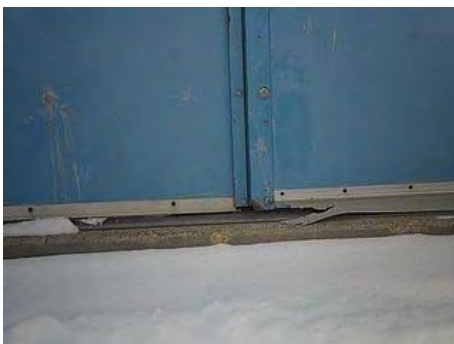
Worn weather-stripping at Doors on west side.

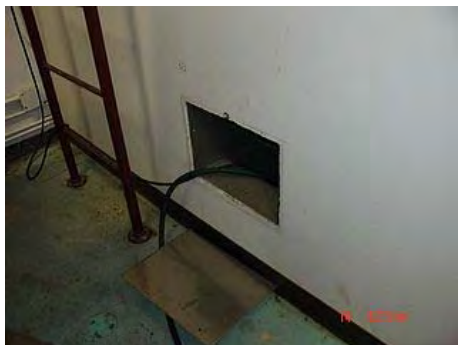
Cover Plate removed and lying on floor.

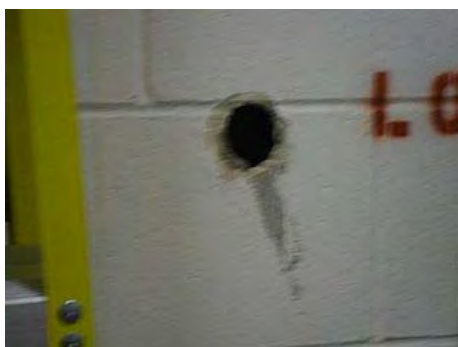
Hole in concrete block.

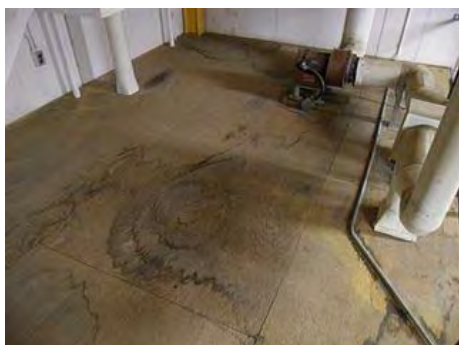
Default Yes
Water stains throughout.

Typical mezzanine floor - water stained plywood.

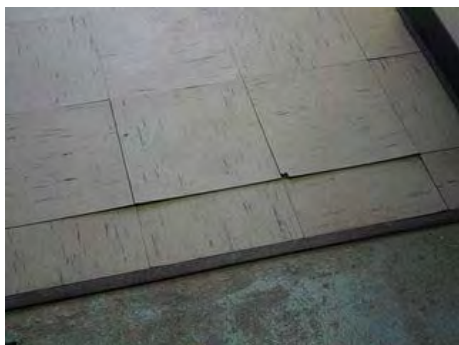
Event delay would promote an increased poor appearance and tripping hazards would be a reality.

Chipped and lifted vinyl tile. Also note, worn paint finish on concrete floor.

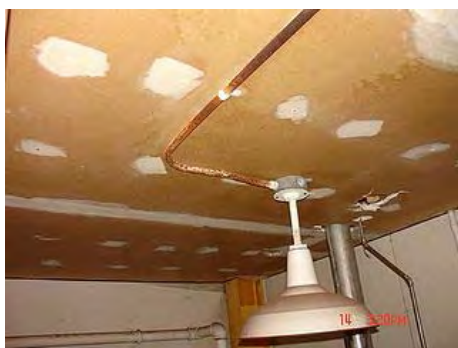
Gypsum ceiling in workshop room, unpainted, water stained and hole.

Repair and paint damaged ceilings.

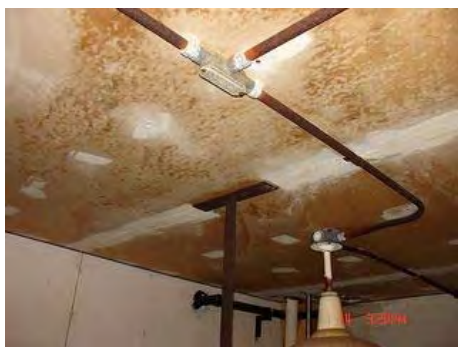
Water stained and unfinished gypsum board ceiling.

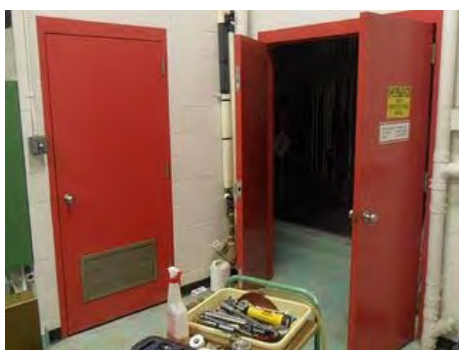
Hardware in average condition and good working order. Note, office door does not stay in open position - may not be plumb. Hardware replacements may not be necessary until 2023.

Typical interior metal doors with knob handsets, butt hinges, air transfer grille and slab lockset.

Replace interior door hardware where required. Since doors have limited use, costing is for two doors.

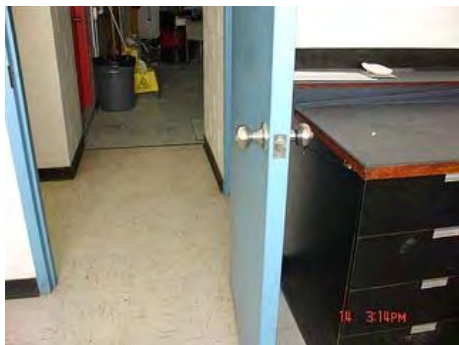
Office door with knob lockset. Door held open with makeshift wire.

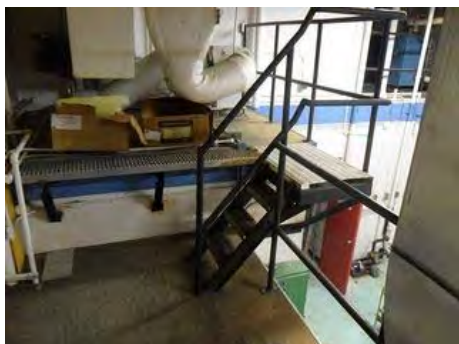
The mezzanine's structural steel stairs appear to be in sound, functional and average condition. Continued surface maintenance (painting) will ensure functionality until 2049 when the unit may need replacement. No replacement event is offered in this BCR document.

Mezzanine painted steel stair over Pit room.

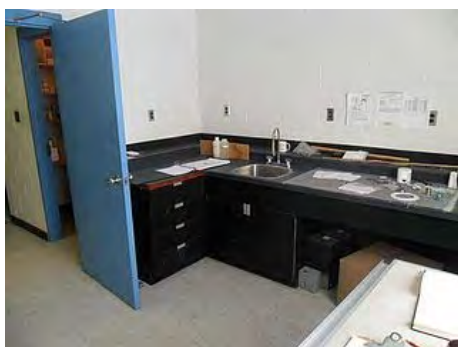
Laminate surface is peeled off and damaged. Casework's overall condition is considered fair. Repairs should be implemented in 2015 and full replacement may be warranted in 2023.

Built-in casework in Office, with delaminated laminate countertop.

Casework refurbishment will maintain functionality, appearance until replacement is warranted.

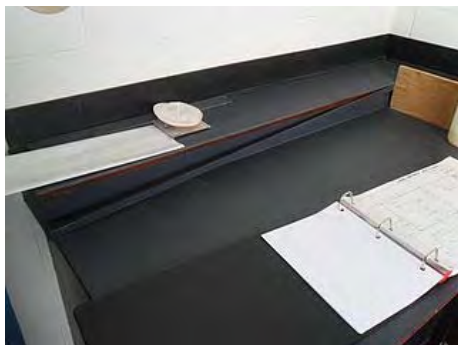
Countertop with unfastened laminate trim.

Replace entire casework assembly.

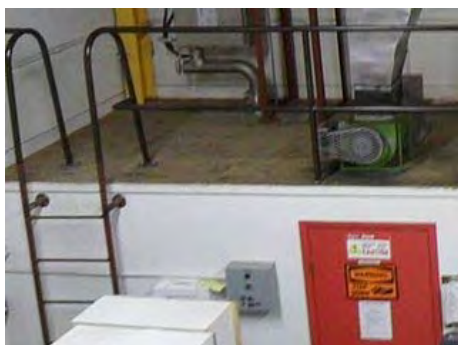
Wall mounted pipe ladder for accessing north mezzanine.

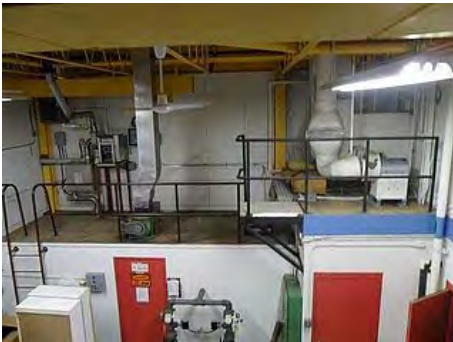
With only marred surfaces, the railings are functionally in average condition. Continued maintenance will ensure this element performs until 2024, when replacement may be warranted.

Painted pipe railing associated with north mezzanine.

Replace pipe railing associated with mezzanines.

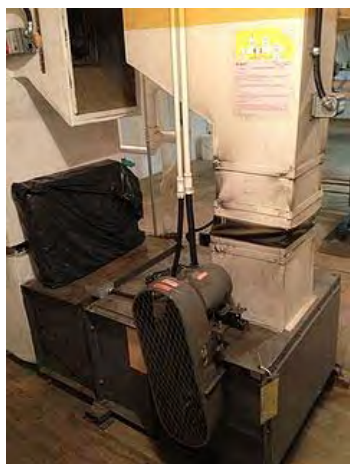
AHU-401 appears to be in average operating condition based on age (installed in 1974). The expected life-cycle of 25 years ended in 1999, but replacement has been scheduled for 2018 when it can be reevaluated at the time of the next BCR.

AHU 401 in mezzanine

This event is to replace AHU-401 when it has reached the end of its serviceable life.

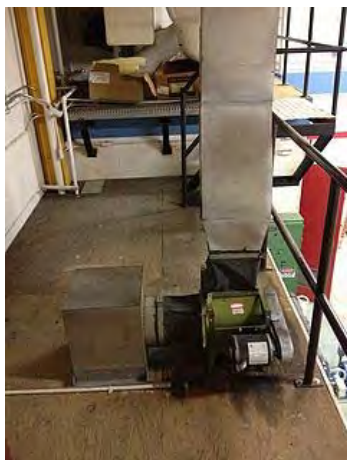
The ventilation fans appear to be in average condition with no reported issues. The life cycle replacement would have fallen on 1999. They could be considered for upgrade or replacement at the time of the next BCR in 2018.

EF 88 Ozone Mixer Fan

This event is for the replacement of the 5 exhaust fans.

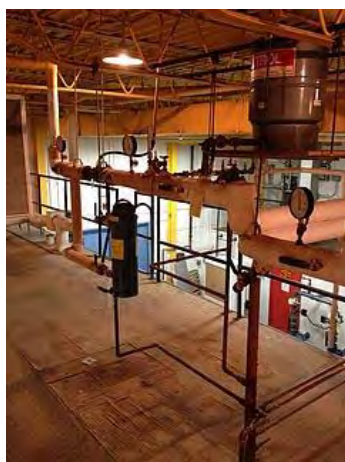
The heating piping system appeared to be in average condition with no urgent problems. The projected expected life of these systems is 30 years (2004) but this could be deferred until after the next BCR so has been scheduled for 2020.

Heating water loop

This event includes replacement of the heating piping system from the Mechanical Room in the mezzanine to the AHU and unit heaters.

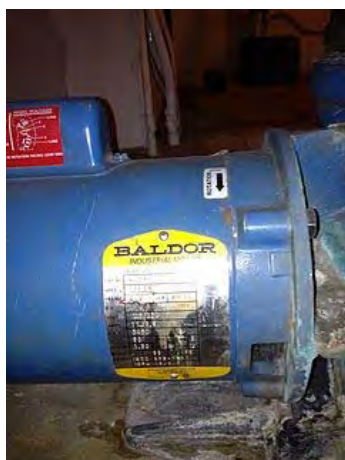
The pumps appear to be in average condition. Assuming these to be original 1974 equipment, they should have been due for replacement in approximately 2004 but can wait and be re-assessed on the next BCR in 2018.

Hot water circulating pump

This event is for the combined life cycle replacement of HVAC system pumps.

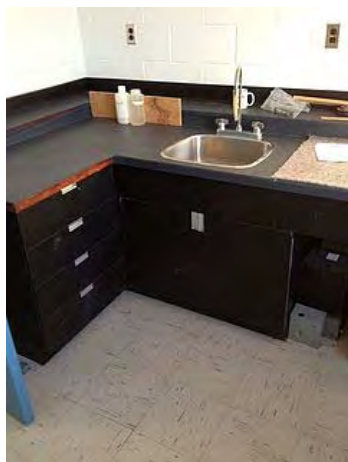
Lab sink no longer used but still functional

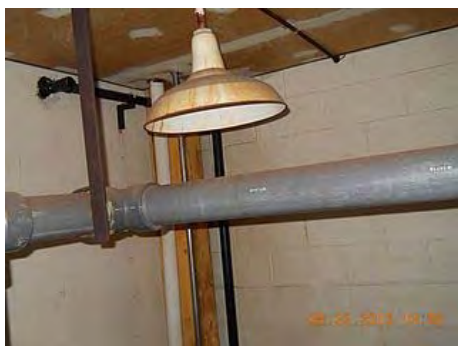
Corroding equipment.

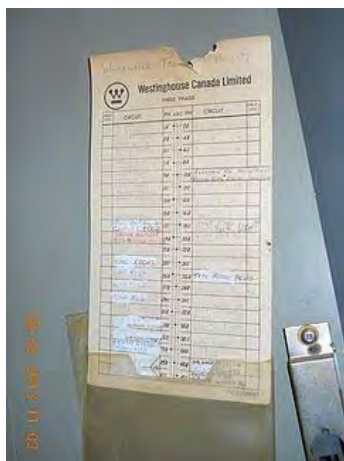
Handwritten panel directory to be upgraded.

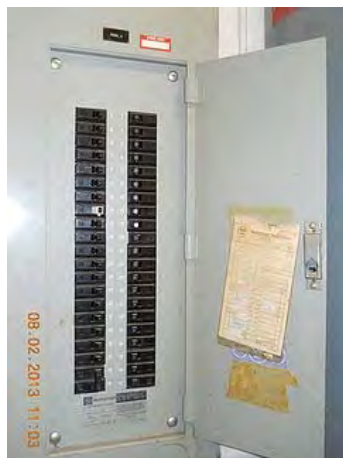
Directories are not up to date.

Panelboard in electrical room area.

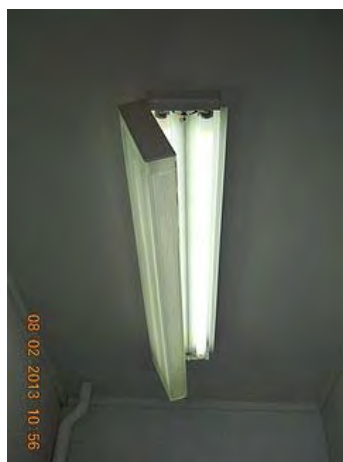
T12 lamps are obsolete.

T12 wrap around fixture.

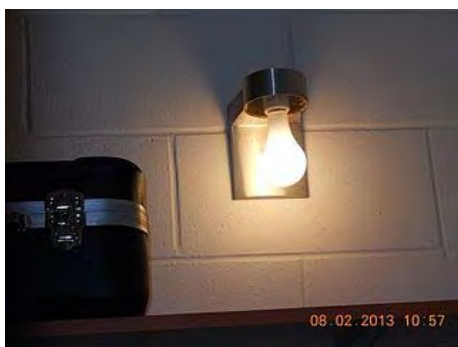
Incandescent fixture without globe.

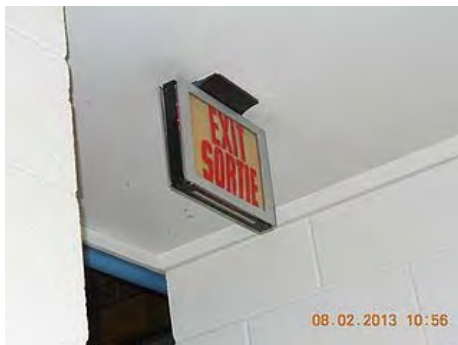
Fixtures do not meet Government standard.

Exit sign at front egress.

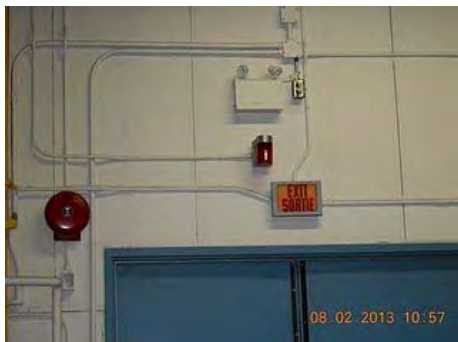
Battery pack with integral heads.

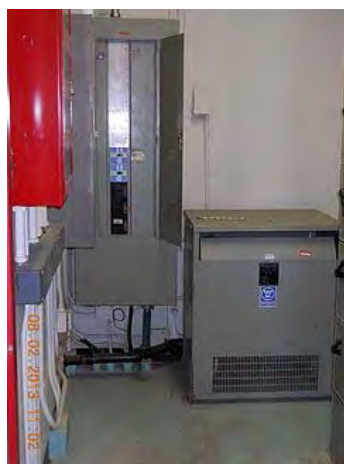
The grounding is integral with the distribution and although in average condition, the grounding should be re-instituted in 2018.

Grounding at service entry, below panel.

Replace the grounding system when the distribution is also completed.

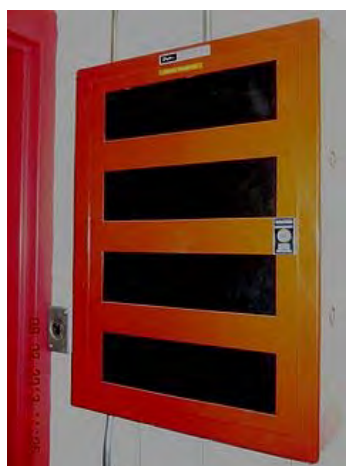
The fire alarm system piggy backs to the main building Simplex system and the condition of the devices in this building are fair. Any changes should be tied to the upgrade of the main system in 2018.

Fire alarm panel in electrical room.

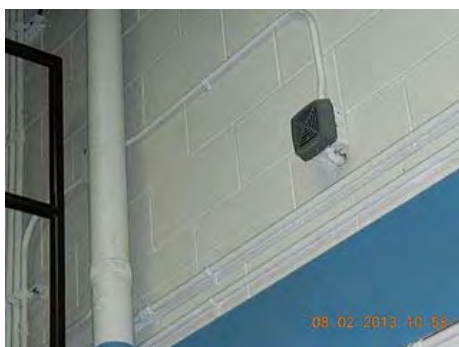
The security does not appear to tie to the main building for access but there are alarms that are both local and tied to the Building Management System. The condition of these alarms are operational and in fair condition and should be replaced with all mayor upgrades in 2018.

Alarm signal device.

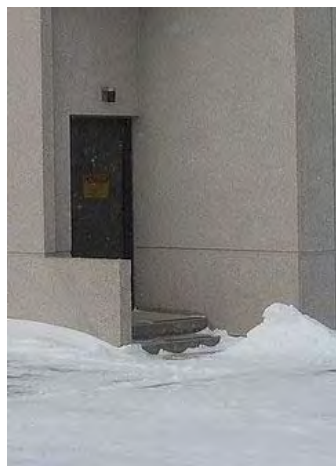
Alarm beacon over door.

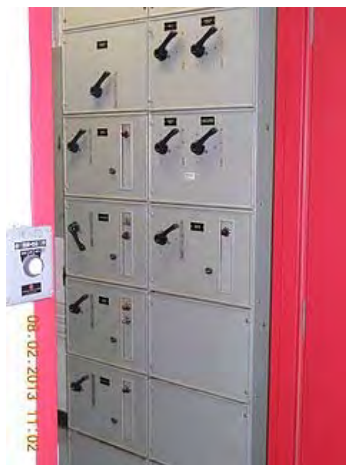
MCC Motor Control Centre.

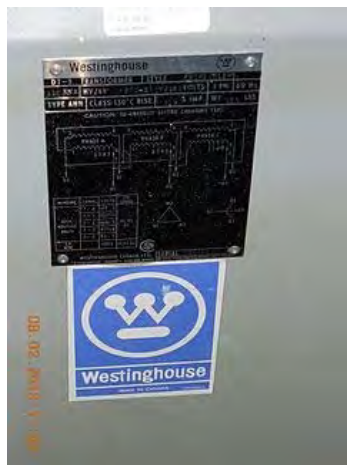
Transformer to be cleaned and torqued.

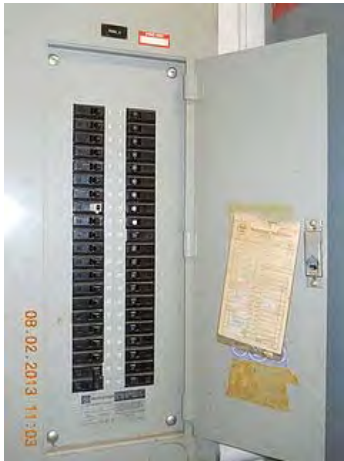
Panel to be scanned.
