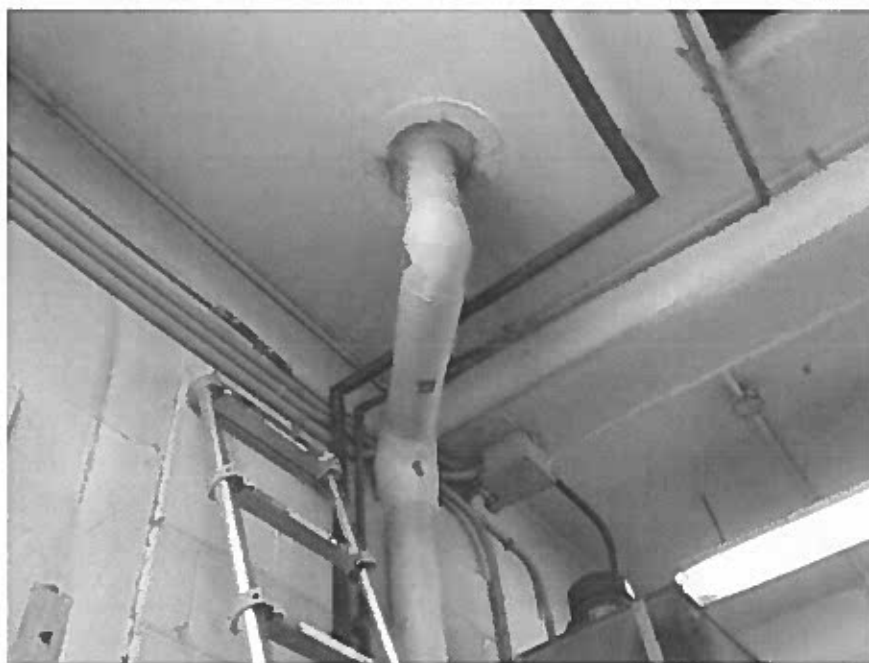
Photo 2 – Rez-de-chaussée – Isolant sur sections régulières et irrégulières de tuyauterie, sans amiante, #1-A, 1-B, 1-C

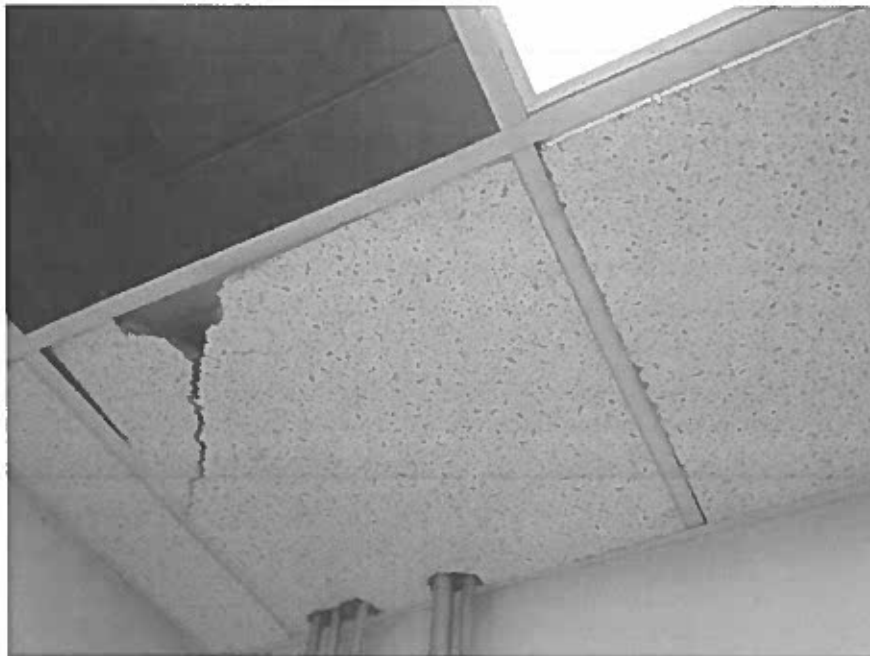
Photo 9 – Local C-019 – Sous-sol (section ajoutée) – Tuile acoustique 2'X4' avec lignes et trous, sans amiante, #1

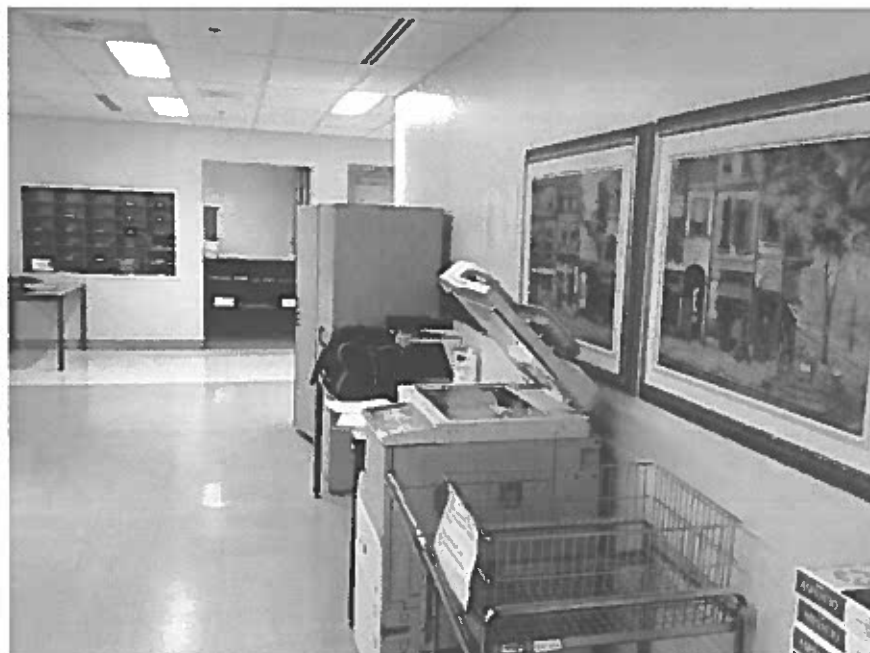
Photo 10 – Locaux C-019, C-025/C-026, C-025, C-025/C-013, C-013, C-021 – Sous-sol (section ajoutée et quais) - Composé à joint sur placoplâtre sur mur, sans amiante, #2-A à 2-I

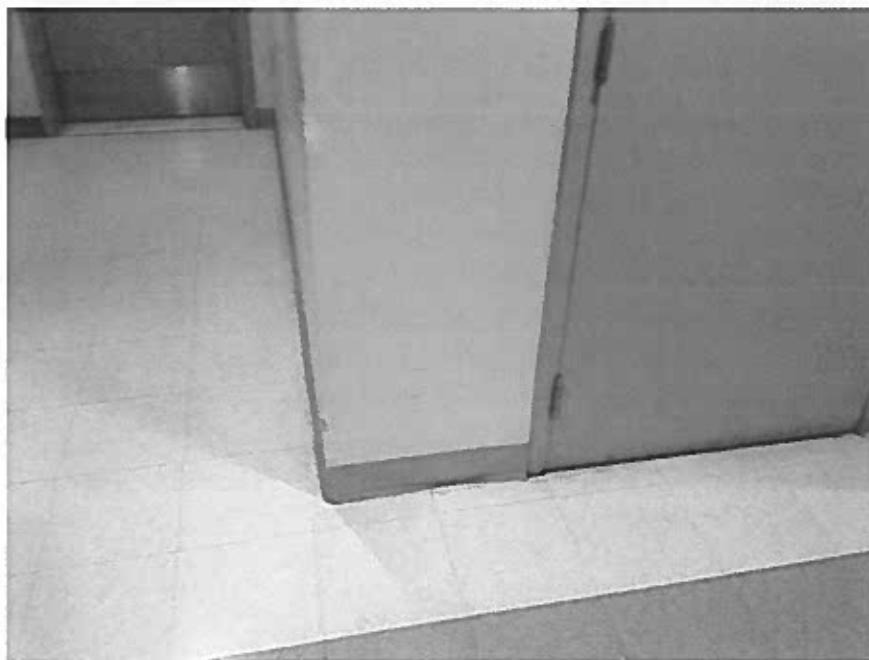
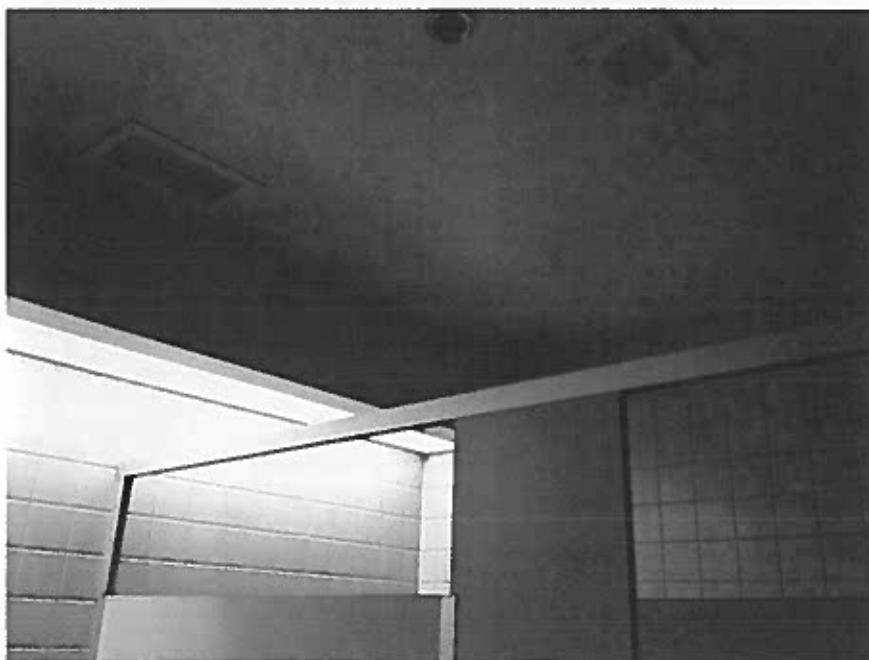
Photos 11 et 12 – Locaux C-011, C-005, C-015, C-014, C-016, C-029 – Sous-sol  
(section rénovée) – Composé à joint sur placoplâtre sur mur et plafond,  
sans amiante, #3-A à 3-I

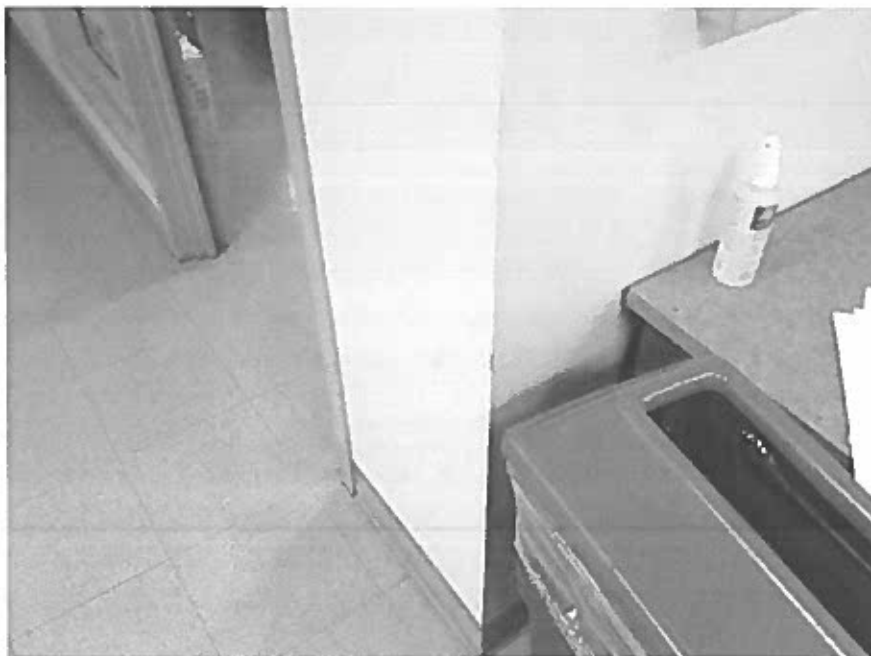
Photo 13 – Local C-019 – Sous-sol (section ajoutée et quais) – Tuile de vinyle 1'X1' grise avec points bleus, sans amiante, #4

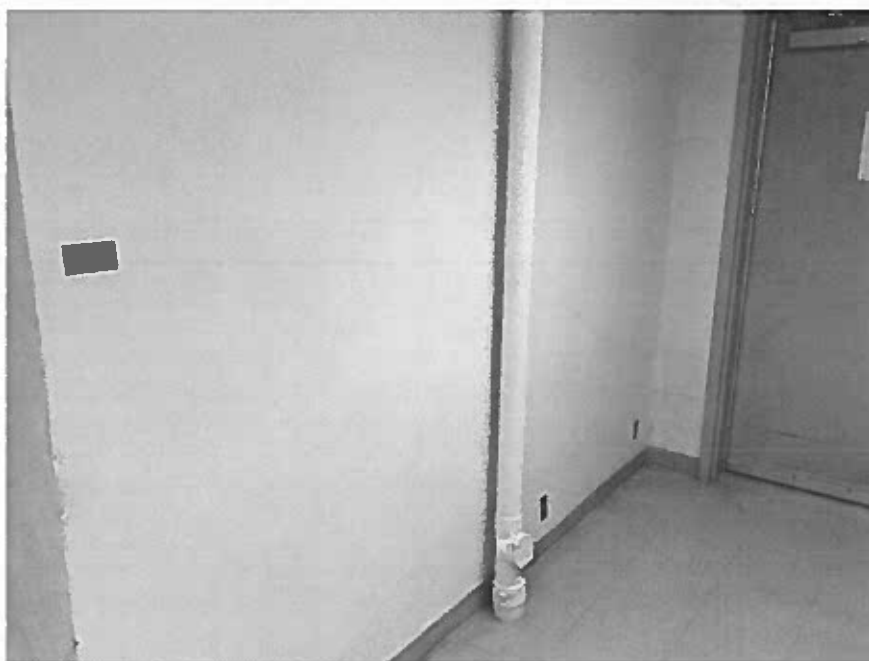
Photo 16 – Corridor donnant sur la salle mécanique C-001 – Sous-sol –  
Petite surface de mur recouverte de plâtre, SS-MUR-PL-01 à 05

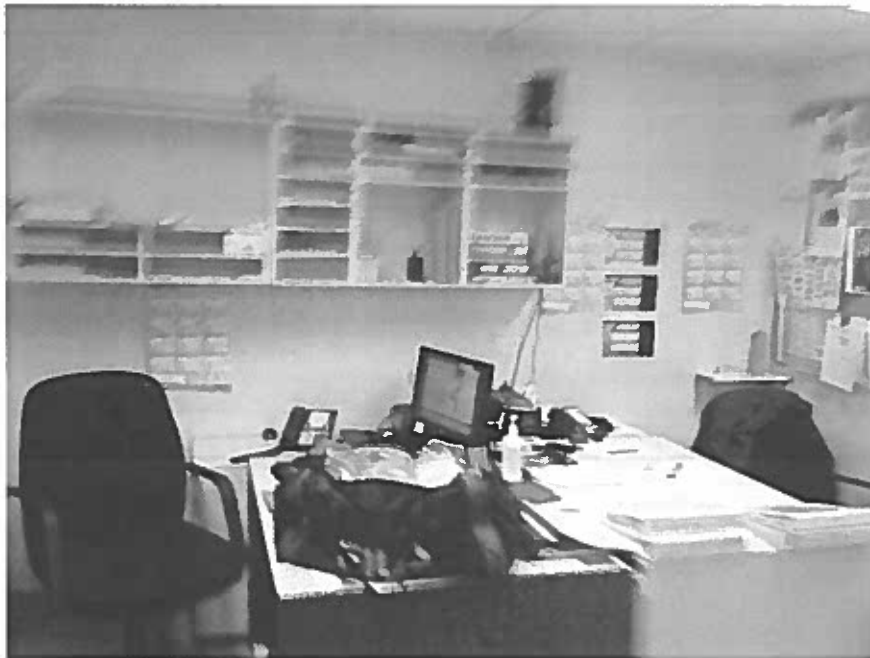
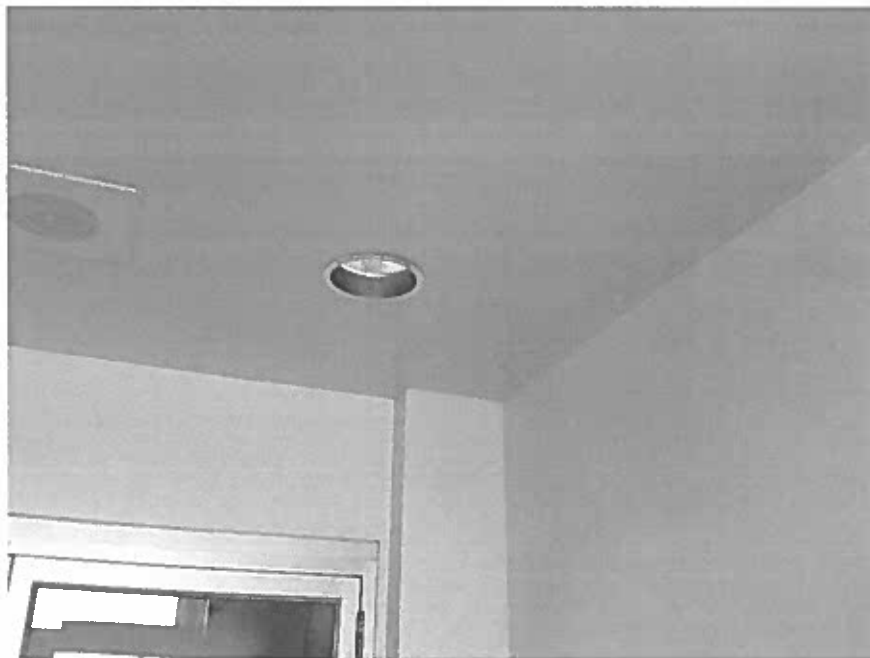
Photos 17 et 18 – Locaux C-124, C-121, C-131, C-128 – Rez-de-chaussée  
(section rénovée) – Composé à joint sur placoplâtre sur mur et plafond,  
sans amiante, #6-A à 6-I

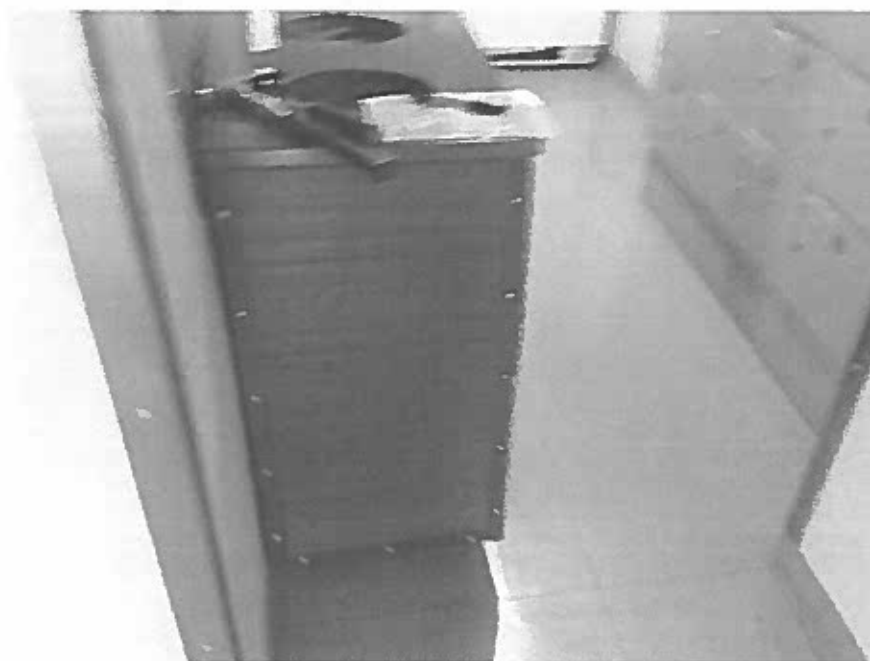
Photo 22 – Local C-128 – Rez-de-chaussée (section rénovée) – Tuile de vinyle 1'X1' grise, sans amiante, #8

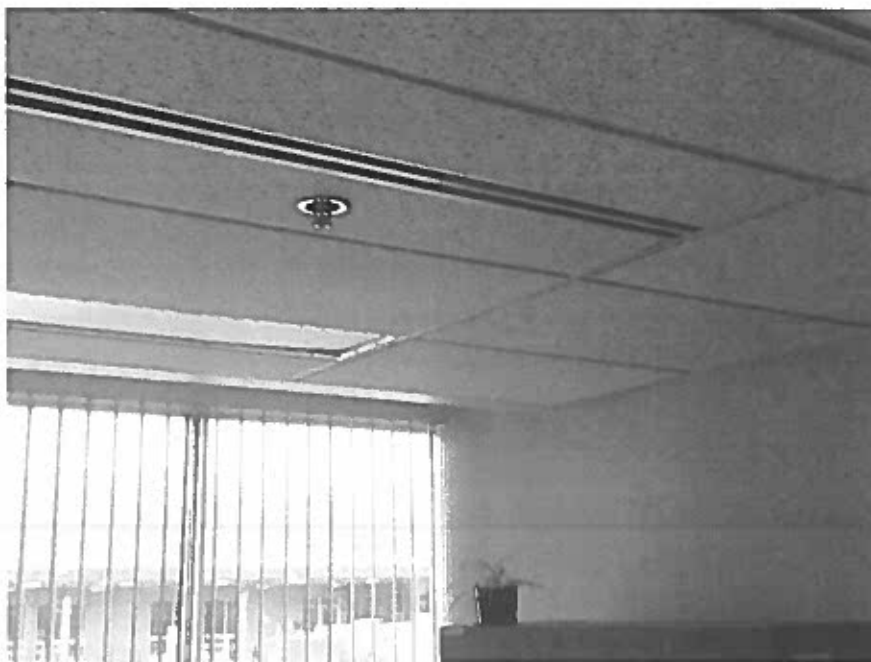
Photo 25 – Local C-124 – Rez-de-chaussée (section rénovée) – Tuile acoustique 2'X4' avec lignes et trous concentrés, sans amiante, #11

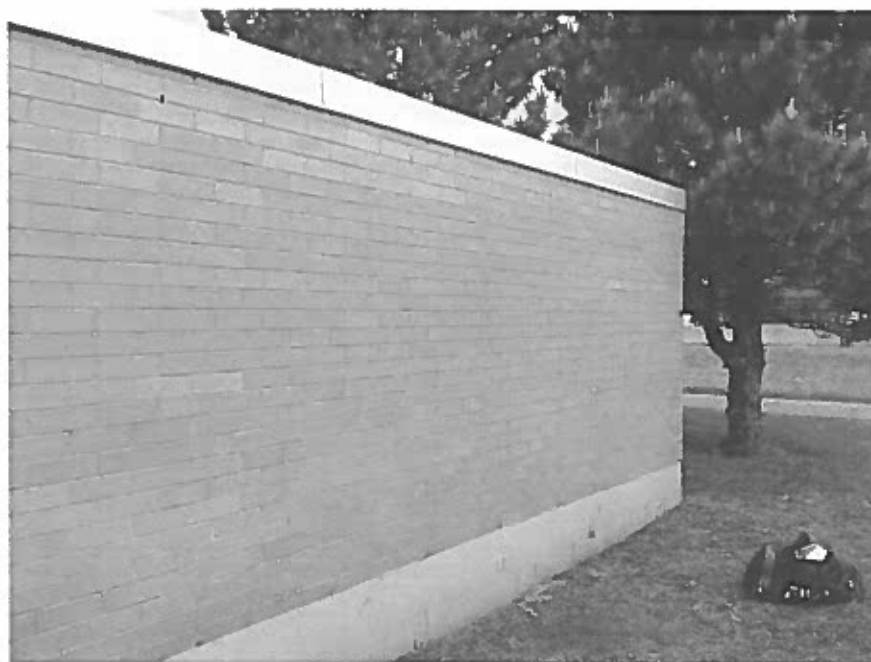
Photo 26 – Extérieur – Rez-de-chaussée – Crépi cimentaire, sans amiante, #12-A à 12-C

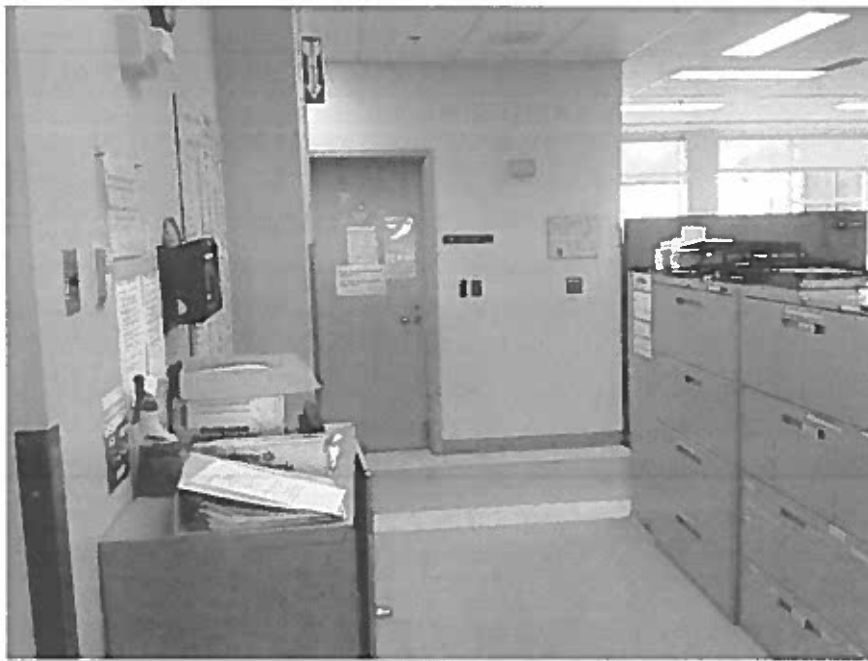
Photo 29 – Locaux I-138, I-135 I-113, I-109, I-107, I-137 – Rez-de-chaussée – Composé à joint sur placoplâtre sur mur et plafond, sans amiante, #4-A à 4-I

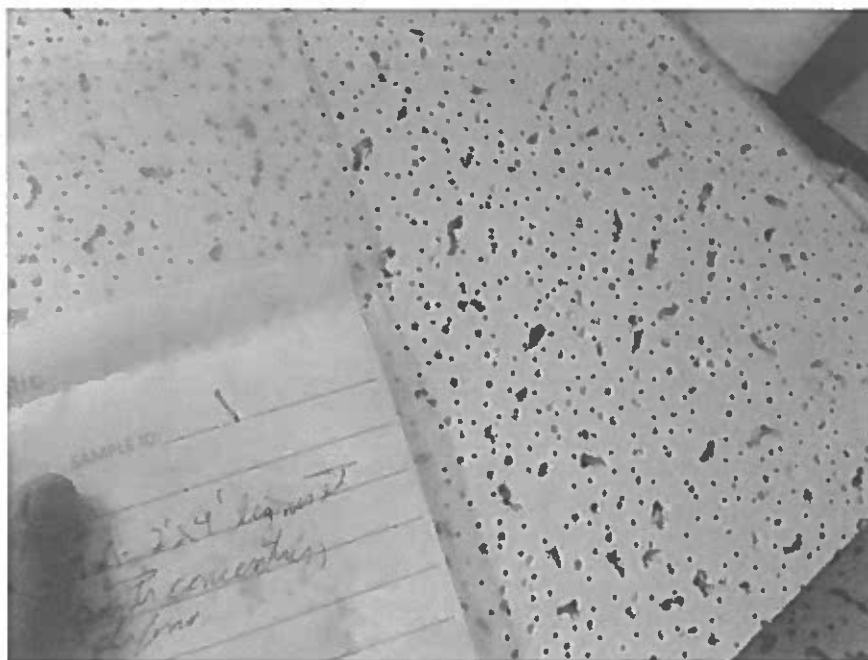
Photo 30 – Local I-222 – 2<sup>e</sup> étage – Tuile acoustique 2'X4' avec lignes et points concentrés (entrepasée), sans amiante, #1

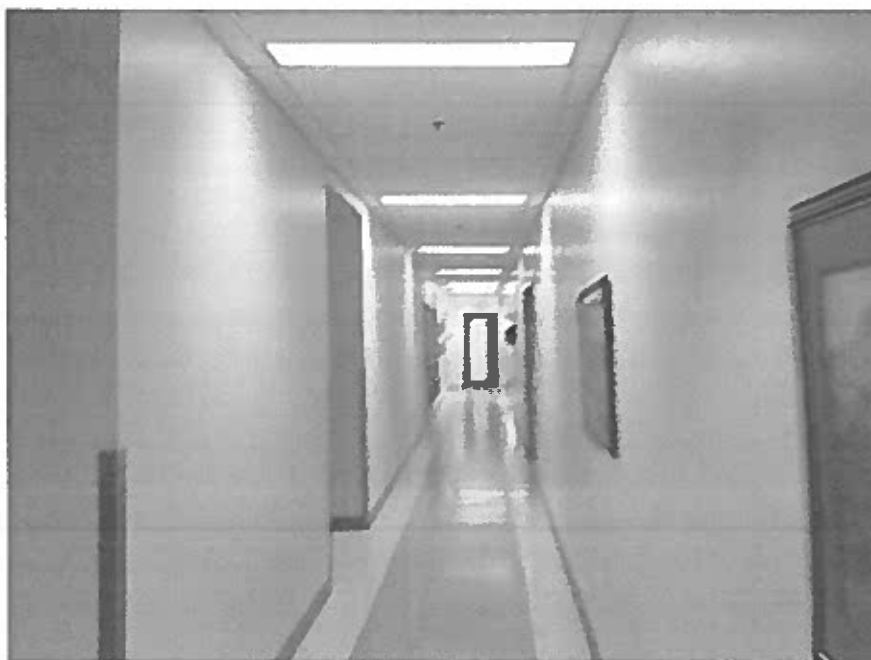
Photo 33 – Locaux I-223, I-201, I-221, I-219, I-211, I-200, I-204, cage d'escalier I-225 – 2<sup>e</sup> étage –  
Composé à joint sur placoplâtre sur mur et plafond, sans amiante, #4-A à 4-I

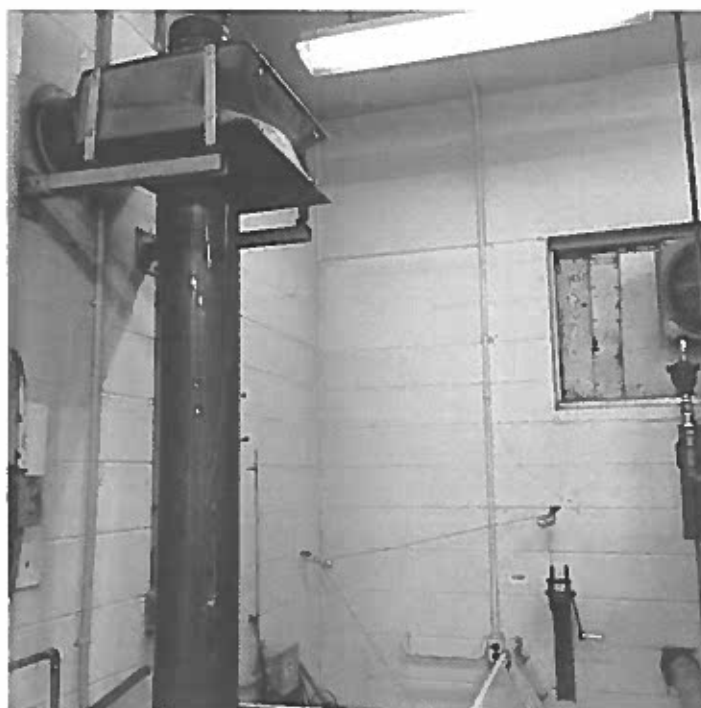
Photo 52 – Les murs en bloc de béton sont recouverts d'une peinture beige (échantillon P-2)

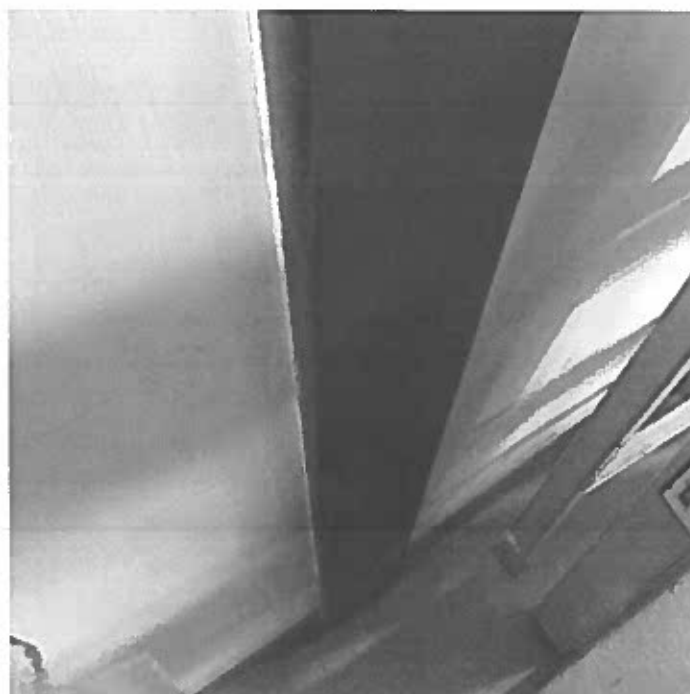
Photo 73 – 2<sup>e</sup> étage, salle mécanique – Colonne métallique recouverte d'une peinture rouge (échantillon P-3)

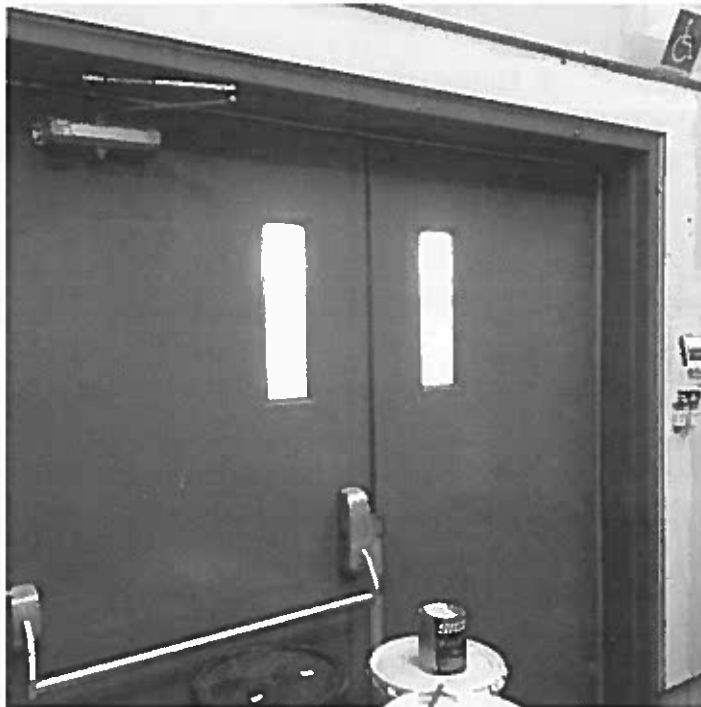
Photo 86 – Porte et cadrage métallique recouvert d'une peinture mauve au plomb  
(échantillon P-8)

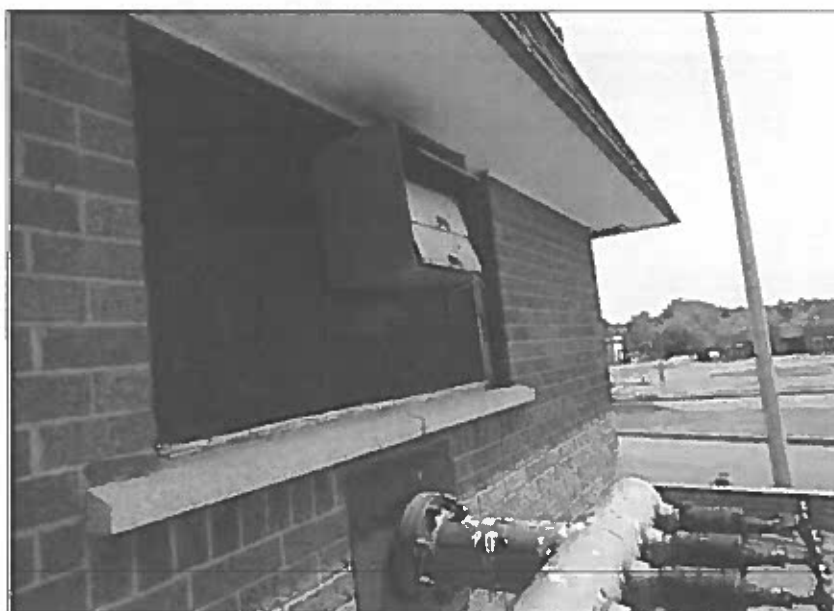
Photo 89 – Présence d'un nid d'oiseaux occupé dans la prise d'air.  
Présence probable de fiente d'oiseaux

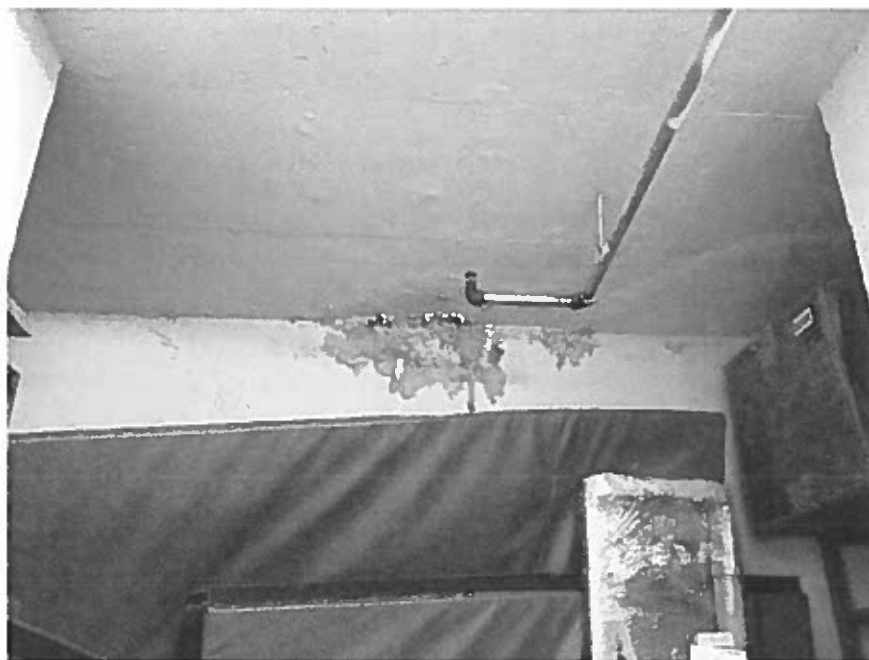
Photo 94 – C-005 – Sous-sol – Peinture sur le béton sans contamination fongique
