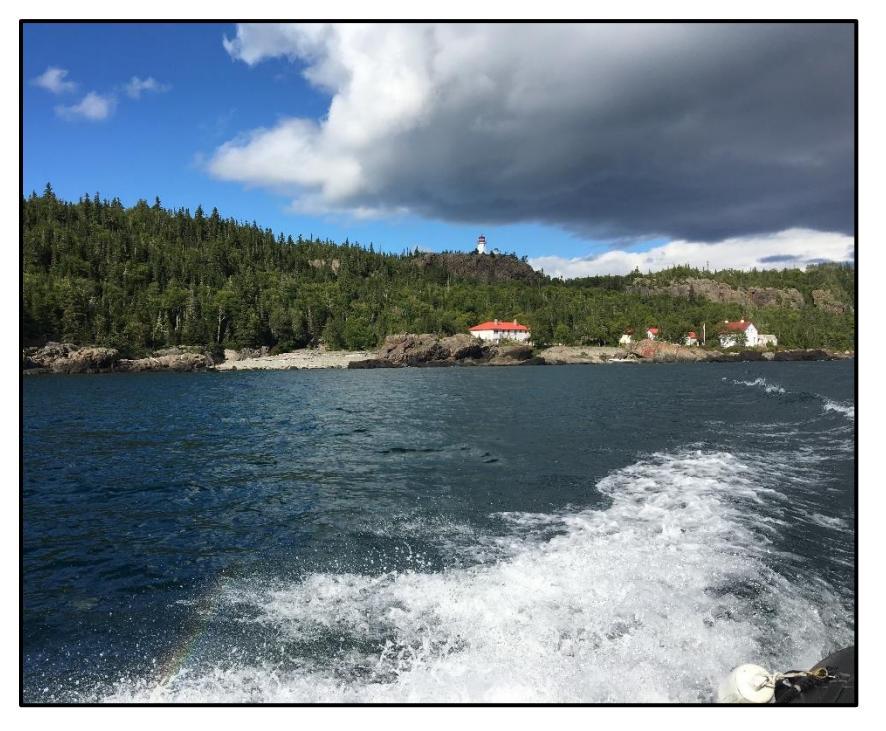
Photograph 1: View of Main Site (CS-1), facing north.

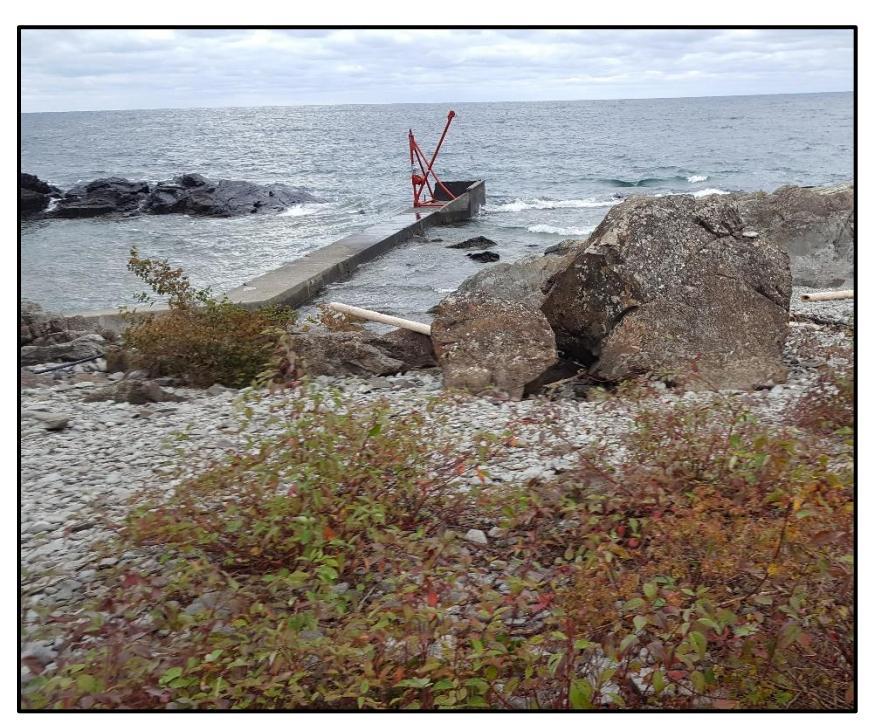
Photograph 2: View of concrete dock and hoist at CS-1, facing south.

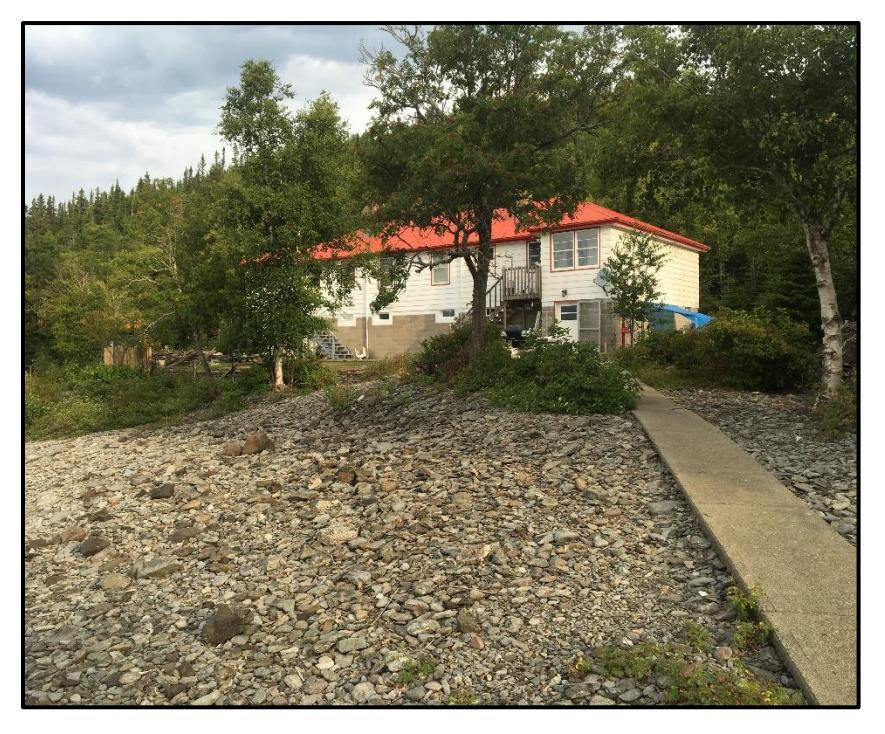
Photograph 3: View of duplex dwelling facing northwest.

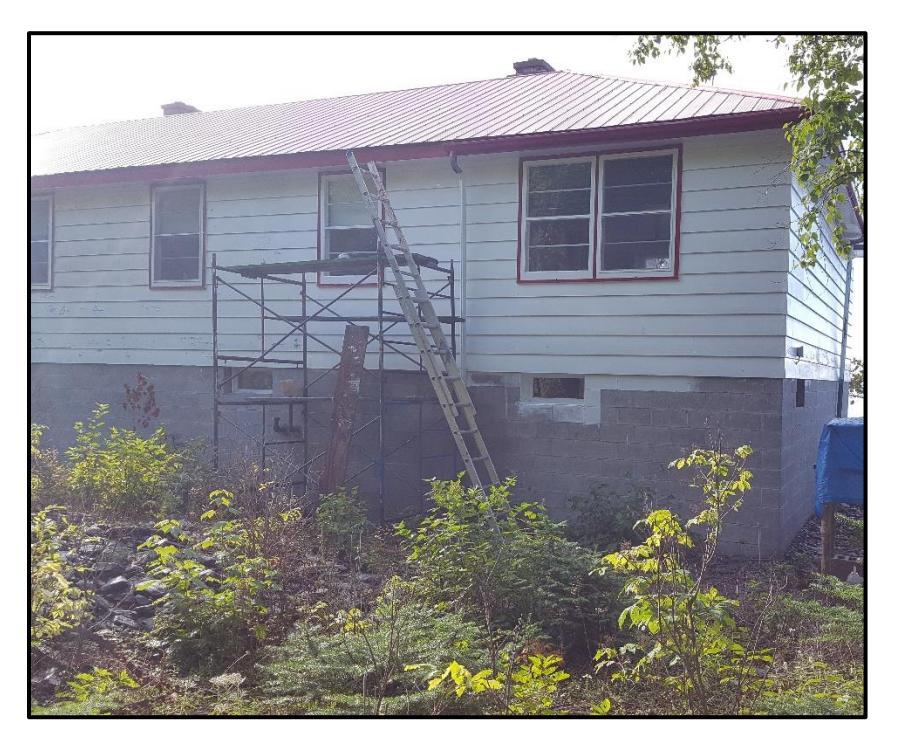
Photograph 4: View of duplex dwelling facing south.

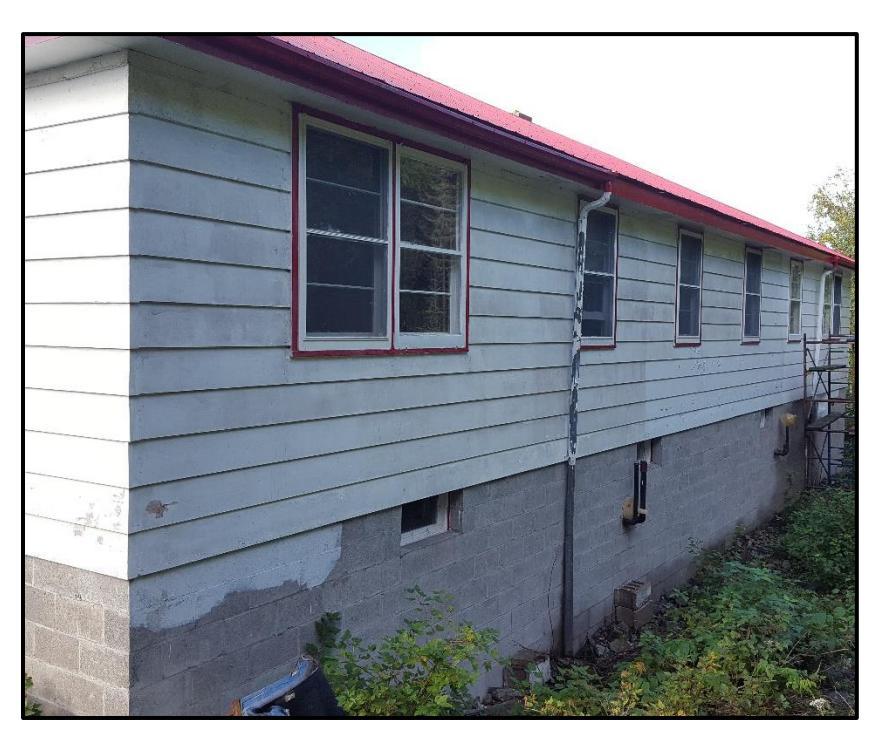
Photograph 5: View of poor condition, lead containing white paint on the exterior of the duplex dwelling, facing southwest.

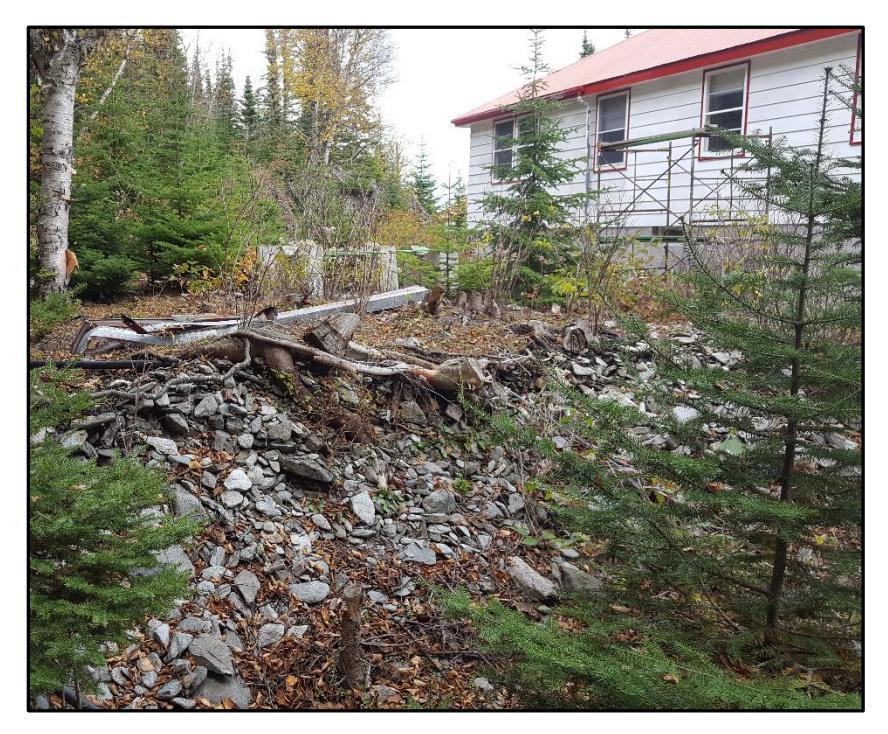
Photograph 6: View of cobble stone soils near duplex dwelling, facing southeast.

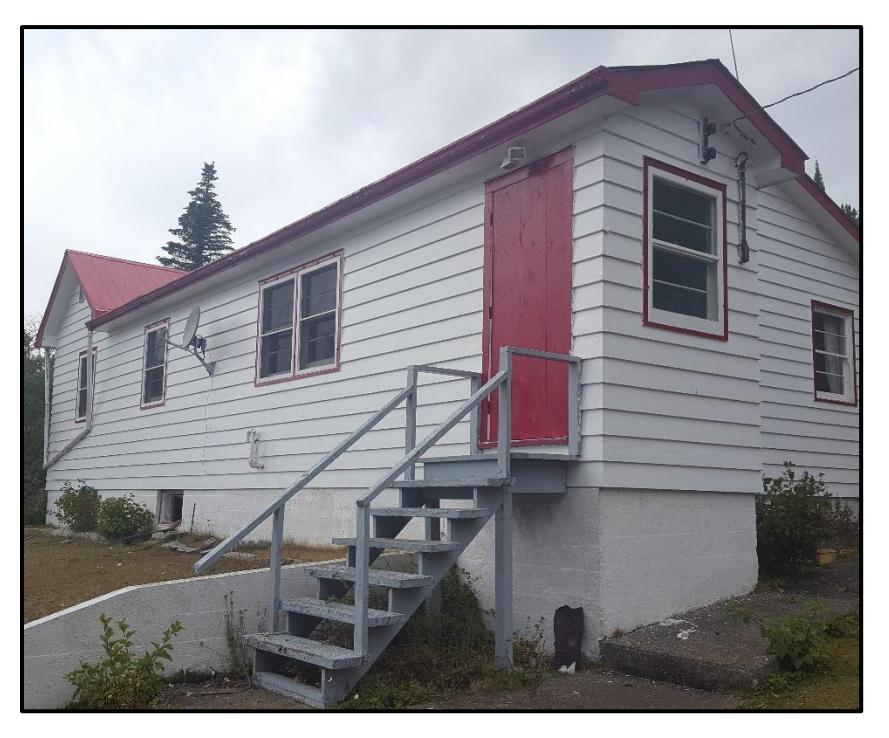
Photograph 7: View of main dwelling facing northwest.

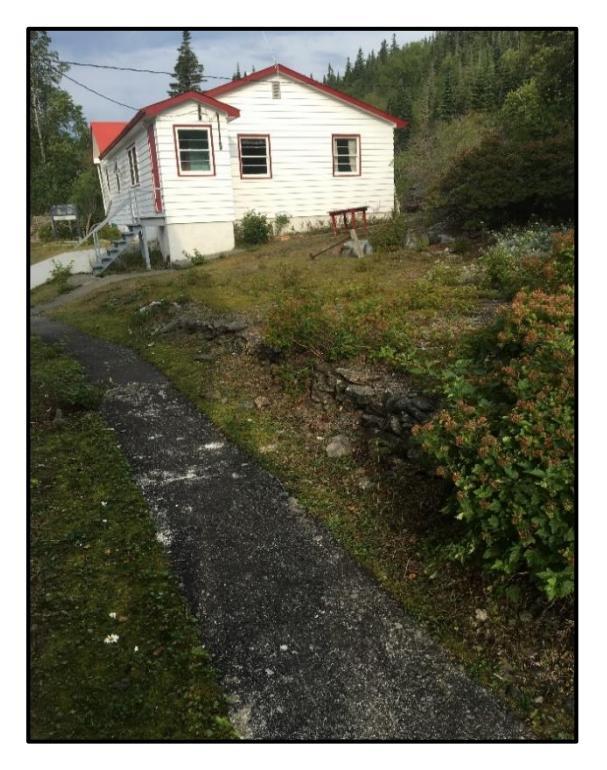
Photograph 8: View of grassed area and path east of main dwelling facing west.

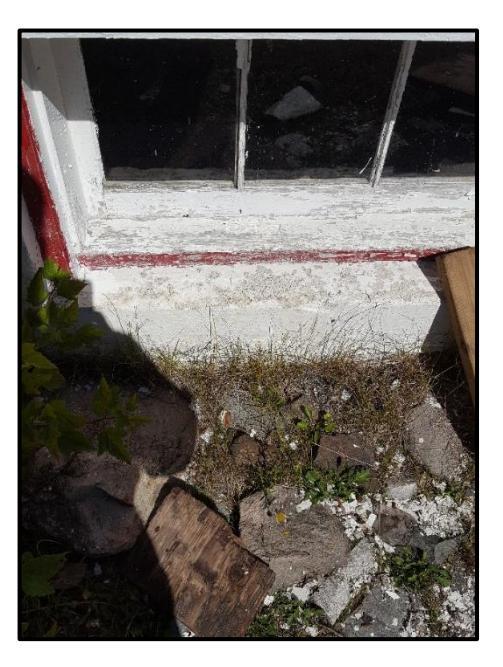
Photograph 9: View of poor condition, asbestos-containing window caulking on main dwelling, and paint debris on ground surrounding the building.

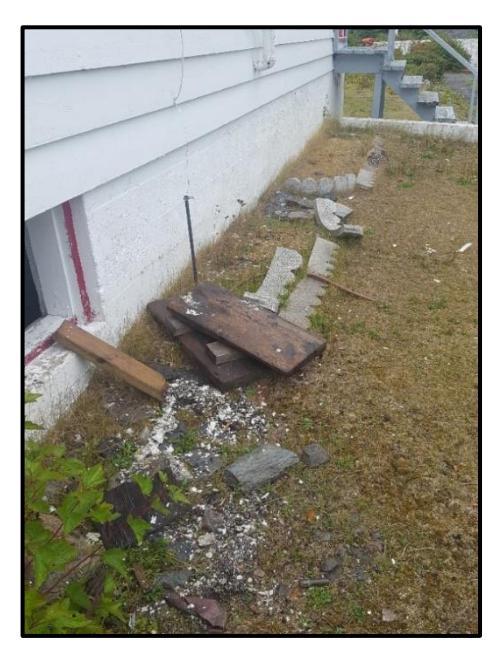
Photograph 10: View of lead-containing, white paint on main dwelling, and paint debris on ground surrounding the building.

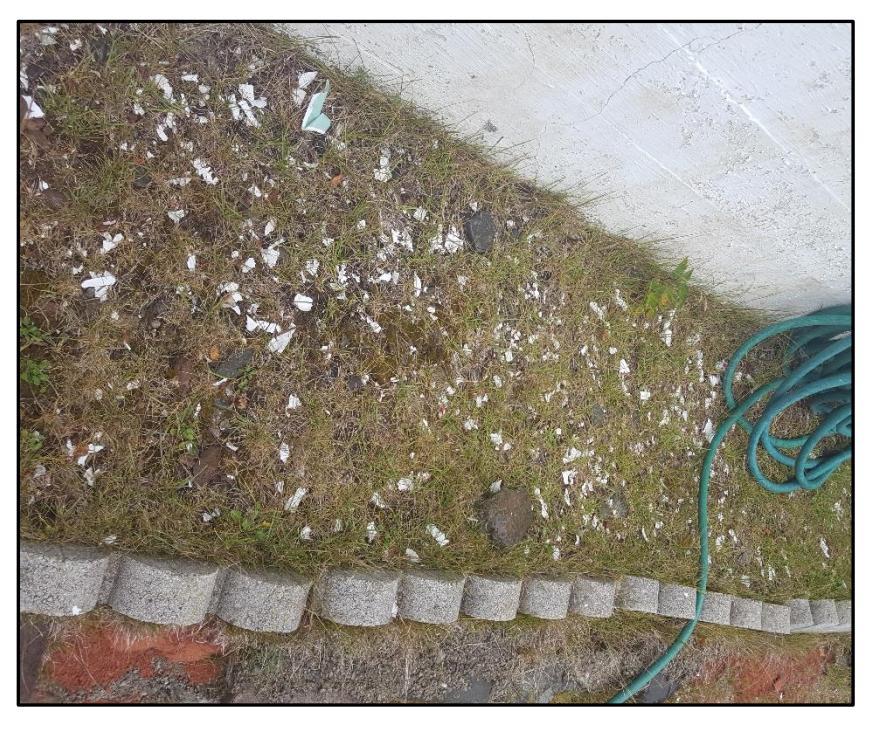
Photograph 11: View of paint debris along the perimeter of the main dwelling building, facing east.

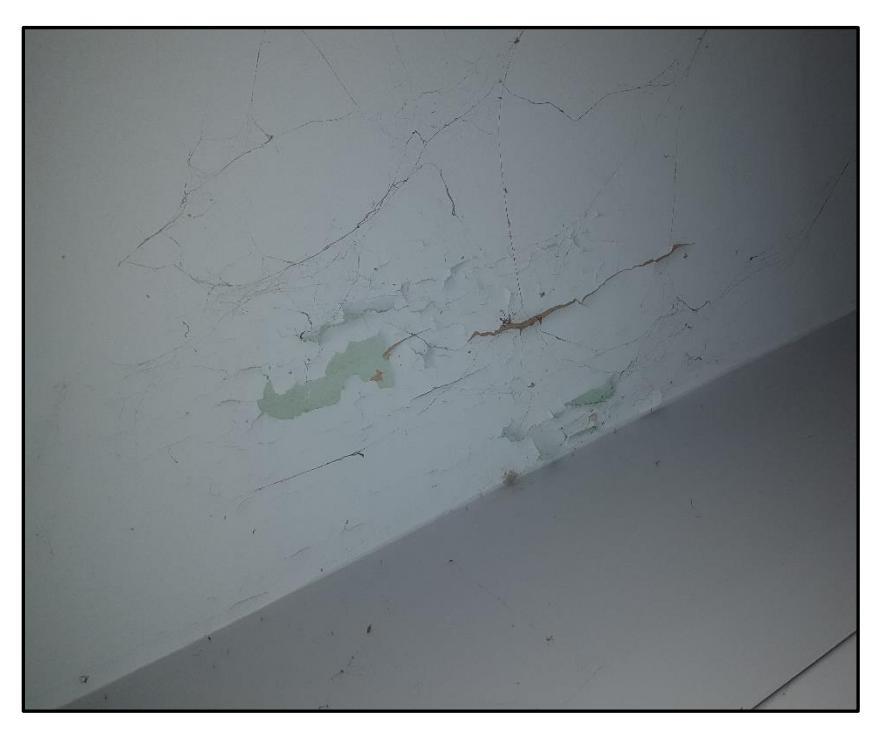
Photograph 12: View of poor condition paint in basement stairwell of the main dwelling.

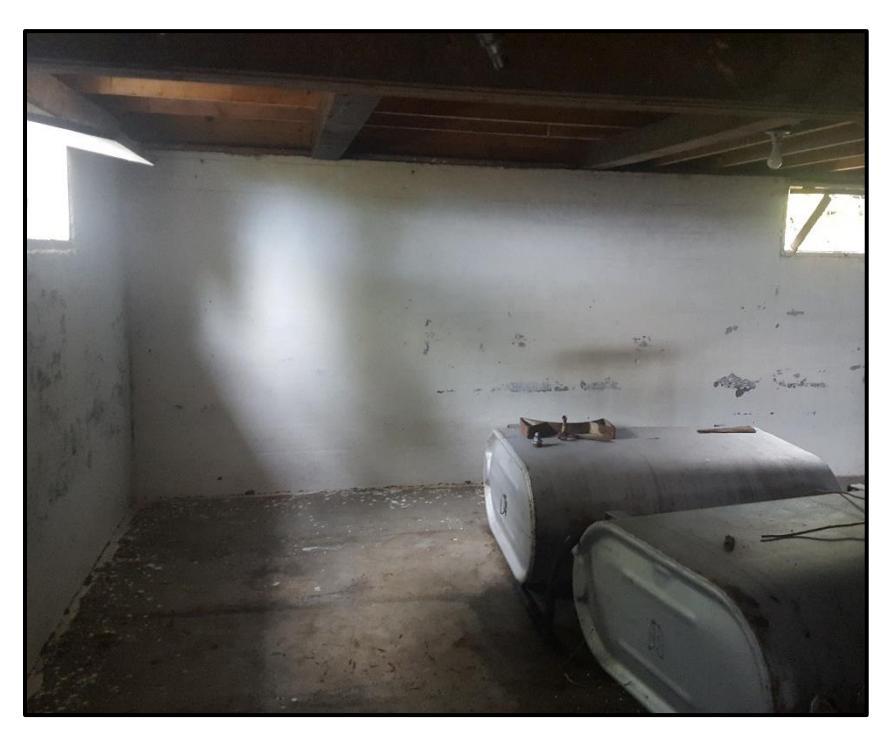
Photograph 13: View of poor condition white paint and above ground storage tanks in basement of main dwelling.

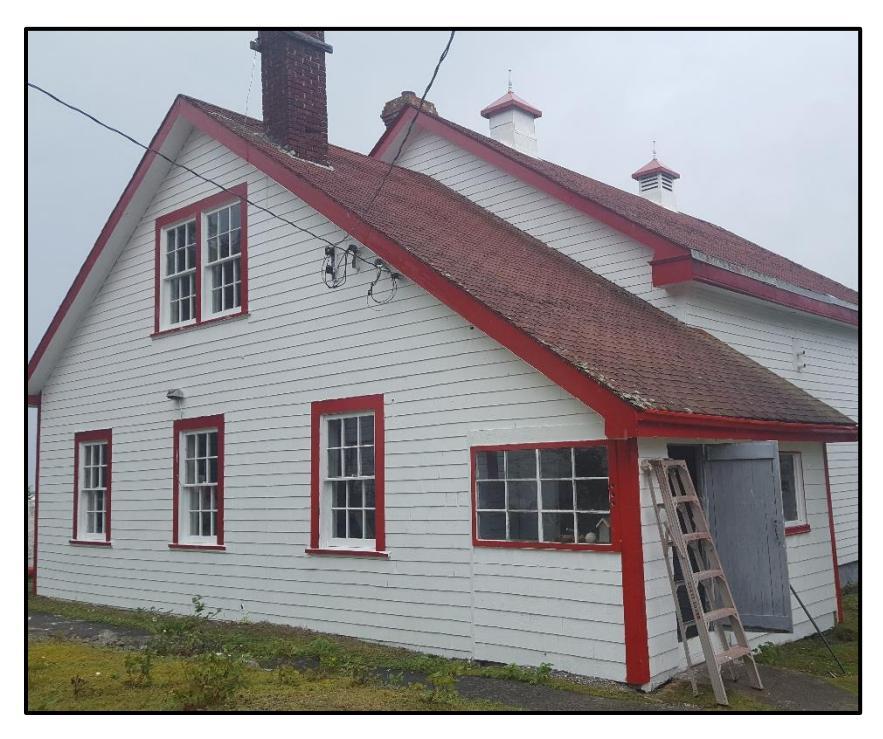
Photograph 14: View of old fog alarm / generator building, facing southeast.

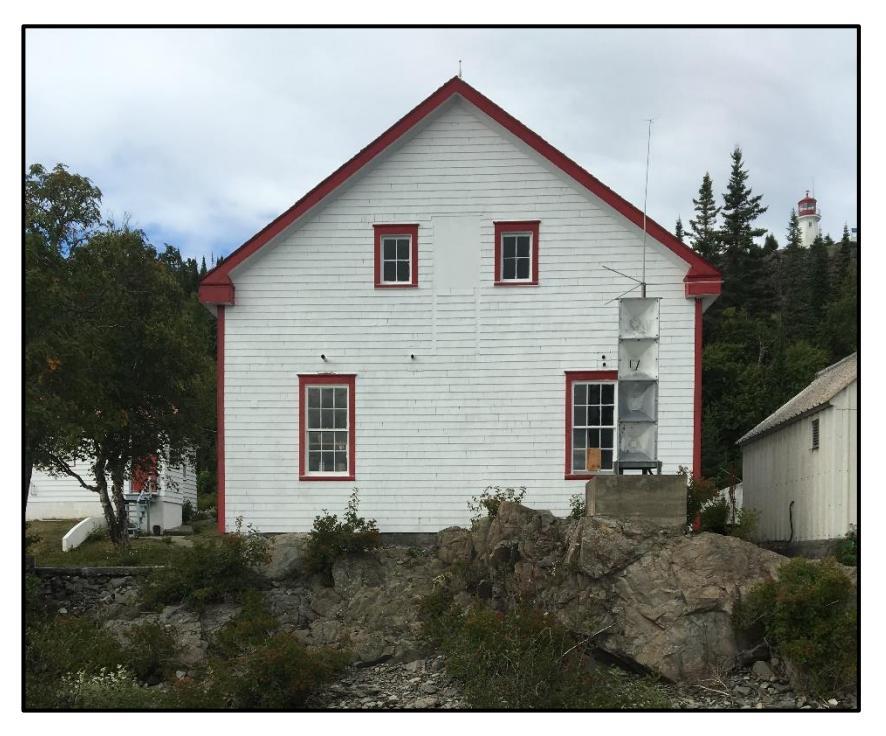
Photograph 15: View of old fog alarm / generator Building, facing north.

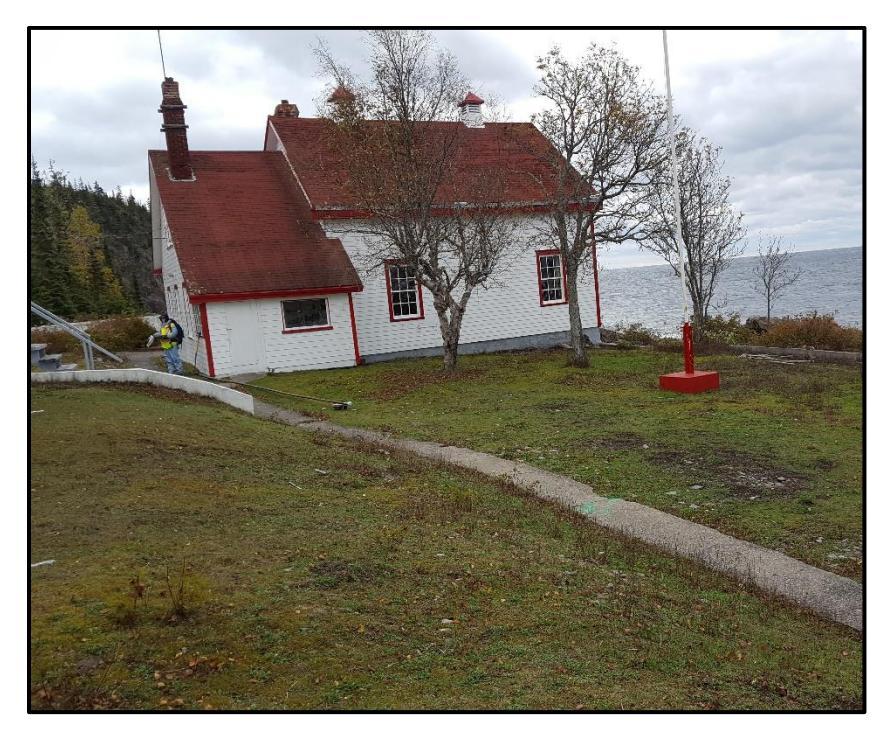
Photograph 16: View of grassed area near the old fog alarm / generator building, and poor condition asbestos containing red and black shingles on roof, facing southeast.

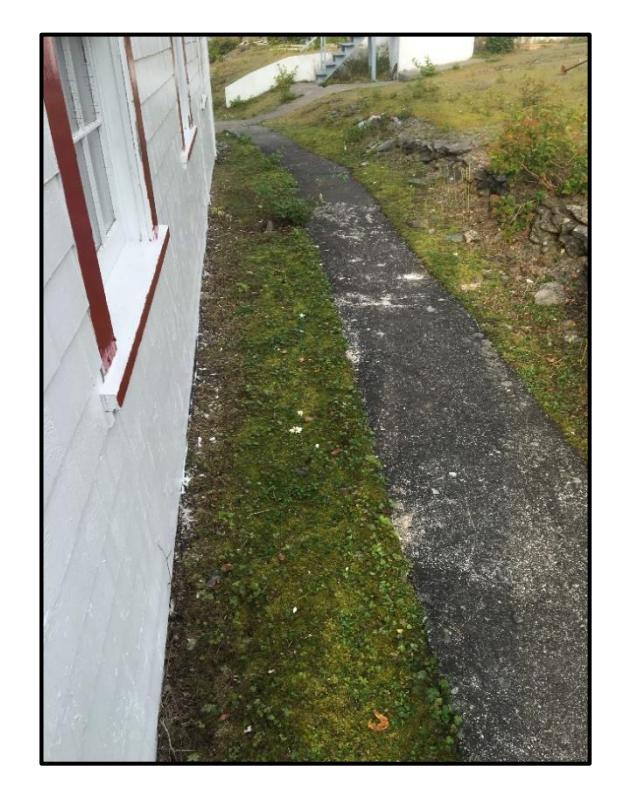
Photograph 17: View of grassed area and path north of the old fog alarm/generator building, facing west.

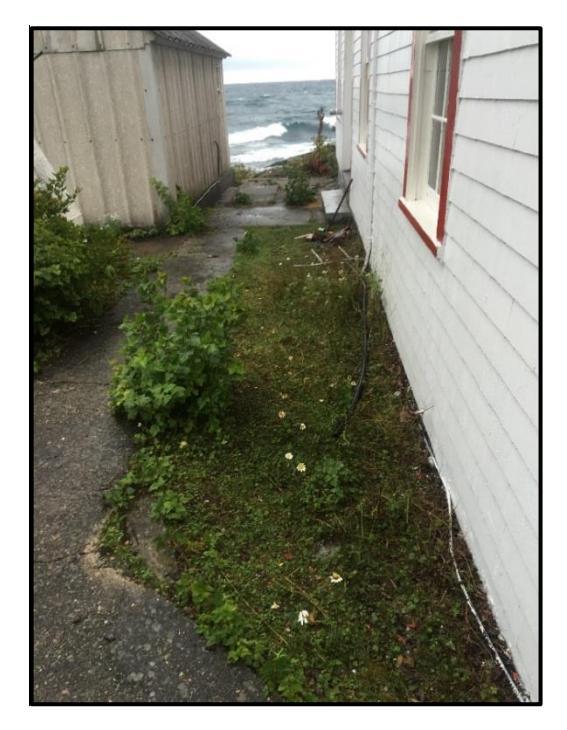
Photograph 18: View of grassed area on the east side of the old fog alarm/generator building, facing south.

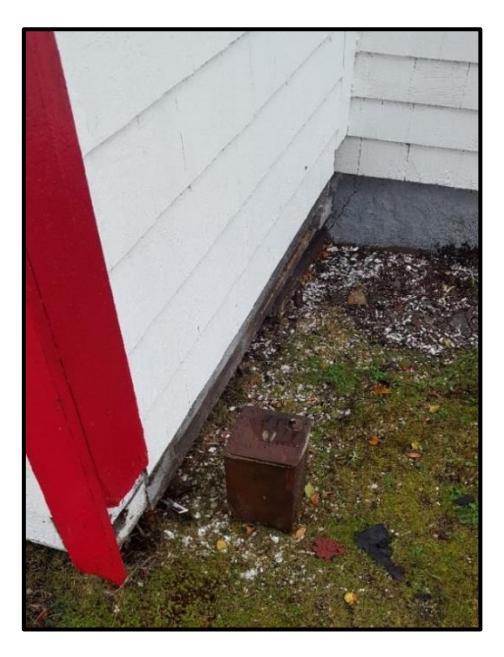
Photograph 19: View of poor condition, lead containing white paint, and paint debris on the ground surrounding old fog Alarm/generator building.

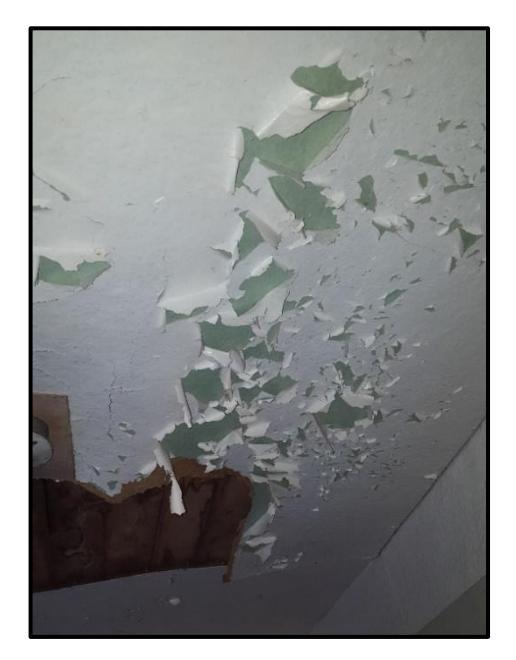
Photograph 20: View of poor condition, lead-containing white paint and water damaged material on ceiling in old fog alarm/generator building.

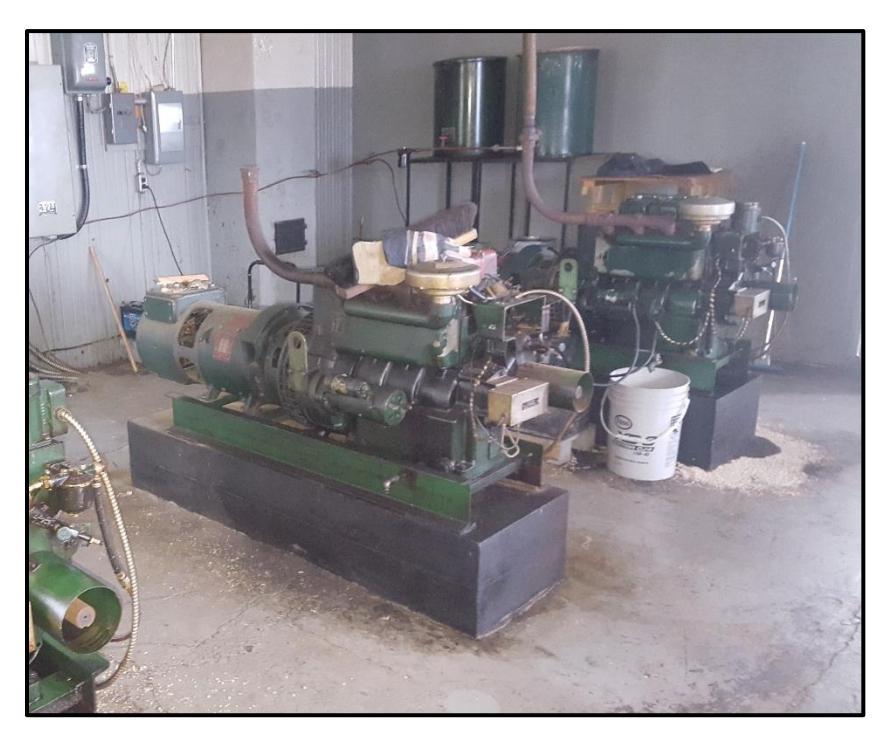
Photograph 21: View of poor condition, lead-containing grey paint and generators in old fog alarm/generator building.

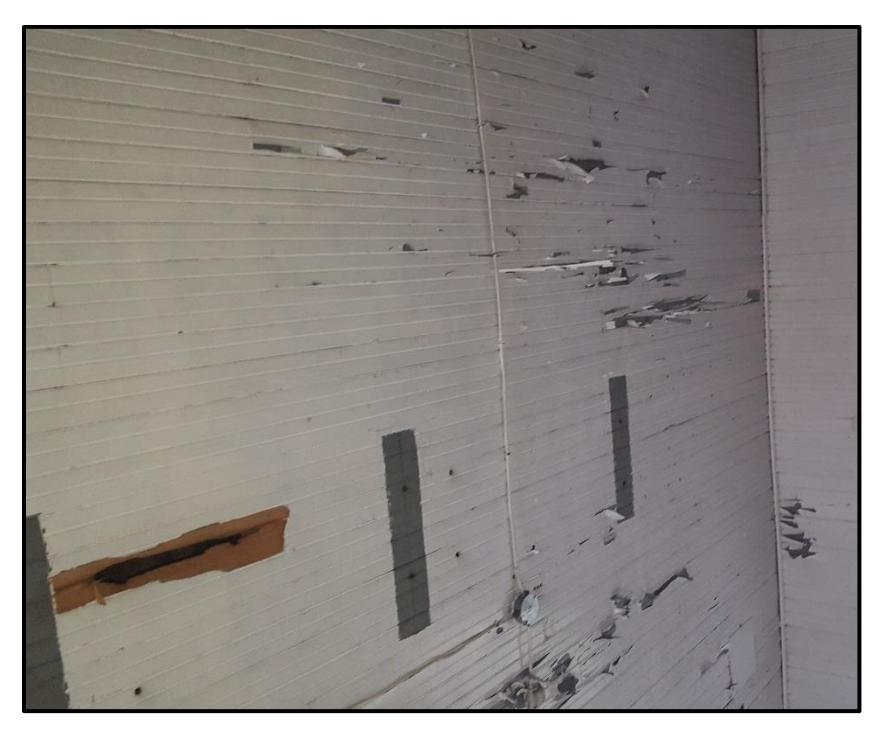
Photograph 22: View of paint on ceiling of old fog alarm / generator building in the machinery room found to be in poor condition.

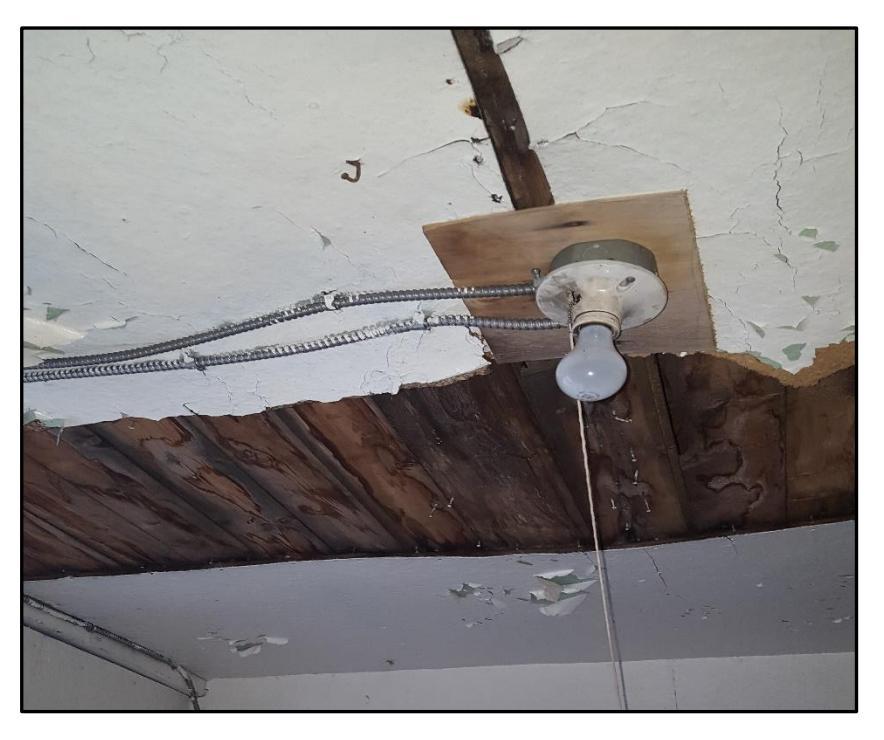
Photograph 23: View of poor condition paint on ceiling with visible signs of water damage in old fog alarm / generator building.

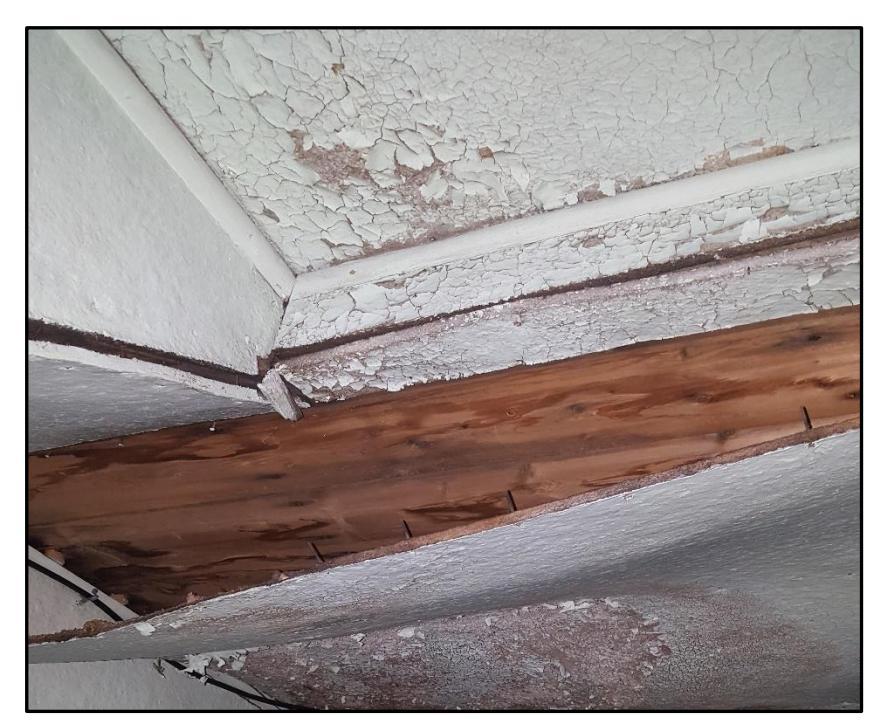
Photograph 24: View of poor condition paint on ceiling of second level with visible signs of water damage in old fog alarm / generator building.

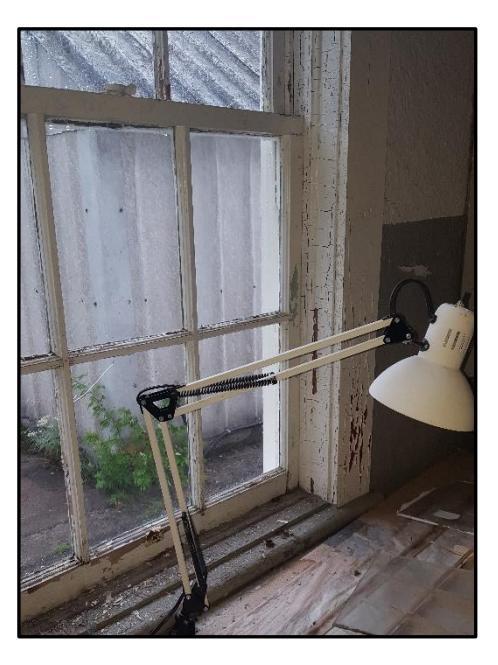
Photograph 25: View of poor condition white paint on the main level of the old for alarm / generator building.

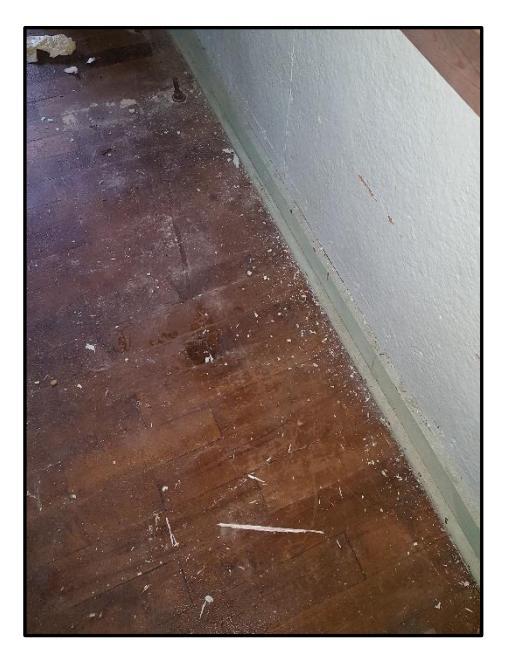
Photograph 26: View of paint debris on the second level floor of the old for alarm / generator building.

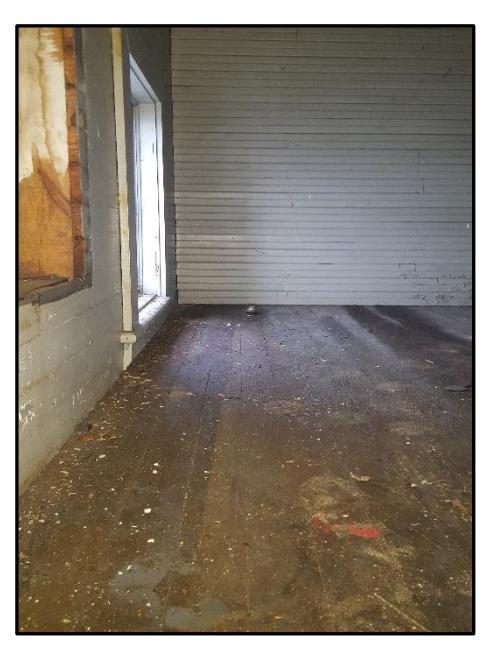
Photograph 27: View of the attic of the old fog alarm / generator building found to have paint debris on floor and lead containing painted surfaces in poor condition.

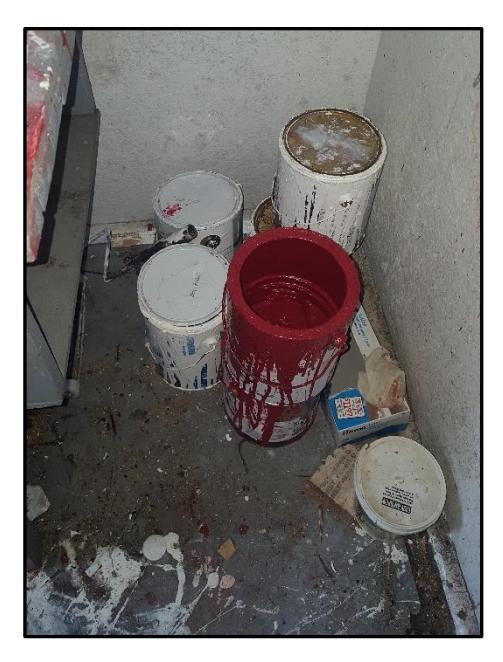
Photograph 28: View of used paint supply debris in the paint room of the old fog alarm / generator building.

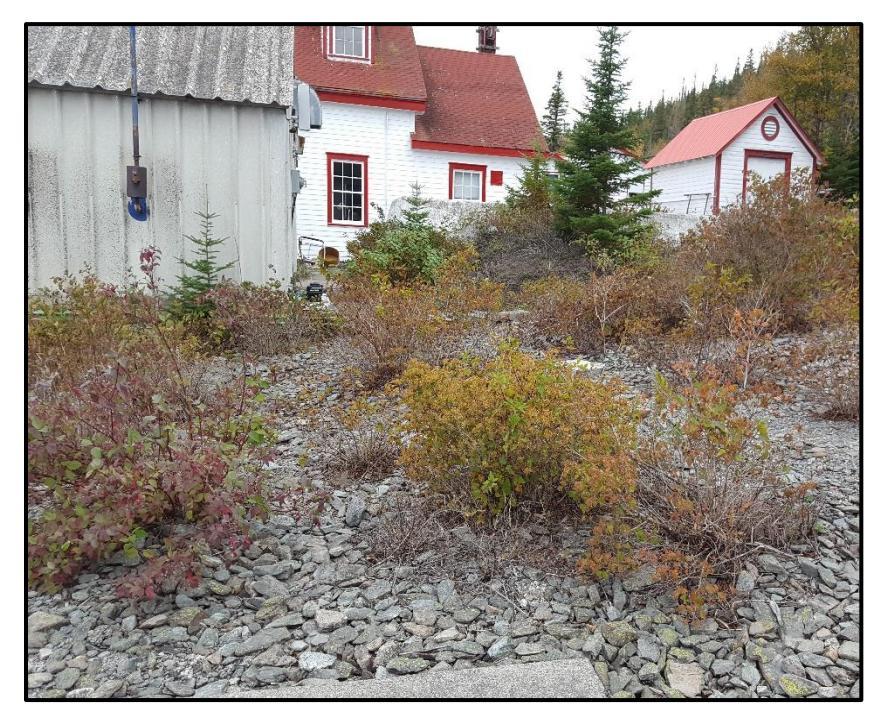
Photograph 29: View of cobble stone soil, new diesel generation building, old fog alarm / generator building and former oil house, facing northeast.

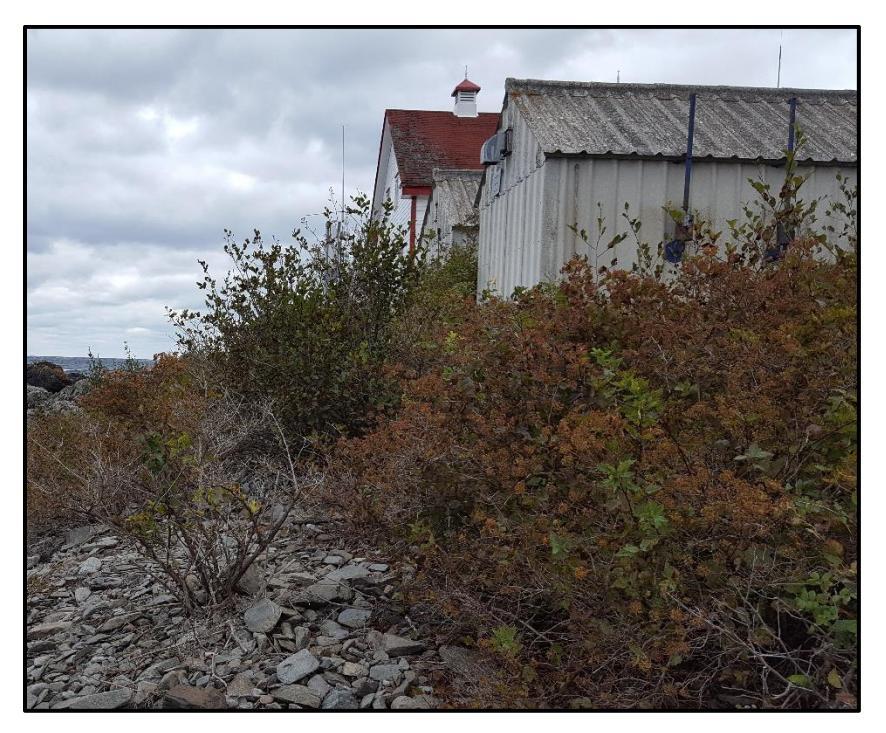
Photograph 30: View of cobble stone soil on the south side of the New Fog Alarm/Generator Building, and New Diesel Generator Building, facing west.

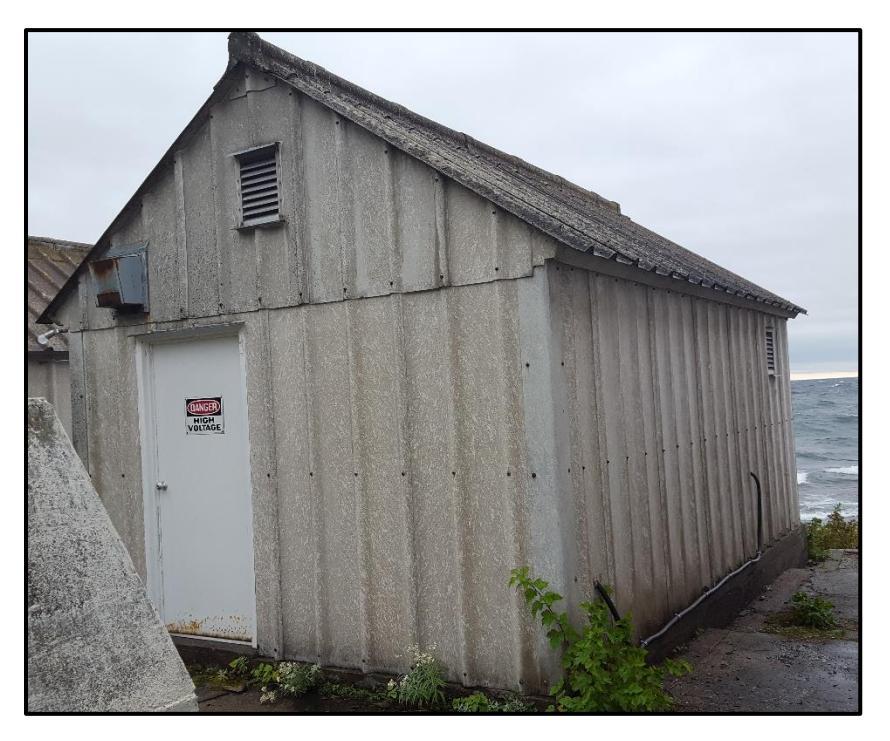
Photograph 31: View of New Fog Alarm Building, facing southeast.

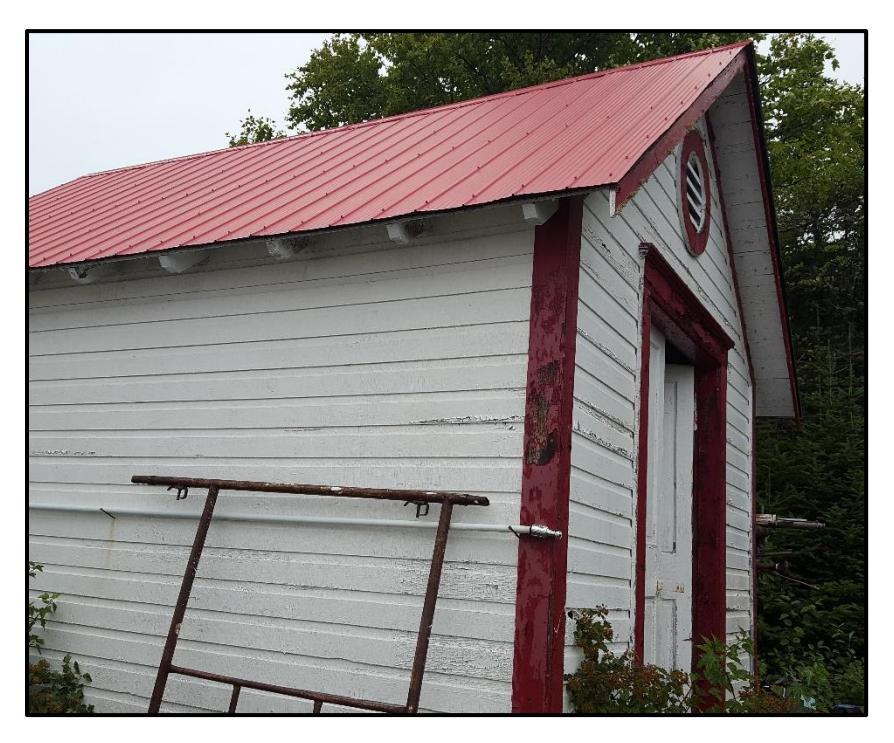
Photograph 33: View of poor condition, lead containing white and red paint on Former Oil House, facing northeast.

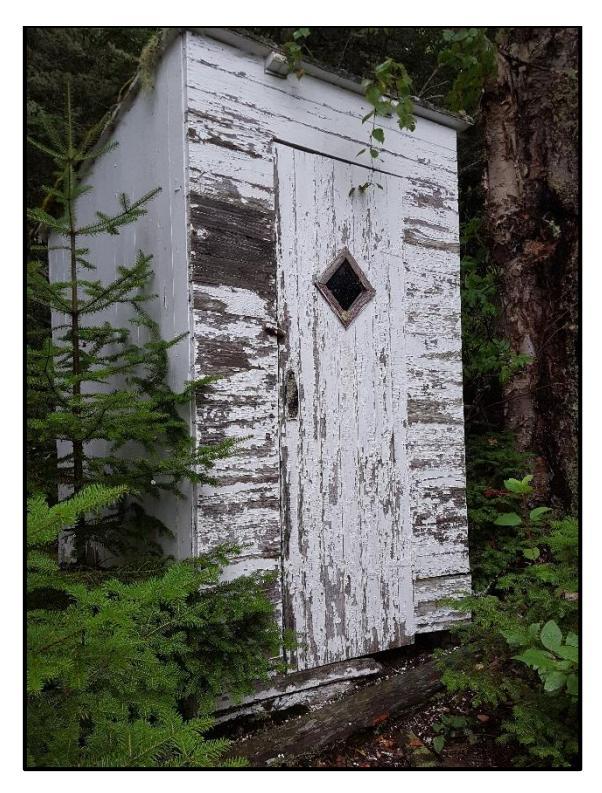
Photograph 34: View of poor condition, lead-containing, white paint on Outhouse at CS-1, facing northeast.

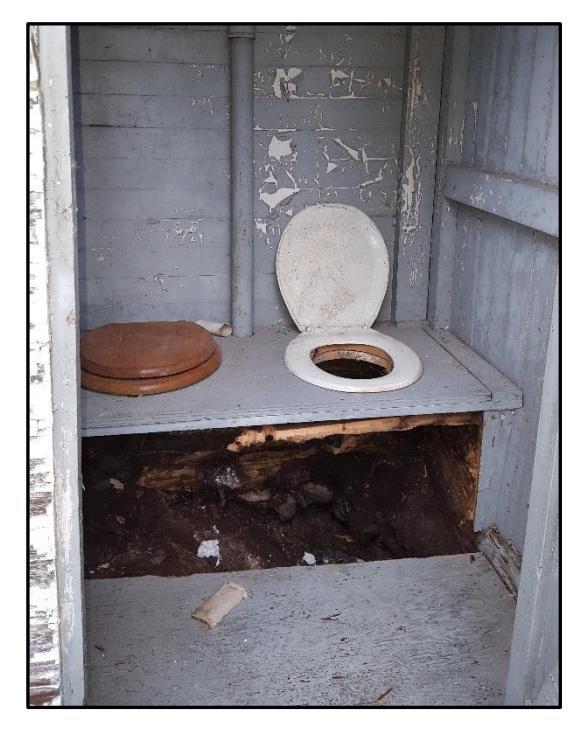
Photograph 35: View of interior of outhouse at CS-1, showing poor condition paint.

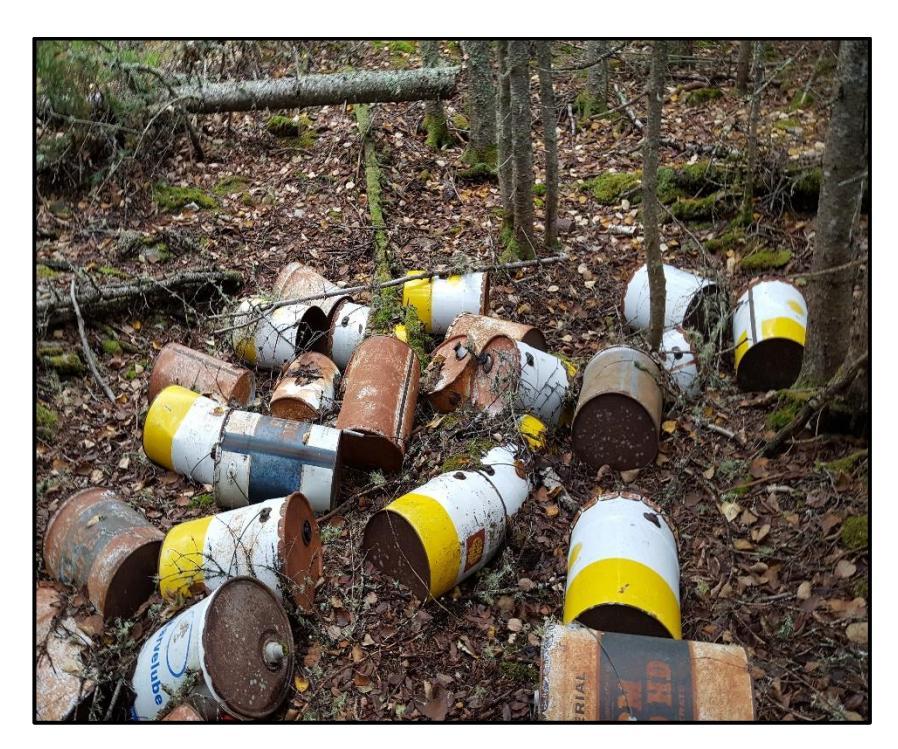
Photograph 36: View of waste in Debris Pile 1B (East Debris Pile) containing empty oil pails, facing east.

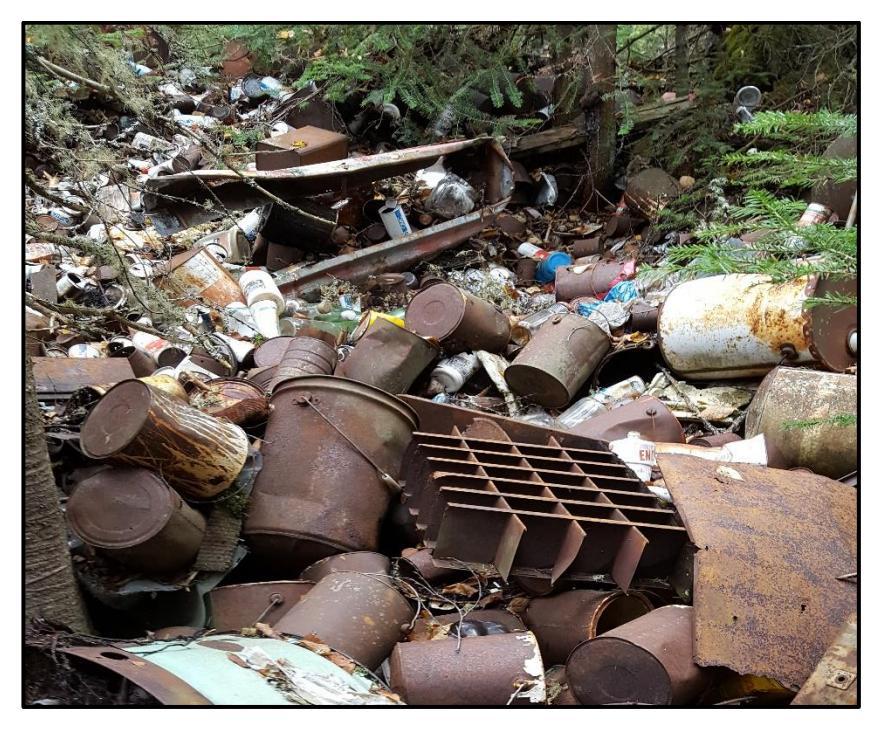
Photograph 37: View of waste in Debris Pile 1B (East Debris Pile), facing west.

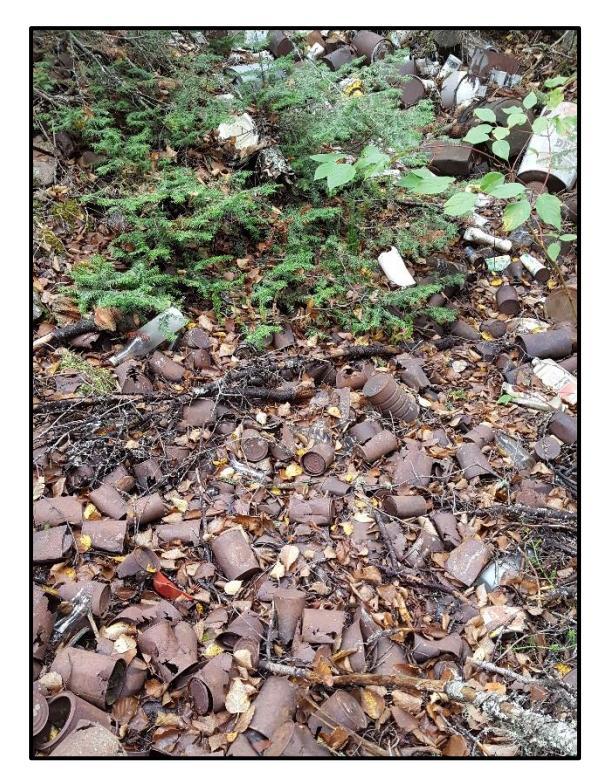
Photograph 38: View of waste in Debris Pile 1B (East Debris pile).

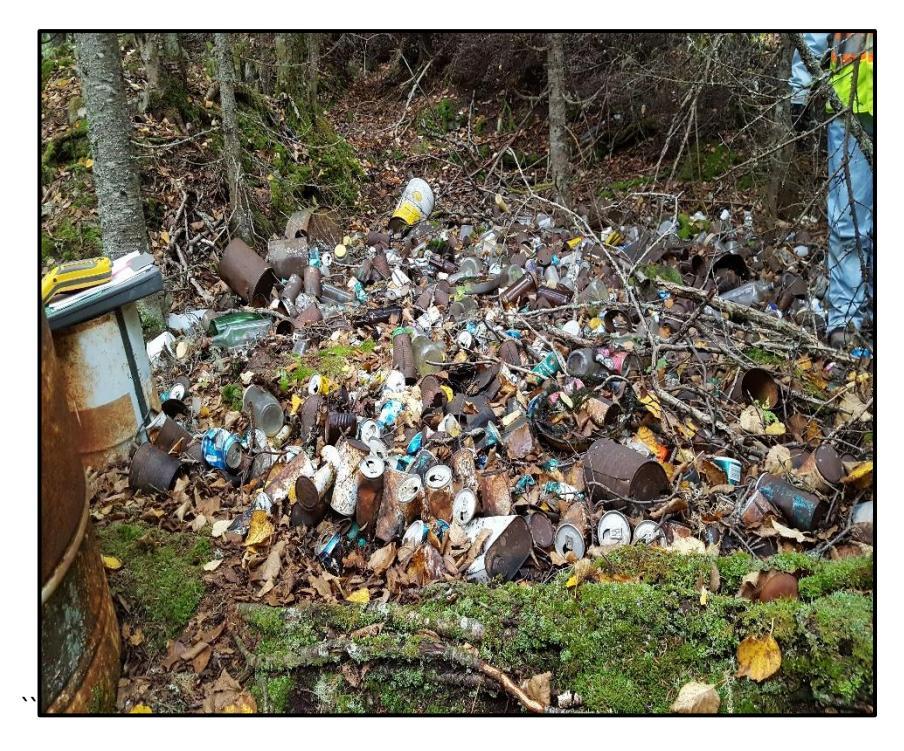
Photograph 39: View of waste in Debris Pile 1A (West Debris Pile), facing west.

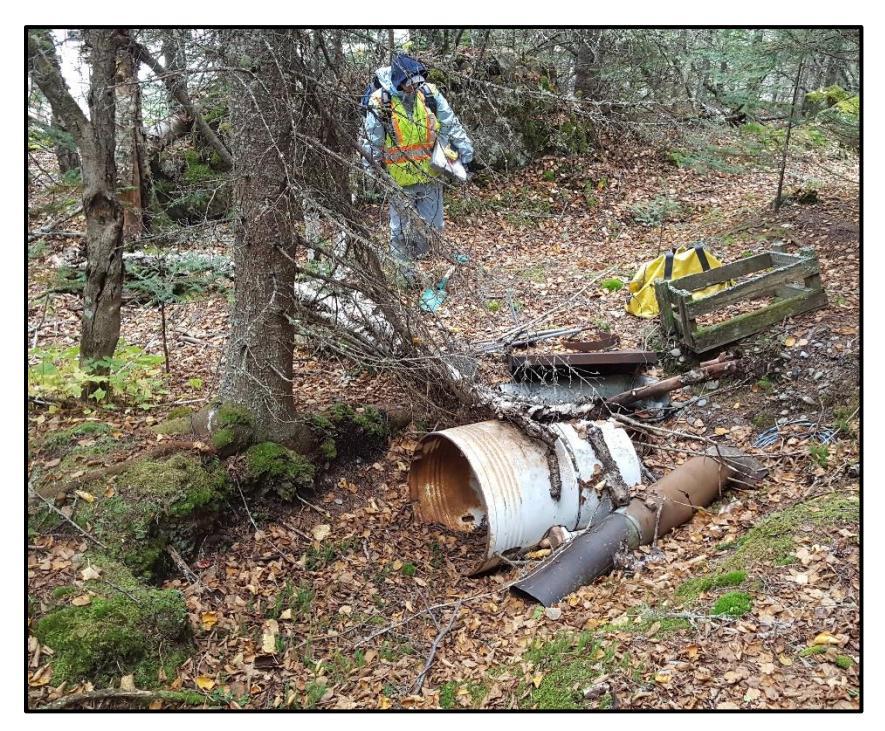
Photograph 40: View of waste in Debris Pile 1A (West Debris Pile), facing west.
