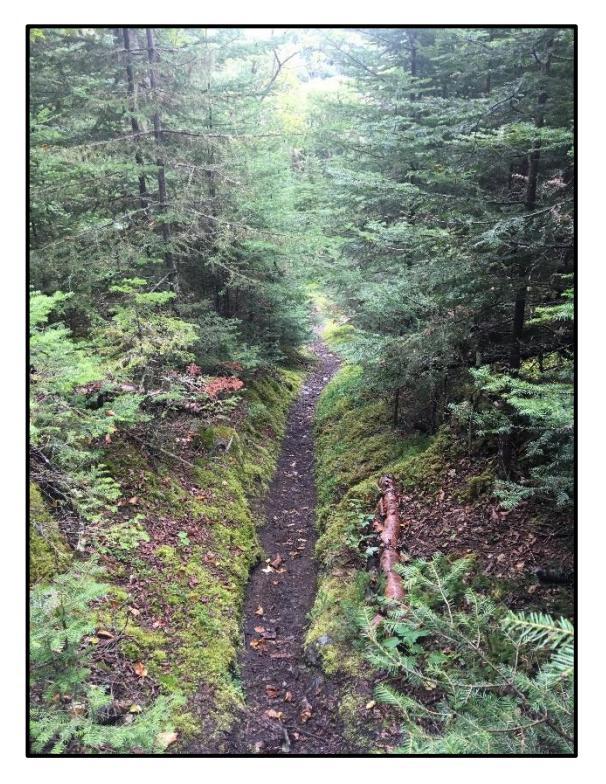
Photograph 41: View of foot path from CS-3 to leading to CS-2, facing south.

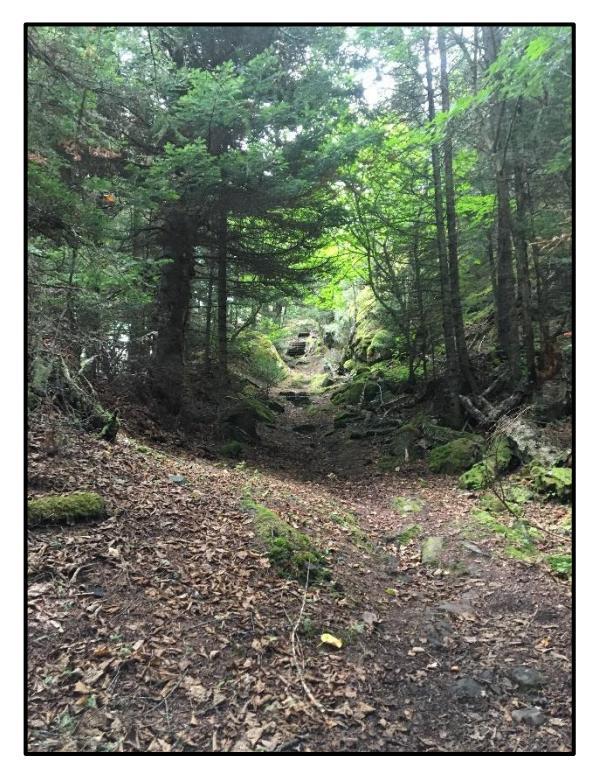
Photograph 42: View of foot path leading to CS-2, facing east.

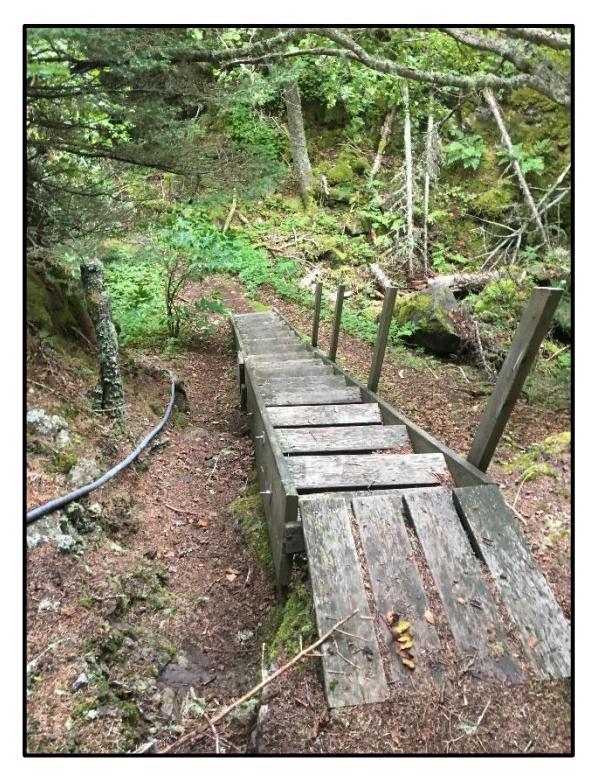
Photograph 43: View of stairway from CS-2 leading to CS-1, facing south.

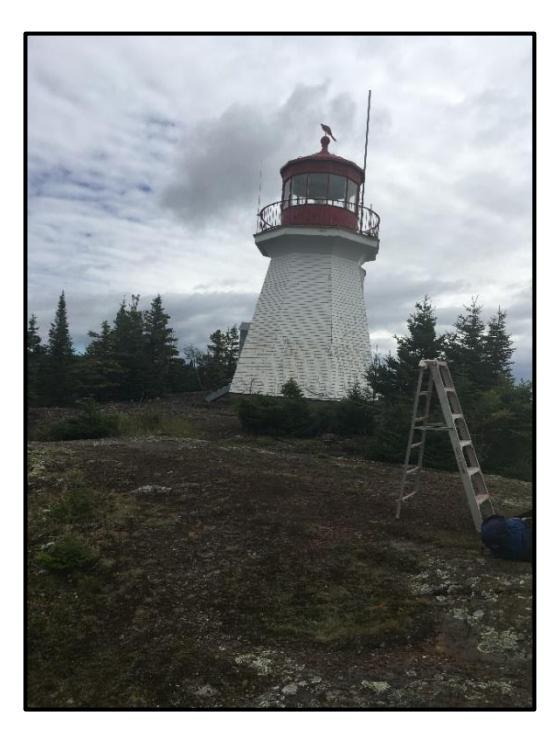
Photograph 44: View of Lighthouse, facing east.

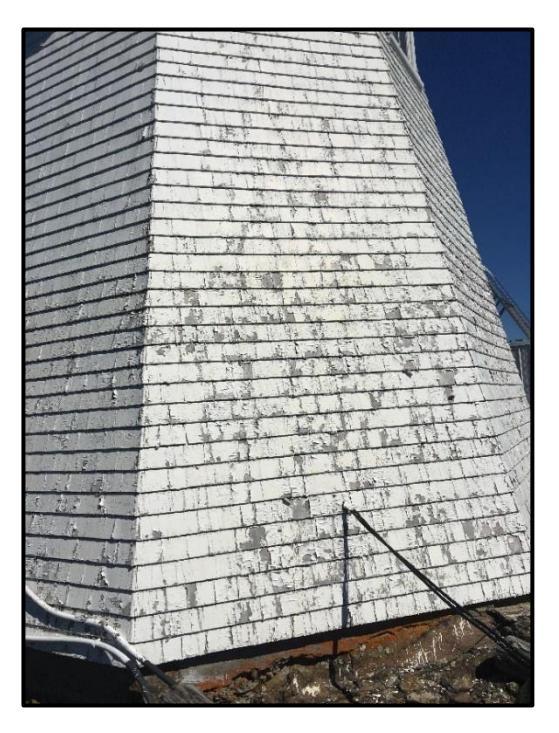
Photograph 45: View of poor condition, lead-containing white paint on Lighthouse.

- Paint on interior surfaces should be abated using appropriate Type 1 procedures as outlined in the MoL *Guideline: Lead on Construction Projects*;
- Paint debris surrounding the perimeter of the buildings and structures should be remediated scrapping top layer of soil to a depth of up to 5 cm where feasible. Where debris is located on bedrock, sidewalks or cobblestone, debris should be removed using HEPA filtered vacuums. Debris found in the interior of buildings should be remediated following MoL precautionary measures, outlined in the document referenced above; and,

- Based on the current scope of remediation as discussed with PWGSC, the remediation of lead paint will be completed on all identified lead-base interior surfaces, all exterior paint and all paint debris as noted in Table 4 of Appendix B. It should also be noted that where lead paint remediation is to be completed on asbestos containing substrate material, the most stringent guidelines shall be applied.

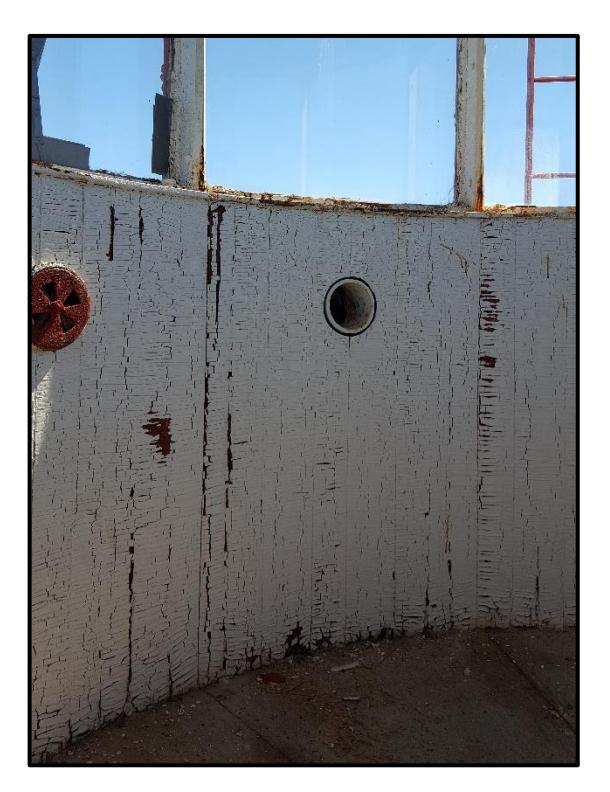
Photograph 46: View of poor condition, lead containing white paint and debris on top balcony of Lighthouse.

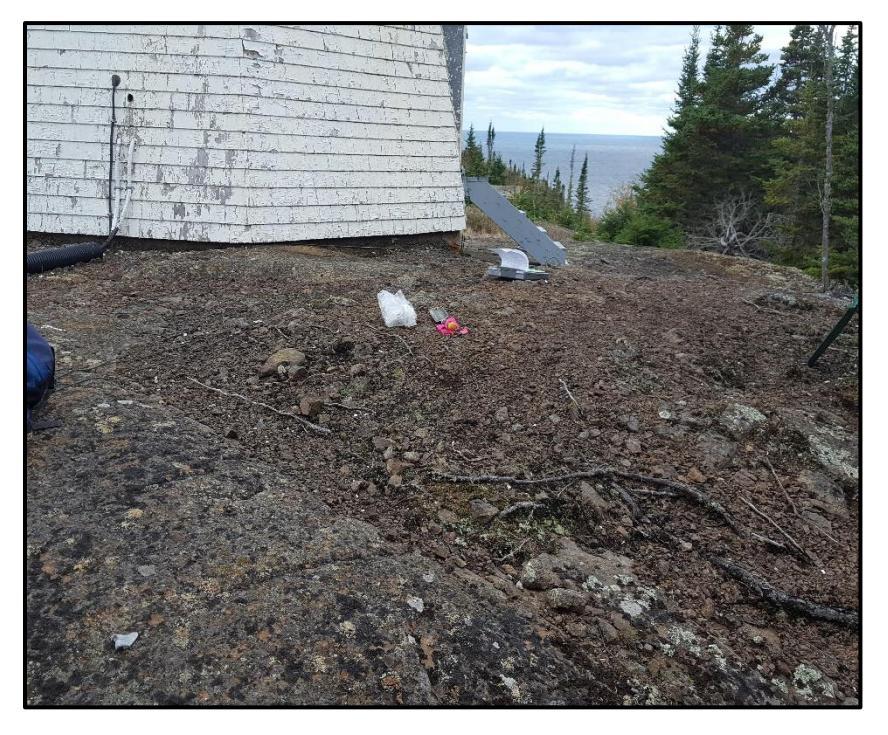
Photograph 47: View of soil surrounding Lighthouse, facing west.

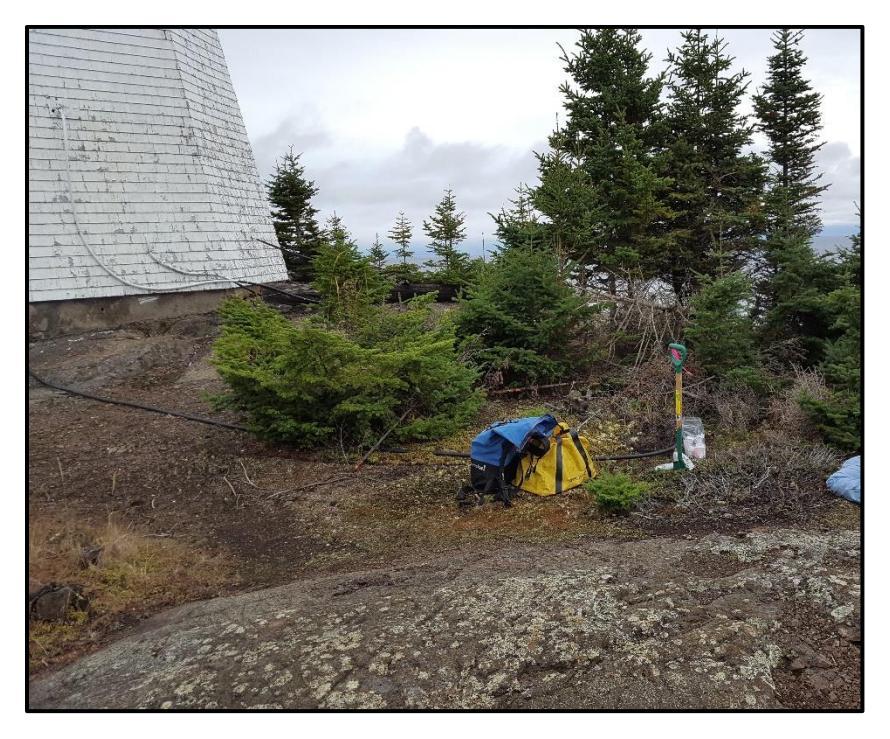
Photograph 48: View of soil surrounding Lighthouse, facing east.

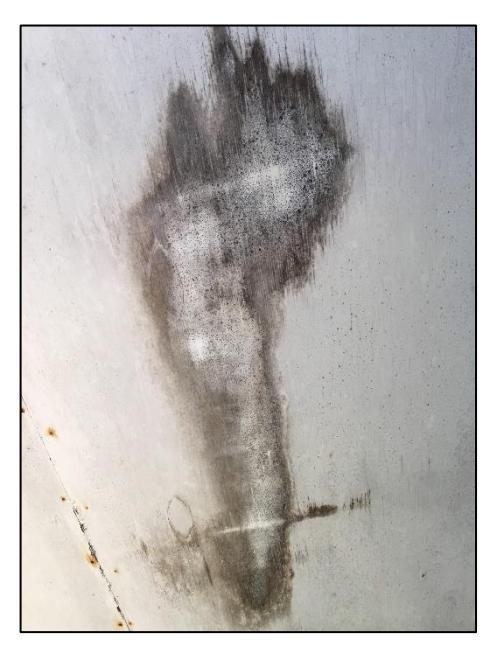
Photograph 49: View of interior mould impacted materials on ceiling of main level of the Lighthouse building.

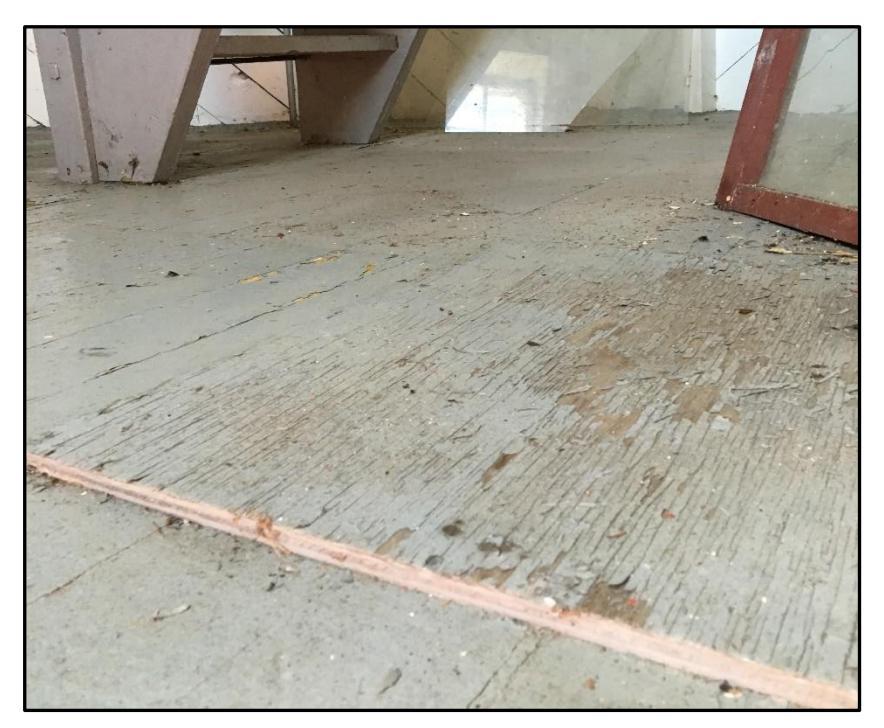
Photograph 50: View of poor condition grey paint on the main level floor of the Lighthouse building.

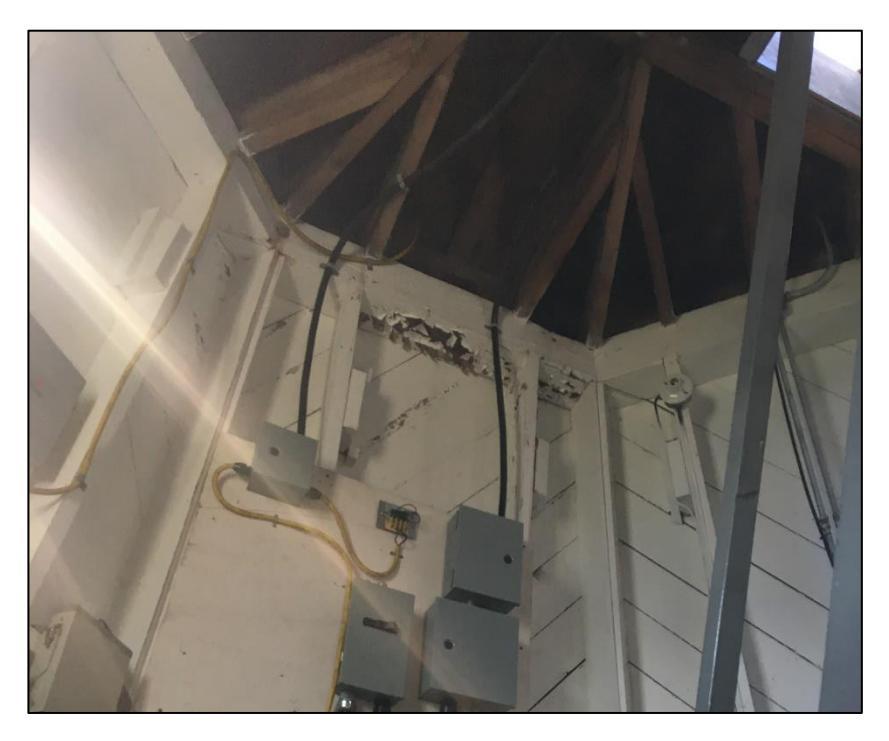
Photograph 51: View of interior poor condition white paint on the second level of the lighthouse building.

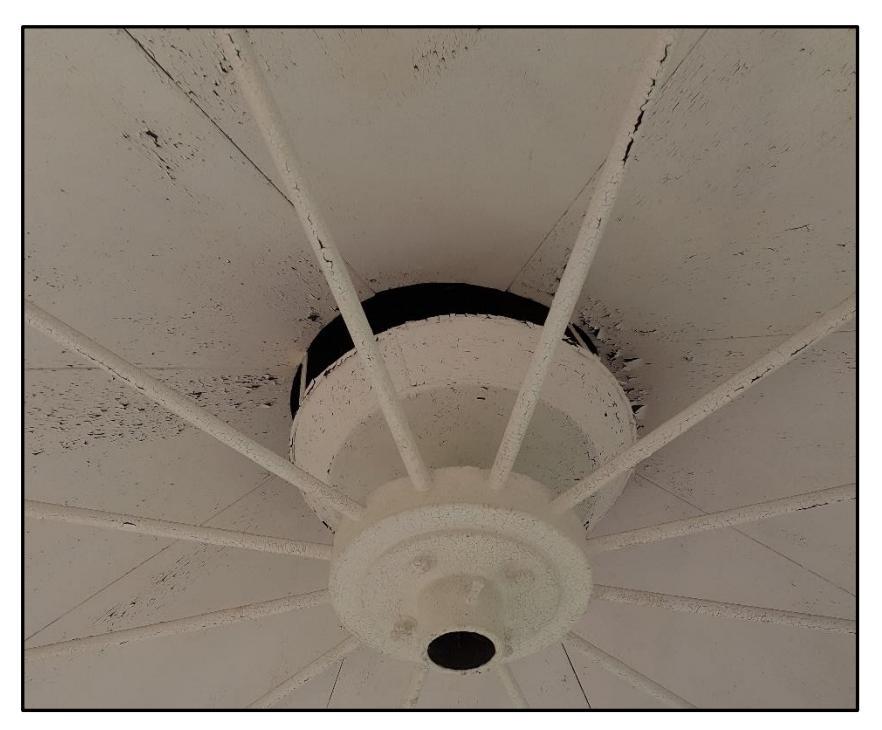
Photograph 52: View of interior of lighthouse upper level ceiling, found to have lead-containing white paint in poor condition.

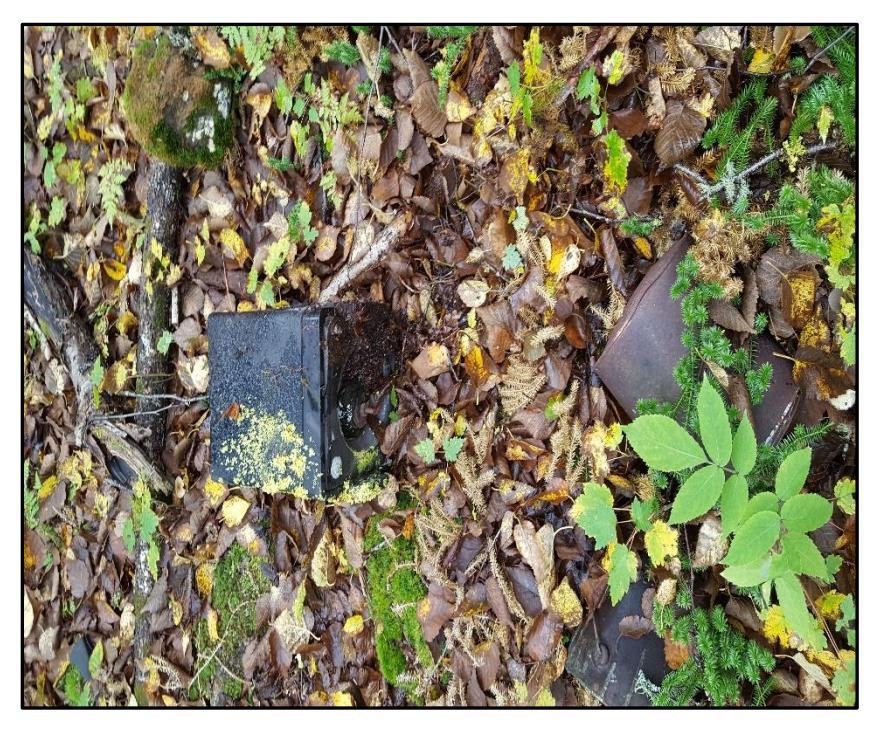
Photograph 53: View of waste in Debris Pile 3A (Lighthouse).

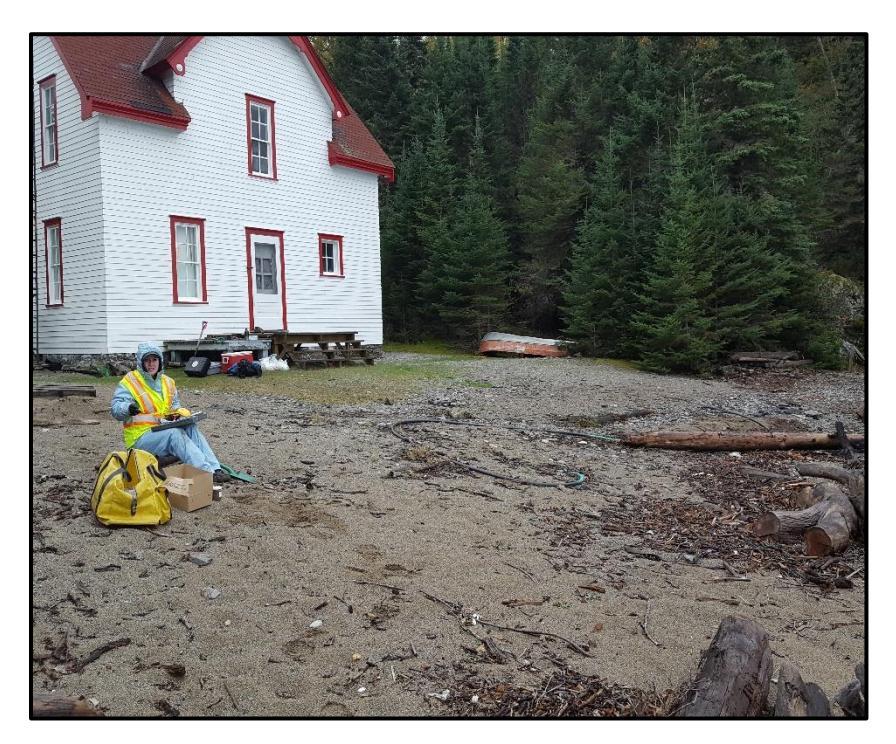
Photograph 54: View of Old Dwelling Building, facing southeast.

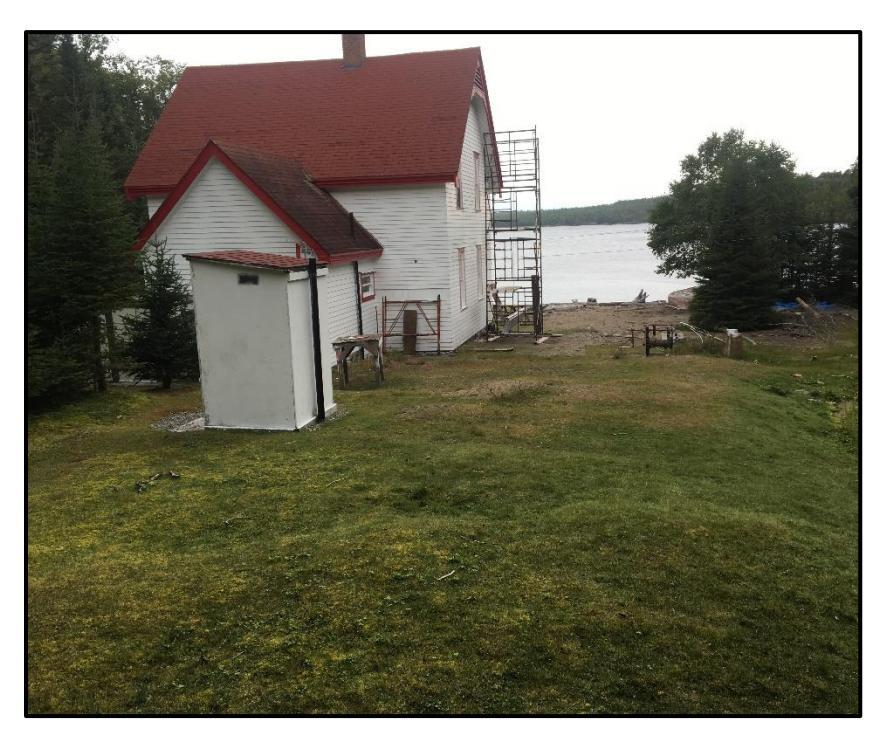
Photograph 55: View of Old Dwelling at CS-3, facing west.

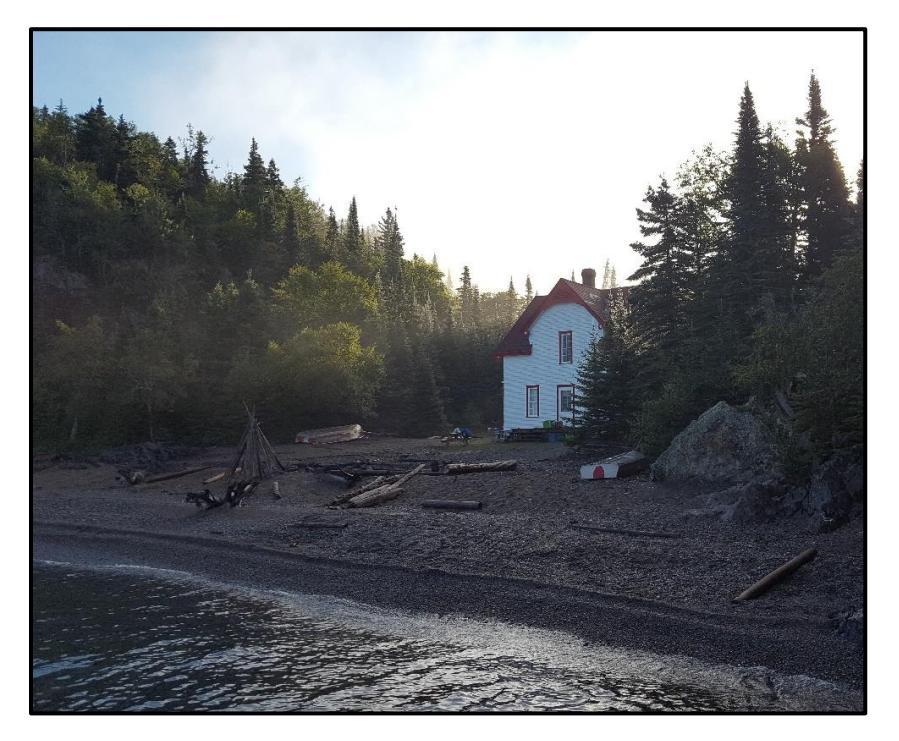
Photograph 56: Overview of CS-3 (Old Dwelling), facing east.

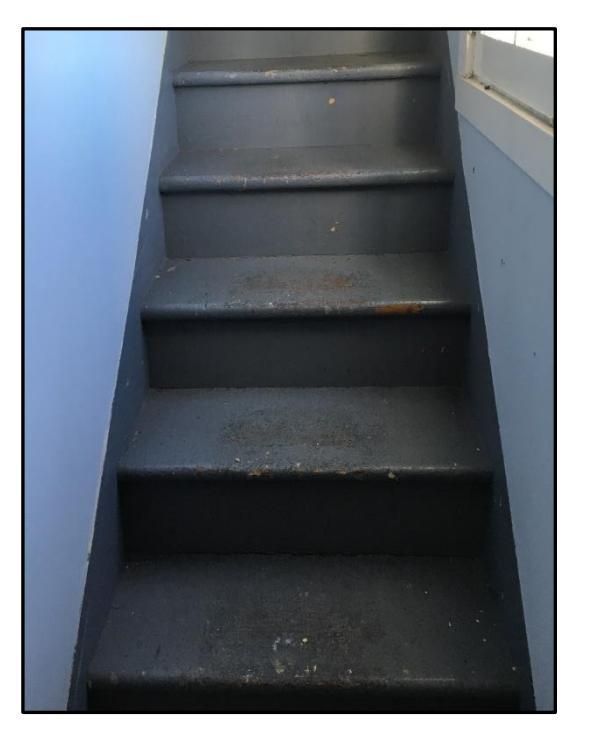
Photograph 57: View of stairs leading to the second level of the old dwelling building found to have leadcontaining grey paint in poor condition.

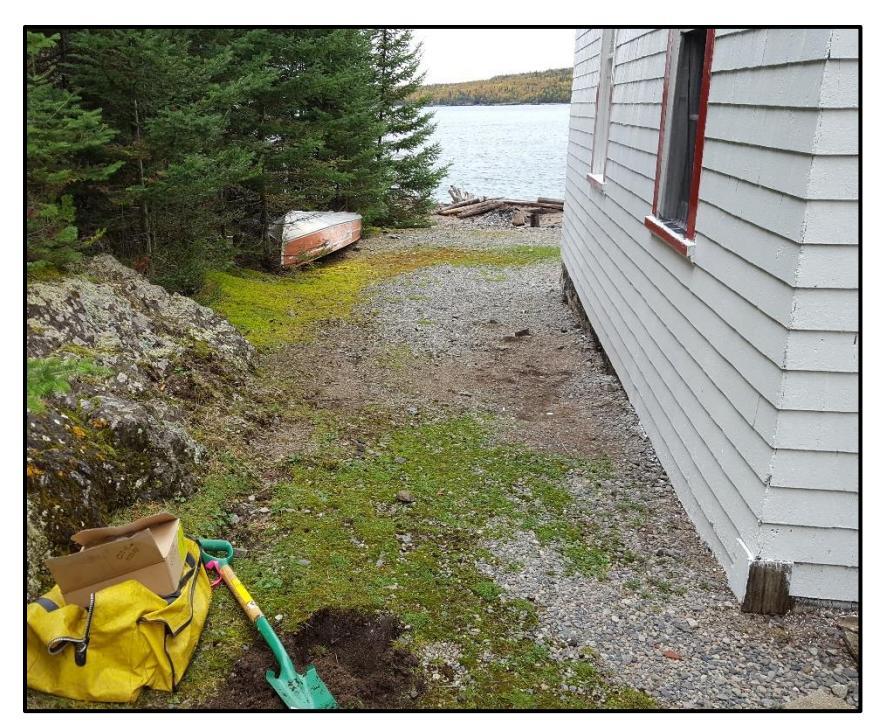
Photographs 58: View of soil along old dwelling building perimeter, facing west.

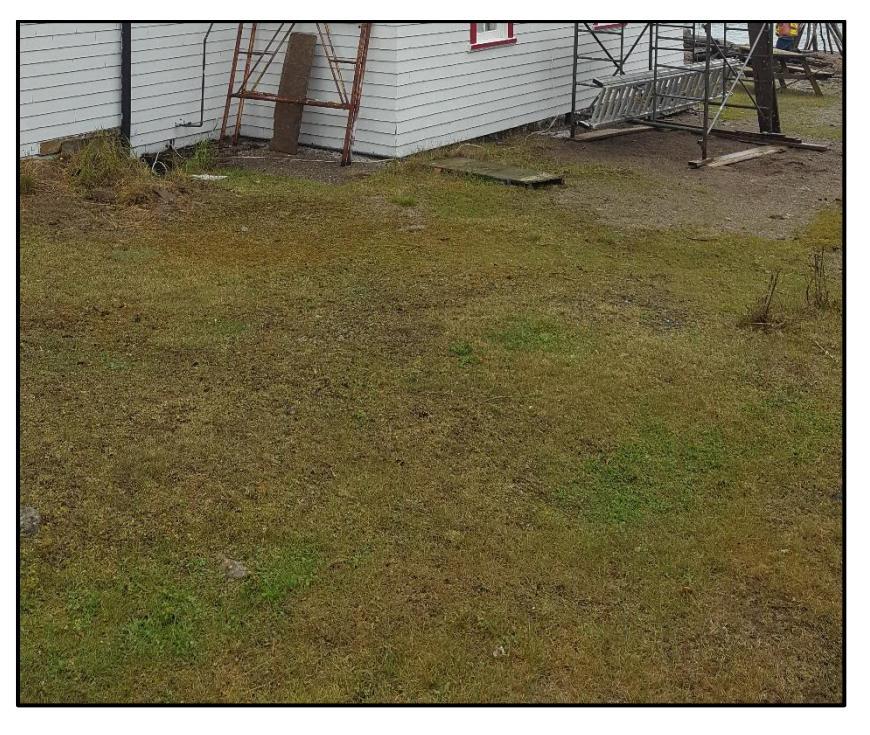
Photograph 59: View grassed area near old dwelling builling, facing northwest.

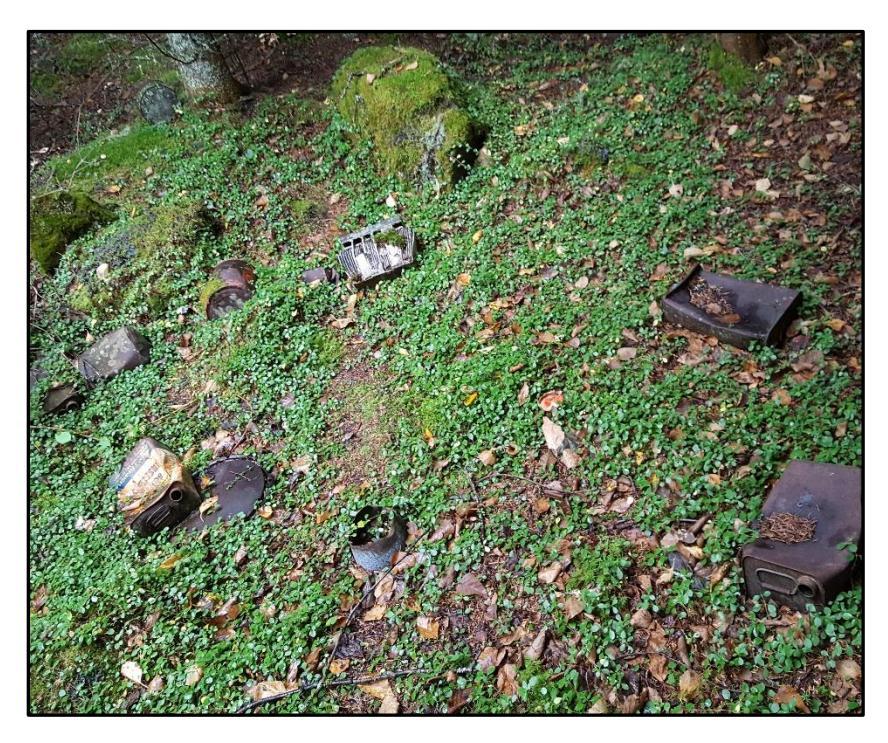
Photograph 60: View of waste in Debris Pile 2A, facing east.

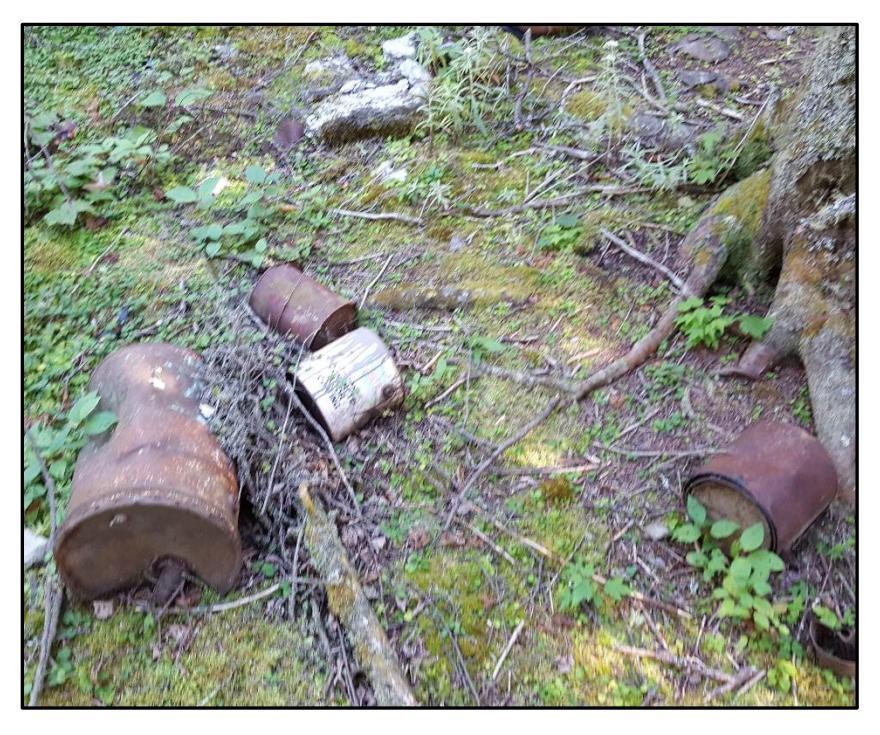
Photograph 61: View of waste in Debris Pile 2 B.

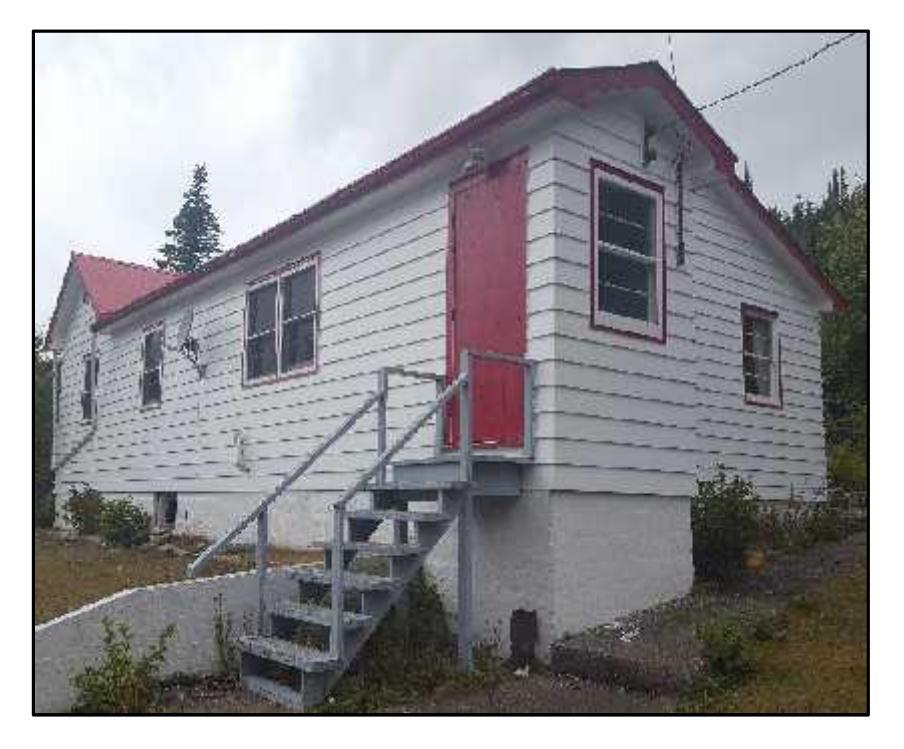
Photograph 1: Exterior view of Main Dwelling, facing northwest.

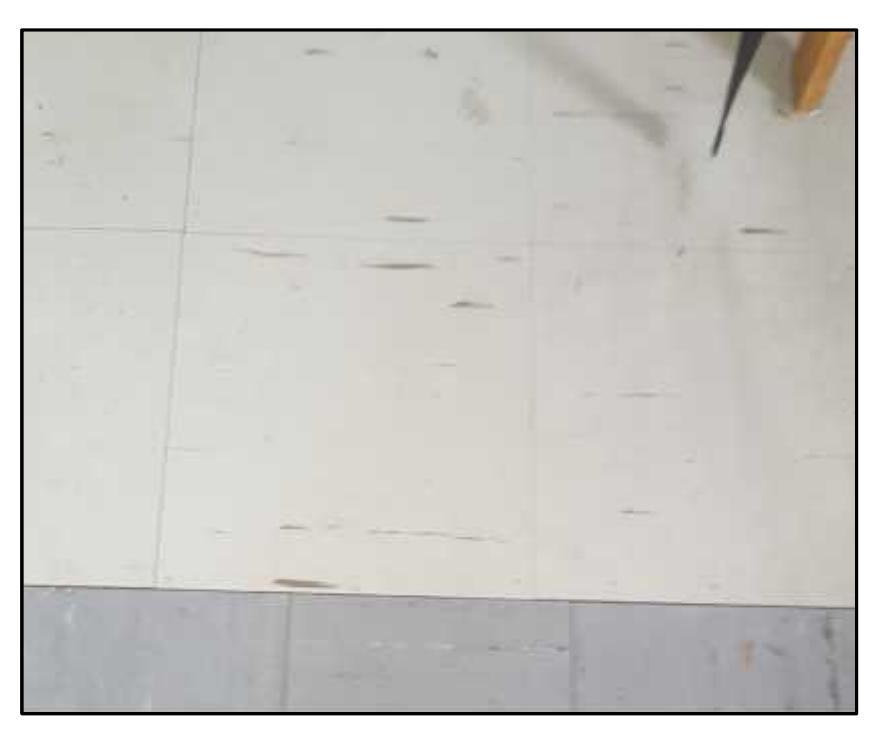
Photograph 2: View of the Main Dwelling's kitchen Beige floor tiles found to contain asbestos.

- Materials found in poor condition should be abated using appropriate precautionary measures;
- Materials must be maintained in good condition;
- Appropriate work procedures and precautionary measures must be used, as outlined in O. Reg. 278/05, Asbestos on Construction Projects and in Buildings and Repair Operations enabled under the Occupational Health and Safety Act R.S.O. 1990, Chapter 1 (O. Reg. 278/05), as amended, when performing work that may disturb ACMs or suspected ACMs, including prior to building demolition;

- Disturbance and/or removal of ACMs must be appropriately recorded as part of the building's Asbestos Management Plan;
- If ACMs or suspected ACMs become damaged and worker exposure to the material is likely to occur, the damaged material must be repaired or removed following work procedures outlined in O. Reg. 278/05, as amended; and

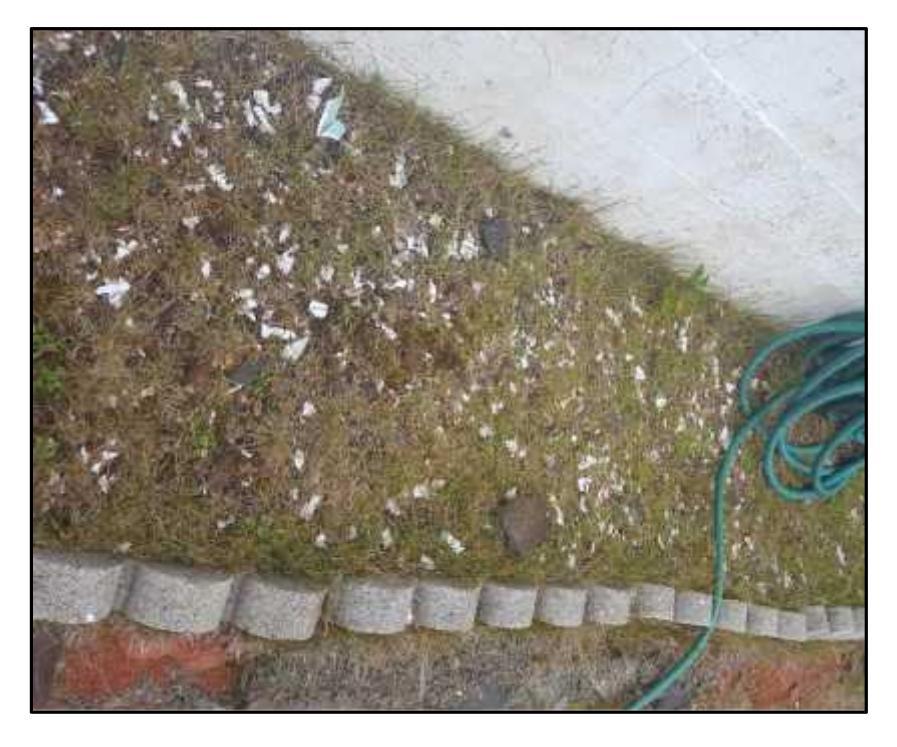
Photograph 3: View of paint debris along the perimeter of the Main Dwelling Building

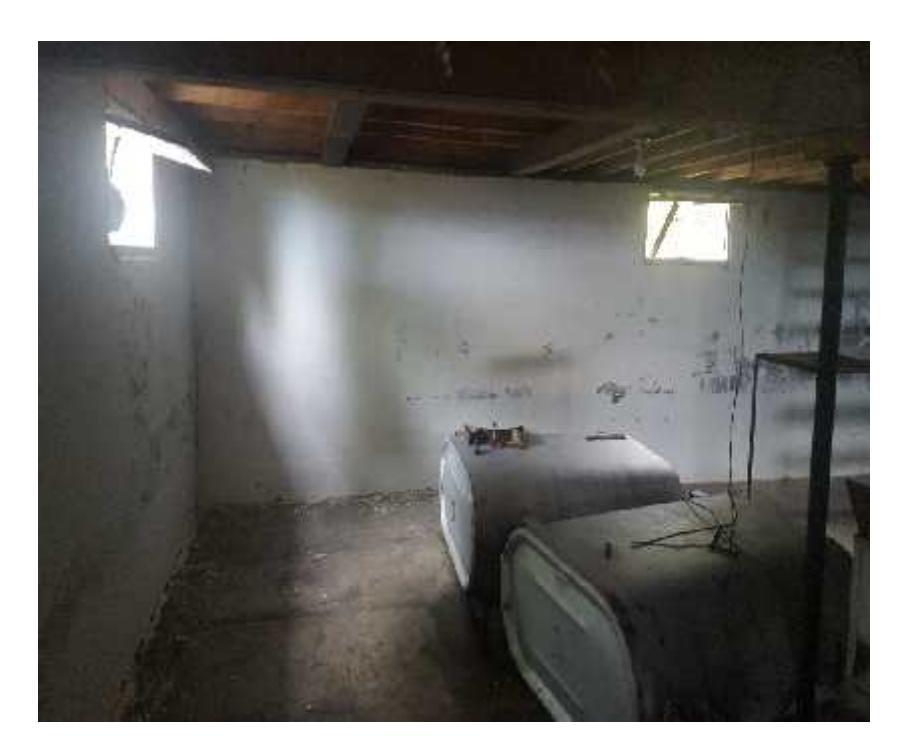
Photograph 4: View of the Main Dwelling's basement foundation walls, painted white and found to be in poor condition.

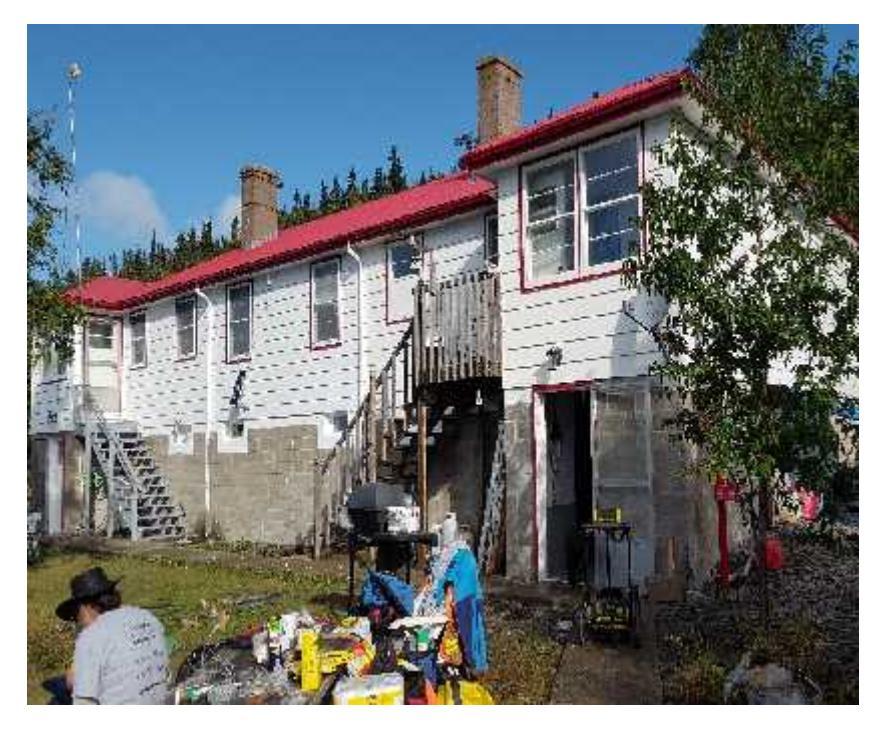
Photograph 5: Exterior view of Duplex Dwelling, facing northwest.

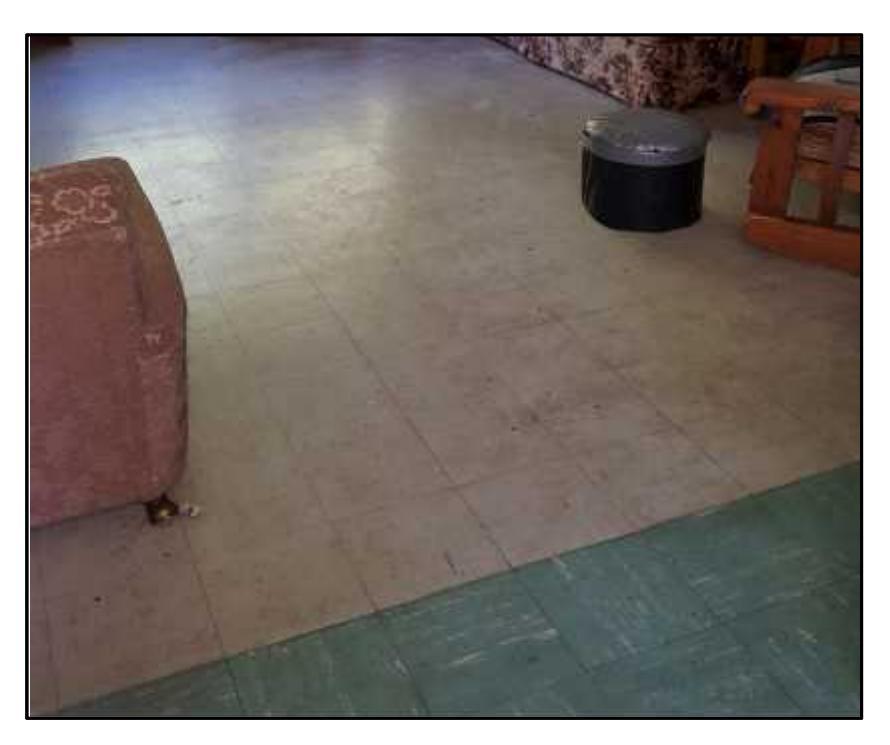
Photograph 6: View of two vinyl floor types, white with brown streaks and green with white streaks, in the Duplex Dwelling found to contain asbestos.

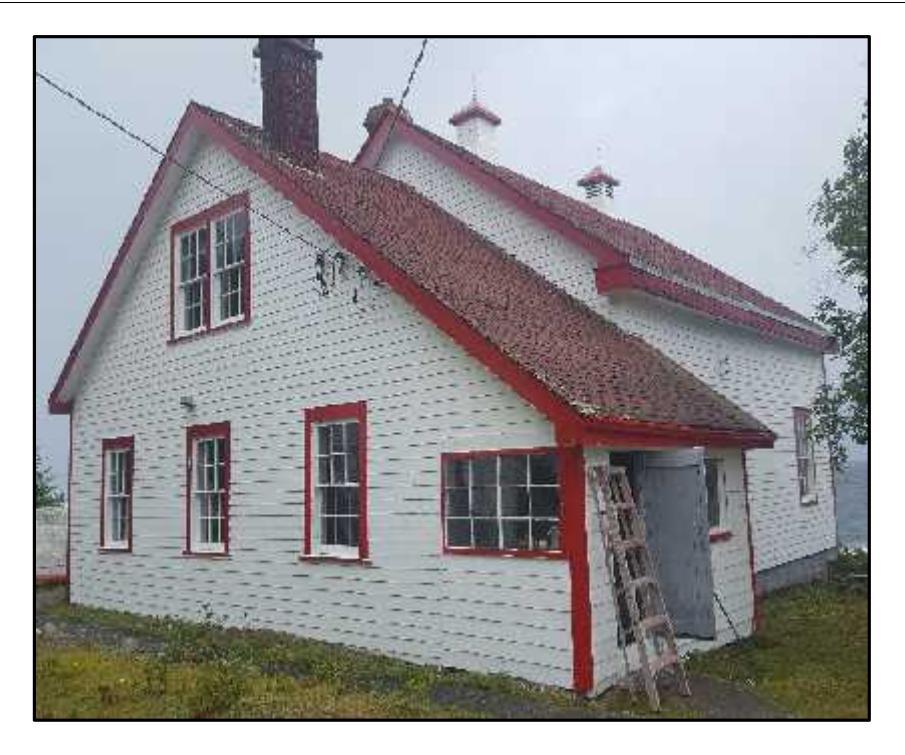
Photograph 7: View of Old Fog Alarm / Generator Building, facing southeast.

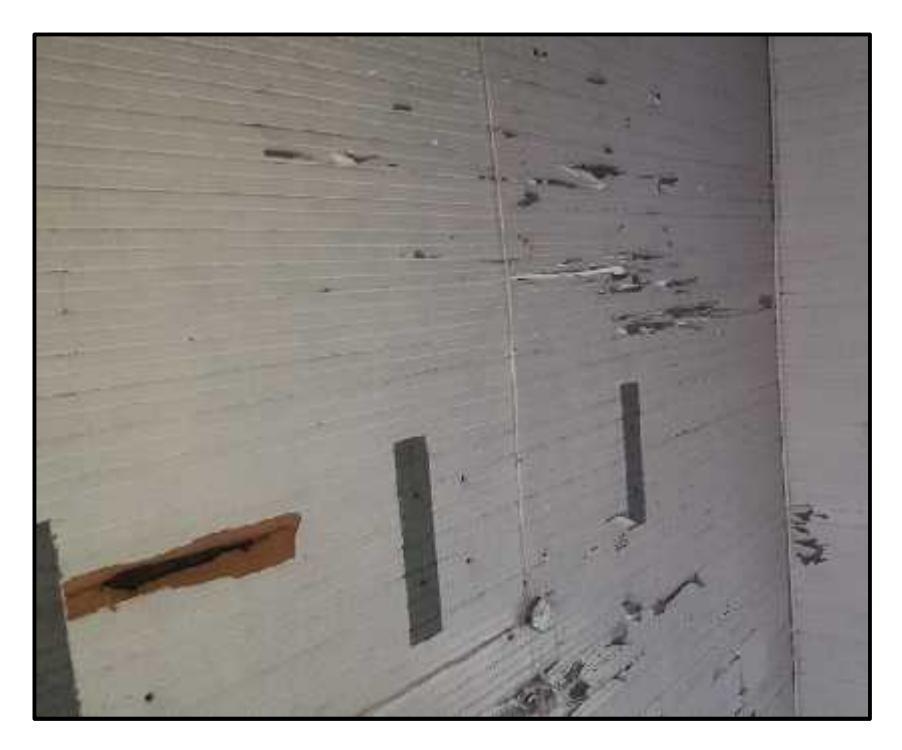
Photograph 8: View of paint on ceiling of Old Fog Alarm / Generator Building in the Machinery Room found to be in poor condition.

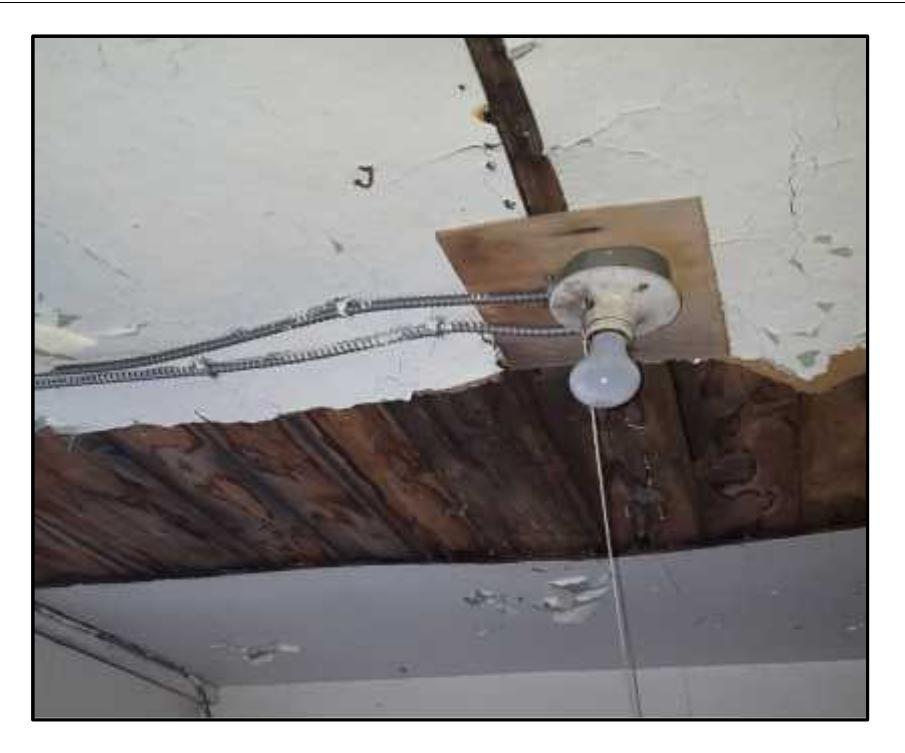
Photograph 9: View of poor condition paint on ceiling with visible signs of water damage in Old Fog Alarm / Generator Building.

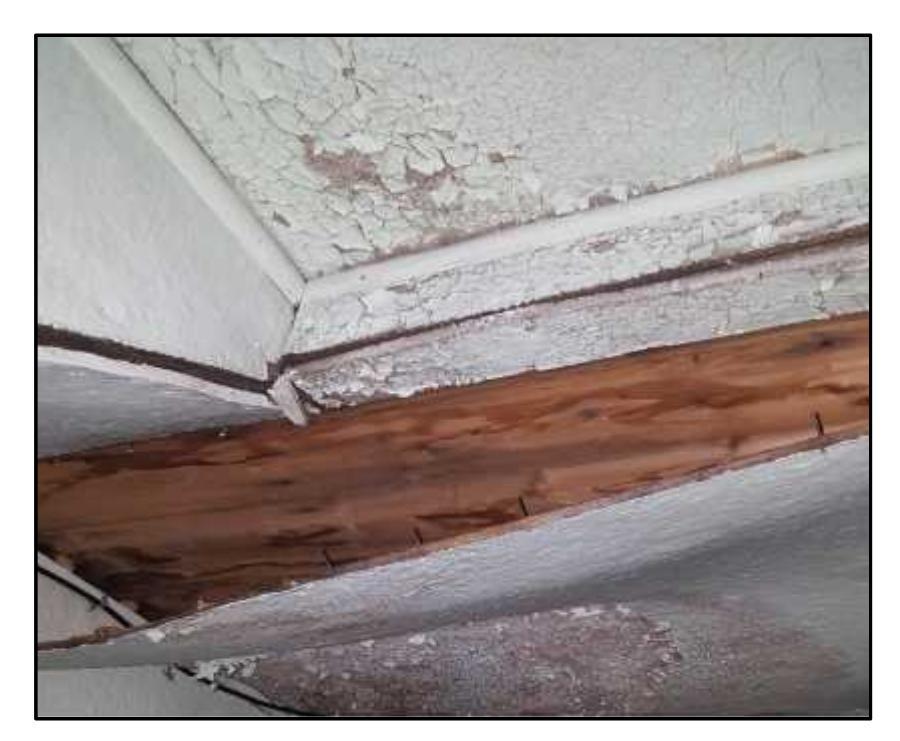
Photograph 10: View of poor condition paint on ceiling of second level with visible signs of water damage in Old Fog Alarm / Generator Building.

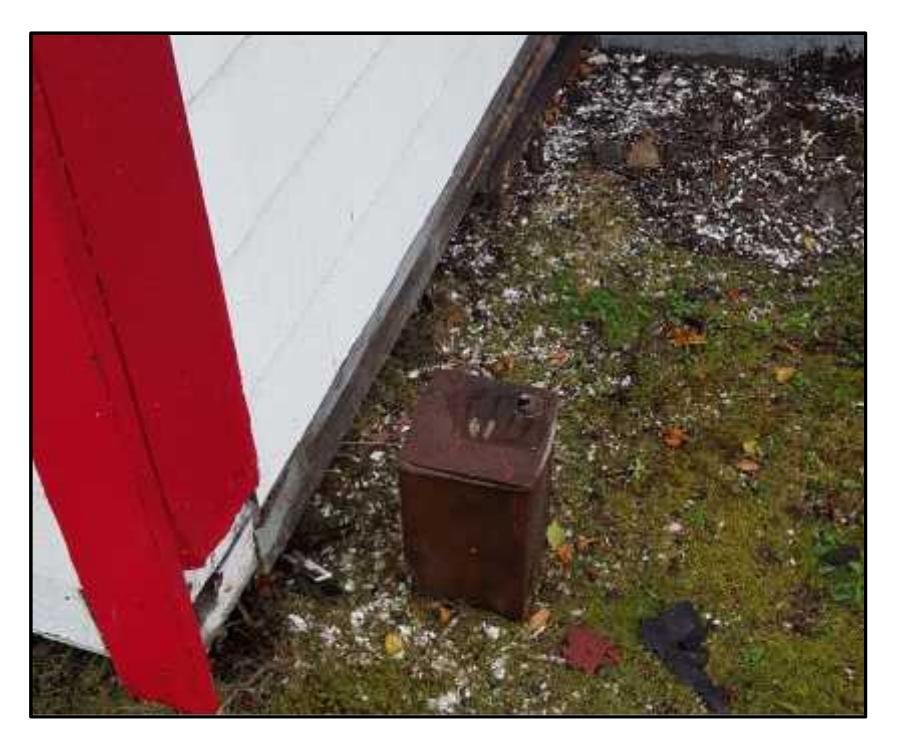
Photograph 11: View of paint debris on and suspect asbestos containing roof single debris along the perimeter of the Old Fog Alarm / Generator Building.

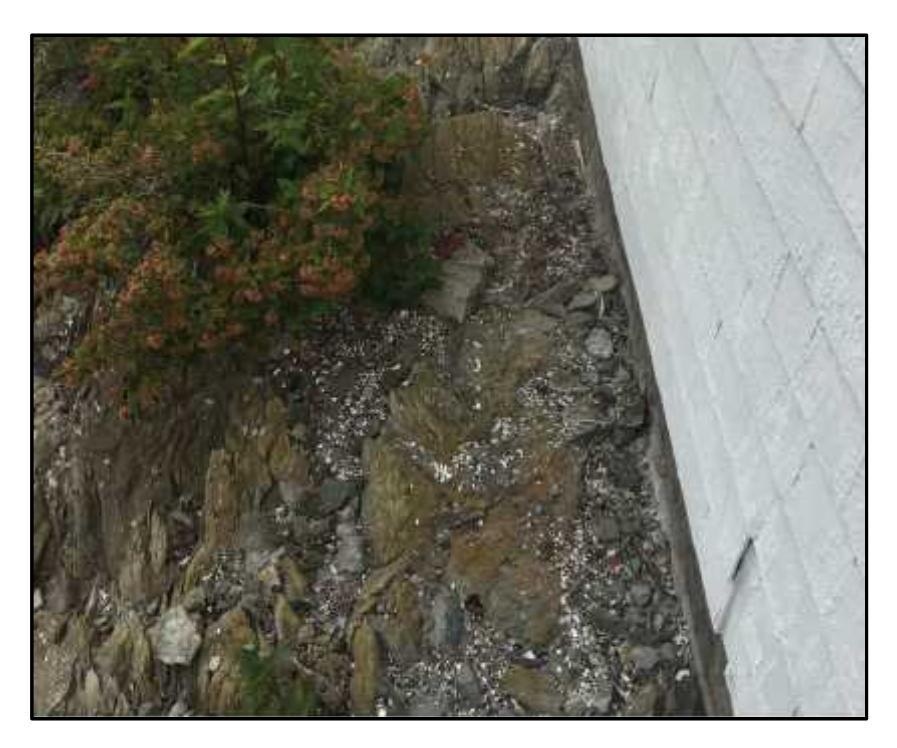
Photograph 12: View of paint debris on south side of the Old Fog Alarm / Generator Building.

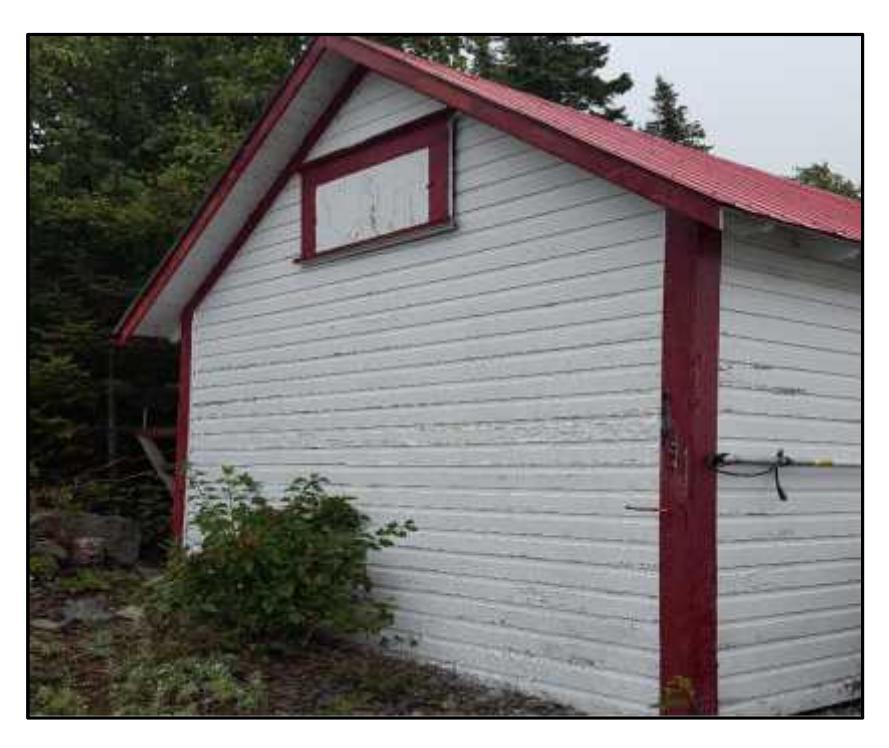
Photograph 14: View of Former Oil House, found to have exterior paint in poor condition.

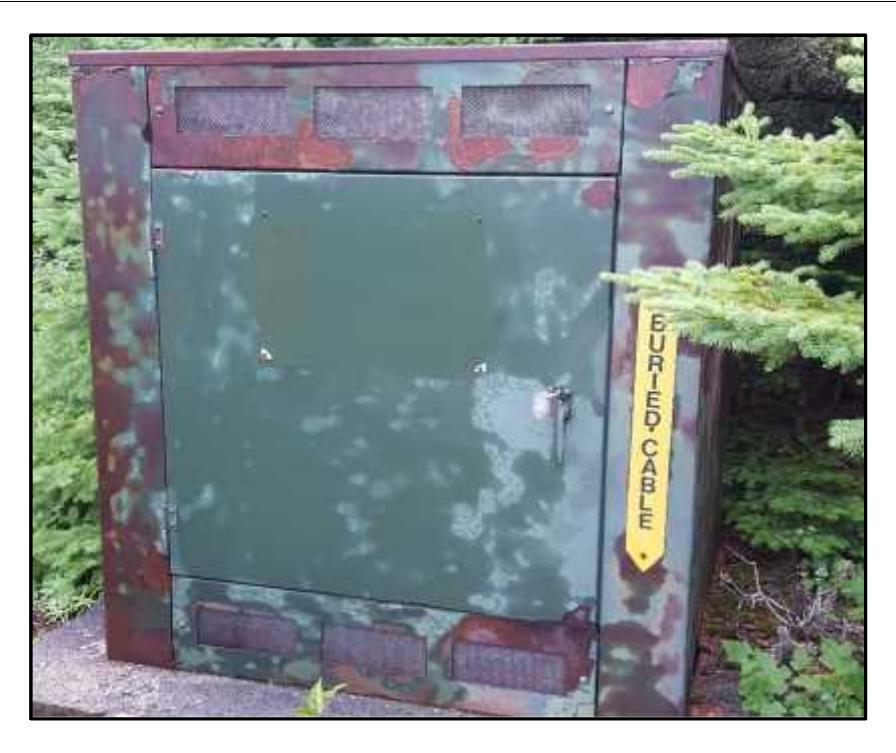
Photograph 15: View of Ground-Mounted Transformer, having paint in poor condition and suspect PCB contain transformer oil.
