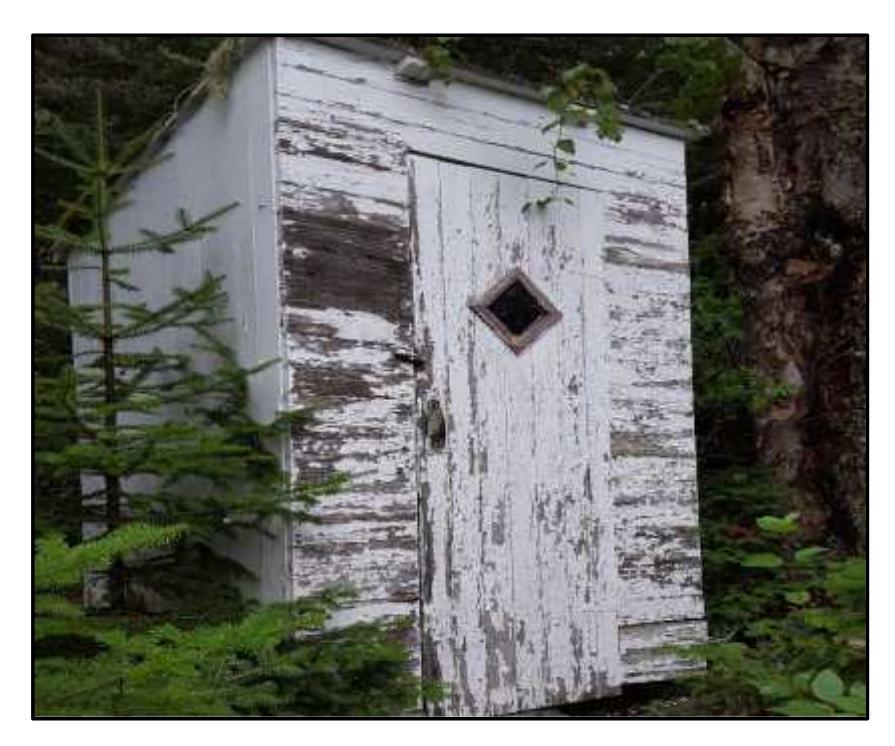
Photograph 16: View of outhouse on Site 1, having poor condition paint and extensive signs of water damage.

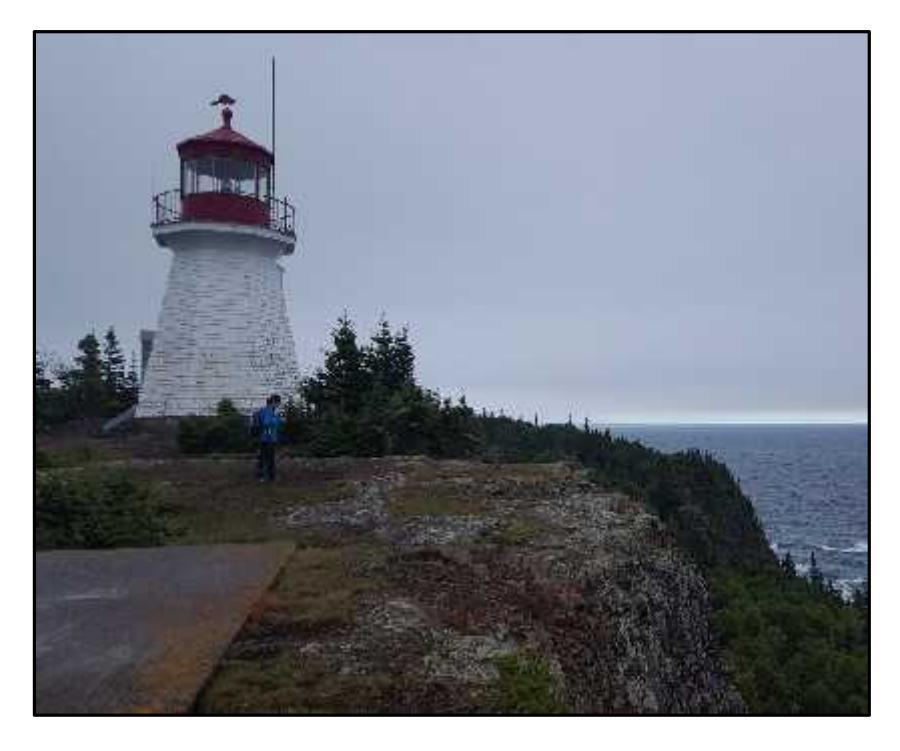
Photograph 17: View of Lighthouse, found to have exterior paint in poor condition.

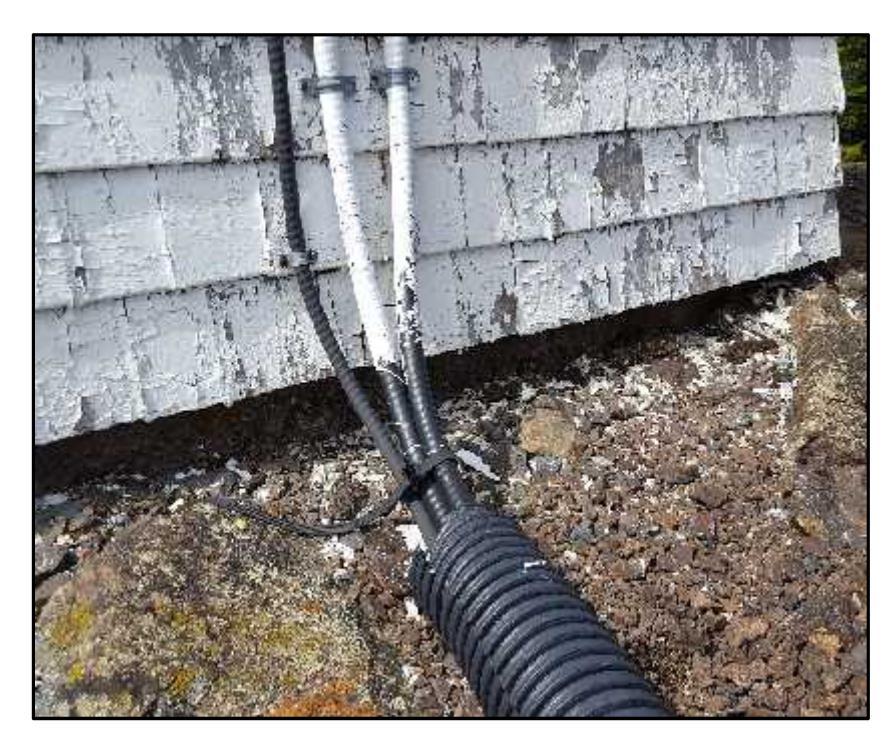
Photograph 18: View of debris along the base of the perimeter of the lighthouse.

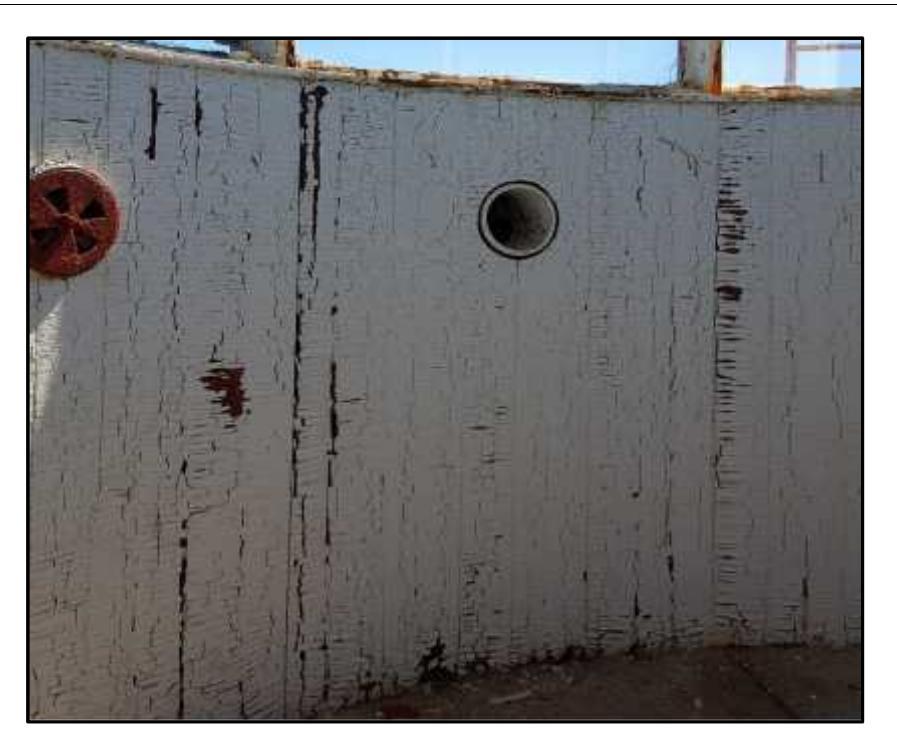
Photograph 19: View of interior of Lighthouse upper level lantern, found to have paint in poor condition, paint debris on floor and signs of water damage.

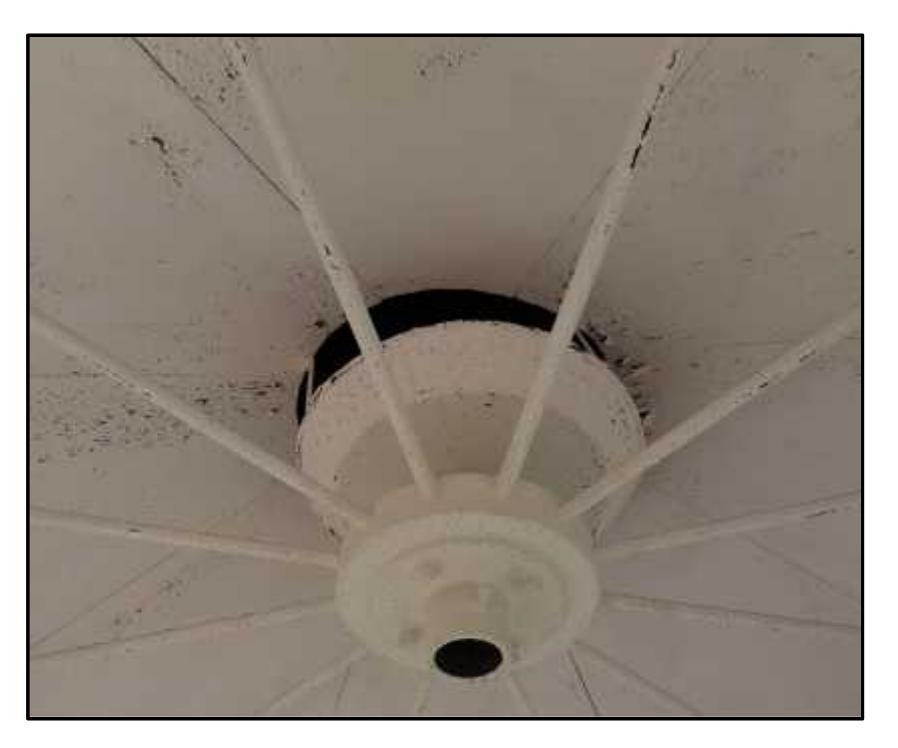
Photograph 20: View of interior of Lighthouse upper level lantern ceiling, found to have paint in poor condition.

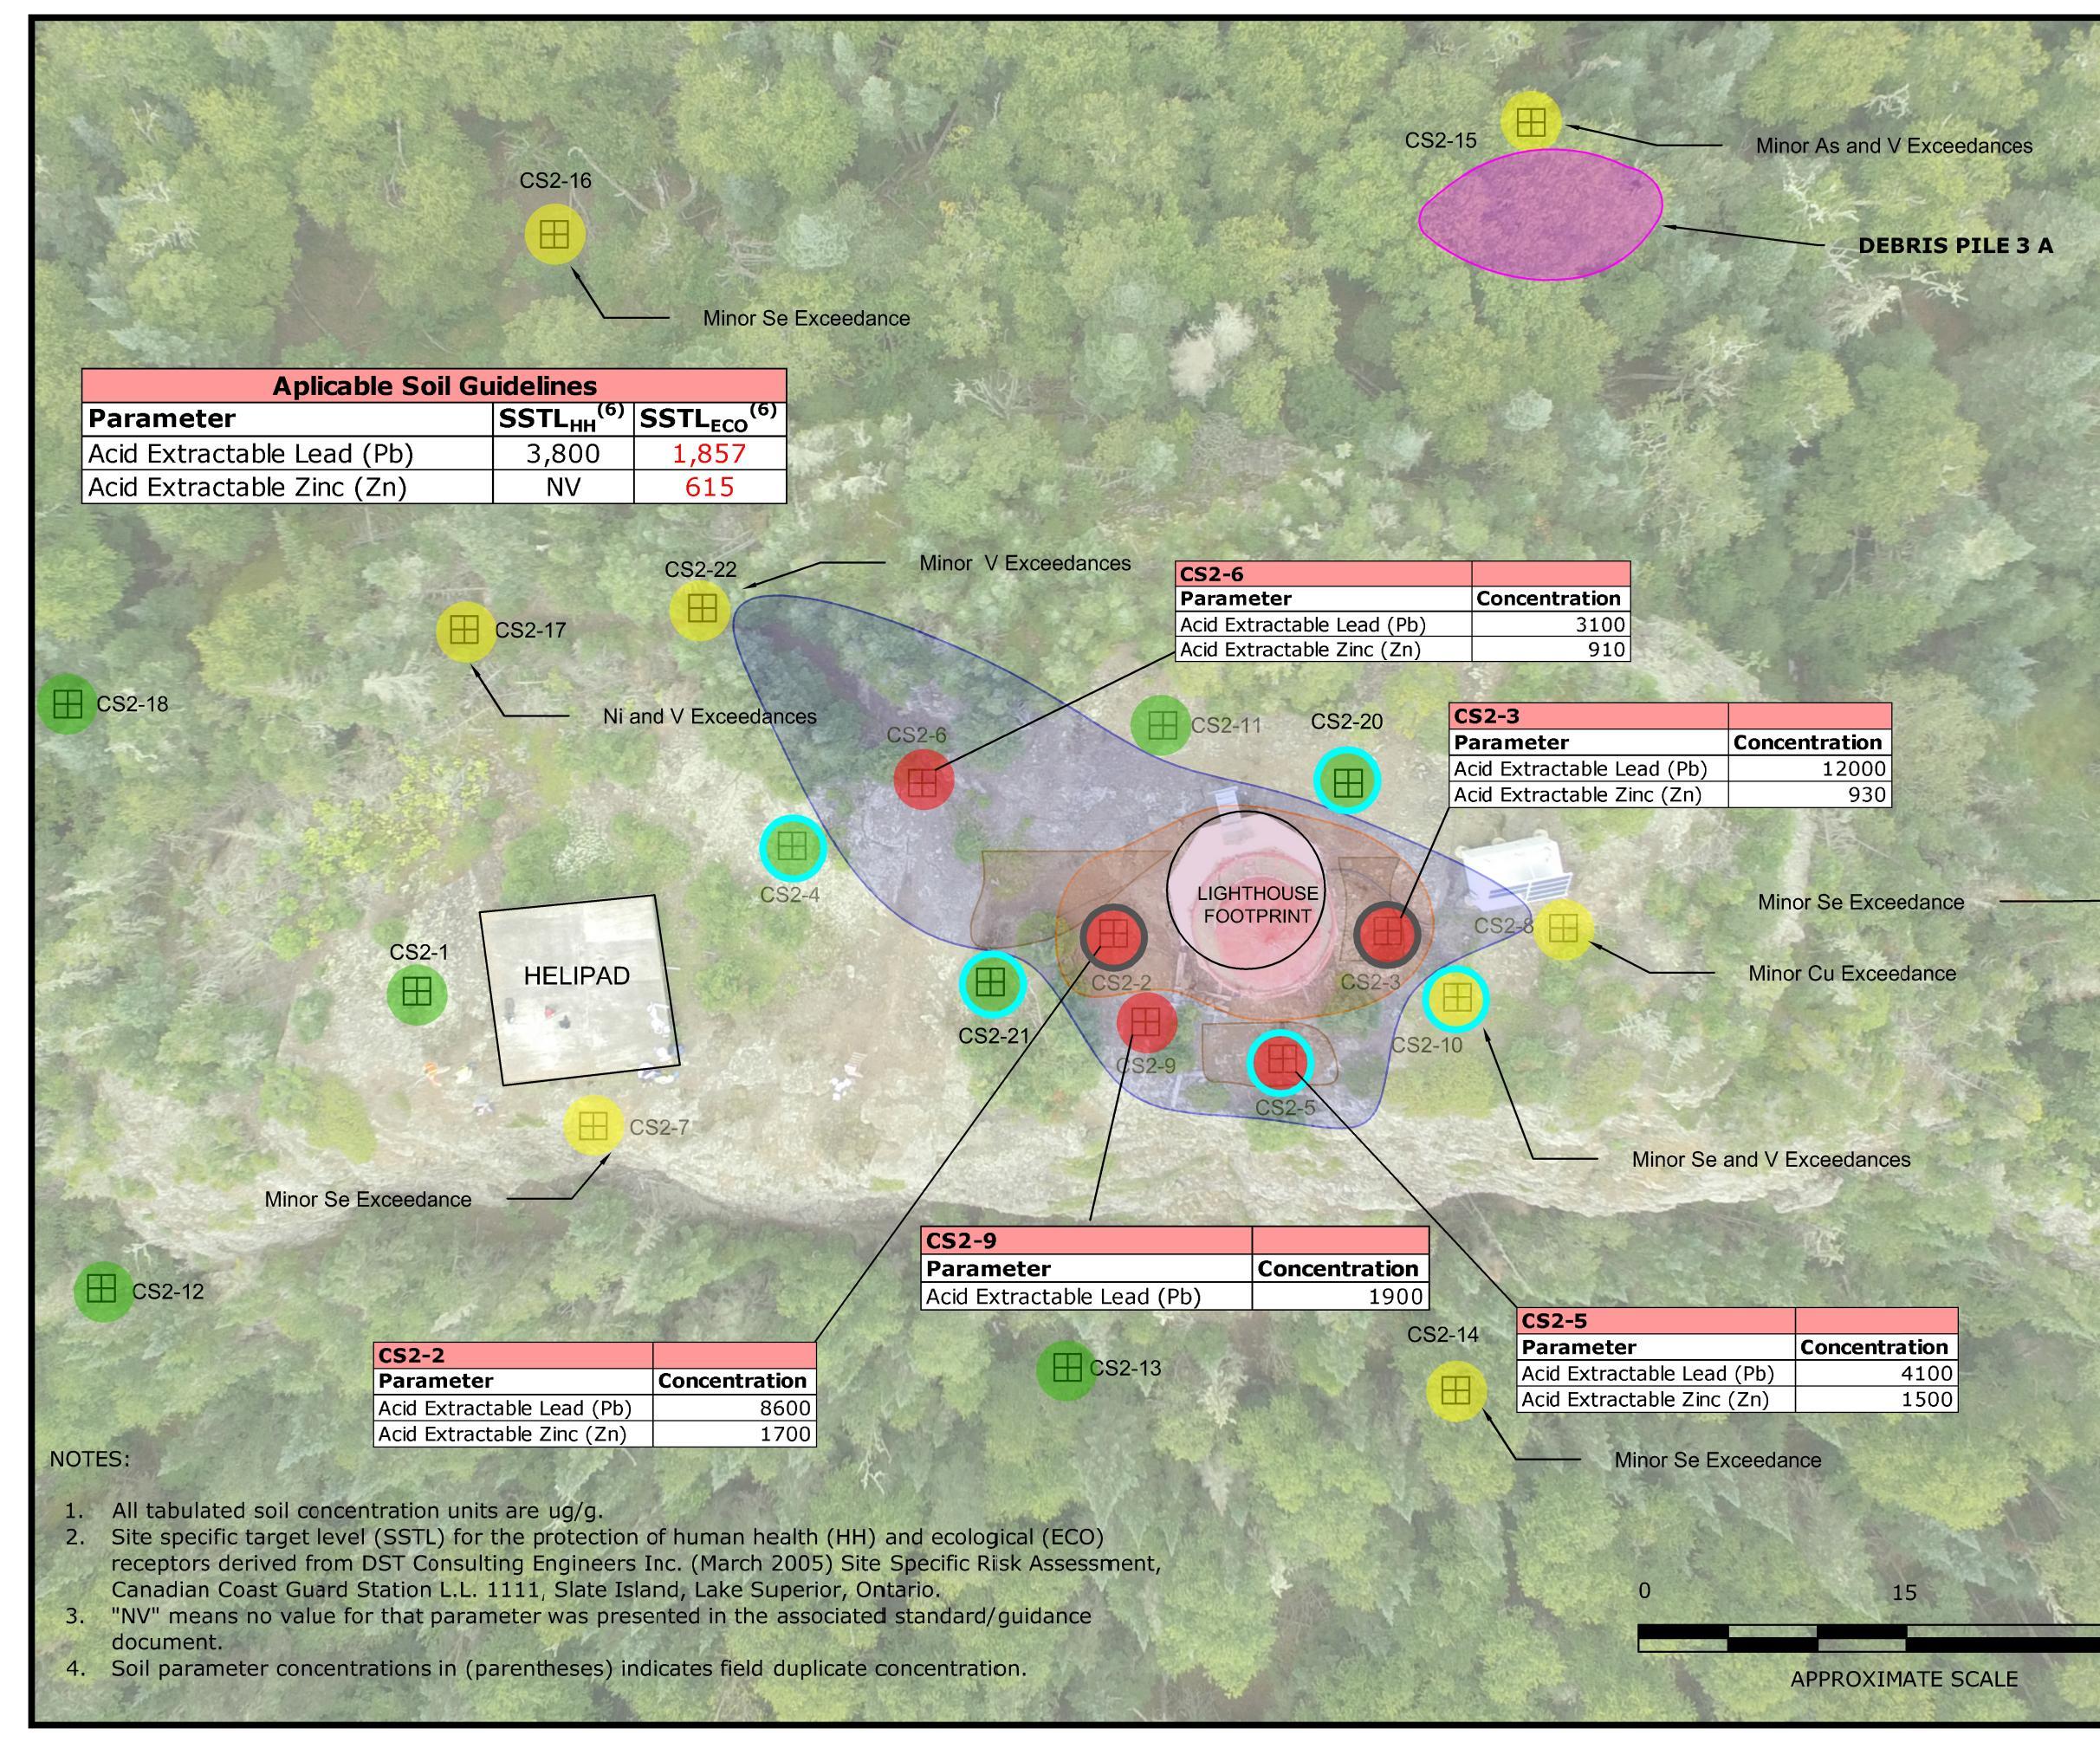
DESIGNED BY:	SCALE:
JW	As Shown
DRAWN BY:	DATE:
JR	MARCH 2017
APPROVED BY:	PROJECT NO.:
CS	GV-TB-027105
FIGURE NO.: FIGU	JRE 14

For CS-2, the surface area of shallow soil estimated to contain lead and/or zinc concentrations greater than the HH SSTL is approximately 600 m². It is estimated, based on the parameters presented in Section 5.6.1, that CS-2 contains a volume of approximately 70 m³ of solid non-hazardous waste and 30 m³ of hazardous waste as defined by Reg. 347. The leachate-hazardous and non-hazardous contaminated soil is all centred around the lighthouse structure as shown on Figure 14.

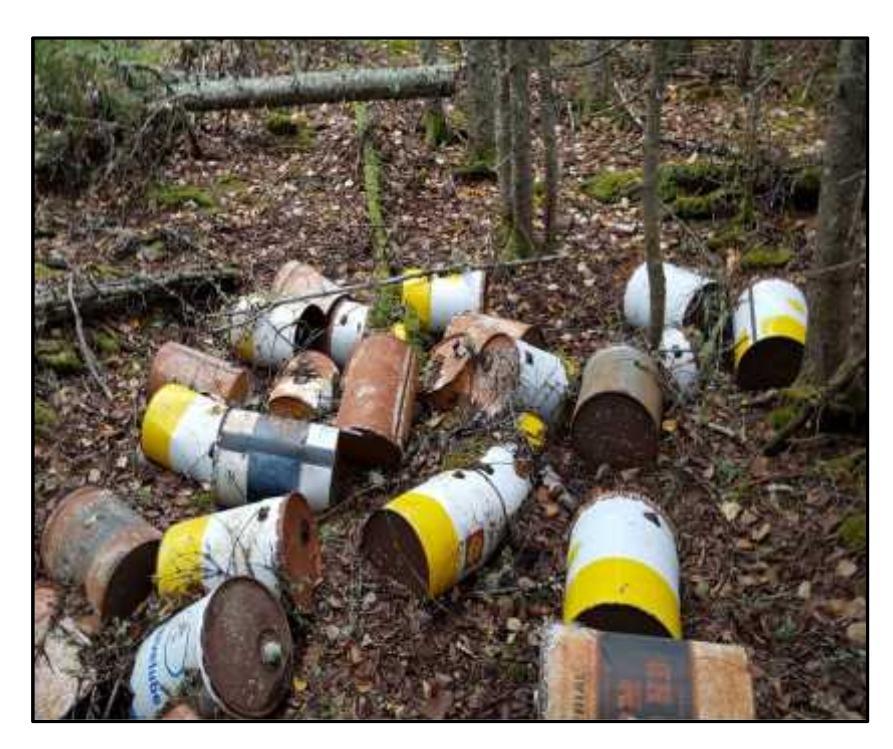
Photograph 6: View of waste pile in East Dump containing empty oil pails, facing east.

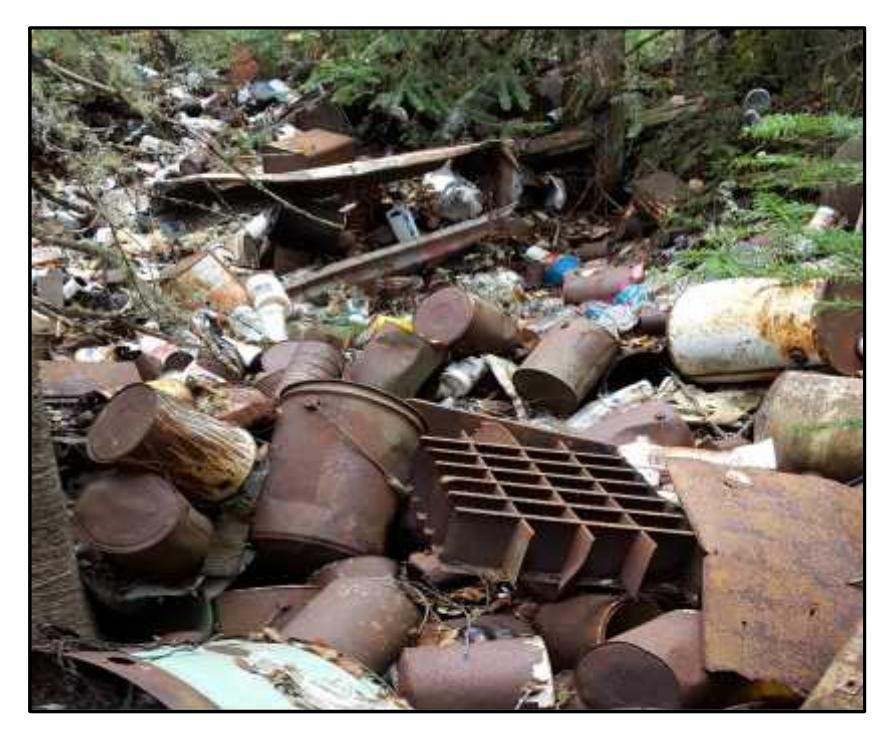
Photograph 7: View of waste pile in East Dump, facing west.

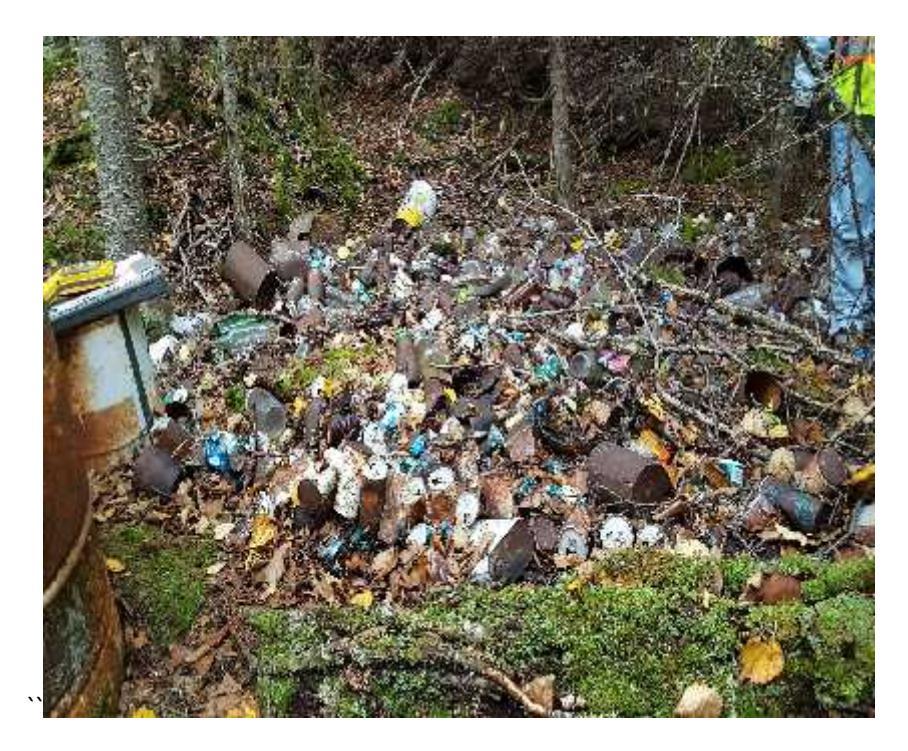
Photograph 8: View of waste in West Dump, facing west.

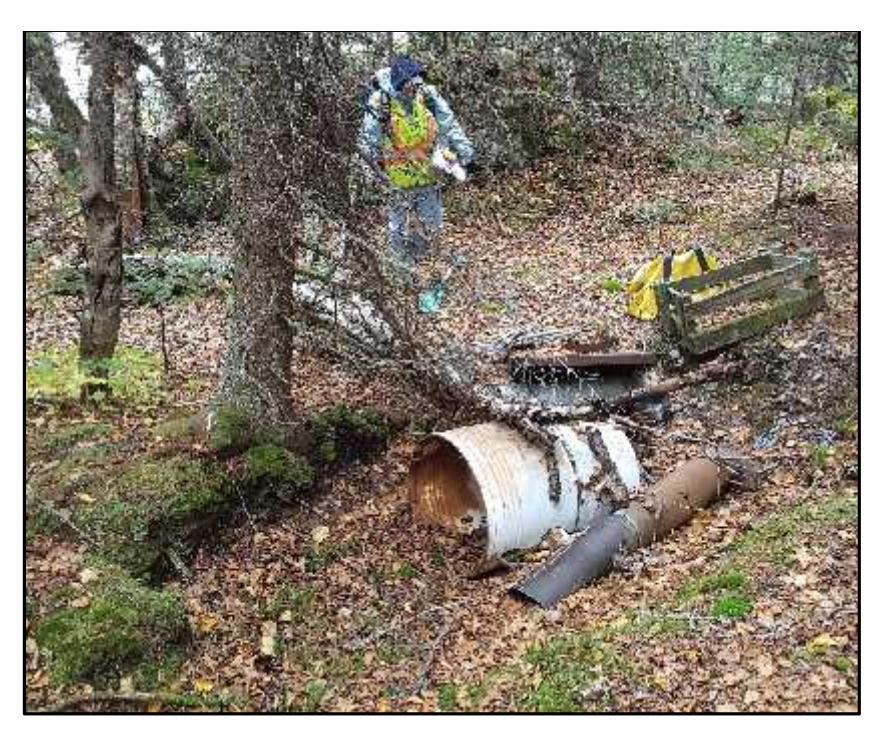
Photograph 9: View of waste pile in West Dump, facing west.

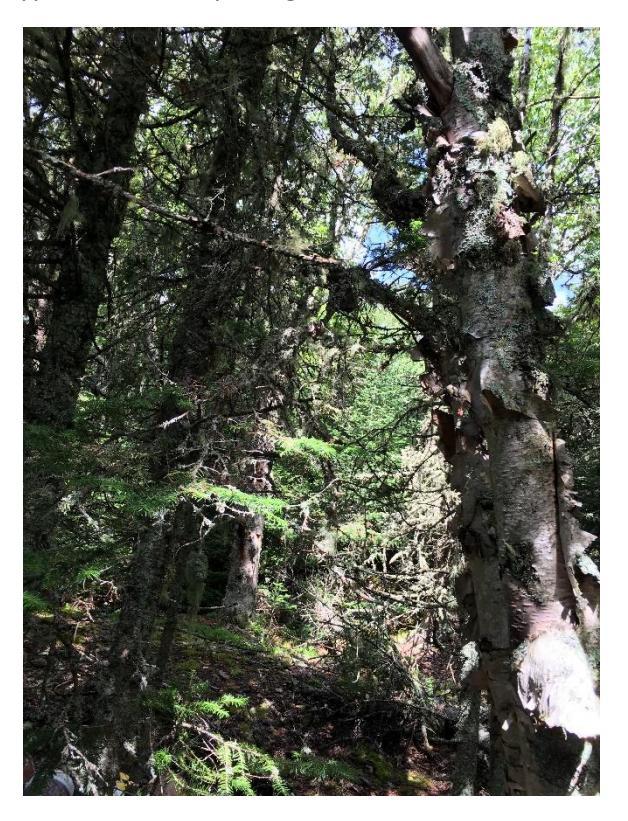
Photograph 4: Understory in area of historic dump.

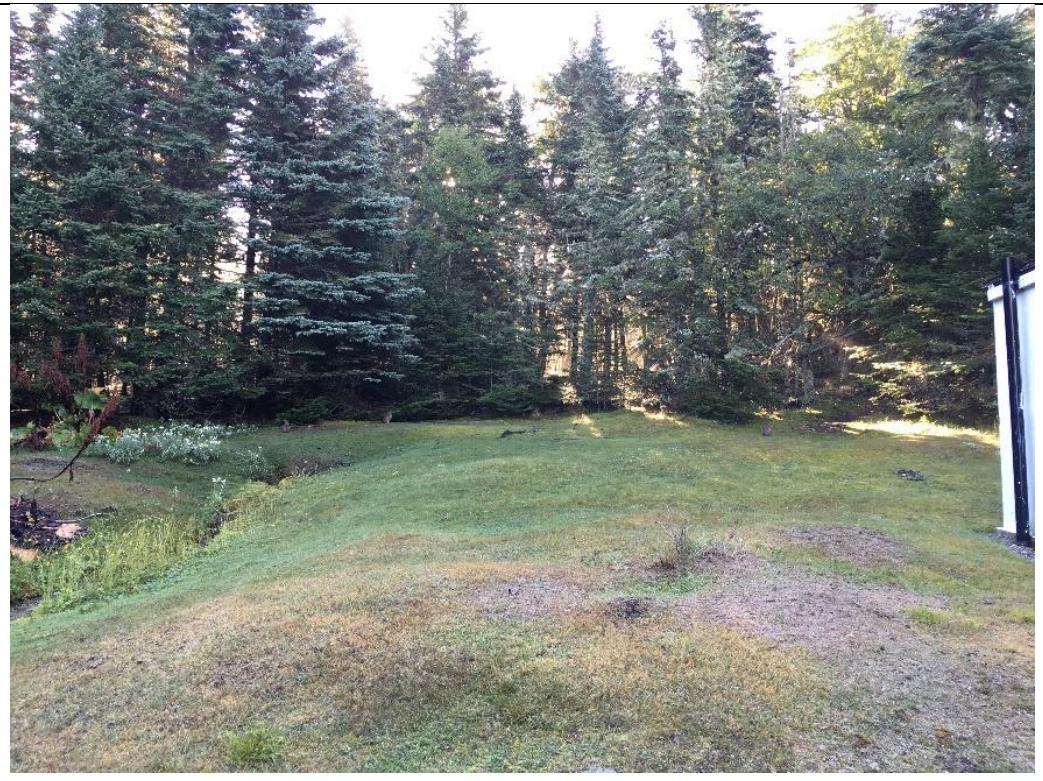
Photograph 5: Open grassy area near Old Dwelling.

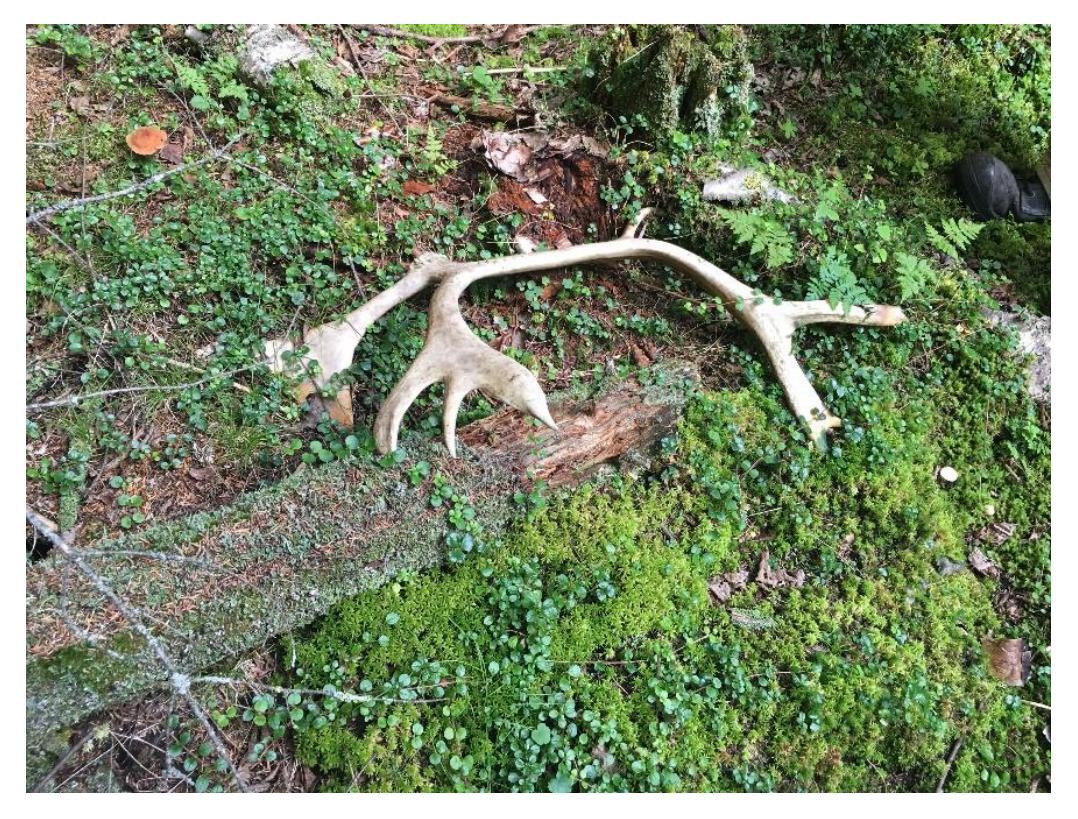
Photograph 6: Weathered caribou antler located in area of Old Dwelling.

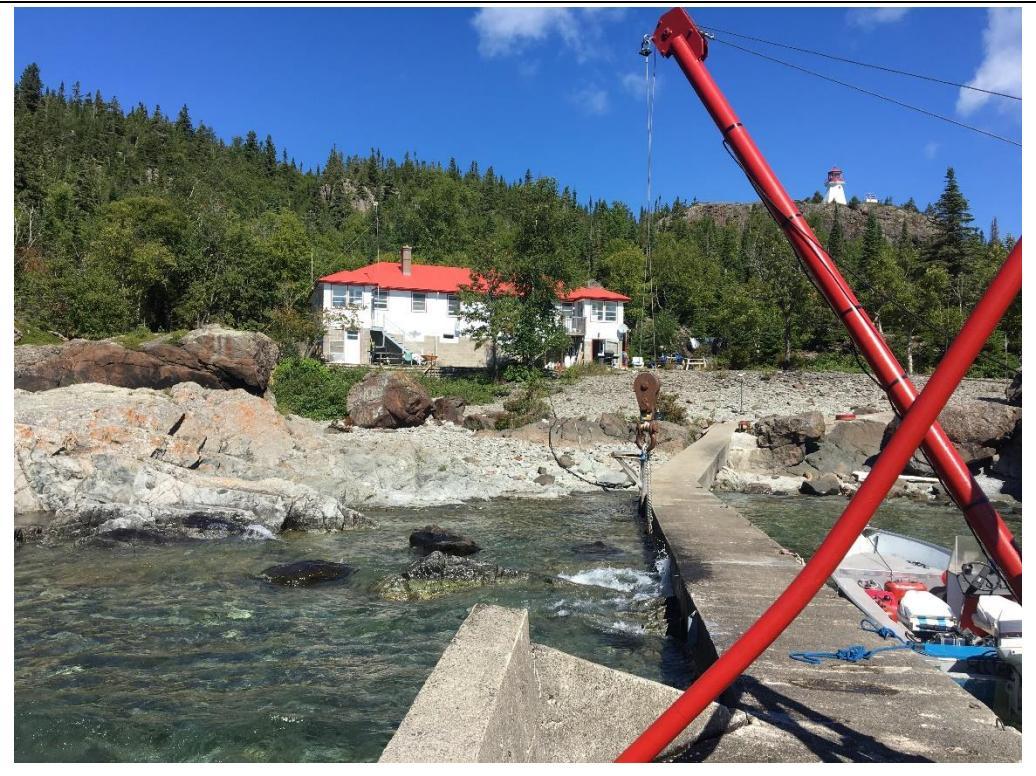
Photograph 1: View of main dwelling and lighthouse in background, facing north.

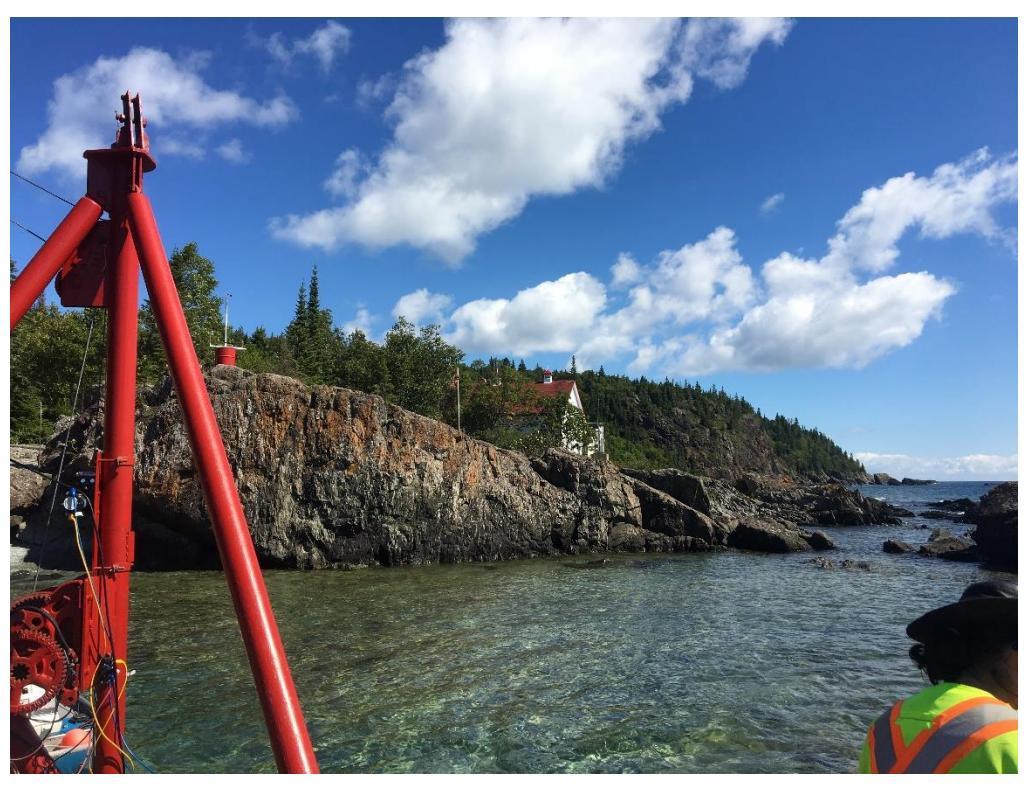
Photograph 2: View of main site shoreline, facing northeast.

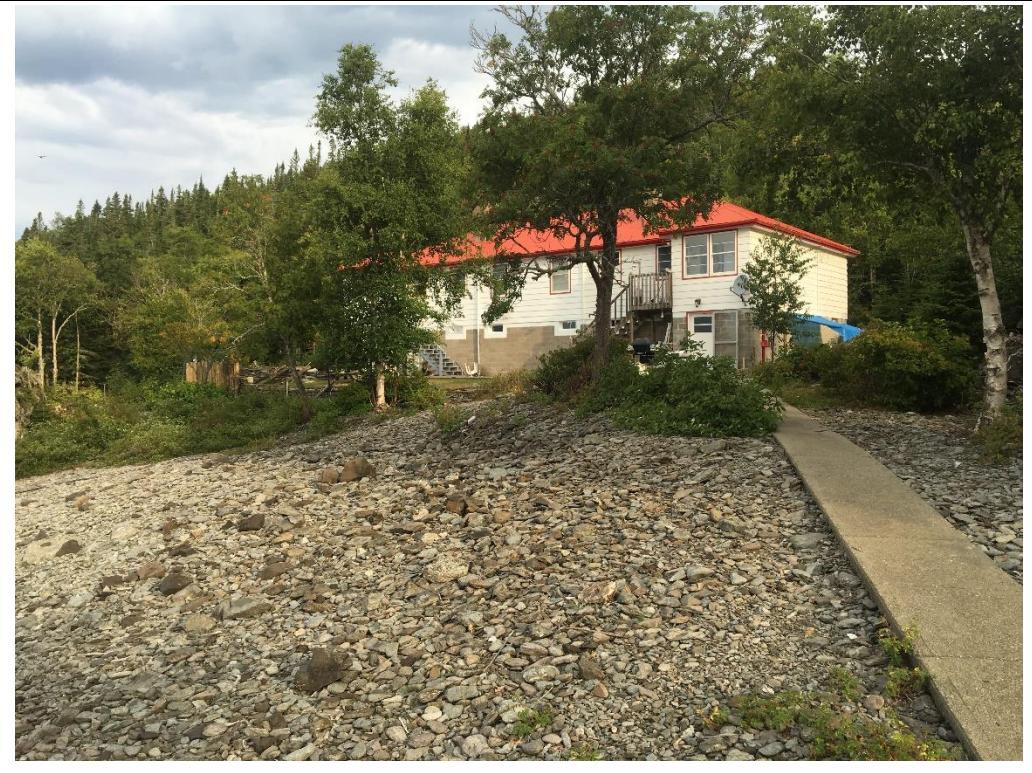
Photograph 3: View of duplex dwelling and surrounding area, facing northwest.

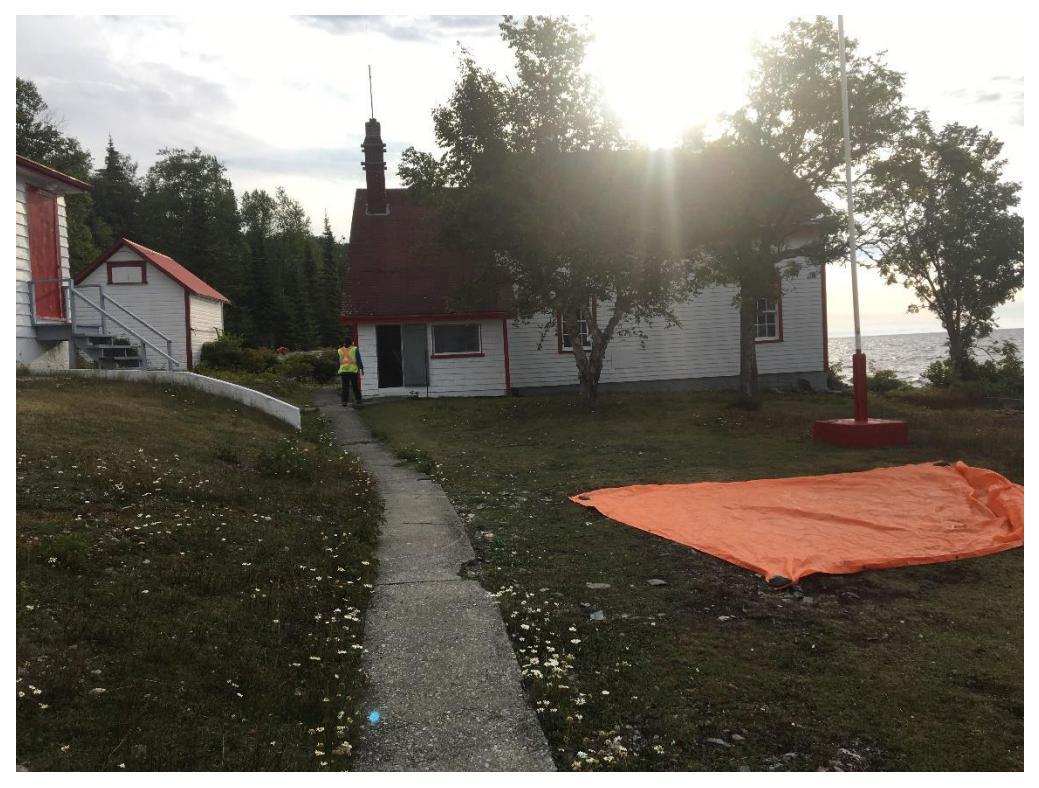
Photograph 4: View of fog alarm building, facing east.

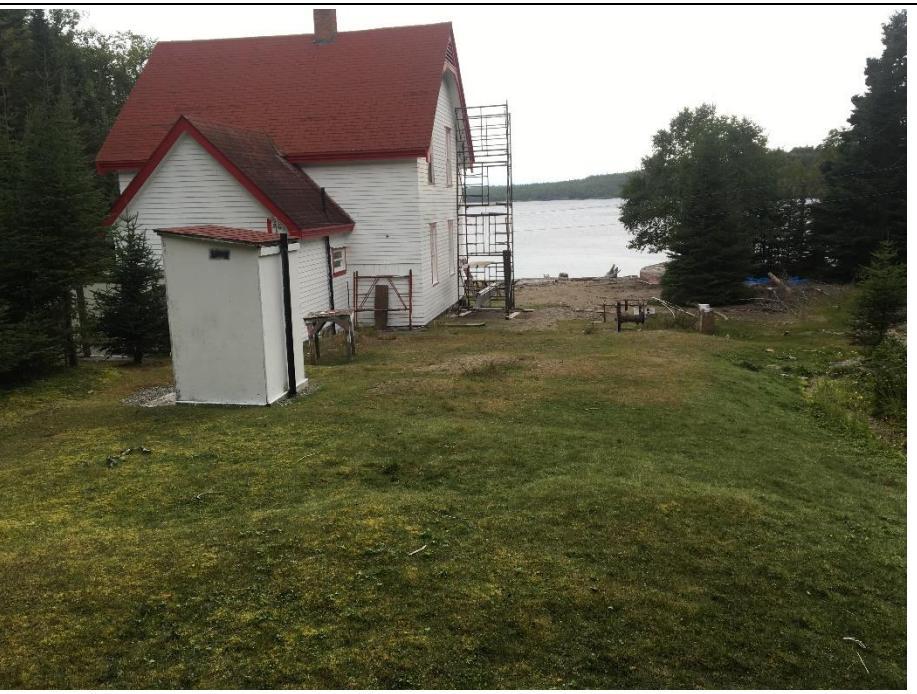
Photograph 5: View of old dwelling, facing north.

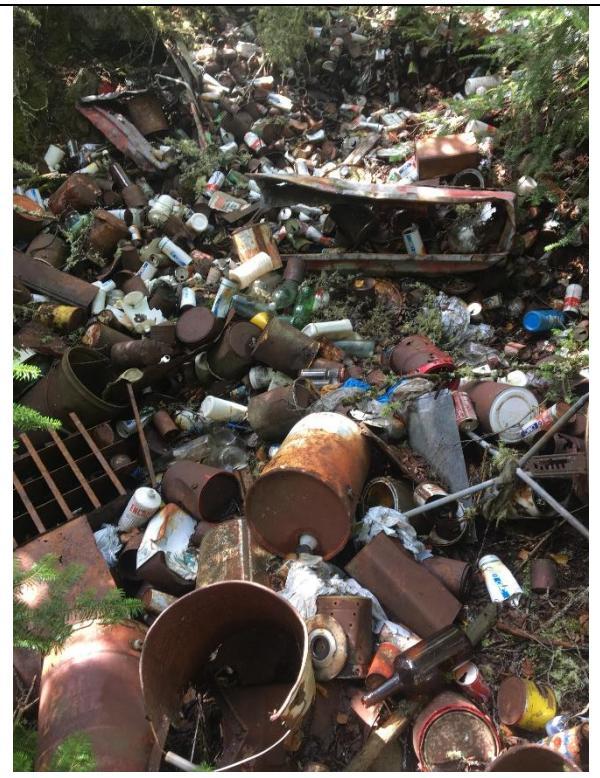
Photograph 11: View of dump area located northwest of the Main Site, facing east.

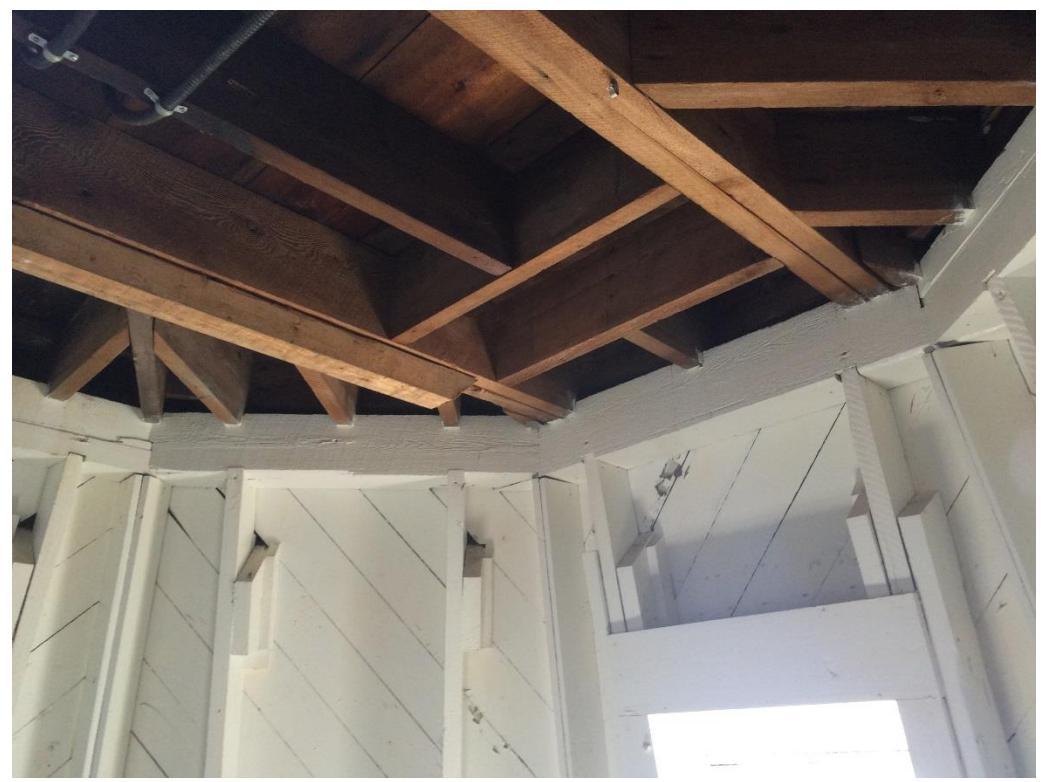
Photo 4: Lighthouse floor and wall construction.

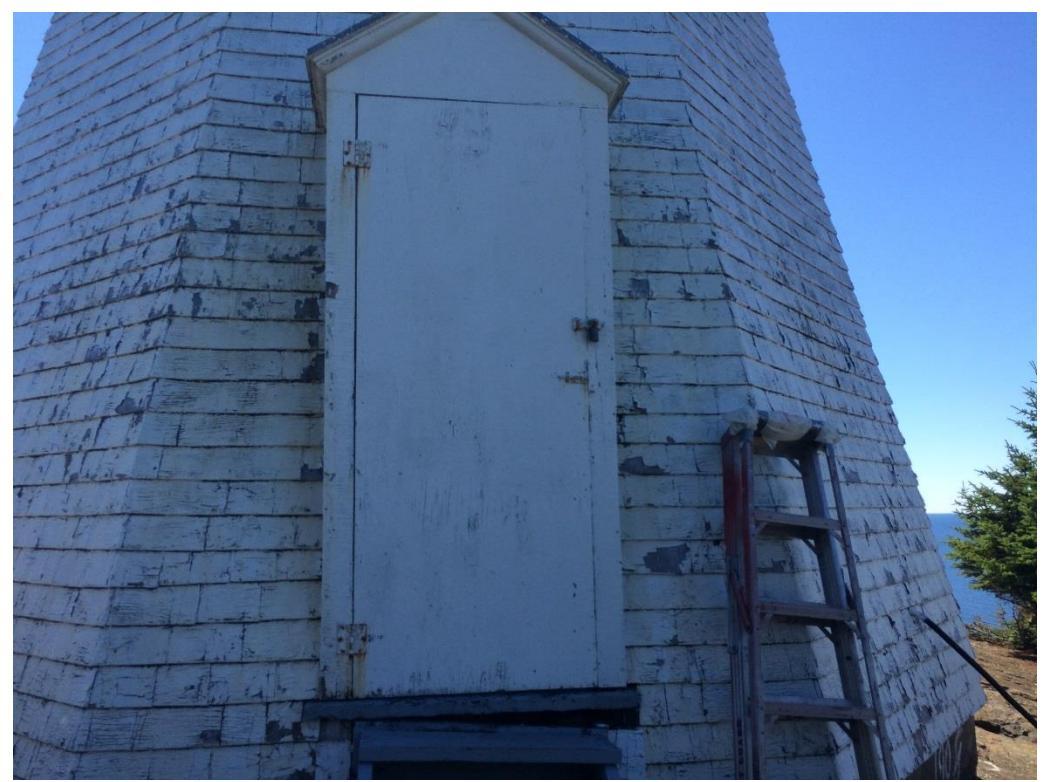
Photo 6: Exterior door.

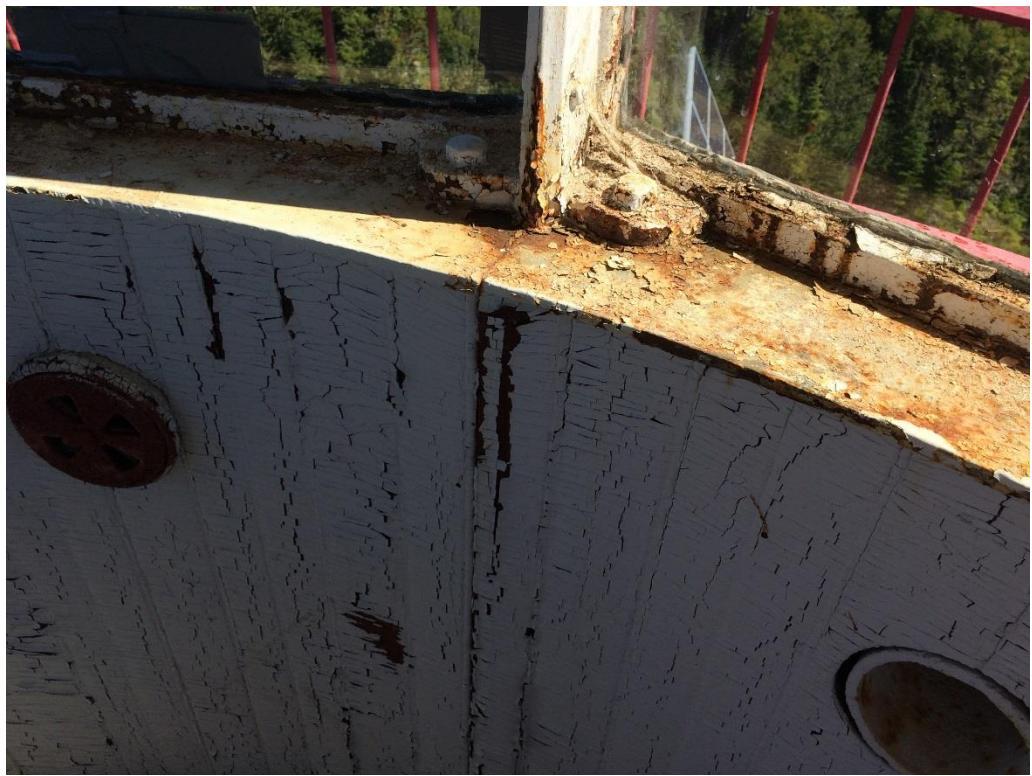
Photo 11: Peeling paint and light corrosion at lantern.

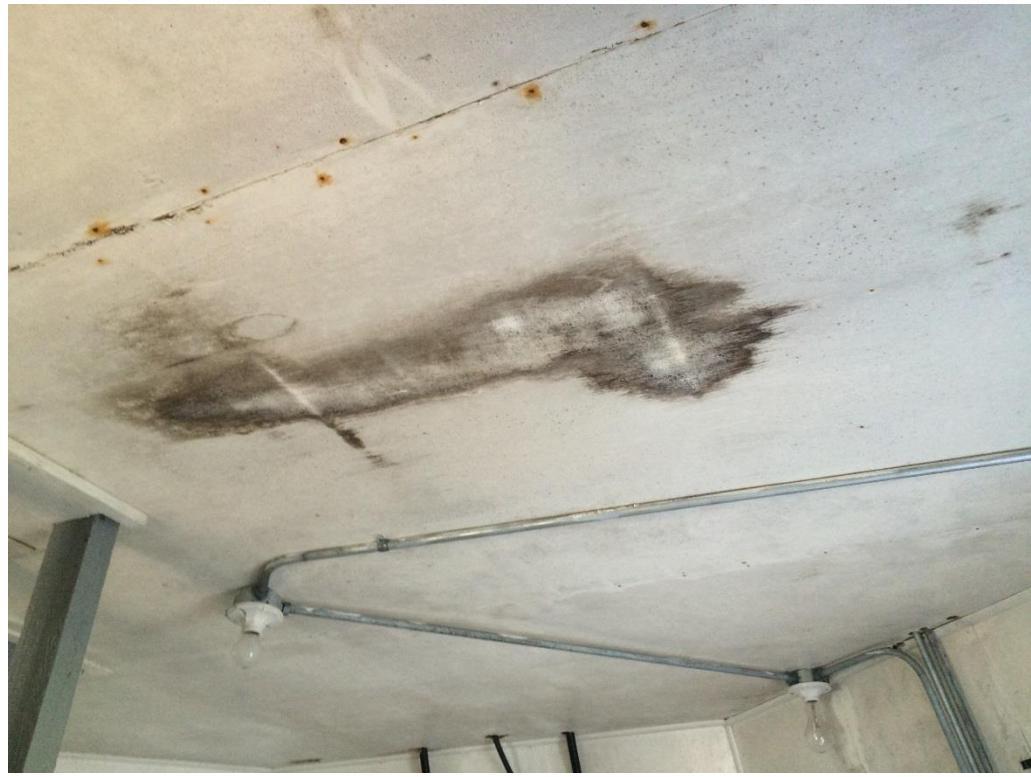
Photo 15: Mold, mildew, and water damage at wood ceiling.

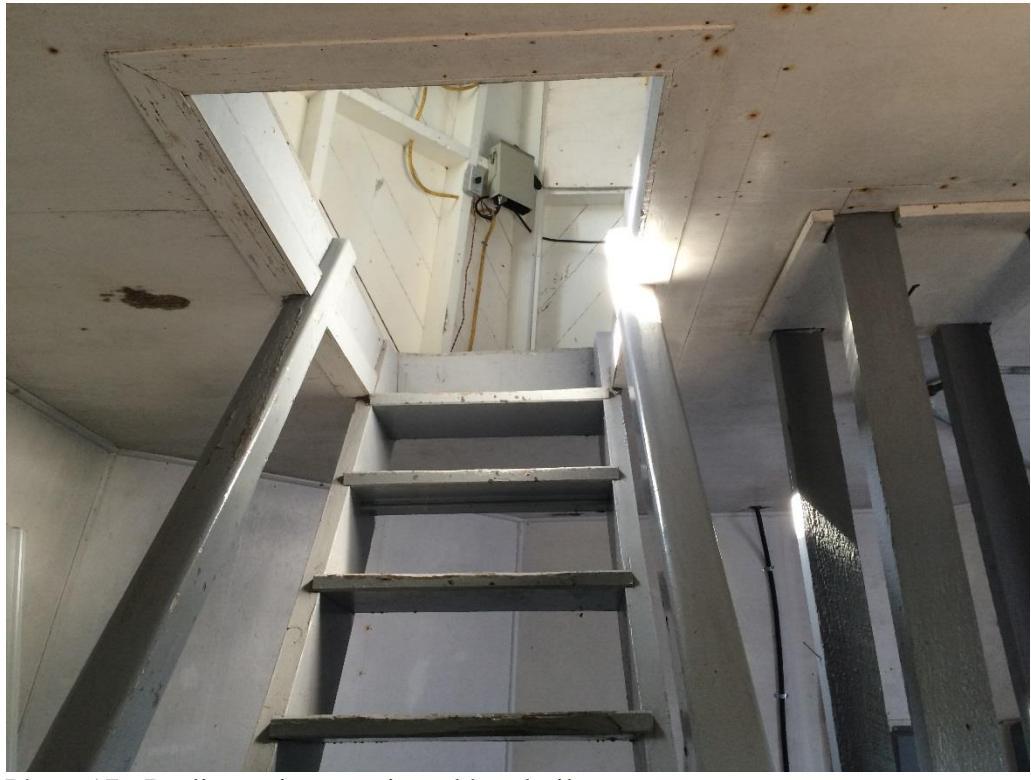
Photo 17: Peeling paint at stair and handrail.

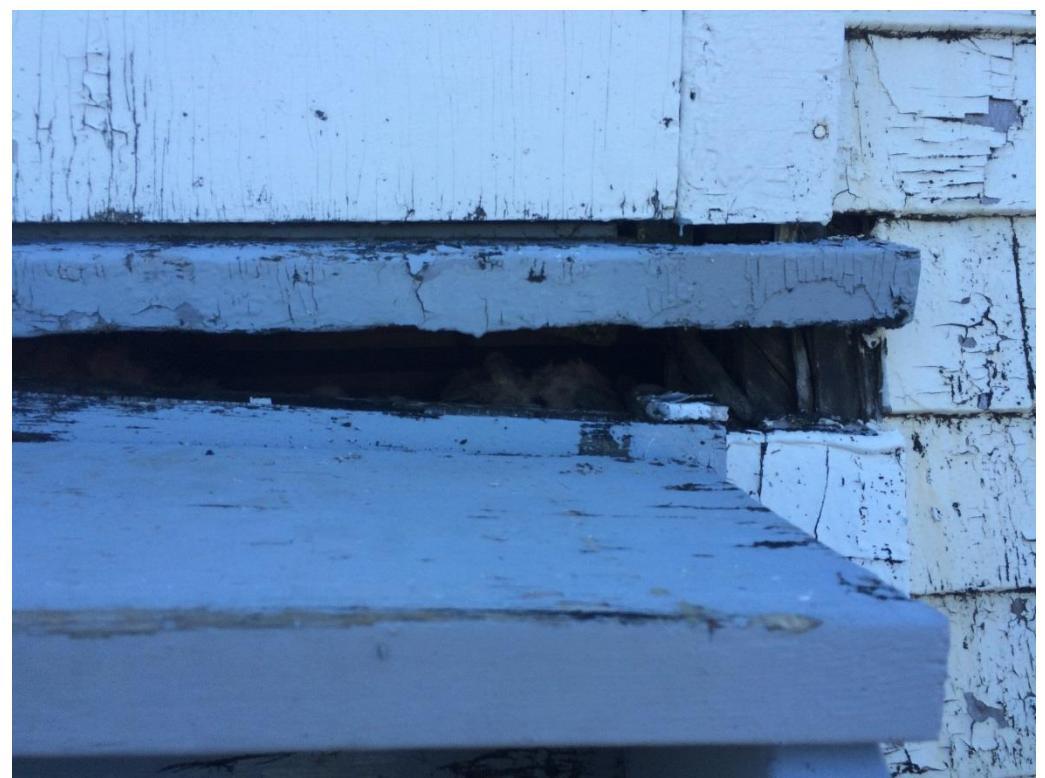
Photo 20: Gap below timber sill.

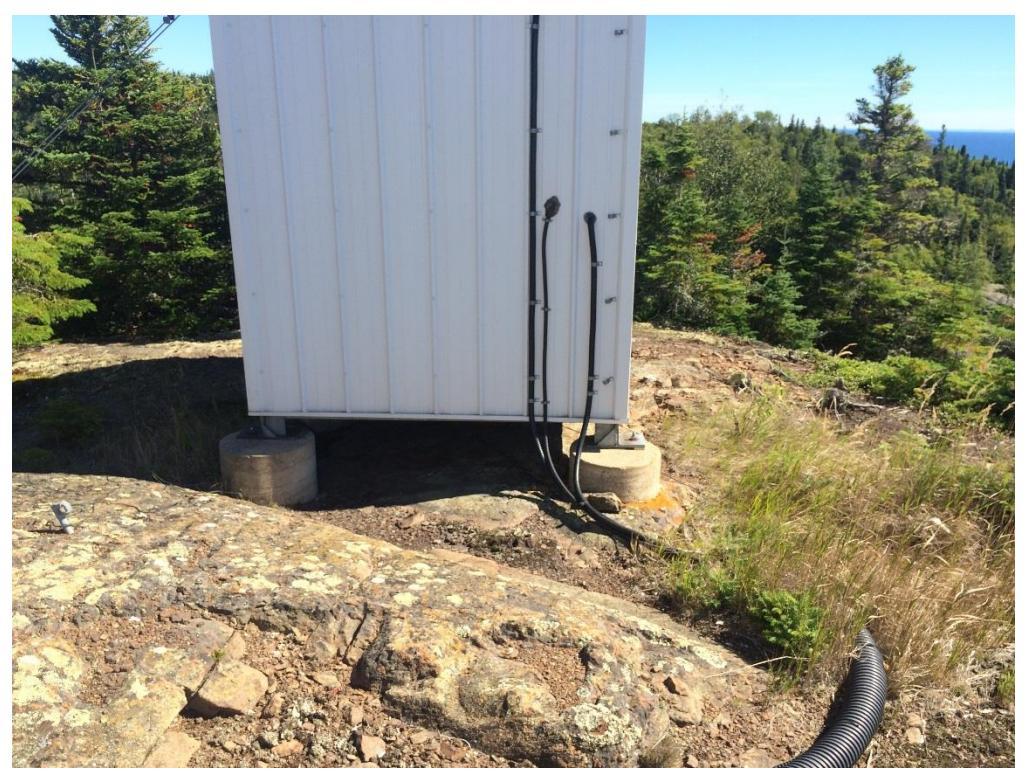
Photo 3: Solar Building foundation.
