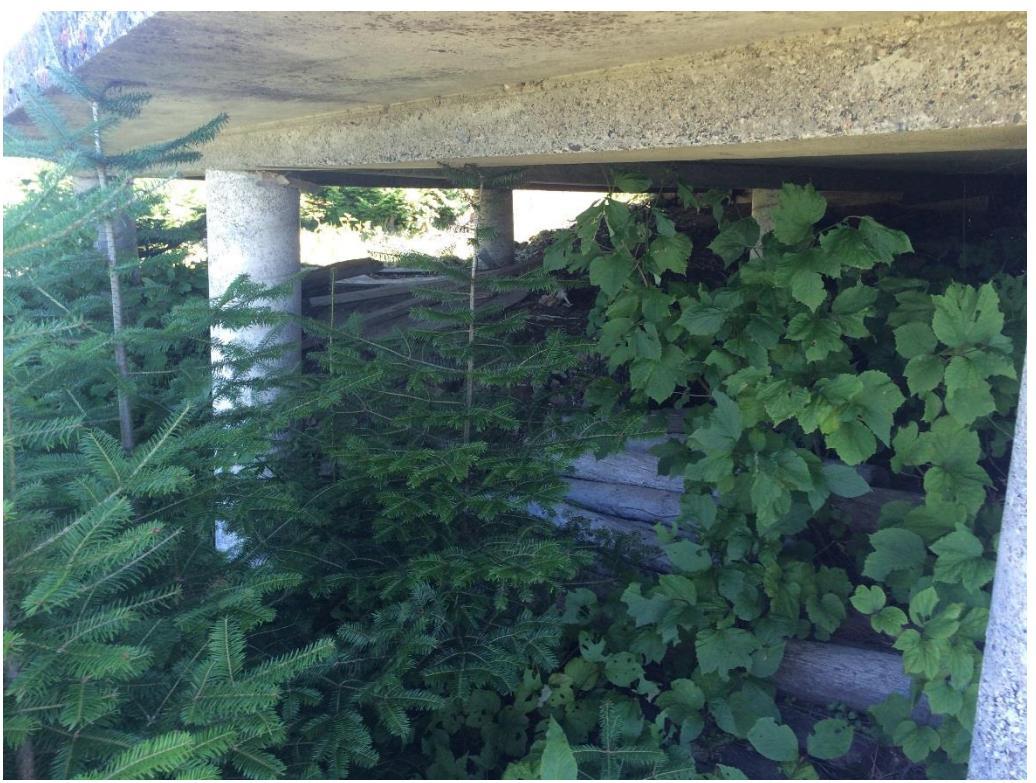
Photo 3: Vegetative growth below concrete slab.

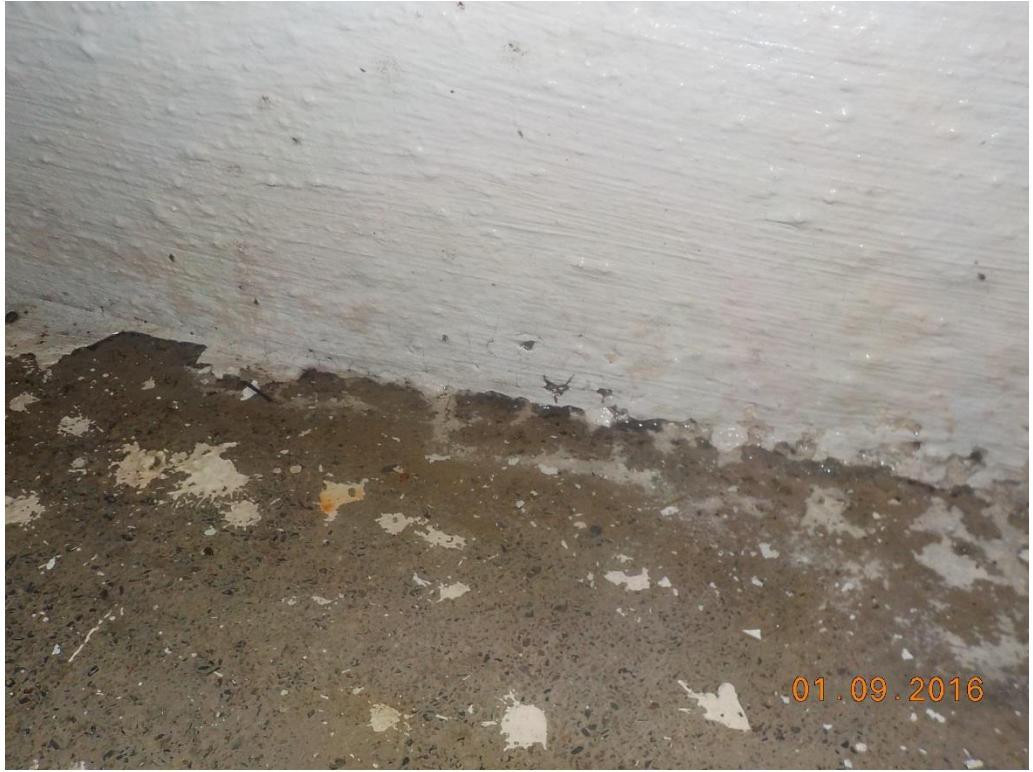
Photo 7: Leak at north foundation wall.

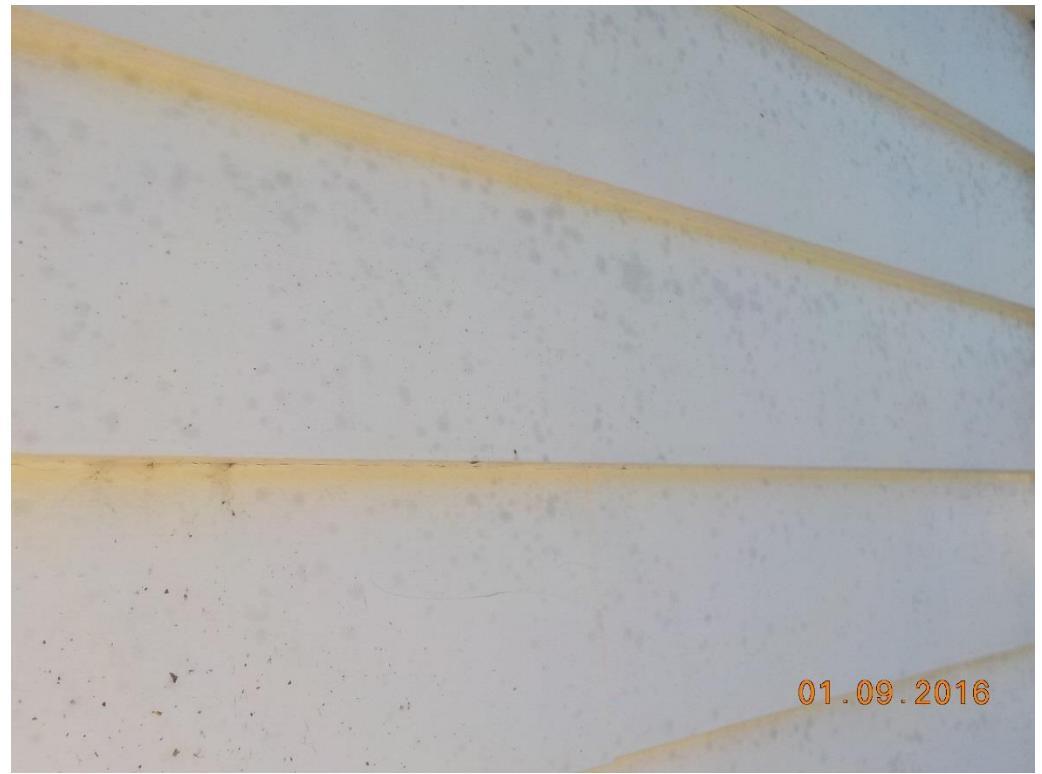
Photo 10: Mildew at wood siding.

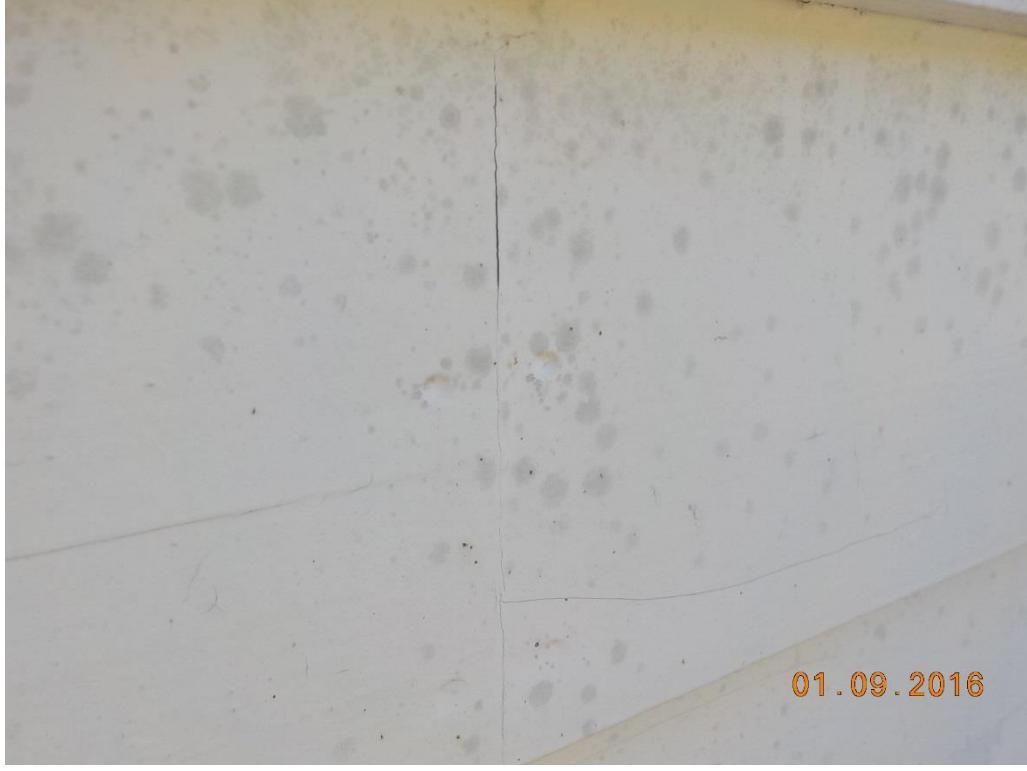
Photo 11: Cracks at wood siding.

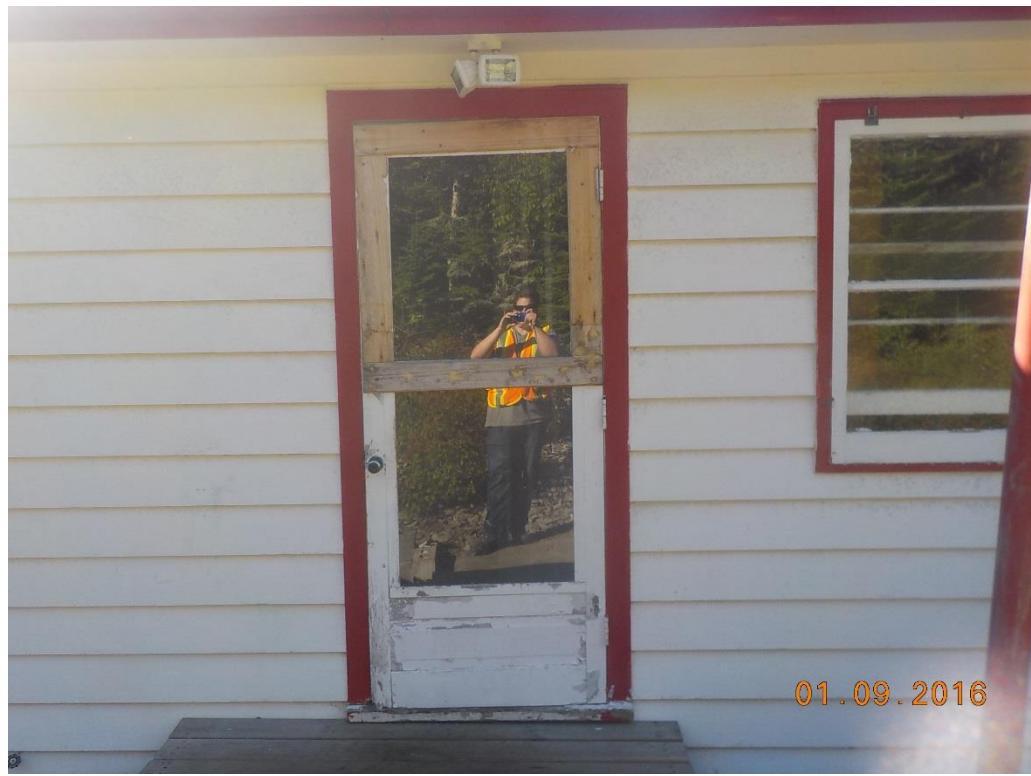
Photo 12: Northern door in poor condition.

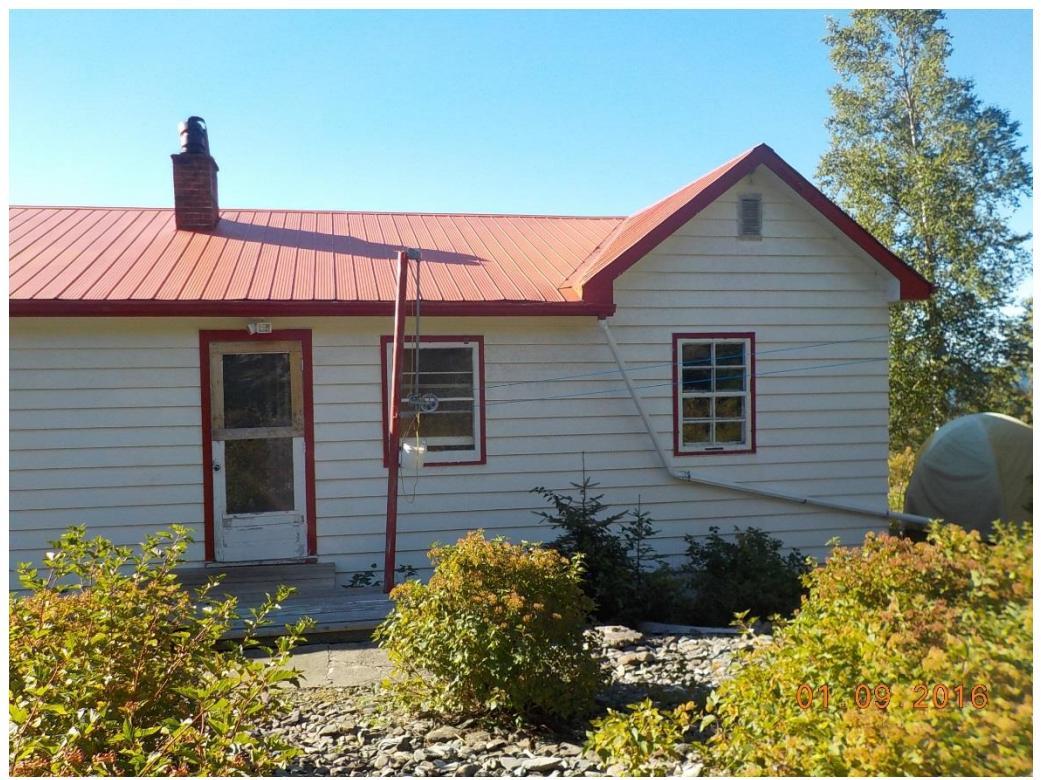
Photo 16: Preformed metal roofing over asphalt shingles.

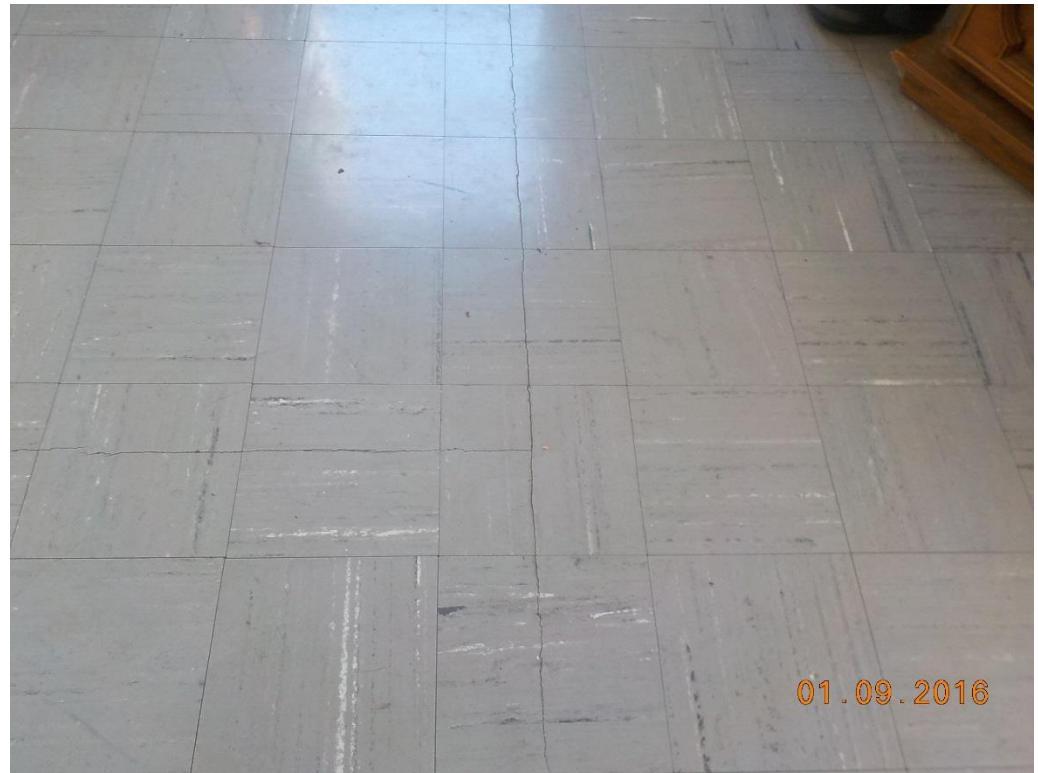
Photo 17: Cracks in vinyl flooring in living room.

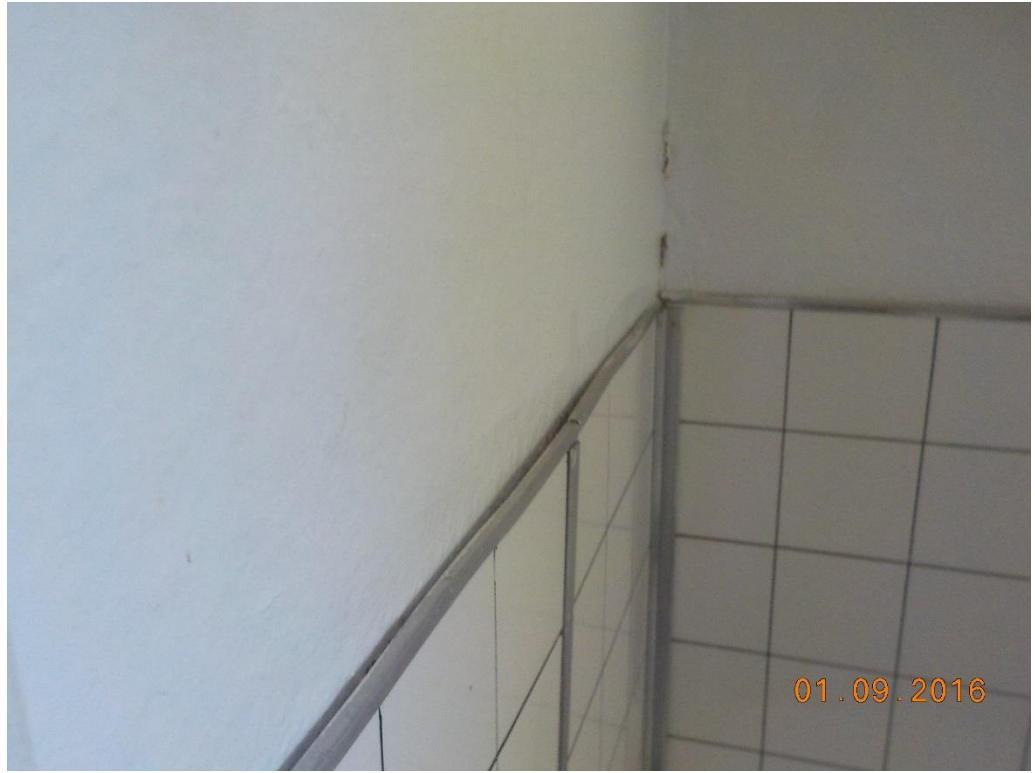
Photo 21: Tub surround separating from wall within bathroom.

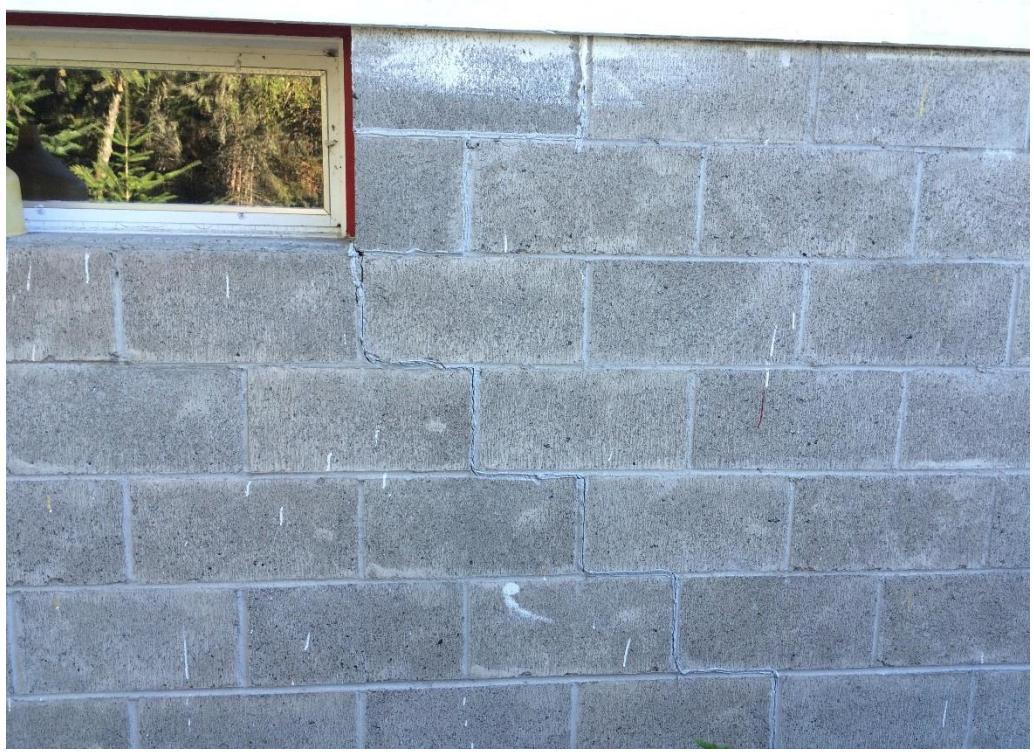
Photo 3: Typical step cracking at foundation wall.

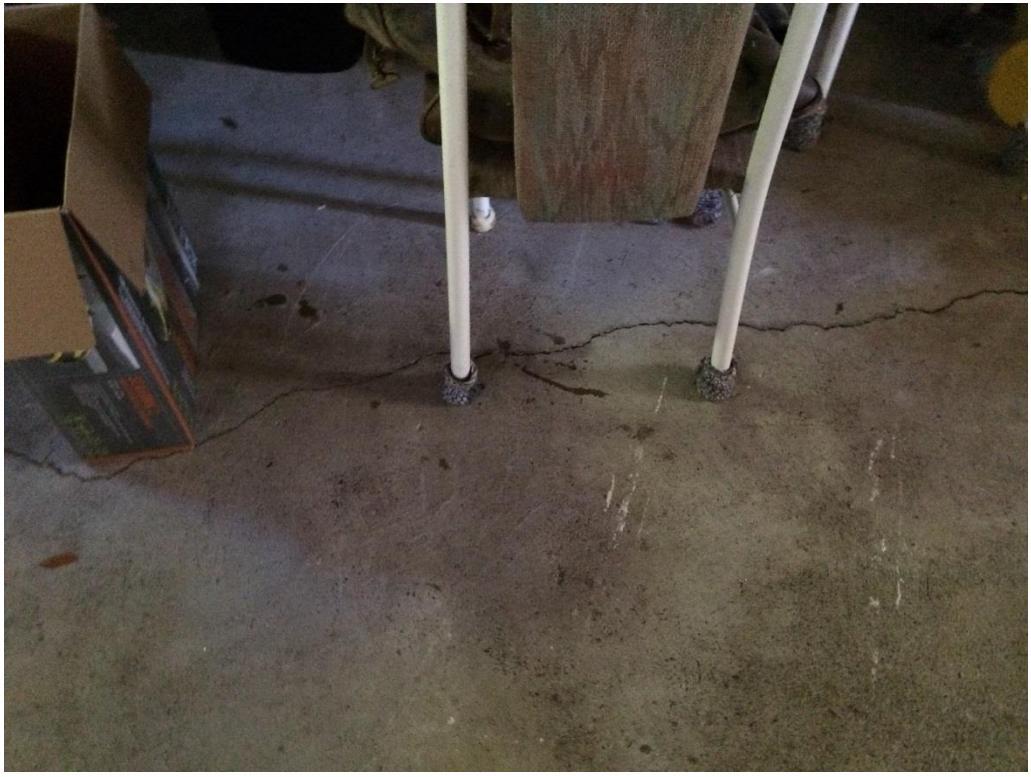
Photo 5: Wide crack at concrete slab.

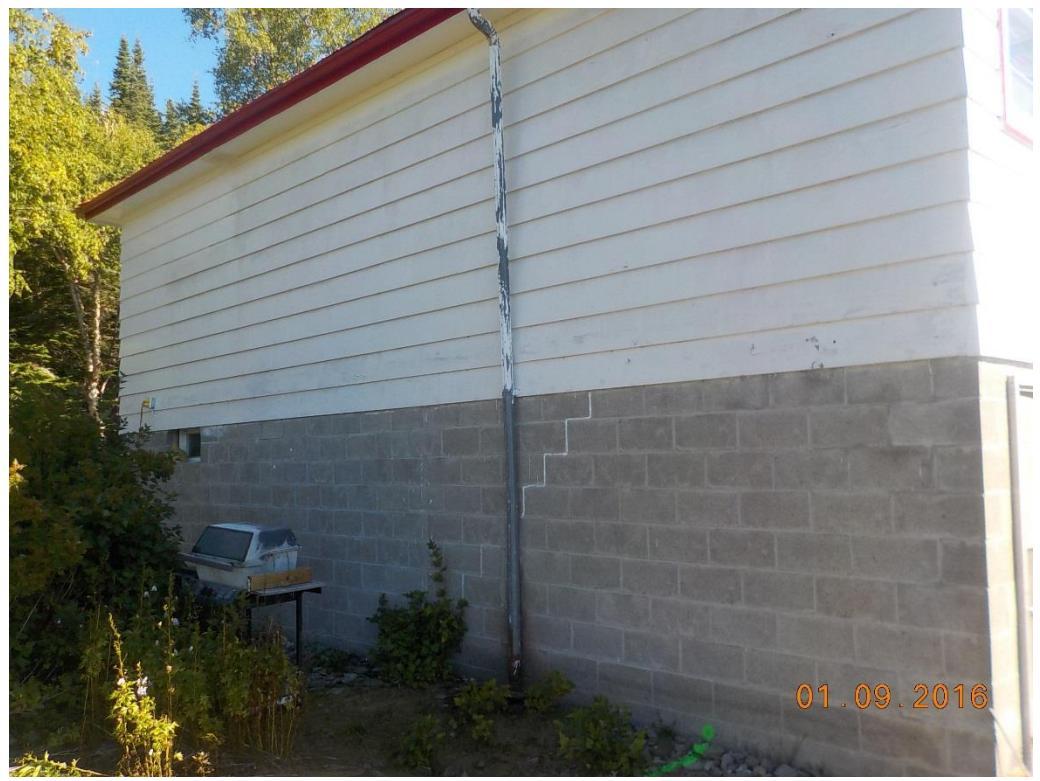
Photo 7: Typical weathering and paint peeling at siding.

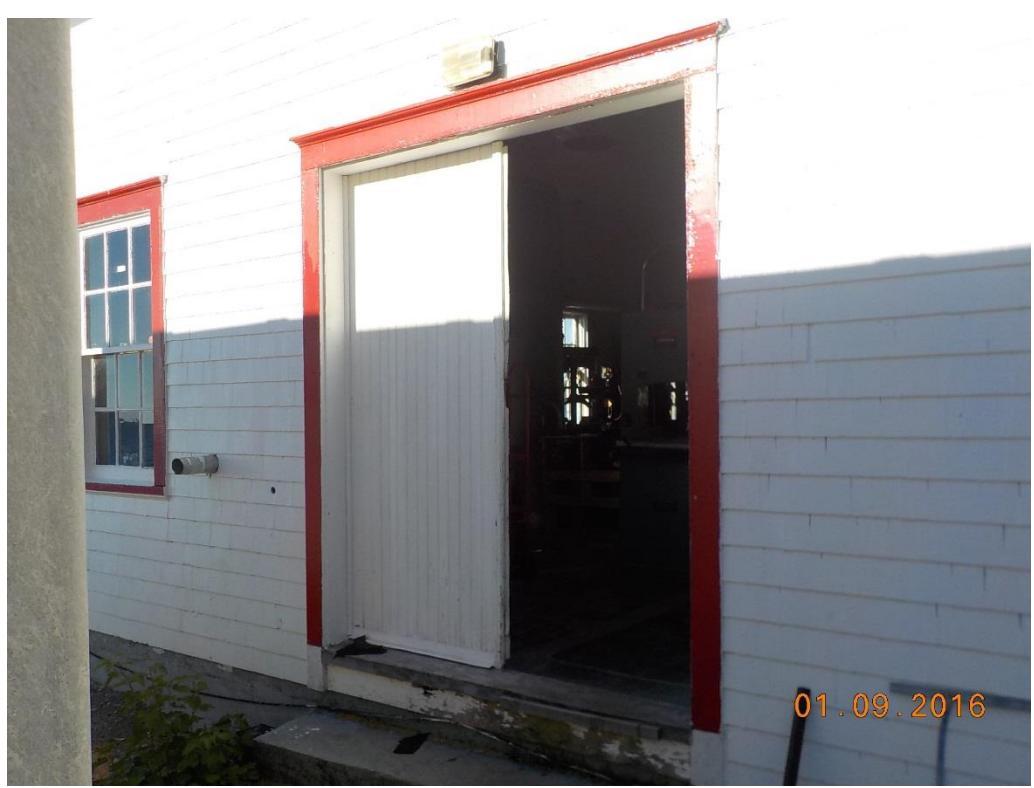
Photo 6: Weathering and peeling paint, ineffective weather stripping at east door.

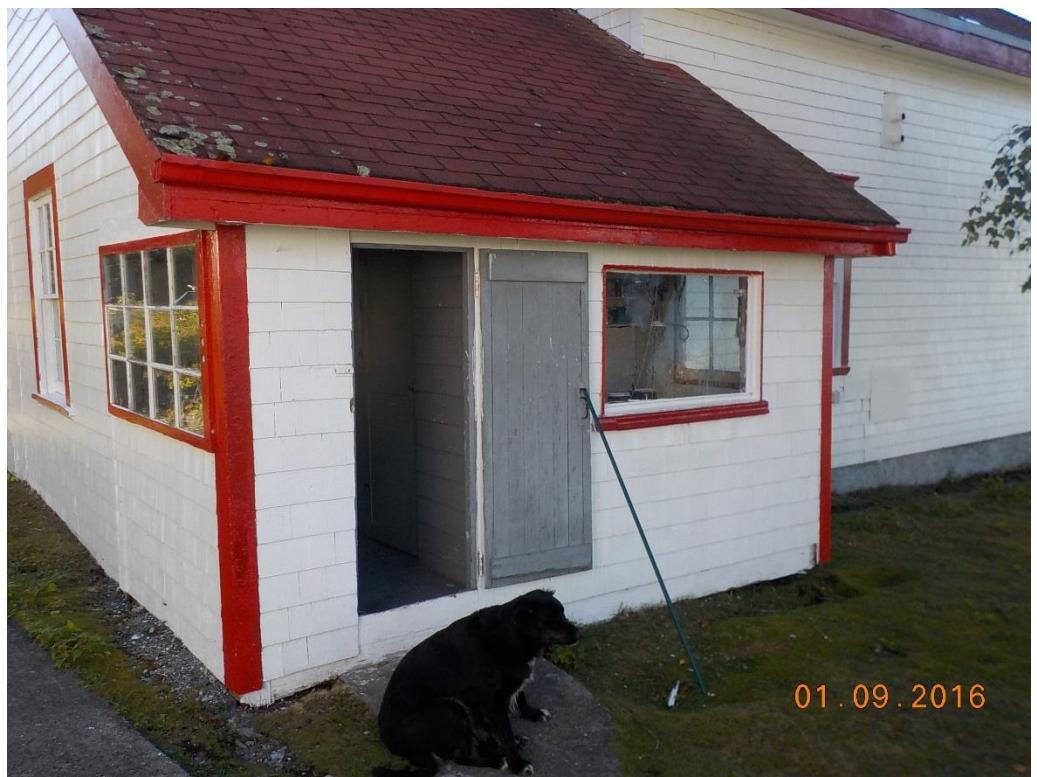
Photo 7: No weather stripping or sill at west door.

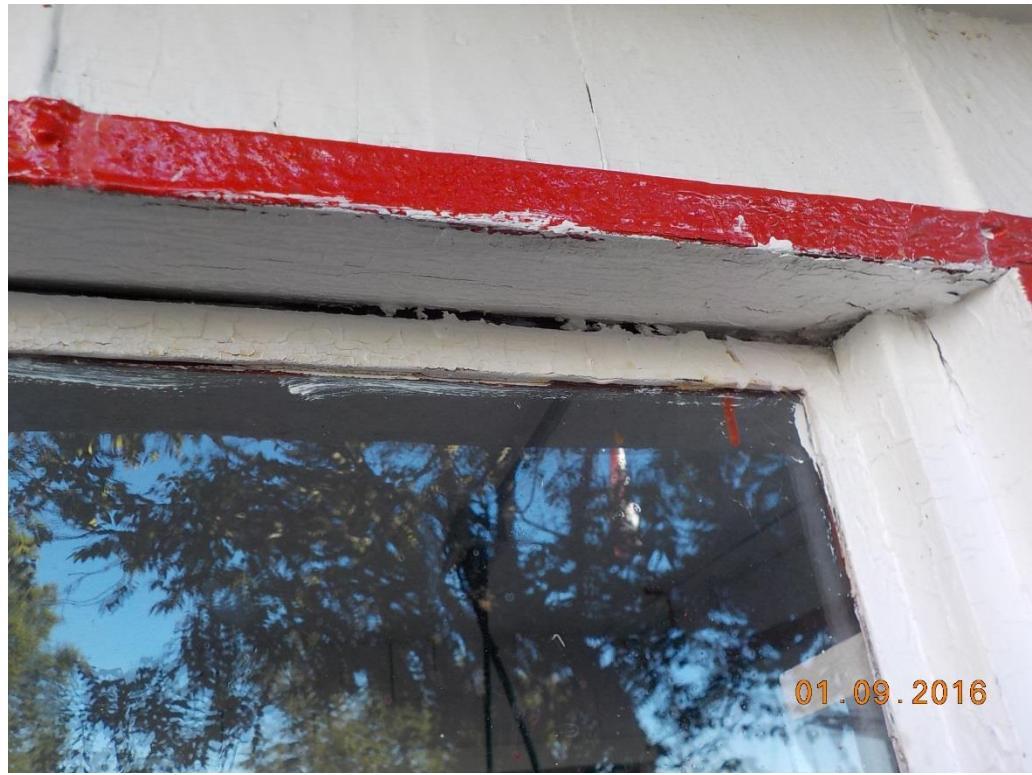
Photo 11: Typical paint peeling and failed sealants at windows.

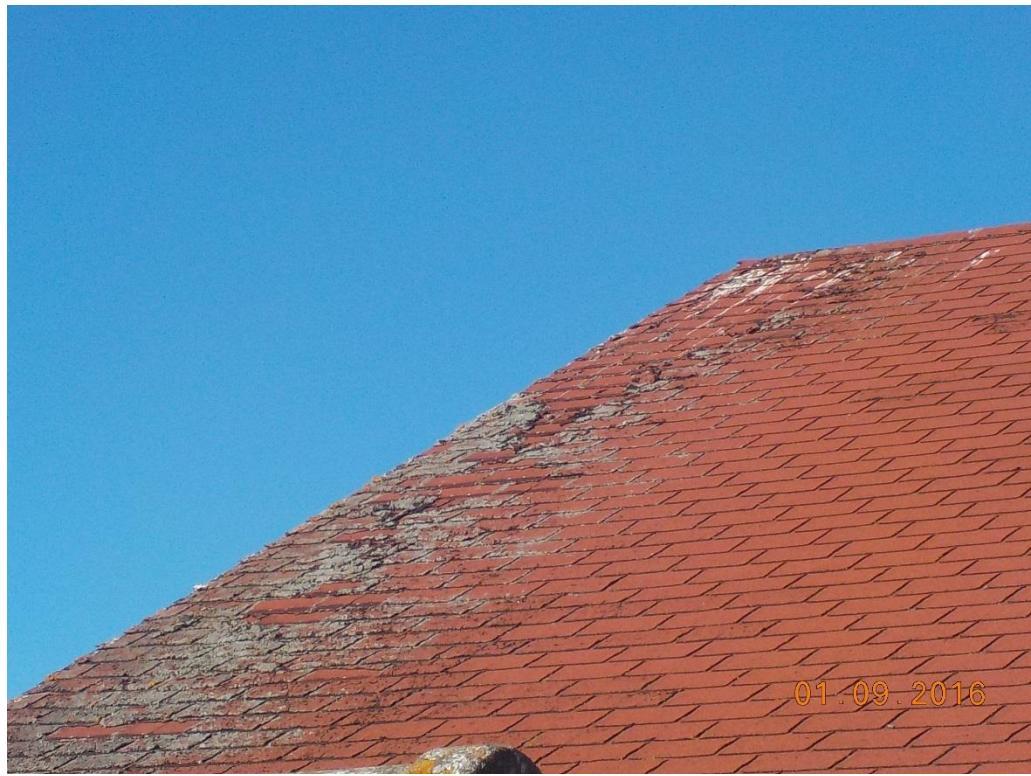
Photo 13: Typical fishmouthing, curling and moss growth at shingles.

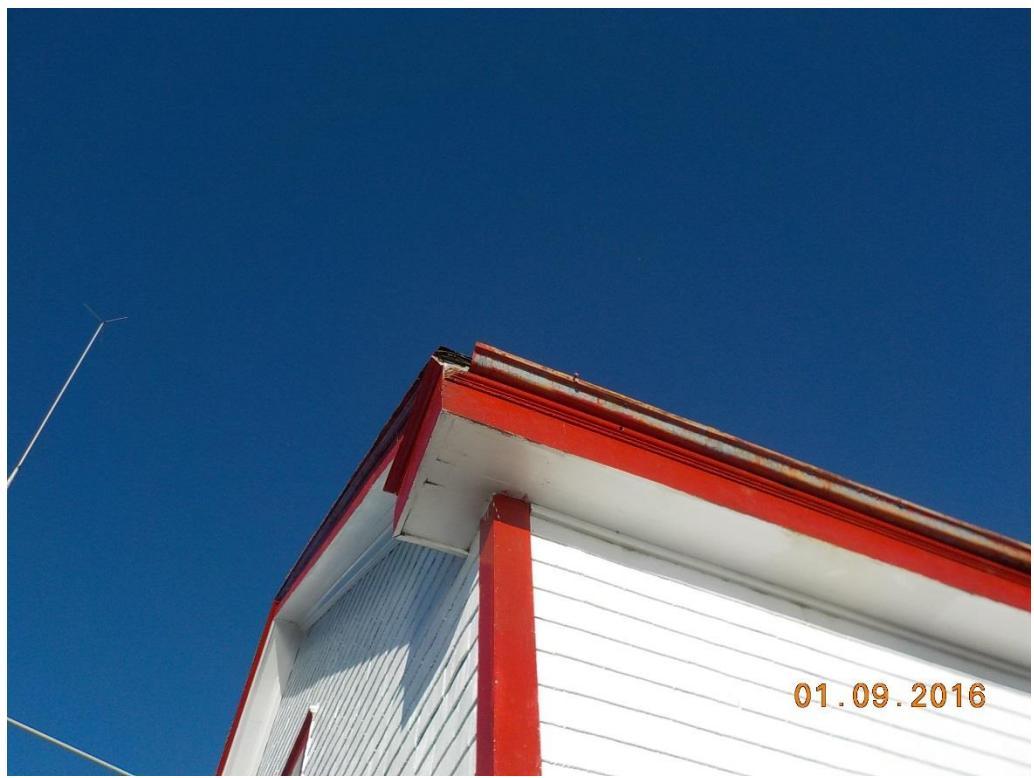
Photo 14: No downspout.

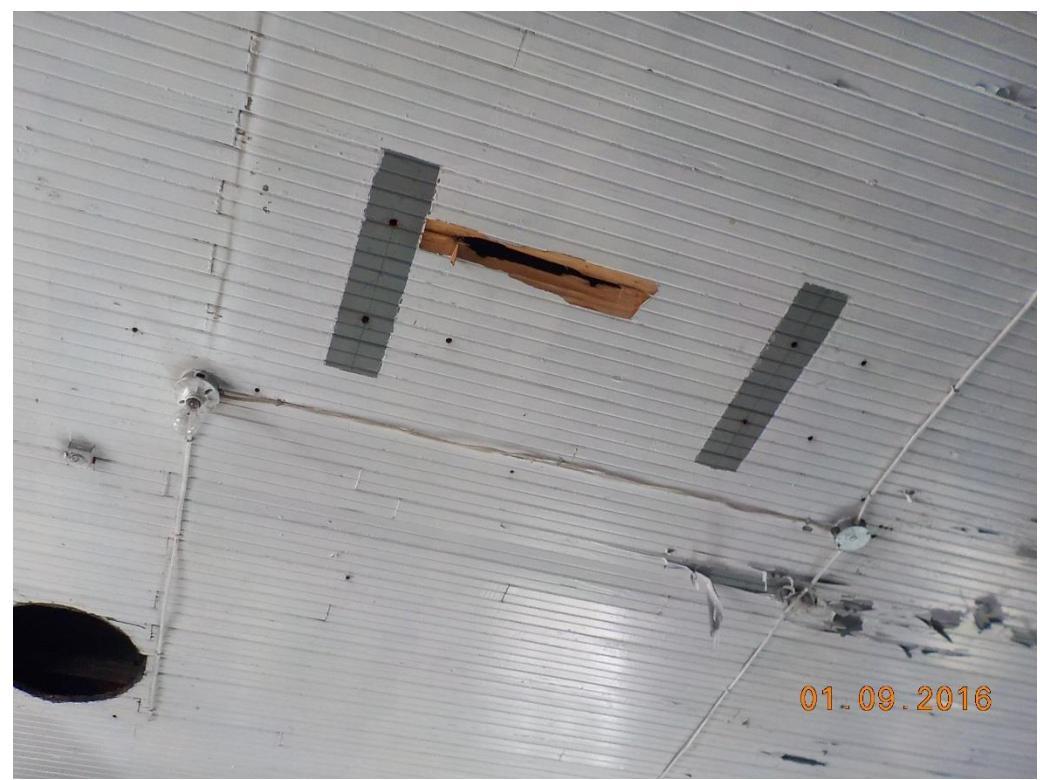
Photo 16: Typical paint peeling and hole in ceiling.

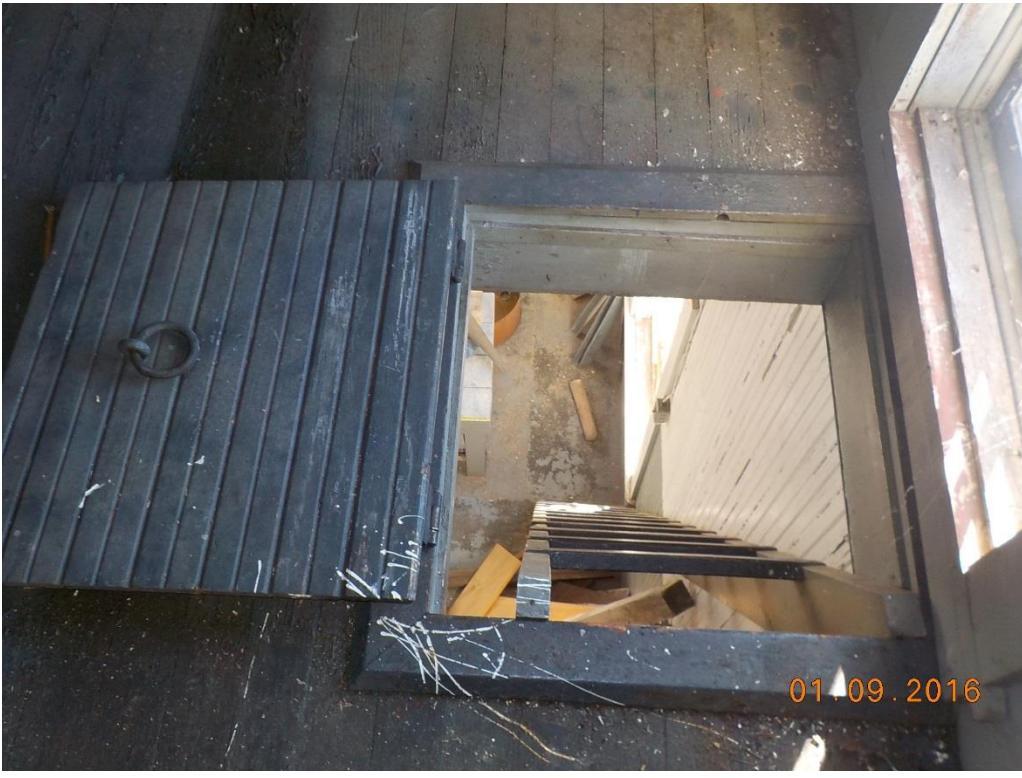
Photo 22: Nonstandard ladder.

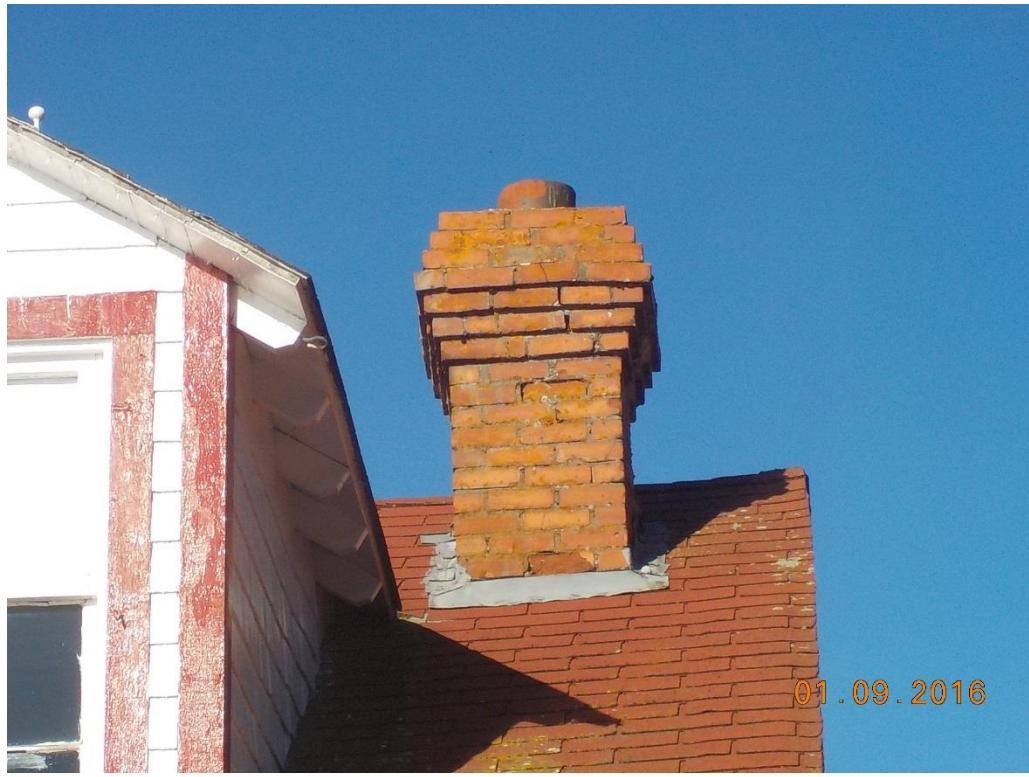
Photo 23: Voids at mortar joints and poor flashing at chimney.

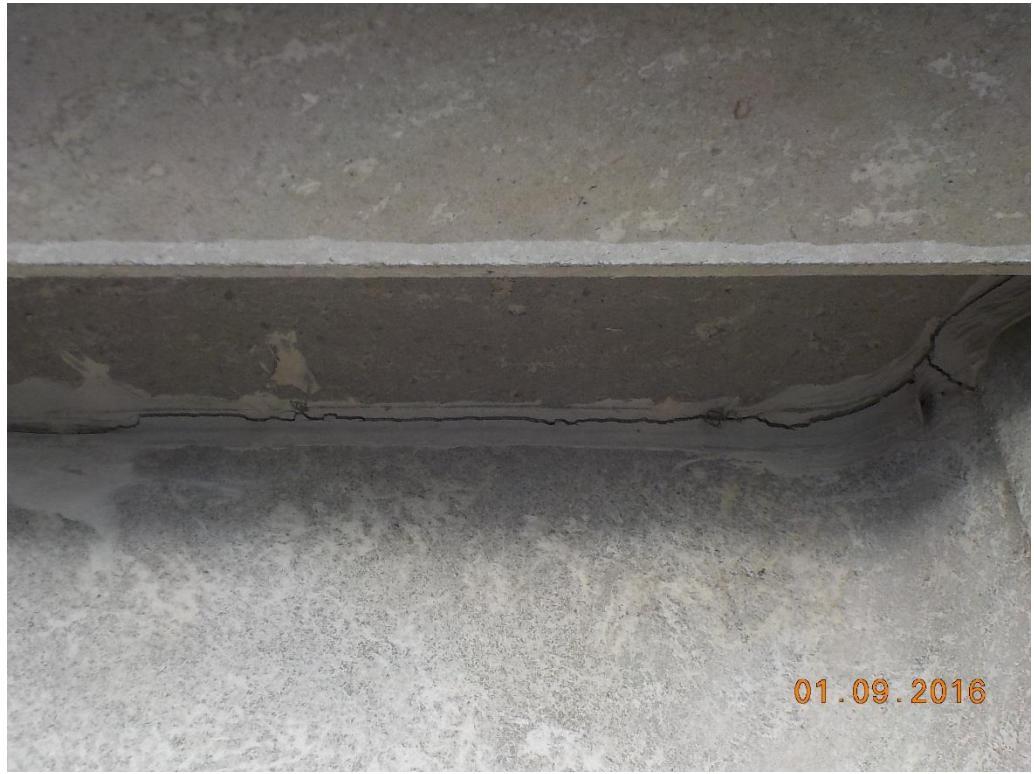
Photo 5: Cracked sealant between wall and roof.

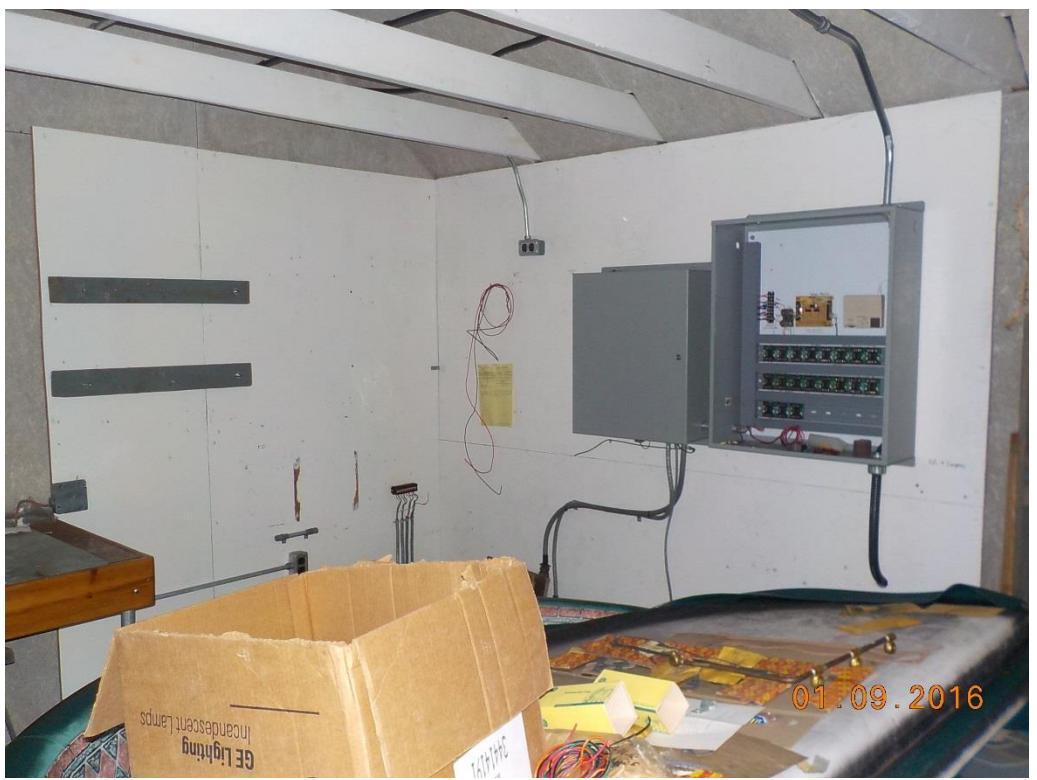
Photo 9: Electrical panel.

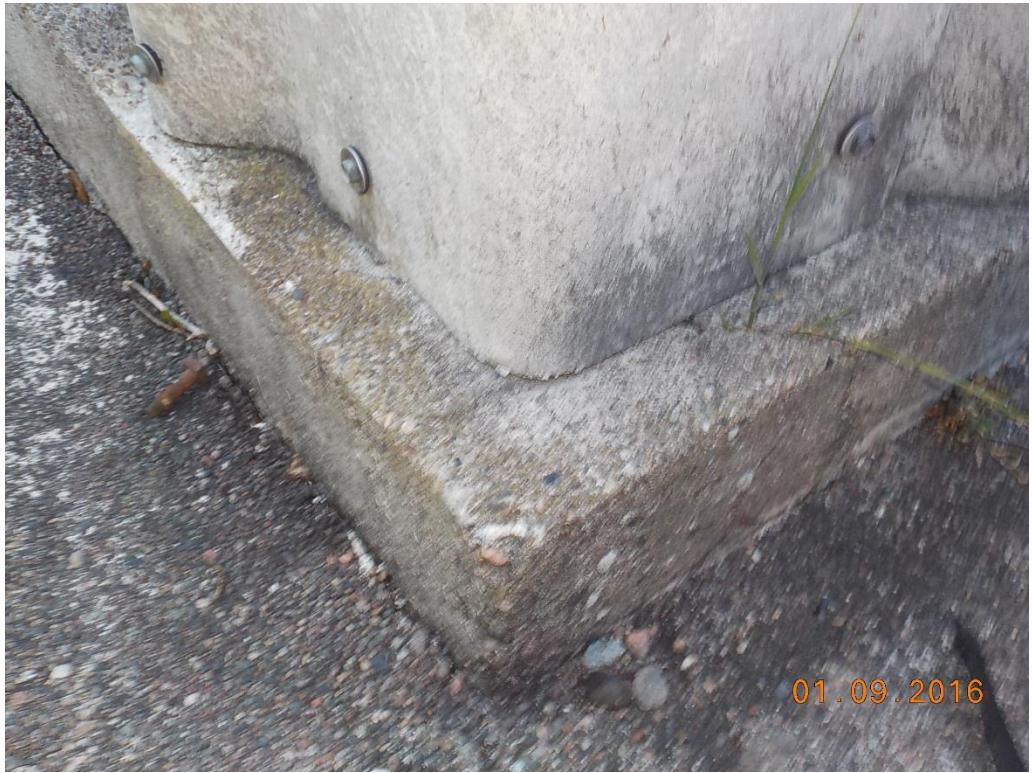
Photo 5: Wide crack at northwest corner of foundation slab. Missing sealant between wall and foundation.

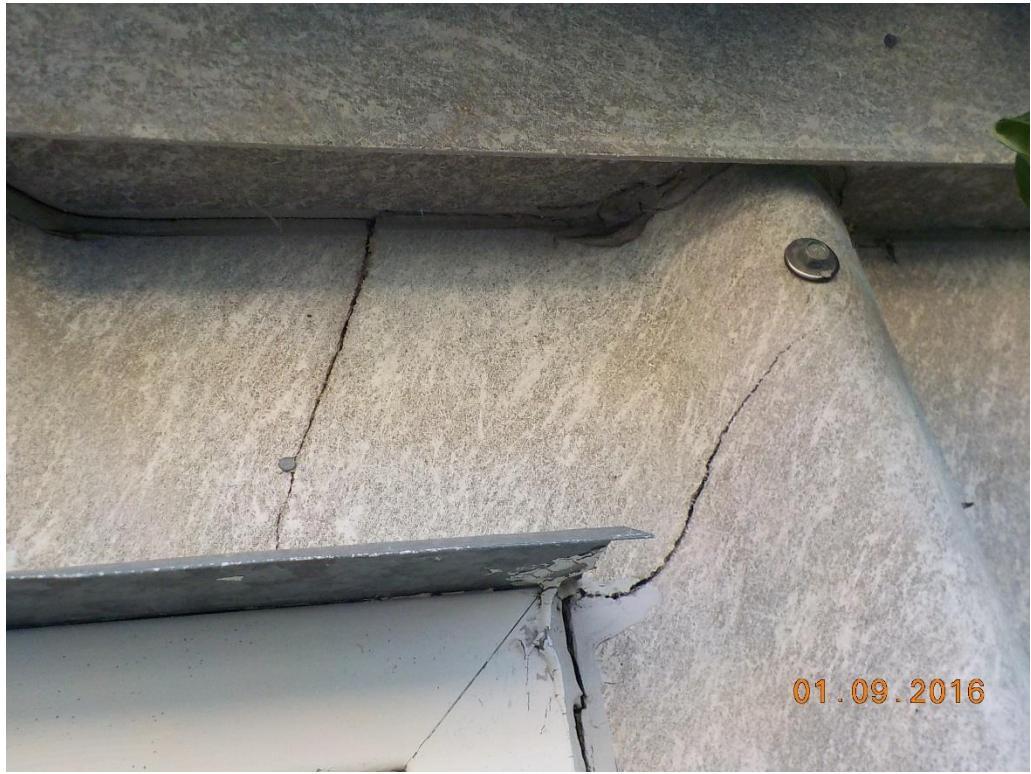
Photo 7: Cracks in siding (typical).

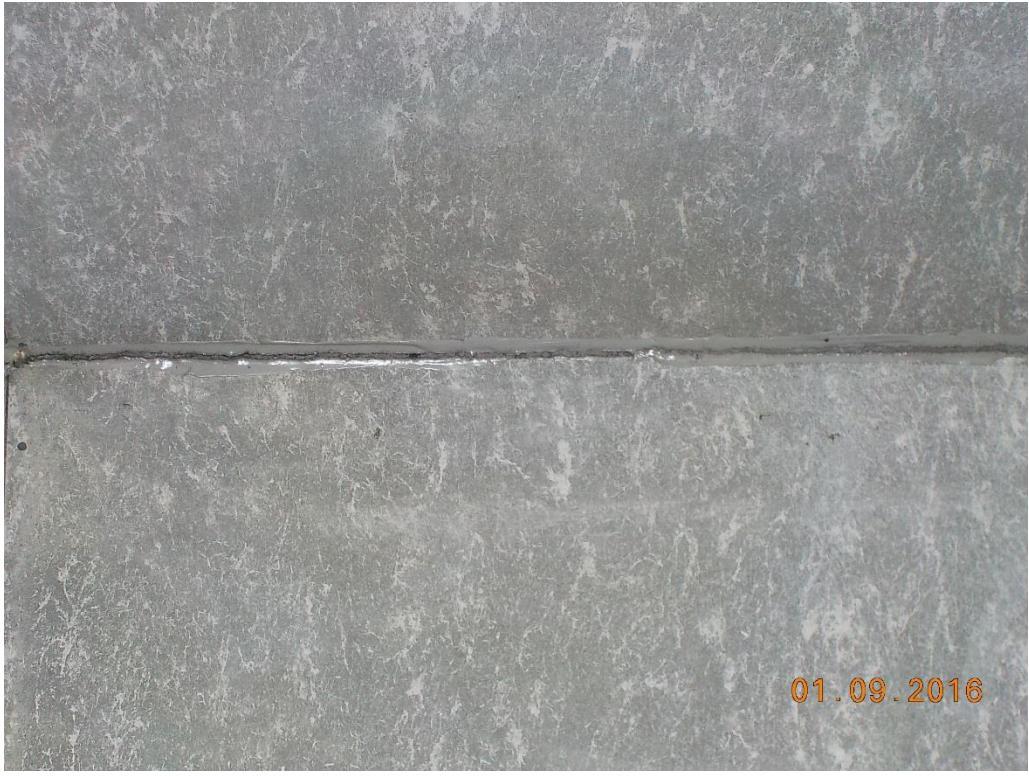
Photo 11: Cracked sealant at interior.

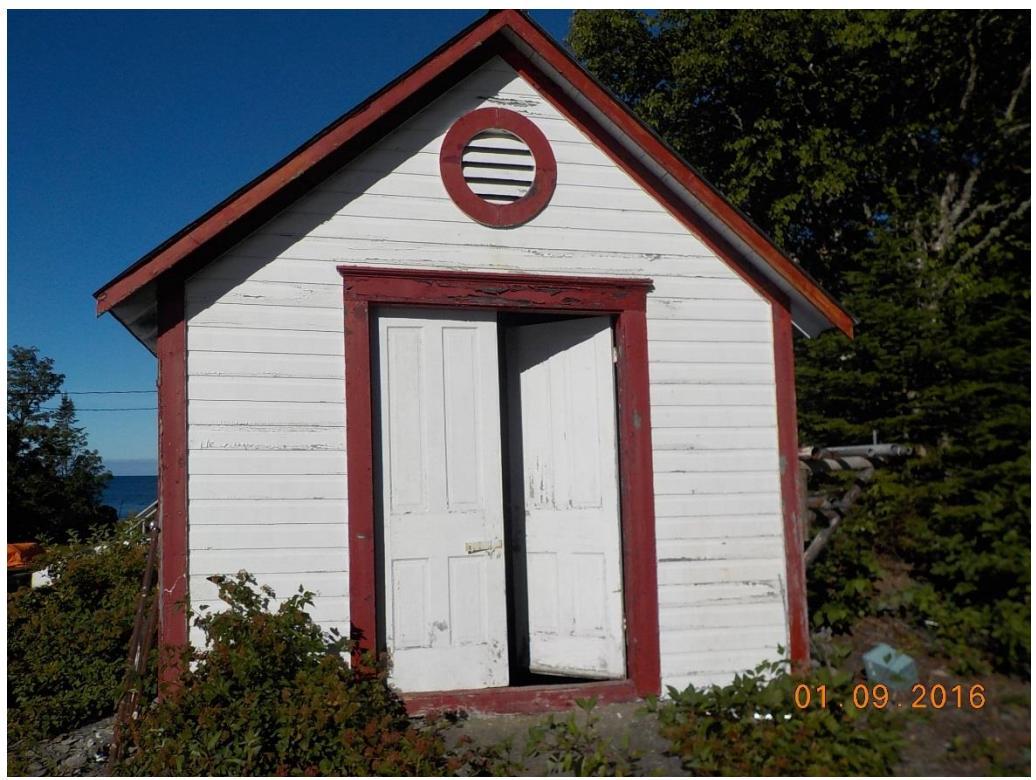
Photo 4: Paint peeling at exterior walls and door.

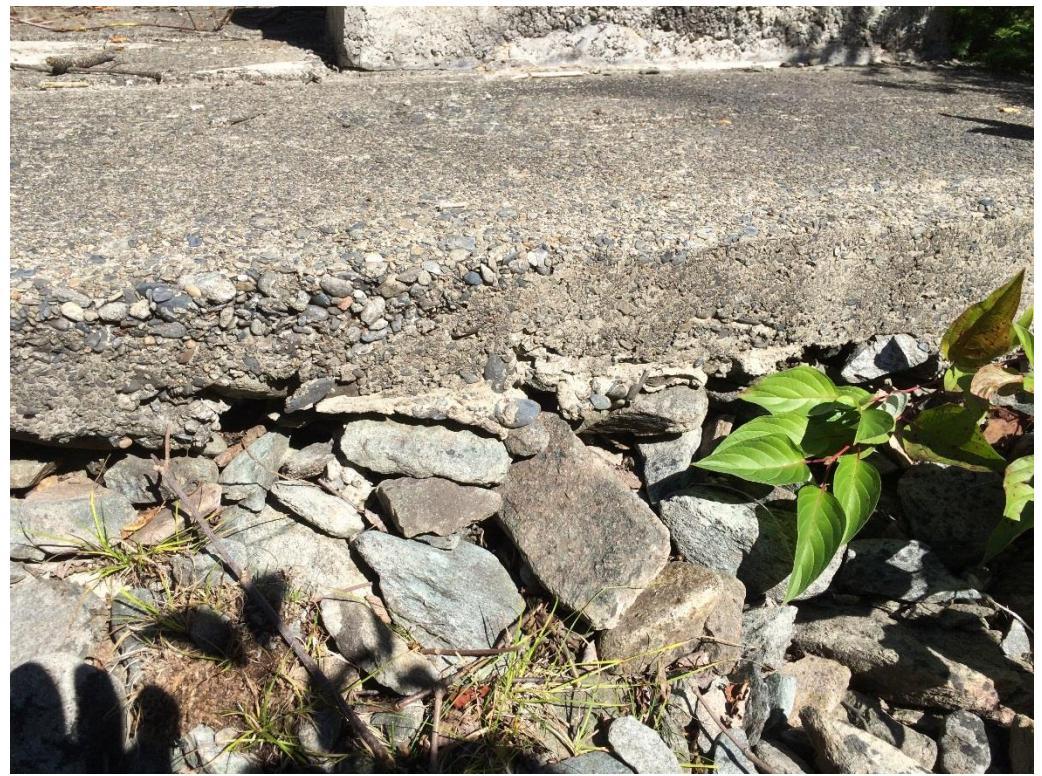
Photo 2: Typical scaling and erosion at concrete slab.

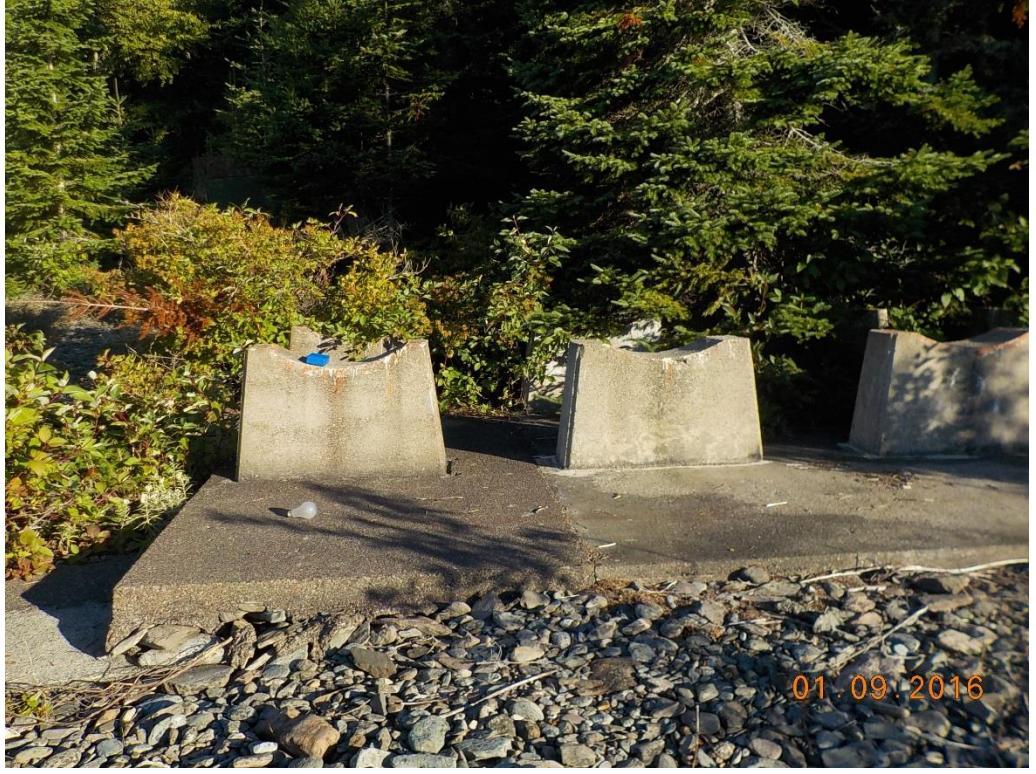
Photo 2: Typical scaling at concrete slab.

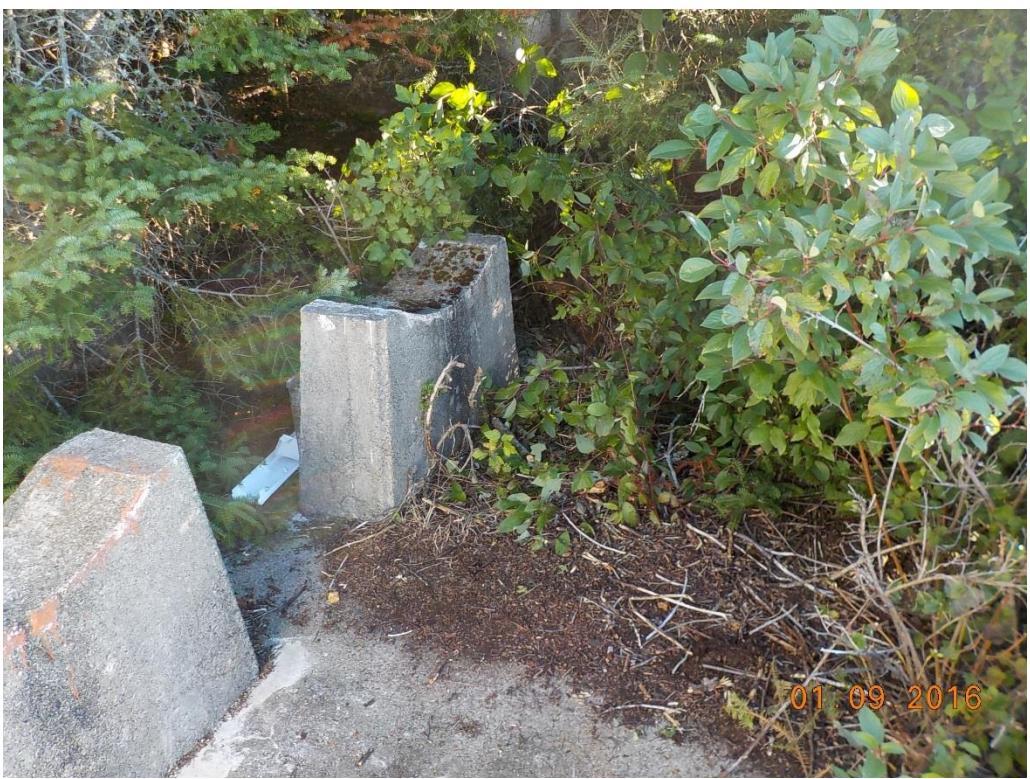
Photo 3: Vegetative growth.
