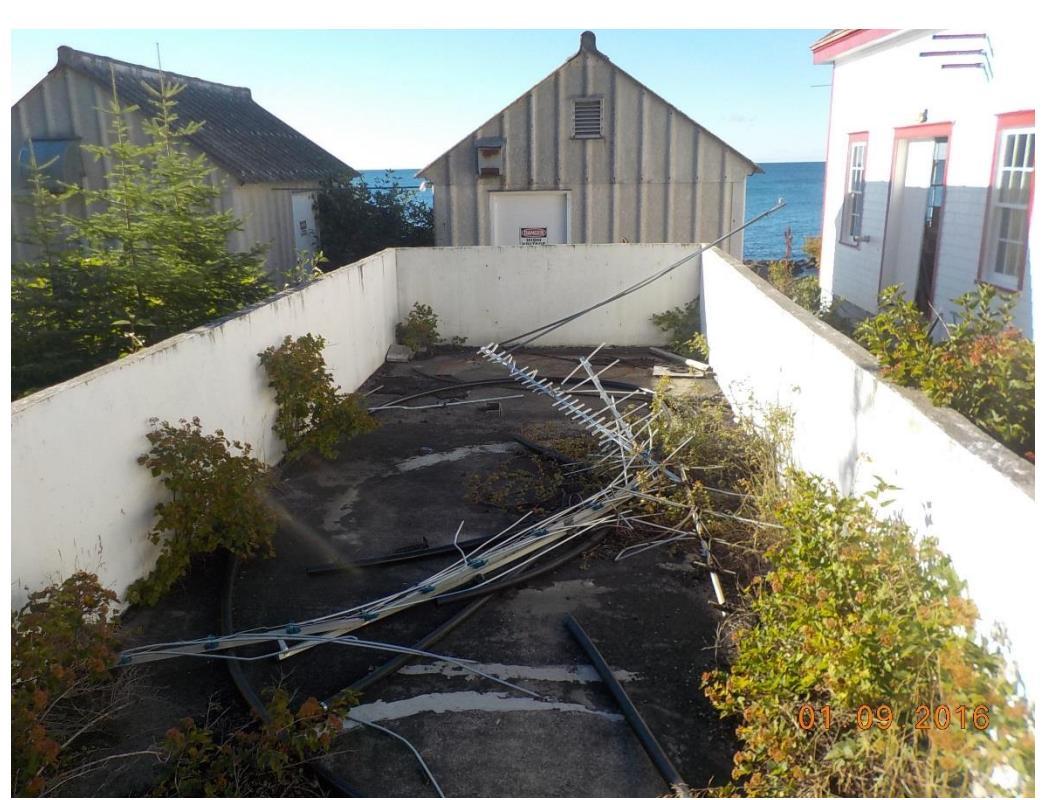
Photo 3: Vegetative growth at concrete slab.

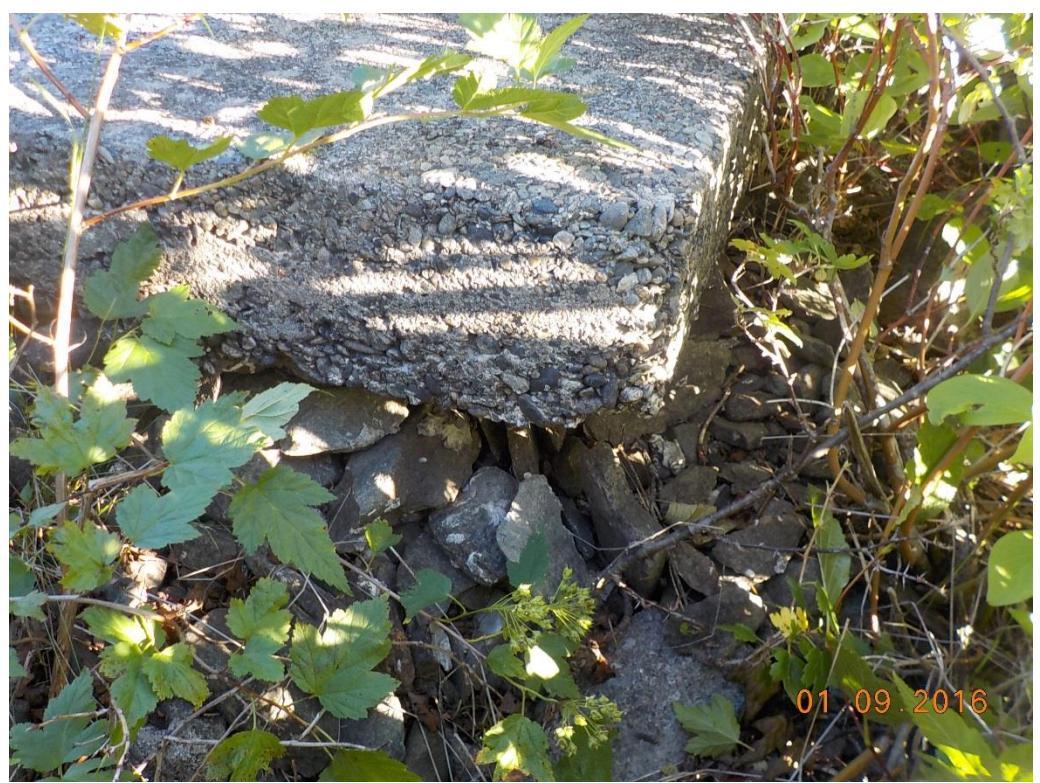
Photo 3: Light scaling and erosion.

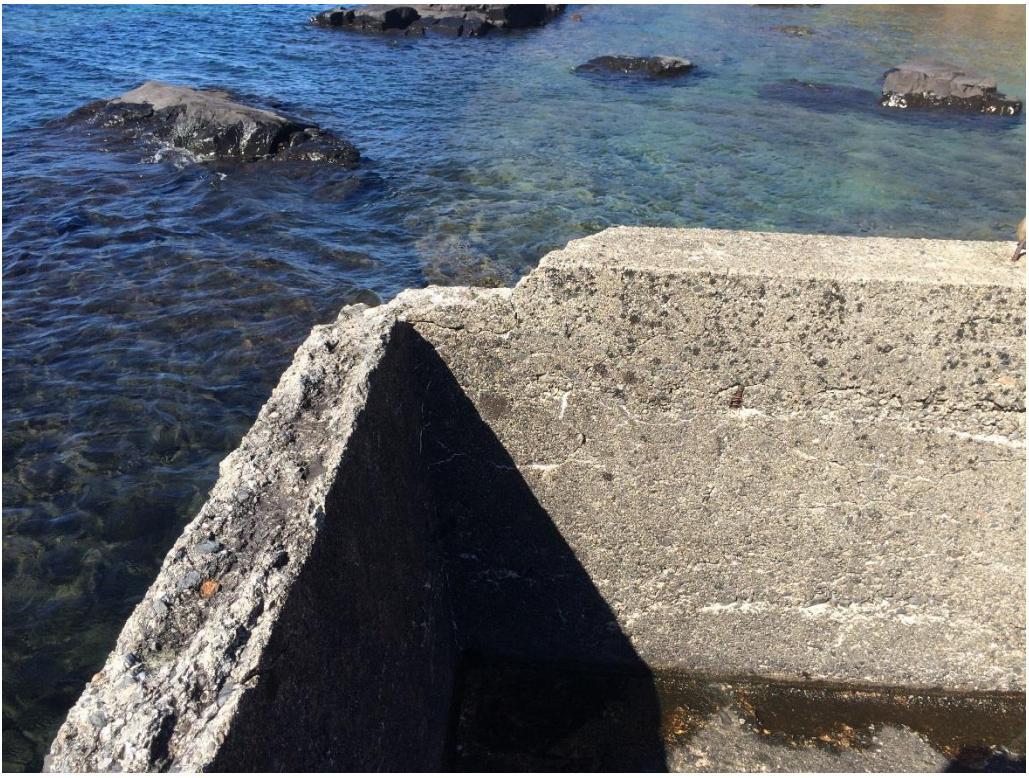
Photo 5: Severe spalling and wide cracks at concrete walls.

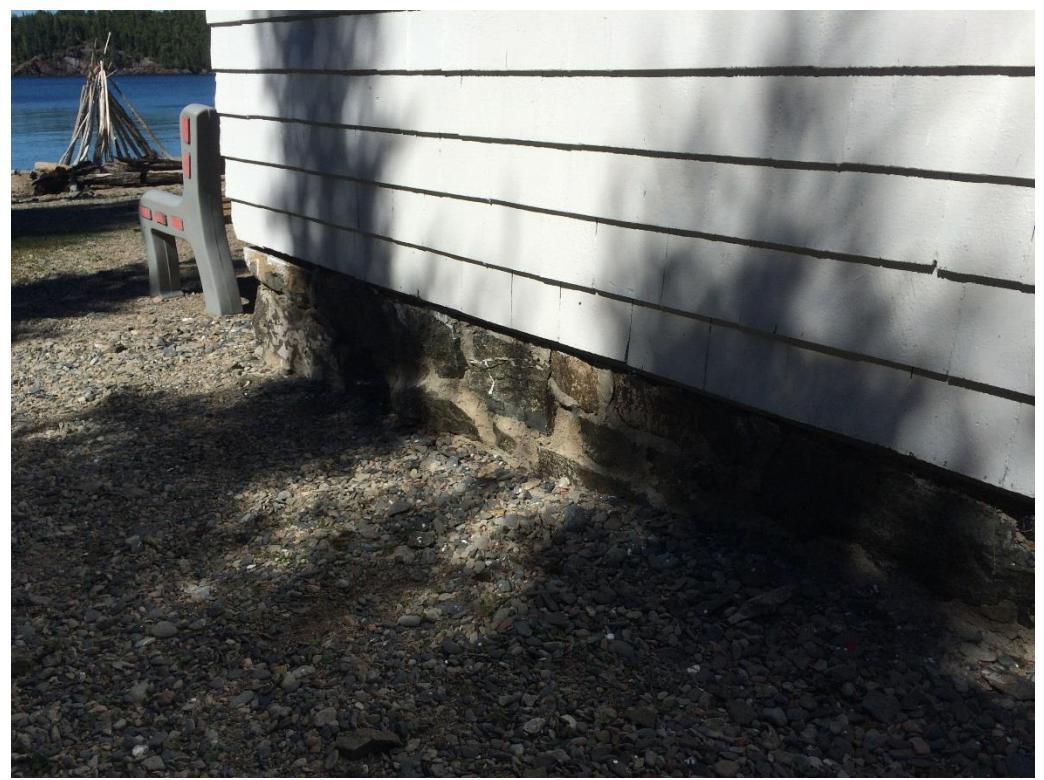
Photo 4: Typical stone and mortar foundation wall.

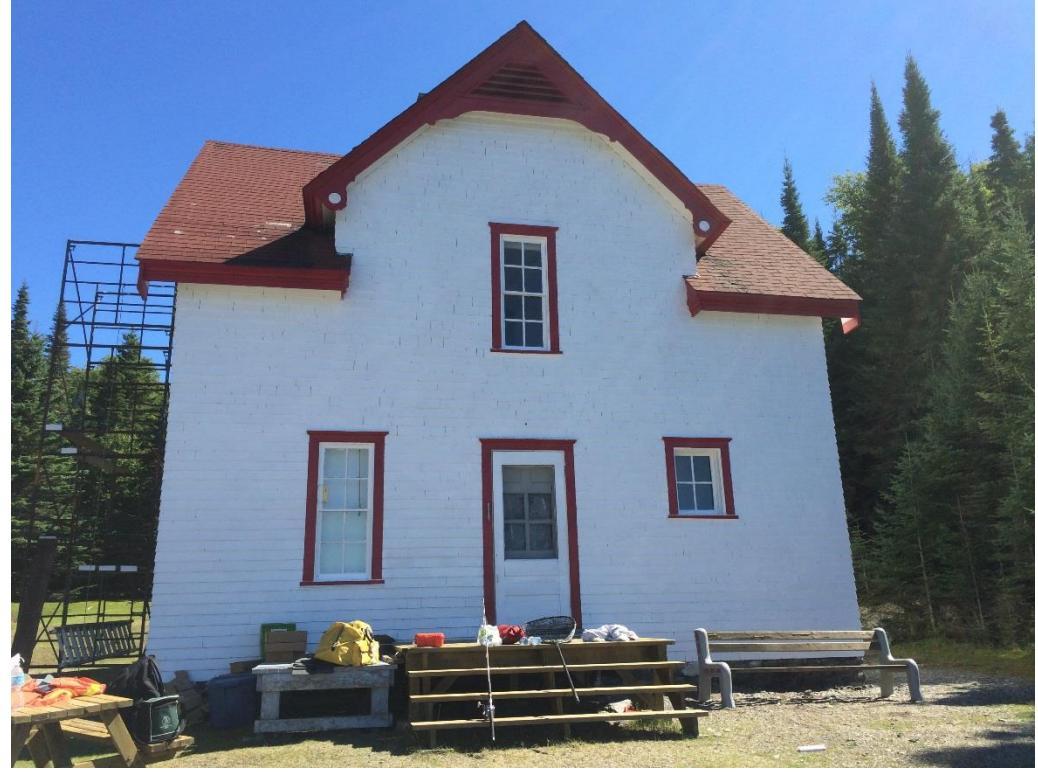
Photo 9: Typical exterior door, windows, siding.

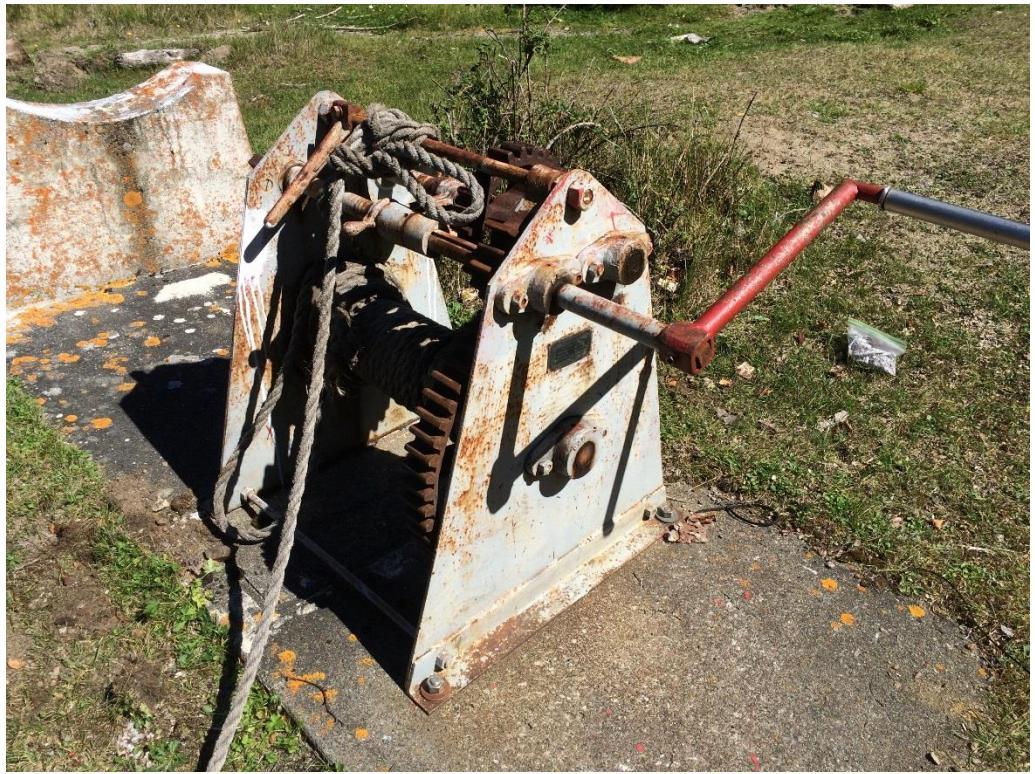
Photo 2: Light corrosion at winch.

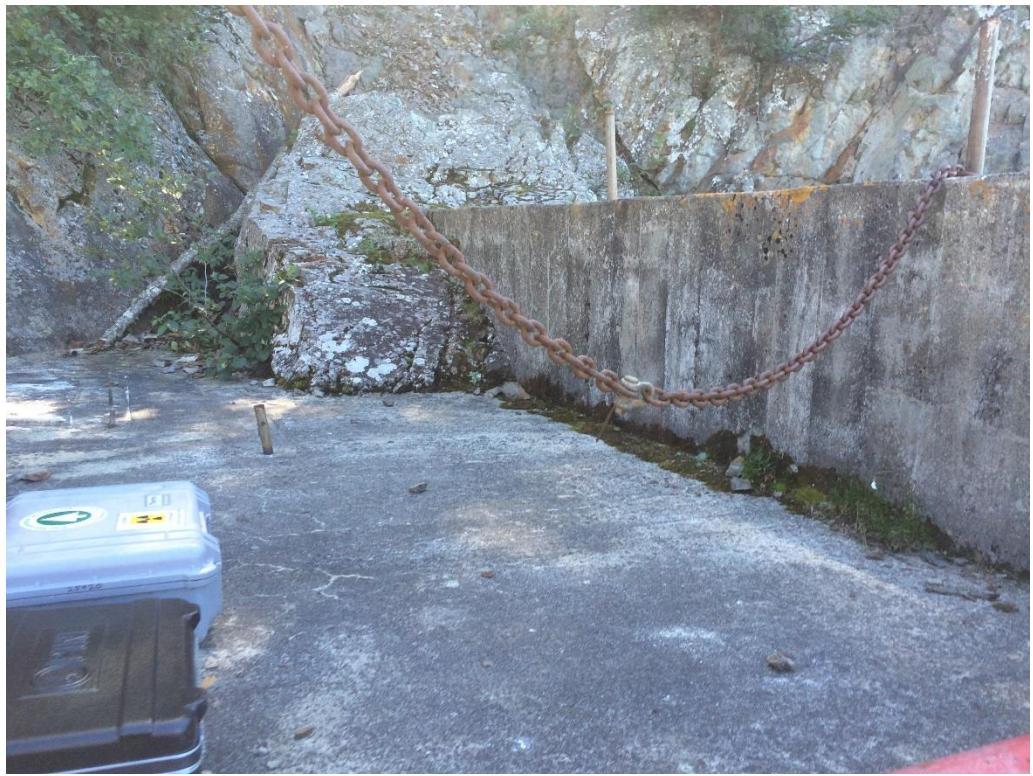
Photo 3: Narrow cracks with efflorescence and vegetative growth.
