REMOVAL OF VARIOUS SURPLUS INFRASTRUCTURE
AT BACCALIEU LIGHT STATION

BACCALIEU ISLAND, NL
PROJECT NUMBER: F6879-171005

Fisheries and Oceans Canada

Project:	DEMOLITION HAZARDOUS BUILDING MATERIALS ASSESSMENT AND INVENTORY, BACCALIEU ISLAND LIGHTSTATION (DFRP 80521), BACCALIEU ISLAND, NL		
Title:	SITE LOCATION PLAN		
Scale:	1:50,000	Project No.:	TF14076579
		Figure No.:	1.1

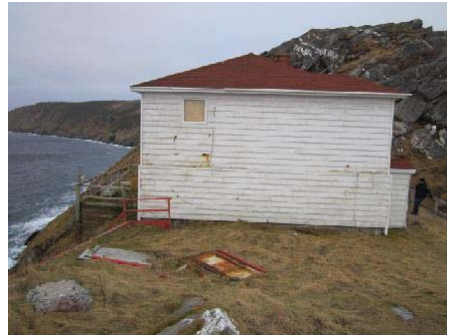
Photo 6: View of former winch house concrete foundation near double dwelling.

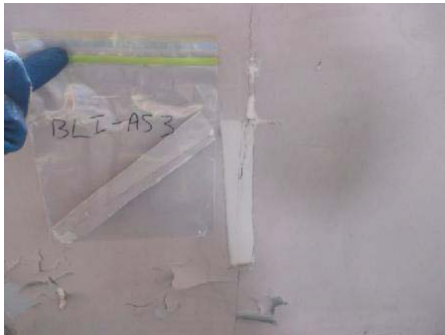
Painted drywall was observed on the walls and ceilings in the double dwelling. Six (6) samples of drywall joint compound (BLI-AS3, BLI-AS4, BLI-AS5, BLI-AS20, BLI-AS21 and BLI-AS25) were collected from interior and exterior walls and ceilings in Living Room 1, Bathroom 2 and the Workshop and analyzed for asbestos content (refer to Photos 31, 32, 33, 48, 49 and 53, Appendix B2). Chrysotile asbestos (3%) was detected in samples BLI-AS20, BLI-AS21 and

Photo 31: View of drywall joint compound sample BLI-AS3.

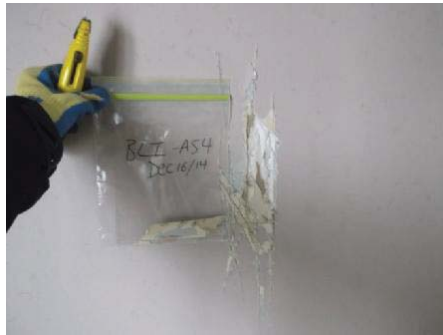
Photo 32: View of drywall joint compound sample BLI-AS4.

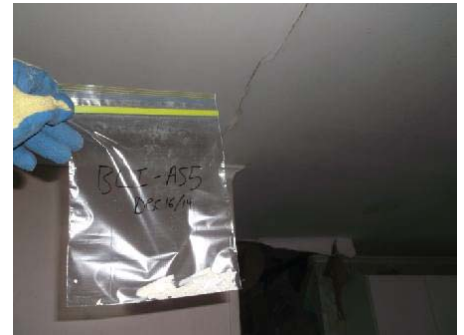
Photo 33: View of drywall joint compound sample BLI-AS5.

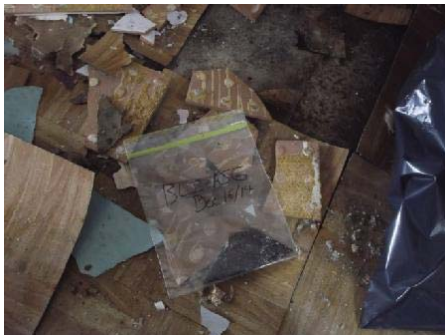
- One (1) sample of vinyl sheet floor tile (brown, wood parquet-like pattern) and mastic (BLI-AS6) was collected from Kitchen 1 (refer to Photo 34, Appendix B2).

Photo 34: View of vinyl sheet floor tile and mastic sample BLI-AS6.

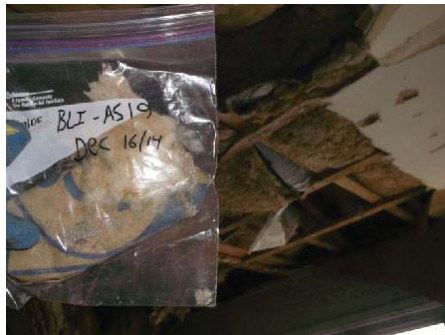
According to the USEPA, PCBs may be present in caulking used in windows, door frames, masonry columns and other building materials in buildings built or renovated between 1950 and 1979. Since the double dwelling was constructed in 1955, four (4) samples of caulking (BLI-AS12, BLI-AS18, BLI-AS28 and BLI-AS29) were collected from interior and exterior surfaces of the building and analyzed for PCB content (refer to Photos 40, 46, 56 and 57, Appendix B2).

Photo 46: View of caulking sample BLI-AS18

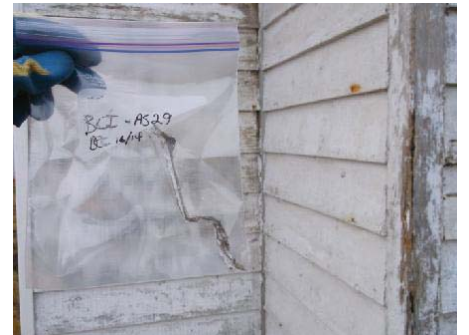
Photo 56: View of caulking sample BLI-AS28

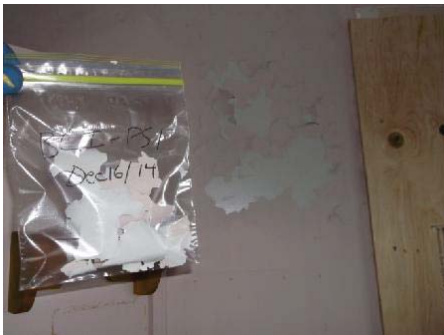
Photo 57: View of caulking sample BLI-AS29

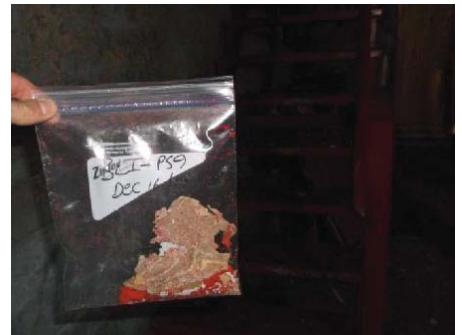
One (1) sample of painted drywall (BLI-MS2) with SVG was collected from an exterior wall in the Workshop and analyzed for mould growth (refer to Figure 2.1, Appendix A2 and Photo 65, Appendix B2). The laboratory results confirmed that moderate to abundant mould growth was present in the sample (refer to Table C2-7, Appendix C2). The types of mould identified in the sample were *Cladosporium*, *Penicillium* and *Acremonium*.

Photo 65: View of paint sample BLI-PS8 and location of mould sample BLI-MS2.

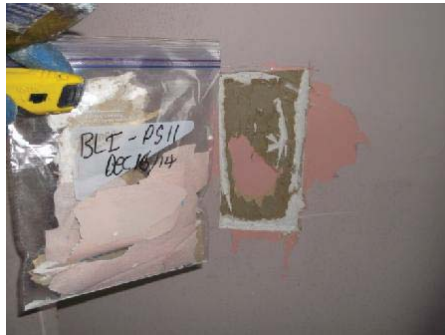
- Paint sample BLI-PS10 (75 mg/L), grey paint, collected from an exterior concrete wall in Basement 2 (refer to Photo 67, Appendix B2). The paint on the walls in Basement 2 is in fair condition and flaking in some areas. The paint on the concrete walls in Basement 2 appeared to be the same colour as the paint on the concrete walls and wooden stairs in Basement 1. The paint on the walls and stairs in Basement 1 and walls in Basement 2 covers an area of approximately 145 m².

Photo 67: View of paint sample BLI-PS10.

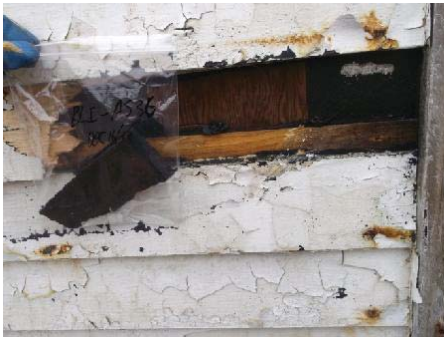
According to the USEPA, PCBs may be present in caulking used in windows, door frames, masonry columns and other building materials in buildings built or renovated between 1950 and 1979. Since the old equipment building was constructed in 1953, two (2) samples of caulking (BLI-AS35 and BLI-AS37) were collected from exterior surfaces of the building and analyzed for PCB content (refer to Photos 24 and 26, Appendix B3).

Photo 24: View of caulking sample BLI-AS35

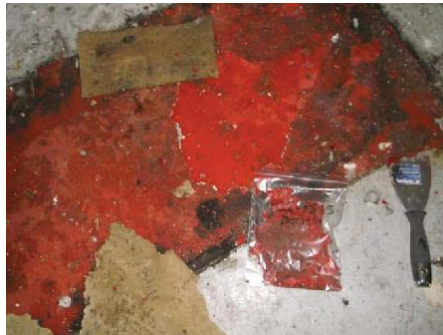
The concentrations of mercury in the paint samples ranged from non-detect (<1.0 mg/kg) to 15 mg/kg (refer to Table C3-3, Appendix C3). One (1) paint sample (BLI-PS14), plus one (1) field duplicate sample (BLI-PS-DUP3; duplicate of BLI-PS23), contained mercury at concentrations above the Federal HPA criterion of 10 mg/kg but below the CCME CSQG of 50 mg/kg for mercury in soil at an industrial site (refer to Photos 31 and 40, Appendix B3). The other 10 paint

Photo 31: View of paint sample BLI-PS14.

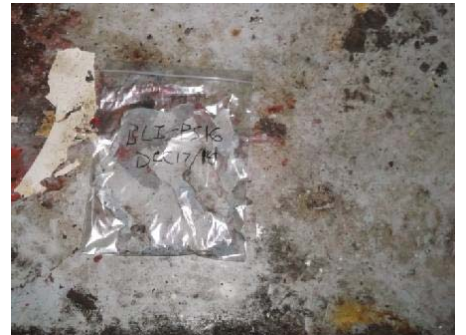
Photo 32: View of paint sample BLI-PS15.

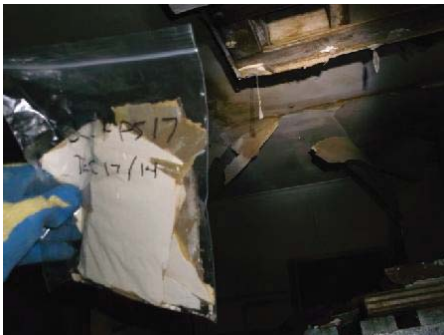
Photo 33: View of paint sample BLI-PS16.

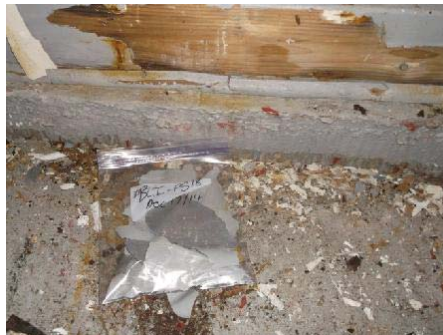
Photo 34: View of paint sample BLI-PS17.

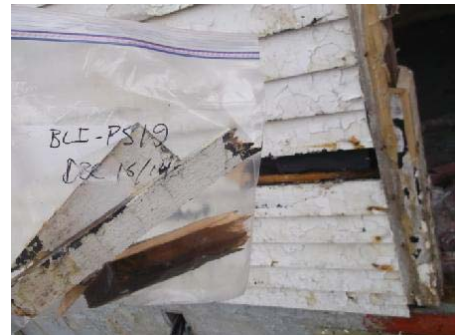
Photo 35: View of paint sample BLI-PS18.

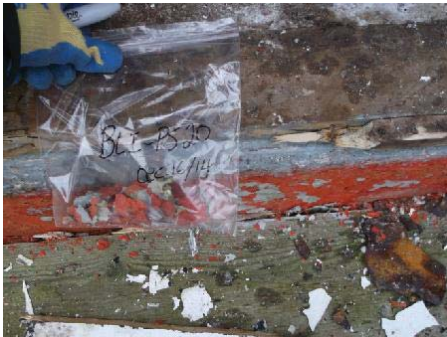
Photo 36: View of paint sample BLI-PS19.

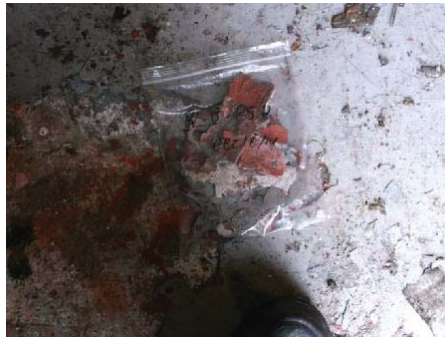
Photo 37: View of paint sample BLI-PS20.

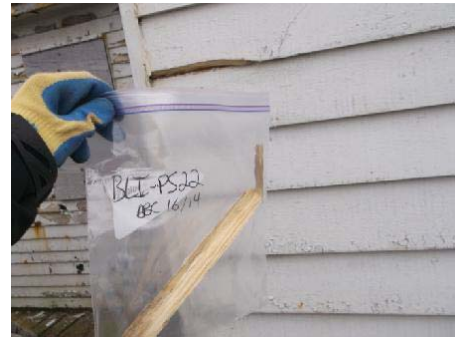
Photo 38: View of paint sample BLI-PS21.

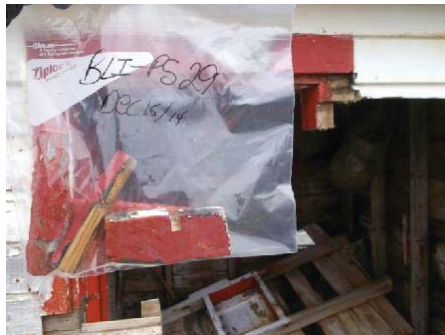
The concentrations of lead in the paint samples ranged from 830 mg/kg to 990 mg/kg (refer to Table C4-2, Appendix C4). The two (2) paint samples (BLI-PS29 and BLI-PS30) analyzed contained lead at concentrations above the Federal HPA criterion of 90 mg/kg but below the former Federal HPA criterion of 5,000 mg/kg (refer to Photos 11 and 12, Appendix B4).

Photo 11: View of paint sample BLI-PS29.

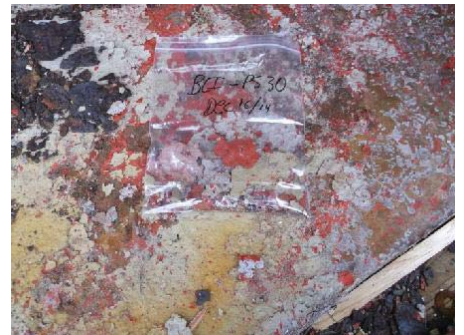
Photo 12: View of paint sample BLI-PS30.

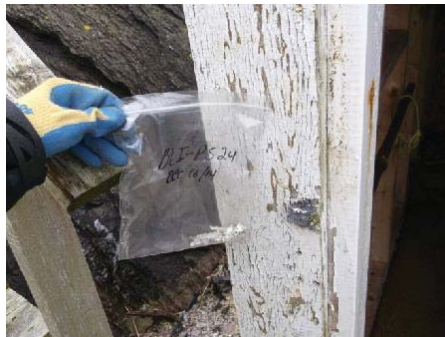
A total of two (2) samples (BLI-PS24 and BLI-PS25) were collected from painted surfaces of the lower winch house and analyzed for lead and mercury content (refer to Photos 11 and 12, Appendix B5). One (1) paint sample (BLI-PS24) was also analyzed for PCB content. Sample descriptions and analytical results are summarized in Tables C5-2 to C5-4, Appendix C5. Sample locations and analytical results are graphically illustrated in Figure 5.1, Appendix A5.

The concentrations of lead in the paint samples ranged from 440 mg/kg to 1,200 mg/kg (refer to Table C5-2, Appendix C5). The two (2) paint samples (BLI-PS24 and BLI-PS25) analyzed contained lead at concentrations above the Federal HPA criterion of 90 mg/kg but below the former Federal HPA criterion of 5,000 mg/kg (refer to Photos 11 and 12, Appendix B5).

Photo 11: View of paint sample BLI-PS24.

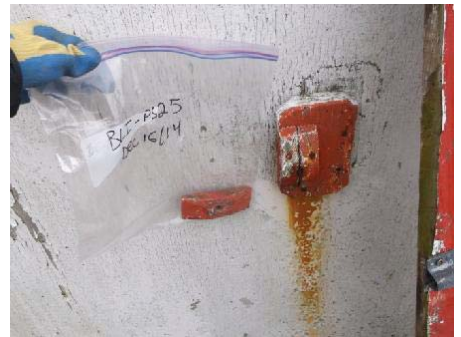
Photo 12: View of paint sample BLI-PS25.

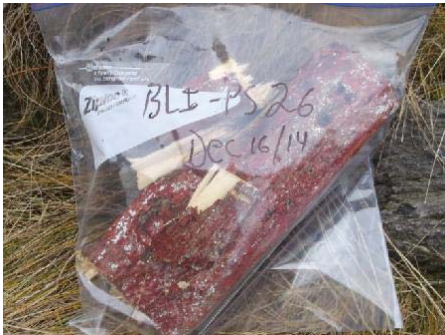
The concentrations of lead in the paint samples ranged from 49 mg/kg to 1,000 mg/kg (refer to Table C6-1, Appendix C6). One (1) paint sample (BLI-PS27) contained lead at a concentration below the Federal HPA criterion of 90 mg/kg (refer to Photo 8, Appendix B6). Three (3) paint samples (BLI-PS26, BLI-PS28 and BLI-PS31) contained lead at concentrations above the Federal HPA criterion of 90 mg/kg but below the former Federal HPA criterion of 5,000 mg/kg (refer to Photos 16 to 18, Appendix B6).

Photo 16: View of paint sample BLI-PS26.

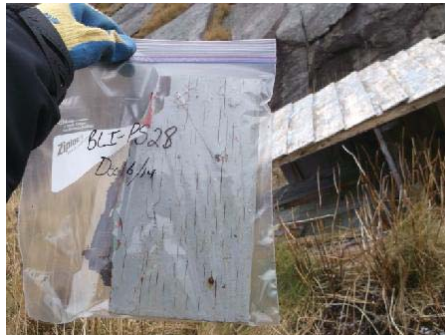
Photo 17: View of paint sample BLI-PS28.

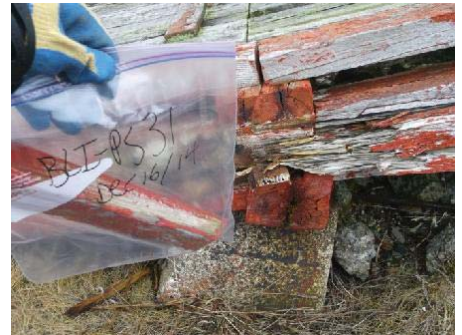
Photo 18: View of paint sample BLI-PS31.

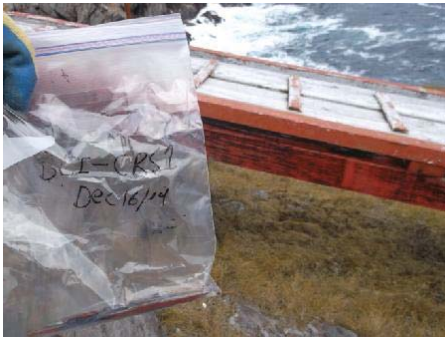
One (1) sample of creosote treated timber (BLI-CRS1) was collected from the stairway located between the upper landing and the helicopter landing pad for benzo(a)pyrene, m/p-cresol, o-cresol and total cresol leachate using the TCLP to determine whether or not the treated wood would be considered hazardous waste upon removal from the Site (refer to Photo 19, Appendix B6). The laboratory could not perform TCLP leachate analysis on the creosote treated timber sample collected from the stairway due to insufficient sample (i.e. minimum of 110 grams of sample required). The sample location is graphically illustrated in Figure 6.1, Appendix A6.

Photo 19: View of creosote treated wood sample BLI-CRS1.
