CCGS Amundsen

# Condition Assessment Report

June 2013

| 16. Summary<br><p><b>This report details a Condition Assessment for the CCGS Amundsen undertaken to determine the current condition of the ship hull structure. Hull Renovation Scheme level 2SS standard was used as a basis for assessment of the current condition and in identifying likely hull elements that will require maintenance for the remaining life of the ship.</b></p> <p><b>The report and supporting surveys concluded that the ship's hull and tanks were generally found in good condition, and at a standard comparable to a classed ship of similar type and age.</b></p> | | | |

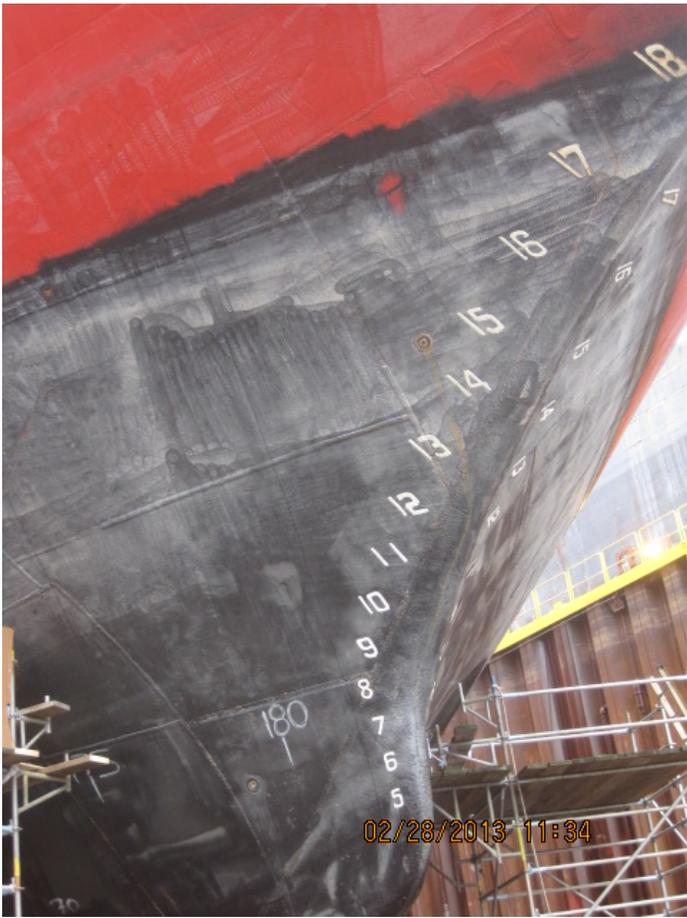
4.4: Bow Stb Side

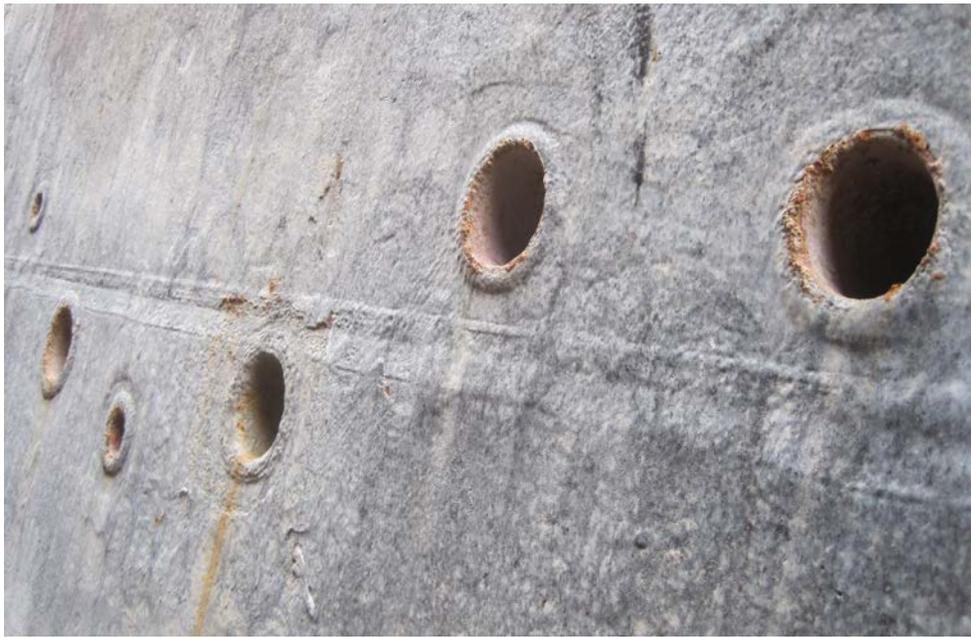
4.5: Stb Side – Mid-length

General condition of shell plating	GOOD
Type (not maker) of coatings	Epoxy
General condition of coatings	GOOD
<p><b>Limit of Inspection (including drafts if afloat)</b> Visual examination carried out of the full area</p> <p><b>Condition of the hull plating</b> Good condition</p> <p><b>Indents (location, extent and effect on the structure)</b> No indents found</p> <p><b>Damage (location extent and effect on the structure)</b> No damage found</p> <p><b>Visible loss of thickness (including grooving of welds)</b> No visual thickness loss found</p> <p><b>Other defects</b> None noted</p>

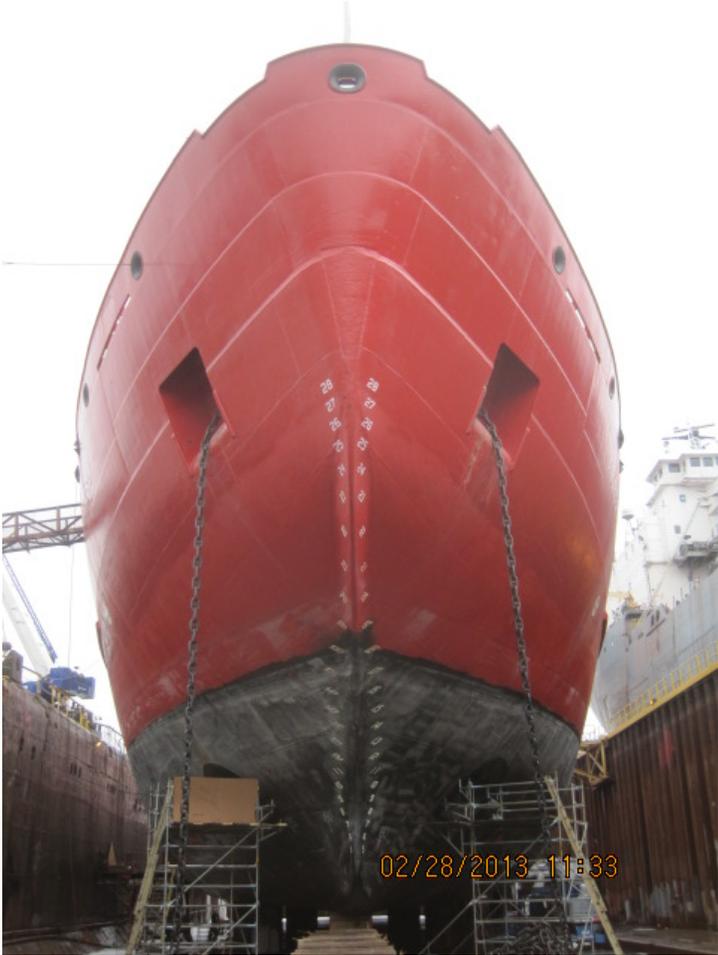
4.6: Bow

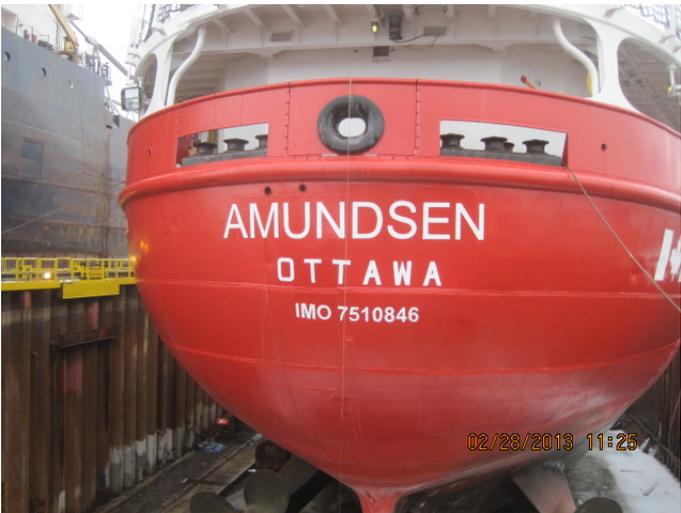
4.7: Stern

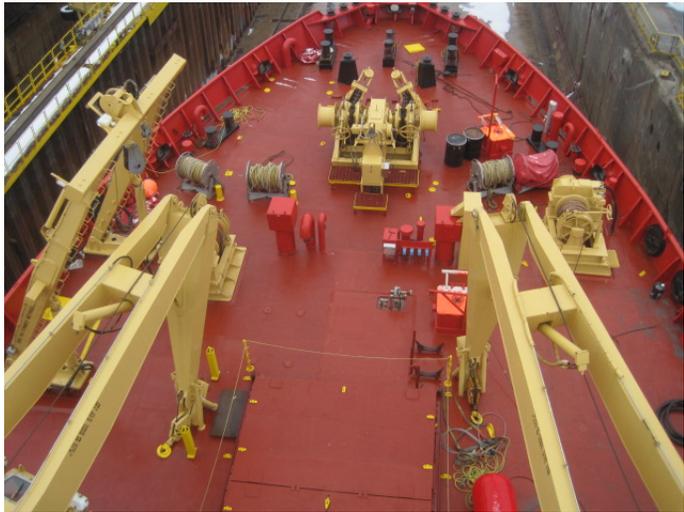
General condition of deck plating	GOOD
General condition of any external stiffening	GOOD
Type of coatings	Epoxy
General condition of coatings	GOOD
<p><b>Limit of Inspection</b> Visual examination carried out of the full area</p> <p><b>Condition of the deck plating, including hatch coamings and supports, external deck stiffening</b> Good condition</p> <p><b>Major defects (location, extent and effect on the structure)</b> No major defects found</p> <p><b>Visible loss of thickness (including plate and edge corrosion, grooving of welds, etc.)</b> No visual thickness loss found</p> <p><b>Pitting (location, depth and extent)</b> No pitting found</p> <p><b>Other defects</b> None noted</p>

4.8: Main Deck Fwd

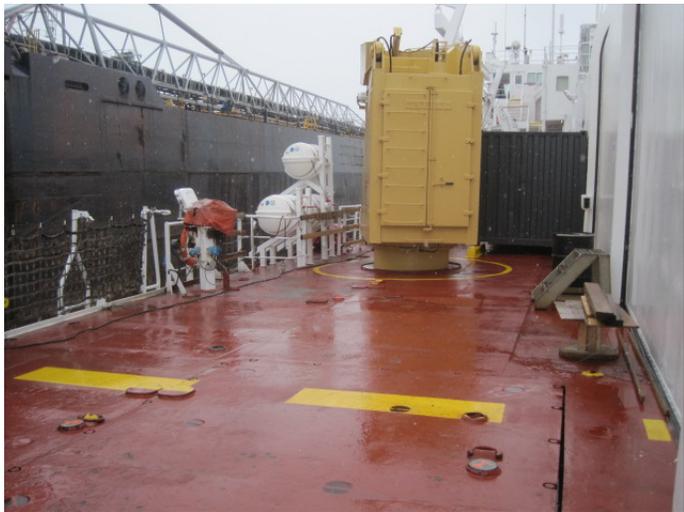
4.9: Port Upper Deck

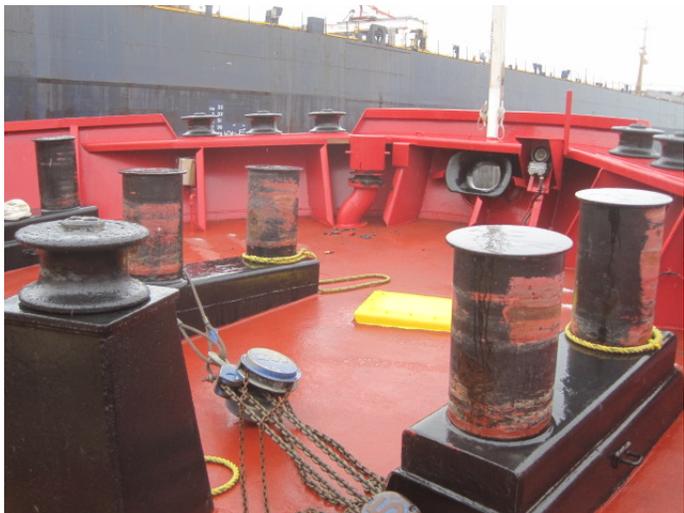
4.10: Main Deck Fwd - Mooring

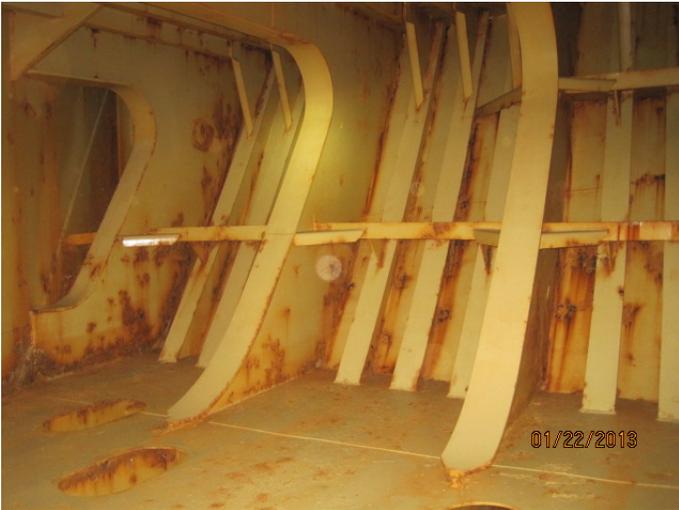
General condition of structure		GOOD	
General condition of cathodic protection		N/A	
General condition of coatings		FAIR,SEE NOTE BELOW	
Type of coatings:	Intertuf JBA 016	Extent	FULL
<p><b>Limit of Inspection</b> Full Visual inspection of tank Located between Frames 176-183, Cleanliness was satisfactory except for bottom plating to be cleaned</p> <p><b>Deckhead</b> Tank top found in good condition no corrosion noted</p> <p><b>Transverse Bulkheads</b> Found satisfactory no damage noted. Welds brackets &amp; stiffeners all found satisfactory</p> <p><b>Deck or Space bottom</b> Found satisfactory no damage noted</p> <p><b>Internal structure</b> Found satisfactory no damage noted</p> <p><b>Other structure</b> None noted</p> <p><b>Coating Details</b> Upper part 15-20% broken down Middle part 10-15% broken down Lower part 10-20% broken down Coating near welding or at not easy access corner found poor</p>

4.12: Fwd Trimming Tank F176-183 – Side Shell

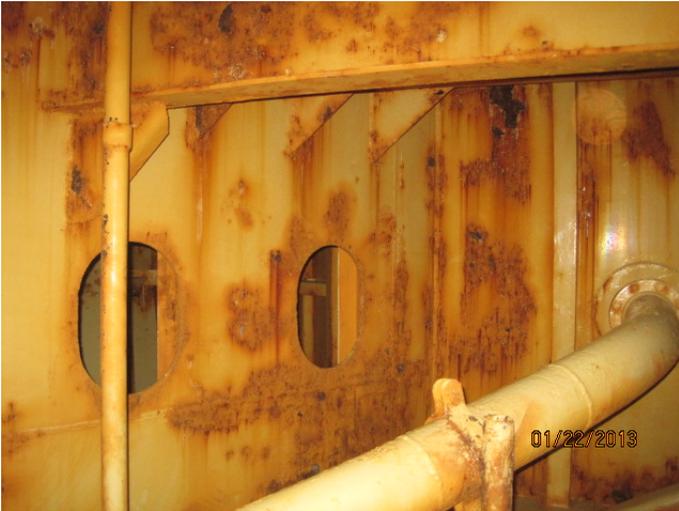
4.13: Fwd Trimming Tank F176-183 – Swash Bhd & Fwd Bhd

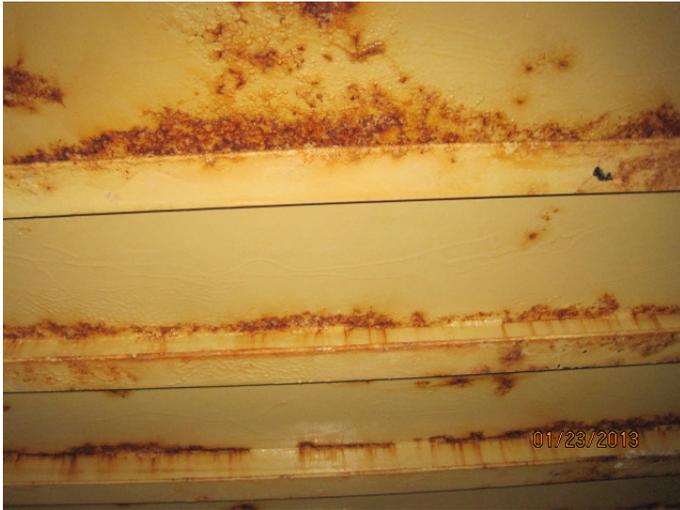
General condition of structure		GOOD	
General condition of cathodic protection		N/A	
General condition of coatings		FAIR	
Type of coatings:	Intertuf JBA016	Extent	FULL
<p><b>Limit of Inspection</b>  Frame 0-aft end  Cleanliness was satisfactory</p> <p><b>Deckhead</b>  No obvious defects found, structure was in good condition.</p> <p><b>Transverse Bulkheads</b>  No obvious defects found, structure was in good condition.</p> <p><b>Deck or Space bottom</b>  No obvious defects found, structure was in good condition.</p> <p><b>Internal structure</b>  No obvious defects found, structure was in good condition.</p> <p><b>Other structure</b>  None noted</p>

4.15: Aft Peak Tank – Deckhead

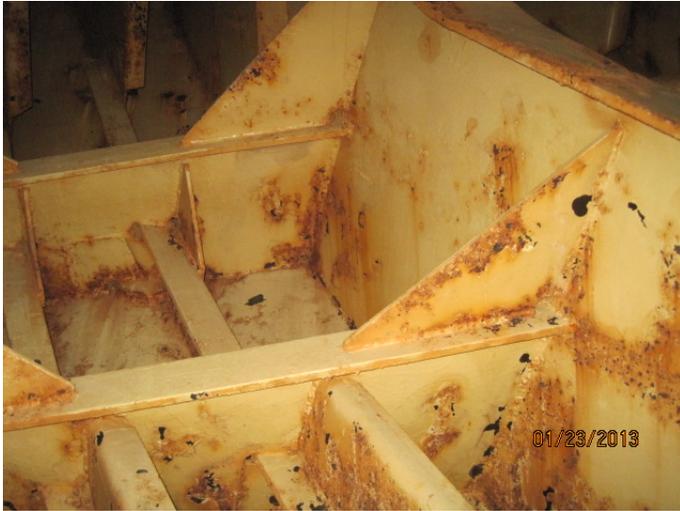
4.16: 7 Aft Peak Tank - Bilge

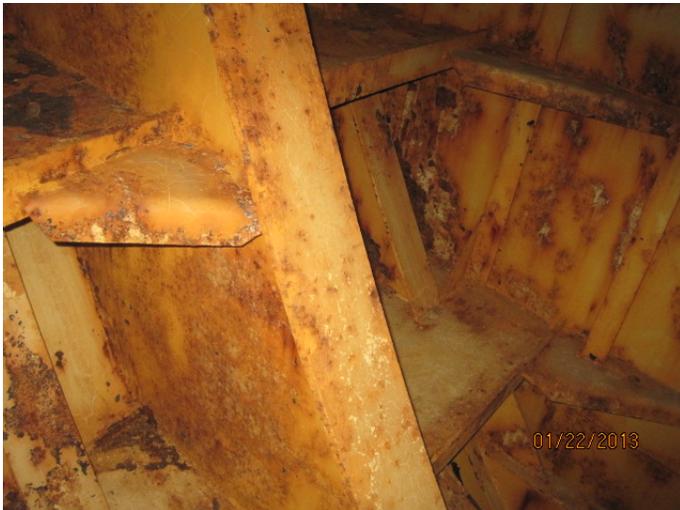
General condition of structure		GOOD	
General condition of cathodic protection		N/A	
General condition of coatings		SEE DETAILS BELOW	
Type of coatings:	Intertuf JBA016	Extent	FULL
<p><b>Limit of Inspection</b>  Frame 183-210  Space under chain lockers to be examined after chain locker cleaning  Cleanliness was satisfactory</p> <p><b>Deckhead</b>  Good condition</p> <p><b>Transverse Bulkheads</b>  Good Condition</p> <p><b>Deck or Space bottom</b>  Good condition</p> <p><b>Internal structure</b>  Center longitudinal bulkhead F191-193 buckled at openings, approx. 12mm in depth.</p> <p><b>Other structure</b>  None noted</p> <p><b>Coating details</b>  Stbd lower part F191-200 coating 20% broken down  Port aft and other areas coating 10-15% broken down  Stbd F183-191 coating 5-10% broken down  Center longitudinal bulkhead F191-203 coating 20% broken down</p>

4.18: FPT Side Shell & Aft Bhd

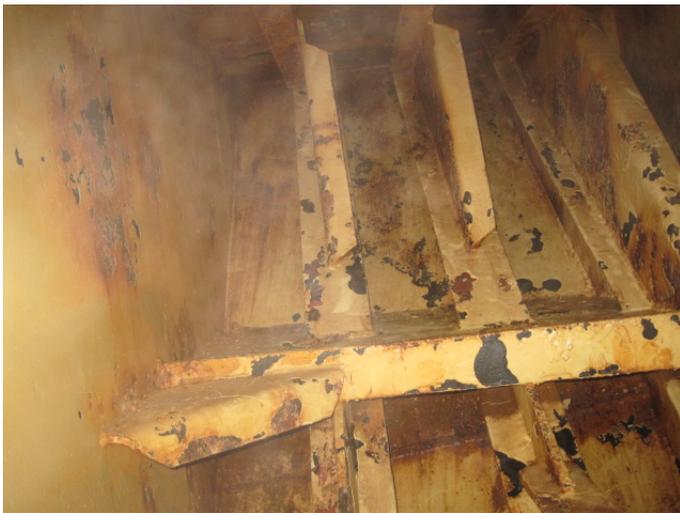
4.19: FPT Under Chain Locker - Side Shell

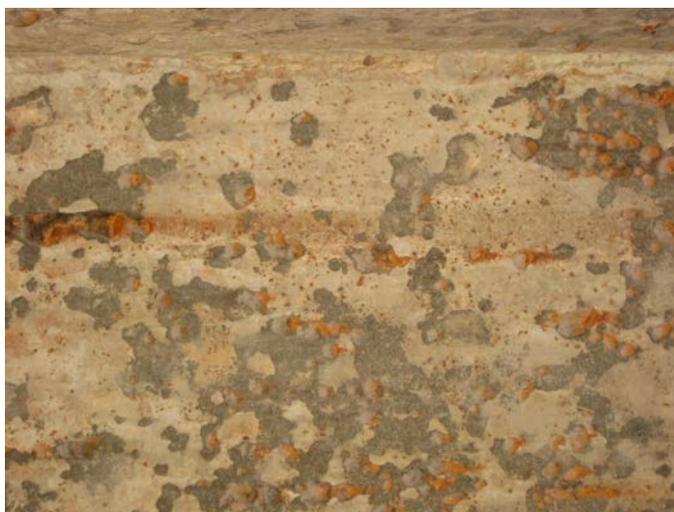
General condition of structure		GOOD	
General condition of cathodic protection		FAIR	
General condition of coatings		Poor, SEE DETAILS BELOW	
Type of coatings:	cement	Extent	FULL
<p><b>Limit of Inspection</b>  Visual inspection of tank located between frames 55-61. Bottom plate covered with ice approx. 1 inch thick.</p> <p><b>Deckhead</b>  Good condition</p> <p><b>Transverse Bulkheads</b>  Good condition</p> <p><b>Deck or Space bottom</b>  Bottom plate covered with ice.</p> <p><b>Internal structure</b>  Good condition</p> <p><b>Other structure</b>  None noted</p> <p><b>Coating details</b>  Cement broken down approx 30%.</p> <p><b>Anode condition</b>  Anode wasted approx. 15%.</p>

4.21: Sea Bay Motor Propulsion Room-Starboard

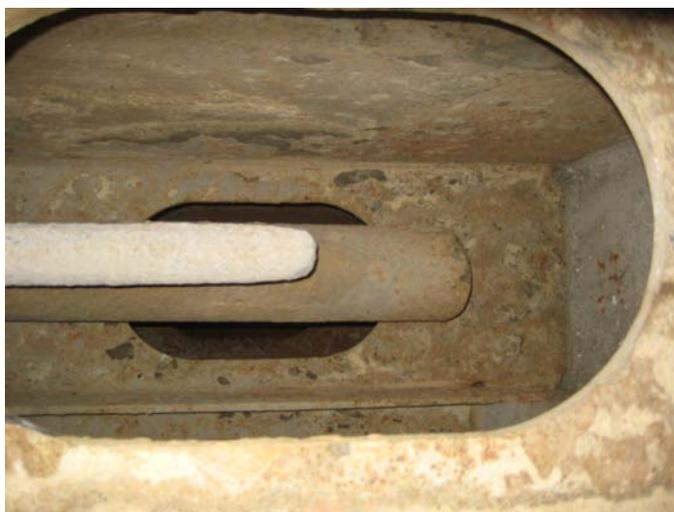
General condition of structure		GOOD	
General condition of cathodic protection		FAIR	
General condition of coatings		POOR, SEE DETAILS BELOW	
Type of coatings:	cement	Extent	FULL
<p><b>Limit of Inspection</b>  Visual inspection of tank located between frames 93-95. Stbd access blocked by vertical pipes, access not possible. Cleanliness was satisfactory</p> <p><b>Deckhead</b>  Good condition</p> <p><b>Transverse Bulkheads</b>  Good condition</p> <p><b>Deck or Space bottom</b>  Good condition</p> <p><b>Internal structure</b>  Good condition</p> <p><b>Other structure</b>  None noted</p> <p><b>Coating details</b>  Cement broken down more than 50%.</p> <p><b>Anode condition</b>  Anode wasted approx 20%.</p>

4.23: Aft Sea Bay- Port Side

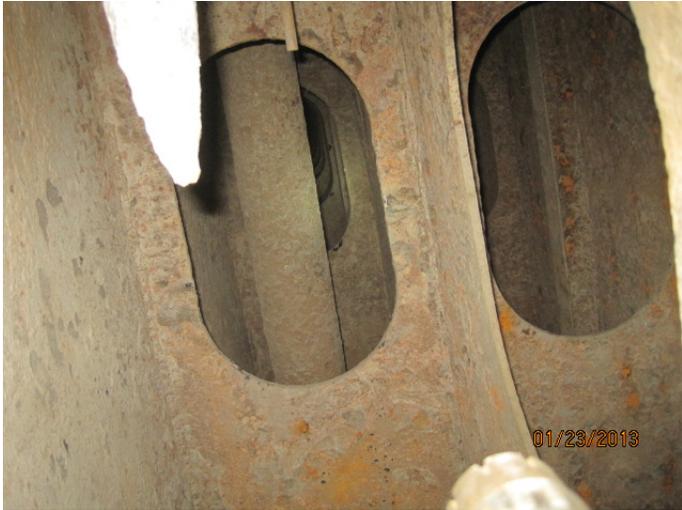
General condition of structure		GOOD	
General condition of cathodic protection		Fair	
General condition of coatings		FAIR see details below	
Type of coatings:	cement	Extent	FULL
<p><b>Limit of Inspection</b>  Frame 95-97. Stbd part not inspected - manhole not opened. Cleanliness was satisfactory.</p> <p><b>Deckhead</b>  No obvious defects found, structure was in good condition.</p> <p><b>Transverse Bulkheads</b>  No obvious defects found, structure was in good condition.</p> <p><b>Deck or Space bottom</b>  No obvious defects found, structure was in good condition.</p> <p><b>Internal structure</b>  No obvious defects found, structure was in good condition.</p> <p><b>Other structure</b>  None noted</p> <p><b>Coating details</b>  Cement coating generally fair.  Anodes wastage at various levels: 5-40%.</p>

4.25: Fwd Sea Bay (Port Side) - Stbd View

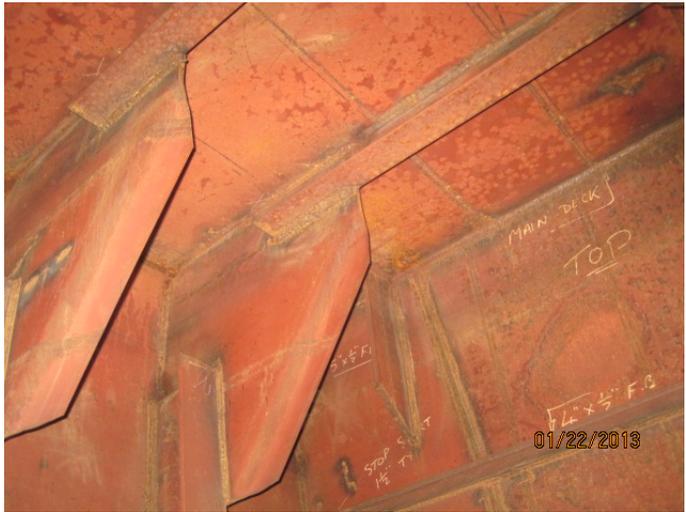
General condition of structure		GOOD	
General condition of cathodic protection		N/A	
General condition of coatings		N/A	
Type of coatings:	N/A	Extent	N/A
<p><b>Limit of Inspection</b>  Upper part Frame 61-91, lower part Frame 61-95  Cleanliness was satisfactory</p> <p><b>Deckhead</b>  Good condition</p> <p><b>Transverse Bulkheads</b>  Good condition</p> <p><b>Deck or Space bottom</b>  Good condition</p> <p><b>Internal structure</b>  Good condition  Structure was cut previously for machinery removal and is now closed. New welds examined visually and found satisfactory.</p> <p><b>Other structure</b>  Pipe condition good</p>

4.26: Aft Engine Room F.O. Tank Port - Overhead

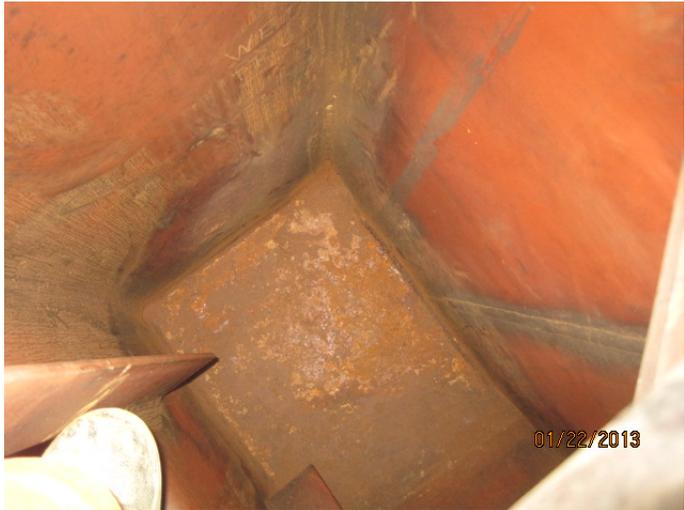
General condition of structure		GOOD	
General condition of cathodic protection		N/A	
General condition of coatings		N/A	
Type of coatings:	N/A	Extent	N/A
<p><b>Limit of Inspection</b> Upper part Frame 61-91, lower part Frame 61-95 Cleanliness was satisfactory</p> <p><b>Deckhead</b> Good condition</p> <p><b>Transverse Bulkheads</b> Good condition</p> <p><b>Deck or Space bottom</b> Good condition</p> <p><b>Internal structure</b> Good condition</p> <p><b>Other structure</b> Pipe condition good</p>

4.27: Aft Engine Room F.O. Tank Starboard - Side Bottom

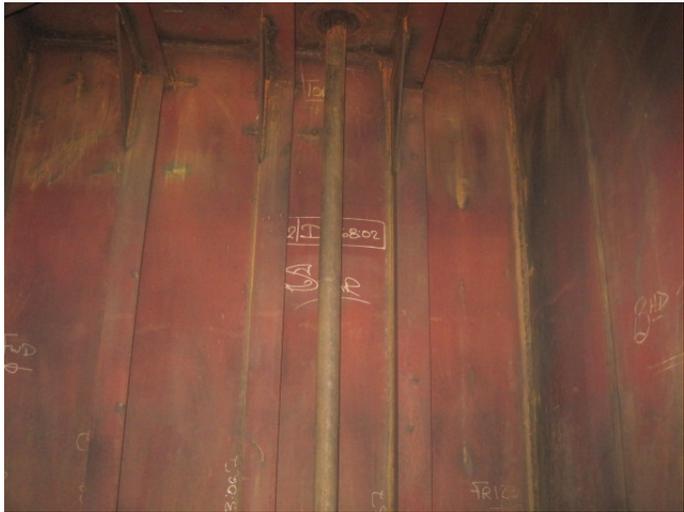
General condition of structure		GOOD	
General condition of cathodic protection		N/A	
General condition of coatings		N/A	
Type of coatings:	N/A	Extent	FULL
<p><b>Limit of Inspection</b>  Frame 123-127  Cleanliness was satisfactory</p> <p><b>Deckhead</b>  No obvious defects found, structure was in good condition.</p> <p><b>Transverse Bulkheads</b>  No obvious defects found, structure was in good condition.</p> <p><b>Deck or Space bottom</b>  No obvious defects found, structure was in good condition.</p> <p><b>Internal structure</b>  No obvious defects found, structure was in good condition.</p> <p><b>Other structure</b>  None noted</p>

4.28: Center D.O.Day Tank - Starboard Longitudinal Bhd

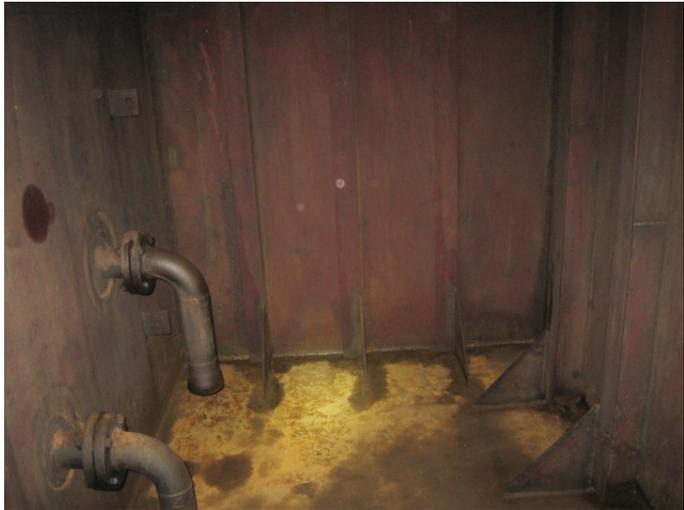
4.29: Center D.O.Day Tank - Port Longitudinal Bhd

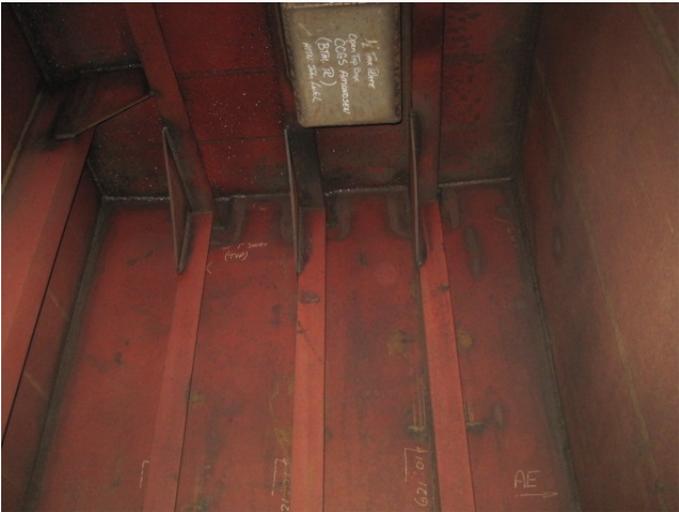
General condition of structure		GOOD	
General condition of cathodic protection		N/A	
General condition of coatings		N/A	
Type of coatings:	N/A	Extent	FULL
<p><b>Limit of Inspection</b>  Frame 123-127  Cleanliness was satisfactory</p> <p><b>Deckhead</b>  No obvious defects found, structure was in good condition.</p> <p><b>Transverse Bulkheads</b>  No obvious defects found, structure was in good condition.</p> <p><b>Deck or Space bottom</b>  No obvious defects found, structure was in good condition.</p> <p><b>Internal structure</b>  No obvious defects found, structure was in good condition.</p> <p><b>Other structure</b>  None noted</p>

4.30: D.O. Settling Tank Port Inboard Bhd

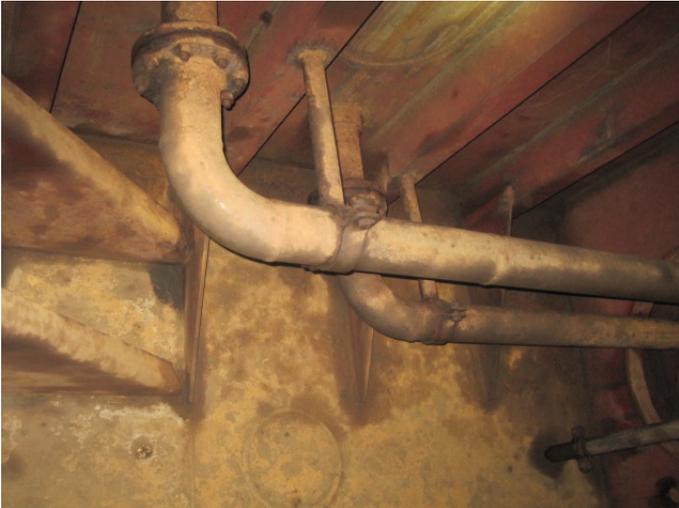
4.31: D.O. Settling Tank Port Bottom

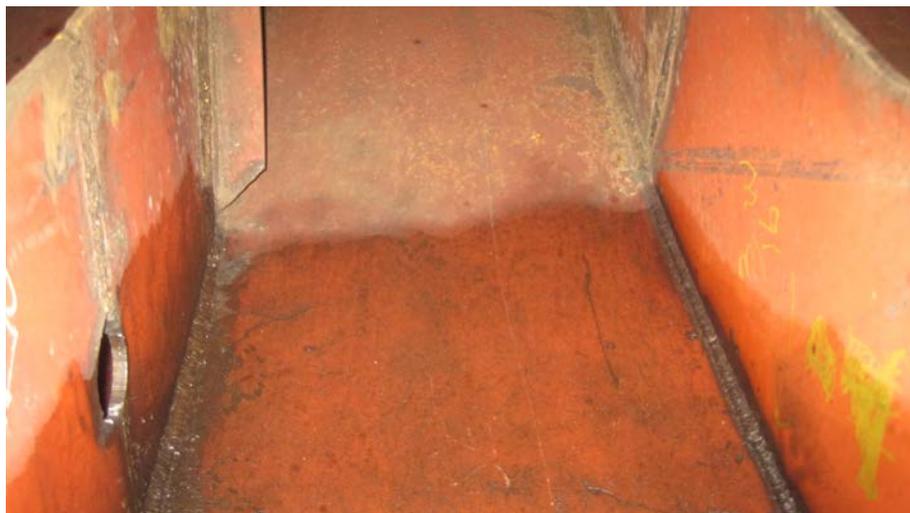
General condition of structure		GOOD	
General condition of cathodic protection		N/A	
General condition of coatings		N/A	
Type of coatings:	N/A	Extent	FULL
<p><b>Limit of Inspection</b>  Frame 112-115  Cleanliness was satisfactory</p> <p><b>Deckhead</b>  No obvious defects found, structure was in good condition.</p> <p><b>Transverse Bulkheads</b>  No obvious defects found, structure was in good condition.</p> <p><b>Deck or Space bottom</b>  No obvious defects found, structure was in good condition.</p> <p><b>Internal structure</b>  No obvious defects found, structure was in good condition.</p> <p><b>Other structure</b>  None noted</p>

4.32: Dirty Oil Tank Bottom

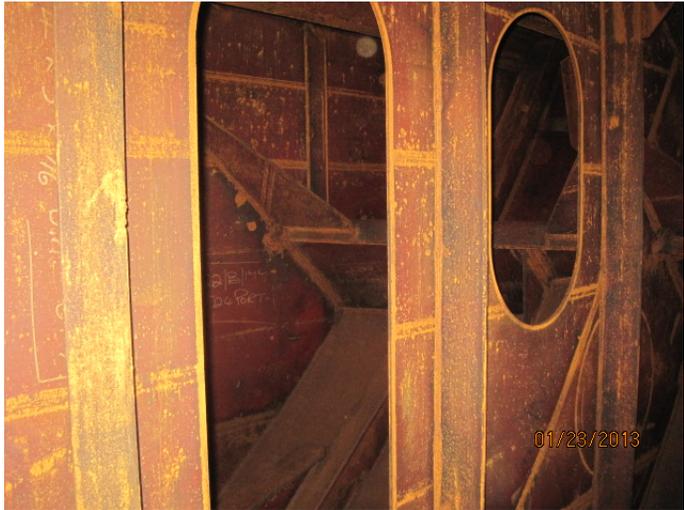
General condition of structure		GOOD	
General condition of cathodic protection		N/A	
General condition of coatings		N/A	
Type of coatings:	N/A	Extent	FULL
<p><b>Limit of Inspection</b>  Frame 18-30  Cleanliness was satisfactory</p> <p><b>Deckhead</b>  No obvious defects found, structure was in good condition.</p> <p><b>Transverse Bulkheads</b>  No obvious defects found, structure was in good condition.</p> <p><b>Deck or Space bottom</b>  No obvious defects found, structure was in good condition.</p> <p><b>Internal structure</b>  No obvious defects found, structure was in good condition.</p> <p><b>Other structure</b>  None noted</p>

4.33: F.O. Deep Tankk Port - Structure

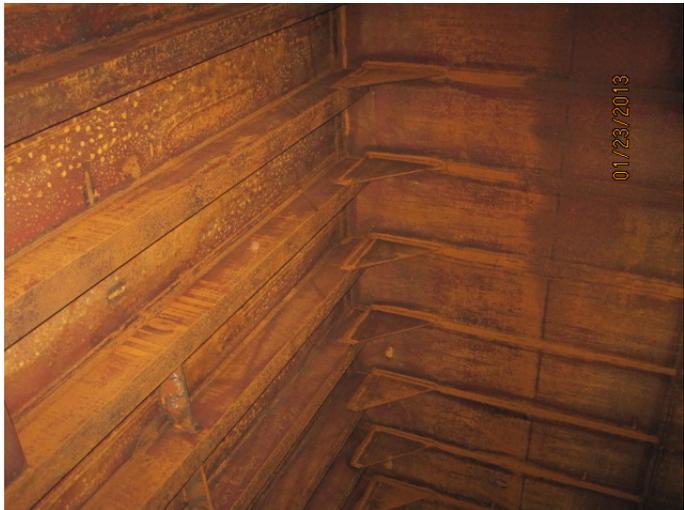
4.34: F.O. Deep Tank Port - Longitudinal Bhd & Deck

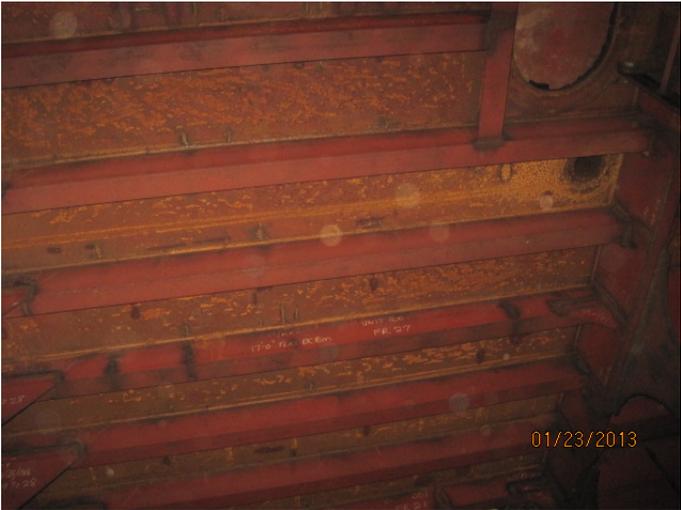
General condition of structure		GOOD	
General condition of cathodic protection		N/A	
General condition of coatings		N/A	
Type of coatings:	N/A	Extent	FULL
<p><b>Limit of Inspection</b>  Frame 18-30  Ice and water between F18-21, area not inspected  Cleanliness was satisfactory</p> <p><b>Deckhead</b>  No obvious defects found, structure was in good condition.</p> <p><b>Transverse Bulkheads</b>  No obvious defects found, structure was in good condition.</p> <p><b>Deck or Space bottom</b>  No obvious defects found, structure was in good condition.</p> <p><b>Internal structure</b>  No obvious defects found, structure was in good condition.</p> <p><b>Other structure</b>  None noted</p>

4.35: F.O. Deep Tank Starboard - Longitudinal Bhd

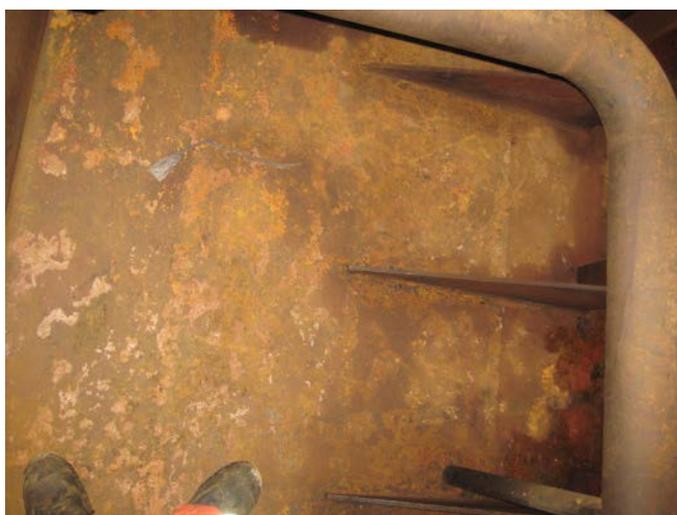
General condition of structure		GOOD	
General condition of cathodic protection		N/A	
General condition of coatings		N/A	
Type of coatings:	N/A	Extent	FULL
<p><b>Limit of Inspection</b>  Visual inspection of tank located between frames 123-127. Cleanliness was satisfactory</p> <p><b>Deckhead</b>  Good condition</p> <p><b>Transverse Bulkheads</b>  Good condition</p> <p><b>Deck or Space bottom</b>  Good condition</p> <p><b>Internal structure</b>  Good condition</p> <p><b>Other structure</b>  None noted</p> <p><b>Coating details</b>  Bottom plate primer broken around 50%. In general, coating broken down at welds.</p>

4.38: F.O. Settling Tank - Lower Level Bottom

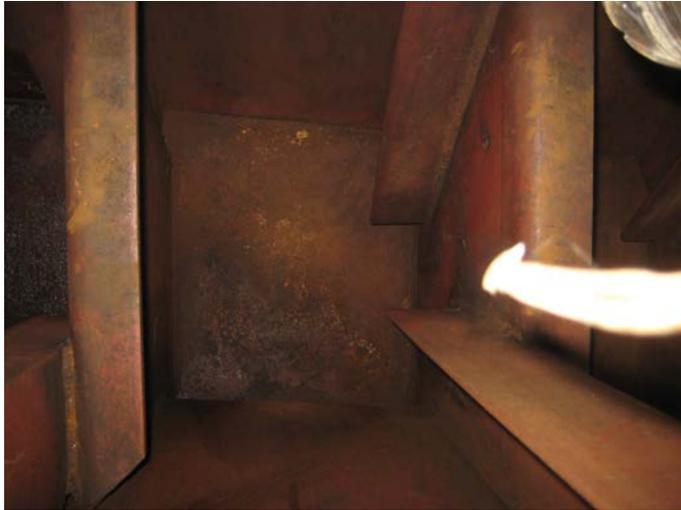
General condition of structure		GOOD	
General condition of cathodic protection		N/A	
General condition of coatings		N/A	
Type of coatings:	N/A	Extent	FULL
<p><b>Limit of Inspection</b>  Visual inspection of tank located between frames 95-123  Cleanliness was satisfactory</p> <p><b>Deckhead</b>  Good condition</p> <p><b>Transverse Bulkheads</b>  Good condition</p> <p><b>Deck or Space bottom</b>  Good condition</p> <p><b>Internal structure</b>  Good condition.</p> <p><b>Other structure</b>  None noted</p> <p><b>Coating details</b>  Aft bulkhead plate primer broken around 30%. In general, coating broken down at welds.</p>

4.40: Fwd Engine Room Wing Tank Port - Lower Level Bottom

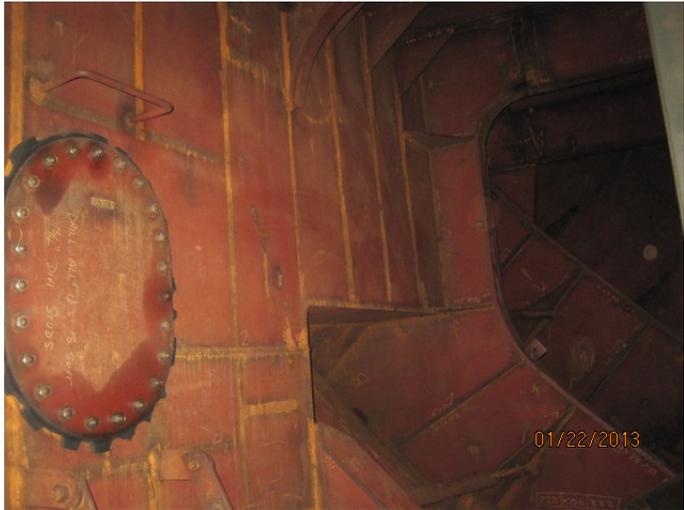
General condition of structure		GOOD	
General condition of cathodic protection		N/A	
General condition of coatings		N/A	
Type of coatings:	N/A	Extent	N/A
<p><b>Limit of Inspection</b>  Frame 146-165  Cleanliness was satisfactory</p> <p><b>Deck head</b>  Good condition</p> <p><b>Transverse Bulkheads</b>  Good condition</p> <p><b>Deck or Space bottom</b>  Good condition</p> <p><b>Internal structure</b>  Good condition</p> <p><b>Other structure</b>  Good condition</p>

4.43: Fwd F.O. Tank Port - Longitudinal Bhd & Structure

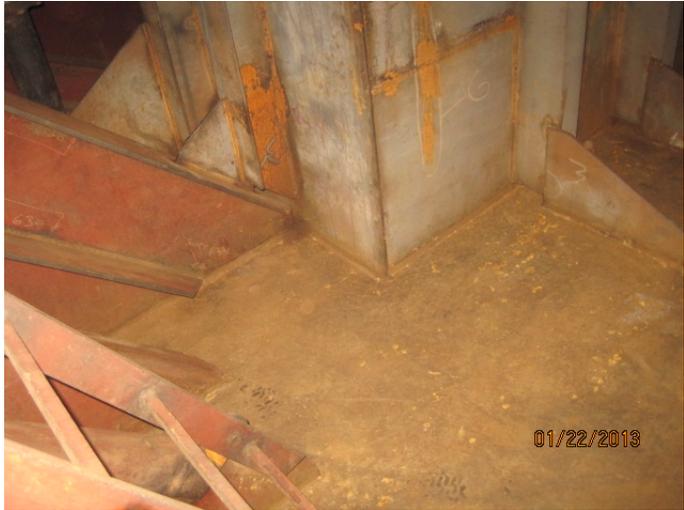
4.44: Fwd F.O. Tank - Bottom

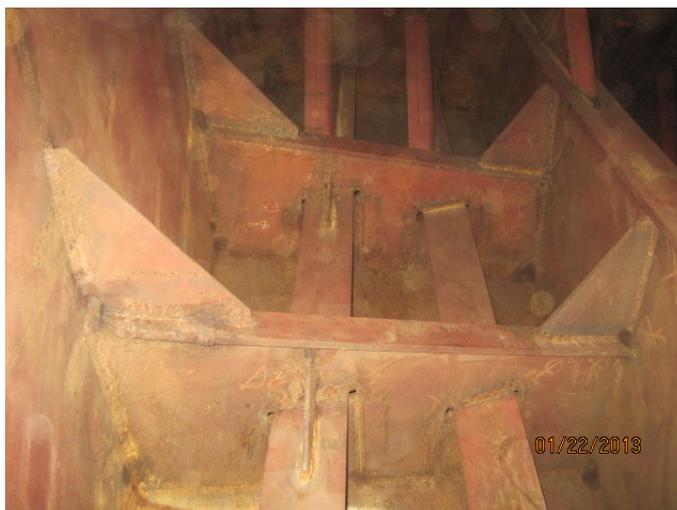
General condition of structure		GOOD	
General condition of cathodic protection		N/A	
General condition of coatings		N/A	
Type of coatings:	N/A	Extent	N/A
<p><b>Limit of Inspection</b>  Frame 146-165  Cleanliness was satisfactory</p> <p><b>Deckhead</b>  Good condition</p> <p><b>Transverse Bulkheads</b>  Good condition</p> <p><b>Deck or Space bottom</b>  Good condition</p> <p><b>Internal structure</b>  Good condition</p> <p><b>Other structure</b>  None noted</p>

4.45: Fwd F.O. Tank Starboard - Fwd Structure & Bhd

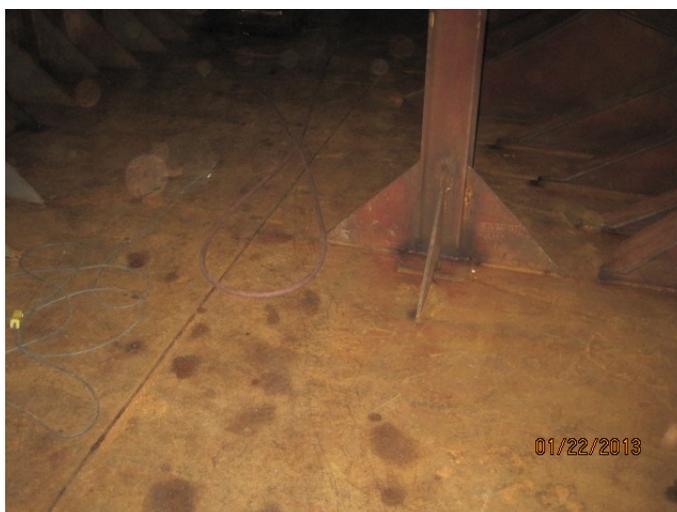
4.46: Fwd F.O. Tank Starboard - Bottom

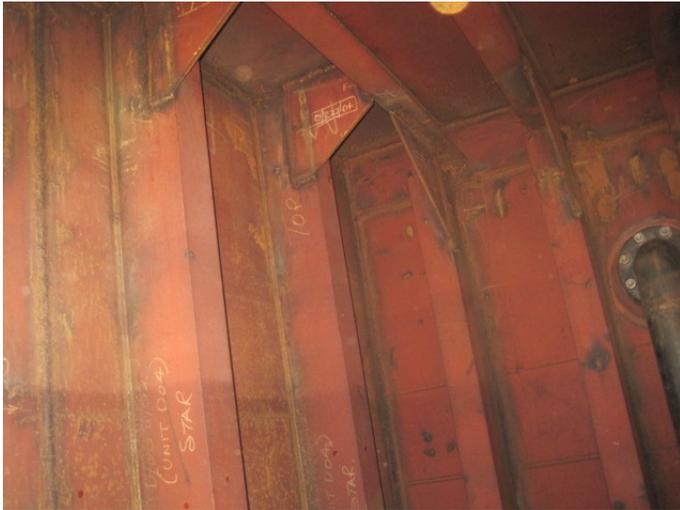
General condition of structure		GOOD	
General condition of cathodic protection		N/A	
General condition of coatings		N/A	
Type of coatings:	N/A	Extent	FULL
<p><b>Limit of Inspection</b>  Frame 138-158  Cleanliness was satisfactory</p> <p><b>Deckhead</b>  No obvious defects found, structure was in good condition.</p> <p><b>Transverse Bulkheads</b>  No obvious defects found, structure was in good condition.</p> <p><b>Deck or Space bottom</b>  No obvious defects found, structure was in good condition.</p> <p><b>Internal structure</b>  No obvious defects found, structure was in good condition.</p> <p><b>Other structure</b>  None noted</p>

4.47: Fwd Lower D.O. Side Tank – Aft Bhd

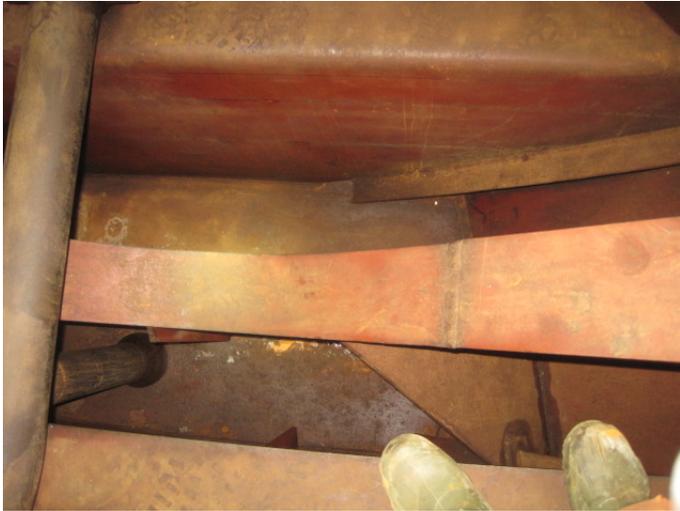
4.48: Fwd Lower D.O. Side Tank – Bottom

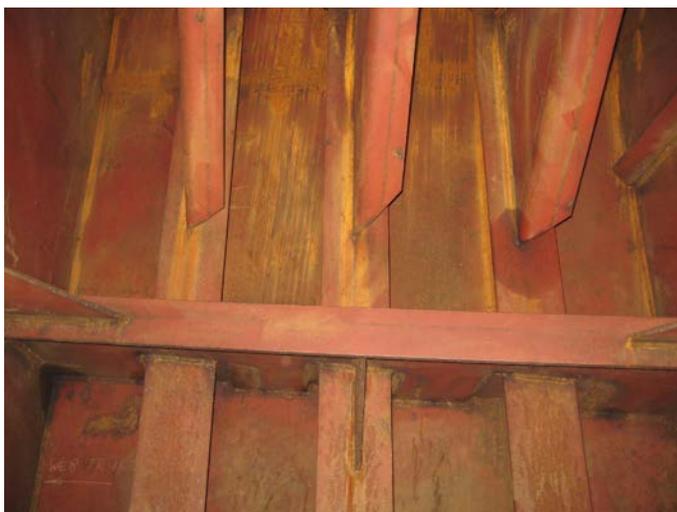
General condition of structure		GOOD	
General condition of cathodic protection		N/A	
General condition of coatings		GOOD, SEE BELOW	
Type of coatings:	N/A	Extent	FULL
<p><b>Limit of Inspection</b>  Visual inspection of tank located between frames 138-158. Cleanliness was satisfactory</p> <p><b>Deckhead</b>  Good condition</p> <p><b>Transverse Bulkheads</b>  Good condition</p> <p><b>Deck or Space bottom</b>  Good condition</p> <p><b>Internal structure</b>  Good condition.</p> <p><b>Other structure</b>  None noted</p> <p><b>Coating details</b>  Primer locally broken less than 5%.</p>

4.49: Fwd Lower Side Fuel Tank – Port

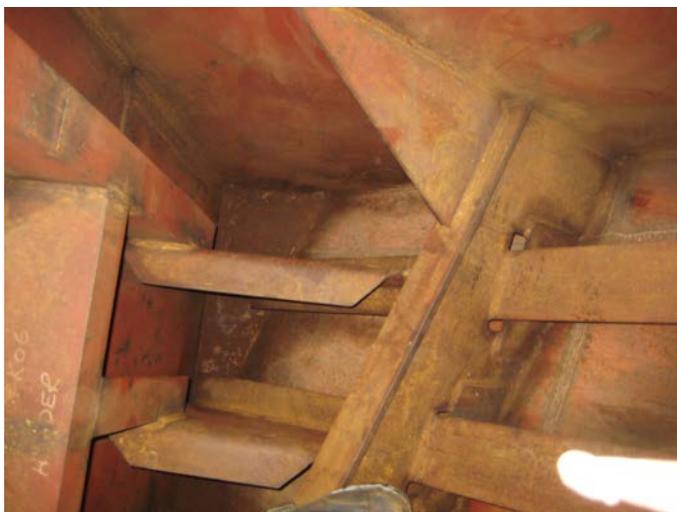
4.50: Fwd Lower Side Fuel Tank - Bottom

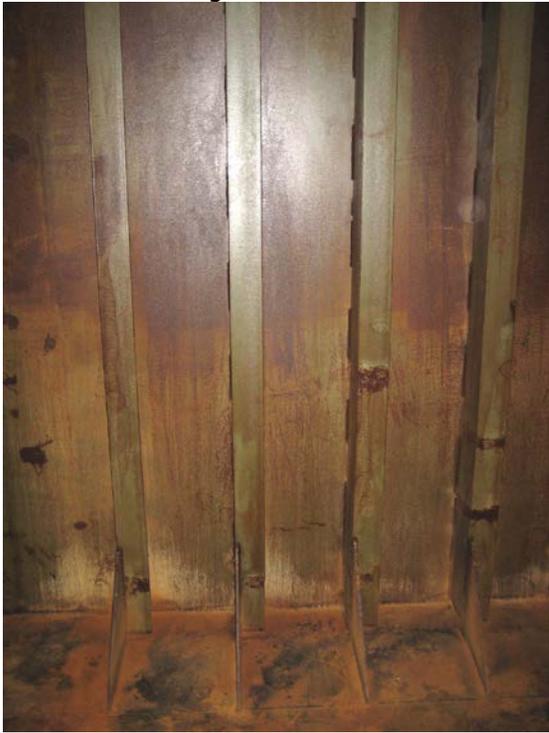
General condition of structure		GOOD	
General condition of cathodic protection		N/A	
General condition of coatings		SEE NOTE BELOW	
Type of coatings:	N/A	Extent	FULL
<p><b>Limit of Inspection</b> Full Visual inspection of tank located between Frames 138-165. Cleanliness was satisfactory.</p> <p><b>Deckhead</b> Tank top found in good condition no corrosion noted</p> <p><b>Transverse Bulkheads</b> Found satisfactory no damage noted.</p> <p><b>Deck or Space bottom</b> Found satisfactory no damage noted</p> <p><b>Internal structure</b> Corroded welds noted at shell frames above top side shell stringer Fr. 138-Fr. 142, 149-151 and top stringer at Fr. 158.</p> <p><b>Other structure</b> None noted</p> <p><b>Coating details</b> Primer found generally broken on welds. Coating poor at bottom and side bulkheads up to 0.5m up from bottom plate.</p>

4.52: Heeling Tank Stbd – Stbd View

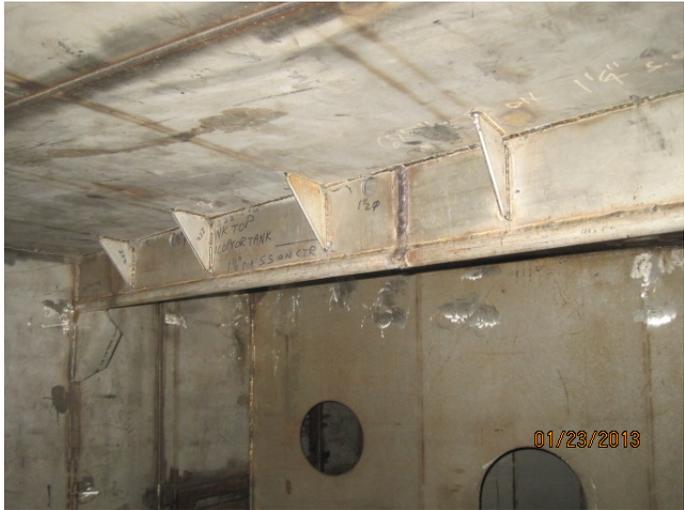
4.55: Helicopter Fuel Tank – Deck

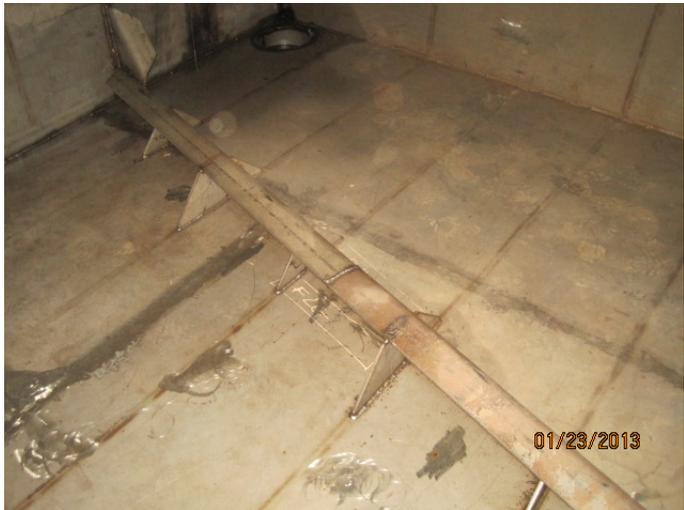
4.56: Helicopter Fuel Tank - Bottom

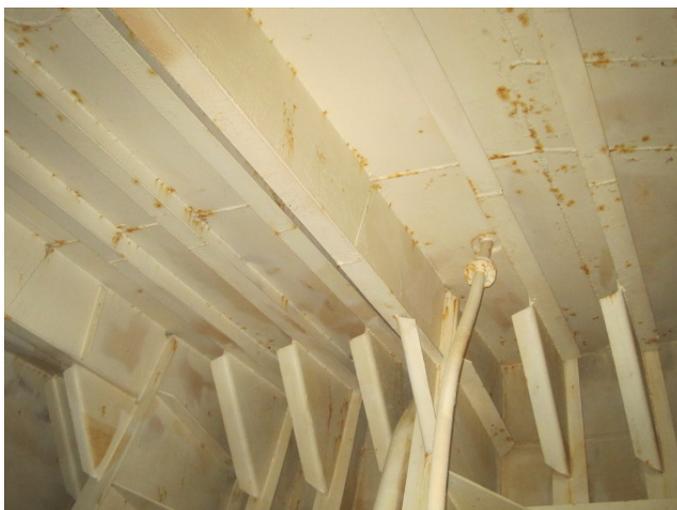
4.57: Lower Flume Tank - Deckhead

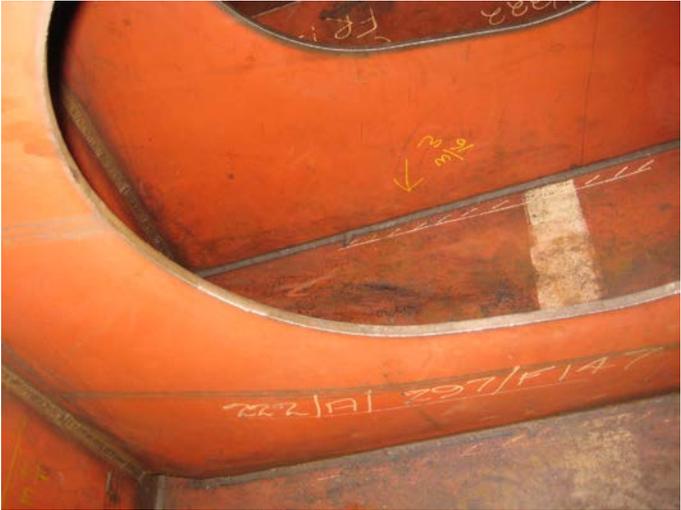
4.60: Double Bottom F.O Tank No. 1 Port - Bottom

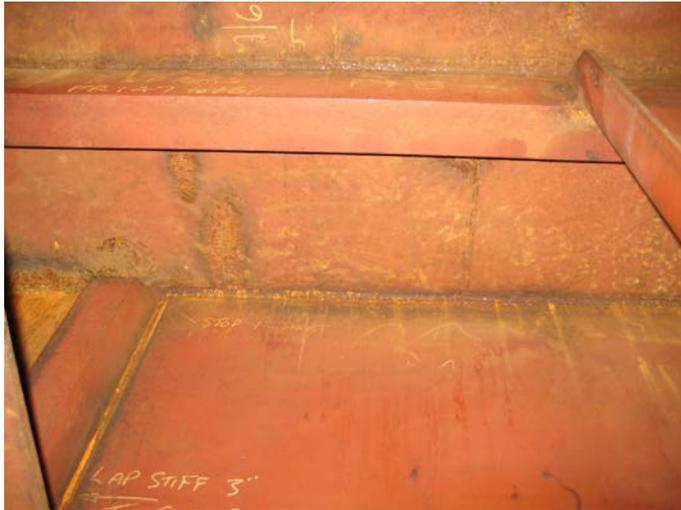
4.61: Double Bottom F.O Tank No. 1 Stbd – Top

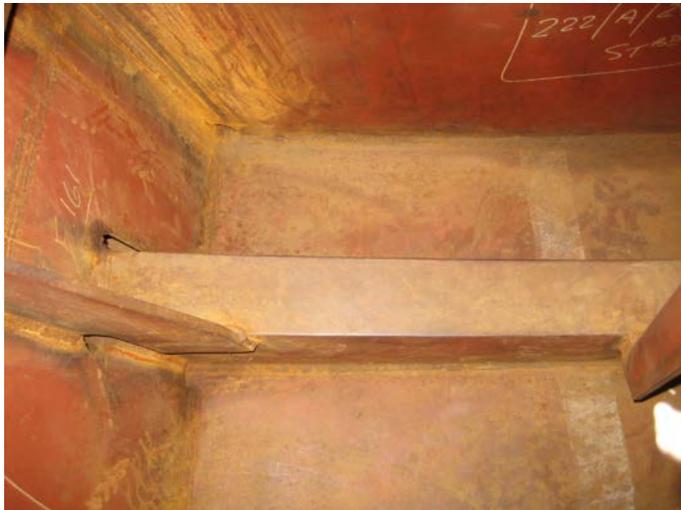
4.62: Double Bottom F.O Tank No. 1 Stbd - Bottom

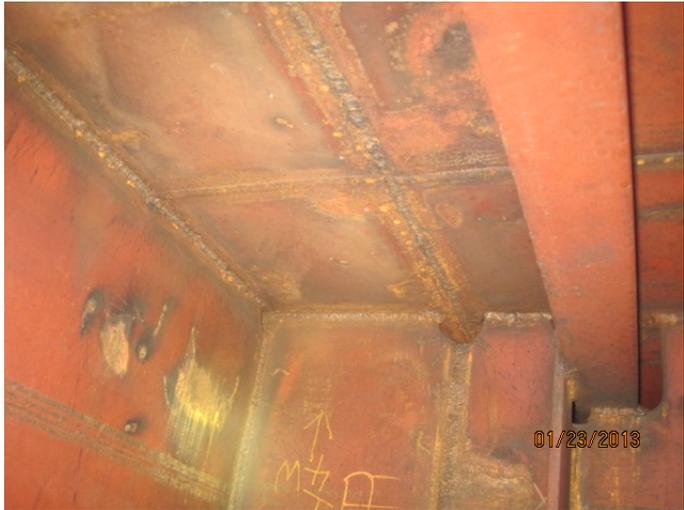
4.63: No.2 D.B.F.O.Tank Port – Deckhead and Structure

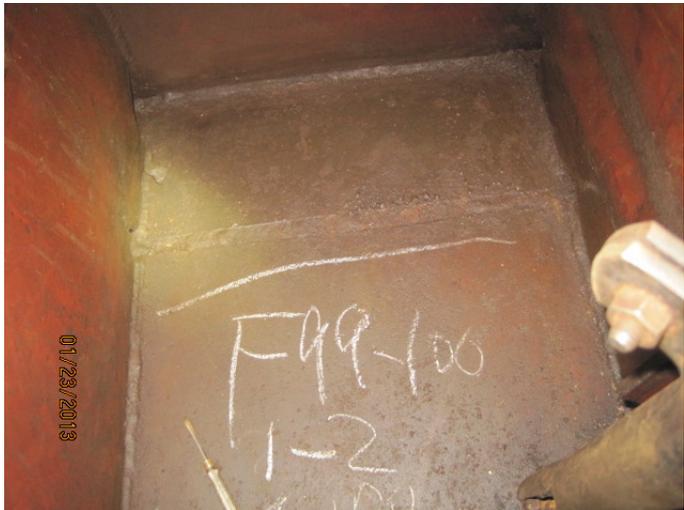
General condition of structure		good	
General condition of cathodic protection		N/A	
General condition of coatings		N/A	
Type of coatings:	N/A	Extent	FULL
<p><b>Limit of Inspection</b>  Frame 97-123  Bottom plating covered with oil at F97-103 between longitudinal bhd and 1<sup>st</sup> girder from inboard, were not inspected  Cleanliness was satisfactory</p> <p><b>Deckhead</b>  No obvious defects found, structure was in good condition.</p> <p><b>Transverse Bulkheads</b>  No obvious defects found, structure was in good condition.</p> <p><b>Deck or Space bottom</b>  Poor welding repair found-welding seam height is lower than base steel plate surface at F99-100 between 1<sup>st</sup> and 2<sup>nd</sup> girder from inboard.  Pitting initiated along bottom plate longitudinal weld seam between 2<sup>nd</sup> and 3<sup>rd</sup> girder from inboard  All other area found good</p> <p><b>Internal structure</b>  No obvious defects found, structure was in good condition.</p> <p><b>Other structure</b>  None noted</p>

4.64: No.2 D.B.F.O.Tank Port - Bottom F99-100

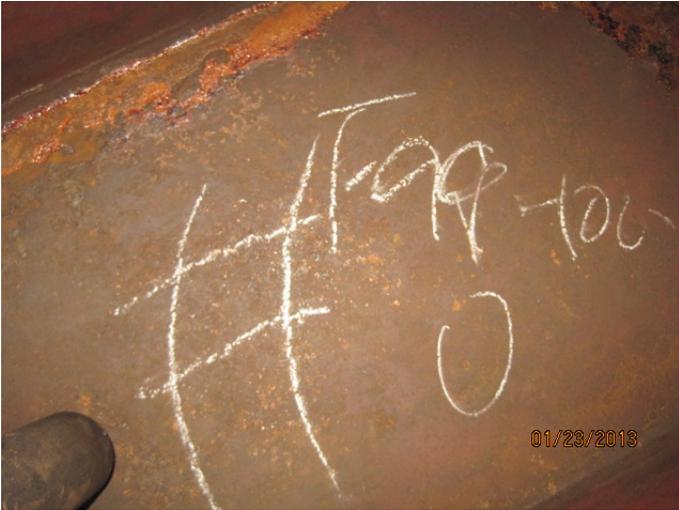
4.66: No.2 D.B.F.O.Tank Stbd - Bottom Dent

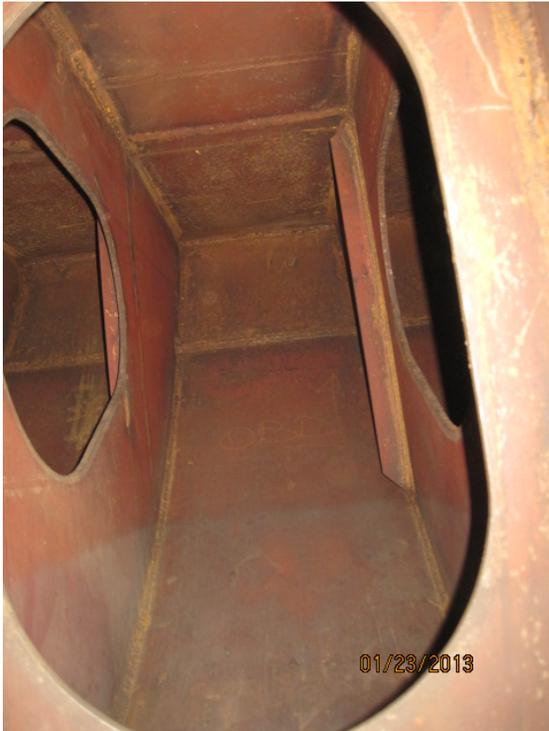
General condition of structure		GOOD	
General condition of cathodic protection		N/A	
General condition of coatings		N/A	
Type of coatings:	N/A	Extent	N/A
<p><b>Limit of Inspection</b>  Frame 61-93  Cleanliness was satisfactory</p> <p><b>Deckhead</b>  No obvious defects found, structure was in good condition.</p> <p><b>Transverse Bulkheads</b>  No obvious defects found, structure was in good condition.</p> <p><b>Deck or Space bottom</b>  Pitting initiated at F61-65 between center line and 1<sup>st</sup> girder</p> <p><b>Internal structure</b>  In space between center line to 1<sup>st</sup> girder from center line, floors buckled slightly mid-height, approx depth 40mm.</p> <p><b>Other structure</b>  None noted</p>

4.67: No.3 D.B.F.O.Tank Port - Side Shell
