CCGS Amundsen

# Condition Assessment Report

June 2013

| 16. Summary<br><p><b>This report details a Condition Assessment for the CCGS Amundsen undertaken to determine the current condition of the ship hull structure. Hull Renovation Scheme level 2SS standard was used as a basis for assessment of the current condition and in identifying likely hull elements that will require maintenance for the remaining life of the ship.</b></p> <p><b>The report and supporting surveys concluded that the ship's hull and tanks were generally found in good condition, and at a standard comparable to a classed ship of similar type and age.</b></p> | | | |

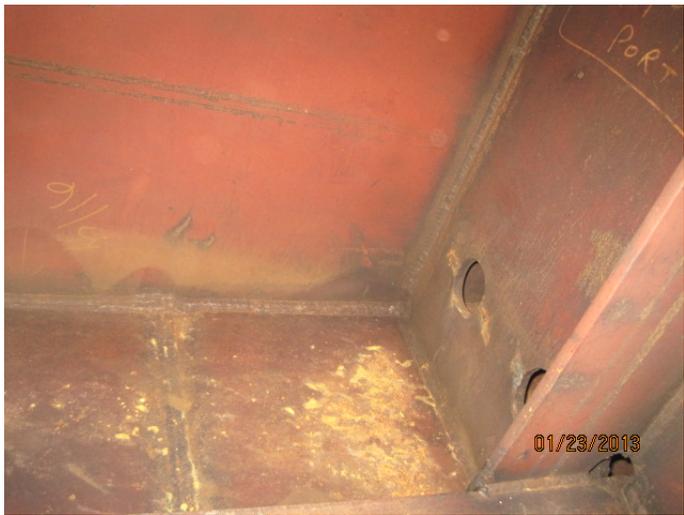
4.68: No.3 D.B.F.O.Tank Port - Aft Bhd and Bottom Plate

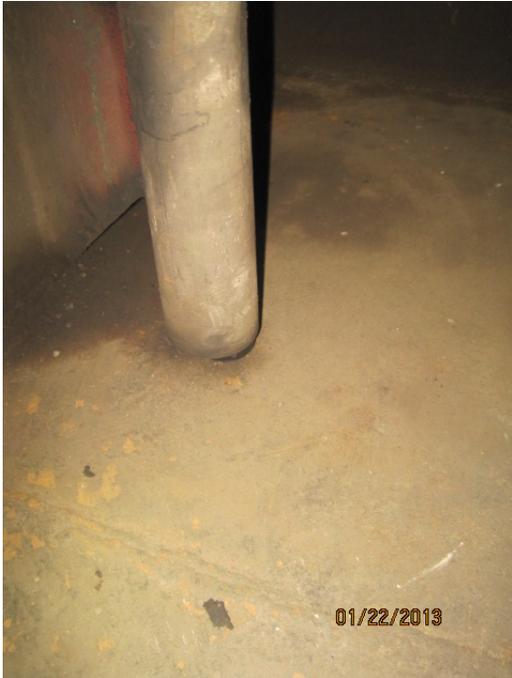
General condition of structure		SATISFACTORY	
General condition of cathodic protection		SATISFACTORY	
General condition of coatings		FAIR,SEE DETAIL BELOW	
Type of coatings:	N/A	Extent	FULL
<p><b>Limit of Inspection</b>  Frame39-55  Ship side space is too narrow to enter for inspection  Cleanliness was satisfactory</p> <p><b>Deckhead</b>  Good condition</p> <p><b>Transverse Bulkheads</b>  Good condition</p> <p><b>Deck or Space bottom</b>  Very shallow pitting initiated at 1-5%  Scar pitting developed along bottom plate longitudinal welding butt seam, especially at scallop cut.  Marks were made for TM/repair to be done.</p> <p><b>Internal structure</b>  Good condition</p> <p><b>Other structure</b>  None noted</p> <p><b>Coating details</b>  Bottom plate primer almost gone</p>

4.72: No.4 D.B. Bilge Tank Port - Bottom Plate

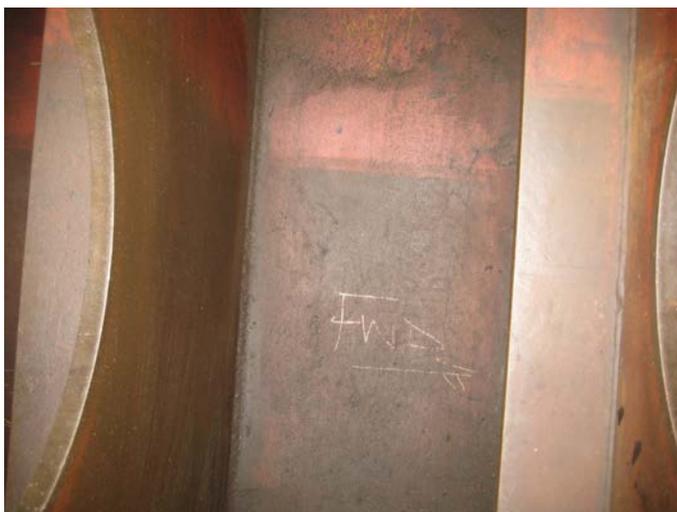
4.73: No. 4 D.B. F.O Tank Stbd – Port View

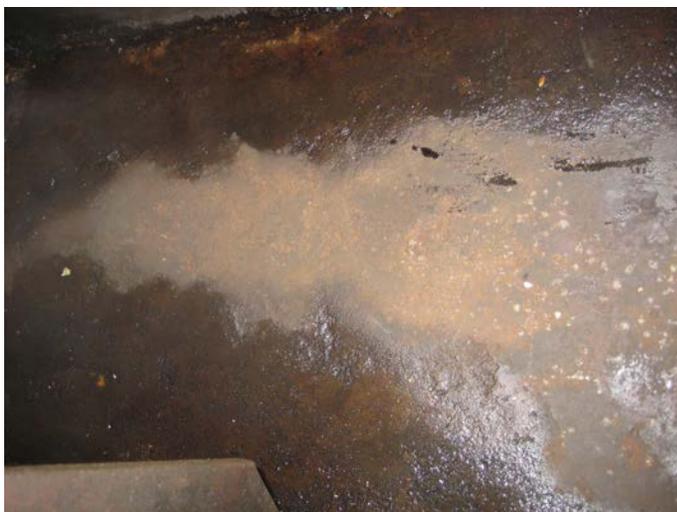
General condition of structure		SATISFACTORY	
General condition of cathodic protection		GOOD	
General condition of coatings		N/A	
Type of coatings:	N/A	Extent	FULL
<p><b>Limit of Inspection</b>  Visual inspection of tank located between frames 39-61. outboard bay was not inspected due to poor accessibility</p> <p><b>Deckhead</b>  Good condition</p> <p><b>Transverse Bulkheads</b>  Good condition</p> <p><b>Deck or Space bottom</b>  Pitting initiated corrosion located at bottom plate between F40-46, depth average 2.0-4.0mm, welding seam eroded at F44-45 inboard bay</p> <p><b>Internal structure</b>  Good condition.</p> <p><b>Other structure</b>  Good condition</p>

4.74: No. 4 D.B. F.O Tank Stbd - Bottom Pitting

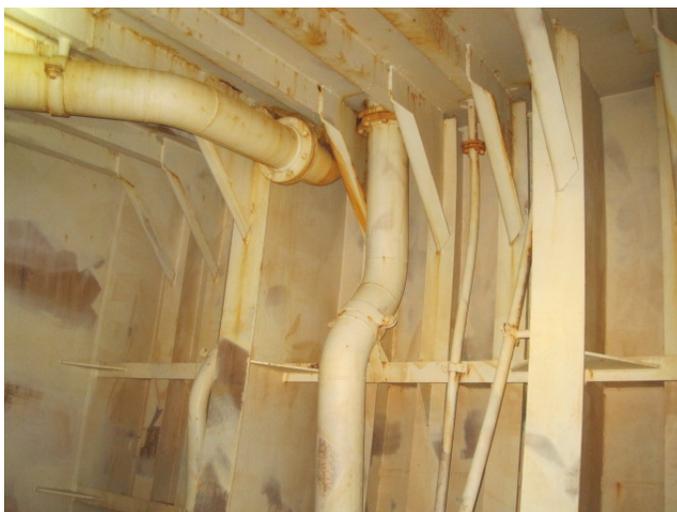
4.75: Upper Flume Tank - Port Shell

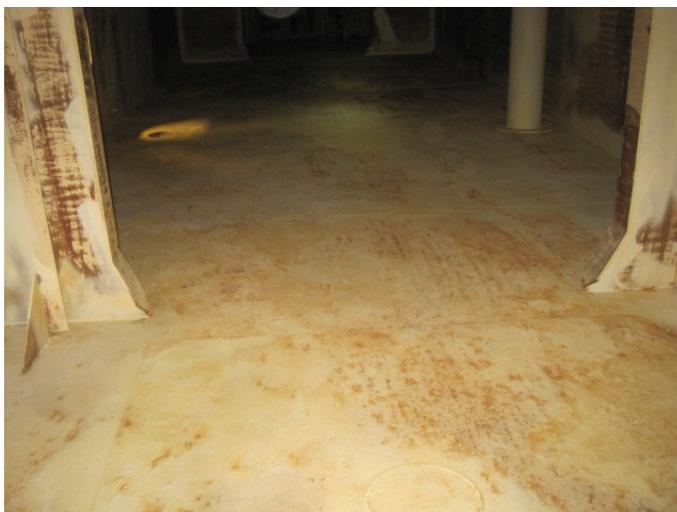
4.76: Upper Flume Tank - Bottom

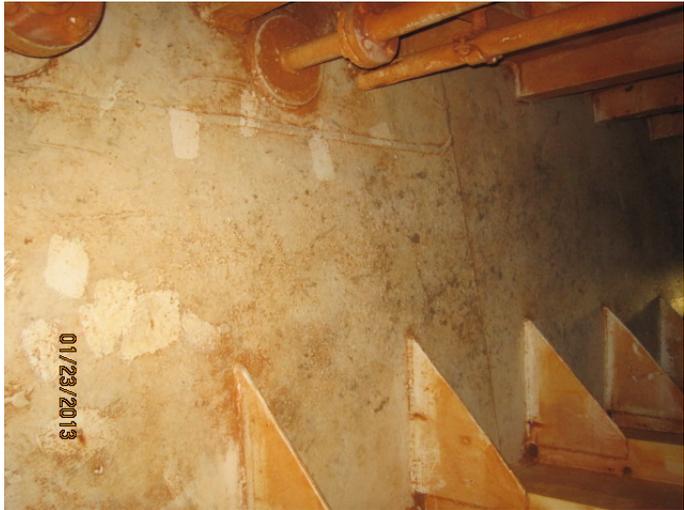
4.77: Feed Water Tank Port - Bottom

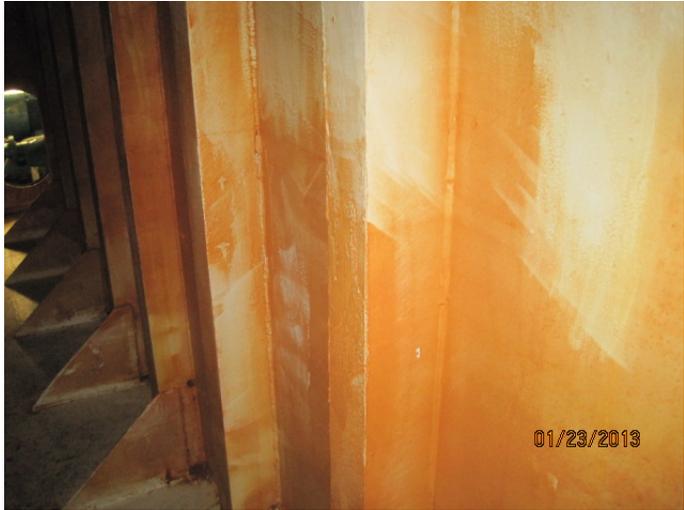
4.78: Feed Water Tank Port - Aft Bhd

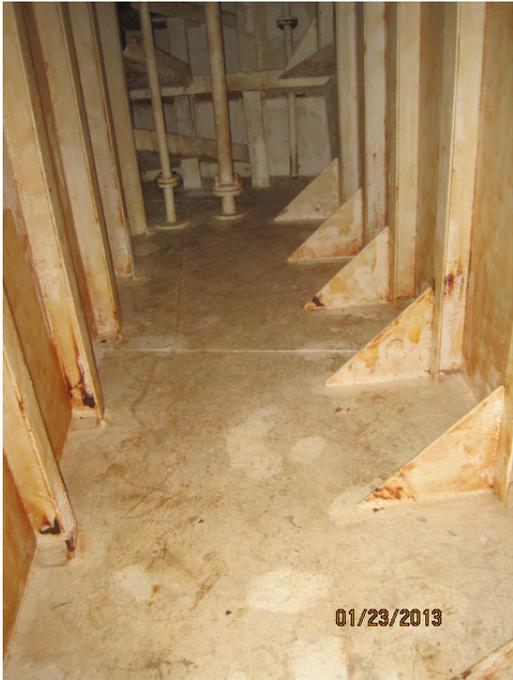
4.79: Feed Water Tank Stbd - Bottom

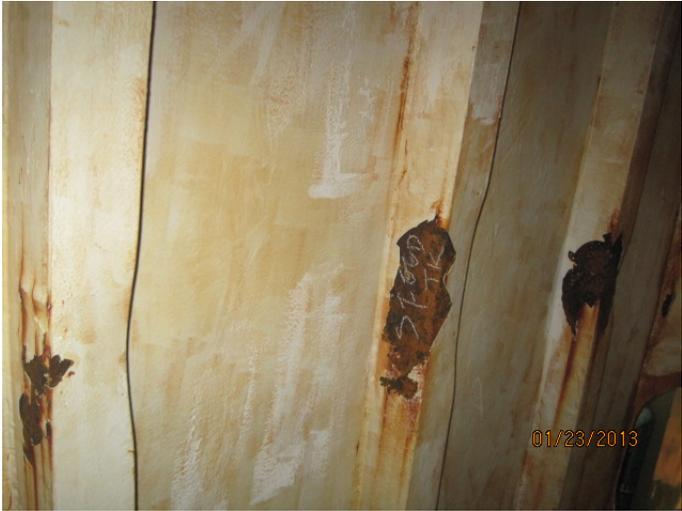
4.80: Feed Water Tank Stbd - Aft Bhd

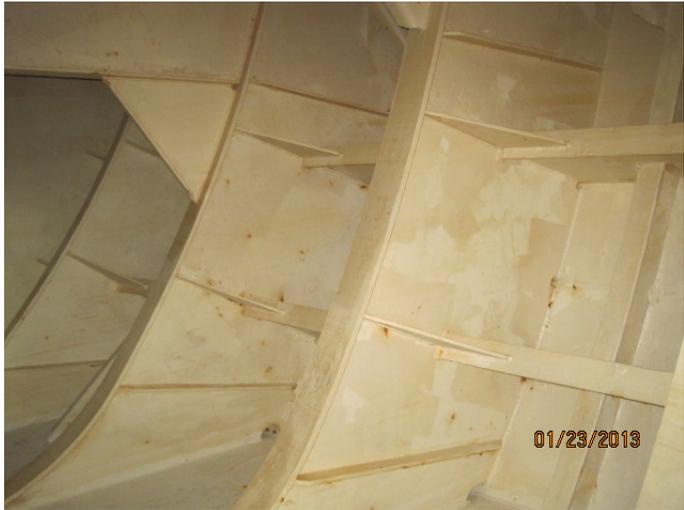
4.81: Fresh Water Tank Port - Side Shell

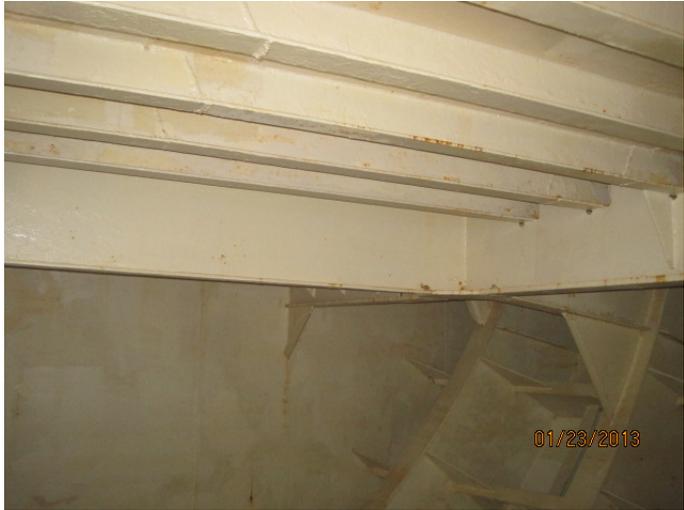
4.82: Fresh Water Tank Port – Deckhead and Fwd Bhd

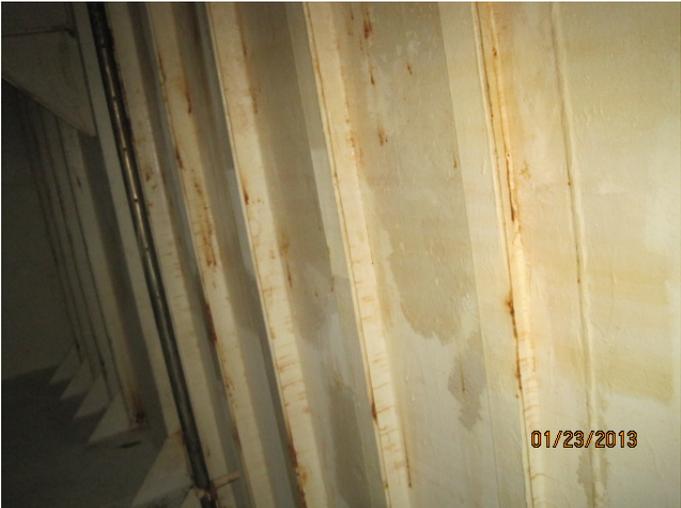
4.83: Fresh Water Tank Starboard - Longitudinal Bhd

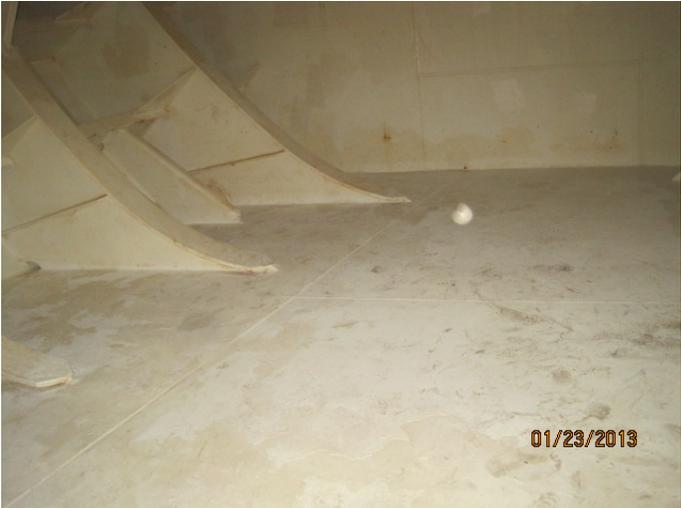
4.84: Fresh Water Tank Starboard - Bottom

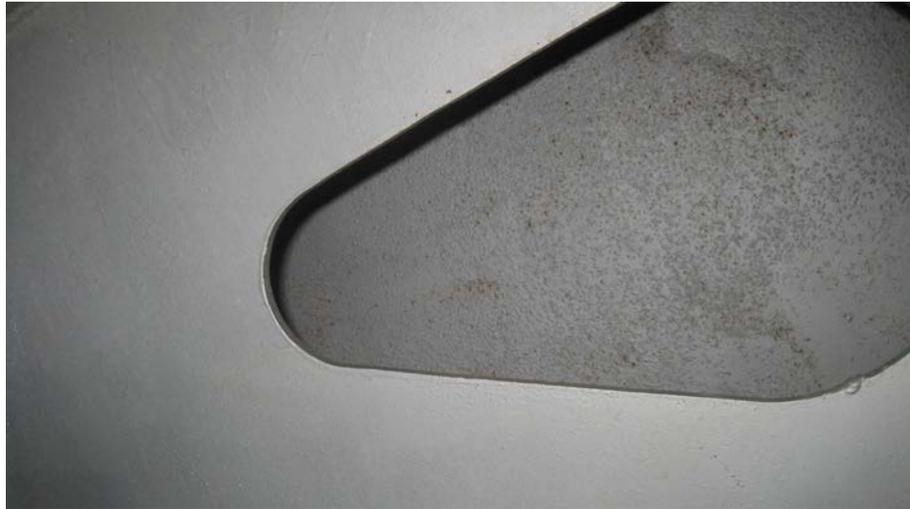
4.85: Jacket Water Tank Port - Structure and Bhd

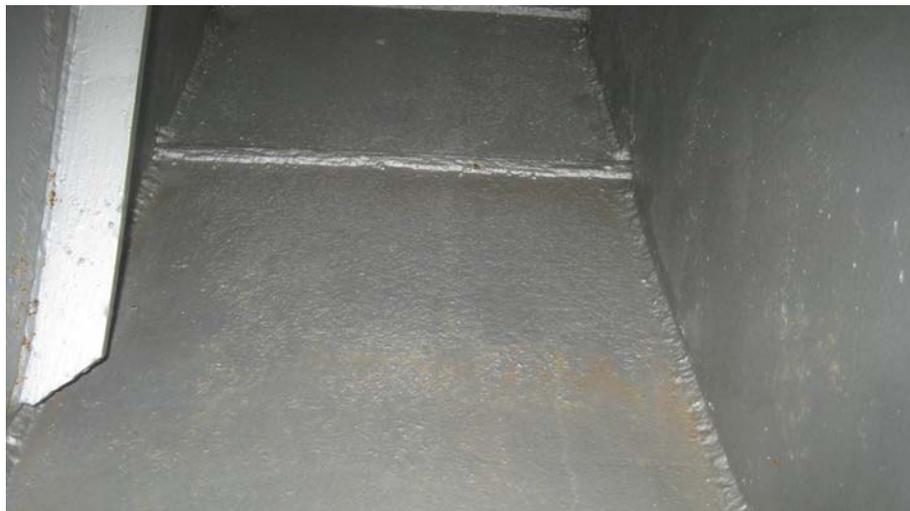
4.86: Jacket Water Tank Port - Shell Plate

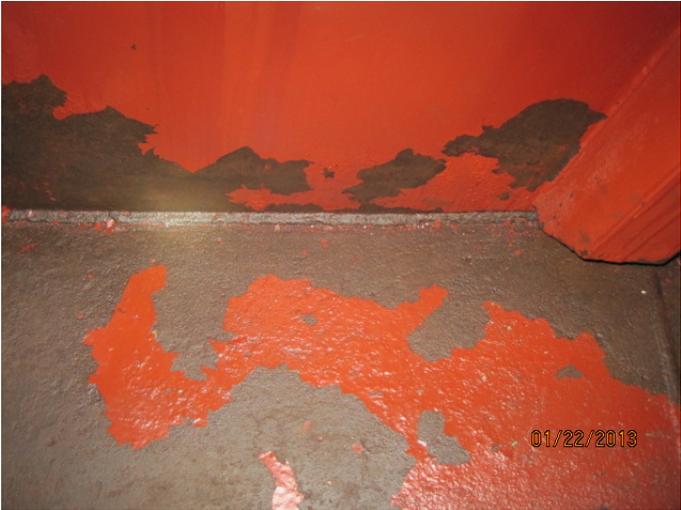
General condition of structure		GOOD	
General condition of cathodic protection		N/A	
General condition of coatings		FAIR, SEE DETAILS BELOW	
Type of coatings:	EPOXY	Extent	FULL
<p><b>Limit of Inspection</b>  Frame 31-39  Cleanliness was satisfactory</p> <p><b>Deckhead</b>  Good condition</p> <p><b>Transverse Bulkheads</b>  Good condition</p> <p><b>Deck or Space bottom</b>  Good condition</p> <p><b>Internal structure</b>  Good condition</p> <p><b>Other structure</b>  None noted</p> <p><b>Coating details</b>  Between longitudinal bulkhead and girder, F35-37 overhead coating gone  F31-39 bottom plate coating gone  F31-33 floor coating broken down at approx 150mm from bottom</p>

4.90: Aft Void Space Stbd - Bottom and Side Bhd

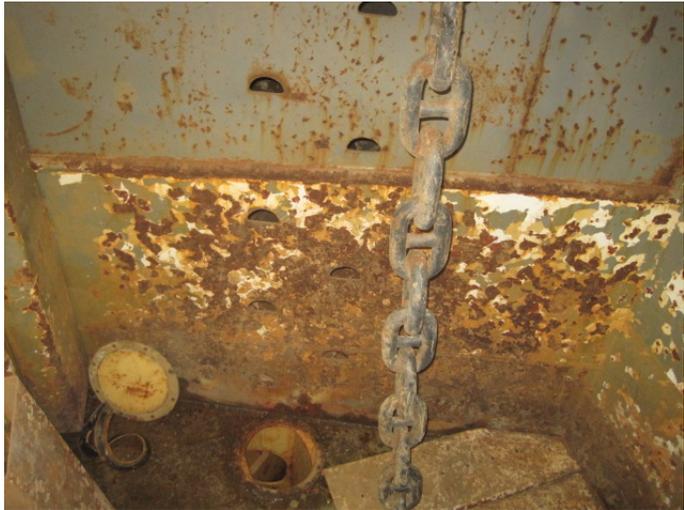
4.93: Stbd Chain Locker - Middle Wall

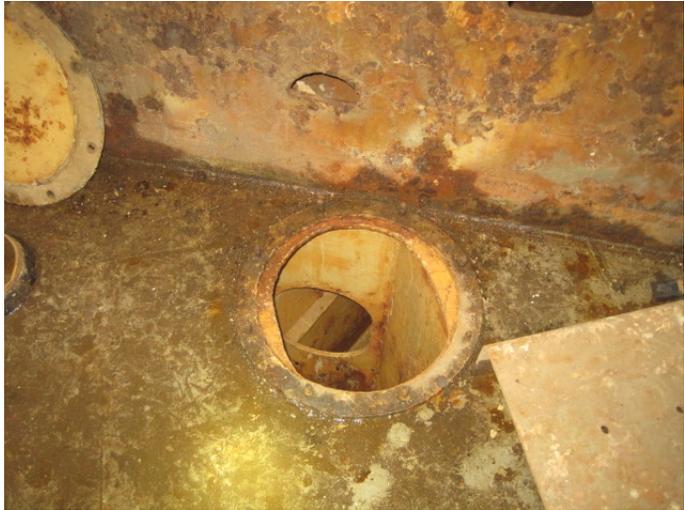
General condition of structure		GOOD	
General condition of cathodic protection		N/A	
General condition of coatings		See details below	
Type of coatings:	EPOXY	Extent	FULL
<p><b>Limit of Inspection</b>  Frame 183-191  Cleanliness was satisfactory</p> <p><b>Deckhead</b>  No obvious defects found, structure was in good condition.</p> <p><b>Transverse Bulkheads</b>  No obvious defects found, structure was in good condition.</p> <p><b>Deck or Space bottom</b>  No obvious defects found, structure was in good condition.</p> <p><b>Internal structure</b>  No obvious defects found, structure was in good condition.</p> <p><b>Other structure</b>  None noted</p> <p><b>Coating details</b>  Upper area coating found good and lower part coating found poor</p>

4.94: Stbd Chain Locker - Bottom Plating

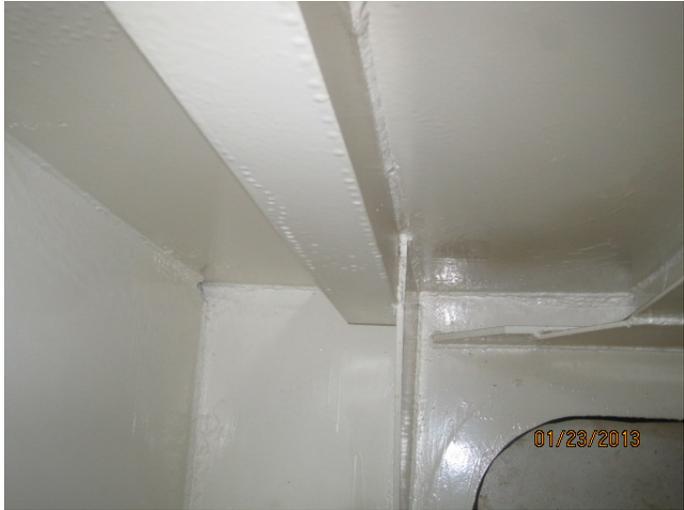
4.98: Cofferdam F18-30 Port - Overhead and Longitudinal Bhd

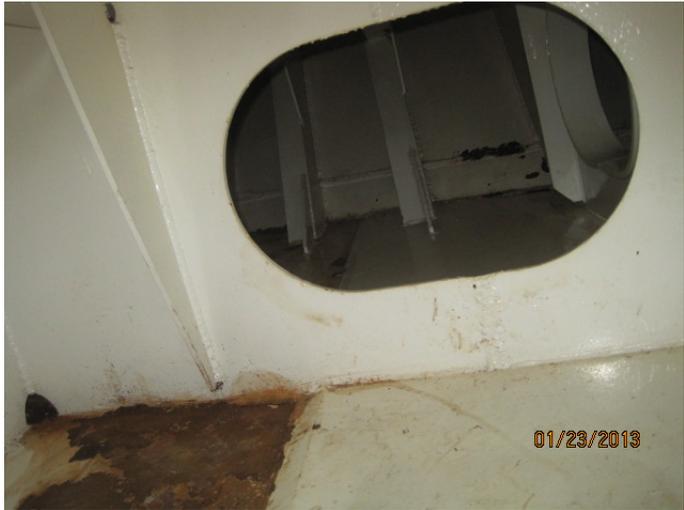
General condition of structure		GOOD	
General condition of cathodic protection		N/A	
General condition of coatings		good	
Type of coatings:	EPOXY	Extent	FULL
<p><b>Limit of Inspection</b>  Frame 18-30  Inboard aft end two frame spaces not seen as pipe occupied access way  Cleanliness was satisfactory</p> <p><b>Deckhead</b>  No obvious defects found, structure was in good condition.</p> <p><b>Transverse Bulkheads</b>  No obvious defects found, structure was in good condition.</p> <p><b>Deck or Space bottom</b>  No obvious defects found, structure was in good condition.</p> <p><b>Internal structure</b>  No obvious defects found, structure was in good condition.</p> <p><b>Other structure</b>  None noted</p> <p><b>Coating details</b>  Fwd outboard corner tank space bottom coat gone locally  Coating broken down at welding seams</p>

4.99: Cofferdam F18-30 Stbd - Side Shell

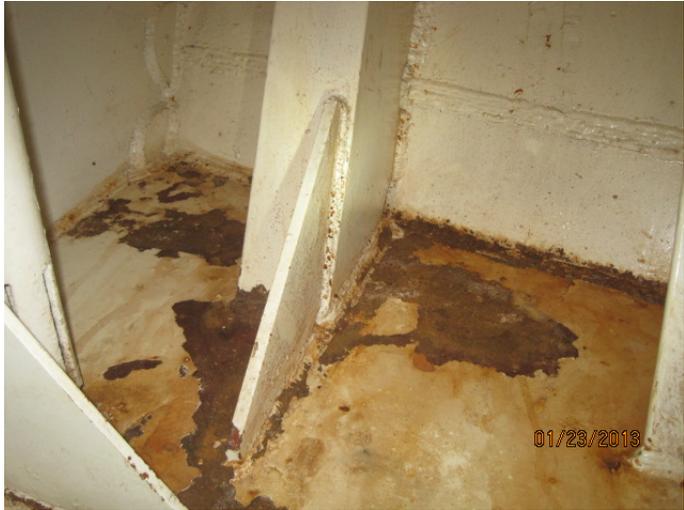
4.100: Cofferdam F18-30 Stbd - Fwd Bottom and Longitudinal Bhd

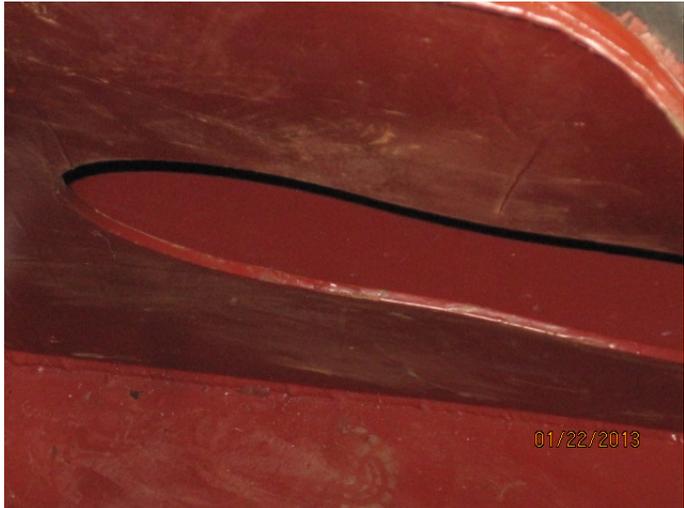
General condition of structure		<i>GOOD</i>	
General condition of cathodic protection		<i>N/A</i>	
General condition of coatings		<i>GOOD</i>	
Type of coatings:	EPOXY	Extent	<i>FULL</i>
<p><b>Limit of Inspection</b>  Frame 162-165  Cleanliness was satisfactory</p> <p><b>Deckhead</b>  Good condition</p> <p><b>Transverse Bulkheads</b>  Good condition</p> <p><b>Deck or Space bottom</b>  Good condition</p> <p><b>Internal structure</b>  F163 floor buckling at opening approx. 10mm in depth</p> <p><b>Other structure</b>  None noted</p>

4.101: Fwd D.B. Void Space Port Side - Structure & Longitudinal Bhd

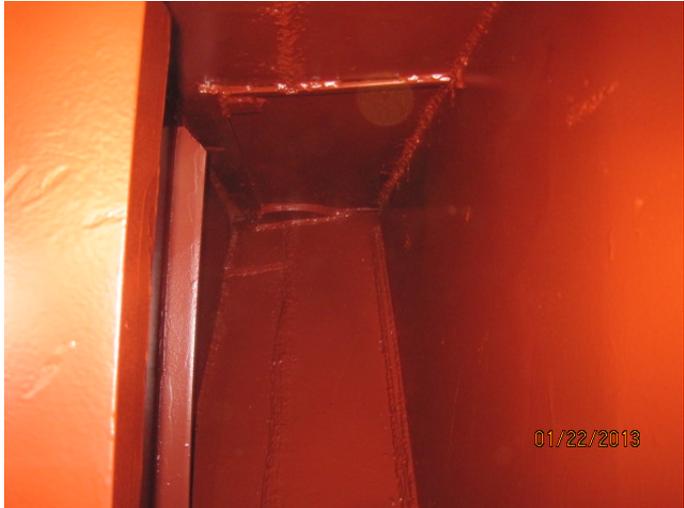
4.102: Fwd D.B. Void Space Port Side - Bottom & Aft Bhd

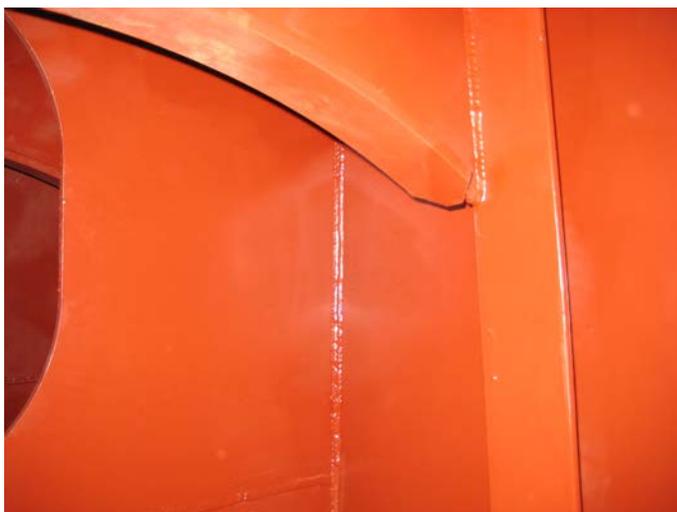
General condition of structure		GOOD	
General condition of cathodic protection		N/A	
General condition of coatings		GOOD	
Type of coatings:	EPOXY	Extent	FULL
<p><b>Limit of Inspection</b>  Full Visual inspection of tank located between Frames 139-146.  Cleanliness was satisfactory.</p> <p><b>Deckhead</b>  Found in good condition</p> <p><b>Transverse Bulkheads</b>  Found in good condition</p> <p><b>Deck or Space bottom</b>  Found in good condition</p> <p><b>Internal structure</b>  Found in fair condition.</p> <p><b>Other structure</b>  None noted</p> <p><b>Coating details</b>  Coating broken down locally less than 5%.</p>

4.103: Fwd DP Thruster Cofferdam - Top

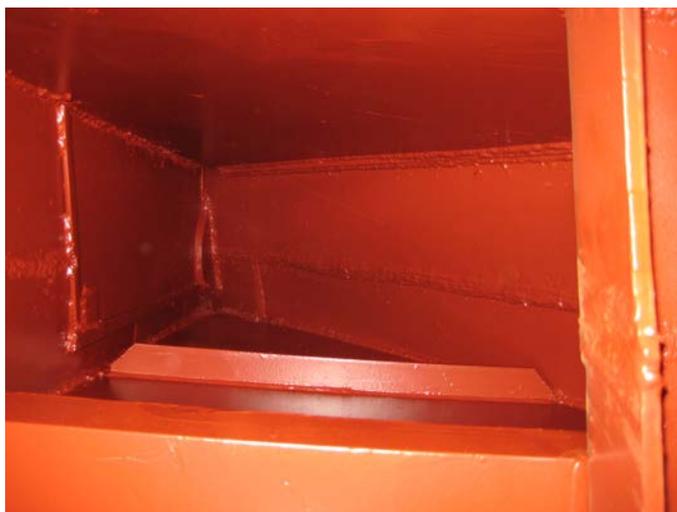
General condition of structure		GOOD	
General condition of cathodic protection		N/A	
General condition of coatings		GOOD	
Type of coatings:	N/A	Extent	FULL
<p><b>Limit of Inspection</b>  Visual inspection of tank located between frames 162-165. Cleanliness was satisfactory</p> <p><b>Deckhead</b>  Good condition</p> <p><b>Transverse Bulkheads</b>  Good condition</p> <p><b>Deeck or Space bottom</b>  Good condition</p> <p><b>Internal structure</b>  Good condition</p> <p><b>Other structure</b>  Good condition.</p>

4.105: No.2 Void Space – Port View

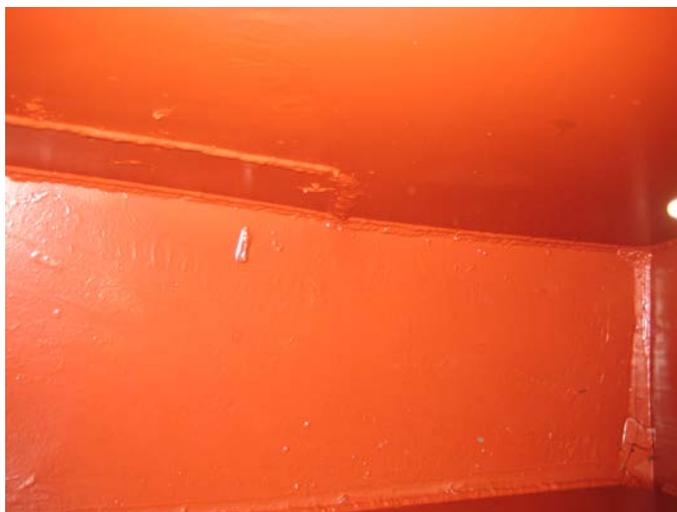
4.106: No.2 Void Space - Bottom

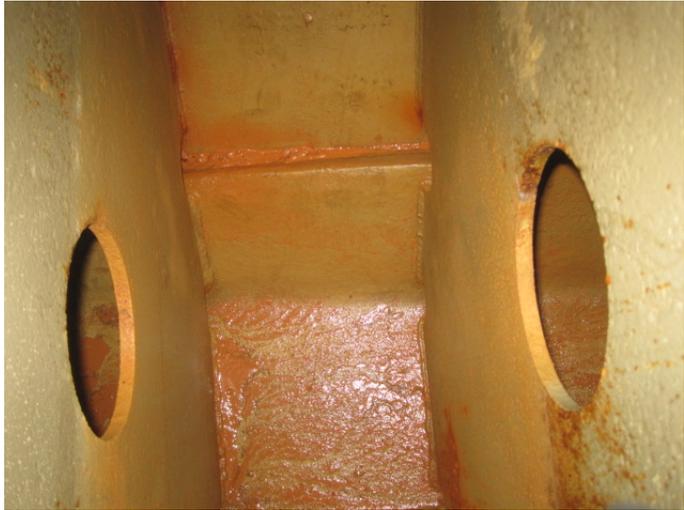
General condition of structure		GOOD	
General condition of cathodic protection		N/A	
General condition of coatings		GOOD	
Type of coatings:	EPOXY	Extent	FULL
<p><b>Limit of Inspection</b>  Frame 165-176  Cleanliness was satisfactory</p> <p><b>Deckhead</b>  No obvious defects found, structure was in good condition.</p> <p><b>Transverse Bulkheads</b>  No obvious defects found, structure was in good condition.</p> <p><b>Deck or Space bottom</b>  No obvious defects found, structure was in good condition.</p> <p><b>Internal structure</b>  No obvious defects found, structure was in good condition.</p> <p><b>Other structure</b>  None noted</p>

4.107: No.5 Void Space - Bottom

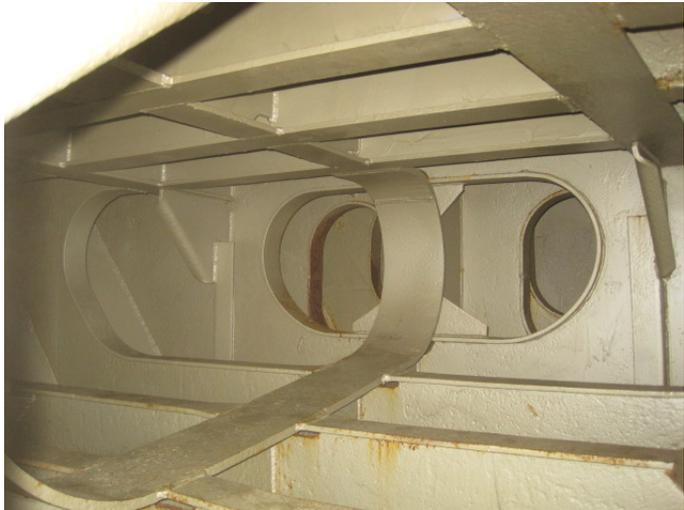
4.108: No.5 Void Space – Internal Structure

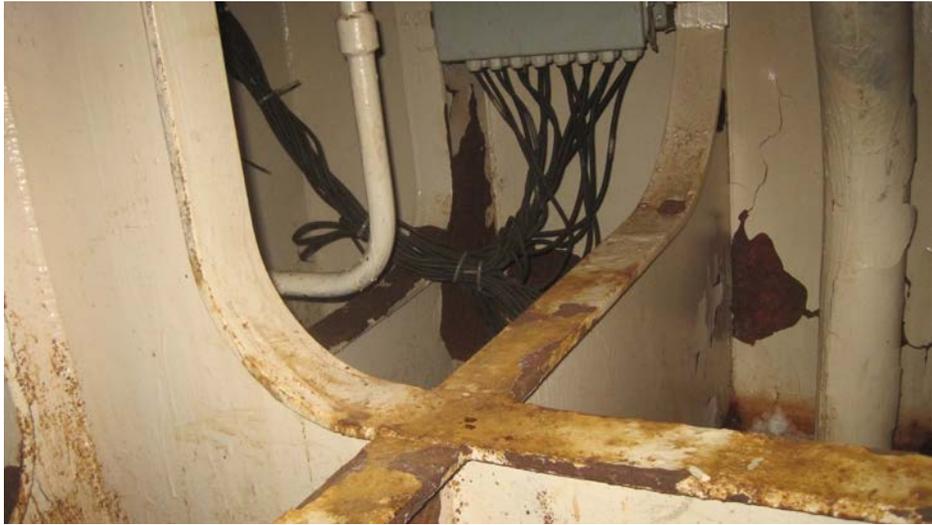
General condition of structure		GOOD	
General condition of cathodic protection		N/A	
General condition of coatings		POOR, SEE DETAILS BELOW	
Type of coatings:	Intertuf JBA016	Extent	SEE DETAILS BELOW
<p><b>Limit of Inspection</b>  Frame 122-166  No access to the middle of the space. Only ends examined.  Cleanliness was satisfactory.</p> <p><b>Deckhead</b>  Found in good condition</p> <p><b>Transverse Bulkheads</b>  Found in good condition</p> <p><b>Deck or Space bottom</b>  Found in good condition</p> <p><b>Internal structure</b>  Found in good condition</p> <p><b>Other structure</b>  None noted</p> <p><b>Coating details</b>  The first three frame spaces from fwd coating gone</p>

4.109: Pipe Tunnel - Aft Structure

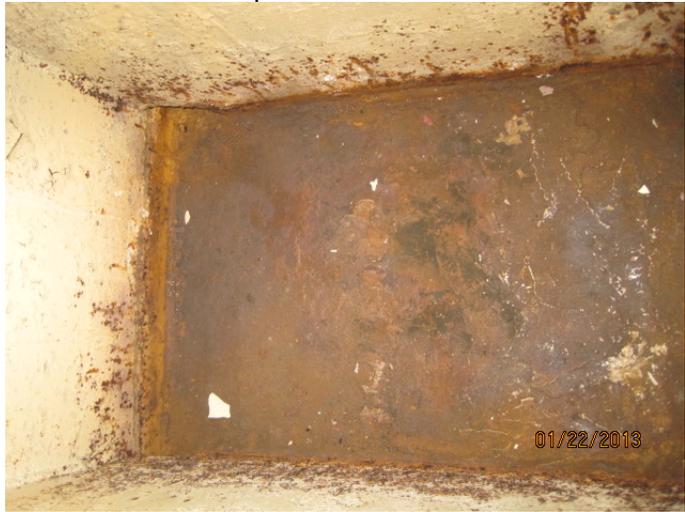
4.110: Pipe Tunnel - Fwd Bottom
