PUBLIC SERVICES AND PROCUREMENT CANADA

# KINGSTON MILLS LOCKS 46 TO 49 REHABILITATION DRAFT GEOTECHNICAL REPORT

JUNE 27, 2018

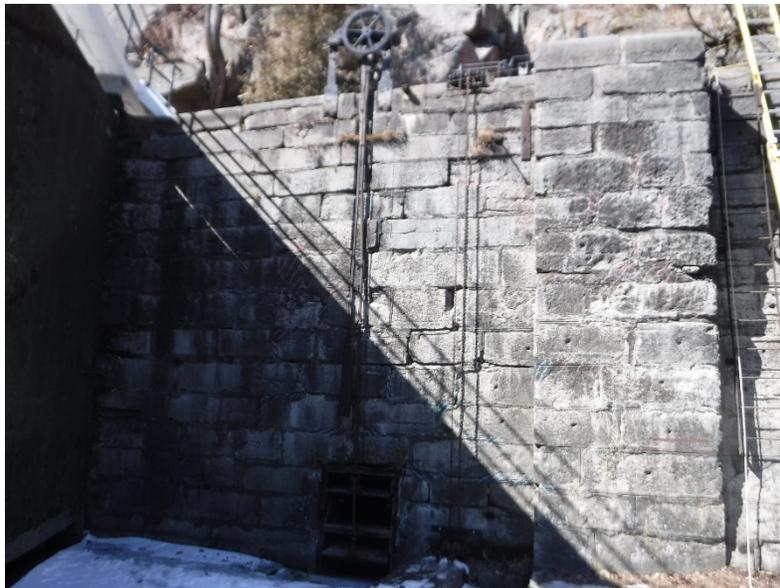
Lock 48  
West Side – Buttress and Vertical Wall

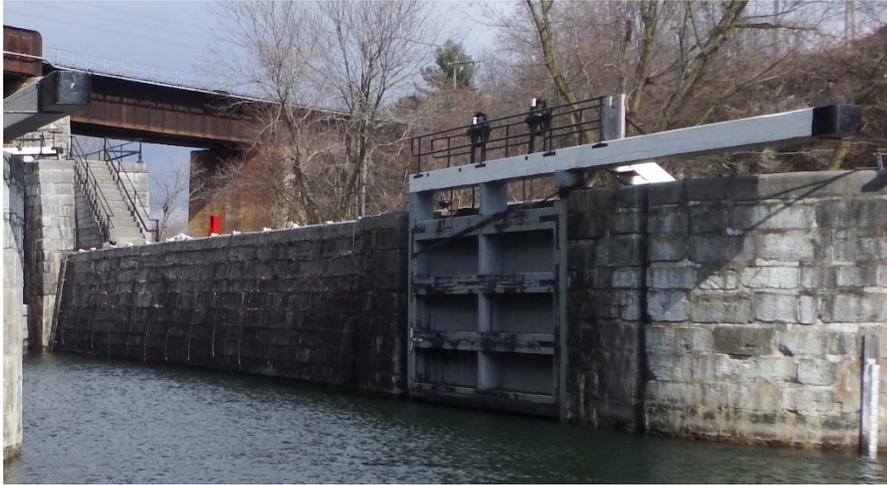
Lock 49  
East Side – Chamber Wall

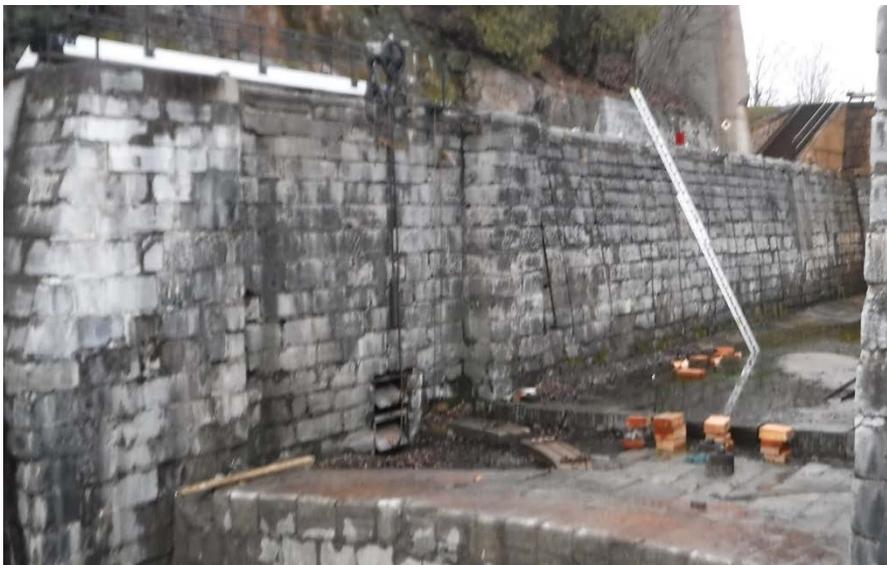
Lock 49  
West Side – Chamber Wall

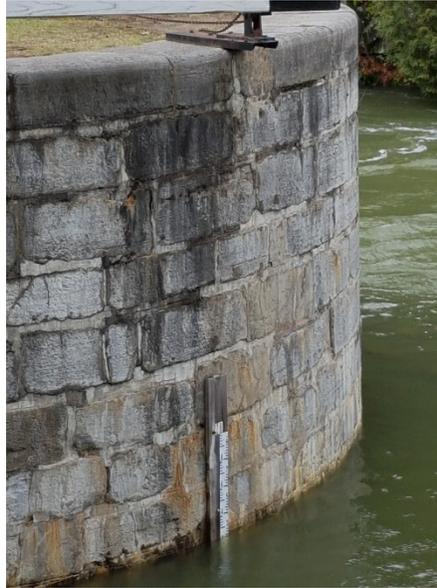
Lock 49  
Wingwall

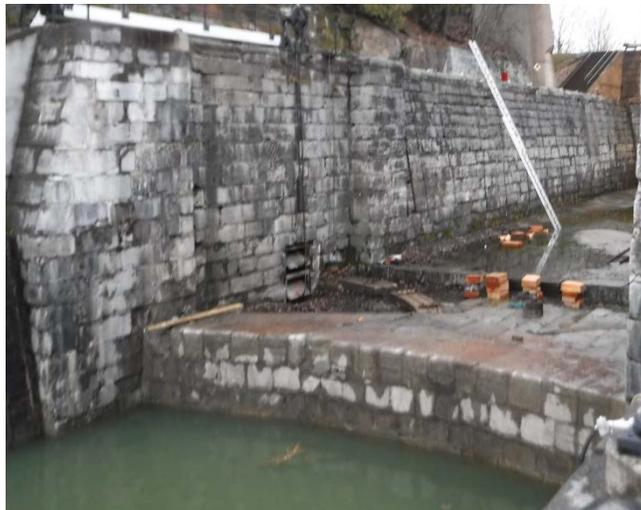
Lock 49  
Breast Wall

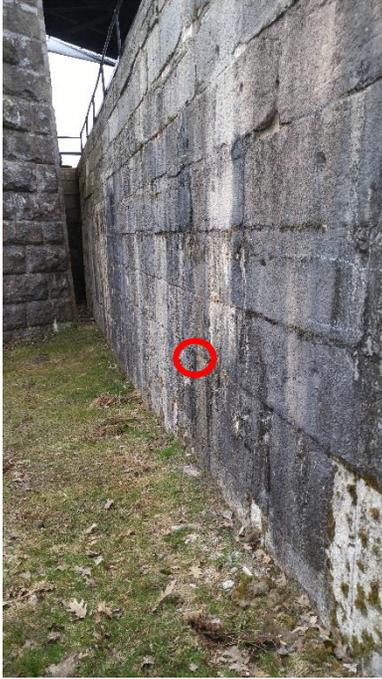
Core Location at East Chamber Wall

<b>ID</b>	CH 19
<b>Date Cored</b>	April 21, 2017
<b>Lock</b>	47
<b>Location</b>	Chamber Wall
<b>Section</b>	47E-CHW1
<b>Direction Core Extracted</b>	Horizontal
<b>Tested</b>	No
<b>Total Hole Depth</b>	440 mm
<b>General Notes:</b> Limestone 0 – 440 mm

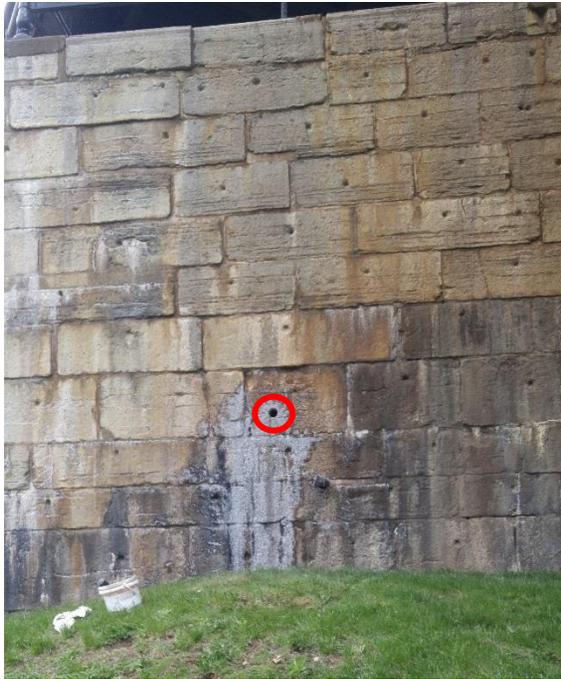
Core Location at East Pier

<b>ID</b>	CH 20
<b>Date Cored</b>	April 21, 2017
<b>Lock</b>	47
<b>Location</b>	Pier
<b>Section</b>	47E-PIE6
<b>Direction Core Extracted</b>	Horizontal
<b>Tested</b>	Yes
<b>Total Hole Depth</b>	480 mm
<b>General Notes:</b> Limestone 0 – 480 mm

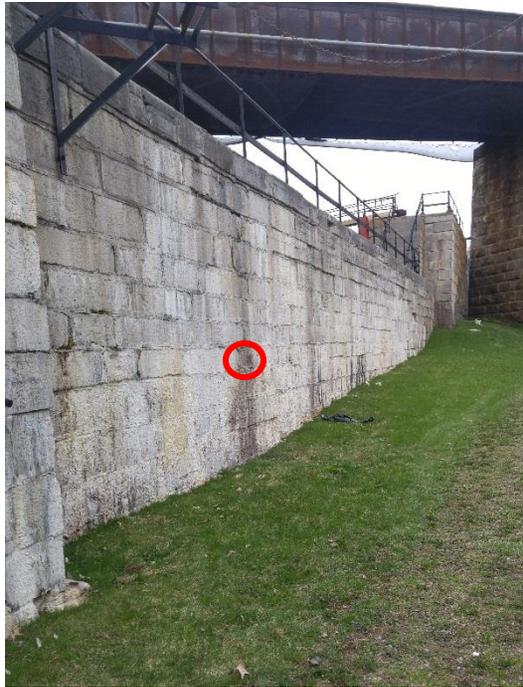
Core Location at East Chamber Wall

<b>ID</b>	CH 21
<b>Date Cored</b>	April 21, 2017
<b>Lock</b>	48
<b>Location</b>	Chamber Wall
<b>Section</b>	48E-CHW2
<b>Direction Core Extracted</b>	Horizontal
<b>Tested</b>	Yes
<b>Total Hole Depth</b>	470 mm
<b>General Notes:</b> Limestone 0 – 470 mm

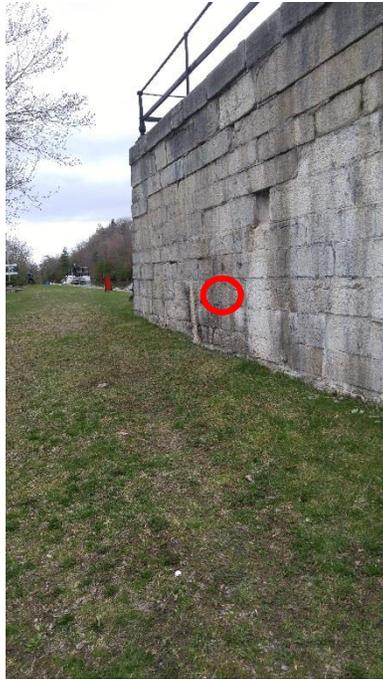
Core Location at West Gate Recess Wall

<b>ID</b>	CH 22
<b>Date Cored</b>	April 21, 2017
<b>Lock</b>	48
<b>Location</b>	Gate Recess Wall
<b>Section</b>	48E-GRW4
<b>Direction Core Extracted</b>	Horizontal
<b>Tested</b>	Yes
<b>Total Hole Depth</b>	480 mm
<b>General Notes:</b> Limestone 0 – 480 mm

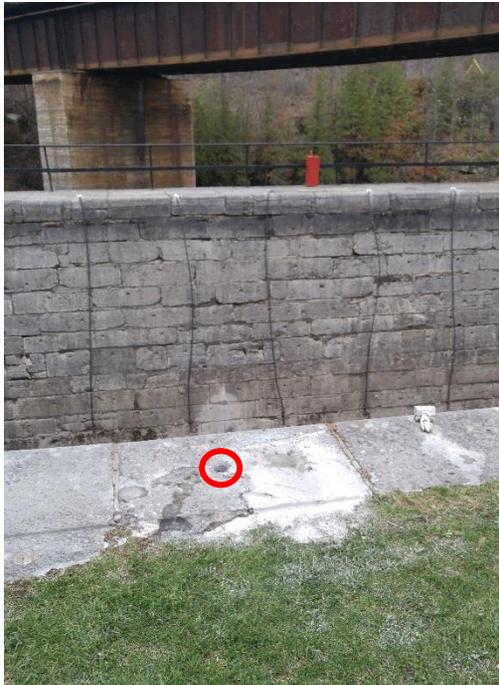
Core Location at West Chamber Wall

<b>ID</b>	CH 23
<b>Date Cored</b>	April 21, 2017
<b>Lock</b>	47
<b>Location</b>	Chamber Wall
<b>Section</b>	47W-CHW2
<b>Direction Core Extracted</b>	Vertical
<b>Tested</b>	Yes
<b>Total Hole Depth</b>	460 mm
<b>General Notes:</b>	
Limestone 0 – 420 mm	
Mortar 420 – 460 mm

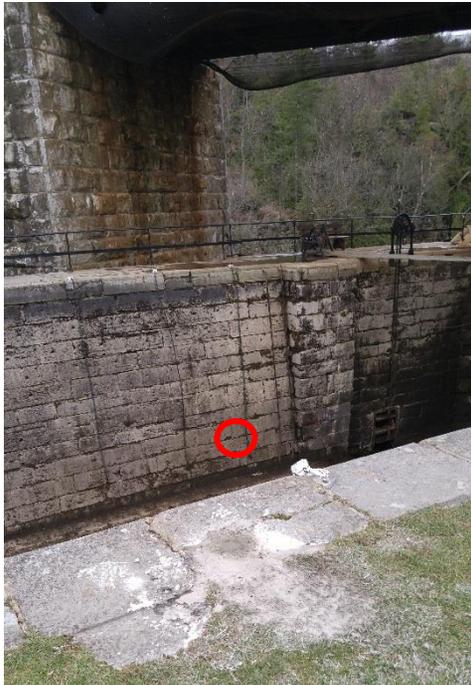
Core Location at West Chamber Wall

<b>ID</b>	CH 24
<b>Date Cored</b>	April 21, 2017
<b>Lock</b>	47
<b>Location</b>	Chamber Wall
<b>Section</b>	47W-CHW1
<b>Direction Core Extracted</b>	Vertical
<b>Tested</b>	Yes
<b>Total Hole Depth</b>	410 mm
<b>General Notes:</b>	
Limestone 0 – 410 mm

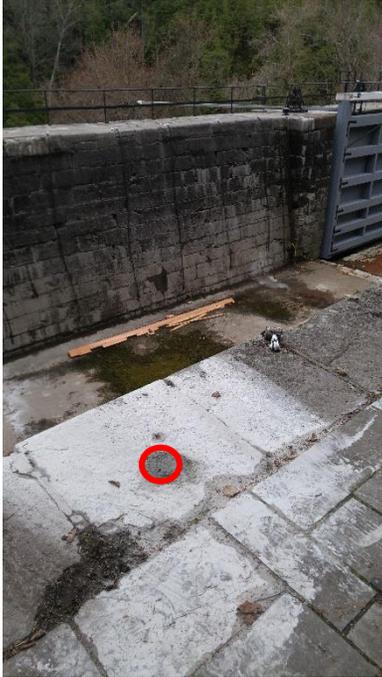
Core Location at West Chamber Wall

<b>ID</b>	CH 25
<b>Date Cored</b>	April 21, 2017
<b>Lock</b>	48
<b>Location</b>	Chamber Wall
<b>Section</b>	48W-CHW1
<b>Direction Core Extracted</b>	Vertical
<b>Tested</b>	Yes
<b>Total Hole Depth</b>	400 mm
<b>General Notes:</b> Limestone 0 – 400 mm

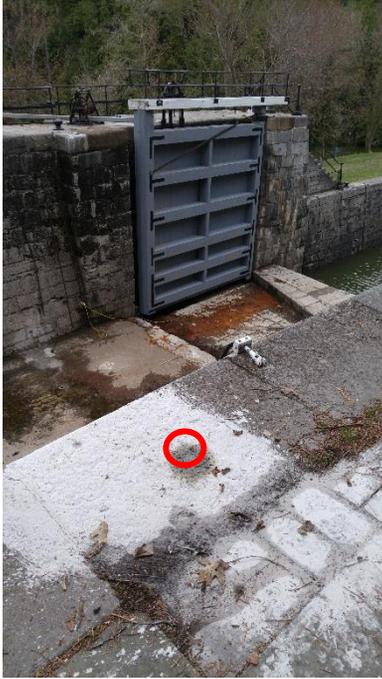
Core Location at West Chamber Wall

<b>ID</b>	CH 26
<b>Date Cored</b>	April 21, 2017
<b>Lock</b>	48
<b>Location</b>	Chamber Wall
<b>Section</b>	48W-CHW1
<b>Direction Core Extracted</b>	Vertical
<b>Tested</b>	No
<b>Total Hole Depth</b>	430 mm
<b>General Notes:</b>	
Limestone 0 – 410 mm	
Mortar/concrete 410 – 430 mm

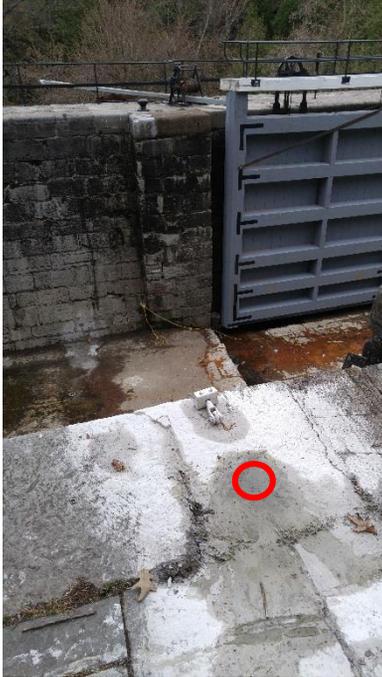
Core Location at West Chamber Wall

<b>ID</b>	CH 27
<b>Date Cored</b>	April 21, 2017
<b>Lock</b>	48
<b>Location</b>	Chamber Wall
<b>Section</b>	48W-CHW1
<b>Direction Core Extracted</b>	Vertical
<b>Tested</b>	Yes
<b>Total Hole Depth</b>	500 mm
<b>General Notes:</b> Limestone 0 – 500 mm

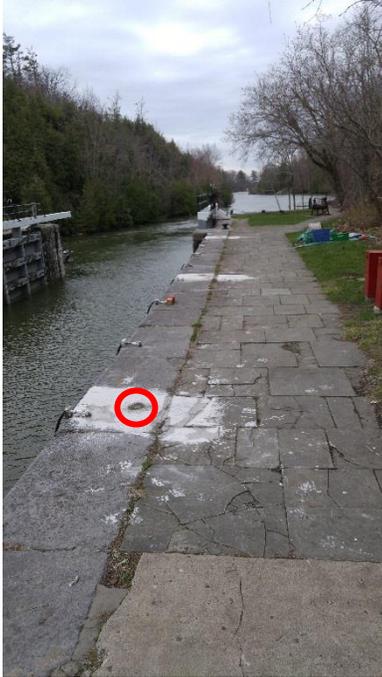
Core Location at West Chamber Wall

<b>ID</b>	CH 28
<b>Date Cored</b>	April 21, 2017
<b>Lock</b>	49
<b>Location</b>	Chamber Wall
<b>Section</b>	49W-CHW2
<b>Direction Core Extracted</b>	Vertical
<b>Tested</b>	Yes
<b>Total Hole Depth</b>	460mm
<b>General Notes:</b> Limestone 0 – 400 mm Mortar/concrete 400 – 460 mm

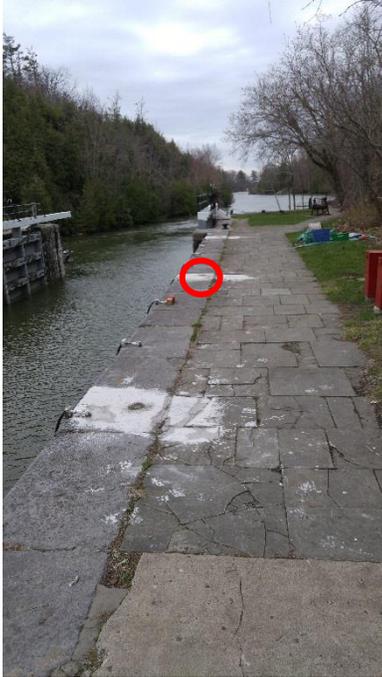
Core Location at West Chamber Wall

<b>ID</b>	CH 29
<b>Date Cored</b>	April 21, 2017
<b>Lock</b>	49
<b>Location</b>	Chamber Wall
<b>Section</b>	49W-CHW1
<b>Direction Core Extracted</b>	Vertical
<b>Tested</b>	No
<b>Total Hole Depth</b>	460 mm
<b>General Notes:</b>	
Limestone 0 – 400 mm	
Mortar 400 – 460 mm

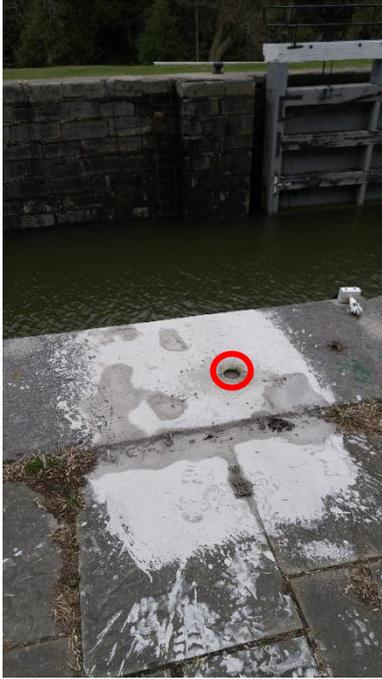
Core Location at West Chamber Wall

<b>ID</b>	CH 30
<b>Date Cored</b>	April 21, 2017
<b>Lock</b>	49
<b>Location</b>	Chamber Wall
<b>Section</b>	49W-CHW1
<b>Direction Core Extracted</b>	Vertical
<b>Tested</b>	Yes
<b>Total Hole Depth</b>	460 mm
<b>General Notes:</b> Limestone 0 – 460 mm

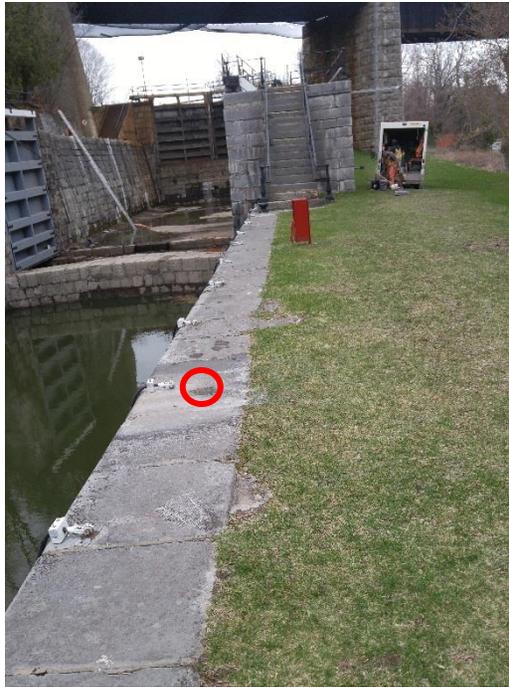
Core Location at East Chamber Wall

<b>ID</b>	CH 31
<b>Date Cored</b>	April 21, 2017
<b>Lock</b>	49
<b>Location</b>	Chamber Wall
<b>Section</b>	49E-CHW2
<b>Direction Core Extracted</b>	Vertical
<b>Tested</b>	Yes
<b>Total Hole Depth</b>	460 mm
<b>General Notes:</b> Limestone 0 – 460 mm

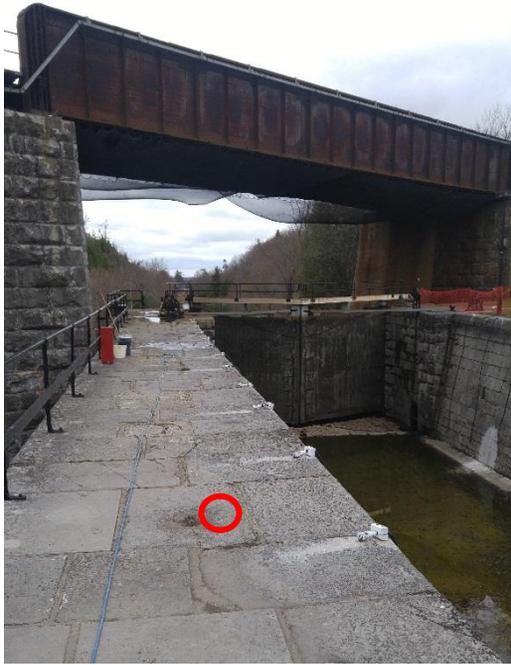
Core Location at East Chamber Wall

<b>ID</b>	CH 32
<b>Date Cored</b>	April 21, 2017
<b>Lock</b>	47
<b>Location</b>	Chamber Wall
<b>Section</b>	47E-CHW2
<b>Direction Core Extracted</b>	Vertical
<b>Tested</b>	Yes
<b>Total Hole Depth</b>	430 mm
<b>General Notes:</b> Limestone 0 – 430 mm

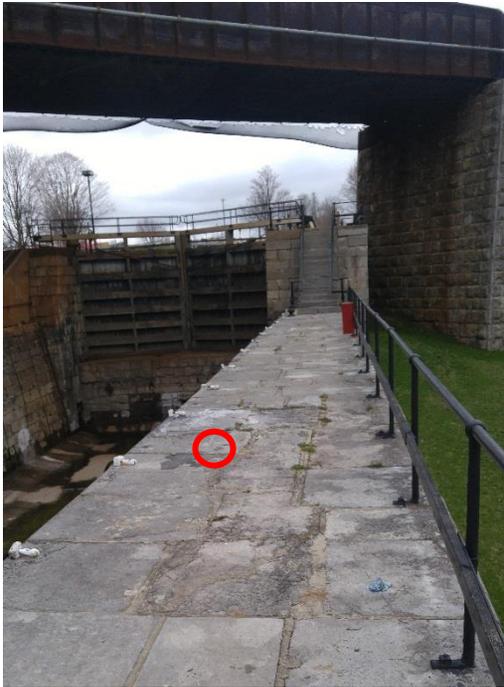
Core Location at East Chamber Wall

<b>ID</b>	CH 33
<b>Date Cored</b>	April 21, 2017
<b>Lock</b>	48
<b>Location</b>	Chamber Wall
<b>Section</b>	48E-CHW2
<b>Direction Core Extracted</b>	Vertical
<b>Tested</b>	Yes
<b>Total Hole Depth</b>	460 mm
<b>General Notes:</b> Limestone 0 – 460 mm

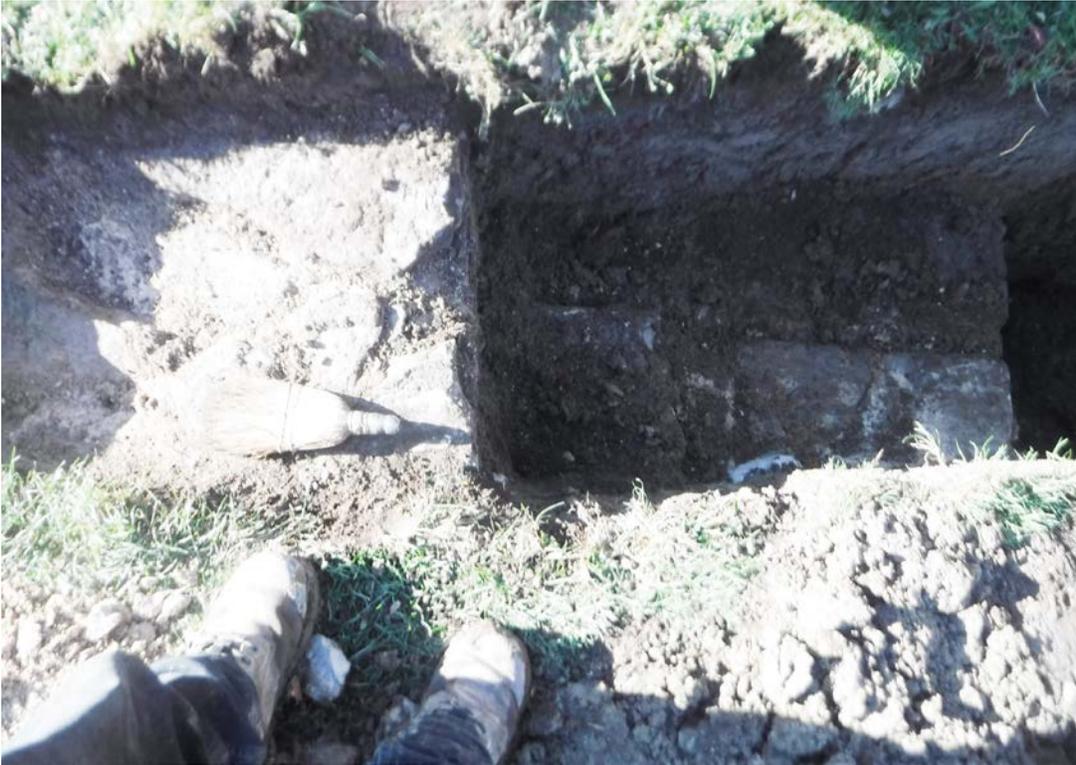
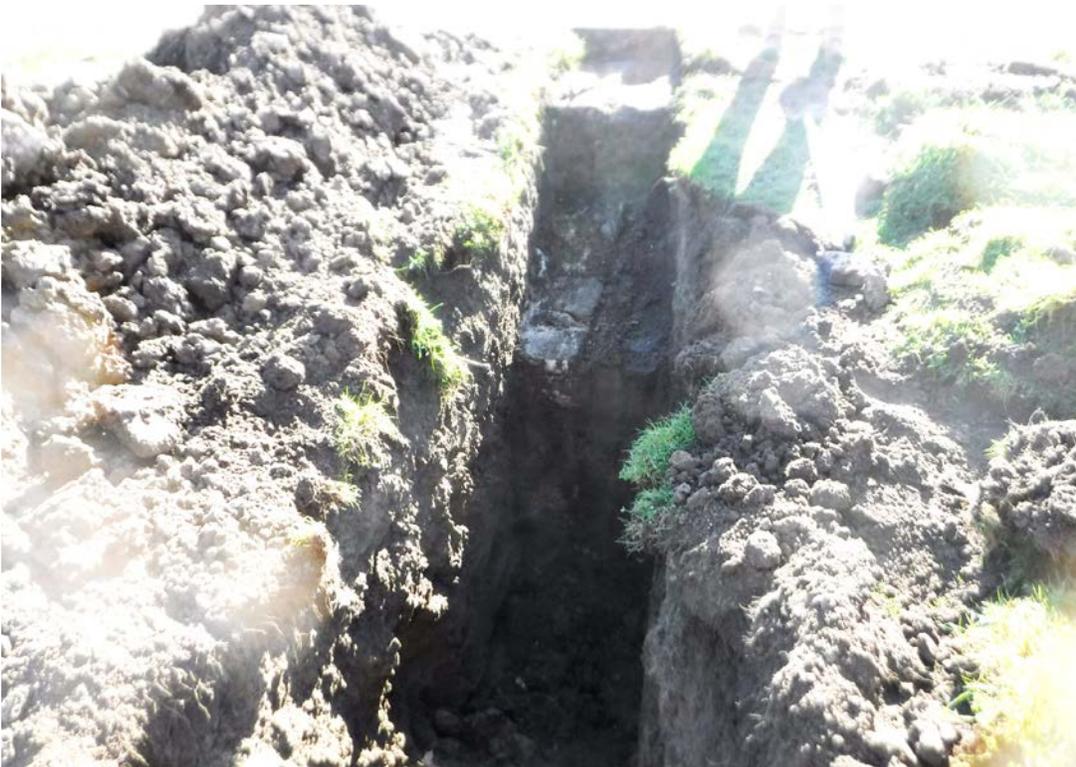
Test Pit #1 – Top of wall and buttress

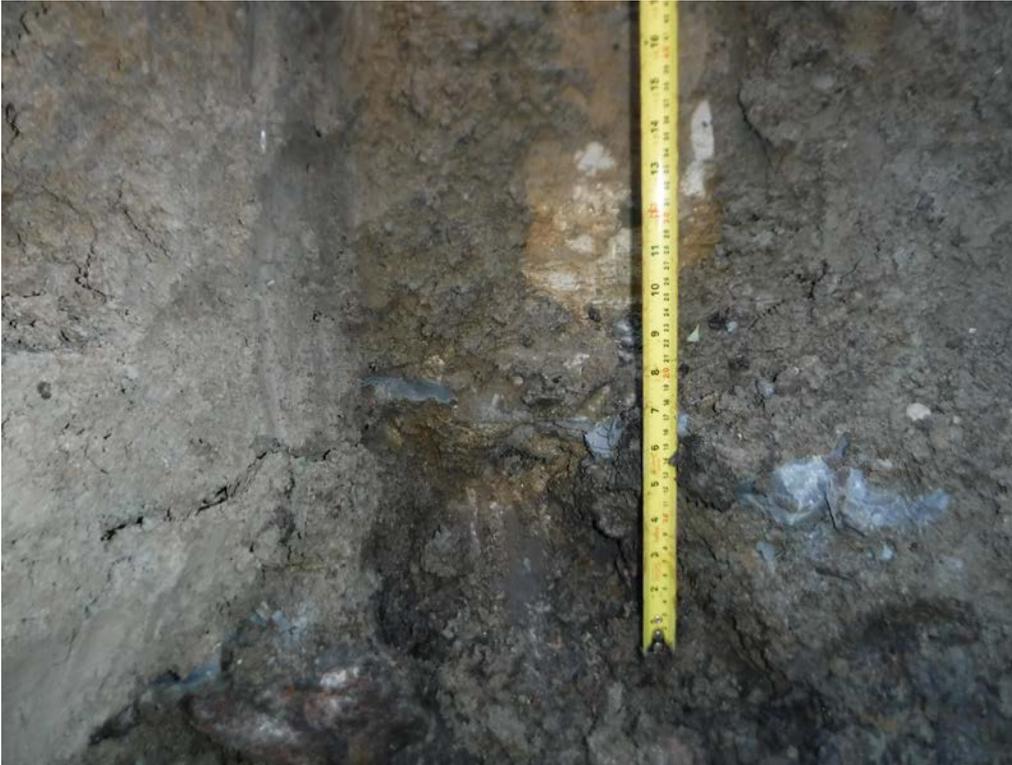
Test pit #1 – Layer of grout at bedrock

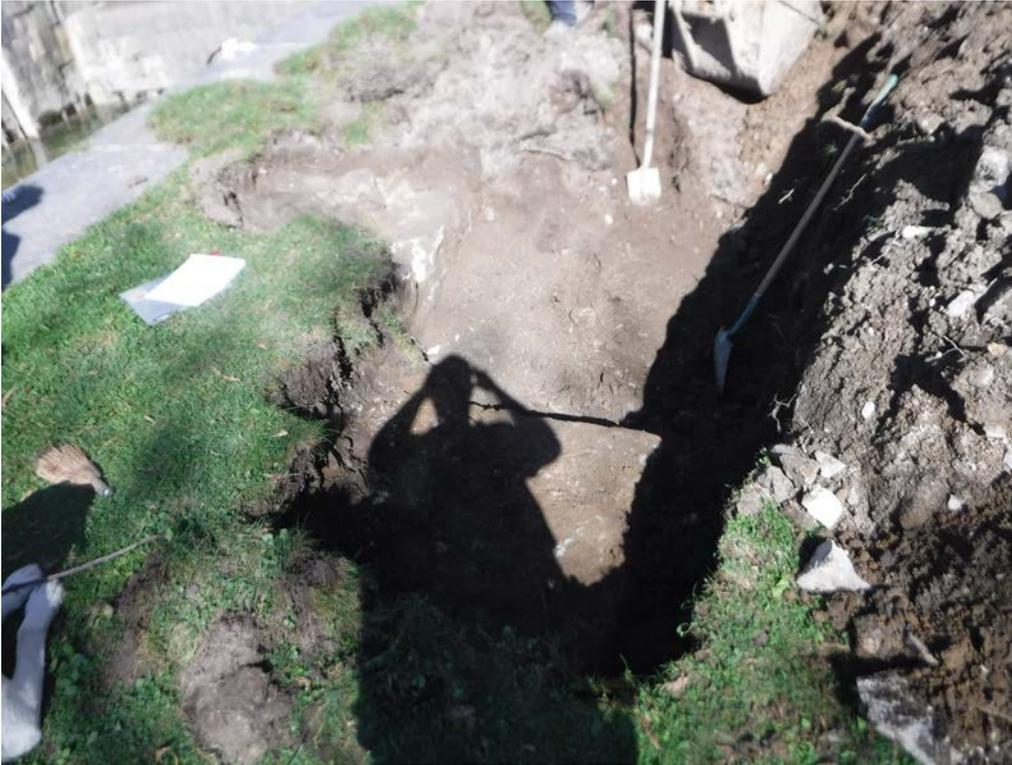
Test Pit #2 – Butterss and back of chamber wall

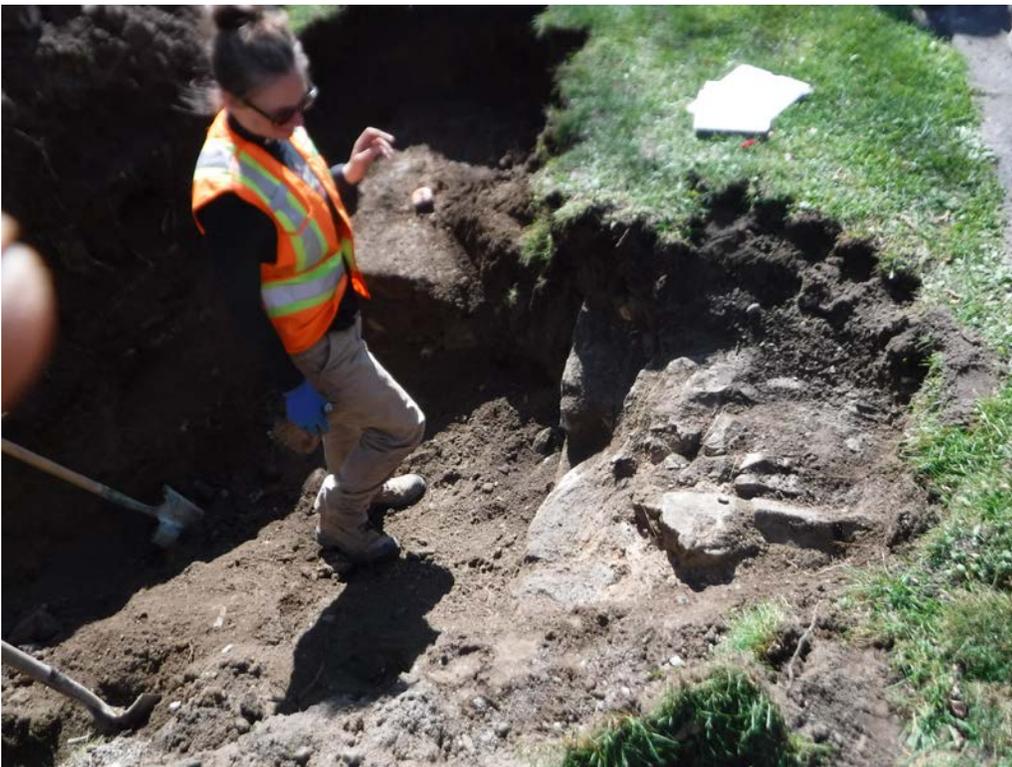
Test Pit #2 – Butterss and back of chamber wall

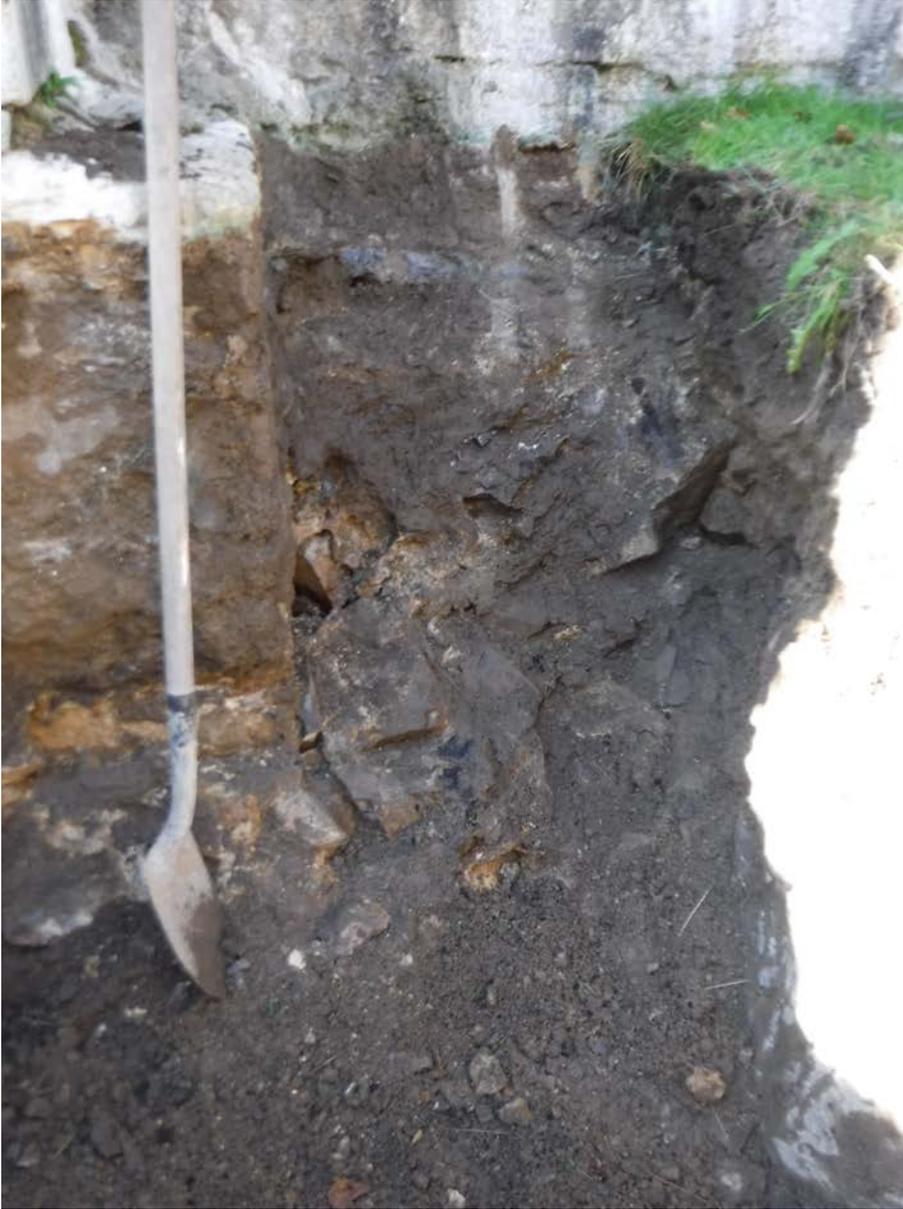
Test Pit #3 – Grouted rubble at base of chamber wall

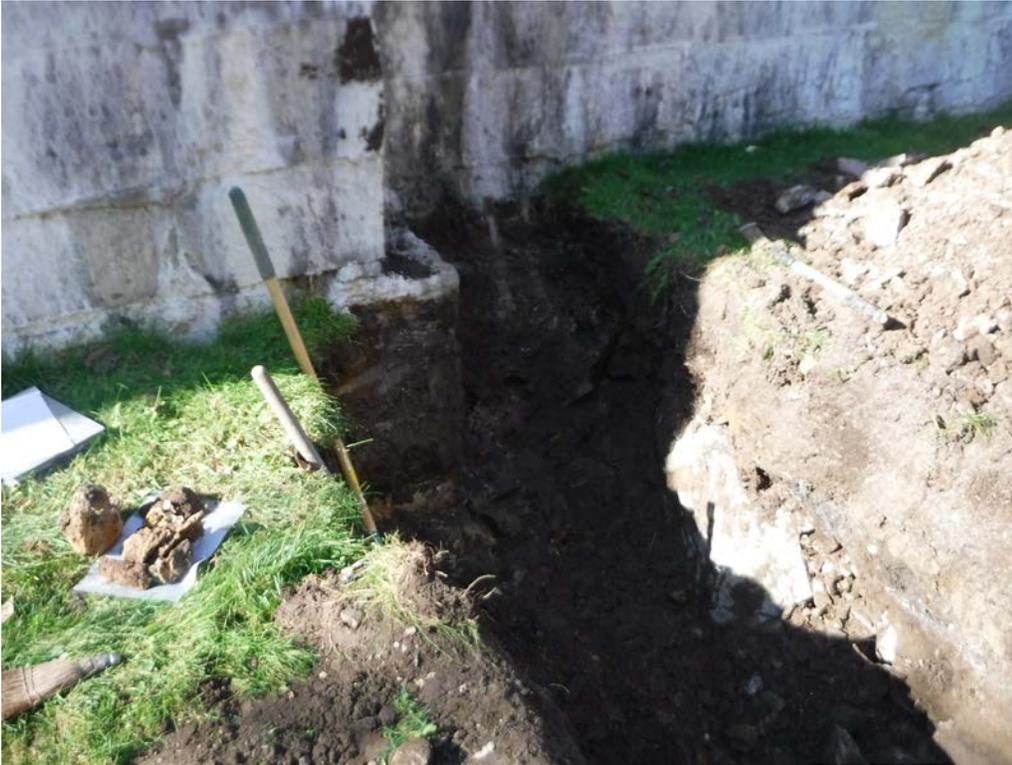
Test Pit #3 – Monolith #4 and back of lock chamber wall

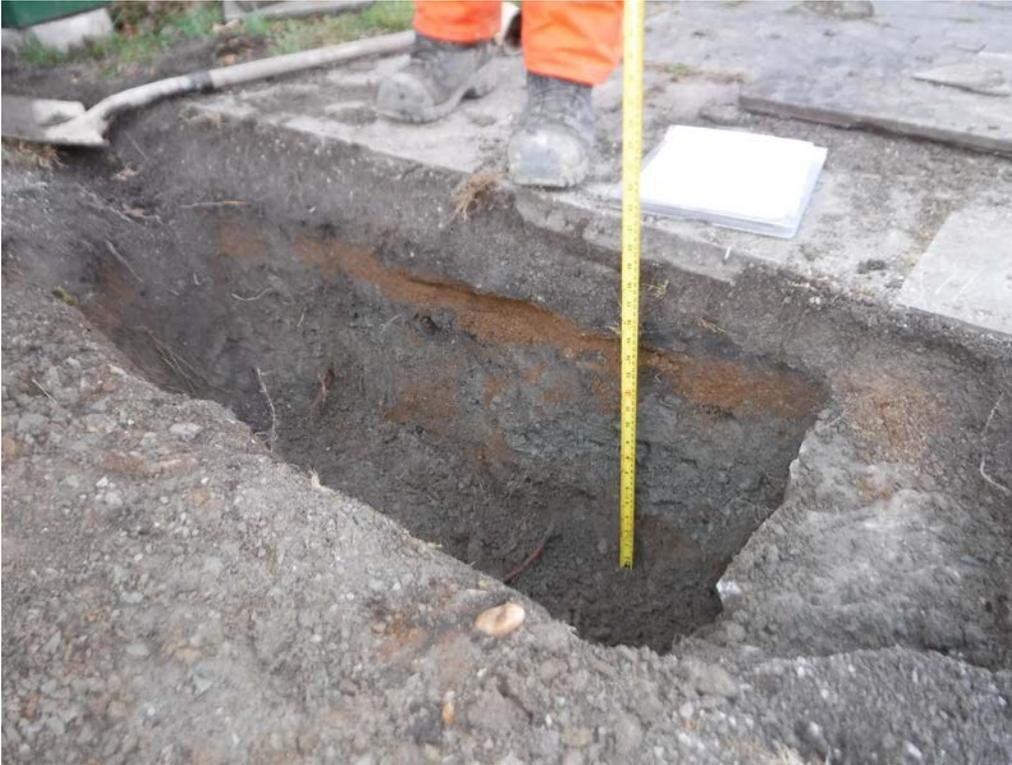
Test Pit #4 – Back of chamber wall

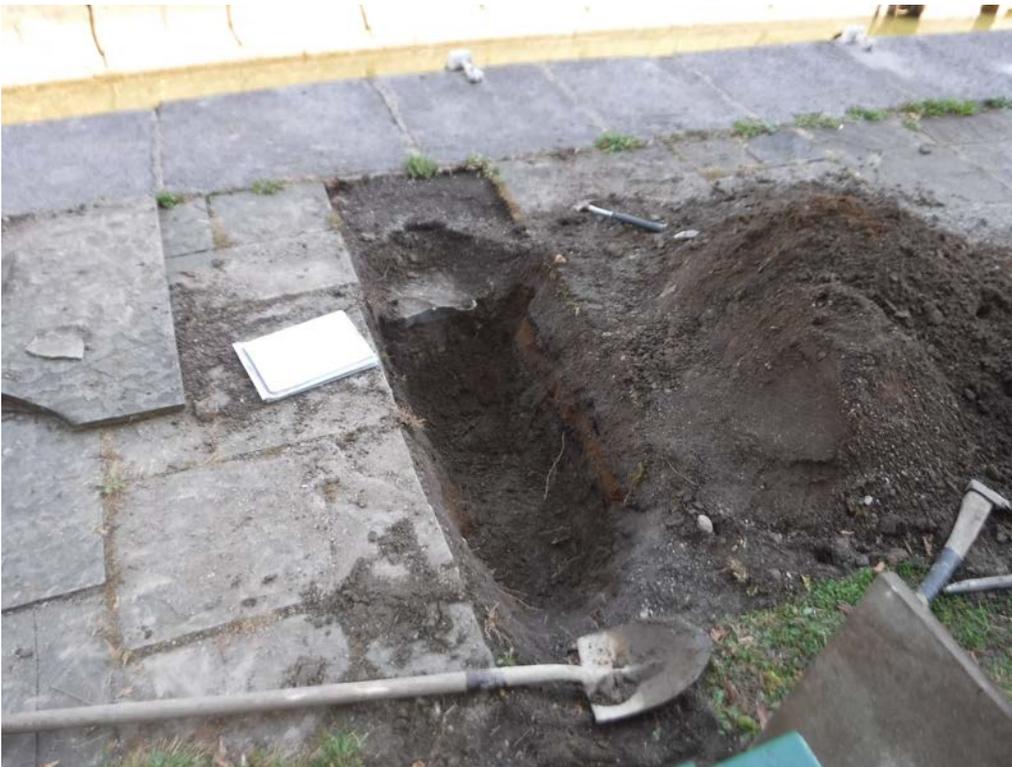
Test Pit #4 – Back of chamber wall

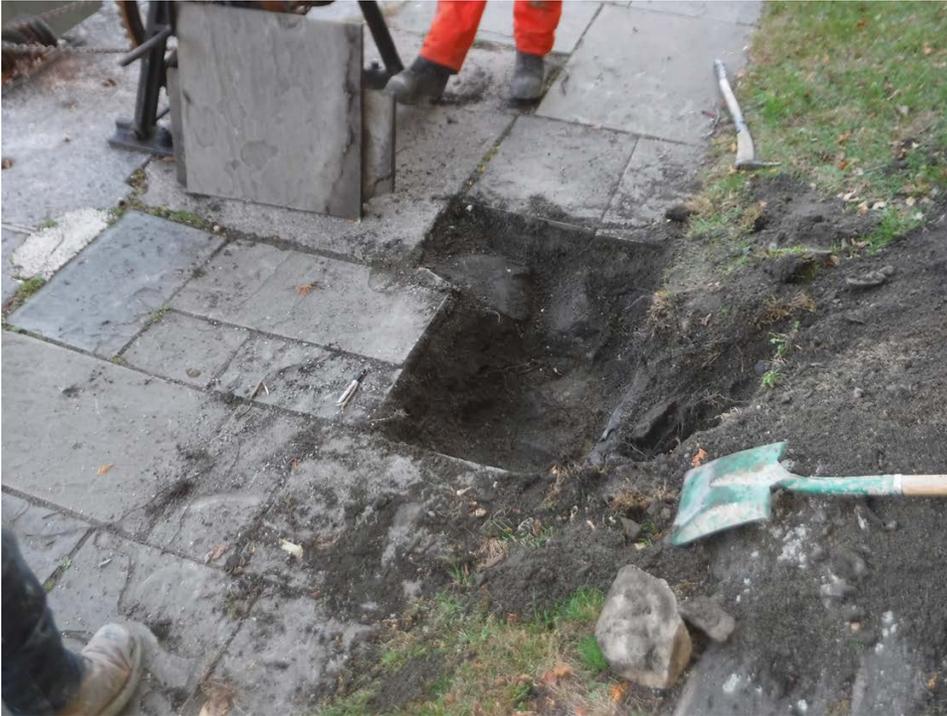
Test Pit #5 – Rubble behind wall to face of bedrock outcrop

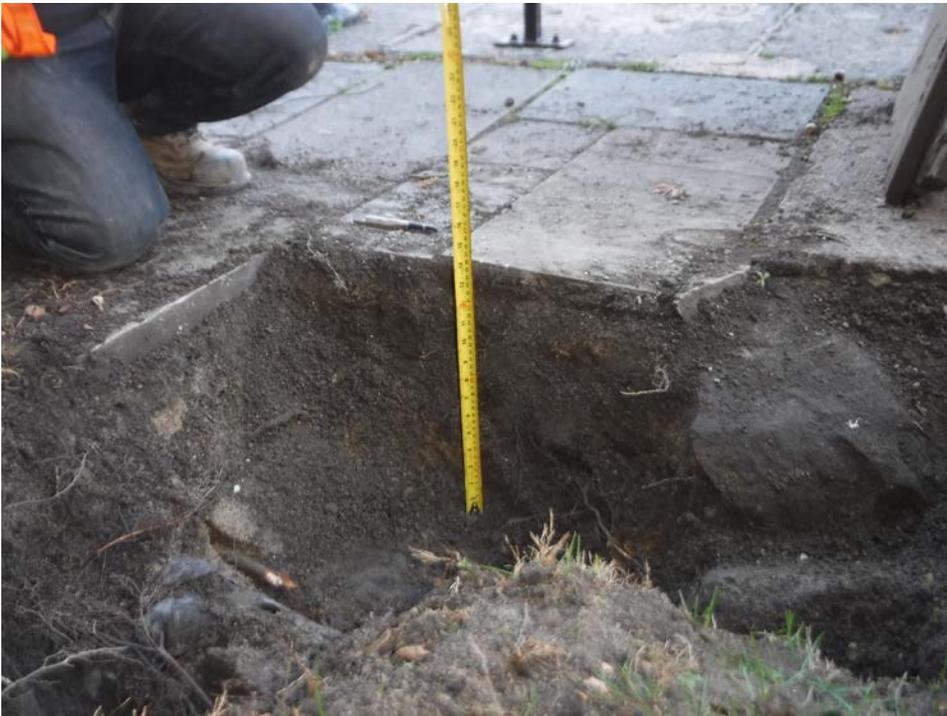
Test Pit #5 – Rubble behind wall to face of bedrock outcrop

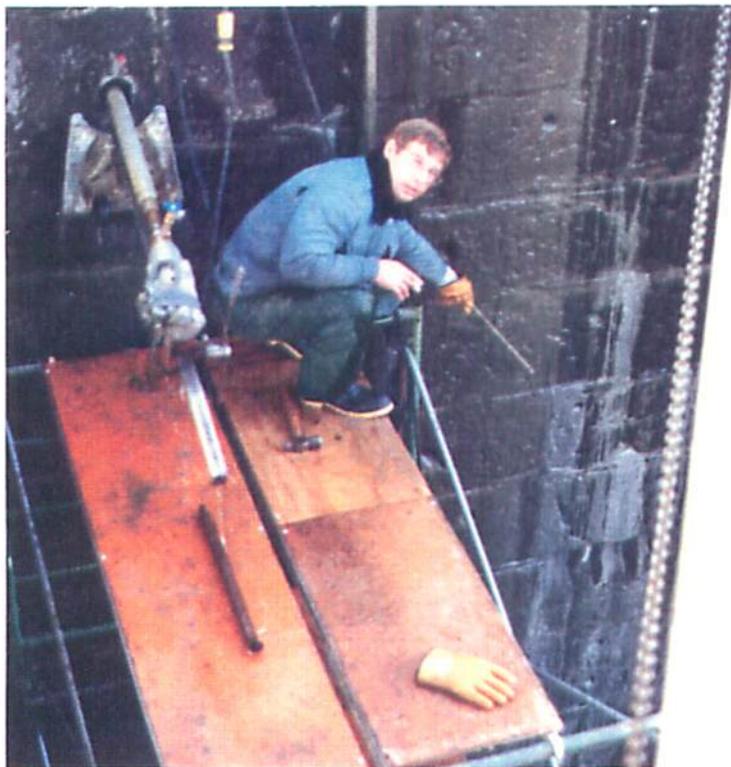
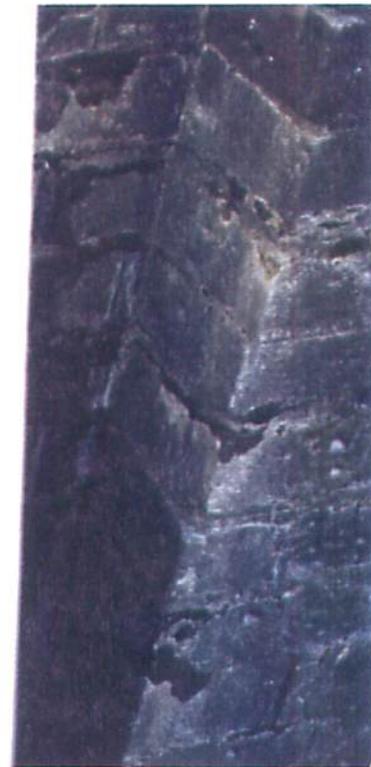
Photograph No. 2      Seepage noted in Run No. 2 - Hole V2

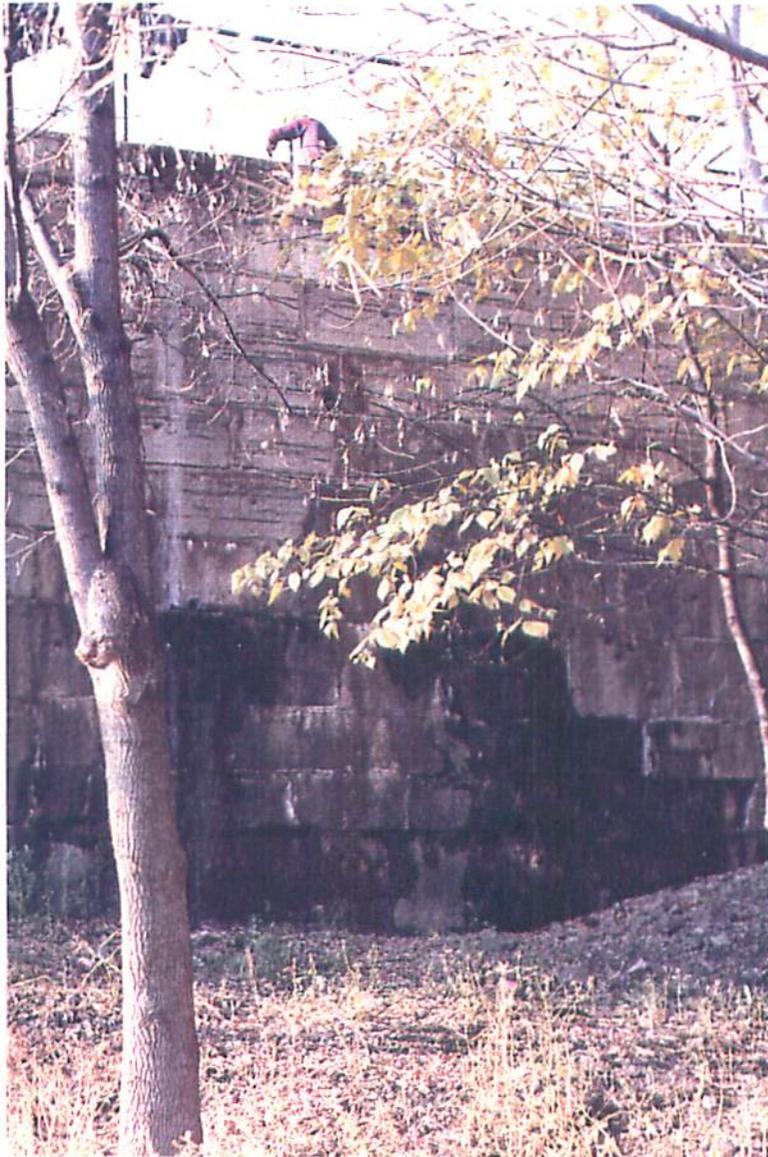
Photograph No. 8      Seepage noted in Run No. 13 - Hole V5

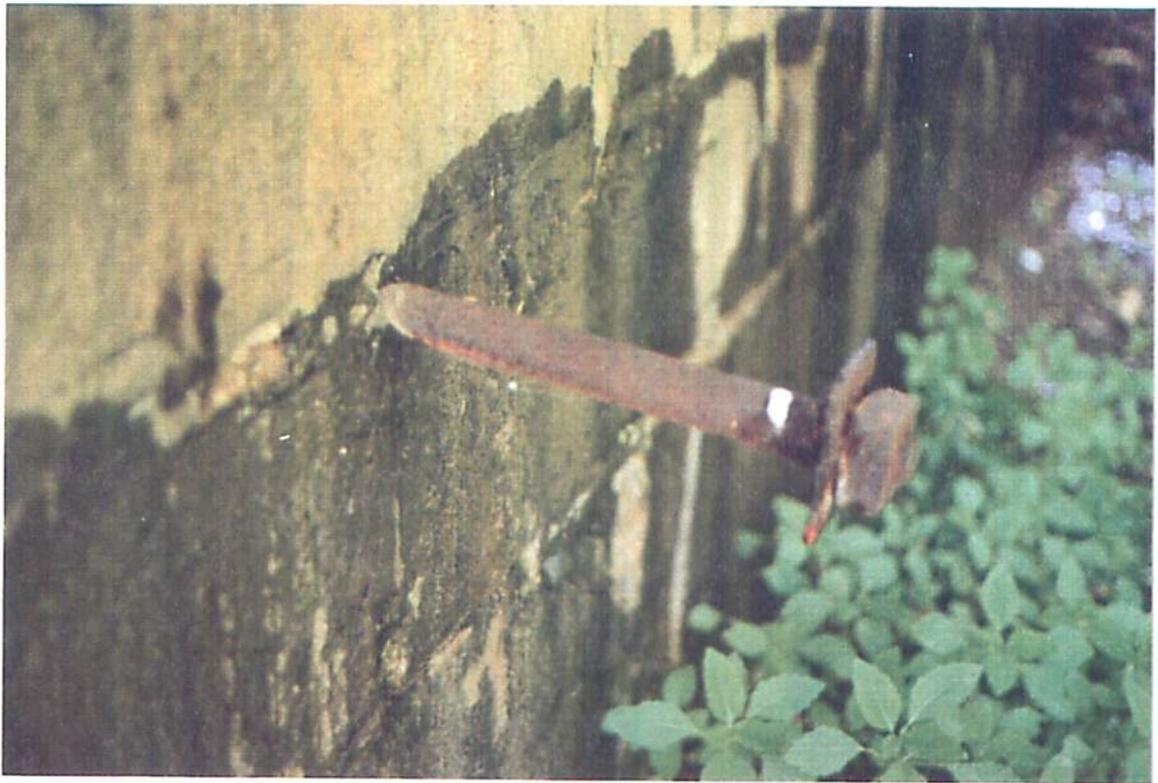
Lock 47 East Wall - External Seepage

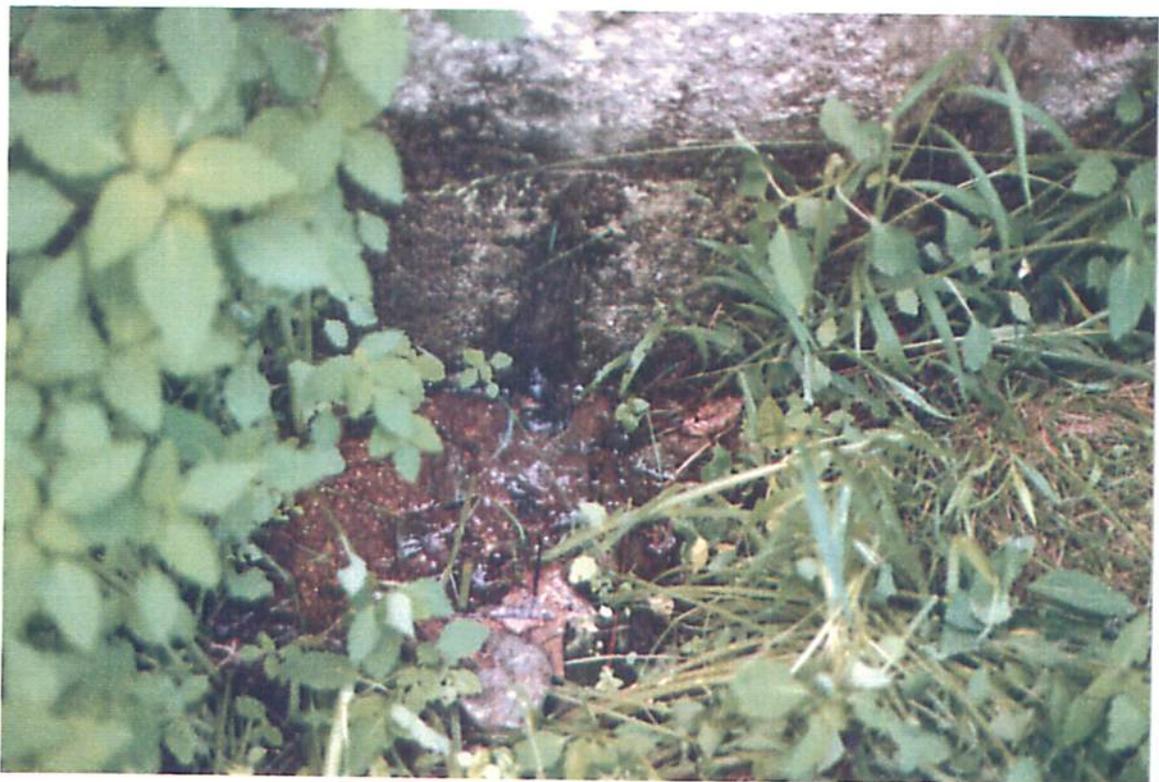
Lock 47 East Wall - External Seepage  
Note Water Bubbling Up From Below Surface

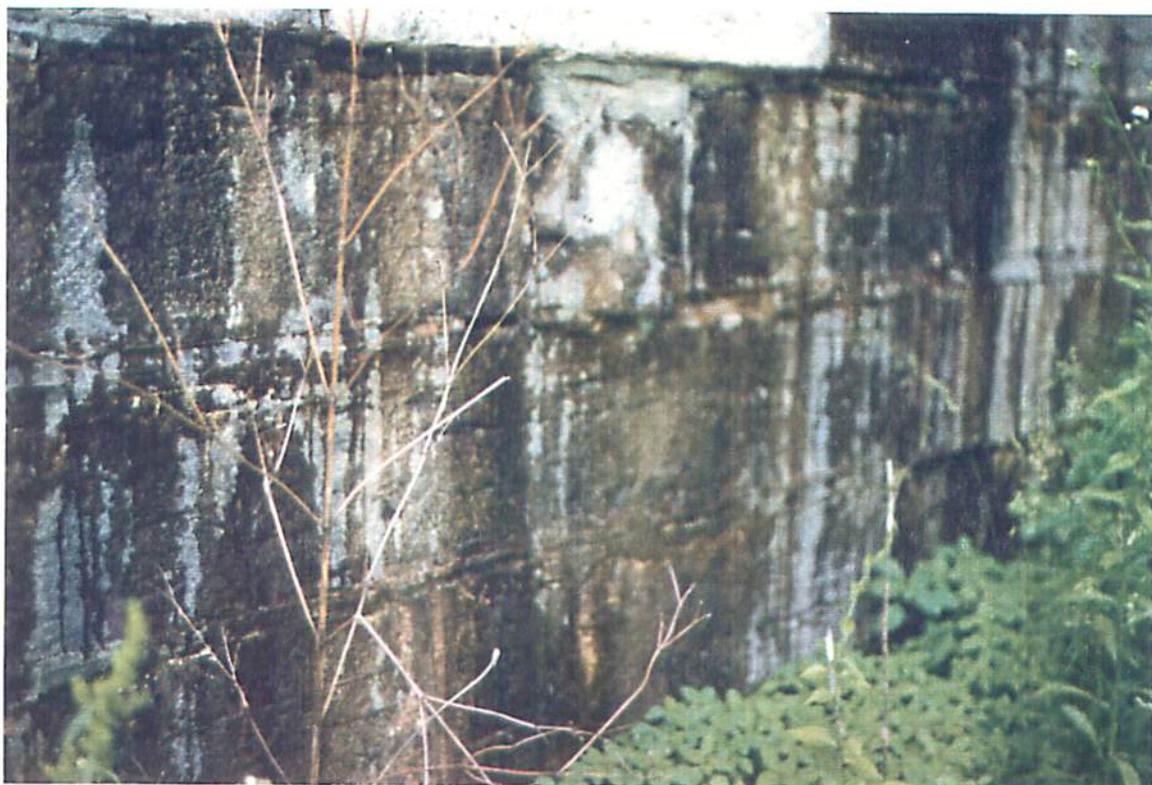
Lock 47 East Wall - External Seepage

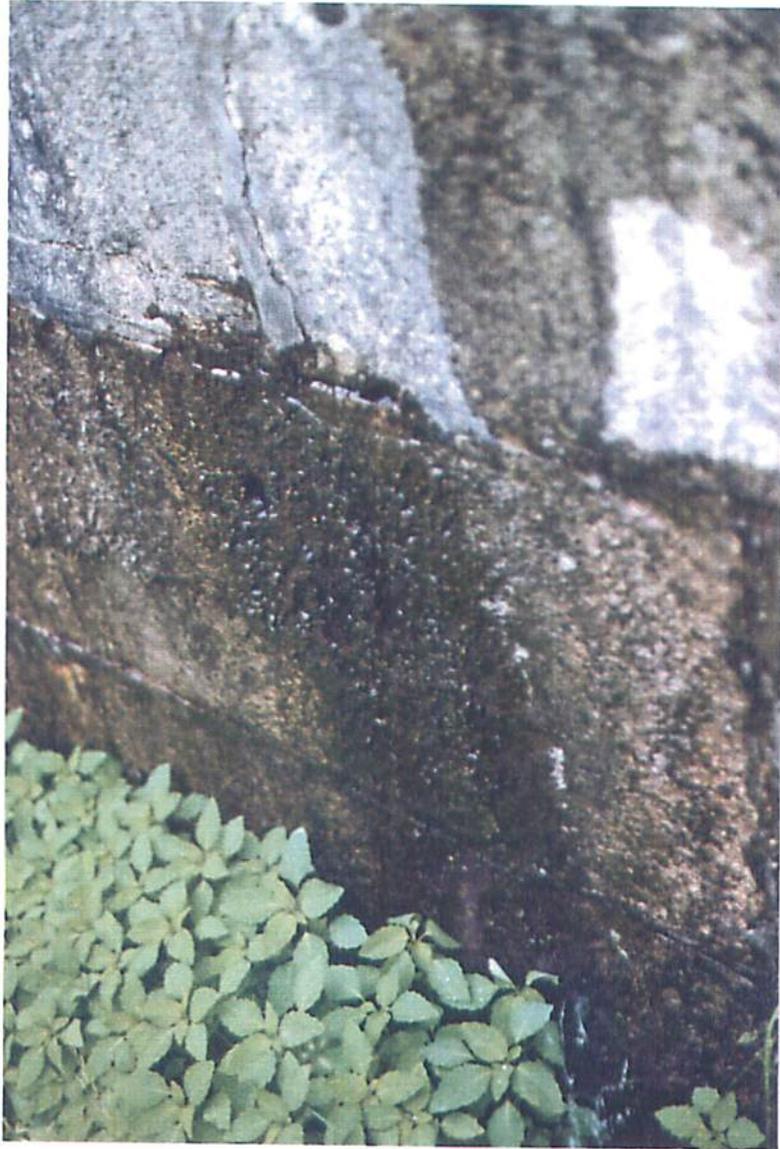
Lock 47 East Wall - External Seepage

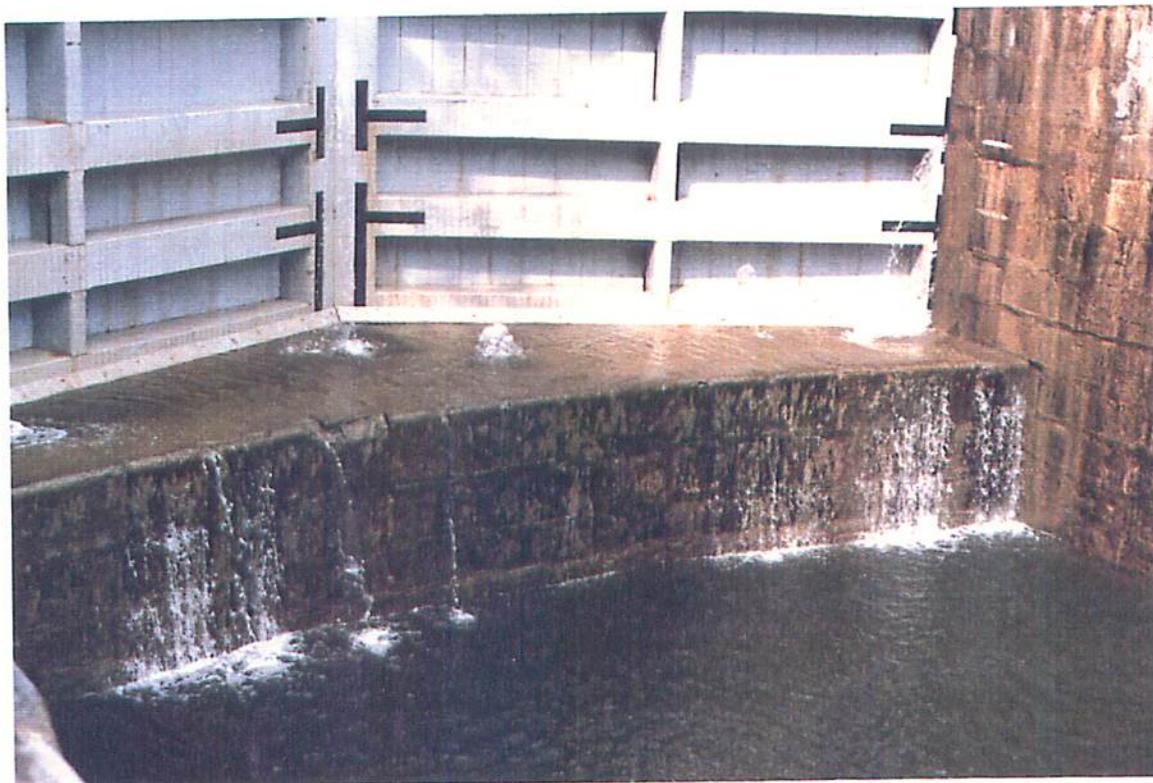
Lock 47 - Upstream Sill  
Note Water Boils On Top Of Sill
