PUBLIC SERVICES AND PROCUREMENT CANADA

# KINGSTON MILLS LOCKS 46 TO 49 REHABILITATION DRAFT GEOTECHNICAL REPORT

JUNE 27, 2018

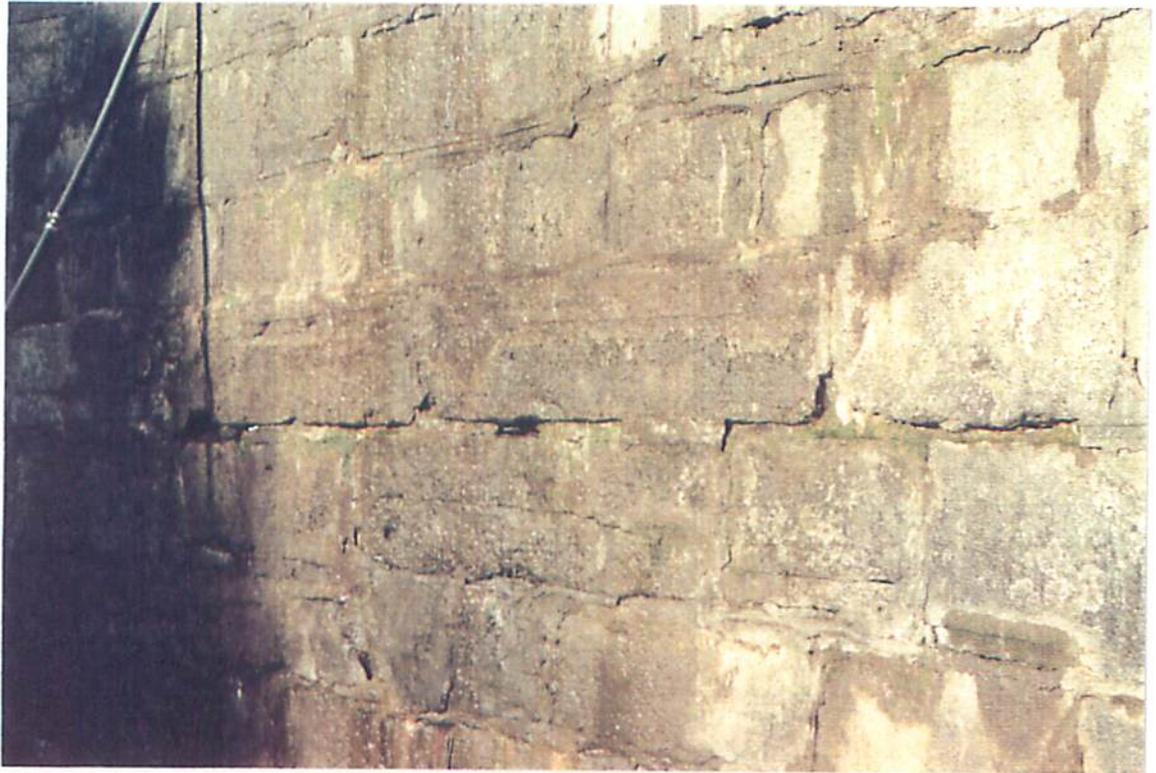
Lock 47 - Showing Open Joints

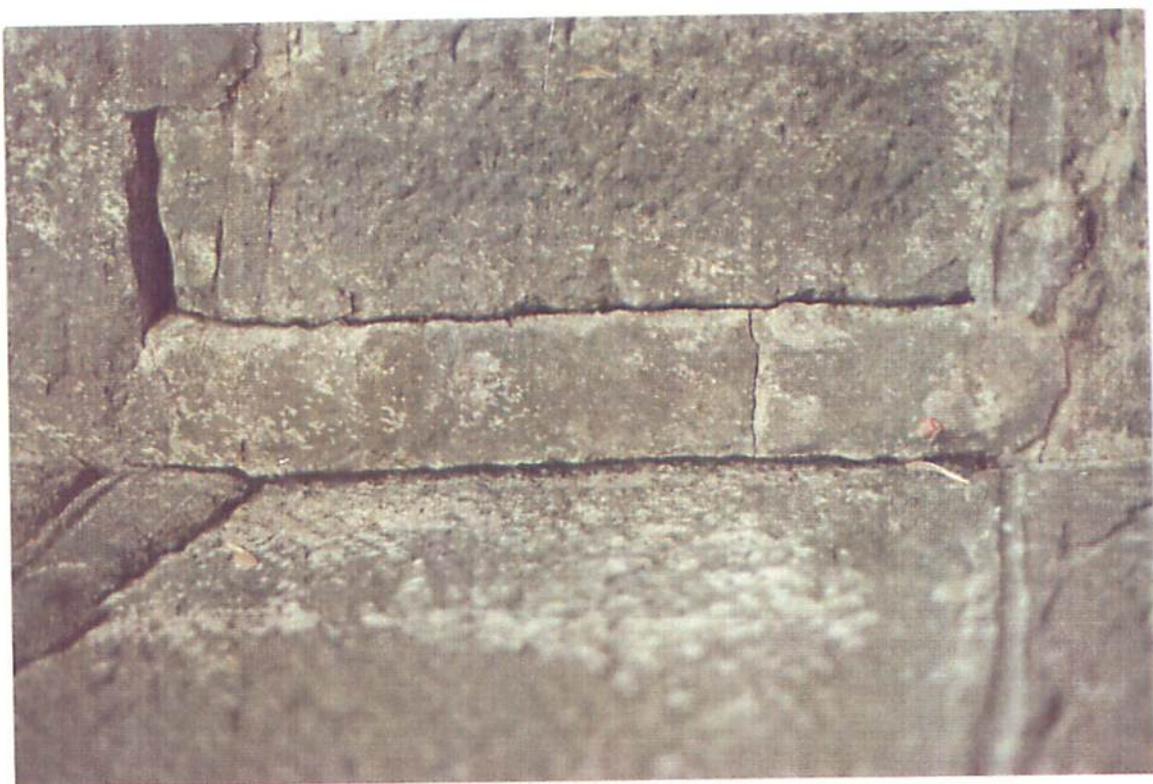
Lock 47 - Showing Open Joints

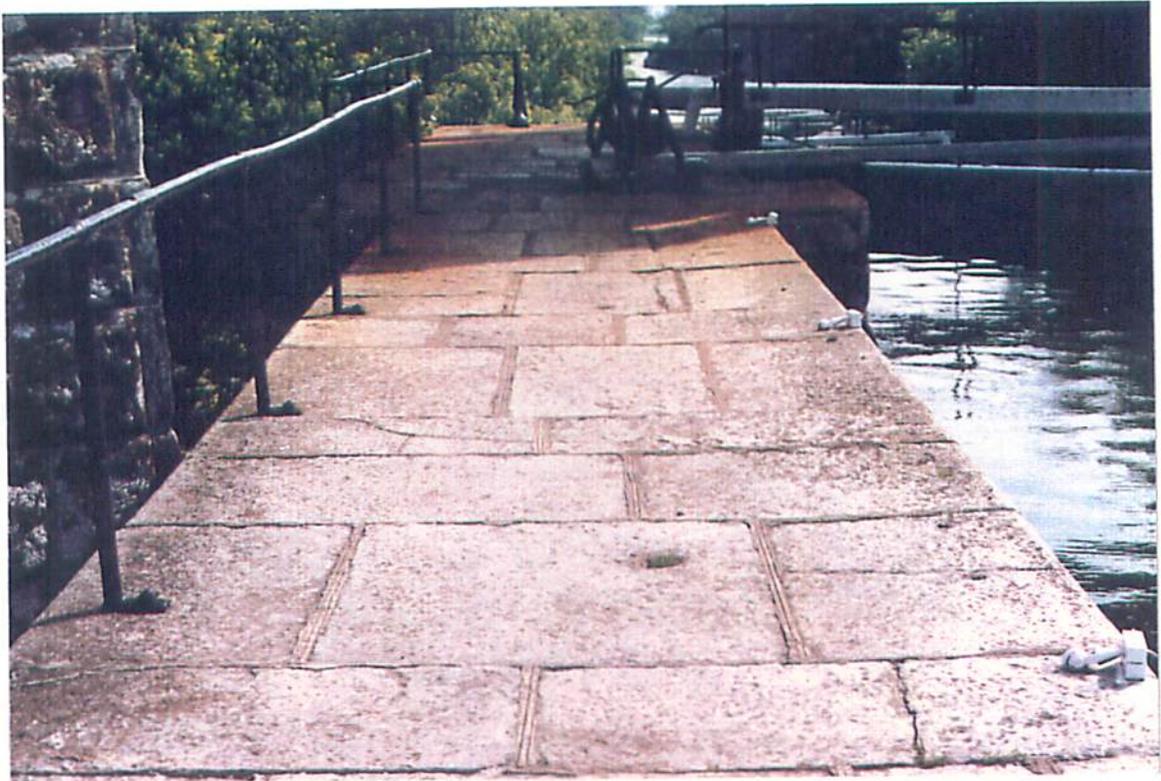
Lock 47 - East Wall  
Dish-Shaped Settlement Due To Loss Of Fines

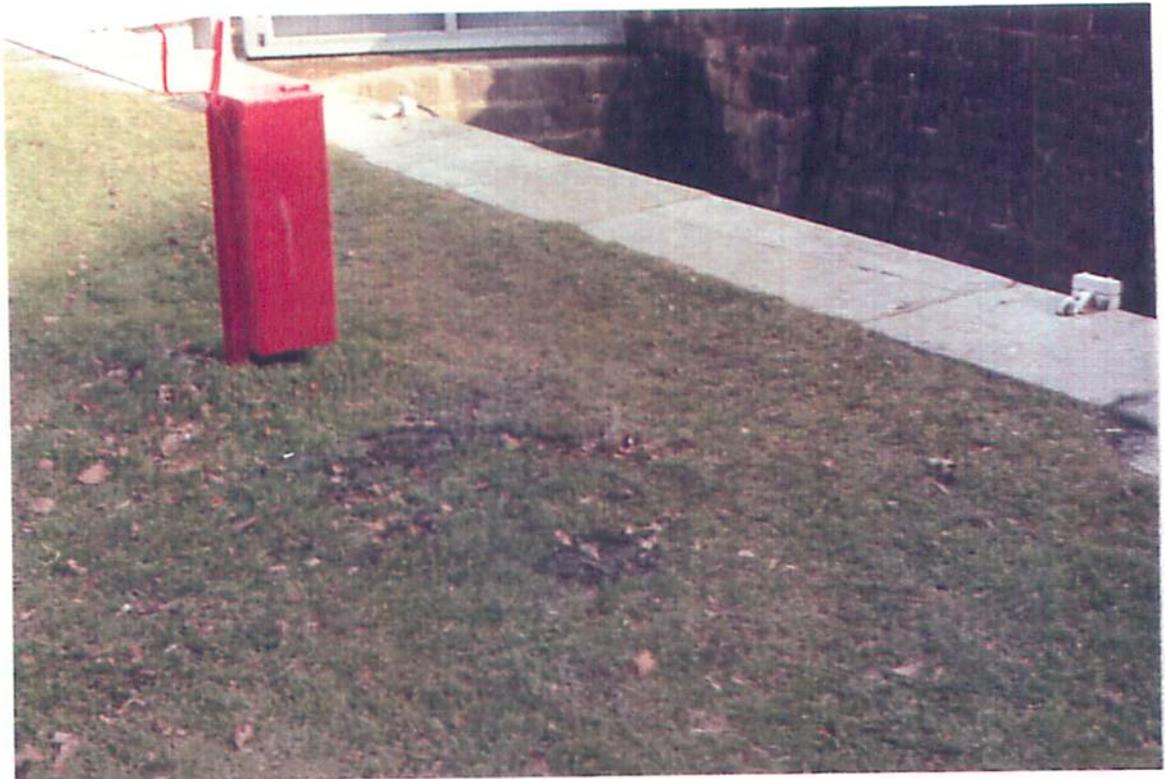
Lock 47 - West Wall Near Test Hole H - 1  
Showing Grout Coming To Surface While Grouting

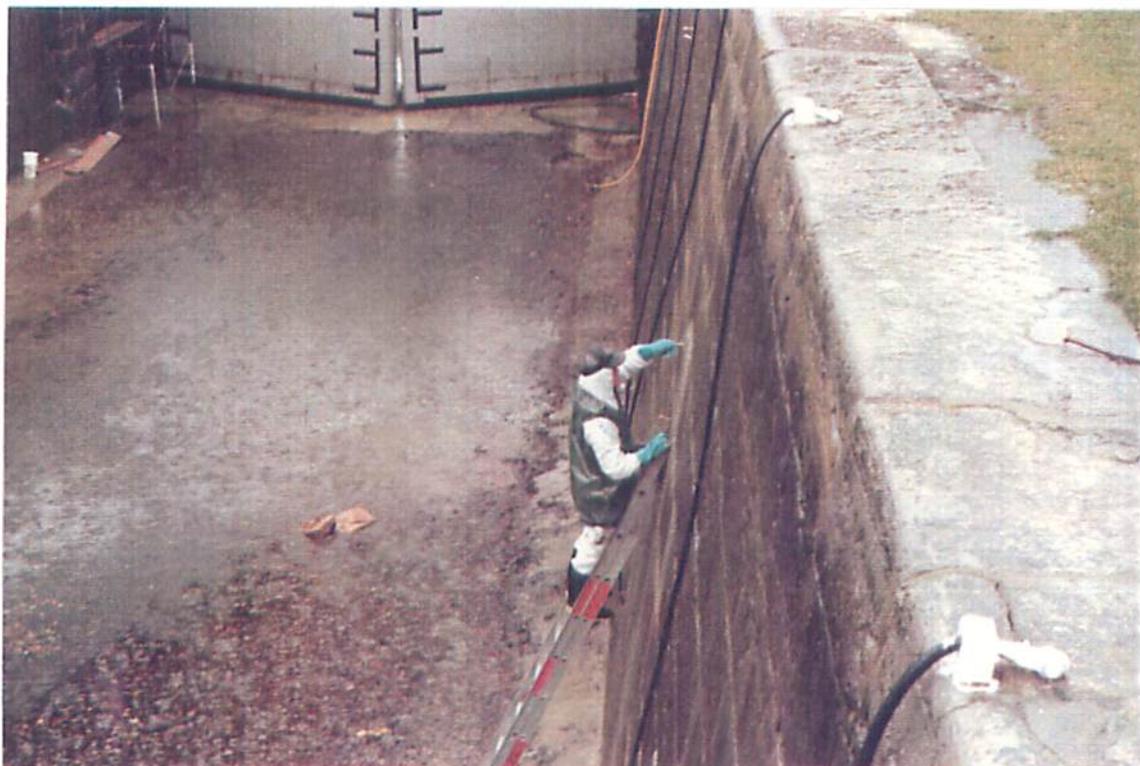
Lock 47 - On West Wall Looking East At Test Hole V - 1  
Showing Top Of Hole Assembly & Pressure Gauge While Grouting

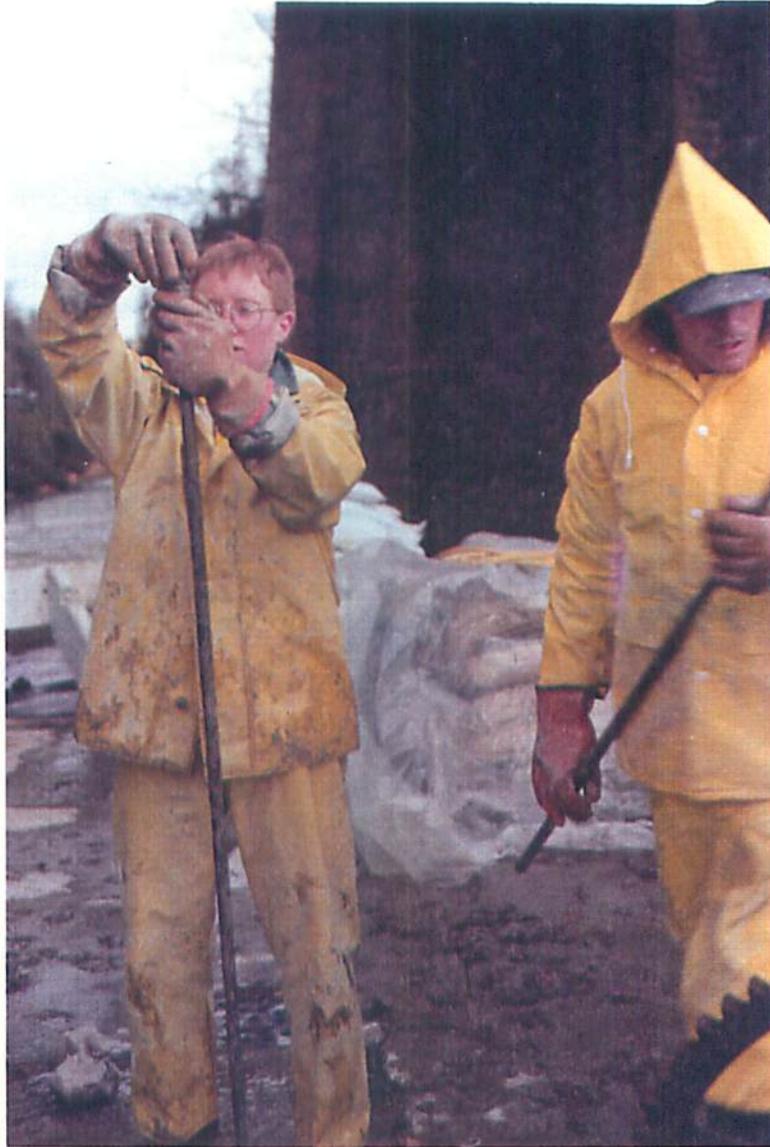
Lock 47 - West Wall Below Test Hole V - 1  
Repointing With Fast Setting Cement Mortar

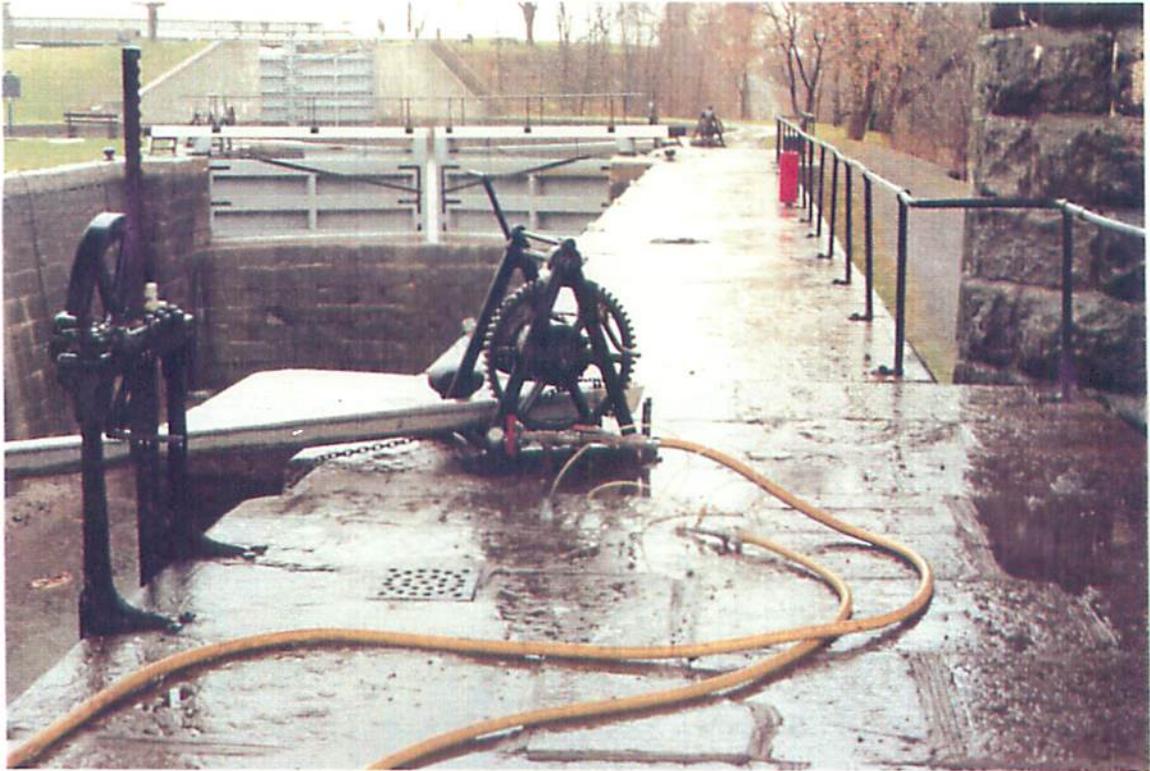
Lock 47 - West Wall Downstream Abutment At Test Hole V - 2  
Showing Installation Of Grout Pipes

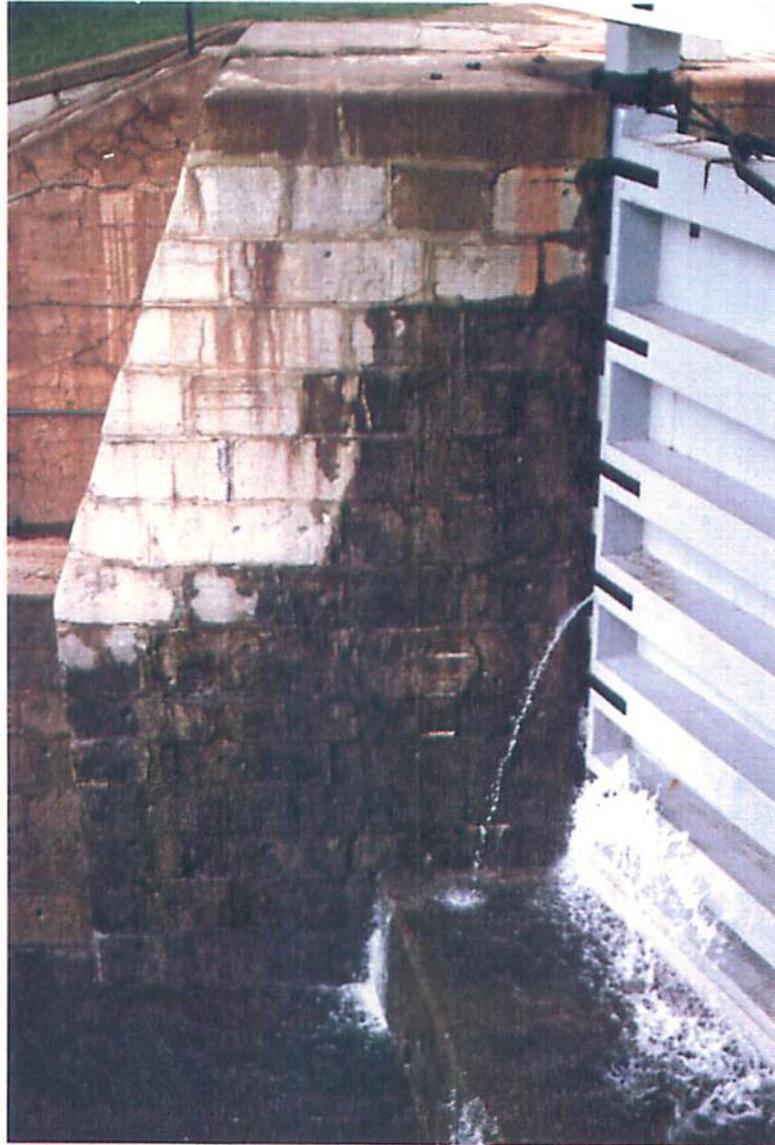
Lock 48 - West Wall At Upstream Gates  
Showing Seepage Through Abutment from Lock 47

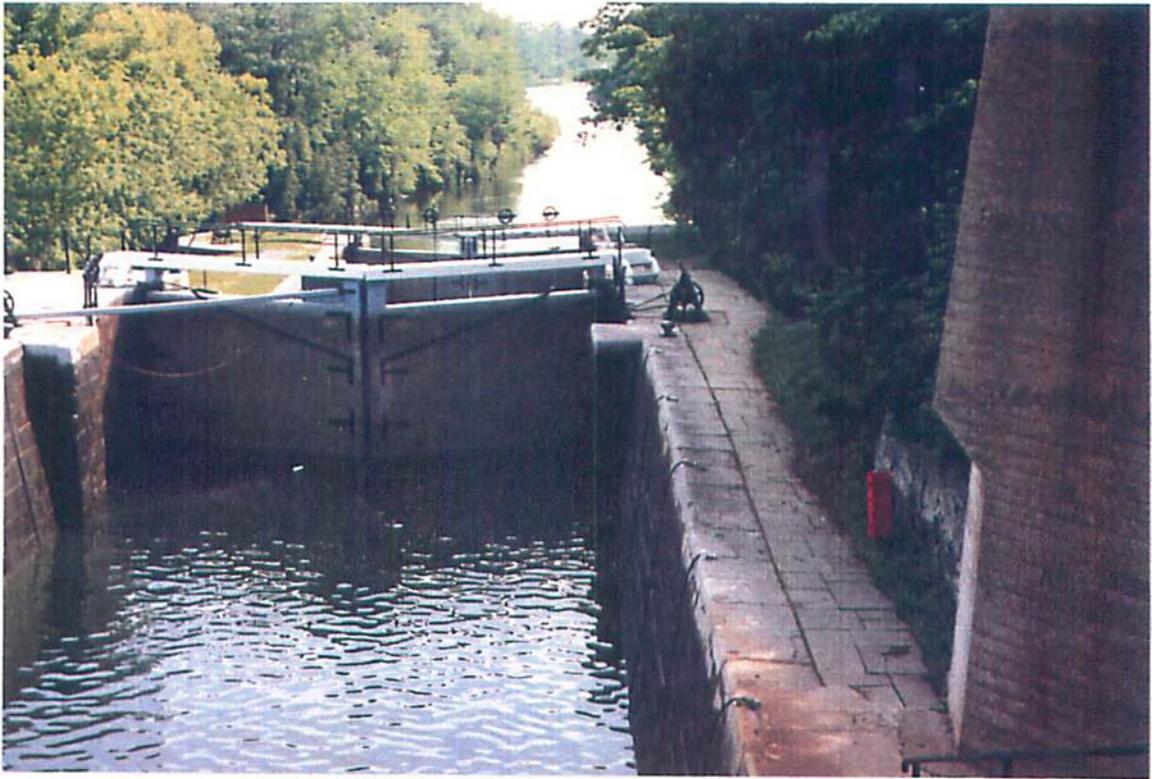
Lock 48 - West Wall At Upstream Gates  
Showing Seepage Through Abutment from Lock 47

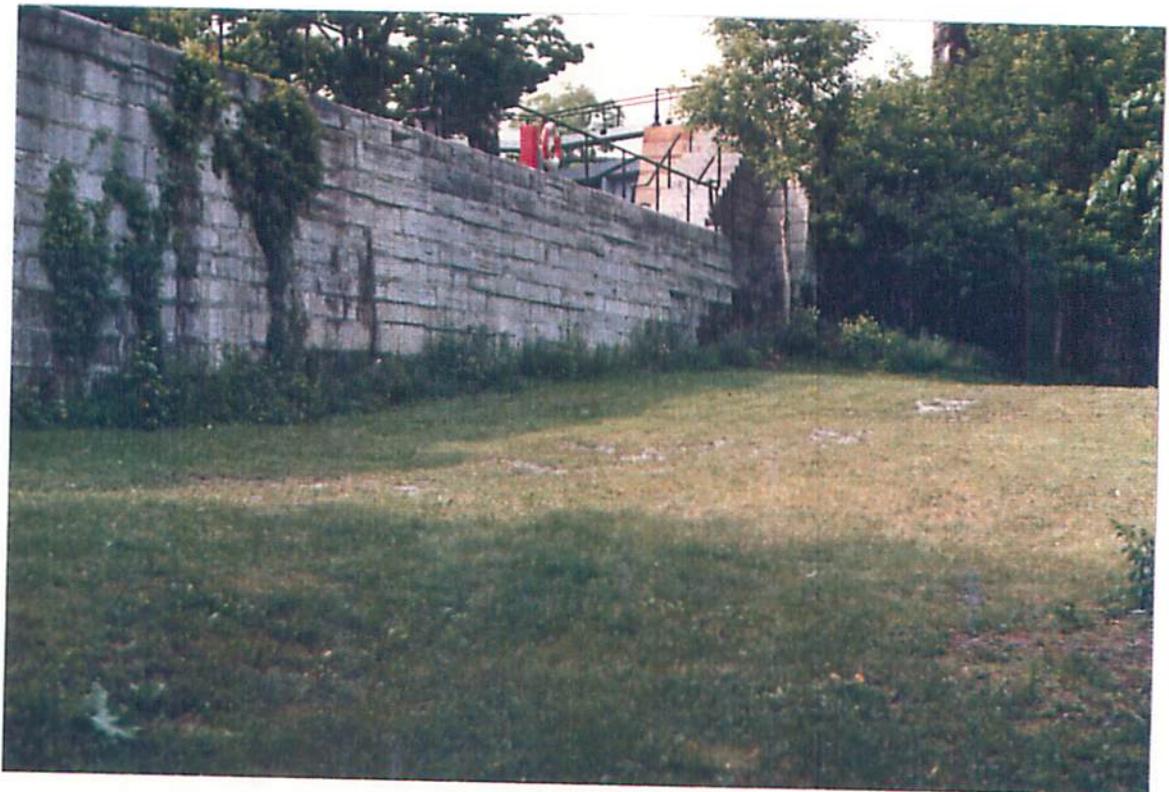
Lock 48 - West Wall Looking Downstream

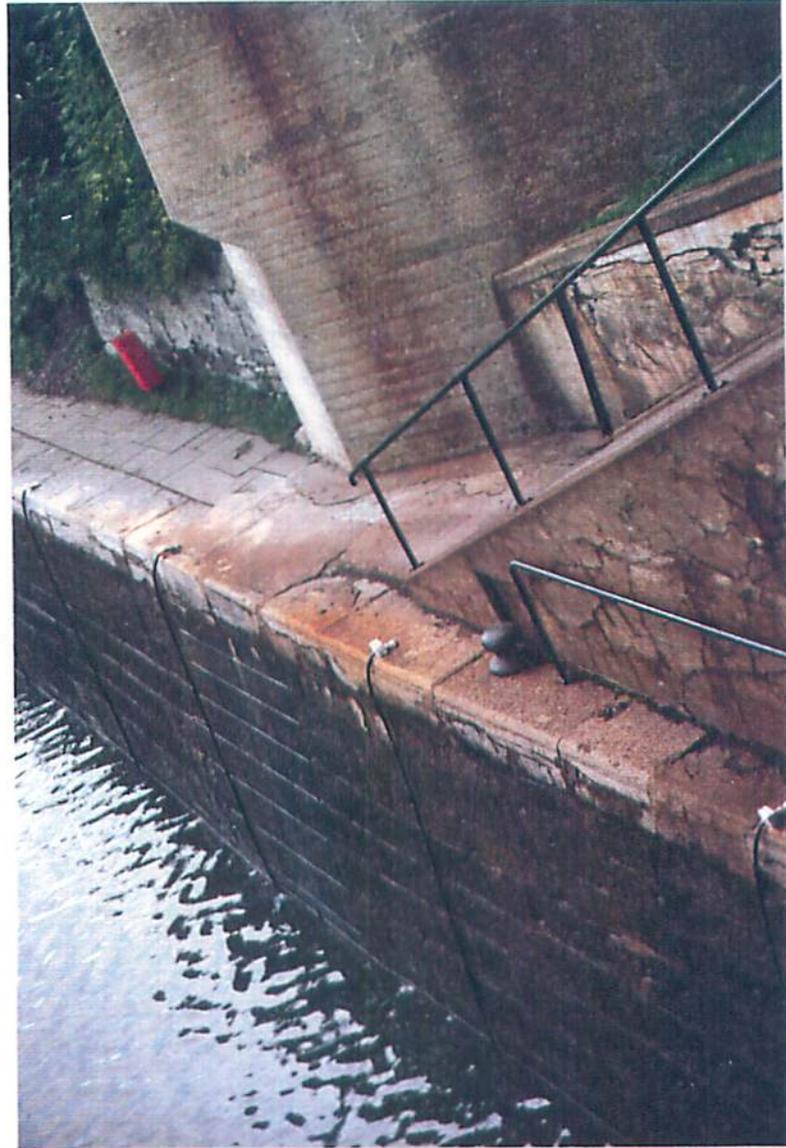
Lock 48 - West Wall  
Showing Bulge Due To Freeze/Thaw Action

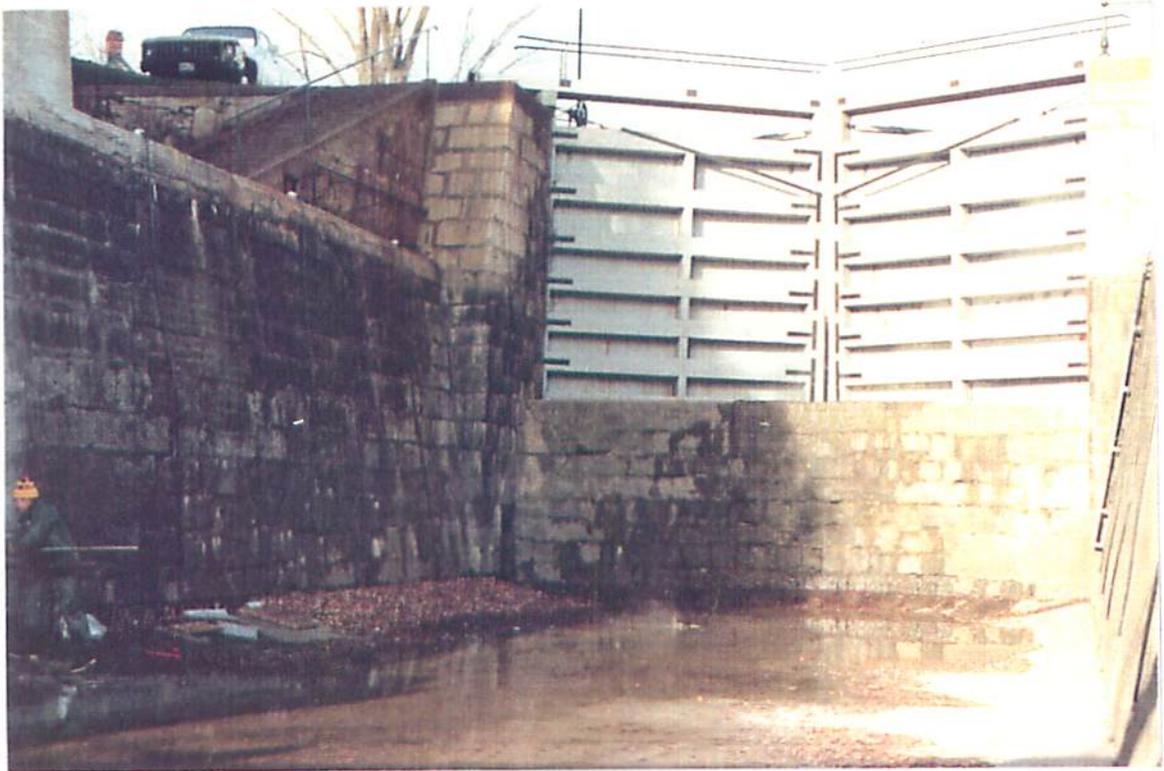
Lock 48 - West Wall  
In Area Of Bulge

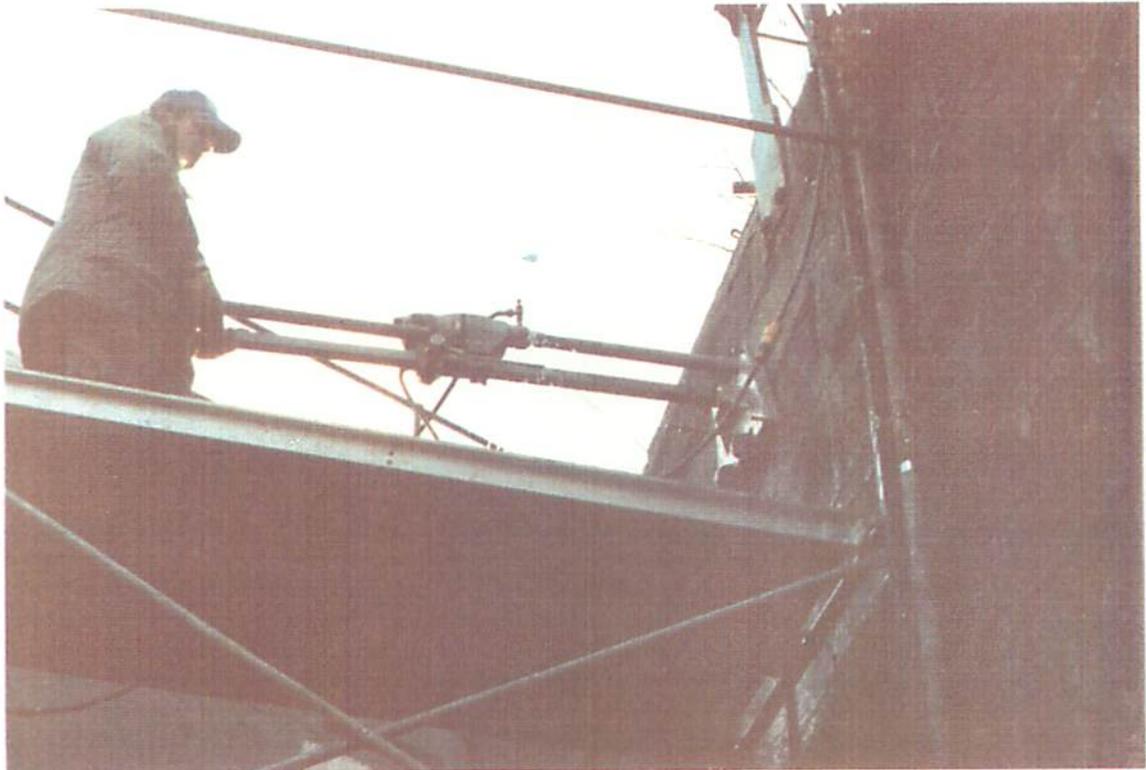
Lock 48 - West Wall Downstream Abutment  
Drilling Test Holes H - 8 (Upper) & H - 10 (Lower)

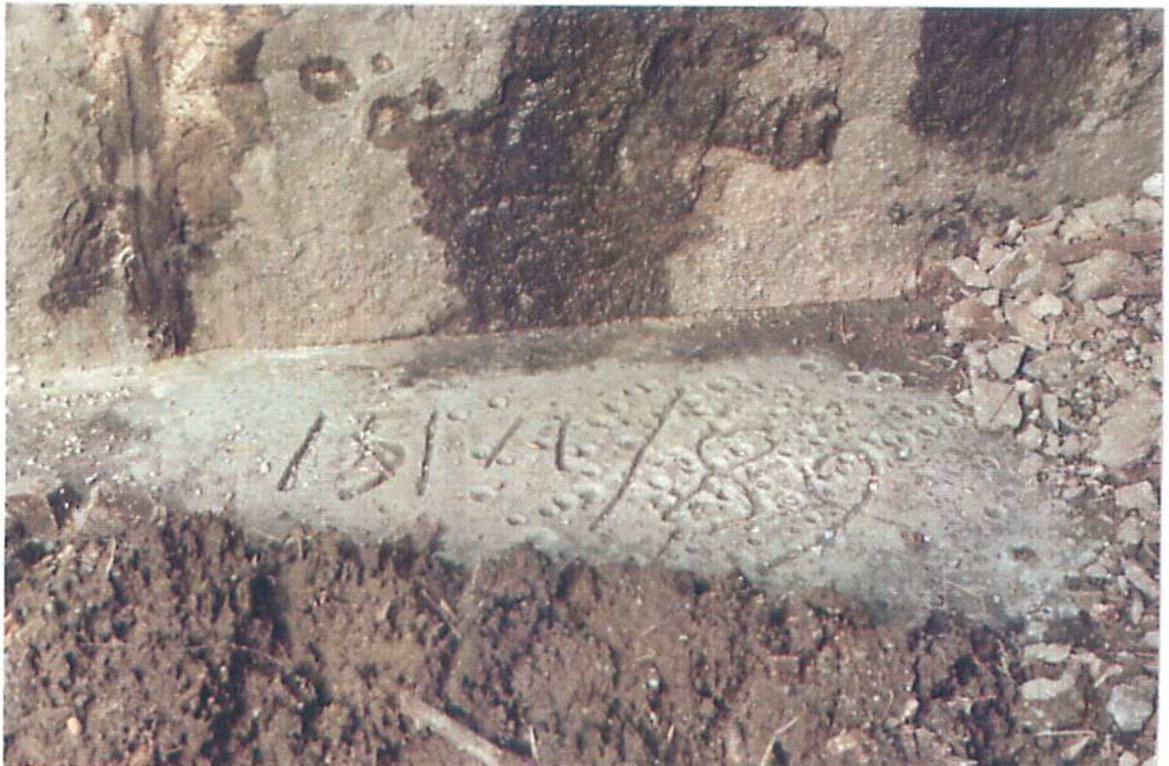
Lock 48 - Exterior East Wall Upstream Abutment  
Showing Water Leak Through Masonry Prior To Grouting

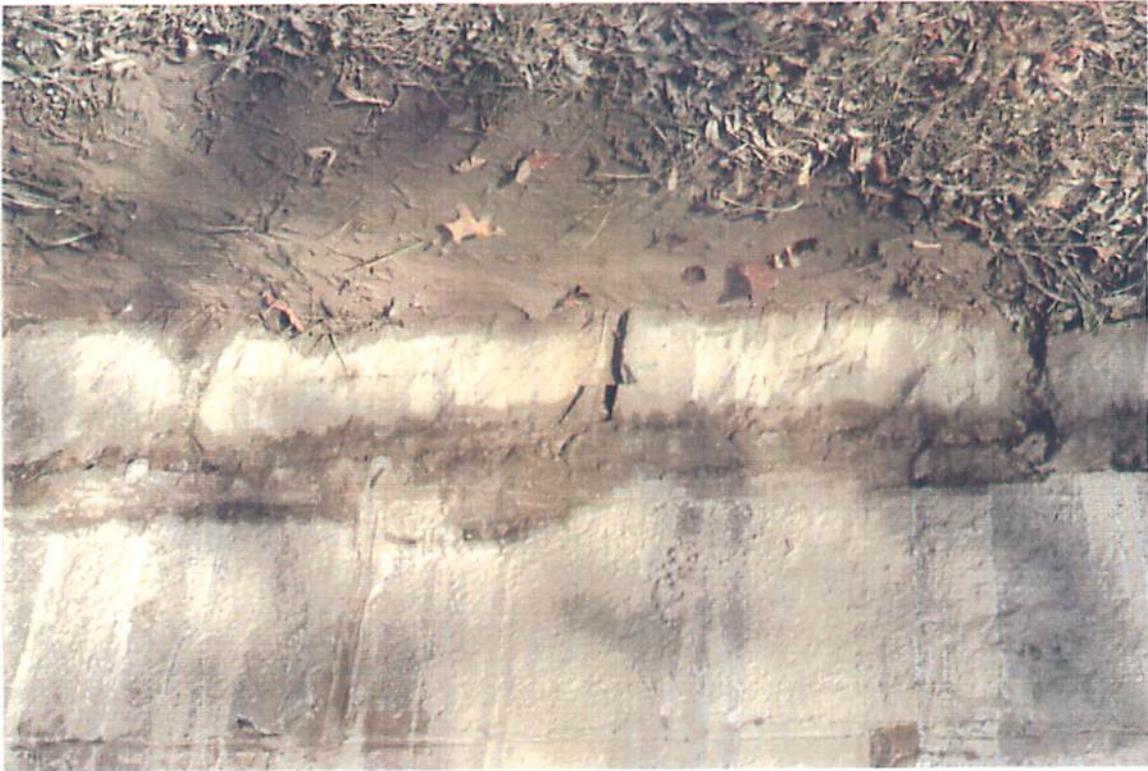
Lock 48 - Exterior East Wall Downstream Abutment  
Successful Plugging Of Leaks By Grouting At Test Hole H - 20

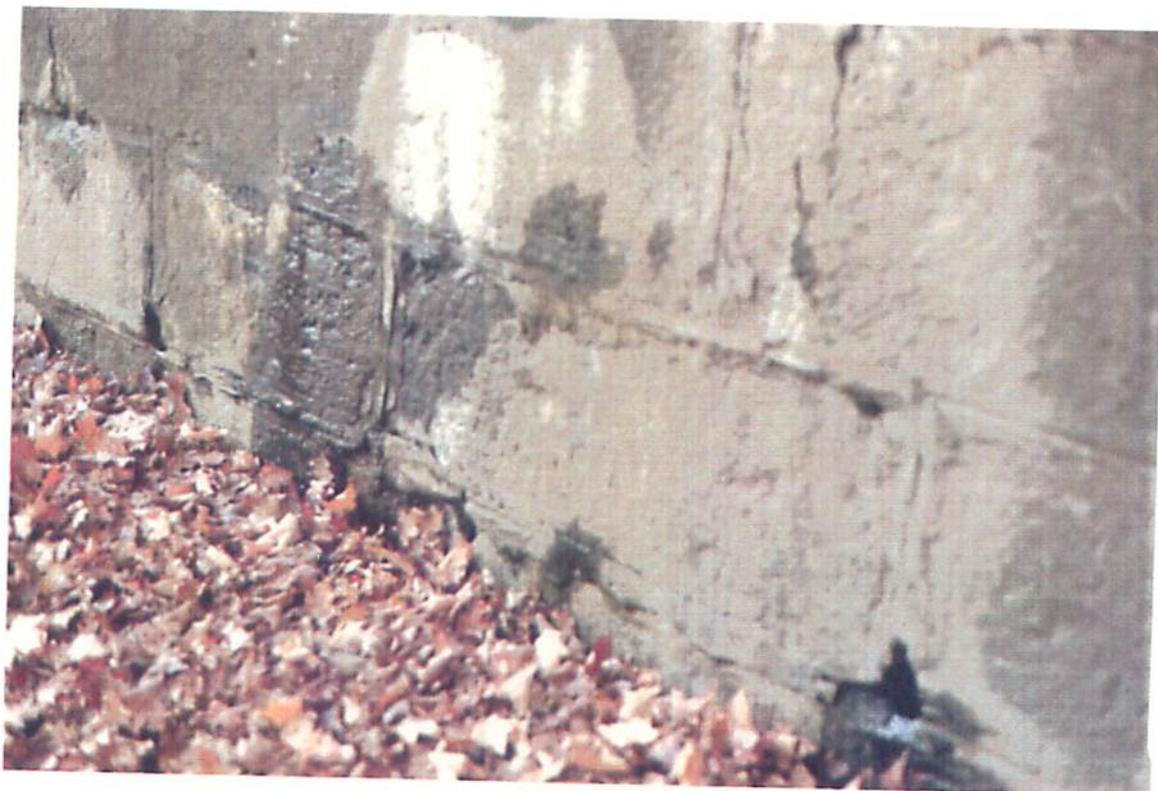
Lock 48 - West Wall Near Test Hole V - 3  
Showing Seepage Prior To Grouting

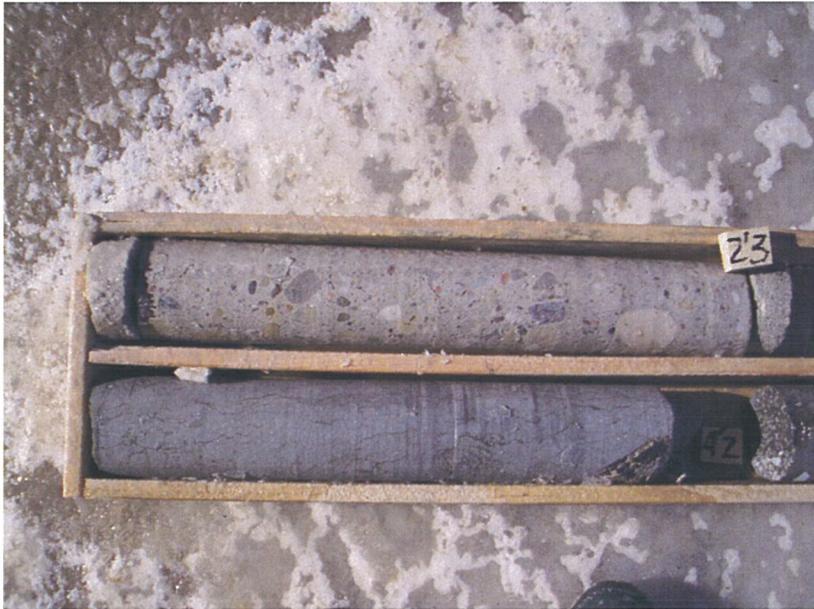
**Photo 2** – BH 05-1, RC 1 – 0'0" to 2'3" – concrete

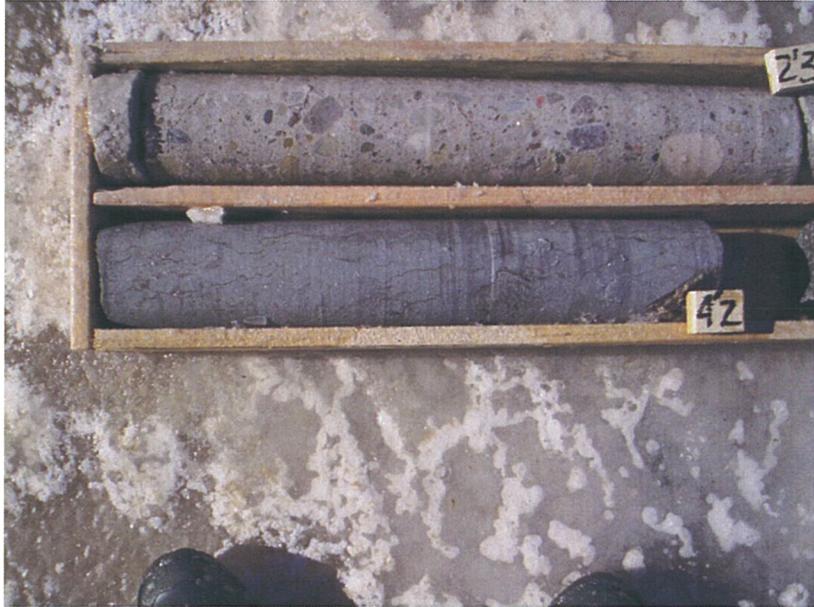
**Photo 3** – BH 05-1, RC 2 – 2'3" to 4'2"  
Limestone block with mortar joints at 2'1.5" to 2'3" and 4'1" to 4'2"  
Specimen taken for compressive strength test (limestone)

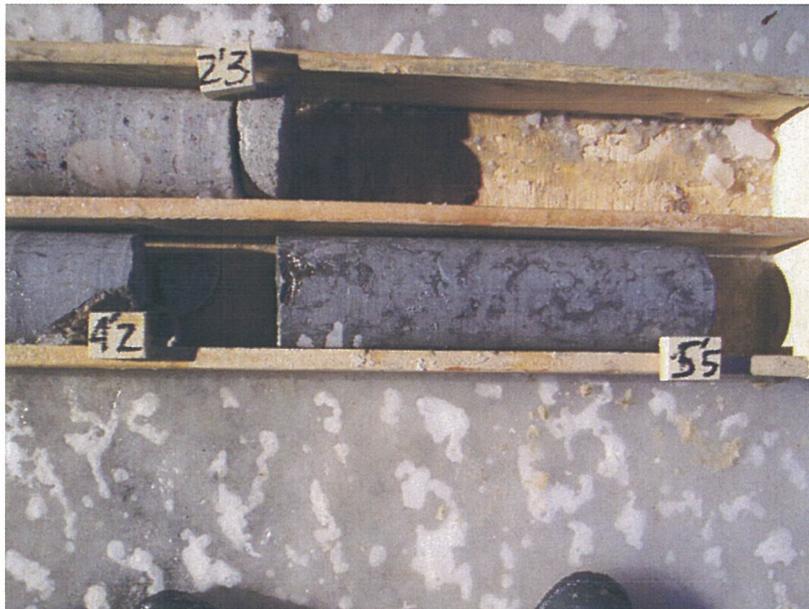
**Photo 4** – BH 05-1, RC 3 – 4'2" to 5'5"  
Limestone block

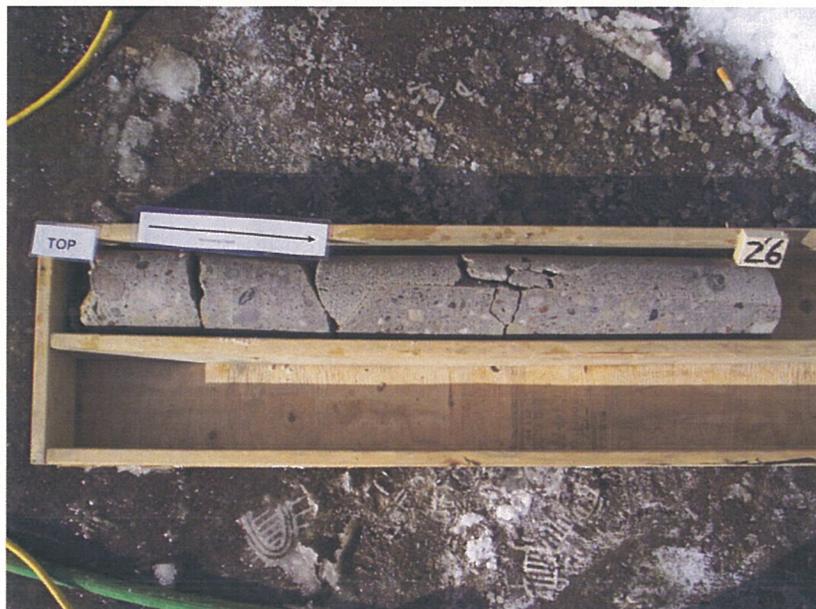
**Photo 2** – BH 05-2, RC 1 – 0'0" to 2'6"  
10" – 2'6" contains mortar and concrete

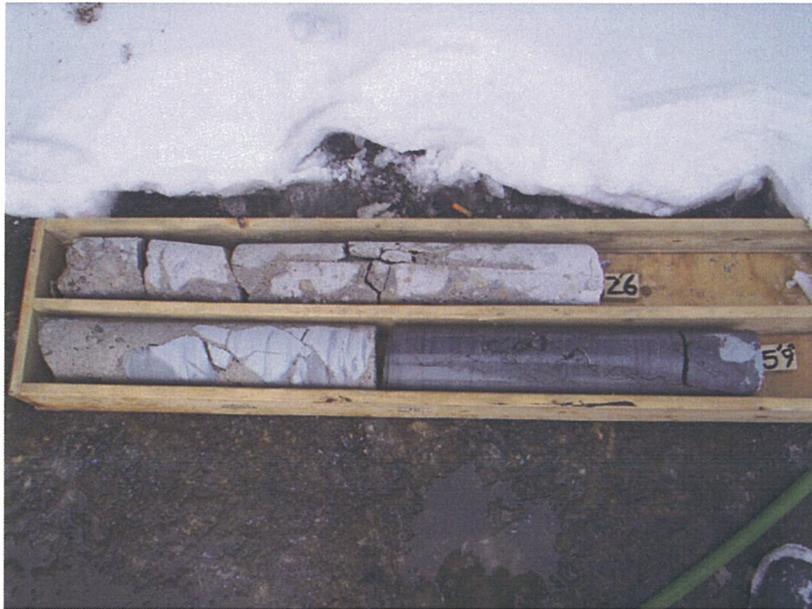
**Photo 3** – BH 05-2, RC 2 – 2'6" to 5'9"  
last 1'8" is a limestone block

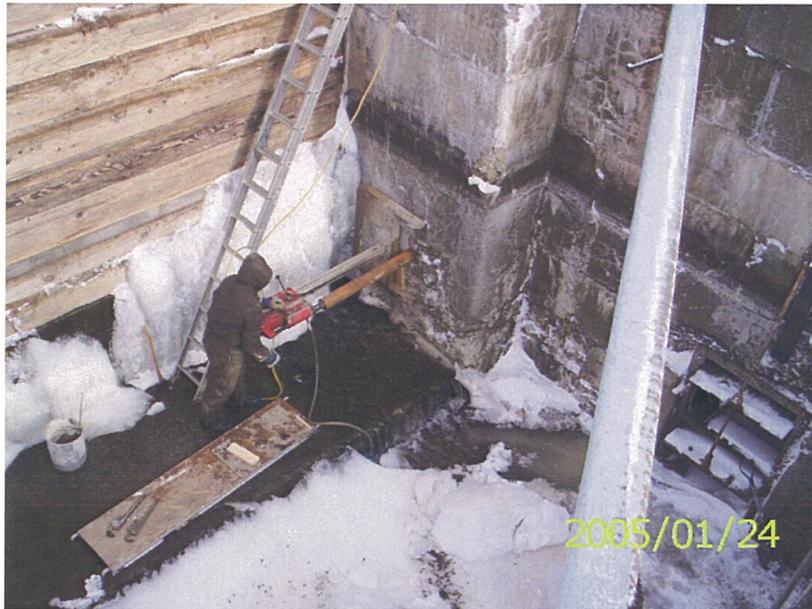
**Photo 3** – Coring BH 05-3  
borehole drilled in a severely spalled area

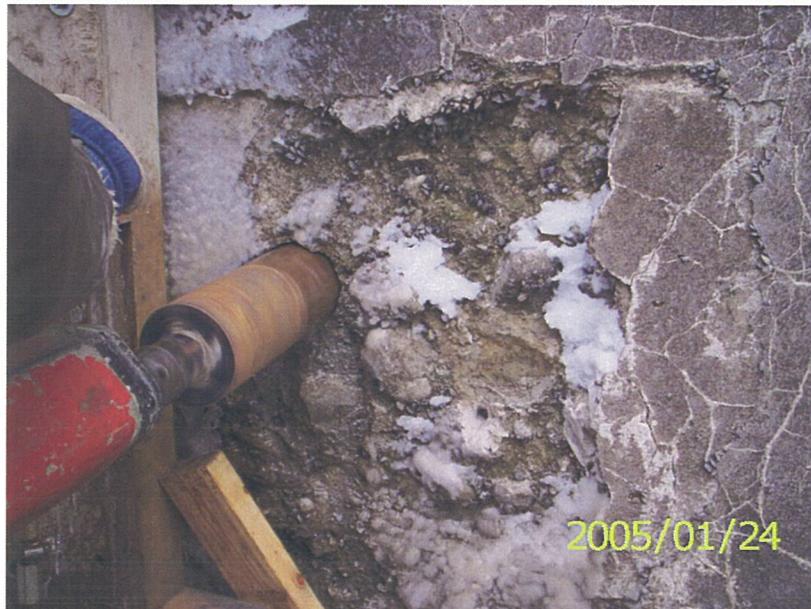
**Photo 4** – Close-up of BH 05-3  
severe spalling at the concrete surface

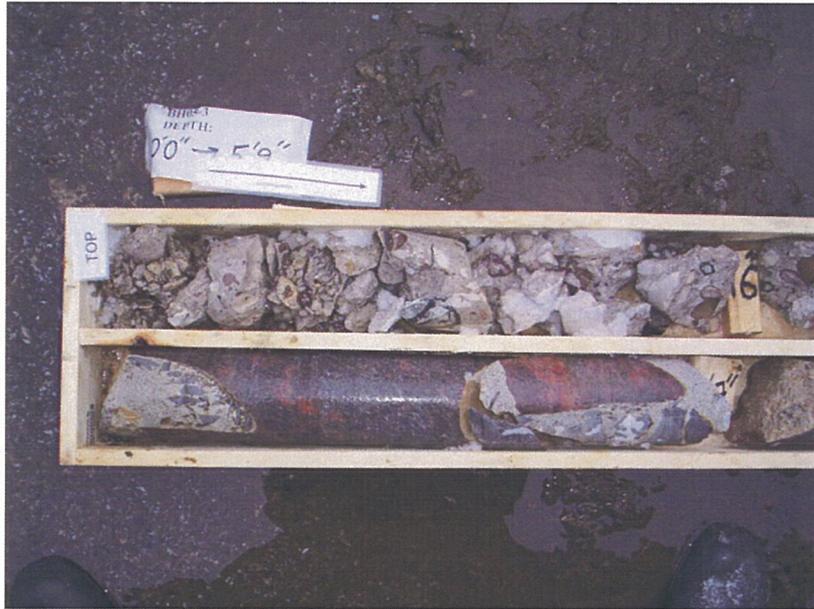
**Photo 7** – BH 05-3, RC 1 – 0'0" to 1'4" (16")  
crumbled concrete

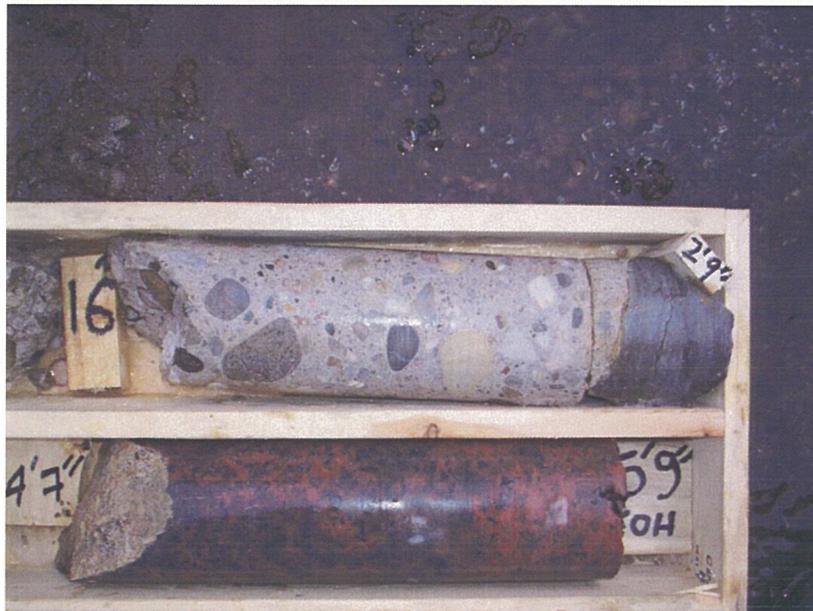
**Photo 8** – BH 05-3, RC 2 – 1'4" to 2'9"  
concrete with a limestone cobble at last 3"  
specimen taken for Petrographic analysis

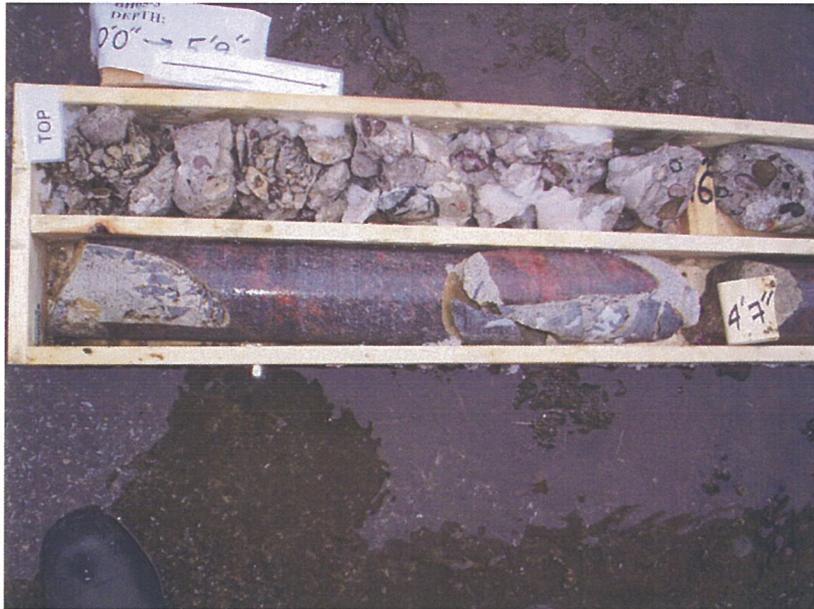
**Photo 9** – BH 05-3, RC 3 – 2'9" to 4'7"  
granite boulder with some concrete

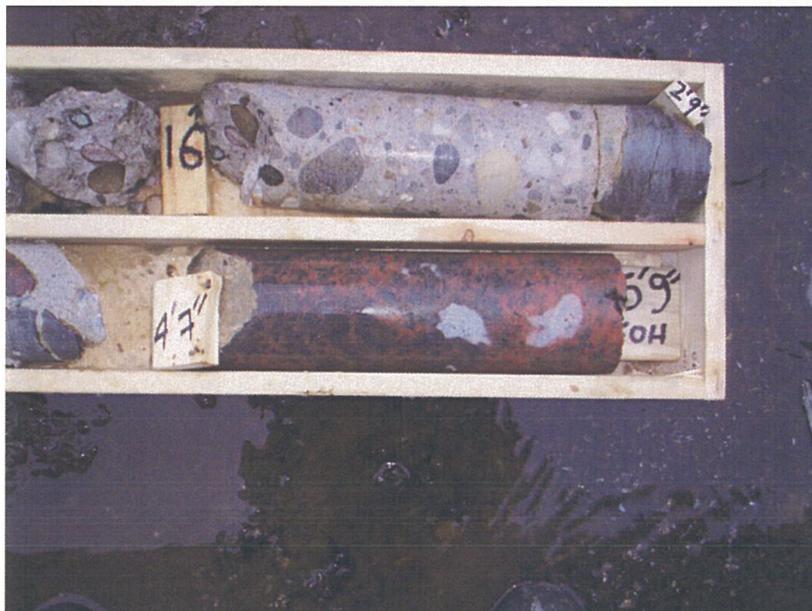
**Photo 10** – BH 05-3, RC 4 – 4'7" to 5'9"  
granite stone or bedrock

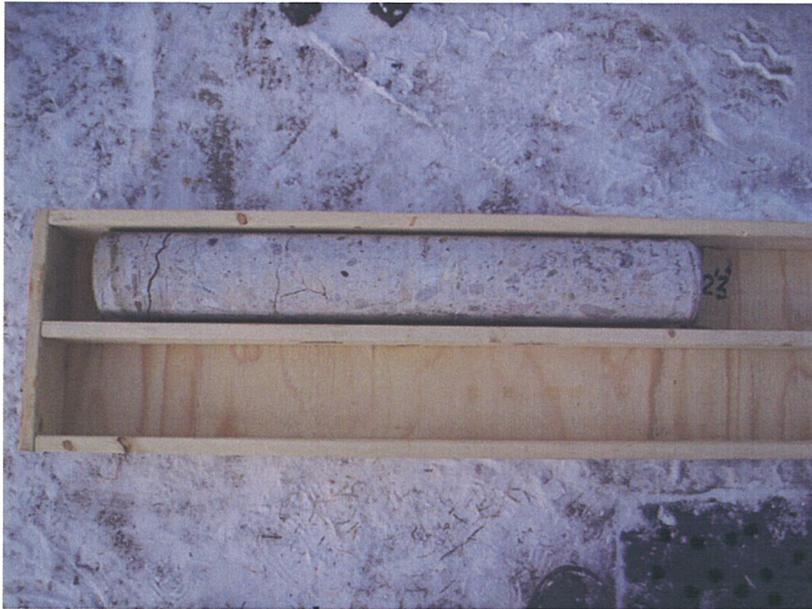
**Photo 3** – BH 05-4, RC 1 – 0'0" – 2'3" (wall thickness)  
0'0" – cracking in concrete  
1'7" – 2'3" - specimen taken for compressive strength test

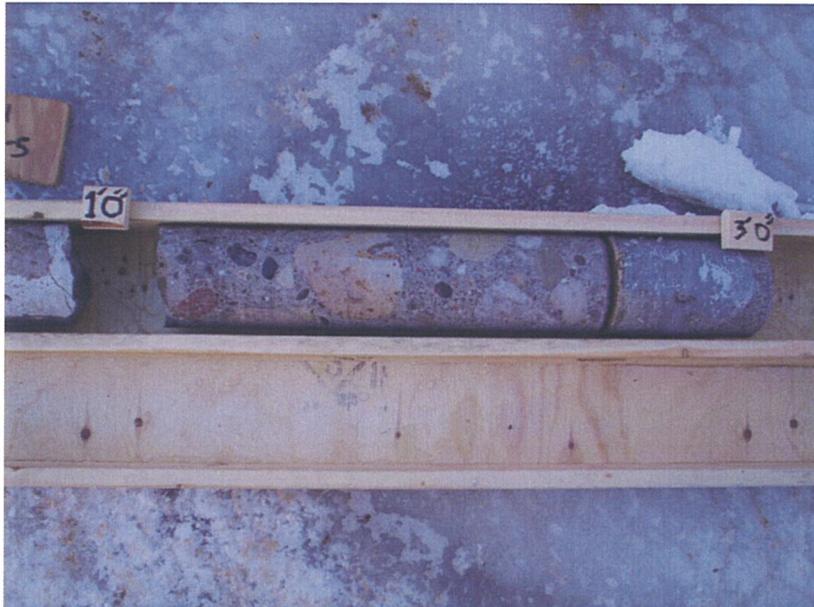
**Photo 3** – BH 05-5, RC 2 – 1'0" to 3'0"  
1'0" – 2'5" - concrete  
2'5" to 3'0" - limestone boulder with mortar in fissures

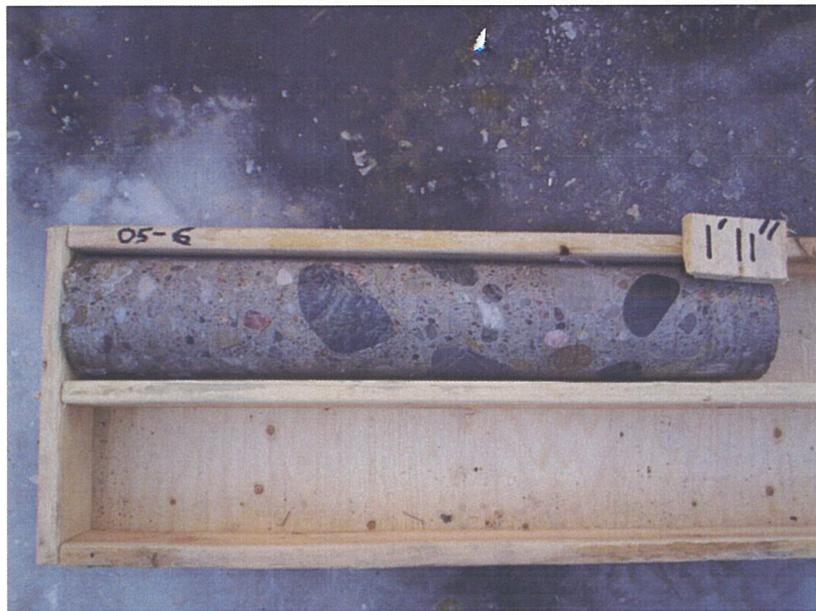
**Photo 2** – BH 05-6, RC 1, 0'0" to 1'11"  
concrete in relatively good shape, some cracking  
1'0" -1'11" – specimen for Petrographic analysis

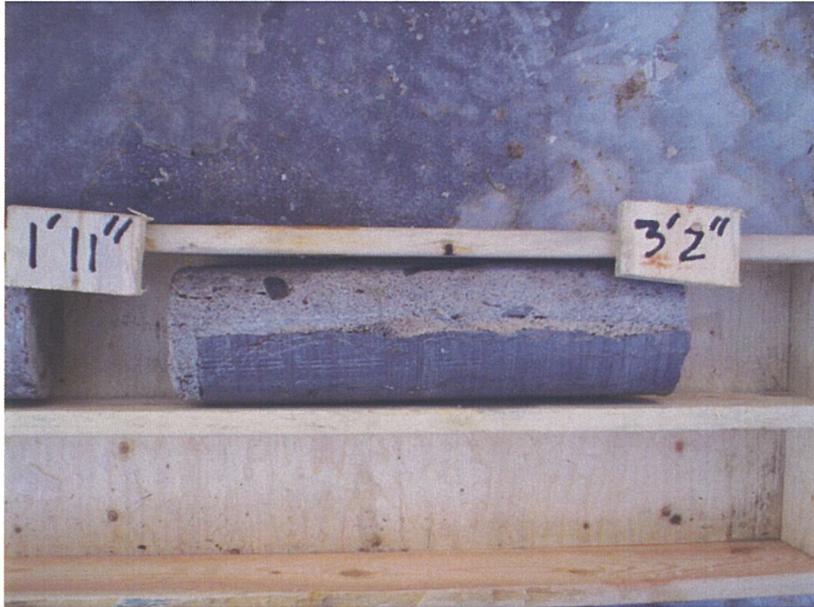
**Photo 3** – BH 05-6, RC 2 – 1'11" to 3'2"  
half of core is limestone block and other half mortar joint

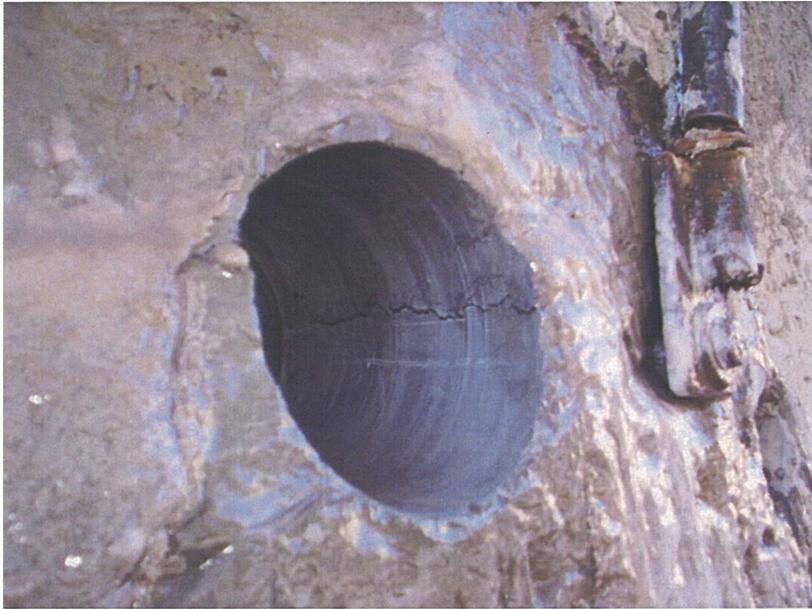
**Photo 3** – BH 05-11, north side of core hole  
Horizontal crack in limestone block
