PUBLIC SERVICES AND PROCUREMENT CANADA

# KINGSTON MILLS LOCKS 46 TO 49 REHABILITATION DRAFT GEOTECHNICAL REPORT

JUNE 27, 2018

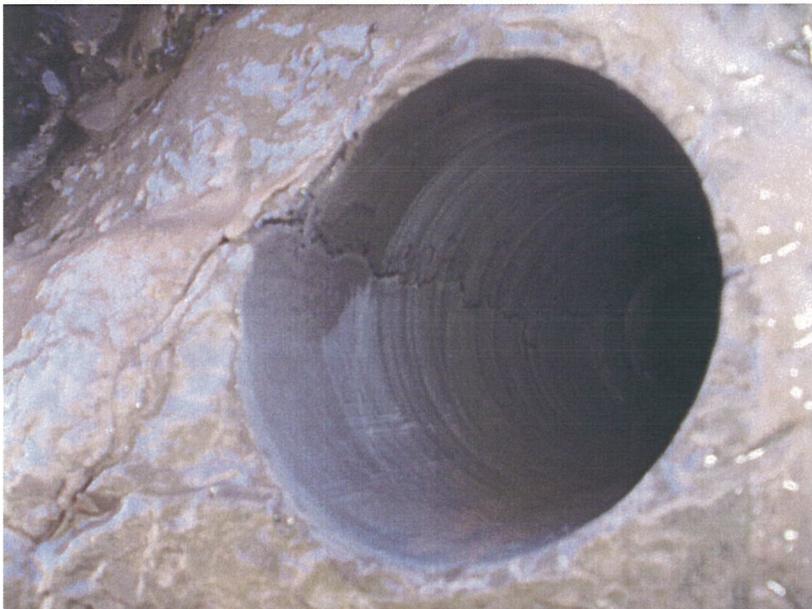
**Photo 4** – BH 05-11, south side of core hole  
Horizontal crack in limestone block

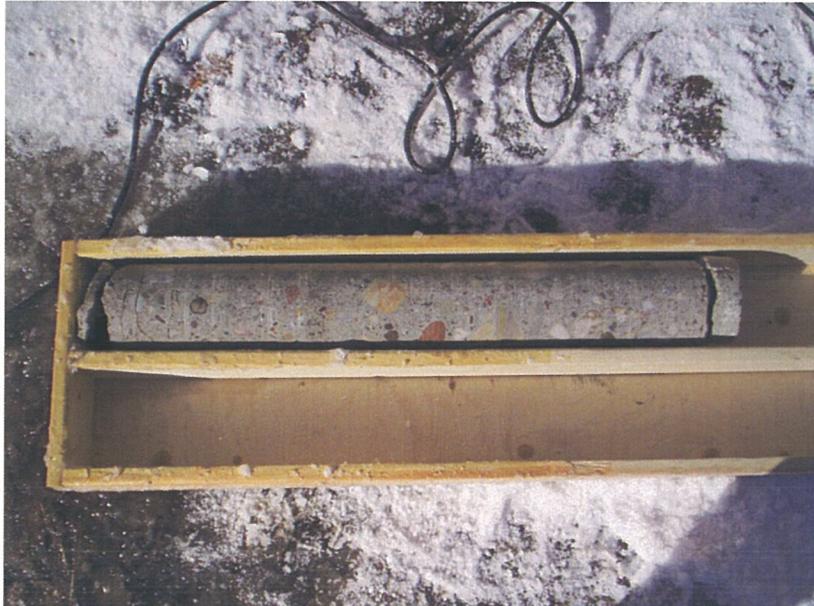
**Photo 2** – BH 05-8, RC 1 – 0'0" to 2'7"  
severe cracking for first 5" and at 8"

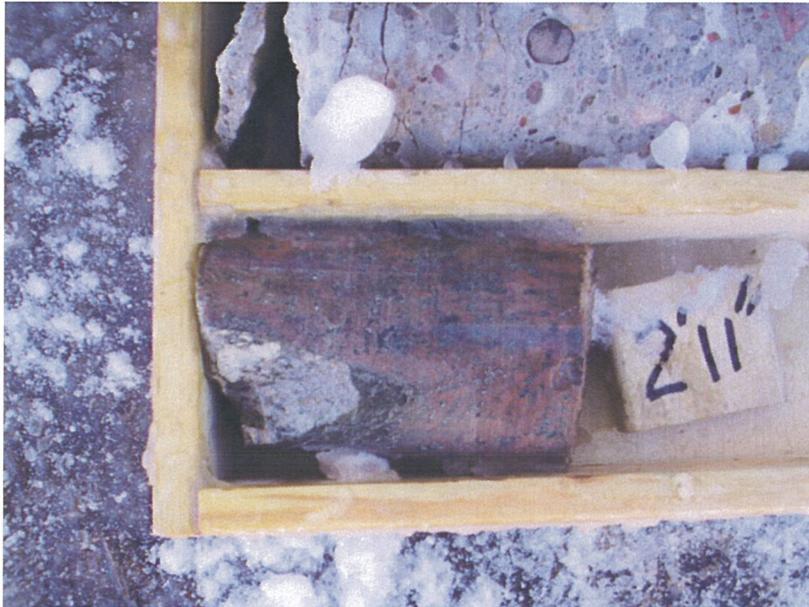
**Photo 3** – BH05-08, RC 2 – 2'7" to 2'11"  
granite boulder or stone

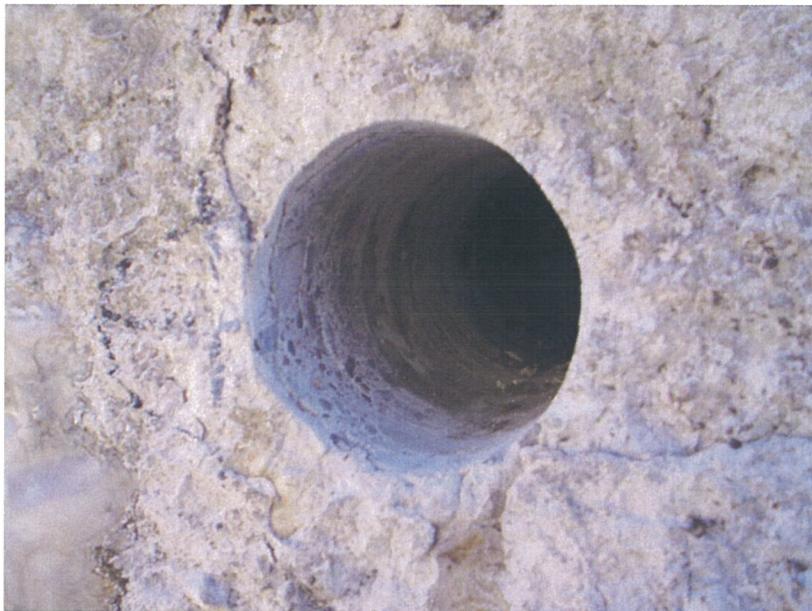
**Photo 4** – BH 05-8  
Surface condition at core location

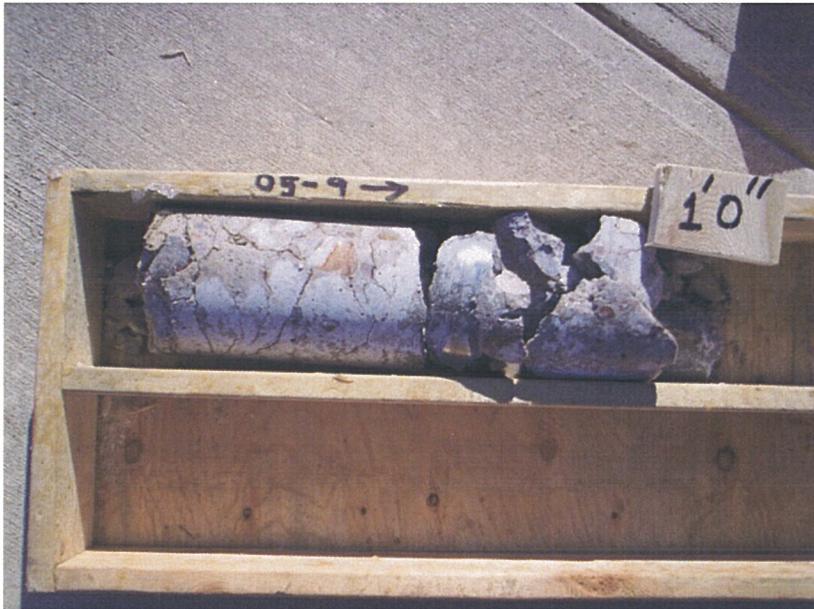
**Photo 2 – BH 05-9, RC 1 – 0'0" to 1'0"**  
0" to 8" - cracking in concrete  
9" - rebar  
8" to 12" - broken into pieces

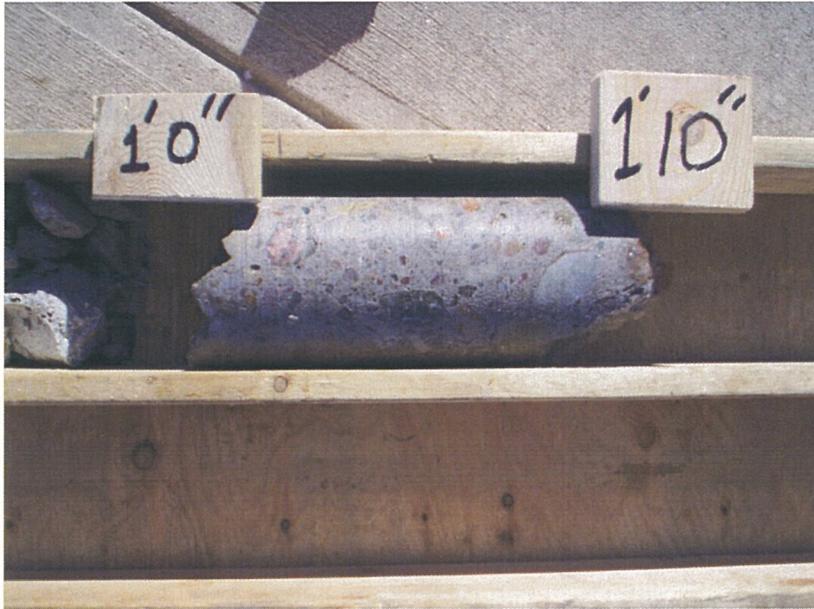
**Photo 3** – BH 05-9, RC 2 – 1'0" to 1'10"  
Concrete solid, used for testing of compressive strength

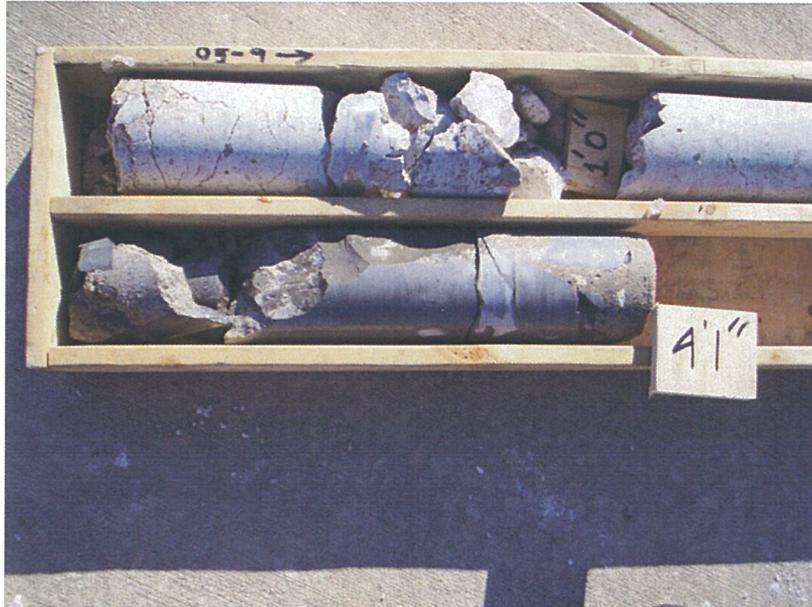
**Photo 5** – RC 4, 2'7" to 4'1"  
limestone block with mortar joints

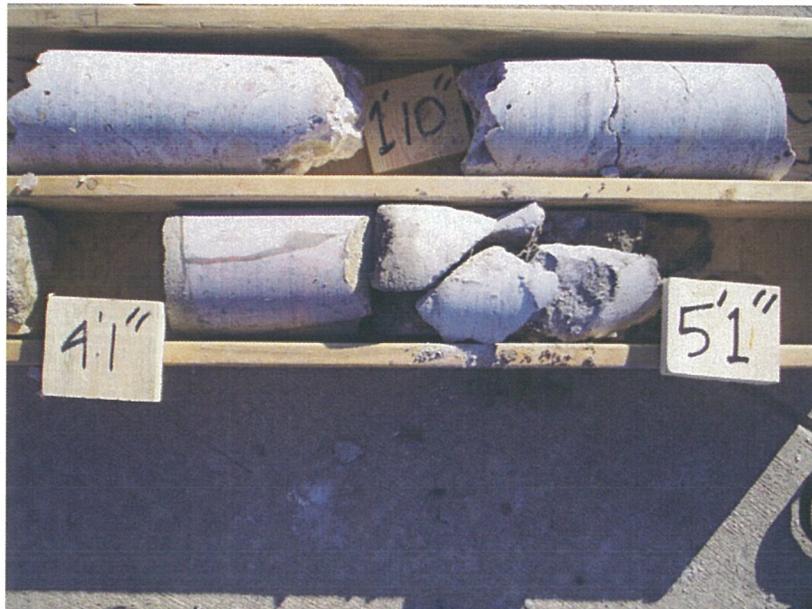
**Photo 6** – BH 05-9, RC 5, 4'1" to 5'1"  
4'1" to 4'7" - granite  
4'7" to 5'1" - broken limestone

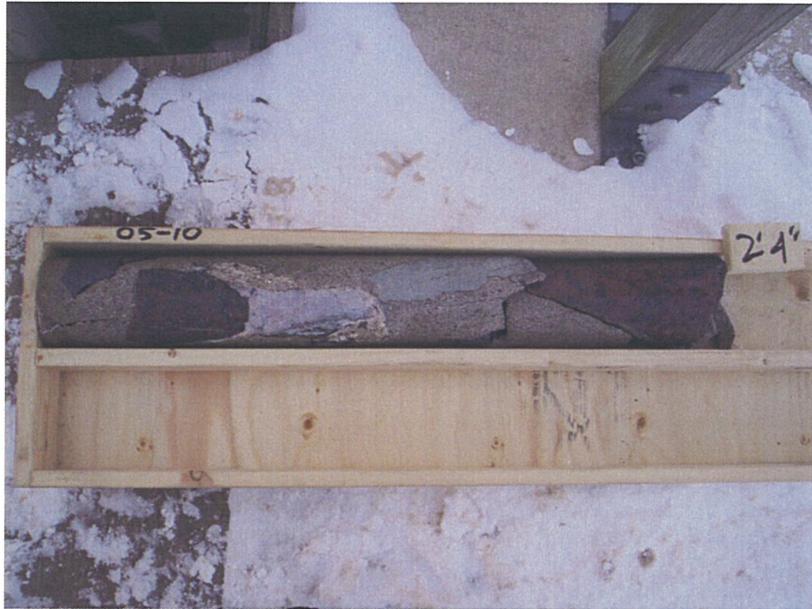
**Photo 1** – BH 05-10, RC 1 – 0'0" to 2'4"  
0 to 20" is mortar with limestone and granite rock  
20" to 28" is granite rock with mortar

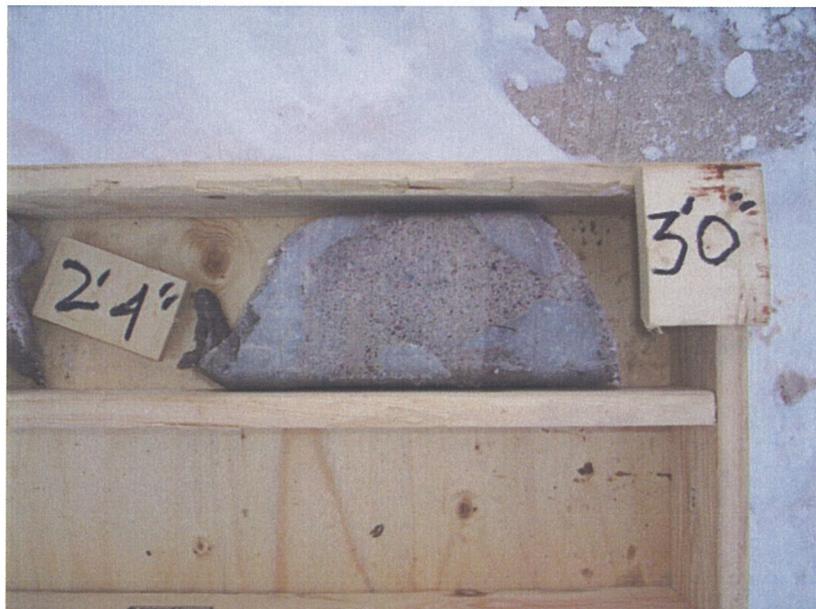
**Photo 2** – BH 05-10, RC 2 – 2'4" to 3'0"  
Broken limestone pieces with mortar

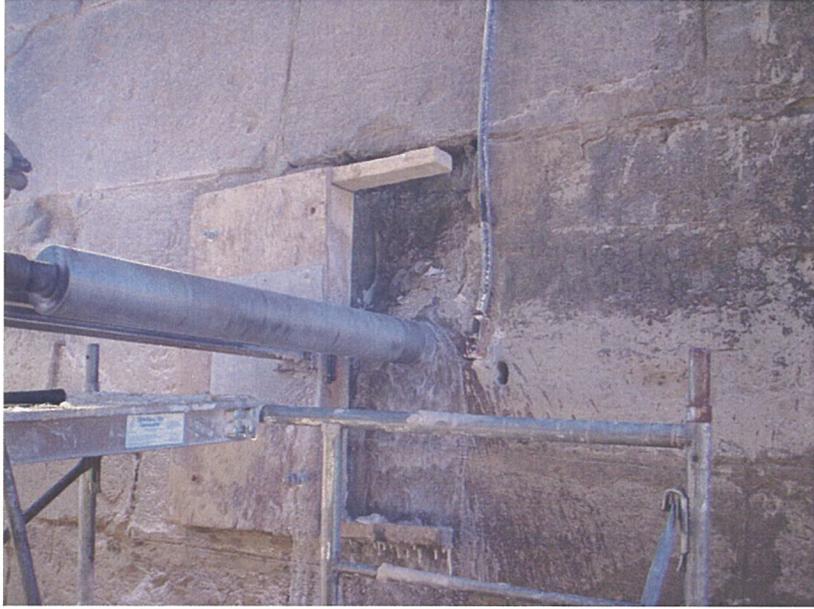
**Photo 1** – BH 05-11, Core location  
in damaged limestone block on west wall

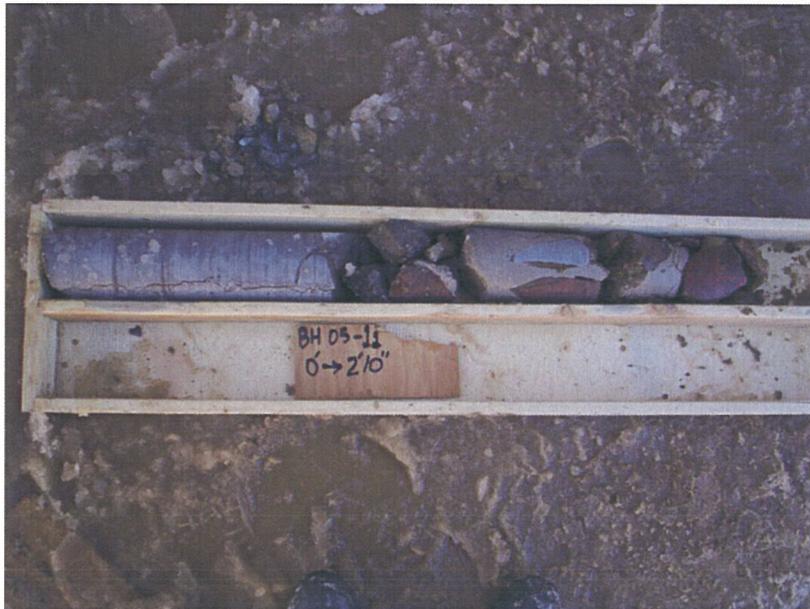
**Photo 2** – BH 05-11, RC 1 – 0'0" – 2'10"  
0'0" to 1'4" - limestone block with vertical and horizontal cracking  
1'4" to 2'10" - granite boulders with grout in fissures

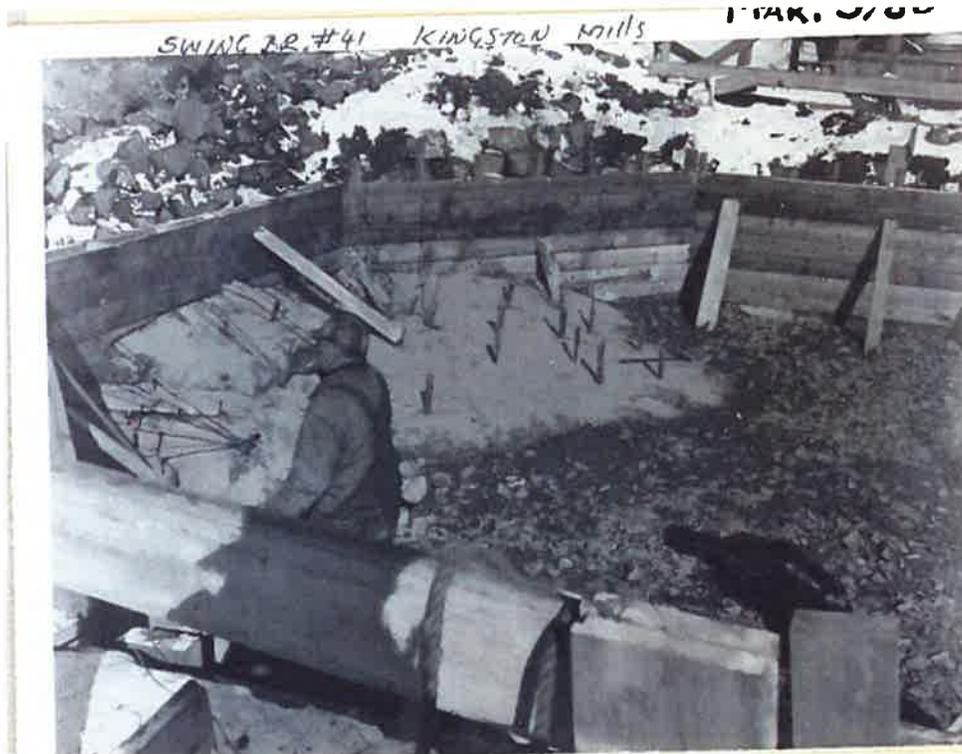
Photograph 2 – Showing the construction of original pier founded on the bedrock on the west side with dowels into the bedrock.

From the photographs provided, the pivot pier appears to be founded on the bedrock surface on the west side and the canal wall on the east side, with fill between those two relatively rigid supports. The fill appears to be granular fill up to the underside of the footing based on the photographs, but the previous investigations indicate that the fill below the pier consists of predominantly clayey silt with cobbles and boulders. The fill beneath the pier would have limited capacity to support additional loading from the pier.

The test pit excavations in the current investigation were extended to the surface of the bedrock and it was found that a pivot pier foundation extends to the surface of the bedrock. Based on the test pits, it appears that the pivot pier may have been underpinned at some point in time after the original construction. The pivot pier may therefore not be supported on fill as indicated in the historical photographs and previous boreholes, or it has been underpinned since the original construction.

For the rehabilitation of the west pivot pier, it is suggested that the entire foundation be excavated around the perimeter of the foundation to assess the extent and quality of underpinning. Any repairs or additional underpinning for support should be made at that time.
