**HAZARDOUS MATERIALS INVESTIGATION
LACOMBE, BEAVERLODGE AND FORT VERMILLION
RESEARCH CENTRES**

April 12, 2011 Revised March 2013
File No. 11166

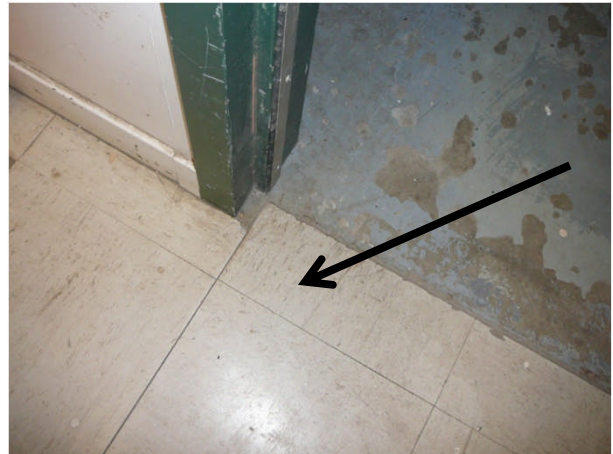
#53 Header House

Sample A27 : Floor tile containing asbestos in room 3E

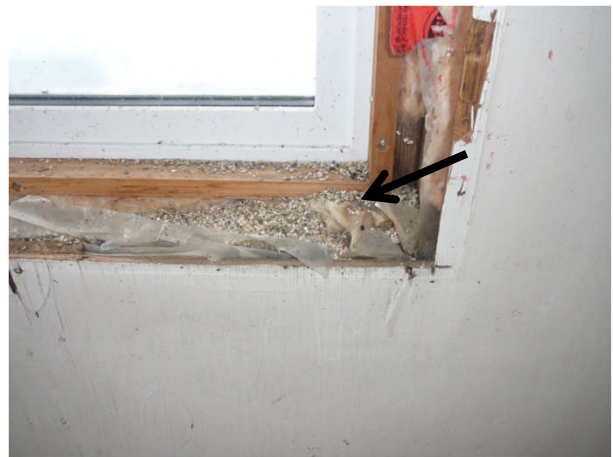
#54 Animal Hospital

Sample A45 : Insulation containing asbestos in the walls & ceiling

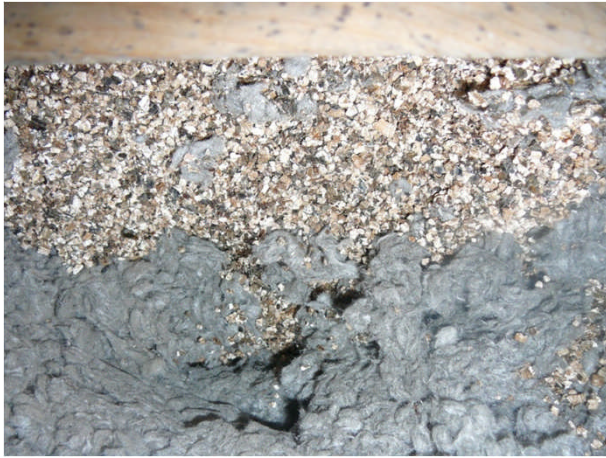
#2 Residence

Sample A63, A90 & A91 : Insulation containing asbestos in the attic

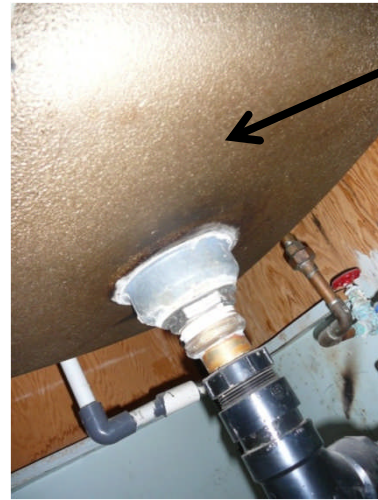
#53 Header House

Sample A64 : Sink insulation containing asbestos in room 2E

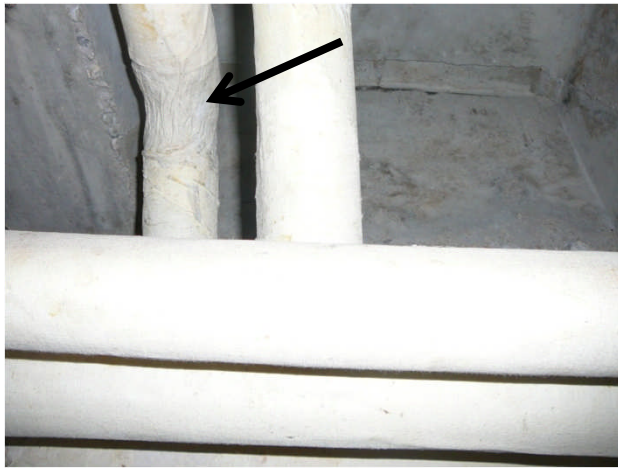
#21 Administration Building

Sample A65 & A66 : Pipe insulation containing asbestos in corridor 3

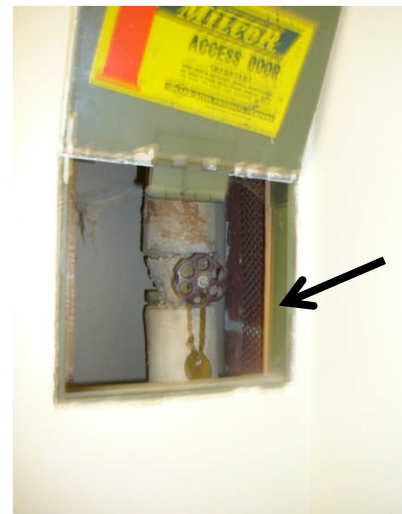
#21 Administration Building

Sample A67 : Pipe insulation containing asbestos in corridor 3

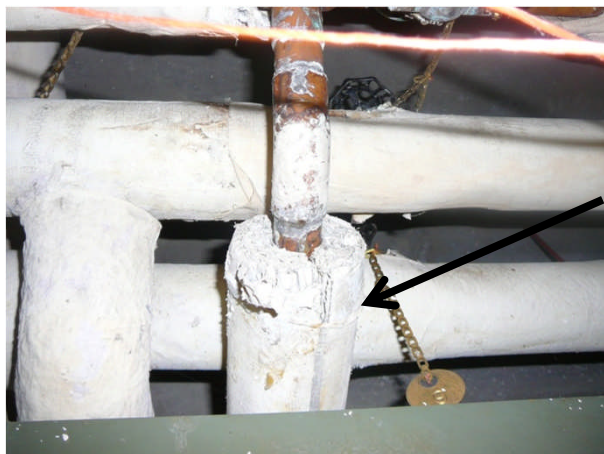
#21 Administration Building

Sample A68 : Pipe insulation containing asbestos in corridor 4

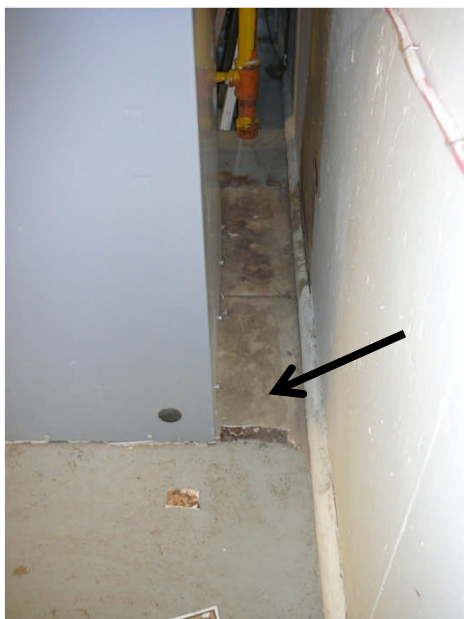
#38A Beef Unit Garage

Sample A70 : Floor tile containing asbestos in room 1

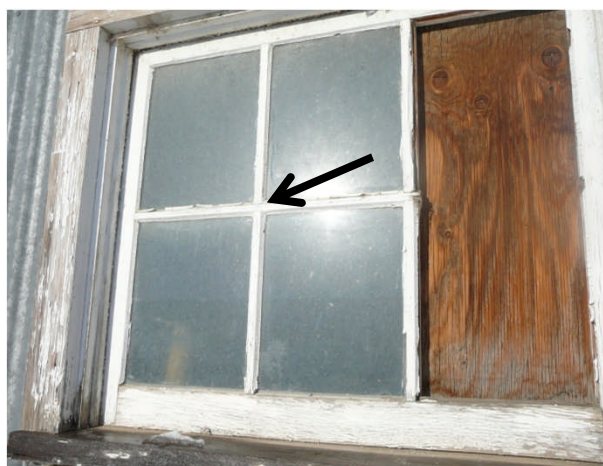
#40 Beef Unit Test Barn

Sample A72 : Window caulking containing asbestos on the exterior

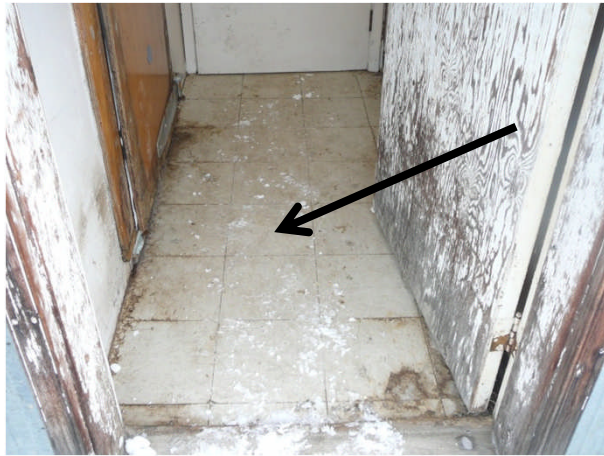
#54 Animal Hospital

Sample A74 : Floor tile containing asbestos in the entrance

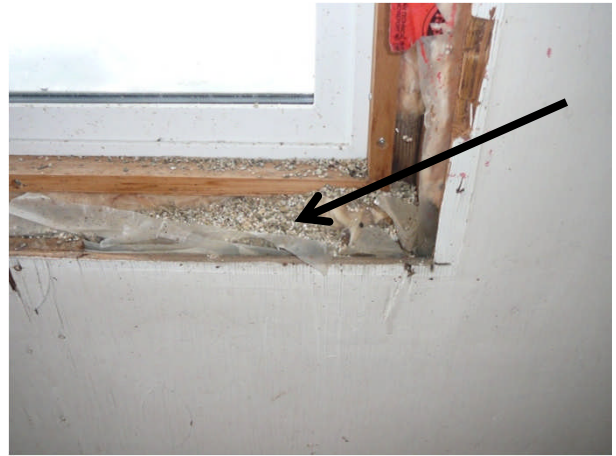
#54 Animal Hospital

Sample A75 & A29 : Insulation containing asbestos in the walls & attic

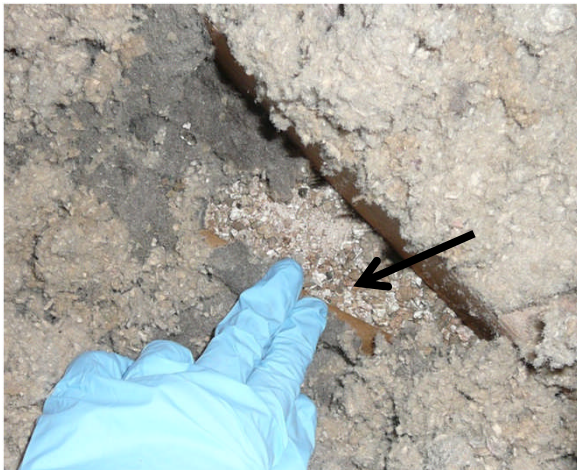
#41 Beef Unit Residence

Sample A58, A88 & A89: Insulation containing asbestos in the attic

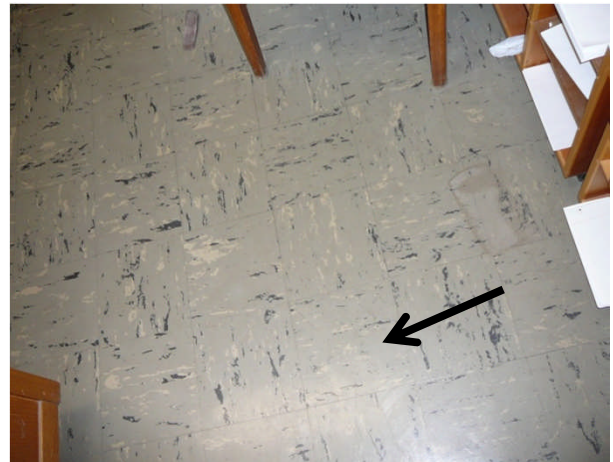
#21 Administration

Sample A94, A95 & A96: Floor tile containing asbestos in rooms 4 & 6

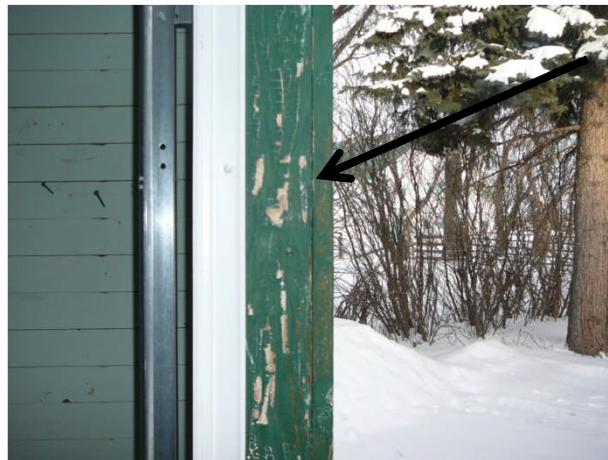
#2 Residence

Sample P13 : Dark green paint containing lead on the exterior

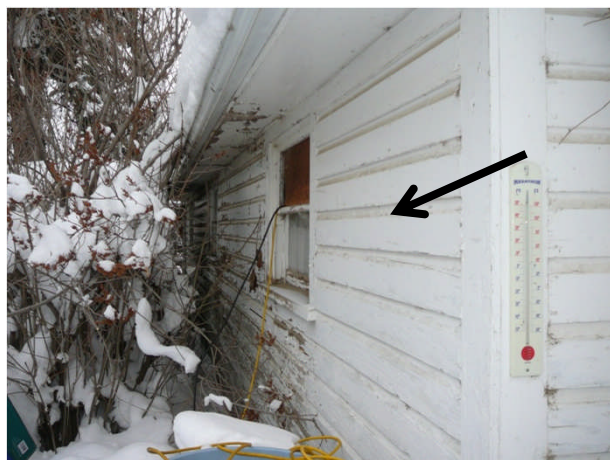
#38A Beef Unit Garage

Sample P16: White paint containing lead on the exterior

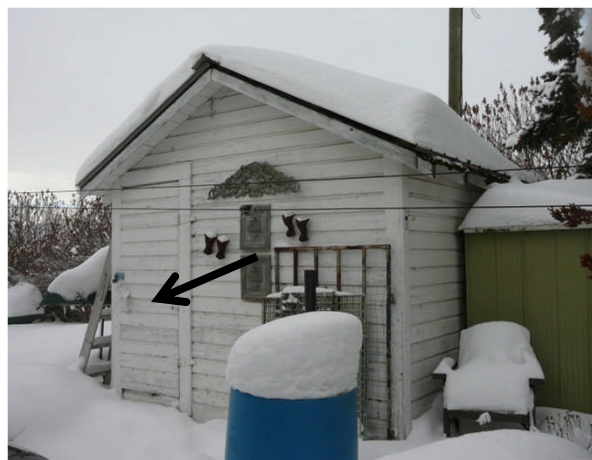
#41A Shed

Sample P17: White paint containing lead on the exterior

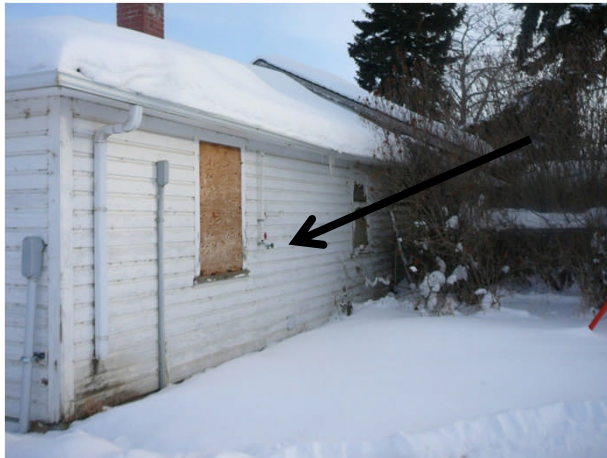
#38A Beef Unit Garage

Sample P21 : White paint containing lead on the exterior

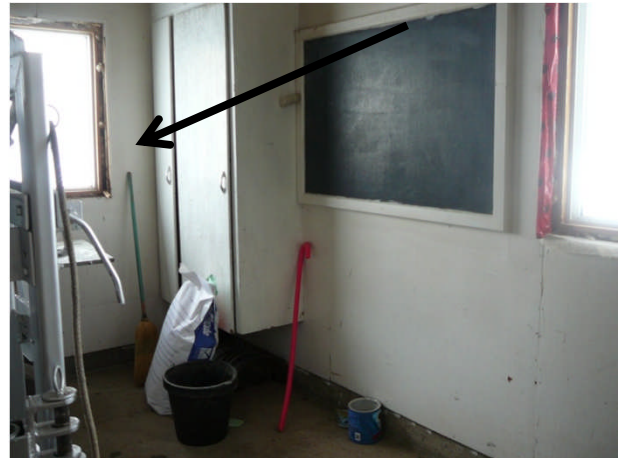
#54 Animal Hospital

Sample P29 : White paint containing lead inside the main room

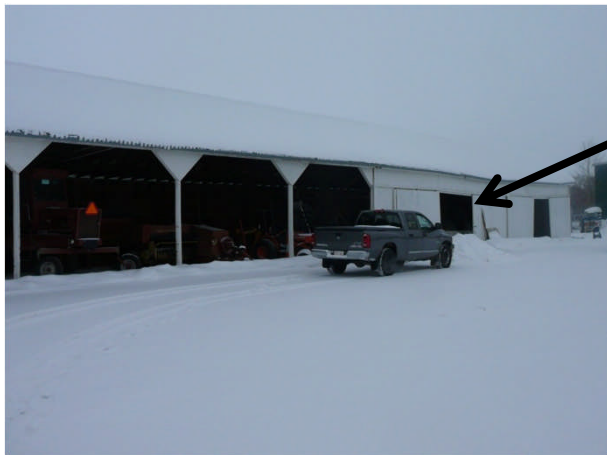
#10 Machine Pole Barn

Sample P31: White paint containing lead on one side of the barn

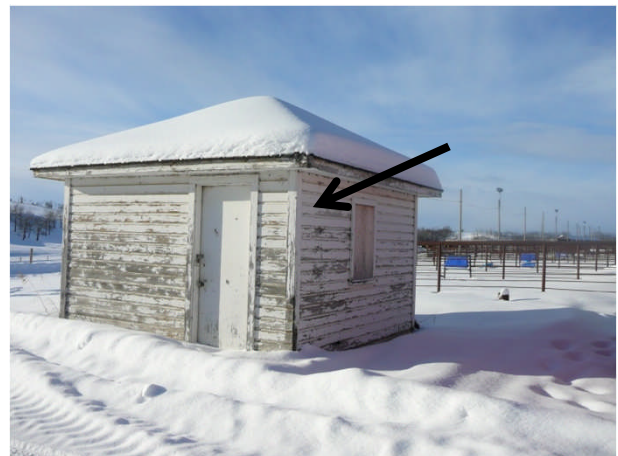
#38 Pump House

Sample P24: White paint containing lead on the exterior

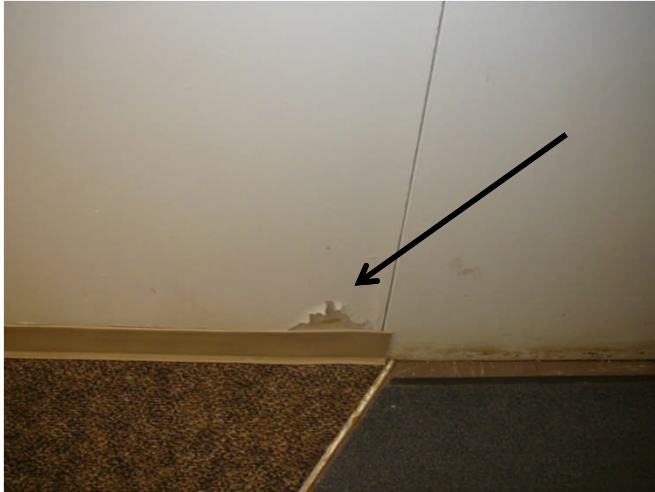
#1: Administration Office

Sample A37: Drywall mud on basement hallway wall

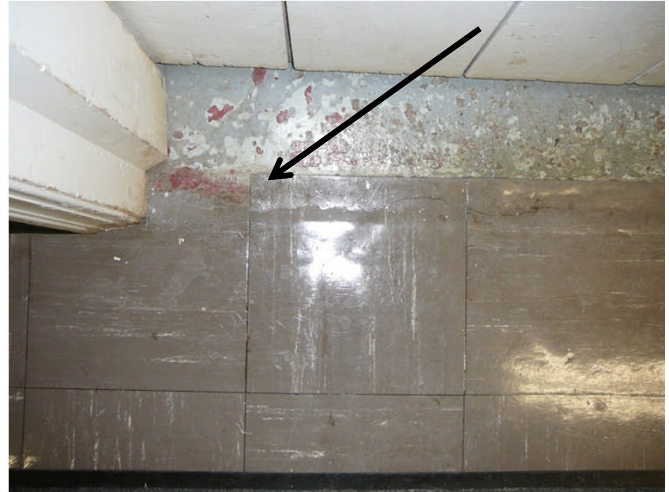
#1: Administration Office

Sample A41 & A75: Brown/white 9x9 floor tile on basement hall floor

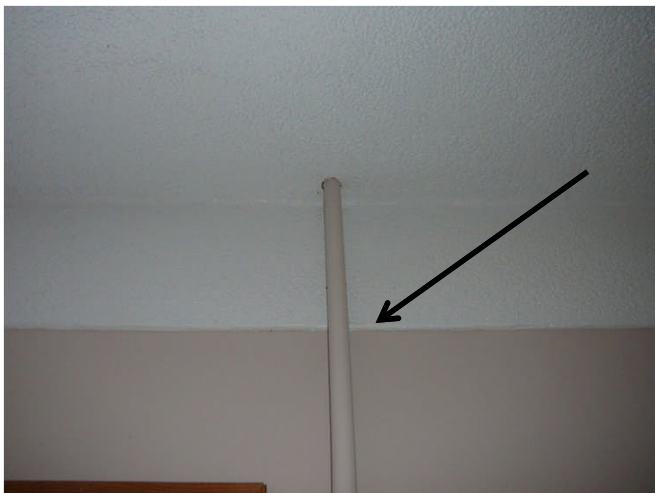
#1: Administration Office

Sample A62: Ceiling texture on SW wall of Office 3

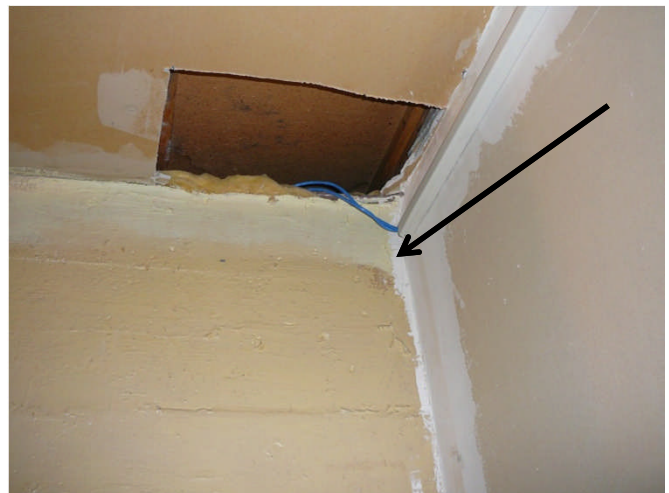
#1: Administration Office

Sample A42: Drywall mud on Furnace Room wall

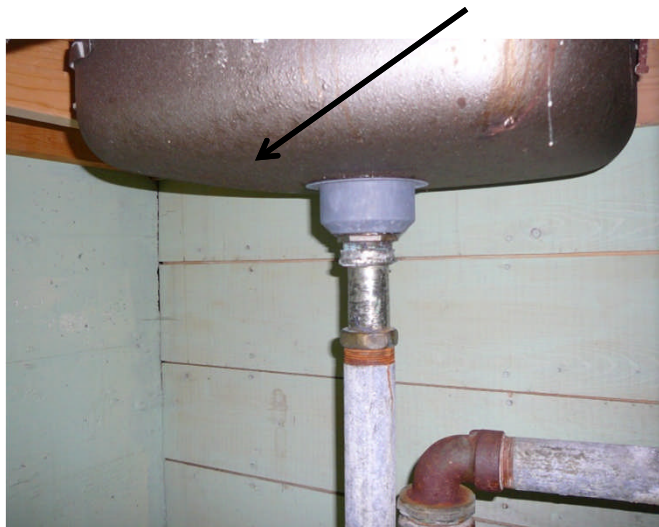
#1: Administration Office

Sample A46: Sink insulation in dark room

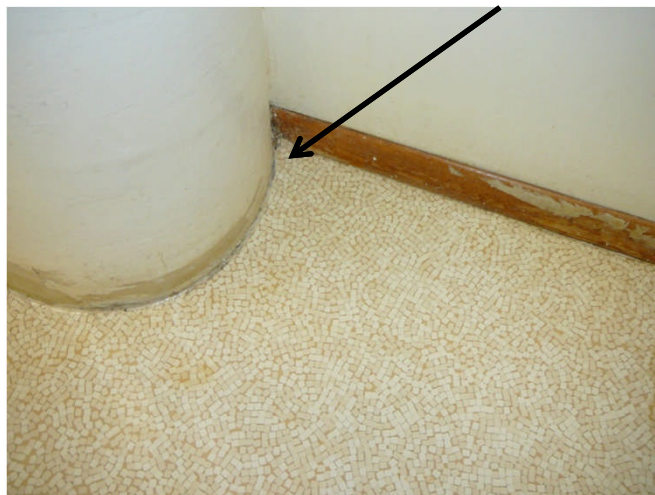
#1: Administration Office

Sample A49: Brown square linoleum on basement conference room floor

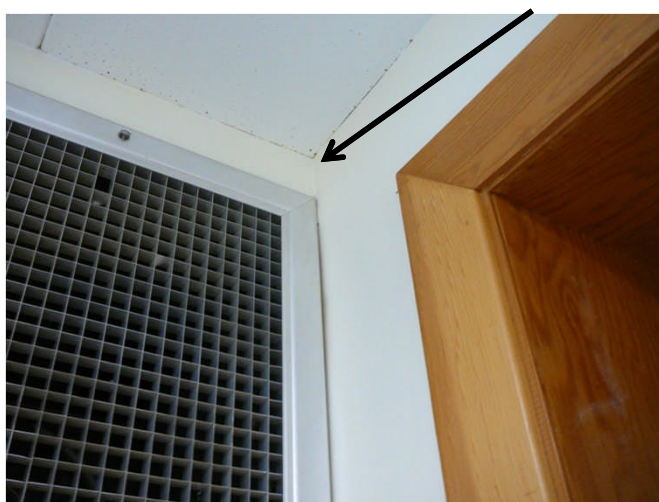
#1: Administration Office

Sample A51: Drywall mud on basement conference wall

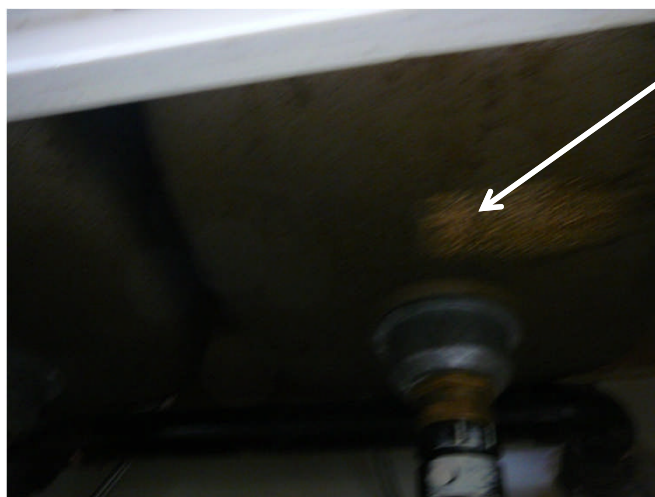
#1: Administration Office

Sample A53: Sink insulation in basement kitchen

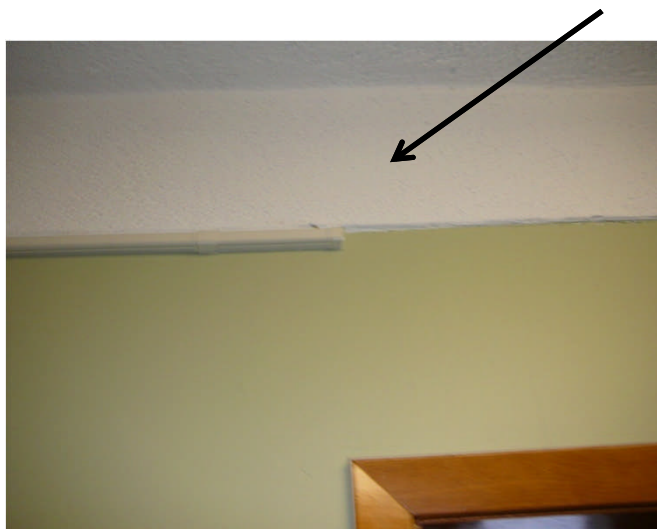
#1: Administration Office

Sample A60: White ceiling texture on main floor hall ceiling

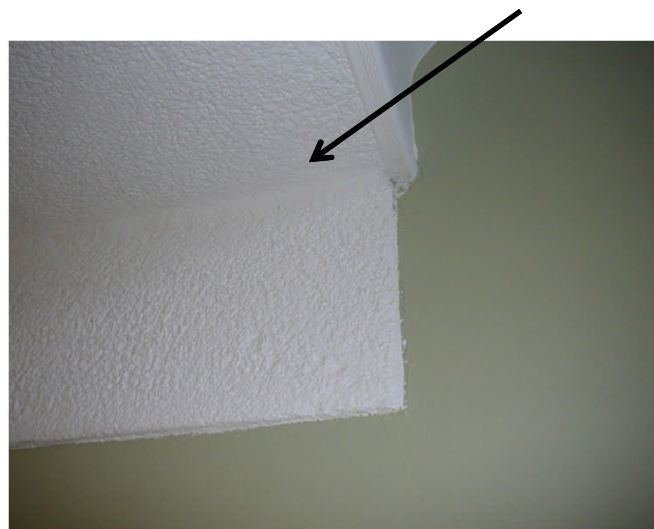
#1: Administration Office

Sample A61: White ceiling texture at east stairs

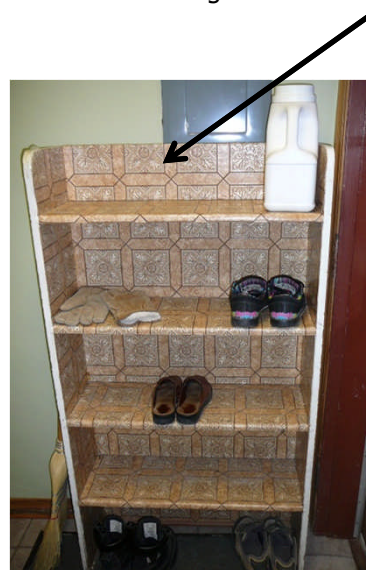
#1: Administration Office

Sample A33: Brown linoleum on shoe rack in east stairwell.

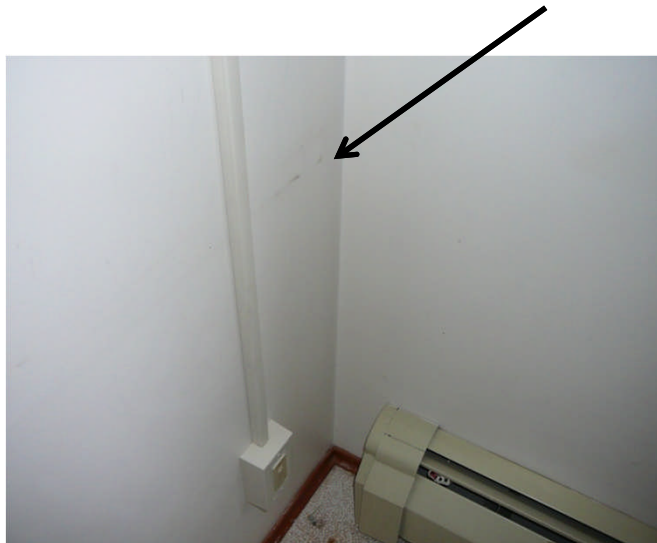
#1: Administration Office

Sample A68: Drywall mud on office 20 wall

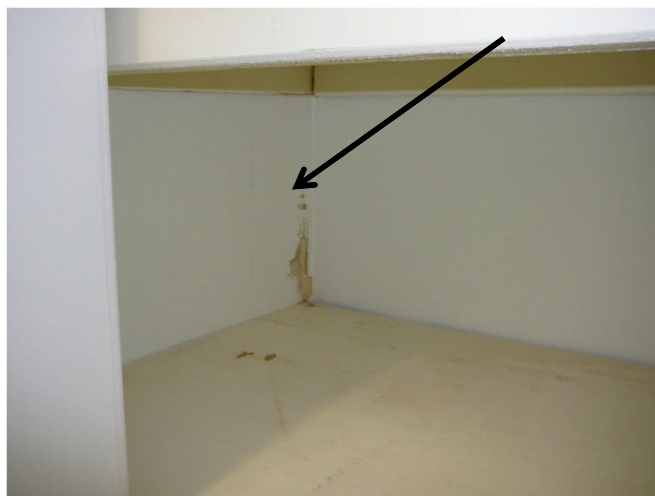
#10: Canola Laboratory

Sample A126: Drywall mud on second level office 6 wall

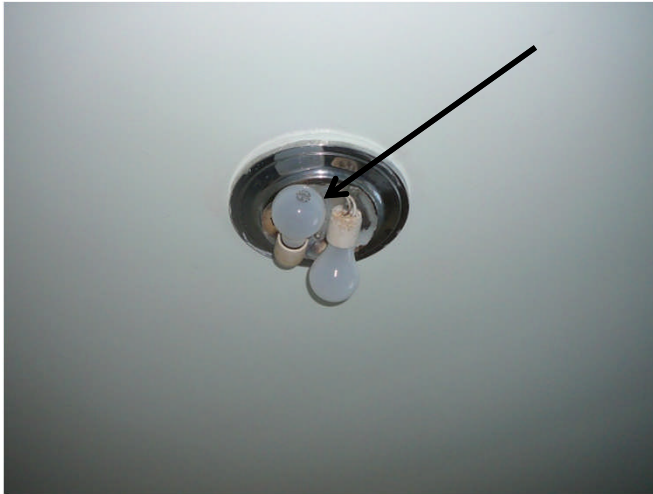
#10: Canola Laboratory

Sample A96: Black/silver light insulation from fixture in second level Office 4

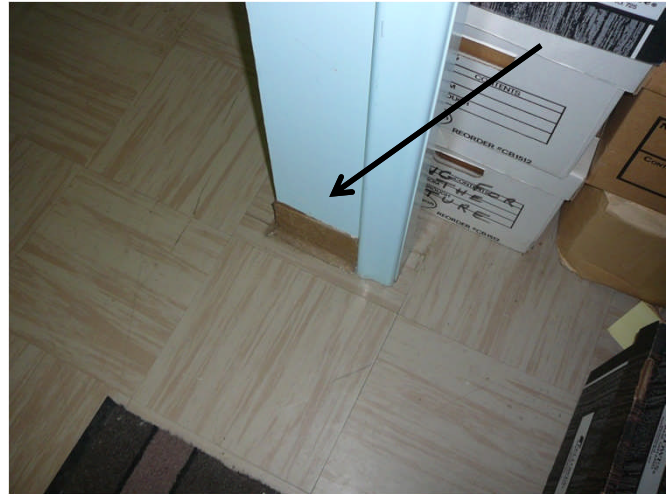
#10: Canola Laboratory

Sample A98: Brown 12x12 floor tile on Office 5 floor

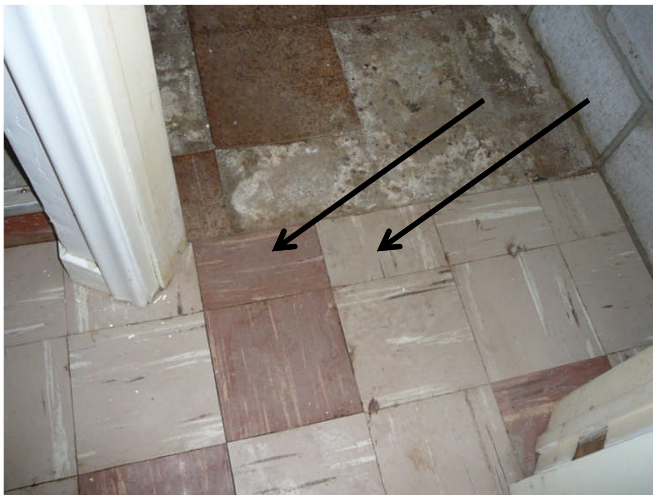
#10: Canola Laboratory

Sample A116 & A117: Light brown & Dark brown 9x9 floor tile on Storage 8 floor

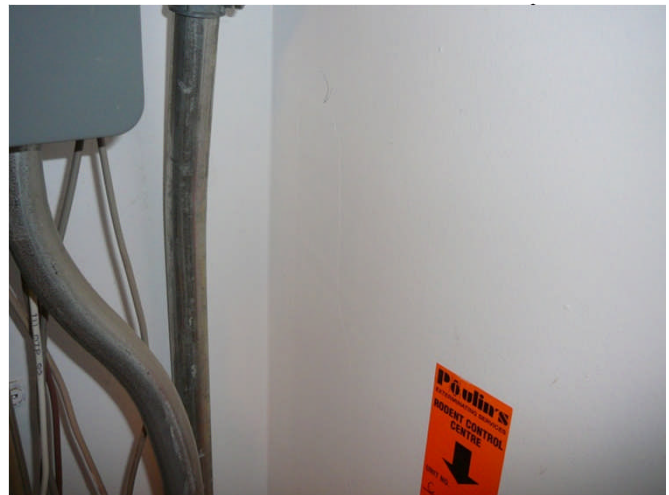
#10: Canola Laboratory

Sample A129: Drywall mud on main level under electrical box wall

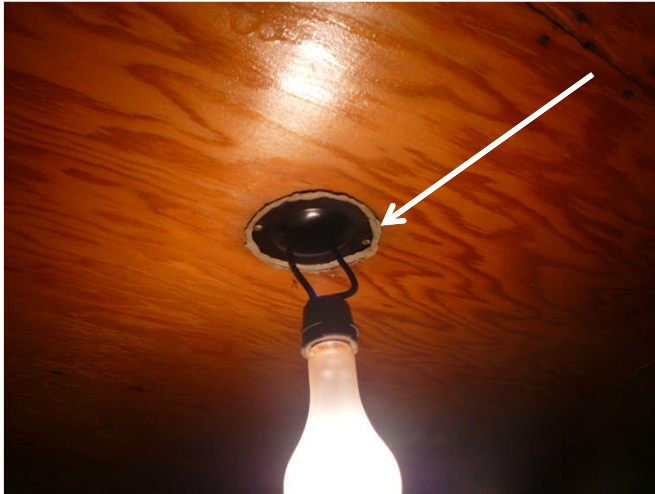
#10: Canola Laboratory

Sample A119: Gray caulking around light in basement storage 8

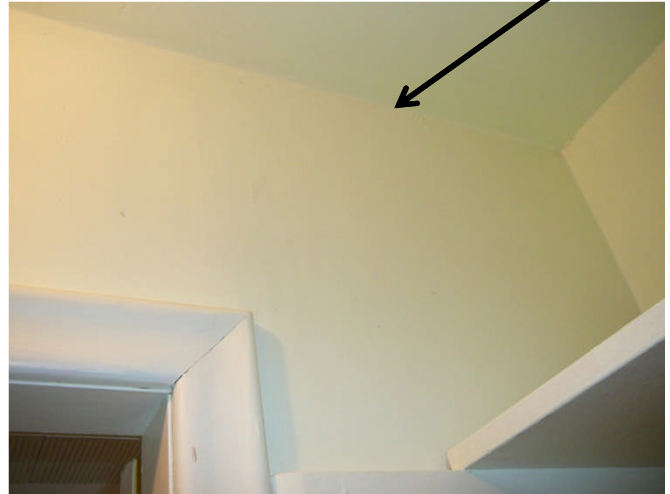
#10: Canola Laboratory

Sample A128: Drywall mud on closet wall of in 2nd floor storage

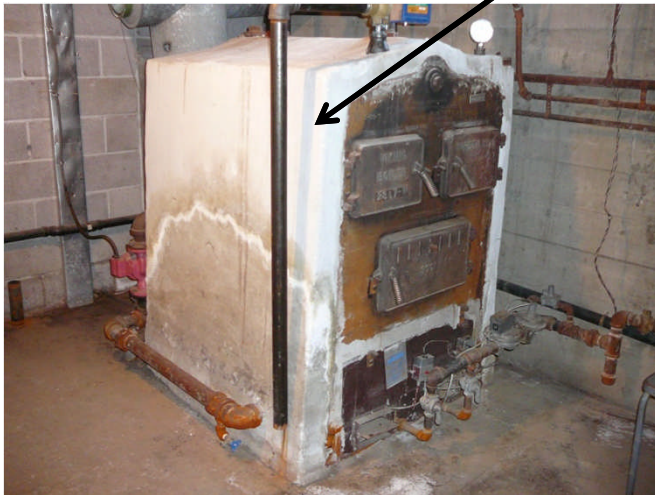
#10: Canola Laboratory

Sample A121: White insulation covering boiler in furnace room

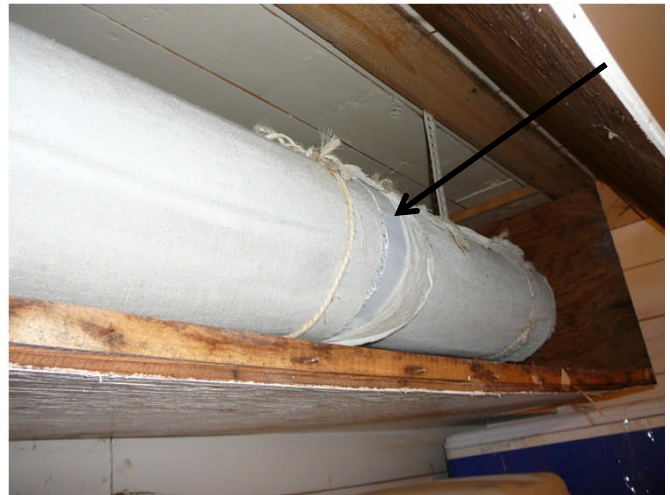
#10: Canola Laboratory

Sample A120: White airocell insulation on basement storage 6 pipe

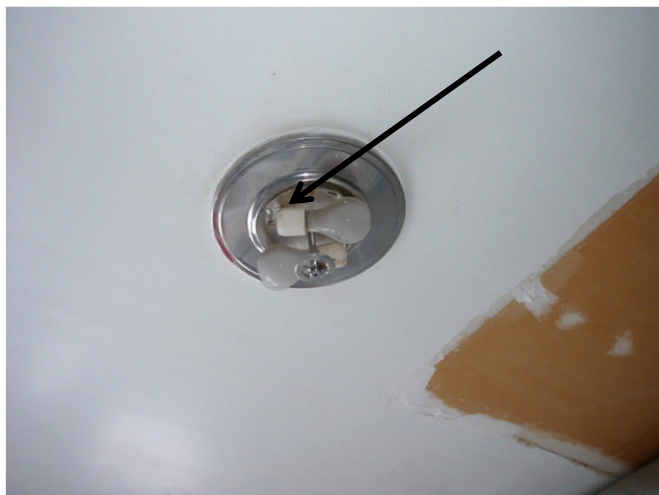
#10: Canola Laboratory

Sample A102: Black/silver light insulation from fixture in main level storage room

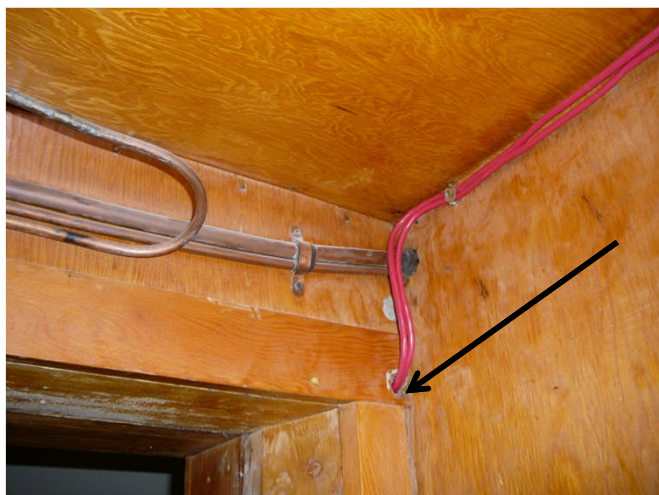
#10: Canola Laboratory

Sample A118: Black caulking around wiring in basement storage 5

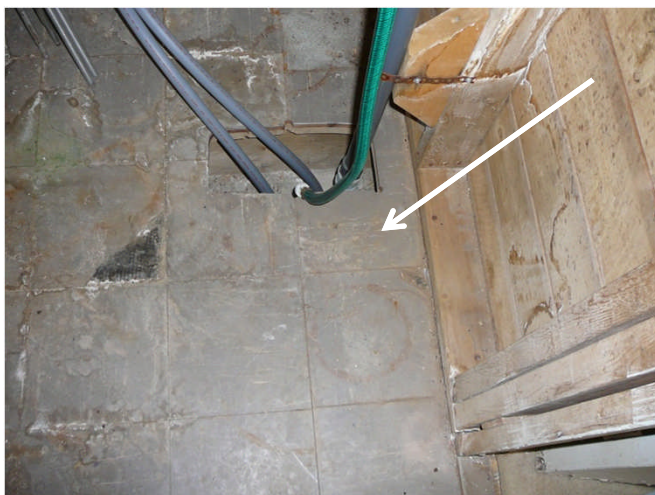
#14: Soils Research Building

Sample A167: Dark gray 9x9 floor tile on second floor power panel room floor

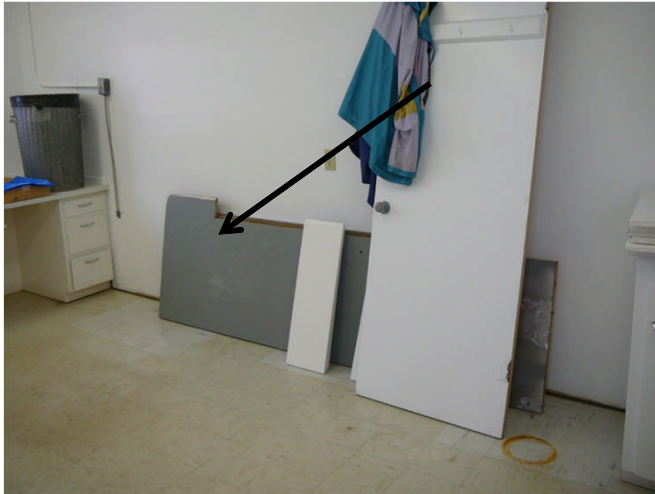
#14: Soils Research Building

Sample 139: Gray cement board stored in main level southwest lab

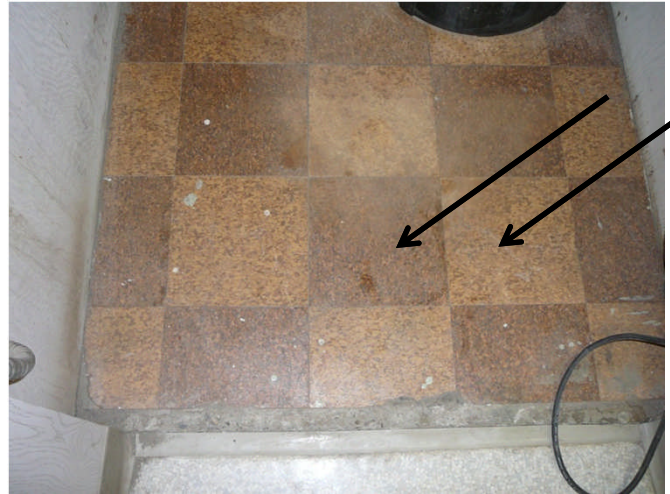
#14: Soils Research Building

Sample A153 & A154: Light brown & dark brown 9x9 floor tile under the stairwell

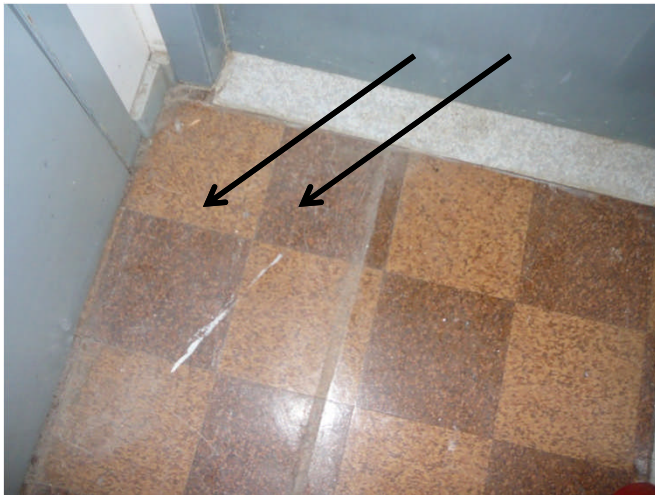
#14: Soils Research Building

Sample A155 & A156: Light brown & dark brown 9x9 floor tile on the main level northwest lab floor

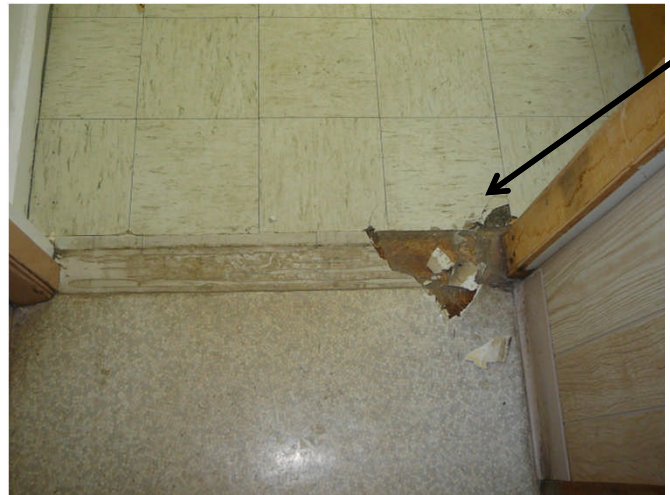
#14: Soils Research Building

Sample A135: Gray 12x12 floor tile on main entry floor under the linoleum

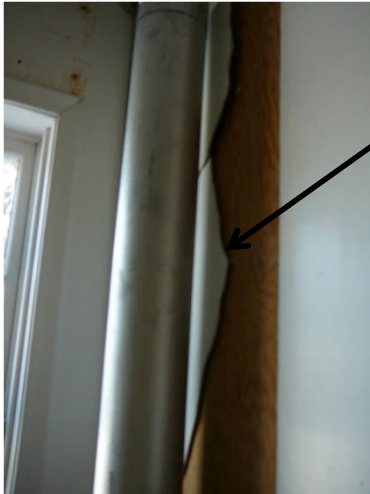
#14: Soils Research Building

Sample A176: White/gray cement board in 2nd floor hall

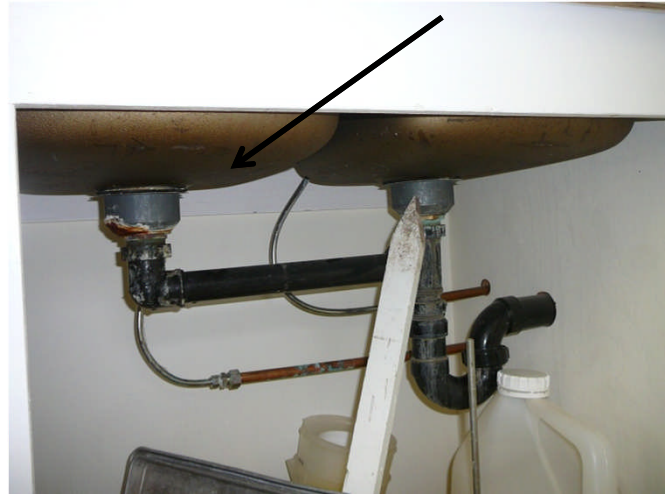
#14: Soils Research Building

Sample A141: Bronze sink insulation in southwest lab

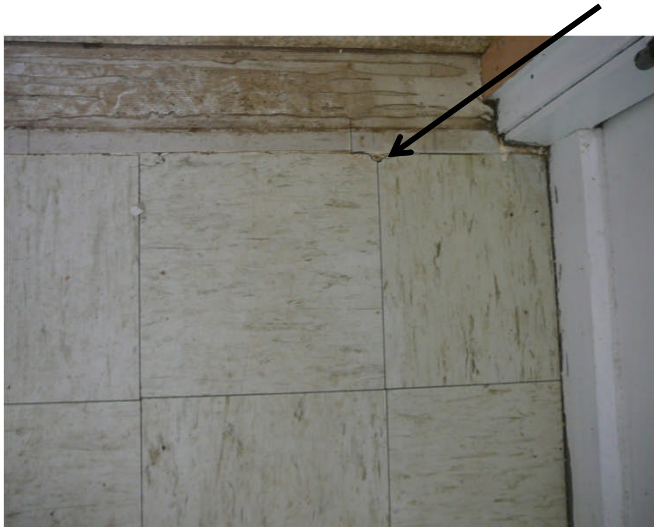
#14: Soils Research Building

Sample A143: White/gray 9x9 floor tile on floor in main level southwest lab

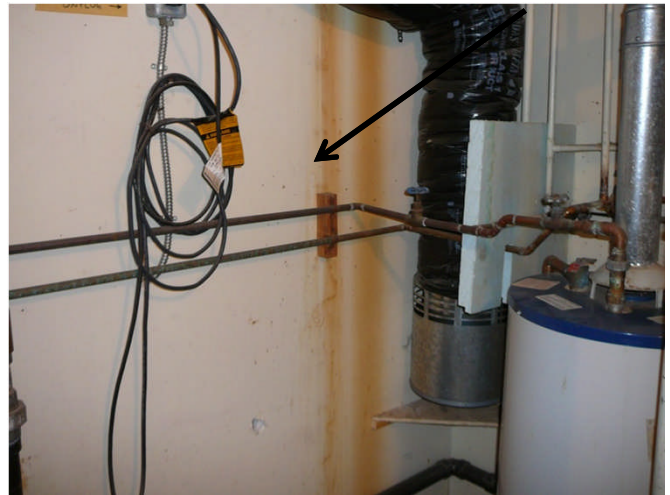
#14: Soils Research Building

Sample A146: Drywall mud on furnace room wall.

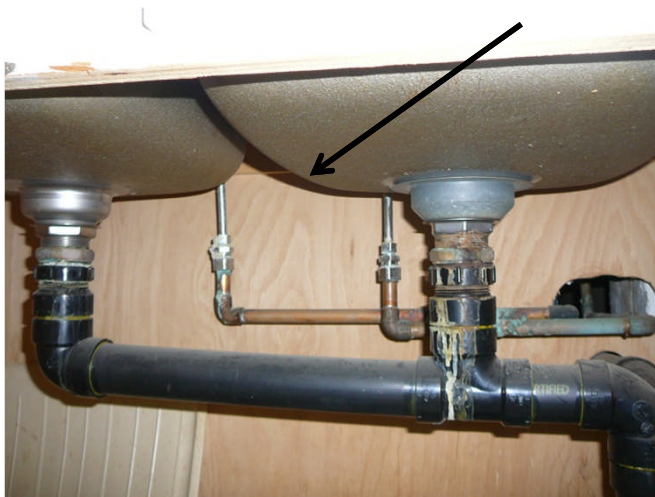
#14: Soils Research Building

Sample A160: Gray sink insulation in main level northeast lab

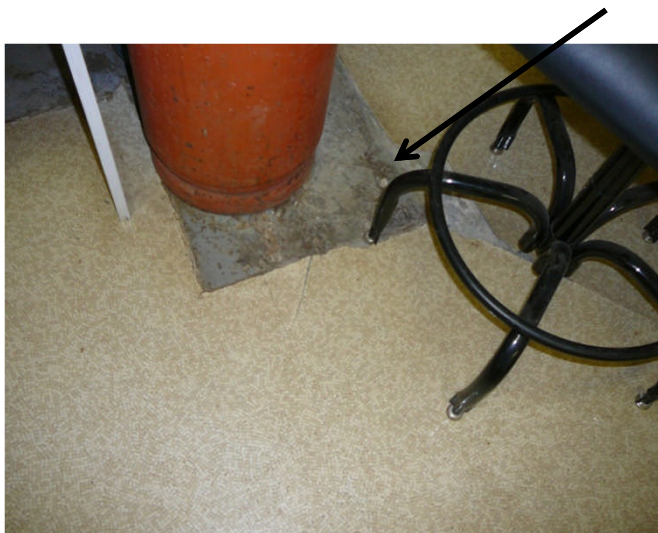
#14: Soils Research Building

Sample A162: Brown square linoleum on main level northeast lab floor

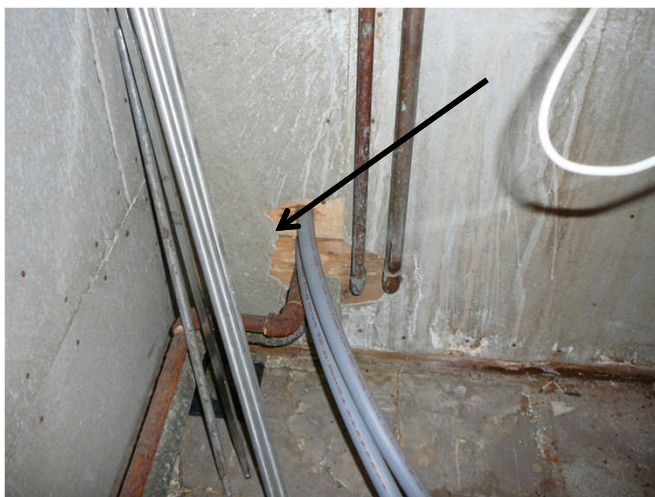
#14: Soils Research Building

Sample A166: Gray transite board in the 2nd level power panel room

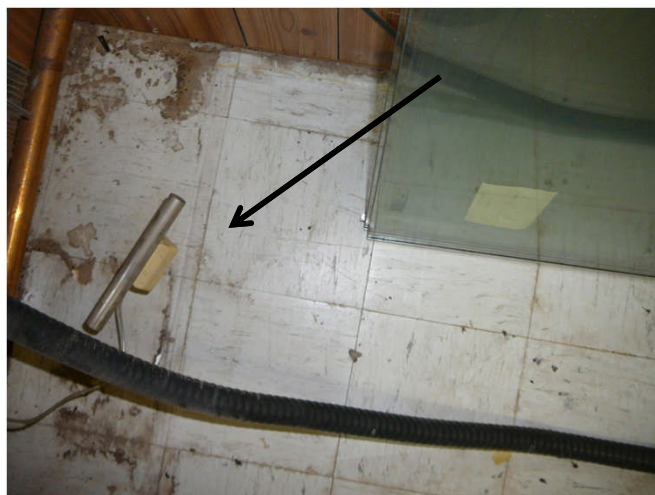
14: Soils Research Building

Sample A171: White/gray 9x9 floor tile on 2nd level lab 1 floor

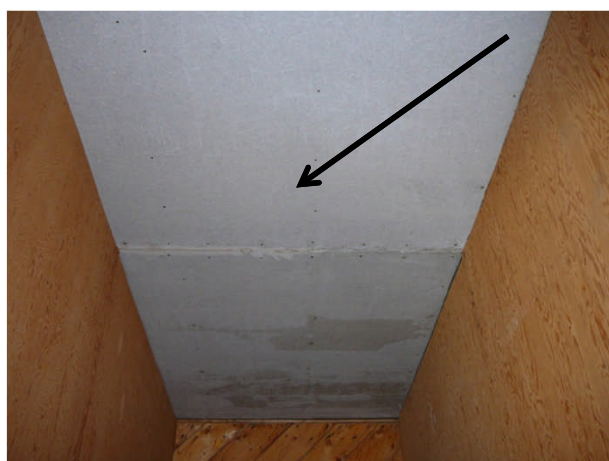
#14: Soils Research Building

Sample A177: White/gray cement board in 2nd level office 1 stairwell

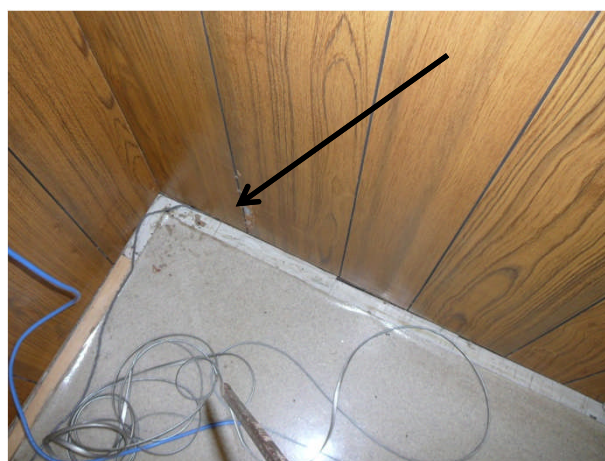
14: Soils Research Building

Sample A178: White/gray 9x9 floor tile on 2nd level office 2 floor

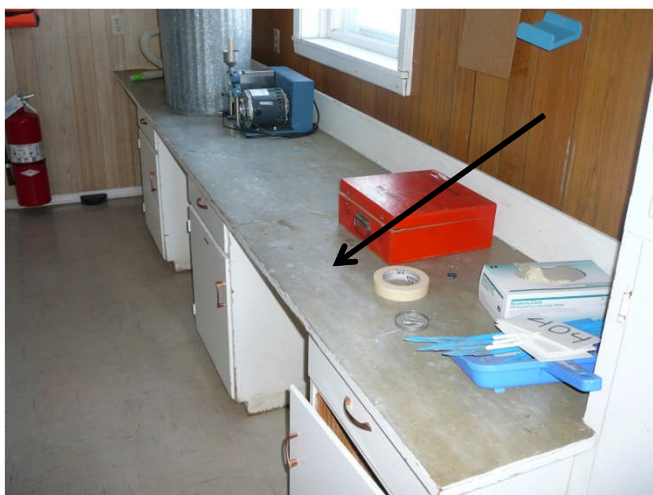
#15: Ecology Building

Sample A11: Gray counter top on main level north lab

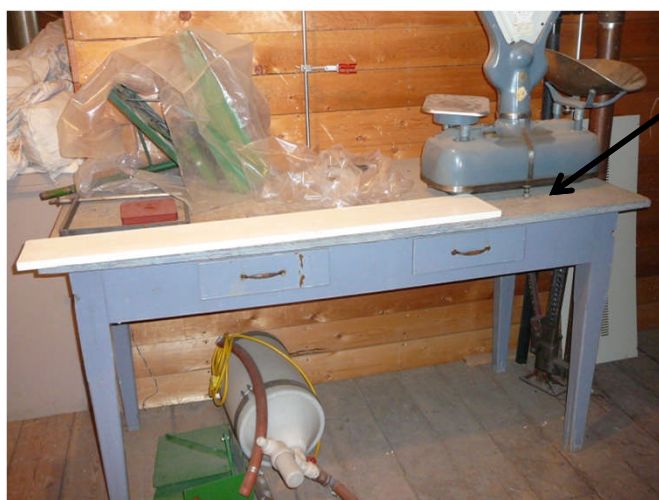
#15: Ecology Building

Sample A20: Gray counter top on 2nd level desk

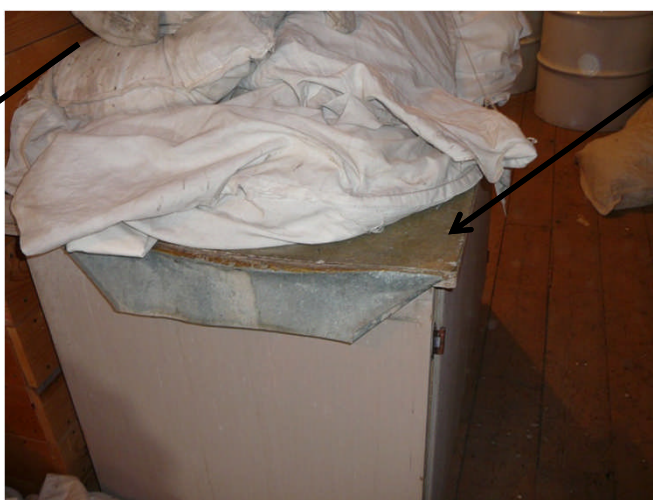
#15: Ecology Building

Sample A21: Green counter top on 2nd level desk

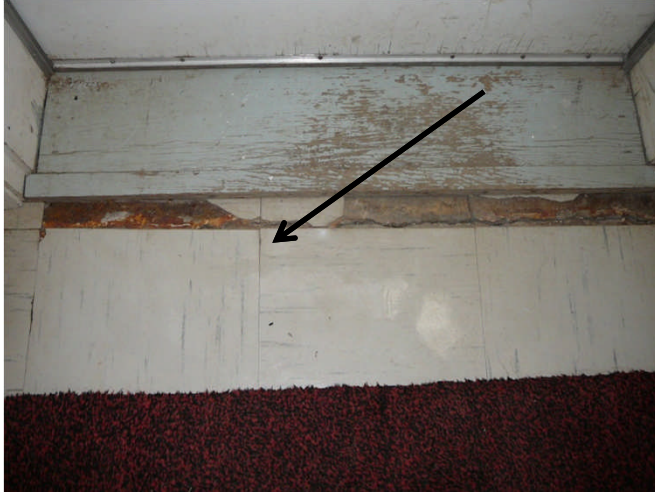
#15: Ecology Building

Sample A7: White/blue 12x12 floor tile on main entrance hall floor

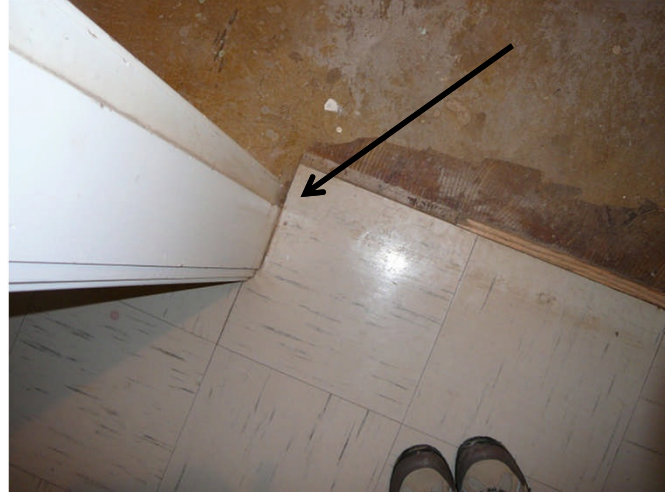
#15: Ecology Building

Sample A18: White/blue 12x12 floor tile on main Hall floor

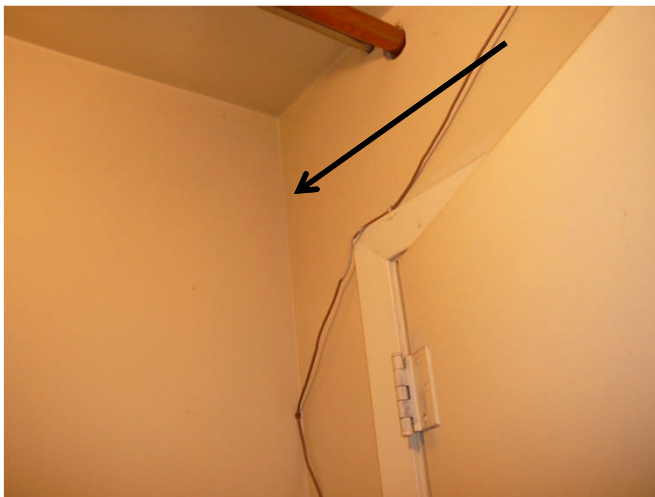
#15: Ecology Building

Sample A15: Drywall mud on furnace room wall

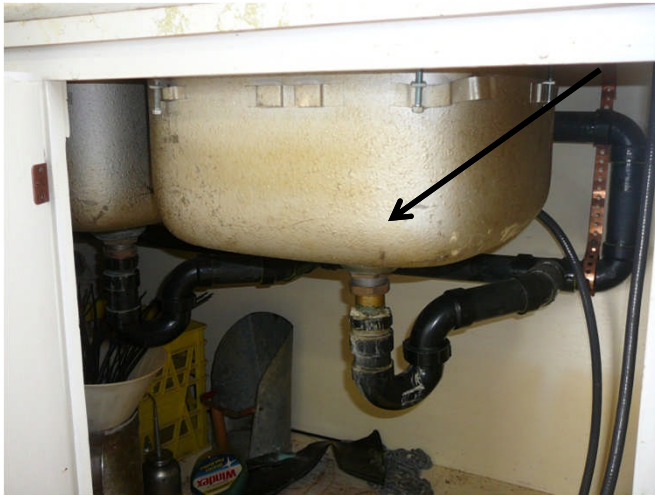
#15: Ecology Building

Sample A1: White/silver sink insulation in main level south lab

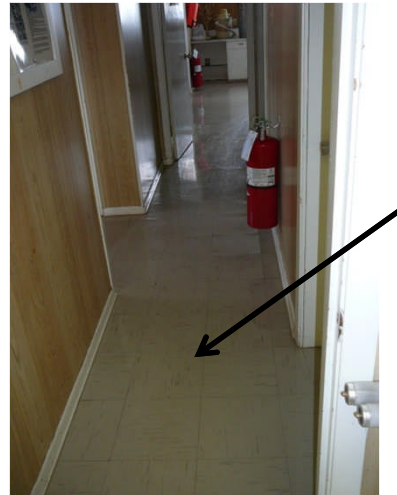
#15: Ecology Building

Sample A3: White/gray 9x9 floor tile on main level south lab floor

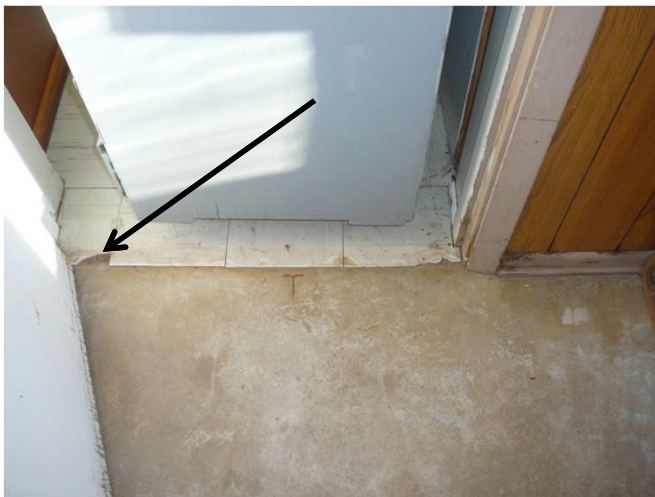
#15: Ecology Building

Sample A4: White/gray 9x9 floor tile on main level south lab floor

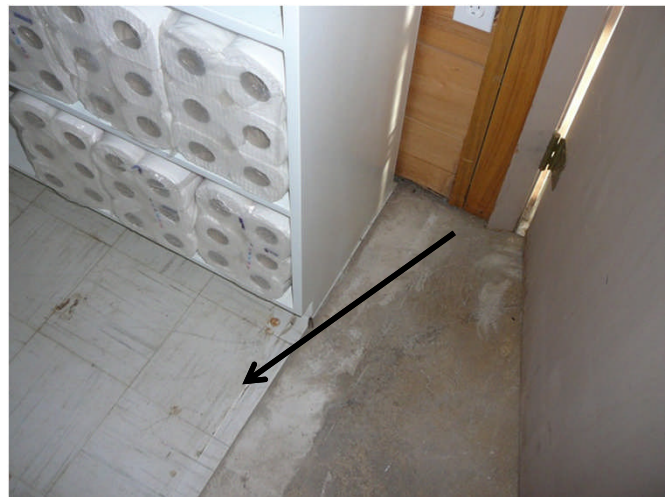
#15: Ecology Building

Sample A5: White/gray 9x9 floor tile on main level south storage floor

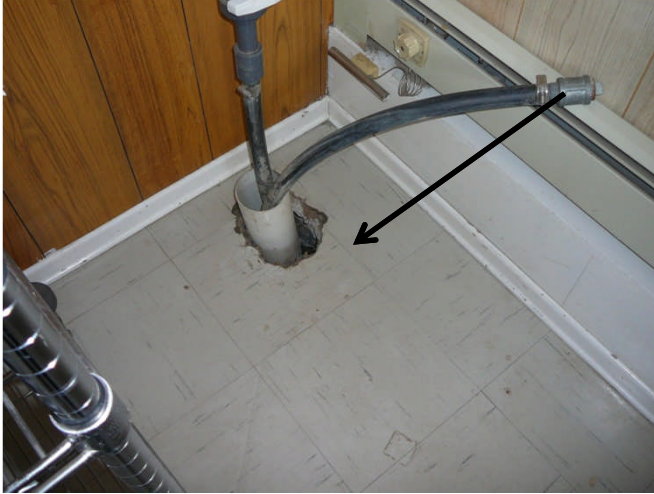
#15: Ecology Building

Sample A8: White/blue 12x12 floor tile on main level office floor

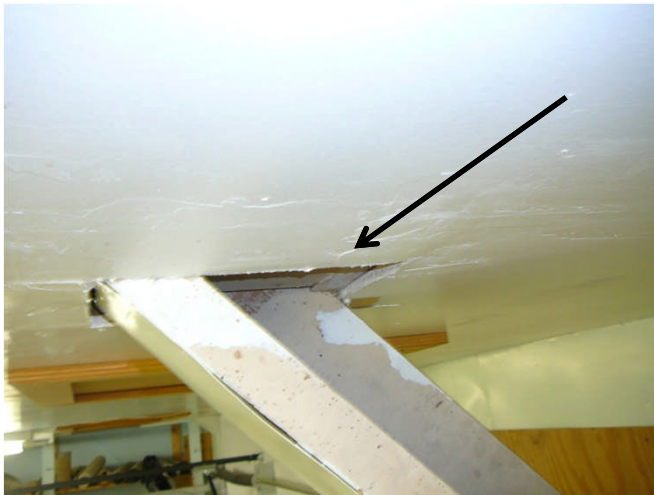
#17: Carpenter Shop

Sample A184: Drywall mud on garage ceiling
