**HAZARDOUS MATERIALS INVESTIGATION
LACOMBE, BEAVERLODGE AND FORT VERMILLION
RESEARCH CENTRES**

April 12, 2011 Revised March 2013
File No. 11166

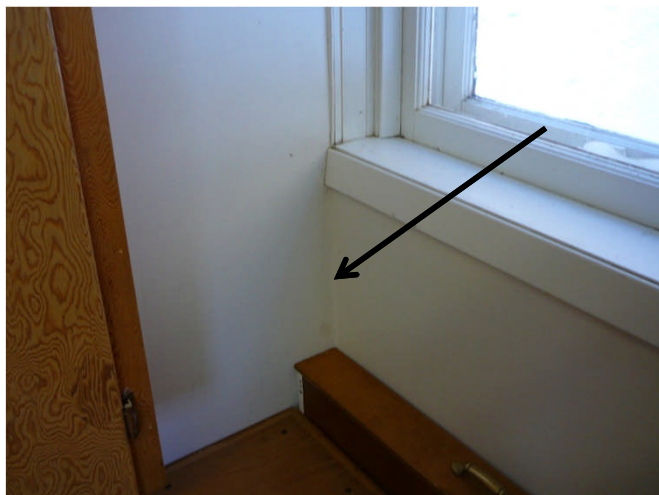
#17: Carpenter Shop

Sample A186: Drywall mud on office wall

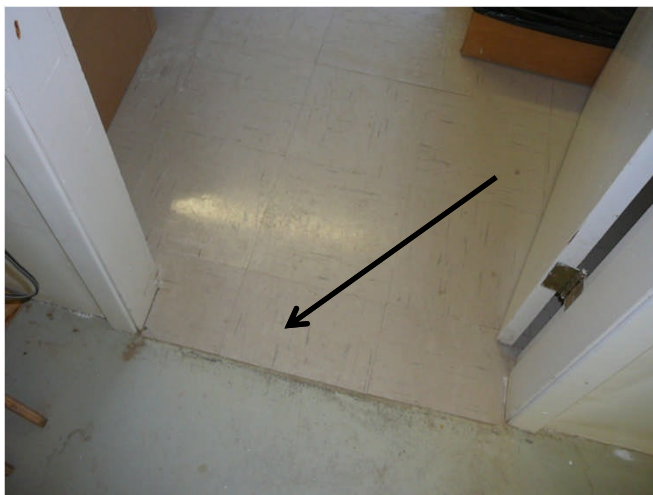
#17: Carpenter Shop

Sample A187: Gray 12x12 floor tile on office floor

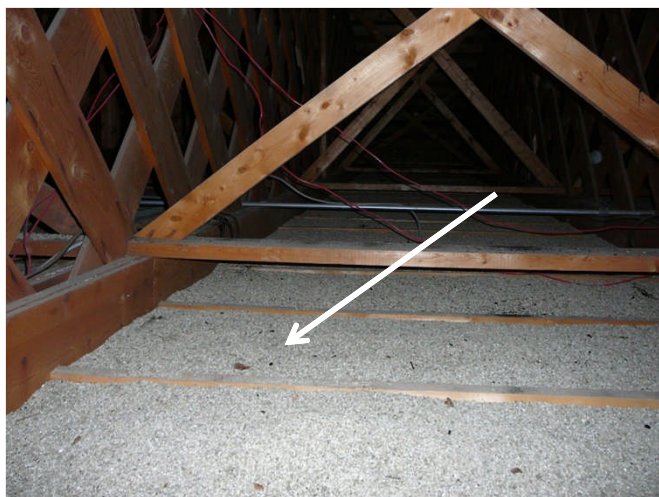
#17: Carpenter Shop

Sample A181: Brown/silver vermiculite in the attic

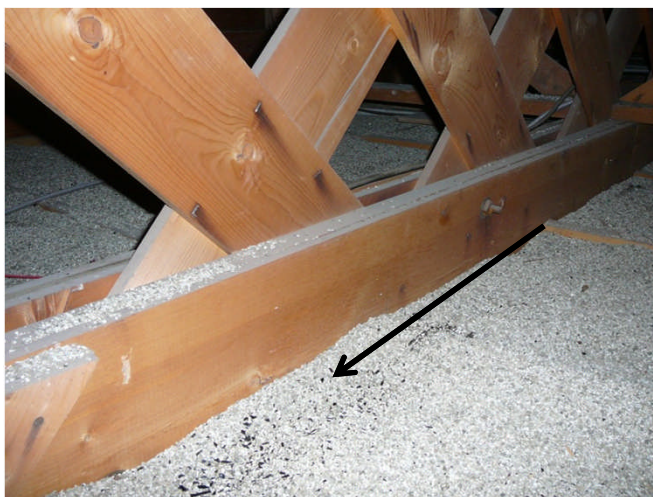
#17: Carpenter Shop

Sample A182: Brown/silver vermiculite in the attic

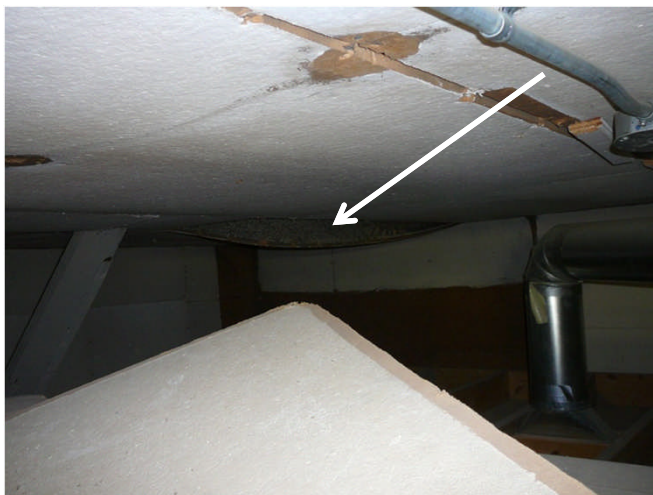
#17: Carpenter Shop

Vermiculite spillage in crawlspace above office

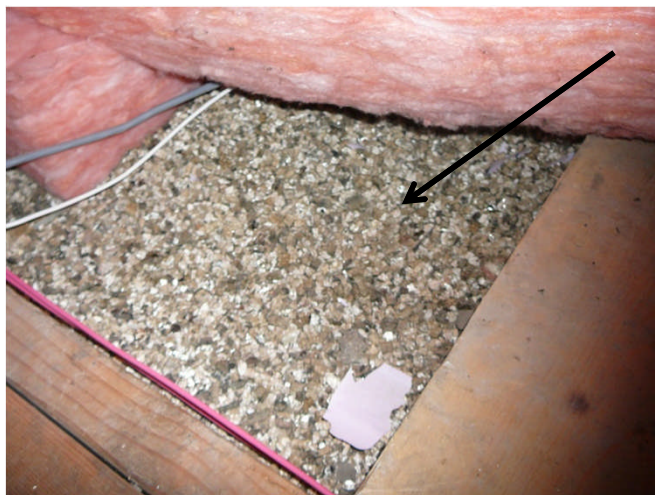
#18: Apiculture Laboratory

Sample A89, A90 & A91: Vermiculite in the attic

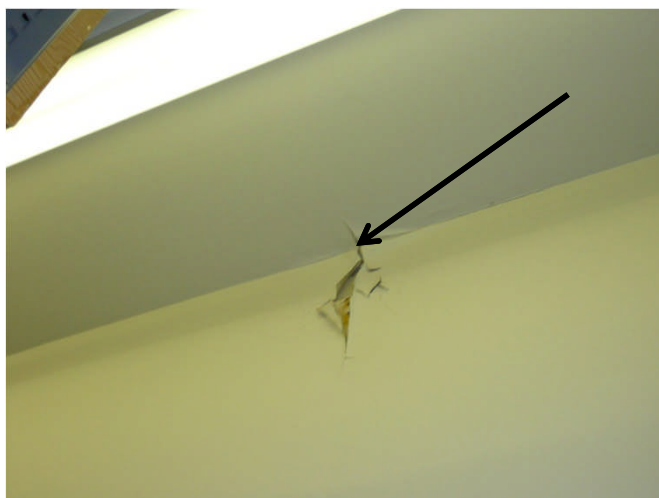
#26: Storage

Sample A206: Gray/white cement board on the furnace room wall

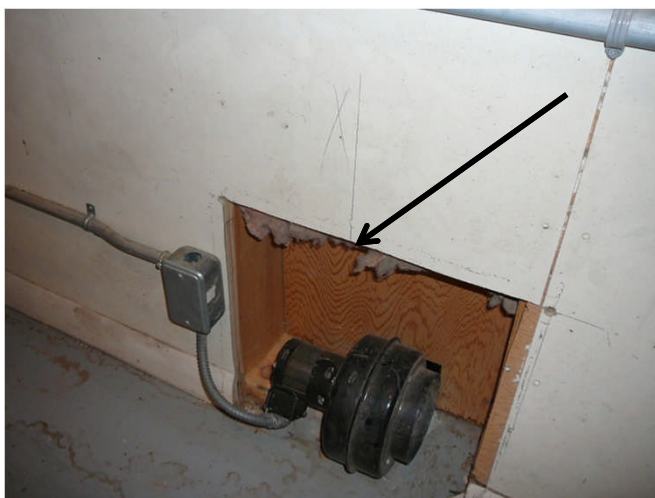
#26: Storage

Sample A208: Drywall mud on air drying room wall

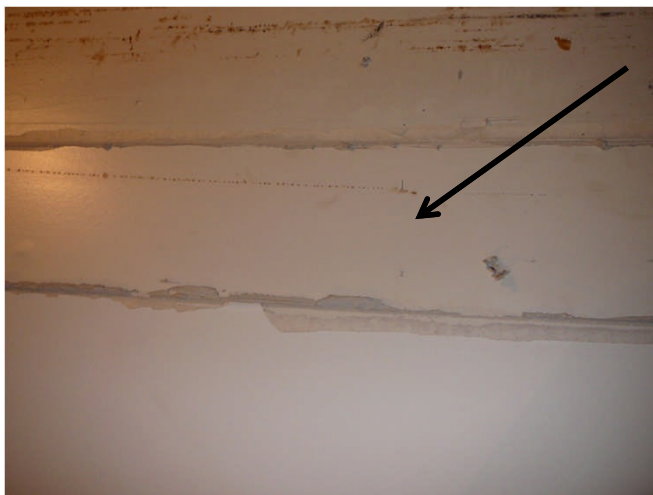
#26: Storage

Sample A216: Drywall mud on Women's washroom wall

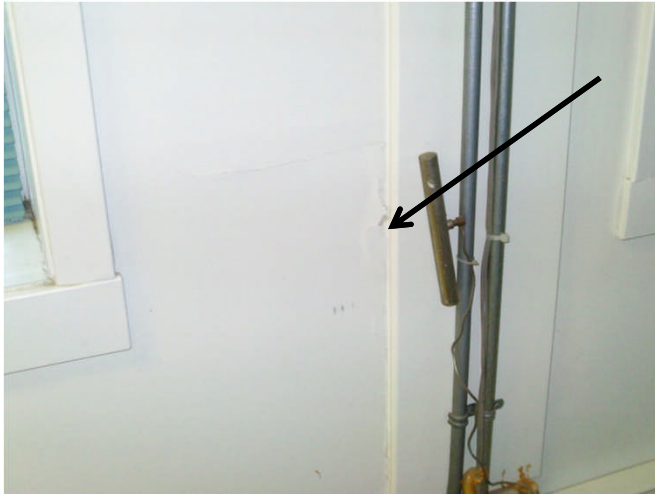
#26: Storage

Sample A224: Drywall mud on main hall wall

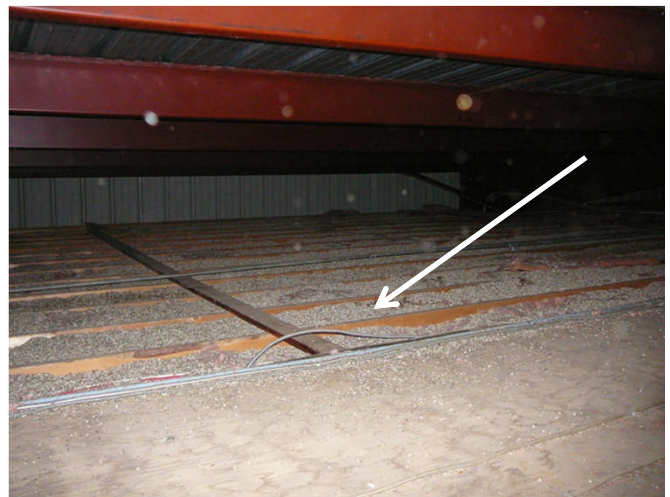
#26: Storage

Sample A226: Brown/silver vermiculite in attic

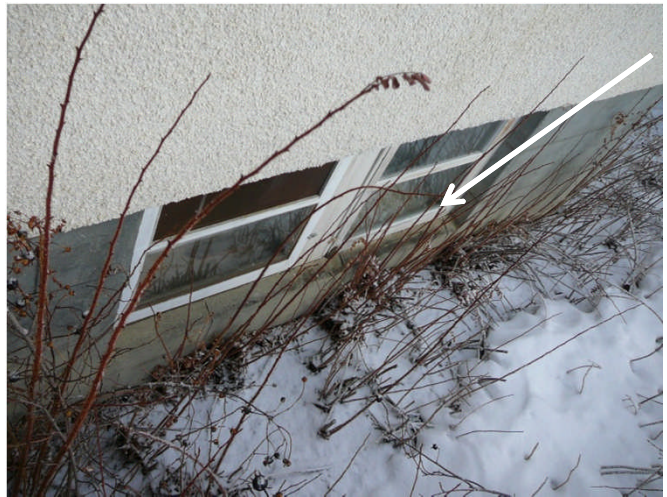
#10: Canola Laboratory

Sample P31: White paint on exterior trim

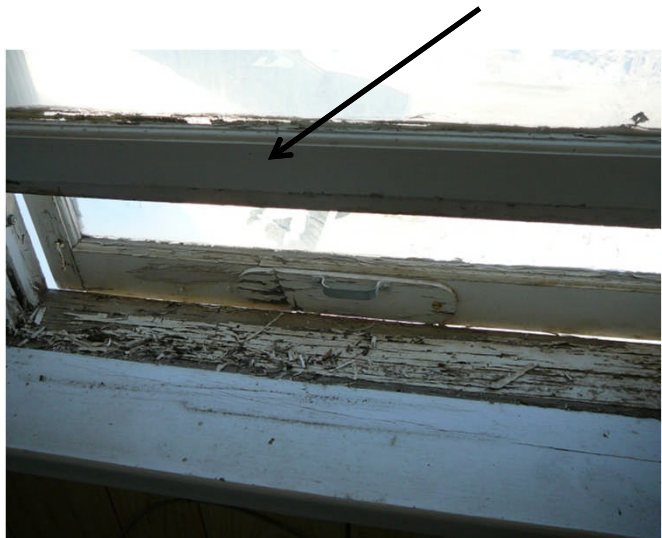
#14: Soils Research Building

Sample P36: White paint on trim in lab 2

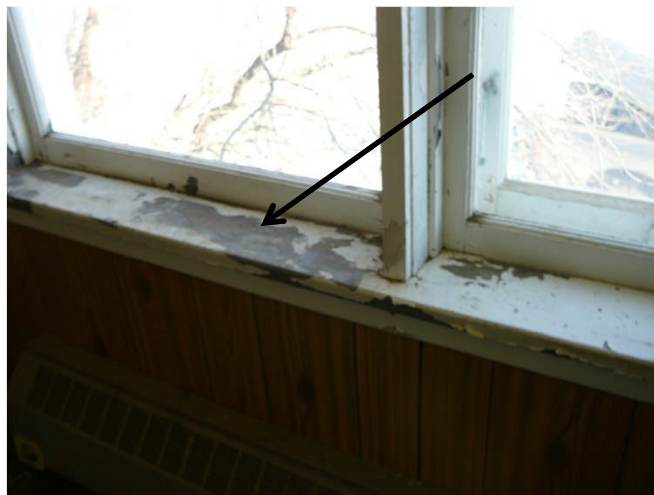
#15: Ecology Laboratory

Sample P10: White paint on 2nd floor walls

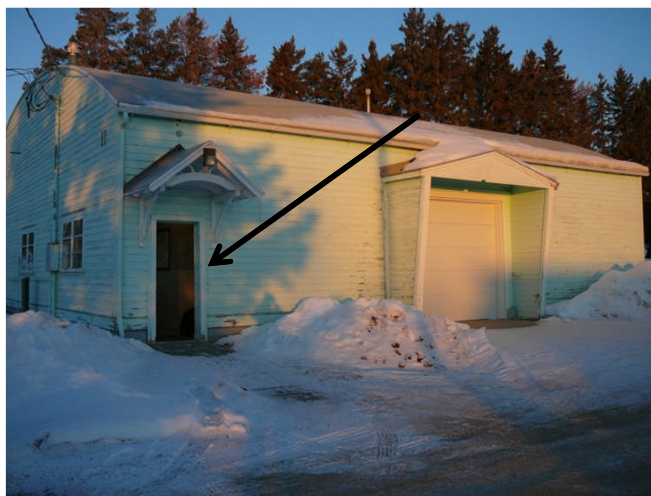
#18: Apiculture Laboratory

Sample P20: White paint on west side of exterior wall

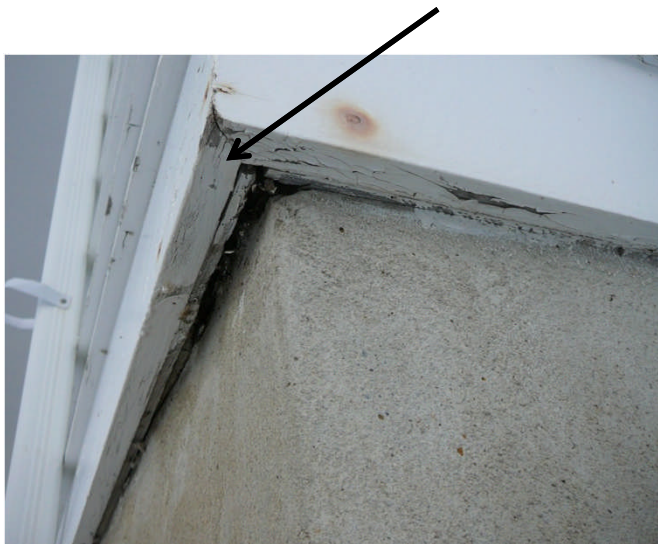
#15: Ecology Building

Example of water intrusion on fume hood vent

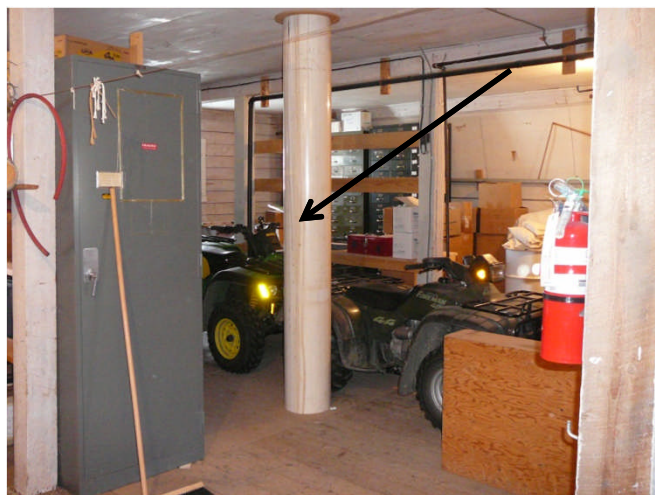
#10: Canola Laboratory

View of flood line in basement

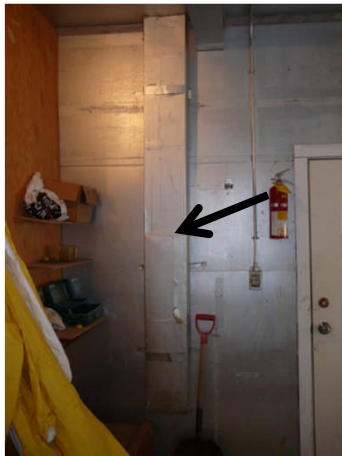
#33 Processing and Carpenter Shop
Sample A1 : Duct insulation containing asbestos

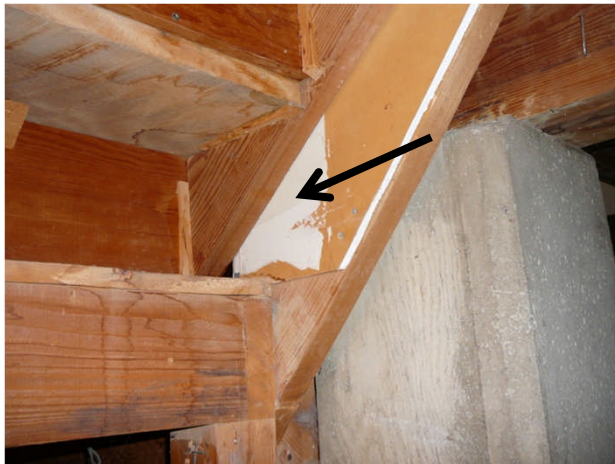
#60 Duplex House
Sample A15 : Drywall mud containing asbestos

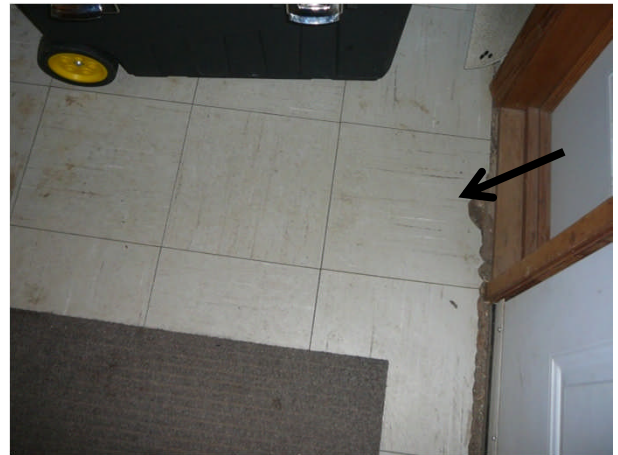
#60 Duplex House
Sample A17 : Floor tile containing asbestos

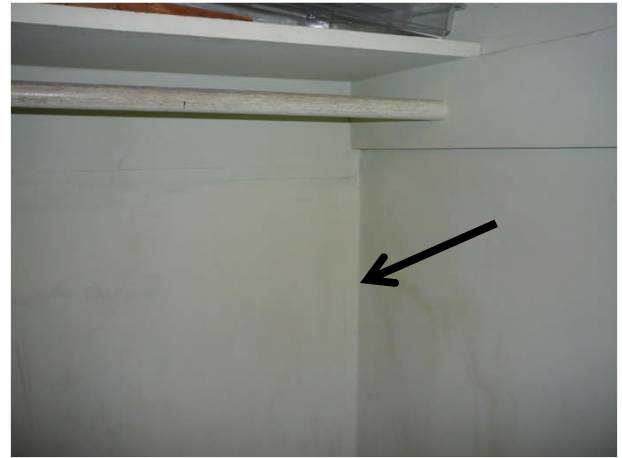
#60 Duplex House

| Building | Floor | Room | Description | Ceiling | Walls | Floor | Misc. | Ceiling Color | Wall Color | Floor Color/Pattern | Ceiling Tile Size | Asbestos Sample | Sample ID | Location | Paint Sample | Sample ID | Location | Result |
|---|---|---|---|---|---|---|--|---|---|---|---|---|---|---|---|---|---|---|
| 60: Duplex House | Second | Conference Room | conference room | tile | drywall | hardwood | closet: green paint & mould & water damage | white | white over green | - | - | drywall putty | A20 | south closet | - | - | - | positive |

Sample A20 : Drywall mud containing asbestos

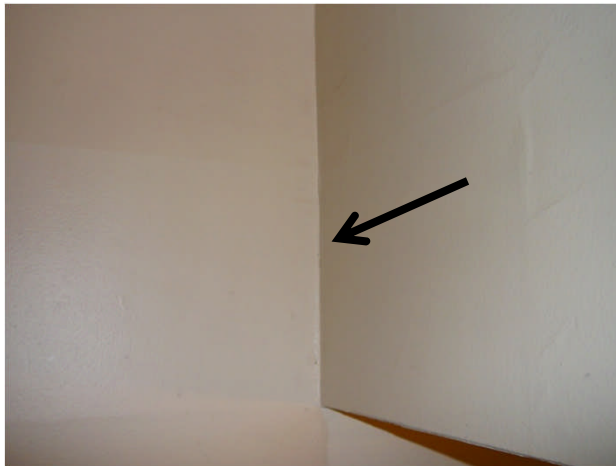
#60 Duplex House

Sample A23 : Drywall mud containing asbestos

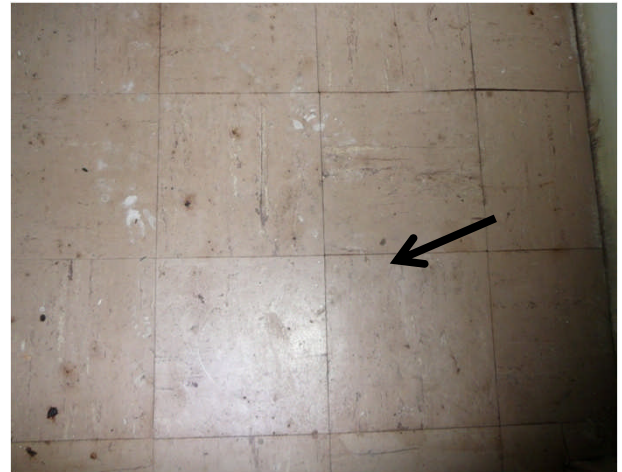
#2 Administration Office

Sample A35 : Floor tile containing asbestos

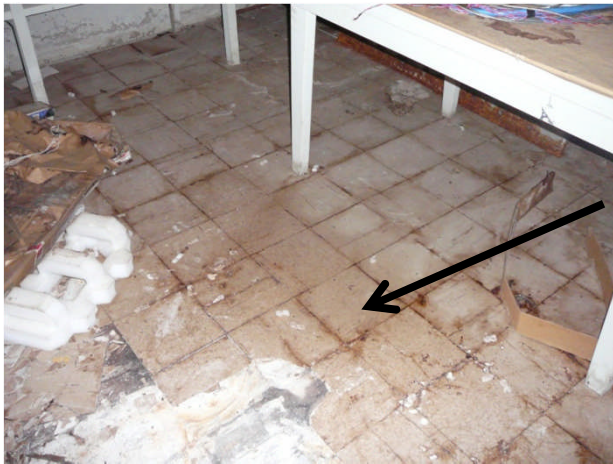
#2 Administration Office

Sample A36 : Floor tile containing asbestos

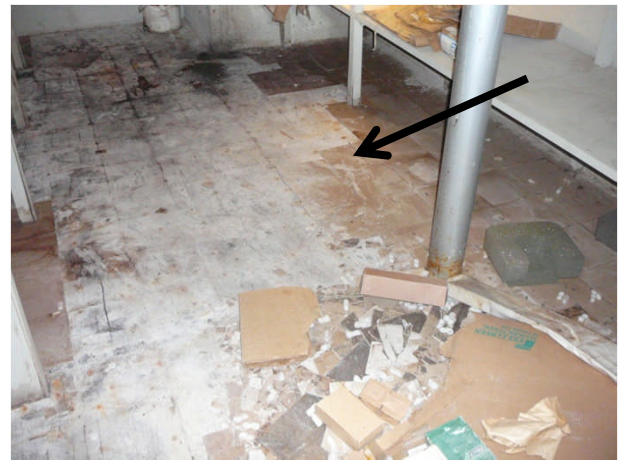
#2 Administration Office

Sample A37 : Floor tile containing asbestos

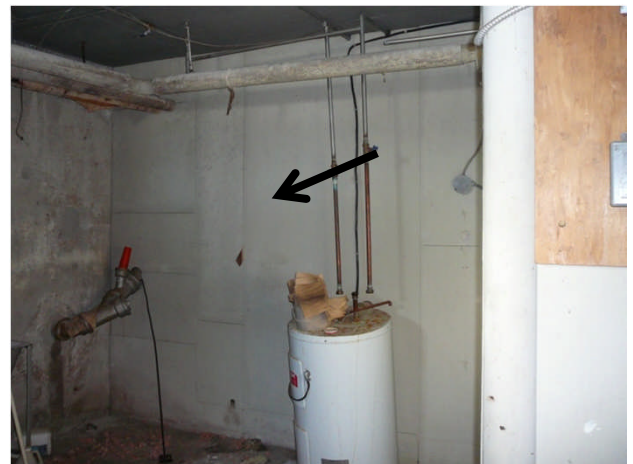
#2 Administration Office

Sample A41 : Transite board containing asbestos

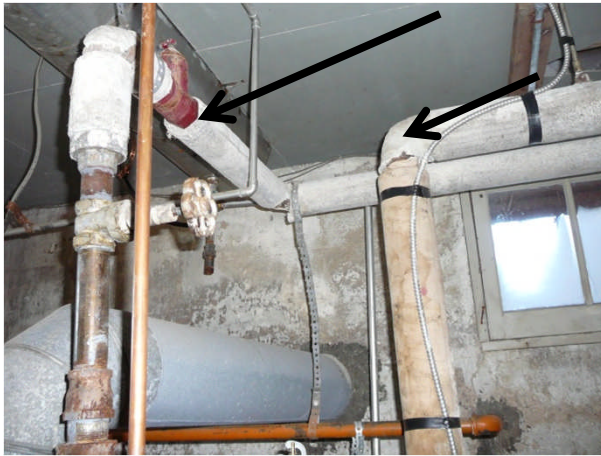
#2 Administration Office

Sample A42 & A43 : Pipe insulation containing asbestos

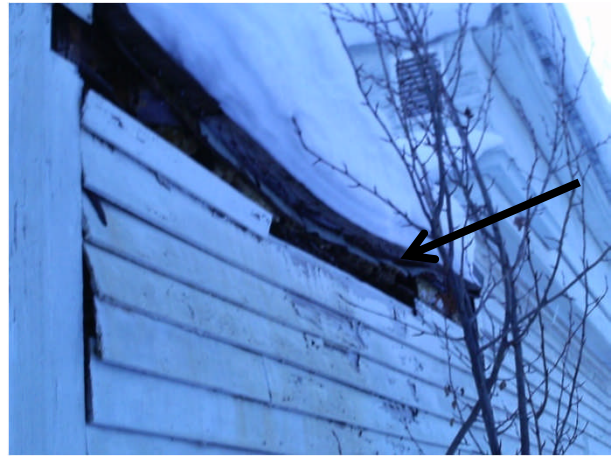
Pump House

Sample A70 & A71: Vermiculite insulation containing asbestos

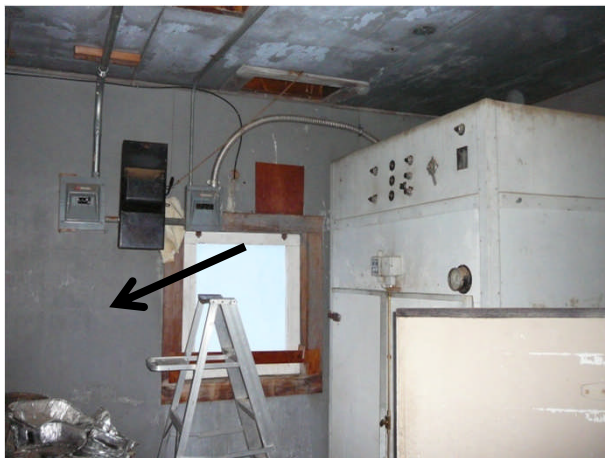
#37 Drying Shed

Sample A72 : Transite board containing asbestos

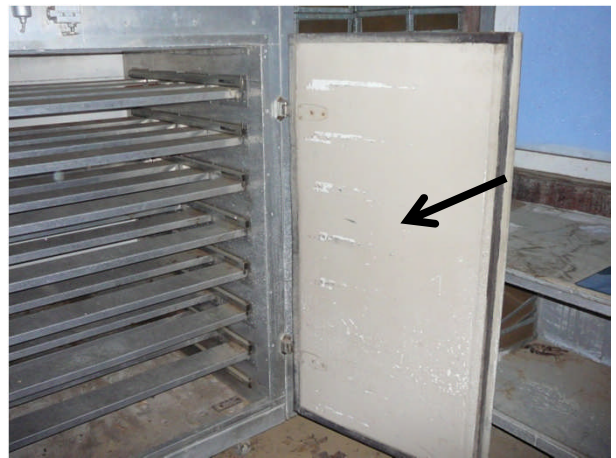
#37 Drying Shed

Sample A73 : Insulation board containing asbestos

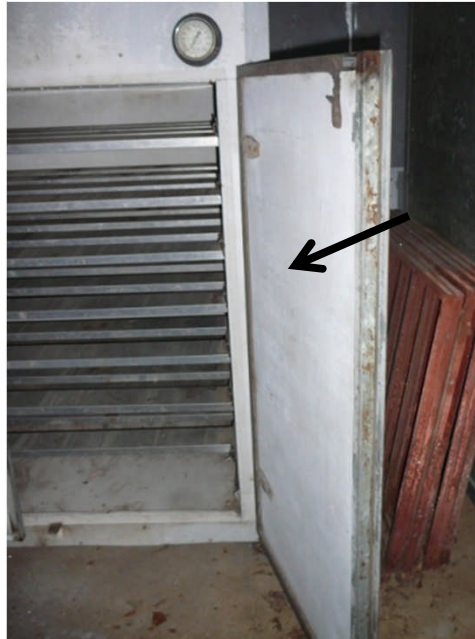
#37 Drying Shed

Sample A76: Insulation board containing
asbestos

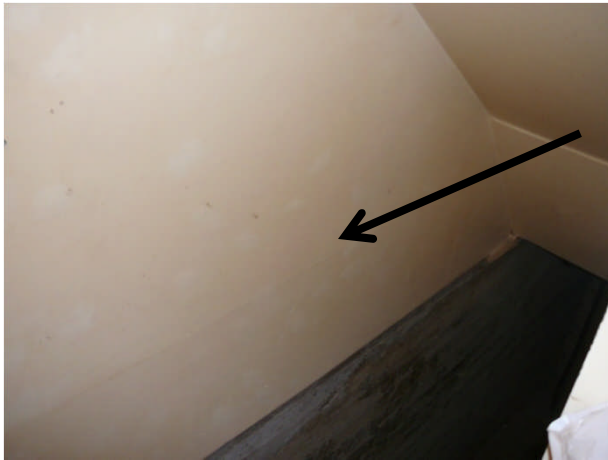
#60 Duplex House

Sample P10 : Yellow paint containing lead

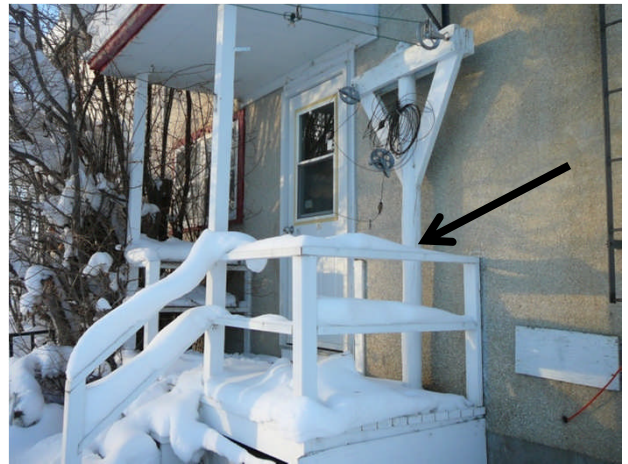
#60 Duplex House

Sample P13 : White paint containing lead

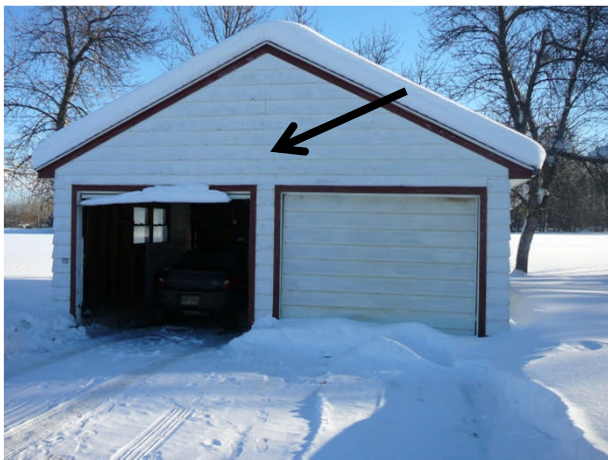
#60A Garage

Sample P14: White paint containing lead

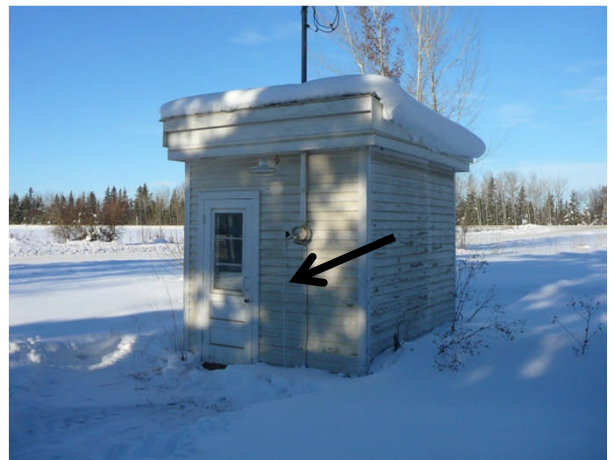
#57 Sewage Lift Pump House

Sample P15: White paint containing lead

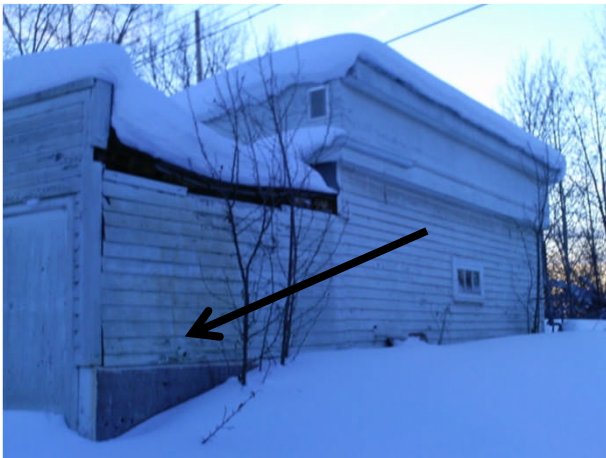
Pump House

Sample P23: White paint containing lead

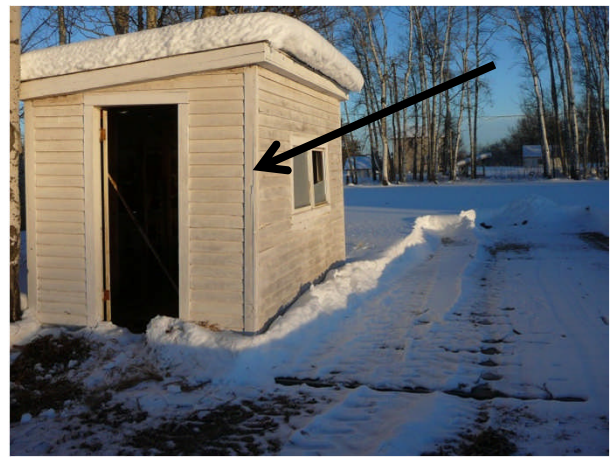
#62 Weigh Scale

Sample P26 : White paint containing lead

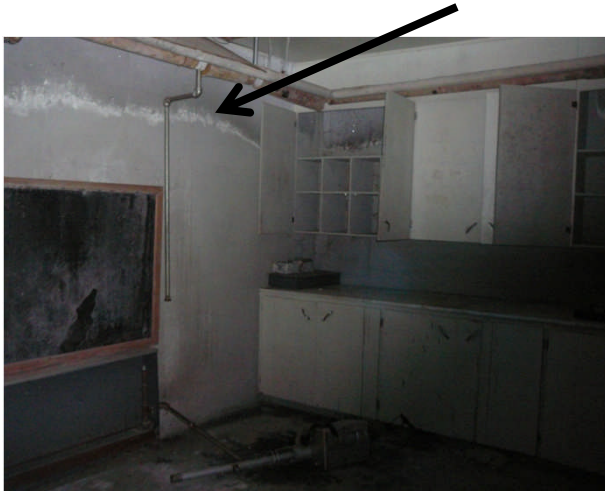
#2 Administration Office - Basement
Suspected high water mark from flooding

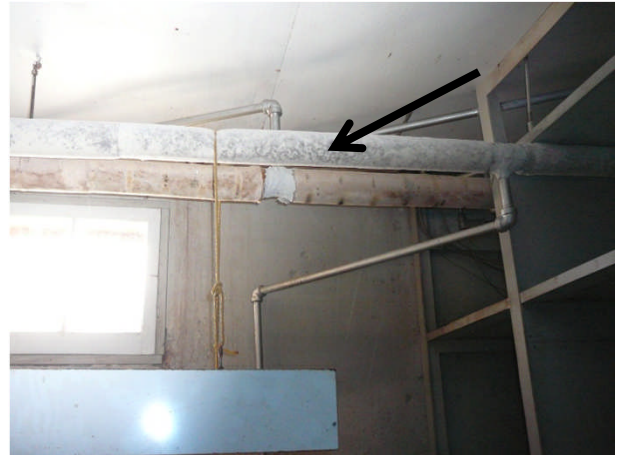
#2 Administration Office - Basement
Suspected mould growth on asbestos pipe insulation
