National Capital Commission  
601, chemin du Lac Meech Rd, Chelsea  
Appendix B - Photos

Asa Meech – 601, chemin du Lac Meech, Chelsea

## Asa Meech House – Heritage Summary

**Phase I Environmental Site Assessment  
NCC Property Asset Number 727  
601 Meech Lake Road, Chelsea, Québec**

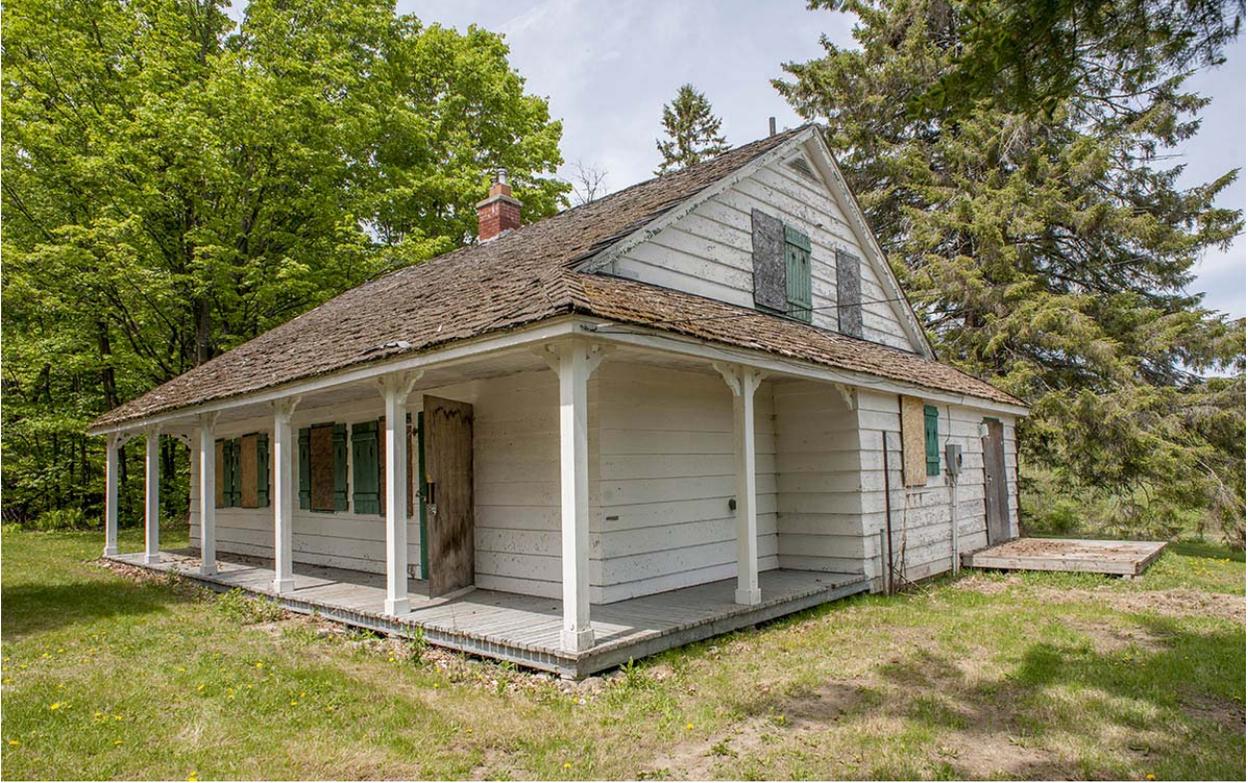
The Asa Meech House is situated slightly southeast of Meech Lake, within Gatineau Park, Quebec. It is currently unoccupied and in a deteriorated condition, with deteriorated and damaged materials as well as the presence of hazardous substances (lead paint, asbestos, mold). Significant alterations to suit needs over the years have resulted in limited remaining original features and, ultimately an uncertain building chronology. To fully understand the original floor plan of the house and potentially date additions or changes such as the locations of wall, window and door openings, an investigation while the interior gypsum board walls are removed is recommended. It is, however evident that the house dates from the early nineteenth century (1821) and that two major renovations were completed in the twentieth century (1930 and 1969-1973). As concluded in the investigation completed by HCS in 2016, "...an early log structure was clearly visible along with diagnostic artifacts, namely machine cut nails."<sup>2</sup> The morphology of the nails dates these elements from between 1820 and 1830, supporting the original construction time frame of the house.<sup>3</sup>

**Image 3:** The Asa Meech House, as seen it stands in the spring of 2017. Source: HCS, 2016

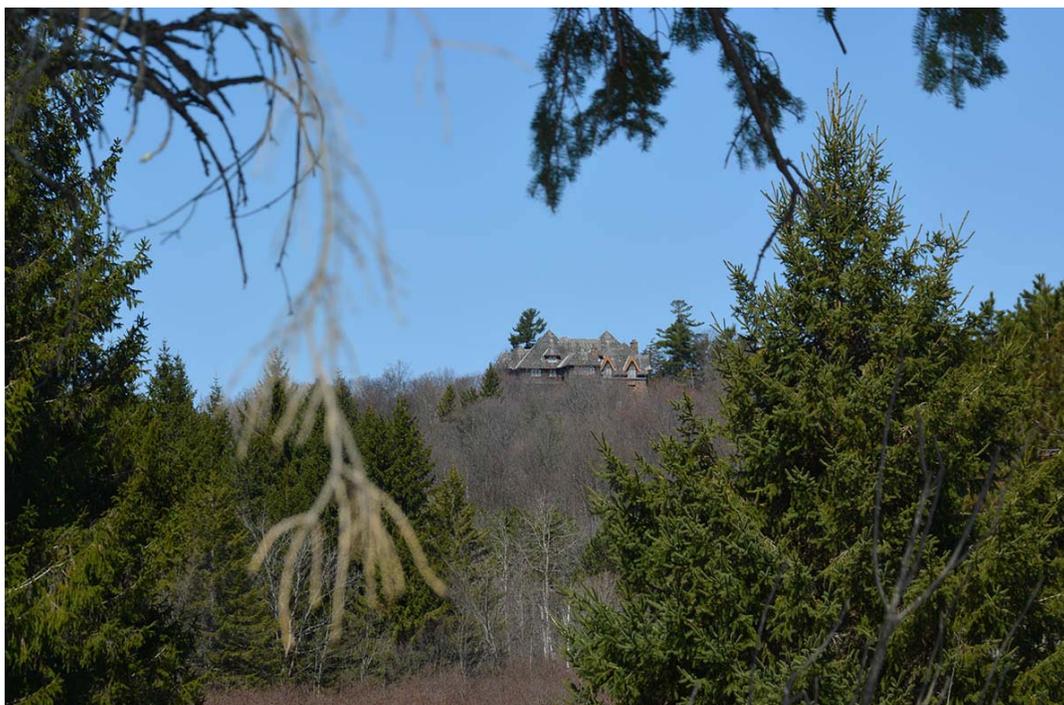
**Image 5:** The O'Brien House is visible from the Asa Meech House site. Source: HCS, 2017

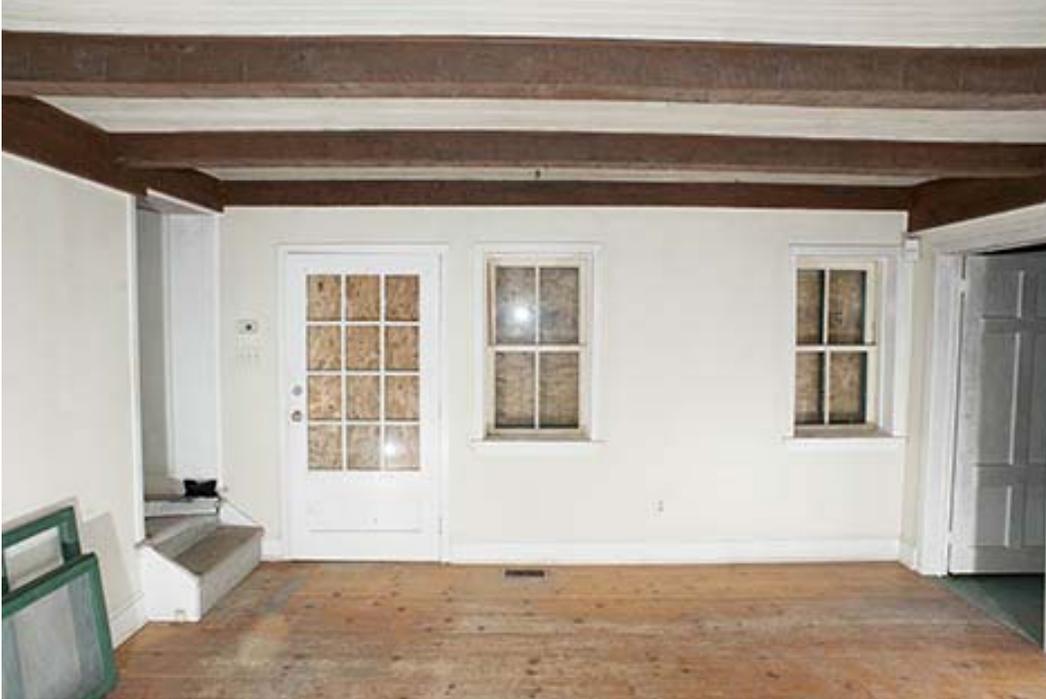
**Image 6:** The use of local materials and craftsmanship is visible in the use of wood elements.  
Source: HCS, 2016

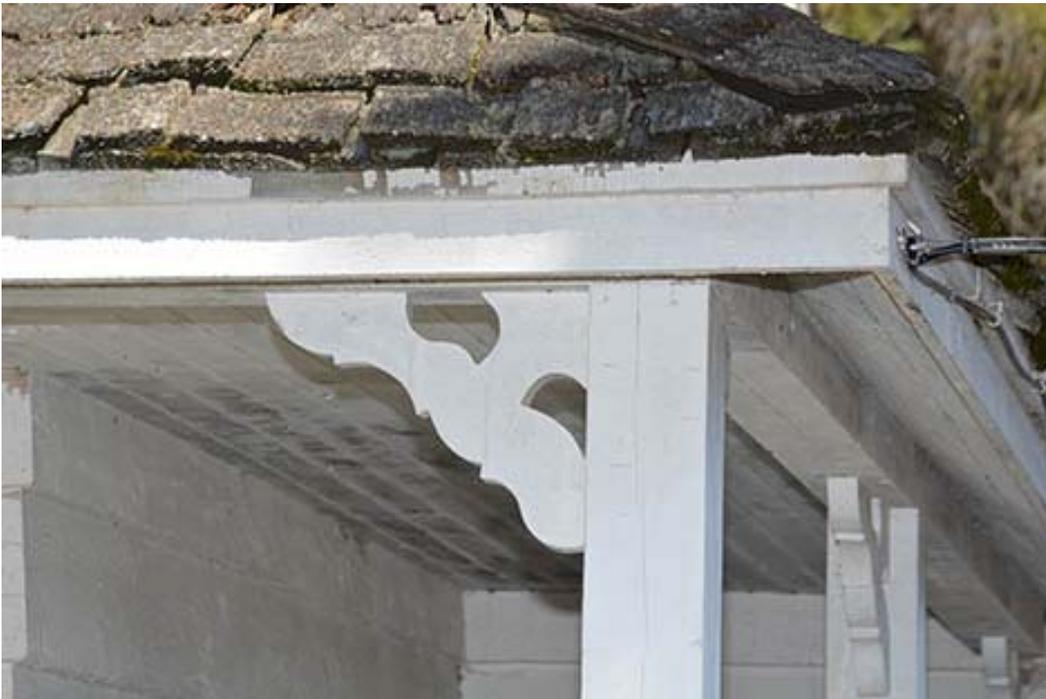
**Image 7:** The simple detailing, as expressed in the limited decorative elements, such as the shutters and verandah roof brackets. Source: HCS, 2017

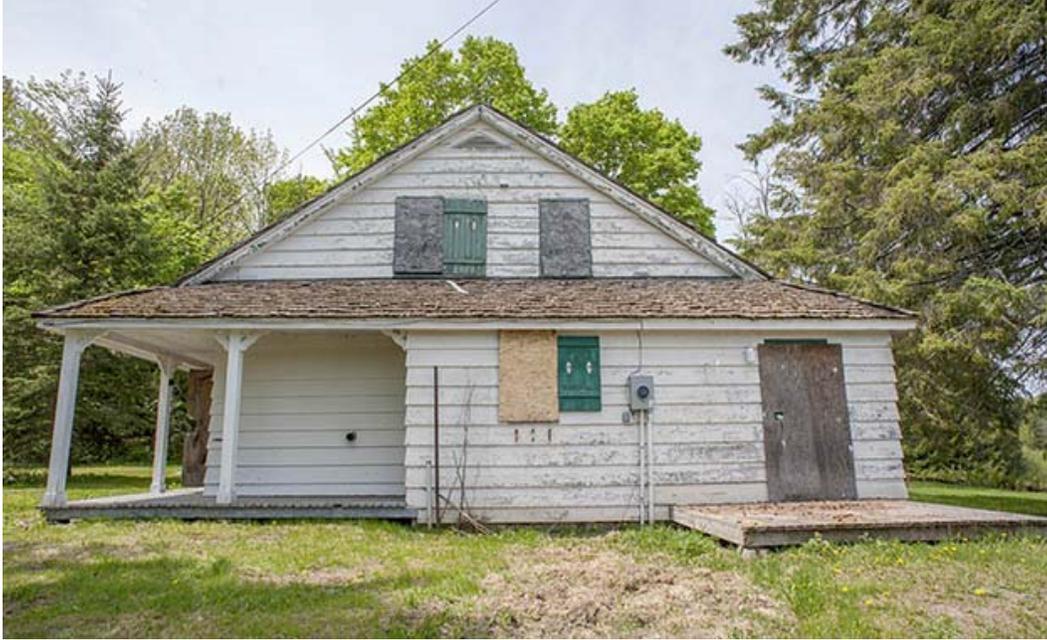
**Image 8:** The irregular elevations and placement of windows expresses the cottage designs of the 1930s. Source: HCS, 2016

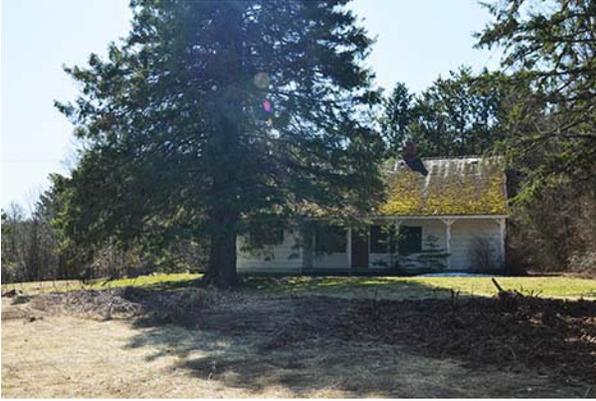
**Image 9:** The picturesque location and setting within the natural landscape. Source: HCS, 2017

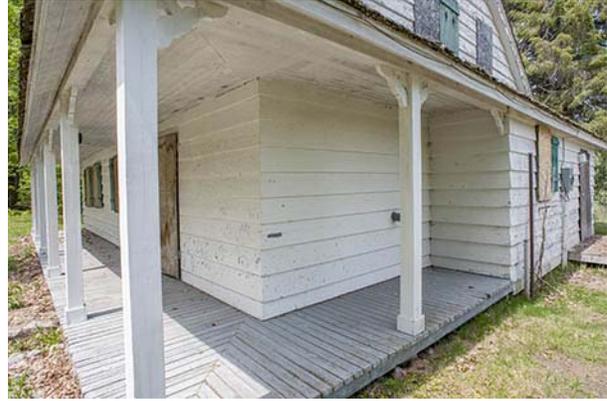
**Image 10:** The verandahs create an interstitial space between the interior and exterior. Source: HCS, 2016

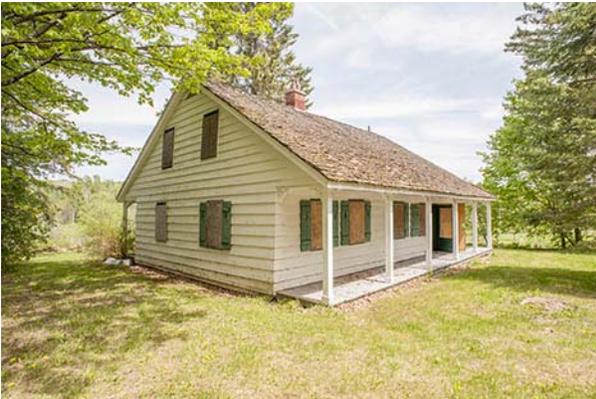
**Image 11:** The exterior colour palette creates a relationship between the surrounding landscape. Source: HCS, 2016

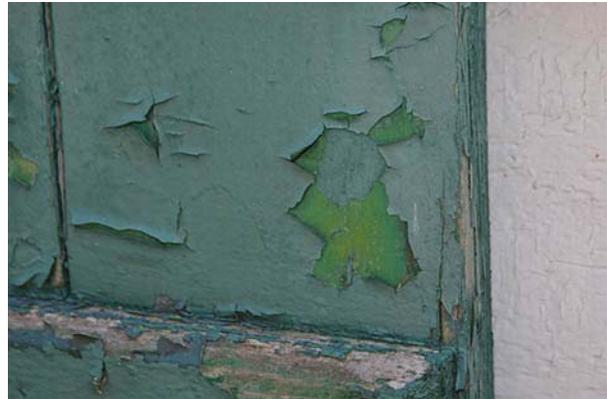
**Image 12:** The “mossy” green paint layer is visible underneath the current green. Source: HCS, 2017

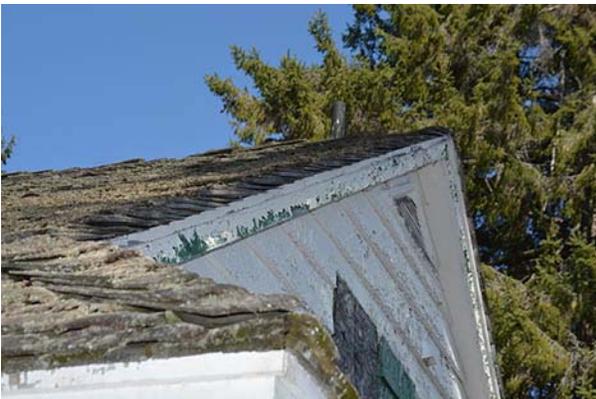
**Image 13:** The trim and accent colours were previously green, but some areas have been painted over with white. Source: HCS, 2017

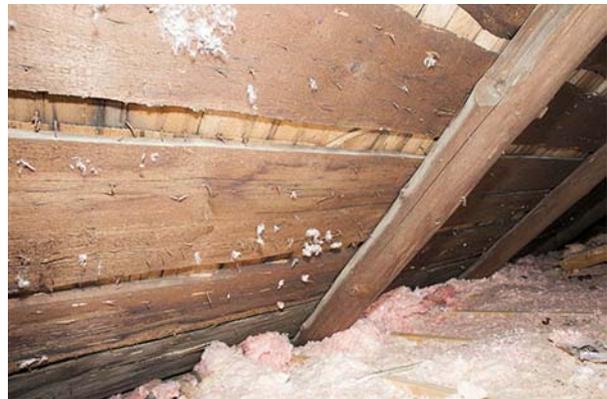
**Image 14:** The remaining original elements represent the age; quite possibly as the oldest existing dwelling in Gatineau Park. Source: HCS, 2016

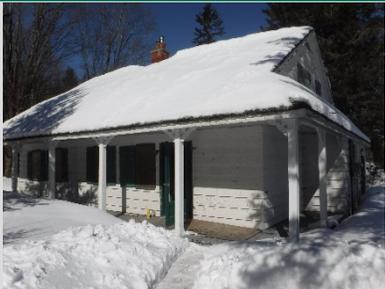
Exterior	Green paint on shutters/windows	Poor	42,000	LP-003	Yes

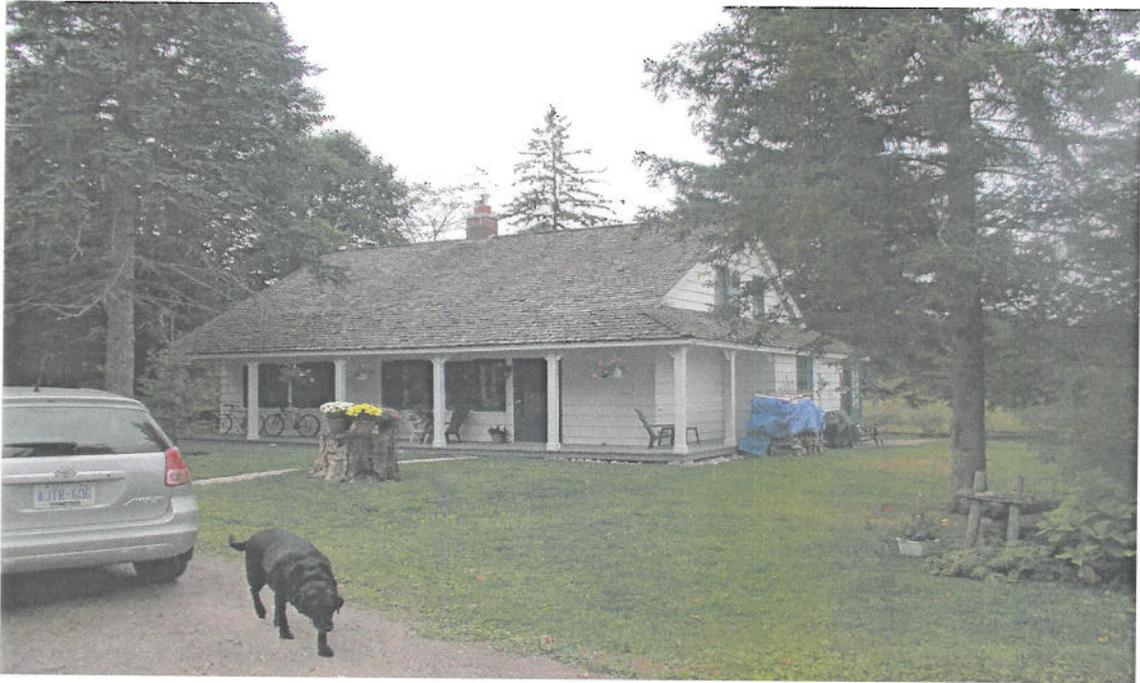
Photo 1: Home on subject site looking northwest.

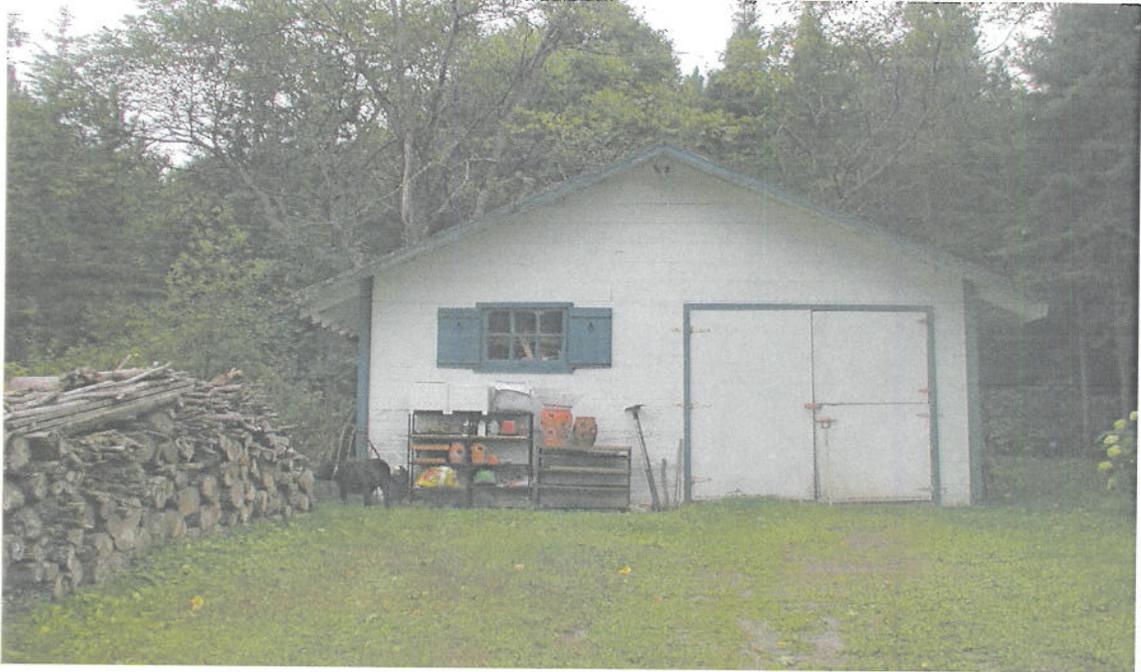
Photo 2: Former Barn, current garage (storage) looking south from laneway.

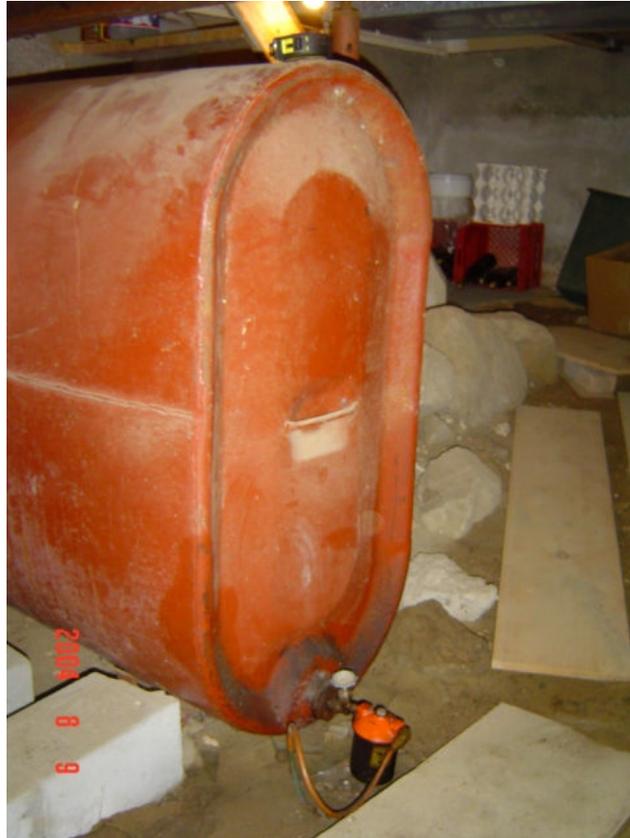
Photo 1: Vue du réservoir avec filtre. (727-01-08-2004.JPG)

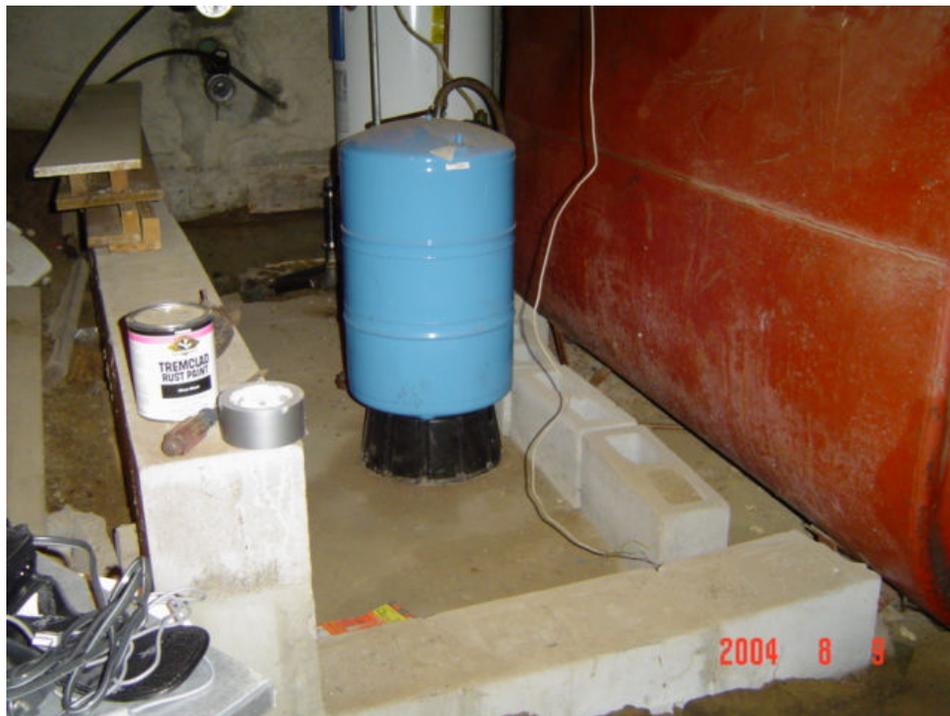
Photo 2: Vue de l'installation autour du réservoir. (727-02-08-2004.JPG)

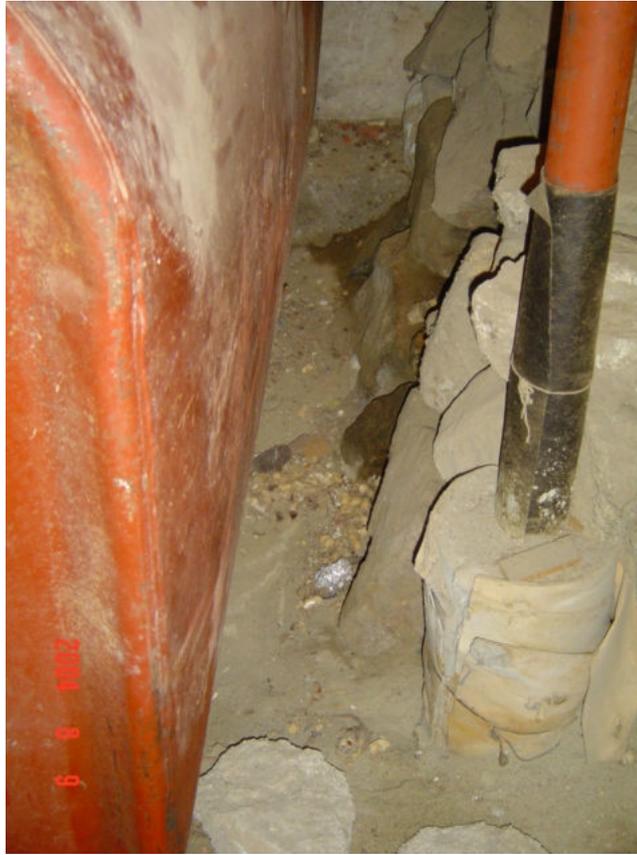
Photo 3: Vue de l'installation autour du réservoir. (727-06-08-2004.JPG)

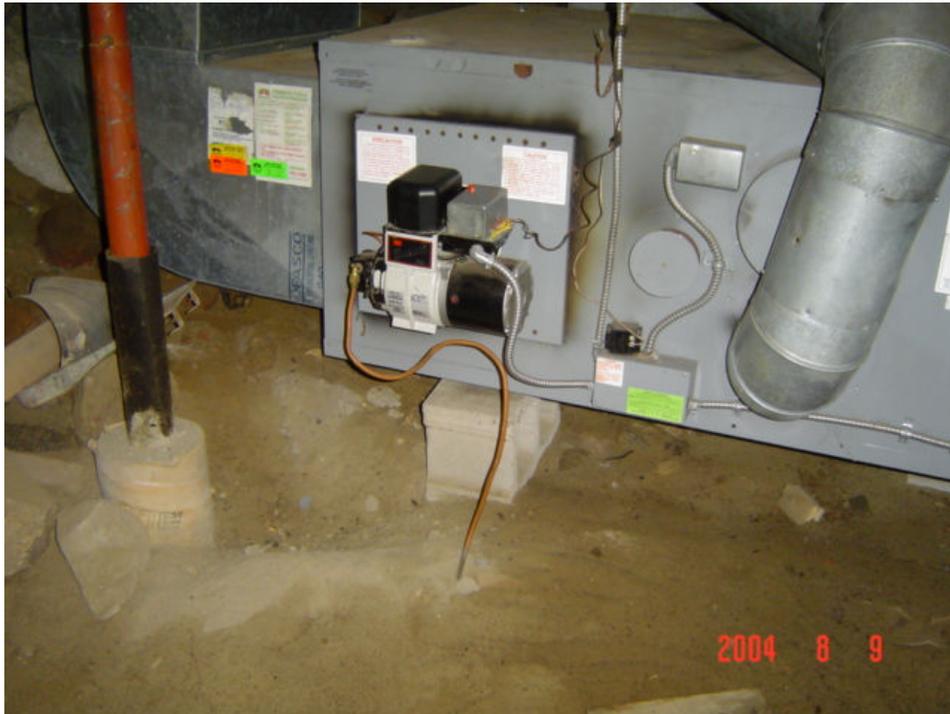
Photo 4: Vue de la fournaise. (727-03-08-2004.JPG)

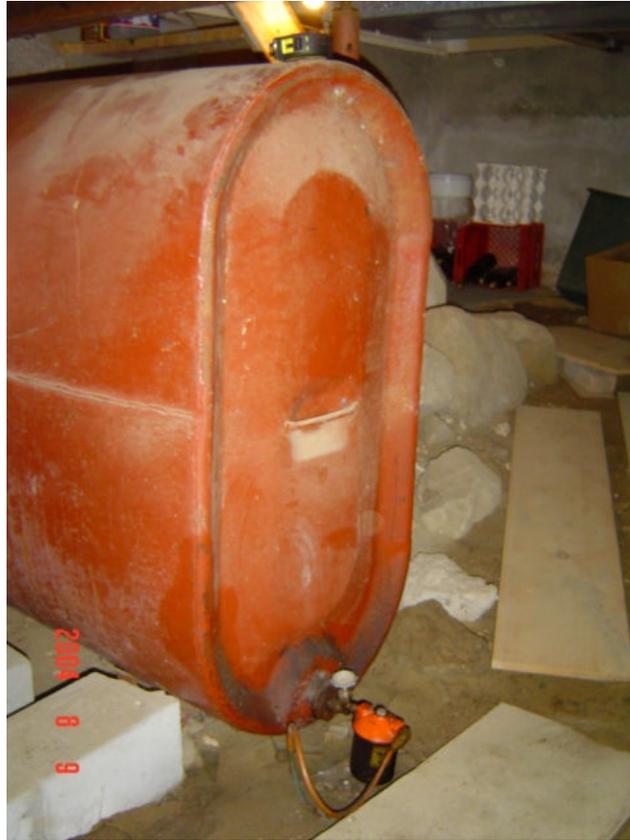
Photo 1: Vue du réservoir avec filtre. (727-01-08-2004.JPG)

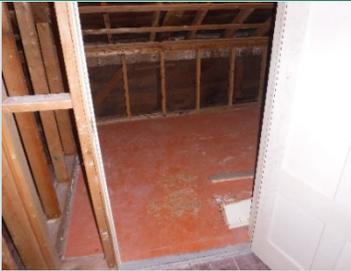
Second floor – Storage room	Orange paint on floor	Poor	470	LP-014	Yes

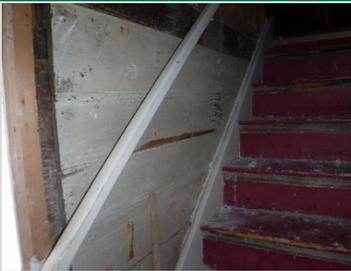
Stairwell between first and second floors	Beige paint along stairwell wall	Poor	35,000	LP-015	Yes

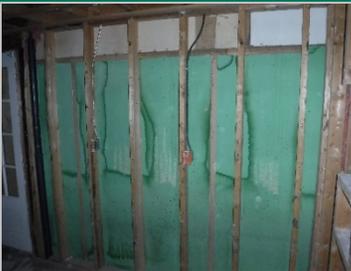
First Floor- Office / bathroom area	Light green paint on fiberboard wall	Good	24,000	LP-016	Yes
