Small Craft Harbours,
Fisheries and Oceans Canada

Port Dalhousie, ON – Harbour Wall Engineering Inspection Report

60432205

December, 2015

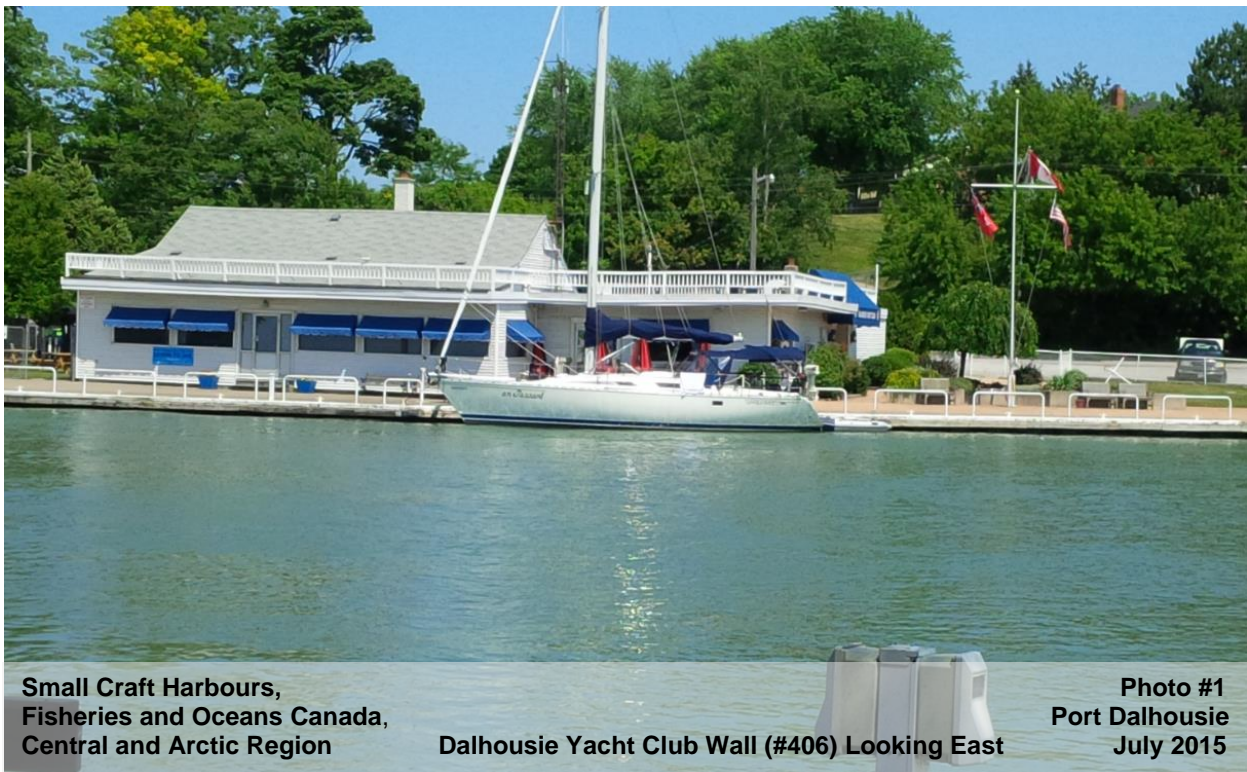
Photo #3, Concrete Deck Slab
Port Dalhousie
July 2015

The deck over the Dalhousie Yacht Club Wall appears to be in good condition. Medium cracks were observed at Station 406+013, Station 406+014, and Station 406+027 (See Photos 4-6 in Appendix B). One (1) small delaminated area was detected on the deck slab at Station 406+000 (See Photo 3 in Appendix B).

Station 406+000
Dalhousie Yacht Club Wall (#406)

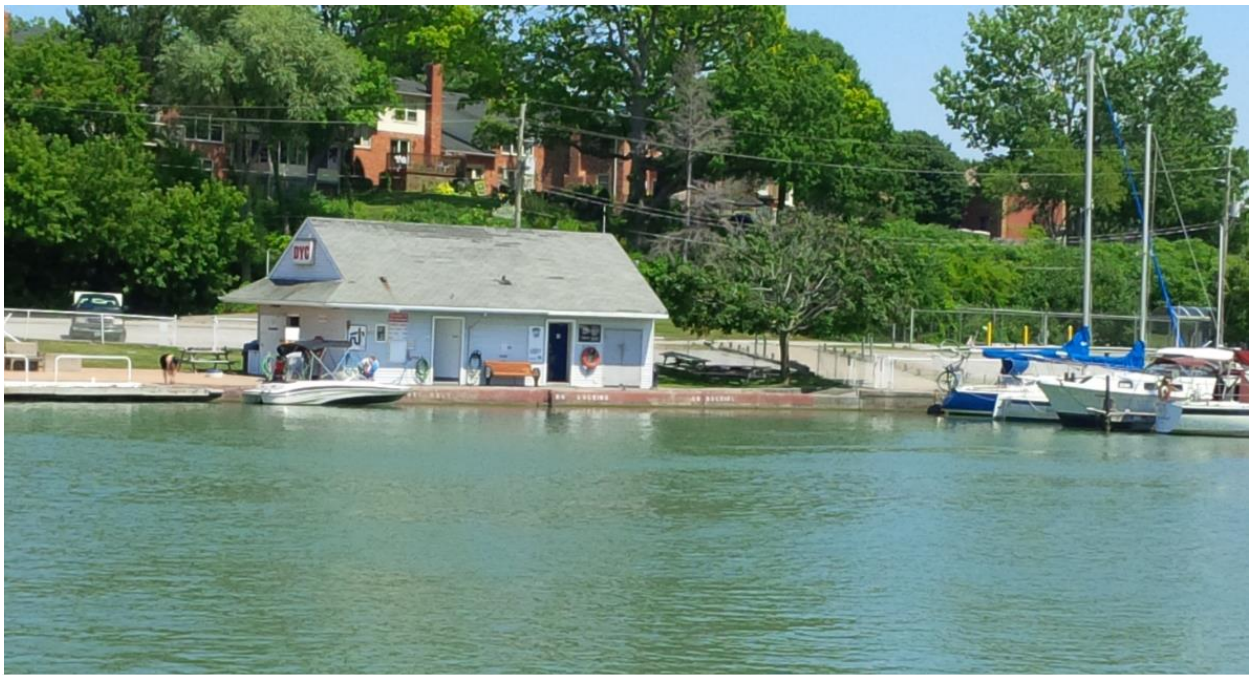
Photo #7
Port Dalhousie
July 2015

East Concrete Wall (#408) Looking East

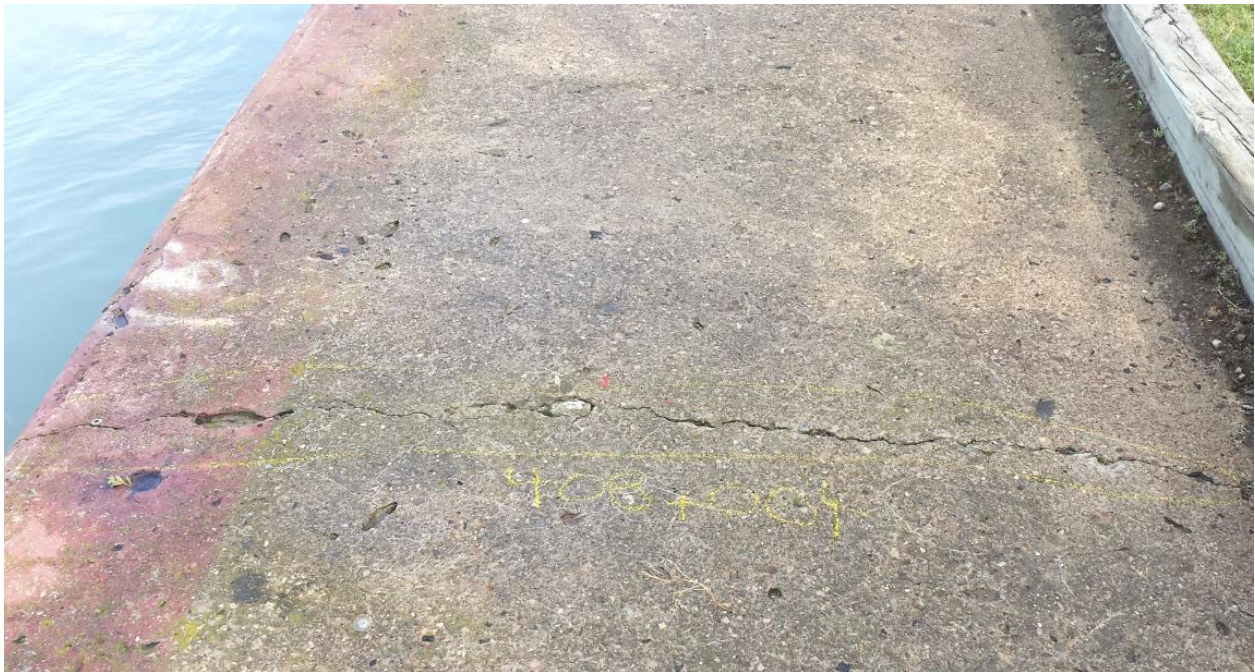
Photo #9, Concrete Deck Slab
Port Dalhousie
July 2015

Station 408+004
East Concrete Wall (#408)

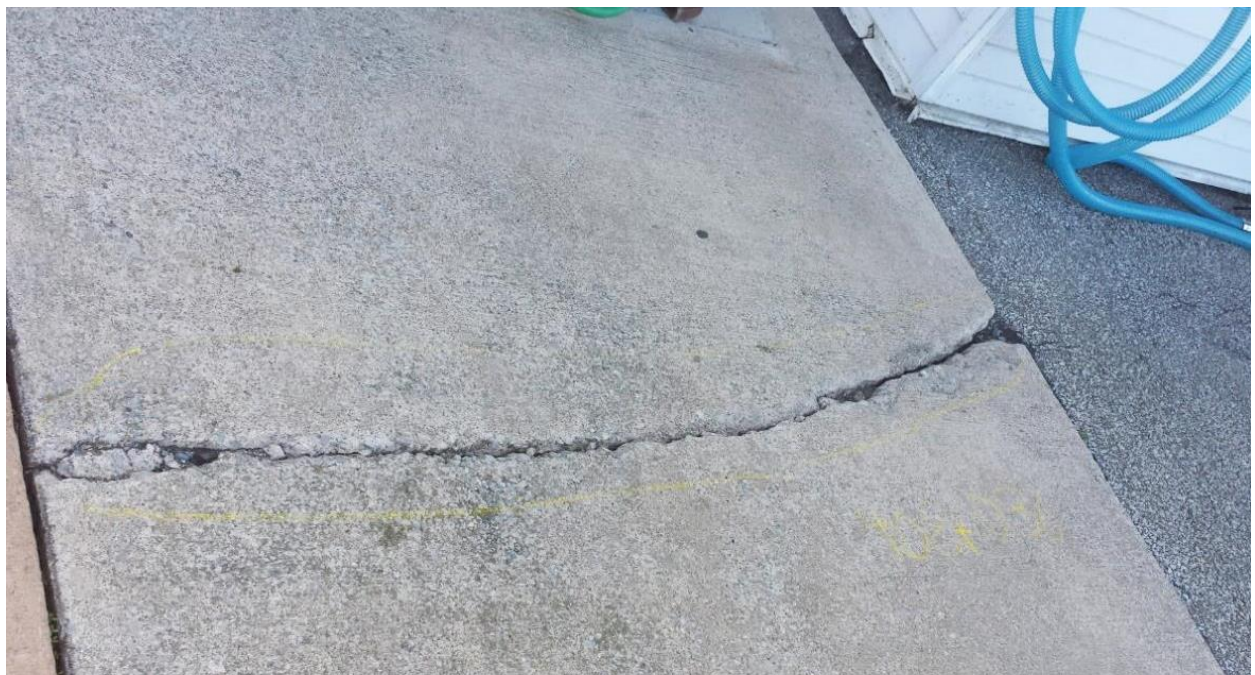
Photo #10, Concrete Deck Slab
Port Dalhousie
July 2015

Station 408+036
East Concrete Wall (#408)

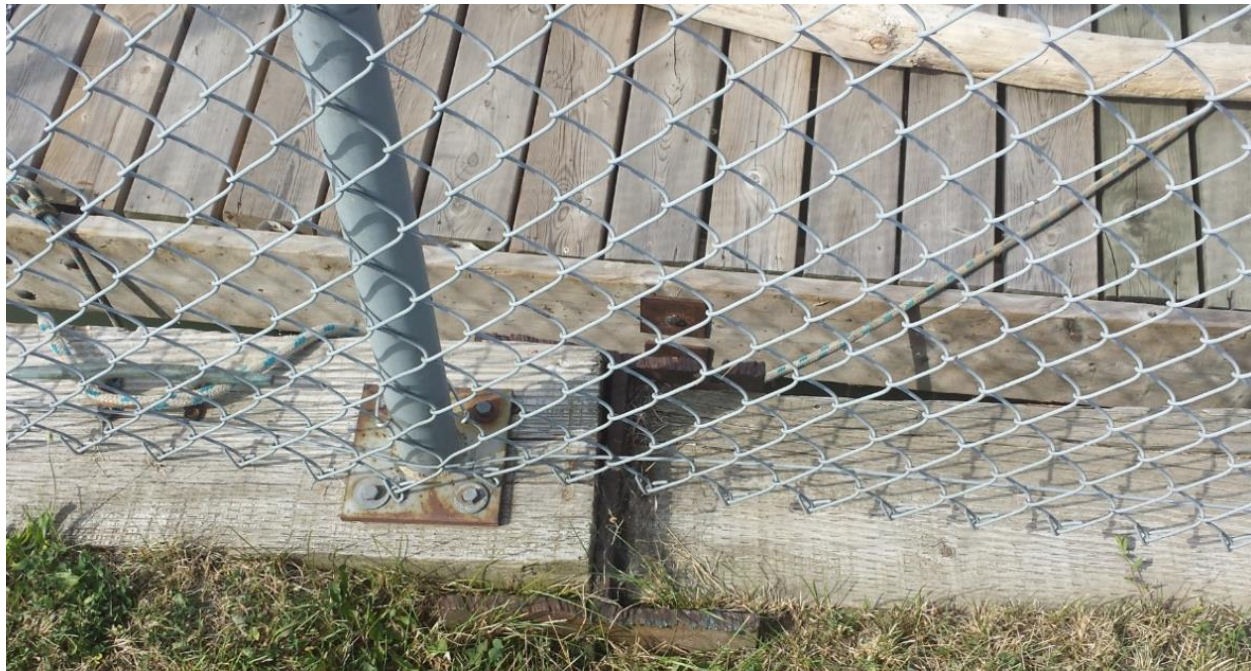
**Photo #13, Soldier Pile
Port Dalhousie
July 2015**

Timber Wall (#410)

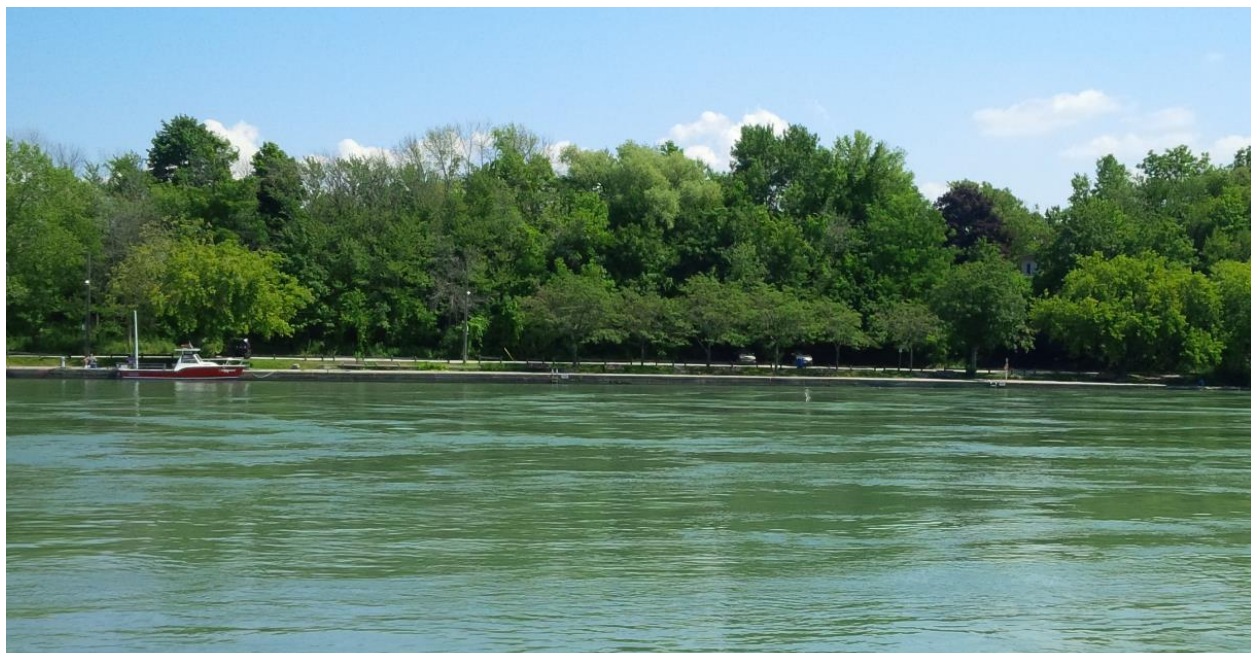
**Photo #14
Port Dalhousie
July 2015**

Southeast Wall (#405) Looking East

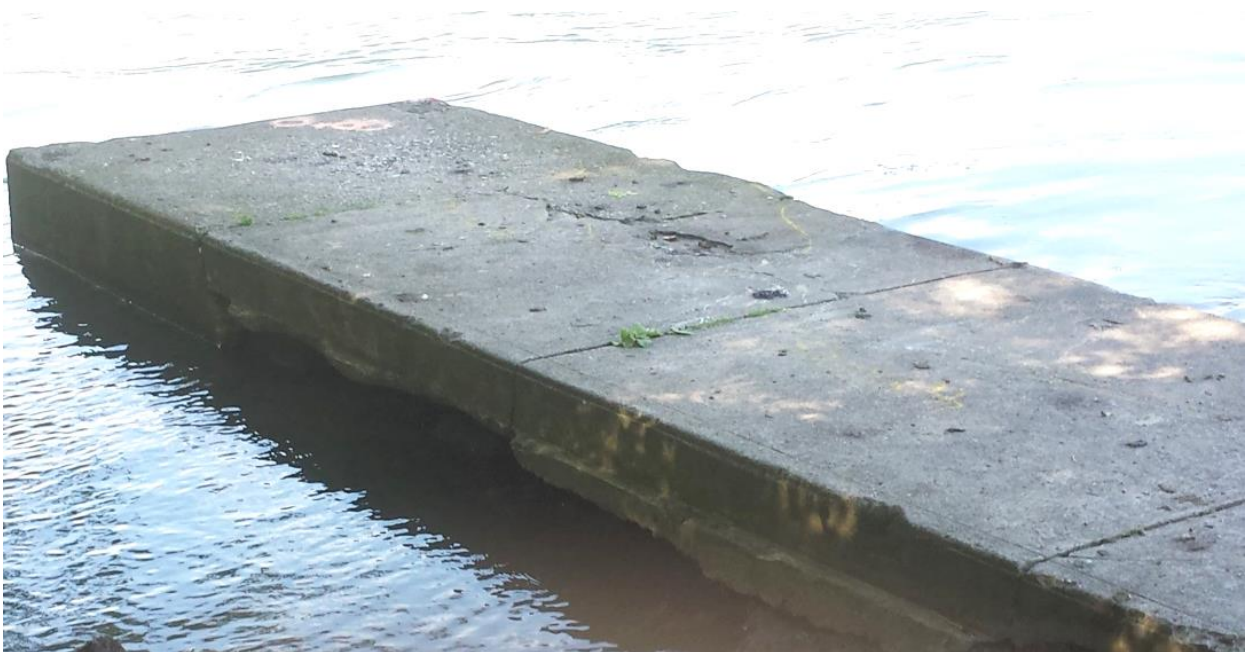
**Photo #15, Concrete Deck Slab
Port Dalhousie
July 2015**

**Station 405+010 to 405+000
Southeast Wall (#405) Looking South**

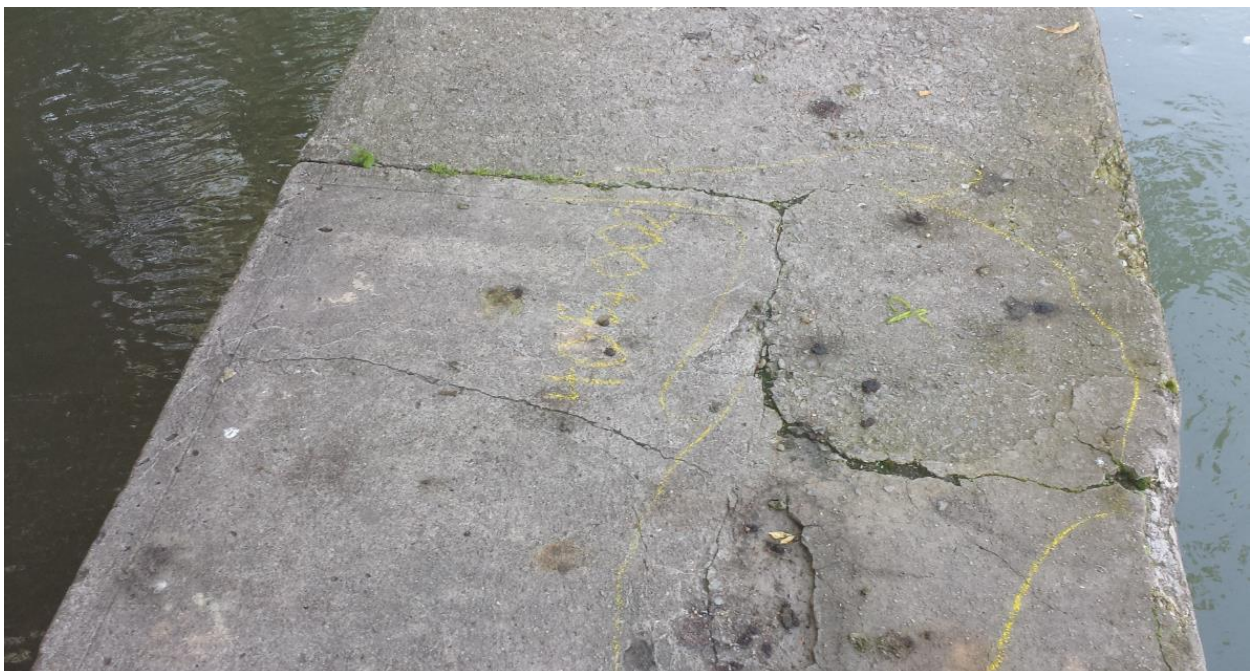
**Photo #16, Concrete Deck Slab
Port Dalhousie
July 2015**

**Station 405+002
Southeast Wall (#405)**

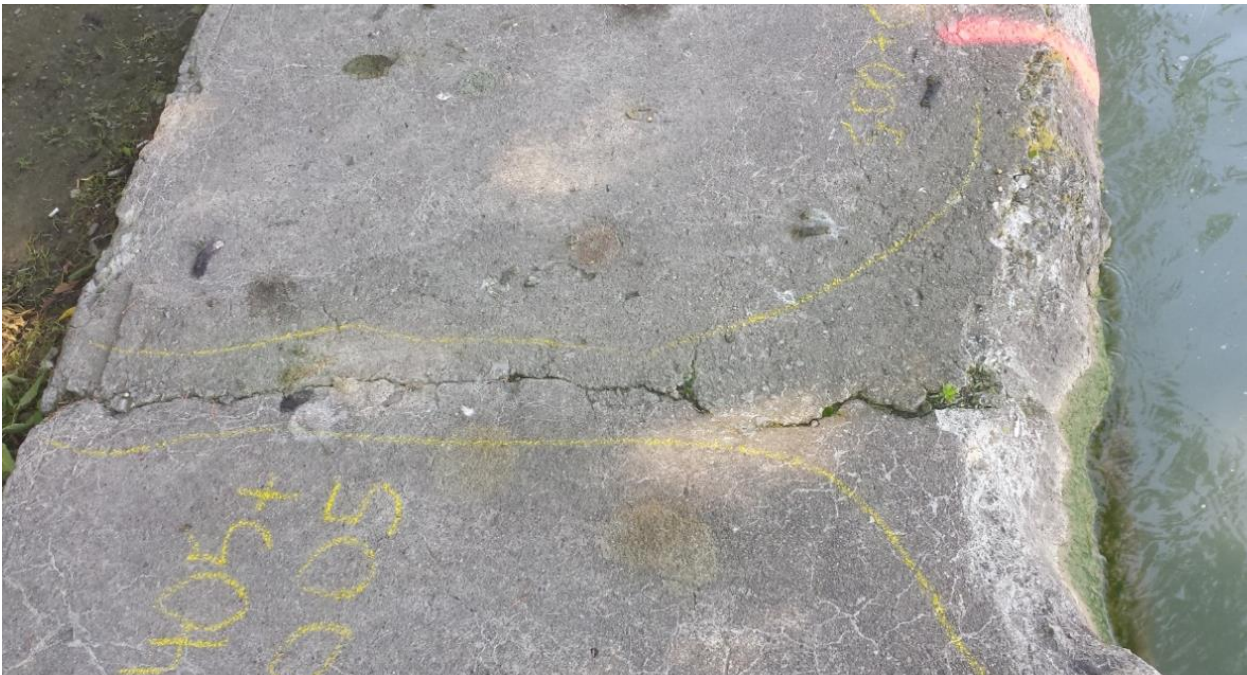
Photo #17, Concrete Deck Slab
Port Dalhousie
July 2015

Station 405+005
Southeast Wall (#405)

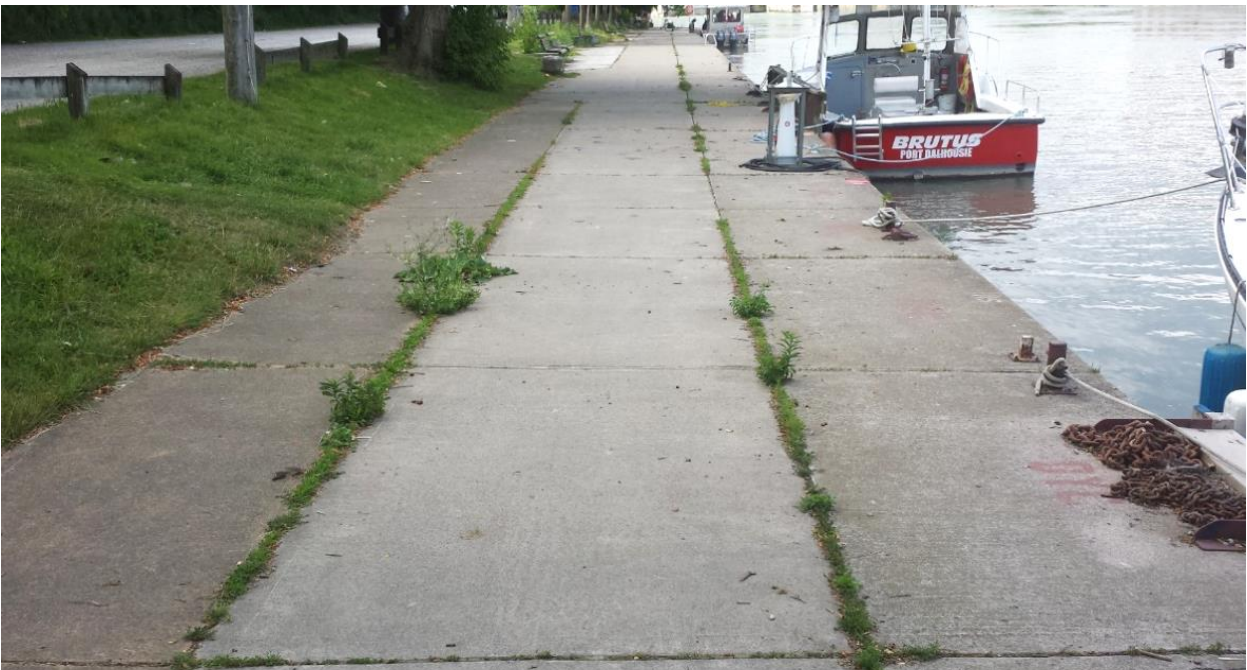
Photo #18, Concrete Deck Slab
Port Dalhousie
July 2015

The concrete deck surface between Station 405+010 to Station 405+169.1 previously received a concrete overlay and is in good condition (See Photo 18 in Appendix B). Only three (3) medium cracks were detected on the deck at Station 405+035, Station 405+057, and Station 405+077 (See Photo 19 in Appendix B) .

Station 405+0169.7 to 405+010
Southeast Wall (#405) Looking South

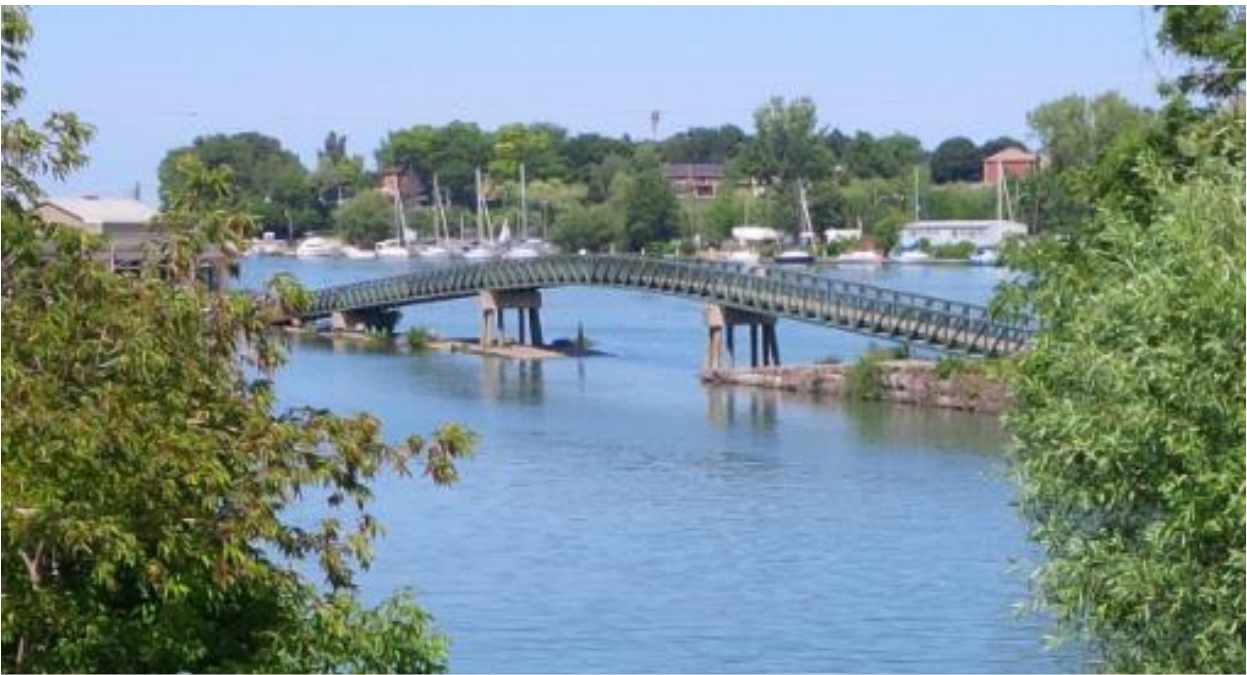
Photo #21
Port Dalhousie
July 2015

Pedestrian Bridge (#202) Looking East

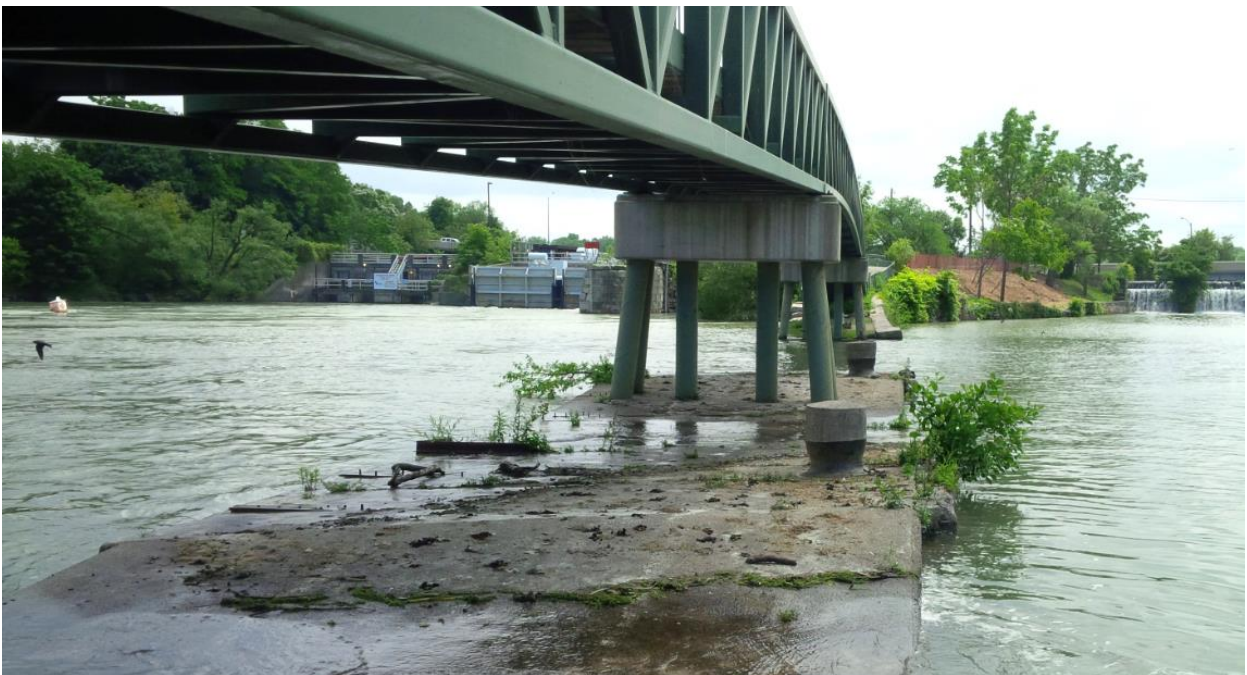
Photo #22
Port Dalhousie
July 2015

Pedestrian Bridge (#202) Looking South

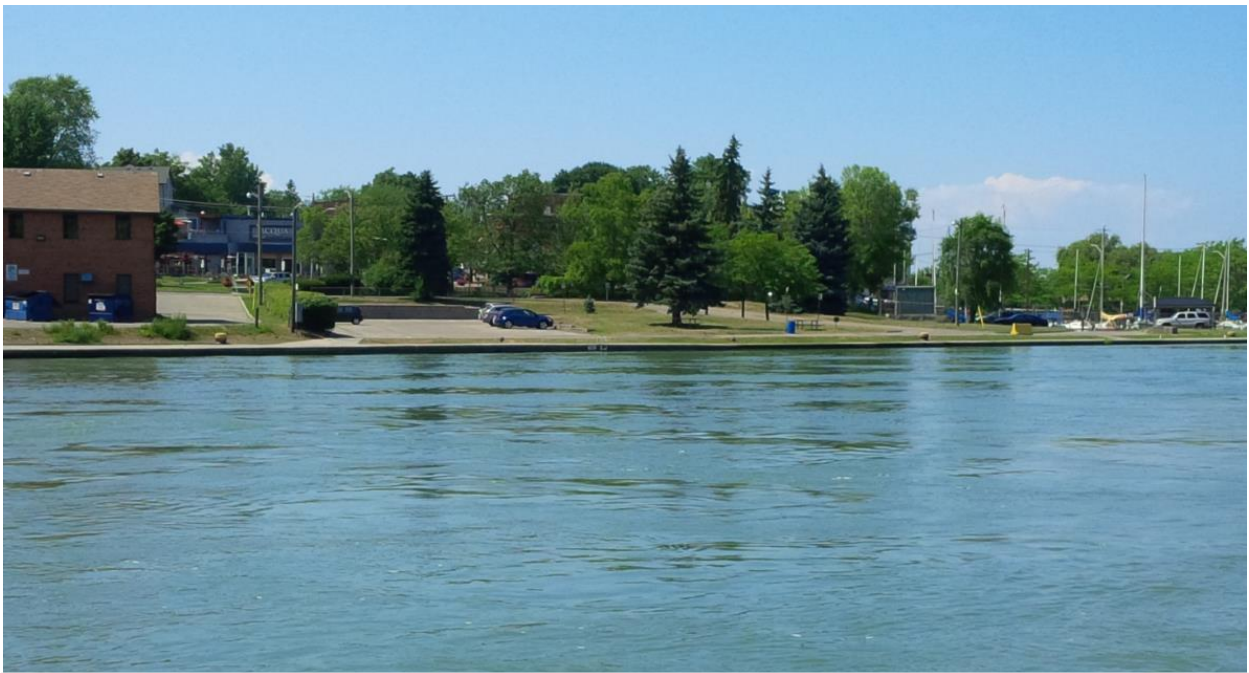
**Photo #23
Port Dalhousie
July 2015**

Southwest (#403) Looking West

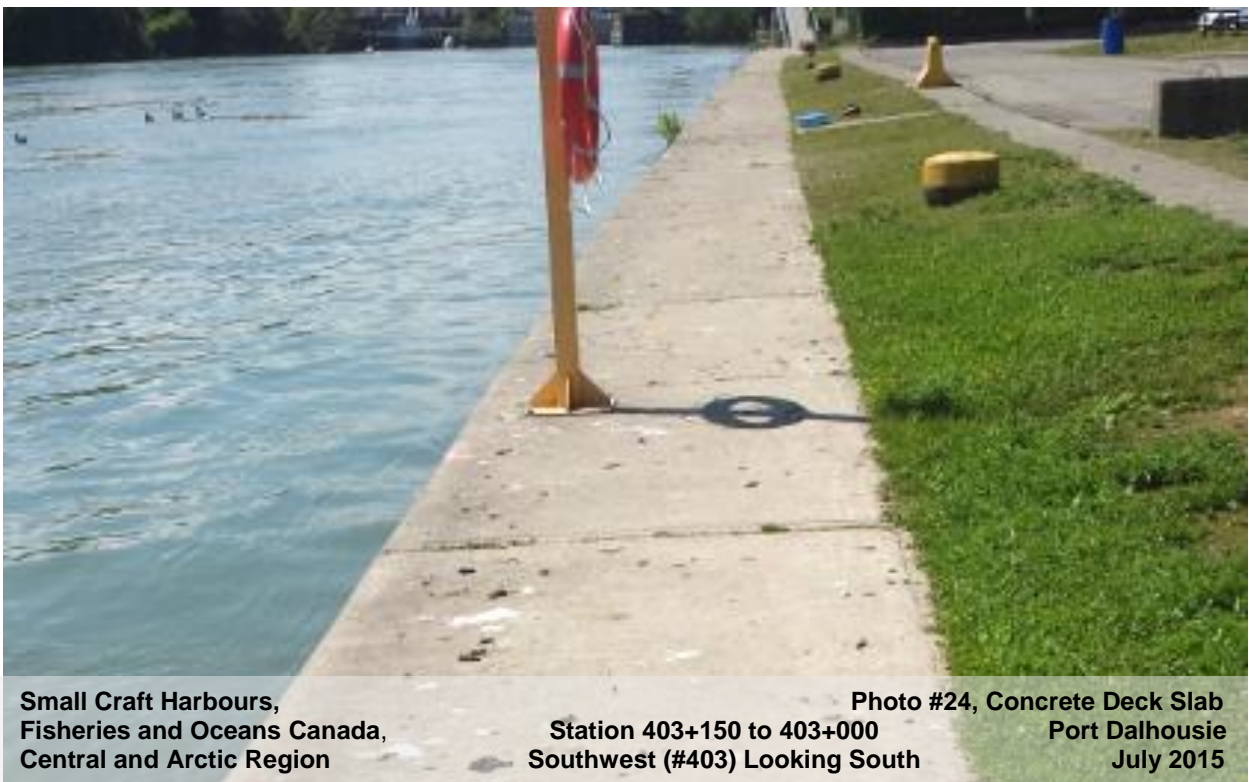
**Photo #24, Concrete Deck Slab
Port Dalhousie
July 2015**

The concrete deck surface appears to be in fair condition (See Photos 24 in Appendix B). Medium cracks were observed on the deck at Station 403+072, Station 403+075, Station 403+105, Station 403+108, Station 403+112, Station 403+117, Station 403+119, Station 403+125, Station 403+127, Station 403+130, Station 403+132, Station 403+137, Station 403+139, and Station 403+142 (See Photos 25 and 26 in Appendix C). These cracks are relatively straight and extend the full width of the wall.

**Station 403+150 to 403+000
Southwest (#403) Looking South**

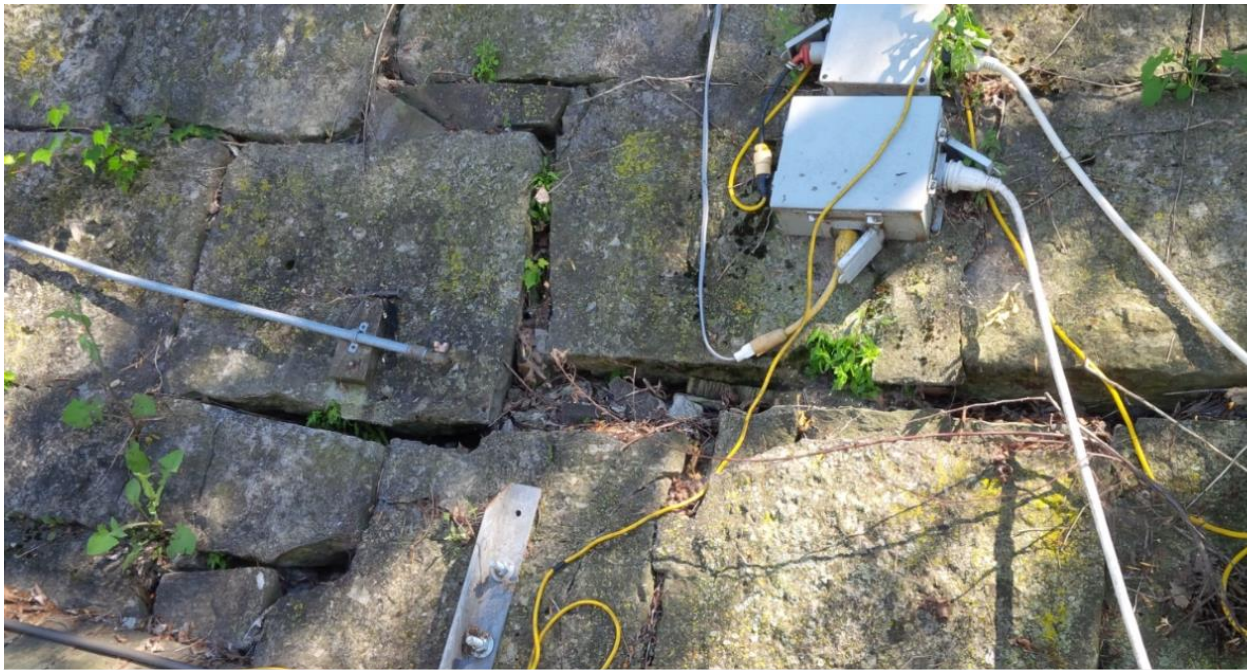
Photo #29, Mortar Joints
Port Dalhousie
July 2015

The Old Canal Walls do not have precast concrete coping units on top of the timber cribs. Instead, the coping units are vertically stacked limestone within the limits of the original lock and sloping limestone units within the original lock entrance. The limestone units appear to be in good condition with no significant deterioration of the units observed. Some of the joints between units in the lower part of the wall appear to be larger than the typical gap and may be a sign of settlement of the underlying timber cribs. However, it may also be the result of plants taking root in the joints. (See Photos 27 and 28 in Appendix B). Many of the mortar joints have disintegrated in the sloped limestone coping locations (See Photo 29 in Appendix B).

Station 407E+048
East Old Canal Wall (#407 E)

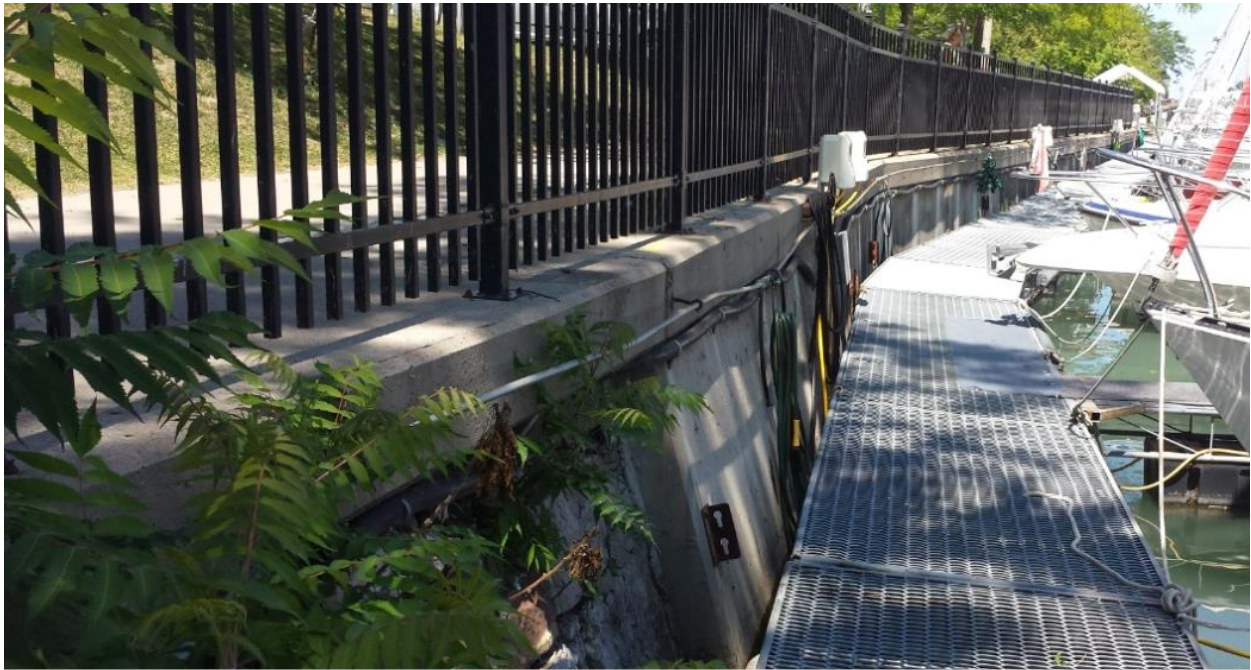
Photo #30
Port Dalhousie
July 2015

Station 407W+010 to 407W+055
West Old Canal Wall (#407 W) Looking North

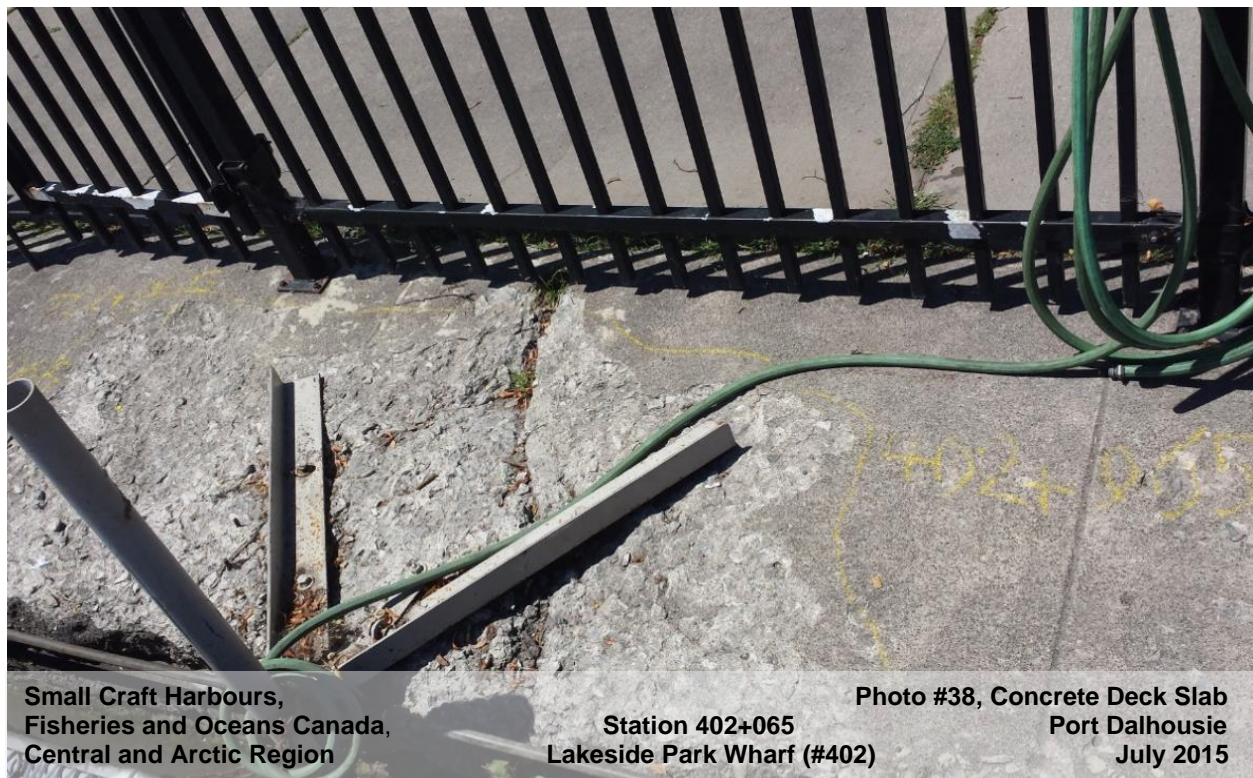
Photo #37, Concrete Deck Slab
Port Dalhousie
July 2015

Station 402+055
Lakeside Park Wharf (#402)

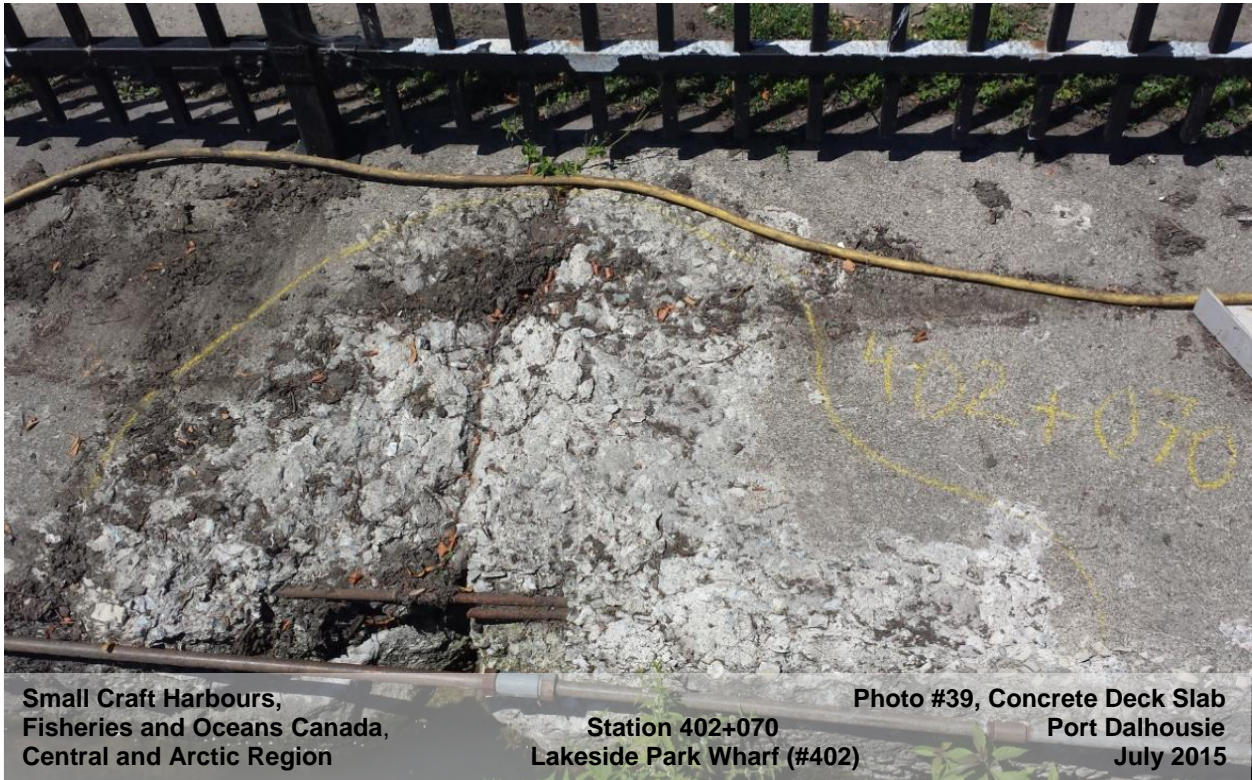
Photo #38, Concrete Deck Slab
Port Dalhousie
July 2015

Station 402+065
Lakeside Park Wharf (#402)

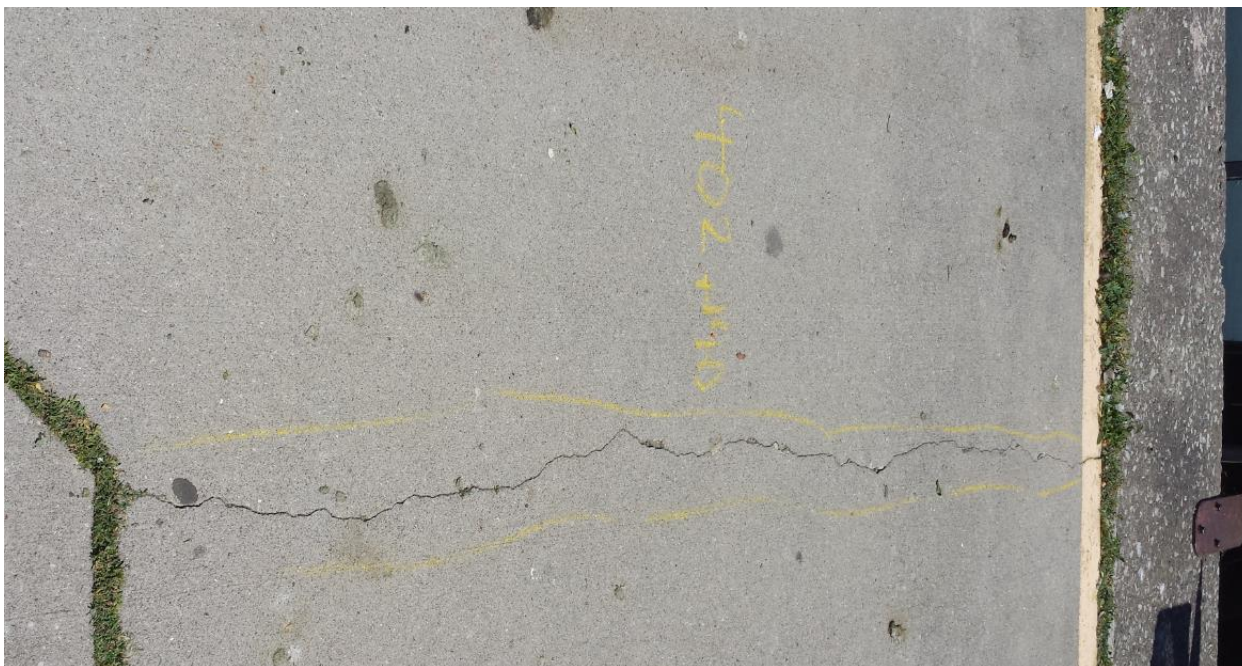
Photo #42, Concrete Deck Slab
Port Dalhousie
July 2015

The concrete deck from Station 402+080 to Station 402+200.8 is in good condition (See Photo 41 in Appendix B). Medium cracks were observed in the deck at 402+123, Station 402+140, Station 402+145, and Station 402+157 (See Photos 42-45 in Appendix B).

Station 402+123
Lakeside Park Wharf (#402)

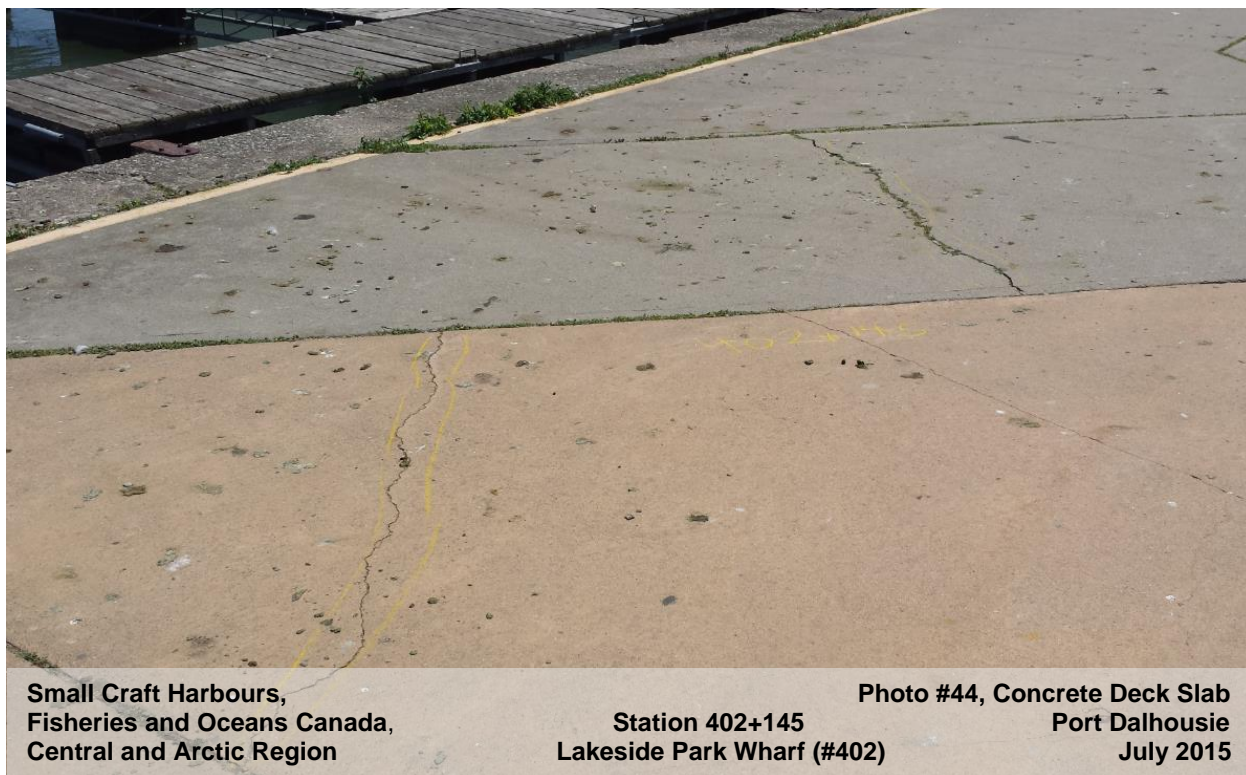
Photo #43, Concrete Deck Slab
Port Dalhousie
July 2015

Station 402+140
Lakeside Park Wharf (#402)

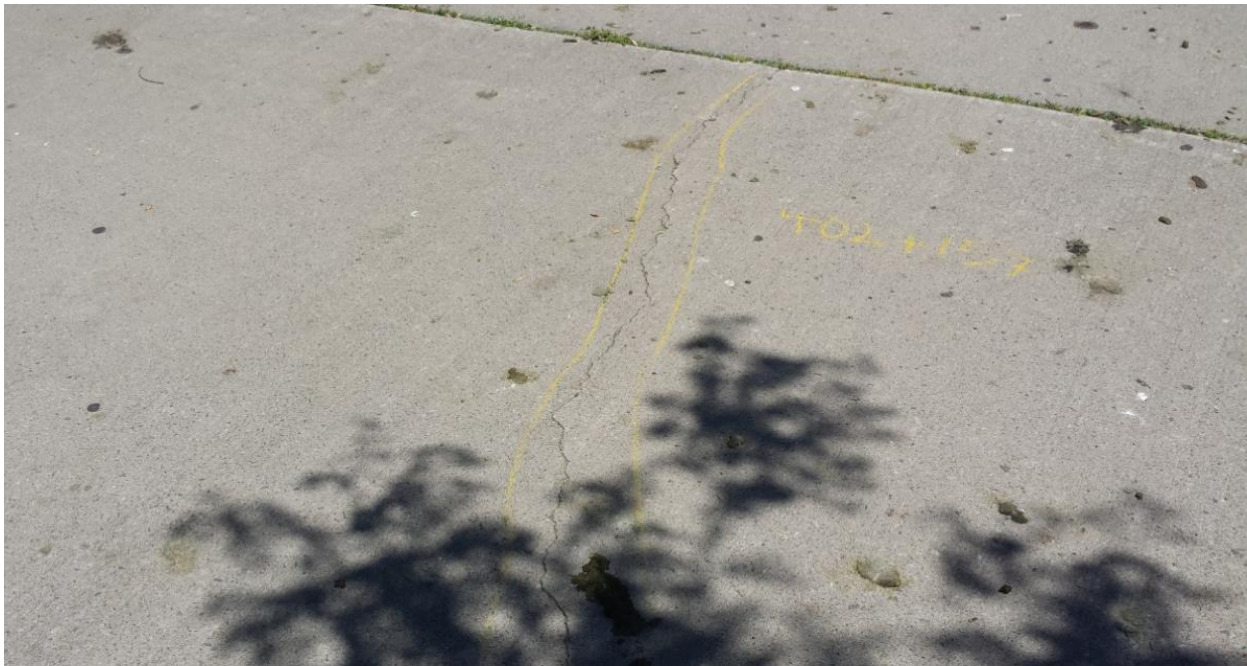
Photo #44, Concrete Deck Slab
Port Dalhousie
July 2015

Station 402+145
Lakeside Park Wharf (#402)
