Fire Alarm System Annual Test & Inspection Report – Individual Device Record

Hazardous Building Materials GAP Assessment

Hazardous Building Materials GAP Assessment - Revised

Grierson Institution
9530 – 101 Avenue, Edmonton,
Alberta

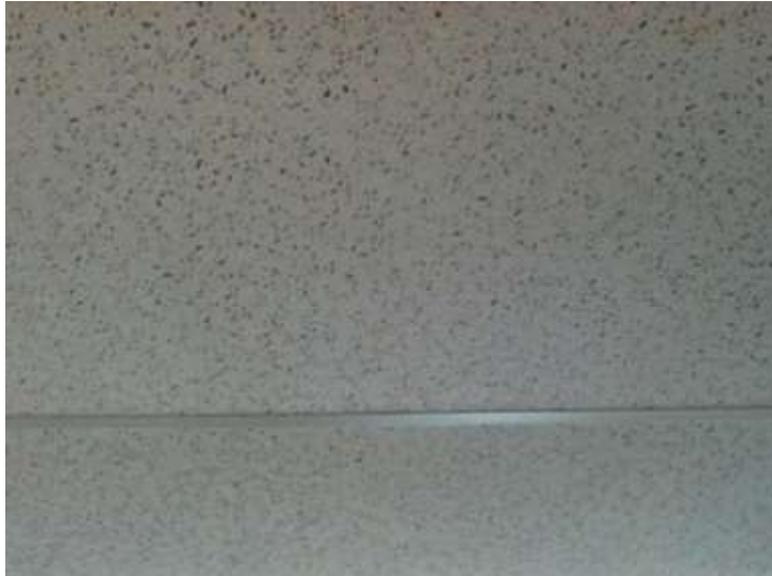
Non-asbestos Lay-in Ceiling Tiles, 2x4 pinholes and small flakes, (Sample S0001B), 1-002-5 (Location:10)

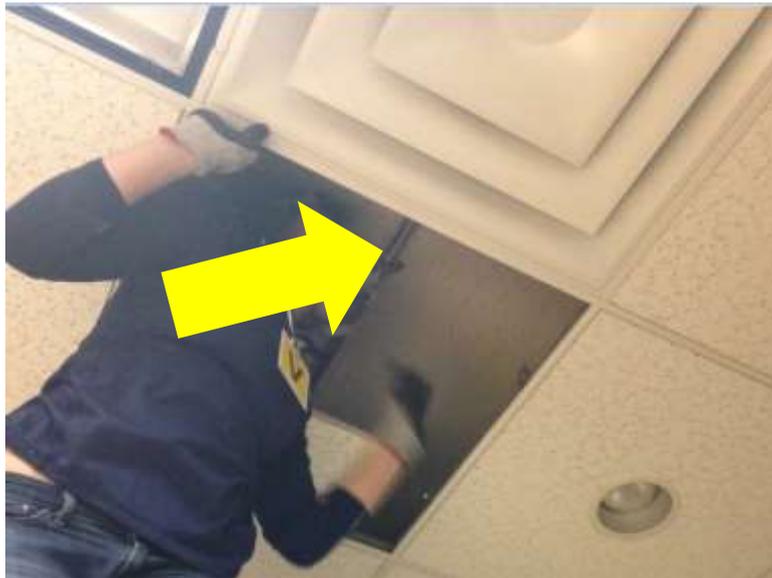
Non-asbestos Glued on Ceiling Tiles 1X1, Ref G-1-102-140, (Sample S002), 1-110 (Location:1)

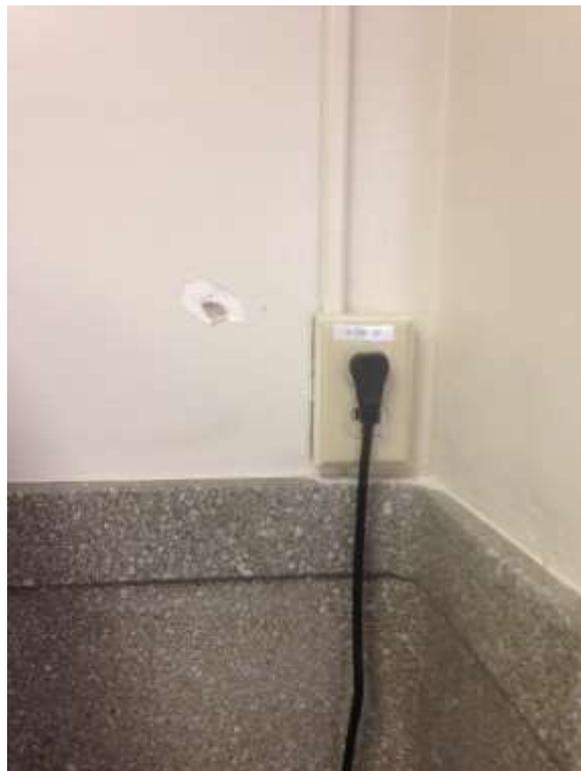
Non-asbestos Plaster, (Sample S004E), 1-129 (Location:22)

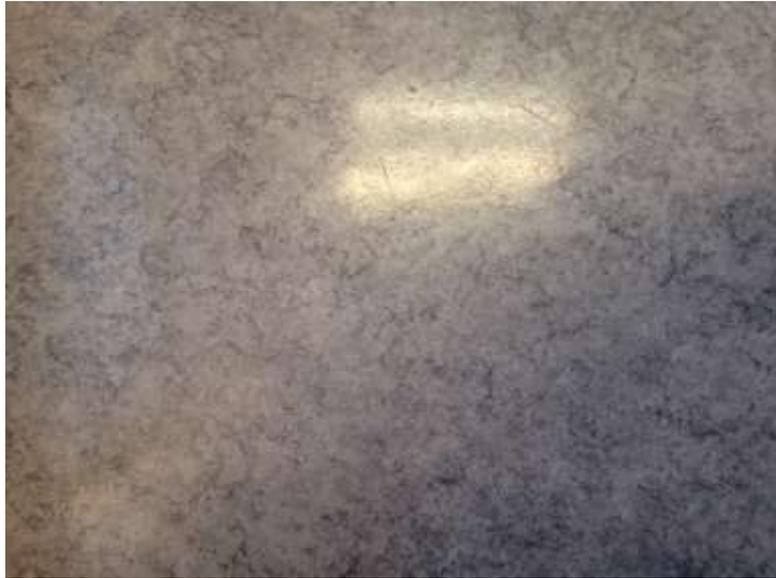
Non-asbestos Vinyl Sheet Flooring, Blue, (Sample S0005), 1-116 (Location:3)

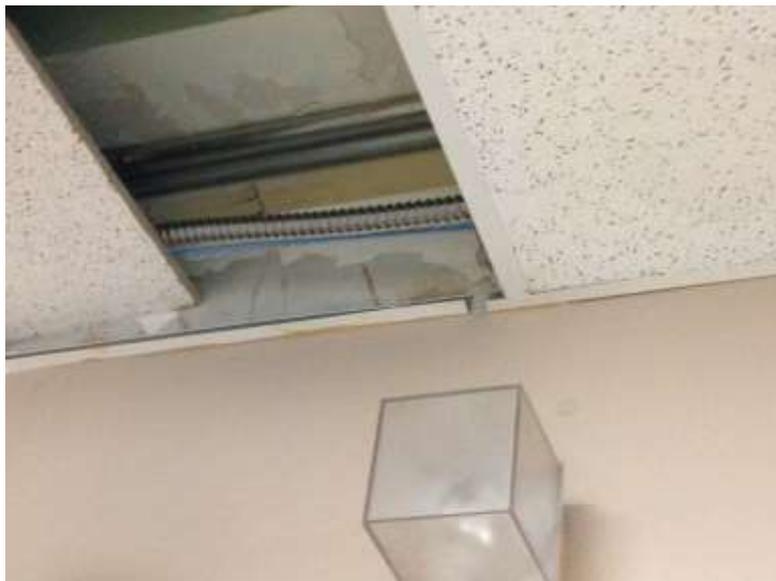
Non-asbestos Plaster, (Sample S0006), 1-011 (Location:6)

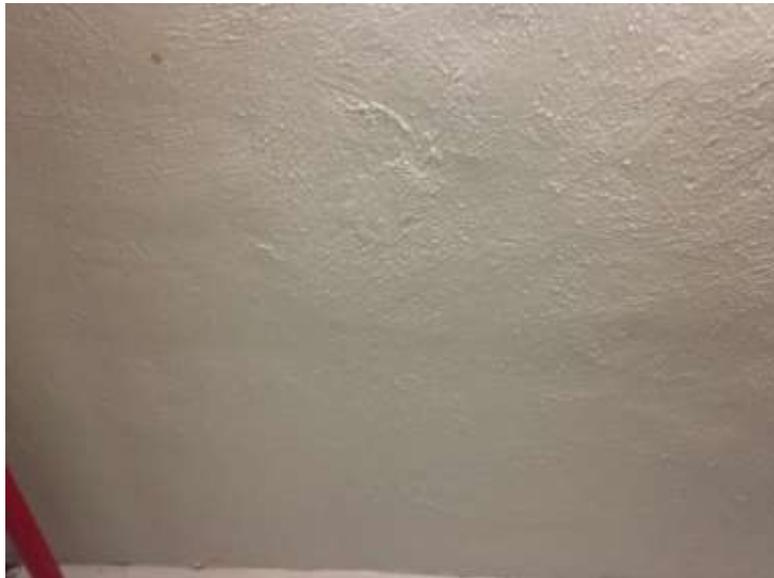
Non-asbestos Plaster texture, Ref 1-007-112 (Sample S0007), 1-007 (Location:5)

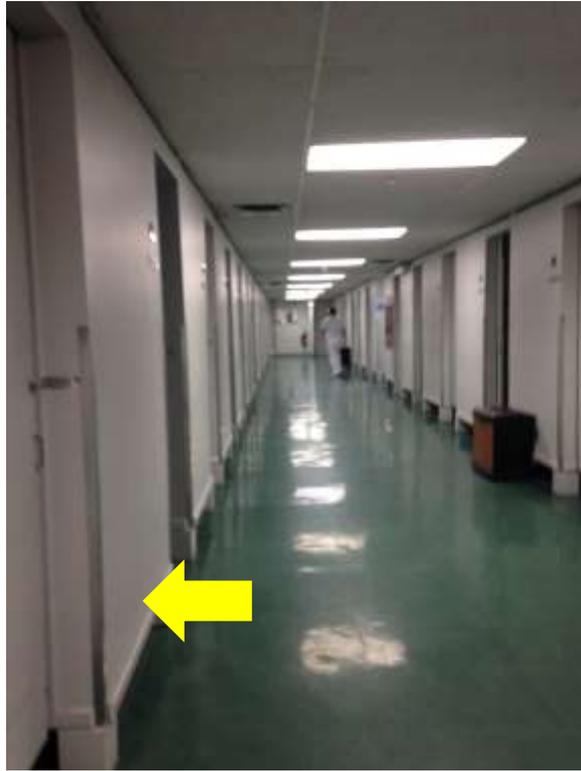
Non-asbestos Drywall and Joint Compound, (Sample S0009), 1-021 (Location:12)

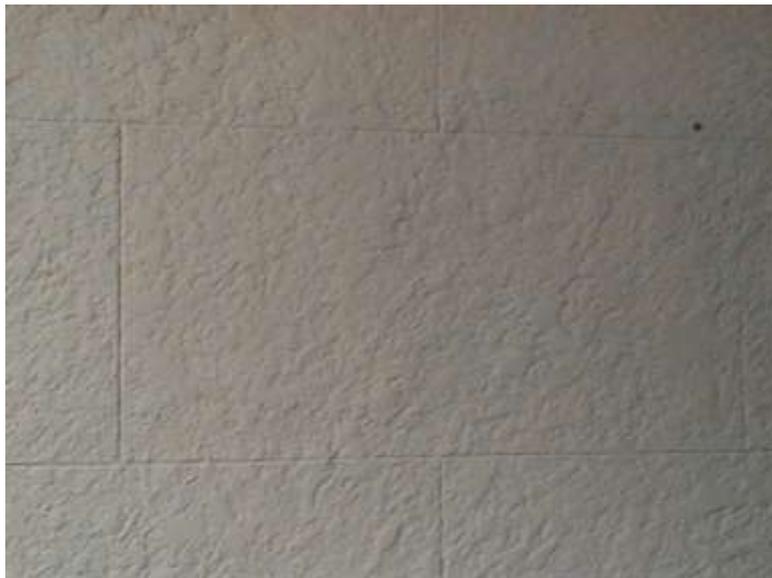
Non-asbestos Texture Finish (Texture Coat),Ref G-1-119-138, (Sample S0012C), 1-119 (Location:19)

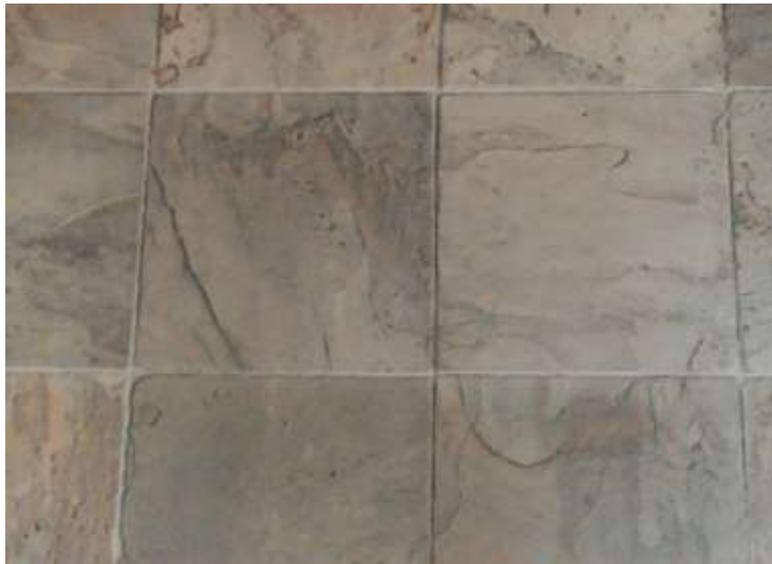
Non-asbestos Vinyl Sheet Flooring, Squares, (Sample S0015), 1-242 (Location:26)

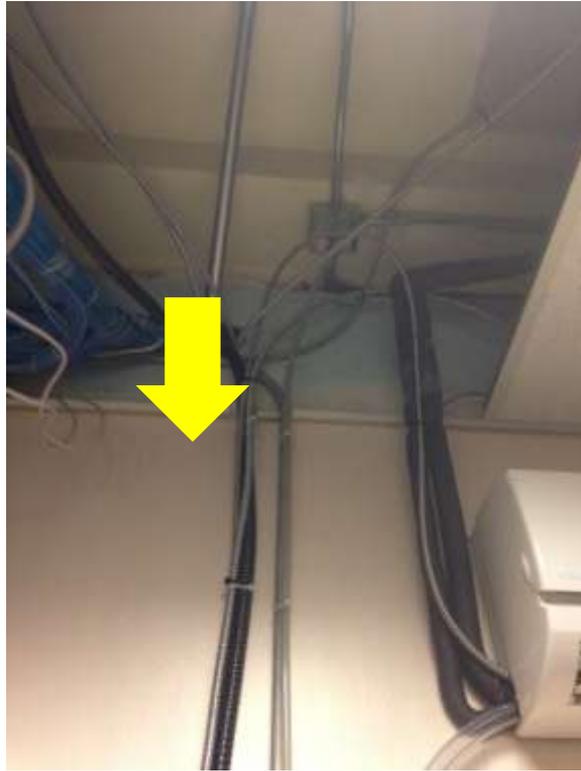
Non-asbestos Drywall and Joint Compound, (Sample S0016), 1-230 (Location:29)

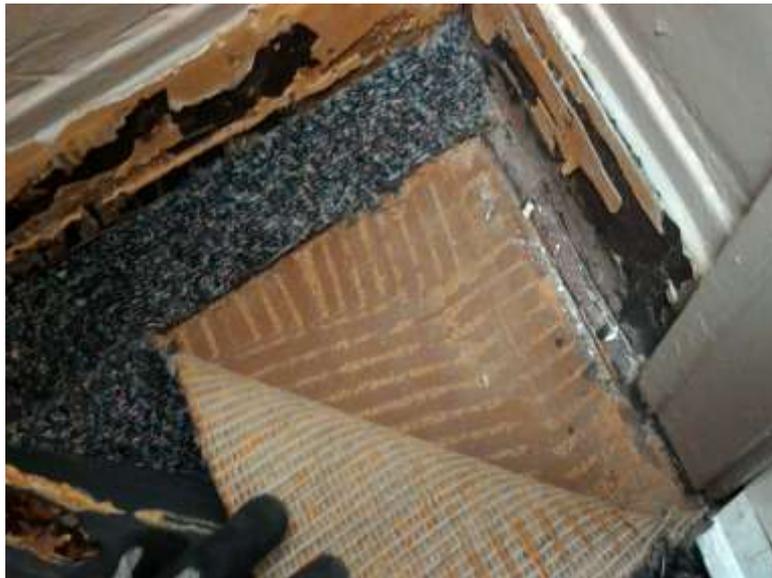
Non-asbestos Unidentified Material*, Brown floor tile underlay, G-1-118-142, (Sample S0017C), 1-213-217 (Location:31)

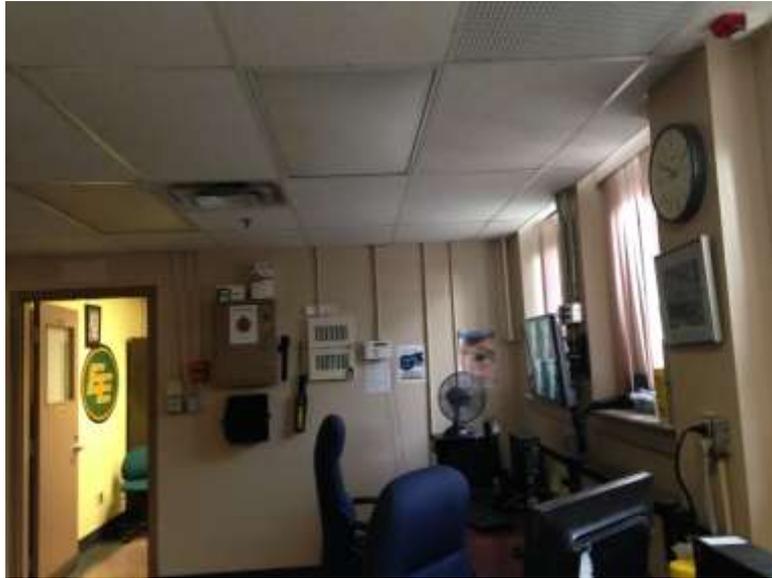
Non-asbestos Drywall and Joint Compound, (Sample S0018), 1-003 (Location:10)

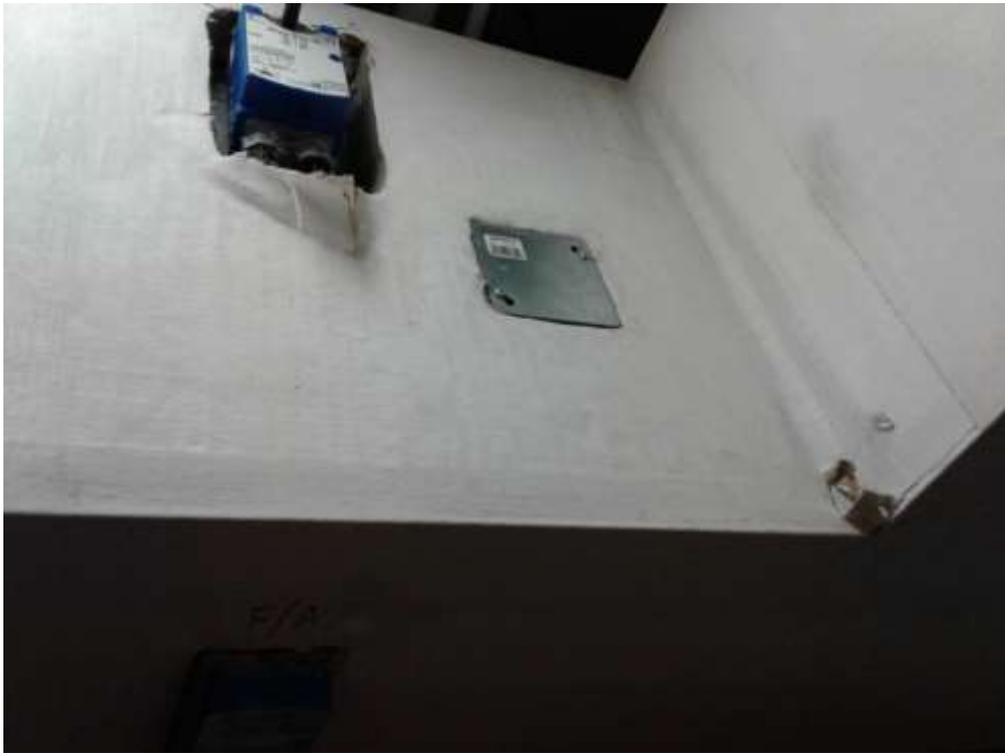
Canvas, (Sample V0000), 1-016 (Location:15)

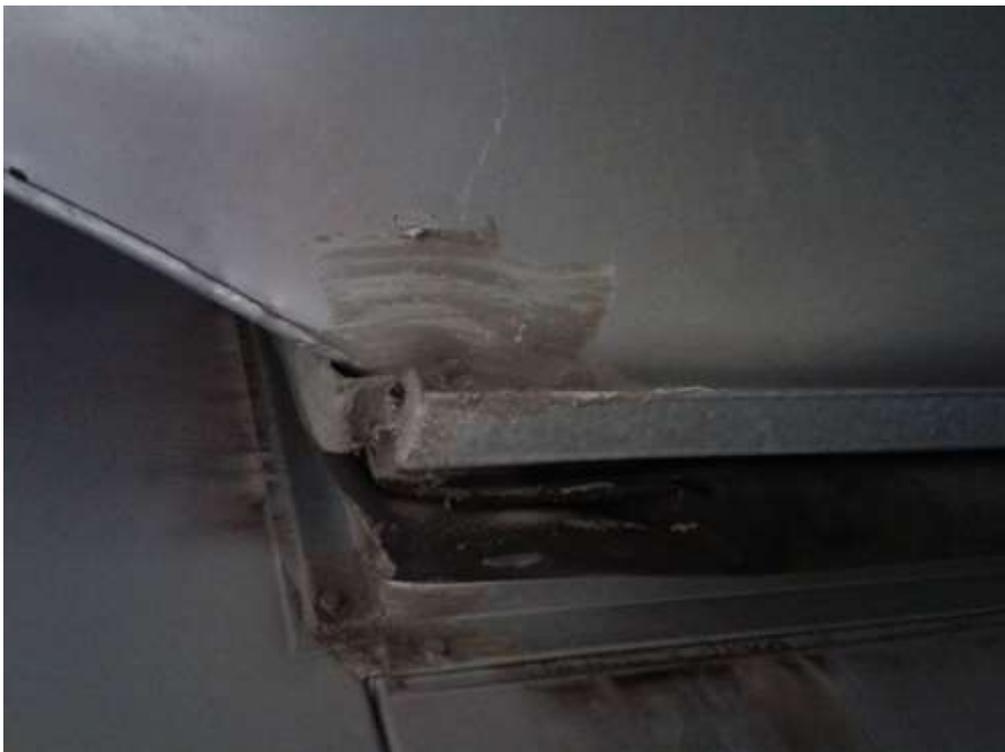
Mastic, Grey mastic on duct, (Sample S0026), 1-016 (Location:15)

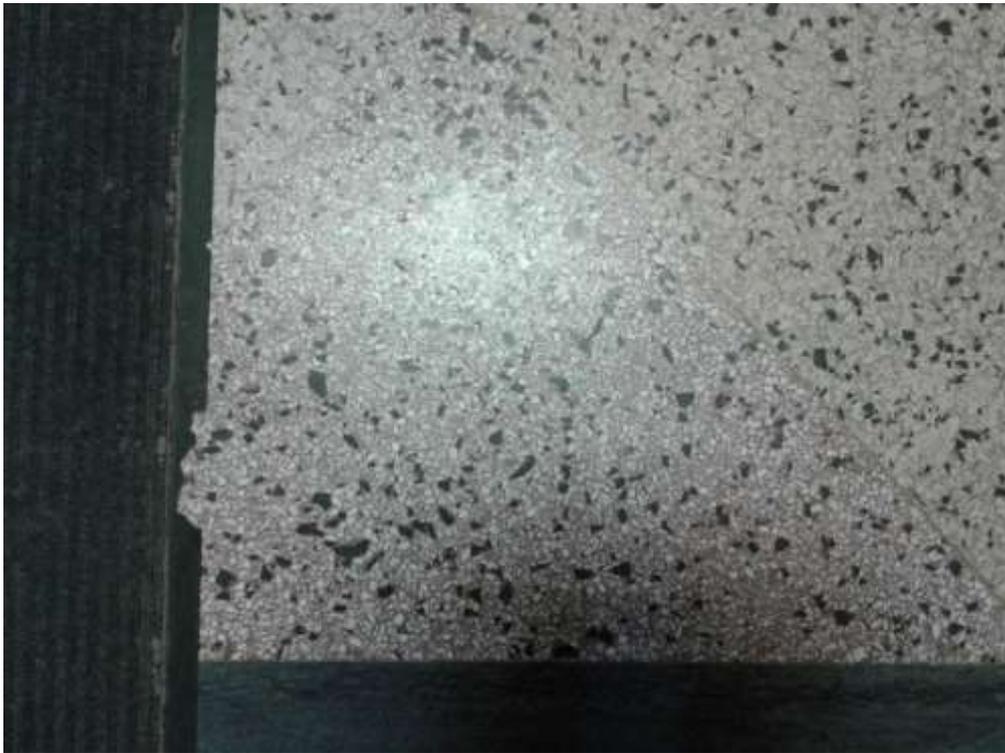
Terrazzo, Pink and black, (Sample S0028), 1-119 (Location:19)

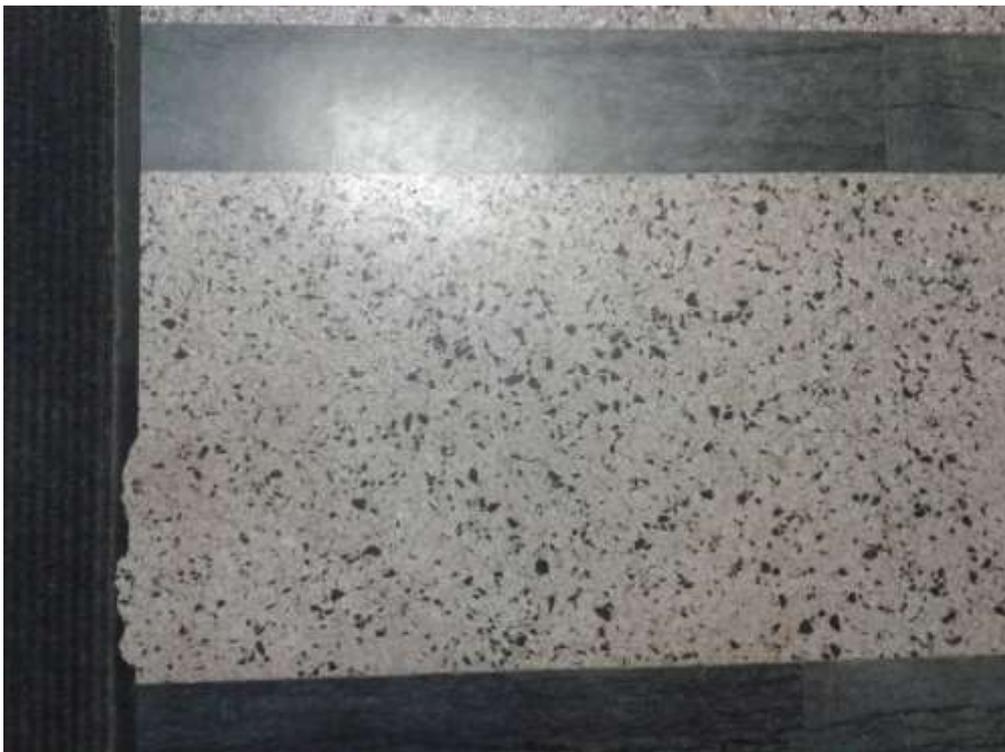
Terrazzo, Beige and black, (Sample S0029), 1-119 (Location:19)

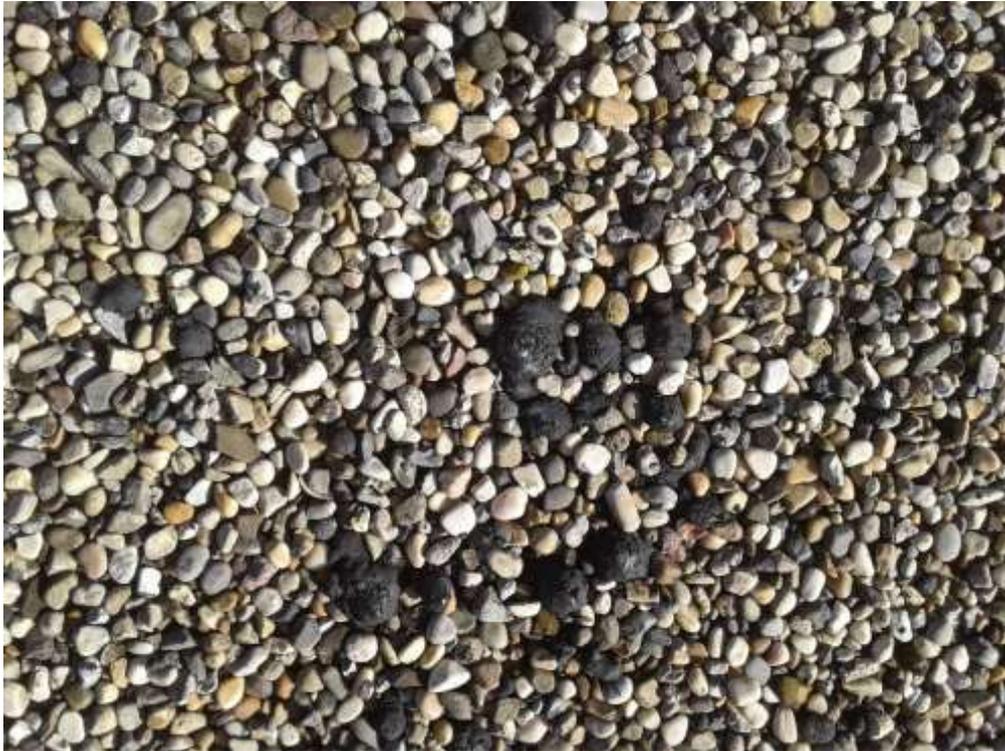
Tar, Asphalt chunks, (Sample S0023), Roof (Location:43)

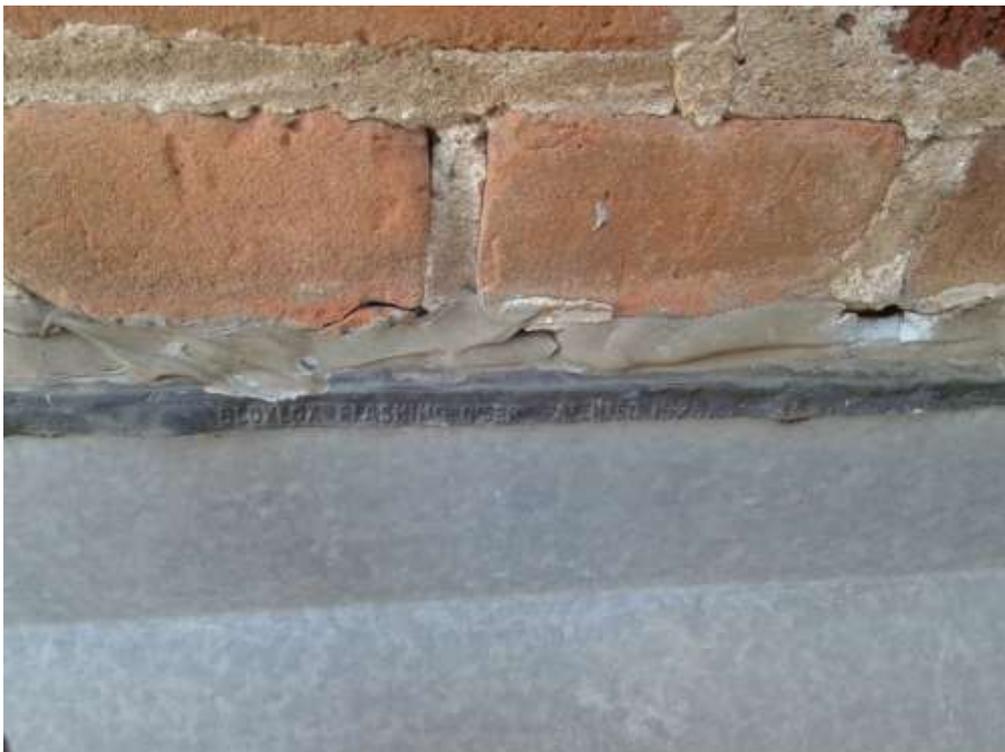
Mastic, Grey mastic at roof flashing , (Sample S0021), Roof (Location:43)

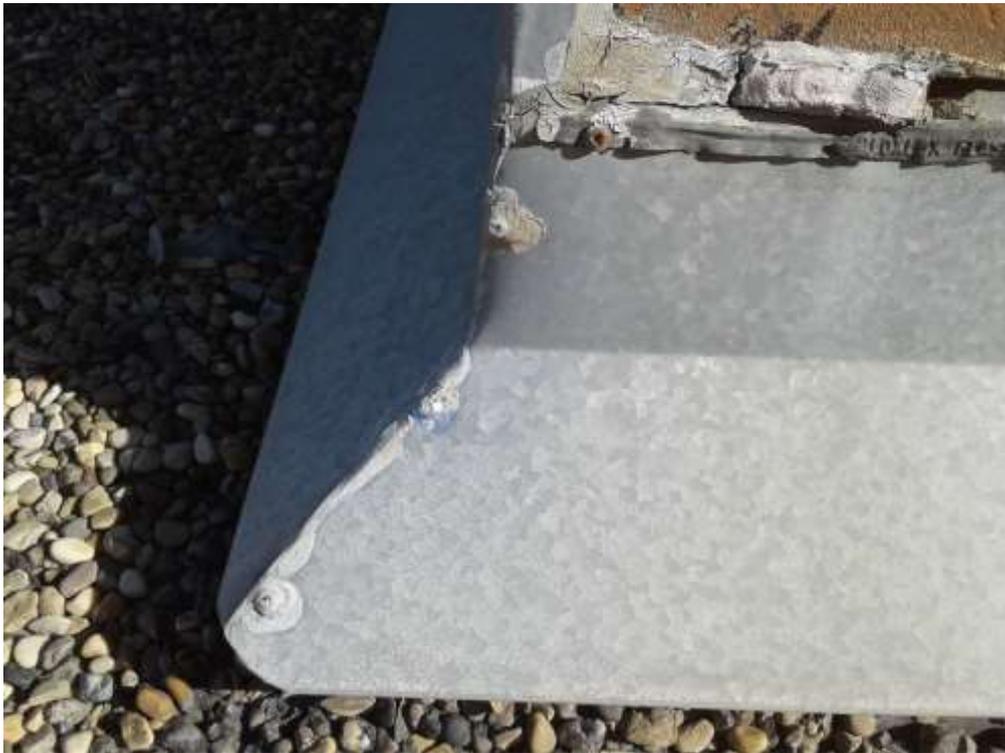
Mastic, White mastic on flashing , (Sample S0024), Roof (Location:43)

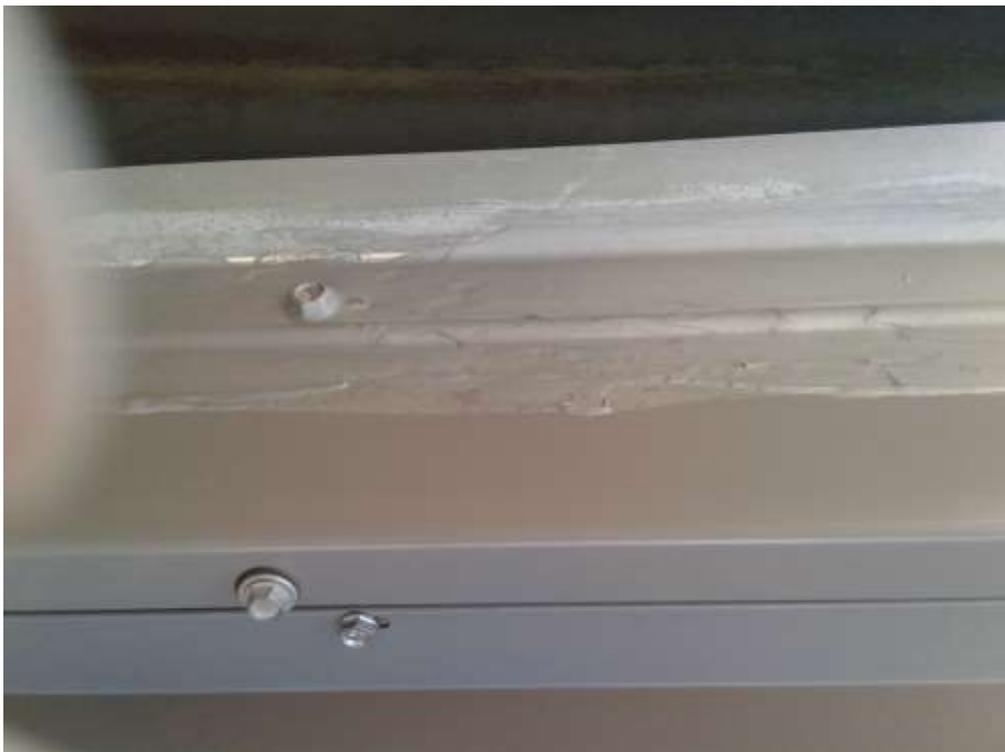
Mastic, Silver mastic on duct, (Sample S0020), Roof (Location:43)

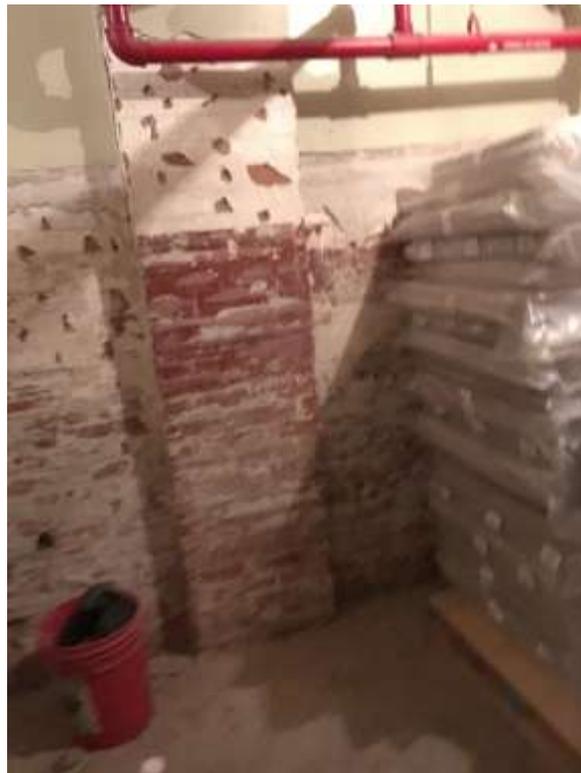
Non-asbestos visually similar Red Brick and Mortar, Ref G-3-014-007 (Samples S0002 and S0003), 4-012 (Location:6)

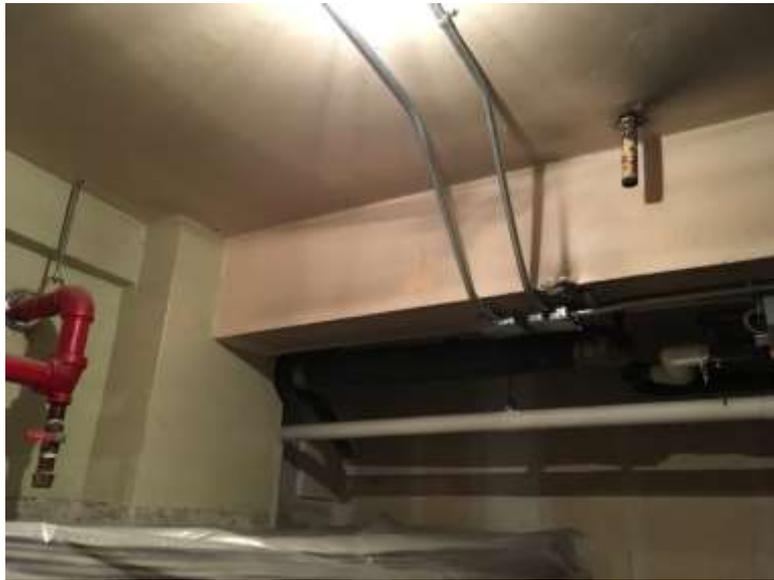
Non-asbestos Plaster, Ref G-3-012-001 (Sample S0005), 3-016 (Location:6)

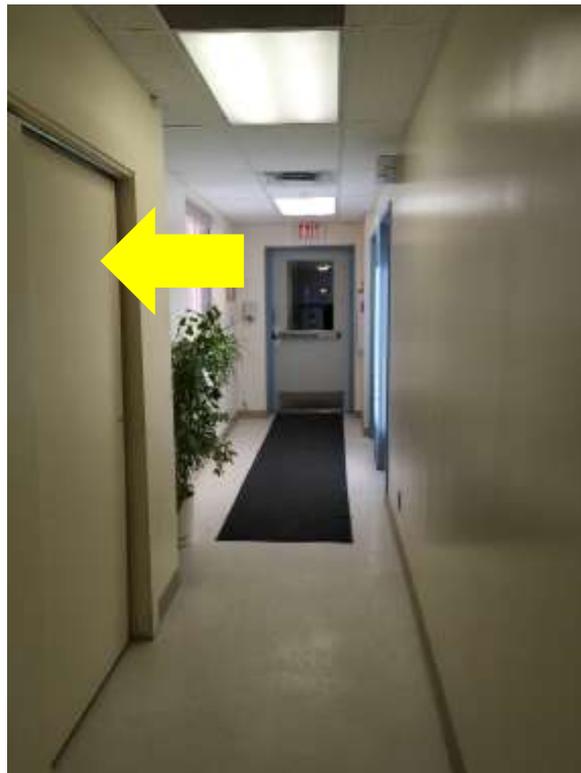
Non-asbestos Drywall and Joint Compound, (Sample S0007), 3-212 (Location:11)

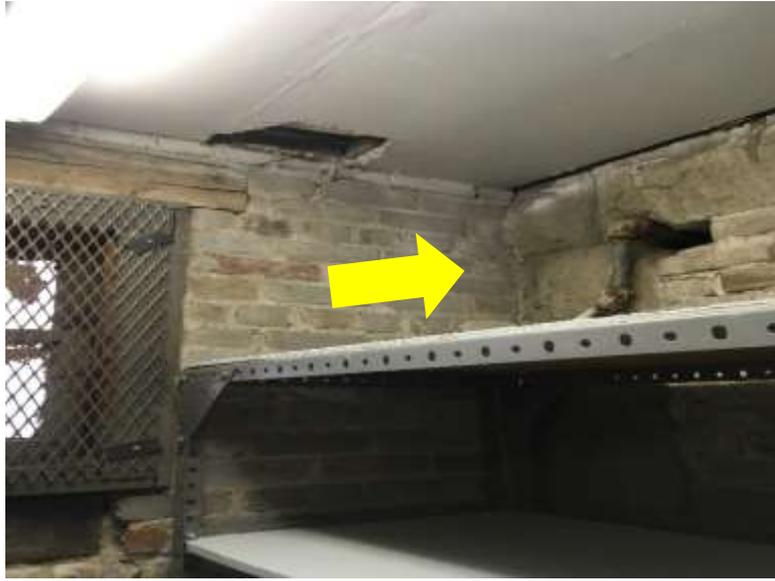
Non-asbestos visually similar Grey Brick and Mortar (Samples S0010 and S0011), 3-211 (Location:12)

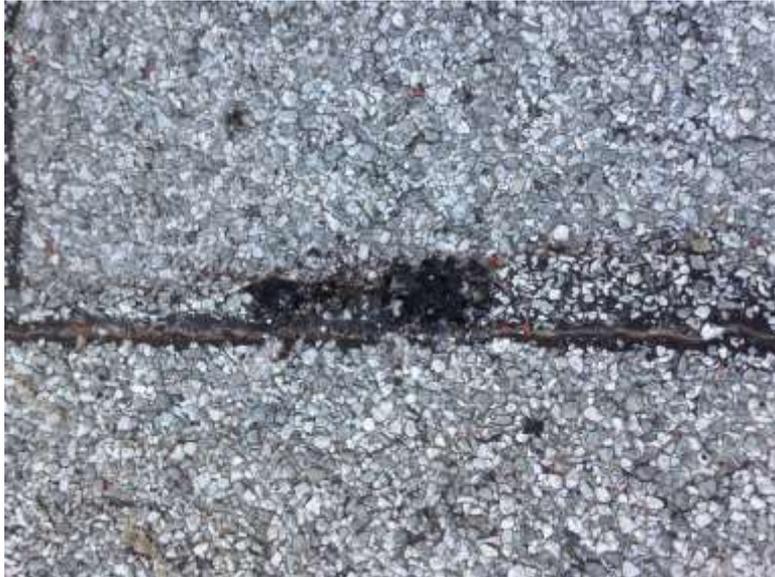
Non-asbestos Asphalt Shingles, (Sample S0015), Roof (Location:36)

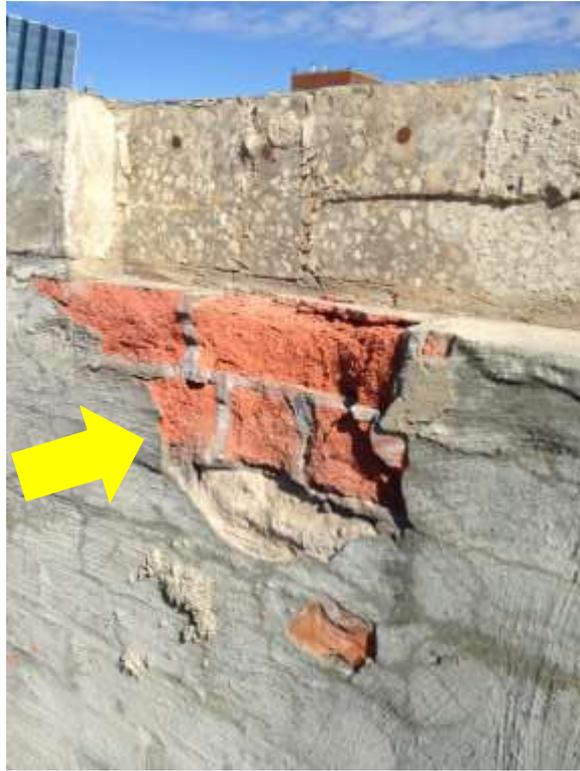
Non-asbestos Stucco and Brick (Samples S0016 and S0017), Roof (Location:36)

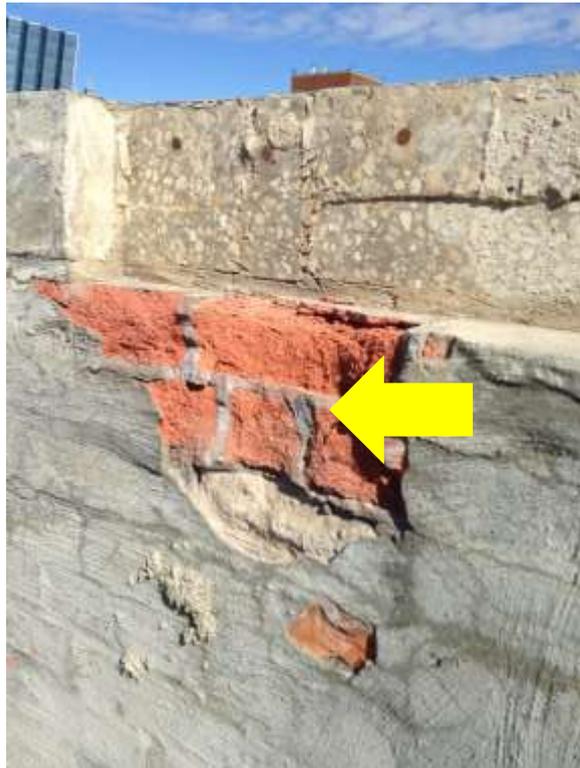
Asbestos Mortar, (Sample S0018), Roof (Location:36)

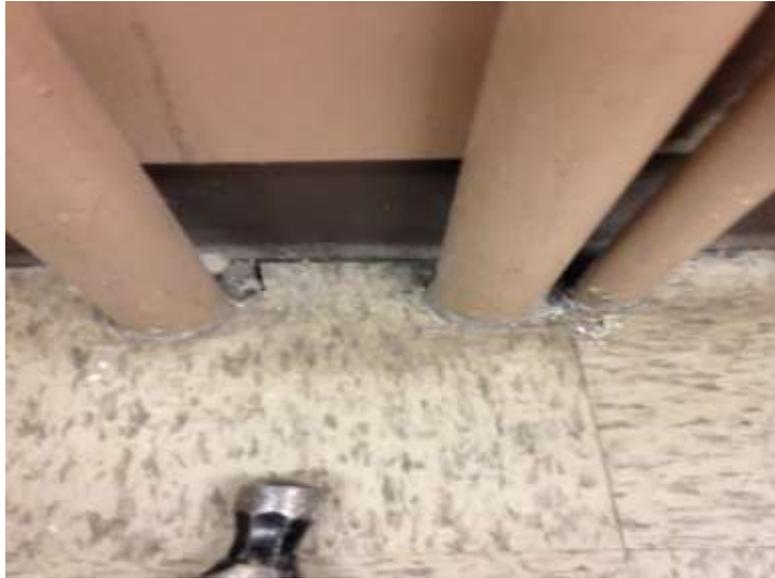
Non-asbestos Vinyl Floor Tiles, 12X12 Light Brown with Grey Flecks (Sample S0001), 4-114 (Location:1)

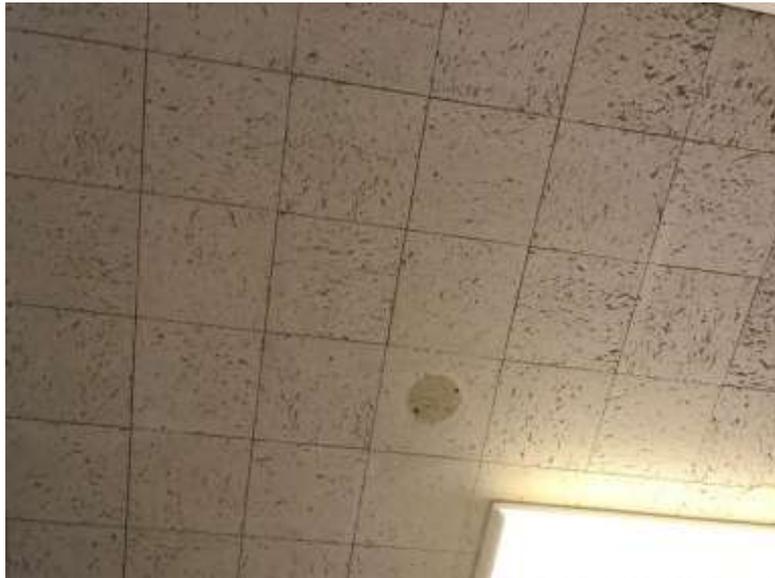
Non-asbestos Glued-on Ceiling Tiles 1X1 With Fissures and Brown Mastic, Ref G-4-132-153 (Sample S0005 and S0006),
4- 131 (Location:20)

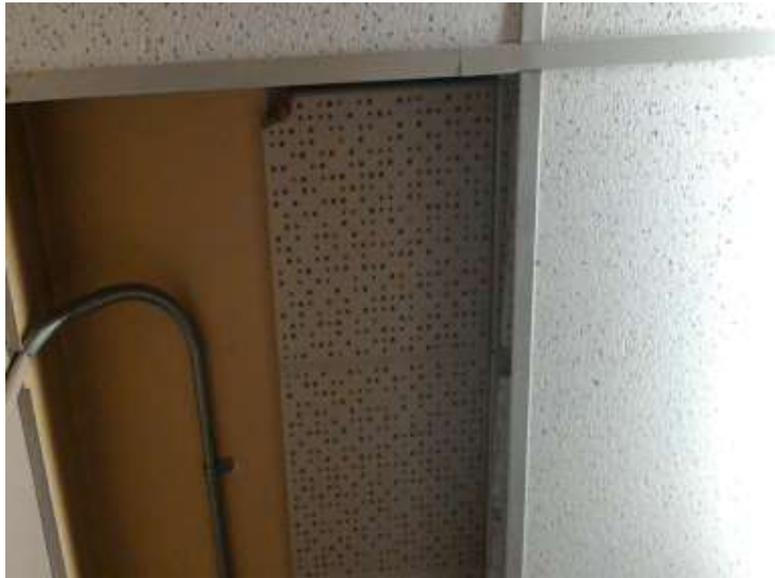
Non-asbestos Glued-on Ceiling Tiles, 1x1 large holes, Ref G-4-203-118, (Sample S0012A), 4-202 (Location:52)

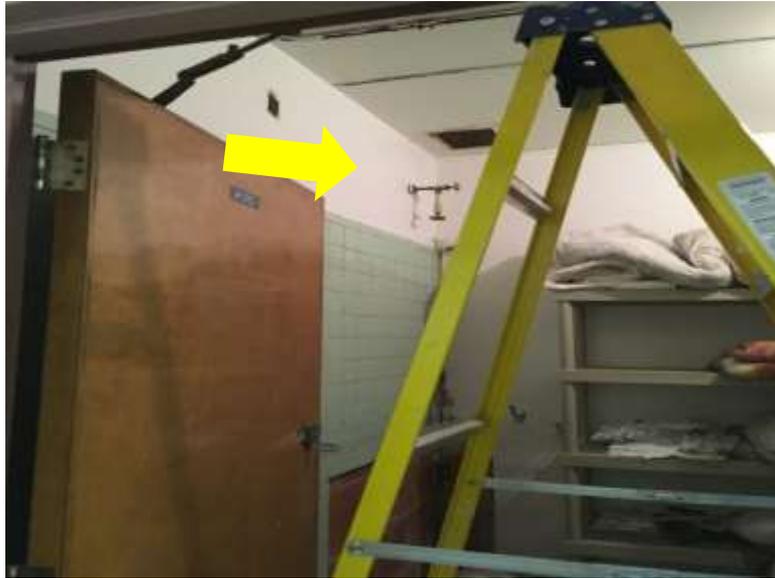
Non-asbestos Drywall and Joint Compound, Ref G-4-206-155 (Sample S0015), 4-210 (Location 58)

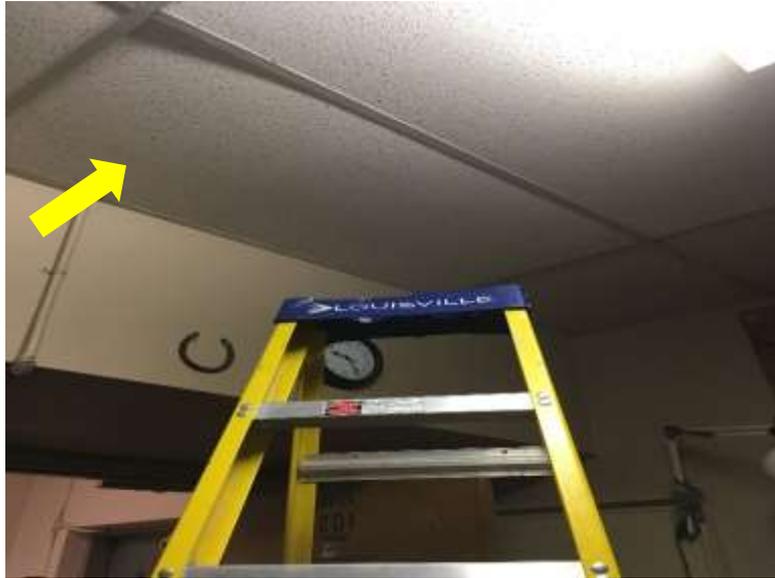
Non-asbestos Lay-In Ceiling Tiles, Pinholes and Long Directional (Sample S0019), 4-206 (Location:53)

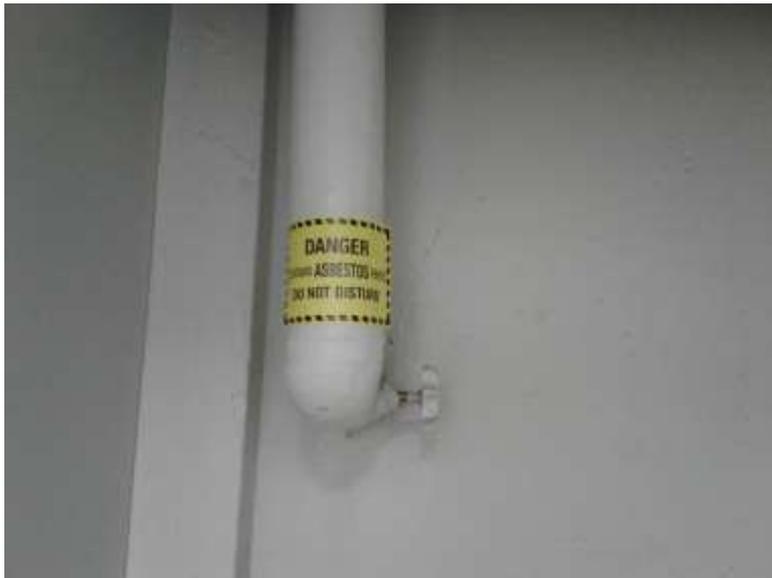
Mould impacted Plaster ceiling, 4-124 (Location:10)

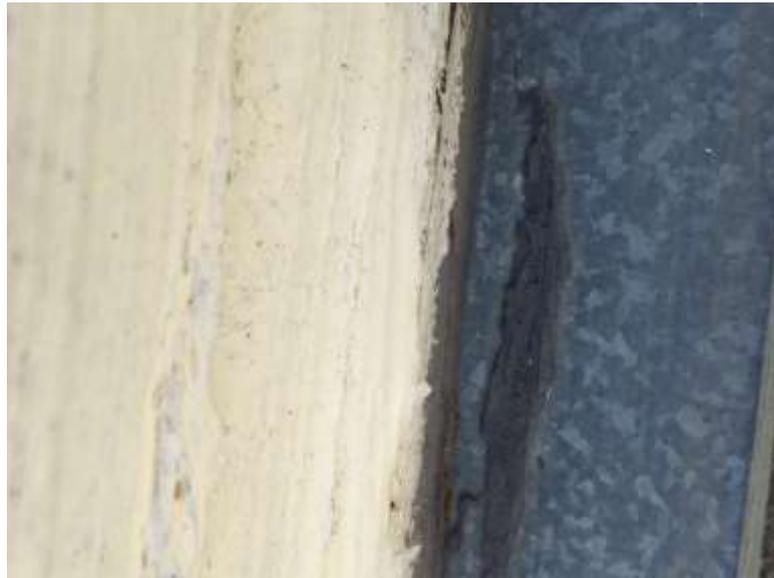
Asbestos-containing light grey mastic on Air Handling Unit, Roof (Location:79)

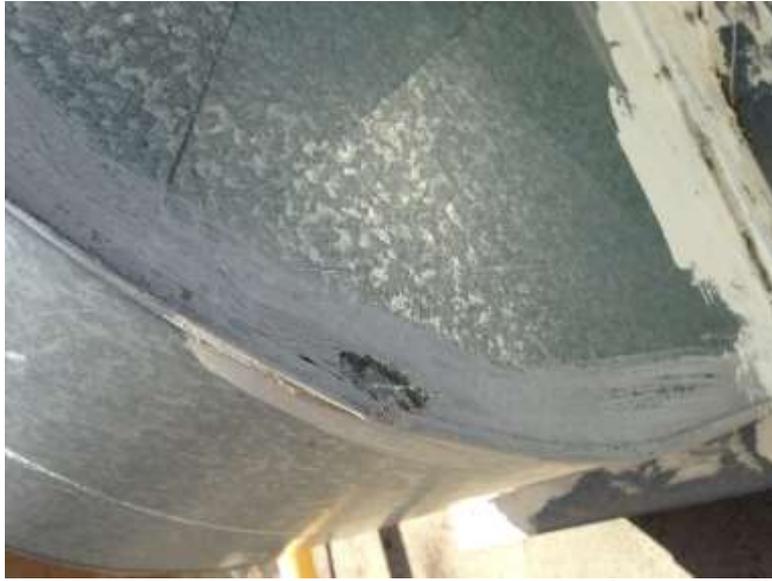
Non-asbestos white mastic on dark grey, Roof (Location:79)

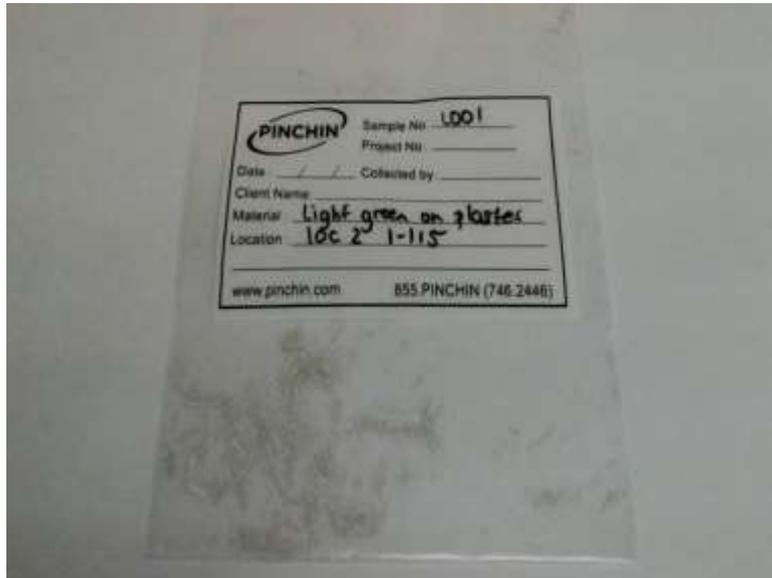
Light green on plaster, (Sample L0001), 1-115 (Location:2)

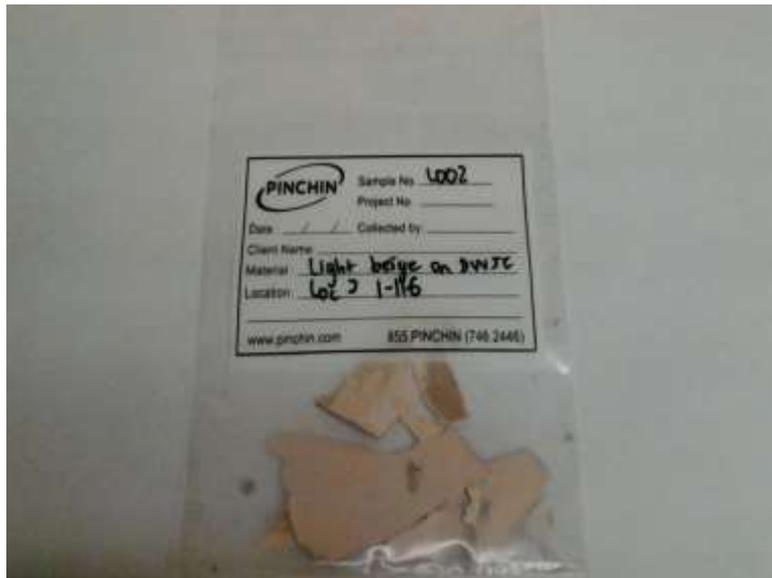
Light beige on DWJC, (Sample L0002), 1-116 (Location:3)

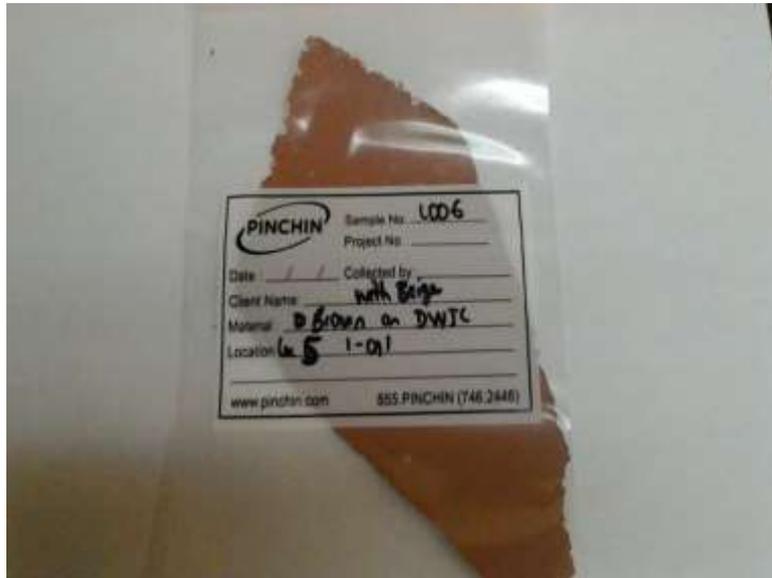
Brown with beige on DWJC, (Sample L006), 1-007 (Location:5)

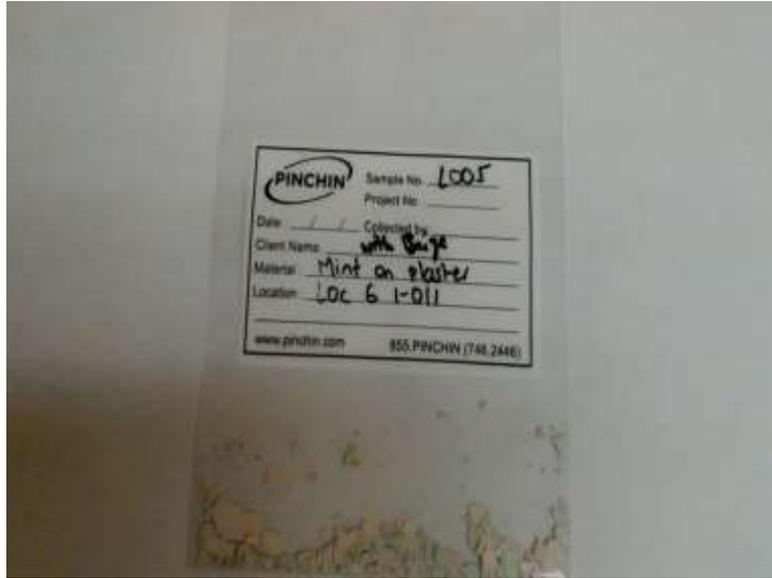
Mint with white on plaster above ceiling, (Sample L0005), 1-011 (Location:6)

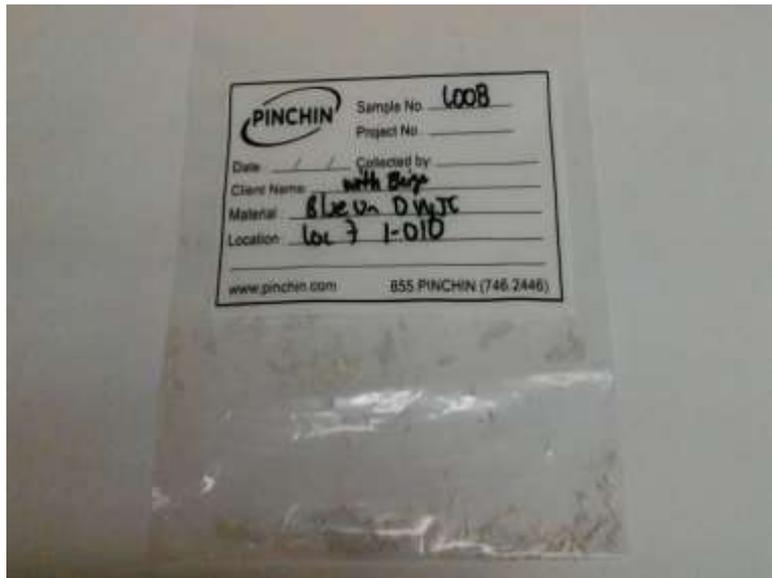
Blue with beige on DWJC, (Sample L0008), 1-010 (Location:7)

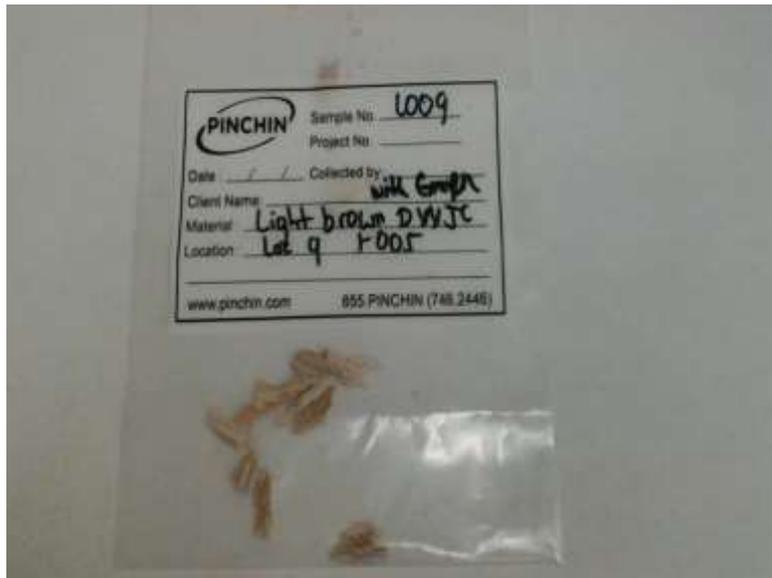
Light brown with green on DWJC, (Sample L0009), 1-005 (Location:9)

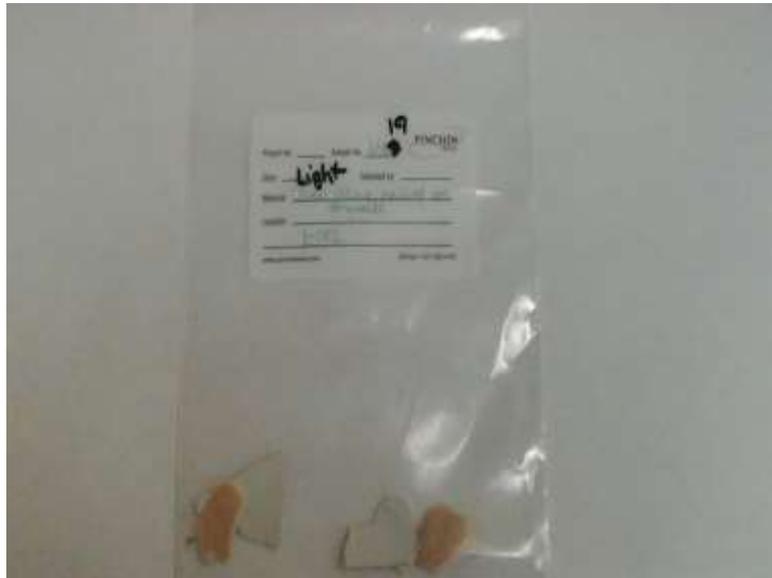
Light grey above ceiling, (Sample L0019), 1-002-5 (Location:10)

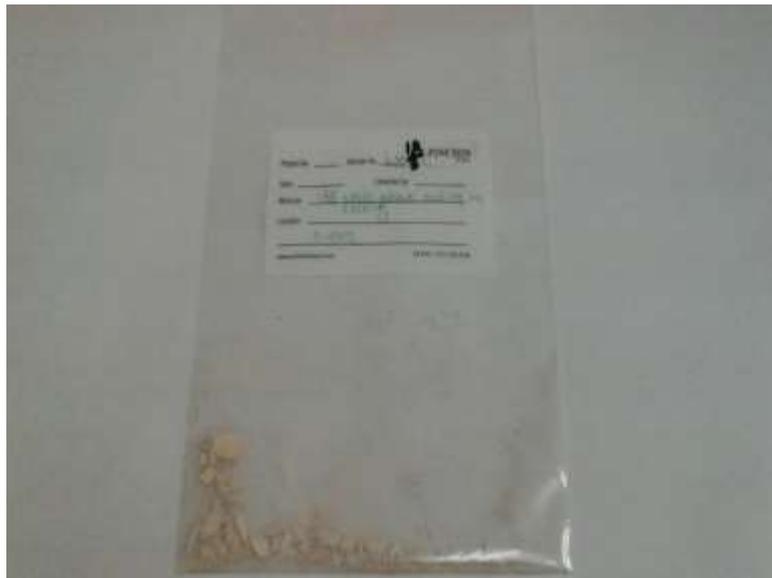
Off White above ceiling on ceiling, (Sample L0018), 1-002-5 (Location:10)

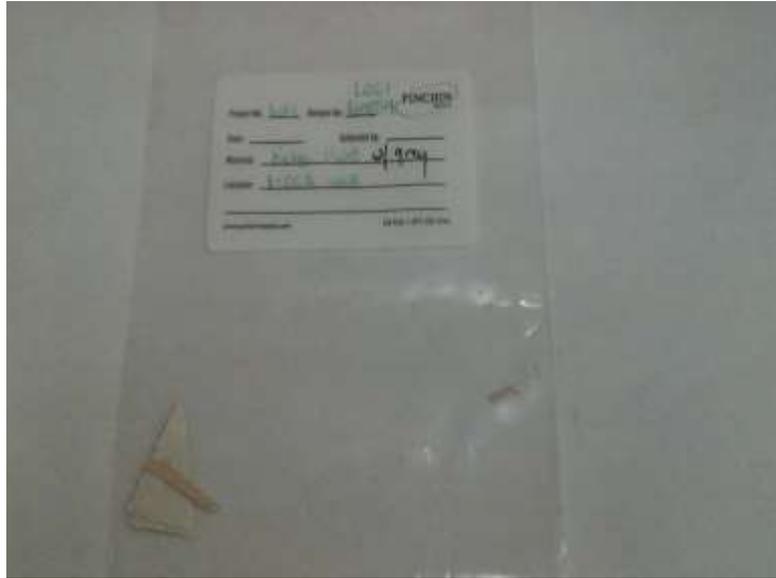
Beige paint with grey, (Sample L0020), 1-002-5 (Location:10)
