Fire Alarm System Annual Test & Inspection Report – Individual Device Record

Hazardous Building Materials GAP Assessment

Hazardous Building Materials GAP Assessment - Revised

Grierson Institution
9530 – 101 Avenue, Edmonton,
Alberta

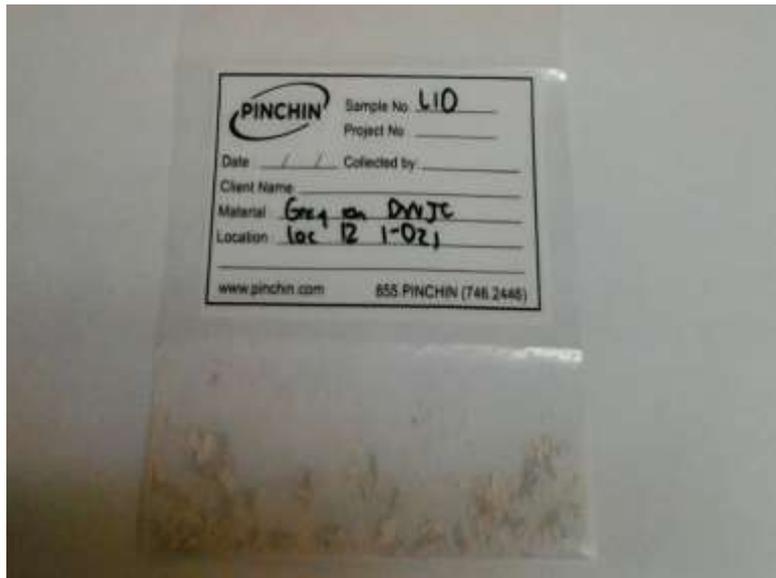
Grey on Drywall, (Sample L0010), 1-021 (Location:12)

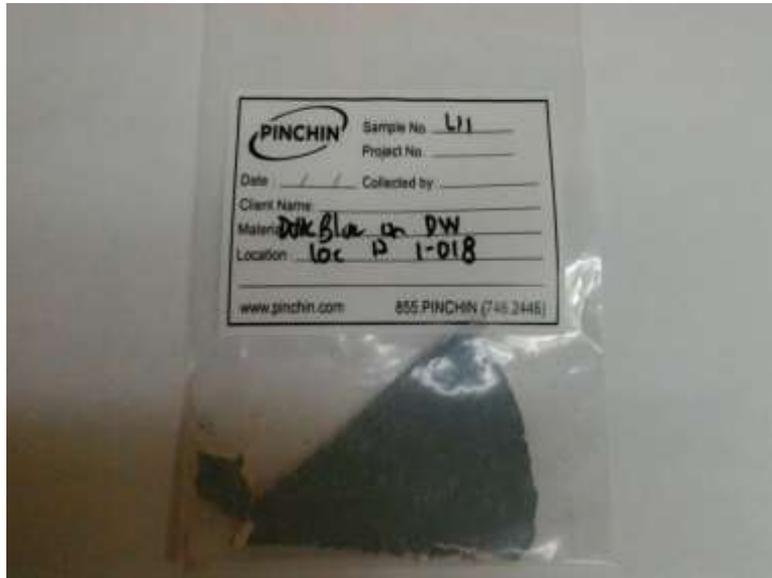
Dark Blue on Drywall, (Sample L0011), 1-017-018-019 (Location:13)

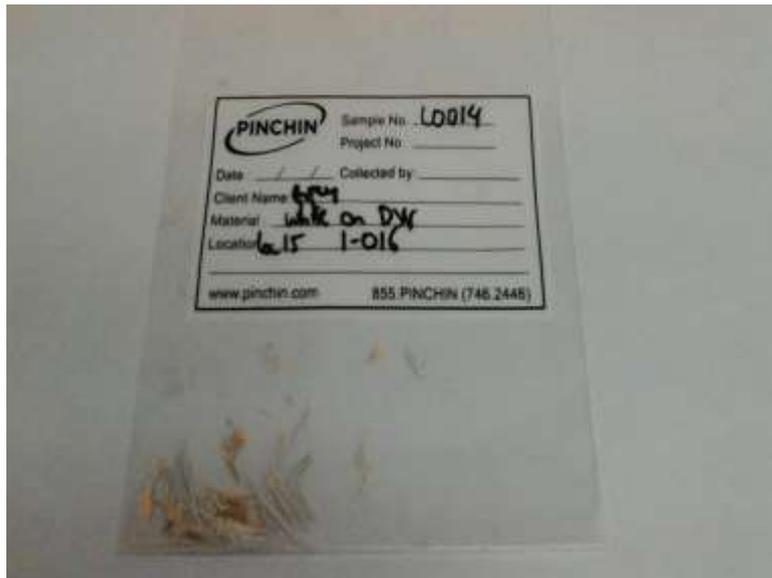
Grey White on Drywall, (Sample L0014), 1-016 (Location:15)

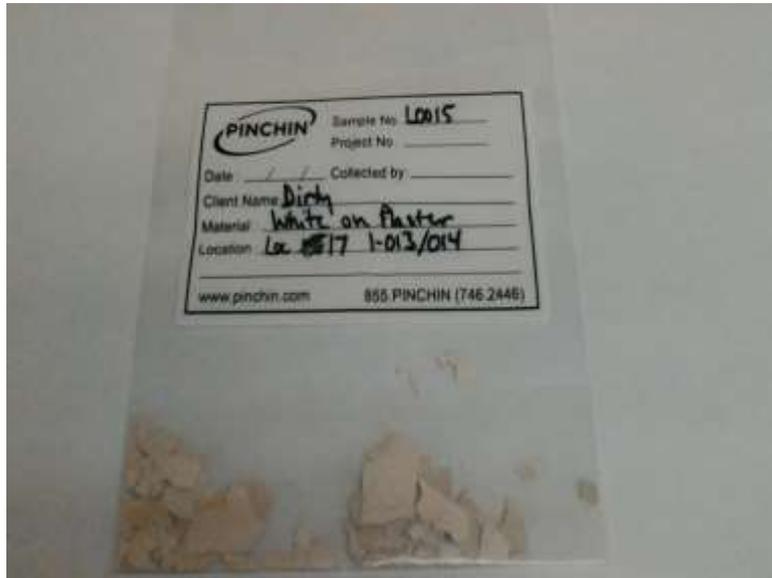
Dirty white on plaster, (Sample L0015), 1-013-14 (Location:17)

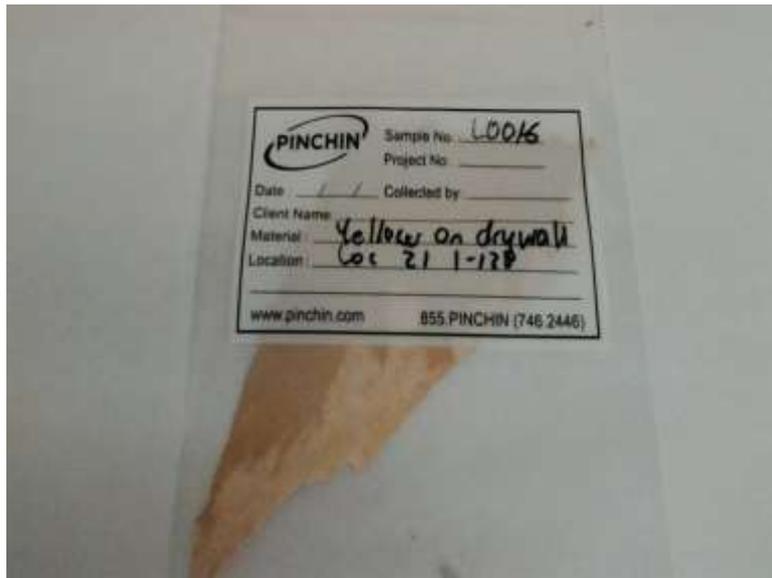
Yellow on drywall above ceiling, (Sample L0016), 1-128 (Location:21)

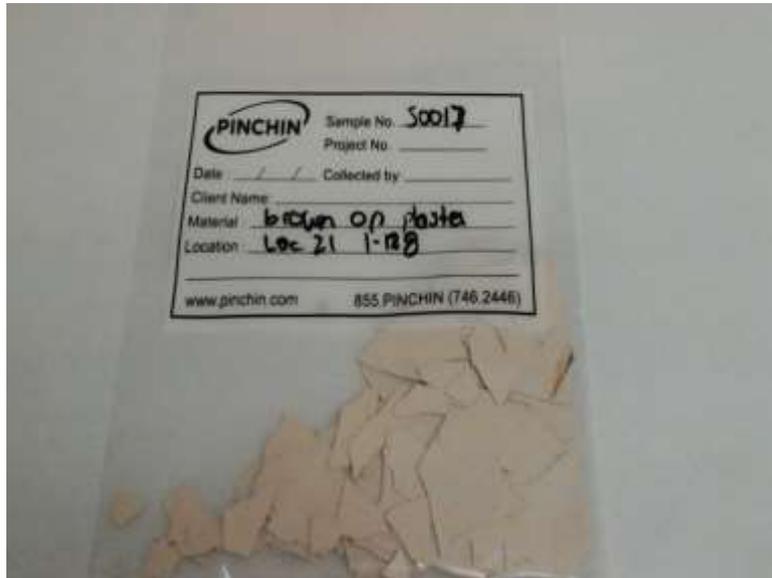
Brown on plaster, (Sample L0017), 1-128 (Location:21)

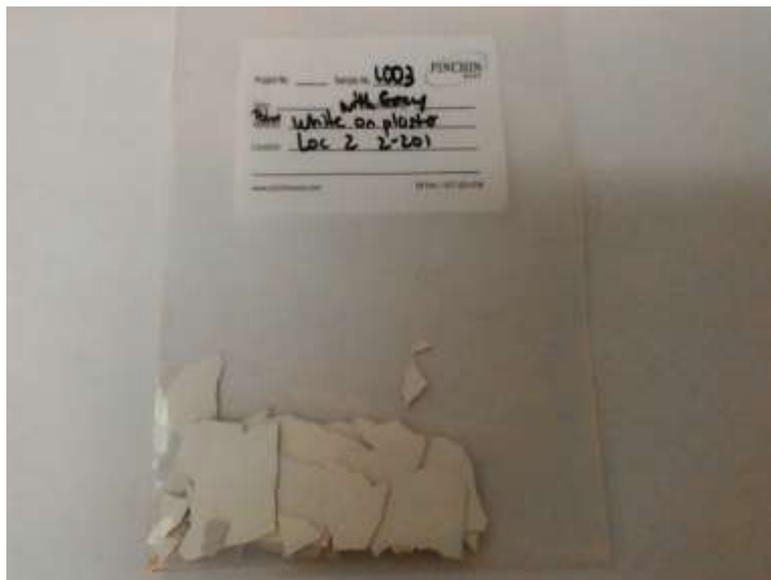
White with grey on plaster, (Sample L0003), Hallway 2-201 (Location:2)

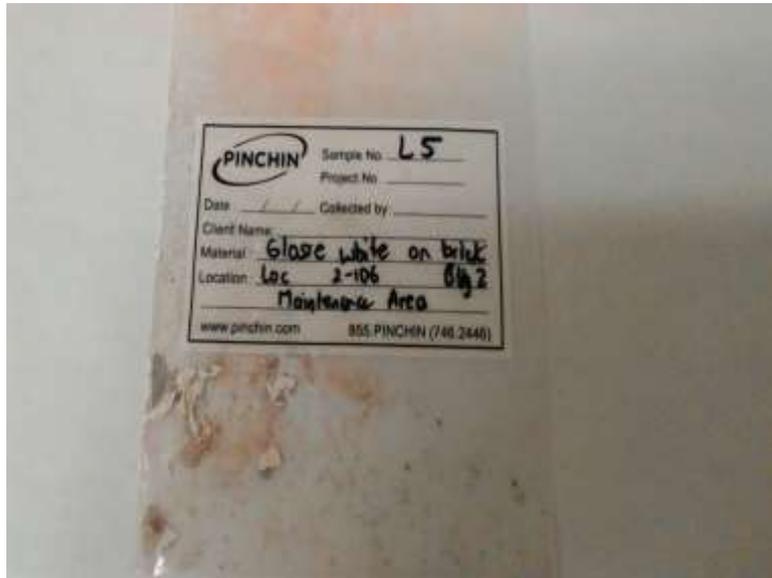
Glossy white on brick, (Sample L0005), 2-106 Maintenance Bay (Location:4)

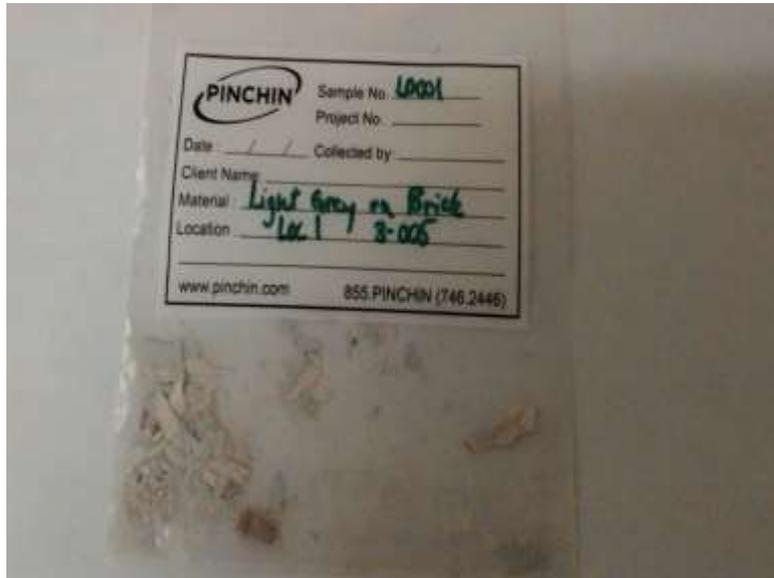
Light grey on brick, (Sample L0001), 3-005 Hallway (Location:1)

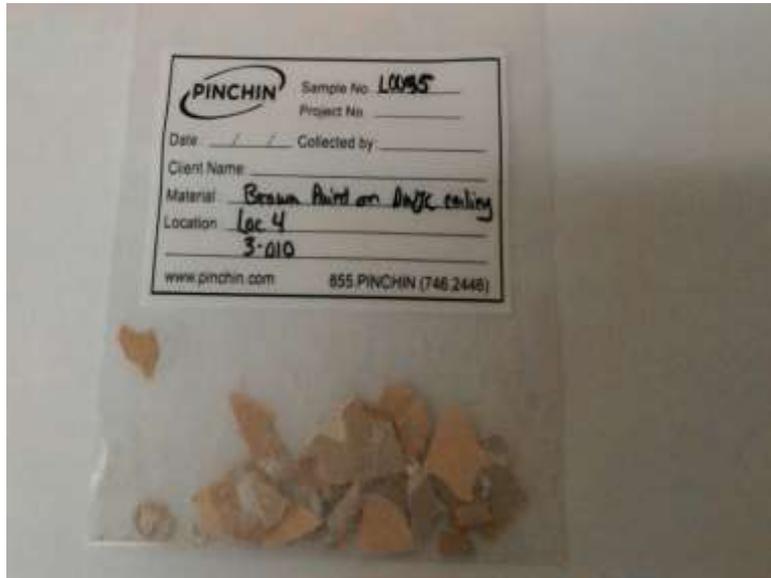
Brown on drywall, (Sample L0005), 3-010 (Location:4)

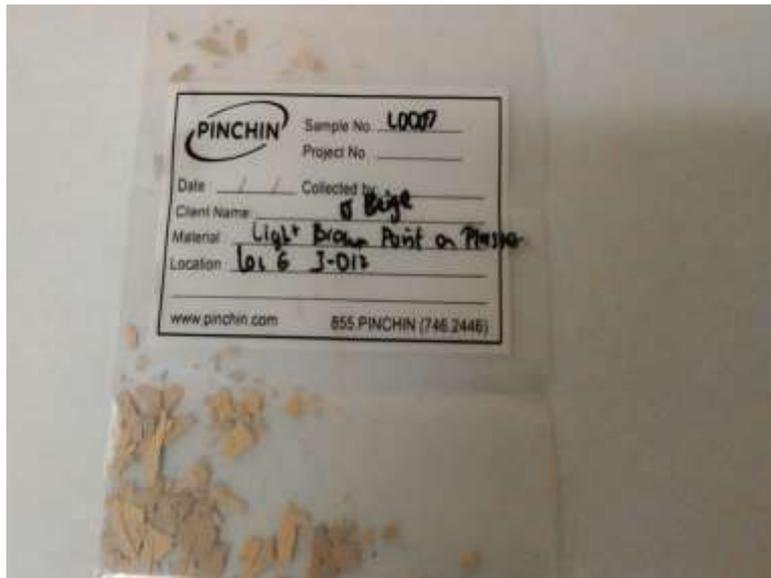
Light brown with beige on plaster, (Sample L0007), 3-012 (Location:6)

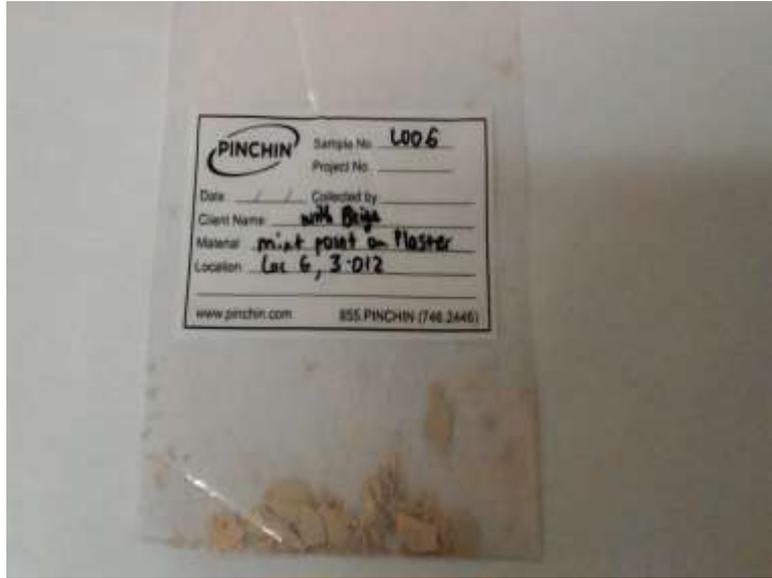
Mint with beige paint on plaster, (Sample L0006), 3-012 (Location:6)

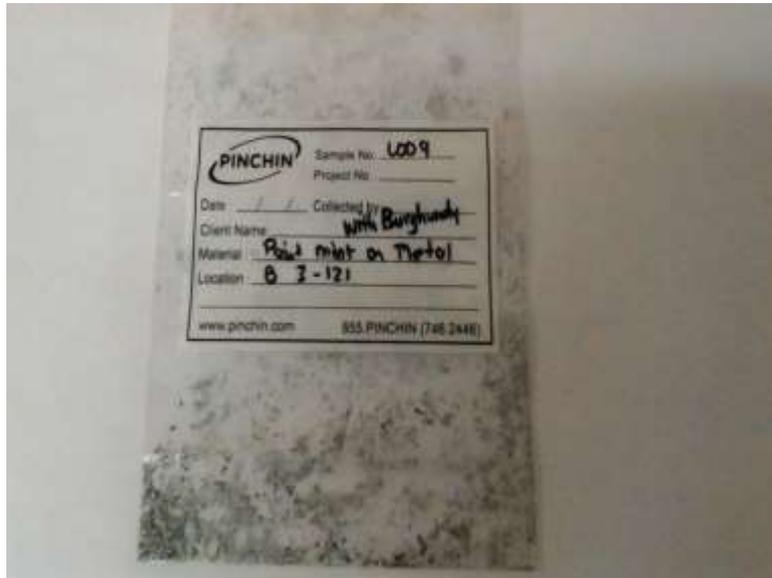
Mint with burgundy paint on metal, (Sample L0009), 3-121 (Location:8)

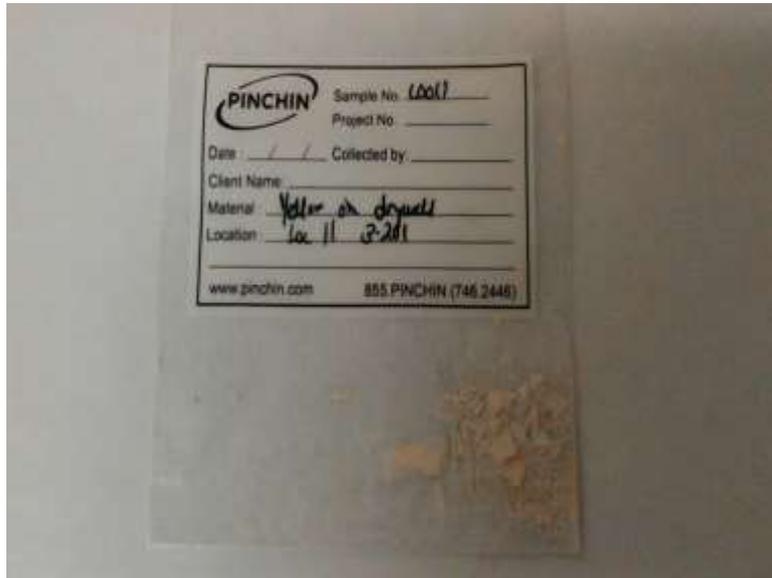
Yellow on drywall, (Sample L0011), Hallway 3-201 (Location:11)

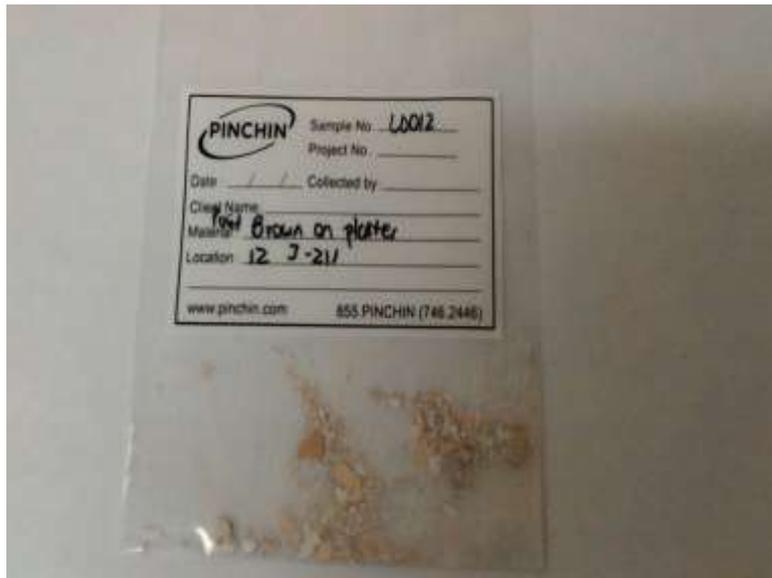
Brown on plaster, (Sample L0012), 3-211 (Location:12)

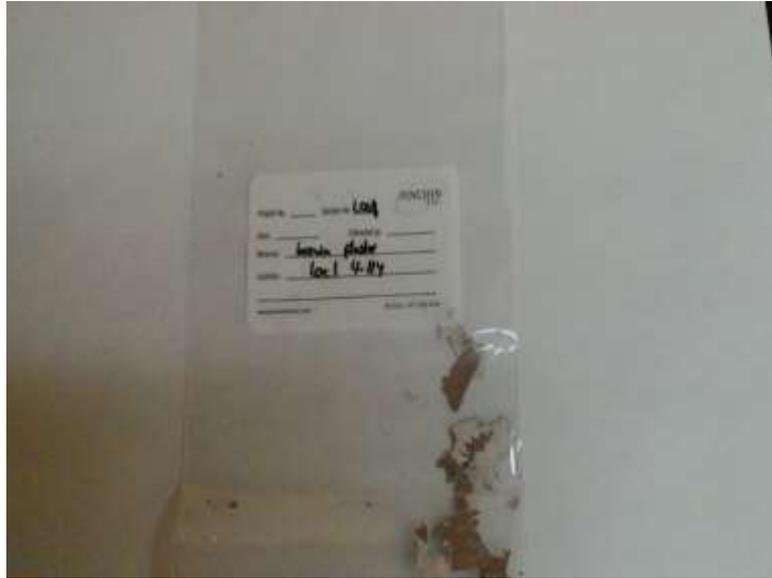
Brown plaster, (Sample V0001), 4-114 (Location:1)

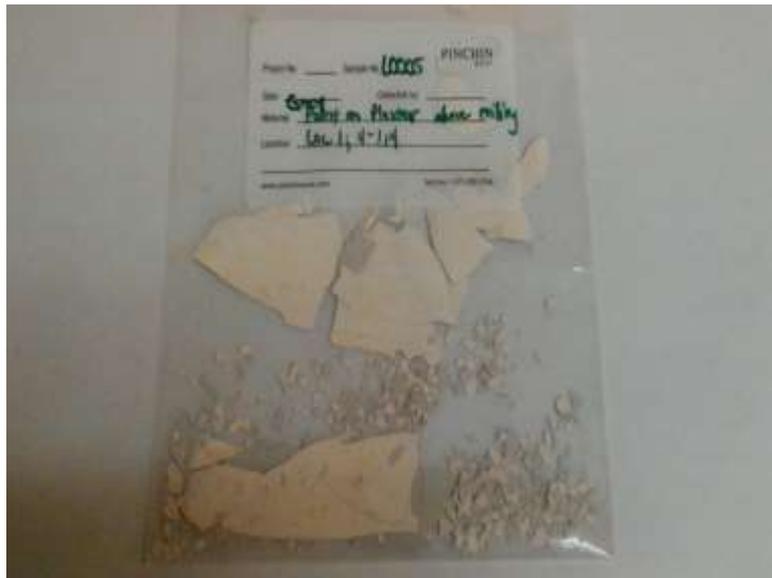
Grey plaster, (Sample L0002), 4-114 (Location:1)

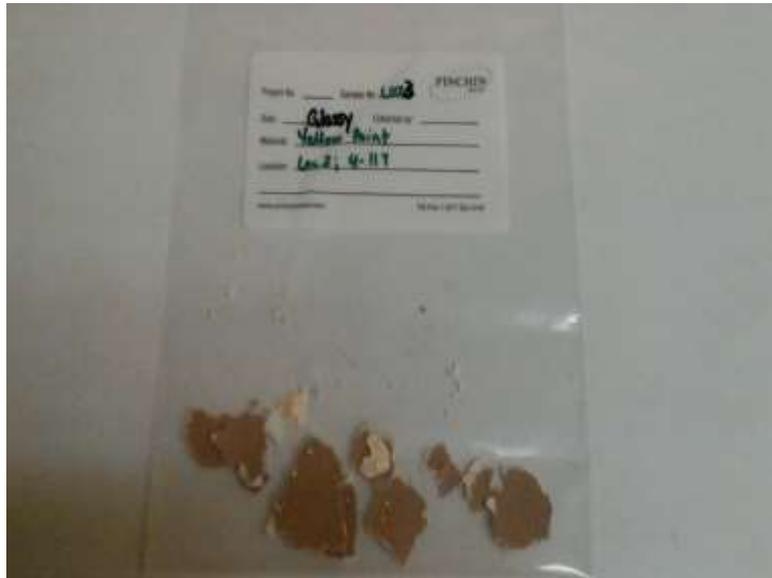
Glossy yellow on texture finish, (Sample L0003), 4-117 (Location:2)

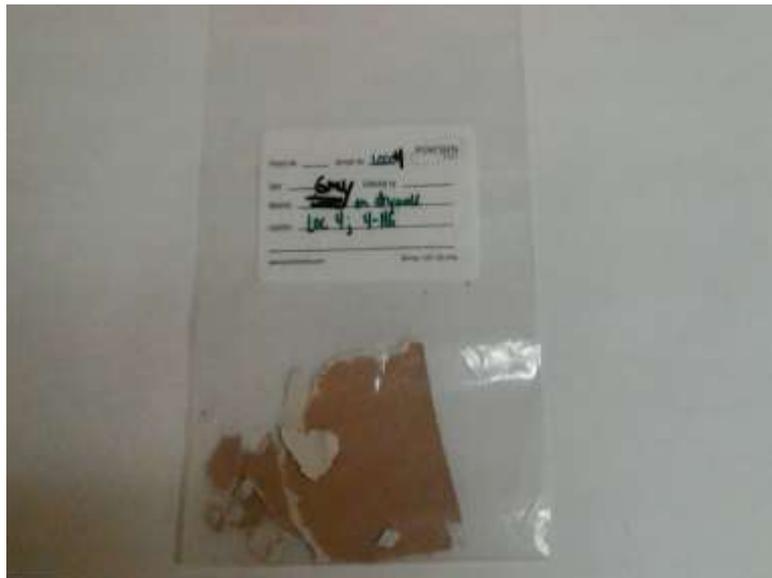
Grey drywall, (Sample L0004), 4-113 (Location:3)

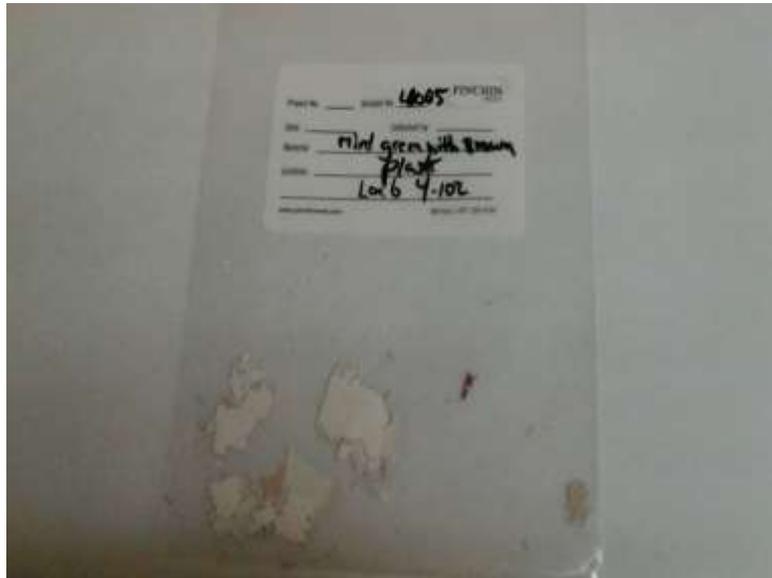
Mint green with brown plaster, (Sample L0005), 4-102 (Location:6)

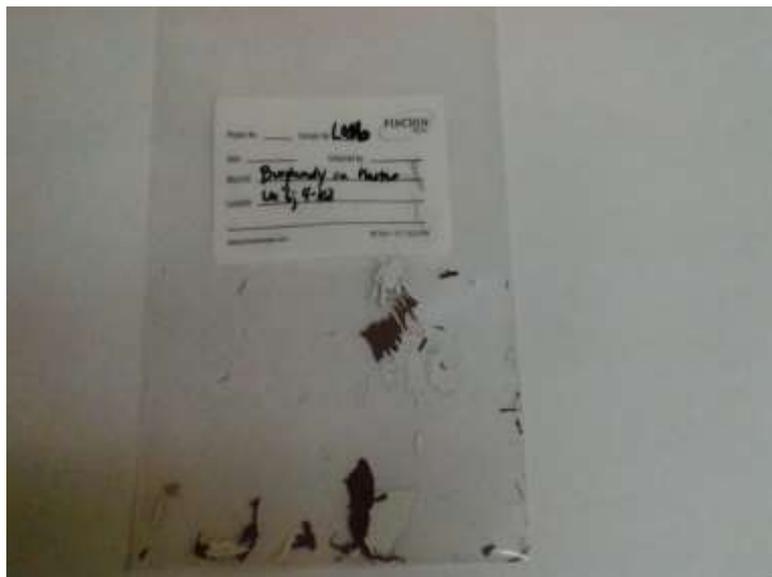
Burgundy plaster, (Sample L0006), 4-102 (Location:6)

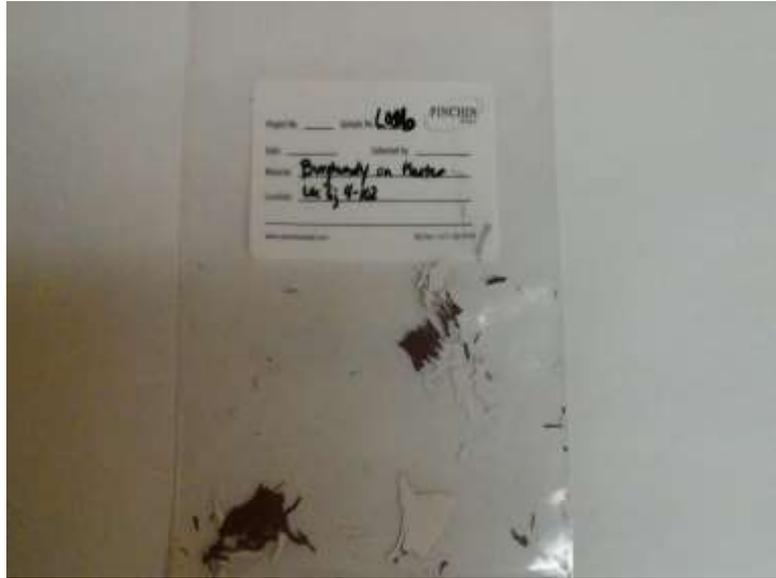
Burgundy, (Sample V0006), 4-101 (Location:7)

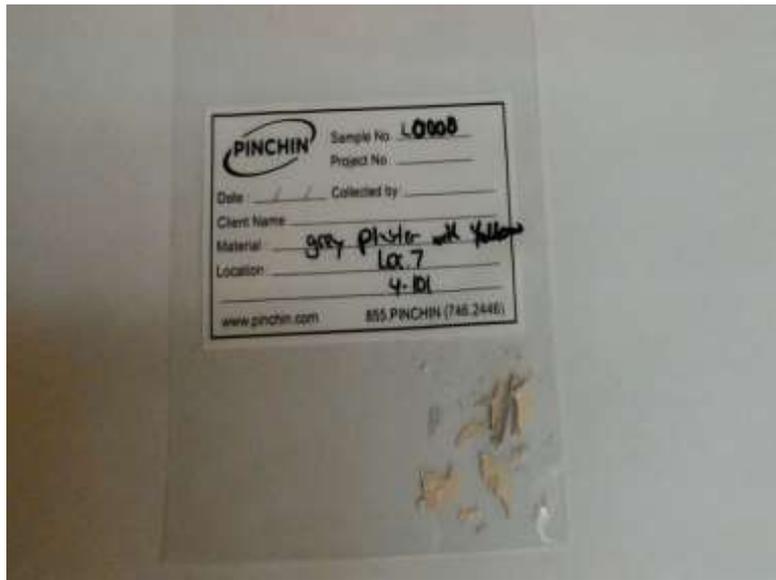
Grey with yellow plaster, (Sample L0008), 4-101 (Location:7)

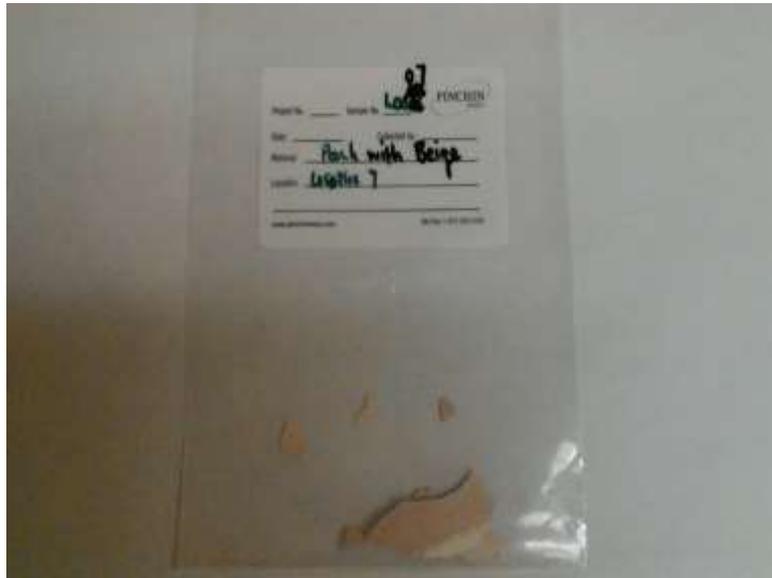
Peach plaster, (Sample L0007), 4-101 (Location:7)

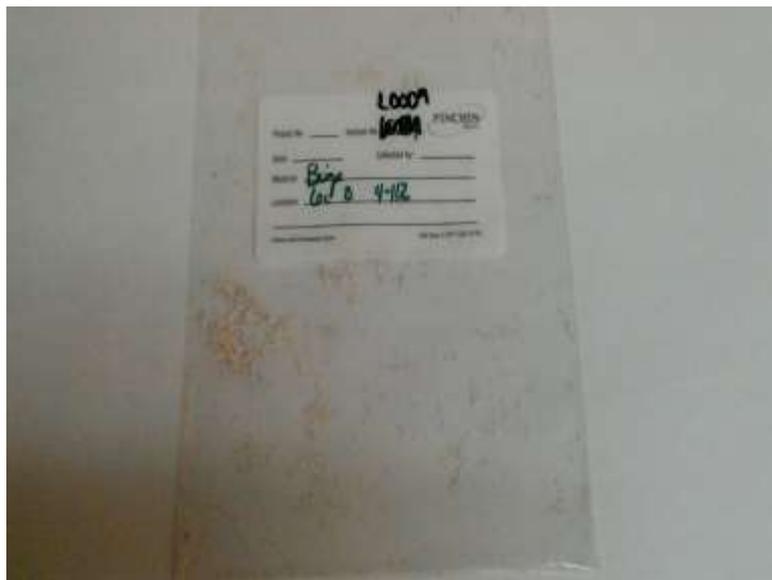
Beige plaster, (Sample L0009), 4-112 (Location:8)

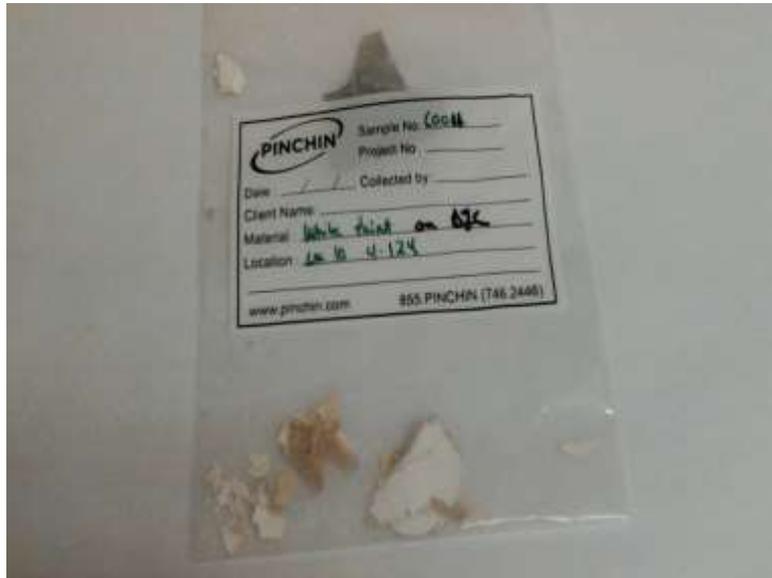
White drywall, (Sample L0011), 4-124 (Location:10)

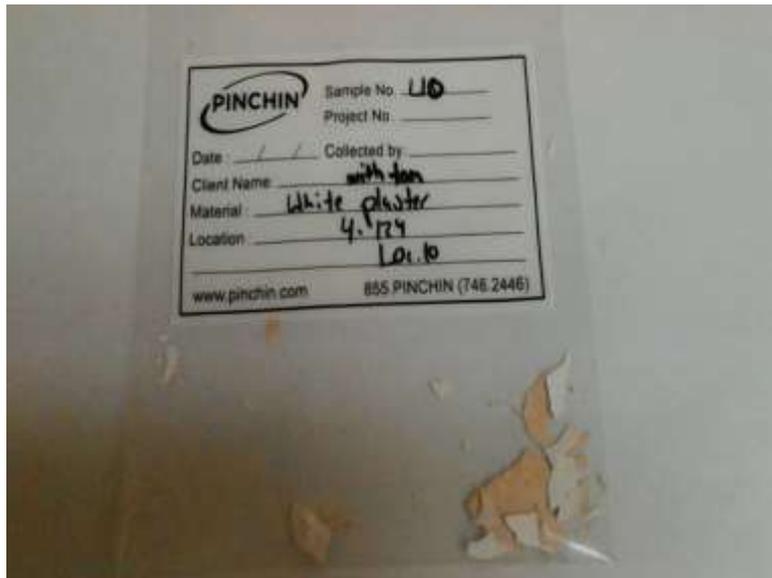
White with tan plaster, (Sample L0010), 4-124 (Location:10)

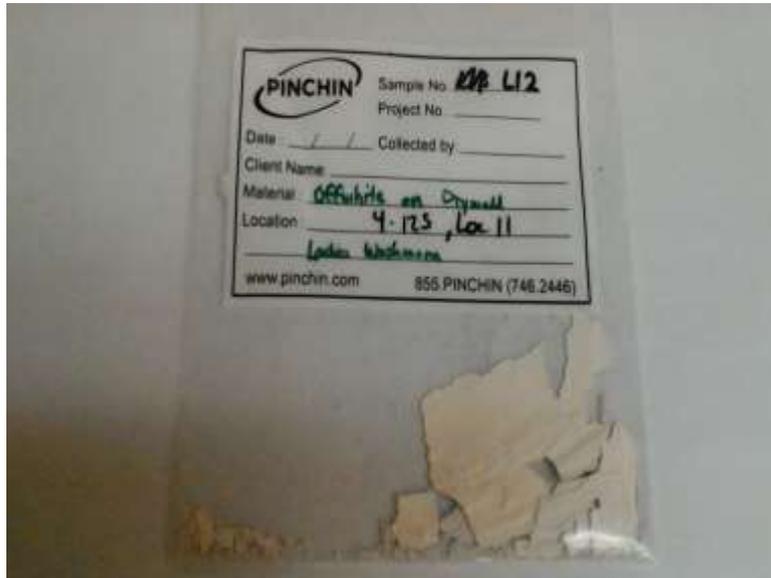
Off white drywall, (Sample V0012), 4-125 (Location:11)

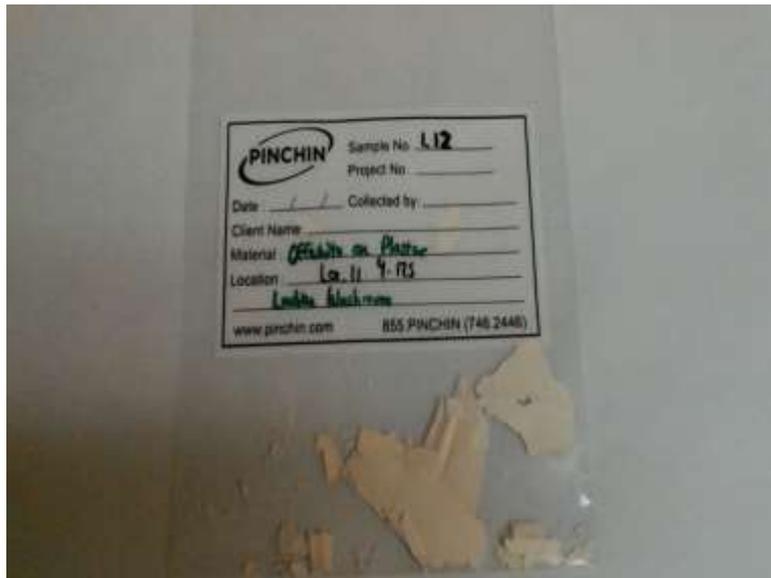
Off white plaster, (Sample L0012), 4-125 (Location:11)

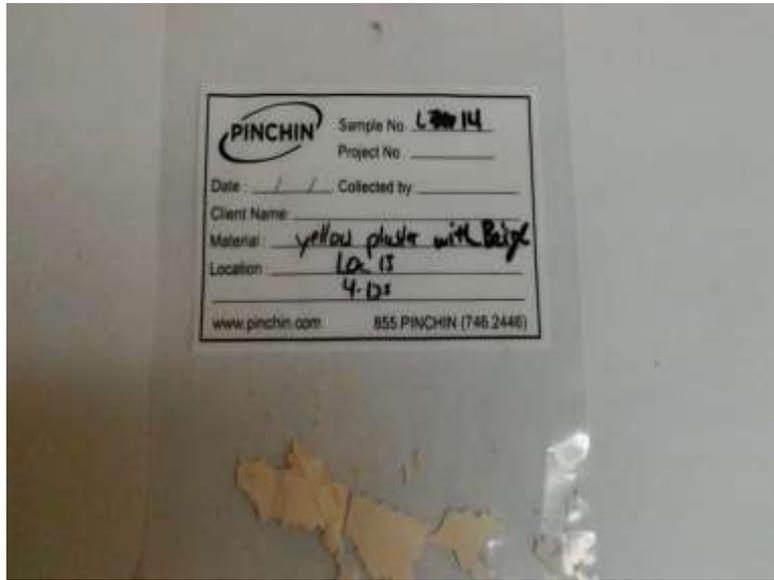
Yellow with beige plaster, (Sample L0014), 4-135 (Location:13)

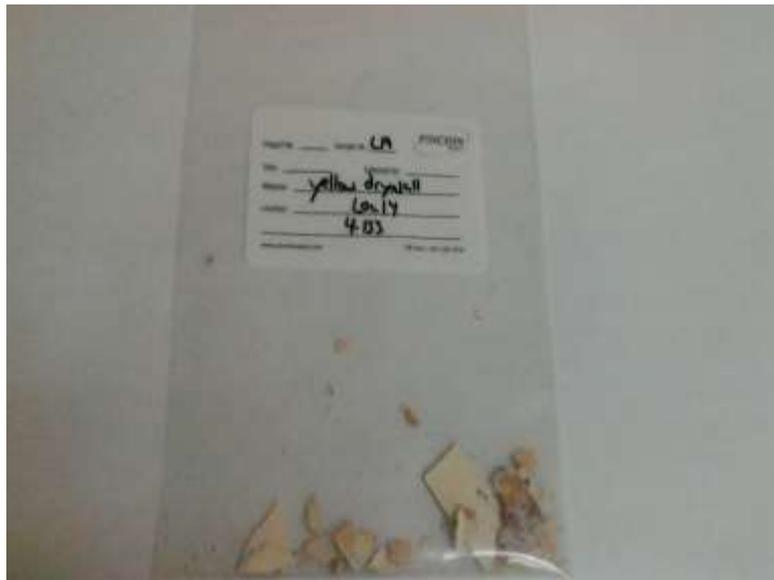
Yellow drywall, Sample L0013), 4-133 (Location:14)

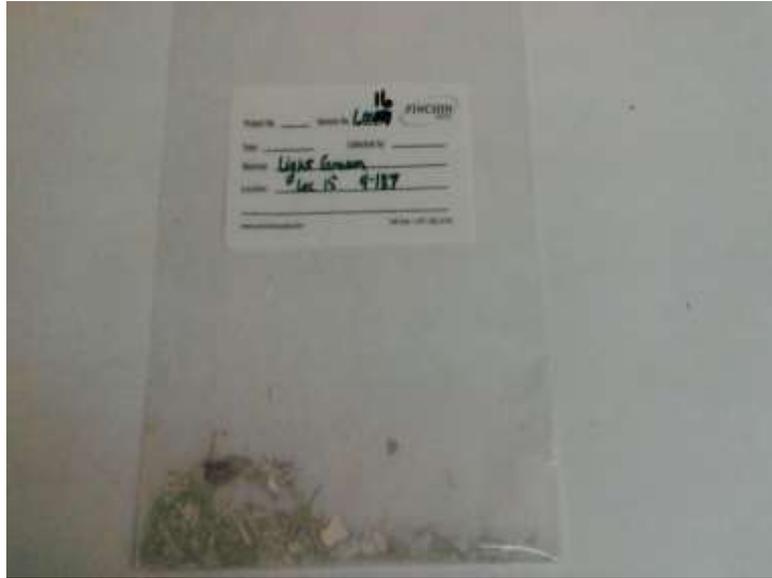
Light green, (Sample L0016), 4-137 (Location:15)

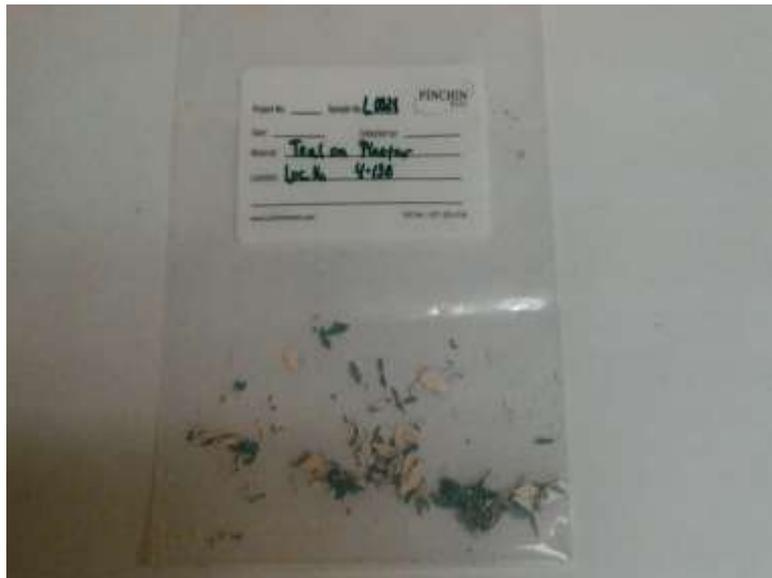
Teal plaster, Sample L0015), 4-138 (Location:16)

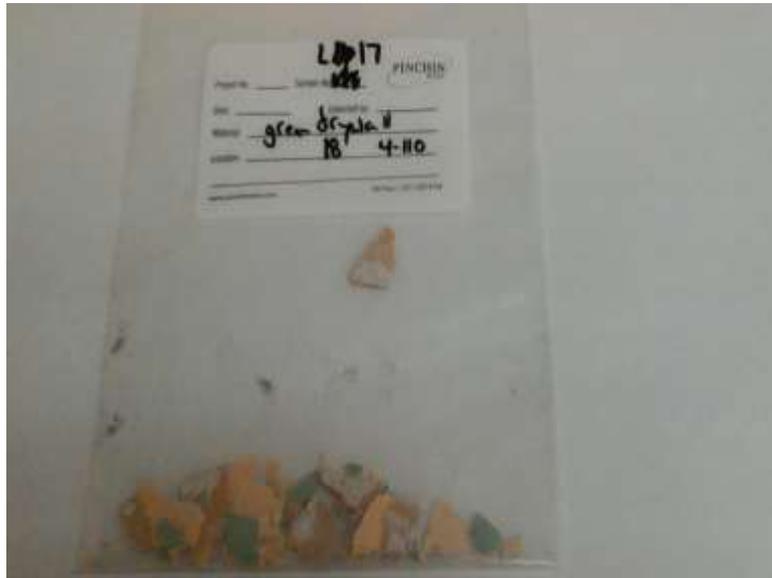
Green drywall, (Sample L0017), 4-110 (Location:18)

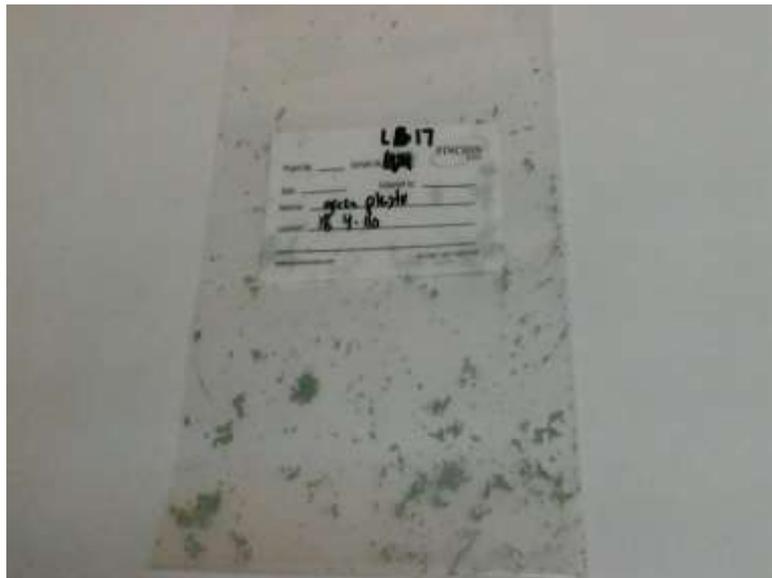
Green plaster, (Sample V0017), 4-110 (Location:18)

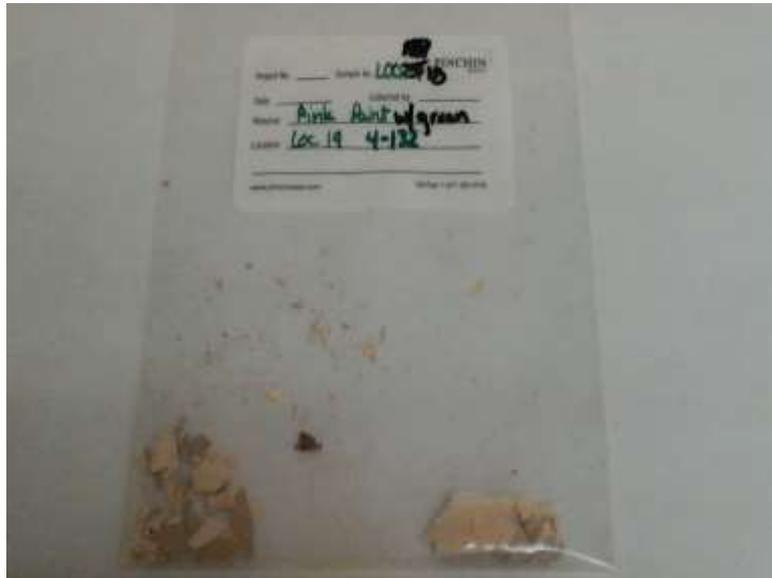
Pink paint with Green, (Sample L0018), 4-132 (Location:19)

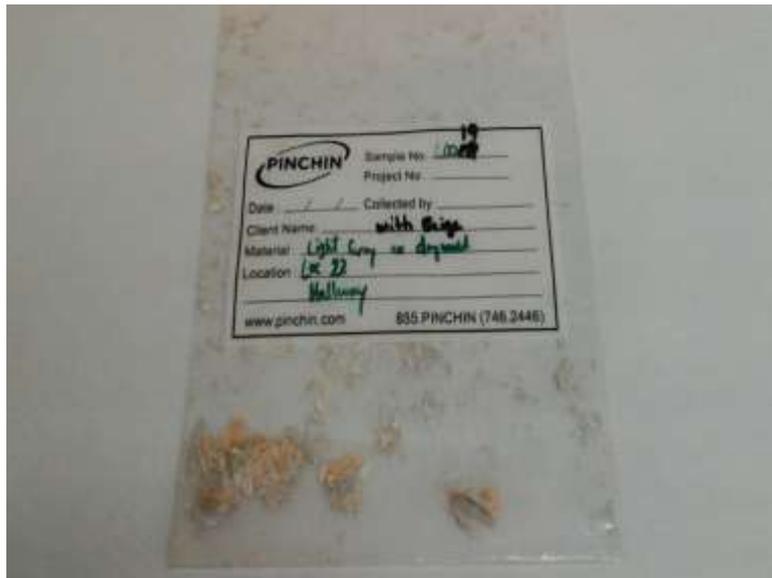
Light grey with beige drywall, (Sample L0019), Hallway (Location:22)

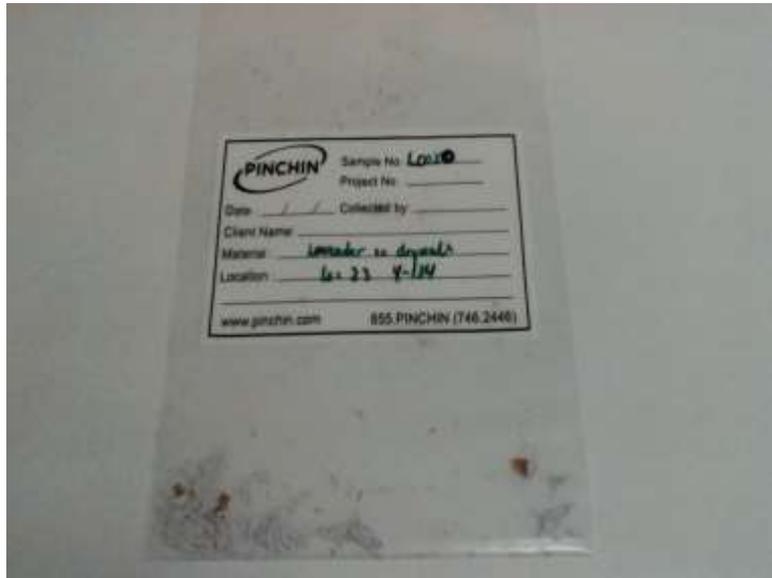
Lavender drywall, (Sample L0020), 4-134 (Location:23)

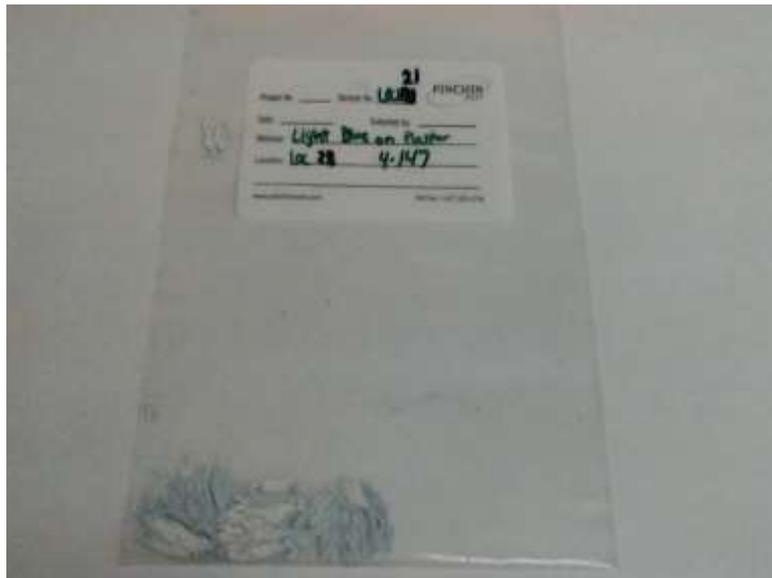
Light blue on plaster, (Sample L0021), 4-147 (Location:28)

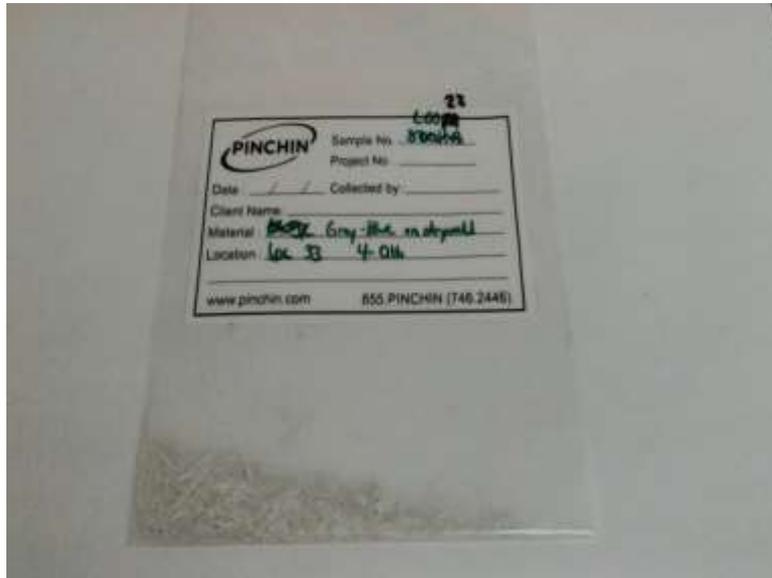
Grey blue drywall, (Sample L0022), 4-016 (Location:33)

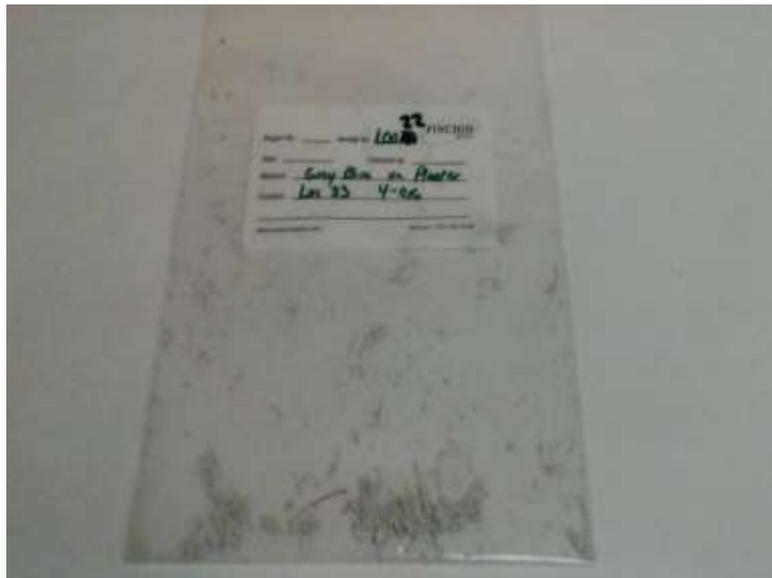
Grey blue plaster, (Sample V0022), 4-016 (Location:33)

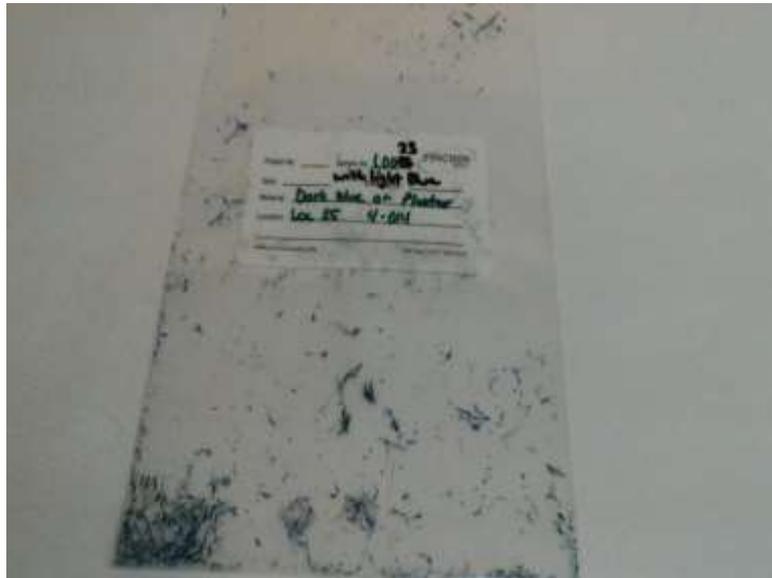
Dark blue with light blue on plaster, (Sample L0023), 4-014 (Location:35)

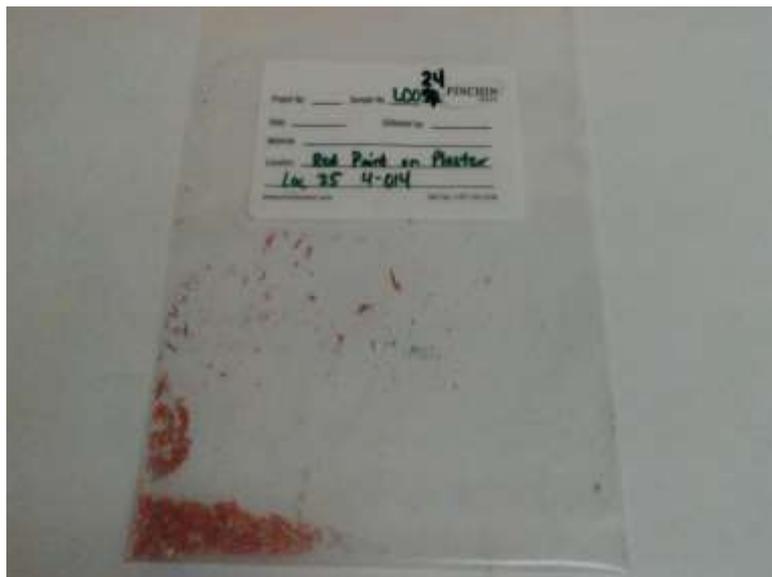
Red with light blue on plaster, (Sample L0024), 4-014 (Location:35)

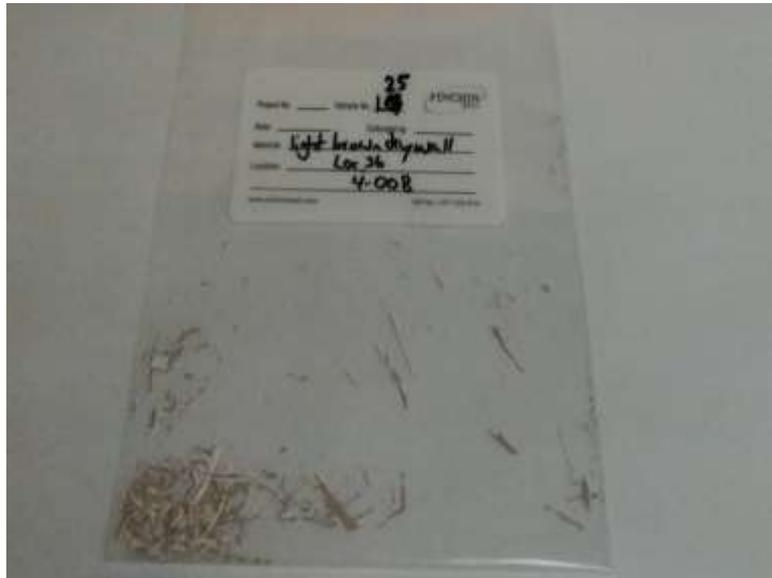
Light brown drywall, (Sample L0025), 4-008 (Location:36)

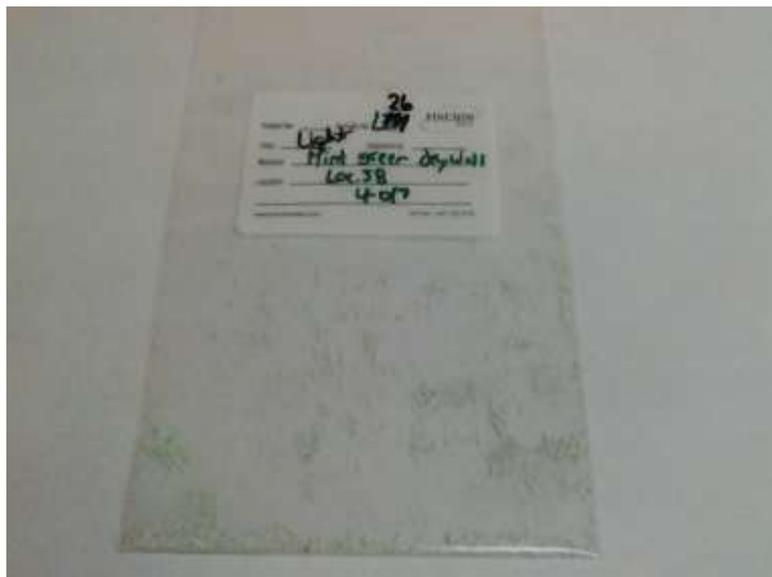
Light mint green on drywall, (Sample L0026), 4-017 (Location:38)

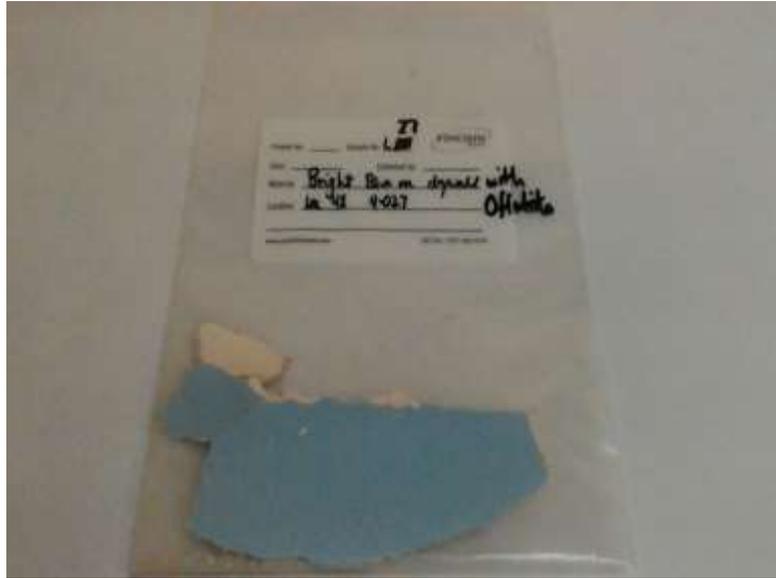
Bright blue with offwhite drywall, (Sample L0027), 4-026-027 (Location:42)

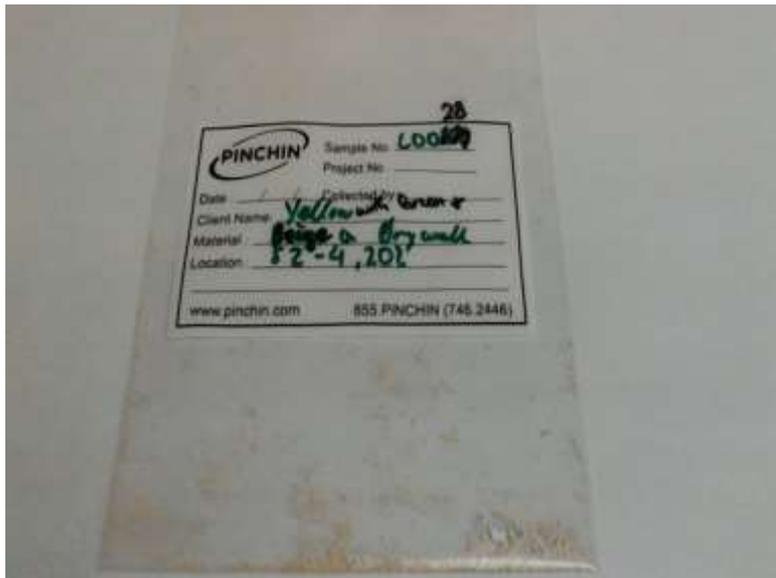
Yellow with green and beige, (Sample L0028), 4-202 (Location:52)

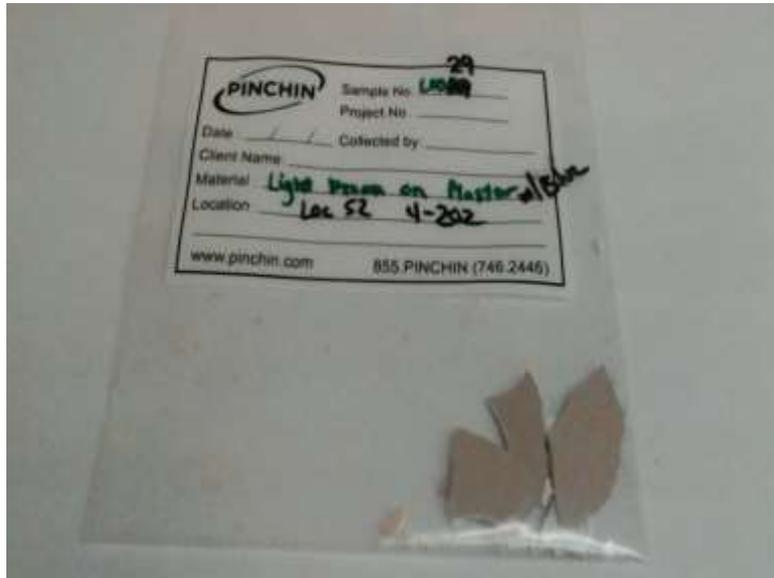
Light Brown with blue on plaster, (Sample L0029), 4-202 (Location:52)

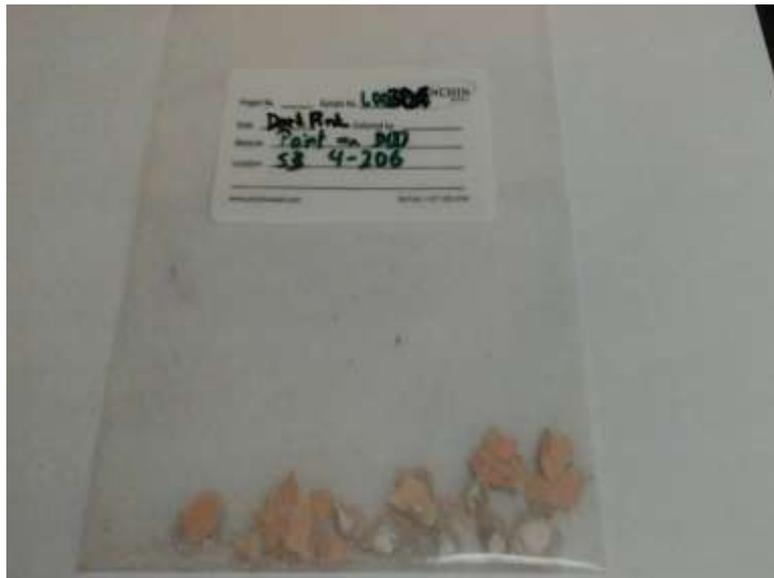
Dark pink on drywall, (Sample L0030), 4-206 (Location:53)

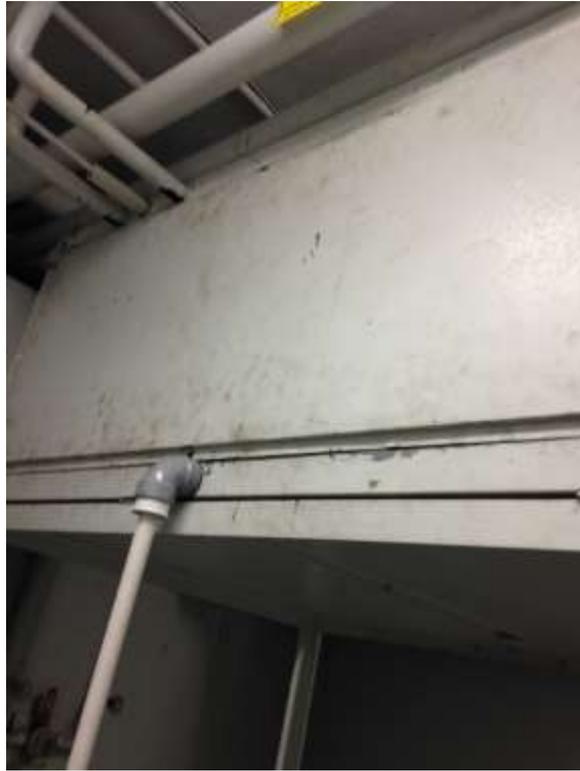
Black paint on rooftop handling units, (Sample L0036), Roof (Location:79)
