DESIGNATED SUBSTANCES AND HAZARDOUS MATERIALS SURVEY – PHASE 0 LAB MODERNIZATION PROGRAM AND SPRINKLER SYSTEM UPGRADE

Canada Centre for Inland Waters
837 Lakeshore Road
Burlington, Ontario

Revised February 28, 2018

702345-009

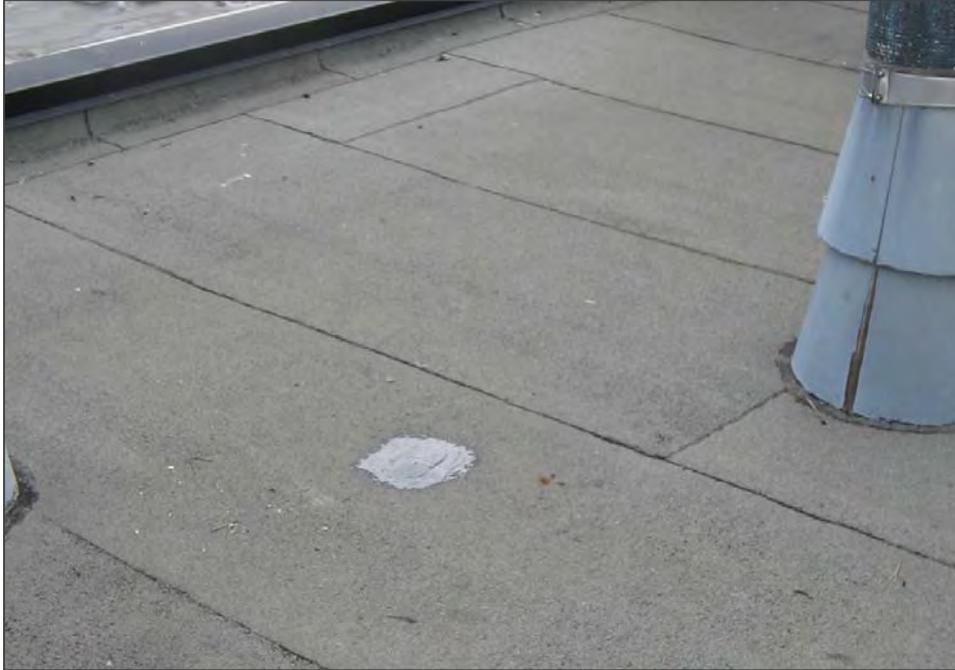
Photo: 1

South Side of Roof.

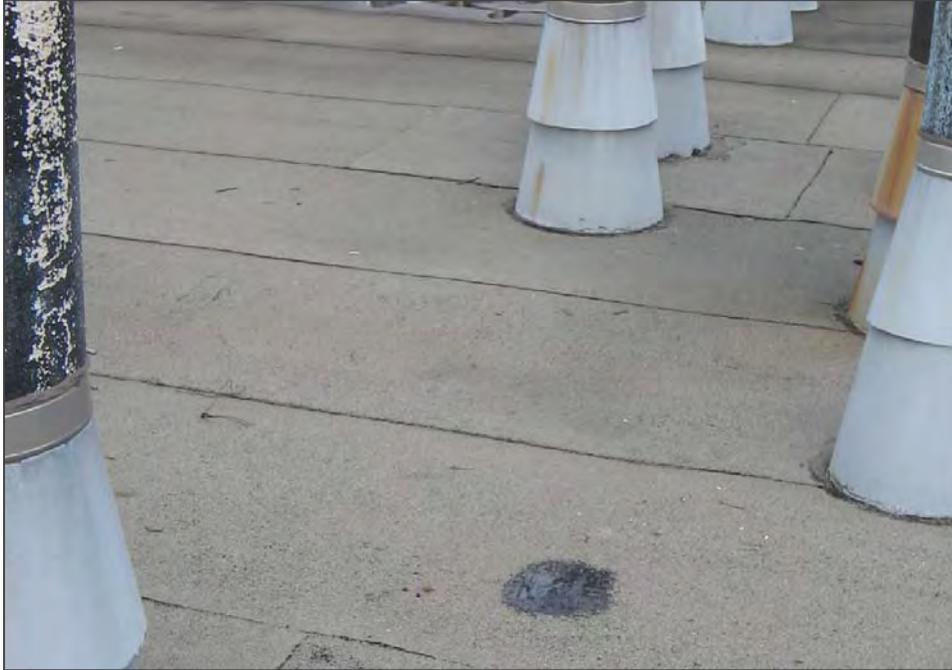
Photo: 3

North side of roof.

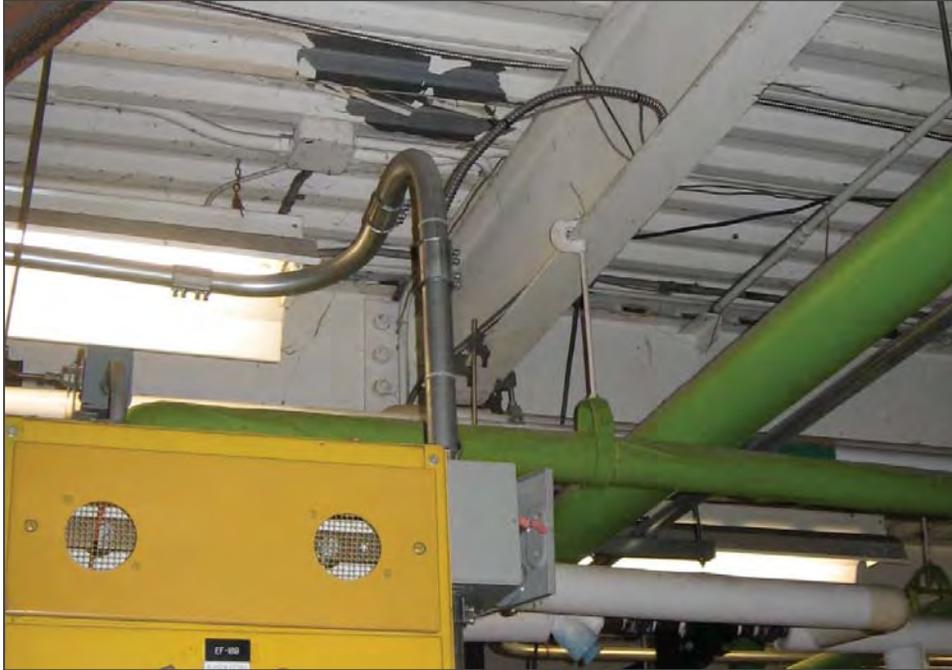
Photo: 5

A&L Eighth floor Mechanical Room.

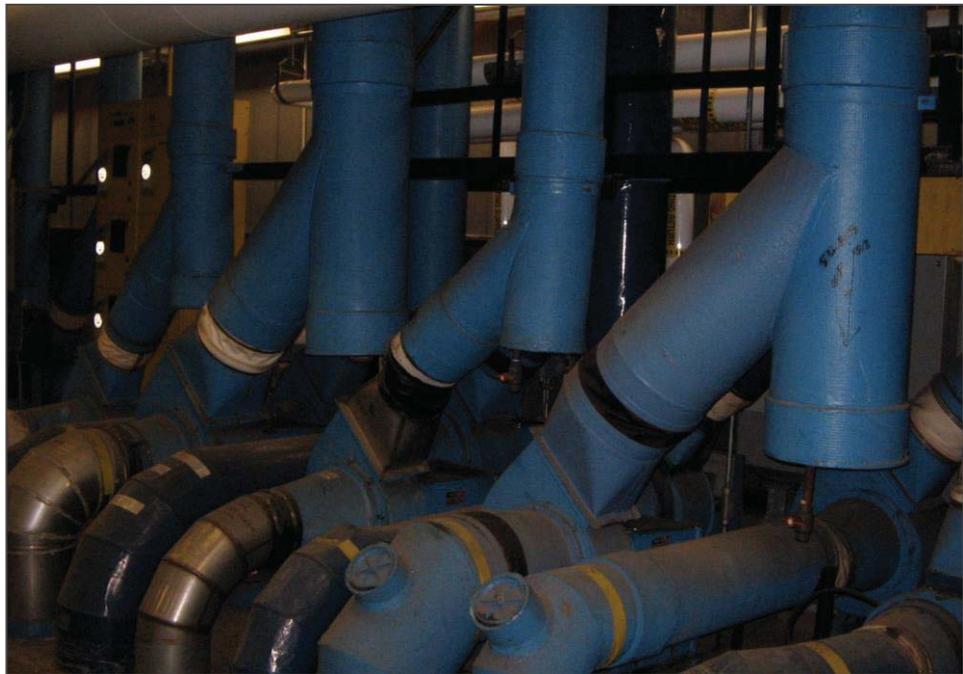
Photo: 8
Date:
August 4, 2017.
Description:
Asbestos cement exhaust
pipe.
Location:
Eighth floor Mechanical
Room.

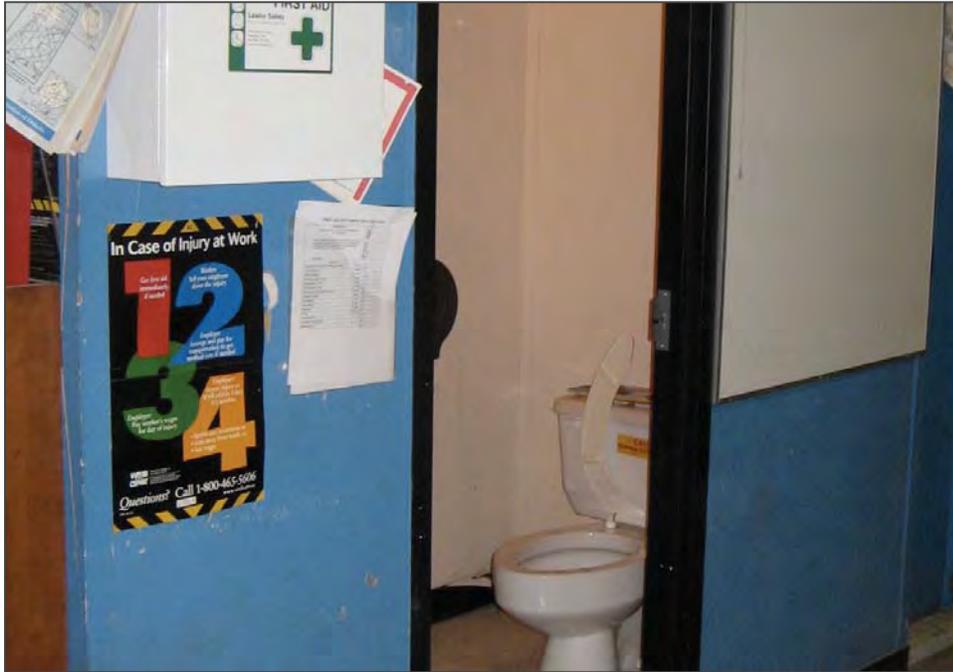
Photo: 9

Third floor Mechanical Room.

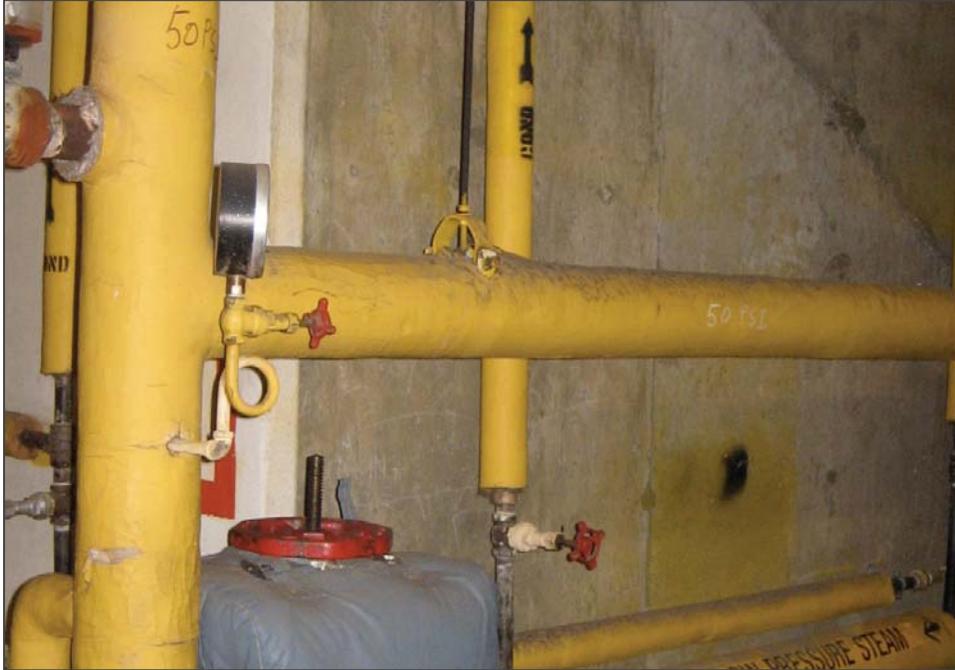
Photo: 11

Third floor Mechanical Room.

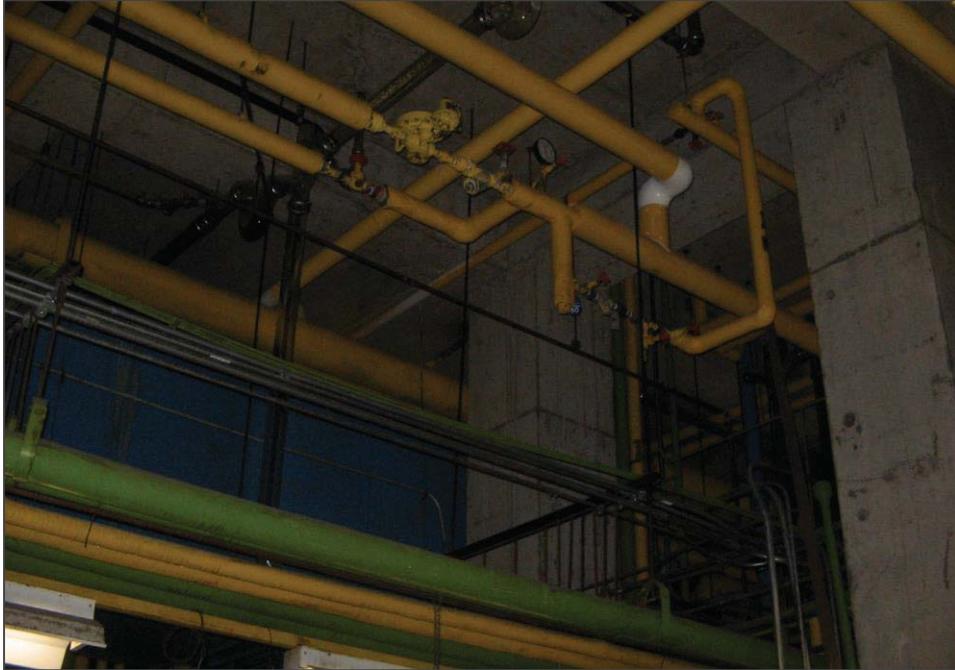
Photo: 13

Third floor Mechanical Room.

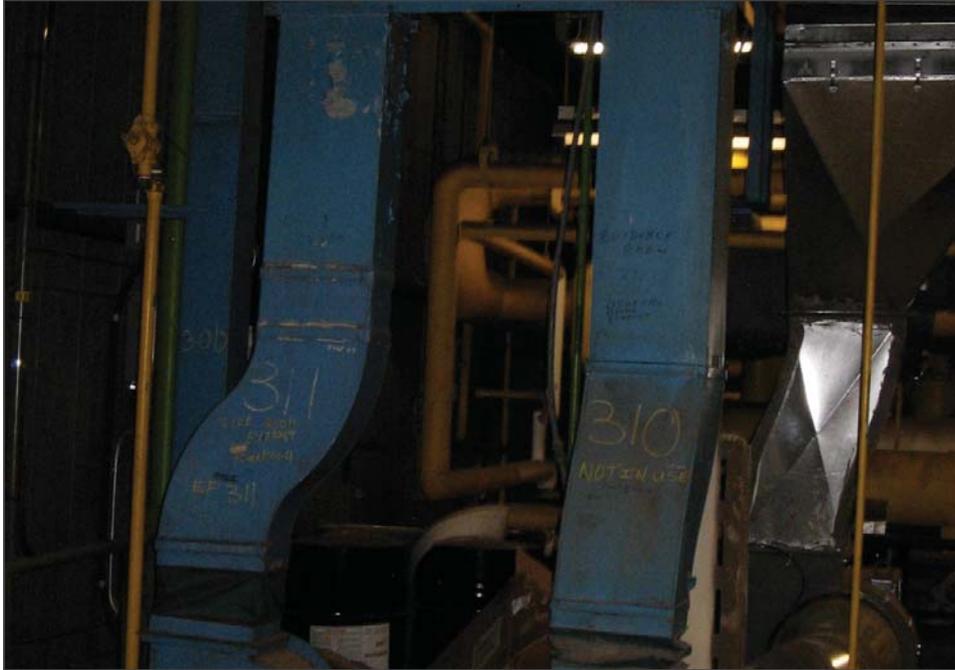
Photo: 15

Third floor Mechanical Room.

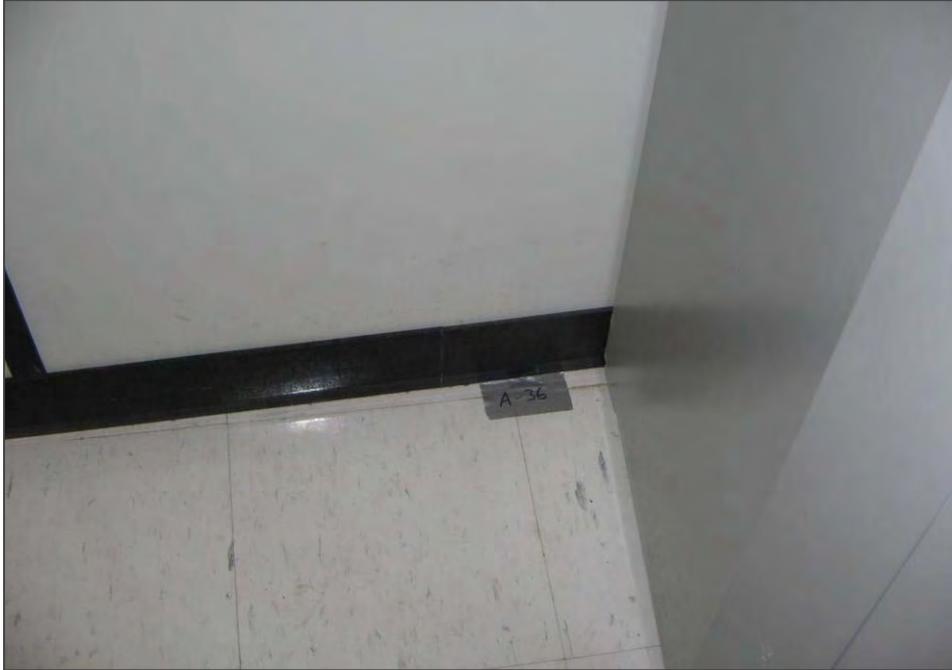
Photo: 17

Room L662.

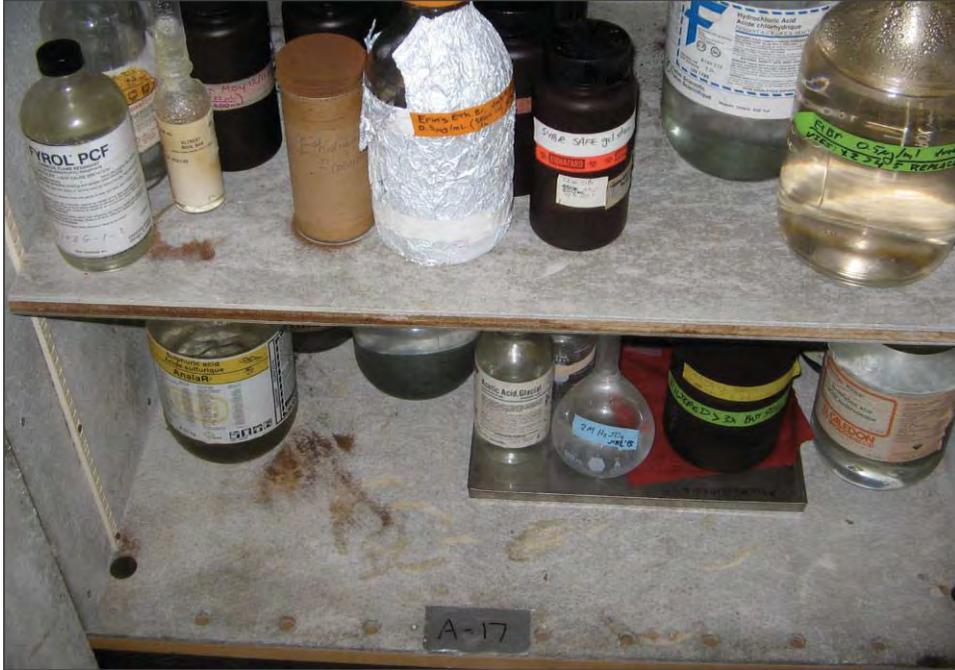
Photo: 37

Description:
Location of Sample A-17
(cement board in fumehood storage).

Location:
Room L446.

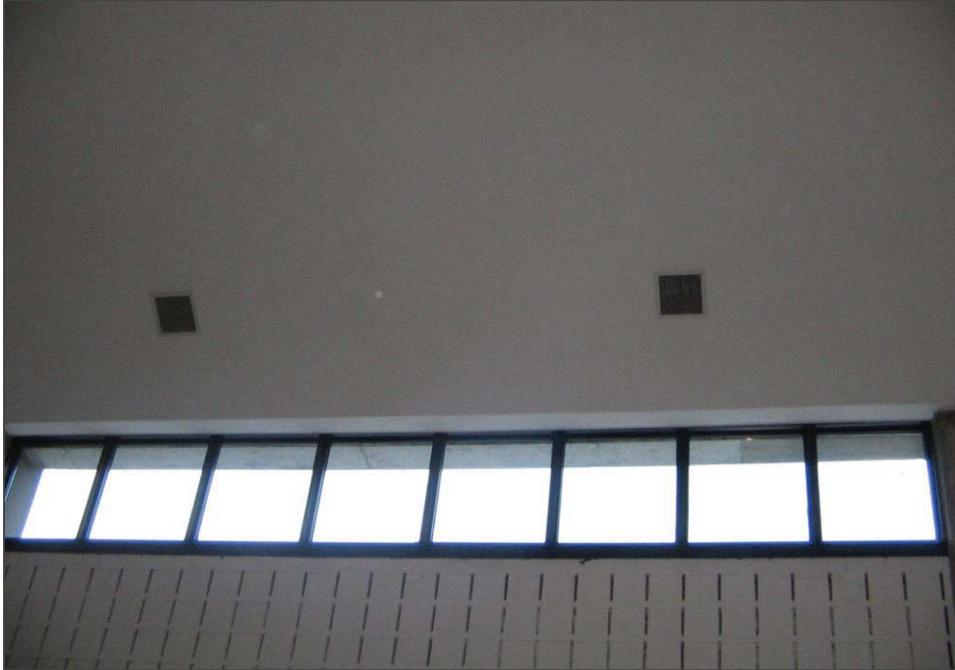
Photo: 59

Mall area.

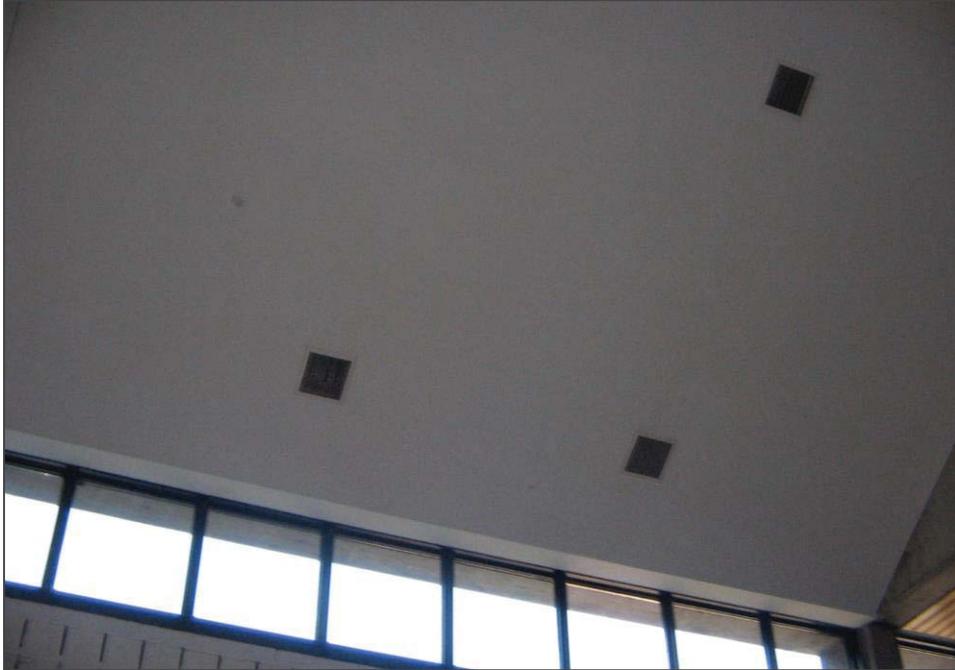
Photo: 61

Mall area.

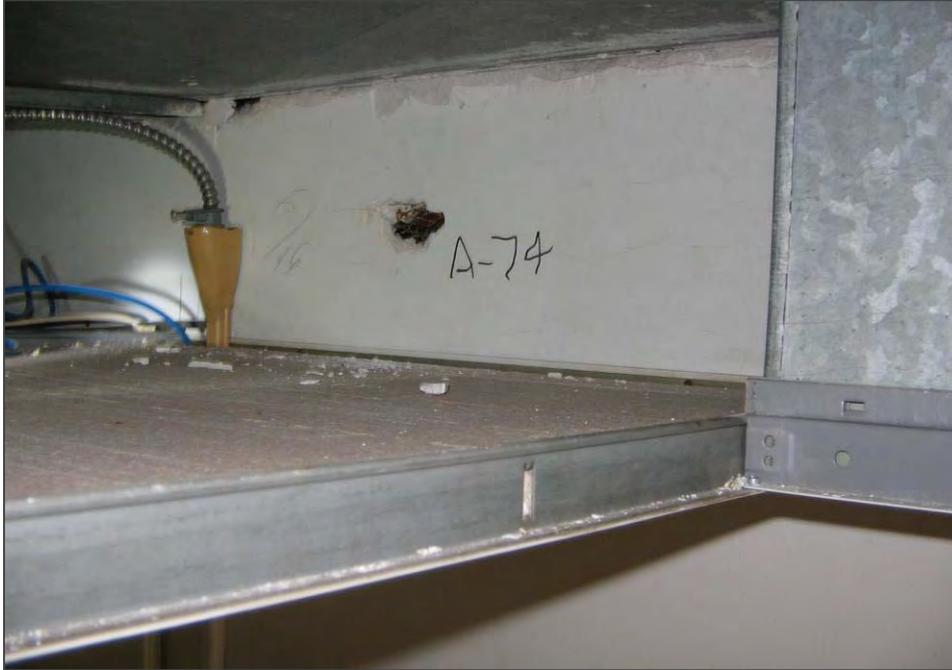
Photo: 63

Room W220.

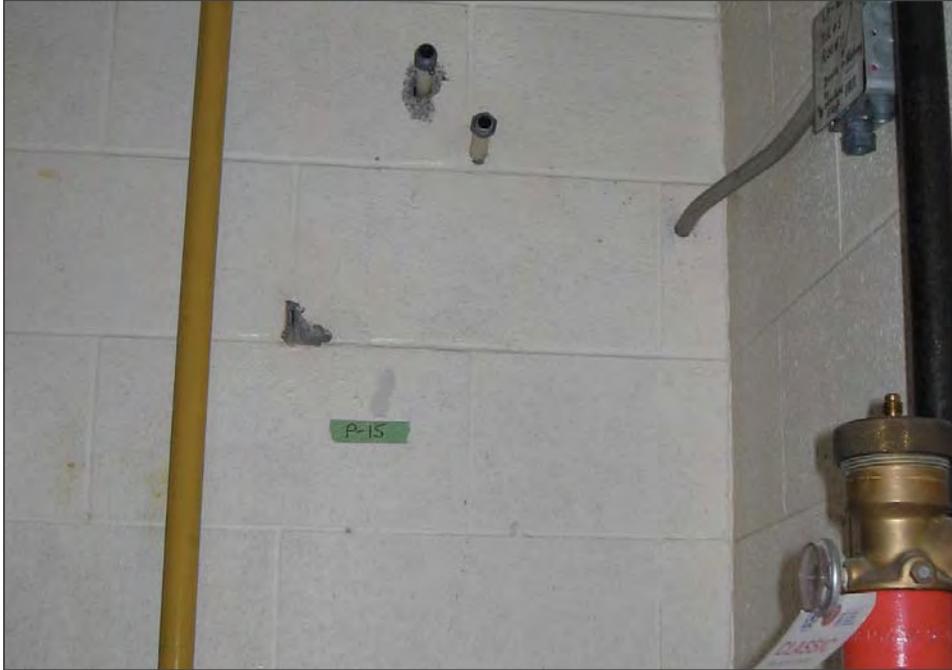
Photo: 65

Room W209.

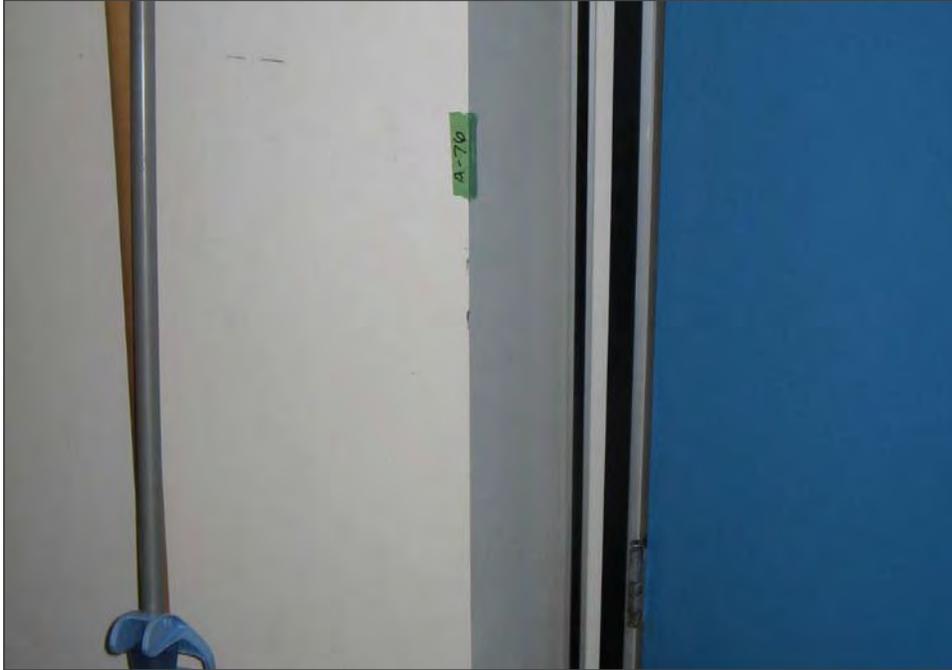
Photo: 67

Room W249.

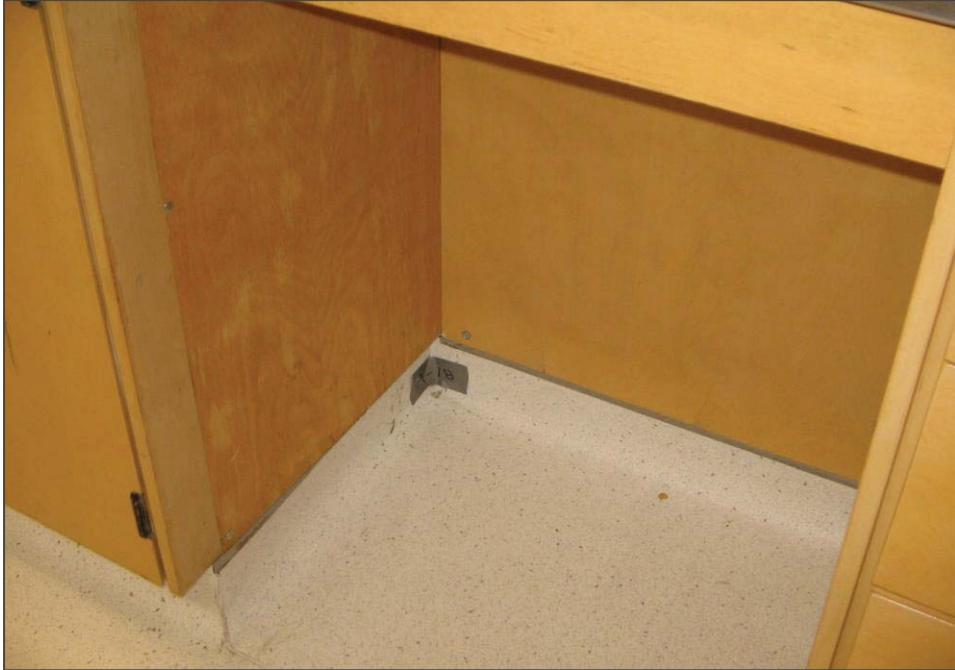
Photo: 69

Room L414.

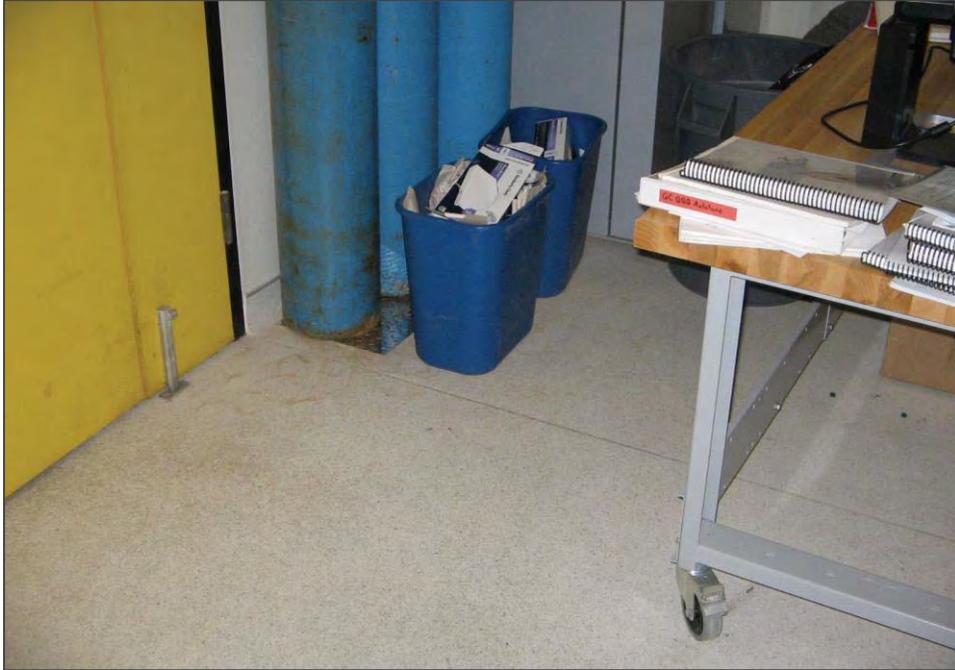
Photo: 71

Room L525.

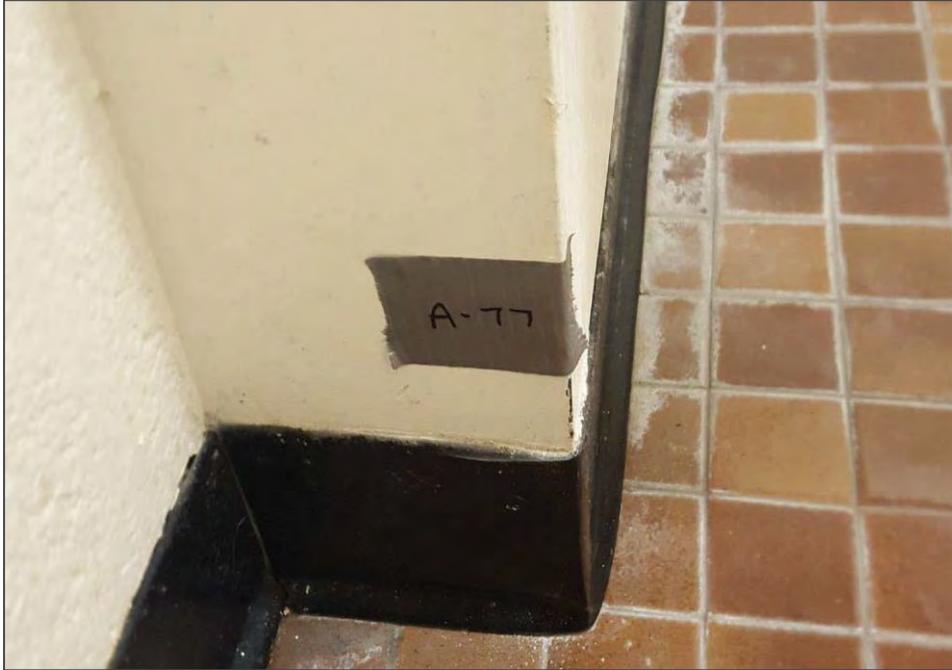
Photo: 75

Room 227.

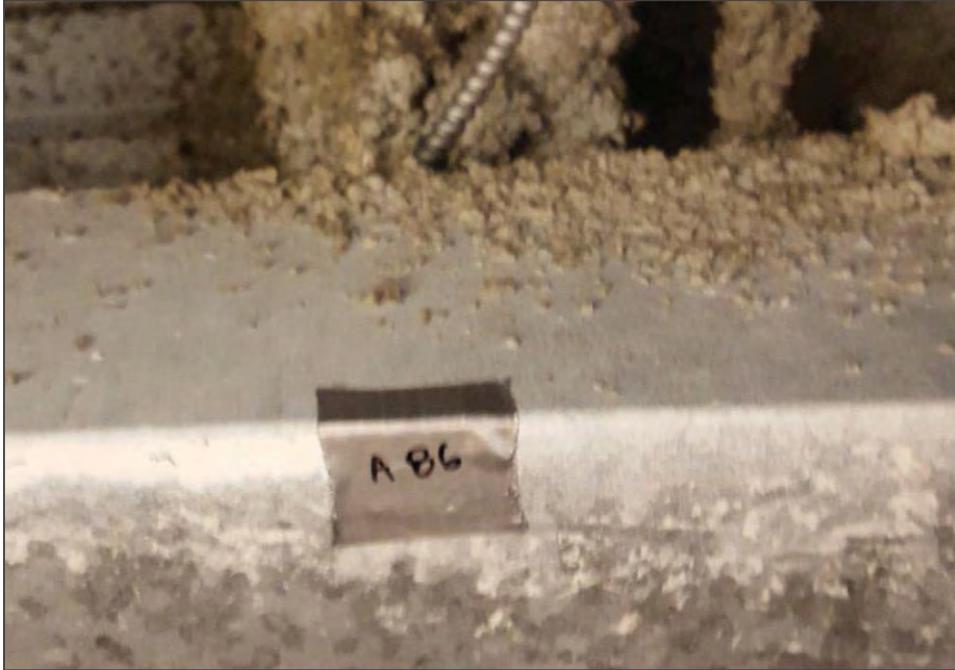
Photo: 81

Room S221.

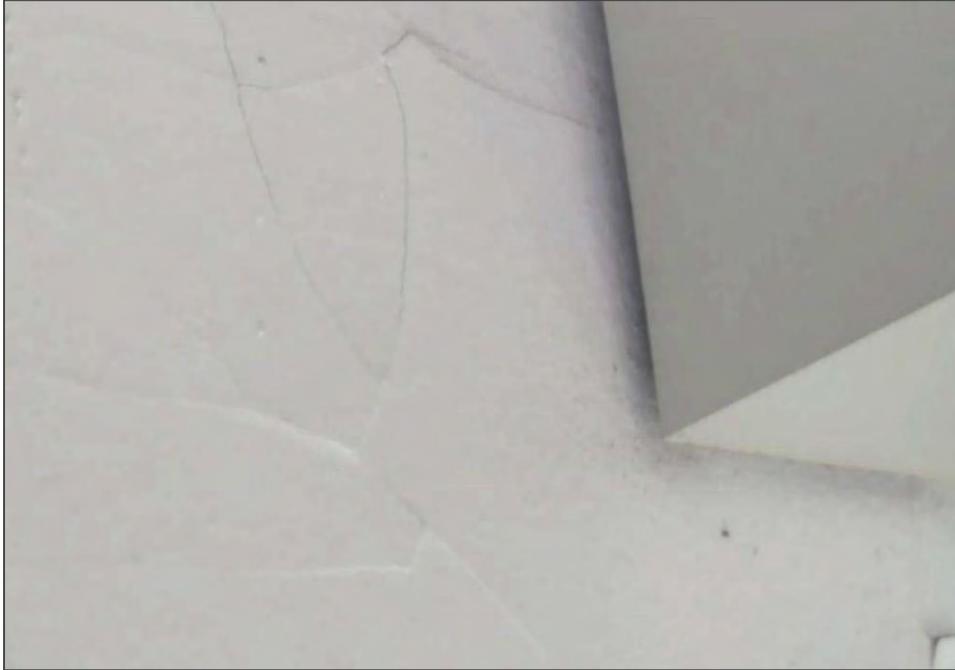
Photo: 83

Room S246.

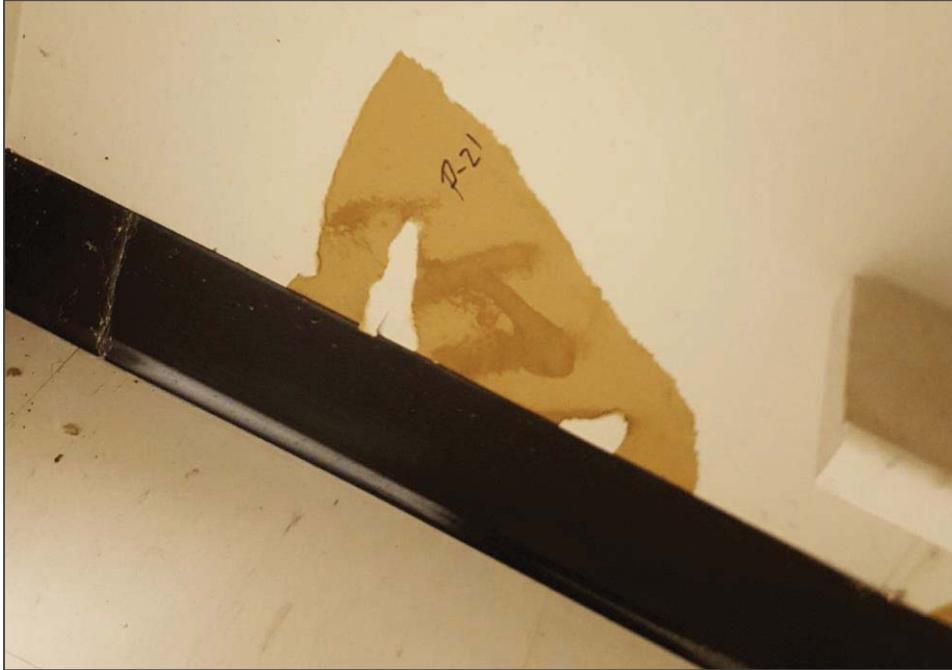
Photo: 85

Room C113.

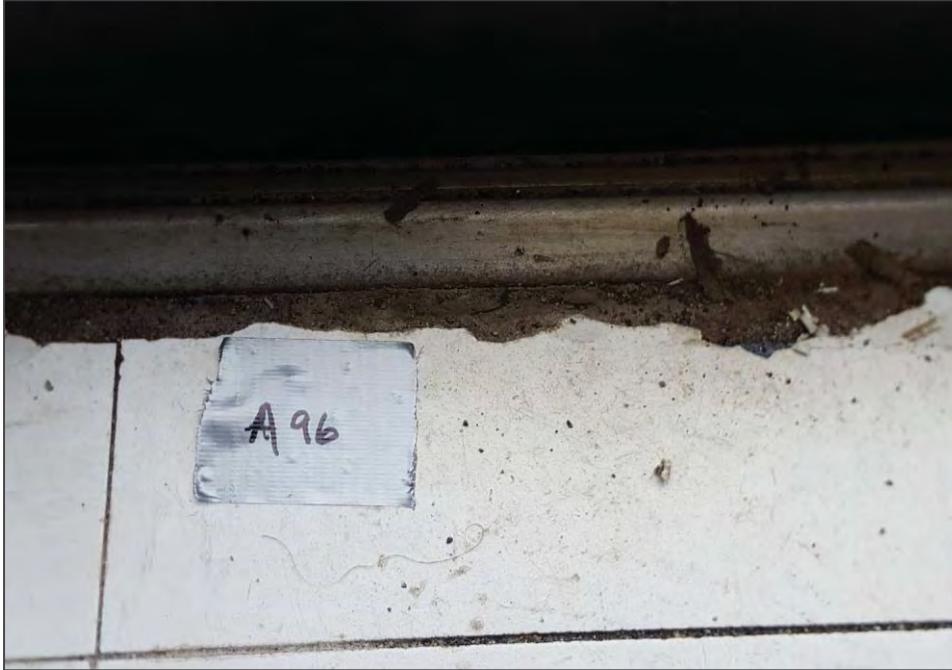
Photo: 87

First Floor Corridor of North Annex.

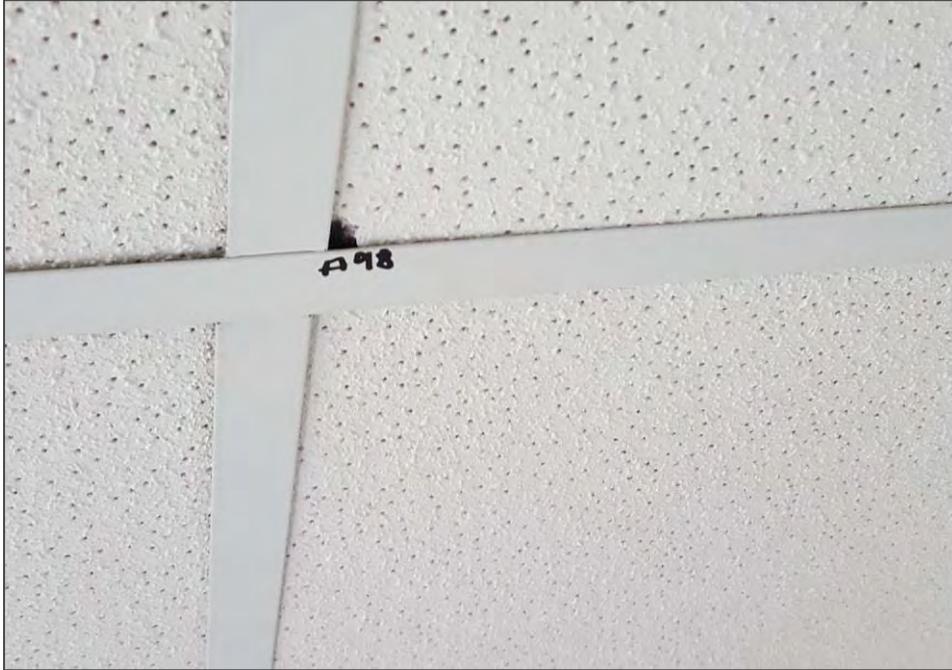
Photo: 89

Room C211.

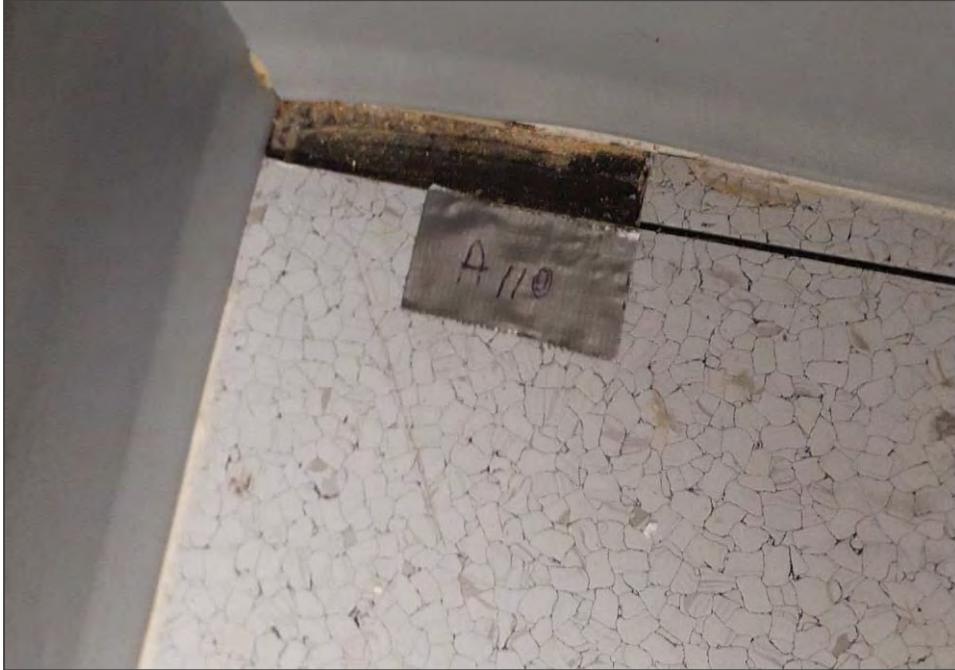
Photo: 91

Room S142.

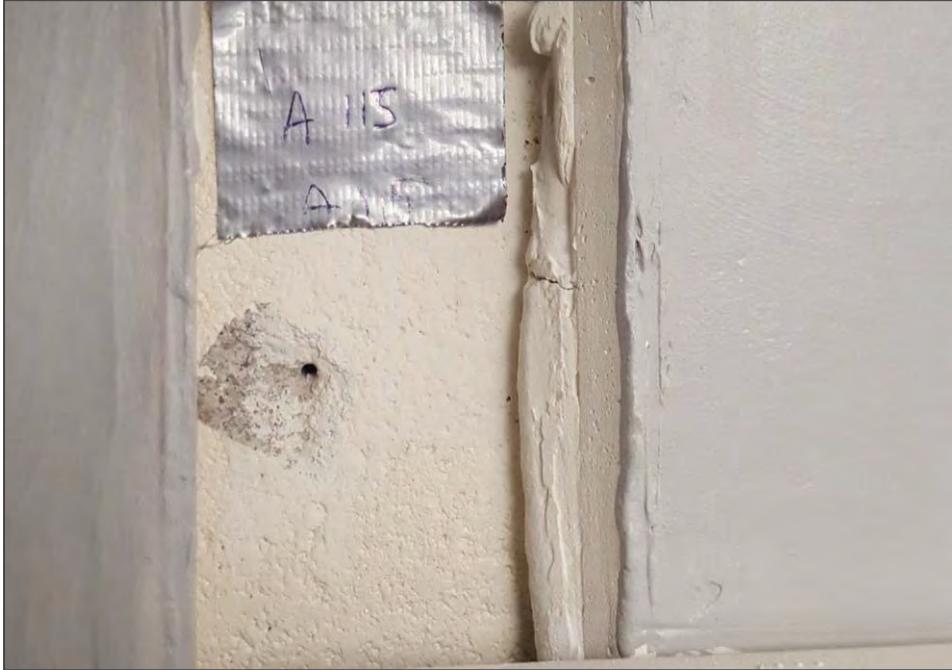
Photo: 93

Room S142.

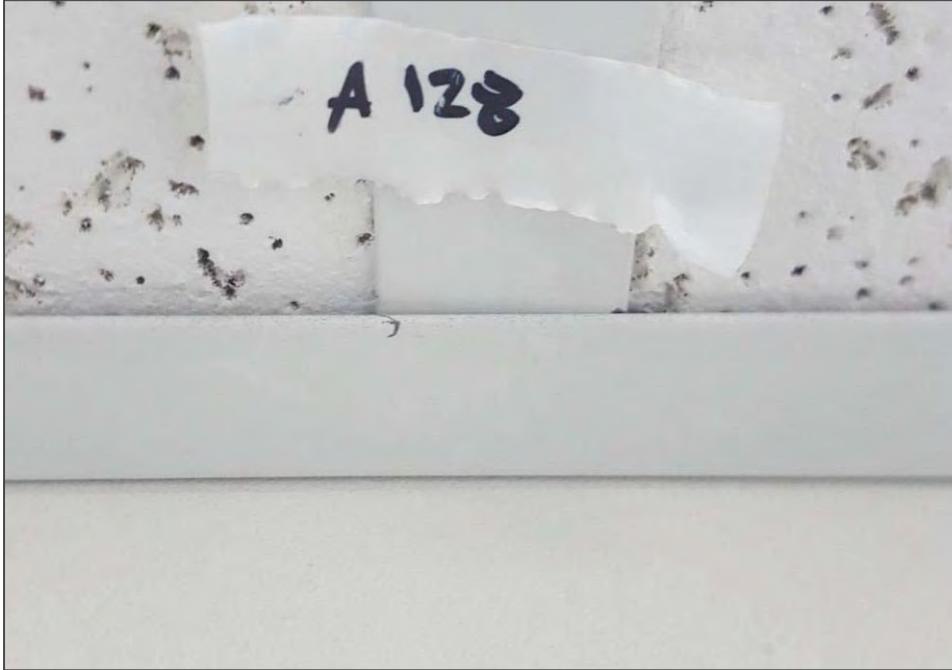
Photo: 95

Portable 2.

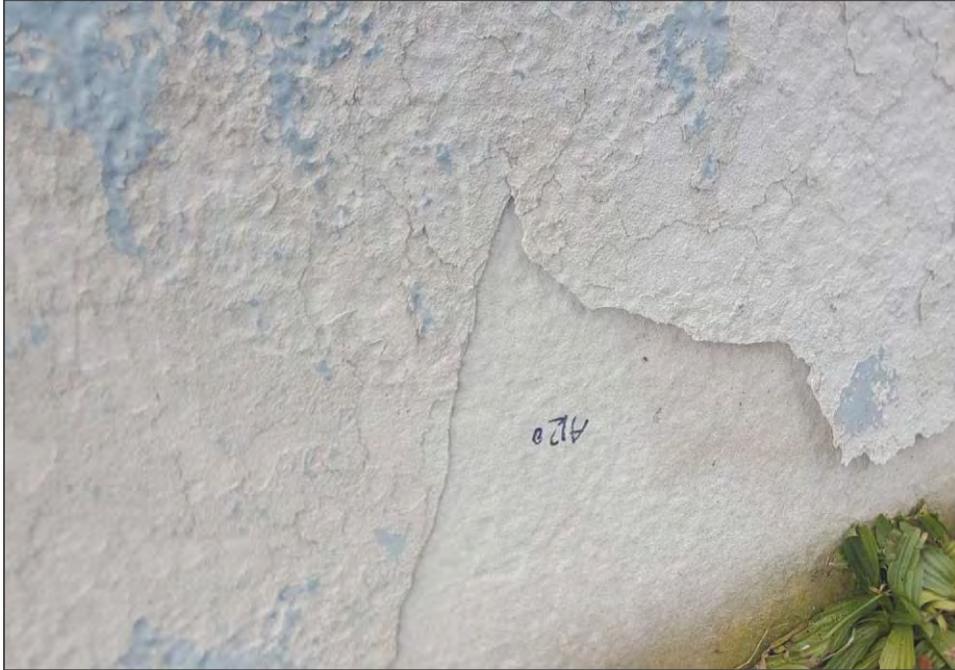
Photo: 99

Portable 2.

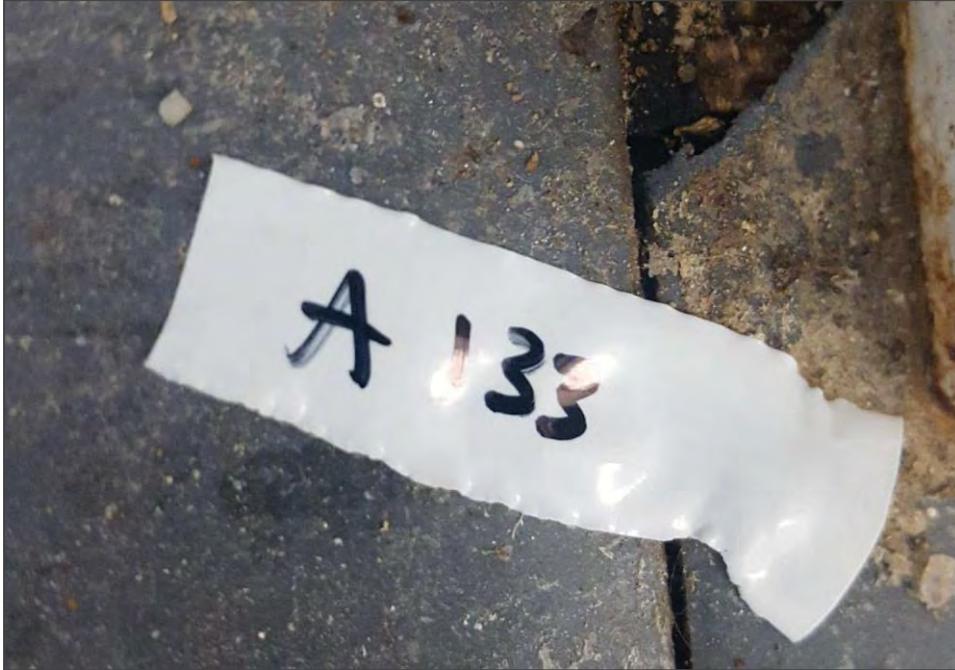
Photo: 103

Portable 2.

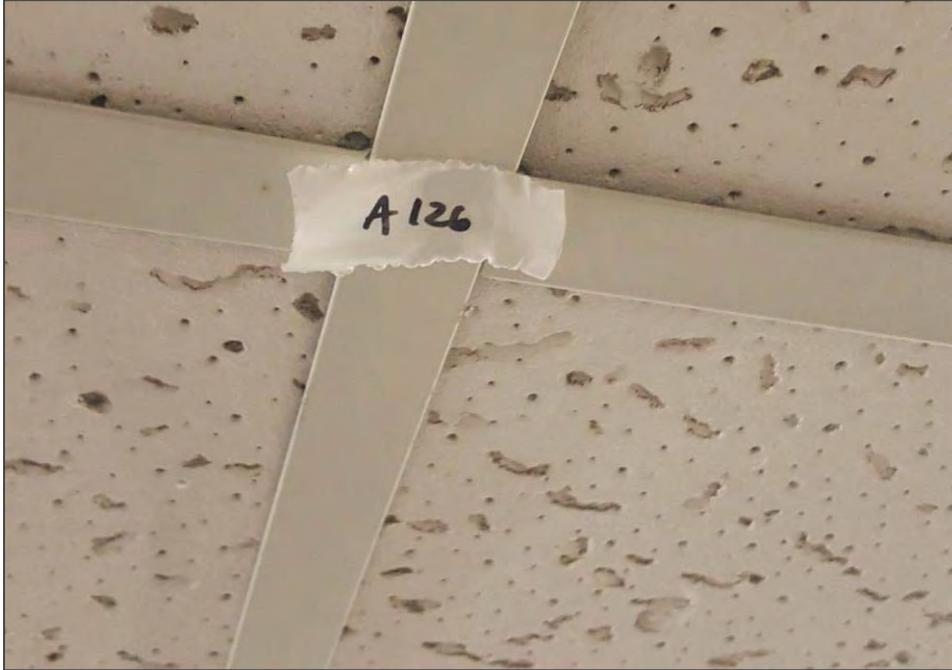
Photo:105

Portable 4.
