Building Condition Report
October 2015

Environment Canada
Exeter Weather Radar Station
Exeter, ON

Technical Services
Professional and Technical Services
Real Property Branch
Ontario Region
PWGSC

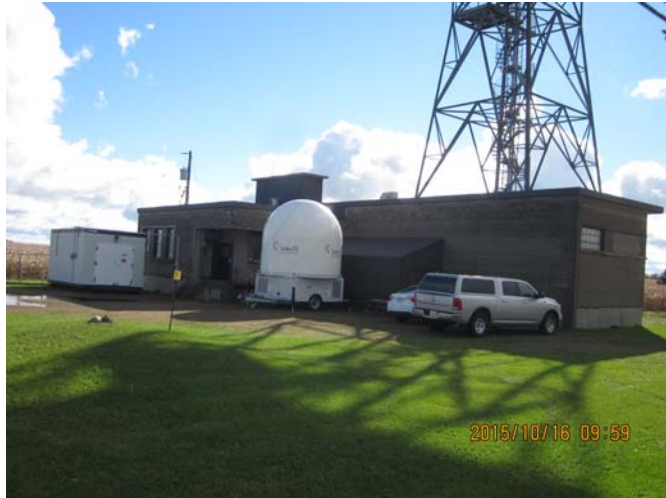
AR-001 – West and north elevations.

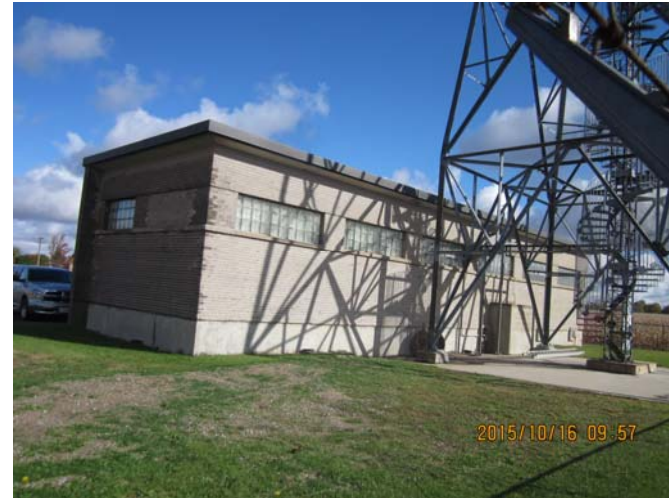
AR-002 – South and part west elevations.

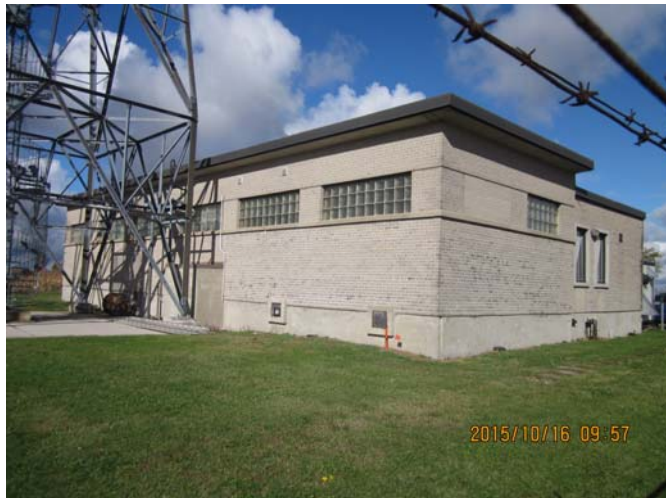
AR-003 – East and south elevations.

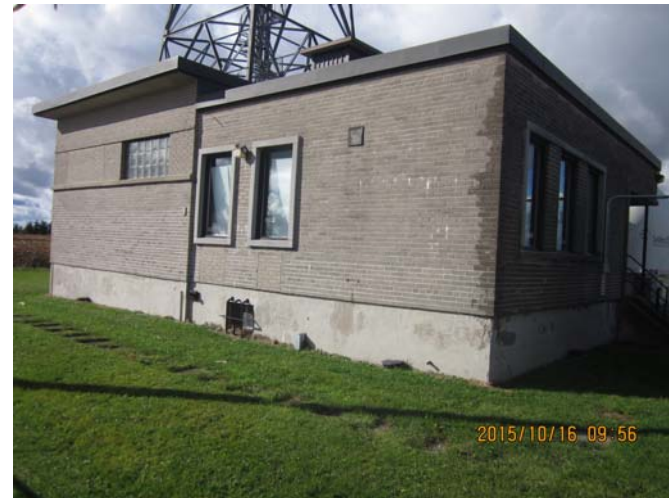
AR-004 – Part north and east elevations.

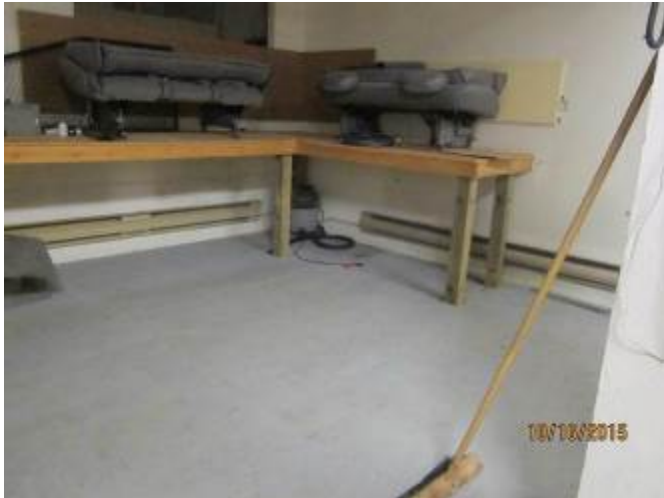
ME-001 – Electric baseboard heaters (basement).

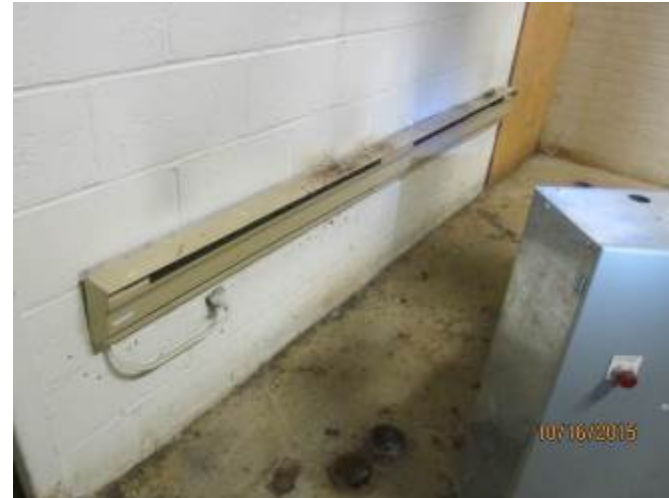
ME-002 – Electric baseboard heater (basement).

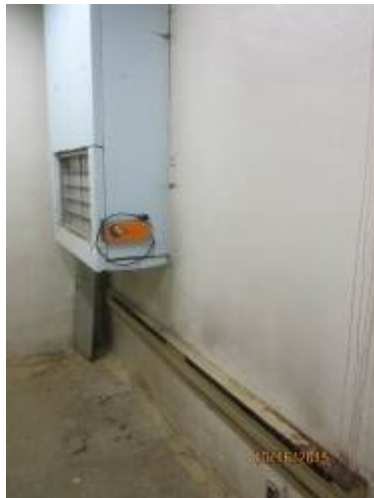
ME-003 - Electric baseboard heater (basement).

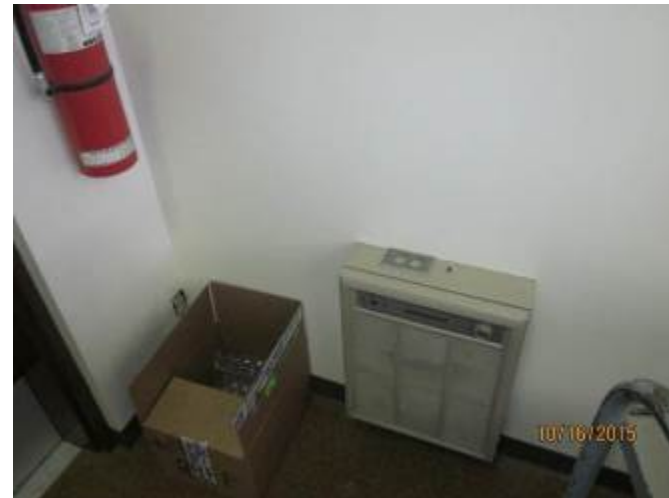
ME-004 – Wall mounted electric fan heater.

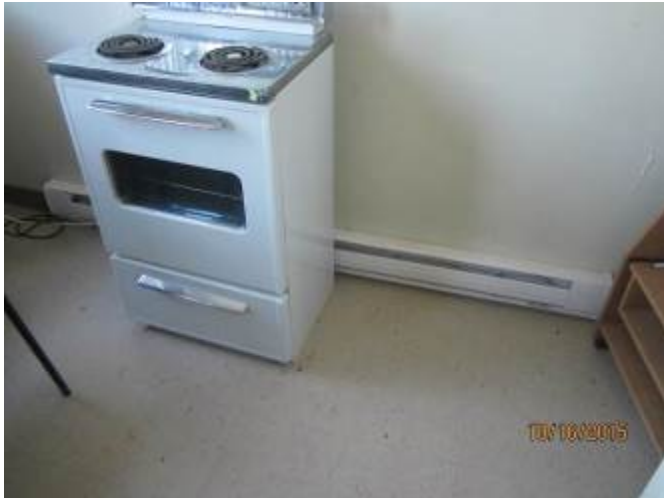
ME-005 – Electric baseboard heater (kitchen).

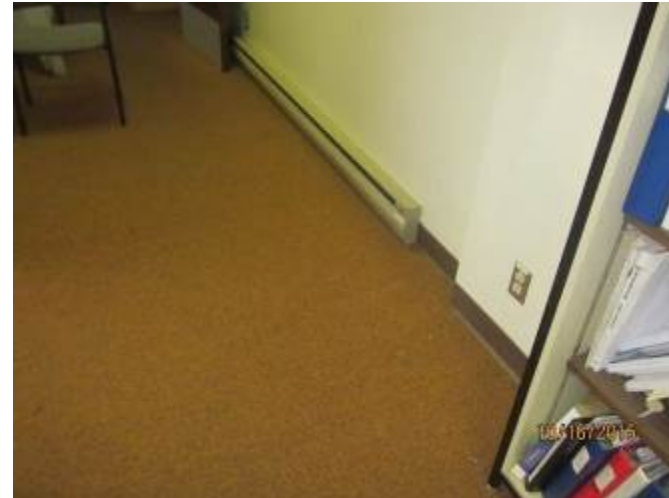
ME-006 - Electric baseboard heater (hallway).

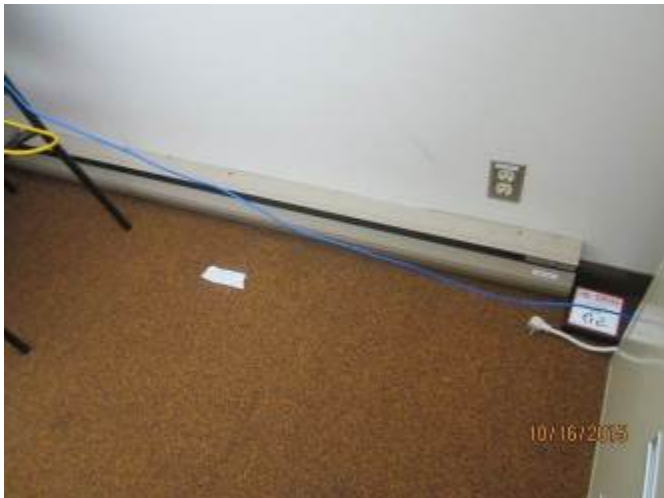
ME-007 – Electric baseboard heater (office).

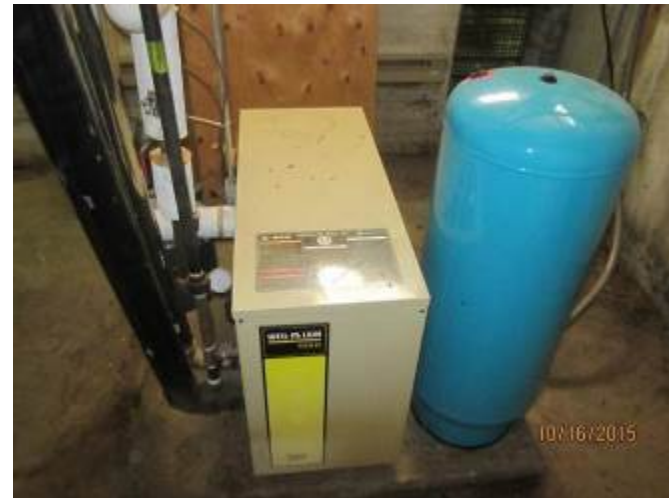
ME-008 – Weil-McLain decommissioned hot water boiler (yr. 1996).

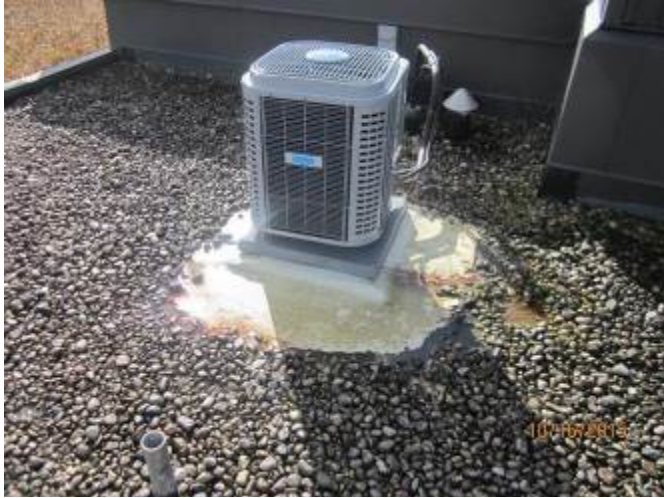
ME-009 – Keep-Rite condenser (roof).

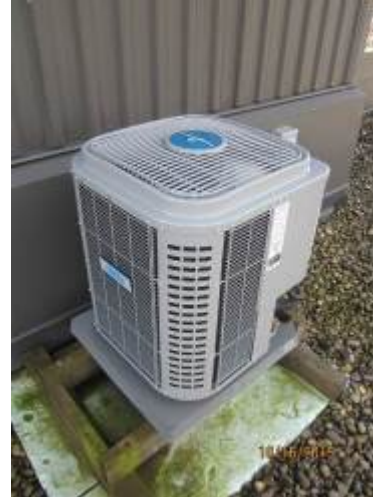
ME-010 – Keep-Rite condenser (roof).

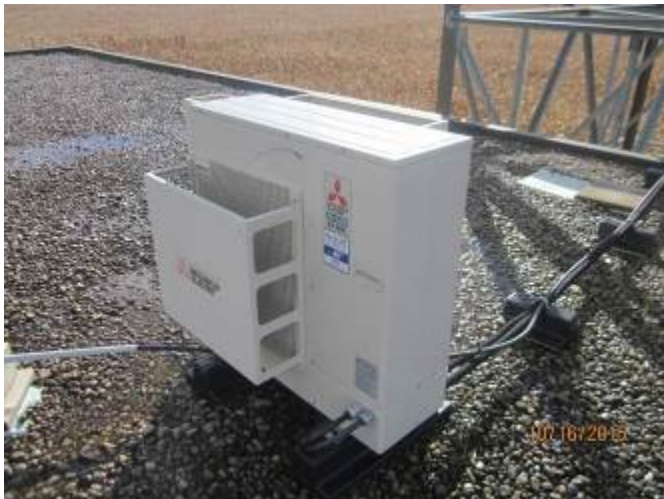
ME-011 – Mitsubishi condenser (roof).

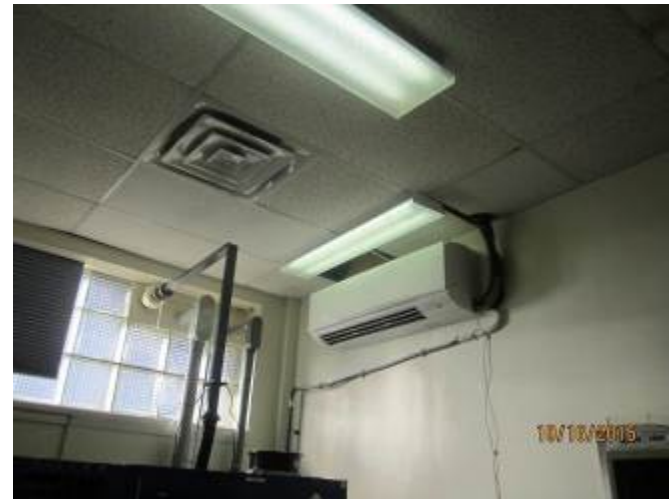
ME-012 – Mitsubishi evaporator (equipment room).

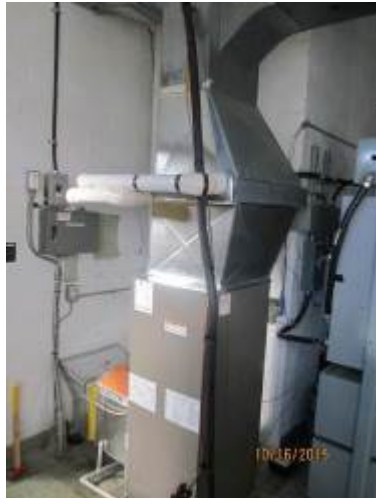
ME-013 – AHU (UPS room).

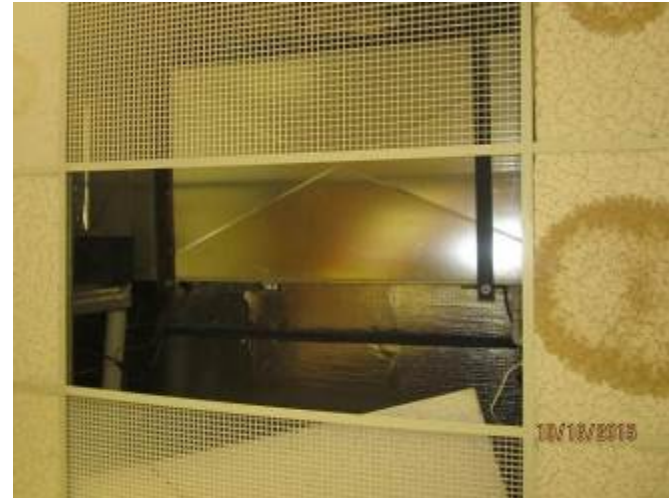
ME-014 – AHU (ceiling space office).

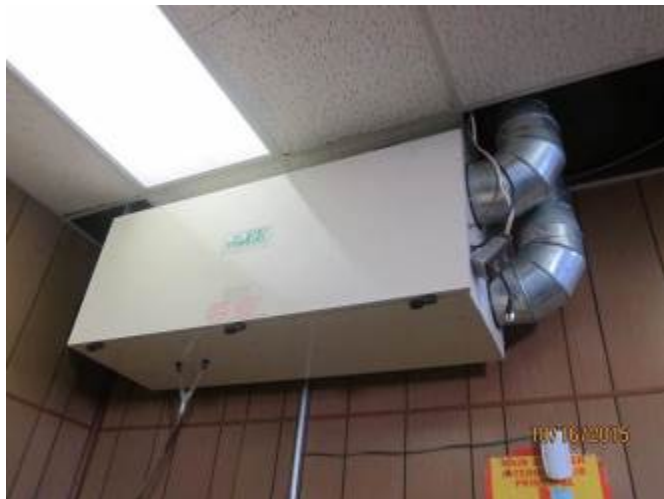
ME-015 – Heat recovery ventilator (disconnected).

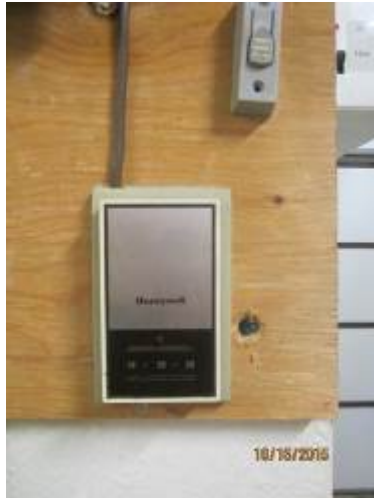
ME-017 – Wall mounted thermostat (baseboard heaters).

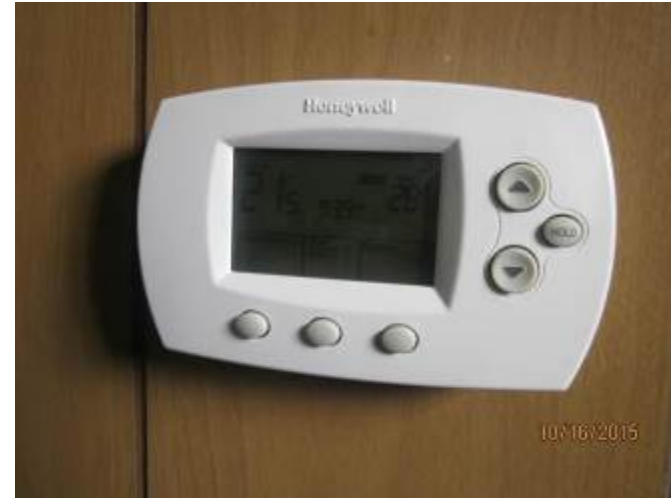
ME-018 – Wall mounted thermostat (AHU).

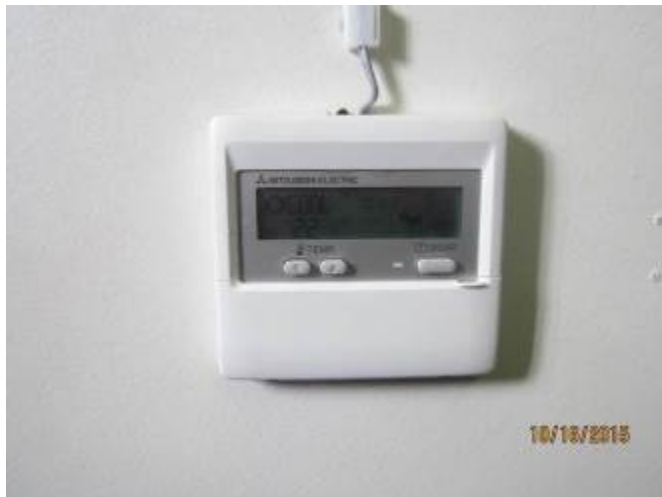
ME-019 – Wall mounted control (AC Mitsubishi).

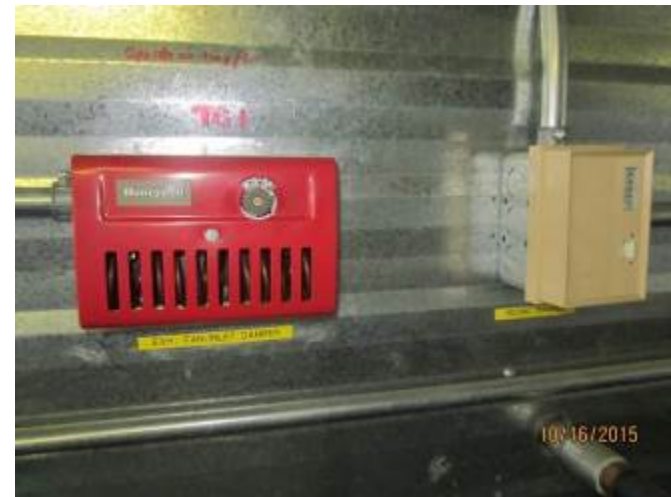
ME-020 – Thermostats for heat control in the emergency generator portable unit.

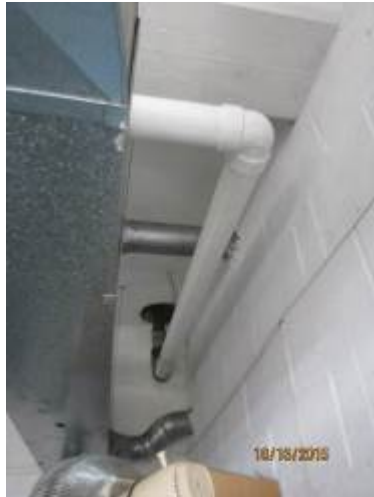
ME-021 – Roof drain.

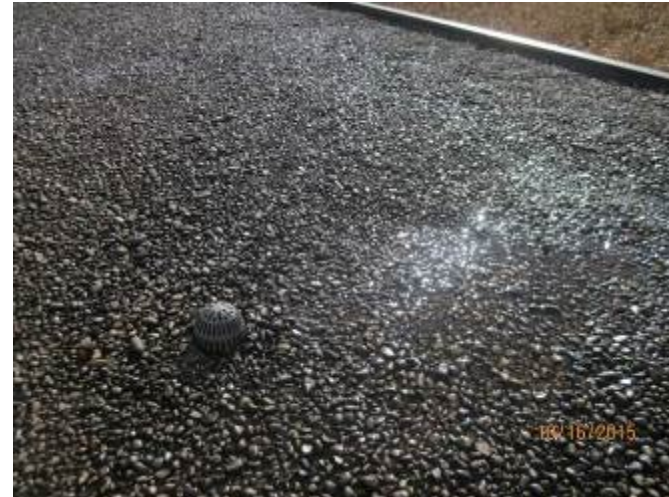
ME-022 – Roof drain collector.

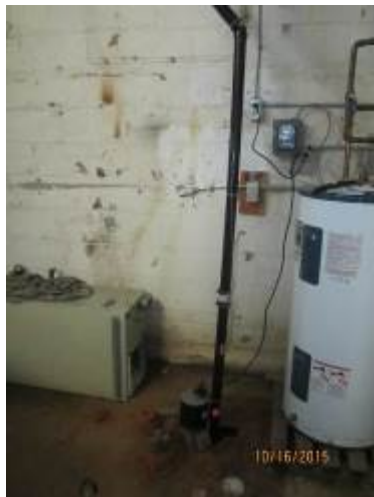
ME-023 – Sump pump (yr. 2012).

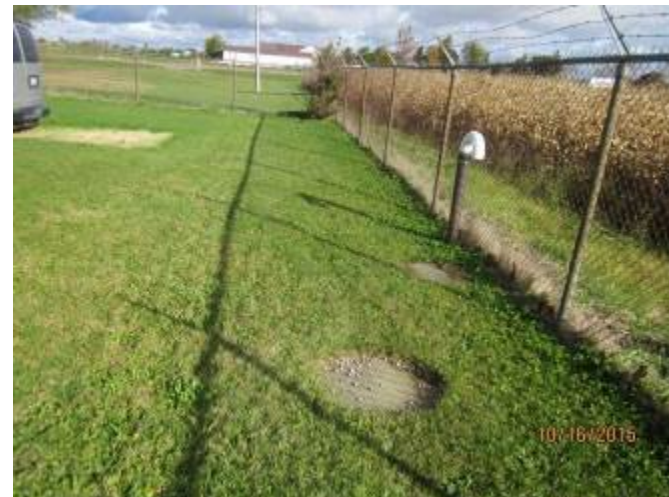
ME-024 – Sewer tank.

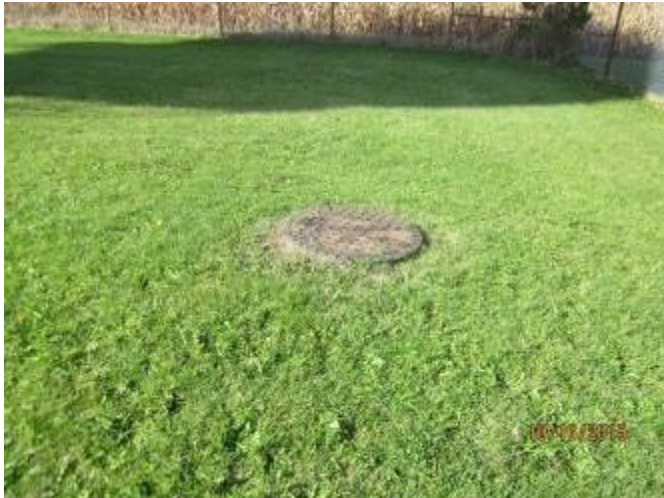
ME-025 – Water well.

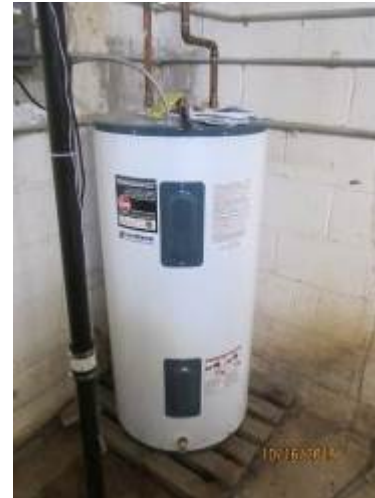
ME-026 – Electric domestic hot water tank (yr. 2006).

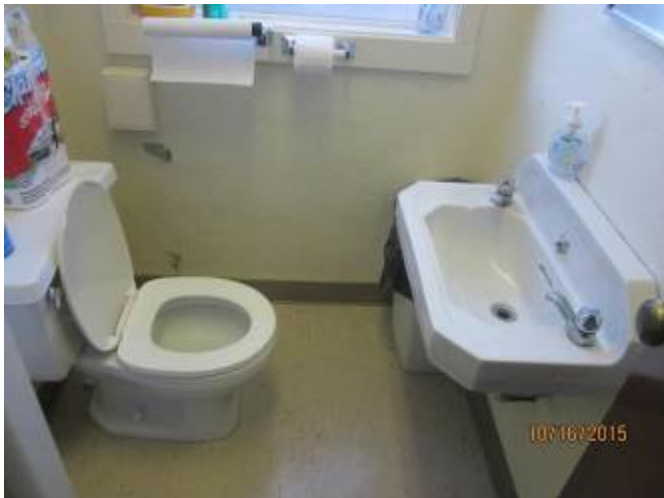
ME-027 – Toilet and sink.

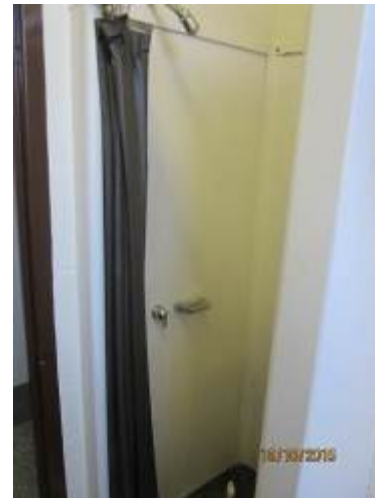
ME-028 – Shower.

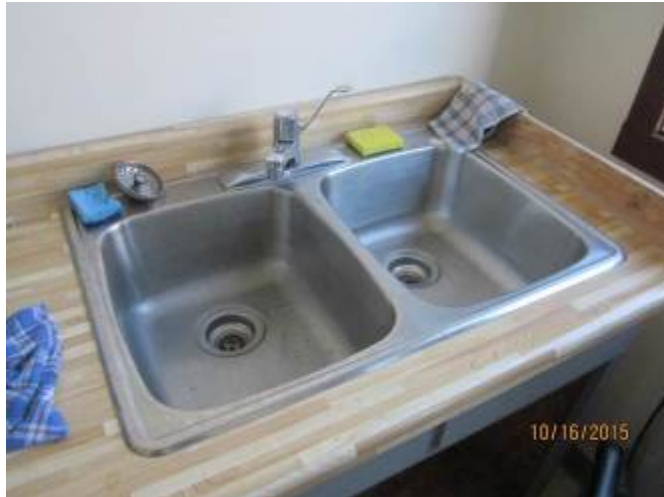
ME-029 – Stainless steel kitchen sink.

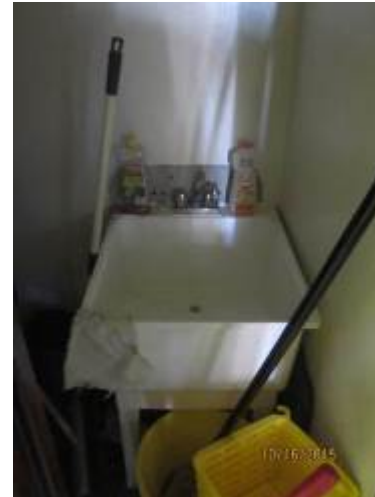
ME-030 – Laundry/janitor sink.

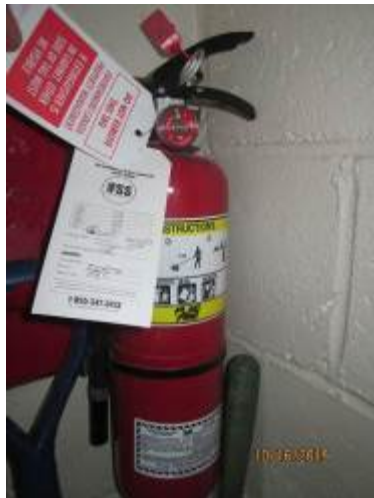
ME-031 – Portable fire extinguisher.

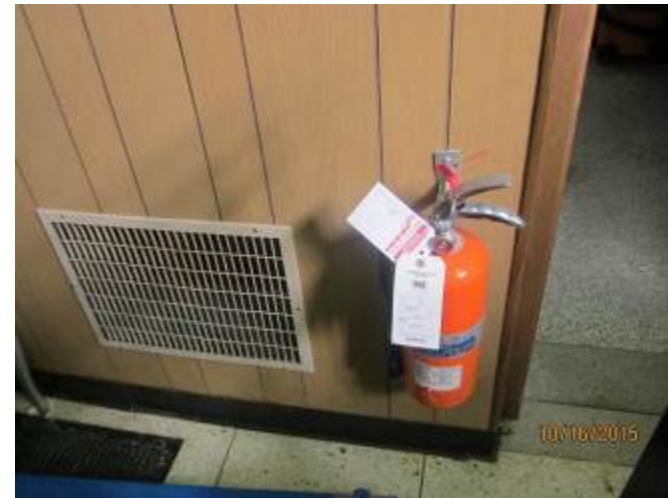
ME-032 – Portable fire extinguisher.

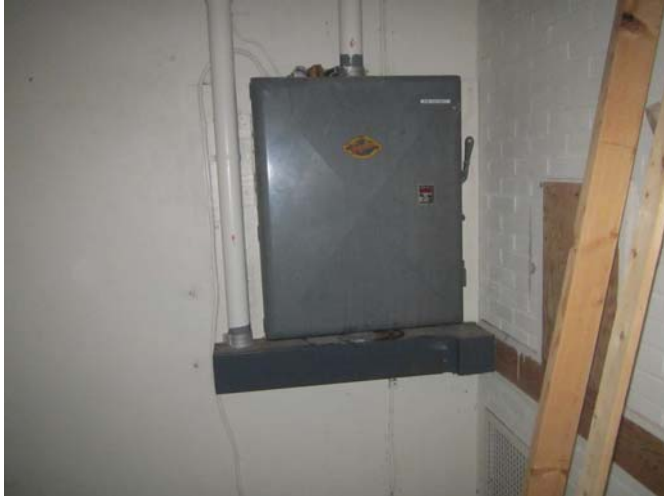
EL-001 – Main electrical 400A disconnect.

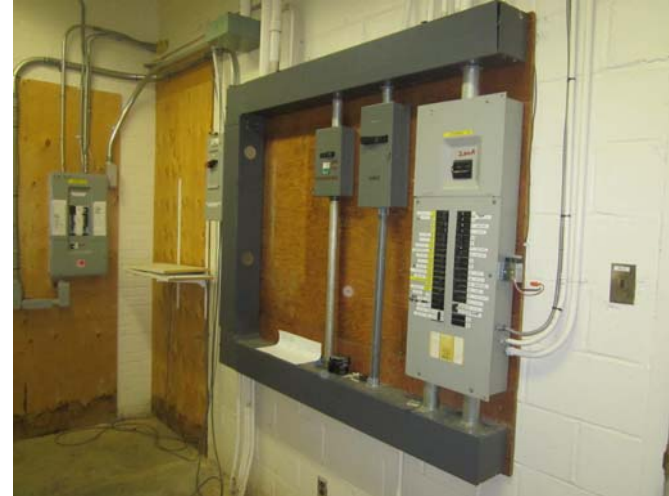
EL-002 – Main service equipment and troughs.

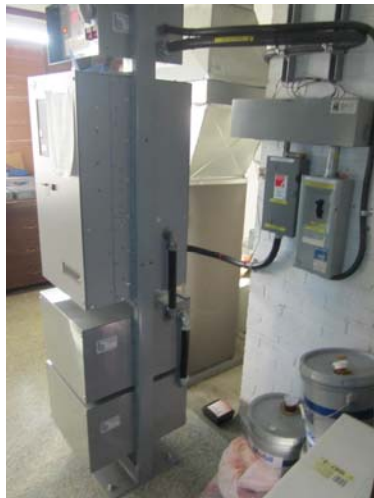
EL-007 – UPS installed in furnace room near heat source and flammable materials.

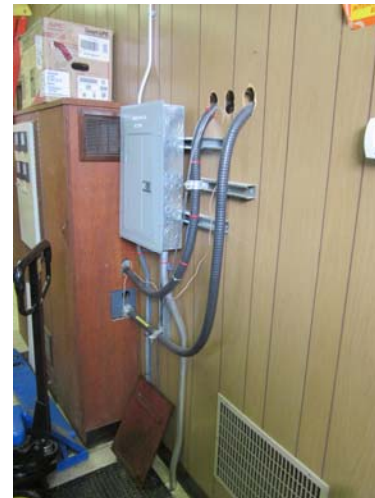
EL-008 – UPS backed up power panels.

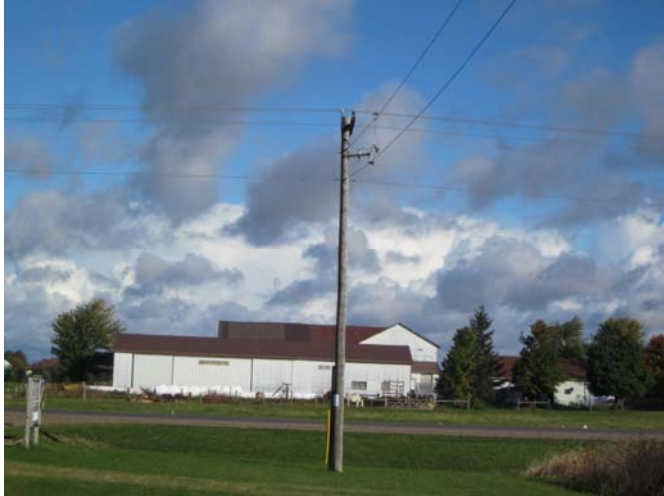
EL-009 – Consumer hydro pole line.

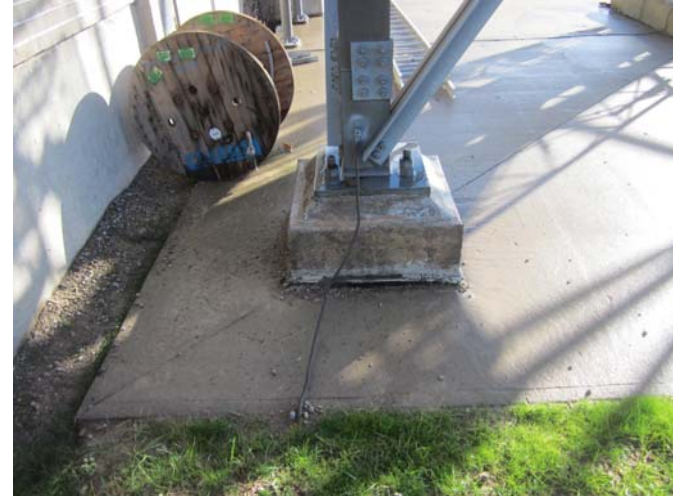
EL-010 – Typical lightning grounding/protection installation.

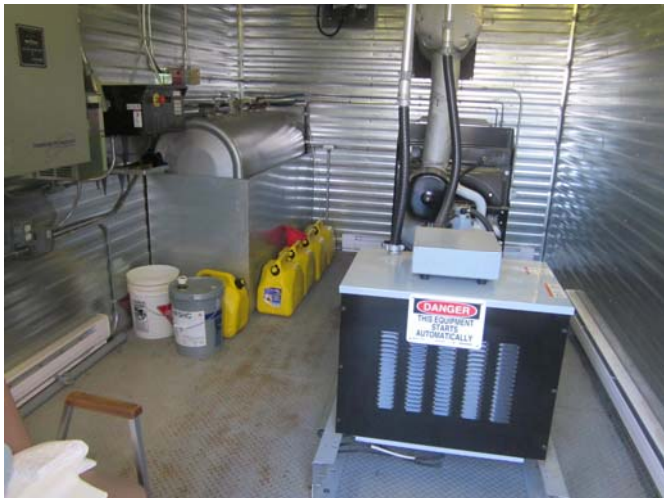
EL-011 – Emergency power generator system.

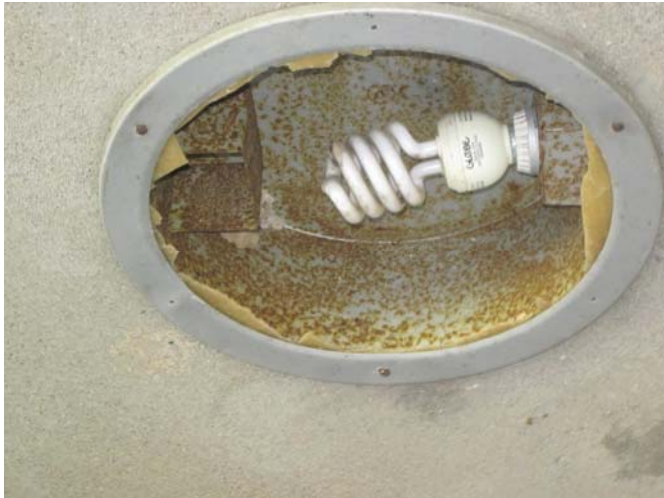
EL-013 – Exterior light under canopy.

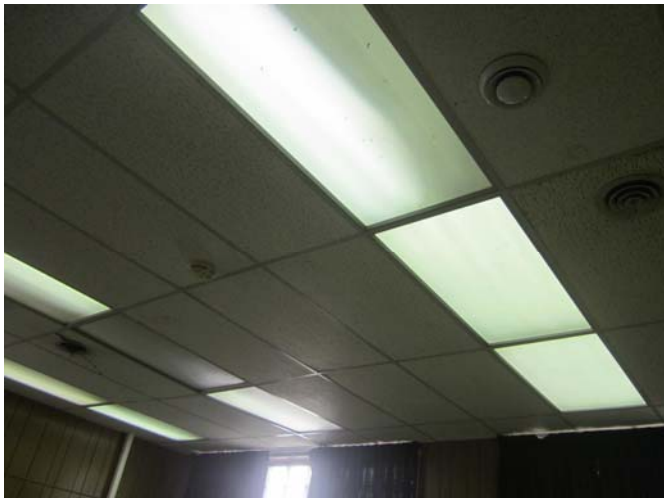
EL-015 – Typical interior lighting.

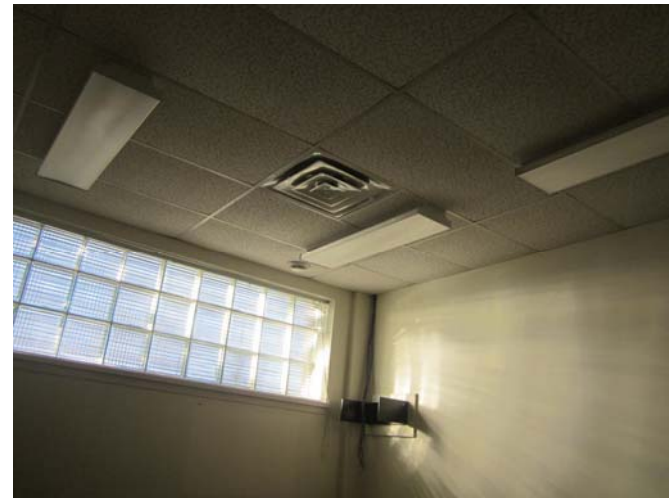
EL-016 – Typical interior lighting.

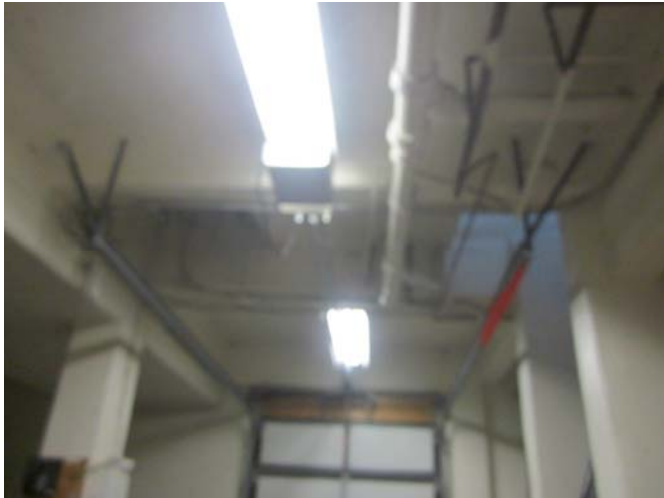
EL-017 – Basement lighting.

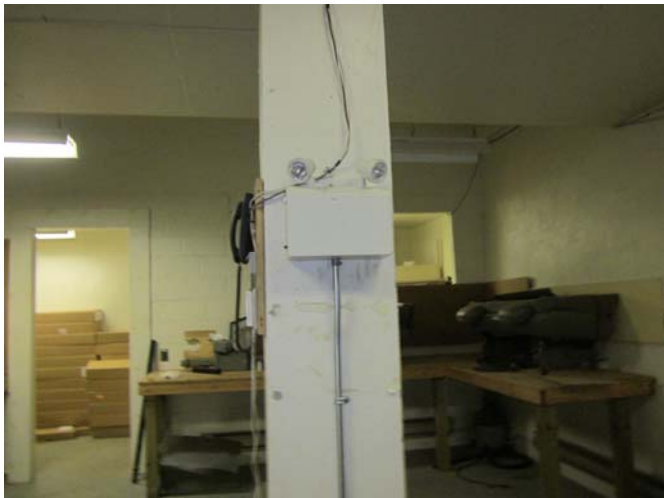
EL-019 – Typical emergency lighting pack.

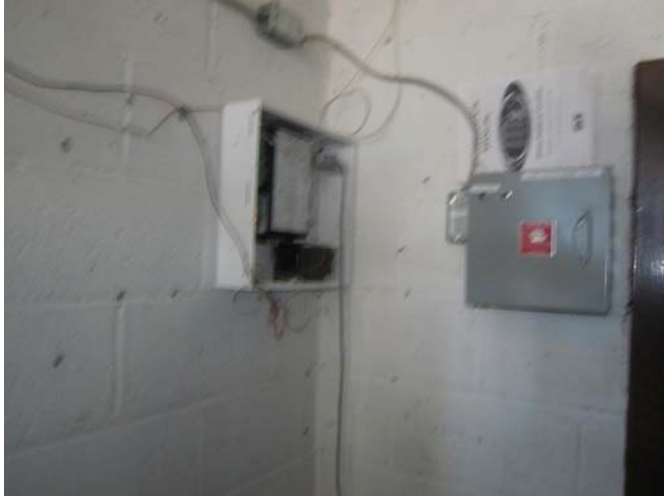
EL-021 – Main security system panel.

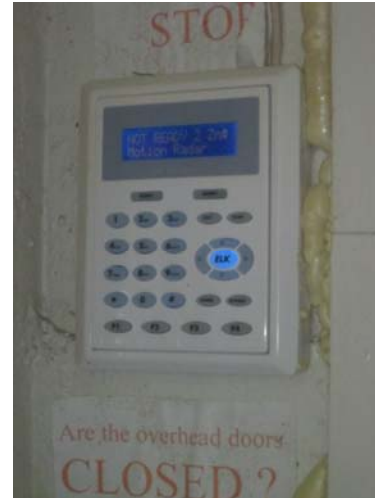
EL-022 – Security system keypad.

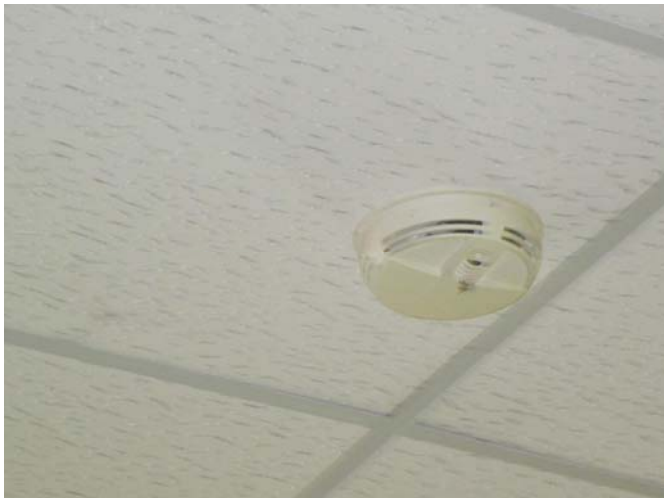
EL-023 – Integrated smoke detector to security system.

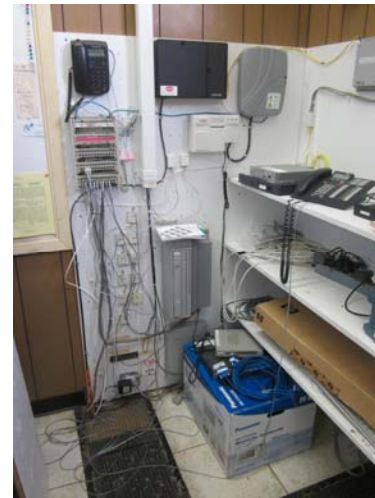
EL-024 – Main telephone/communications equipment.
