PWGSC Moosonee Buildings Demolition

SPECIFICATIONS

DESIGNATED SUBSTANCES & HAZARDOUS MATERIALS SURVEY

FOUR BUILDINGS NATIONAL DEFENCE RADAR BASE MOOSONEE, ONTARIO

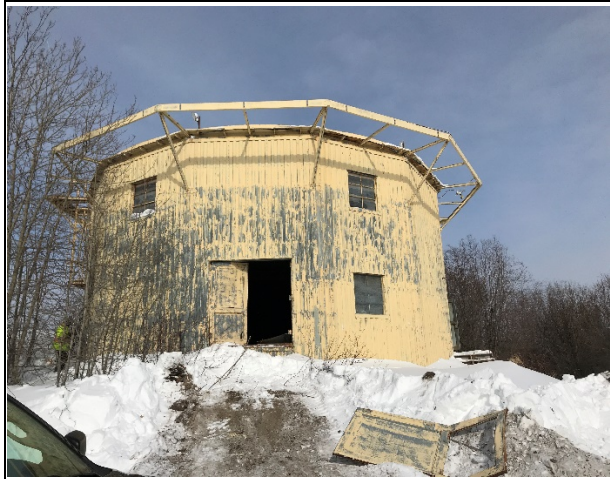
Photo 1: Building 1 – view of the exterior of the building

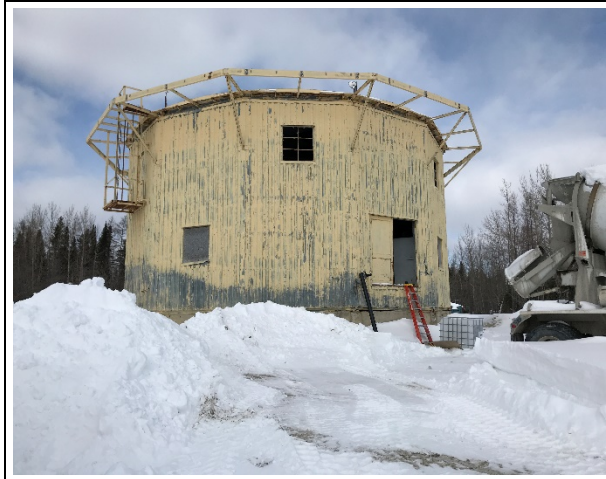
Photo 5: Building 1A – view of the exterior of the building

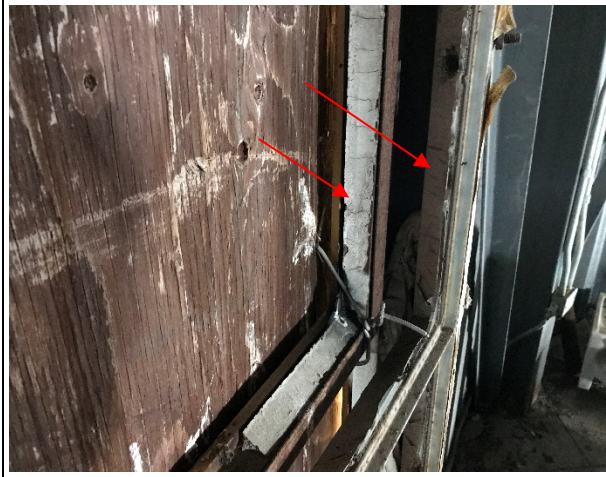
Photo 9: Building 1A – asbestos-containing (2% chrysotile) interior window glaze compound – grey

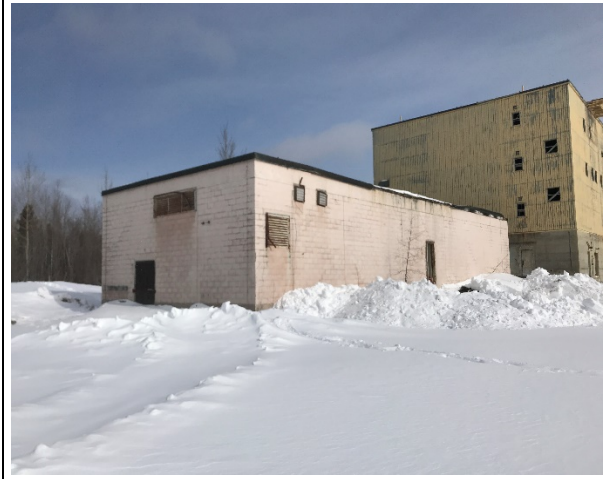
Photo 13: Building 2 – view of the exterior of the building

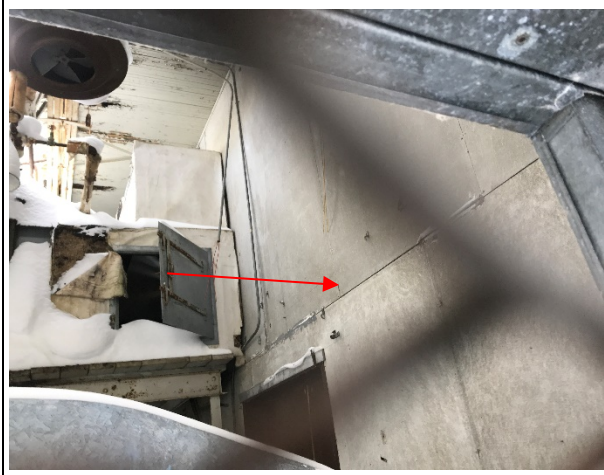
Photo 17: Building 2 – presumed asbestos-containing cement board panel located in room 1

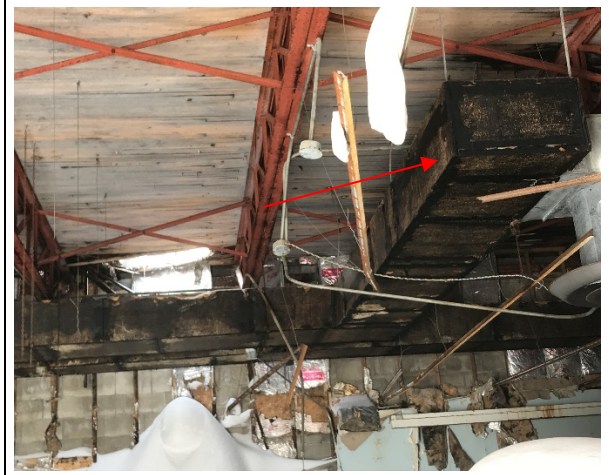
Photo 18: Building 2 – presumed asbestos-containing duct insulation – black located in room 2

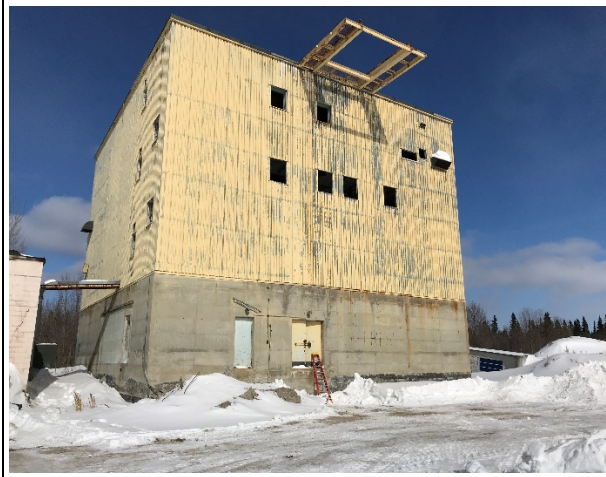
Photo 21: Building 3 – view of the exterior of the building

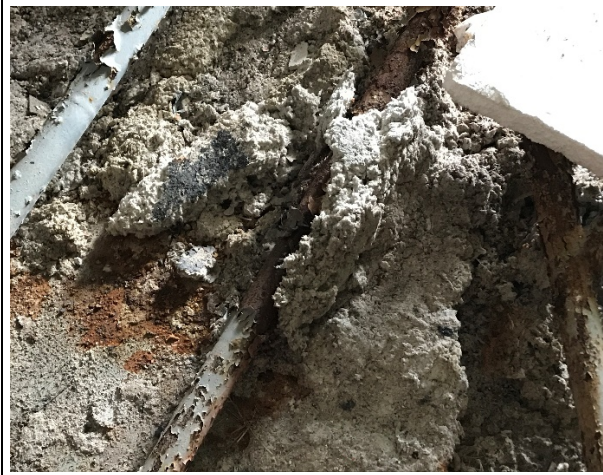
Photo 25: Building 3 – asbestos-containing (10% chrysotile) sprayed fireproofing debris located on the floor in the entrance

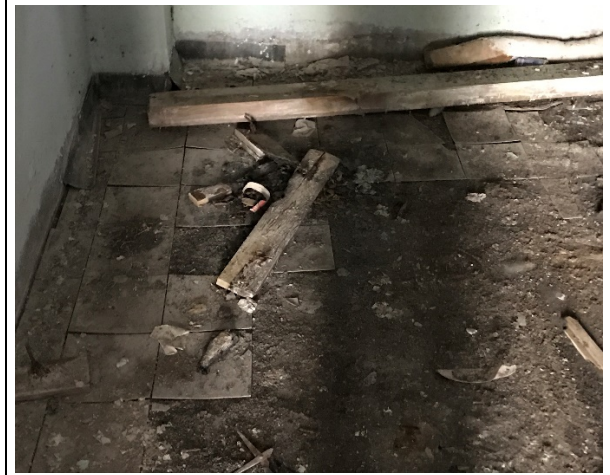
Photo 26: Building 3 – asbestos-containing (2% chrysotile) 9"x9" vinyl floor tile – grey located in the entrance

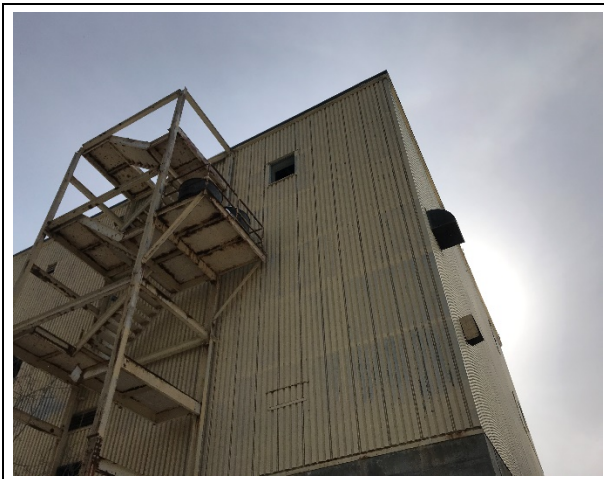
Photo 31: Building 3 – lead-containing (200 ppm) yellow/off-white coloured paint located on the exterior metal cladding

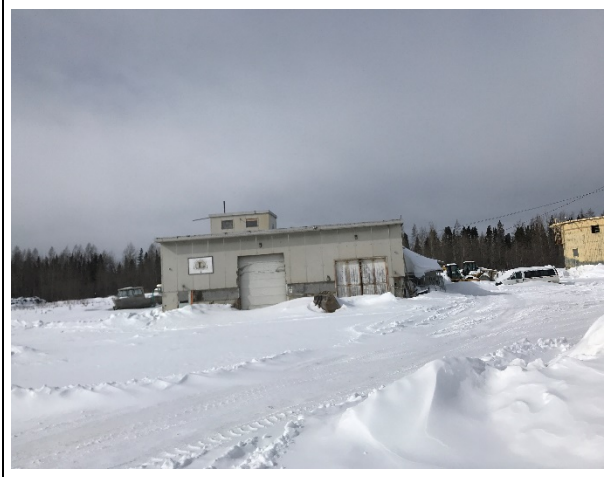
Photo 37: Building 4 – view of the exterior of the building

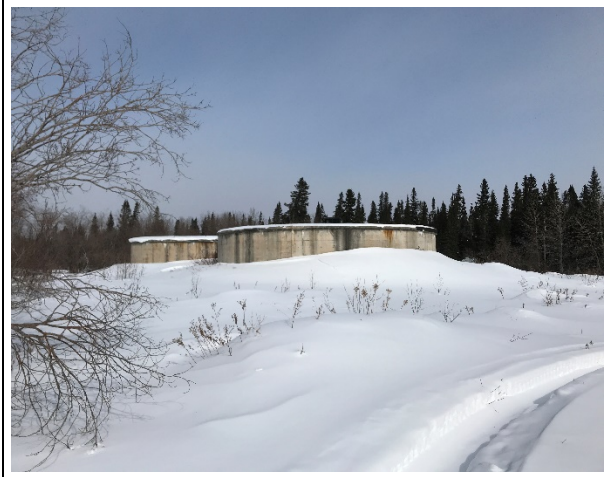
Photo 45: Building 5&6 – view of the exterior of building 5 and building 6 (decommissioned clarifiers)
