Port Severn Dam

PUBLIC WORKS CANADA

PORT SEVERIN DAM

GEOTECHNICAL
INVESTIGATION

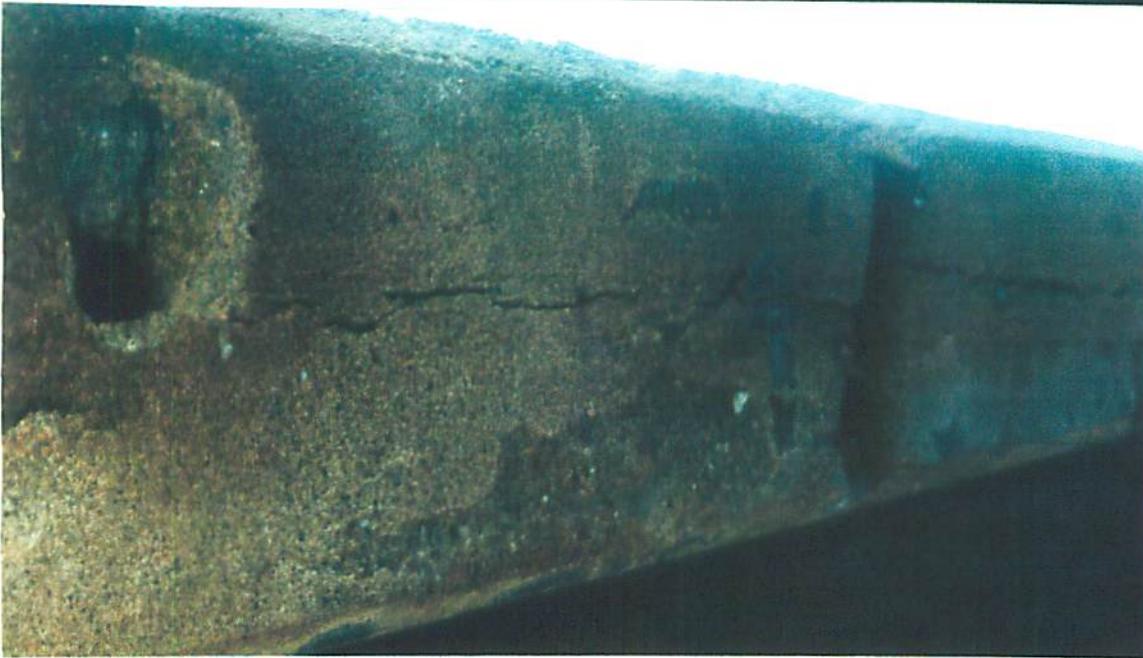
9/5
Bottom
Beam No. 1

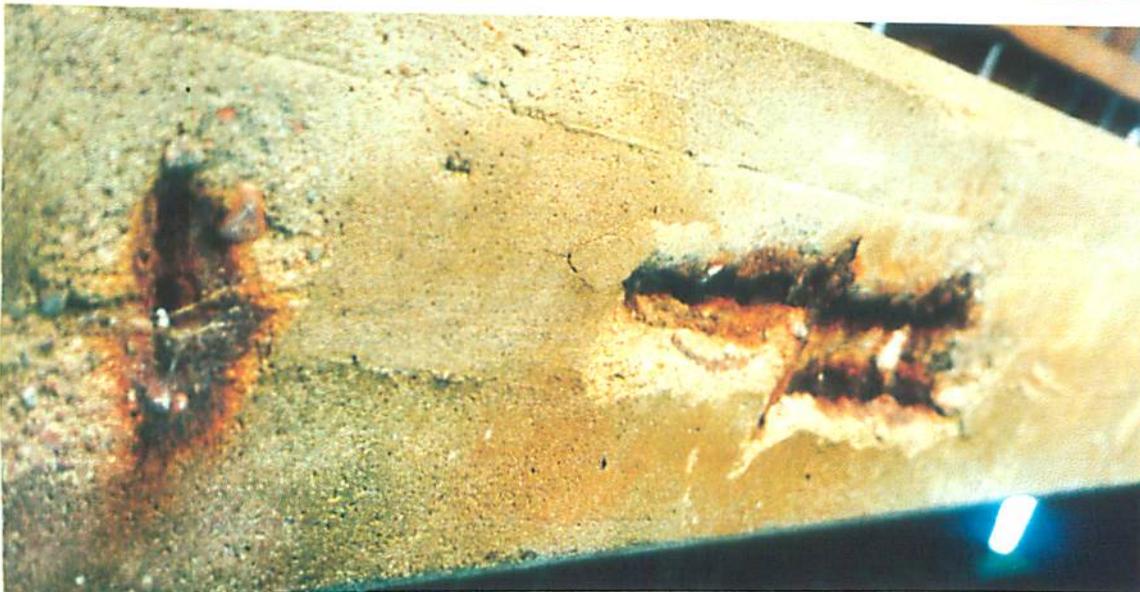
9/15
Beam No. 3
Bottom Face

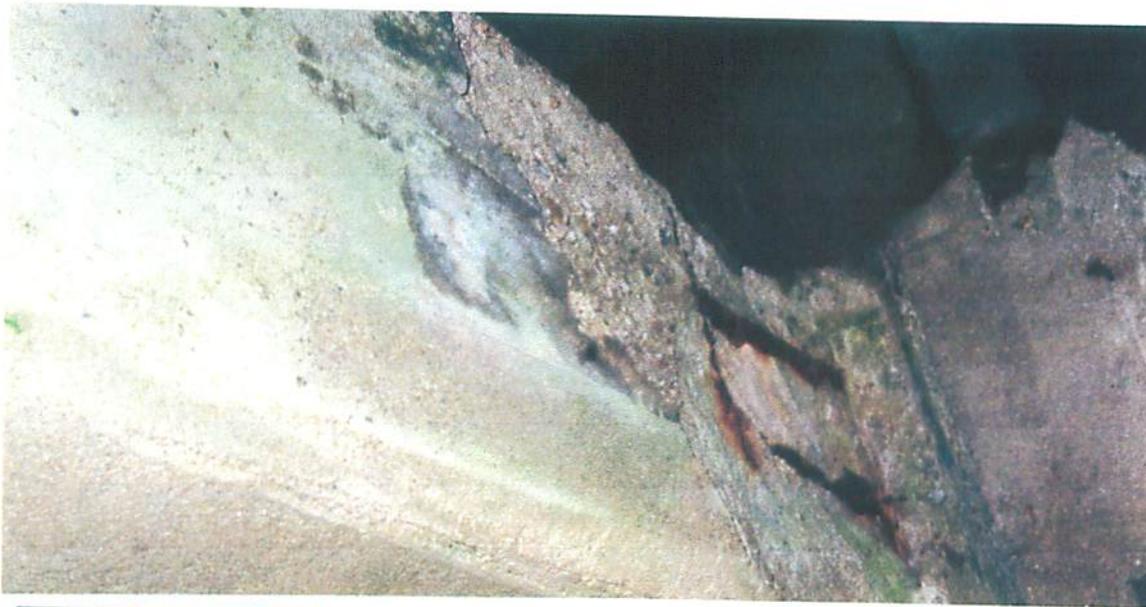
4/12
Support Beam
No. 3
