Project No.: R.051116.002

December 2013

Dam Safety Reviews: Port Severn Dams Main Dam, Lock 45, Upstream Shoreline Wall and Dam D

**Dam Safety Review Report
Final**

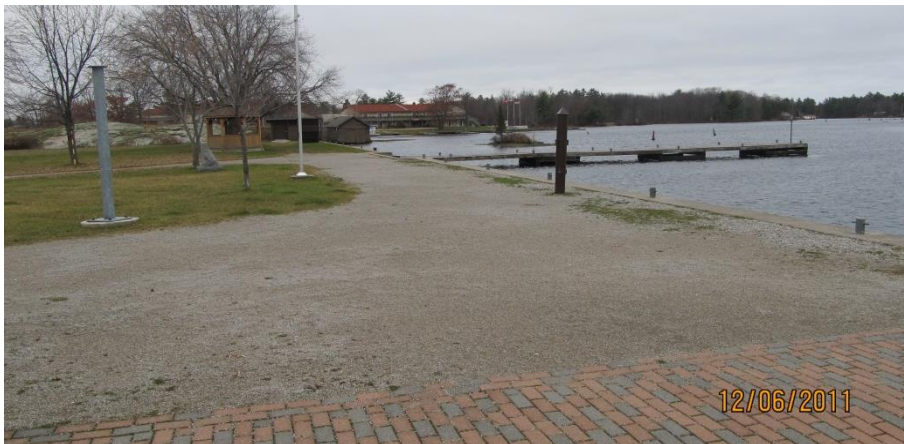
Figure 7.9 Fill behind Upstream Shoreline Wall and Lock 45

However, these are concrete structures and the grade of the fill behind Dam D and the Upstream Shoreline Wall is flat. This is shown in Figure 7.9 for Lock 45 and Upstream Shoreline Wall and Figure 7.10 for Dam D.

While there will be some overtopping by waves and accumulation of water in these areas, no damage to the integrity of these structures is likely. This is due to the flat grade on the downstream side, meaning that there will be no velocities or ability for the water to erode the fill. Therefore, overtopping of Lock 45, Dam D and the Upstream Shoreline Wall is not likely to be an issue.

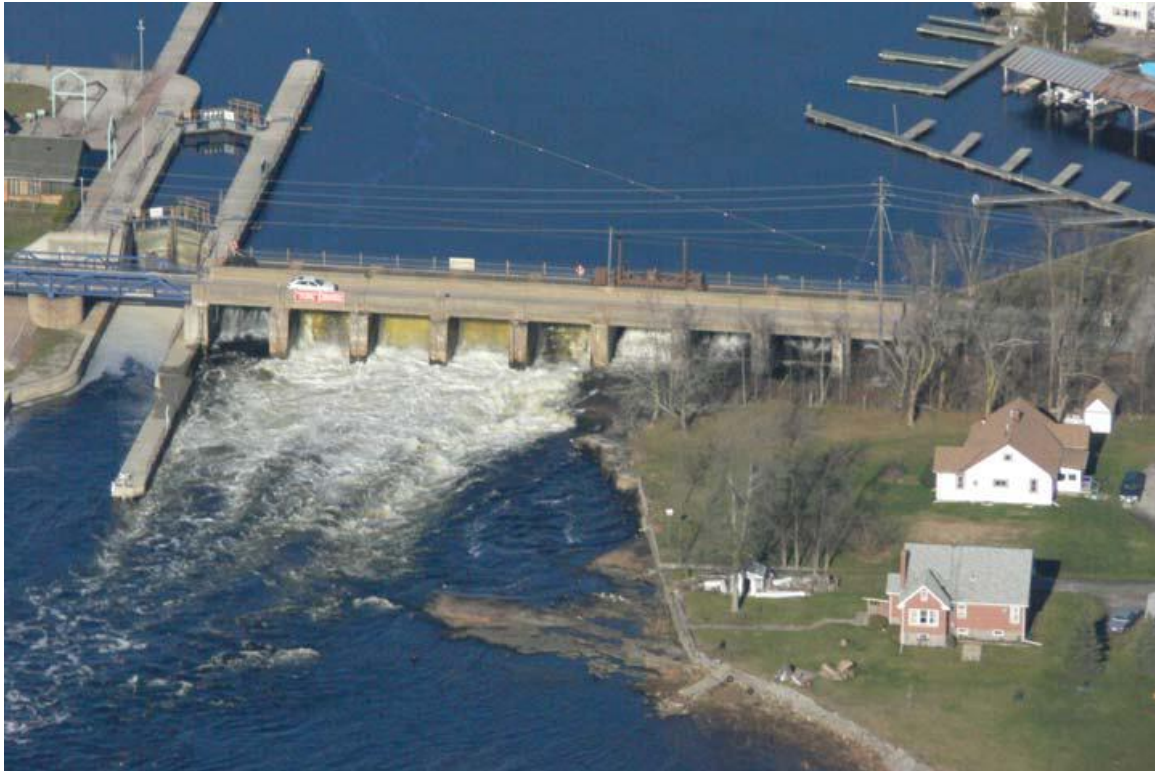
Photo 1: General view

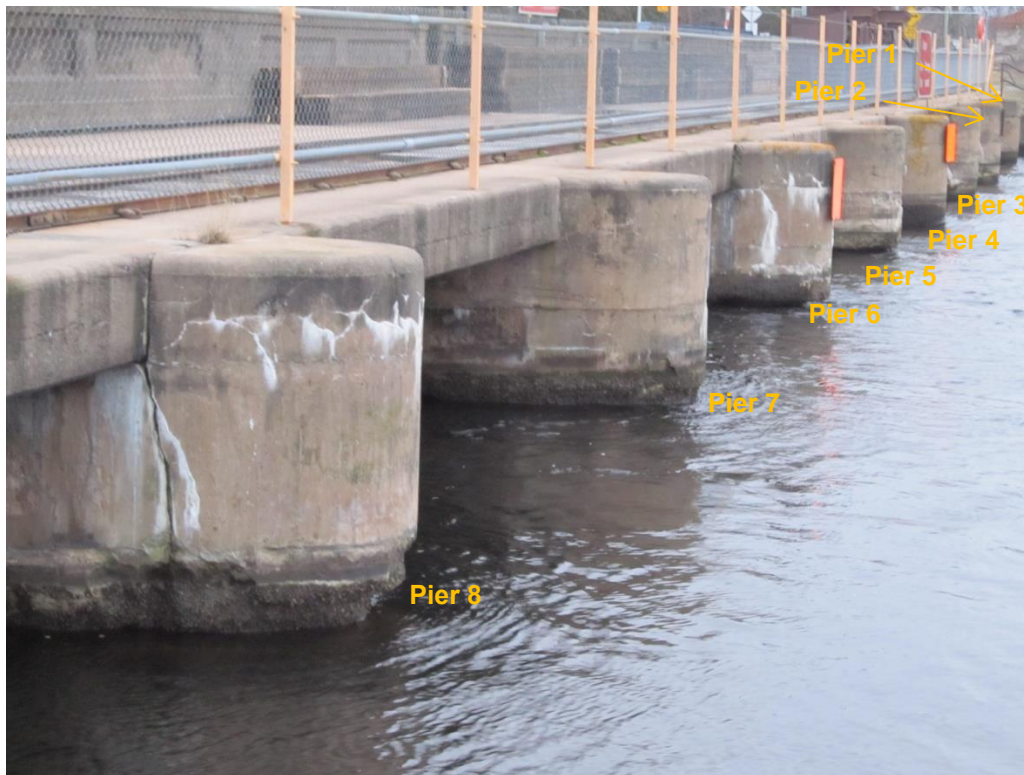
Photo 2: Upstream view

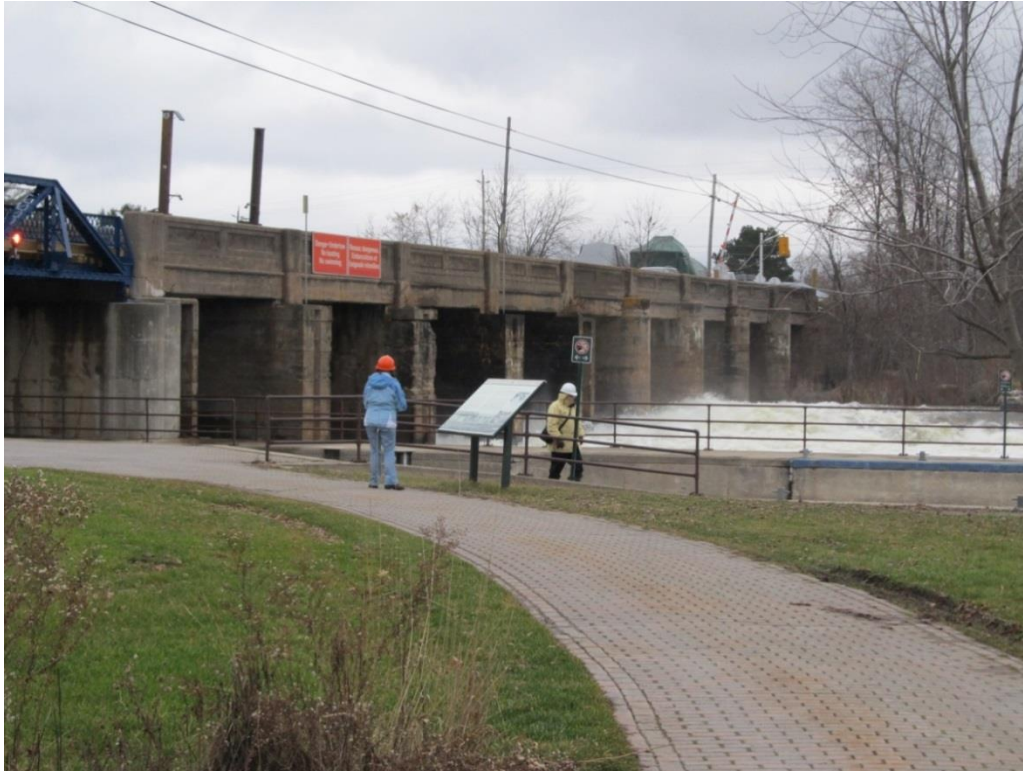
Photo 3: Downstream view

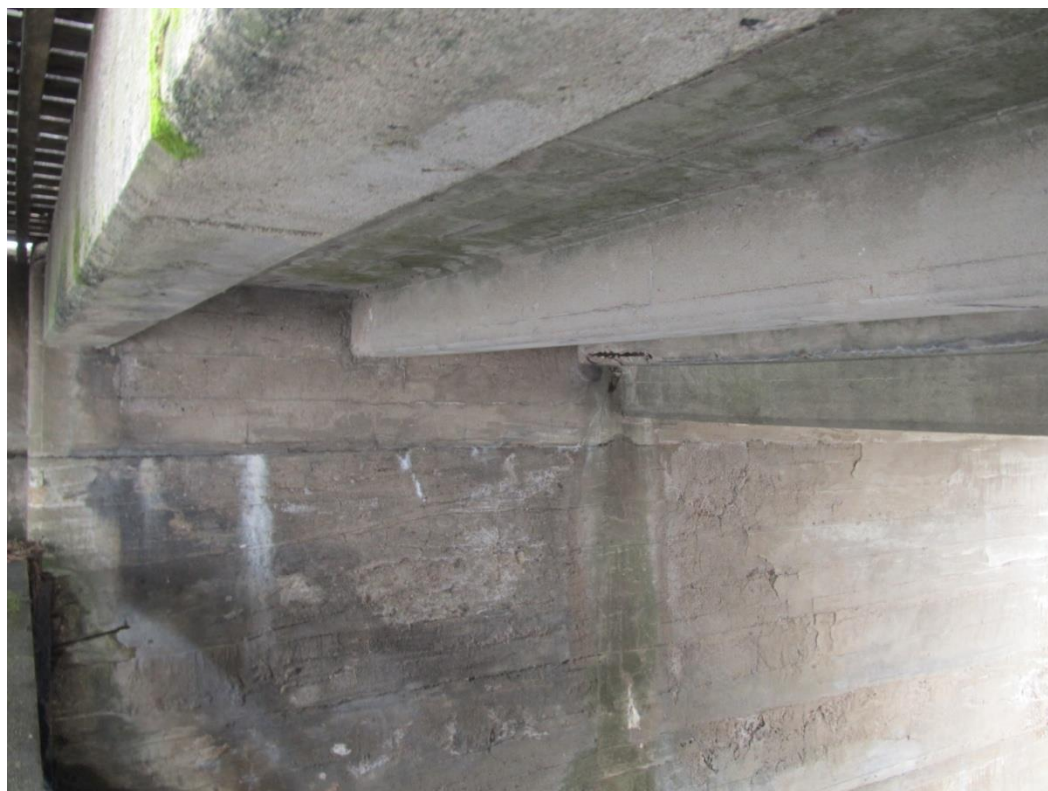
Photo 10: Under-deck concrete in good condition at sluice 7

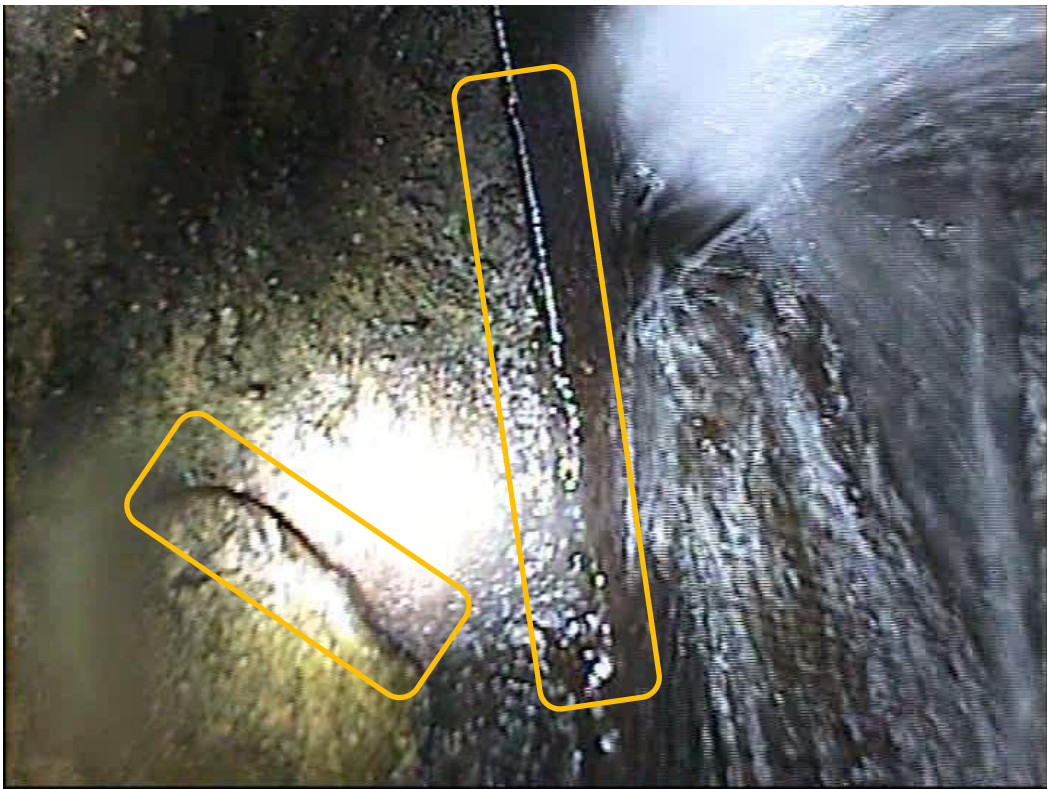
Photo 17: Open construction joint on the left side of pier no. 2

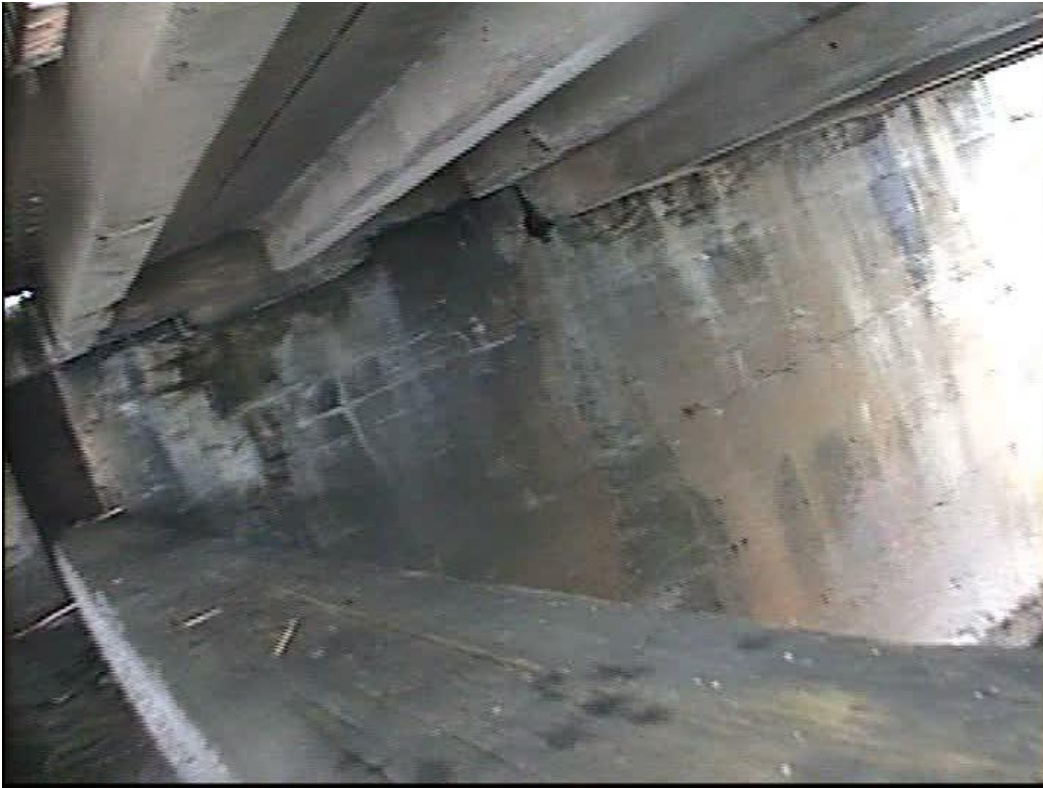
Photo 18: Open construction joint near embedded parts of gains, pier 2

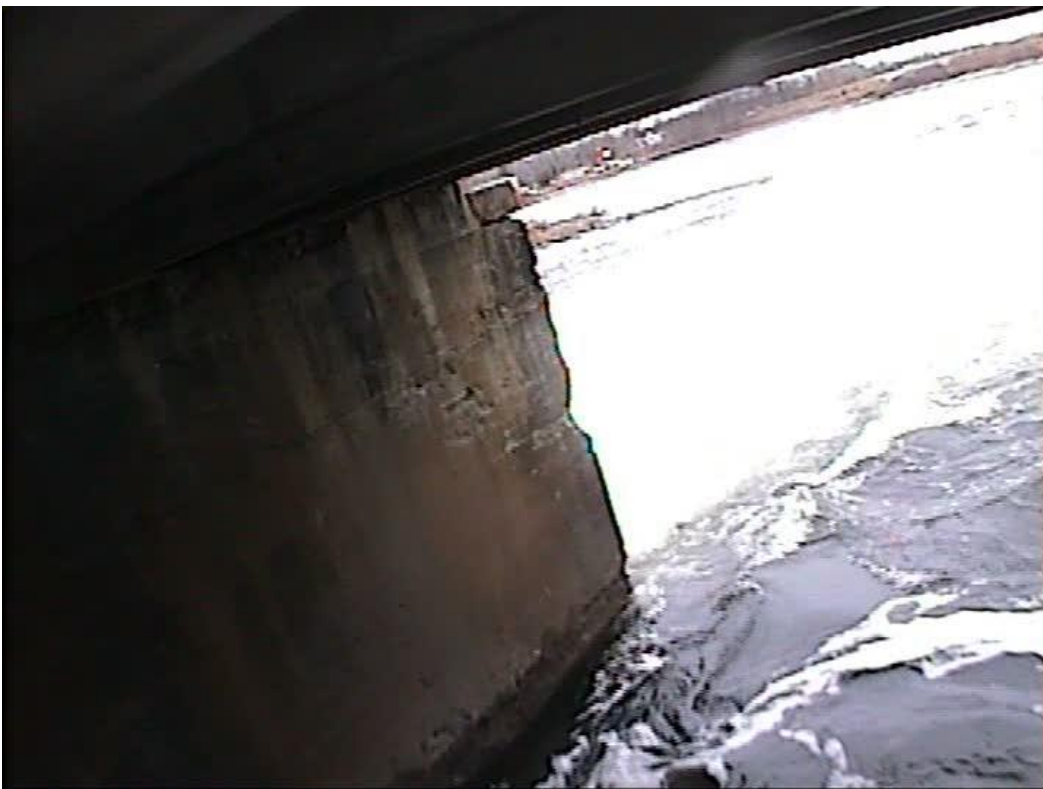
Photo 19: Concrete of pier 3 right face

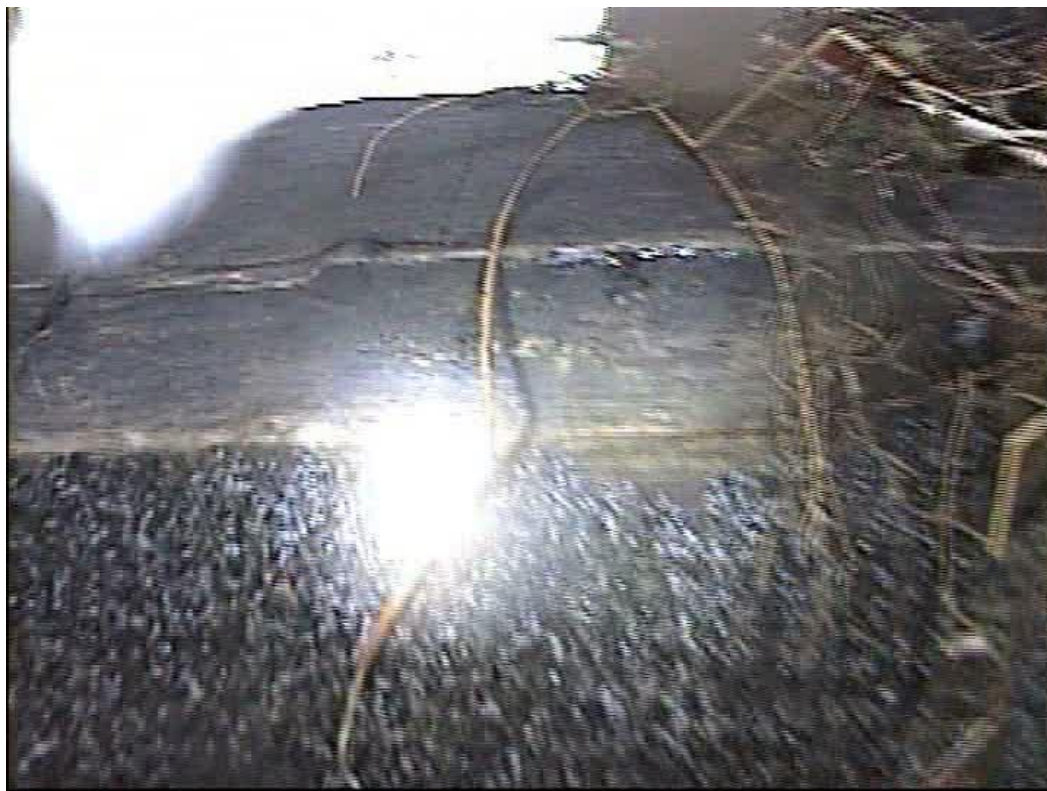
Photo 20: Crest of downstream pier 3

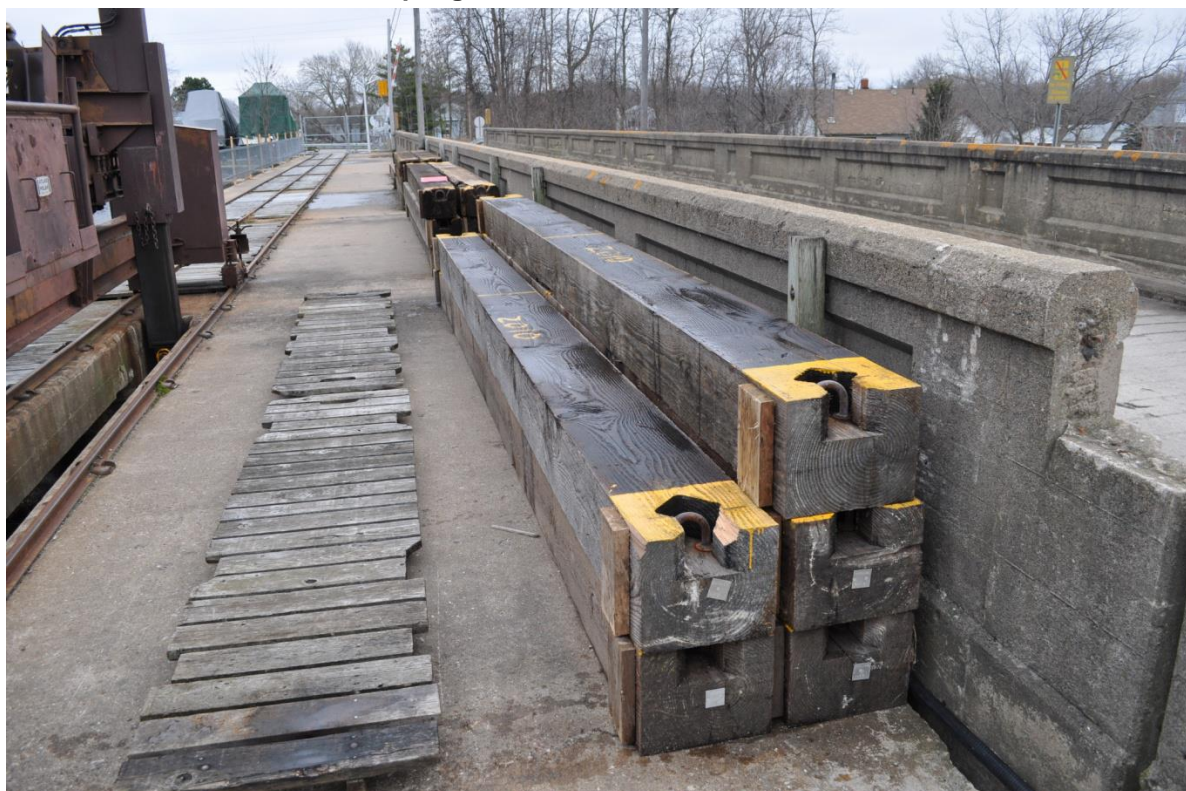
Photo 21: Sluice 2 wooden stop logs

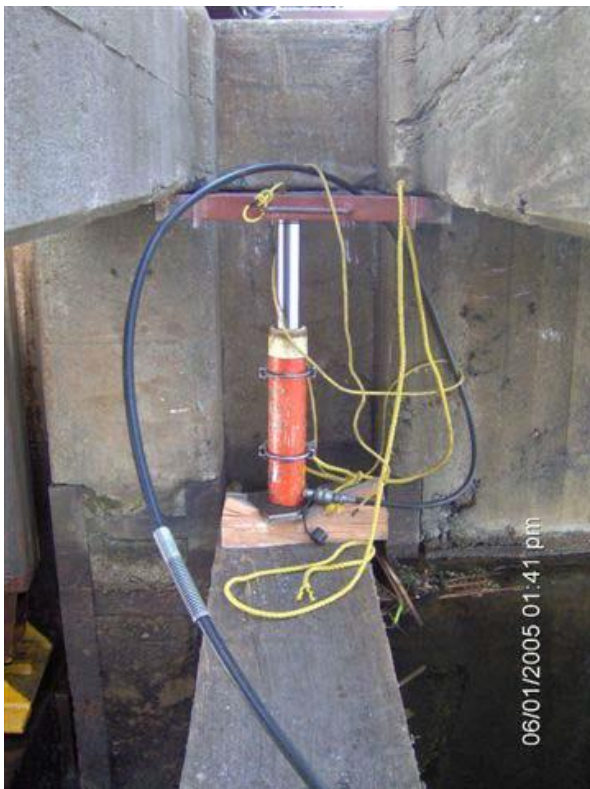
Photo 31: Used rails and damaged concrete due to “jacking”

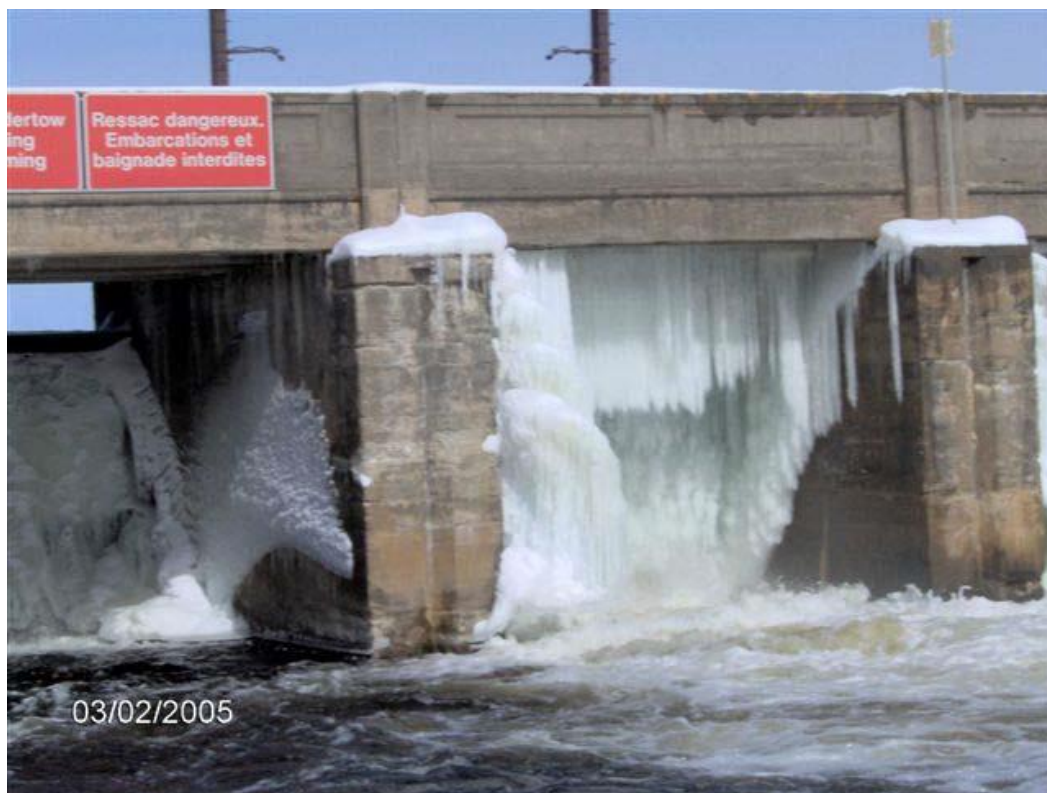
Photo 34: Well-maintained deck in wintertime (Photo provided by PCA)

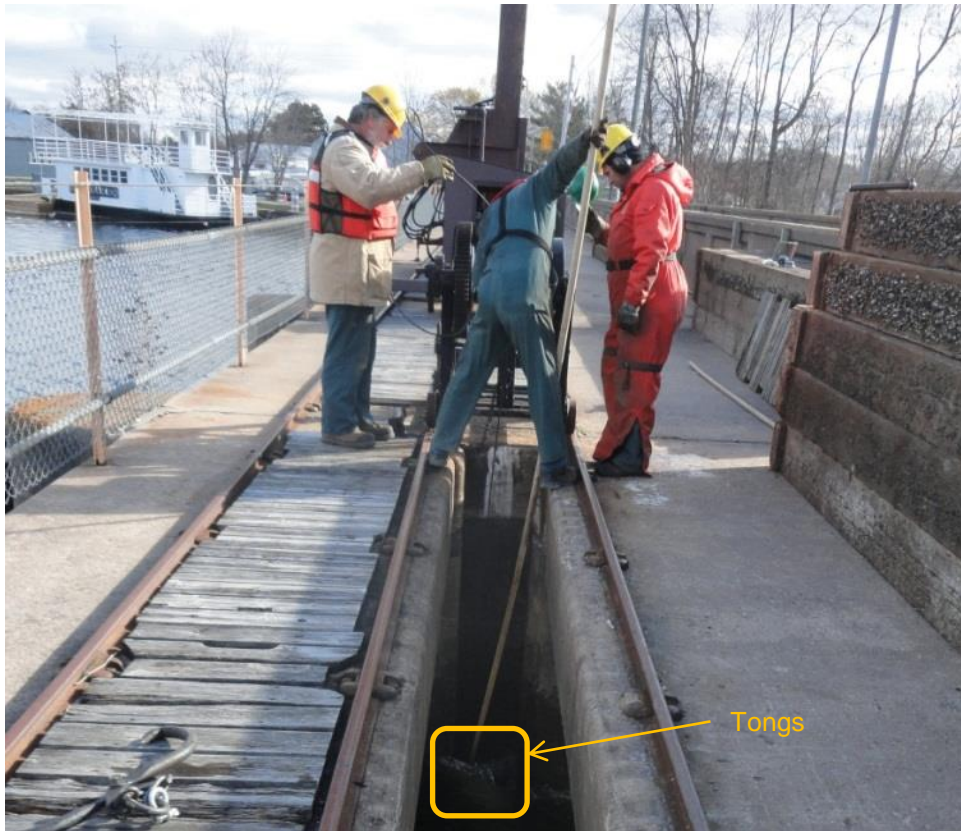
Photo 36: Use of tongs with log lifter

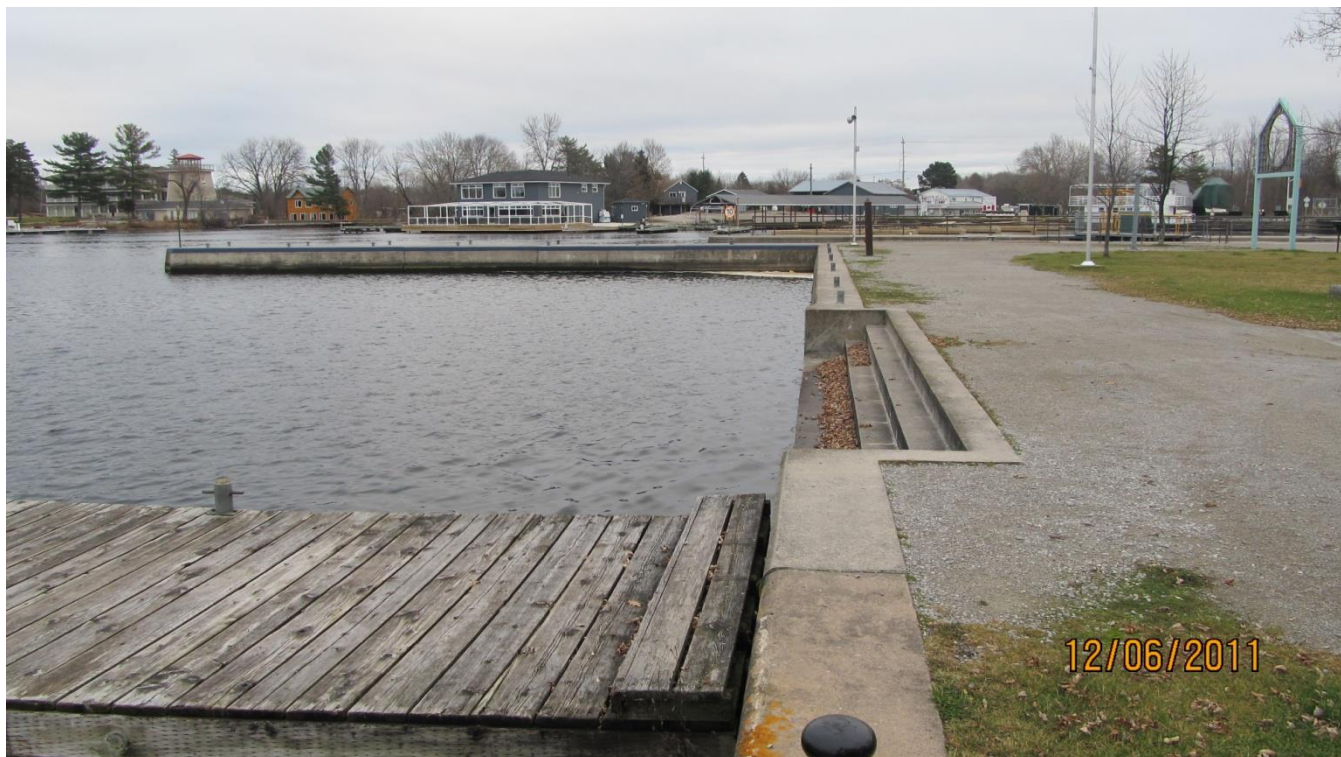
Photo 12: Beginning of Upstream Shoreline Wall and added pier at junction with lock canal

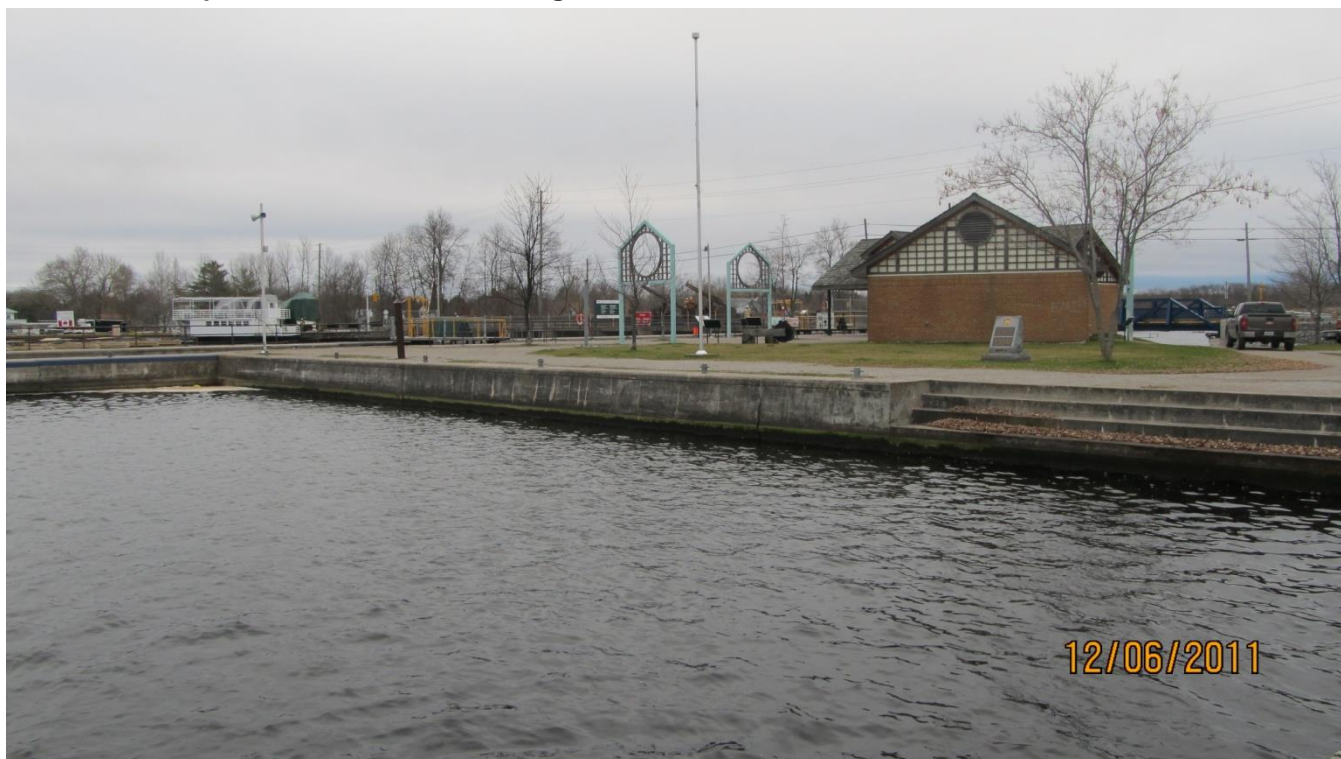
Photo 13: Left portion of wall with boarding dock

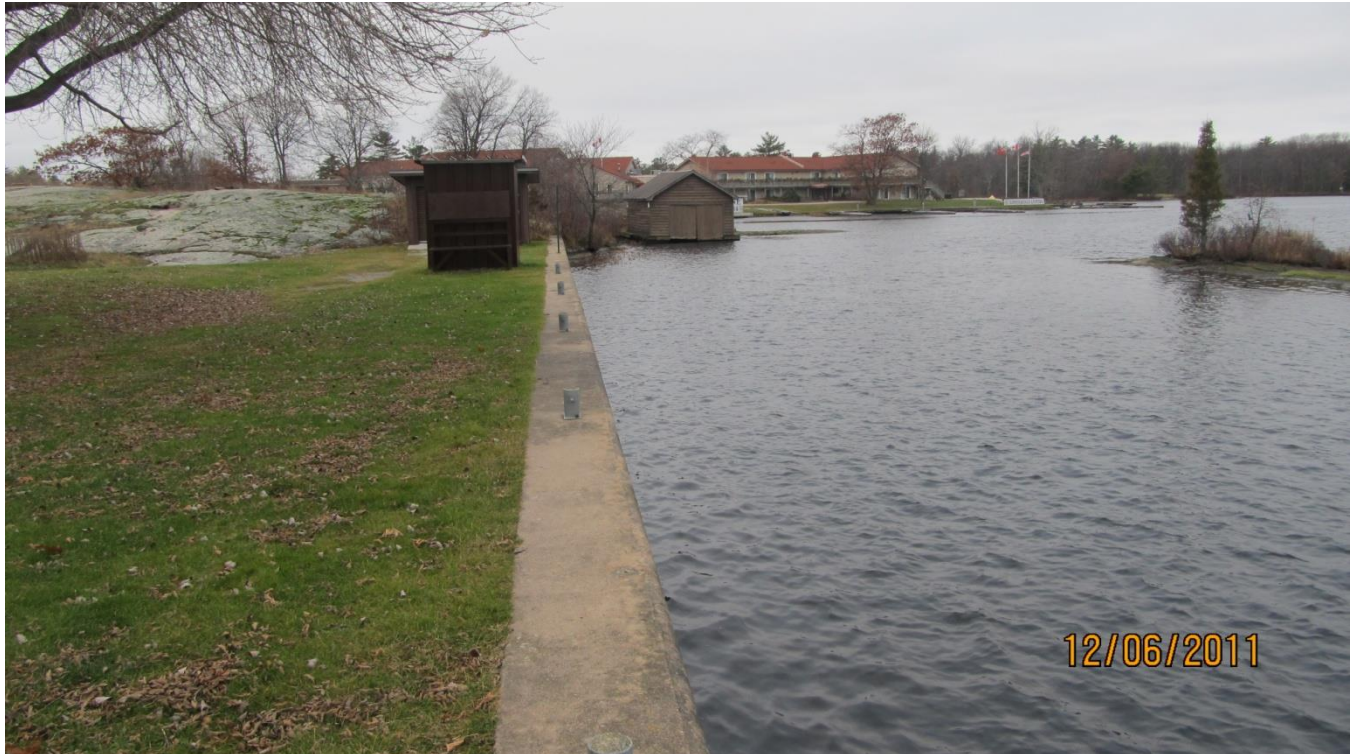
Photo 15: Right portion of wall (toward Bay View)

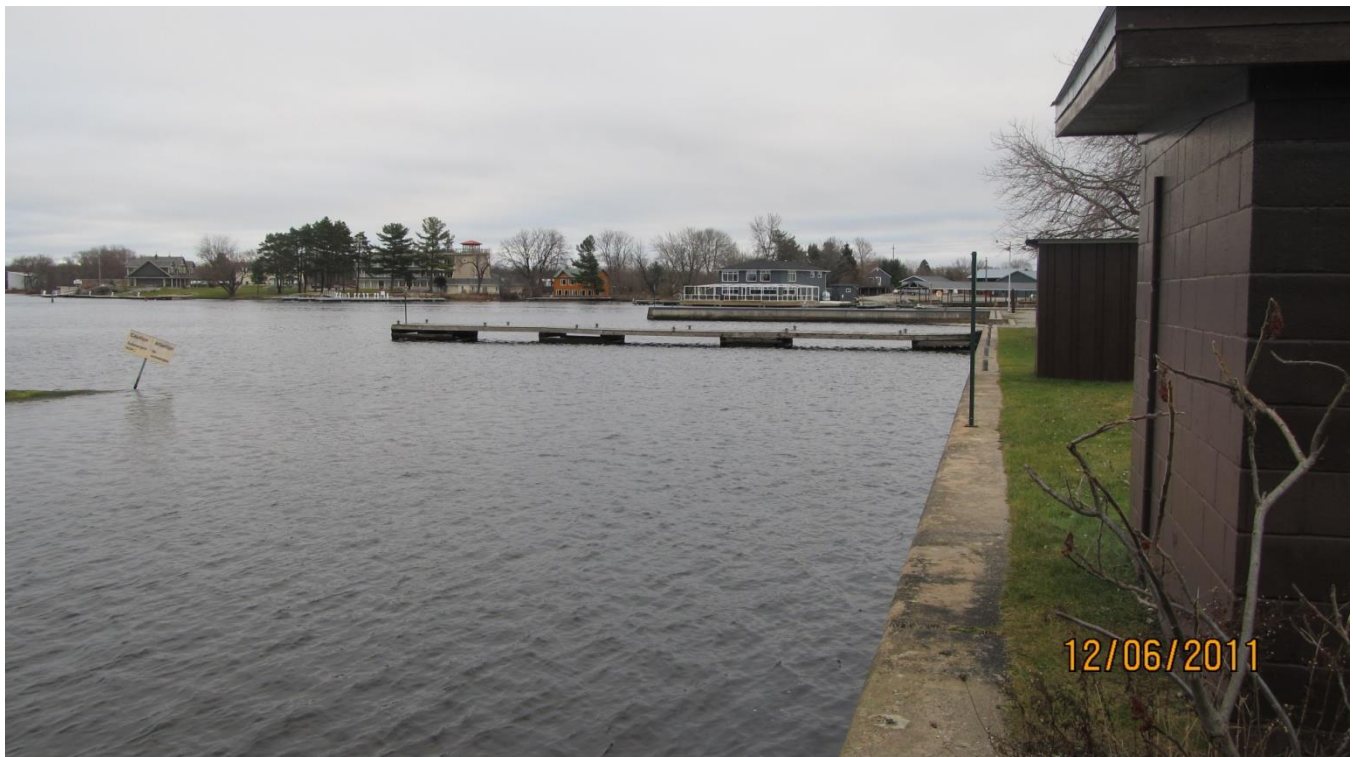
Photo 16: Right portion of wall (view toward lock canal)

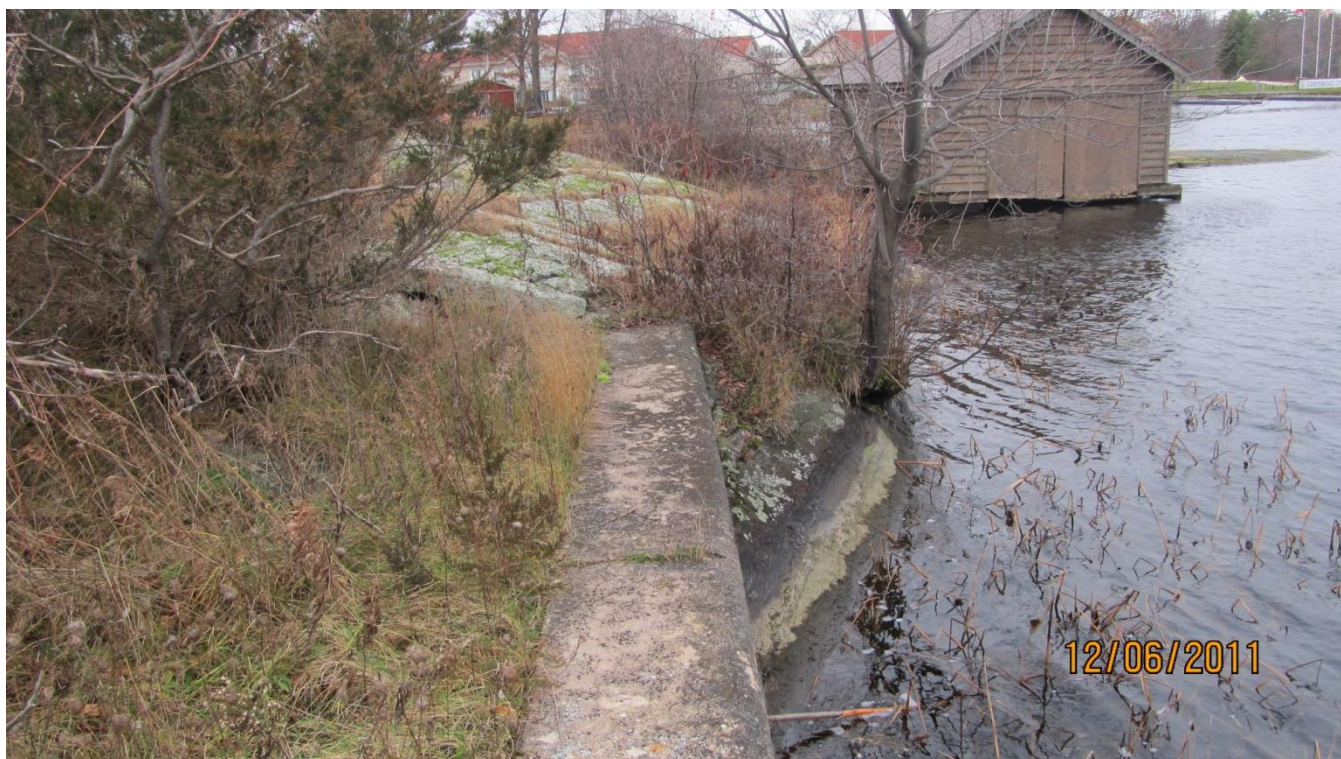
Photo 17: Right end of wall

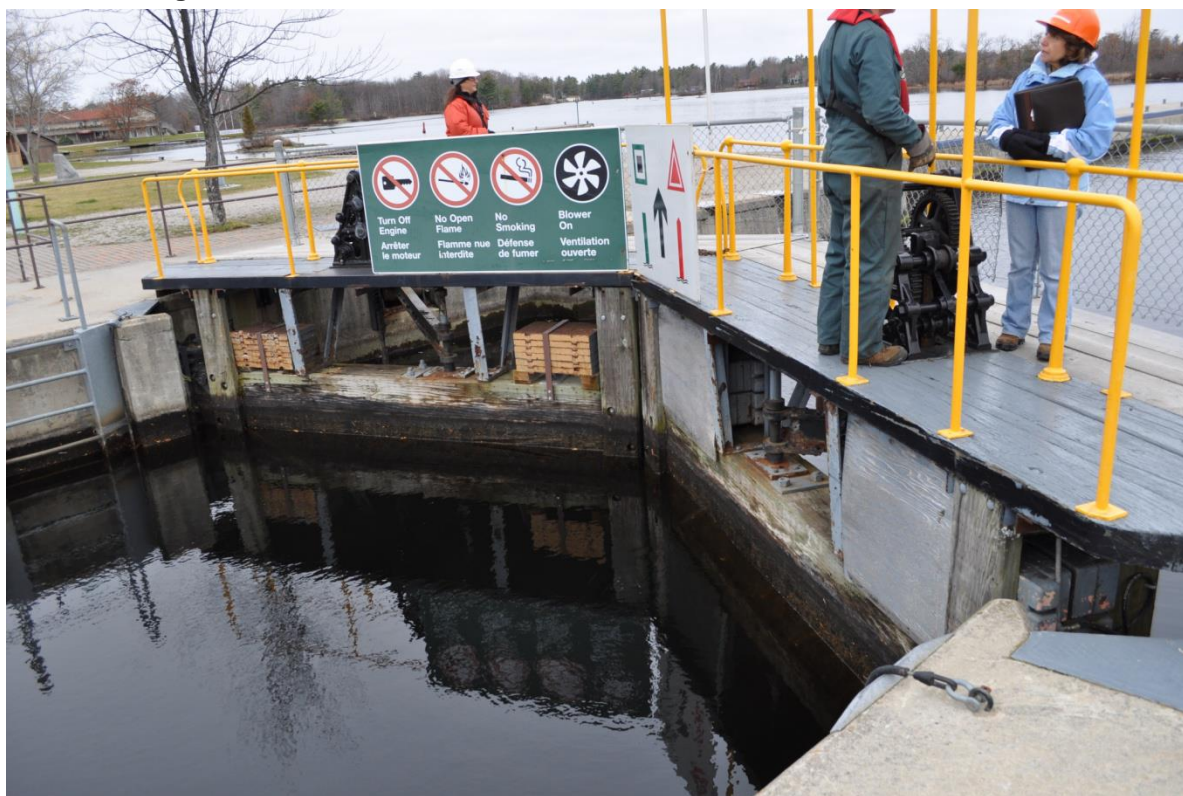
Photo 18: Old and additional walkways

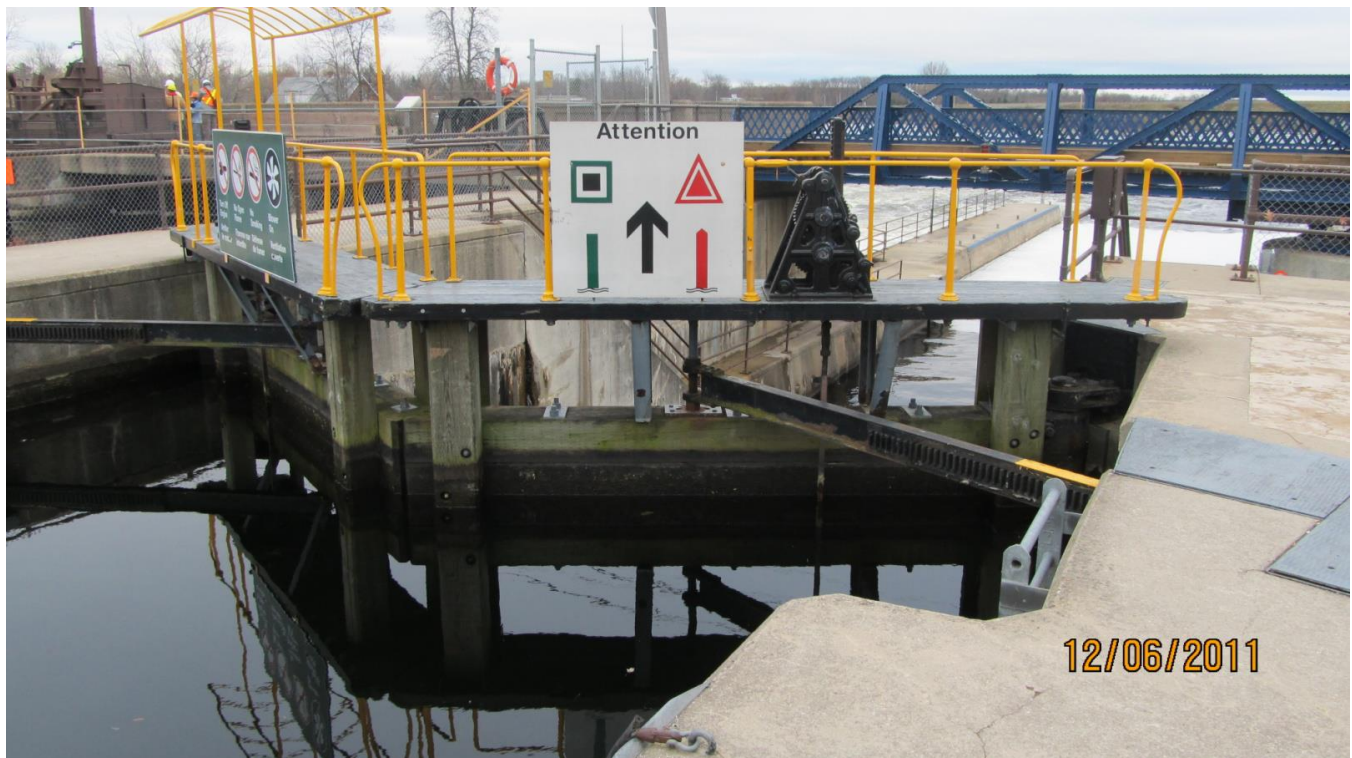
Photo 20: Downstream lock gate

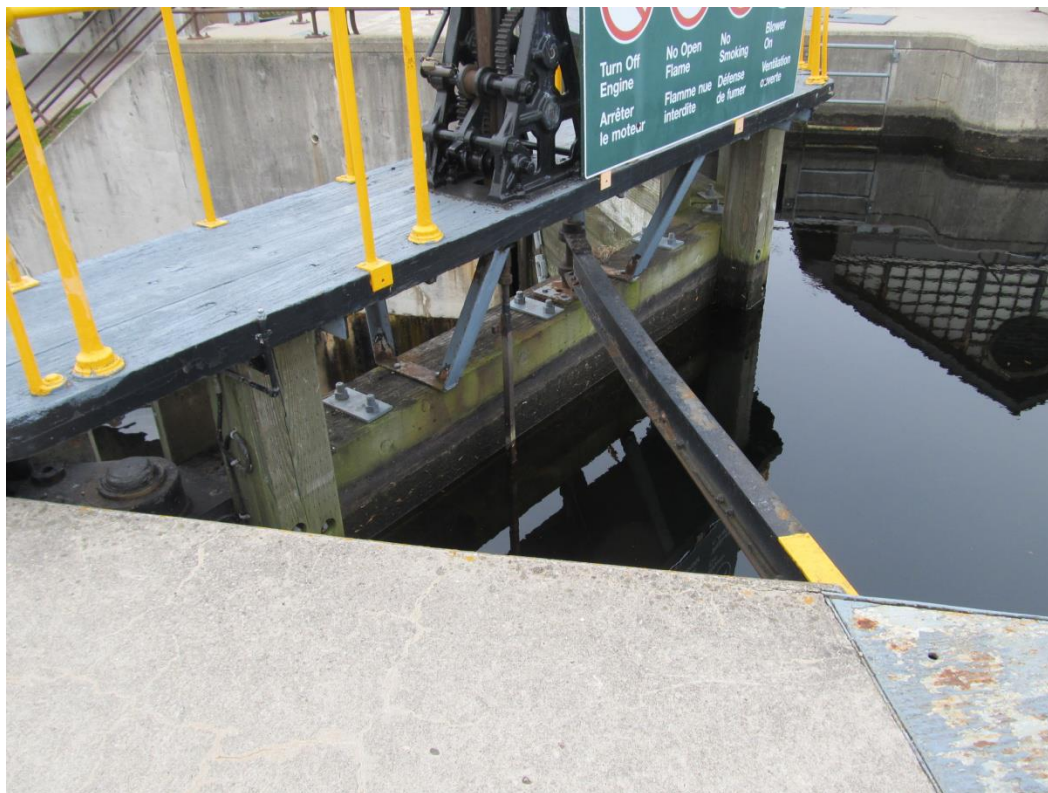
Photo 21: Downstream lock gate, left arm bent

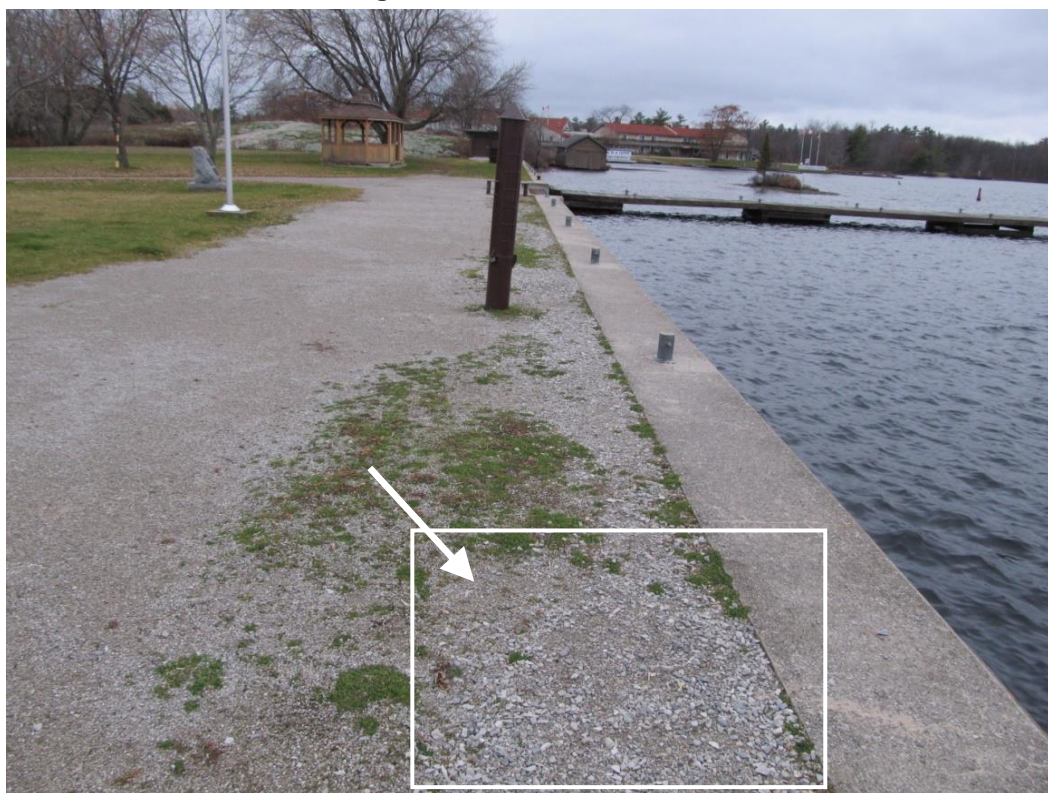
- No erosion has been observed on the lock abutments at the contact of the concrete structure and rock foundation.
- No seepage has been observed around the lock and the upstream shoreline wall.
- Sinkholes have been observed near the Upstream Shoreline Wall. These sinkholes have been filled recently with sand and gravel (Photos 22 and 23 of App. B2).

Photo 22: Filled sinkholes near the upstream shoreline wall

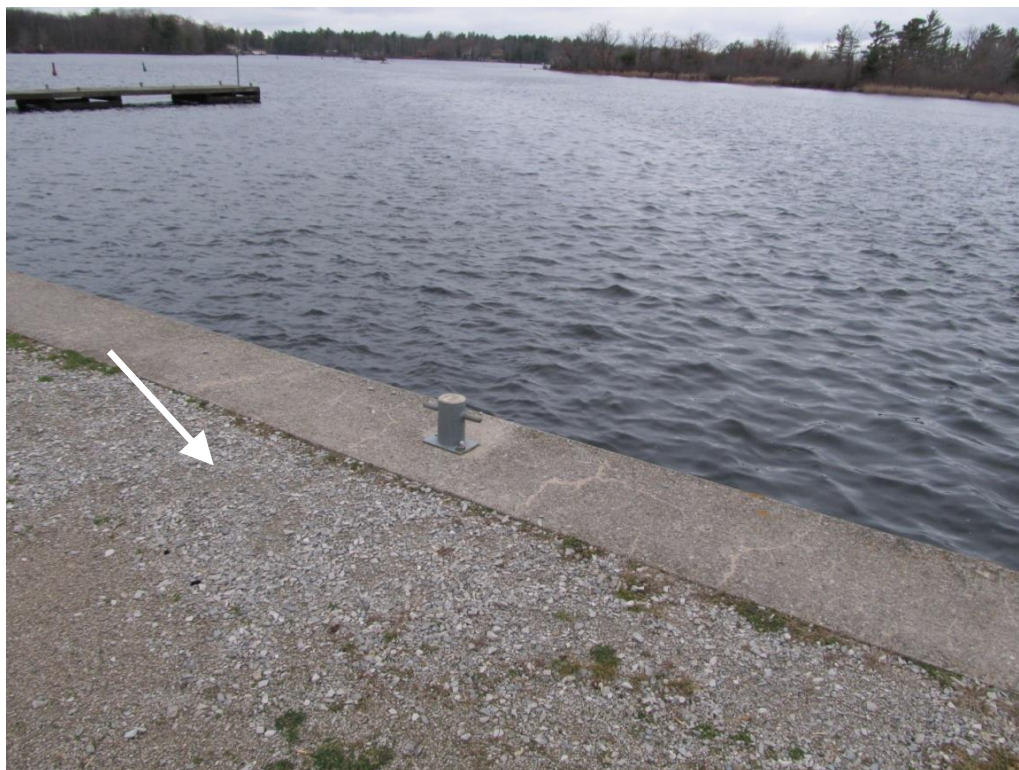
Photo 23: Filled sinkholes near the upstream shoreline wall

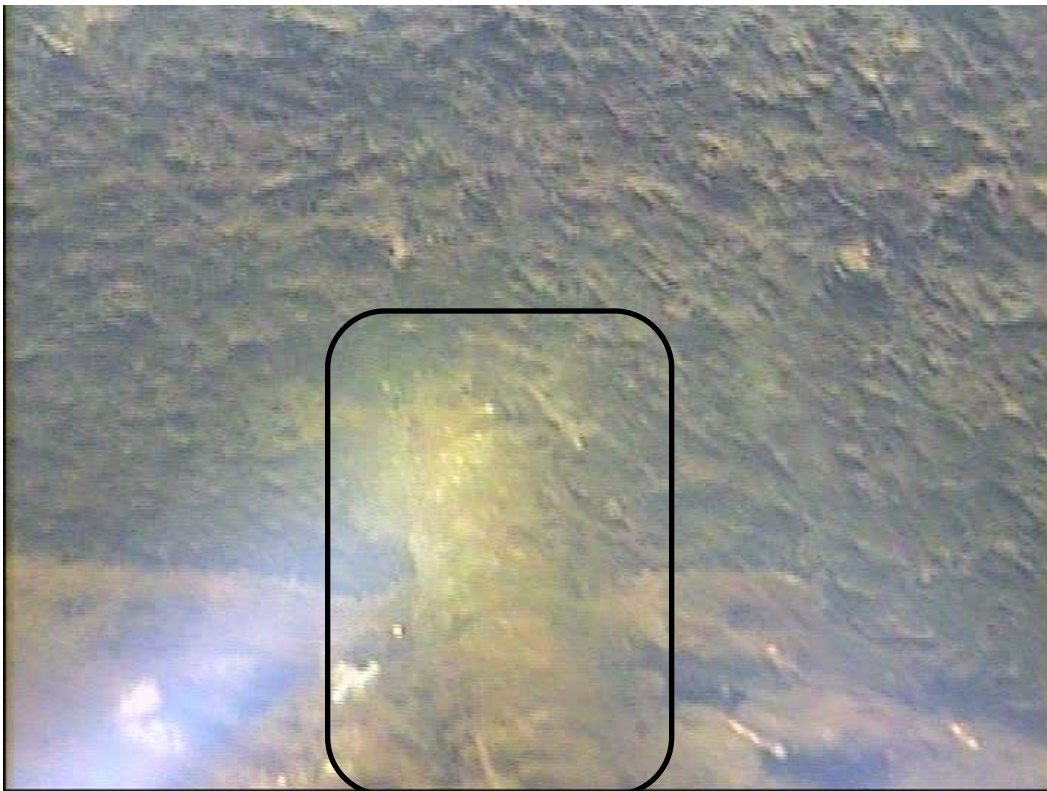
Photo 6: Drainage pipe at the base of dam

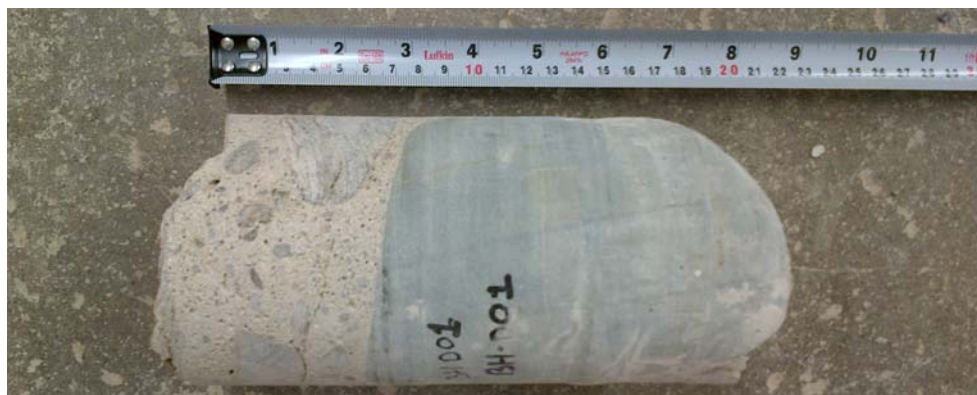
Picture 9: Dam D: Large aggregate at the bottom of the core sample, Corehole CH-D01.

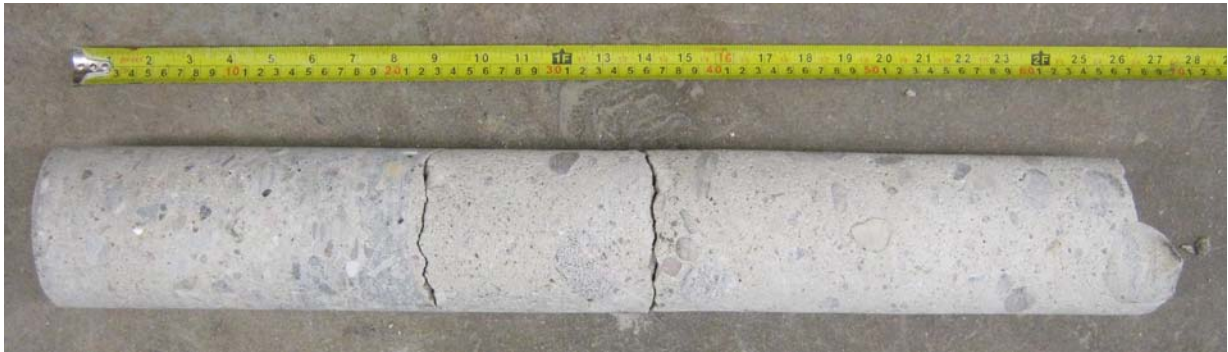
Picture 13: Lock 45: Concrete core from Corehole CH-L45-01. Upper patch/ repair.

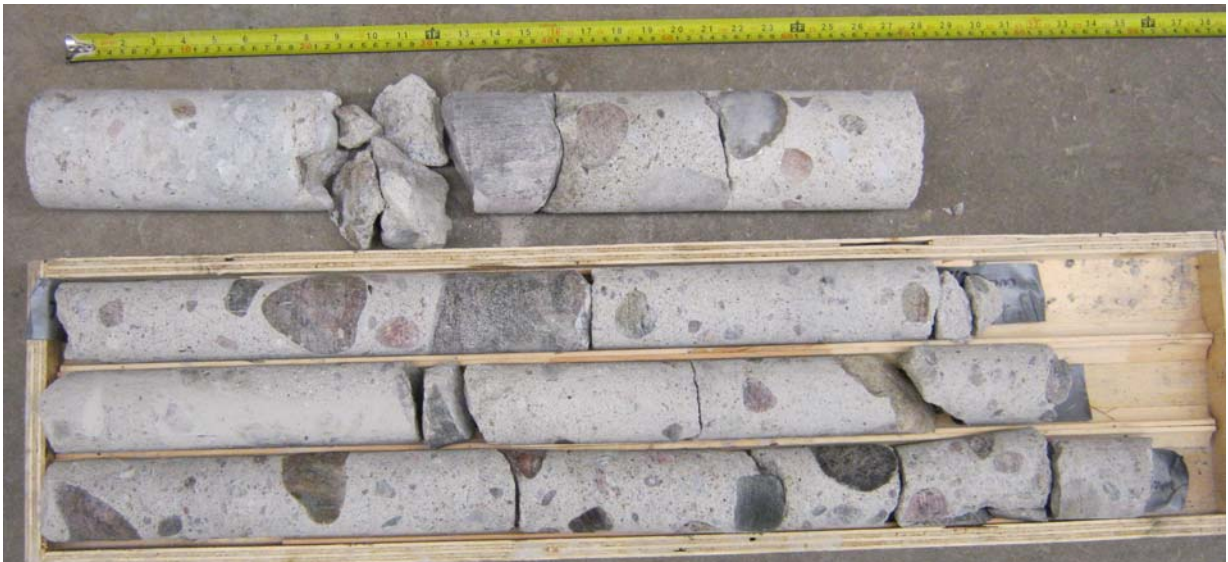
Picture 14: Lock 45: Concrete core from Corehole CH-L45-02. Upper patch/ repair.

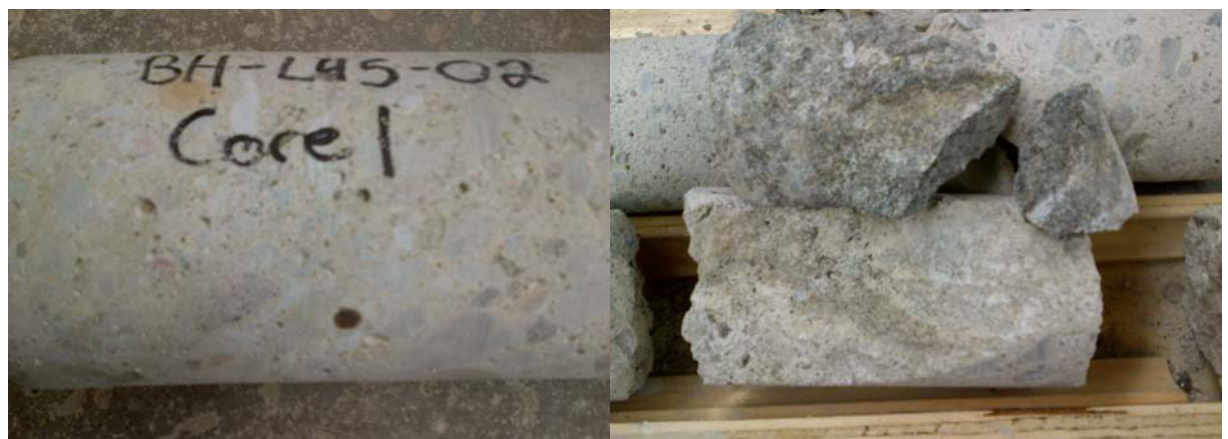
Picture 15: Lock 45: Corehole CH-L45-02, photo on the left showing 6mm diameter steel, photo on the right showing aggregate containing pyrite.
