Project No.: R.051116.002

December 2013

Dam Safety Reviews: Port Severn Dams Main Dam, Lock 45, Upstream Shoreline Wall and Dam D

**Dam Safety Review Report
Final**

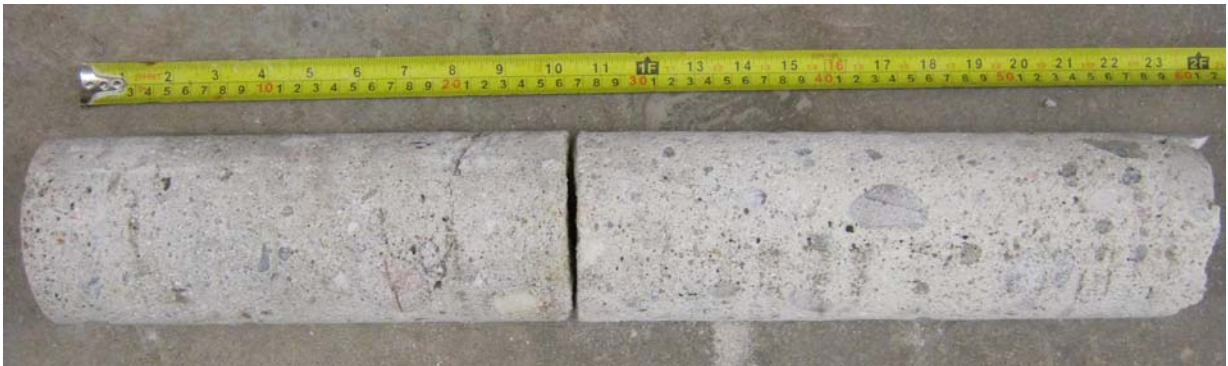
Picture 17: Dam G: Concrete core from Corehole CH-G02. Cold joint shown.

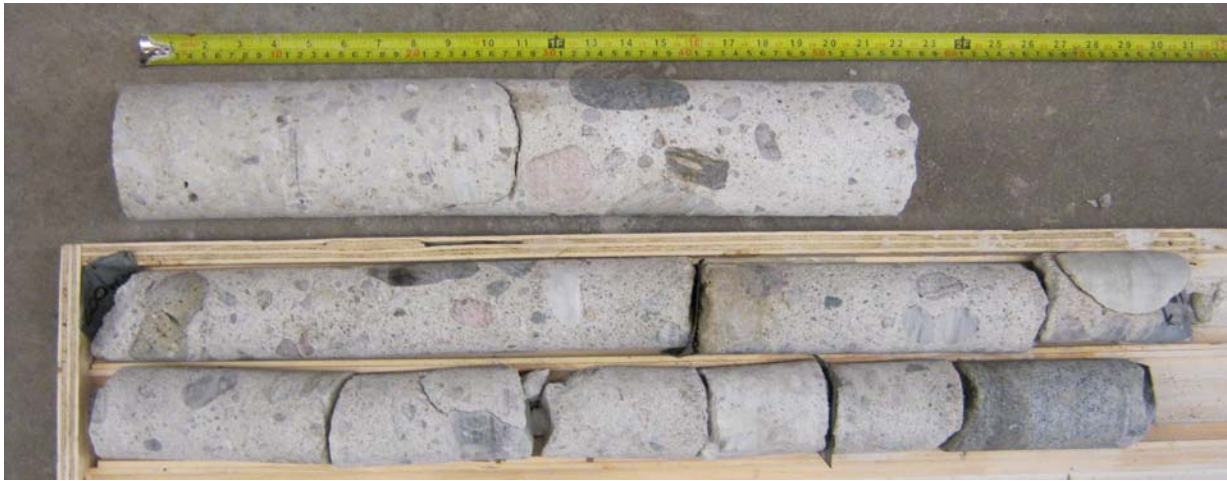
Picture 18: Dam G: Concrete core from Corehole CH-G03. Upper patch/ repair.

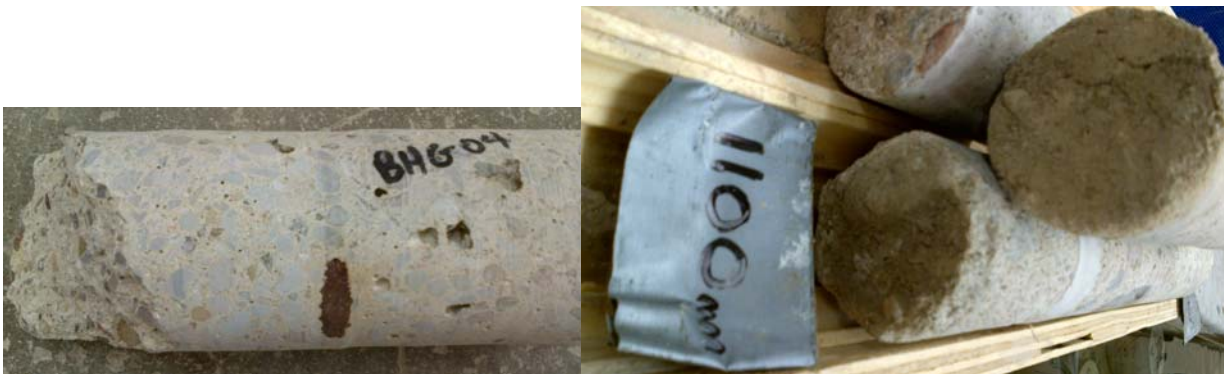
Picture 19: Dam G: Concrete core from Corehole CH-G04. Upper portion patch/ repair.

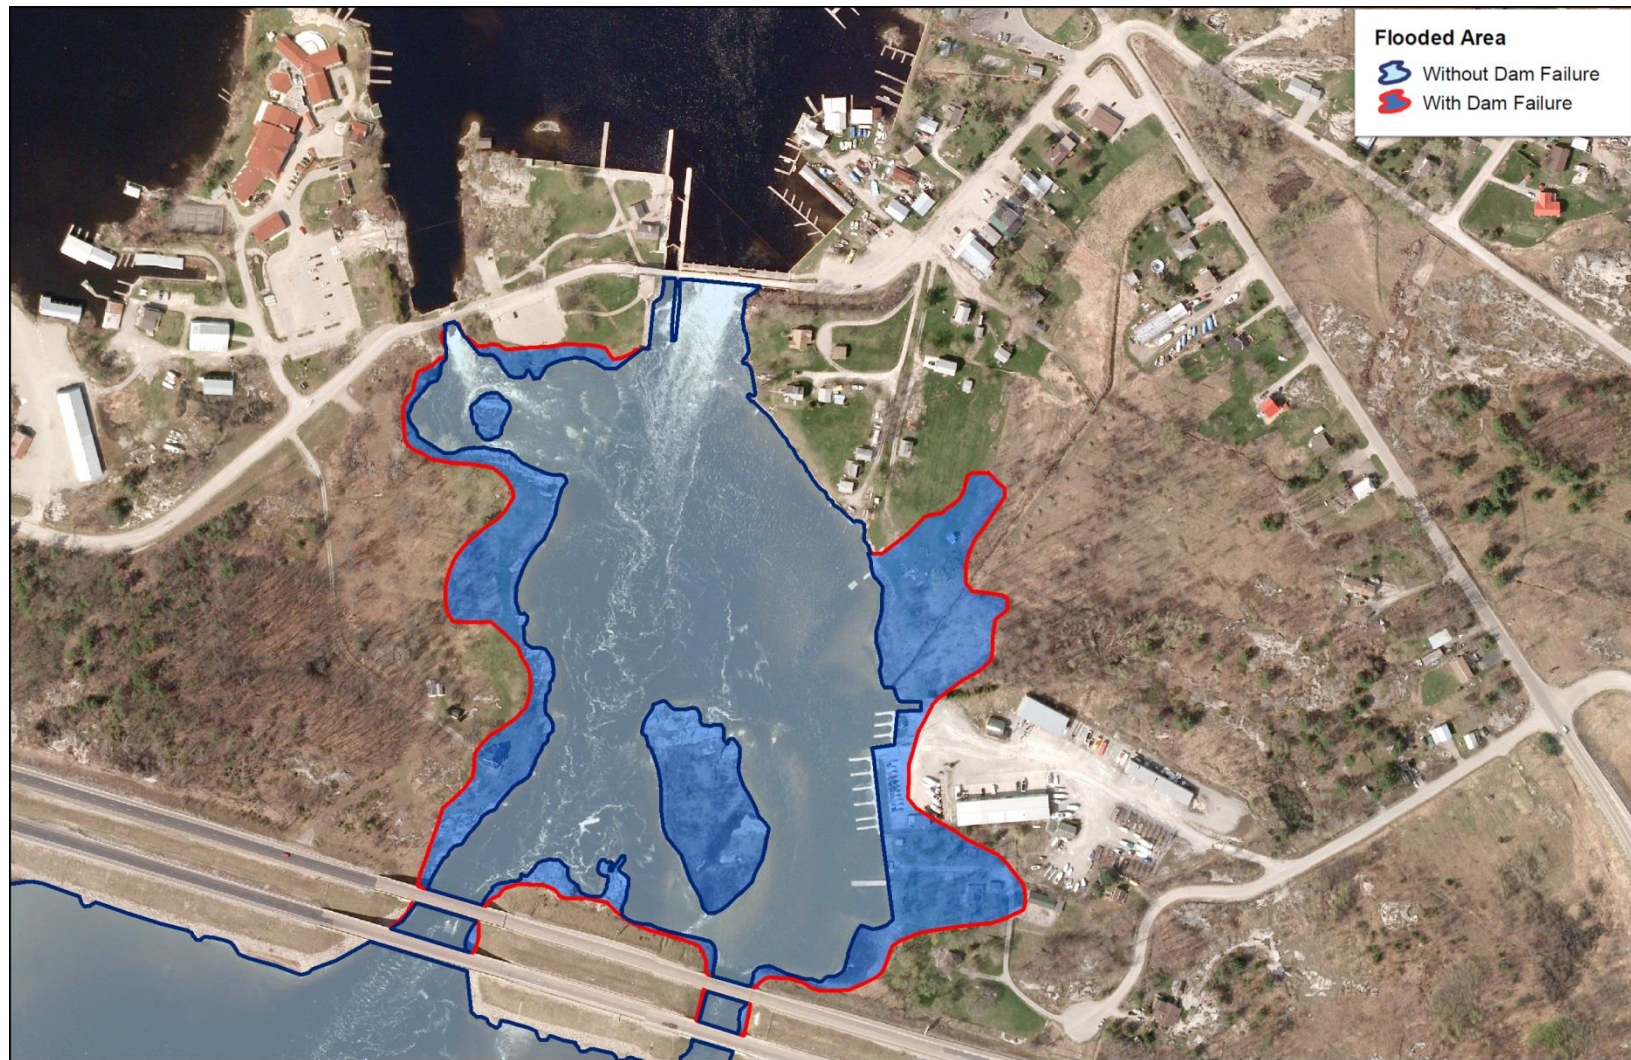
Figure I.1 Main Dam – Inundation mapping – Sunny Day Scenario (With and Without Dam Failure)

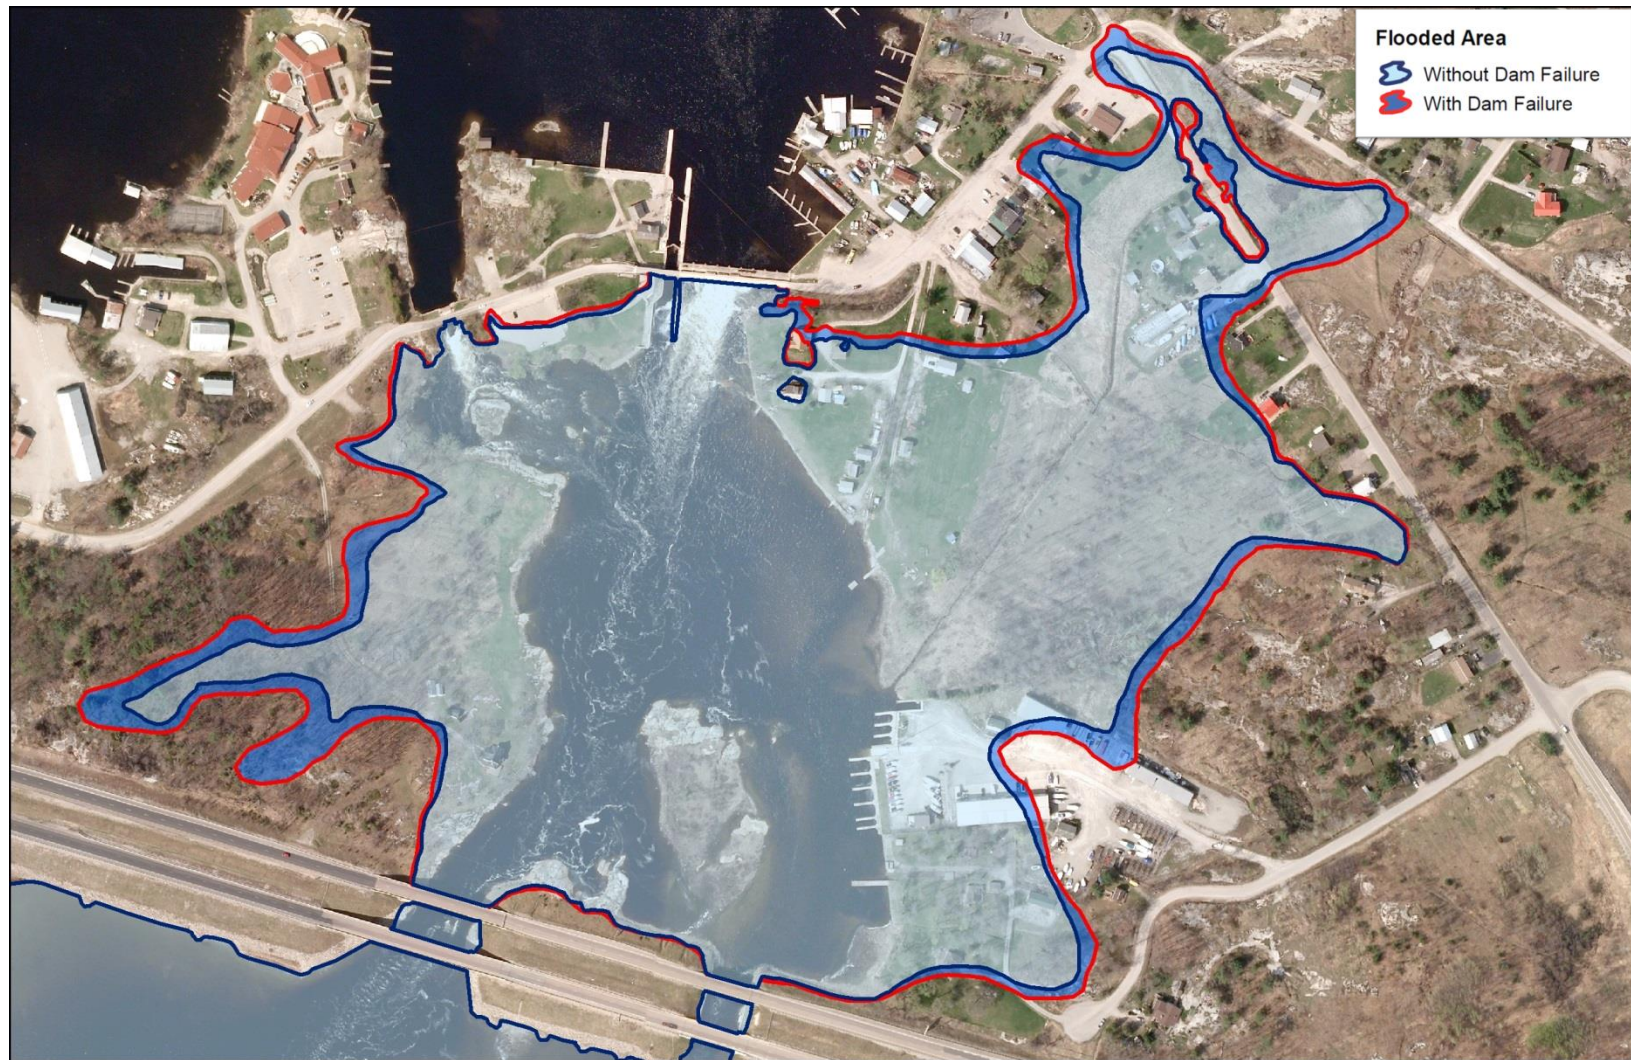
Figure I.5 Main Dam – Inundation mapping – PMF Scenario (With and Without Dam Failure)
