Rehabilitation of Port Severn Area Dams, Fixed Bridge and Lock

Investigation Report

Public Works and Government Services Canada

November 21 2017

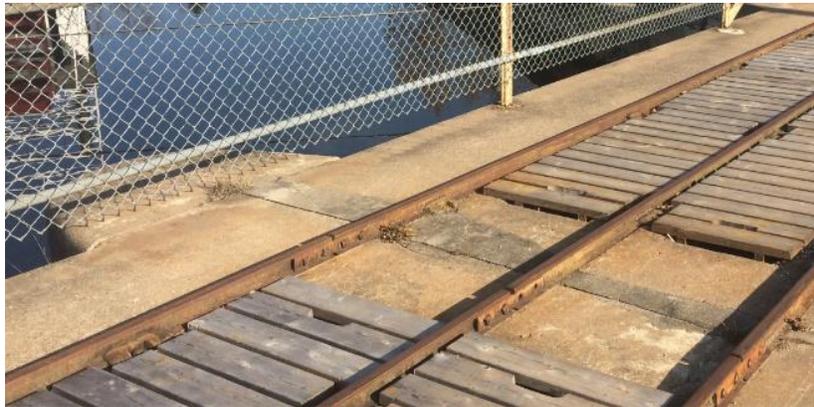
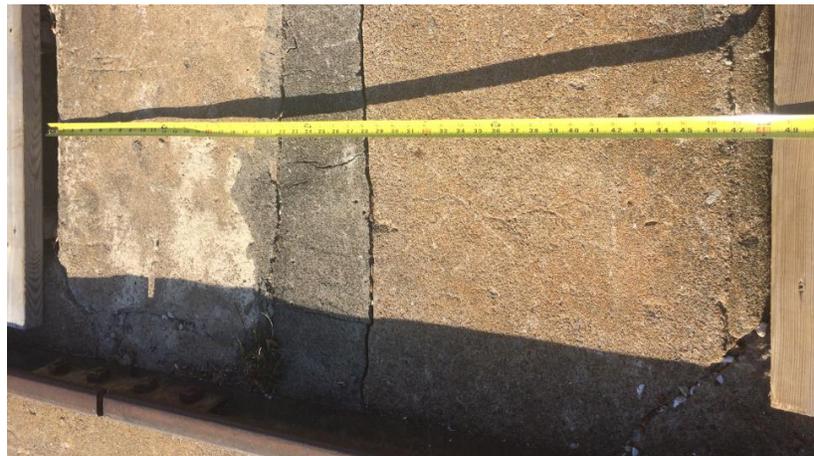
Cracks and previous joint repairs on deck

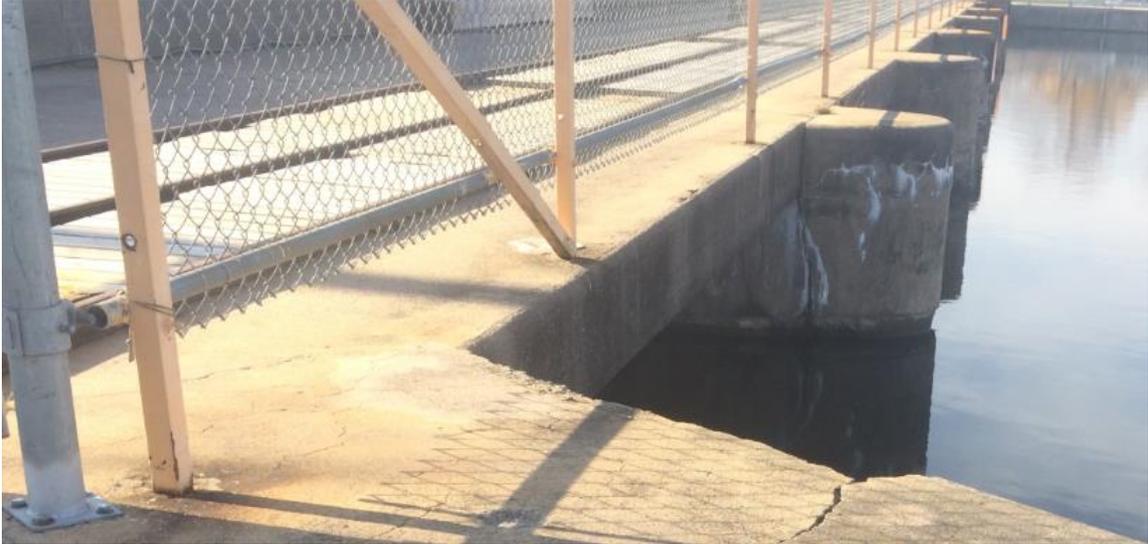
Cracks and efflorescence on upstream side of dam

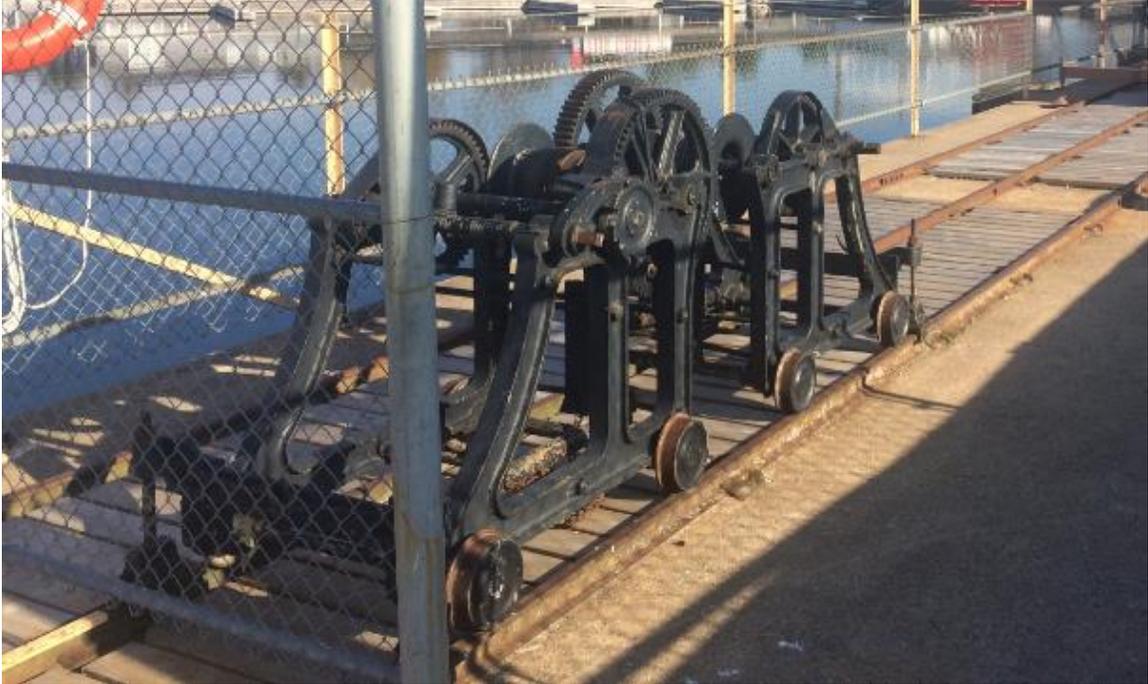
Manual winch to be retained for all concept design options

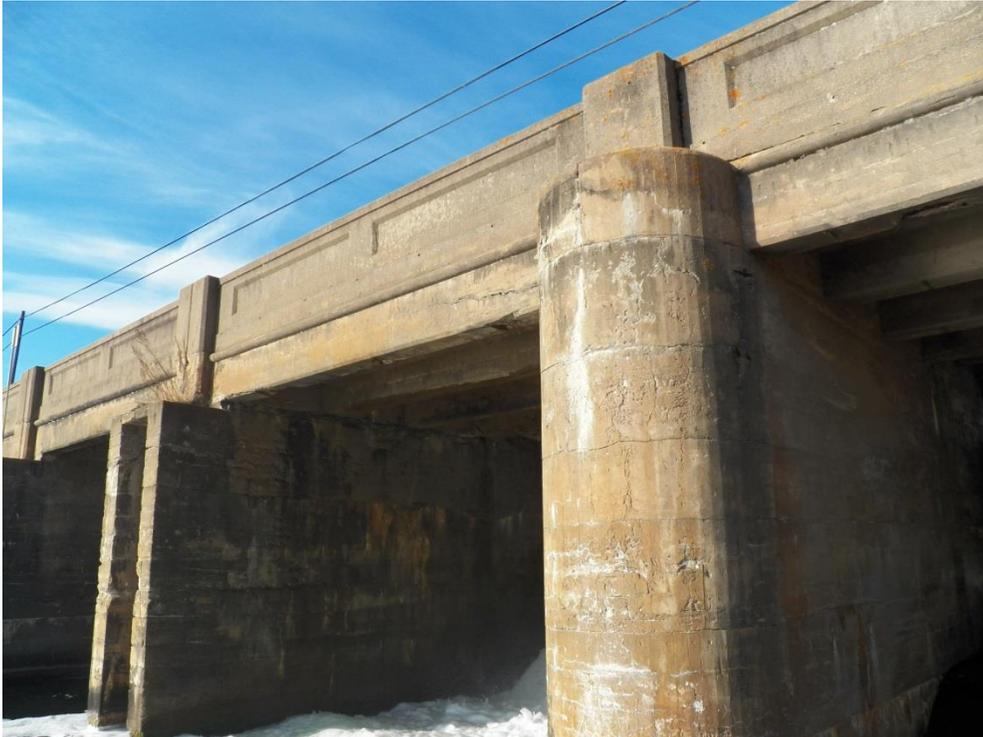
Fixed Bridge on piers

1. Replace the bridge with a new structure as per the Morrison Hershfield Report.
2. Replace the bridge with a new structure with a semi-integral configuration and heritage-style lighting and barriers.

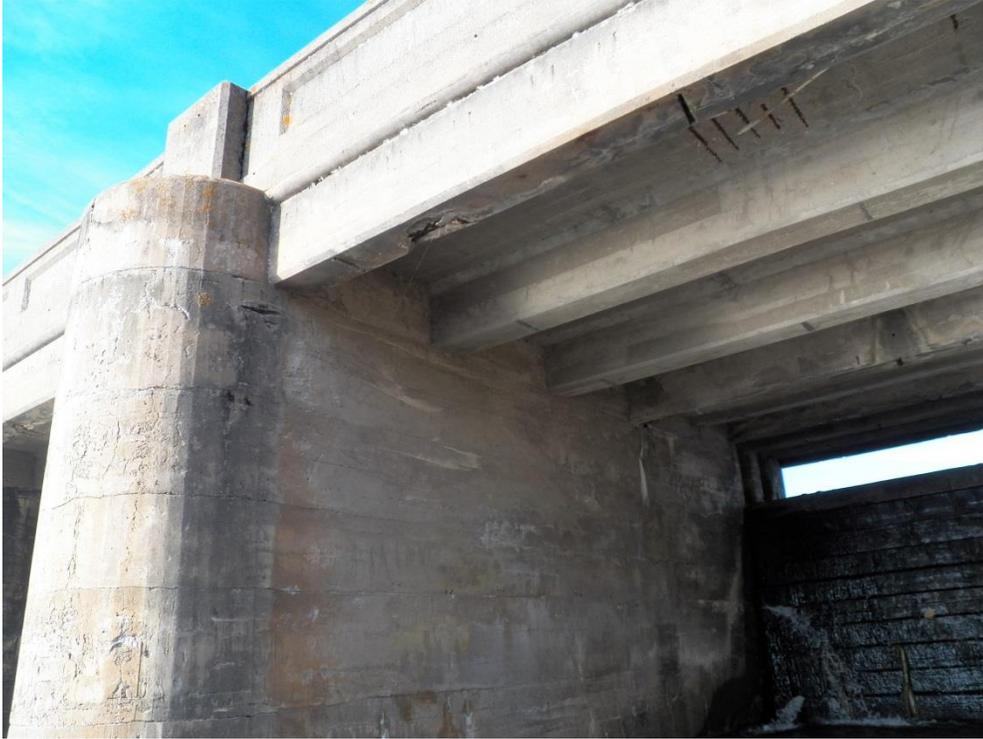
Fixed Bridge on pier bearing

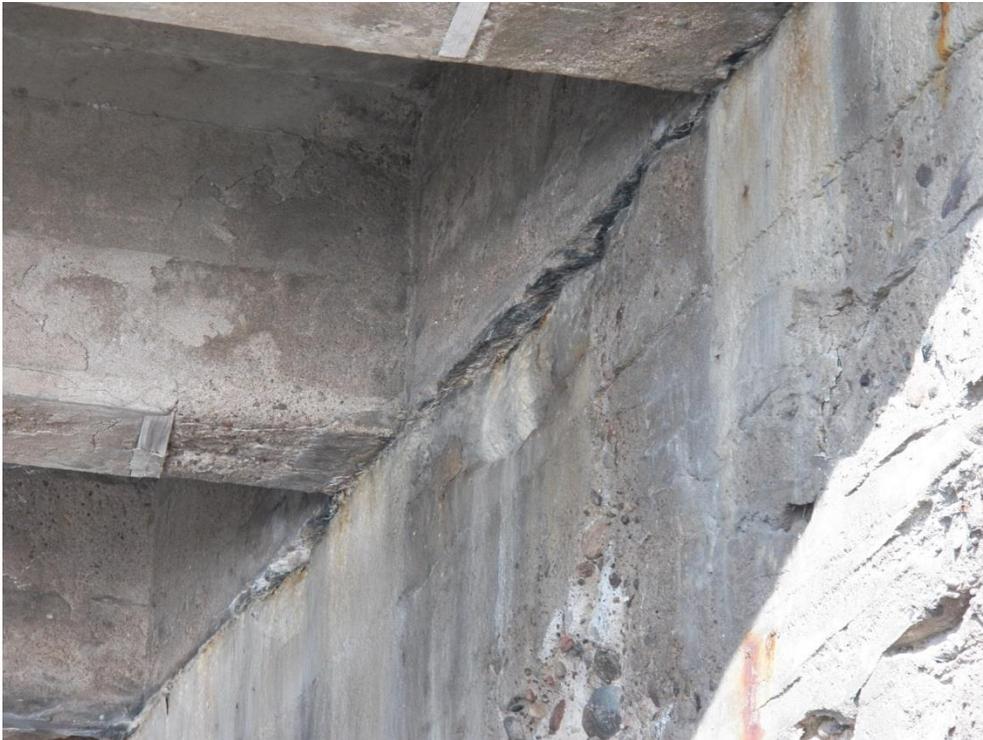
Fixed Bridge on pier bearing

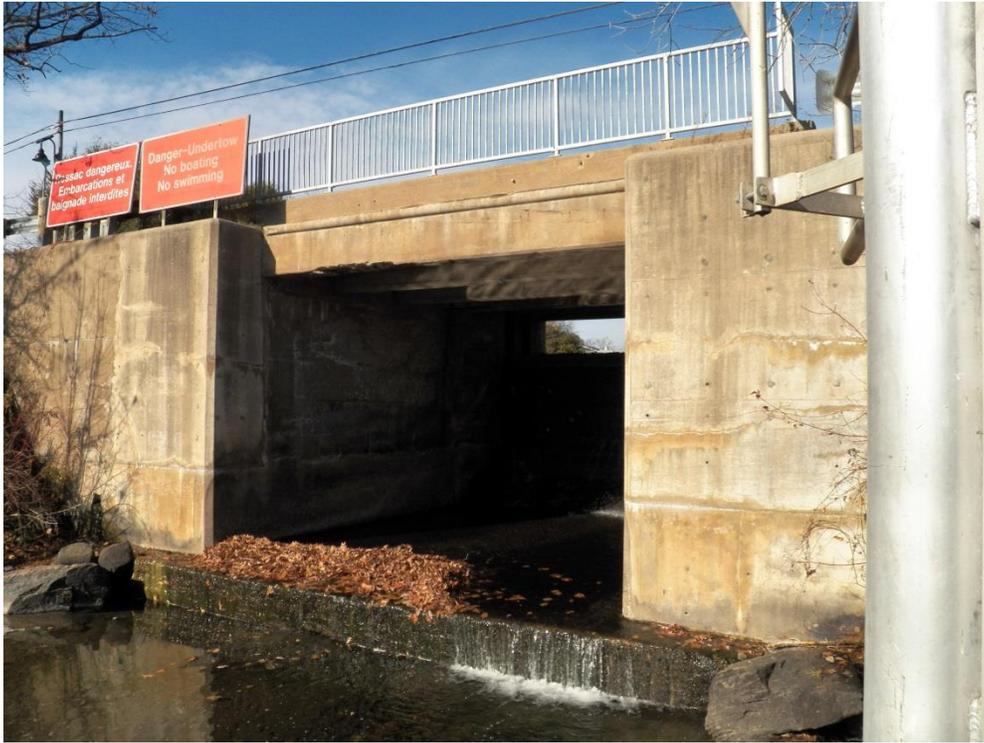
A steady flow of water was observed from one of the subdrains behind the abutment. This suggests that water is leaking under the abutment on this side.

Dam E (outflow)

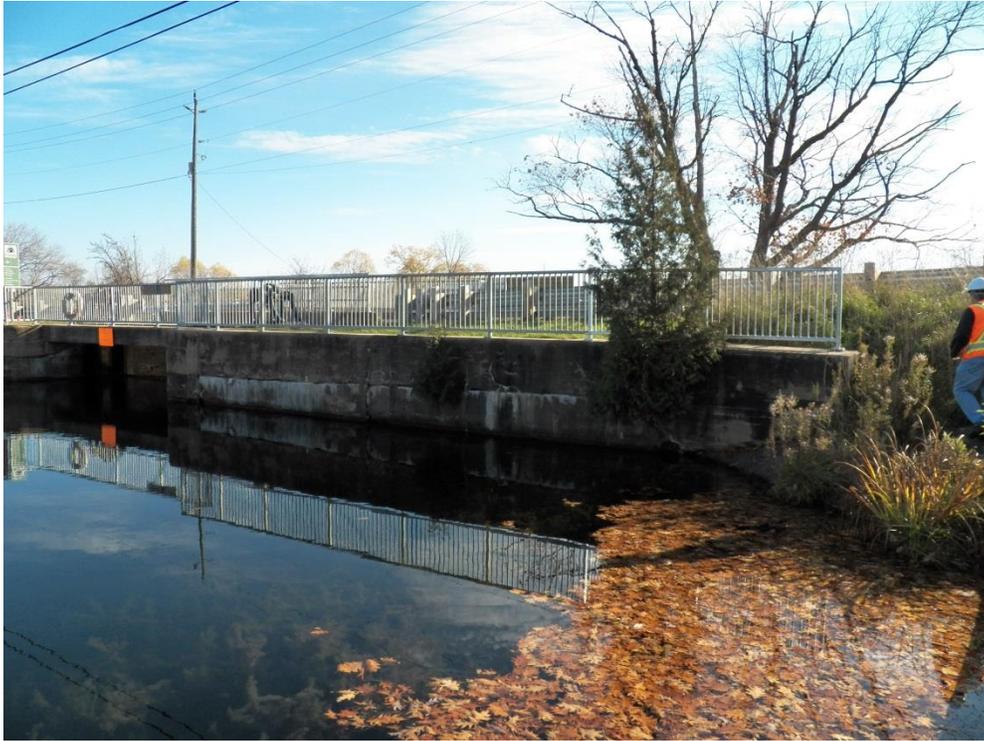
Dam E (inflow)

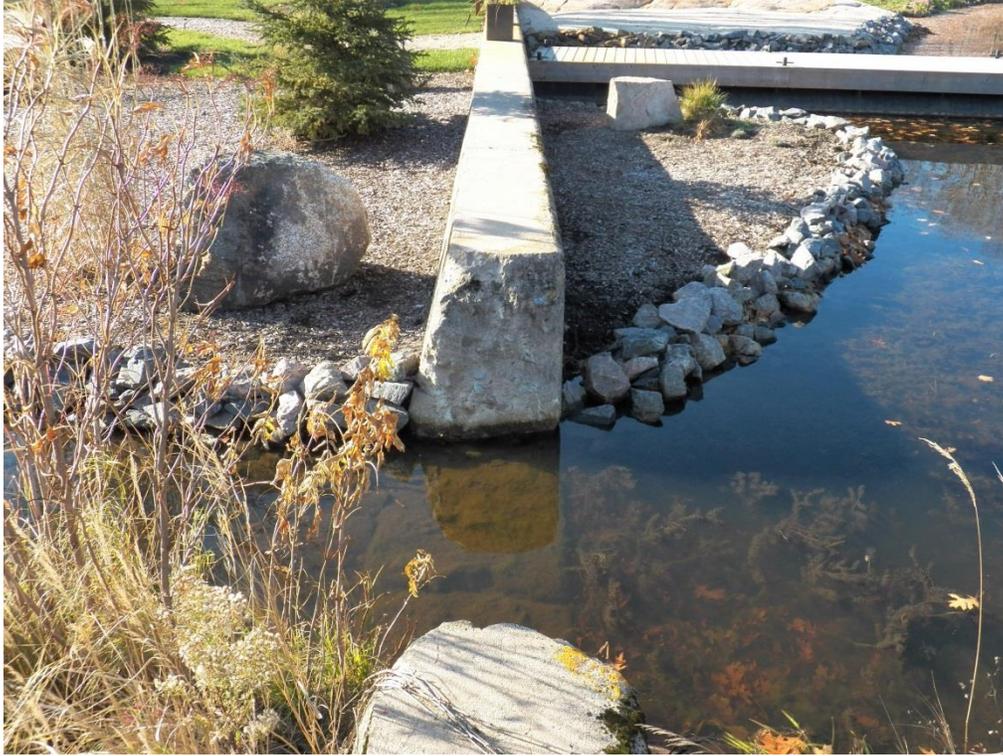
The dam is approximately 43 m long with an average height of approximately 1.4 m. The PA identifies a single manmade breach of 3 m in the dam; however, two manmade breaches were observed. The breaches appear to have been made to drain the wetlands.

Breach at middle of dam (Baguley Road to the left)

The scope of work given in the PA consists of preparing designs to repair the breaches in the dam, block the culvert under Baguley Road, fill the bay behind the dam, and address the drainage behind the dam.

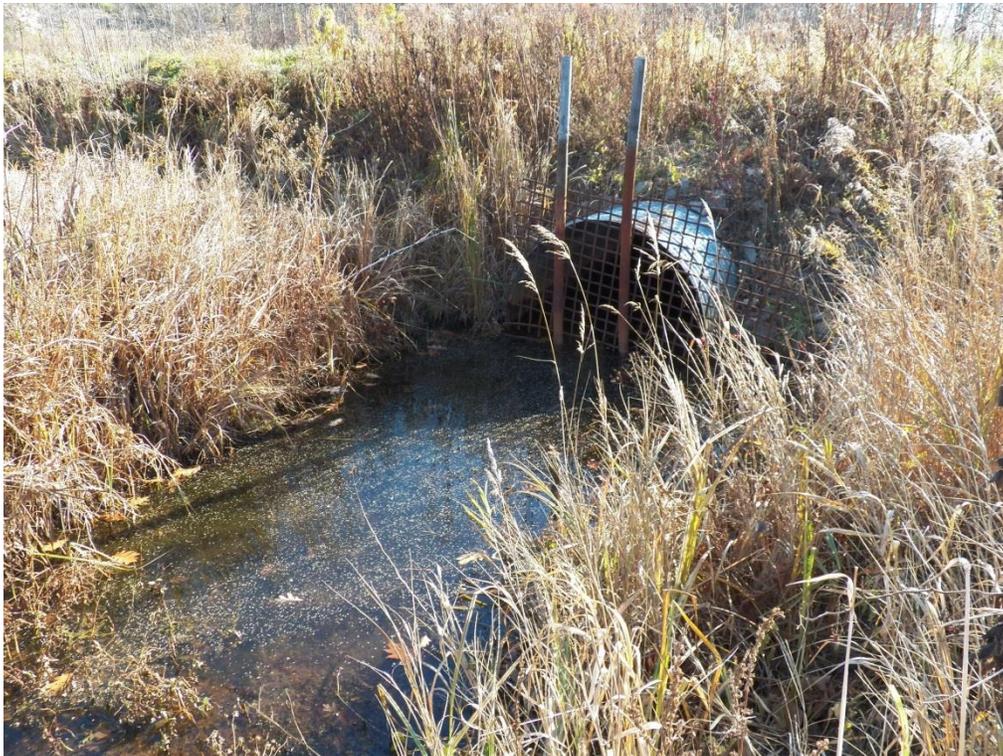
Culvert under Baguley Road (owned by Severn Township)

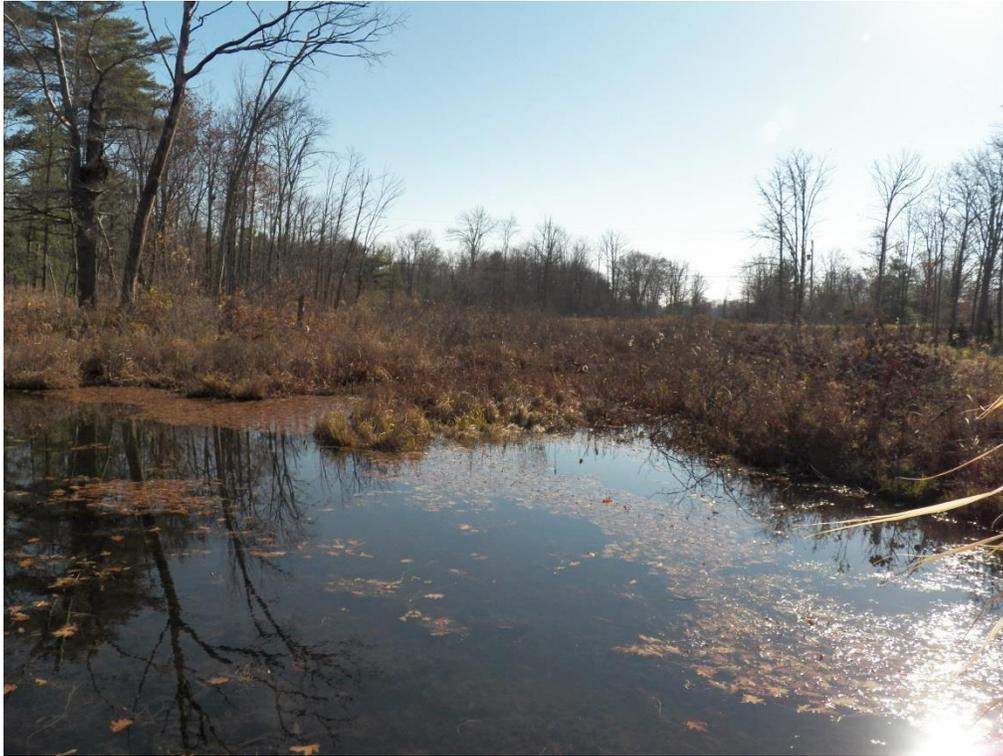
Area under consideration to be filled (facing Baguley Road)

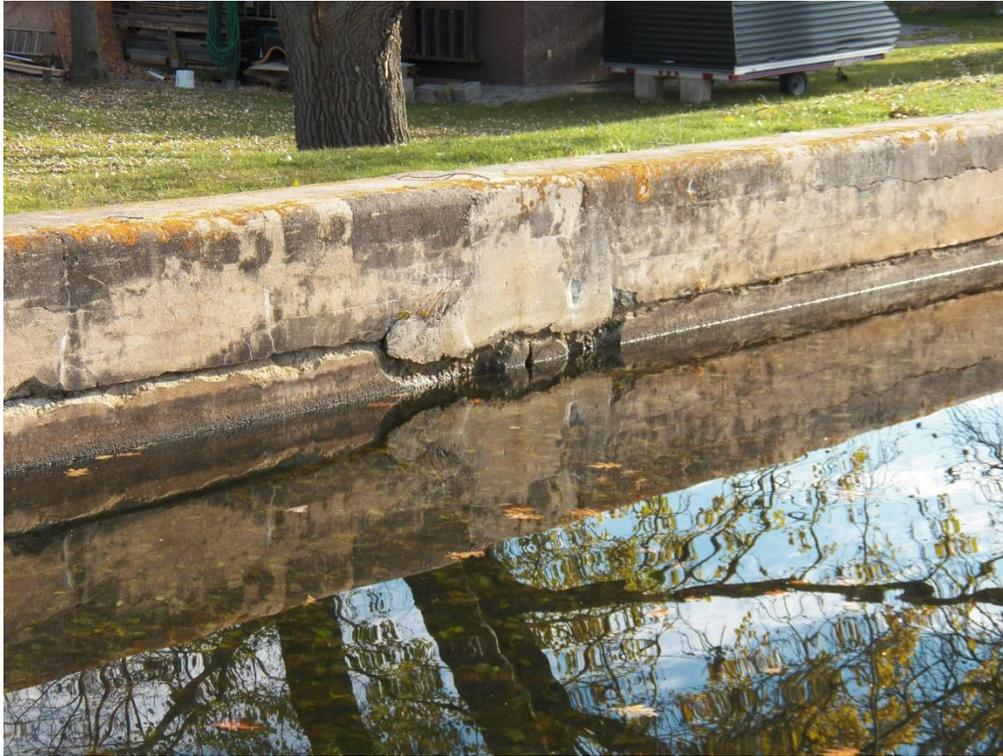
Dam C (gouge in concrete)

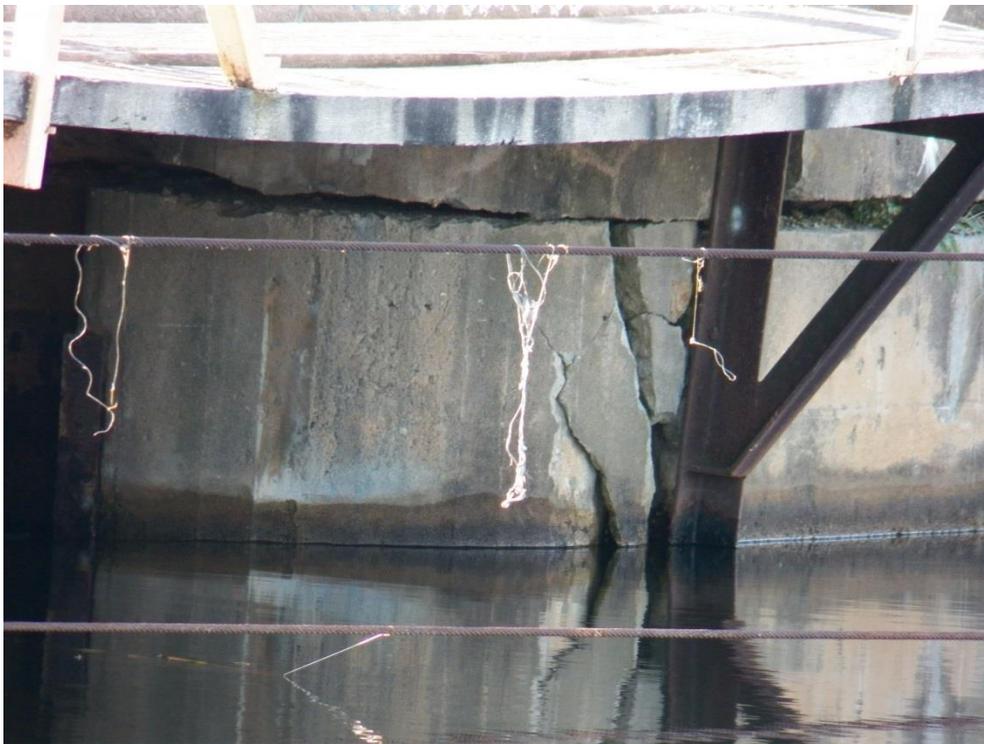
Dam G (concrete walls under service deck extension)

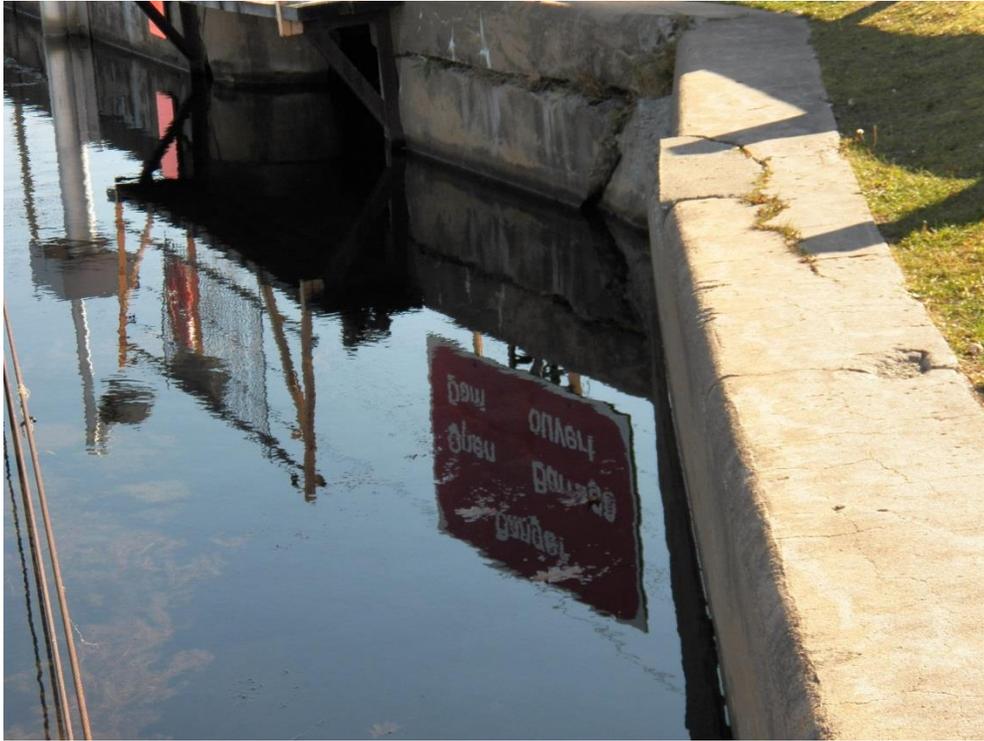
Dam G (concrete walls under service deck extension)

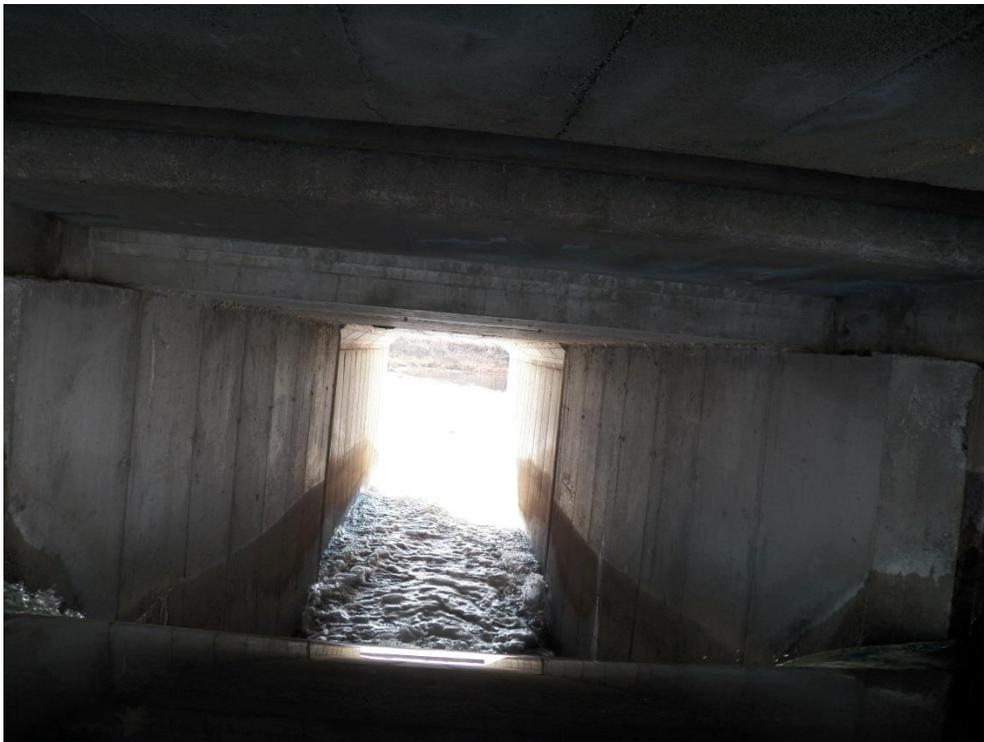
Dam G (flow through the dam)

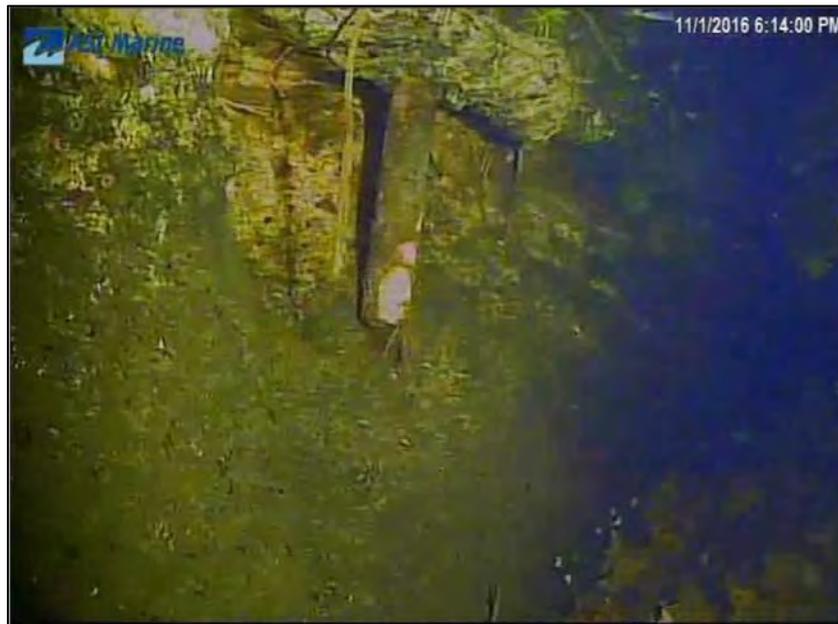
Figure 20: Spalling with exposed rebar

Joints in the dam face located at 10.3 m (Image 3A-02) and 31.5 m (Image 3A-04) were observed to have slight separation as well as minor spalling. The joint at 10.3 m had a separation of 5 cm and undercutting on the north side extending 50 cm from the joint and was 5 cm in depth. The joint observed at 31.5 m had a separation of 5 cm and a depth of 2 cm. A joint in the dam face observed at 25.5 m (Image 3A-03) was observed to exhibit minor spalling near the water surface approximately 5 cm in width and minimal depth, narrowing to no separation at 15 cm below the water surface. At a payout of 56 m there was an apparent piece of re-bar protruding from the dam face with spalling in the concrete surrounding the piece (Figure 20). This spalling was observed to be up to 10 cm deep and up to 20 cm wide.

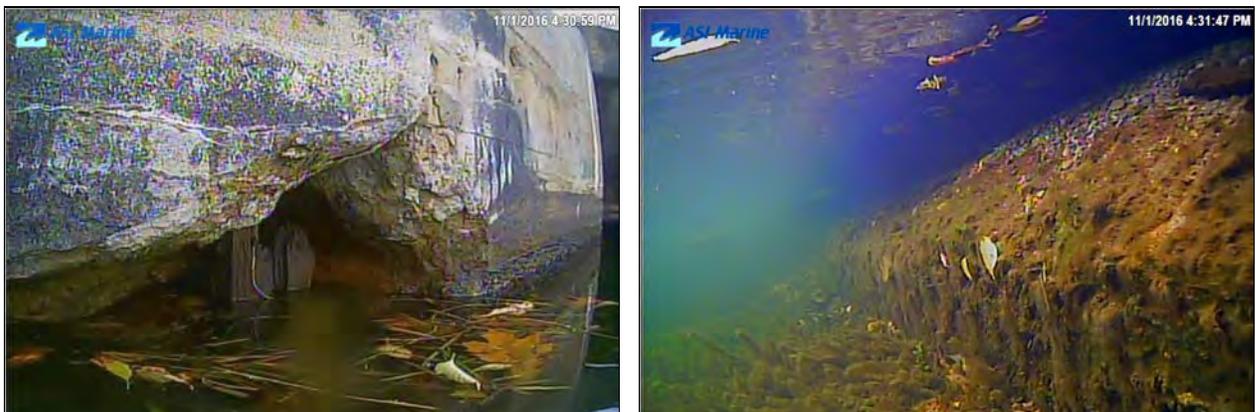
Figure 21: Spalling starting at 0 m and continuing to 10 m. Left image taken at 0 m, right image taken at 4 m facing north.

Significant undercutting was present in three locations. Undercutting observed from 0 m (Figure 21) to 15 m (Image 3B-09) was near the surface with a maximum depth of 30 cm and a height ranging from 15 cm to 30 cm below water surface. This undercutting was significant enough to reveal the wood sub structure at 0 m (Images 3B-01 and 3B-02) and at 8.5 m (Image 3B-06). At 8.5 m there was a possible piece of exposed PVC pipe protruding through the concrete into the water. There was undercutting observed from 29 m to 30.7 m approximately 10 cm in depth at the deepest point and varied from 5 cm to 10 cm in height from the bottom. There was slight undercutting observed from 46 m to 47.5 m which was 5 cm in height and 5 cm in depth.

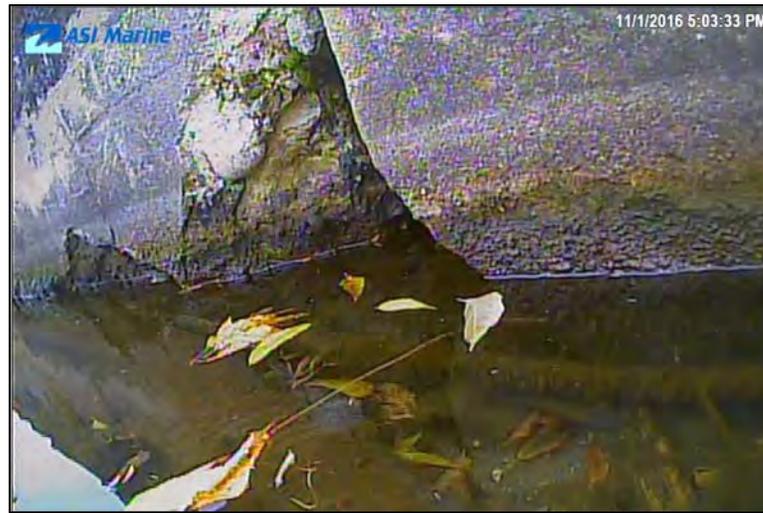
Figure 22: Spalling in dam face observed at 34.5 m

Spalling was found in three locations. At 25.8 m (Image 3B-12) the spalling appears to be centred on a joint but is covered by significant biofouling. At 24.3 m (Image 3B-15) the spalling is mostly above the waterline and seems to be concentrated on the northern side of a joint. From 34.5 m (Figure 22) the spalling was significant enough to have created a cavity in the concrete approximately 80 cm wide and 15 cm deep.

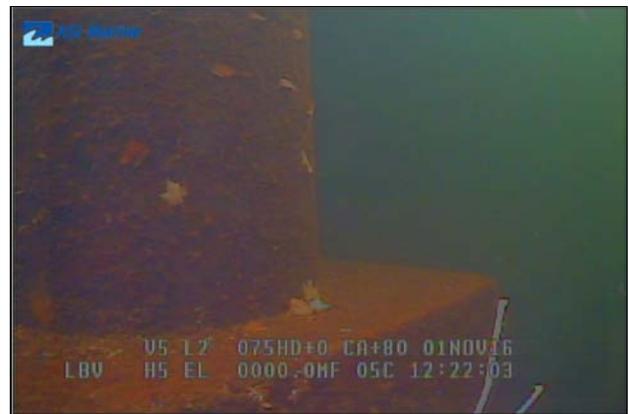
Figure 27: Protruding concrete footing beneath Pier 6

Scouring was identified on Pier 5 near the water surface between the stop log slots in the 2015 inspection. Pier 6 had significant spalling observed on both the east (Images 3C-01 and 3C-03) and west (Image 3C-02) sides. The spalling continued around the upstream face of the pier and varied in height from 5 cm to 20 cm. The depth of the spalling was typically observed to be 5 cm to 10 cm. The Pier 6 bullnose was observed to be situated on a square footing 3.1 m below the water surface. This squared concrete footing protruded past the face of the pier 0.25 m to the north, east, and west (Figure 27).

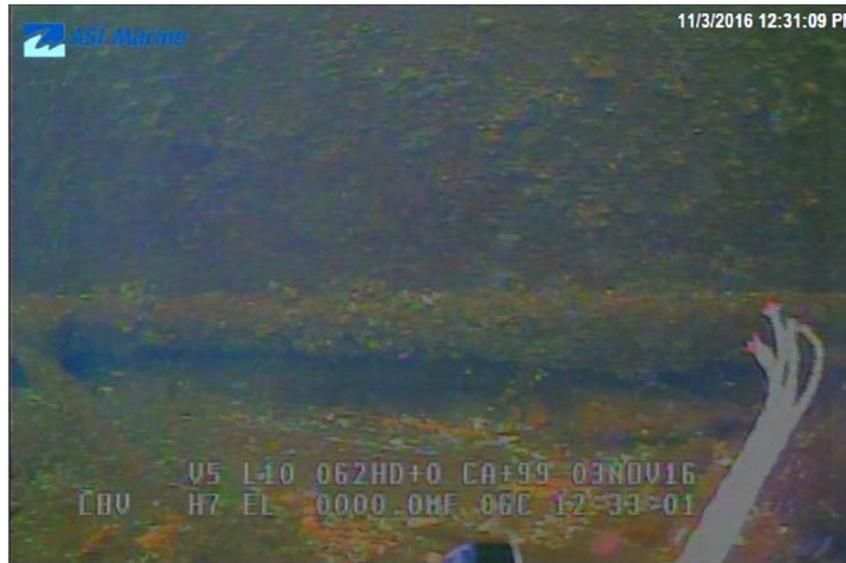
Figure 28: Slight undercutting observed beneath Pier 2 footing

Image 3D-01 shows the condition of the downstream slab of Gate 5. Image 3D-02 shows erosion on the ledge below Gate 4 and Gate 5. Figure 28 shows undercutting below the concrete footing under Gate 1 and Pier 2. The undercutting was observed to be 10 cm in height and depth and was 0.7 m in length.

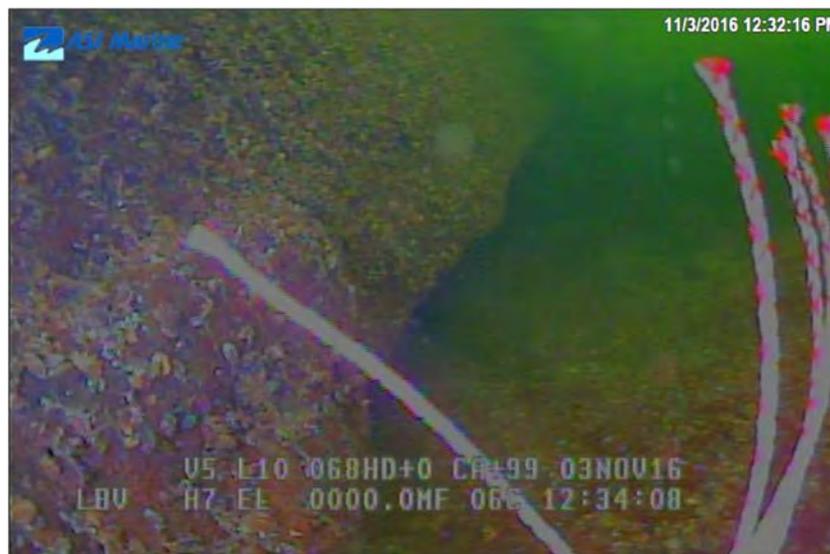
Figure 29: Undercutting observed beneath Gate 2 footing

Figure 29 shows undercutting on the downstream section of Gate 2 below the concrete footing. The undercutting was noted to be significant, spanning the length of Gate 2 with a height of 30 cm to 40 cm. The depth of the undercutting was unknown, but a minimum viewable area indicated a minimum depth of 30 cm.

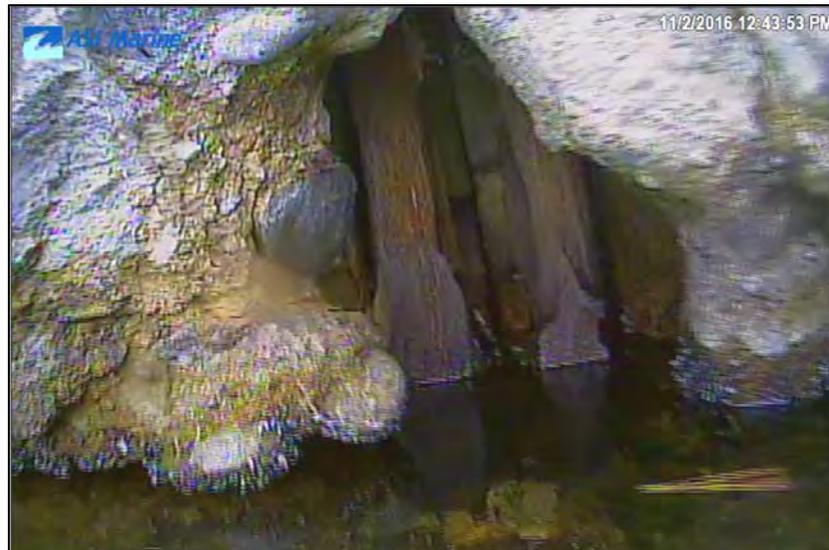
Figure 30: Spalling associated with vertical crack on face of dam

A vertical crack was visible at 5.5 m (Image 3E-01) from above water and had inline spalling on the dam wall. At 21.5 m (Figure 30) there was severe cracking that ran vertically from the top of the dam and down the face. Above the water line the crack had widened to reveal two vertical timbers. The crack continued below the water line (Image 3E-11) to the bottom of the dam face.

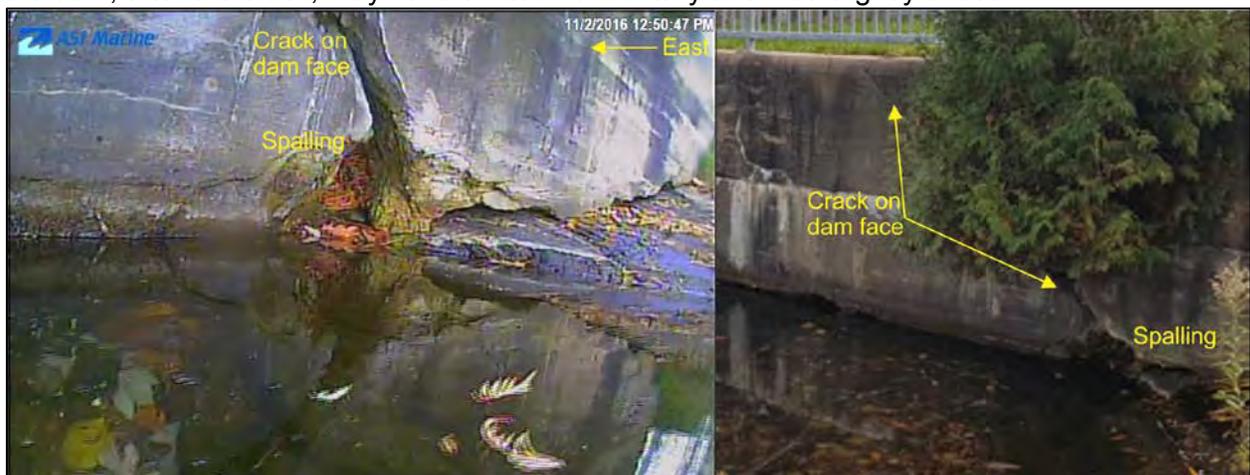
Figure 31: Diagonal crack on dam face with spalling at water surface

Severe cracking was present at the west end of the dam wall at 27.5 m (Figure 31), where it appeared that the crack runs through the entire dam wall. It appeared that the west section of the dam, after the crack, may have shifted horizontally and was slightly offset.

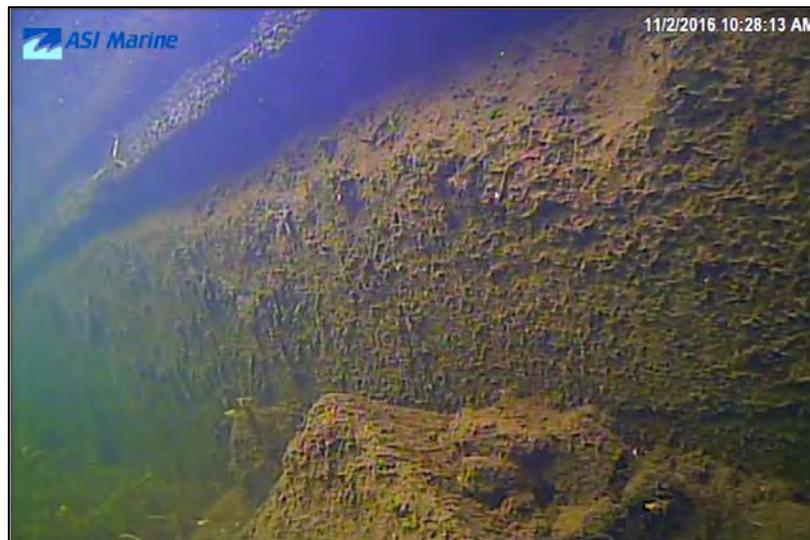
Figure 33: Undercutting on dam face observed from 81 m to 89.2 m

There was a section of undercutting at 60.2 m (Image 3F-12). A large section of undercutting began at a crack observed at 81 m (Figure 33) and continued to 89.2 m (Image 3F-20). The undercutting was observed to vary from 10 cm to 30 cm in height below the water surface and 5 cm to 10 cm in depth. The final section of undercutting begins at 106.3 m (Image 3F-26) and continues for 1.1 m to 107.4 m with a height of 20 cm and a depth under 10 cm (Image 3F-28).

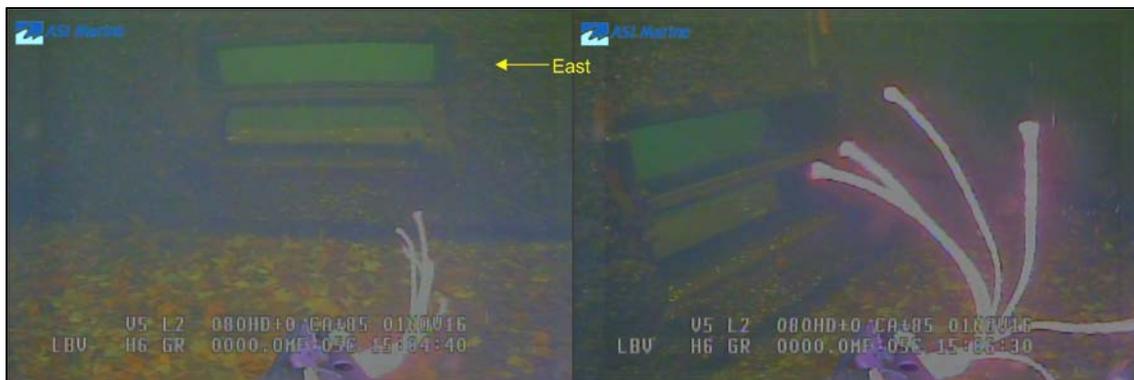
Several purpose-built features were documented. Images 3G-02 and 3G-03 show the first and second stop log slots on the east side of Lock 45 Upstream. The gate slots were observed to be in the open position (Figure 35). Images 3G-06 and 3G-07 show the southwest and northwest stop log slots.

Figure 35: Open gate slots of upper Lock 45

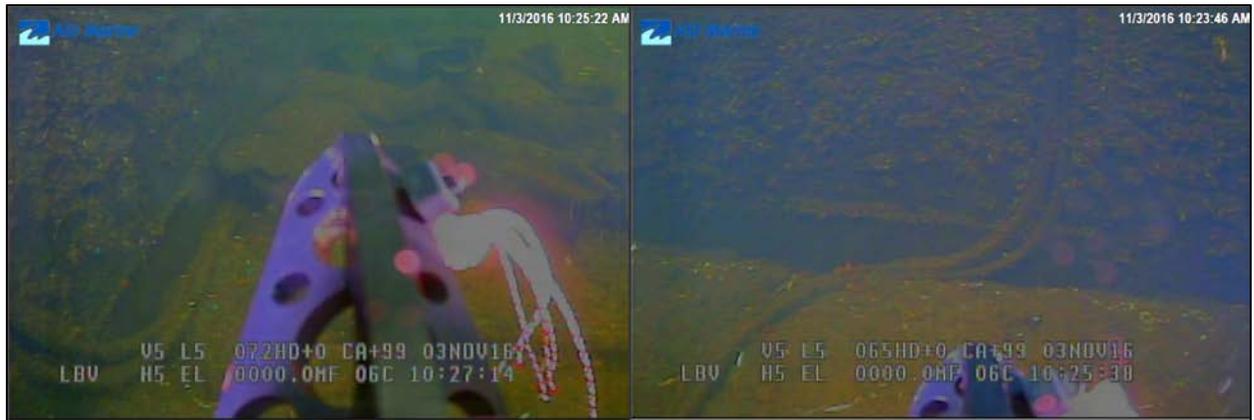
The northern gate slots can be seen in Image 3I-01 (east) and Image 3I-10 (west). The gate slots were in the closed position and showed no signs of apparent scouring or leakage. Two conduits were observed running along the bottom from cut out slots in the east and west walls (Images 3I-02, 3I-03, 3I-11 and 3I-12). The conduit was observed to turn to the south at the bottom of the water way for 1 m before crossing from east to west (Figure 36 and Figure 37).

Figure 36: Image of conduit on east (left) and west (right) intersection of lock wall and bottom

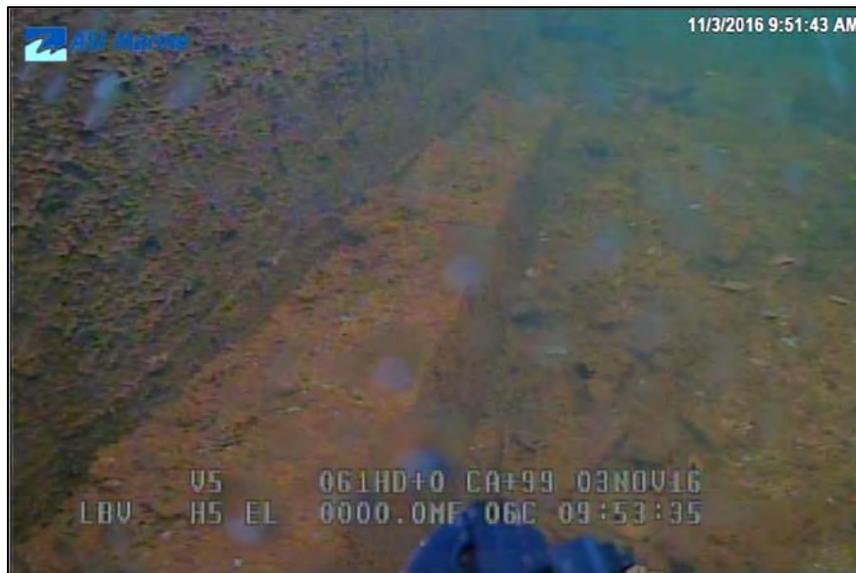
Image 3I-13 shows a horizontal form line with approximately a 10 cm lip. Figure 38 shows a step at the lock bottom of the concrete footing 10 cm in height and 10 cm in width.

Figure 38: Step in concrete at bottom of southwest wall of Lock 45 lower

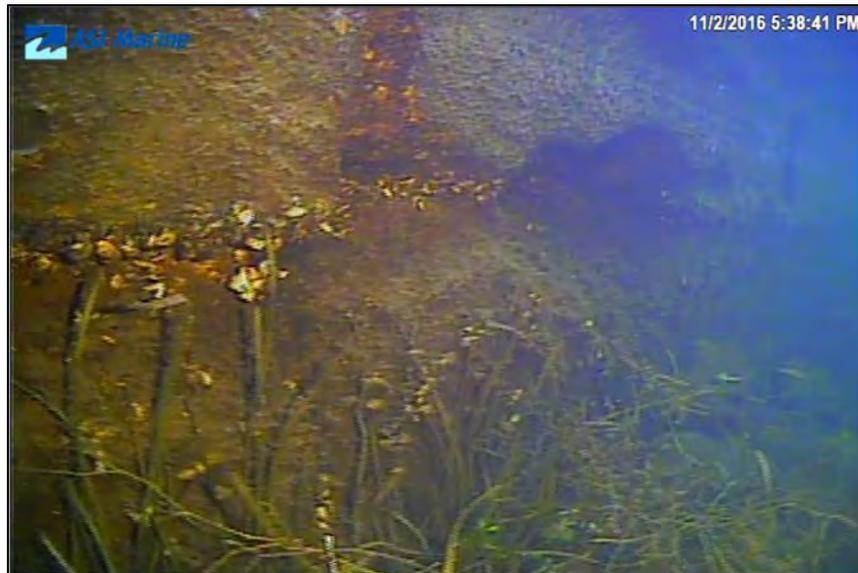
The joint at 13.95 m (Image 3J-03) showed signs of separation and spalling which was 5 cm in width and 5 cm in depth. The joint at 57.7 m (Image 3J-14) was observed to have spalling to a depth of 15 cm, revealing the timber substructure. The width of the separation of the spalling at the joint was 10 cm to 15 cm and had signs of spalling on either side of it (Figure 39).

Figure 39: Spalling in line with a vertical joint at 57.5 m

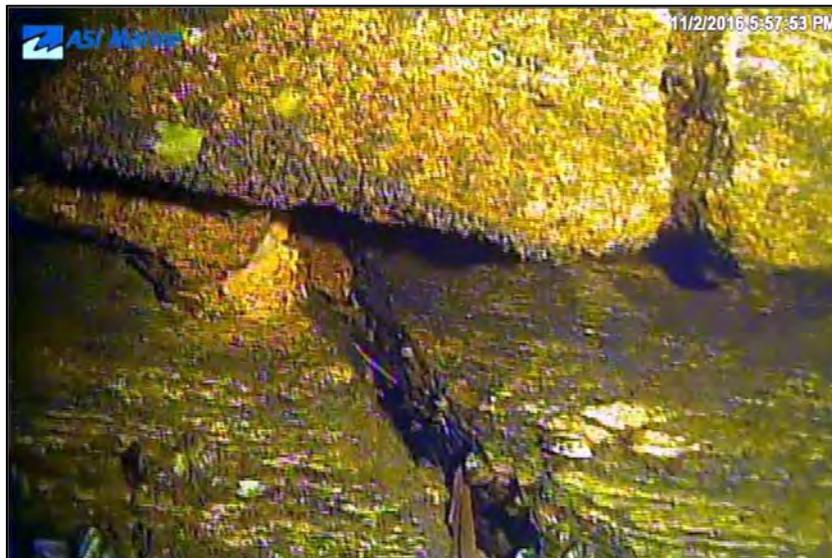
A horizontal crack was observed at 54 m and was approximately 4 m in length with a depth under 5 cm (Image 3J-12). A vertical crack was observed at 50.1 m with slight spalling to a width of 5 cm and depth of 5 cm (Image 3J-11). A vertical crack was also overserved at 67.7 m and had spalling up to 10 cm in width and 5 cm in depth (Image 3J-17). A vertical crack mostly observed above water surface was seen at 79.9 m and had minimal separation and depth (Images 3J-21 and 3J-22). Cracking was observed at 96.7 m (Figure 41) where the wall transitioned to bedrock and was 2 cm to 3 cm in width and 5 cm in depth. This area also showed signs of undercutting at the transition.

Figure 41: Transition from dam wall to bedrock with undercutting and cracking present

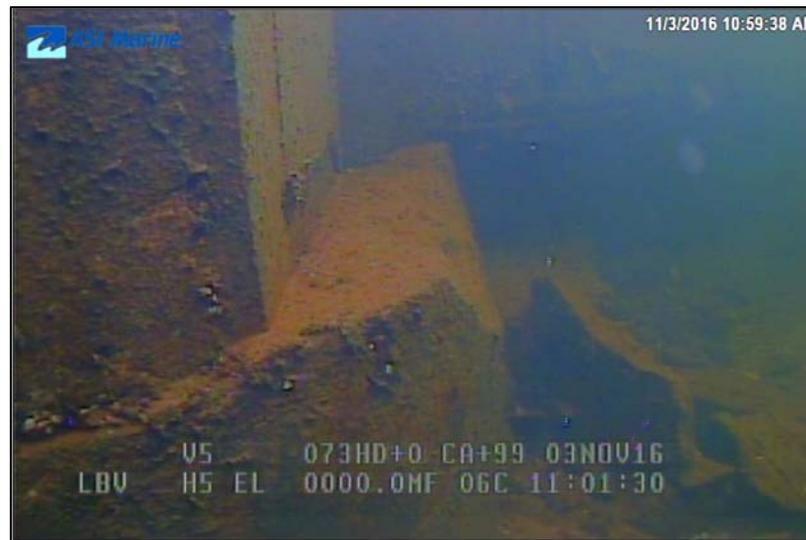
Figure 43: Transition from concrete (north) to timber (south) support structure situated on taper on west side

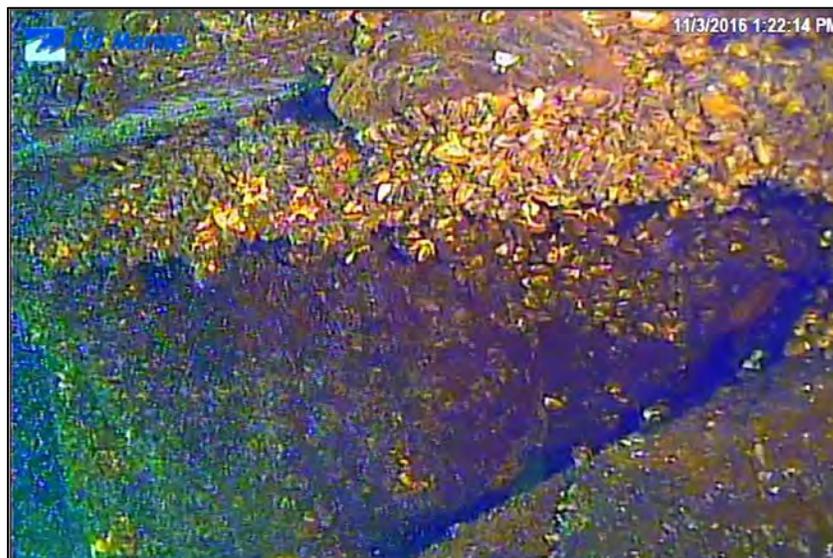
The only observed undercutting was found where the Lower Approach Wall meets Pier 1 of the downstream side of the Main Dam and continued for approximately 1 m downstream. The undercutting had a height ranging from 5 cm to 30 cm and the typical depth was 5 cm to 10 cm. Image 3L-11 shows the northernmost section of undercutting, Image 3L-13 shows where the undercutting continued south and Image 3L-12 shows the end of the undercutting.

Figure 44: Section of undercutting observed at bottom downstream of Pier 1

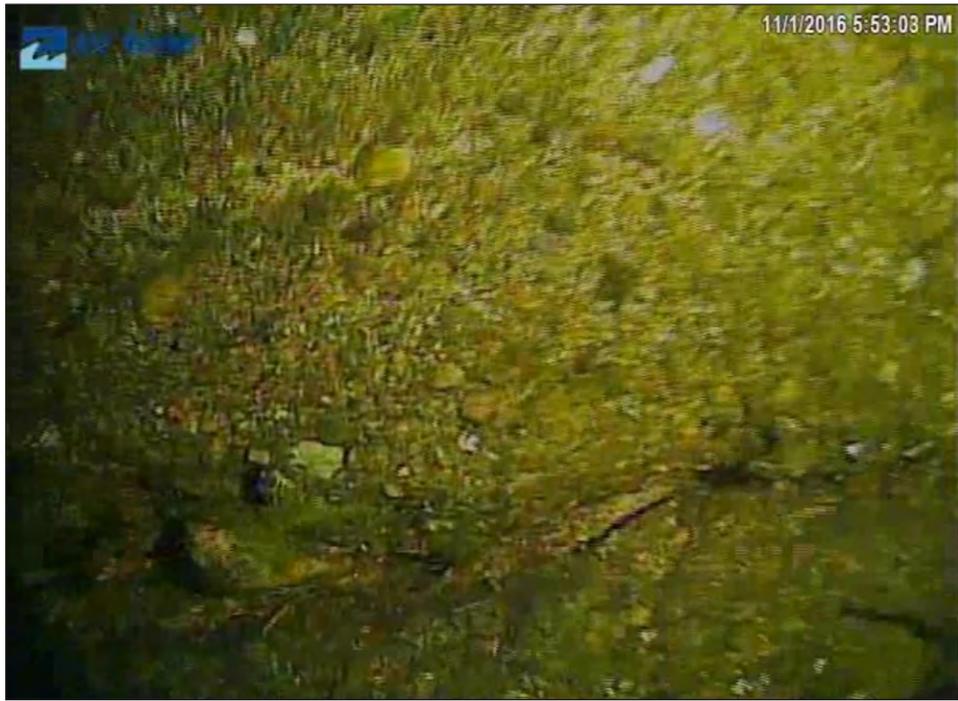
Image 3A-1: 07 m - Minor horizontal crack observed on dam face

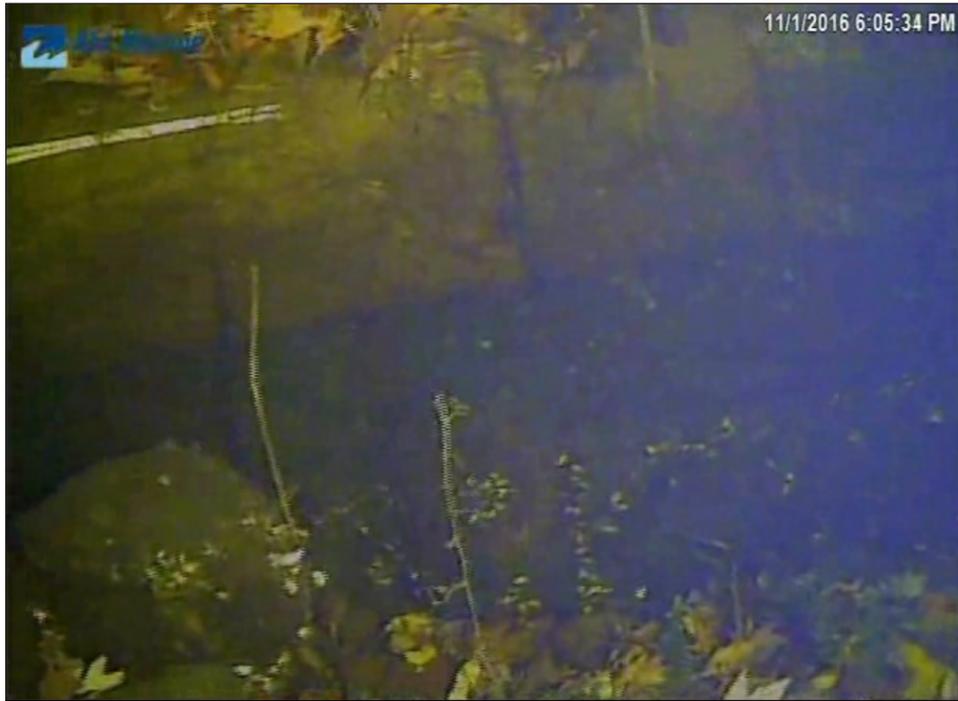
Image 3A-3: 25.5 m - Joint with minor erosion

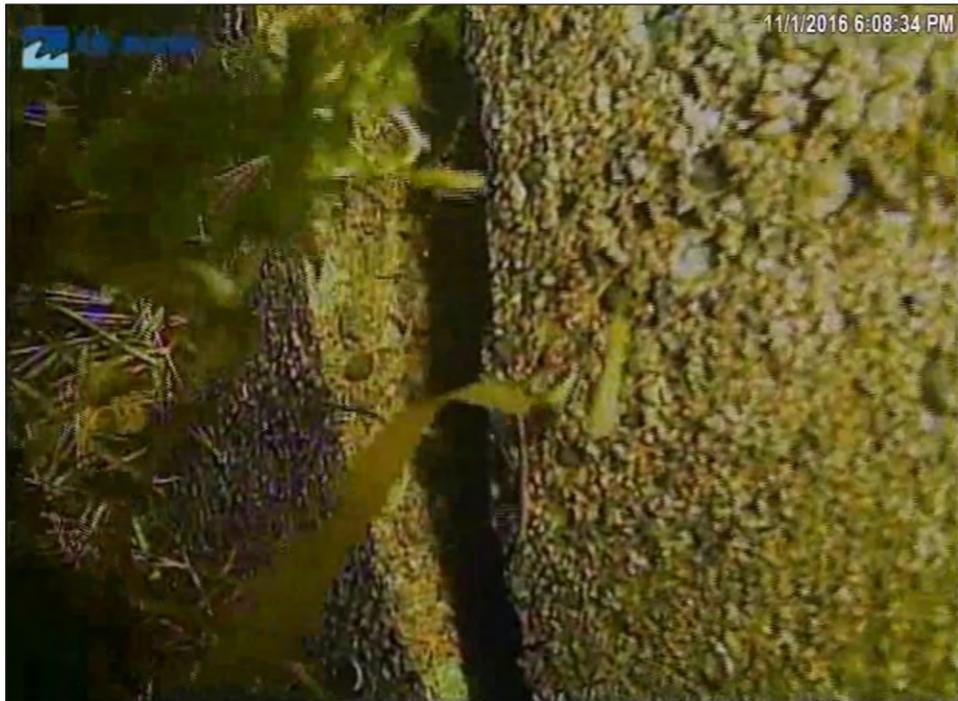
Image 3A-4: 31.5 m - Joint with slight separation
