Rehabilitation of Port Severn Area Dams, Fixed Bridge and Lock

Investigation Report

Public Works and Government Services Canada

November 21 2017

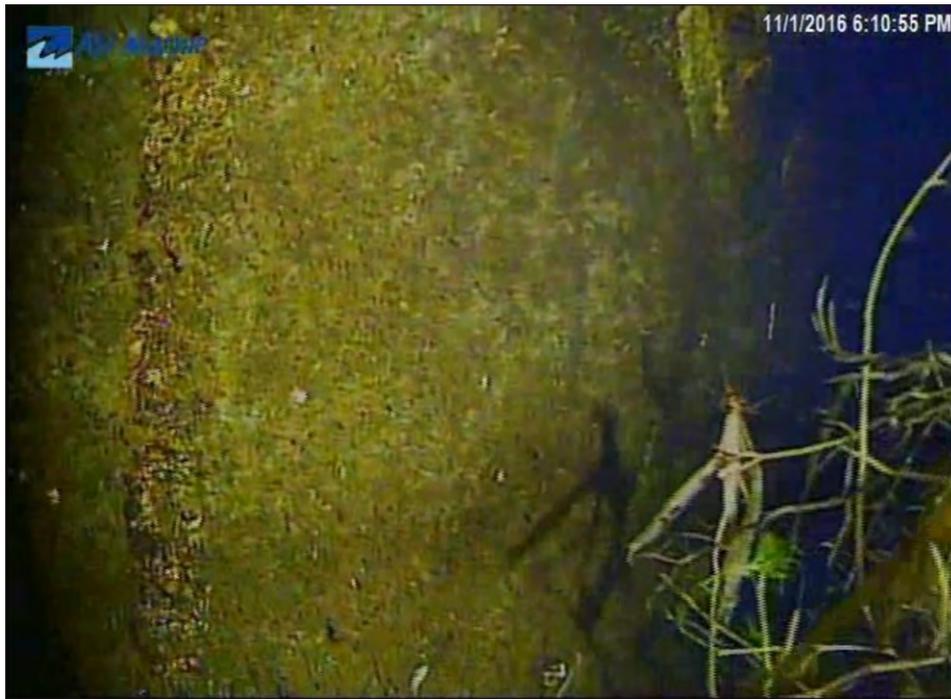
Image 3A-5: 41 m - Slight cracking with slight erosion

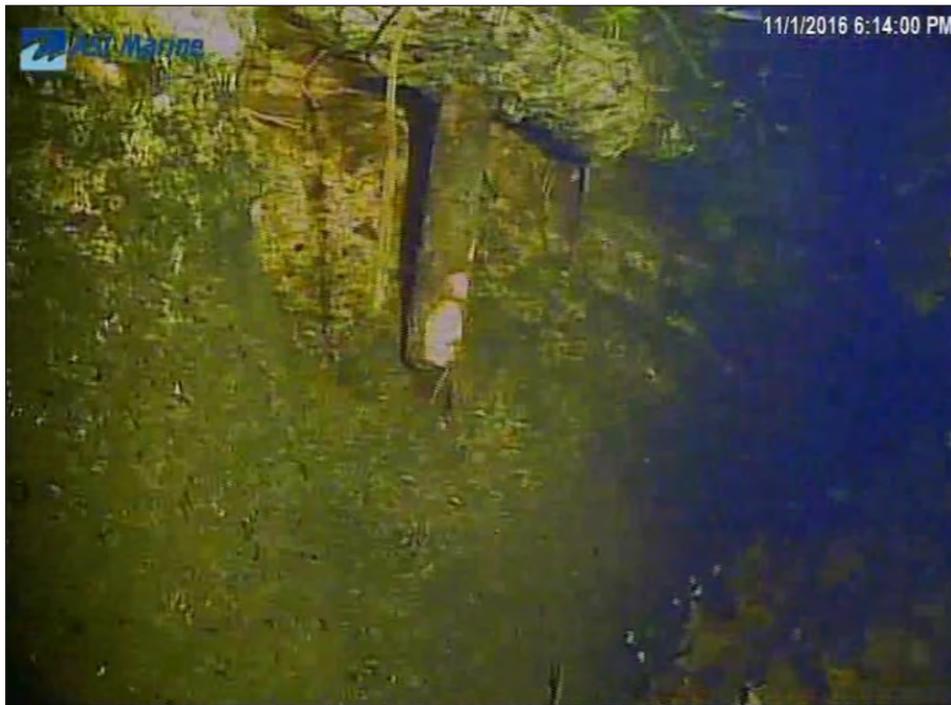
Image 3A-6: 55.5 m - Spalling on crack with rebar protruding

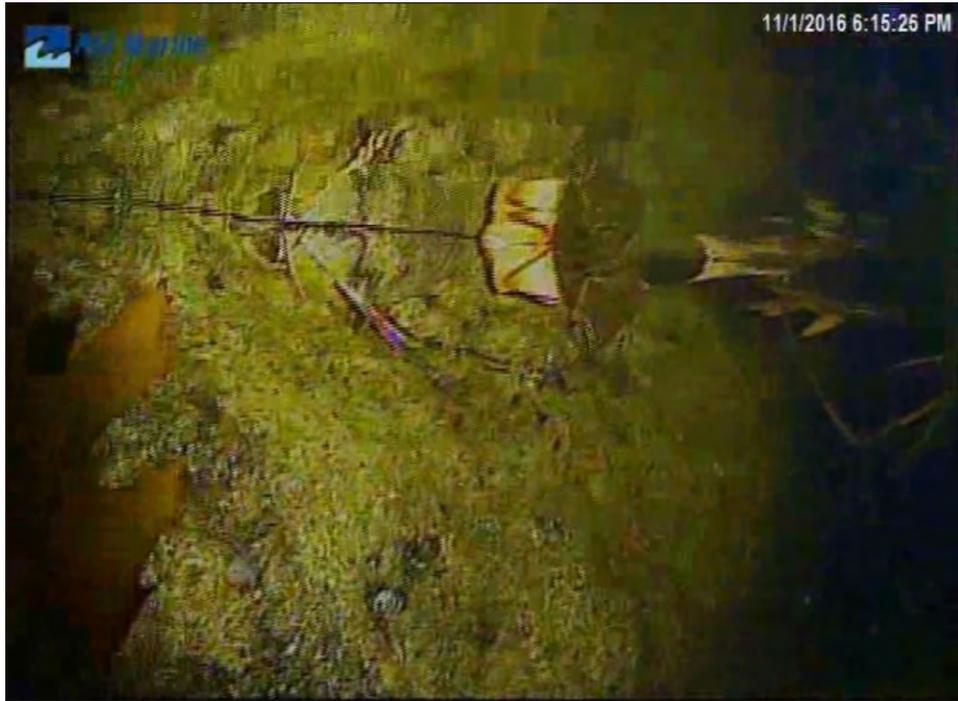
Image 3A-7: 56.5 m - Spalling starting at crack 56 m to 71.5 m mostly above water

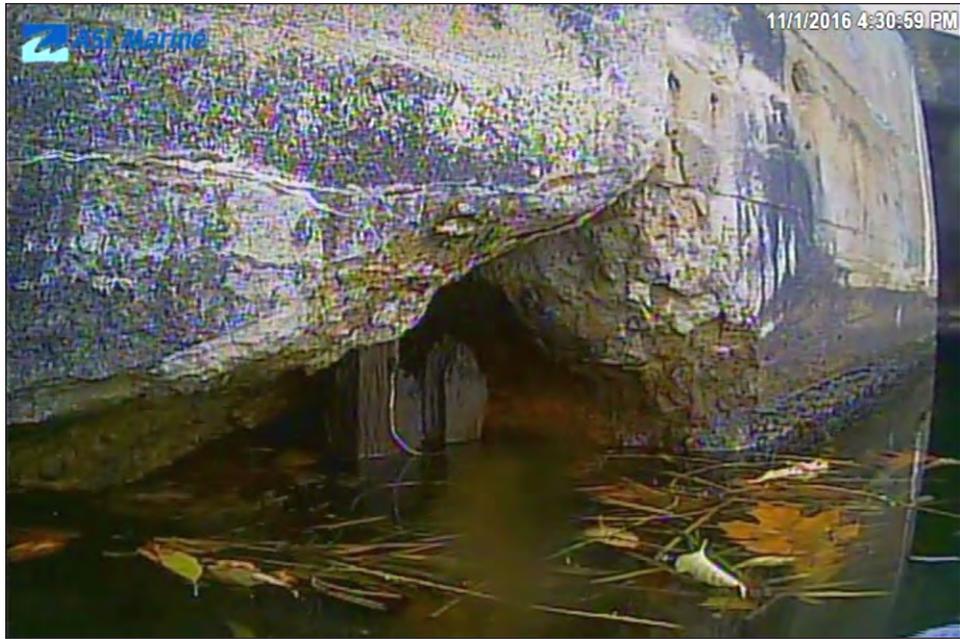
Image 3B-01: 0 m - Undercutting and wooden structure above waterline.

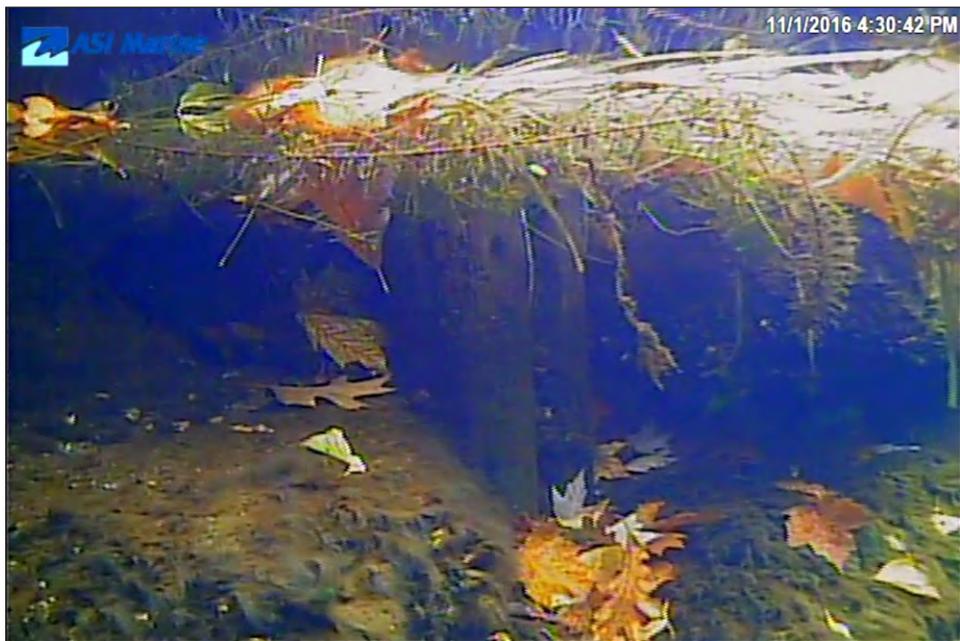
Image 3B-02: 0 m - Undercutting and wooden structure below waterline.

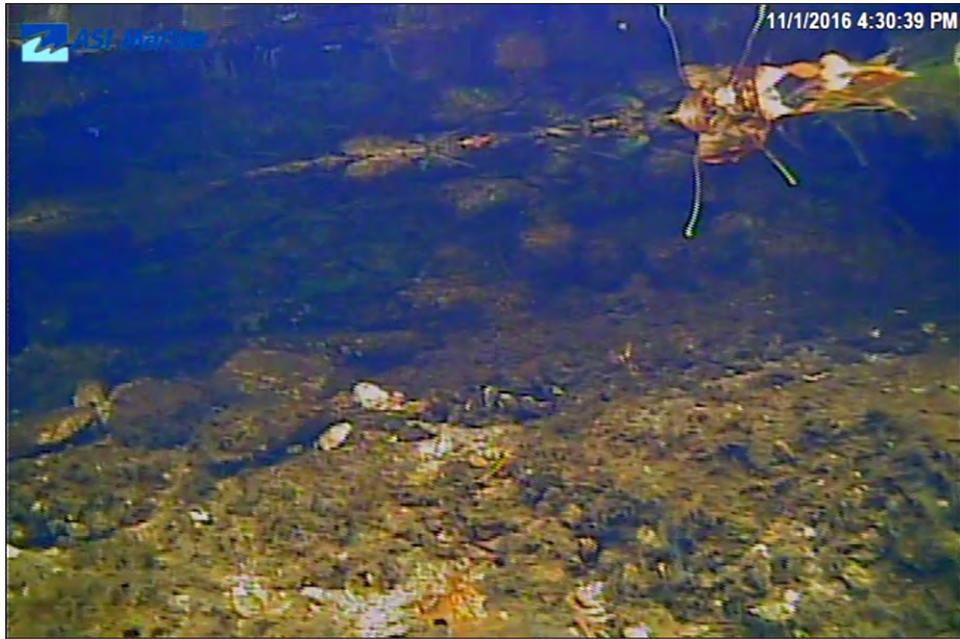
Image 3B-03: 0 m - Undercutting just below surface.

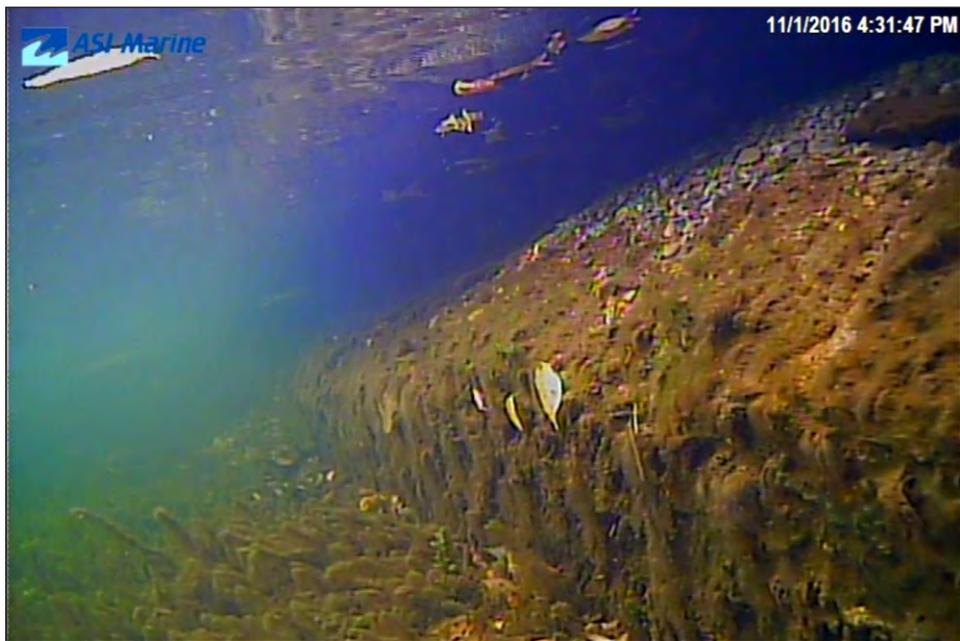
Image 3B-04: 4 m - Undercutting.

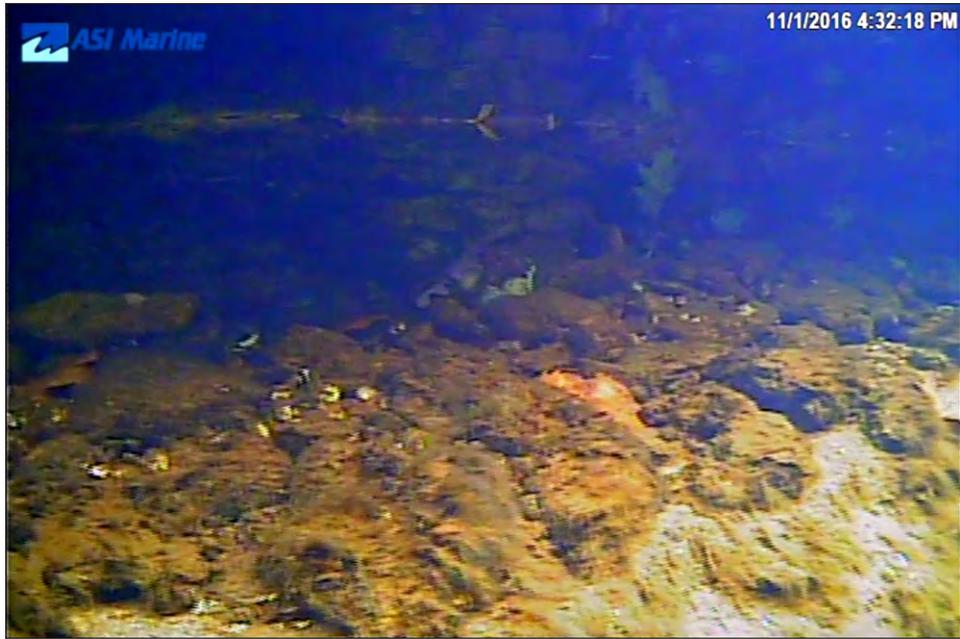
Image 3B-05: 5 m - Undercutting.

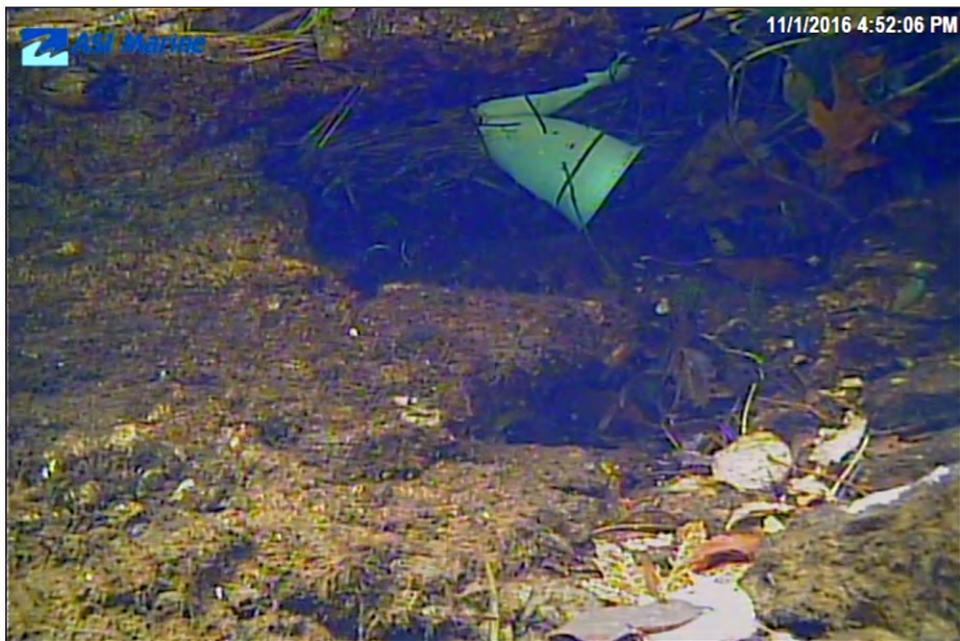
Image 3B-06: 8.5 m - Debris or conduit in deep undercut.

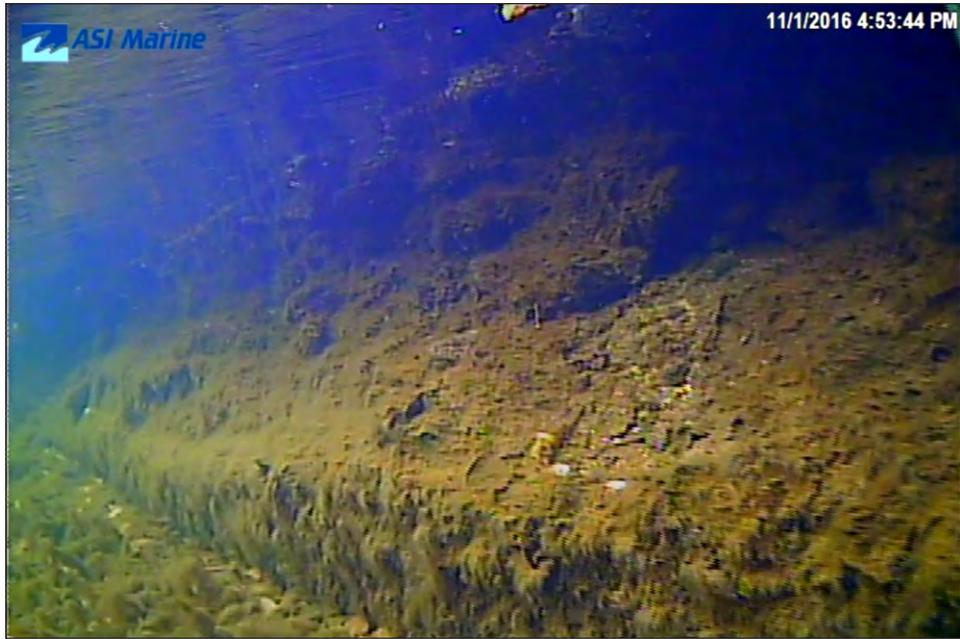
Image 3B-07: 10 m - Undercutting in shallow water depth.

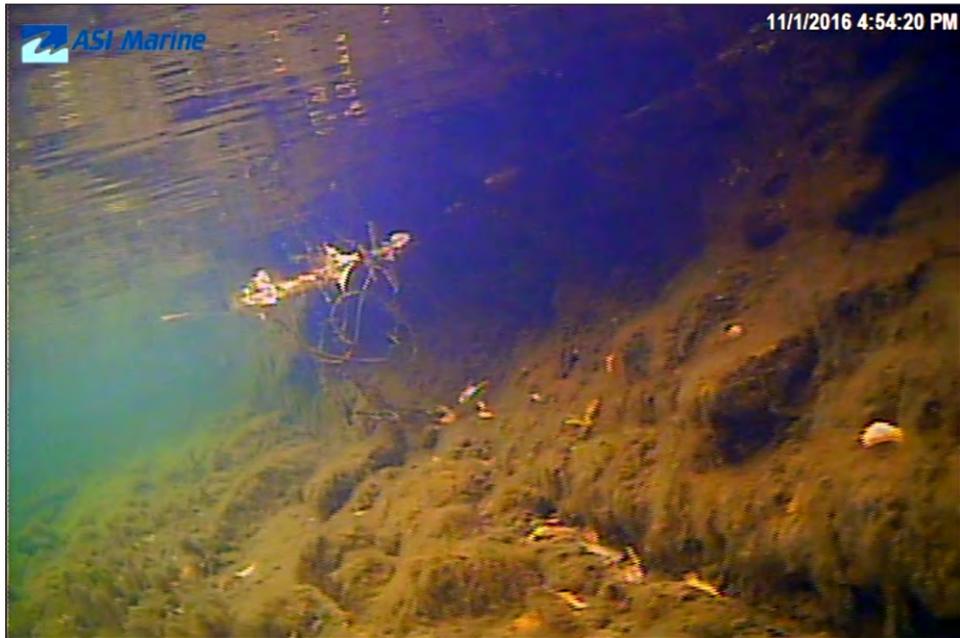
Image 3B-08: 12.5 m - Undercutting deepens.

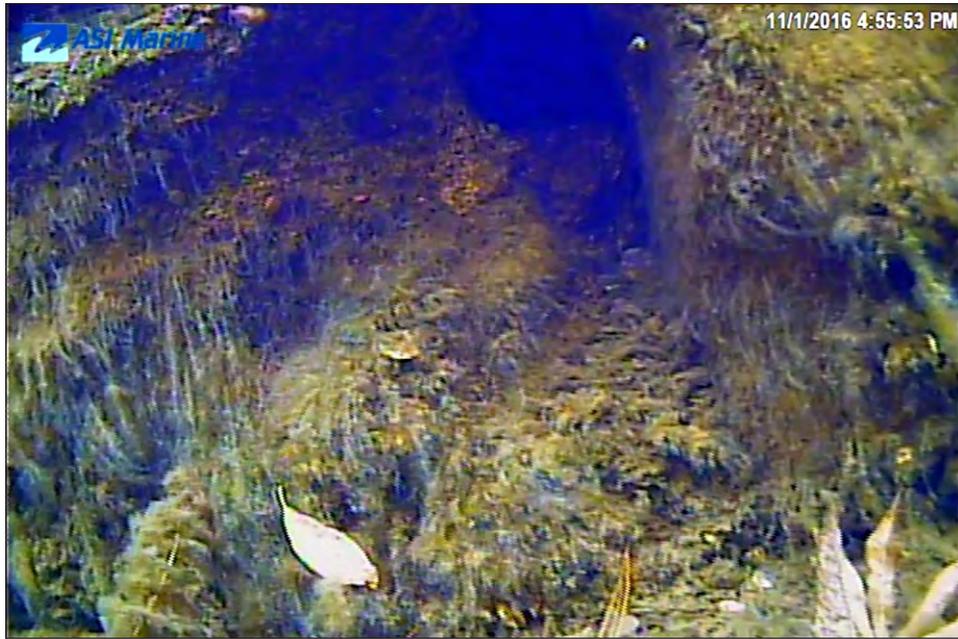
Image 3B-11: 19.6 m - Joint spalling below waterline.

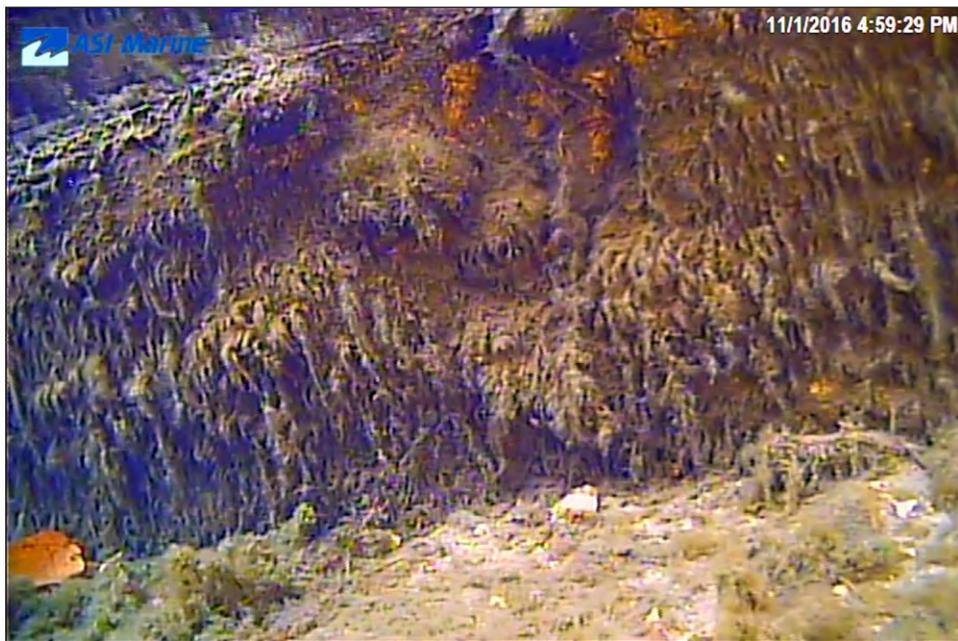
Image 3B-12: 25.8 m - Spalling below surface.

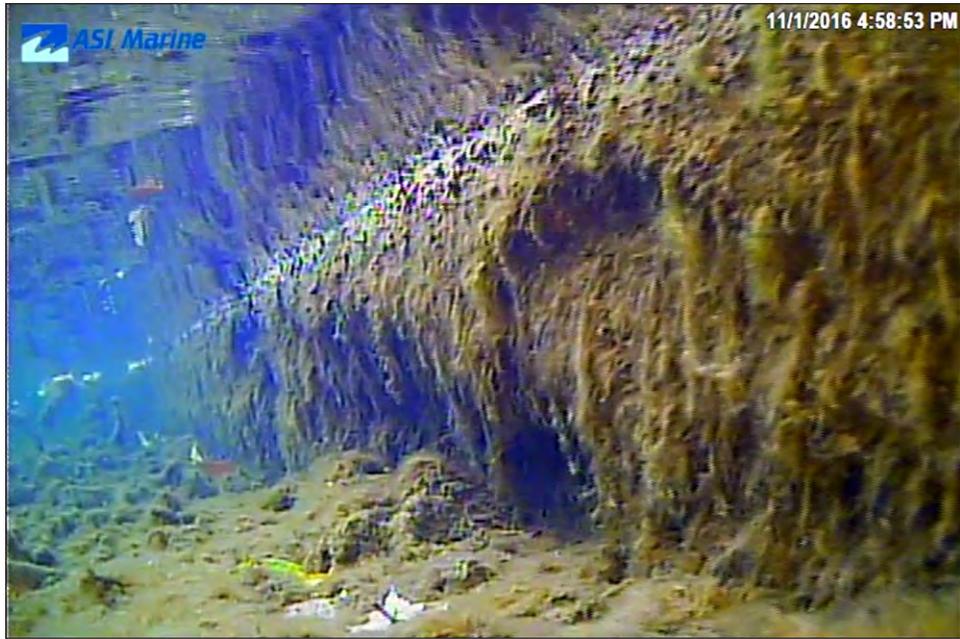
Image 3B-13: 25 m - Undercutting at bottom.

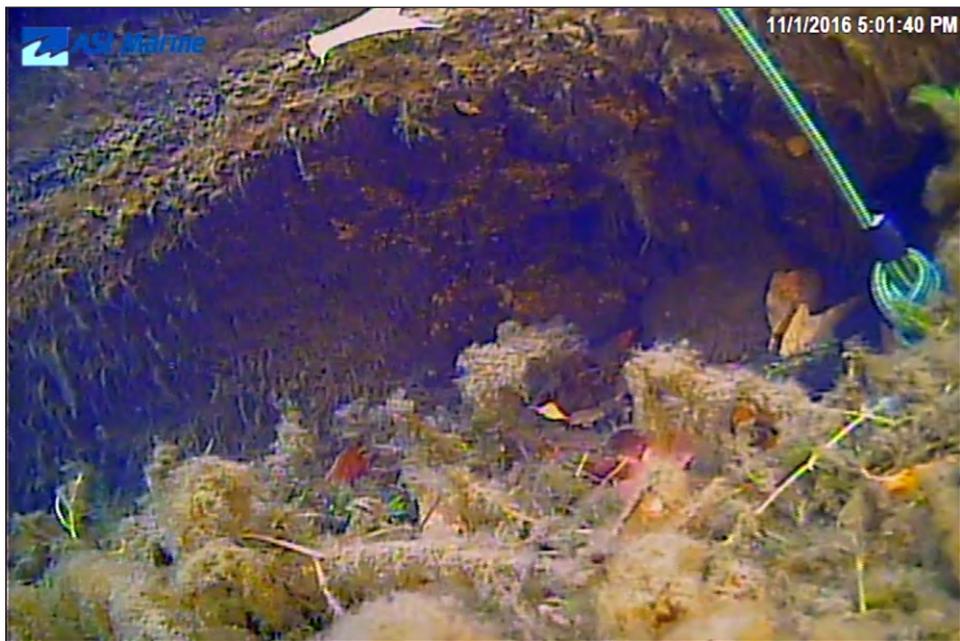
Image 3B-14: 29.5 m - Undercutting.

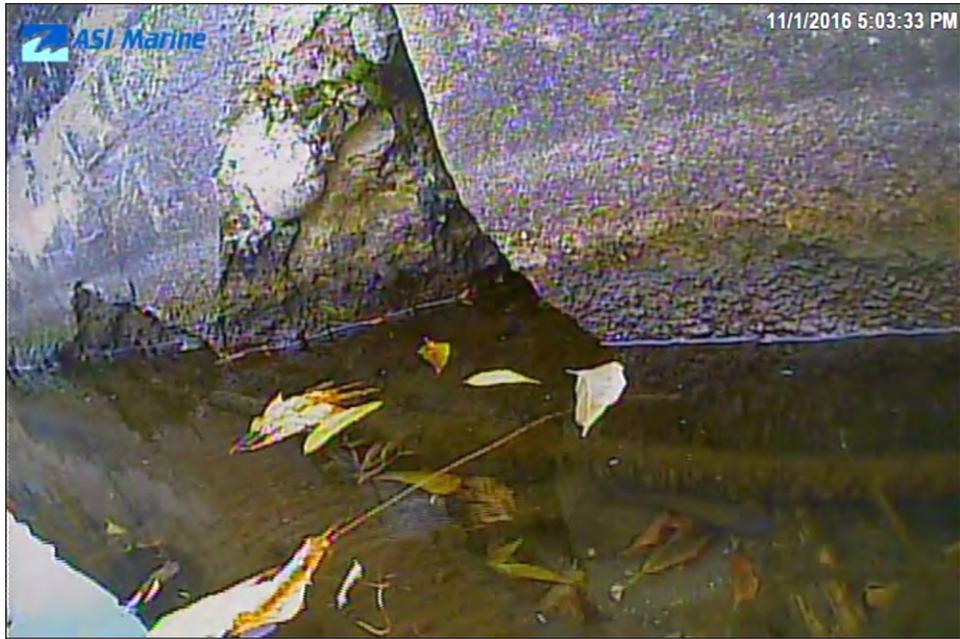
Image 3B-15: 34.3 m - Spalling above water surface.

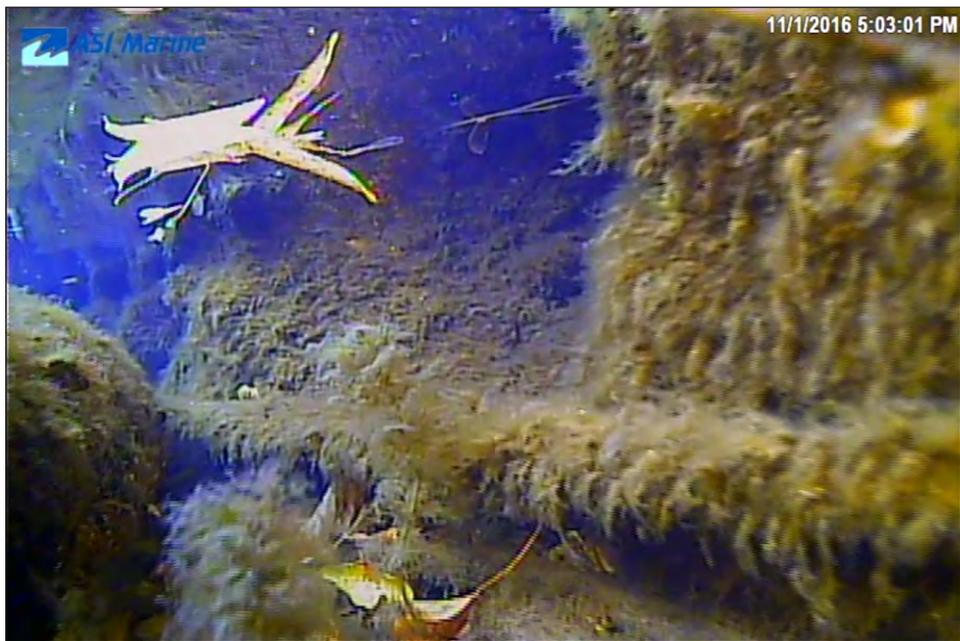
Image 3B-16: 34.3 m - Spalling below water surface.

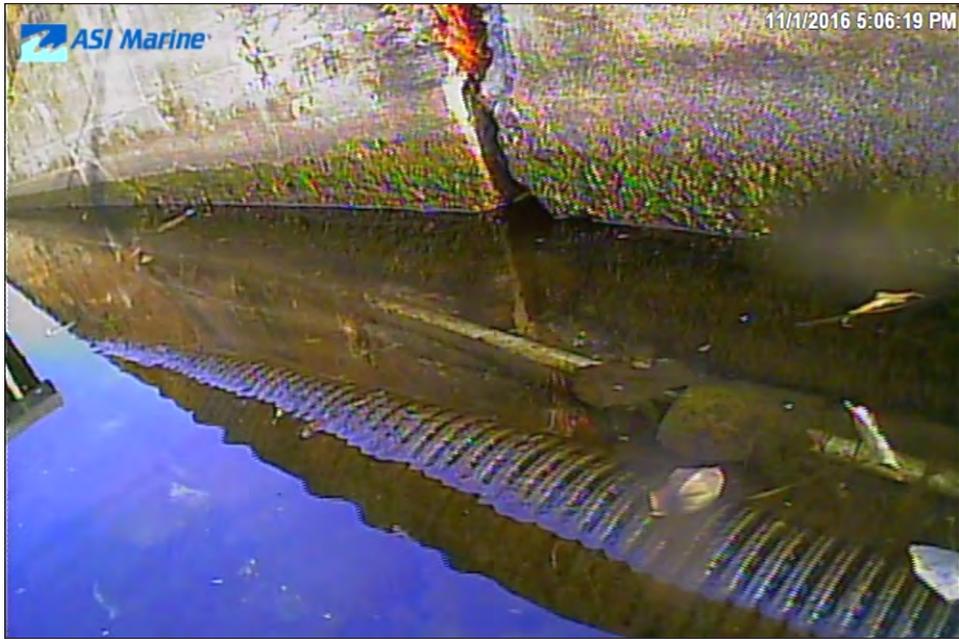
Image 3B-17: 42.7 m - Crack with spalling at waterline.

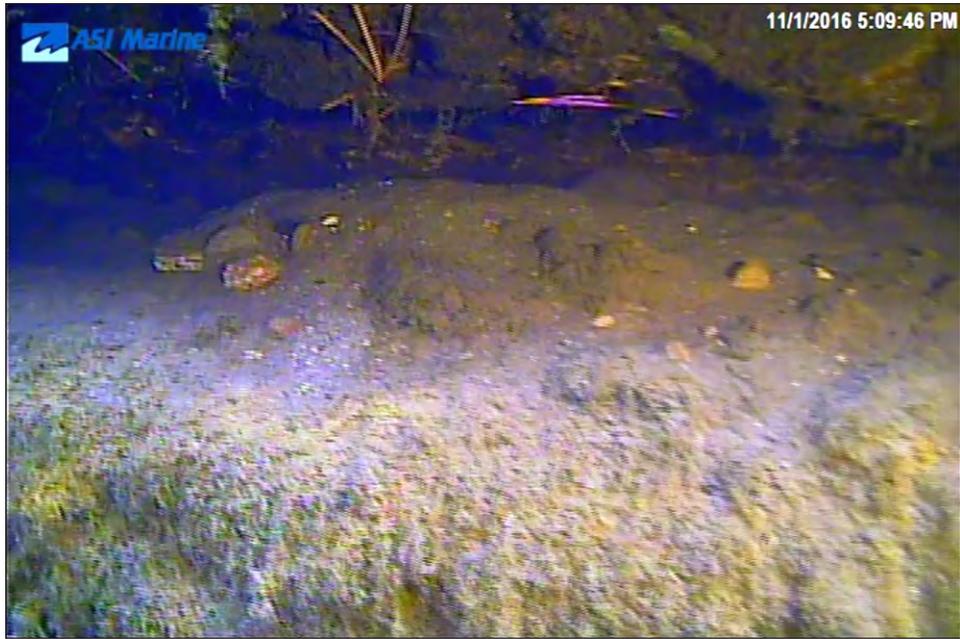
Image 3B-19: 47.5 m - Undercutting at bottom - 30 cm deep.

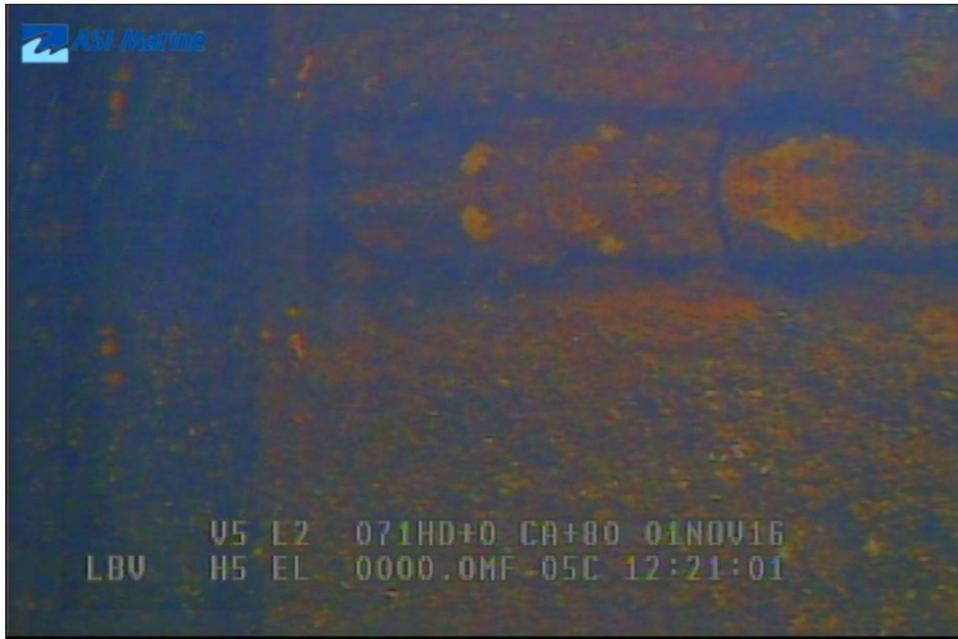
Image 3C-01: Pier 6 - Spalling below surface and behind stop log gain.

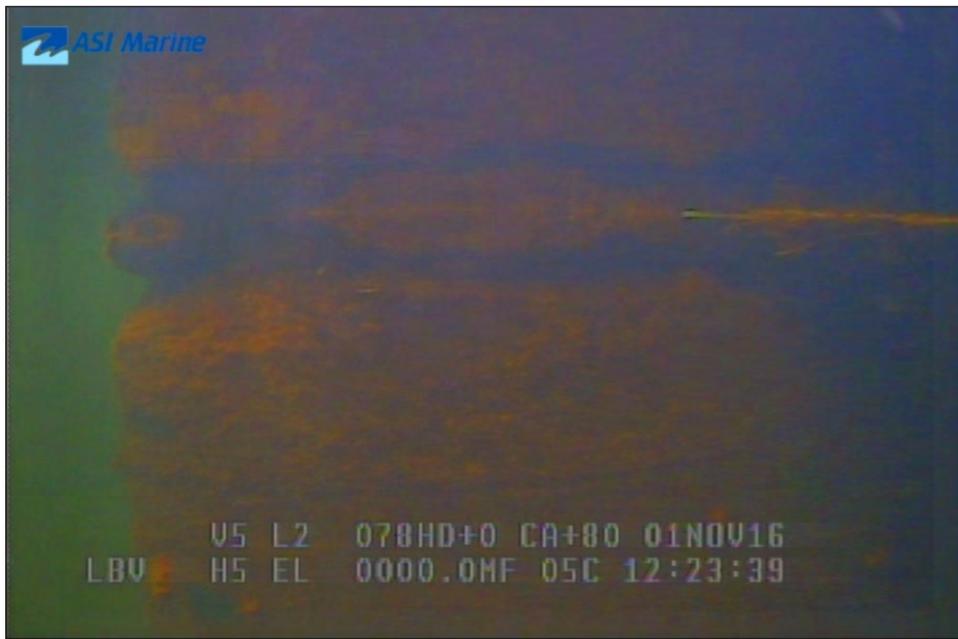
Image 3C-02: Pier 6 - Spalling below surface west side.

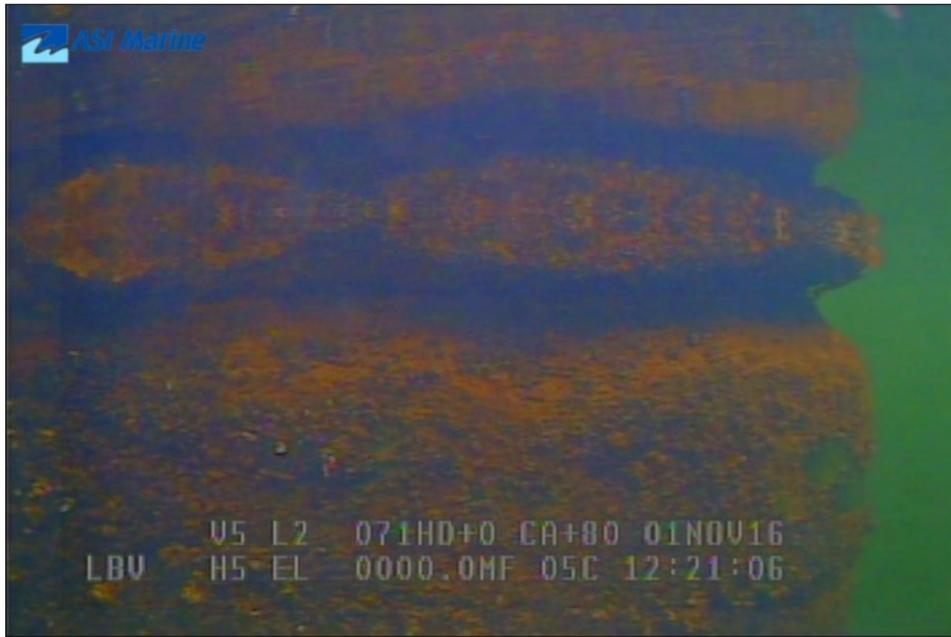
Image 3C-03: Pier 6 - Spalling below surface.

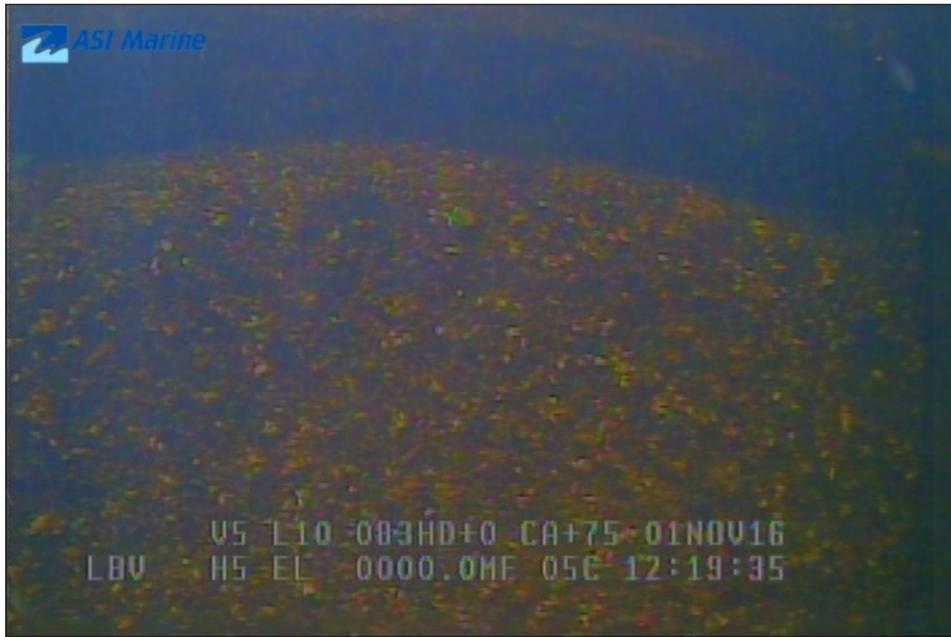
Image 3C-05: Pier 7 - Spalling below surface west side.

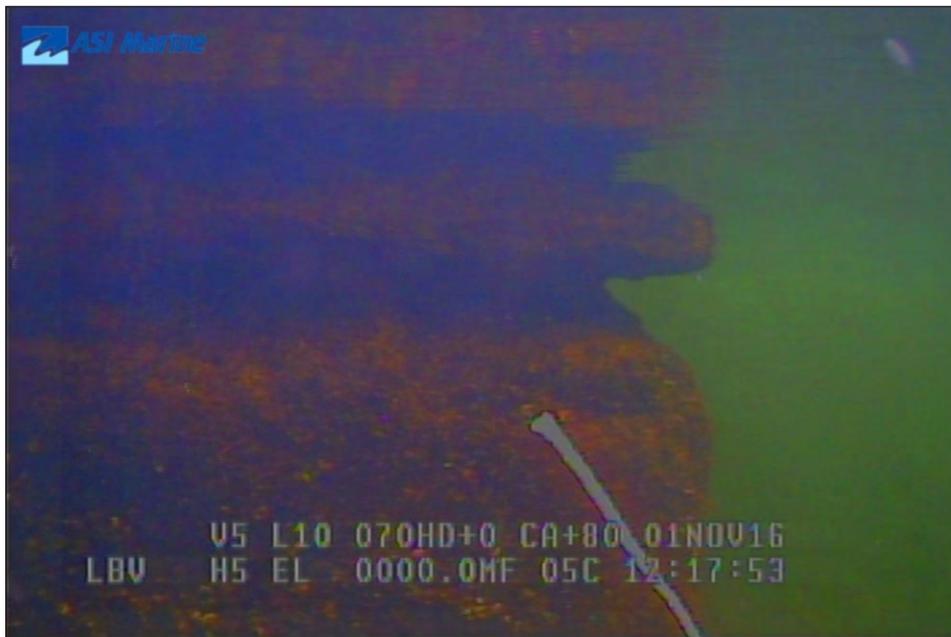
Image 3C-06: Pier 7 - Spalling below surface on east side.

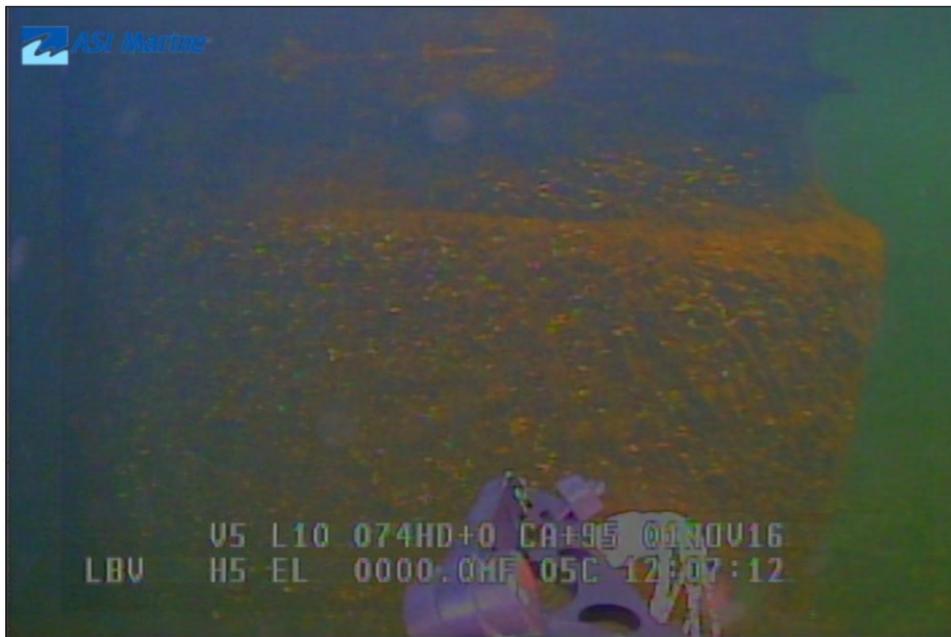
Image 3C-10: Pier 9 - Erosion at surface.

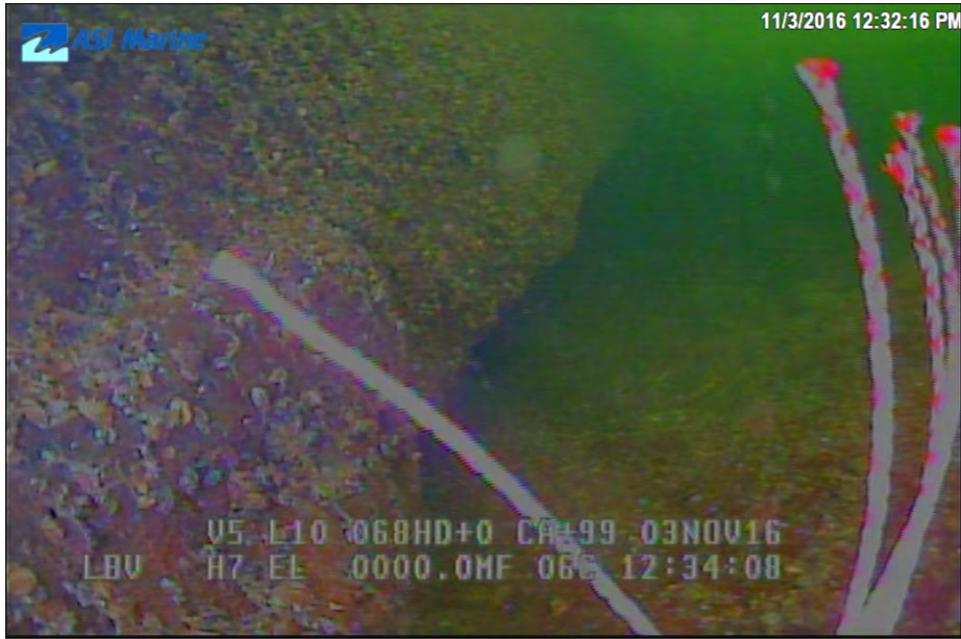
Image 3D-03: Undercutting downstream of Gate 2.

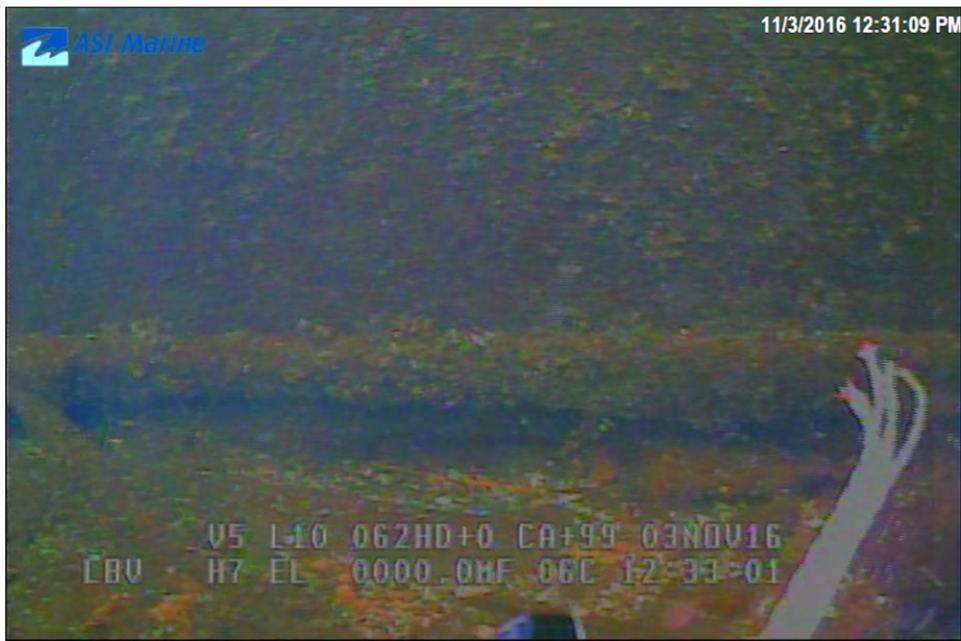
Image 3D-04: Undercutting downstream from Pier 2 bottom

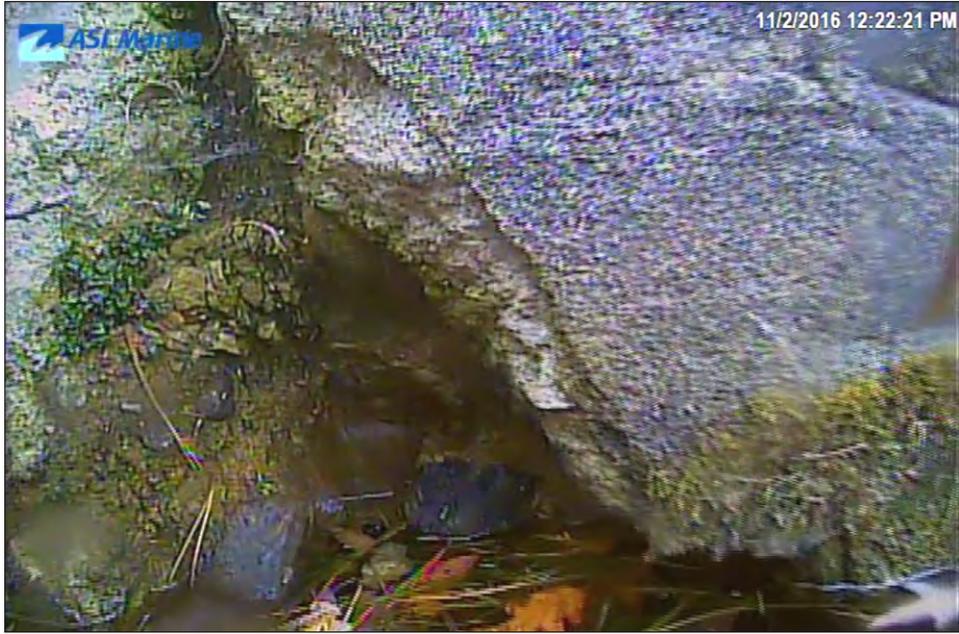
Image 3E-01: 5.5 m - Cracking present above waterline.

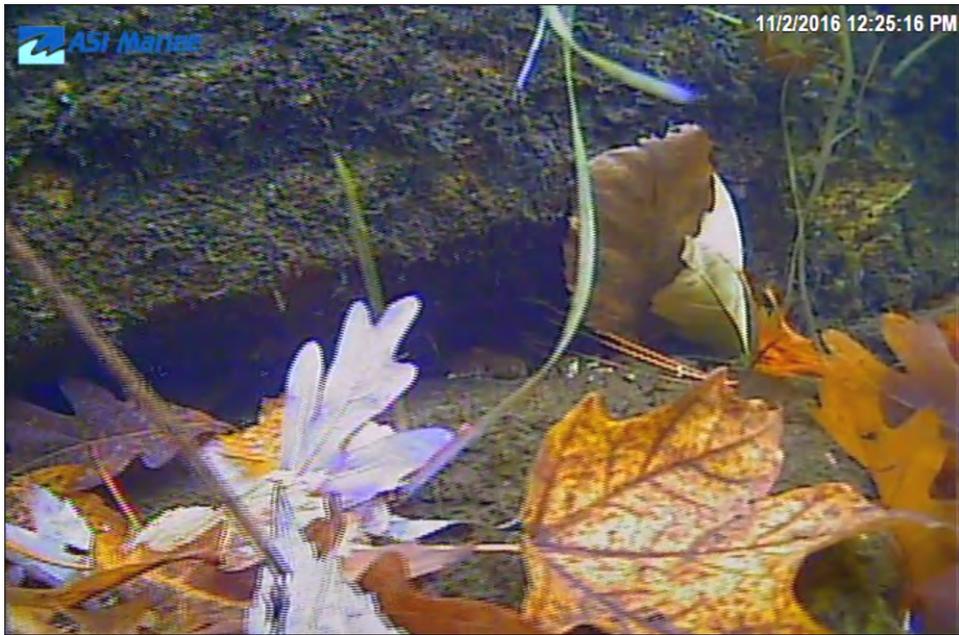
Image 3E-02: 6.7 m - Undercutting

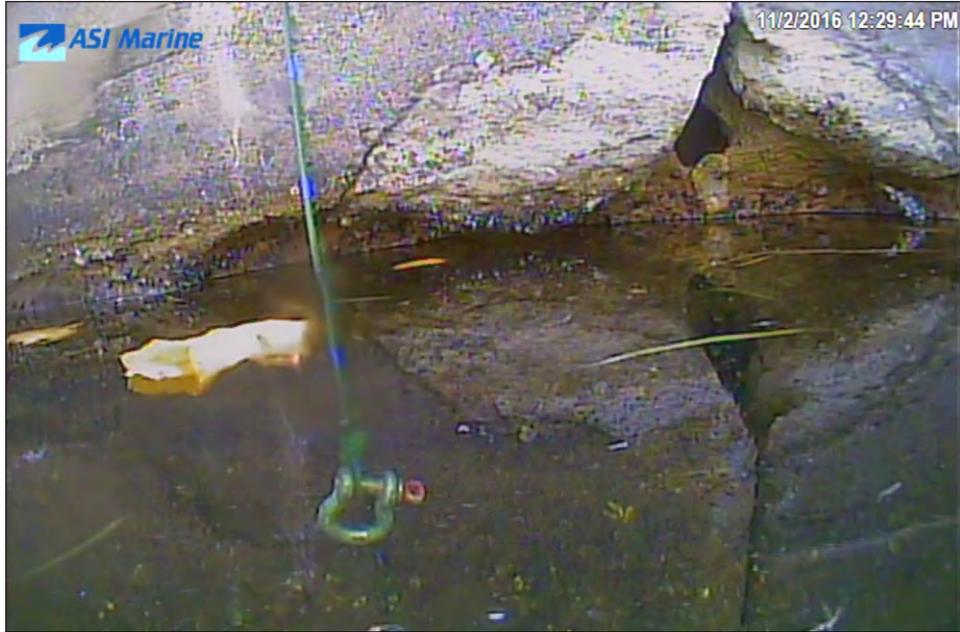
Image 3E-05: 11.8 m - Undercutting continues above waterline.

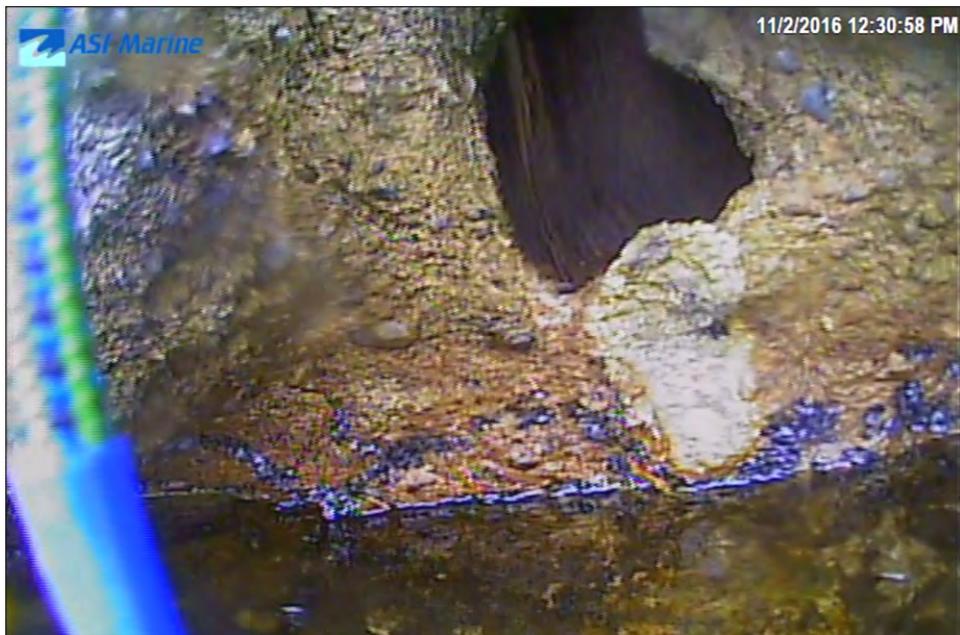
Image 3E-06: 11.8 m - Exposed sub-structure.

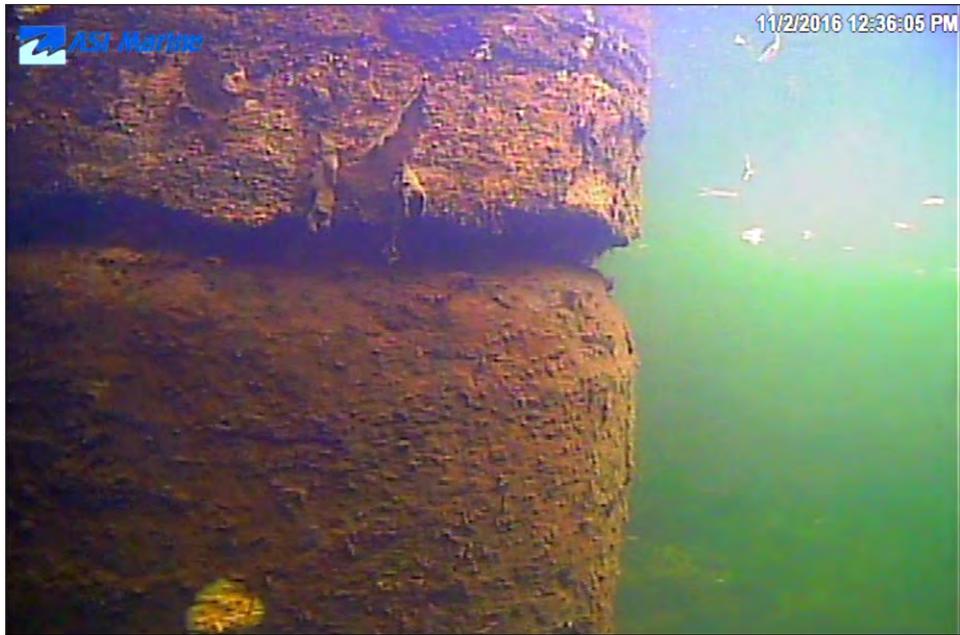
Image 3E-08: 19.9 m - Undercutting.

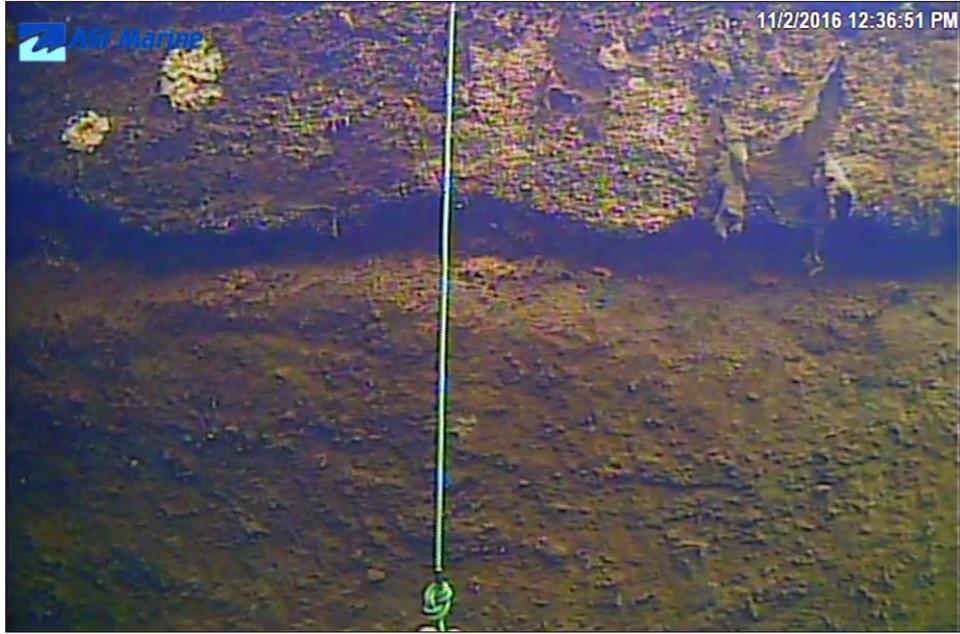
Image 3E-09: 19.9 m - Undercutting continues along radius of corner.

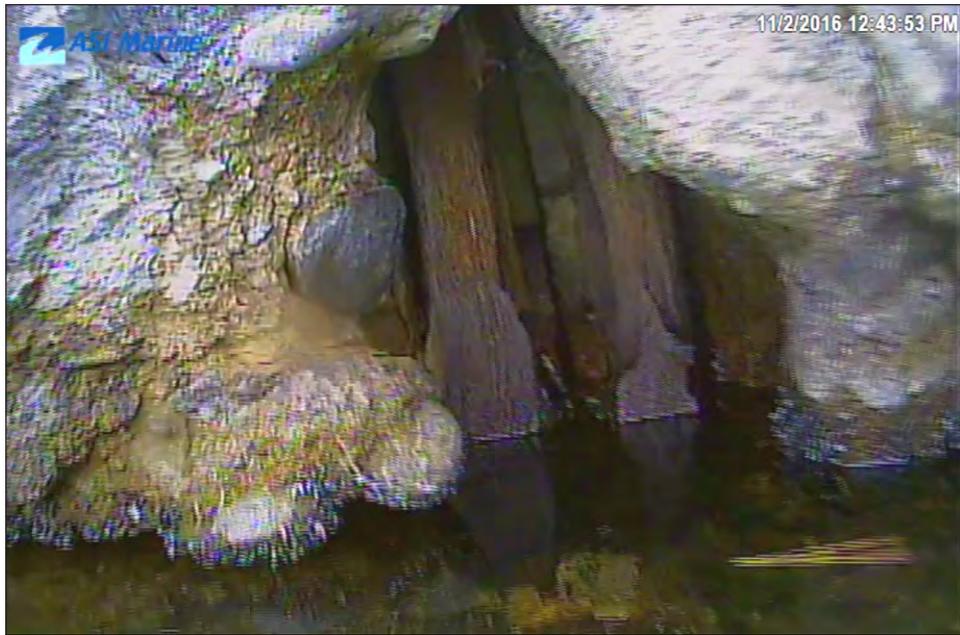
Image 3E-10: 21.5 m - Cracking with exposed sub-structure.

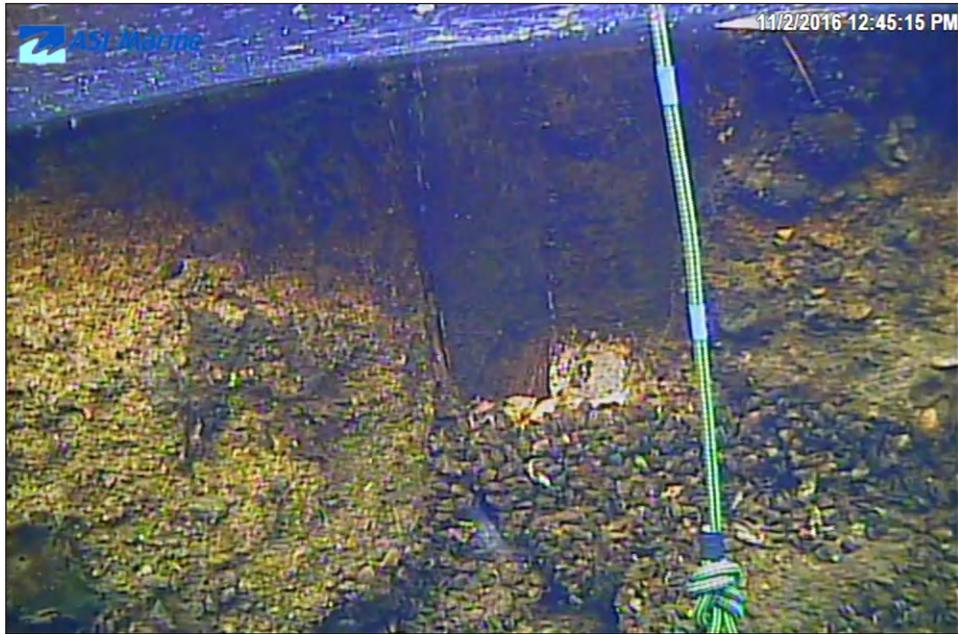
Image 3E-11: 21.5 m - Cracking continues below waterline.

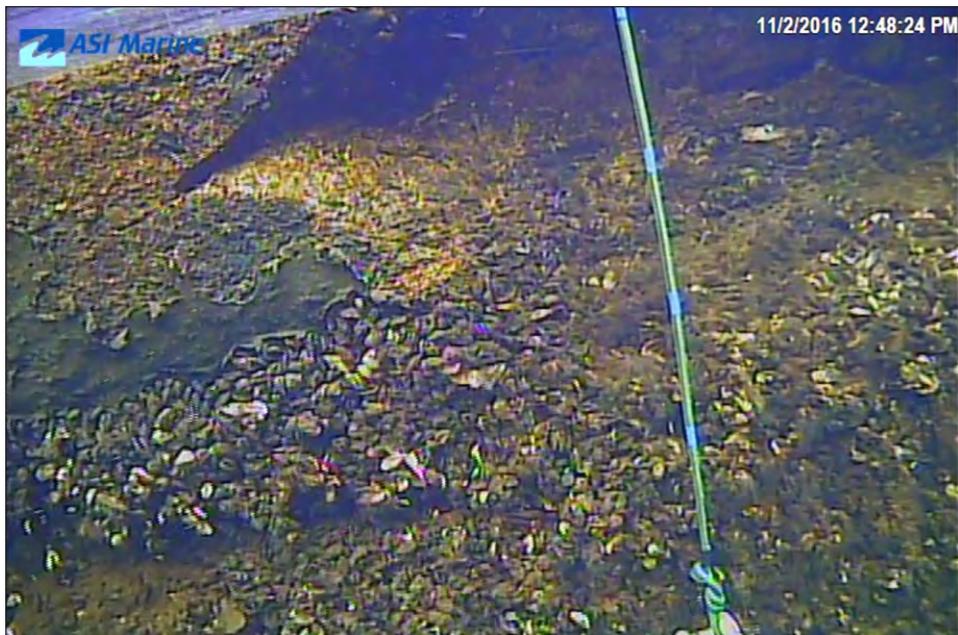
Image 3E-12: 26.5 m - Undercutting below waterline.

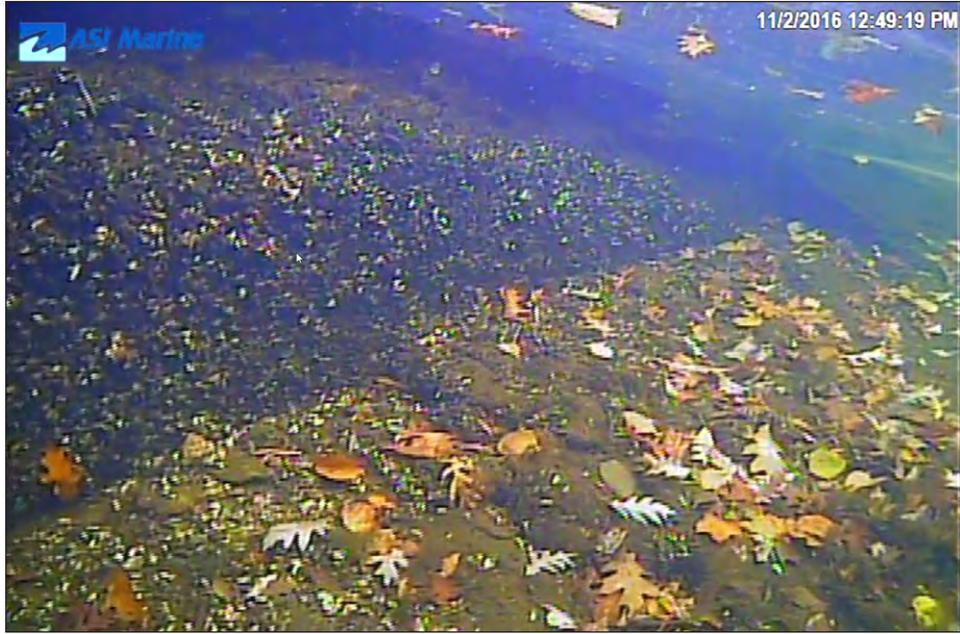
Image 3E-13: 26.4 m - Undercutting continues to waterline.
