Rehabilitation of Port Severn Area Dams, Fixed Bridge and Lock

Investigation Report

Public Works and Government Services Canada

November 21 2017

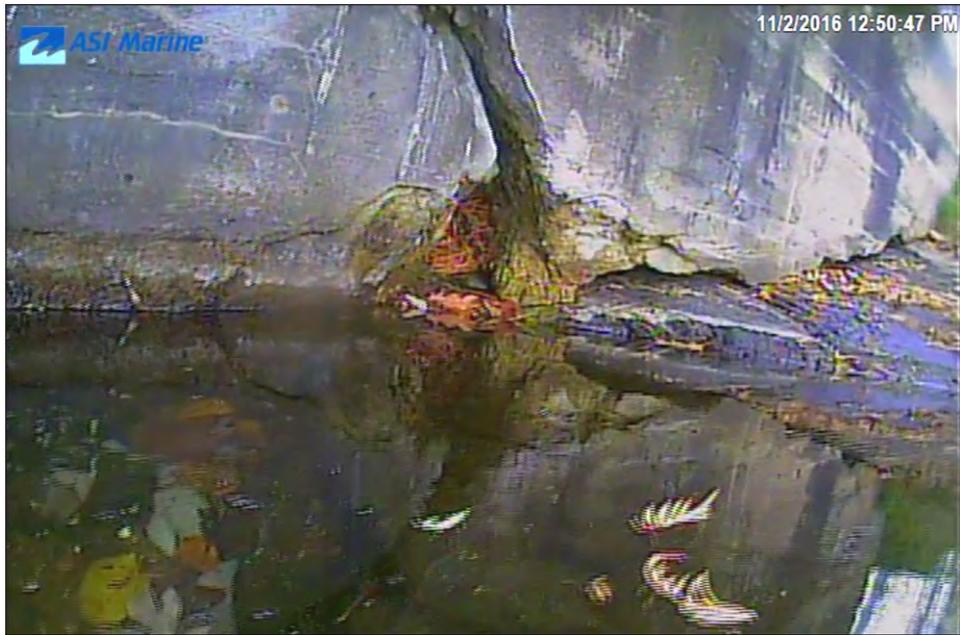
Image 3E-14: 27.5 m - Cracking above water line.

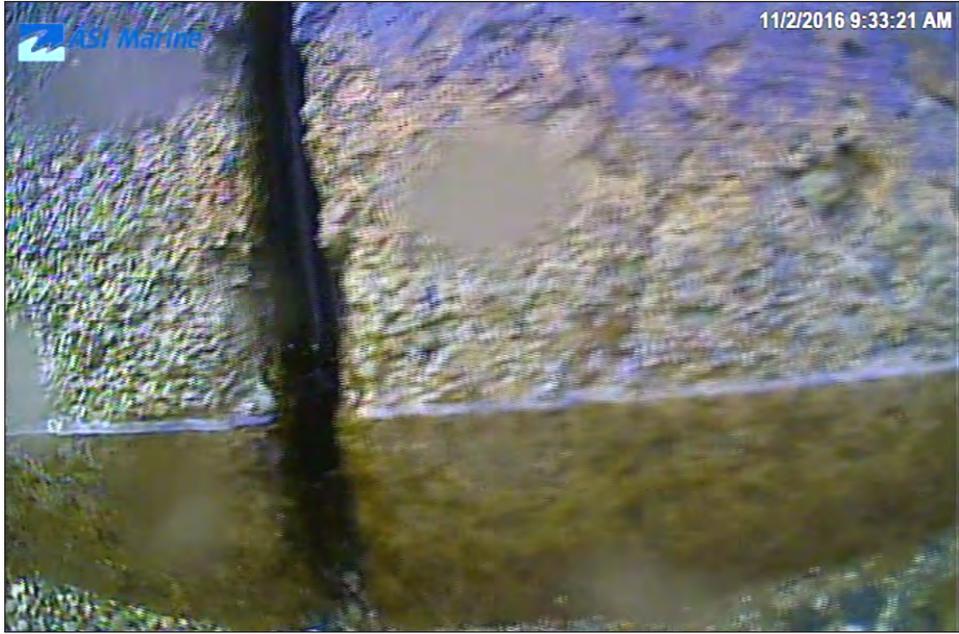
Image 3F-01: 21.8 m - Joint showing slight separation.

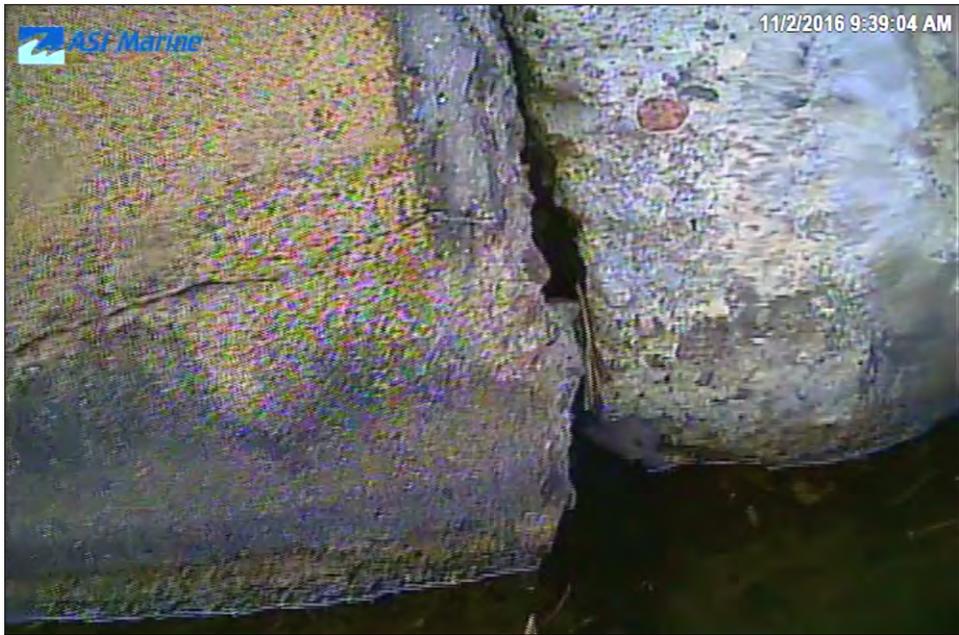
Image 3F-02: 41.7 m - Joint showing signs of spalling.

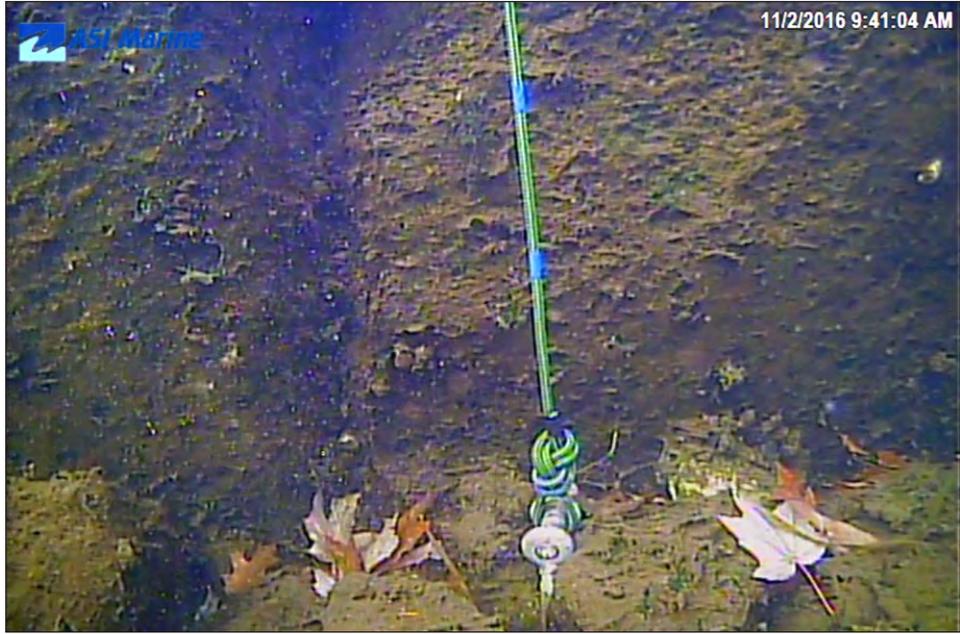
Image 3F-03: 41.7 m - Joint showing signs of erosion.

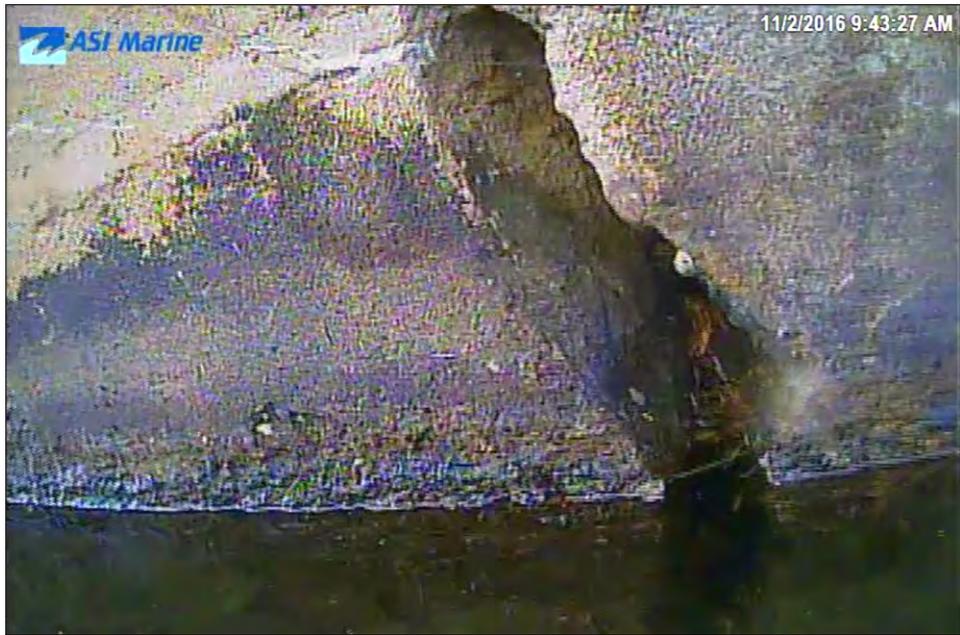
Image 3F-04: 45.5 m - Cracking above waterline.

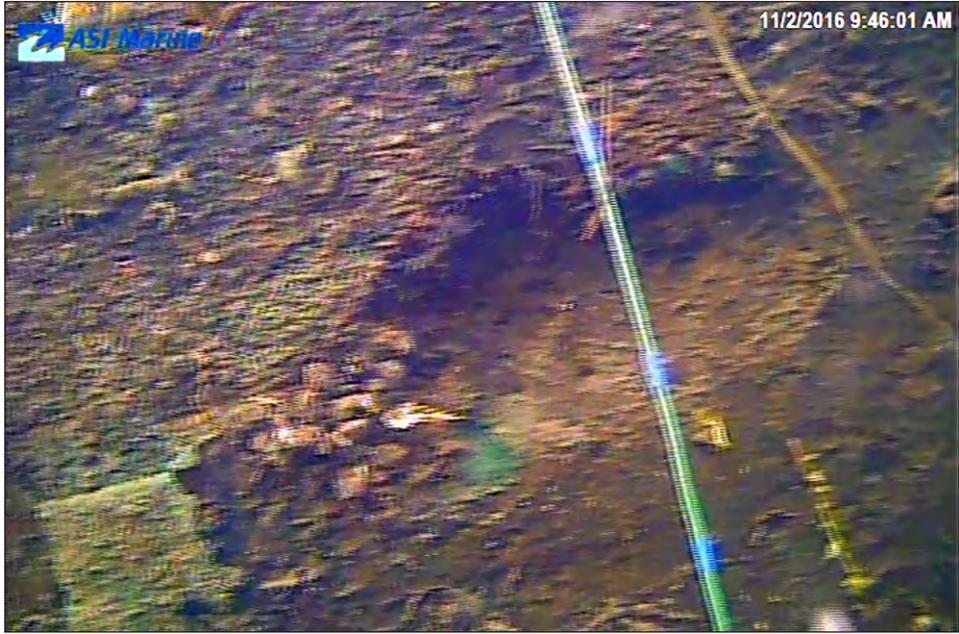
Image 3F-05: 47 m - Scour mark.

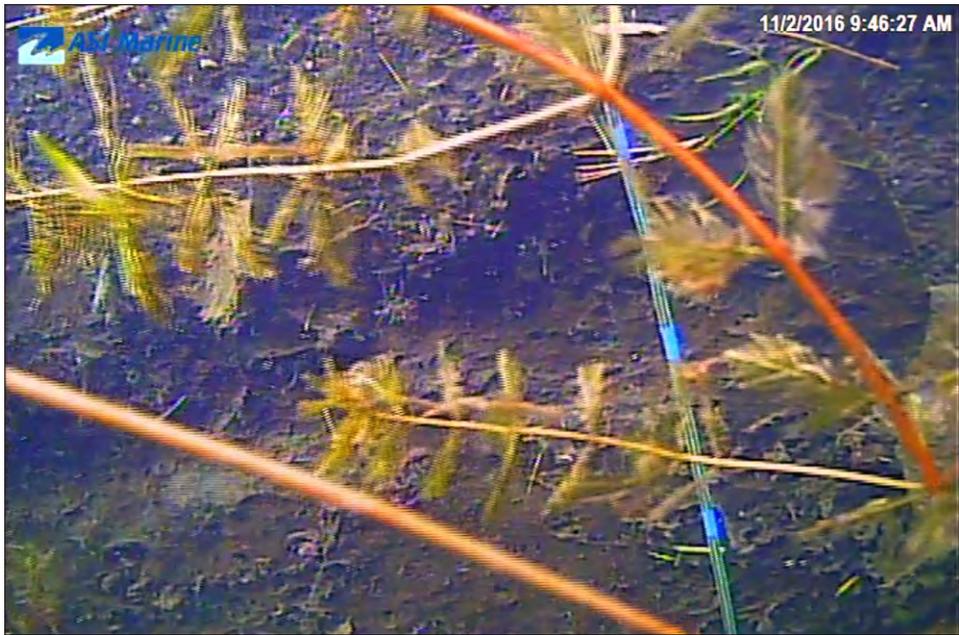
Image 3F-06: 48 m - Scour mark.

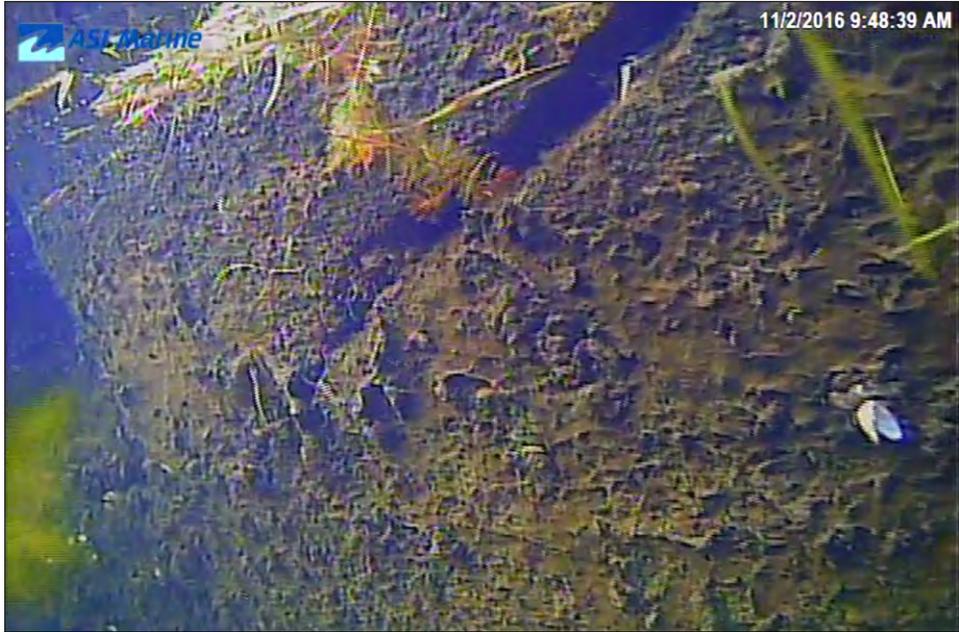
Image 3F-07: 51 m - Cracking

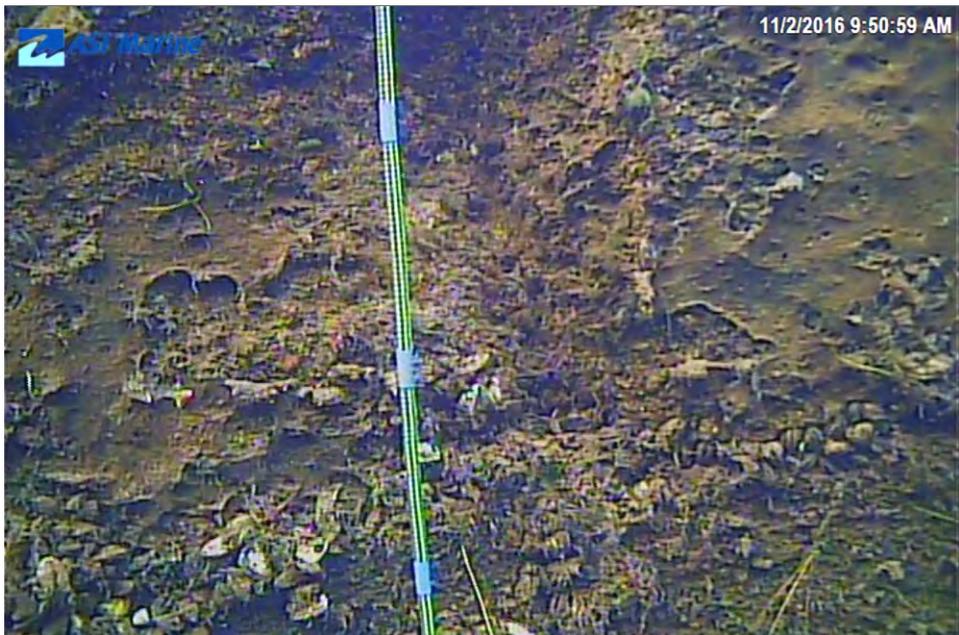
Image 3F-08: 52 m - Joint showing signs of shallow spalling.

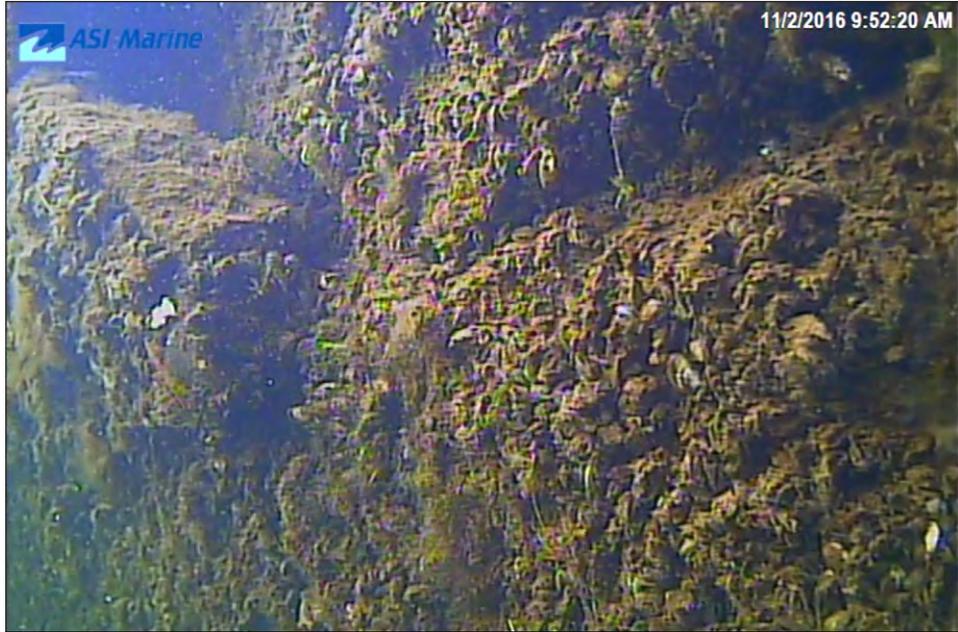
Image 3F-09: 53 m - Cracking.

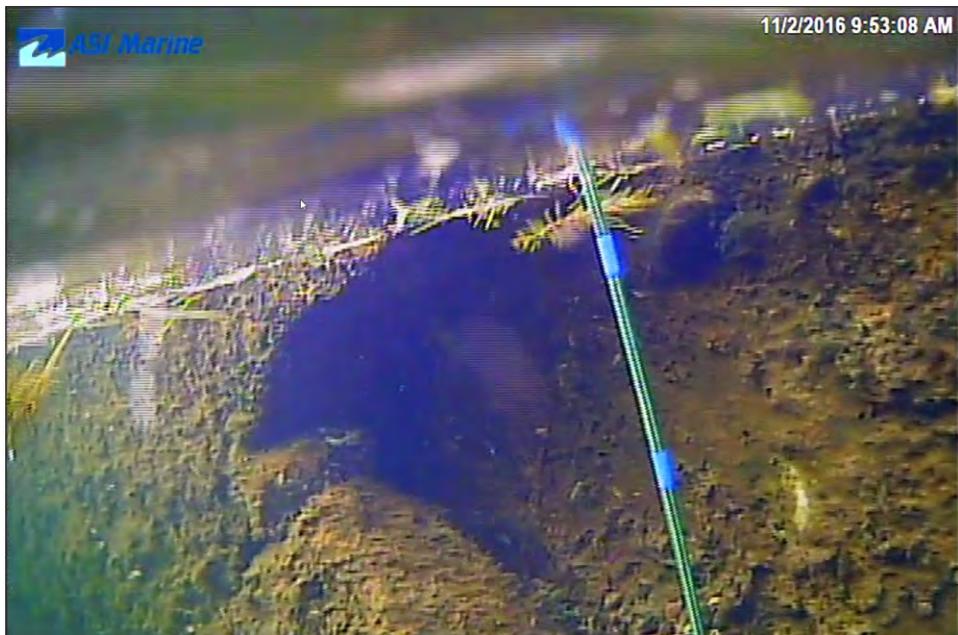
Image 3F-10: 53 m - Cavity behind crack.

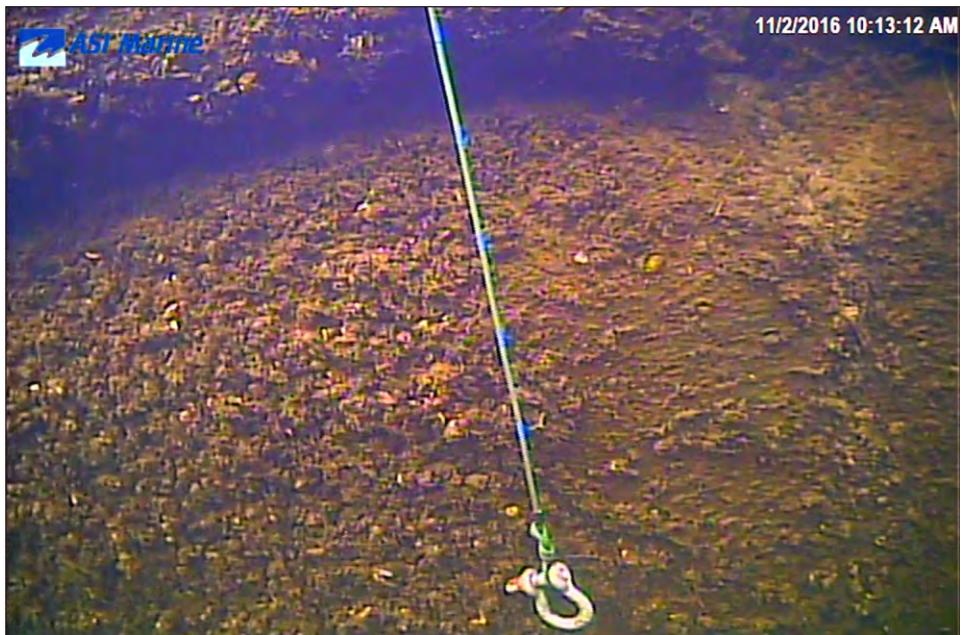
Image 3F-12: 60.2 m - Undercutting.

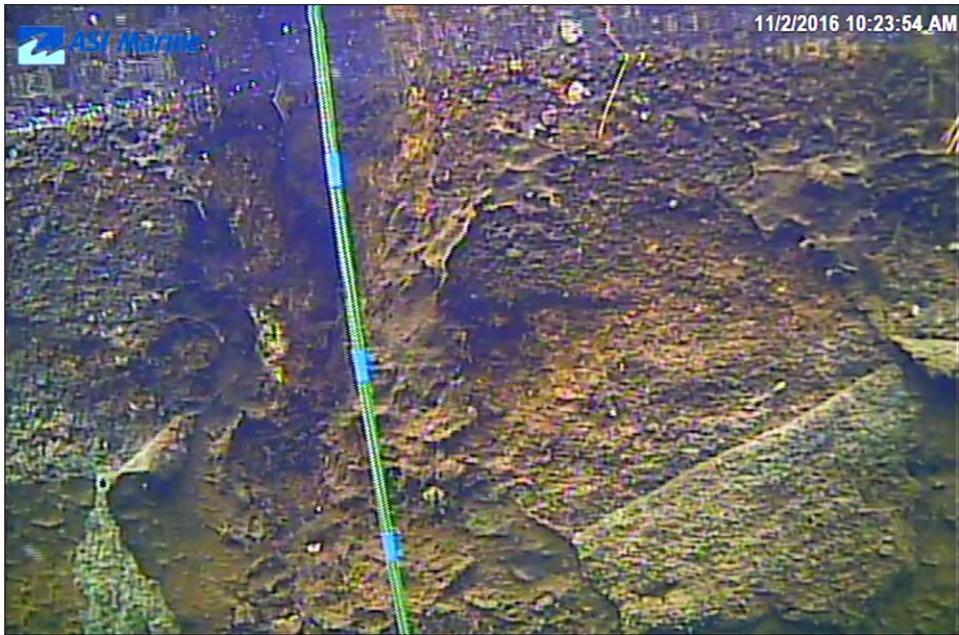
Image 3F-16: 69.6 m - Cracking.

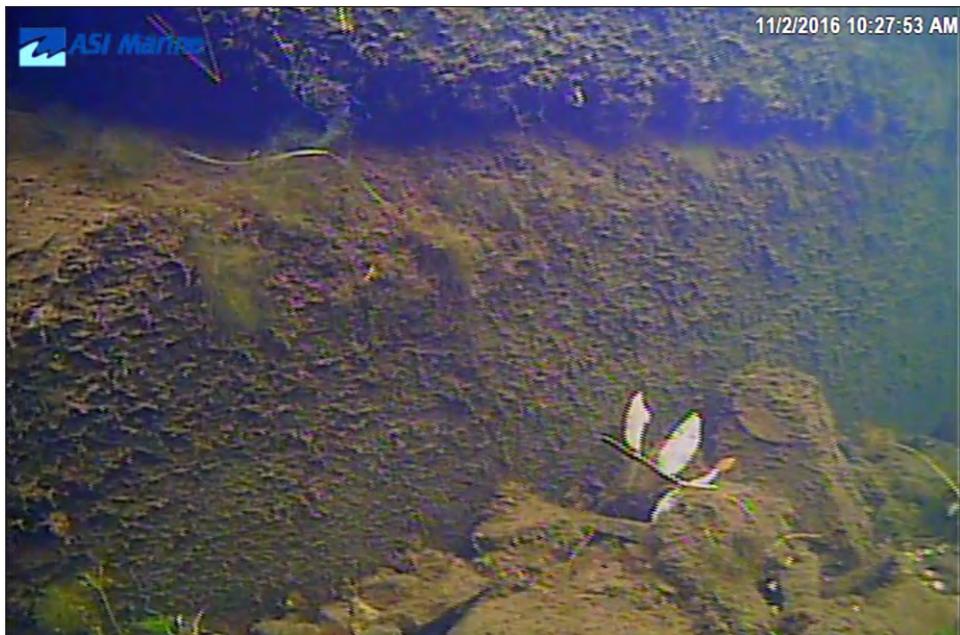
Image 3F-18: 81 m - Undercutting continues west.

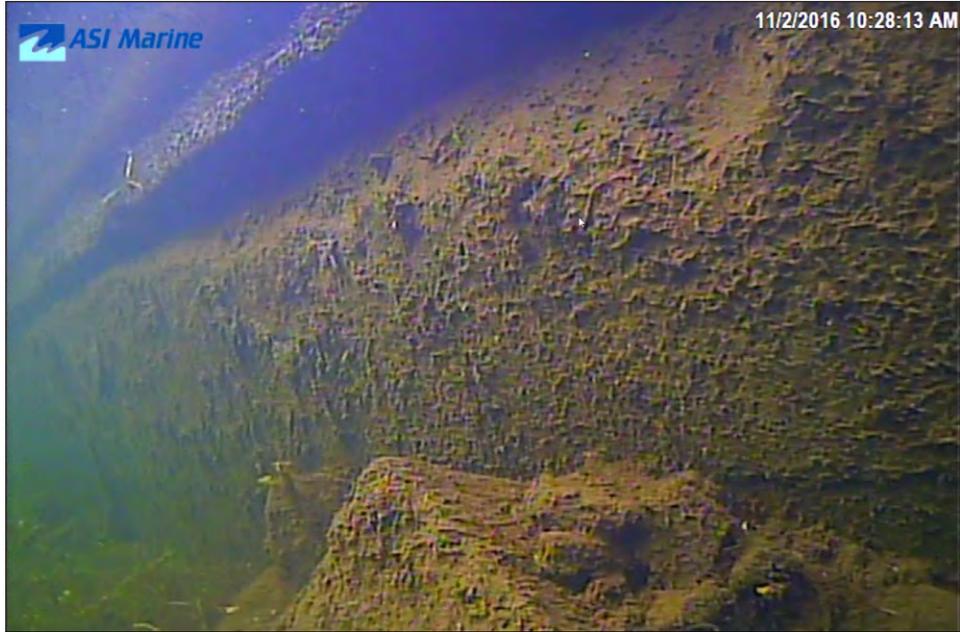
Image 3F-19: 81 m - Undercutting.

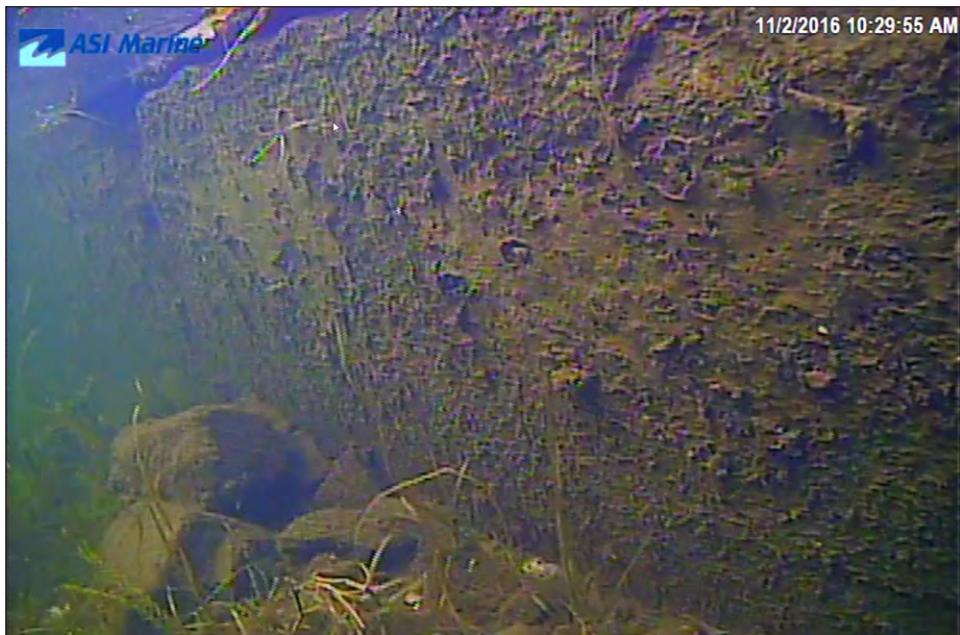
Image 3F-20: 89.2 m - Undercutting from previous images ends here.

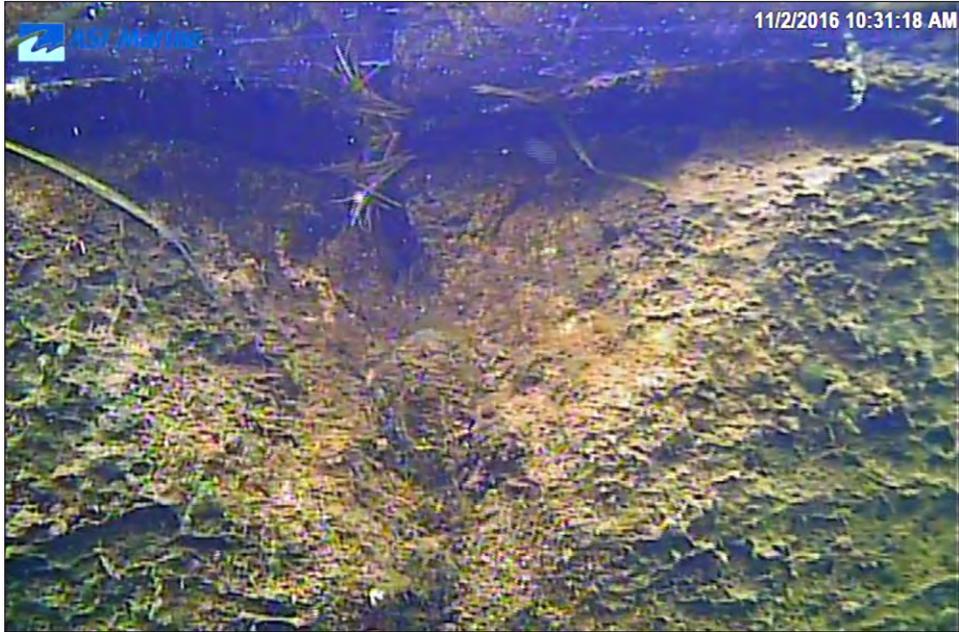
Image 3F-21: 90 m - Joint showing signs of erosion.

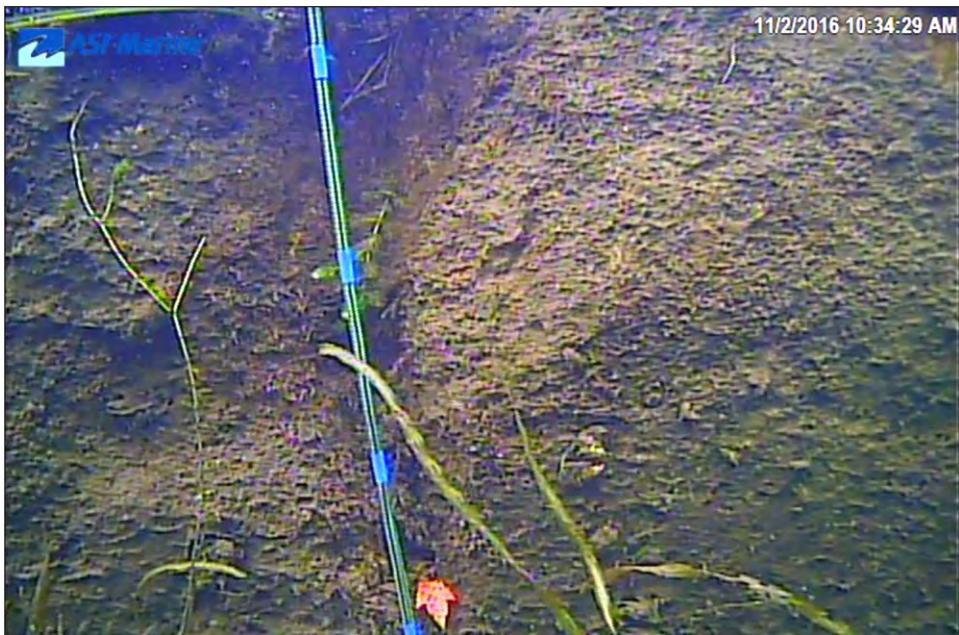
Image 3F-22: 96.3 m - Cracking.

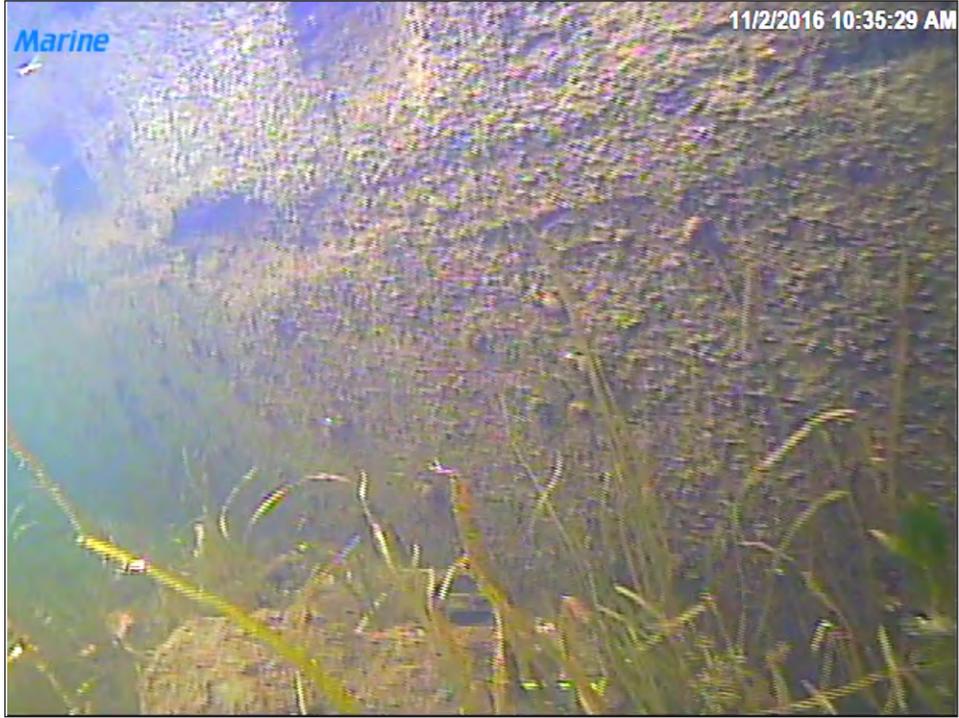
Image 3F-23: 99.6 m to 101 m - Cluster of scour marks.

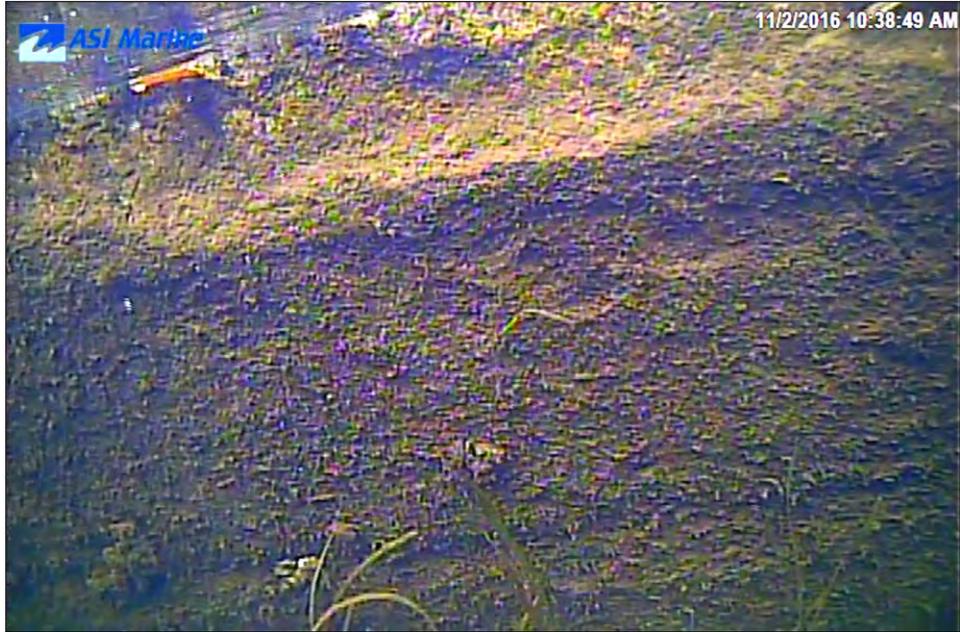
Image 3F-25: 103.8 m - Scour mark.

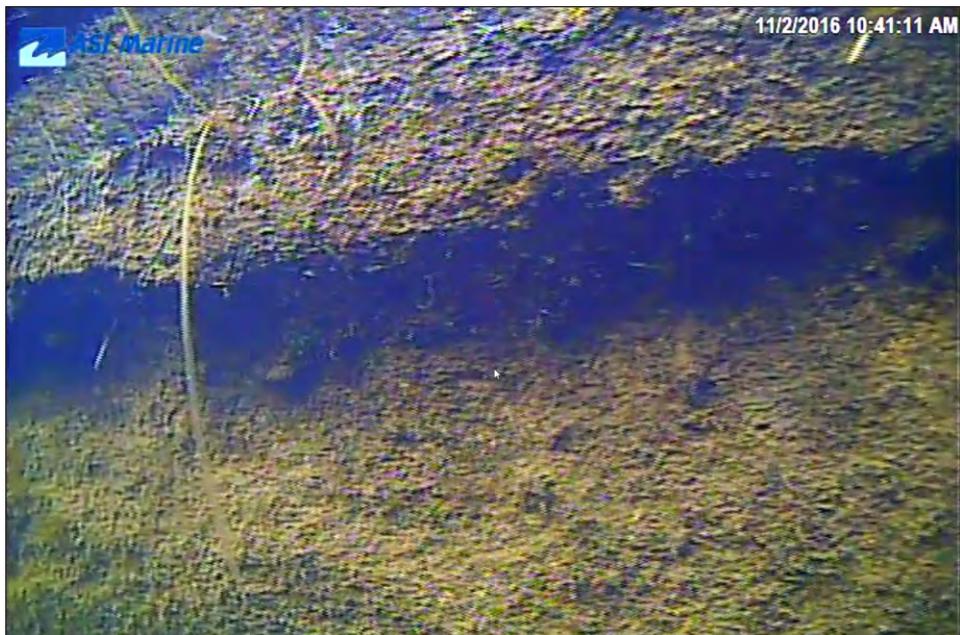
Image 3F-26: 106.3 m - Start of undercutting.

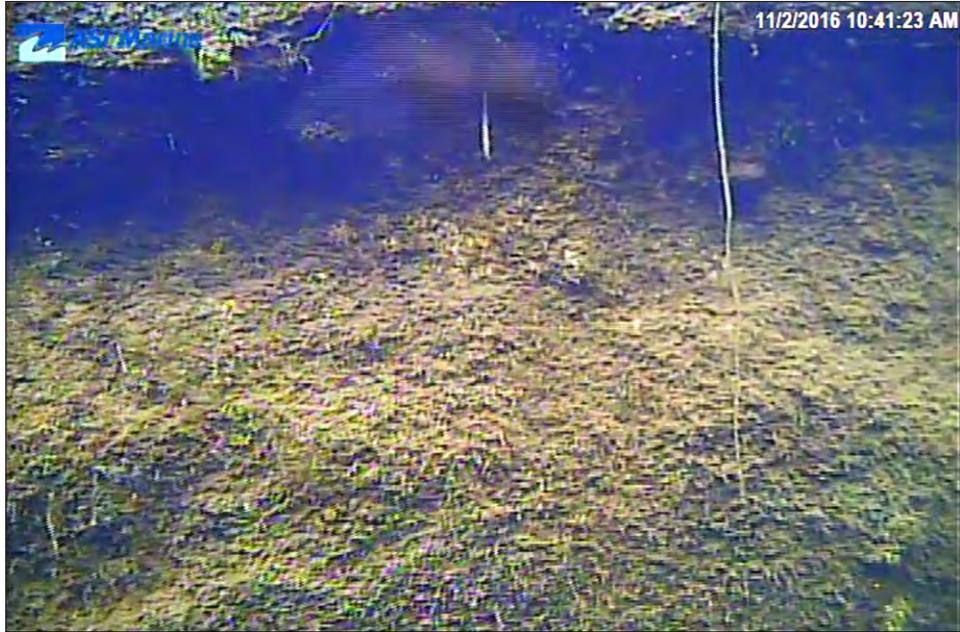
Image 3F-27: 106.8 m - Undercutting continues.

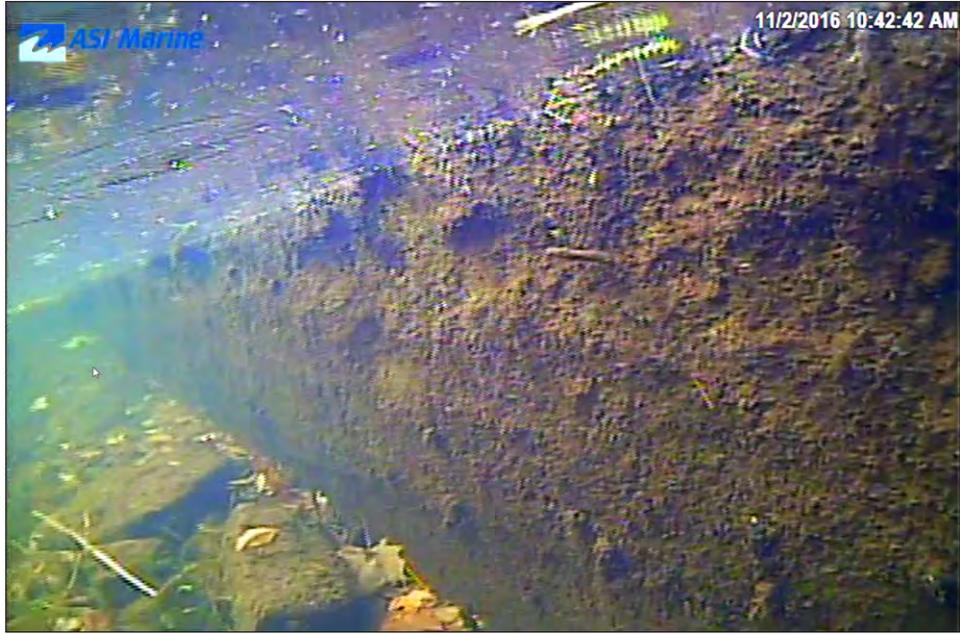
Image 3F-29: 108.3 m to 115.5 m - Cluster of scour marks.

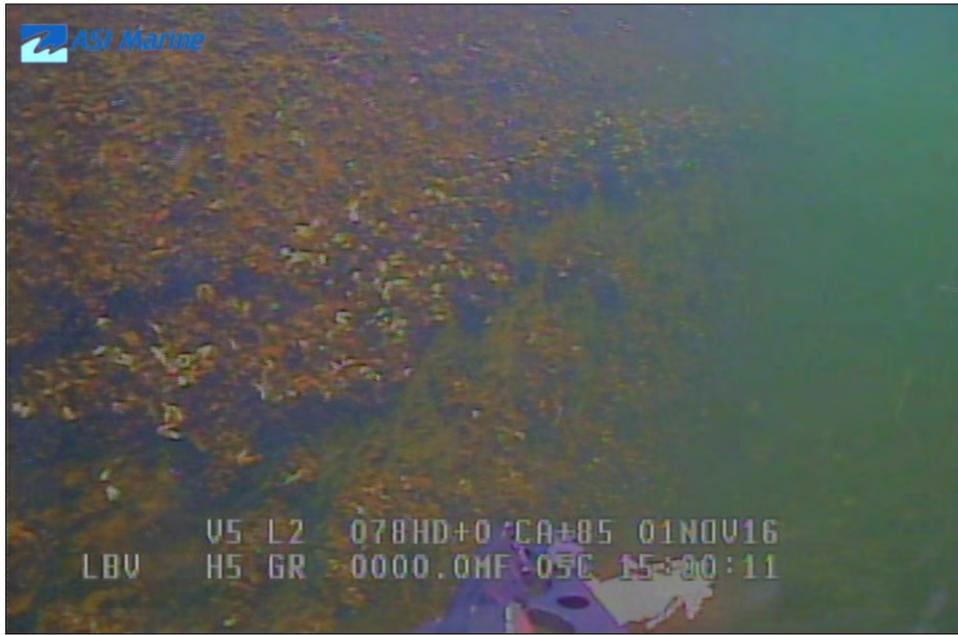
Image 3G-01: Heavy biofouling 2 m from corner.

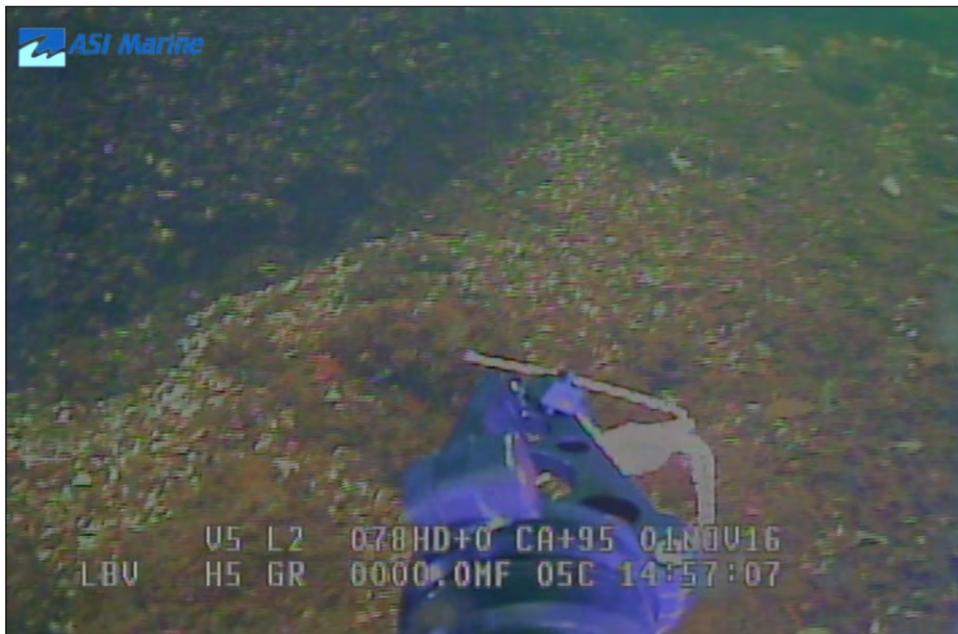
Image 3G-08: Slight undercutting on corner.

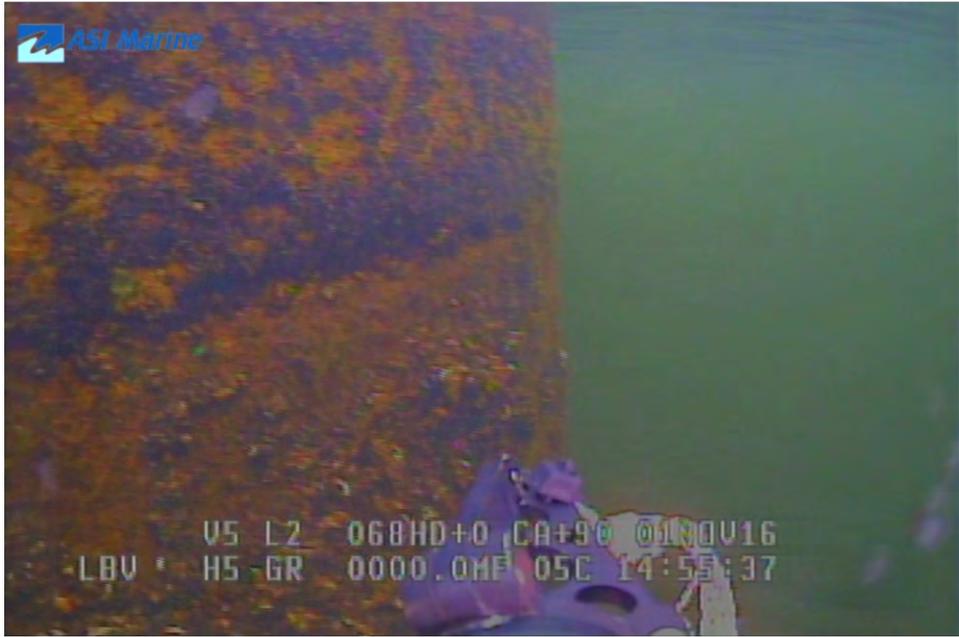
Image 3G-09: Scour mark on the northwest corner.

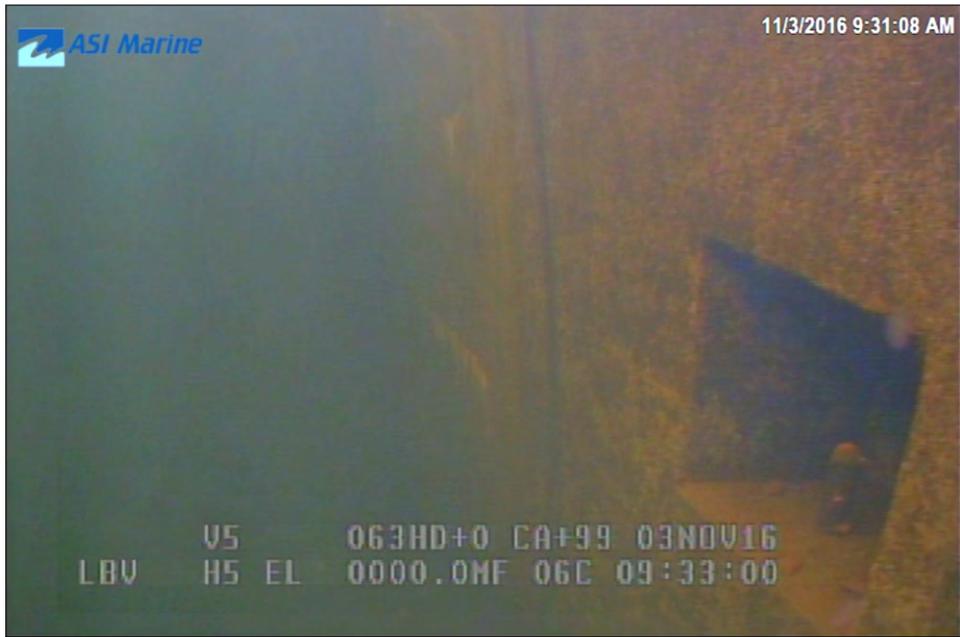
Image 3H-07: Northeast opening in concrete wall.

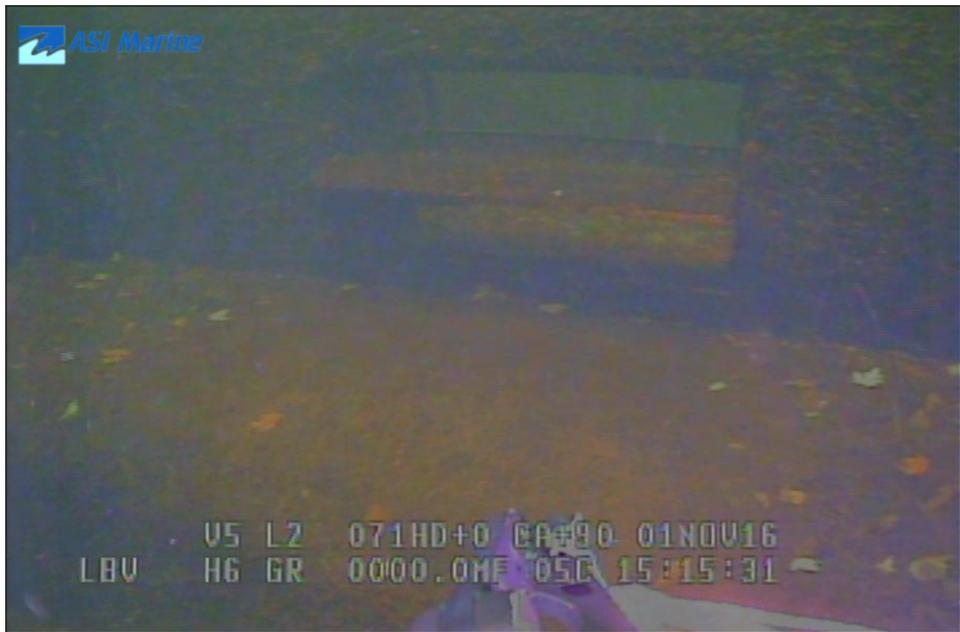
Image 3H-08: Northwest open gate slot.

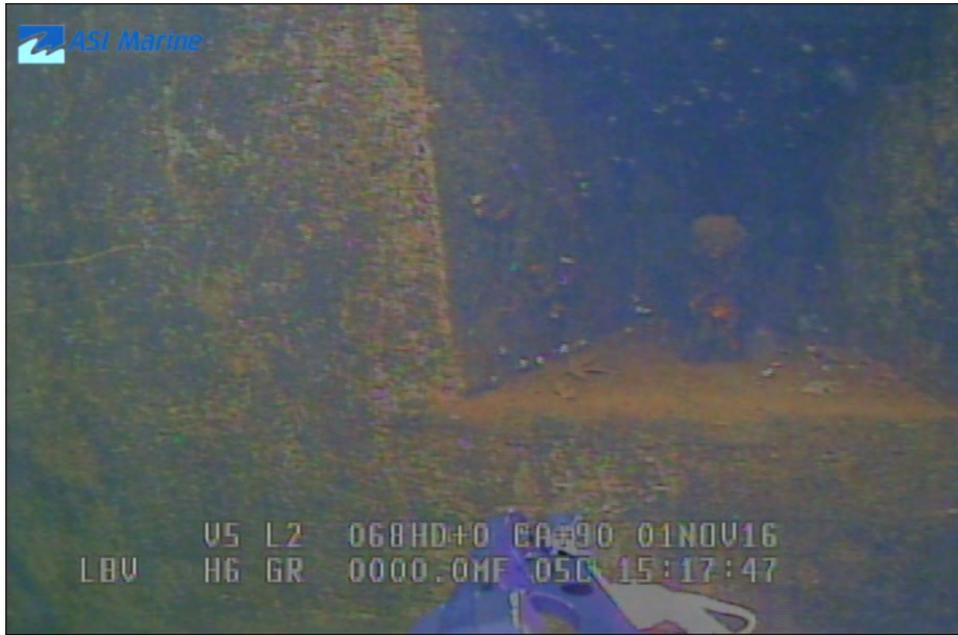
Image 3H-09: Northwest opening in concrete wall.

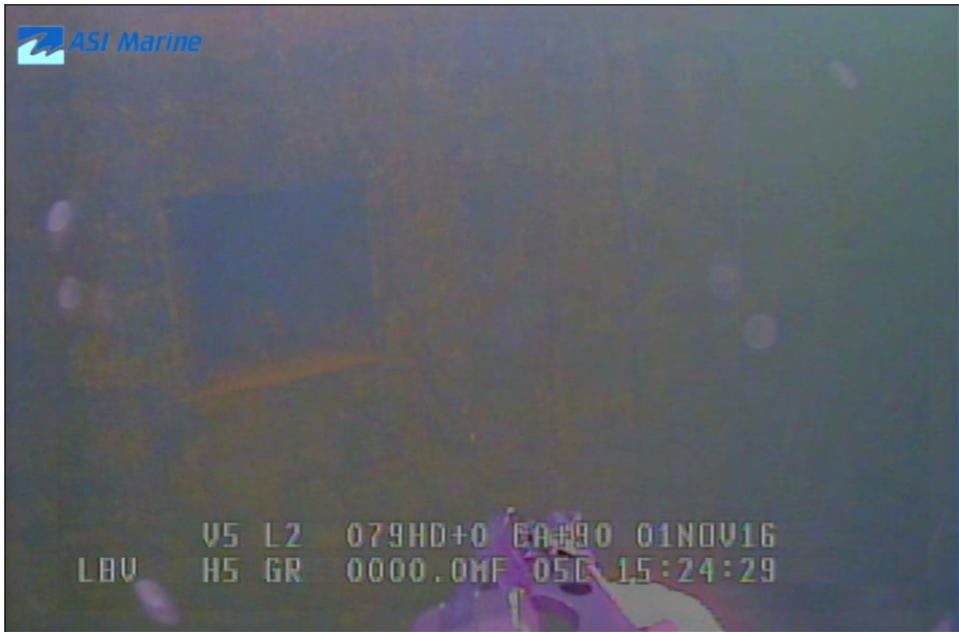
Image 3H-11: Southeast opening in concrete wall.

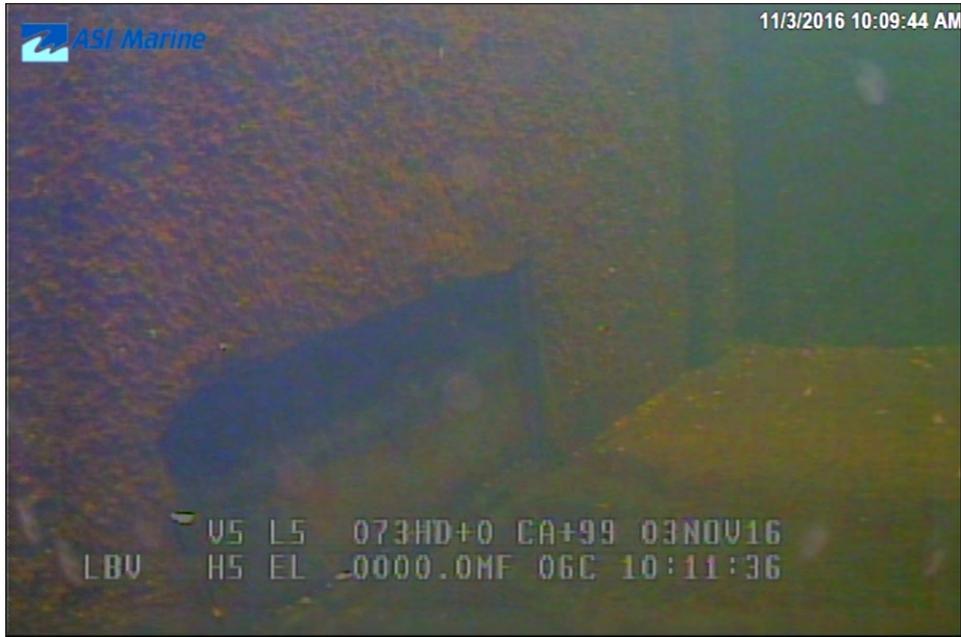
Image 3I-01: Lock 45 lower east gate opening.

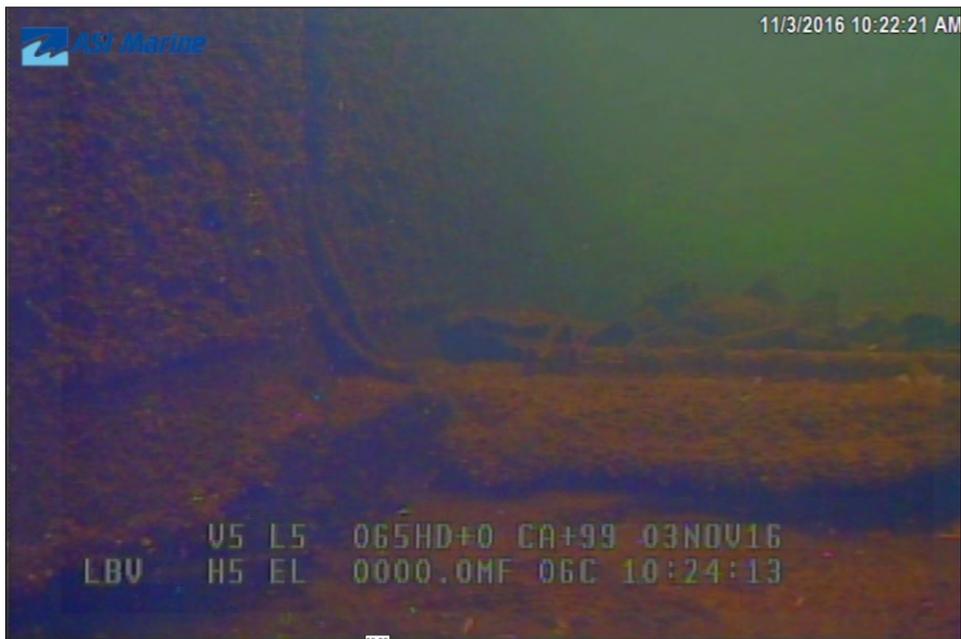
Image 3I-02: Lock 45 lower east wall conduit channel.

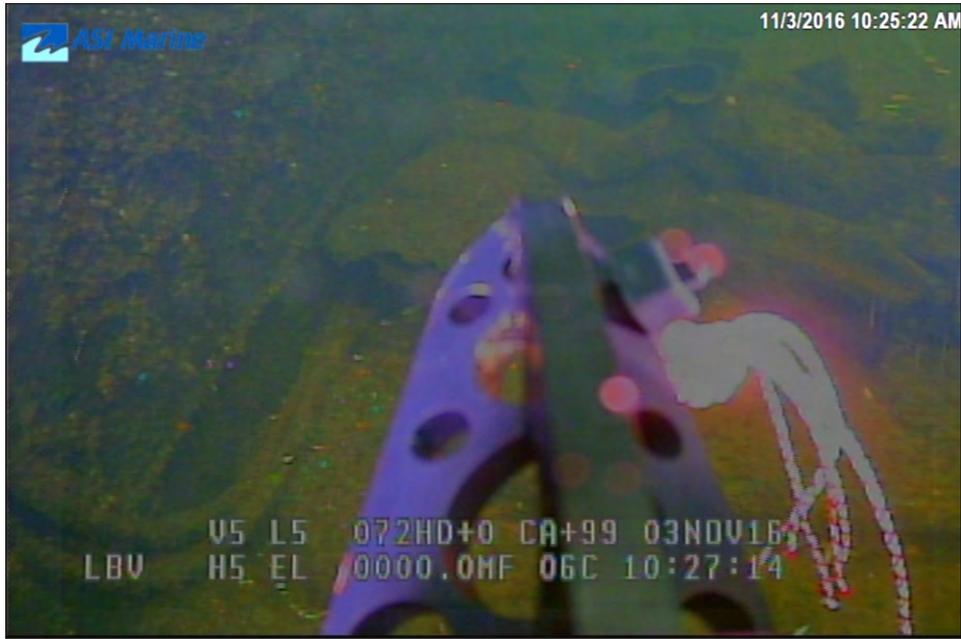
Image 3I-03: Lock 45 lower east wall conduit on bottom.

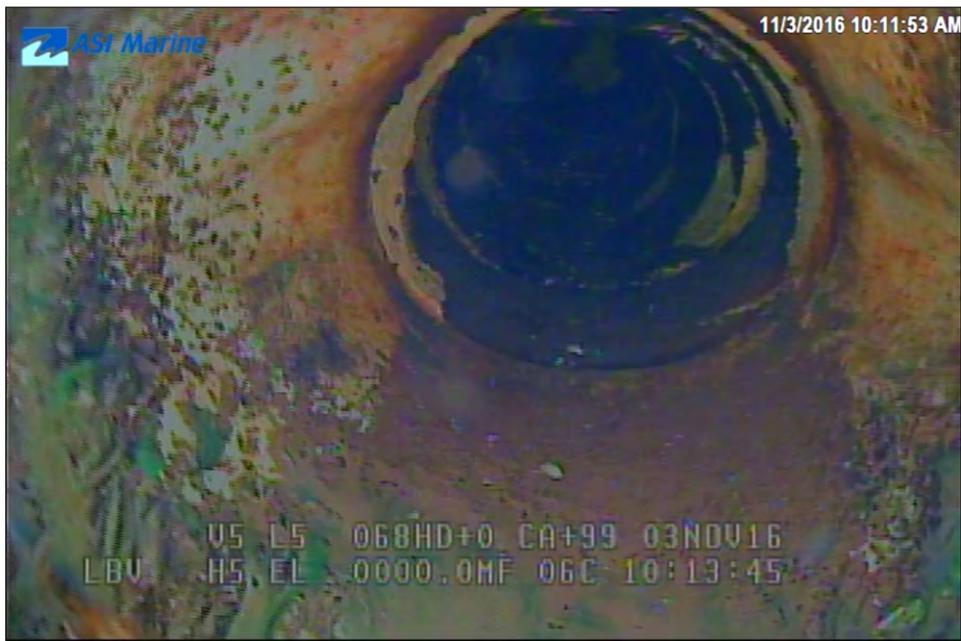
Image 3I-04: Lock 45 lower east wall hole in wall internal.

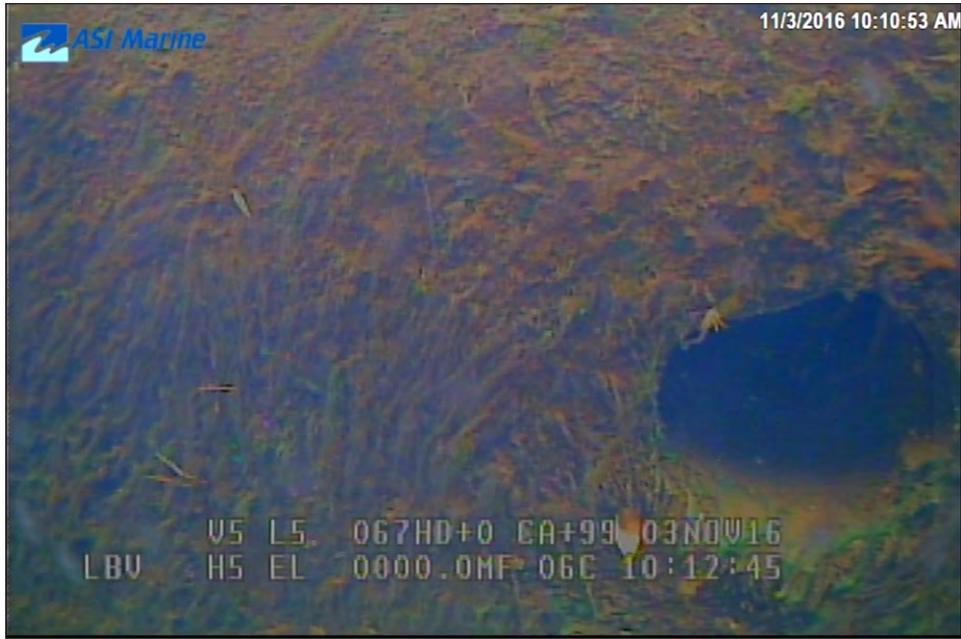
Image 3I-05: Lock 45 lower east wall hole in wall.

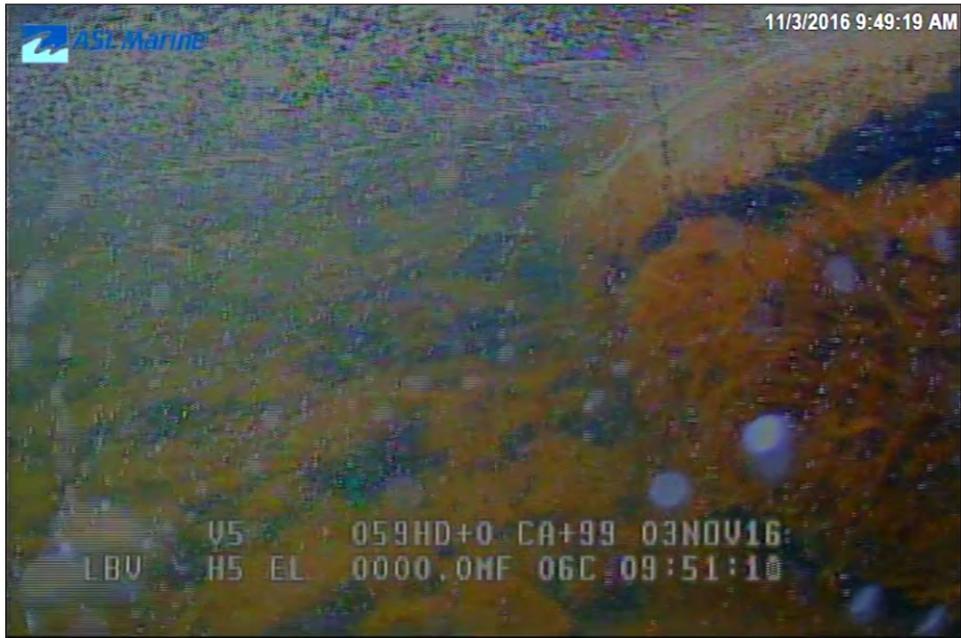
Image 3I-06: Lock 45 lower southwest corner of wall near water surface.

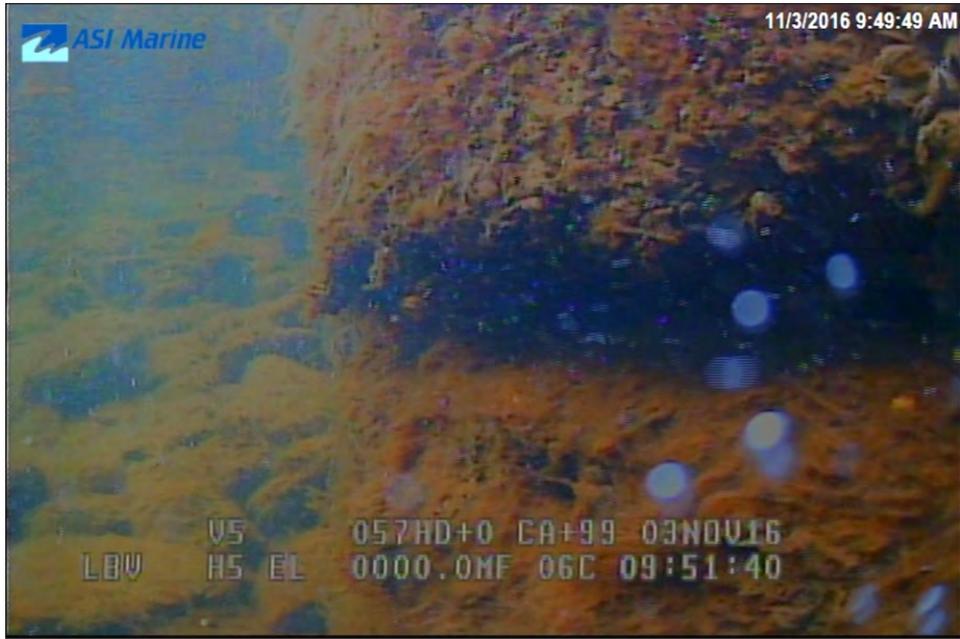
Image 3I-07: Lock 45 lower southwest corner of wall showing spalling near the bottom.
