Rehabilitation of Port Severn Area Dams, Fixed Bridge and Lock

Investigation Report

Public Works and Government Services Canada

November 21 2017

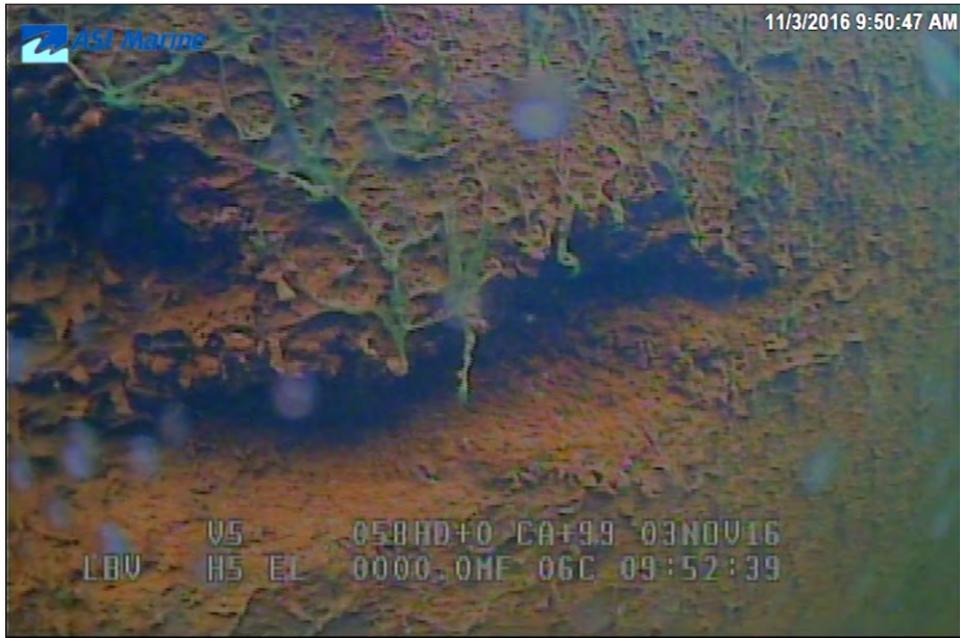
Image 3I-08: Lock 45 lower southwest corner spalling on inside of lock.

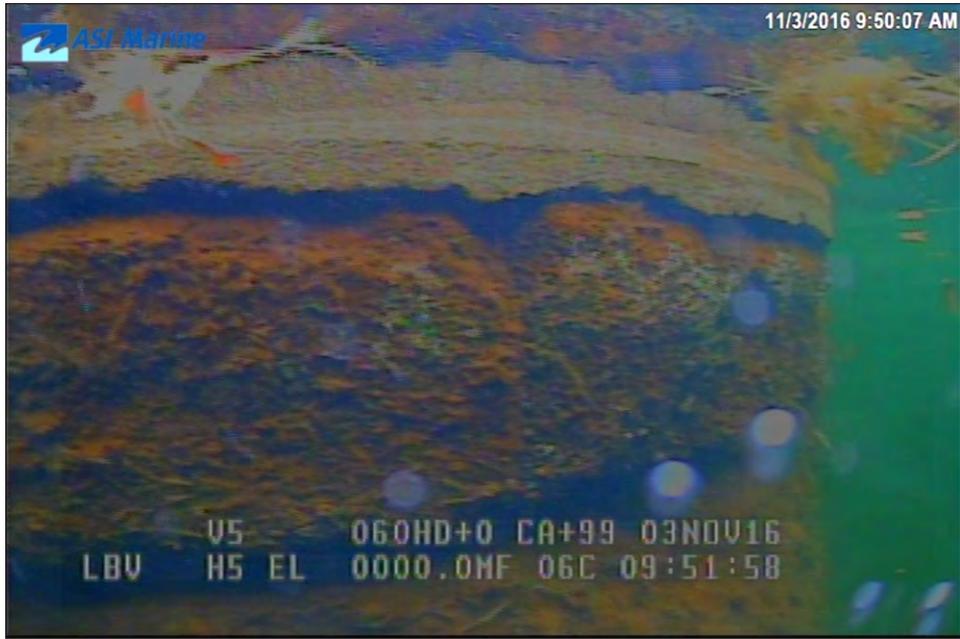
Image 3I-09: Lock 45 lower southwest corner spalling near water surface at end of west wall.

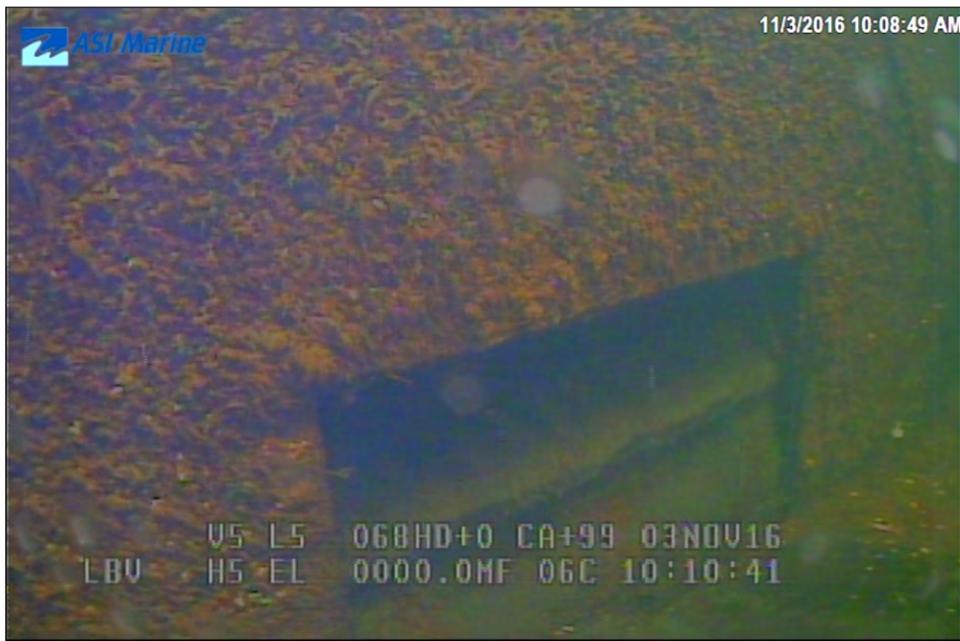
Image 3I-10: Lock 45 lower west gate opening.

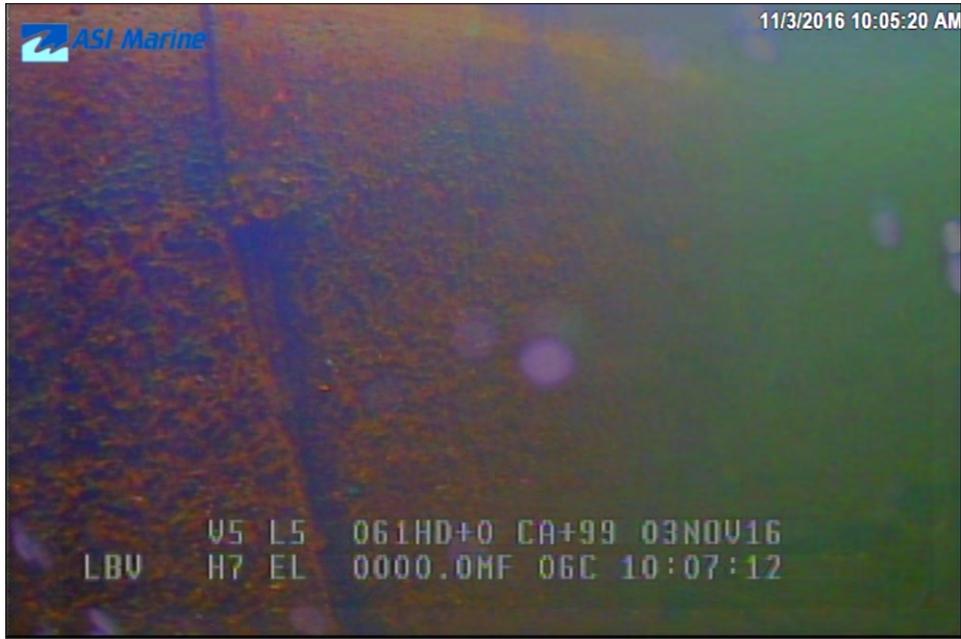
Image 3I-11: Lock 45 lower west wall conduit channel.

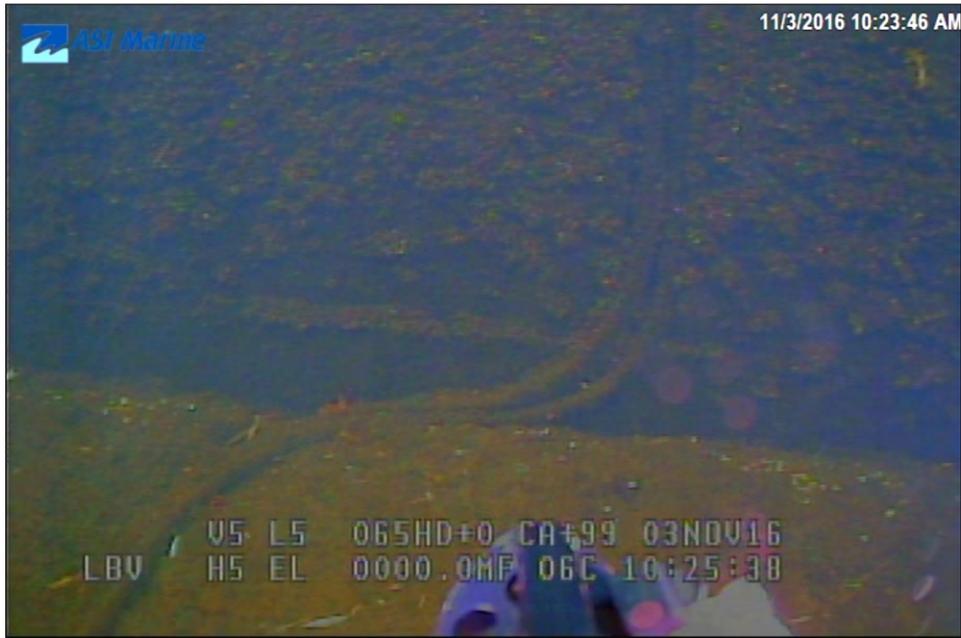
Image 3I-12: Lock 45 lower west wall conduit on bottom.

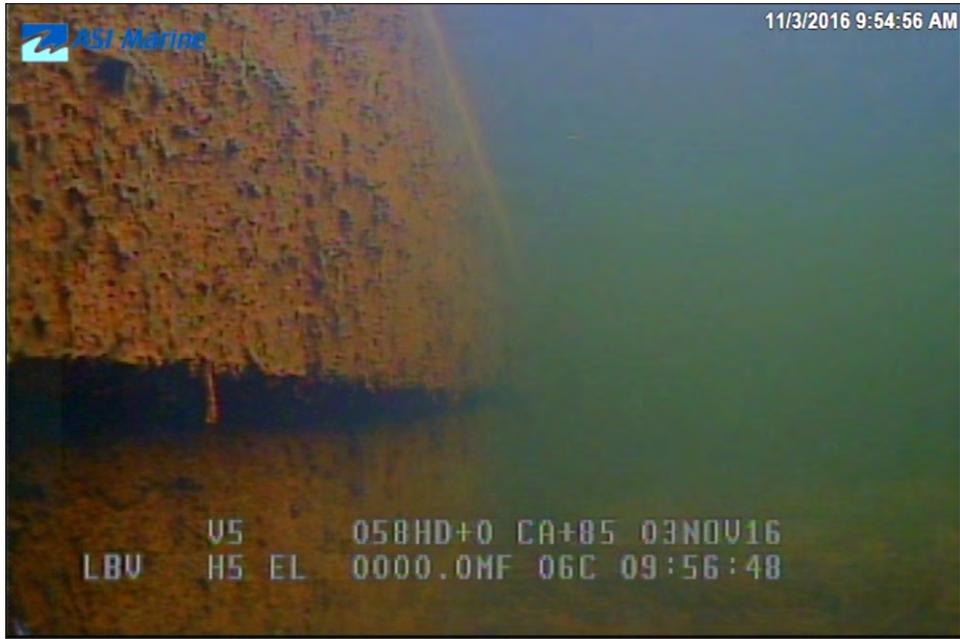
Image 3I-13: Lock 45 lower west wall horizontal form line.

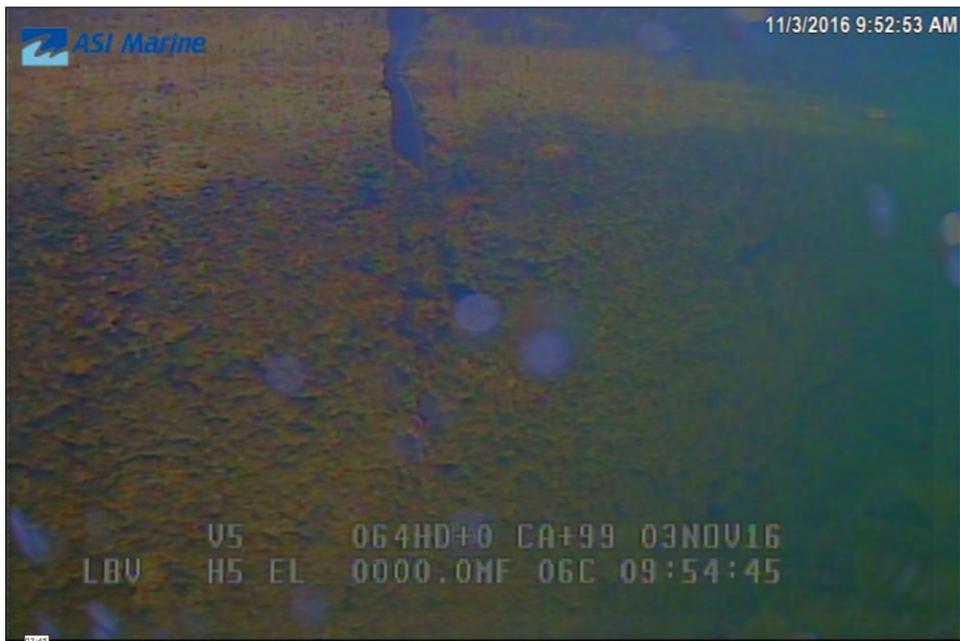
Image 3I-14: Lock 45 lower west wall joint.

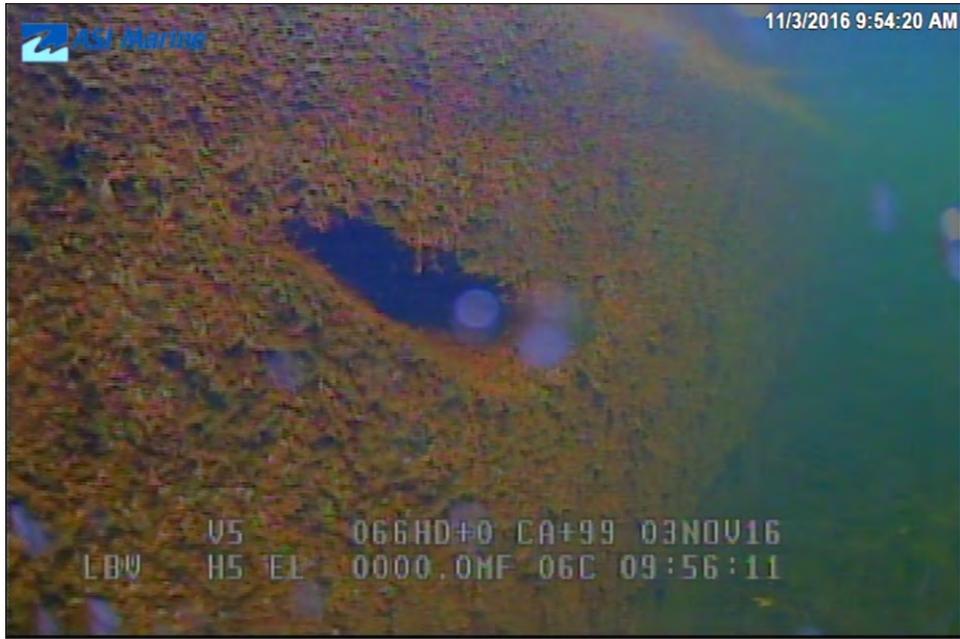
Image 3I-15: Lock 45 lower west wall scour mark - 15 m from edge.

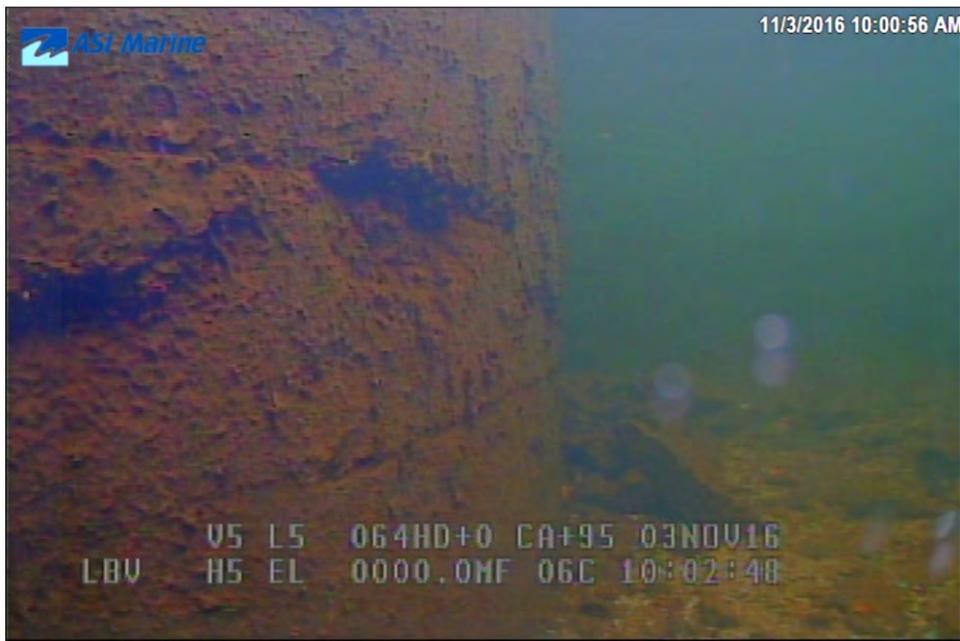
Image 3I-16: Lock 45 lower west wall slight scour on taper of wall.

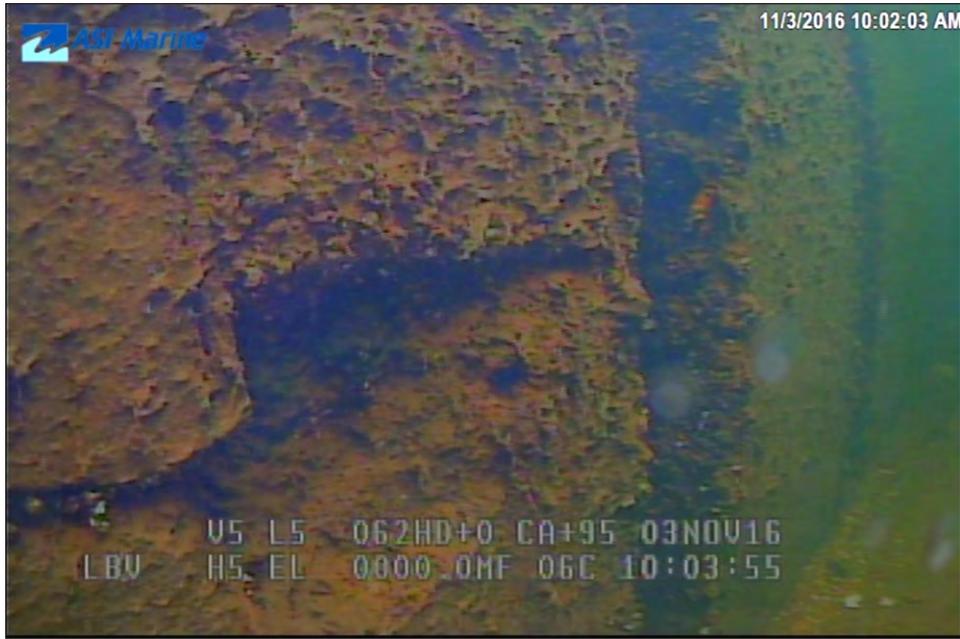
Image 3I-17: Lock 45 lower west wall spalling at downstream gate slot.

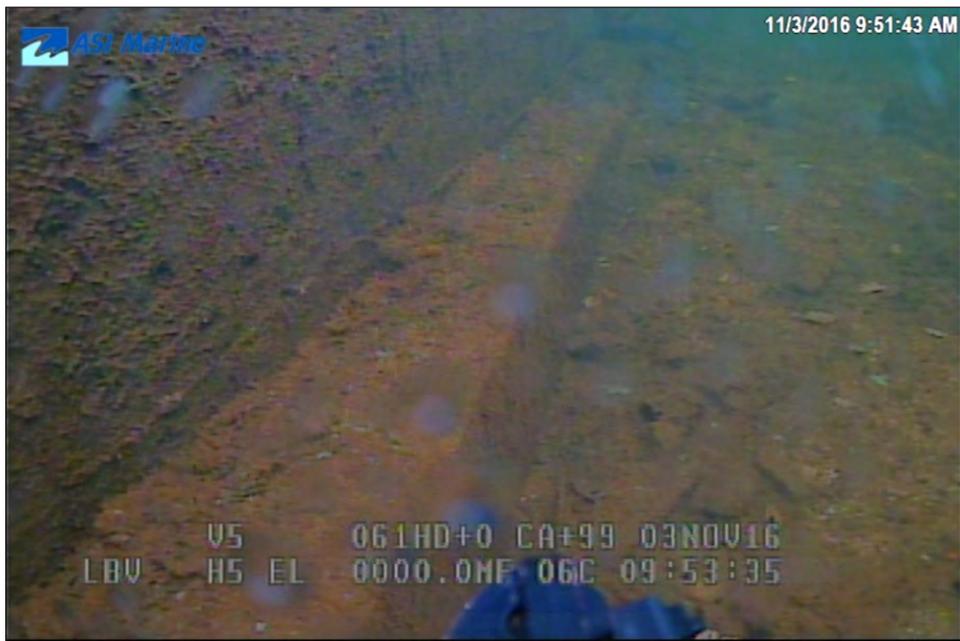
Image 3I-18: Lock 45 lower west wall transition to bottom.

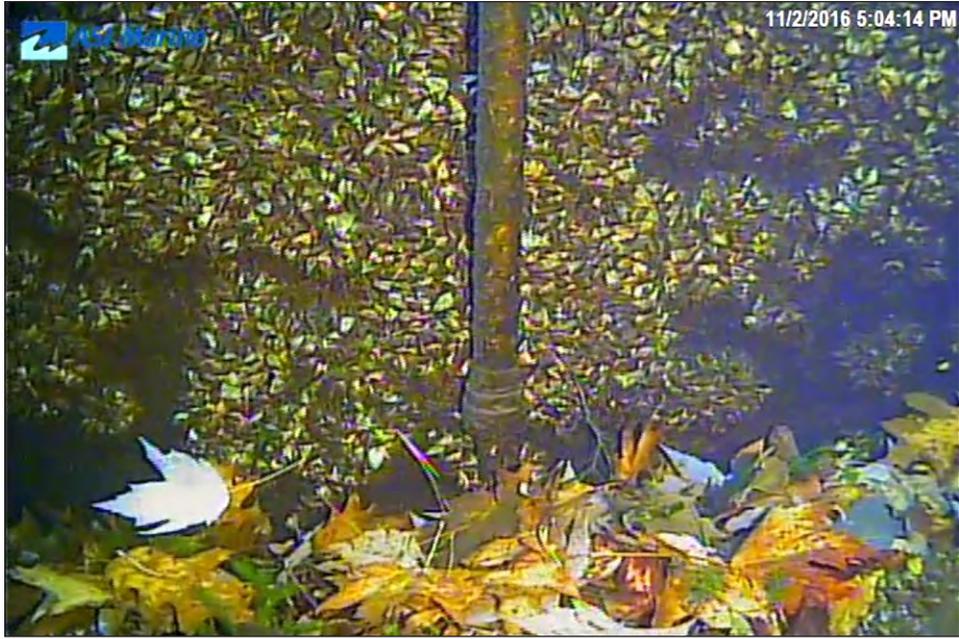
Image 3J-01: 3.2 m - Bottom of pipe.

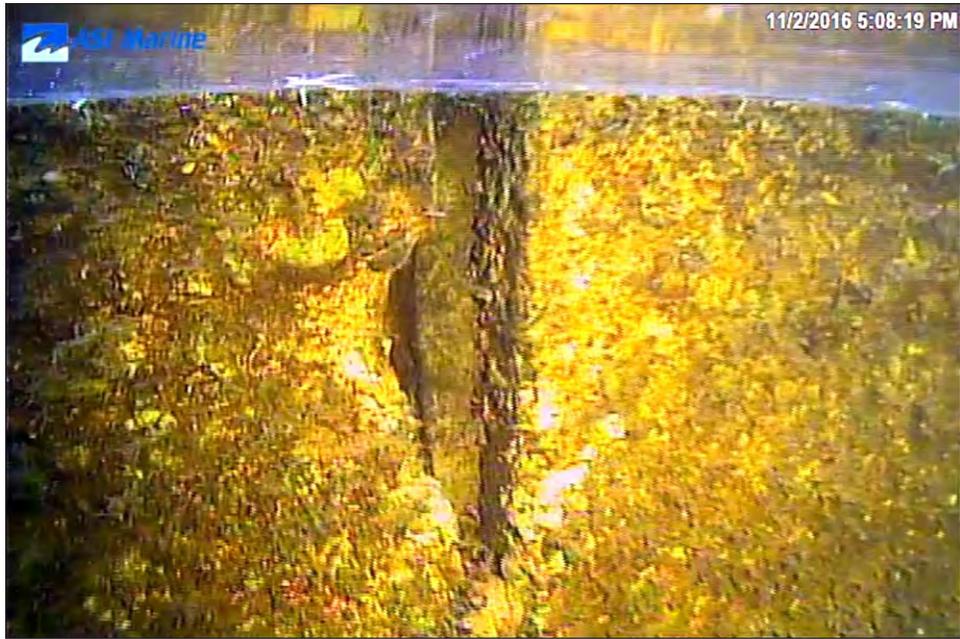
Image 3J-03: 13.95 m - Joint with some separation and spalling.

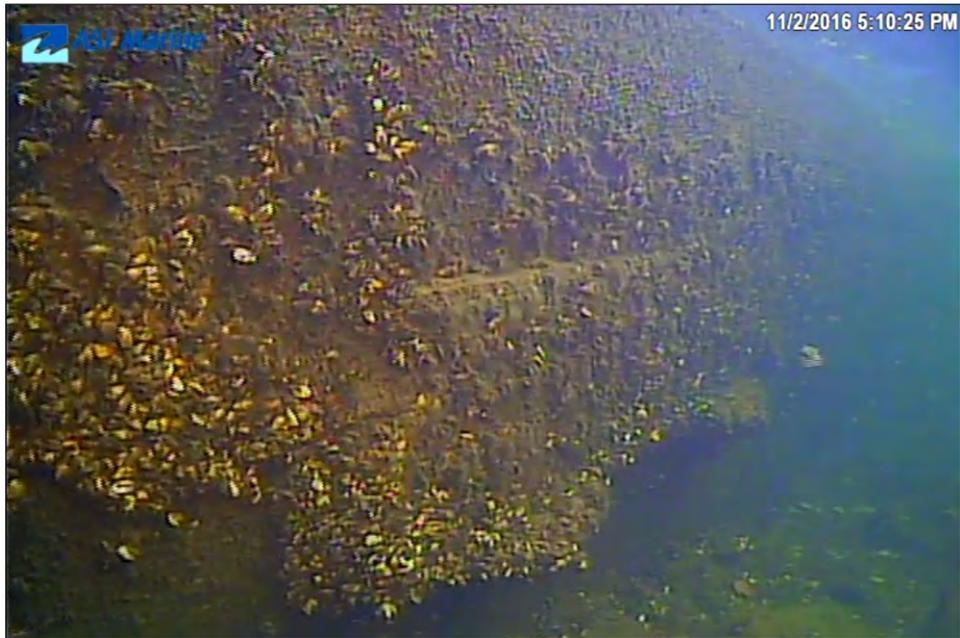
Image 3J-04: 17.6 m - Protrusion from wall continues to 19.2 m.

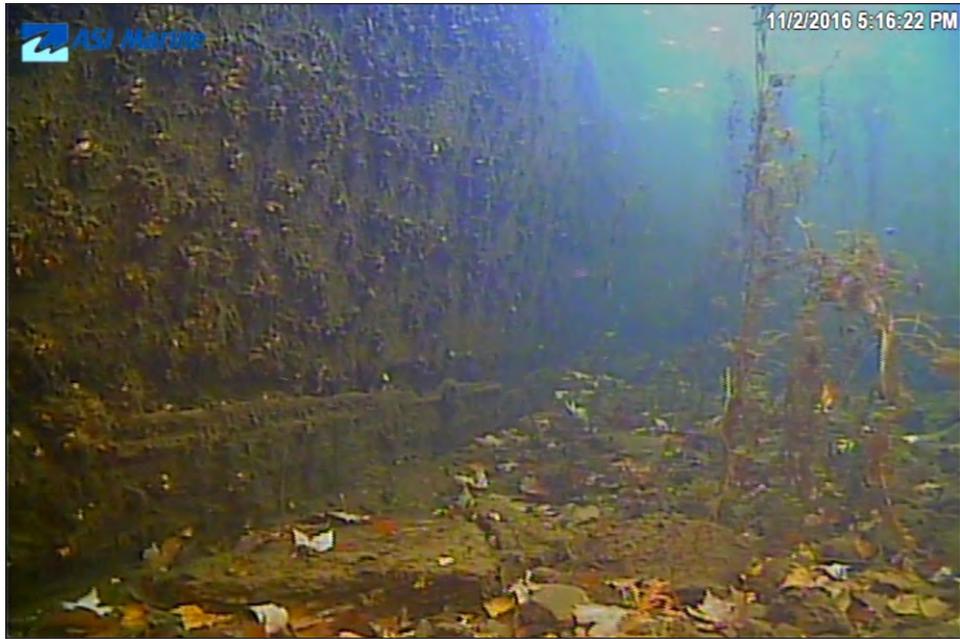
Image 3J-05: 28 m - Wood concrete forms on bottom.

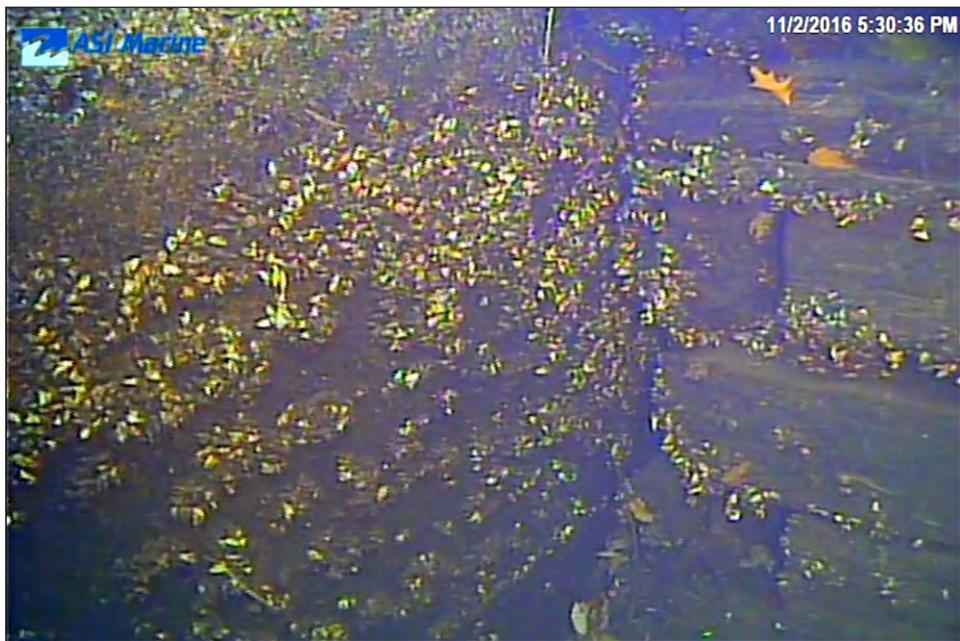
Image 3J-06: 40 m - East side of dock.

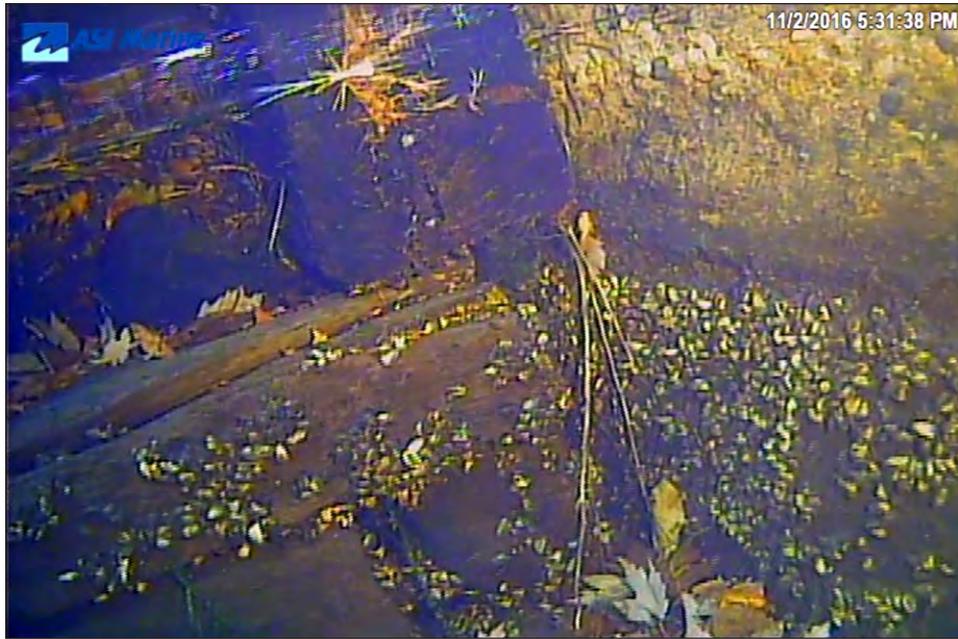
Image 3J-07: 43.3 m - West side of dock.

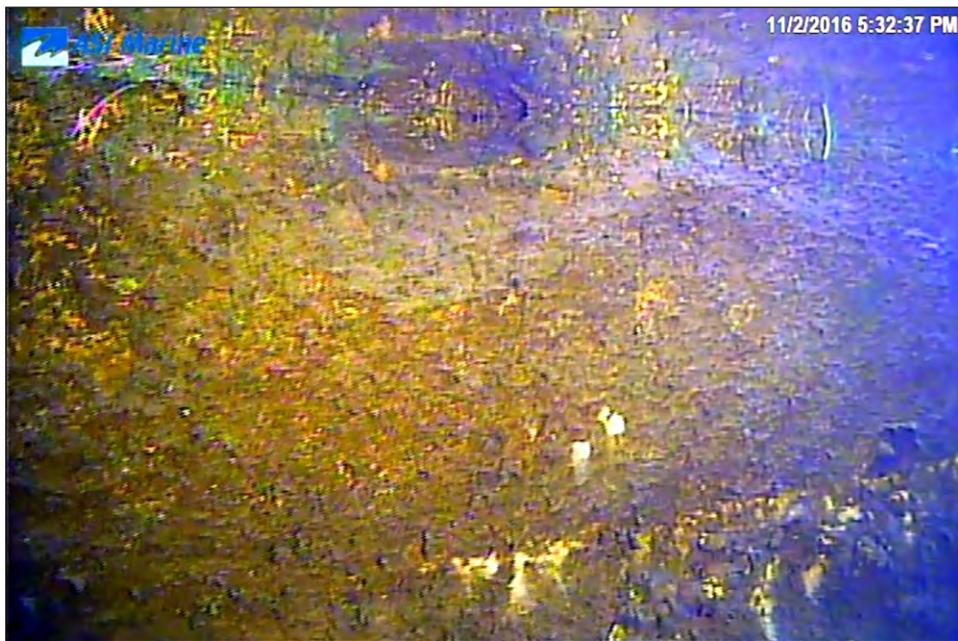
Image 3J-08: 44.4 m - 40 cm wide spall worsening above water surface.

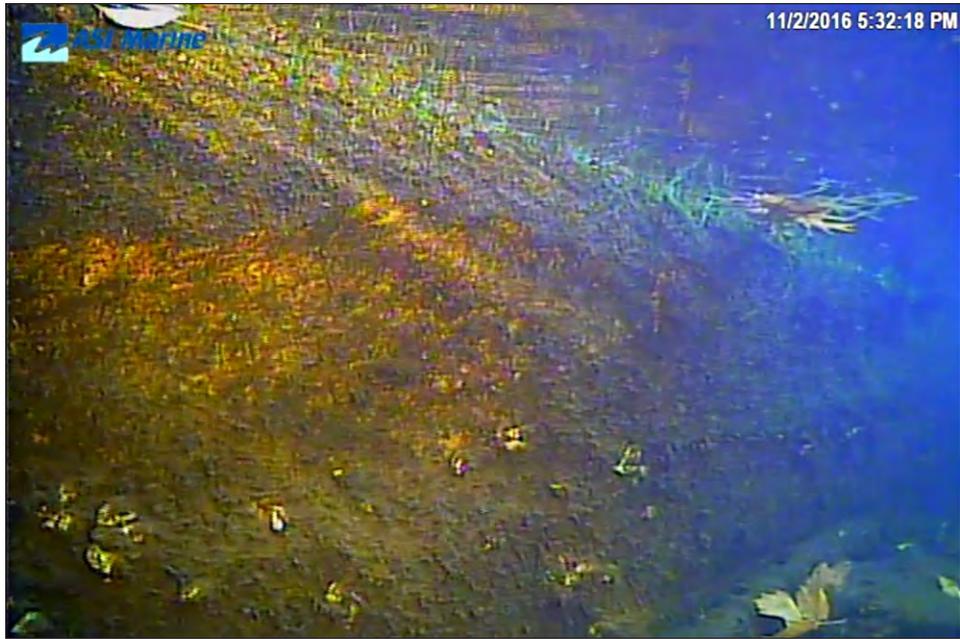
Image 3J-09: 44.4 m - Spalling continues to 44.8 m.

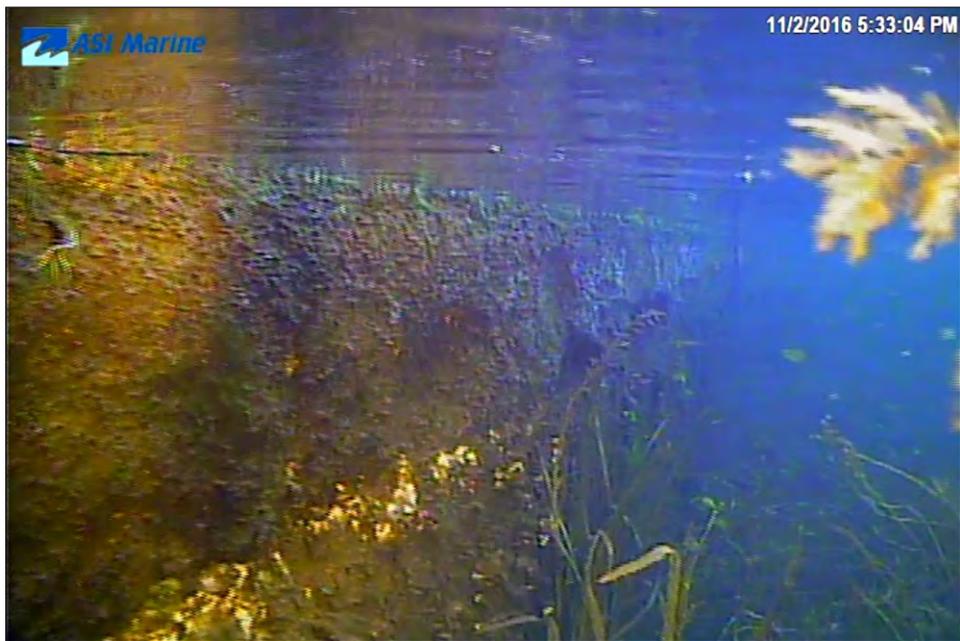
Image 3J-10: 46.2 m - Minor horizontal spalling.

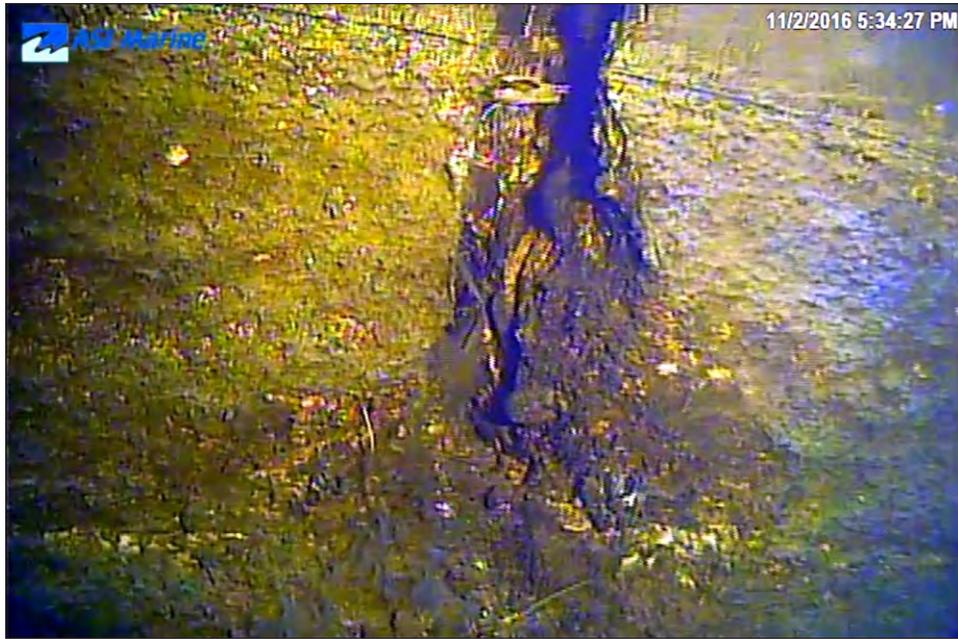
Image 3J-11: 50.1 m - Crack in wall with spalling.

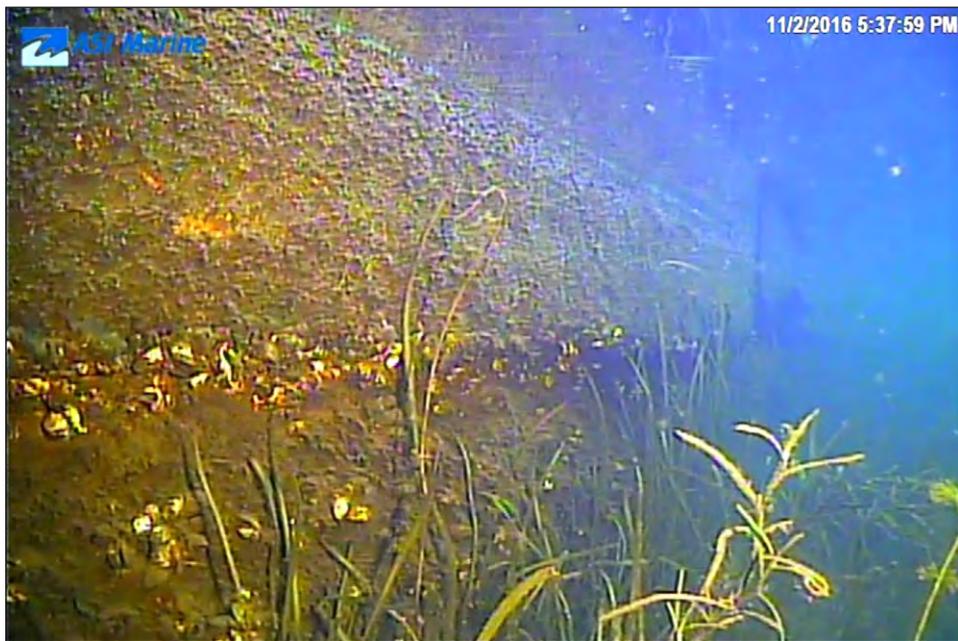
Image 3J-12: 54 m - Horizontal cracking.

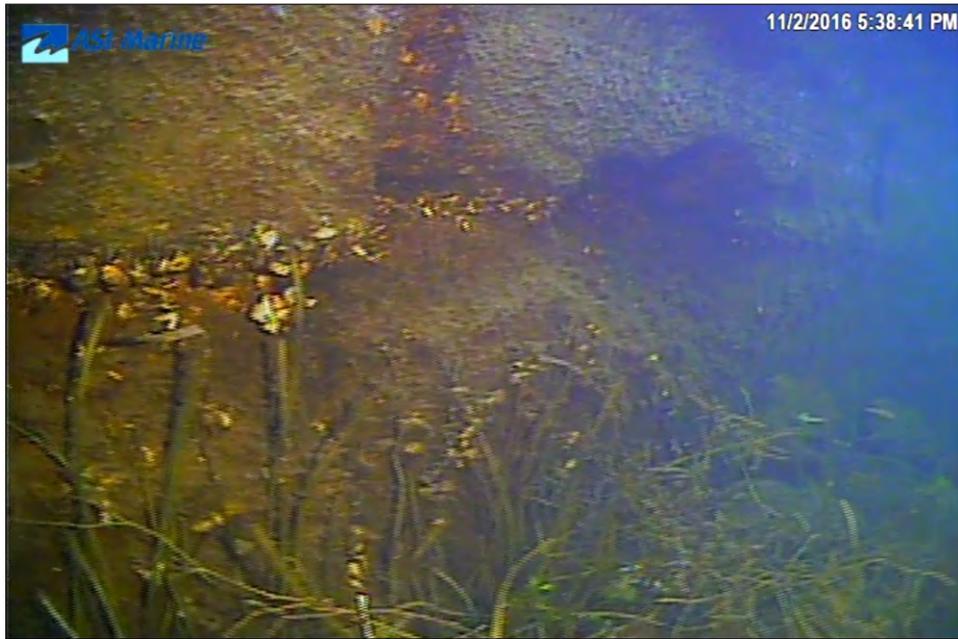
Image 3J-13: 57 m - Spalling on either end of open joint.

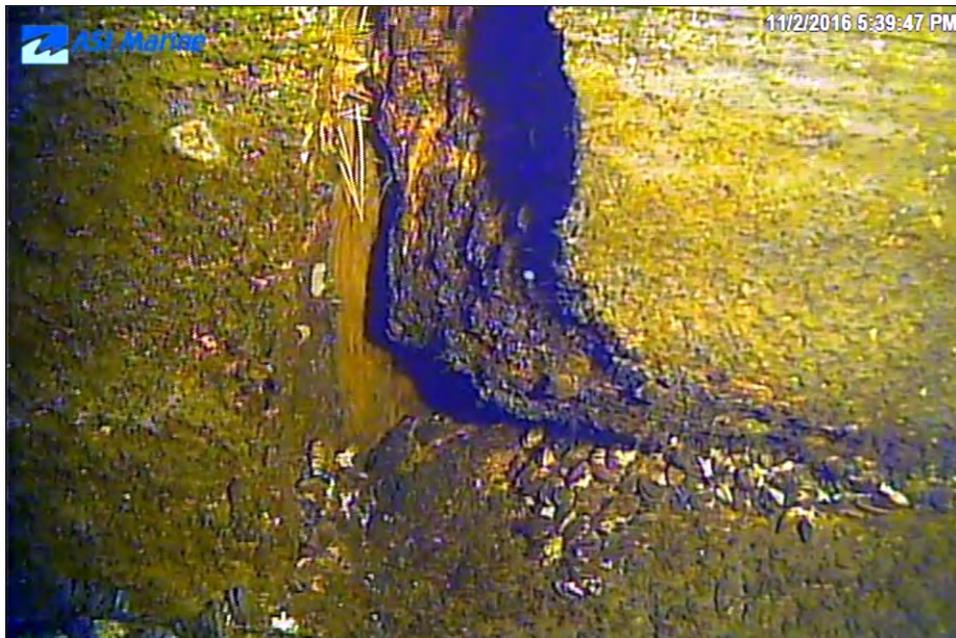
Image 3J-14: 57.7 m - Joint with spalling and wooden material.

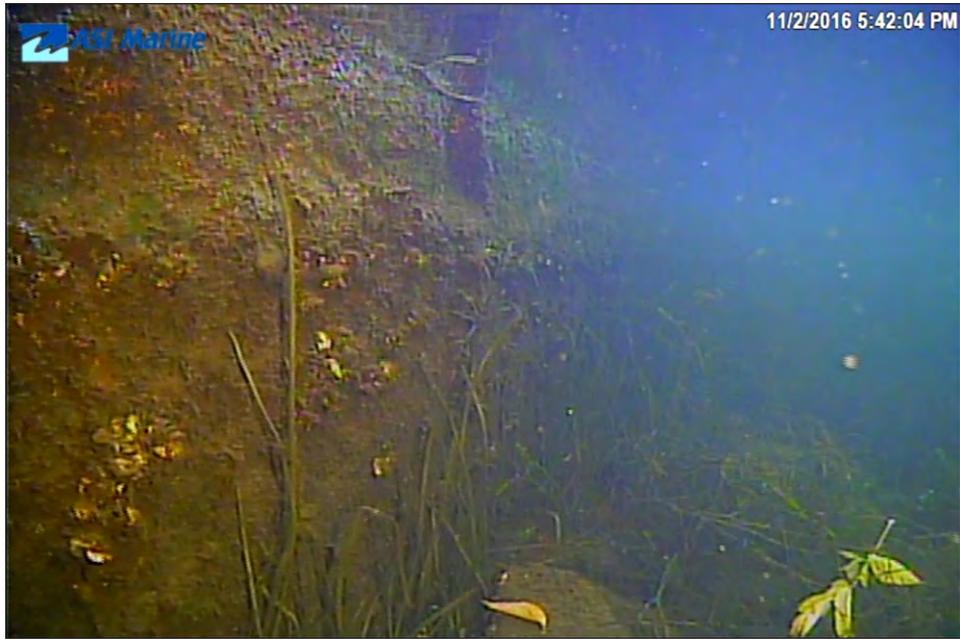
Image 3J-15: 61.9 m - Slight spalling below surface.

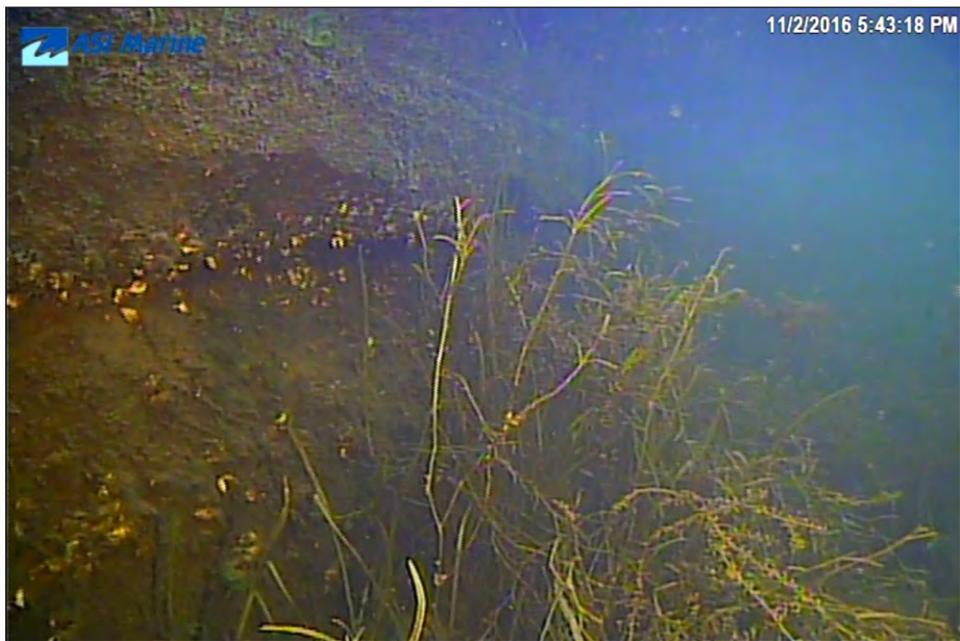
Image 3J-16: 65.1 m - Spalling continues to 66.7 m.

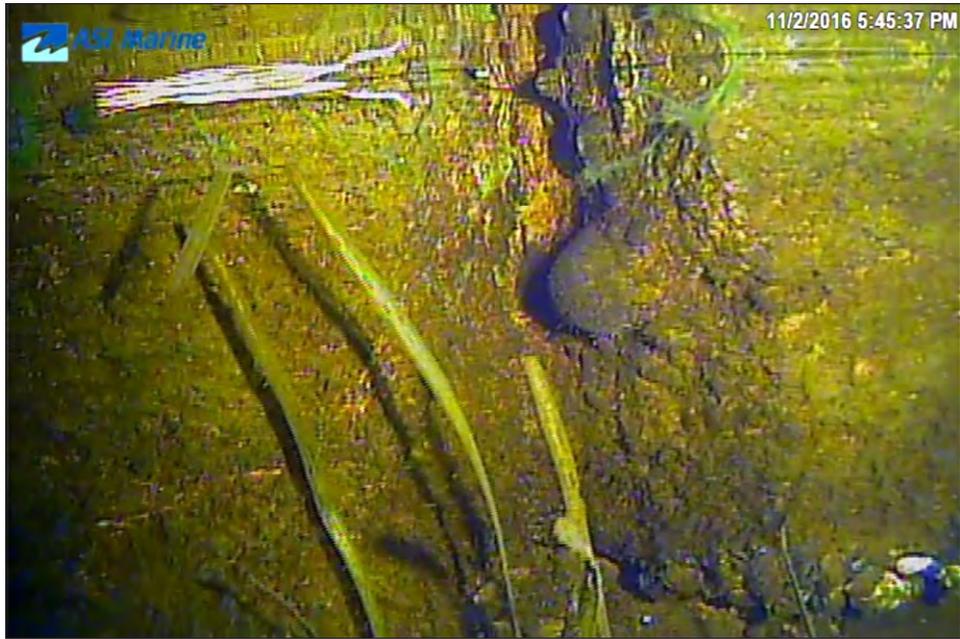
Image 3J-17: 67.7 m - Crack with spalling.

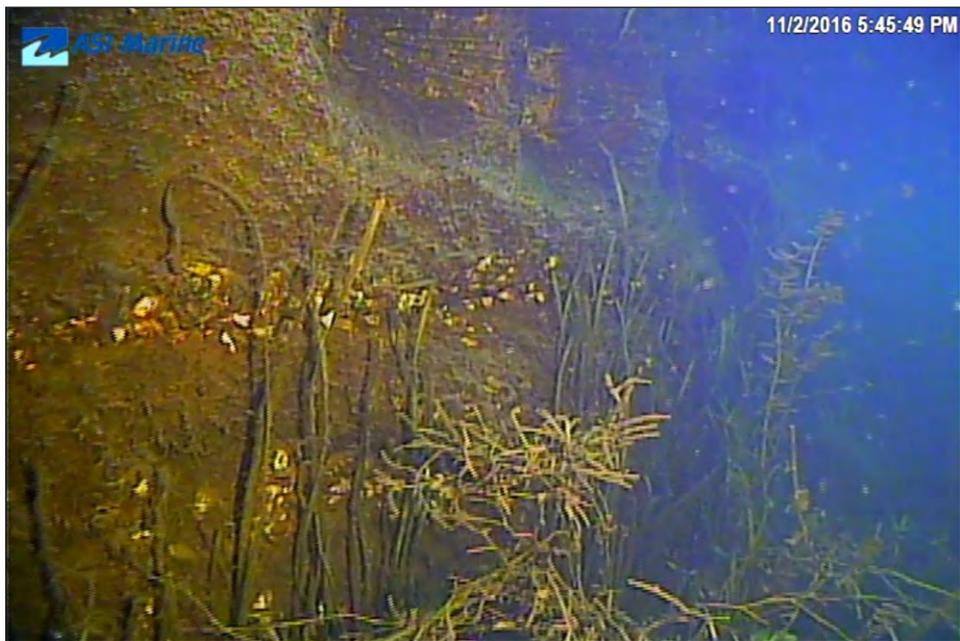
Image 3J-18: 68.6 m - Spalling that continues to 70.5 m.

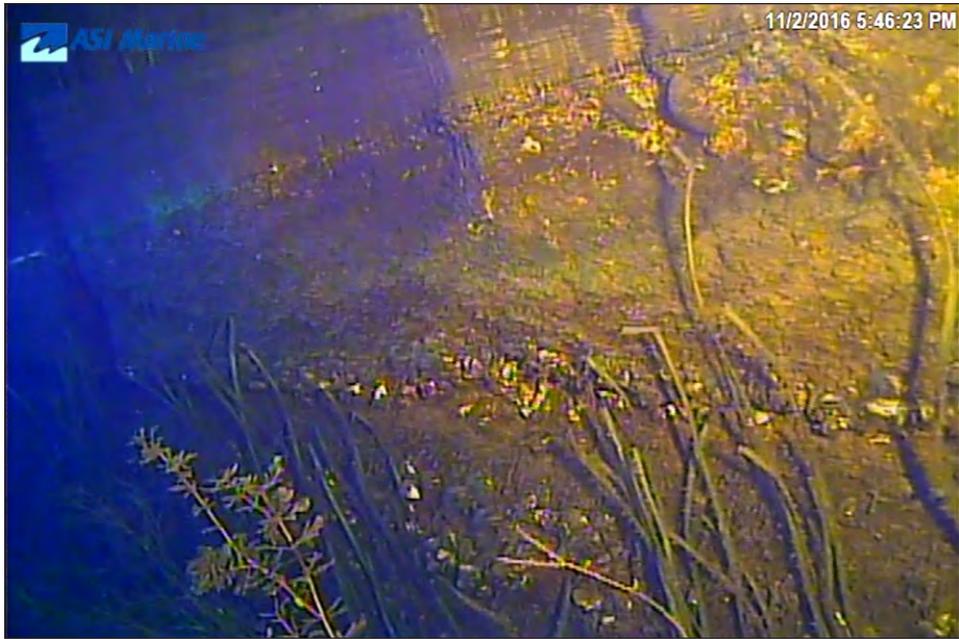
Image 3J-19: 70.5 m - Deep spalling 40 cm.

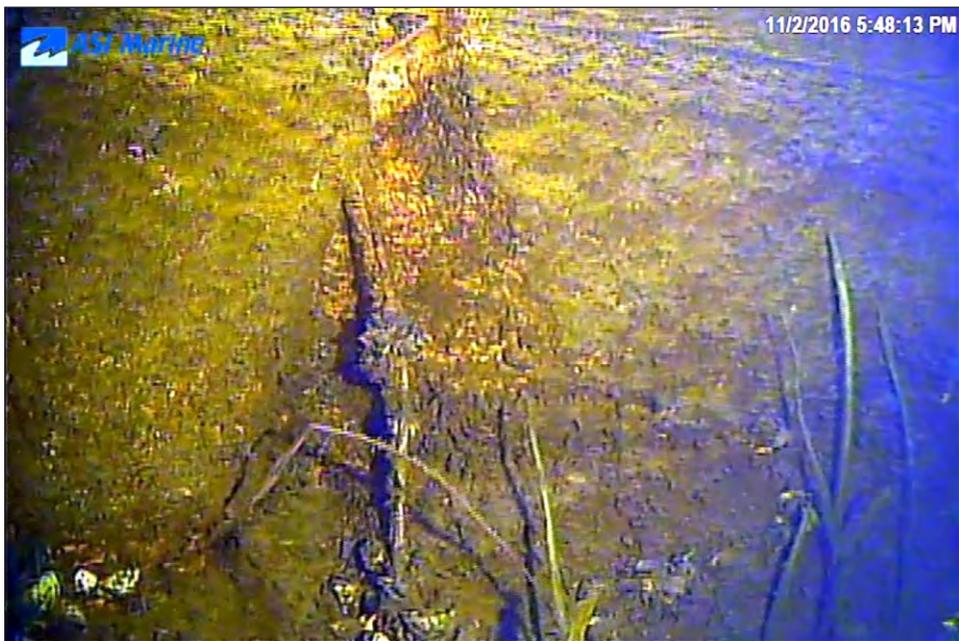
Image 3J-20: 73 m - Joint with spalling.

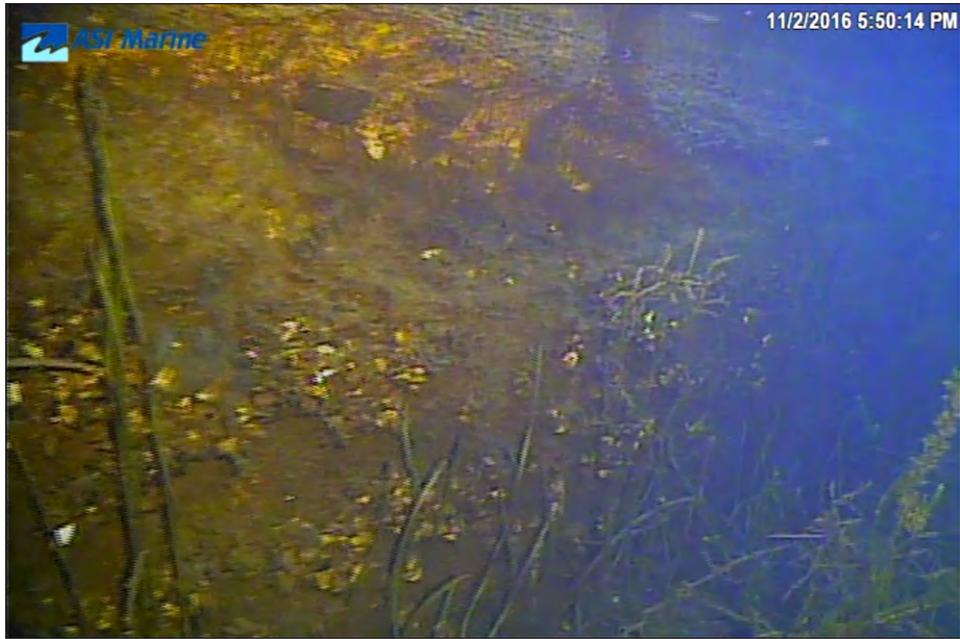
Image 3J-21: 79.9 m - Crack centred on spall that runs from 79.2 m to 80.4 m.

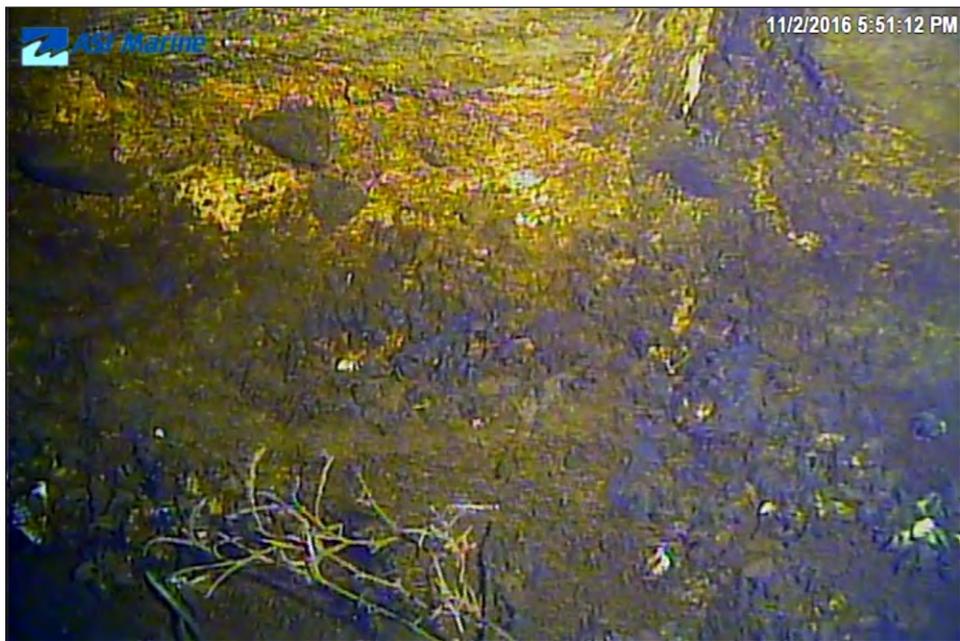
Image 3J-22: 79.9 m - Vertical crack ending at horizontal spalling.

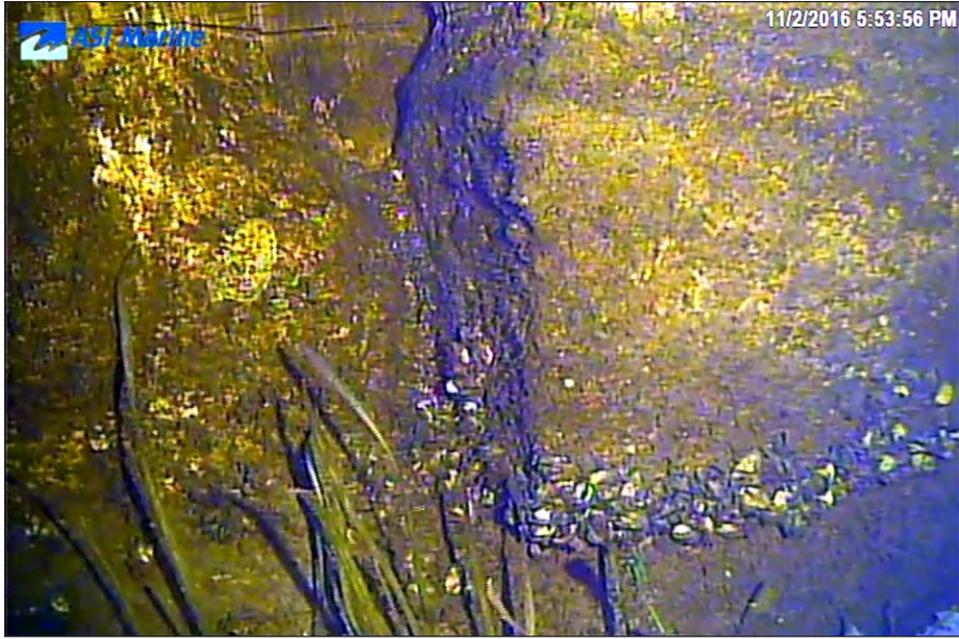
Image 3J-23: 88.2 m - Joint with spalling.

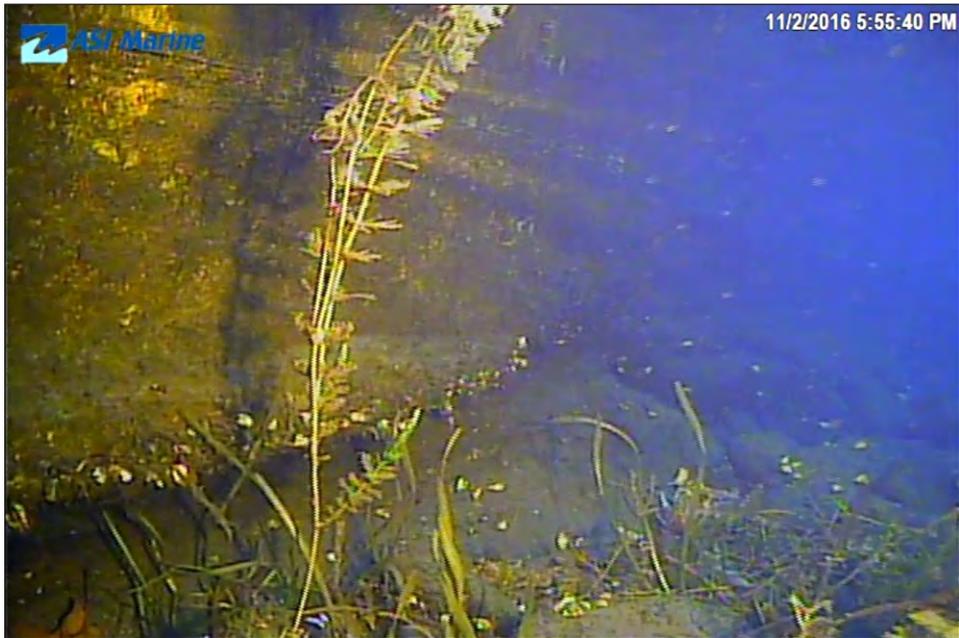
Image 3J-24: 88 m - Undercutting near bottom.

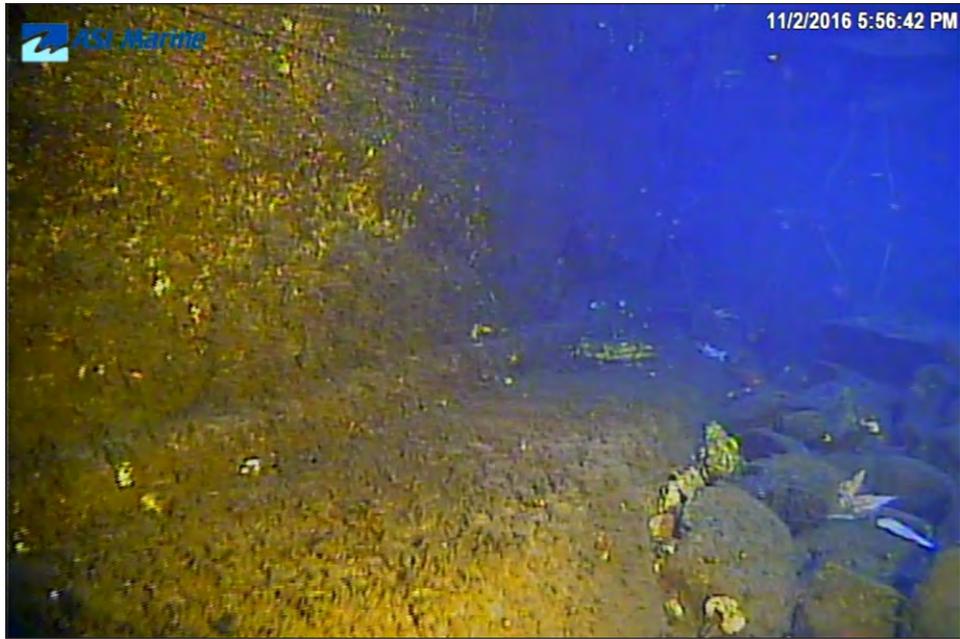
Image 3J-25: 92m - Poured edge near bottom.

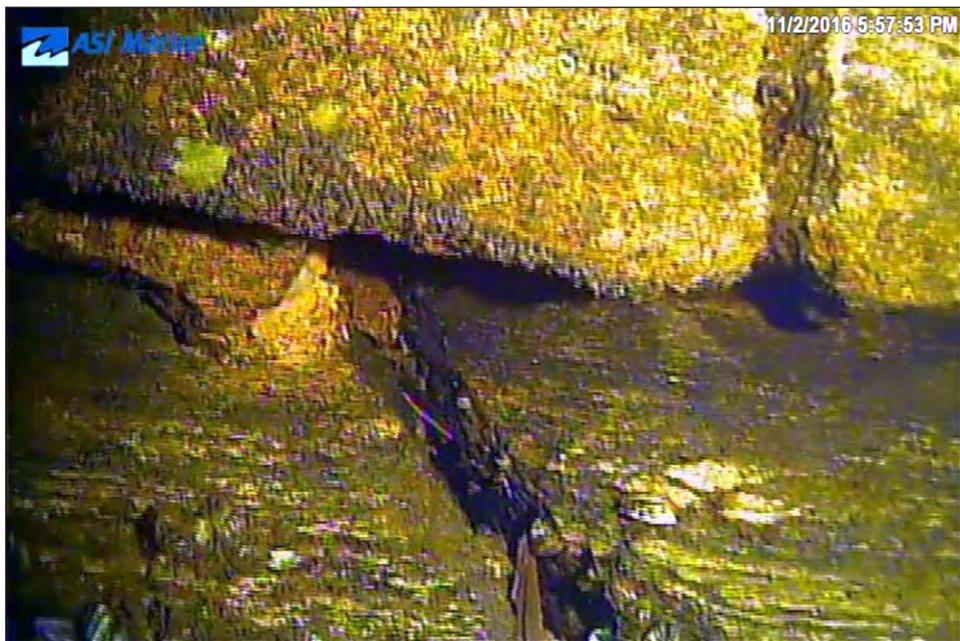
Image 3J-26: 96.7m - Crack at bedrock transition with undercutting.

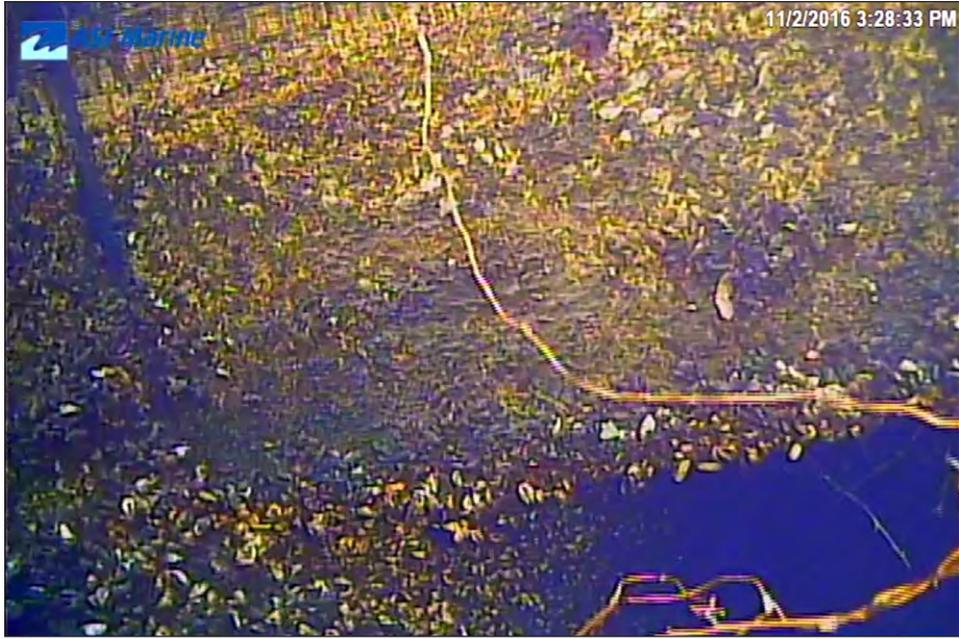
Image 3K-01: 0 m - East side transition to lock.
