Rehabilitation of Port Severn Area Dams, Fixed Bridge and Lock

Investigation Report

Public Works and Government Services Canada

November 21 2017

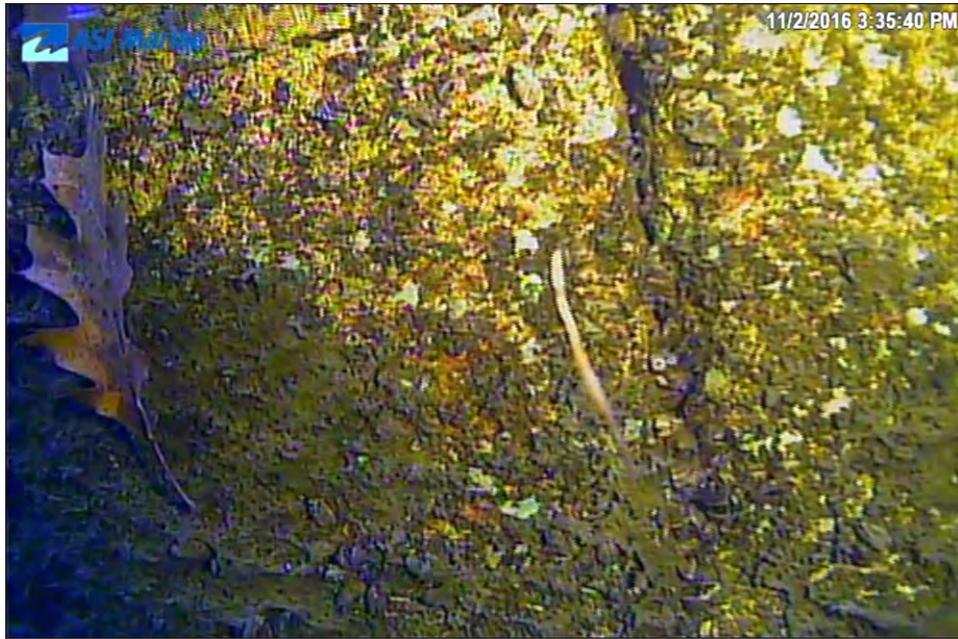
Image 3K-03: 6 m - East side joint.

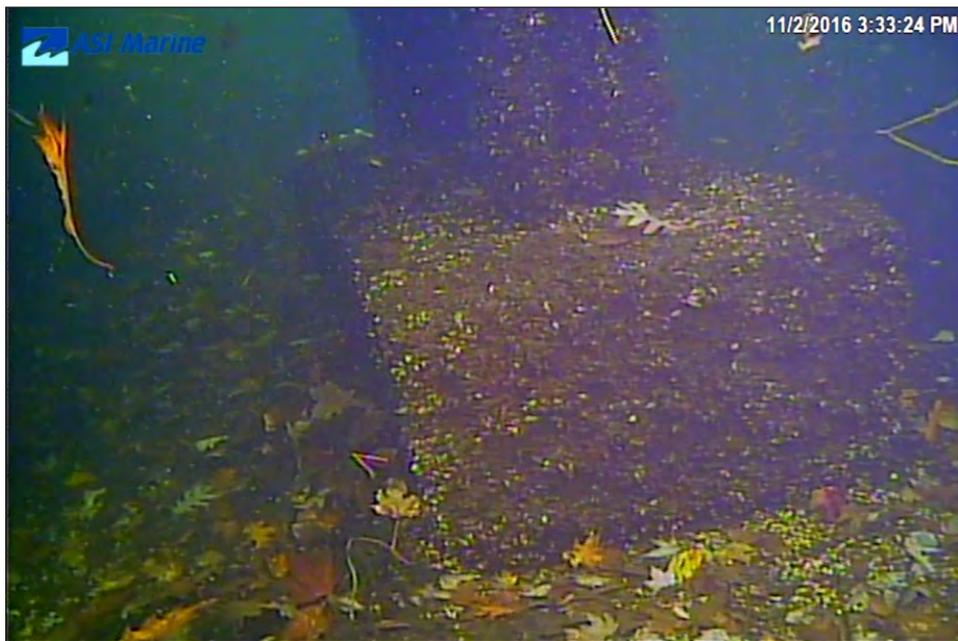
Image 3K-04: 6 m - East side lower column support.

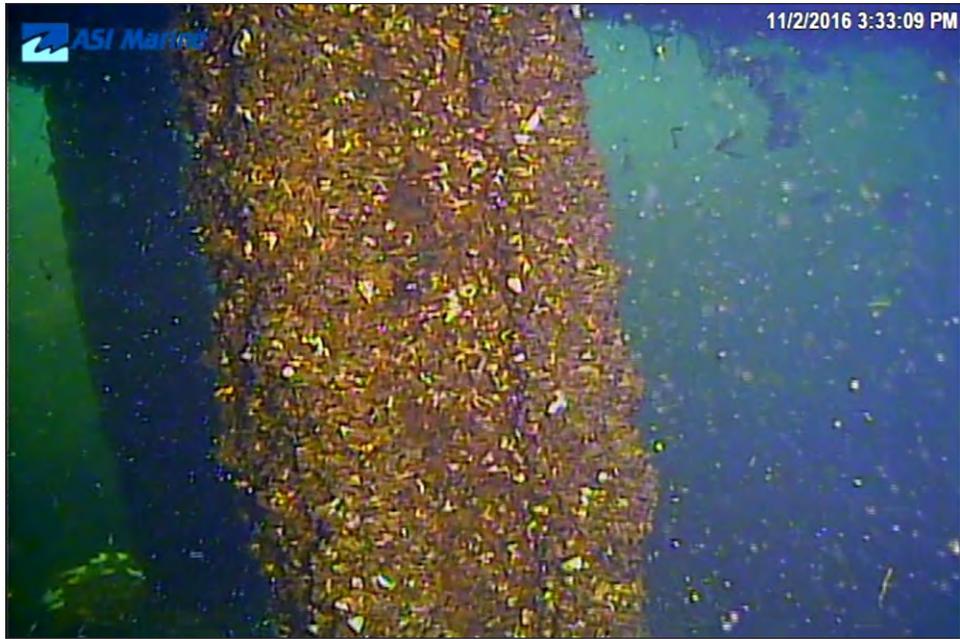
Image 3K-05: 6 m - East side support column.

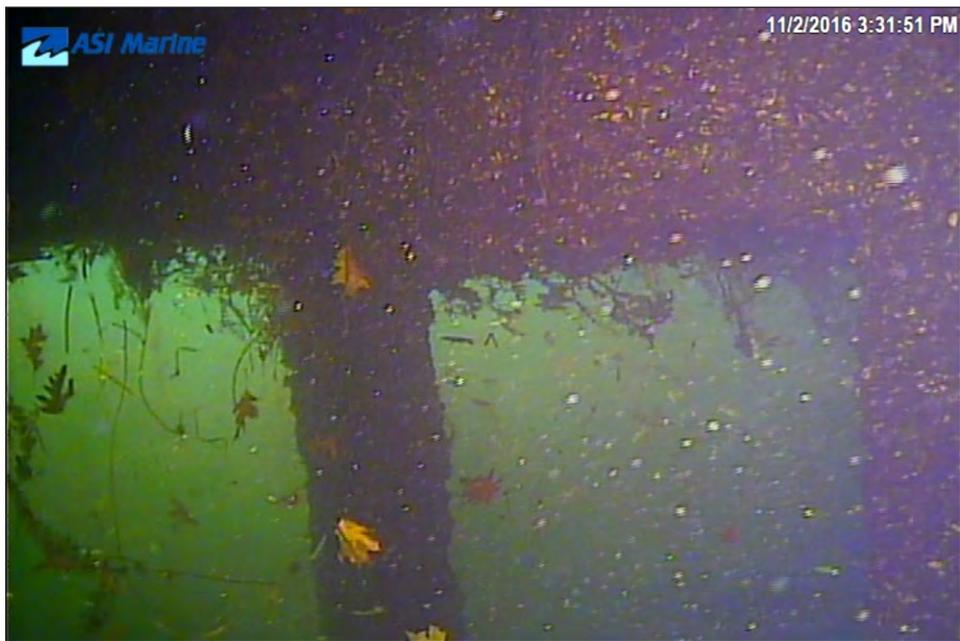
Image 3K-06: 6 m - East side upper column support.

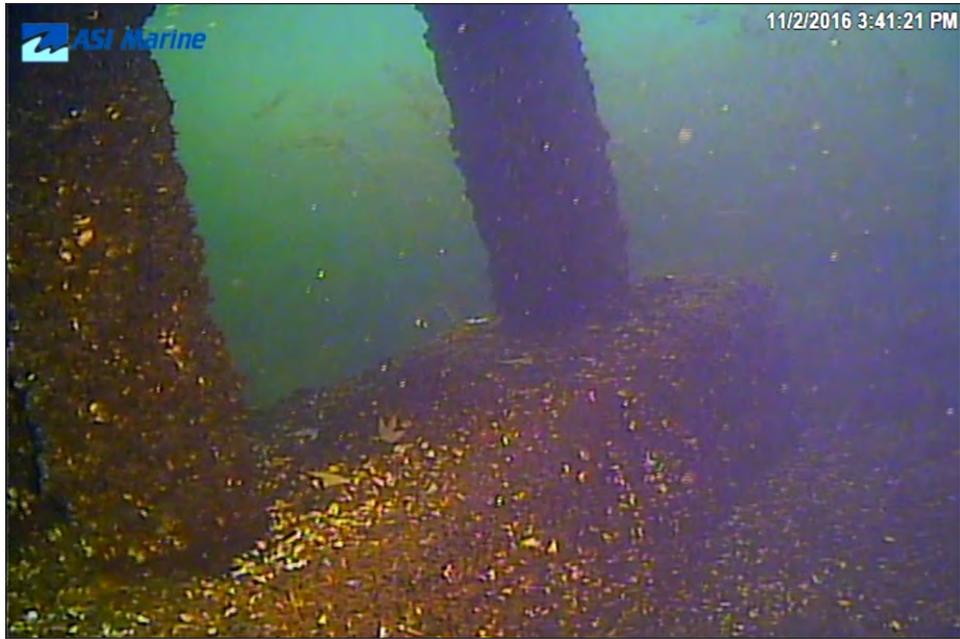
Image 3K-07: 12 m - East side lower column support.

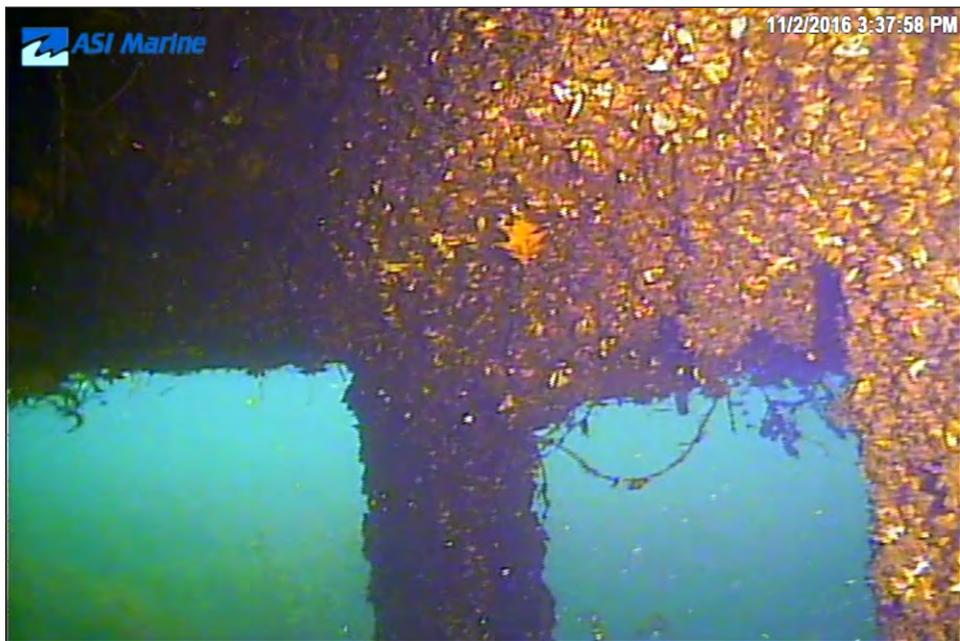
Image 3K-08: 12 m - East side upper column support.

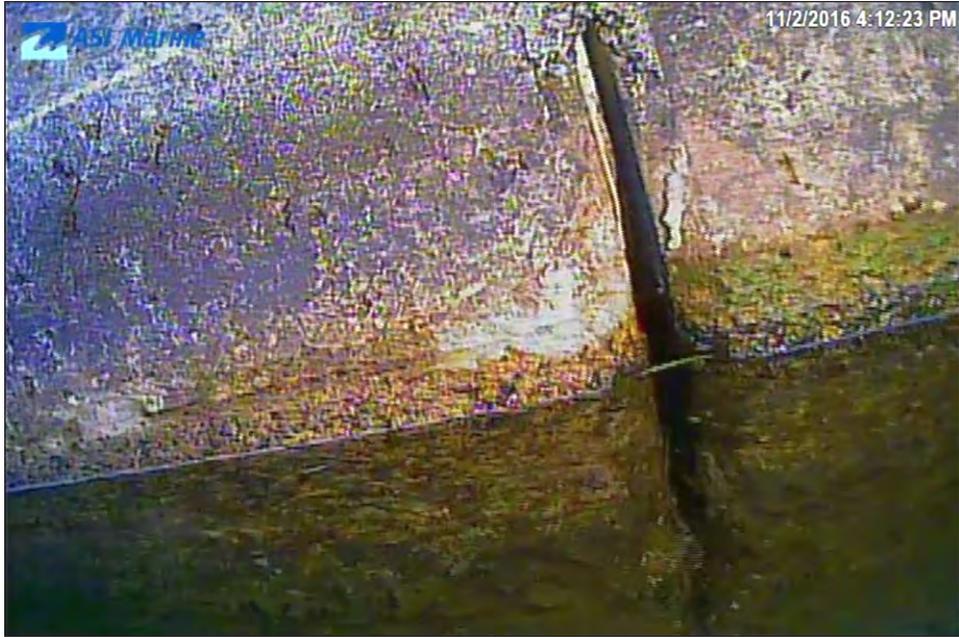
Image 3K-09: 18 m - West side joint.

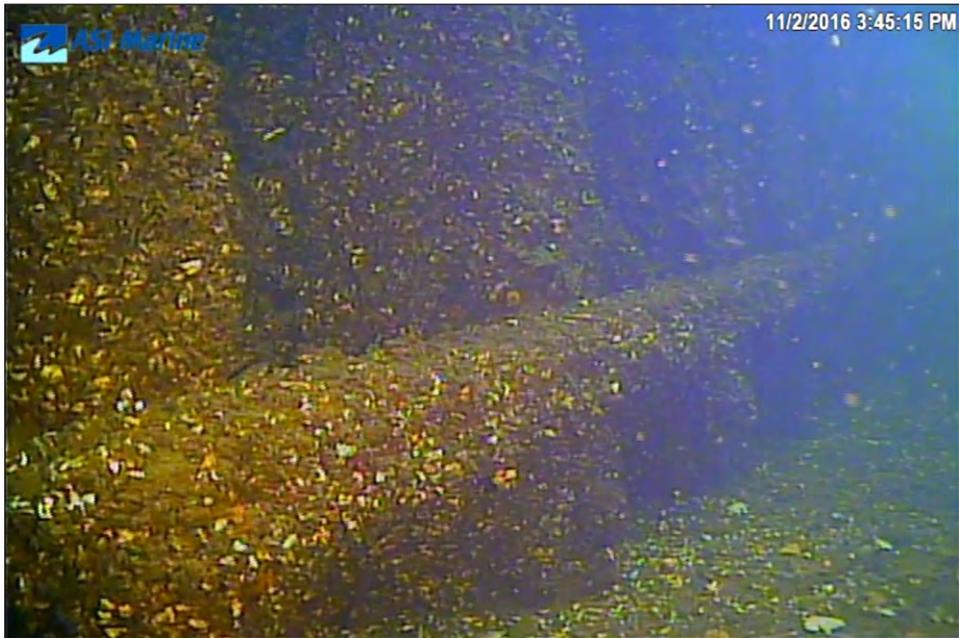
Image 3K-12: 20 m - East side lower crib section.

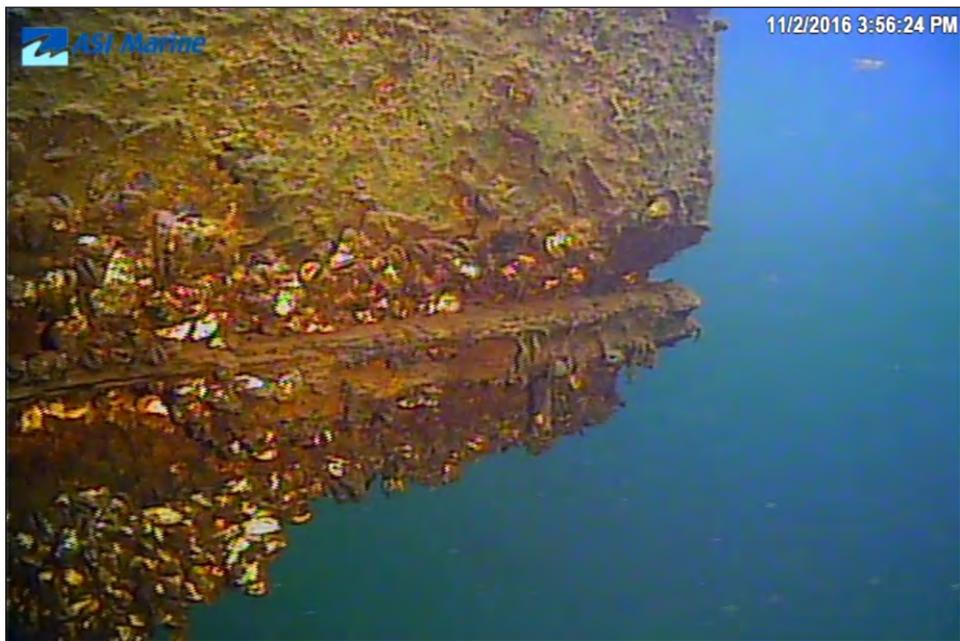
Image 3K-14: 29 m - East side upper crib transition to concrete slab.

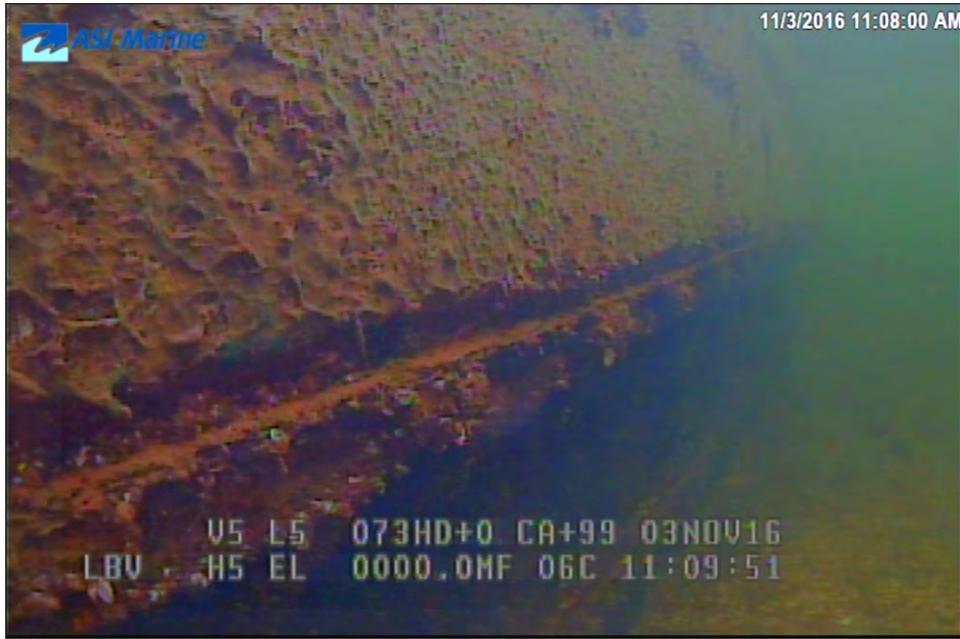
Image 3L-01: Lower approach east wall deck to structure.

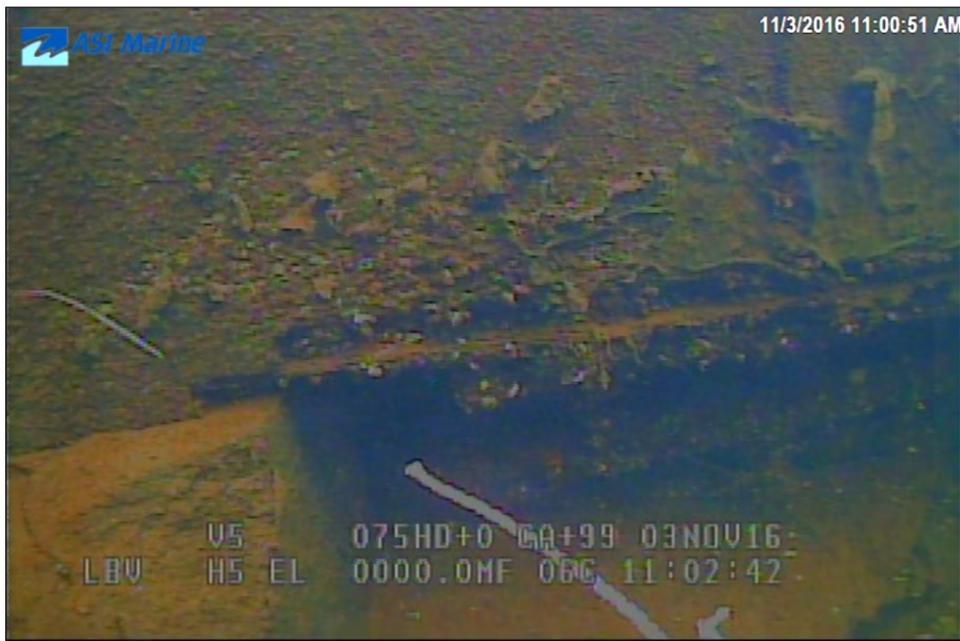
Image 3L-02: Lower approach east wall downstream of bend.

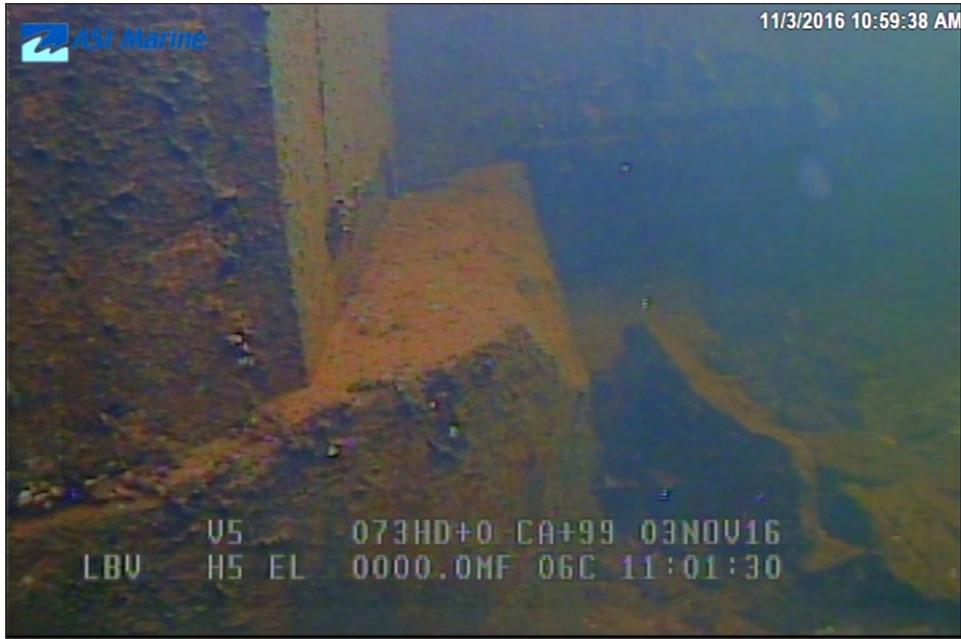
Image 3L-03: Lower approach east wall formed base on taper of west side.

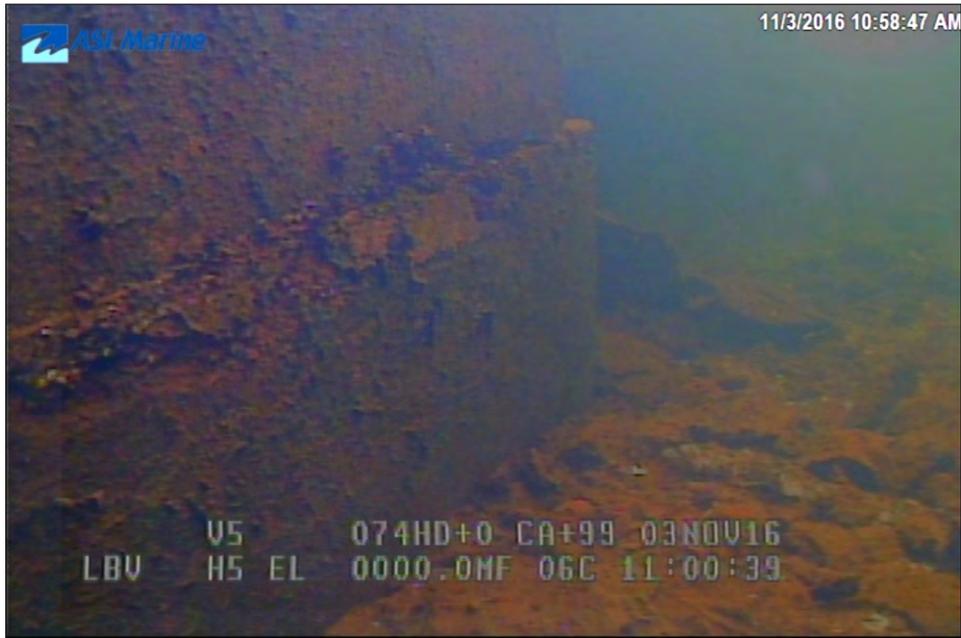
Image 3L-04: Lower approach east wall horizontal form line upstream of bend.

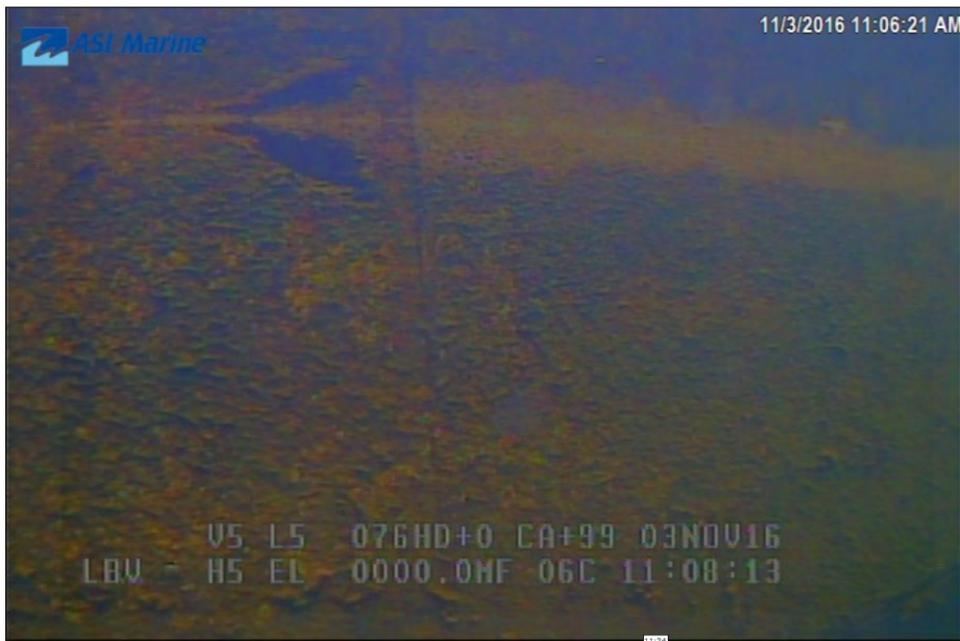
Image 3L-06: Lower approach east wall spall mark beside joint.

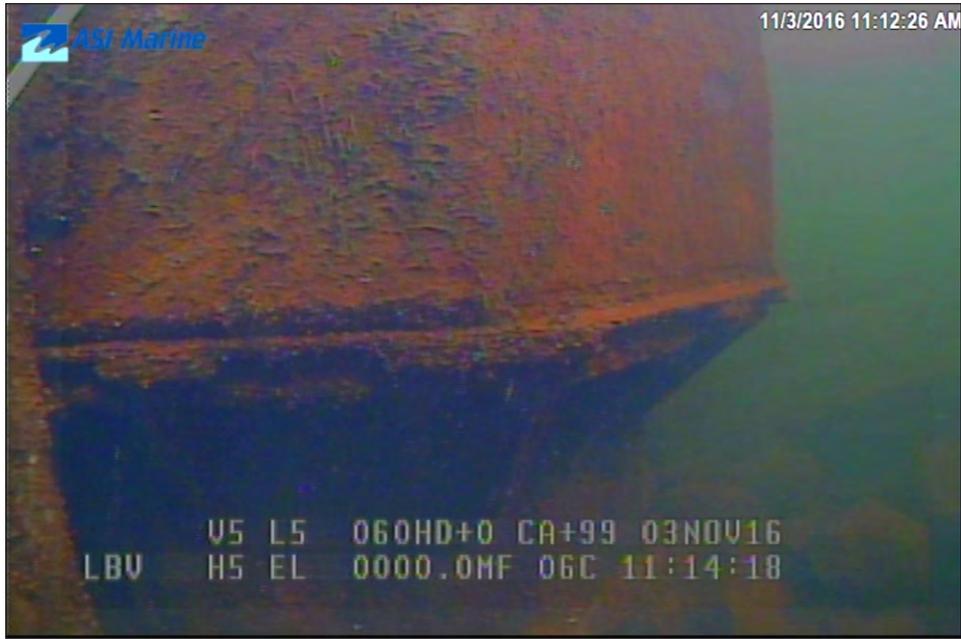
Image 3L-07: Lower approach south wall end cap transition.

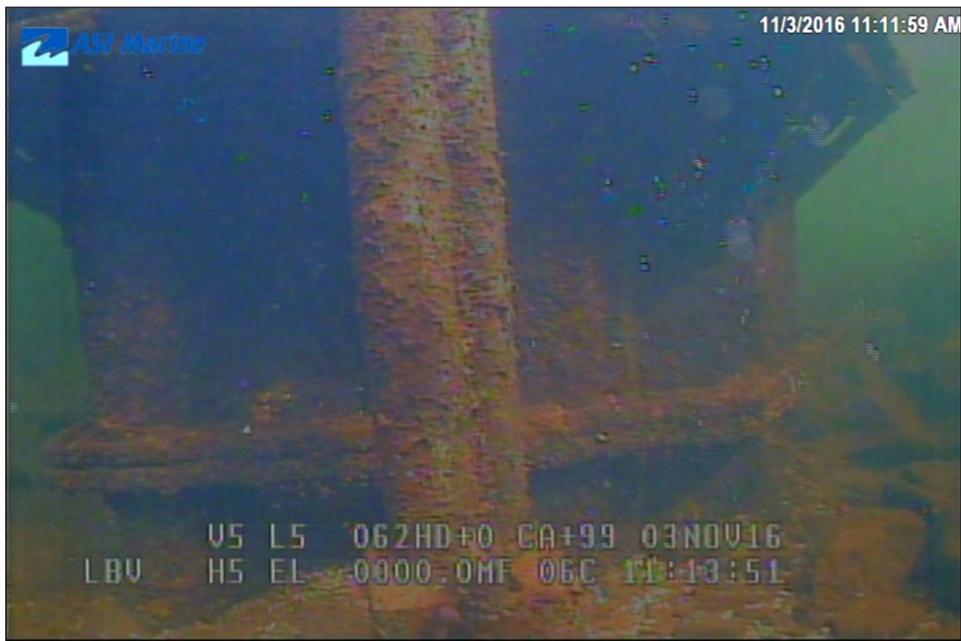
Image 3L-08: Lower approach south wall lower end.

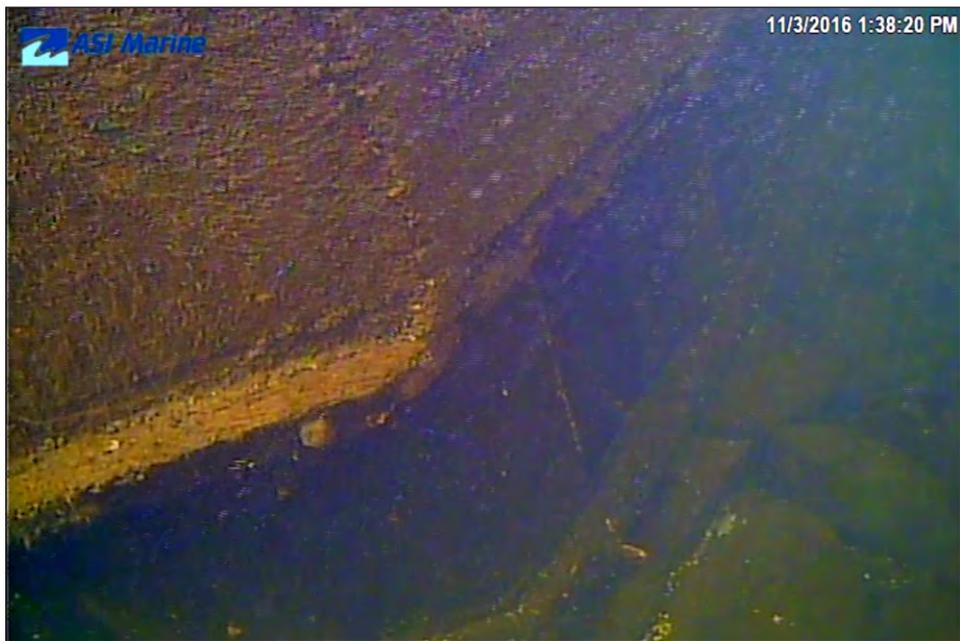
Image 3L-10: Lower approach west side wall south end.

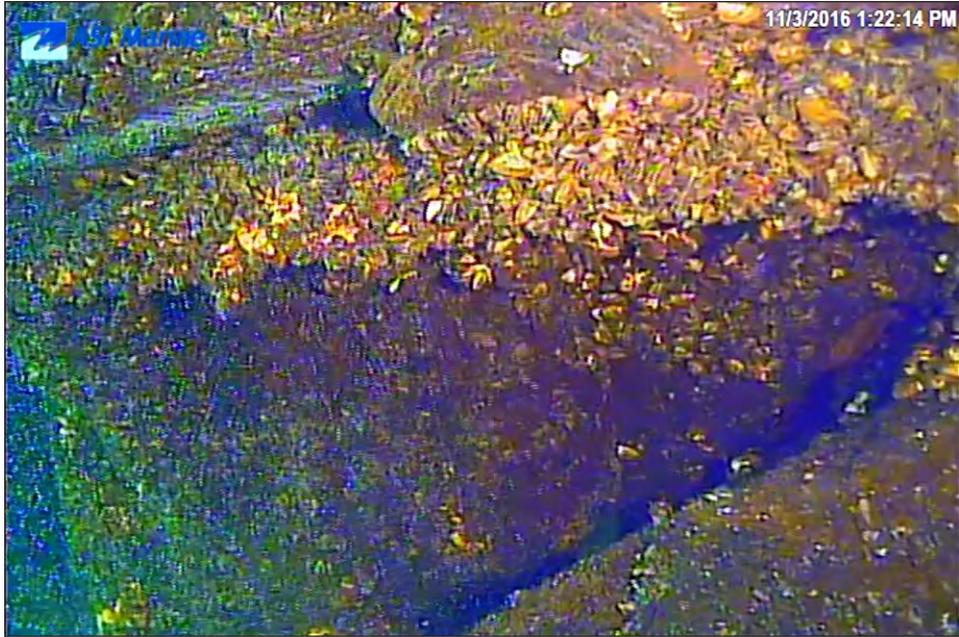
Image 3L-11: Lower approach west side wall undercut downstream of Pier 1.

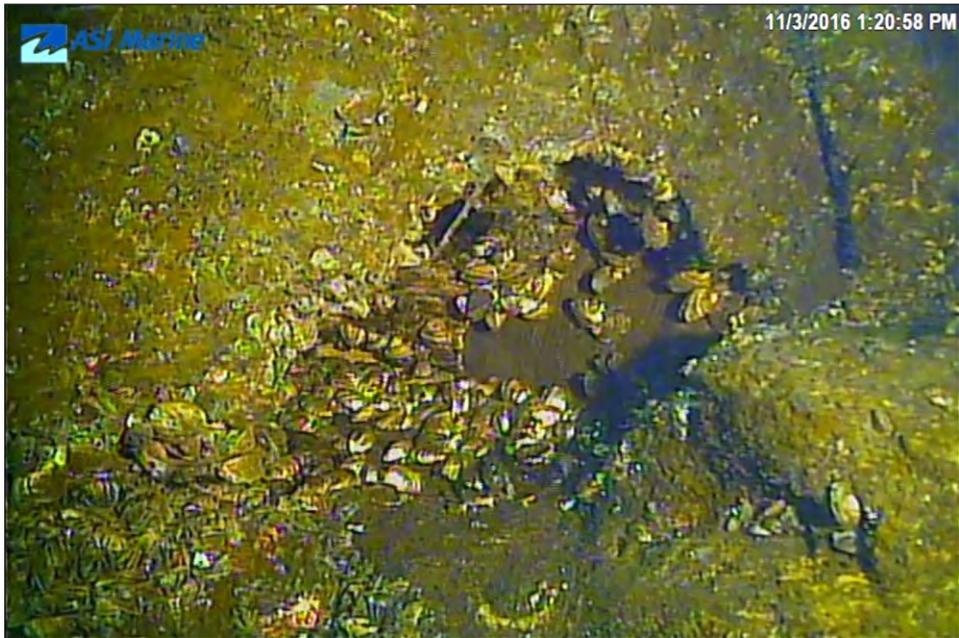
Image 3L-12: Lower approach west side wall undercut downstream of Pier 1.

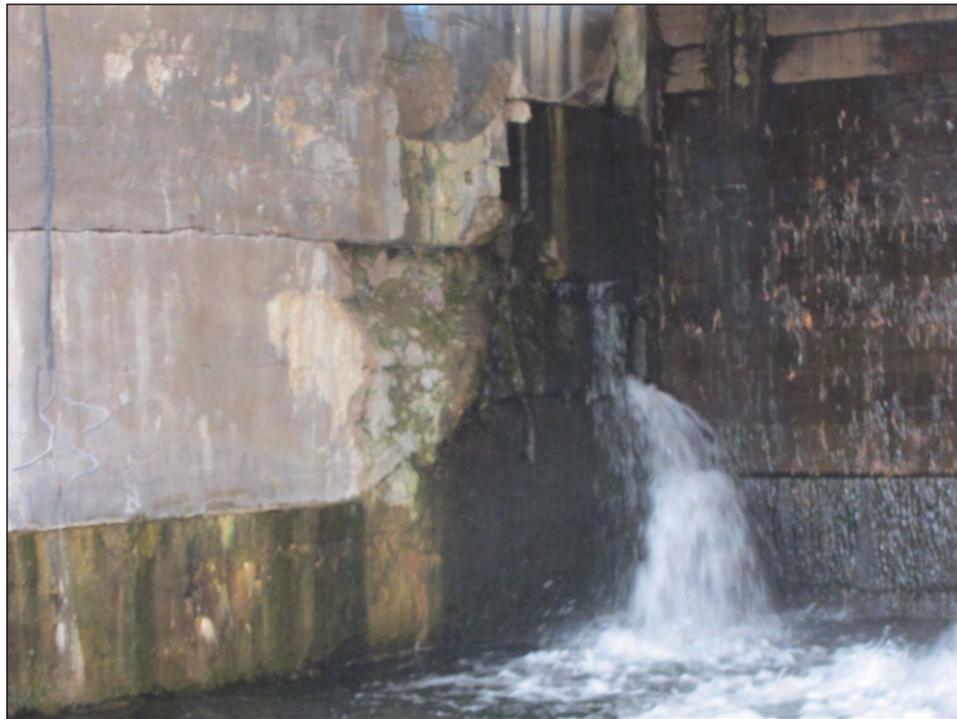
Image 6-02: Gate 1, Pier 1 Spalling

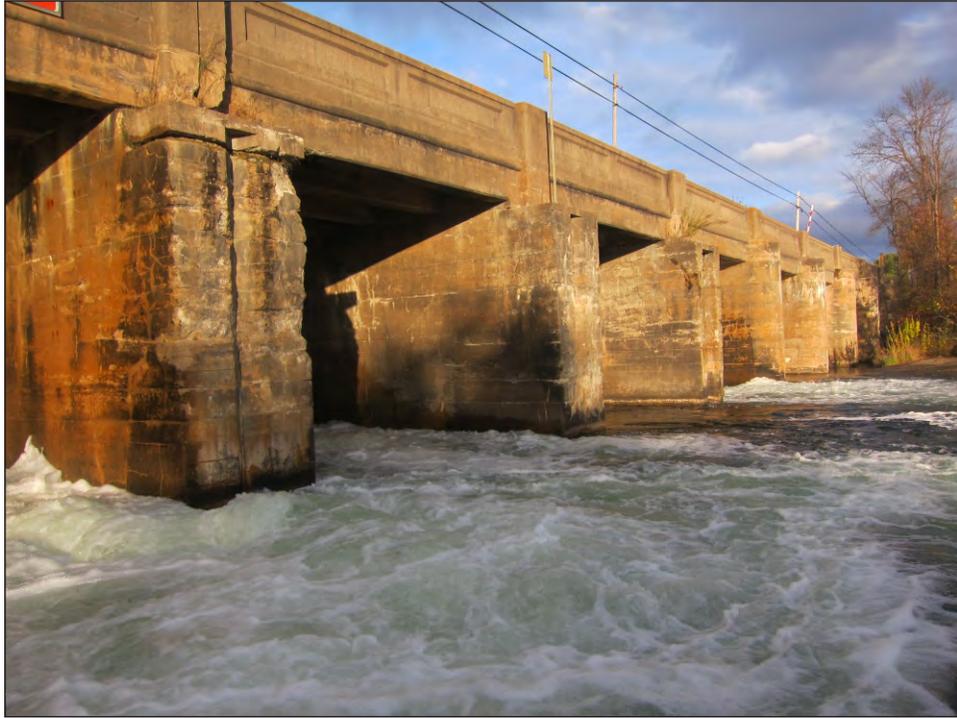
Image 6-05: Gate 2, Pier 3 to far left of image.

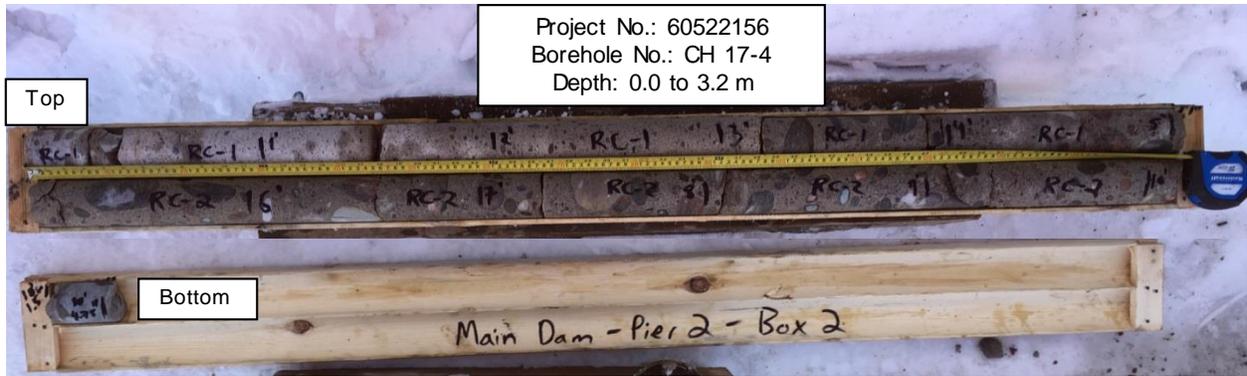
Core Photo 1: Concrete Cores from CH 17-4 from 0.0 to 3.2 m

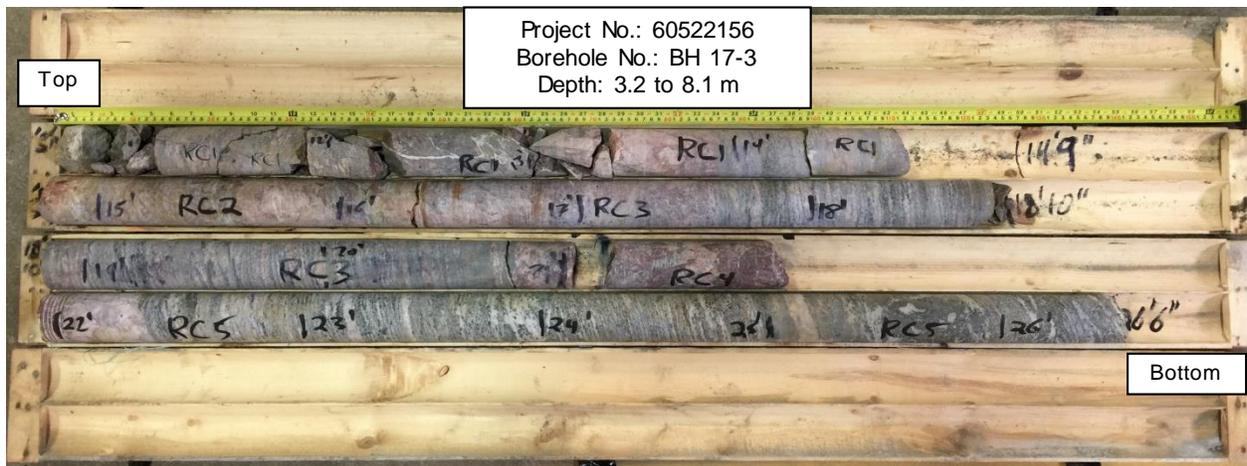
Core Photo 2: Rock Cores from BH 17-3 from 3.2 to 8.1 m

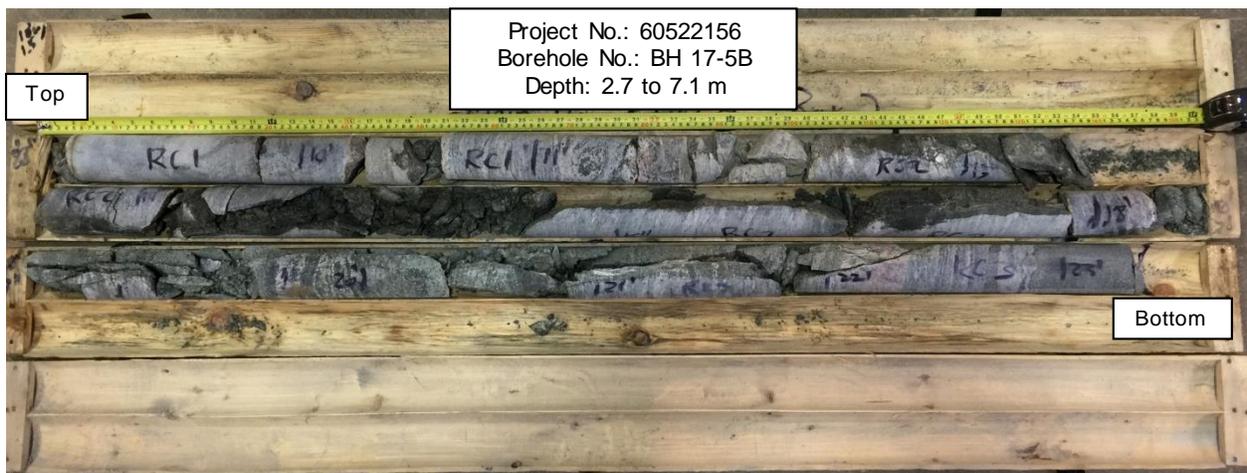
Core Photo 3: Rock Cores from BH 17-5B from 2.7 to 7.1 m

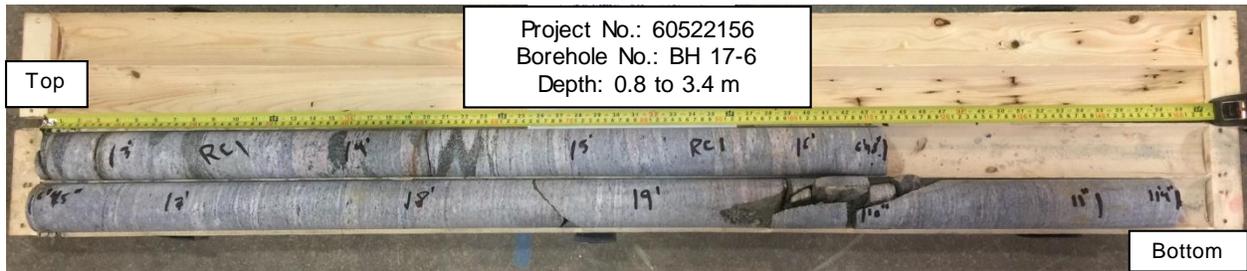
Core Photo 4: Rock Cores from BH 17-6 from 0.8 to 3.4 m

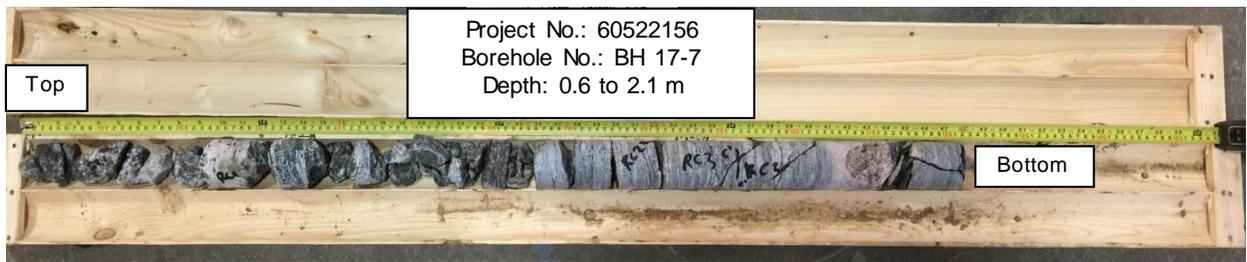
Core Photo 5: Rock Cores from BH 17-7 from 0.6 to 2.1 m

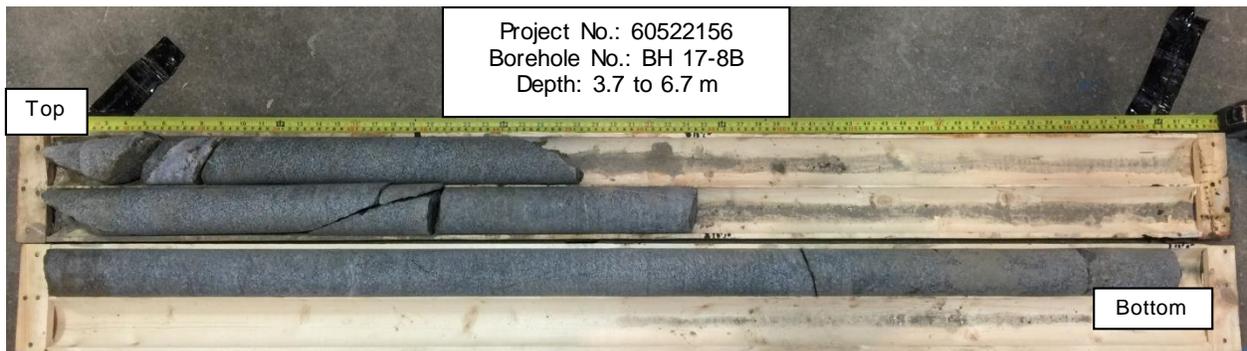
Core Photo 6: Rock Cores from BH 17-8B from 3.7 to 6.7 m

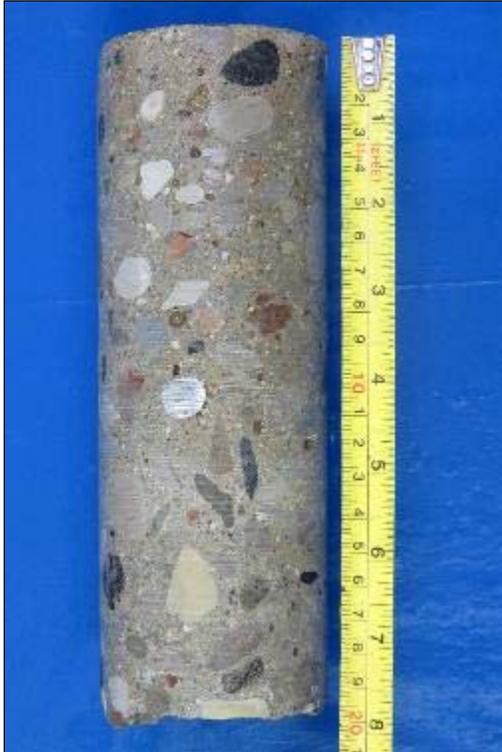
CORE C1 (lower approach wall, west)

- Core C1 – light rust @ 100mm
- Core C2 – light rust @ 110mm, 120mm
- Core C7 – delamination plane @ 240mm, medium crack
- Core C8 – delamination plane @ 185mm
- Core C13 – medium crack
- Core C19 – medium crack
- Core C20 – delamination plane @ 180mm
- Core C26 – medium crack

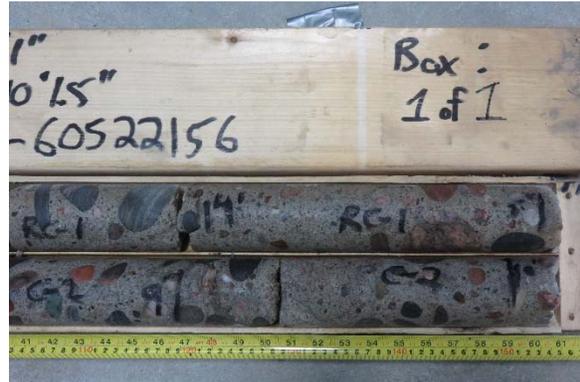
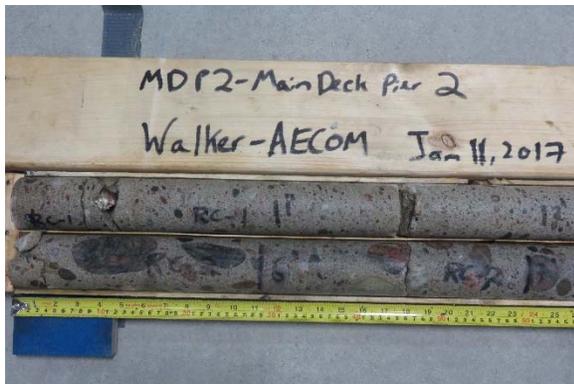
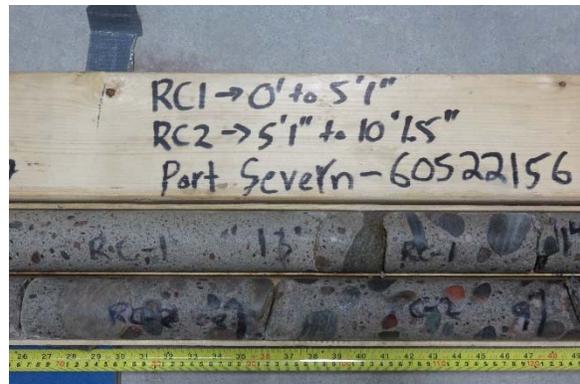
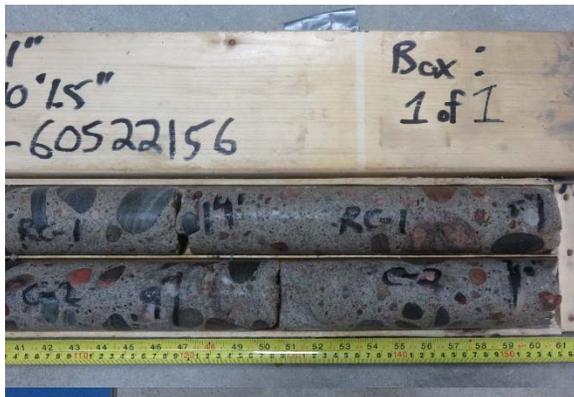
CORE RC1, RC2 (Main Dam, Pier 2)

Core No.		C25		C26		RC1	
Location (between gridlines)		Dam A, top of wall		Dam A, top of wall		Main Dam, Pier 2	
Diameter, mm		70.0		70.0		63.0	
Length, mm		125.0		205.0		10'1.5"	
Full Depth (yes/no)		No		No		No	
Defects in Concrete ⁽¹⁾		-		C		-	
Condition of Rebar ⁽²⁾		N/A		N/A		N/A	
Corrosion Potential		-		-		-	
Compressive Strength, MPa		33.9		45.1		31.1 / 21.8	
Chloride Content % Chloride by Weight of Concrete	0-10 mm	Total	Corrected	Total	Corrected	Total	Corrected
	20-30 mm						
	40-50 mm						
	60-70 mm						
AIR VOIDS	Air Content, %					8.3	8.4
	Spec. Surf., mm ² /mm ³					21.56	19.54
	Spacing Factor, mm					0.209	0.161
TEST LABORATORY		BCC		BCC		BCC	
REMARKS - orientation of rebars and cover - presence of overlay, patch and thickness - other observed defects				Medium crack		31.1 MPa (170-285mm). 21.8 MPa (2530-2645 mm). AVS testing conducted at 520-680mm and 1790-1940mm.

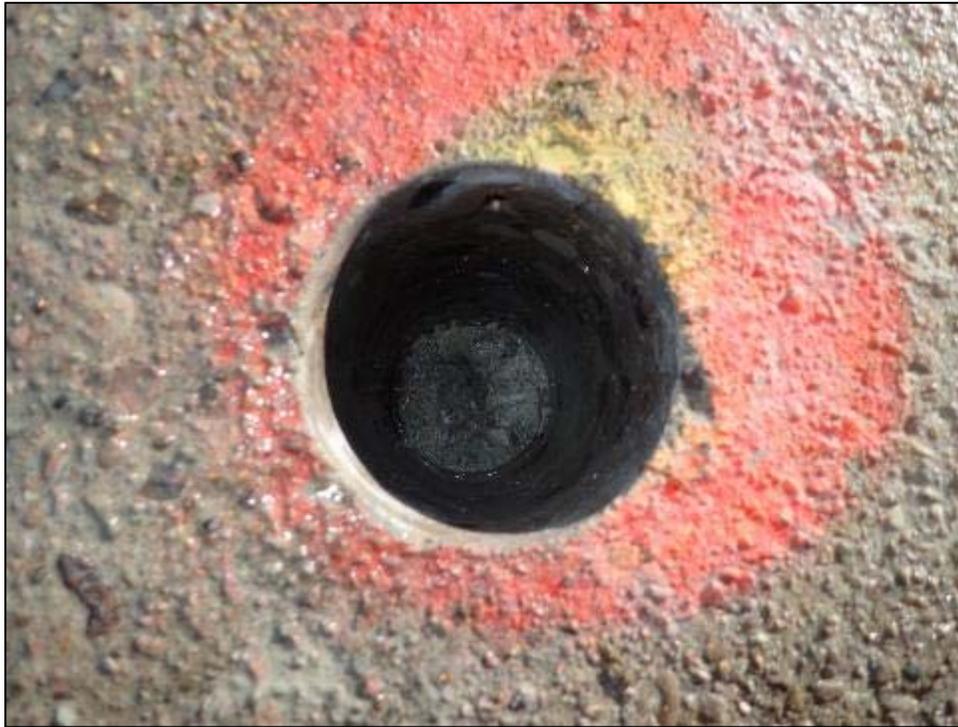
Photo P1 – Typical Condition of Inside of Core C1 (lower approach wall, west wall)

Core No.		C1		C2		C3	
Location (between gridlines)		Lower Approach Wall, west		Lower Approach Wall, west		Lock 45/Main Dam, common wall	
Diameter, mm		70.0		70.0		70.0	
Length, mm		205.0		255.0		240.0	
Full Depth (yes/no)		No		No		No	
Defects in Concrete ⁽¹⁾		-		-		*	
Condition of Rebar ⁽²⁾		LR		LR		G	
Corrosion Potential		-		-		-	
Compressive Strength, MPa		52.2		46.6		47.4	
Chloride Content % Chloride by Weight of Concrete	0-10 mm	Total	Corrected	Total	Corrected	Total	Corrected
	20-30 mm						
	40-50 mm						
	60-70 mm						
	80-90 mm						
AIR VOIDS	Air Content, %			5.3		5.5	
	Spec. Surf., mm ² /mm ³			27.93		38.67	
	Spacing Factor, mm			0.186		0.128	
TEST LABORATORY		BCC		BCC		BCC	
REMARKS - orientation of rebars and cover - presence of overlay, patch and thickness - other observed defects		10M rebar @100mm (transverse, LR)		10M rebar @110mm (transverse, LR): 20M-Rebar @120mm (longitudinal, LR)		Rebar imprint @85mm (transverse). *Core damaged upon removal.

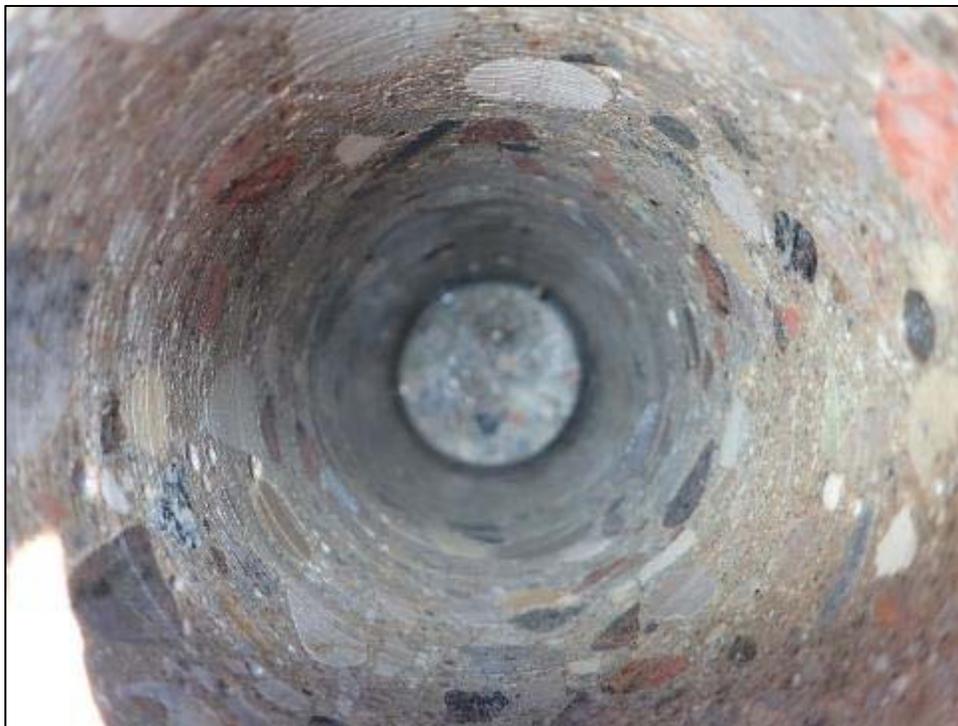
Photo P2 – Typical Condition of Inside Core C2 (lower approach wall, west wall)

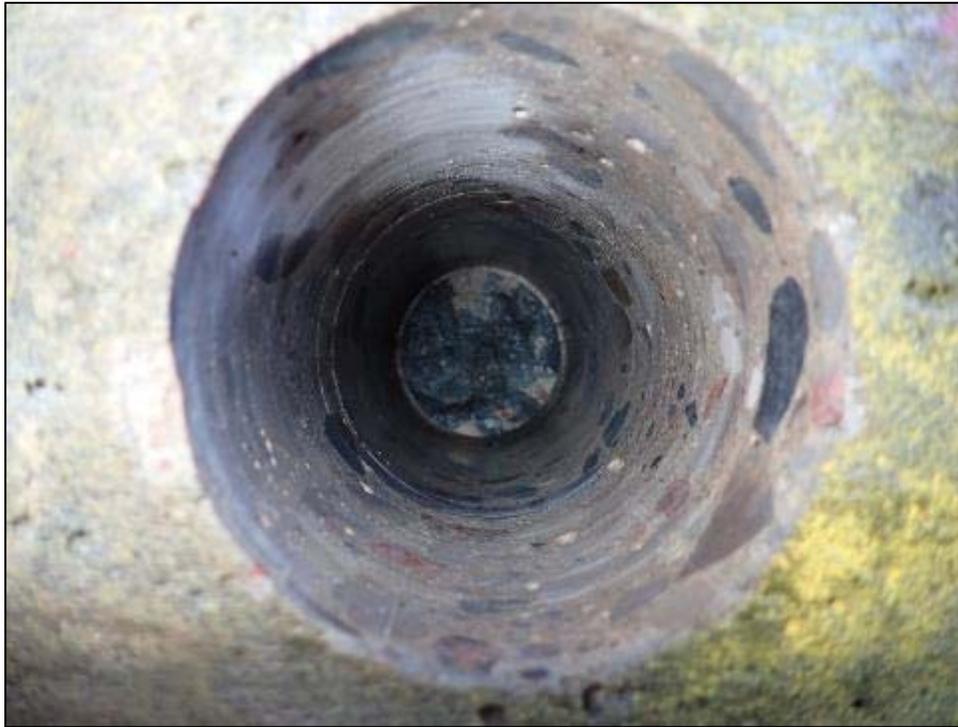
Photo P3 – Typical Condition of Inside Core C3 (Lock 45/Main Dam common wall)

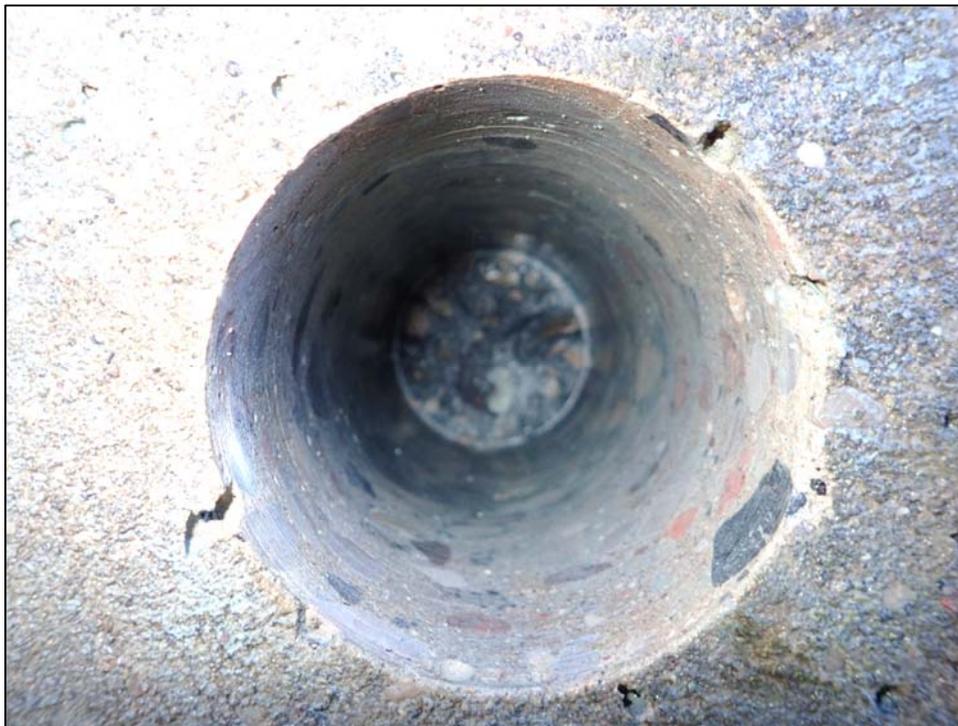
Photo P4 – Typical Condition of Inside Core C4 (Lock 45/Main Dam common wall)

Core No.		C4		C5		C6	
Location (between gridlines)		Lock 45/Main Dam, common wall		Lower Approach Wall, east		Lower Approach Wall, east	
Diameter, mm		70.0		70.0		70.0	
Length, mm		185.0		320.0		425.0	
Full Depth (yes/no)		No		No		No	
Defects in Concrete ⁽¹⁾		-		*		*	
Condition of Rebar ⁽²⁾		N/A		N/A		G	
Corrosion Potential		-		-		-	
Compressive Strength, MPa		49.3		58.9		44.0	
Chloride Content % Chloride by Weight of Concrete	0-10 mm	Total	Corrected	Total	Corrected	Total	Corrected
	20-30 mm						
	40-50 mm						
	60-70 mm						
	80-90 mm						
AIR VOIDS	Air Content, %					3.9	
	Spec. Surf., mm ² /mm ³					36.01	
	Spacing Factor, mm					0.158	
TEST LABORATORY		BCC		BCC		BCC	
REMARKS - orientation of rebars and cover - presence of overlay, patch and thickness - other observed defects				*Core damaged upon removal.		20M rebar @ 250mm (transverse). *Core damaged upon removal.

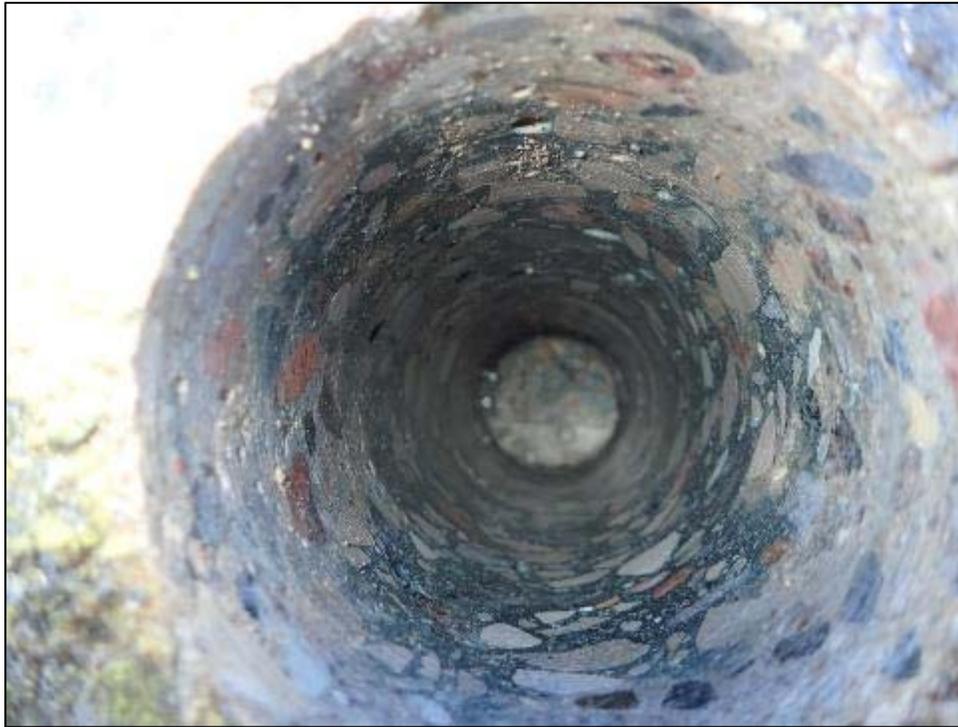
Photo P5 – Typical Condition of Inside Core C5 (lower approach wall, west wall)

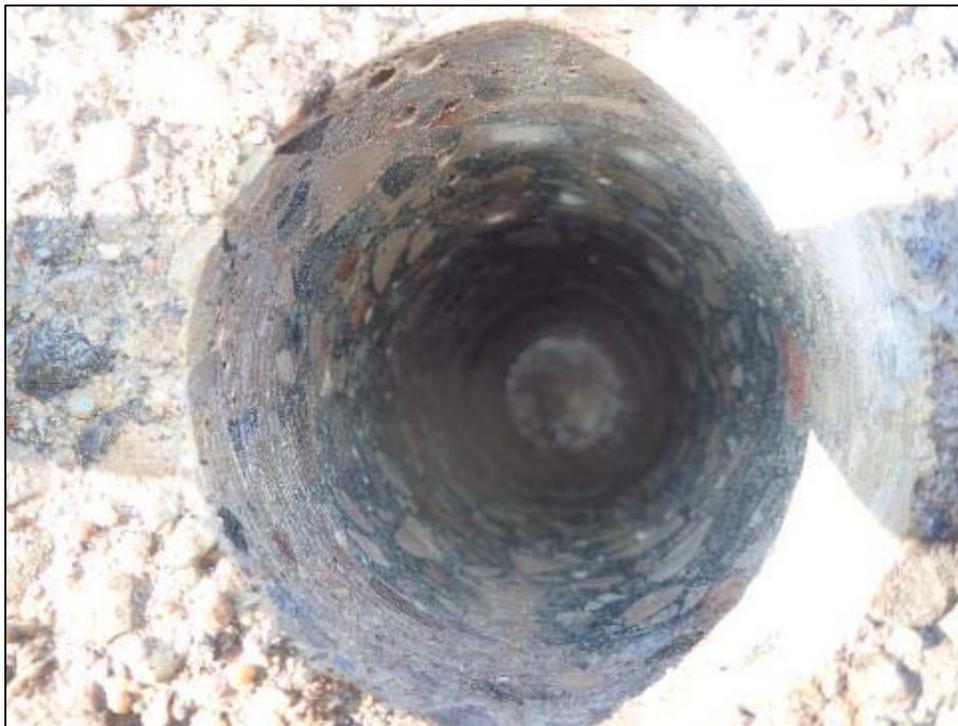
Photo P6 – Typical Condition of Inside Core C6 (lower approach wall, west wall)
