Rehabilitation of Port Severn Area Dams, Fixed Bridge and Lock

Investigation Report

Public Works and Government Services Canada

November 21 2017

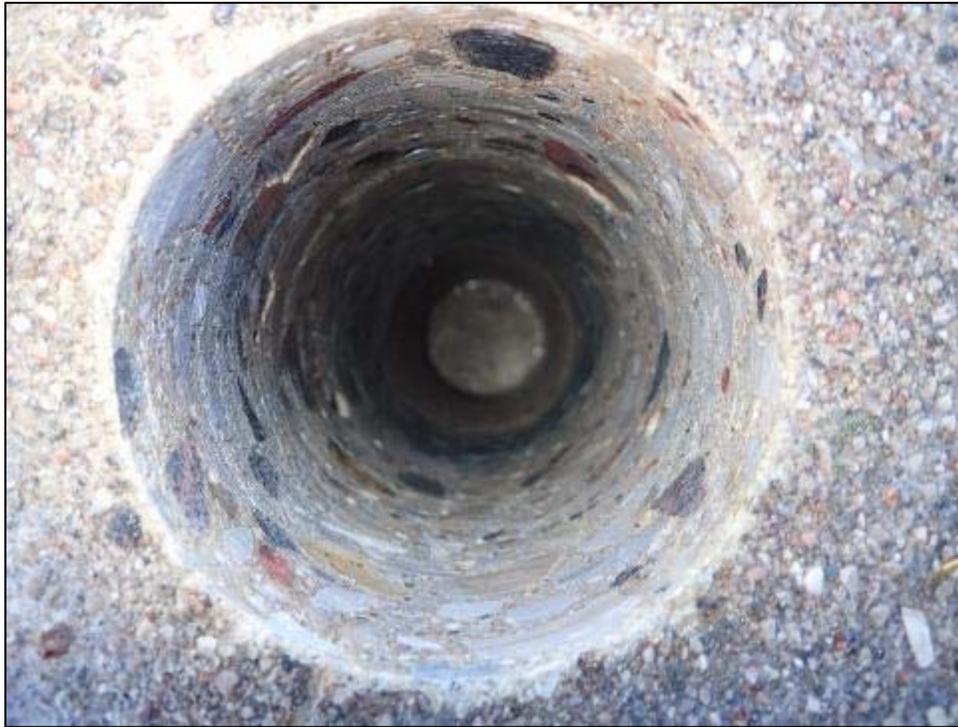
Photo P7 – Typical Condition of Inside Core C7 (lower approach wall, west)

Core No.		C7		C8		C9	
Location (between gridlines)		Upper Approach Wall, west		Upper Approach Wall, west		Dam E - Bayview, top of dam wall	
Diameter, mm		70.0		70.0		70.0	
Length, mm		405.0		425.0		235.0	
Full Depth (yes/no)		No		No		No	
Defects in Concrete ⁽¹⁾		D + C		D		-	
Condition of Rebar ⁽²⁾		N/A		N/A		N/A	
Corrosion Potential		-		-		-	
Compressive Strength, MPa		36.9		42.4		20.7	
Chloride Content % Chloride by Weight of Concrete	0-10 mm	Total	Corrected	Total	Corrected	Total	Corrected
	20-30 mm						
	40-50 mm						
	60-70 mm						
	80-90 mm						
AIR VOIDS	Air Content, %	8.3					
	Spec. Surf., mm ² /mm ³	19.60					
	Spacing Factor, mm	0.186					
TEST LABORATORY		BCC		BCC		BCC	
REMARKS - orientation of rebars and cover - presence of overlay, patch and thickness - other observed defects		Delamination plane @ 240mm. Medium crack.		Delamination plane @ 185mm.

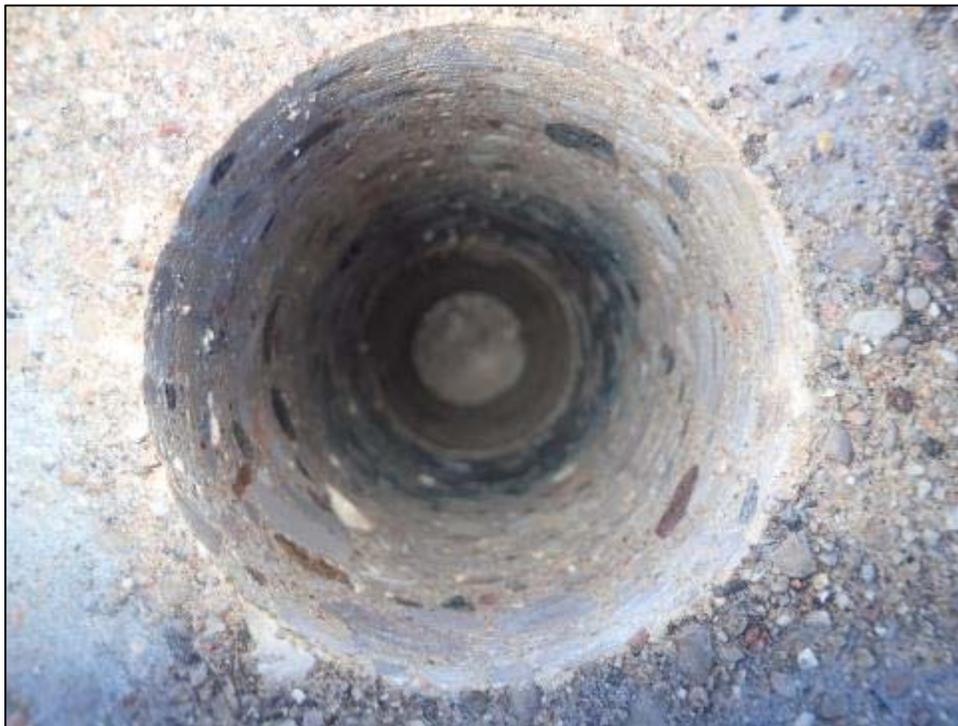
Photo P8 – Typical Condition of Inside Core C8 (lower approach wall, west)

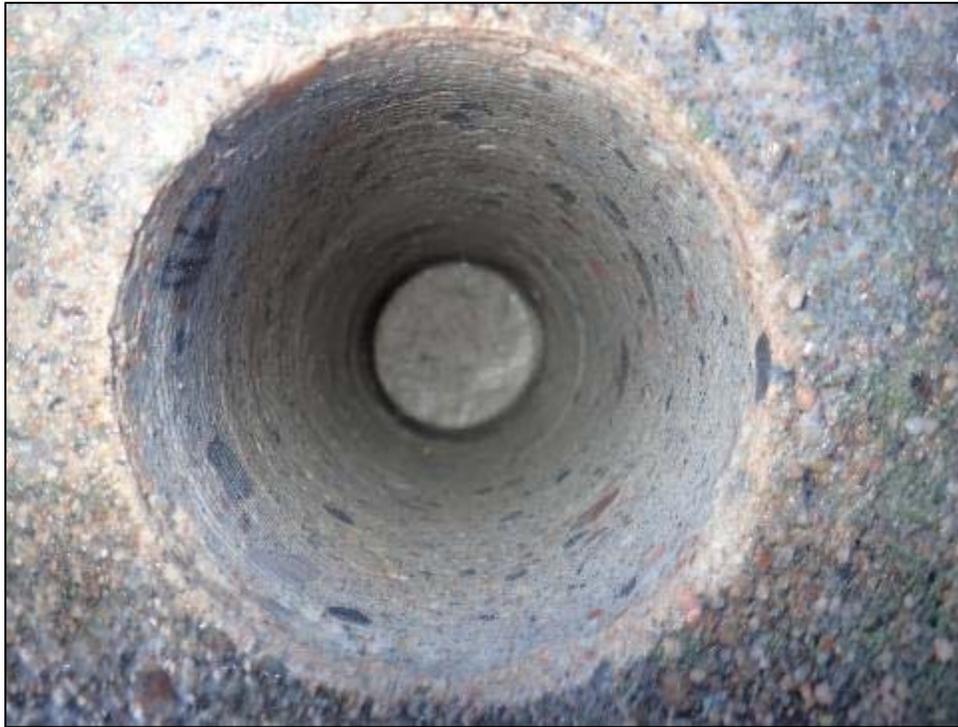
Photo P9 – Typical Condition of Inside Core C9 (Dam E – Bayview, top of dam wall)

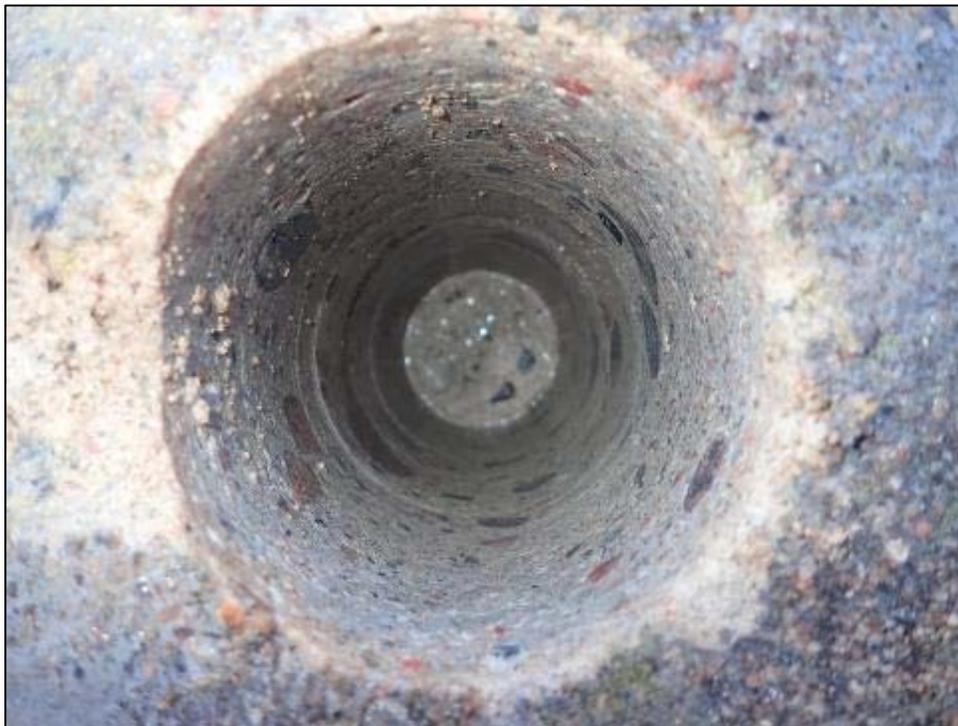
Photo P10 – Typical Condition of Inside Core C10 (Dam E – Bayview, top of dam wall)

Core No.		C10		C11		C12	
Location (between gridlines)		Dam E - Bayview, top of dam wall		Dam E - Bayview, deck @ NE		Dam E - Bayview, deck @ NW	
Diameter, mm		70.0		70.0		70.0	
Length, mm		275.0		275.0		260.0	
Full Depth (yes/no)		No		No		No	
Defects in Concrete ⁽¹⁾		-		-		-	
Condition of Rebar ⁽²⁾		N/A		N/A		N/A	
Corrosion Potential		-		-		-	
Compressive Strength, MPa		22.5				27.5	
Chloride Content % Chloride by Weight of Concrete	0-10 mm	Total	Corrected	Total	Corrected	Total	Corrected
	20-30 mm			0.058	0.053		
	40-50 mm			0.031	0.026		
	60-70 mm			0.015	0.010		
	80-90 mm			0.005	0.000		
	100-110 mm			0.006	0.001		
AIR VOIDS	Air Content, %	6.5		7.9			
	Spec. Surf., mm ² /mm ³	25.60		20.06			
	Spacing Factor, mm	0.183		0.164			
TEST LABORATORY		BCC		BCC		BCC	
REMARKS - orientation of rebars and cover - presence of overlay, patch and thickness - other observed defects				95mm asphalt.		115mm asphalt.

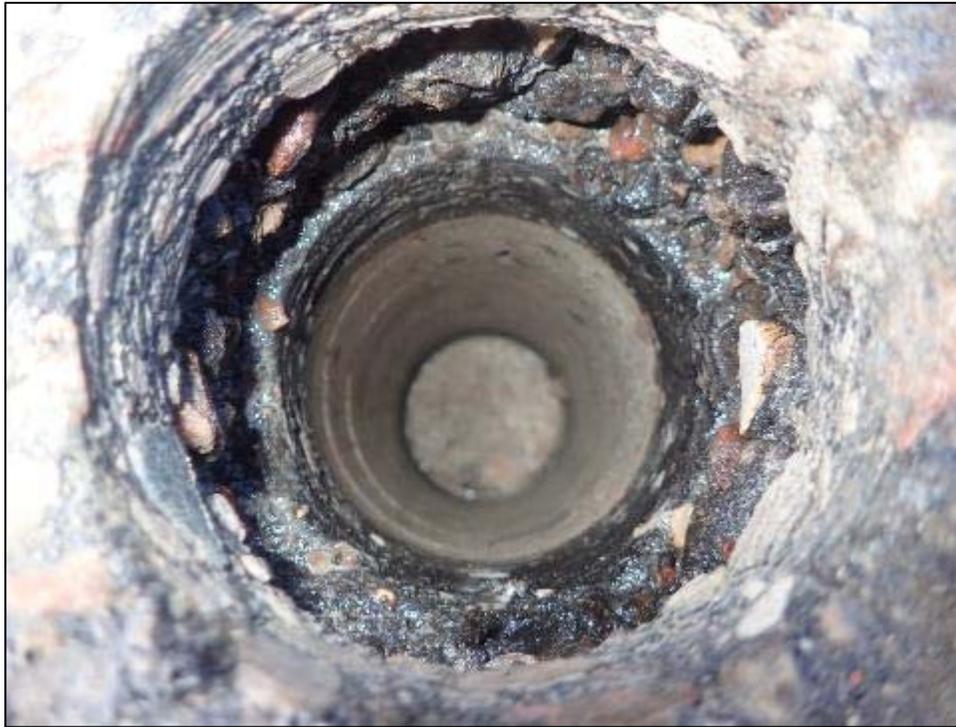
Photo P11 – Typical Condition of Inside Core C11 (Dam E – Bayview, deck @ NE)

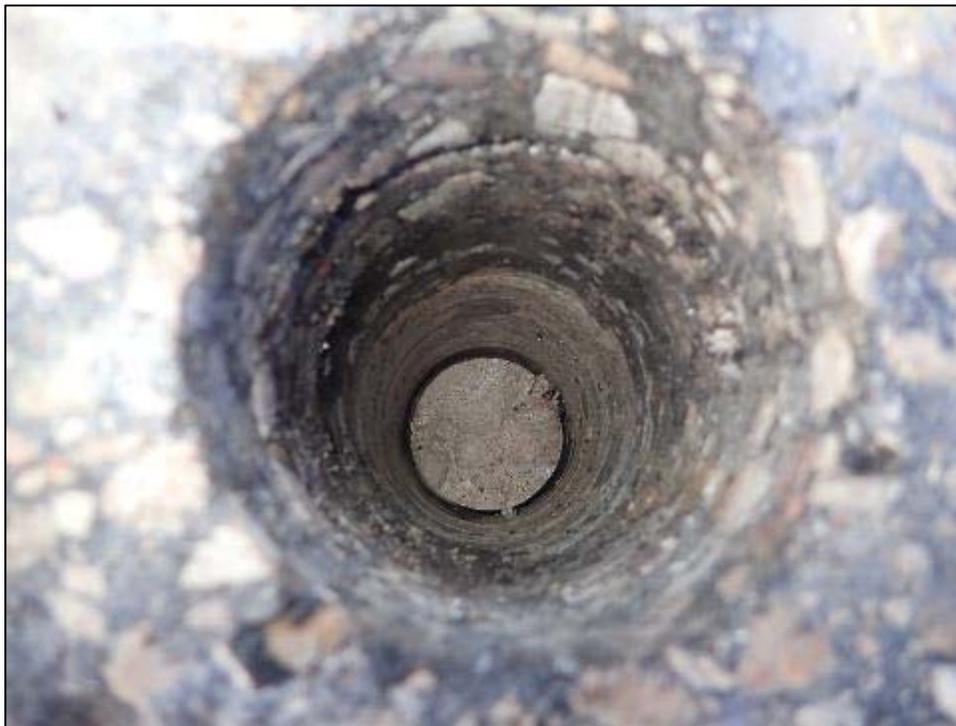
Photo P12 – Typical Condition of Inside Core C12 (Dam E – Bayview, deck @ NW)

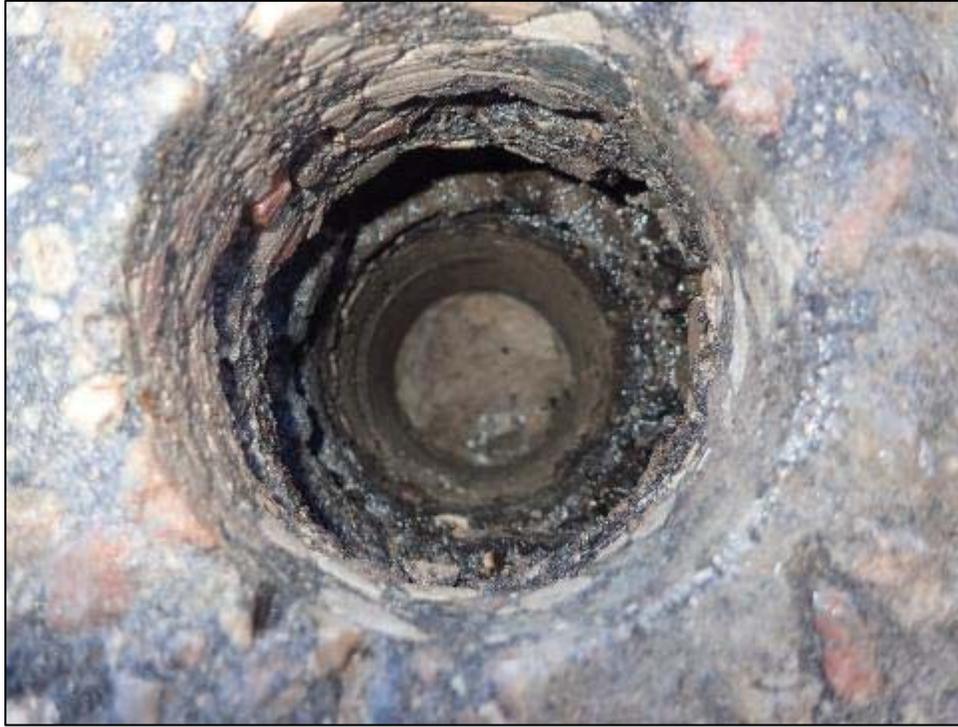
Photo P13 – Typical Condition of Inside Core C13 (Dam E – Bayview, deck @ SW)

Core No.		C13		C14		C15	
Location (between gridlines)		Dam E - Bayview, deck @ SW		Dam E - Bayview, deck @ SE		Dam E - Bayview, west abutment	
Diameter, mm		70.0		70.0		70.0	
Length, mm		135.0		180.0		200.0	
Full Depth (yes/no)		No		No		No	
Defects in Concrete ⁽¹⁾		C		-		-	
Condition of Rebar ⁽²⁾		N/A		G		N/A	
Corrosion Potential		-		-		-	
Compressive Strength, MPa				25.4		17.0	
Chloride Content % Chloride by Weight of Concrete	0-10 mm	Total	Corrected	Total	Corrected	Total	Corrected
	20-30 mm	0.177	0.172				
	40-50 mm	0.160	0.155				
	60-70 mm	0.116	0.111				
	80-90 mm	0.052	0.047				
AIR VOIDS	Air Content, %						
	Spec. Surf., mm ² /mm ³						
	Spacing Factor, mm						
TEST LABORATORY		BCC		BCC		BCC	
REMARKS - orientation of rebars and cover - presence of overlay, patch and thickness - other observed defects		120mm asphalt. Medium crack.		95mm asphalt. Rebar imprint @170mm (transverse).

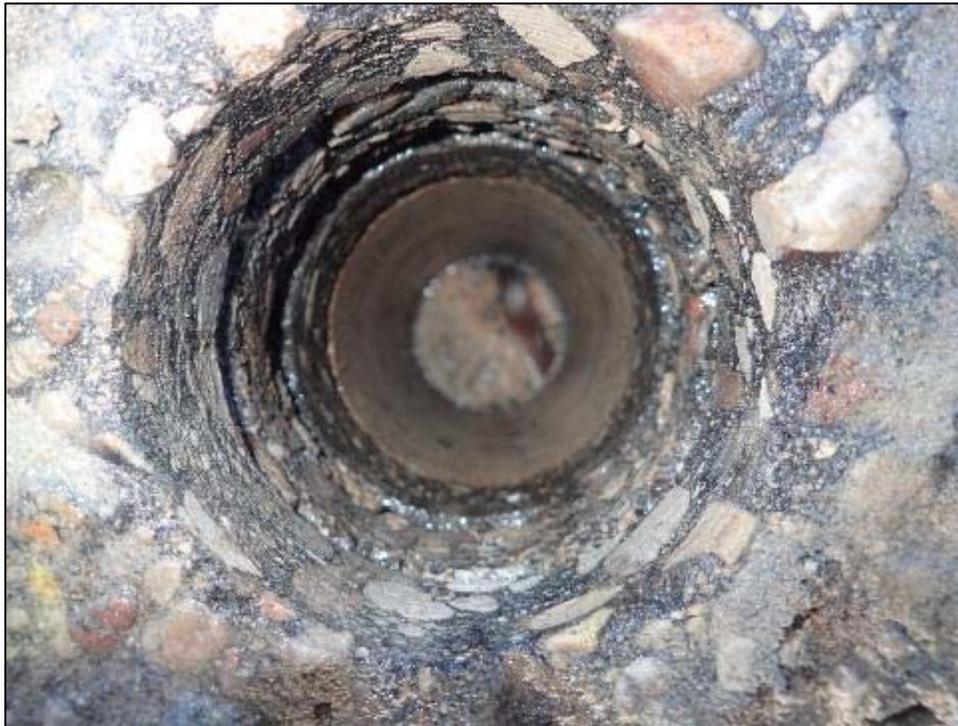
Photo P14 – Typical Condition of Inside Core C14 (Dam E – Bayview, deck @ SE)

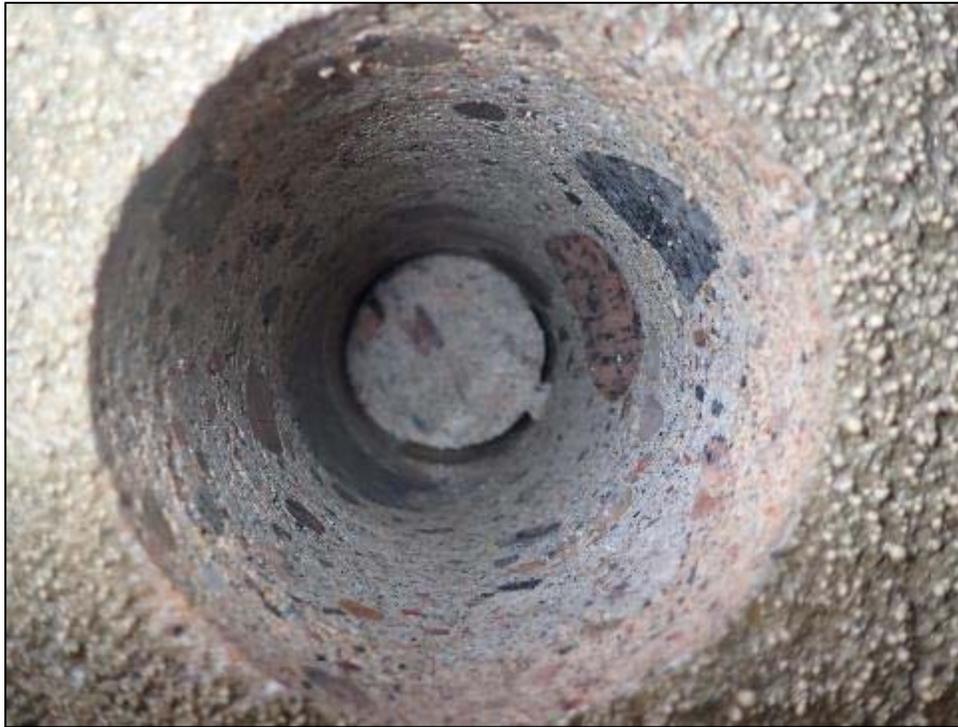
Photo P15 – Typical Condition of Inside Core C15 (Dam E – Bayview, west abutment)

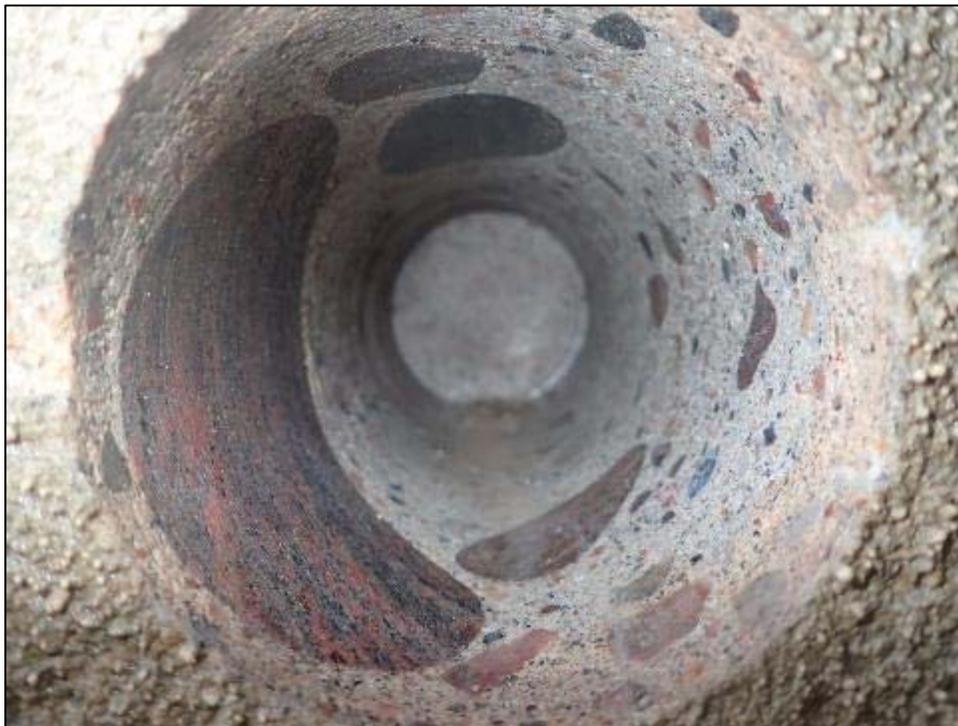
Photo P16 – Typical Condition of Inside Core C16 (Dam E – Bayview, west abutment)

Core No.		C16		C17		C18	
Location (between gridlines)		Dam E - Bayview, west abutment		Dam E - Bayview, east abutment		Dam E - Bayview, east abutment	
Diameter, mm		70.0		70.0		70.0	
Length, mm		220.0		255.0		270.0	
Full Depth (yes/no)		No		No		No	
Defects in Concrete ⁽¹⁾		-		-		-	
Condition of Rebar ⁽²⁾		N/A		N/A		N/A	
Corrosion Potential		-		-		-	
Compressive Strength, MPa		17.9		15.9		17.1	
Chloride Content % Chloride by Weight of Concrete	0-10 mm	Total	Corrected	Total	Corrected	Total	Corrected
	20-30 mm						
	40-50 mm						
	60-70 mm						
	80-90 mm						
AIR VOIDS	Air Content, %	11.3				7.9	
	Spec. Surf., mm ² /mm ³	18.89				20.43	
	Spacing Factor, mm	0.129				0.181	
TEST LABORATORY		BCC		BCC		BCC	
REMARKS - orientation of rebars and cover - presence of overlay, patch and thickness - other observed defects

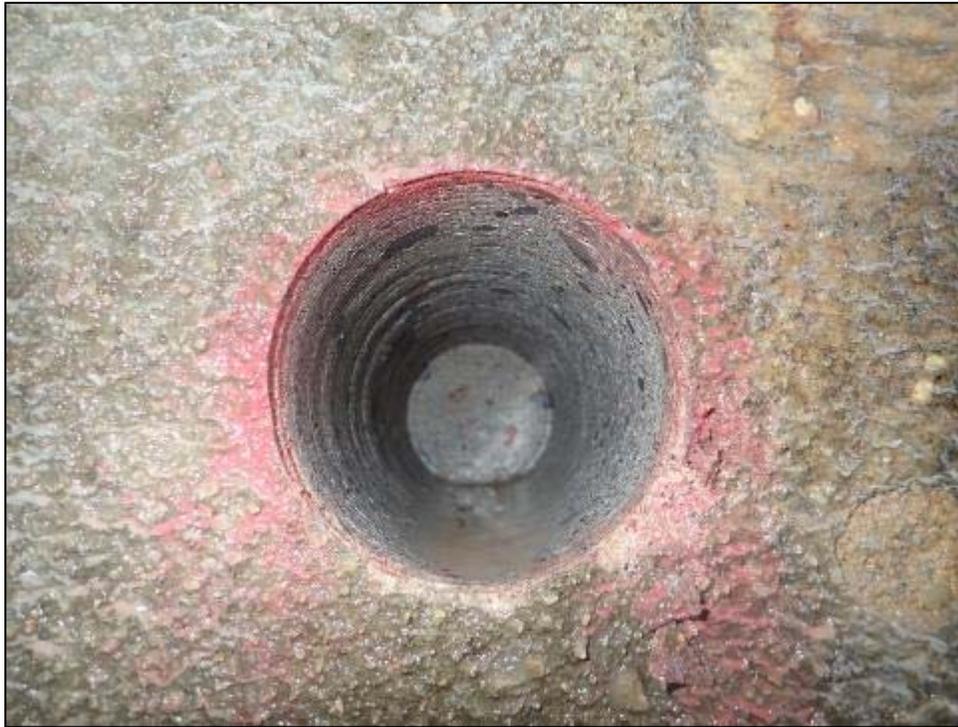
Photo P17 – Typical Condition of Inside Core C17 (Dam E – Bayview, east abutment)

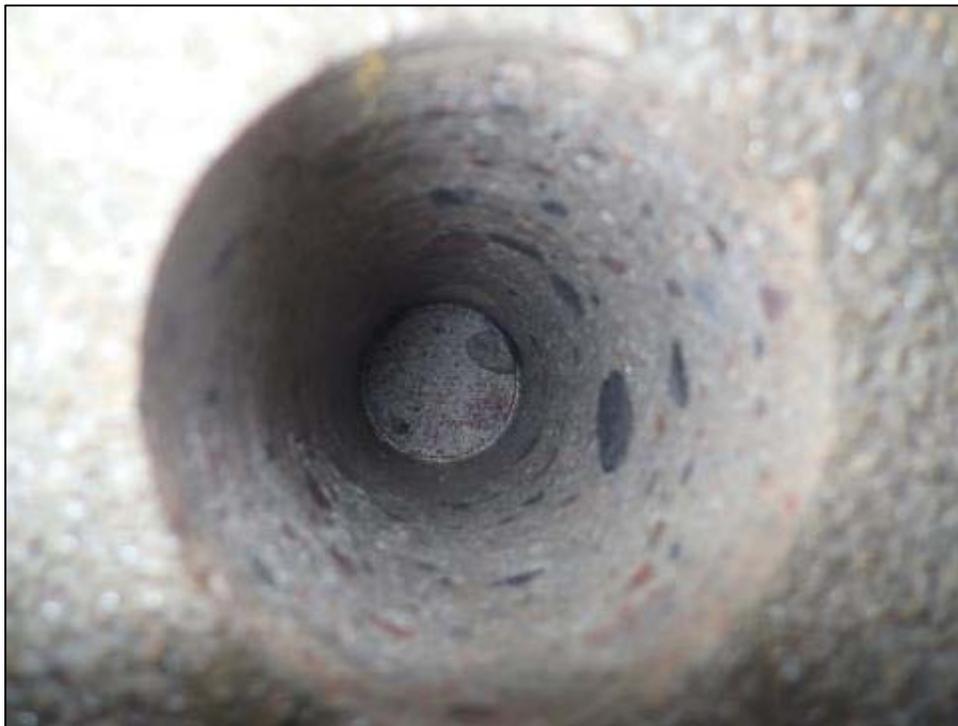
Photo P18 – Typical Condition of Inside Core C18 (Dam E – Bayview, east abutment)

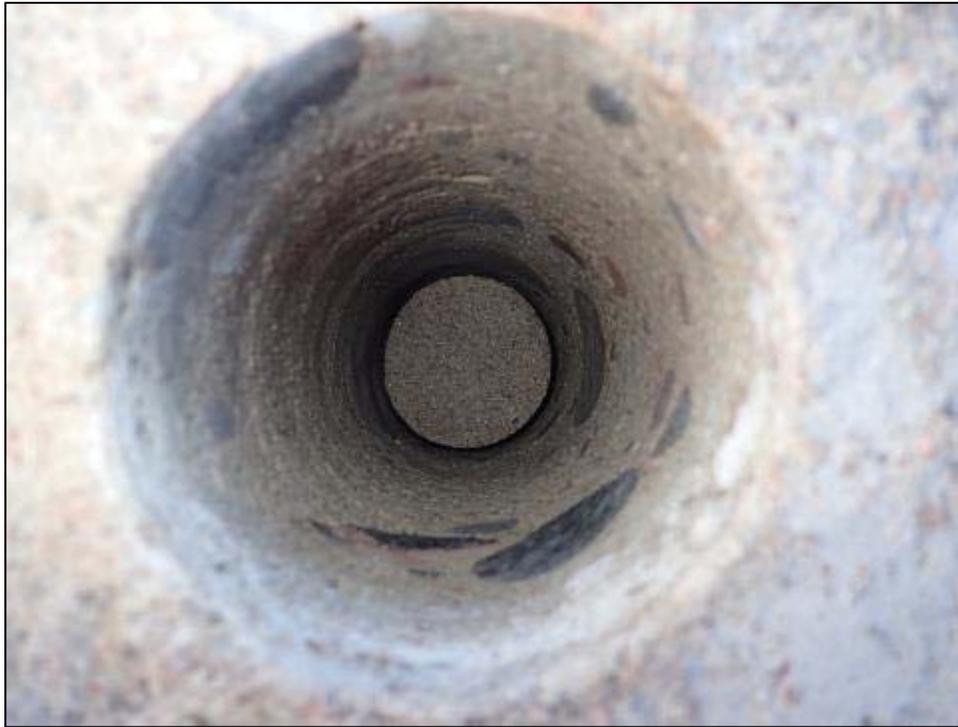
Photo P19 – Typical Condition of Inside Core C19 (Dam D, top of wall)

Core No.		C19		C20		C21	
Location (between gridlines)		Dam D, top of wall		Dam D, top of wall		Dam C, top of wall	
Diameter, mm		70.0		70.0		70.0	
Length, mm		225.0		335.0		190.0	
Full Depth (yes/no)		No		No		No	
Defects in Concrete ⁽¹⁾		C		D		-	
Condition of Rebar ⁽²⁾		N/A		N/A		N/A	
Corrosion Potential		-		-		-	
Compressive Strength, MPa		14.9		14.9		36.7	
Chloride Content % Chloride by Weight of Concrete	0-10 mm	Total	Corrected	Total	Corrected	Total	Corrected
	20-30 mm						
	40-50 mm						
	60-70 mm						
	80-90 mm						
AIR VOIDS	Air Content, %			13.3			
	Spec. Surf., mm ² /mm ³			19.74			
	Spacing Factor, mm			0.103			
TEST LABORATORY		BCC		BCC		BCC	
REMARKS - orientation of rebars and cover - presence of overlay, patch and thickness - other observed defects		Medium crack		Delamination plane @180mm.

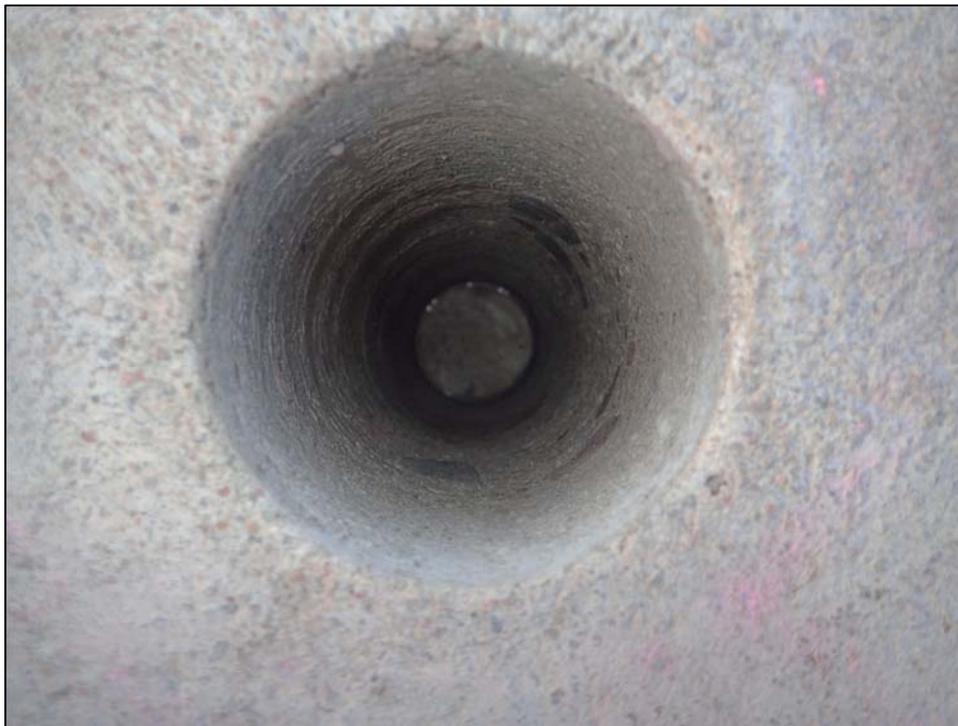
Photo P20 – Typical Condition of Inside Core C20 (Dam D, top of wall)

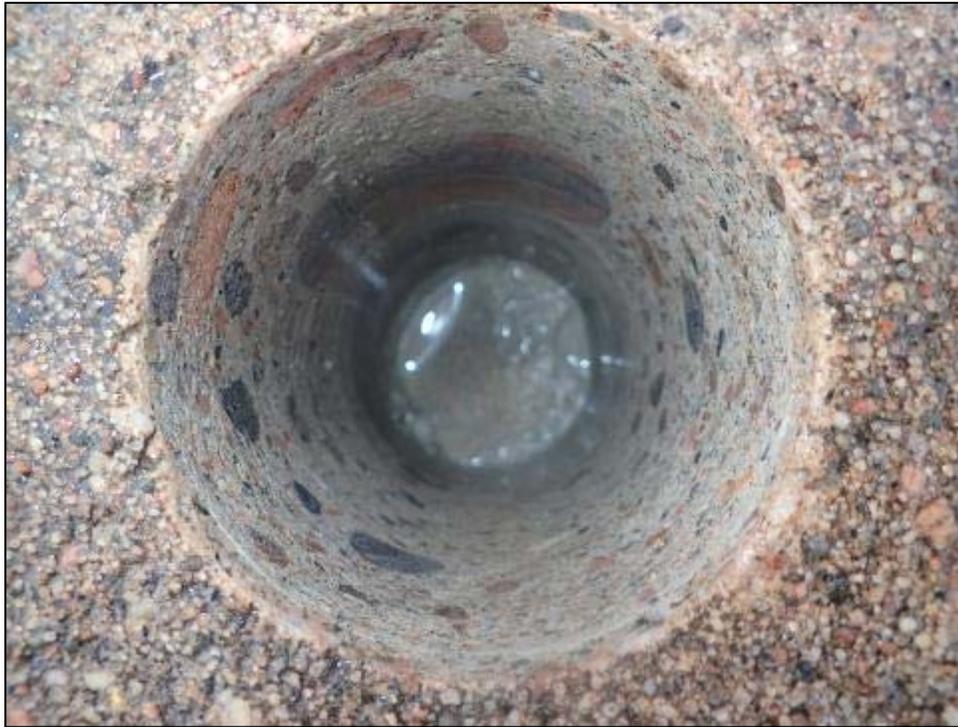
Photo P21 – Typical Condition of Inside Core C21 (Dam C, top of wall)

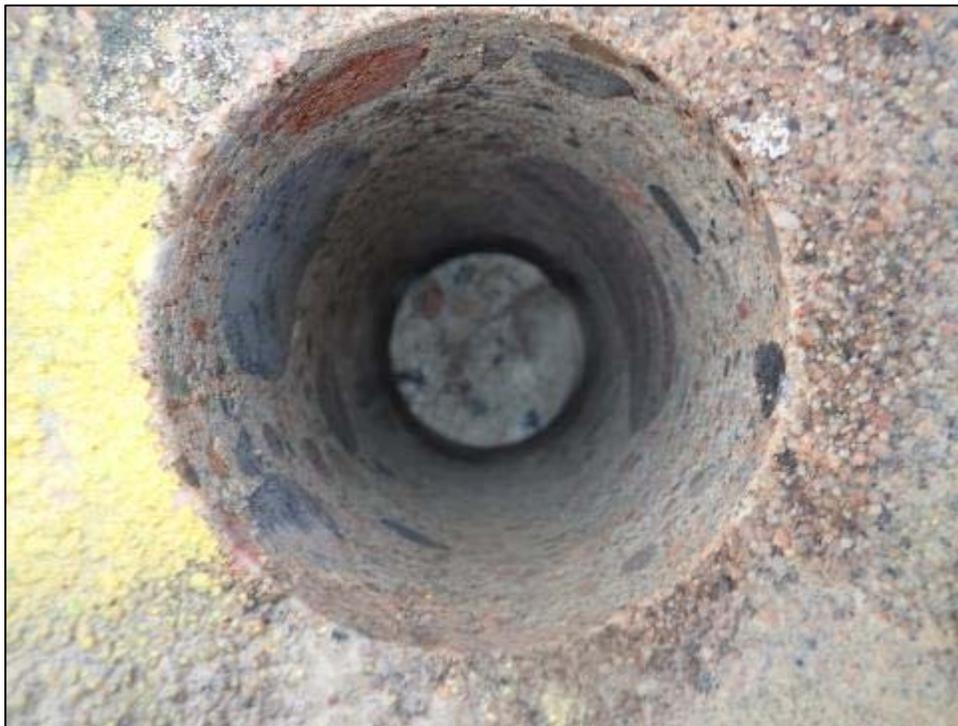
Photo P22 – Typical Condition of Inside Core C22 (Dam C, top of wall)

Core No.		C22		C23		C24	
Location (between gridlines)		Dam C, top of wall		Dam G -Little Chute, top of wall		Dam G -Little Chute, top of wall	
Diameter, mm		70.0		70.0		70.0	
Length, mm		195		220		230	
Full Depth (yes/no)		No		No		No	
Defects in Concrete ⁽¹⁾		-		-		-	
Condition of Rebar ⁽²⁾		N/A		N/A		N/A	
Corrosion Potential		-		-		-	
Compressive Strength, MPa		23.3		36.2		45.0	
Chloride Content % Chloride by Weight of Concrete	0-10 mm	Total	Corrected	Total	Corrected	Total	Corrected
	20-30 mm						
	40-50 mm						
	60-70 mm						
	80-90 mm						
AIR VOIDS	Air Content,%					7.8	
	Spec. Surf.,mm ² /mm ³					15.20	
	Spacing Factor, mm					0.287	
TEST LABORATORY		BCC		BCC		BCC	
REMARKS - orientation of rebars and cover - presence of overlay, patch and thickness - other observed defects

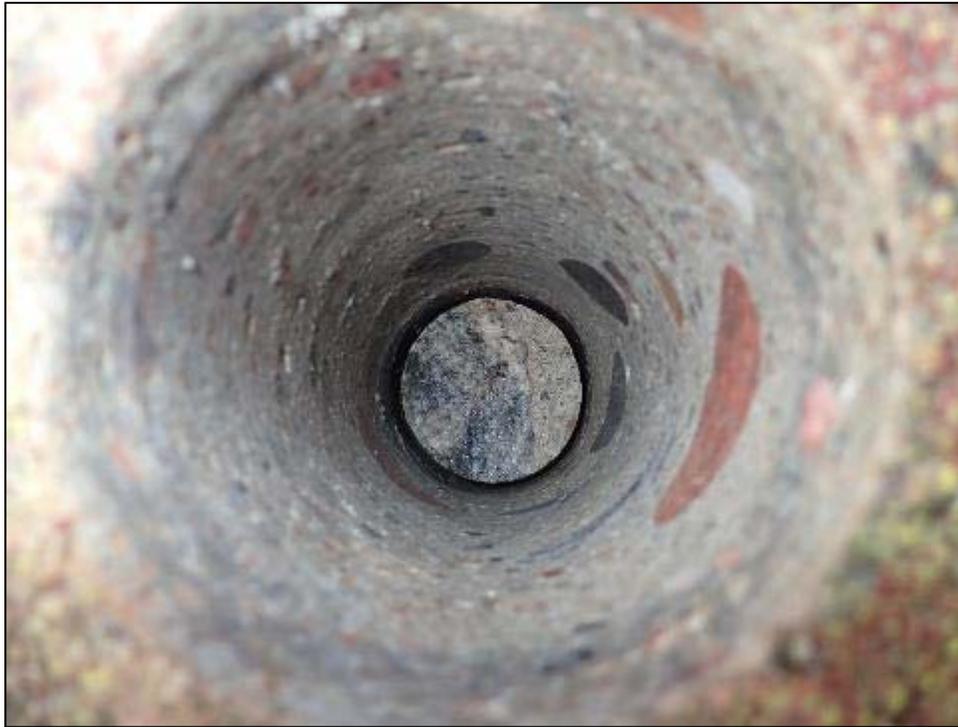
Photo P23 – Typical Condition of Inside Core C23 (Dam G – Little Chute, top of wall)

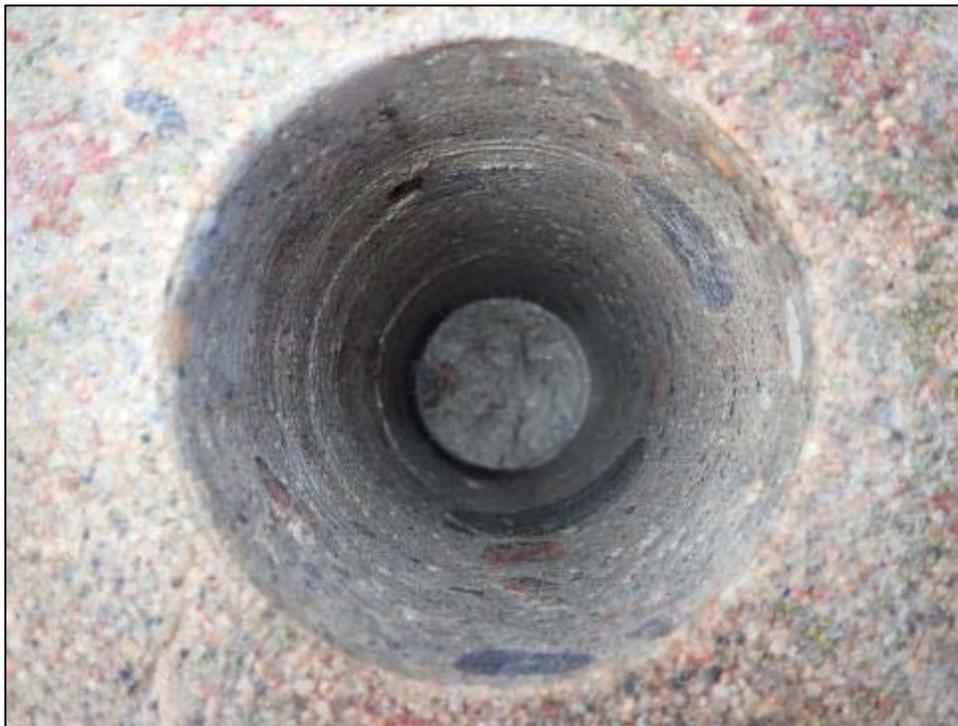
Photo P24 – Typical Condition of Inside Core C24 (Dam G – Little Chute, top of wall)

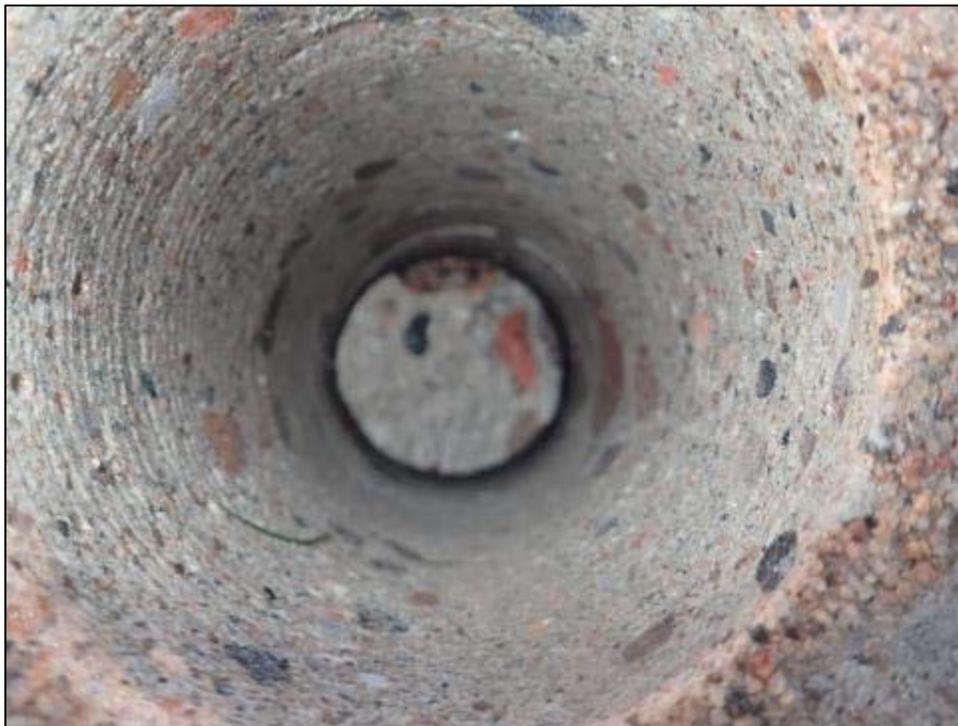
Photo P26 – Typical Condition of Inside Core C26 (Dam A, top of wall)

Core No.		C25		C26		RC1	
Location (between gridlines)		Dam A, top of wall		Dam A, top of wall		Main Dam, Pier 2	
Diameter, mm		70.0		70.0		63.0	
Length, mm		125.0		205.0		10'1.5"	
Full Depth (yes/no)		No		No		No	
Defects in Concrete ⁽¹⁾		-		C		-	
Condition of Rebar ⁽²⁾		N/A		N/A		N/A	
Corrosion Potential		-		-		-	
Compressive Strength, MPa		33.9		45.1		31.1 / 21.8	
Chloride Content % Chloride by Weight of Concrete	0-10 mm	Total	Corrected	Total	Corrected	Total	Corrected
	20-30 mm						
	40-50 mm						
	60-70 mm						
AIR VOIDS	Air Content, %					8.3	8.4
	Spec. Surf., mm ² /mm ³					21.56	19.54
	Spacing Factor, mm					0.209	0.161
TEST LABORATORY		BCC		BCC		BCC	
REMARKS - orientation of rebars and cover - presence of overlay, patch and thickness - other observed defects				Medium crack		31.1 MPa (170-285mm). 21.8 MPa (2530-2645 mm). AVS testing conducted at 520-680mm and 1790-1940mm.

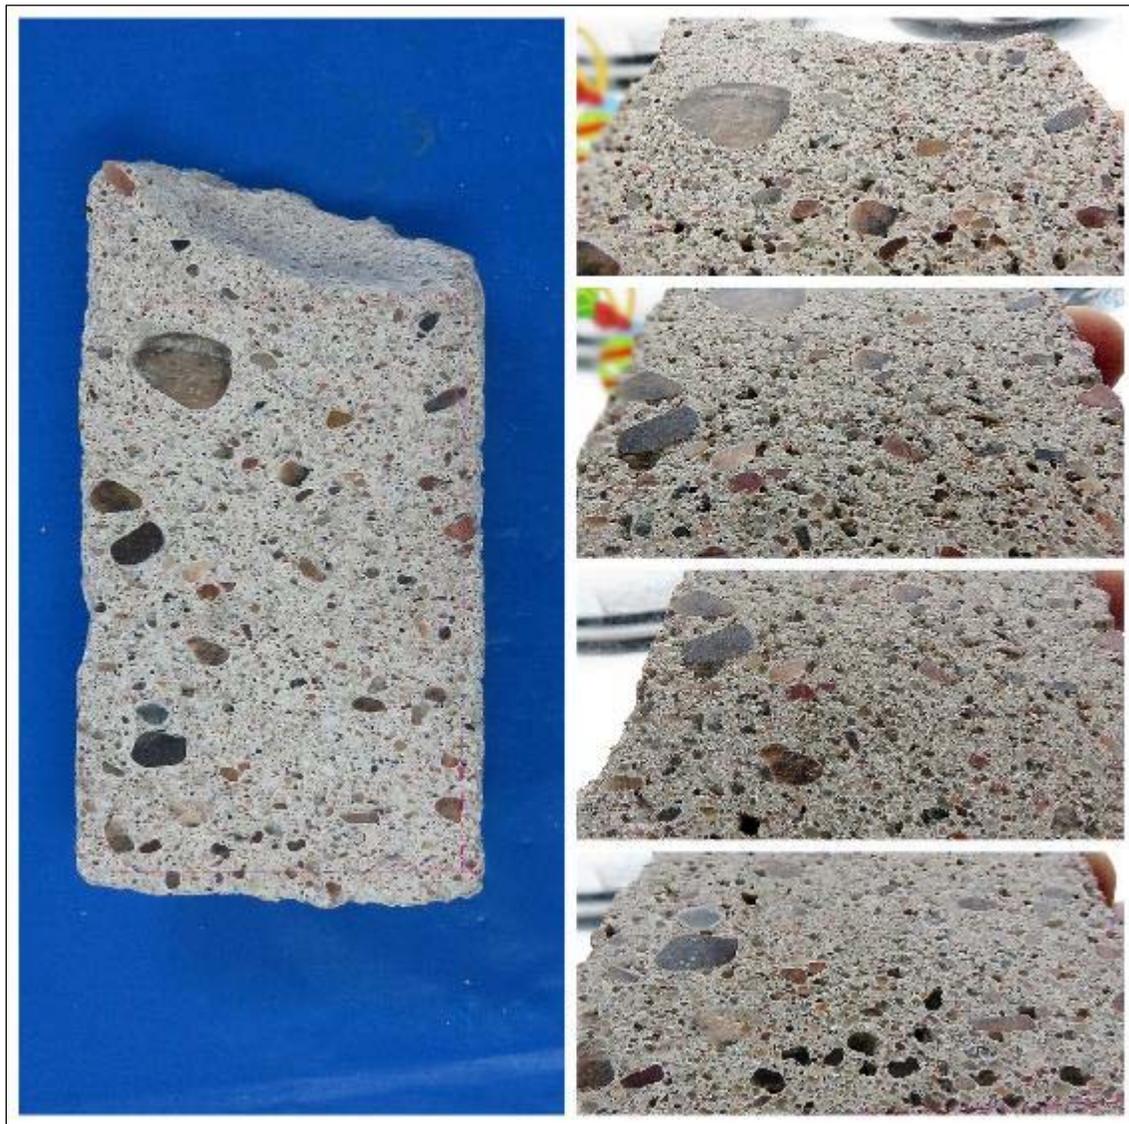
CORE C20 (Dam D, top of wall)

Air Void Test Result
