**FINAL MODIFIED PHASE I ENVIRONMENTAL SITE
ASSESSMENT AND HAZARDOUS MATERIALS SURVEY**

**DALVAY ASSETS
PRINCE EDWARD ISLAND NATIONAL PARK
DALVAY, QUEENS COUNTY, PEI**

**PUBLIC WORKS AND GOVERNMENT SERVICES CANADA FOR
PARKS CANADA**

JANUARY 13, 2011

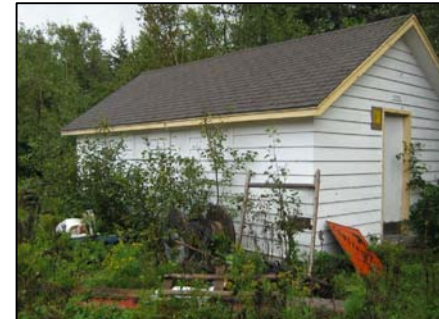
PHOTO 21 - VIEW FACING SOUTHWEST TOWARD ASSET NO. 218 (SHAW'S BEACH CHANGE HOUSE)

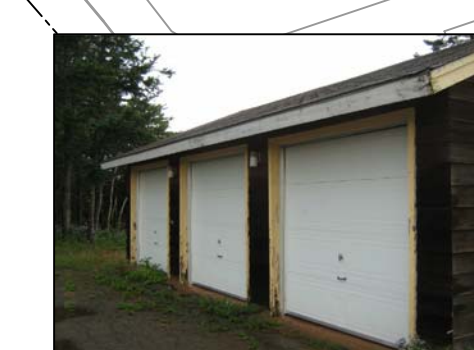
PHOTO 6 - VIEW FACING NORTHEAST TOWARD ASSET NO. 217 (3 CAR GARAGE)

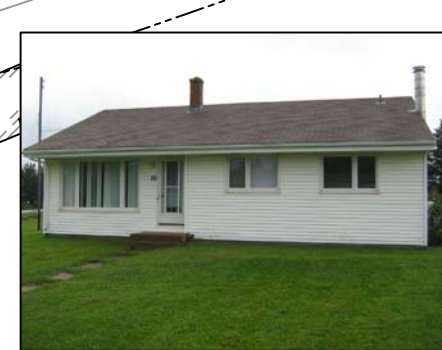
PHOTO 1 - VIEW FACING NORTH TOWARD ASSET NO. 217 (STAFF HOUSE No. 5)

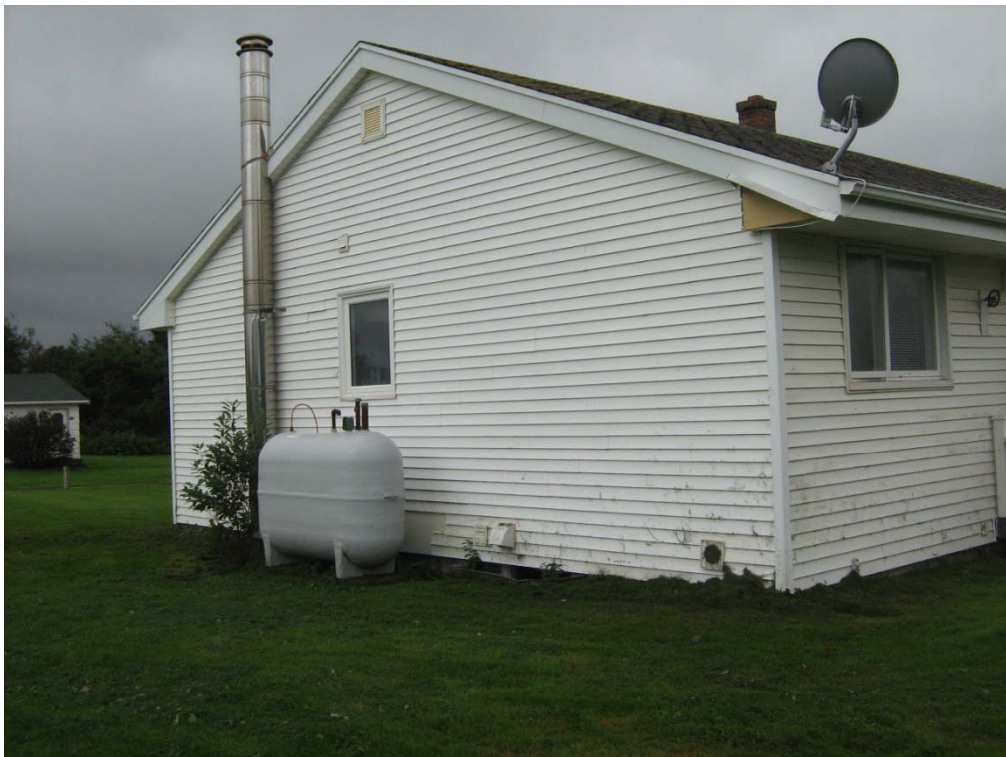
PHOTO 2: Asset 217 – Staff House #5 – photo facing southwest.

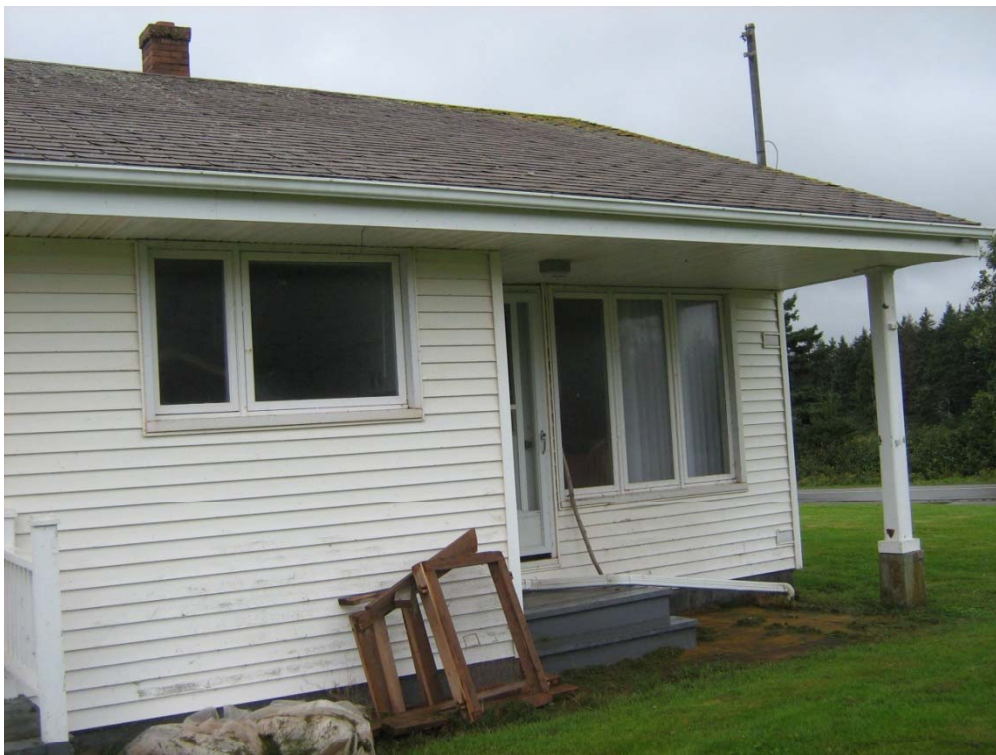
PHOTO 4: Asset 217 – Staff House #5 – photo facing southwest.

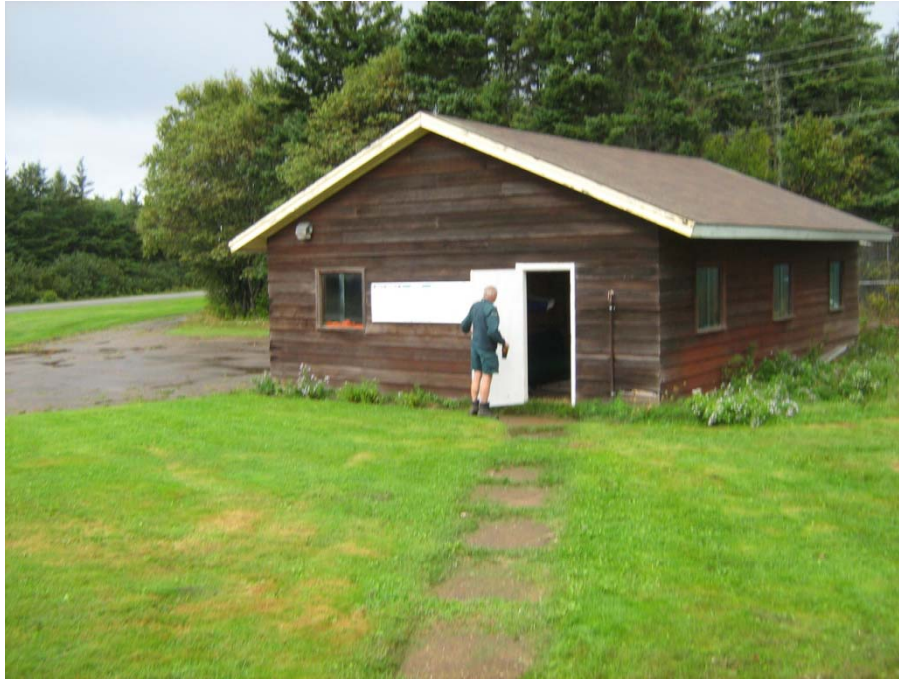
PHOTO 5: Asset 217 – Garage Associated with Staff House #5 – photo facing north

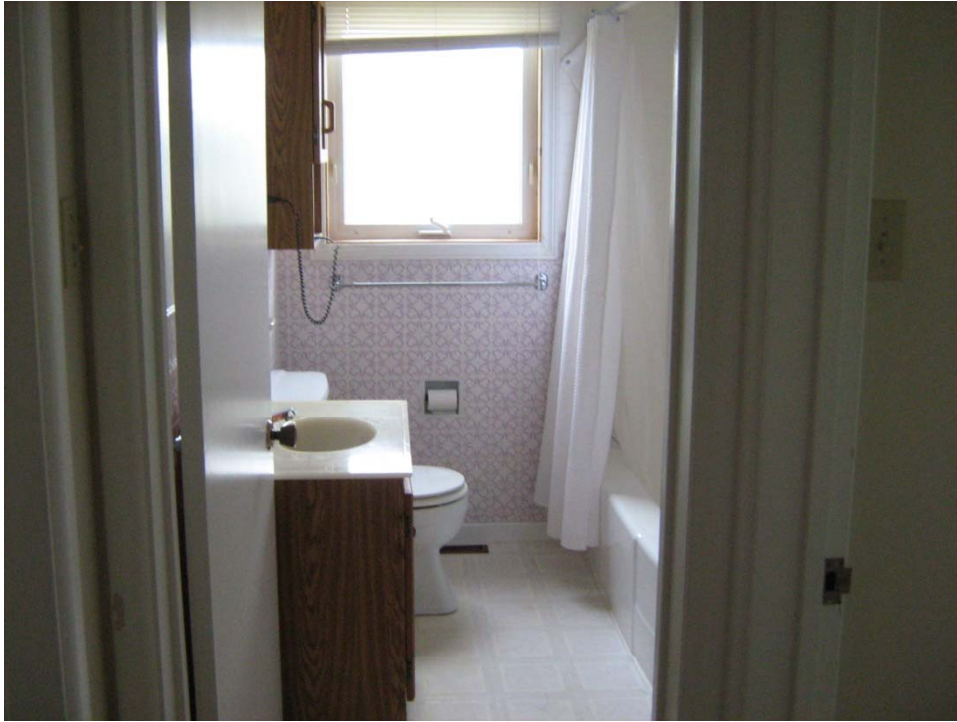
PHOTO 9: Asset 217 –Bathroom – Staff House #5.

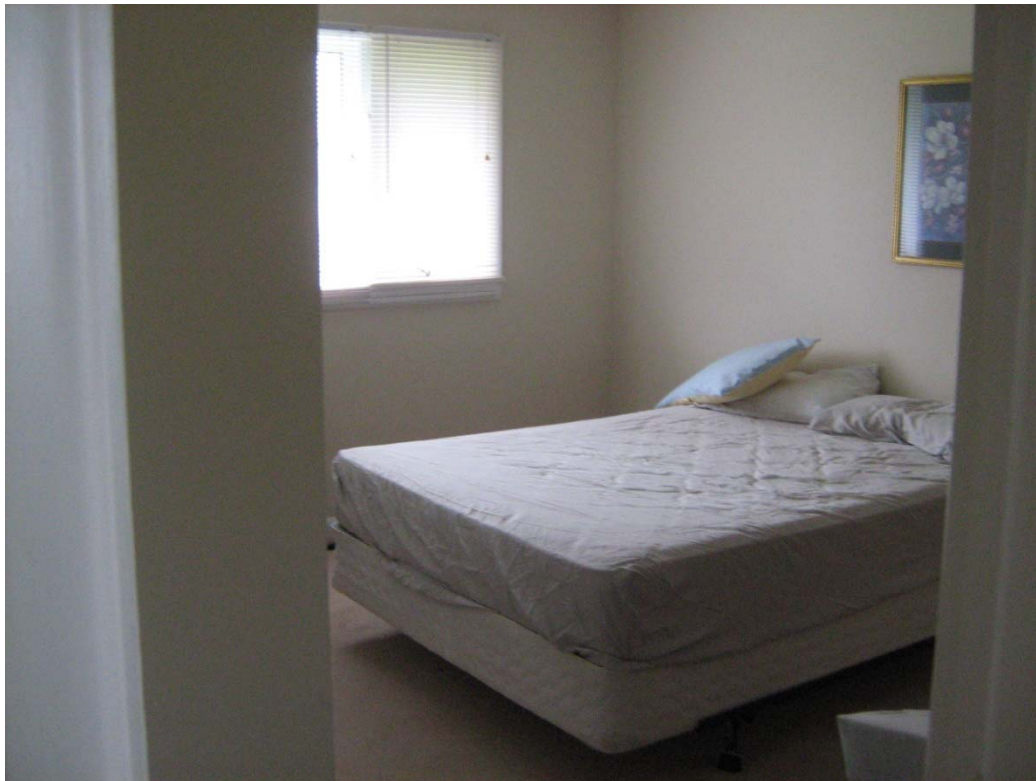
PHOTO 10: Asset 217 – Bedroom – Staff House #5.

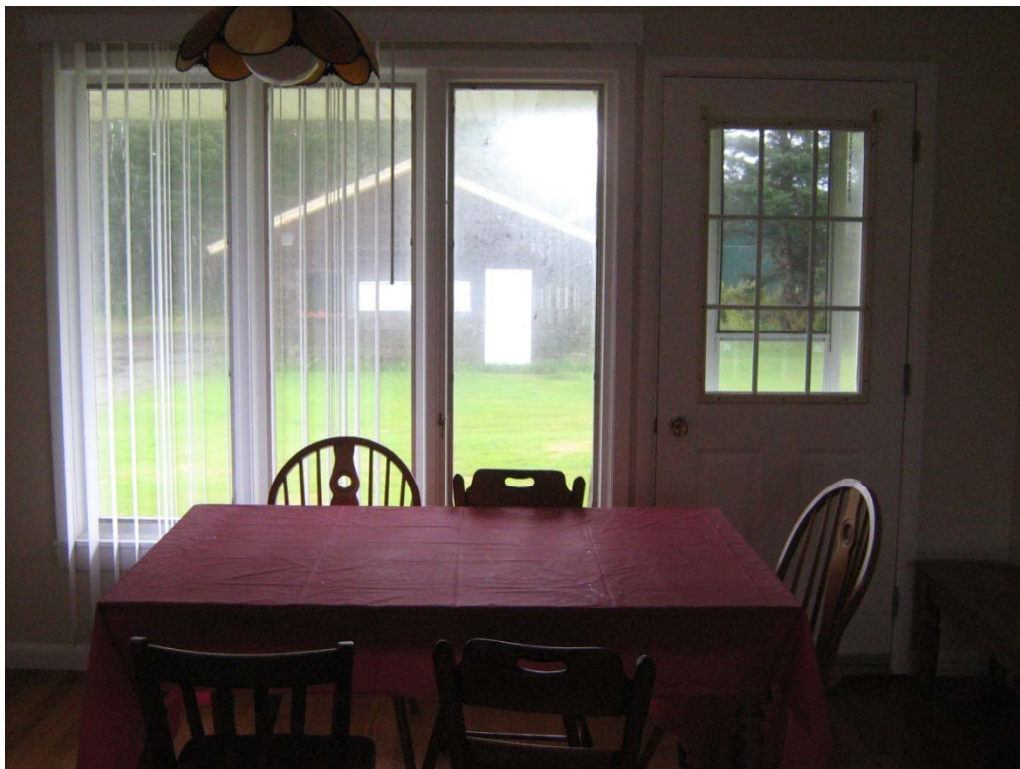
PHOTO 12: Asset 217 –Dinning – Staff House #5..

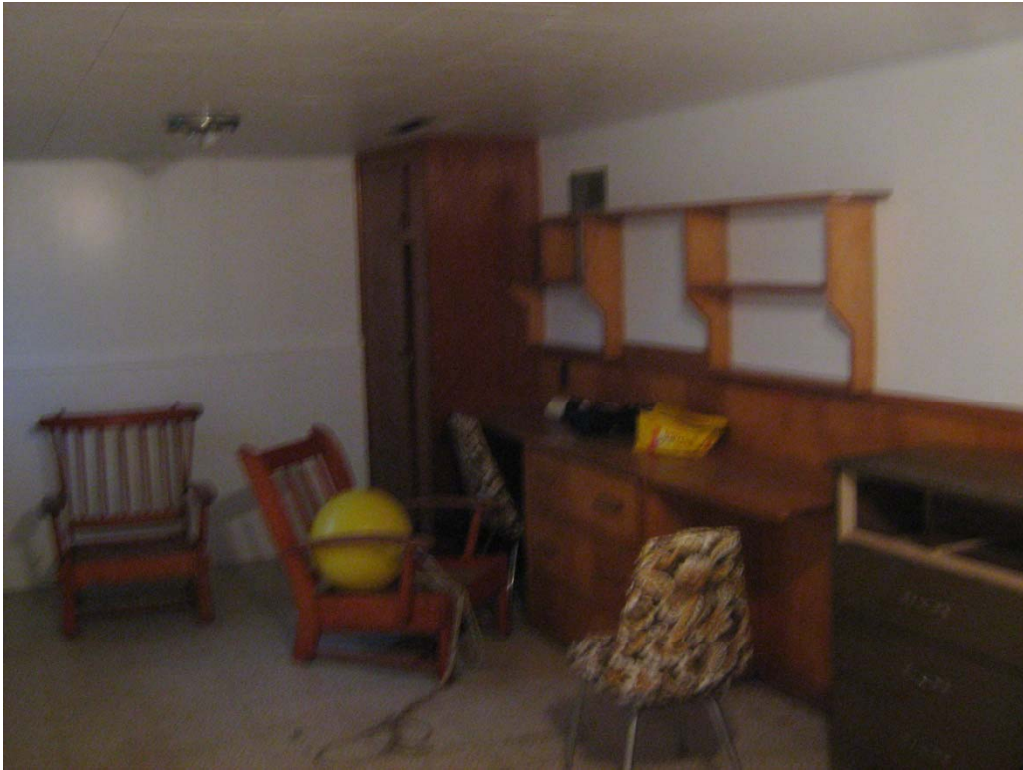
PHOTO 13: Asset 217 –Basement – Staff House #5.

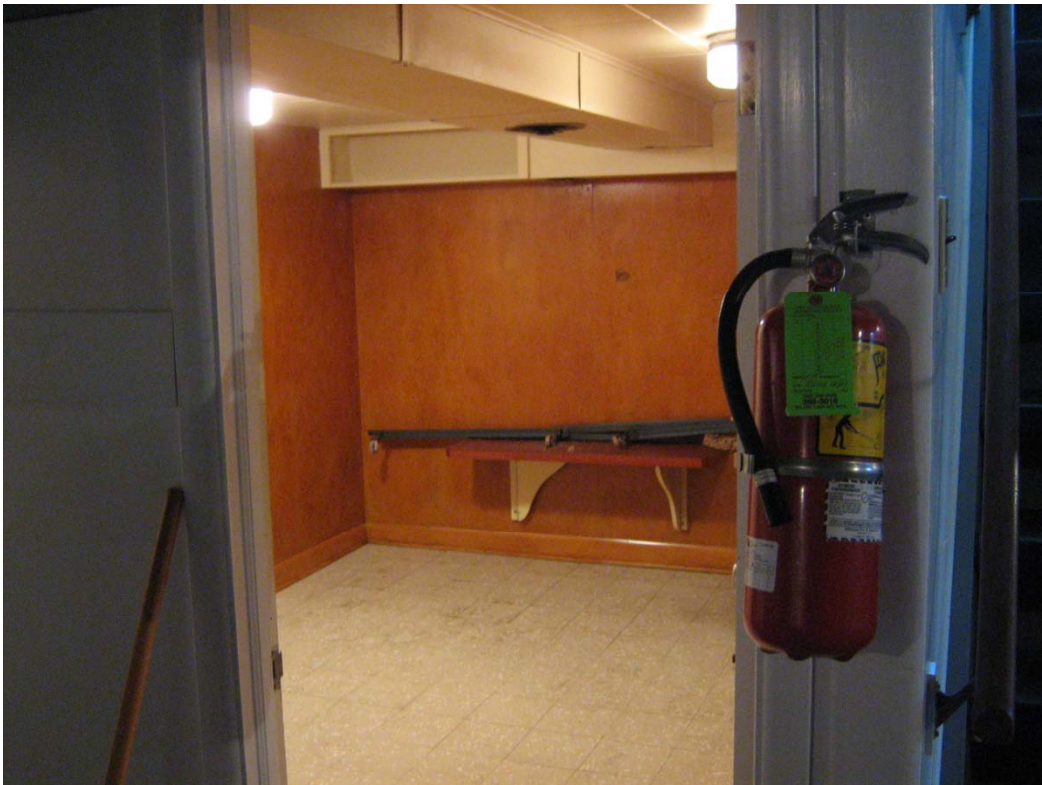
PHOTO 14: Asset 217 – Basement – Staff House #5.

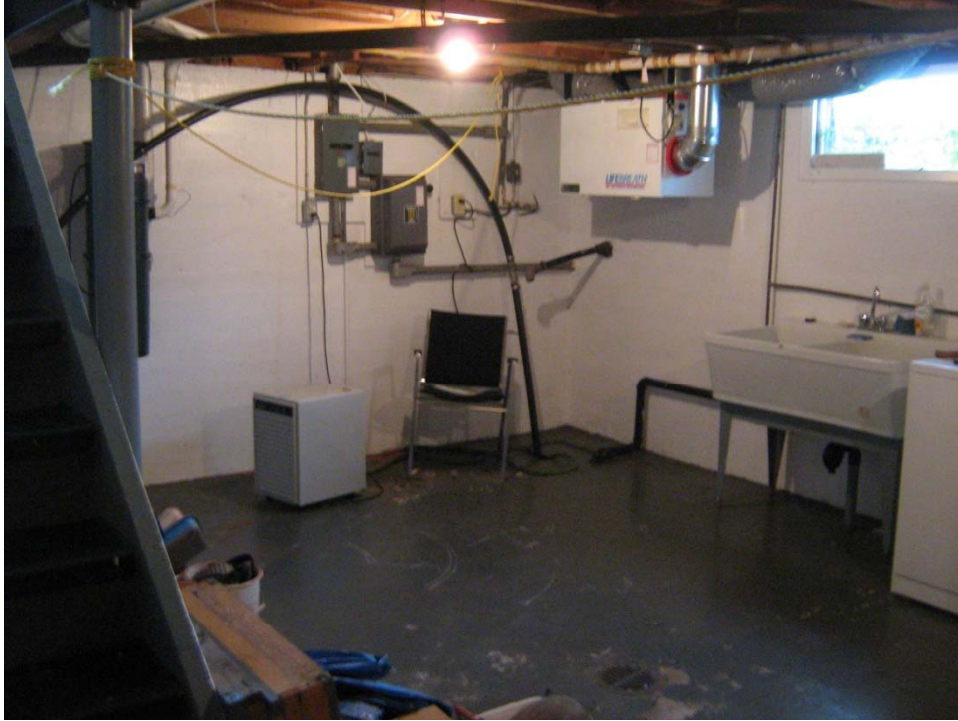
PHOTO 15: Asset 217 – Basement – Staff House #5.

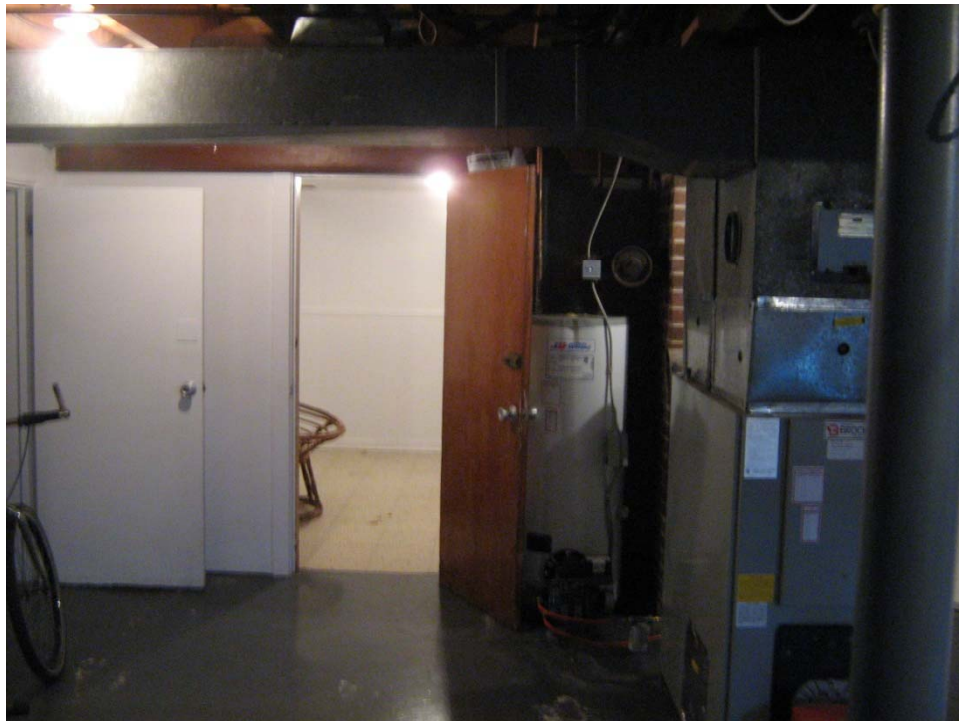
PHOTO 16: Asset 217 – Basement – Staff House #5.

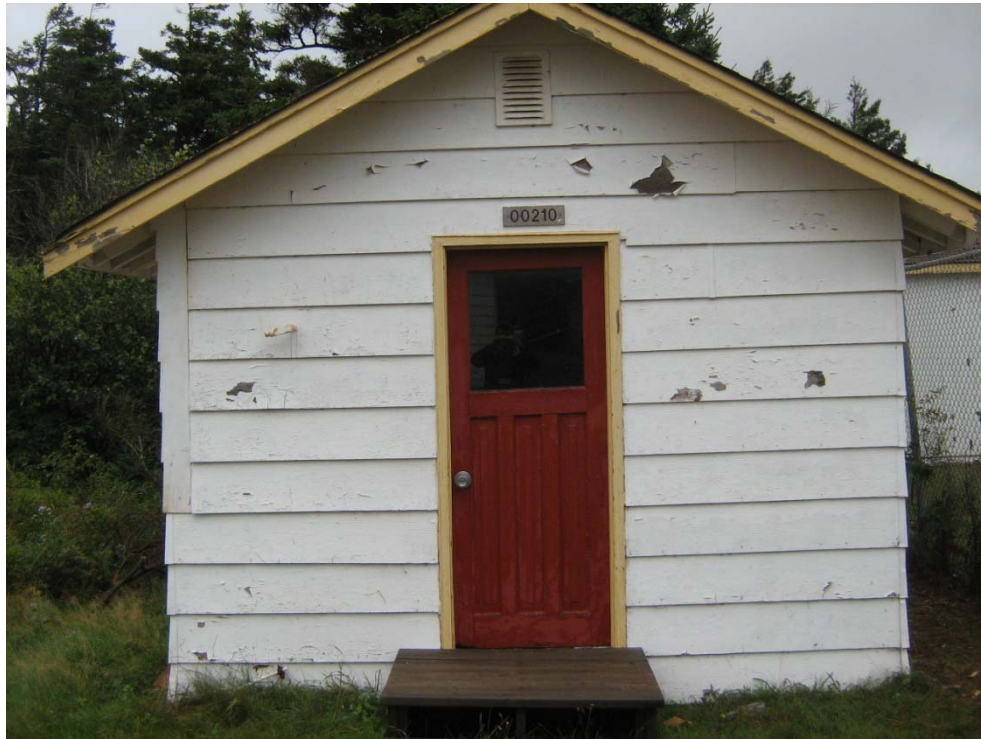
PHOTO 17: Asset 210 – Interpretive Storage Building – photo facing east.

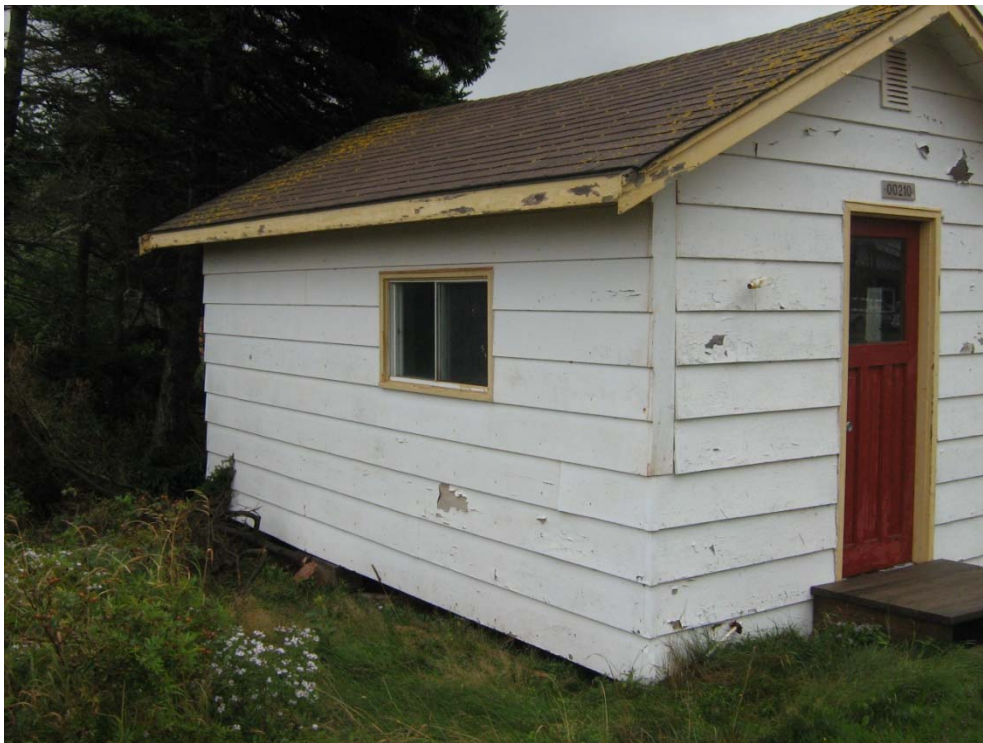
PHOTO 18: Asset 210 – Interpretive Storage Building – photo facing southeast.

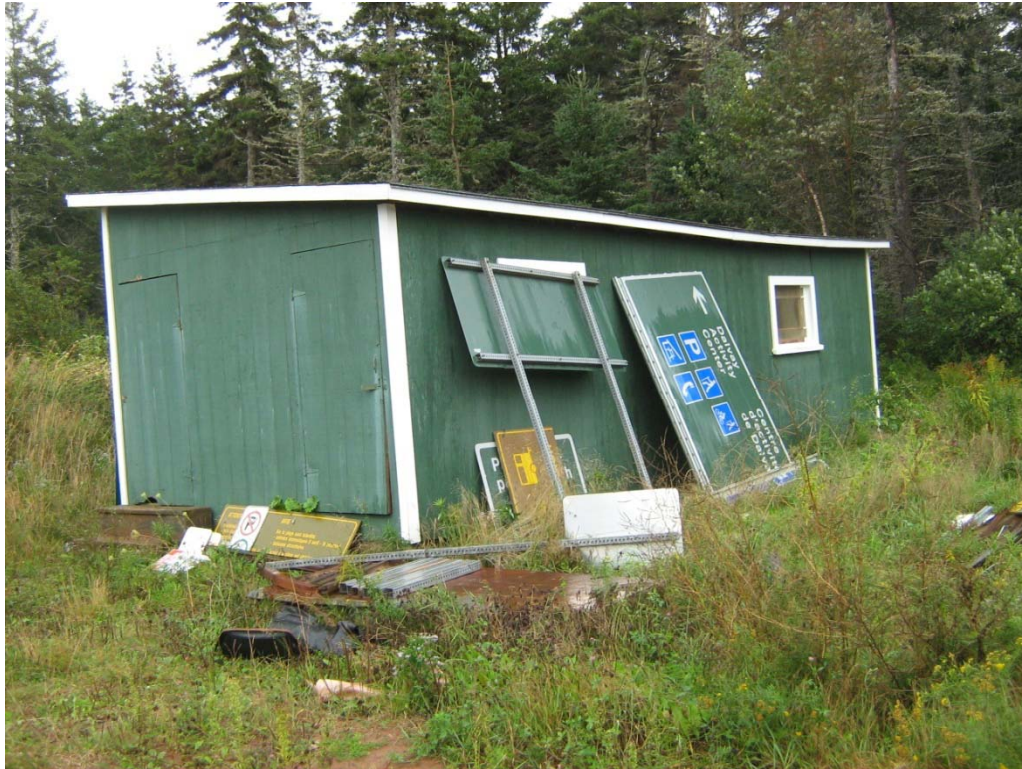
PHOTO 23: Asset 216 – Sign Building- photo facing southeast.

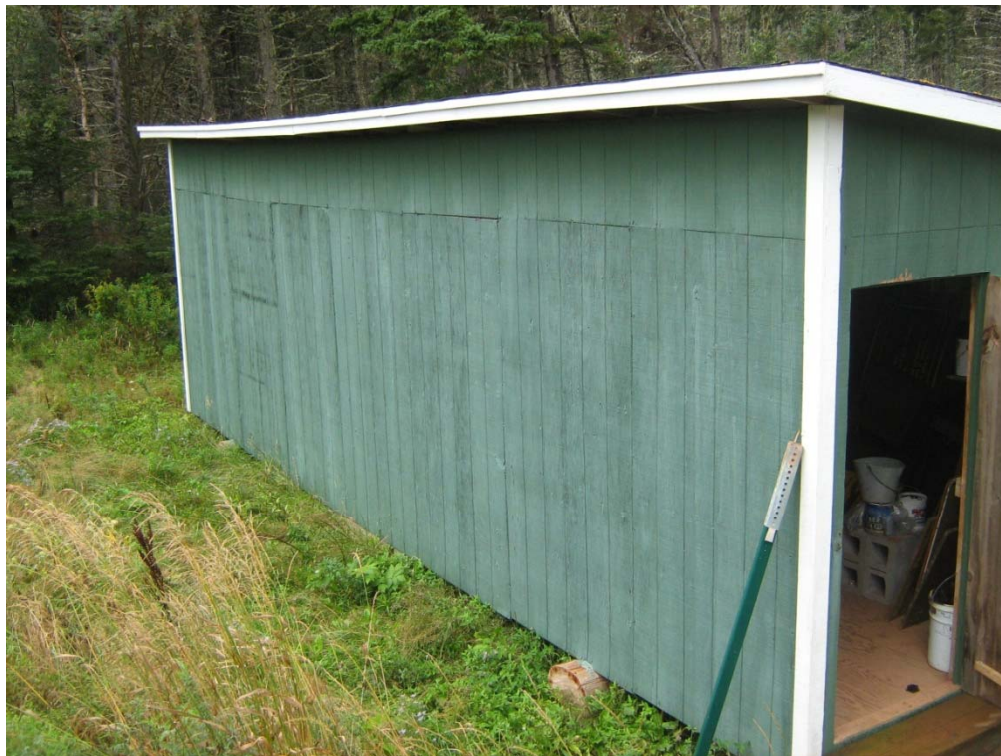
PHOTO 24: Asset 216 – Sign Building - photo facing southwest

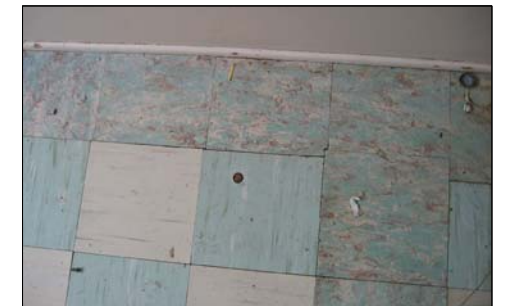
Photo 10: Three Different Colors of Flooring Tile

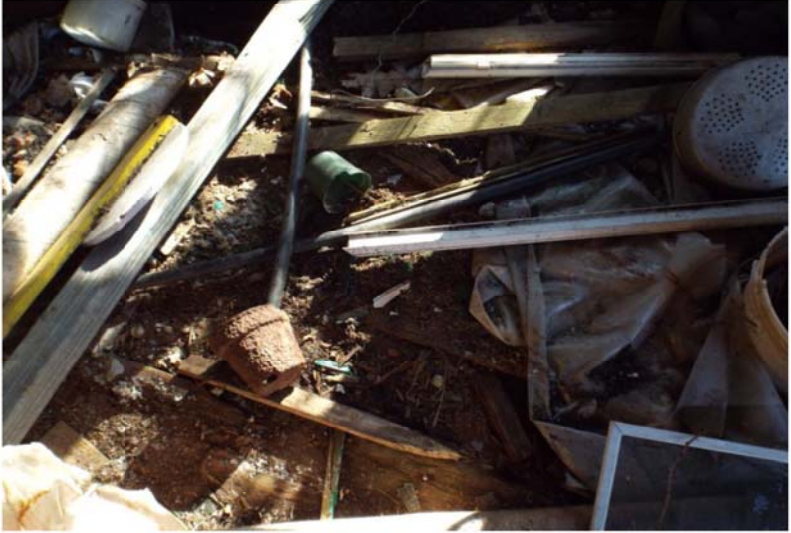
<p>P3</p>	<p>Miscellaneous C&D debris on ground</p>

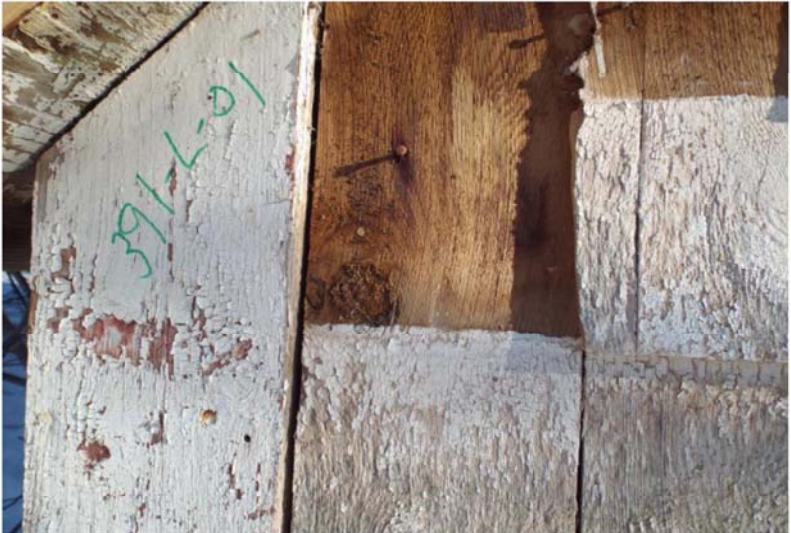
<p>P4</p>	<p>Sample 391-L-01 Exterior white siding paint (Results - 0.2% lead by weight - 1.7 mg/L TCLP)</p>

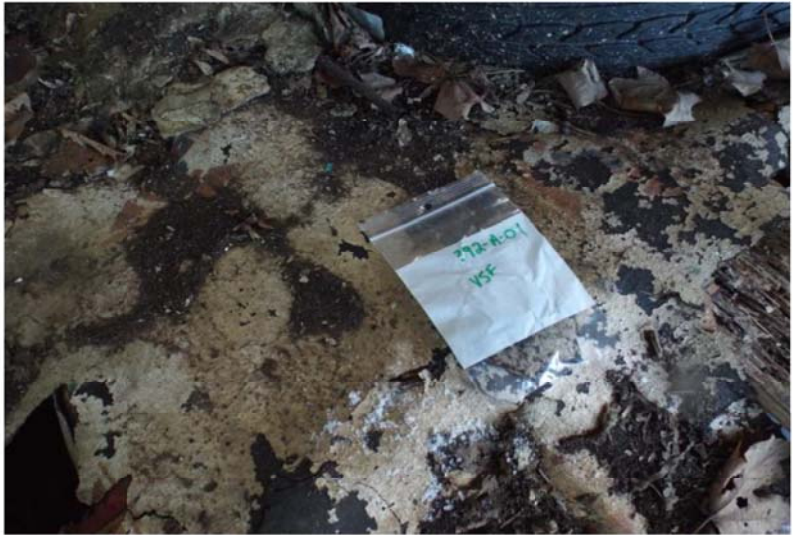
P2	Sample 392-A-01 Vinyl sheet flooring No asbestos detected

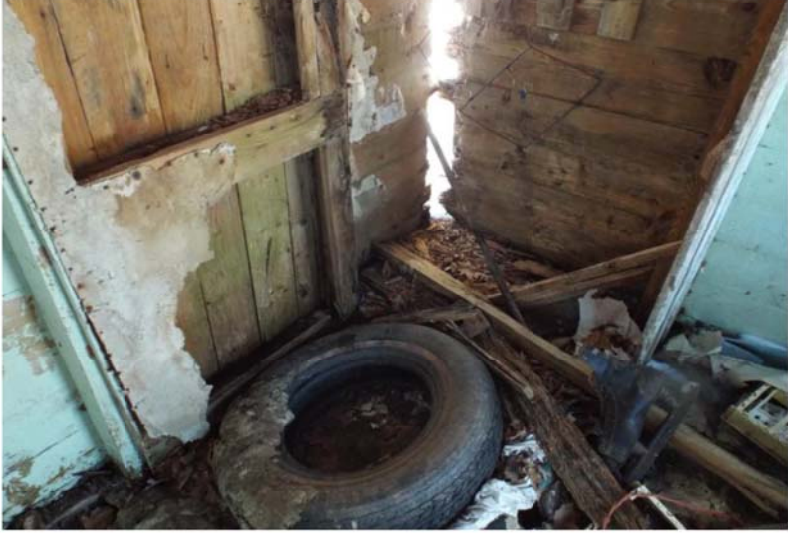
<p>P3</p>	<p>Interior of building. Miscellaneous C&D debris.</p>

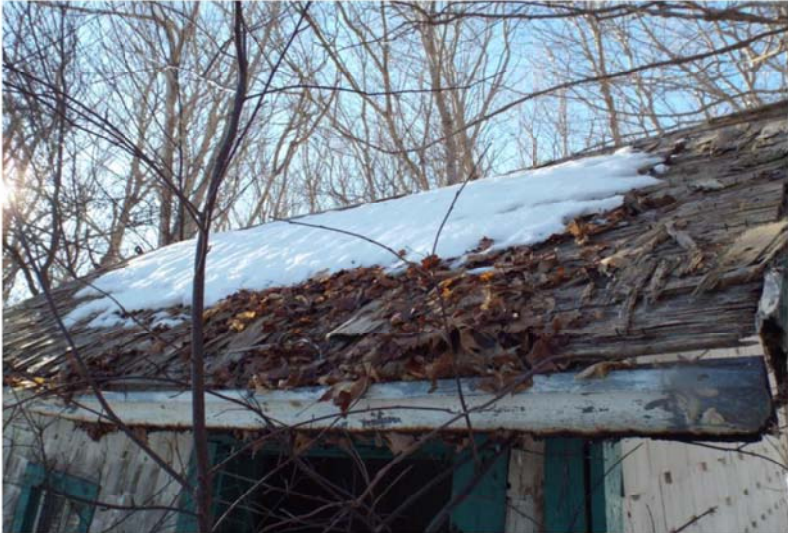
<p>P4</p>	<p>No roofing membrane. Wood only</p>

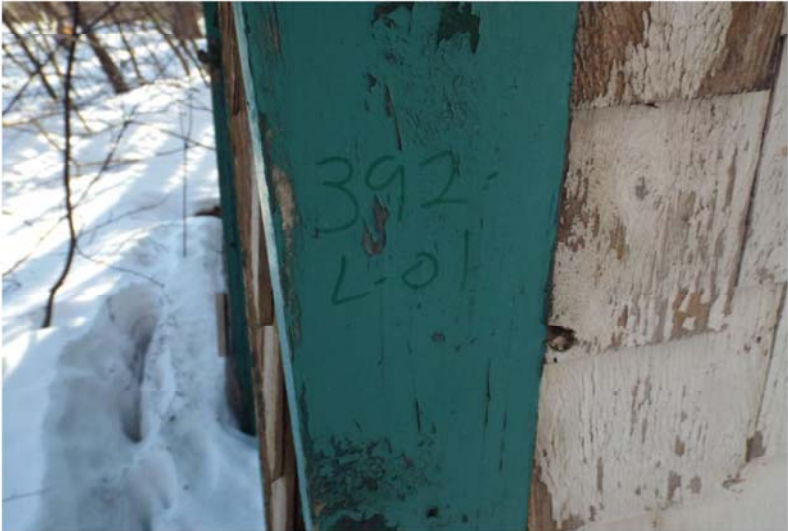
<p>P5</p>	<p>Sample 392-L-01 Exterior green paint on wood trim (Results - 2.0% lead by weight - 0.9 mg/L TCLP)</p>

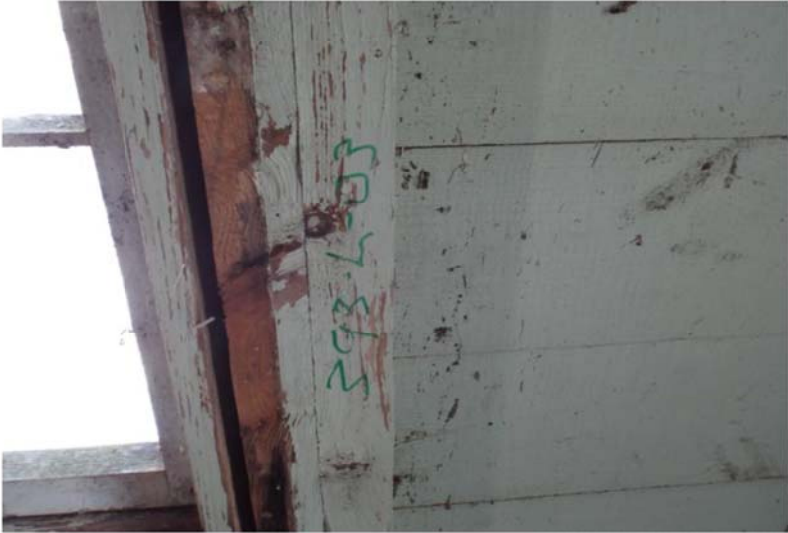
<p>P7</p>	<p>Sample 392-L-03 Interior light green paint on wood trim (Results - 0.01% lead by weight)</p>

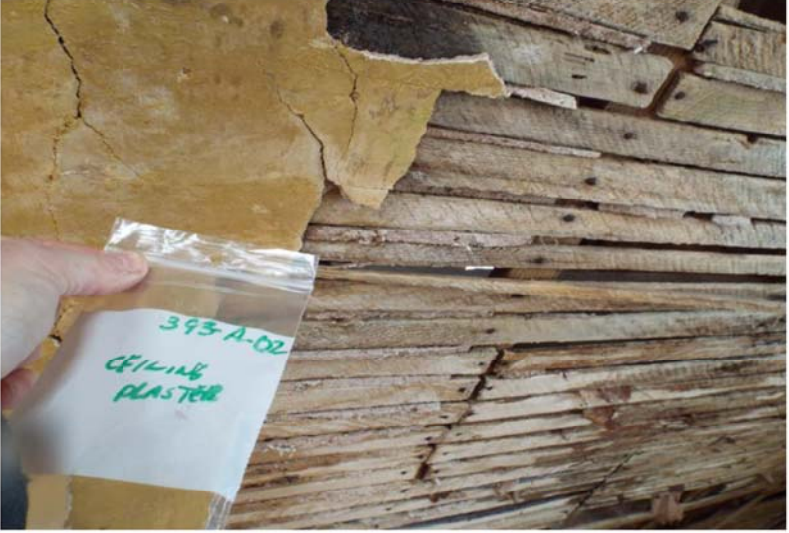
<p>P3</p>	<p>Sample 393-A-02 Ceiling plaster No asbestos detected</p>

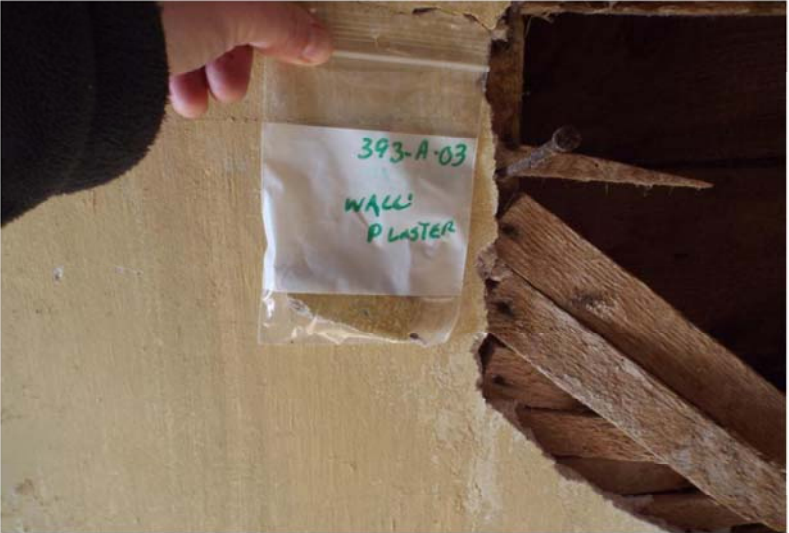
<p>P4</p>	<p>Sample 393-A-03 Wall plaster No asbestos detected</p>

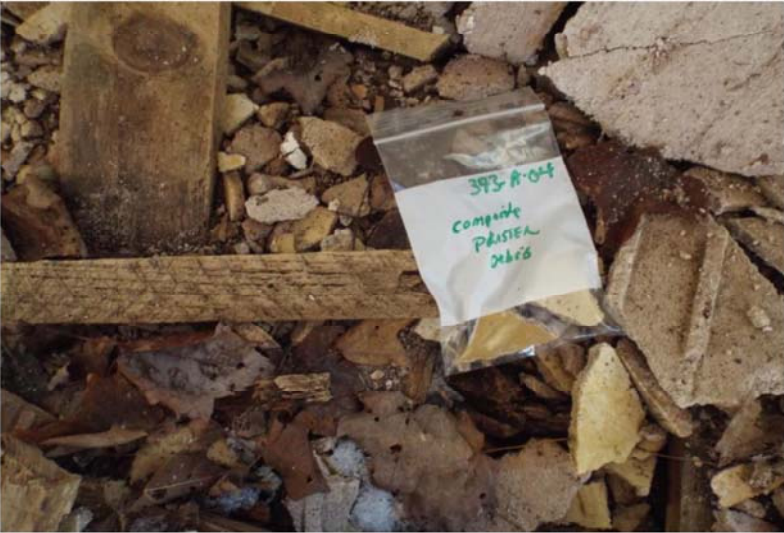
<p>P5</p>	<p>Sample 393-A-04 Composite plaster sample from debris No asbestos detected</p>

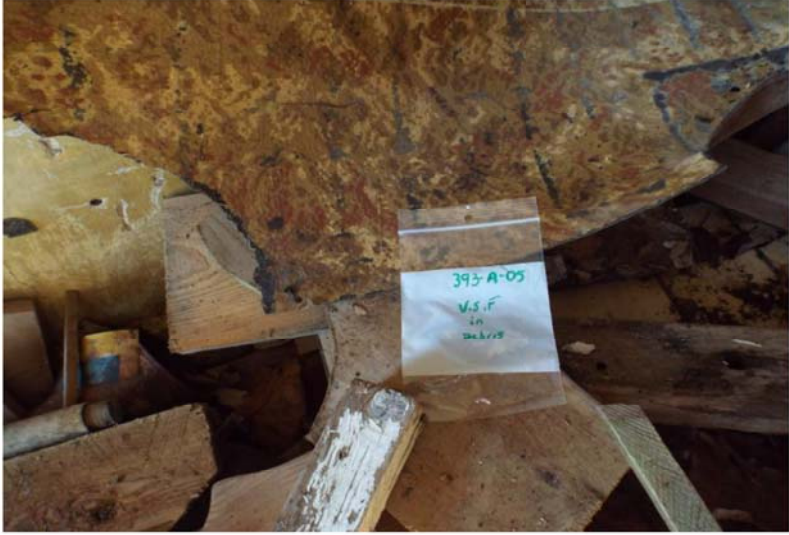
<p>P6</p>	<p>Sample 393-A-05 Vinyl sheet flooring in debris No asbestos detected</p>

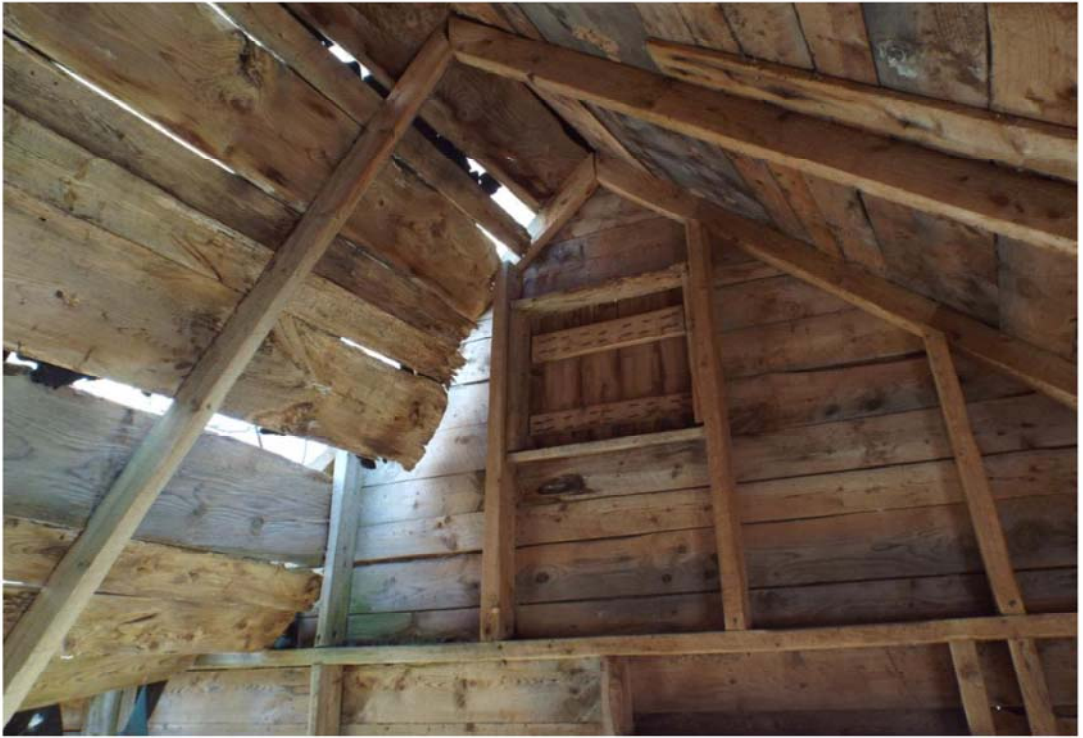
A photograph showing the exterior of a building with a snow-covered roof and bare trees in the foreground. The building appears to be made of stone or concrete blocks.
P2	Interior view of building 394. Wood framing. No finish coat or insulation

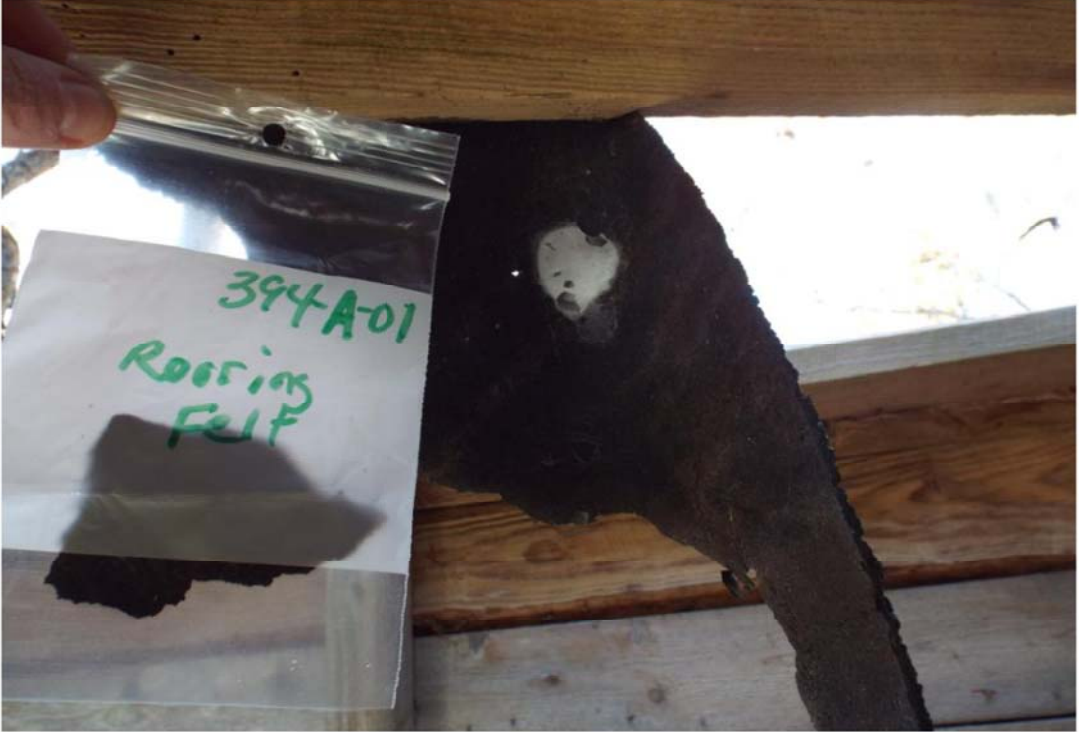
<p>P3</p>	<p>Exterior roof of outbuilding #4 Sample 394-A-01 Roofing Tar Felt</p>

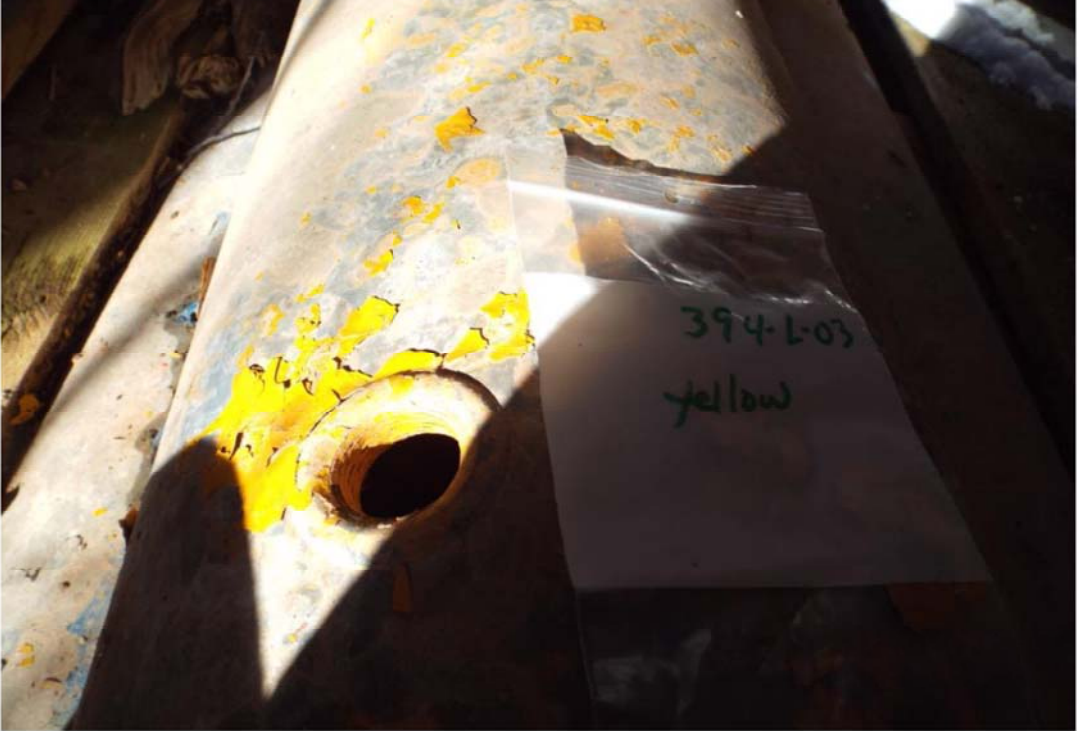
<p>P6</p>	<p>Sample 394-L-03 Yellow paint on metal cylinder (Results - 17.0% lead by weight)</p>

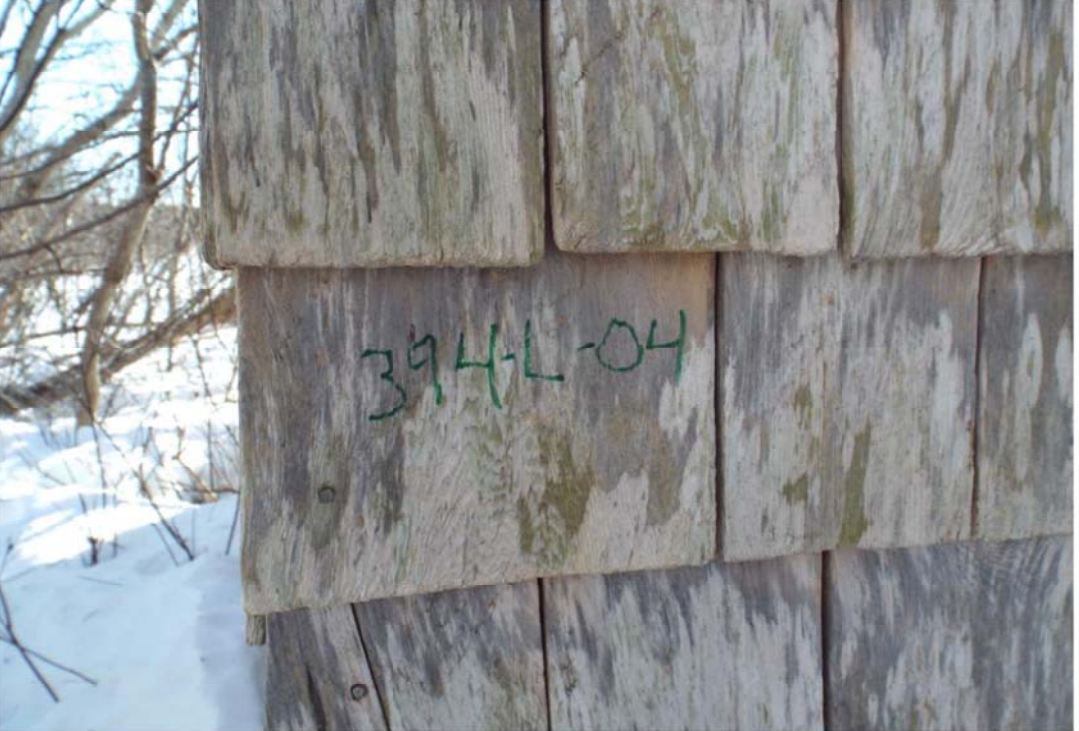
<p>P7</p>	<p>Sample 394-L-04 White paint on ext. Wood siding (Results - 0.0052% lead by weight)</p>

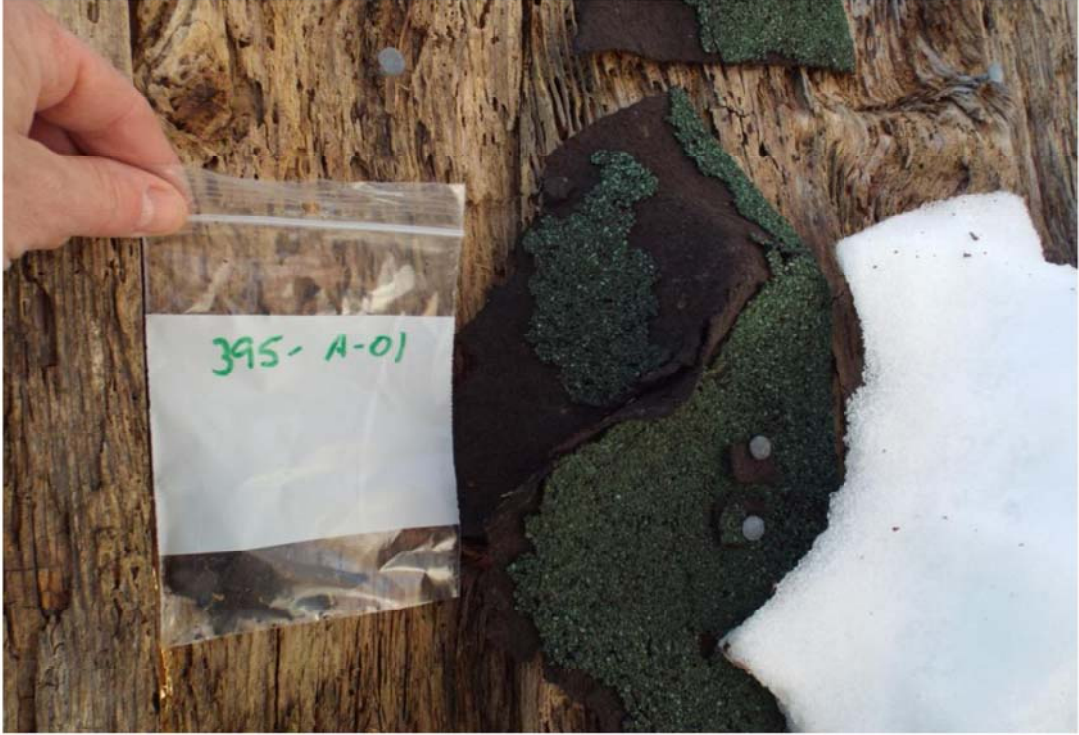
P2	Sample 395-A-01 Roofing felt paper No asbestos detected

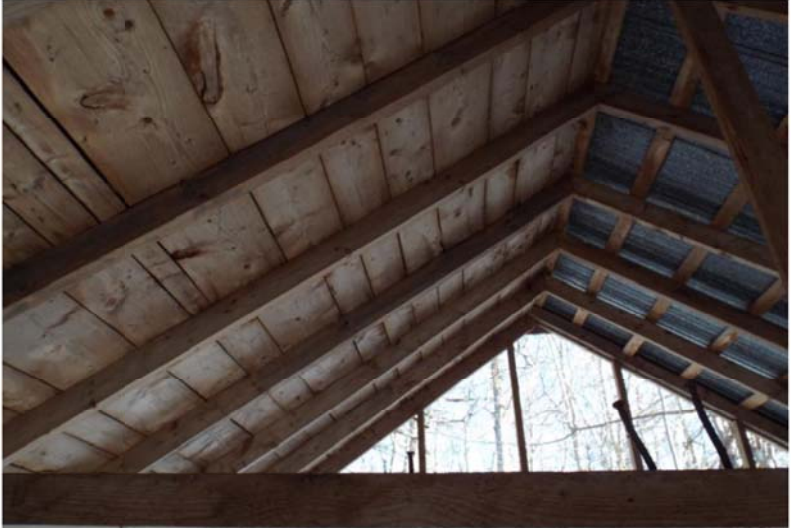
A photograph showing the exterior of a wooden building with a snow-covered roof. The building has several windows, some of which appear to be boarded up or missing. The surrounding area is covered in snow and has bare trees in the background.
P2	Interior view of building non finish / non insulated

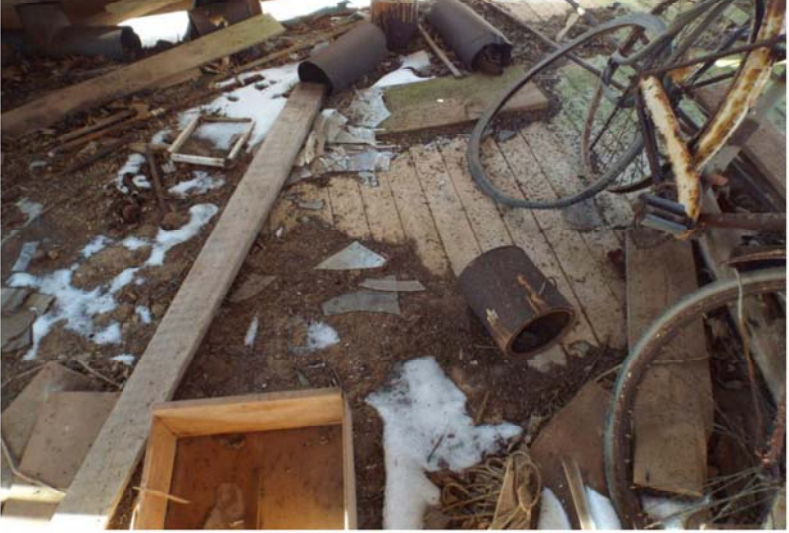
P3	Various C&D debris

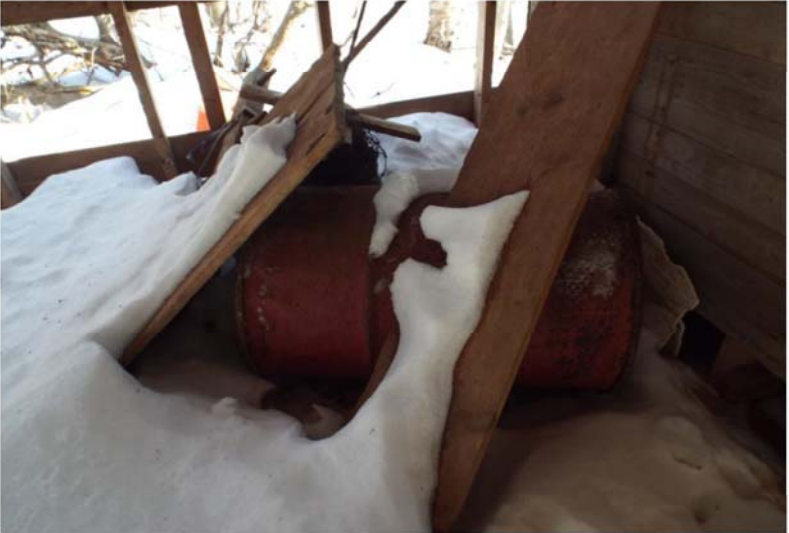
P4	Empty oil barrel inside building

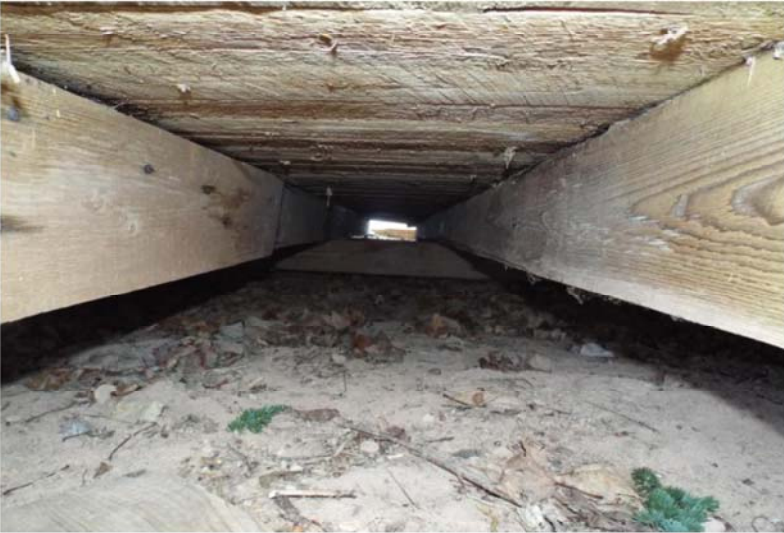
P5	Underneath floor boards. Non insulated. Construction lumber

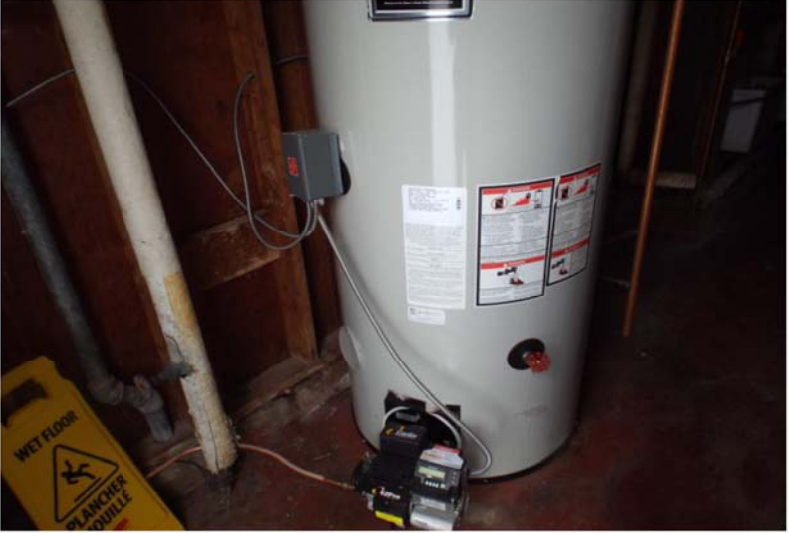
<p>P3</p>	<p>Oil fired hot water heater</p>

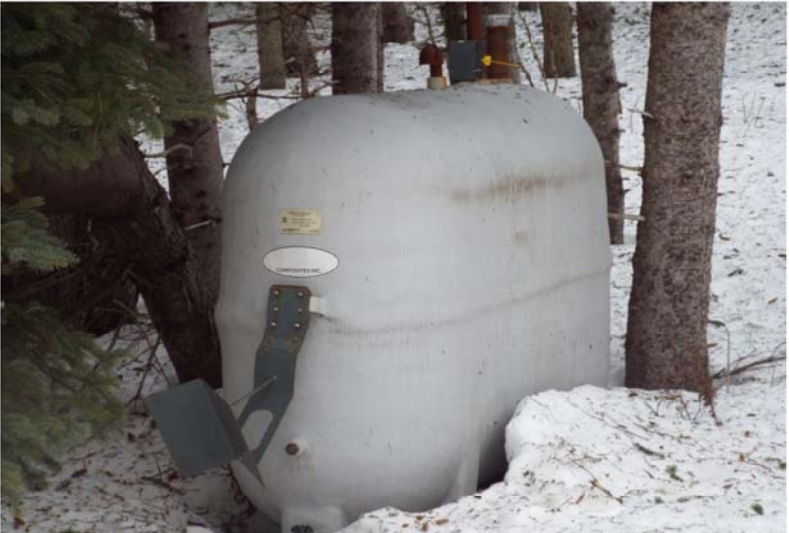
<p>P4</p>	<p>1136 L - fibreglass Above ground fuel storage tank disconnected outside of the building. Not part of scope</p>
