**FINAL MODIFIED PHASE I ENVIRONMENTAL SITE
ASSESSMENT AND HAZARDOUS MATERIALS SURVEY**

**DALVAY ASSETS
PRINCE EDWARD ISLAND NATIONAL PARK
DALVAY, QUEENS COUNTY, PEI**

**PUBLIC WORKS AND GOVERNMENT SERVICES CANADA FOR
PARKS CANADA**

JANUARY 13, 2011

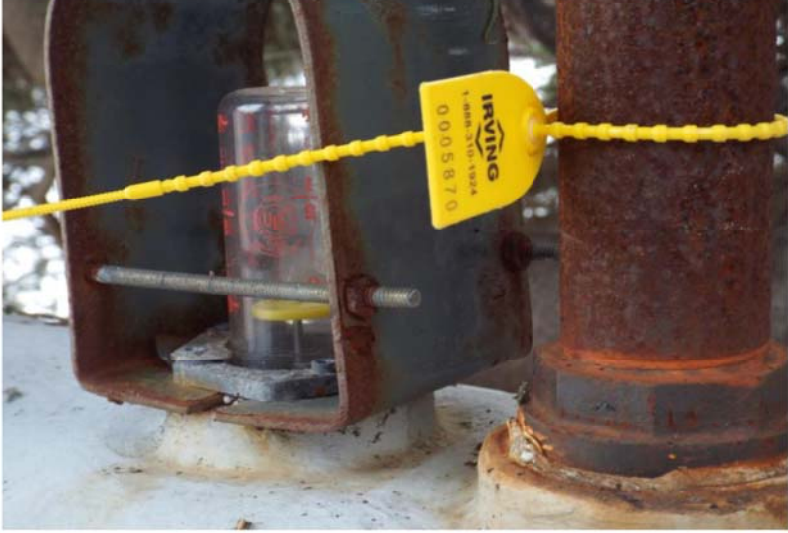
<p>P6</p>	<p>Fuel storage tank gauge showing 1/4 full</p>

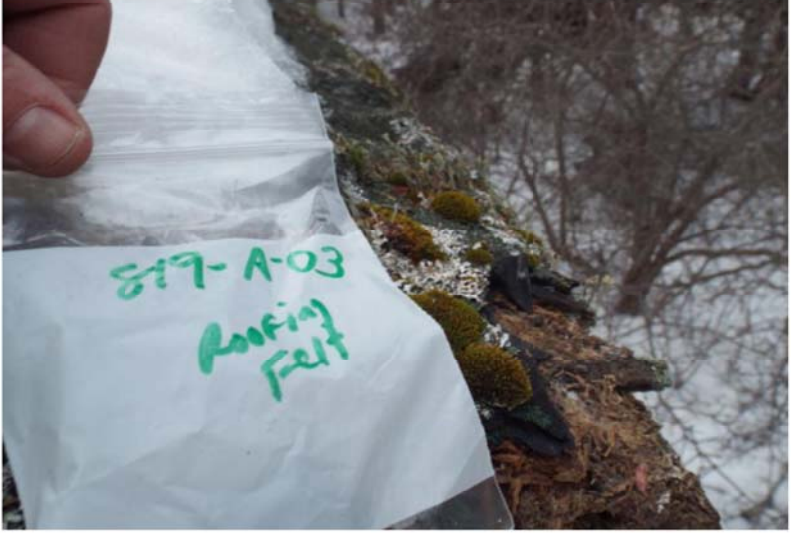
<p>P9</p>	<p>Sample 819-A-03 Roofing felt paper No asbestos detected</p>

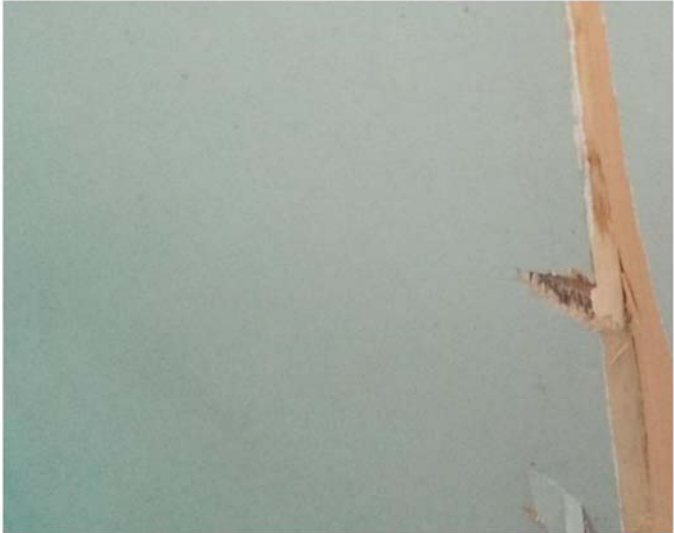
<p>P10</p>	<p>Sample 819-L-01 Light green paint on wood door (Results - < 0.0067% lead by weight)</p>

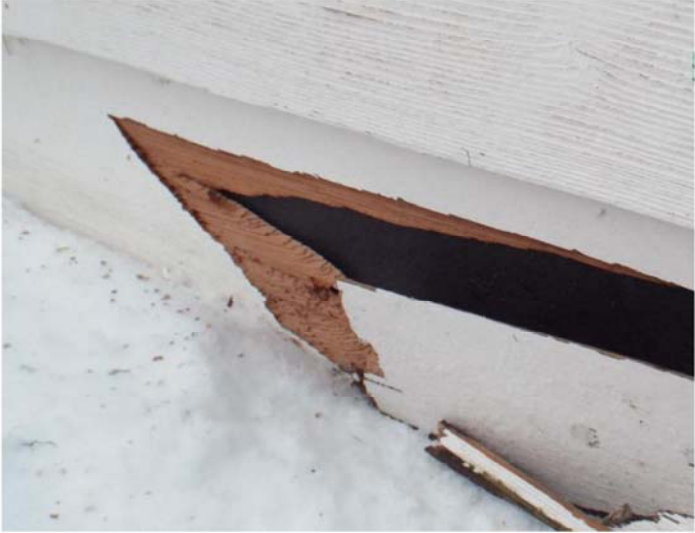
<p>P11</p>	<p>Sample 819-L-02 White paint on ext. Wood siding (Results - < 0.047% lead by weight)</p>

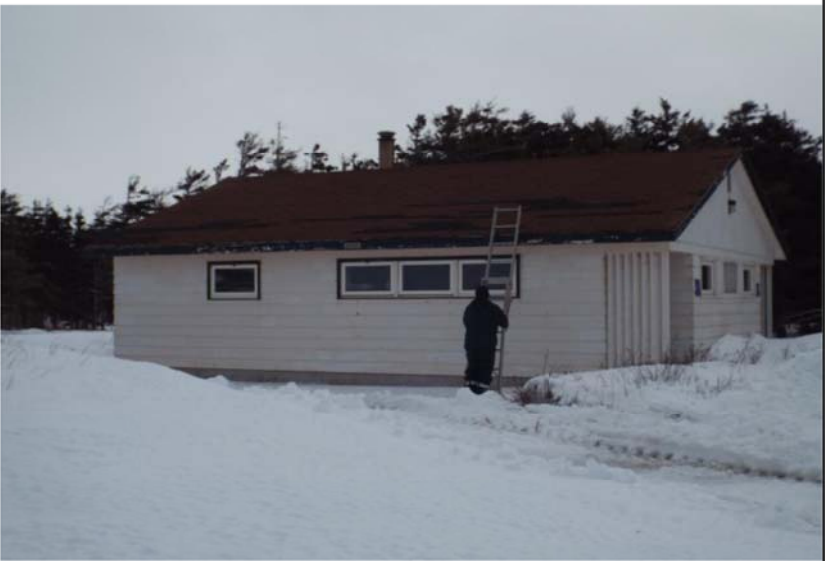
Photo No.	Description / Location	Site Photo
P1	Exterior view of building 821

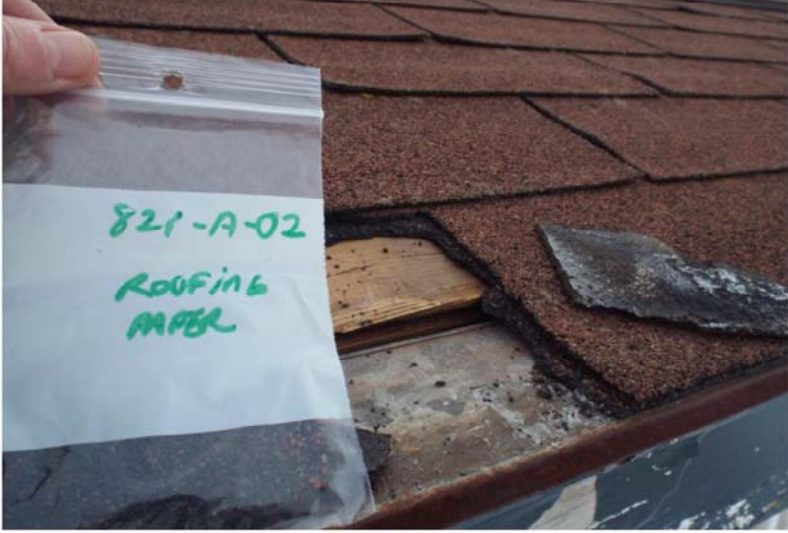
<p>P3</p>	<p>Sample 821-A-02 Roofing felt paper No asbestos detected</p>

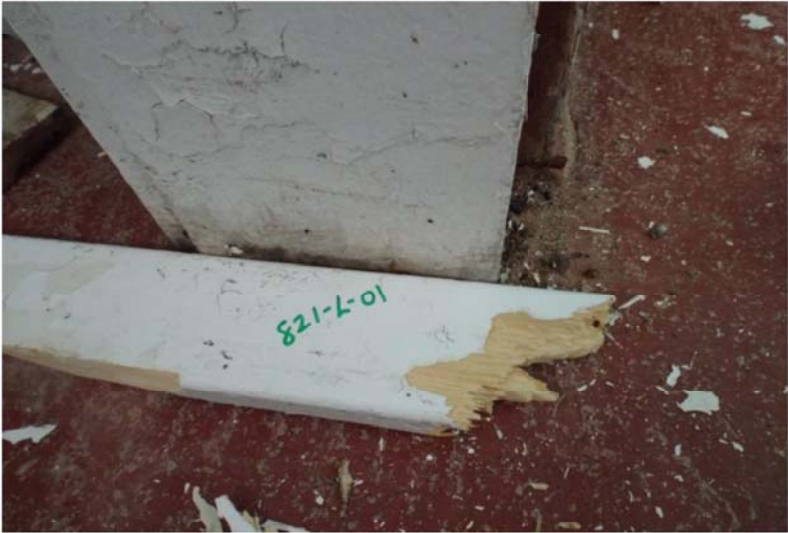
<p>P5</p>	<p>Sample 821-L-01 White paint on int. wood trim (Results - 0.29% lead by weight - 1.2 mg/L TCLP)</p>

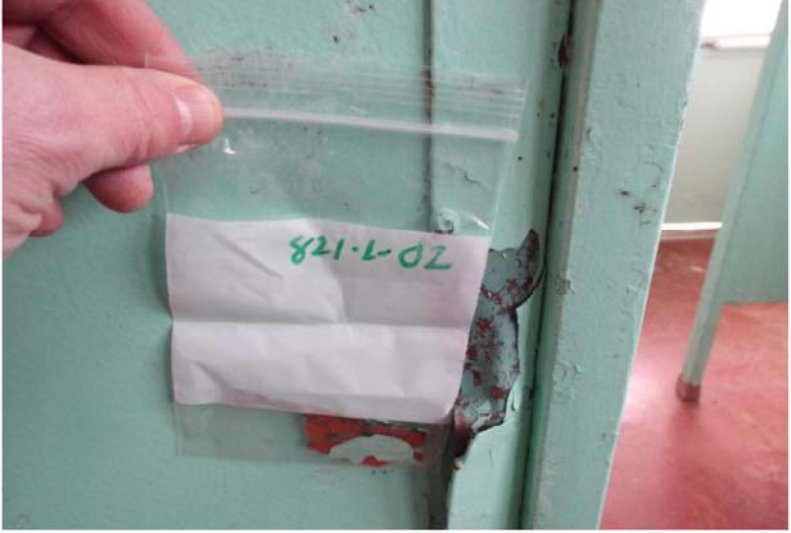
<p>P6</p>	<p>Sample 821-L-02 Light green paint on metal partition wall (Results - 0.59% lead by weight)</p>

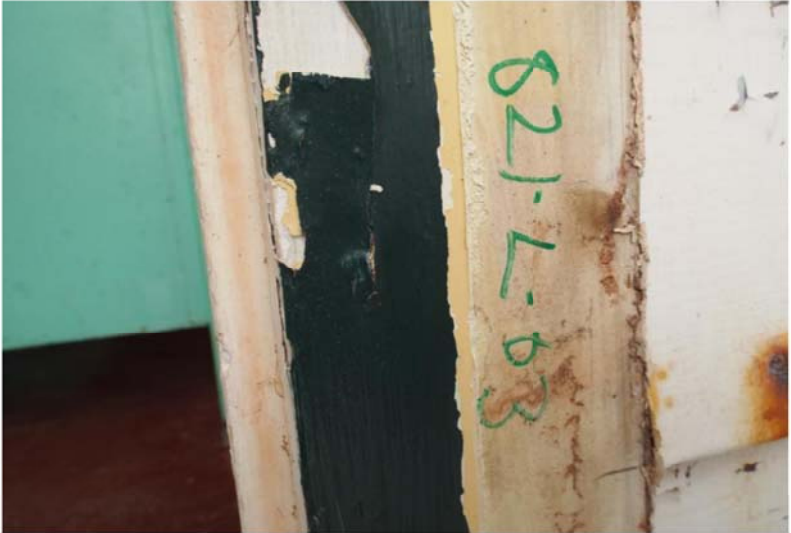
<p>P7</p>	<p>Sample 821-L-03 Dark green paint on ext. wood trim (Results - 0.92% lead by weight - 4.7 mg/L TCLP)</p>

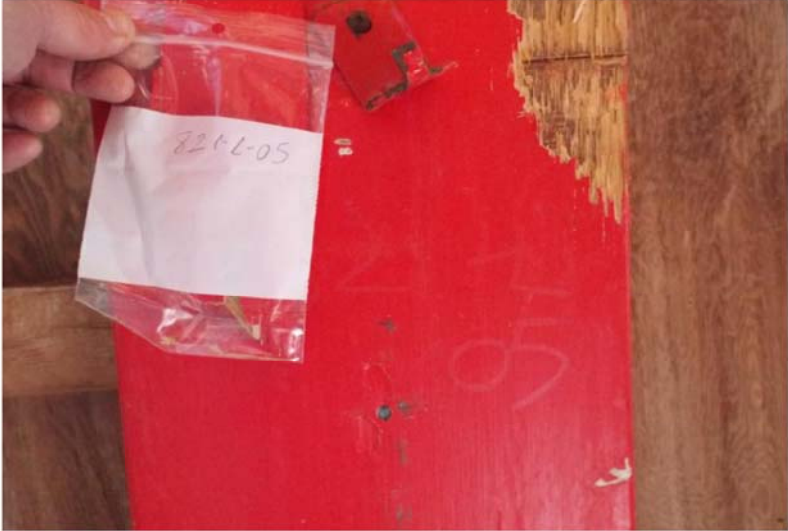
<p>P9</p>	<p>Sample 821-L-05 Red paint on wood door / trim (Results - 2.3% lead by weight)</p>

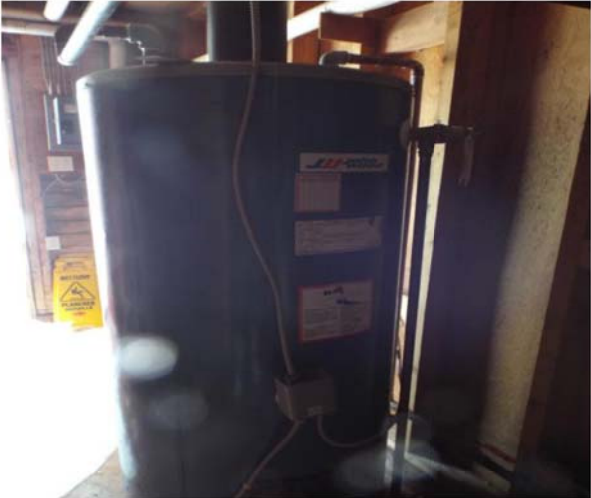
<p>P10</p>	<p>Oil fired hot water heater</p>

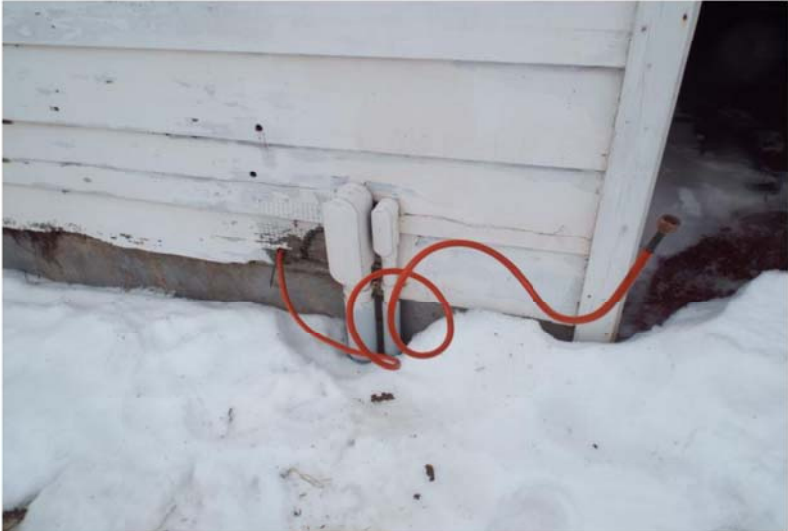
<p>P11</p>	<p>Disconnected oil line to building</p>

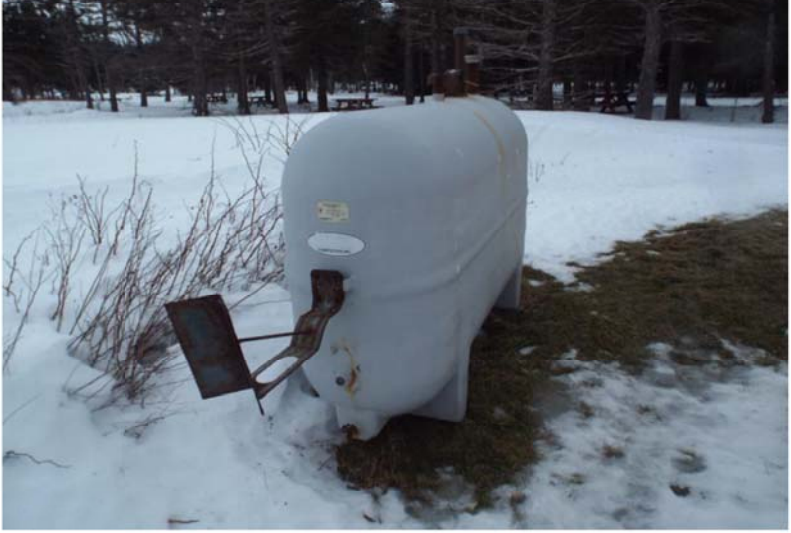
<p>P12</p>	<p>1136 L - fibreglass Above ground fuel storage tank disconnected outside of the building. Not part of scope.</p>

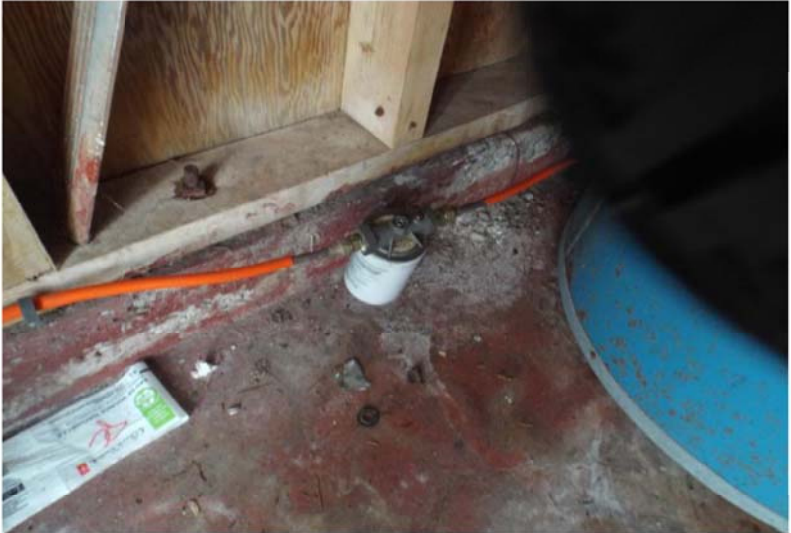
<p>P13</p>	<p>Oil line and filter. No staining observed</p>

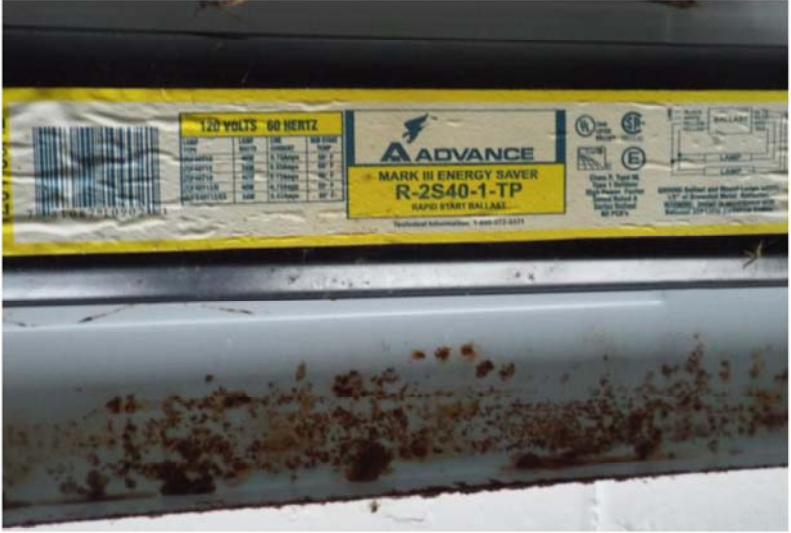
<p>P14</p>	<p>Advance Mark III lamp Ballast - Serial No R- 2S40-1-TP Non PCB marking</p>

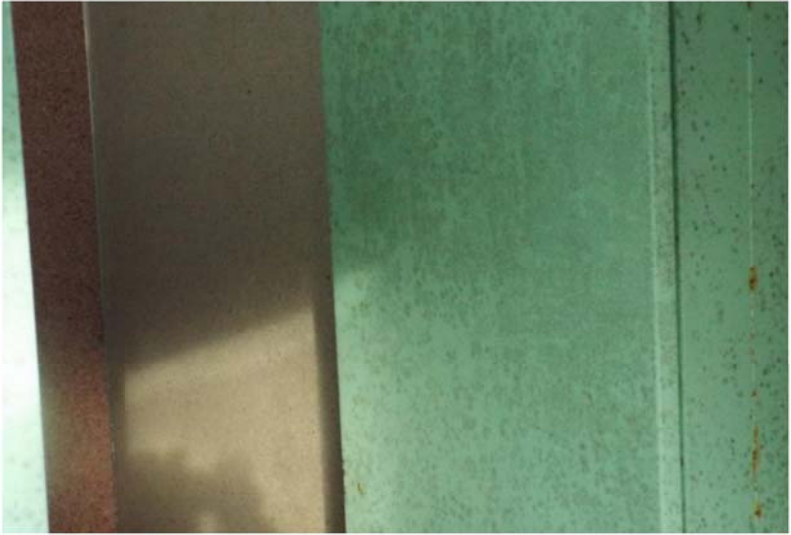
P15	Visible mould on interior partition walls

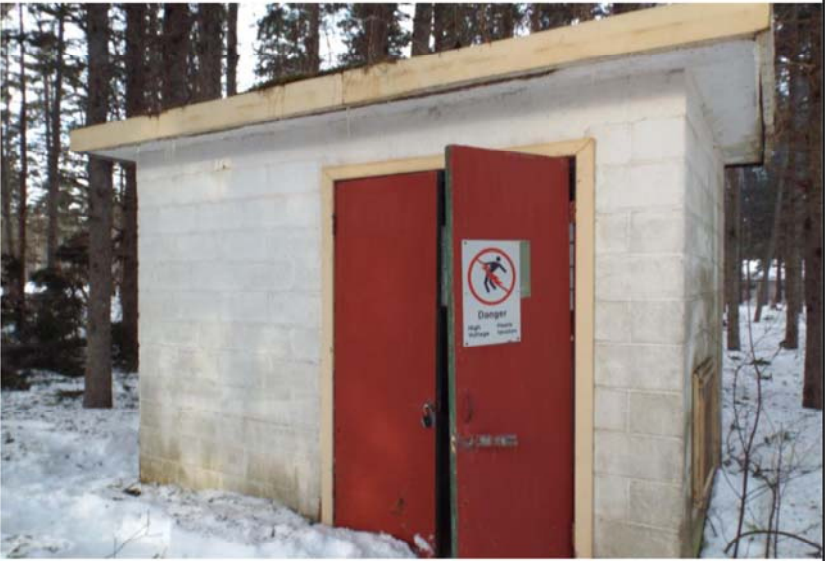
Photo No.	Description / Location	Site Photo
P1	Exterior view of building 829

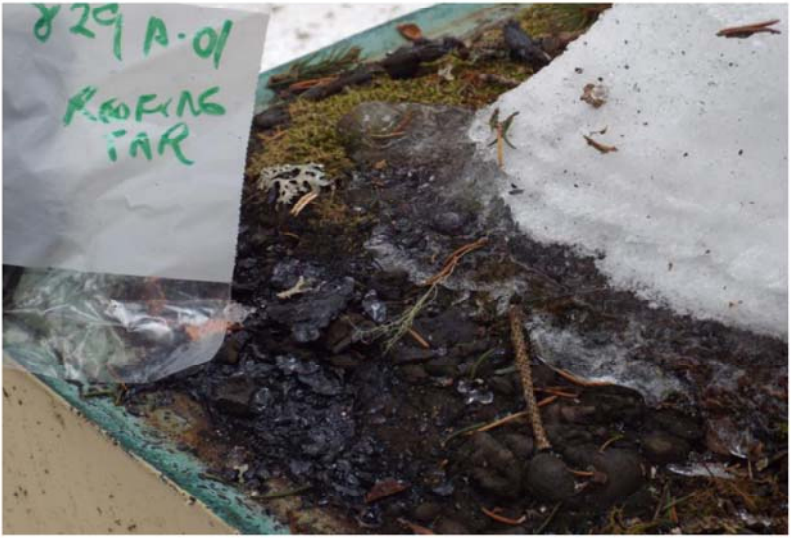
<p>P3</p>	<p>Sample 829-A-01 Roofing felt paper No asbestos detected</p>

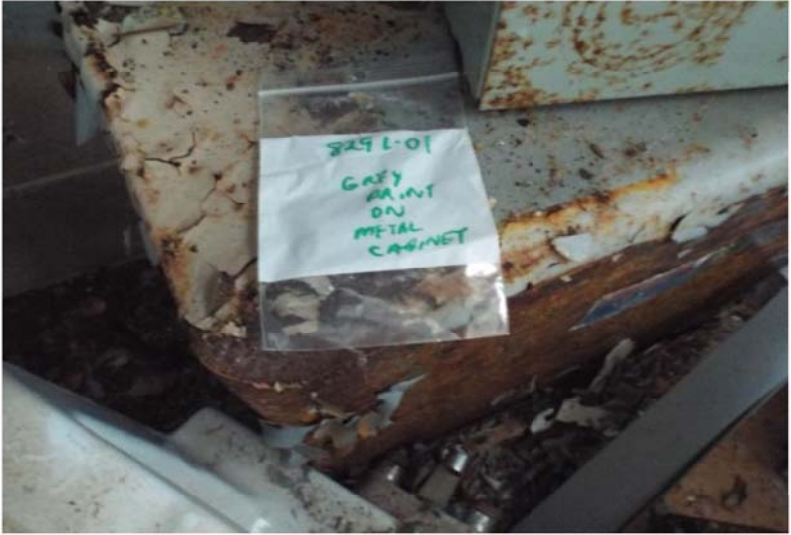
<p>P4</p>	<p>Sample 829-L-01 Grey paint on metal cabinet (Results - 0.041% lead by weight)</p>

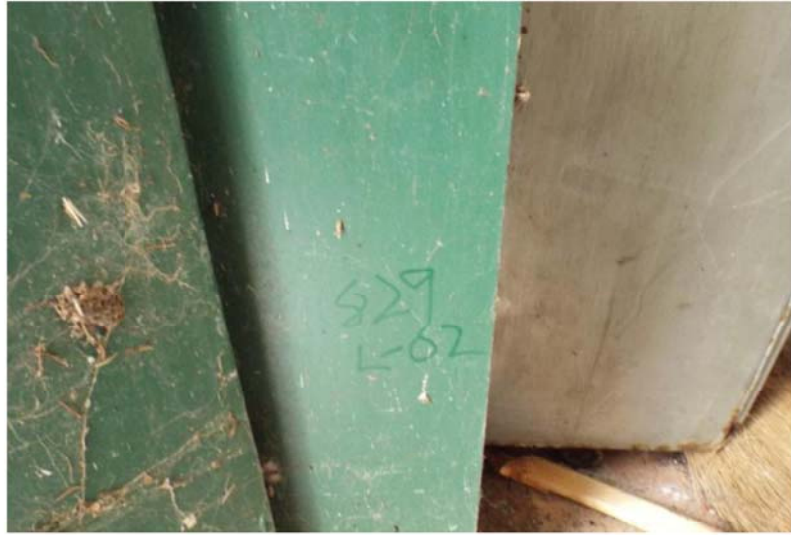
<p>P5</p>	<p>Sample 829-L-02 Green paint on metal trim (Results - 1.1% lead by weight - weight - < 0.2 mg/L TCLP)</p>

White paint on exterior concrete	320	an off island approved facility unless TCLP testing confirms otherwise
	Other	Battery packs (storage)		Hazardous waste disposal
	Concrete & masonry	Floor and walls		Disposal at any approved C&D disposal facility.

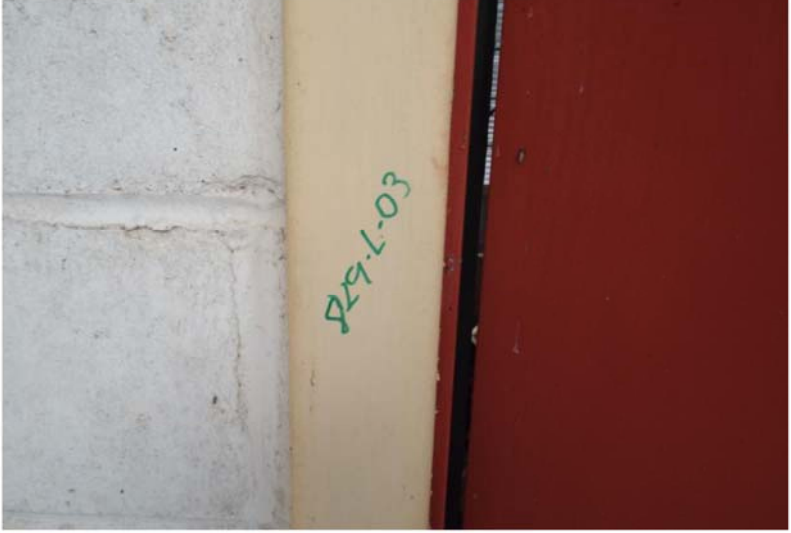
<p>P6</p>	<p>Sample 829-L-03 Cream colour paint on metal trim (Results - 4.6% lead by weight)</p>

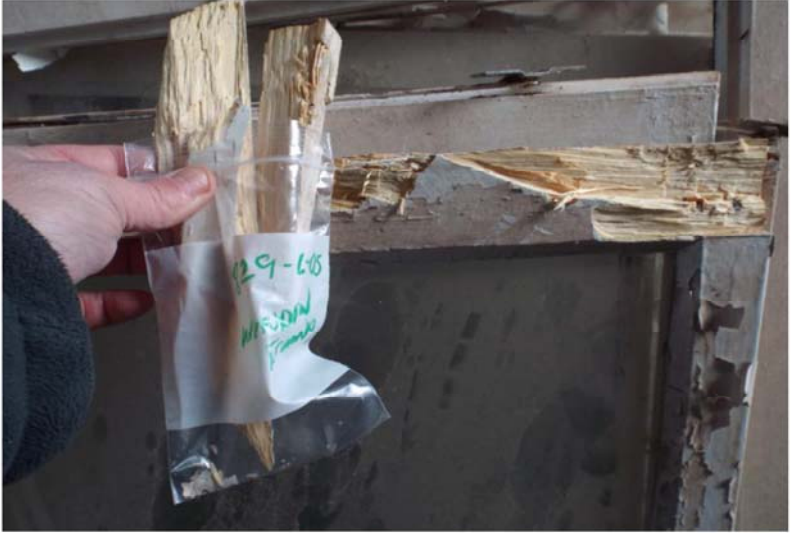
<p>P8</p>	<p>Sample 829-L-05 White paint on wood window frame (storage) (Results - 0.88% lead by weight)</p>

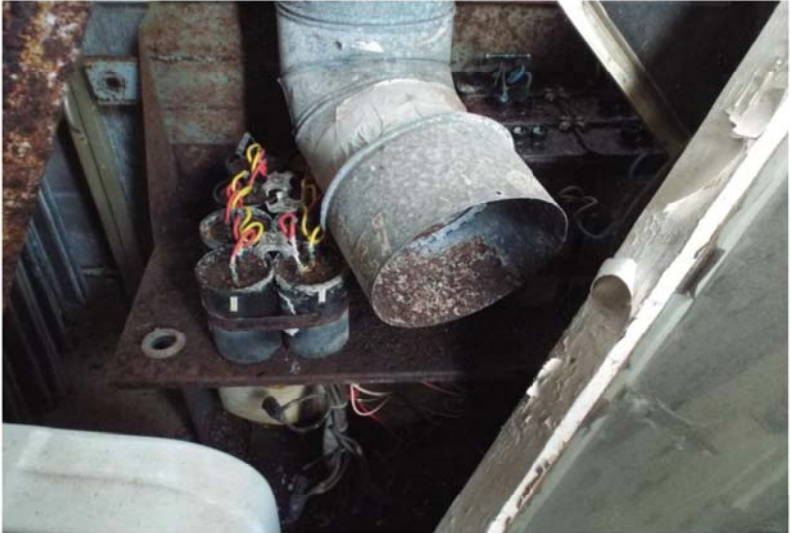
<p>P10</p>	<p>Battery packs (storage)</p>

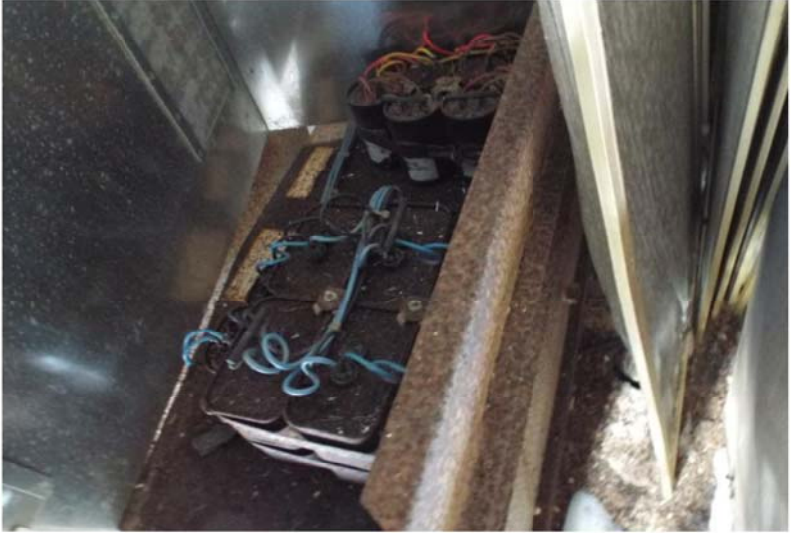
<p>P11</p>	<p>Battery packs (storage)</p>

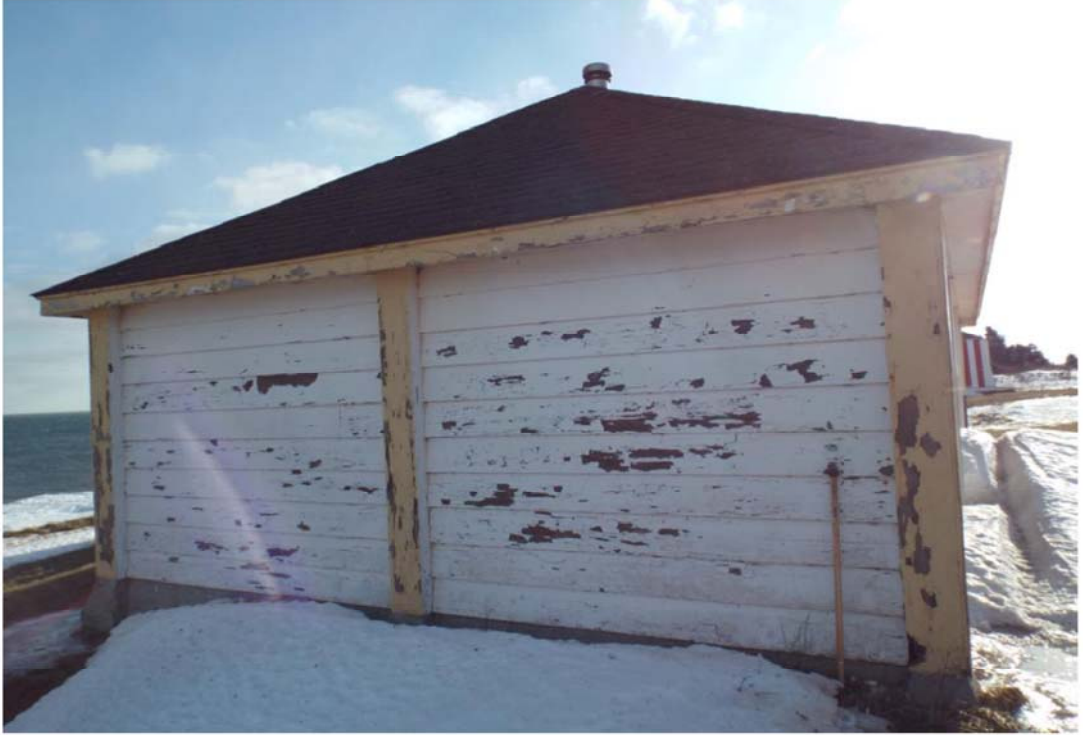
Photo No.	Description / Location	Site Photo
P1	Exterior front view of building 7706	  <p>A photograph showing the exterior front view of building 7706. The building is a single-story structure with a brown gabled roof and a central chimney. It features a covered porch area supported by white wooden posts. The ground in front of the building is covered with a large pile of snow. The background shows a clear blue sky and a glimpse of the ocean.</p>
P2	Exterior back view of building 7706

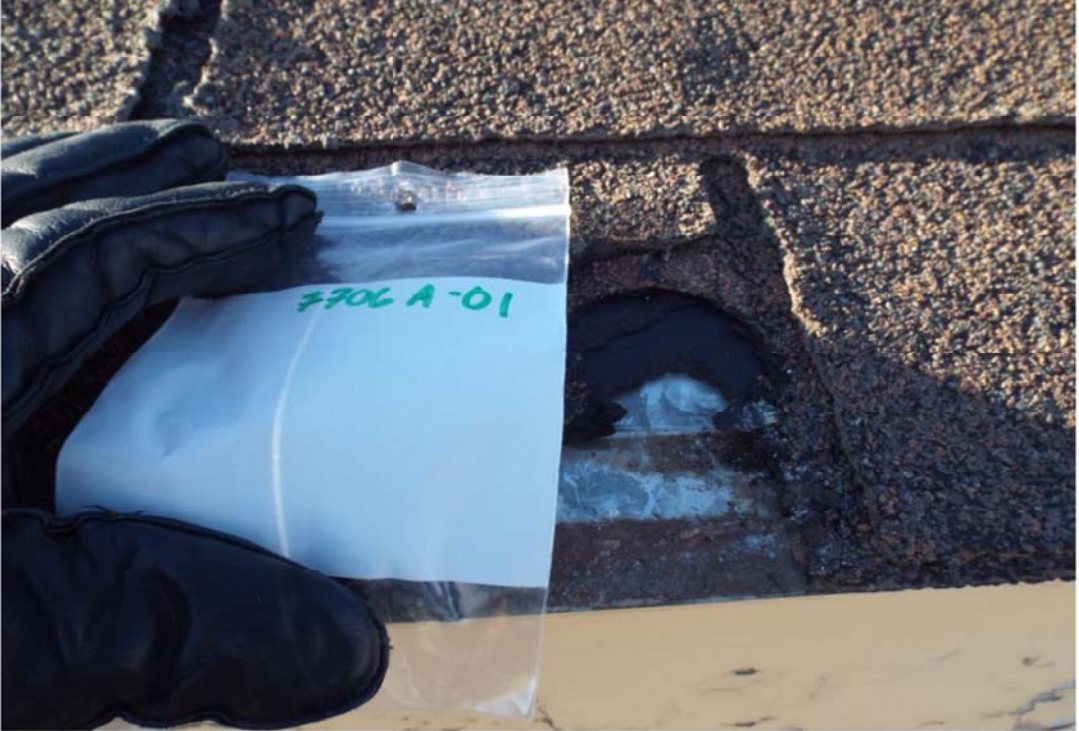
<p>P3</p>	<p>Sample 7706-A-01 Black roofing felt No asbestos detected</p>

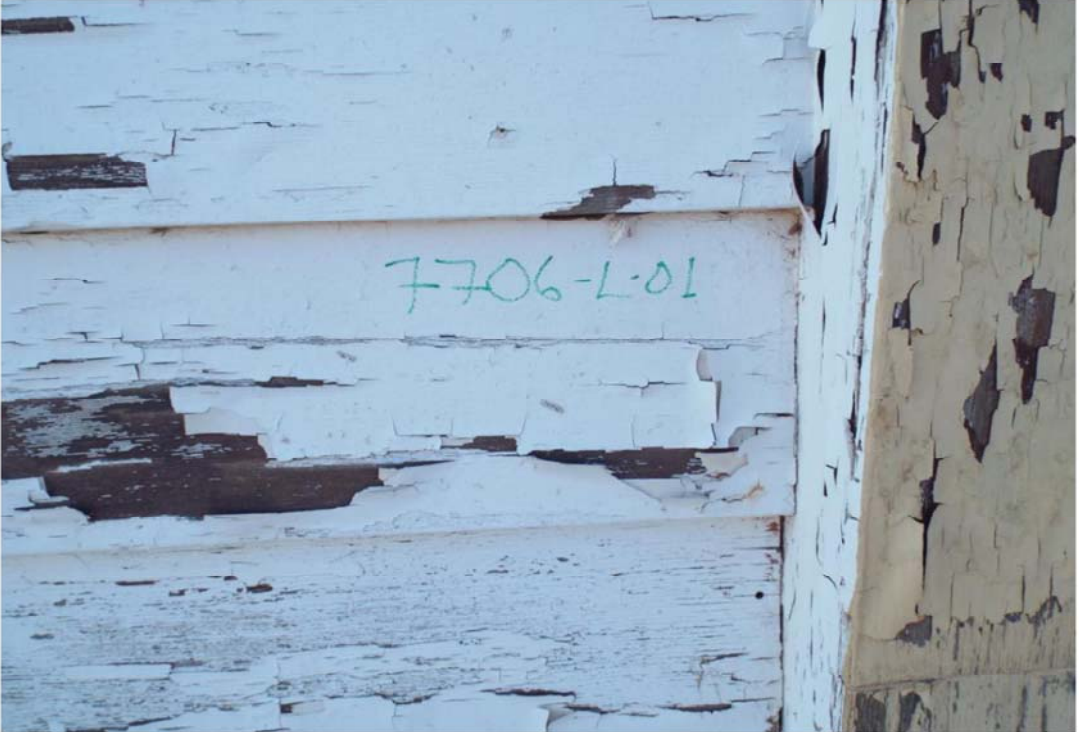
<p>P4</p>	<p>Sample 7706-L-01 Exterior white siding paint (Results - 0.019% lead by weight)</p>

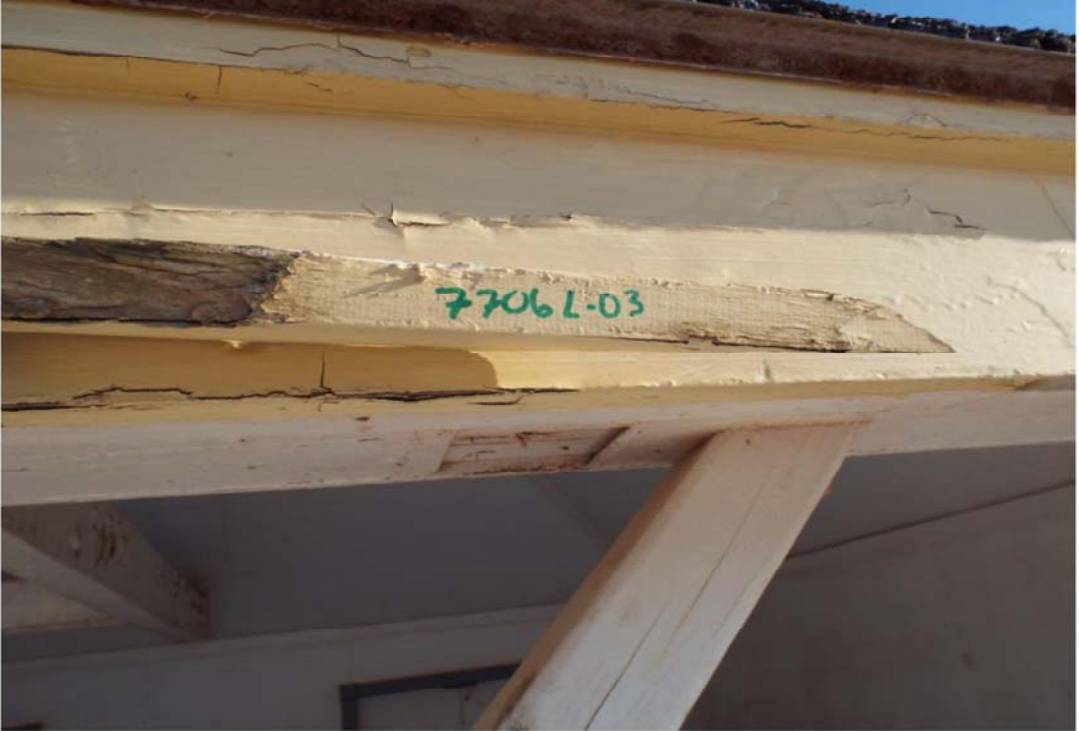
<p>P6</p>	<p>Sample 7706-L-03 Exterior cream colour paint on wood trim (Results - < 0.076% lead by weight)</p>

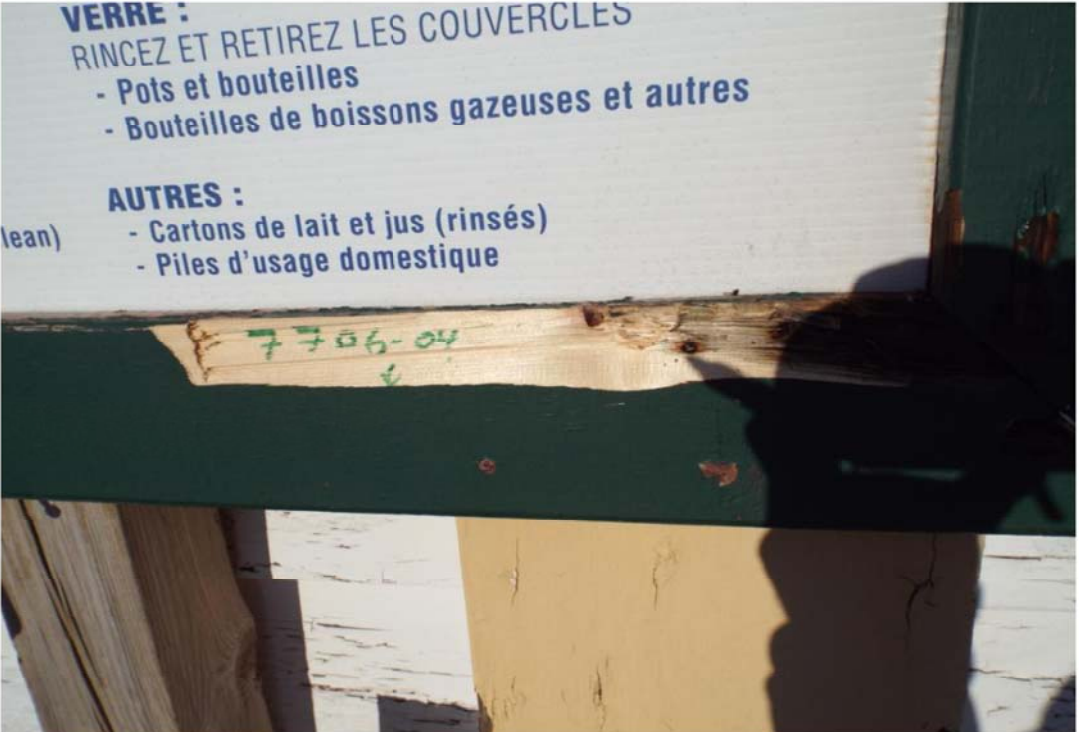
<p>P7</p>	<p>Sample 7706-L-04 Exterior green paint on wood trim (Results - < 0.011% lead by weight)</p>
