**FACILITY CONDITION ASSESSMENT
BOWDEN INSTITUTION
Innisfail, Alberta
TS: 11344**

Prepared for:
Correctional Services Canada

Prepared by:
ALTUS GROUP COST CONSULTING

Issued: **April 30, 2012**

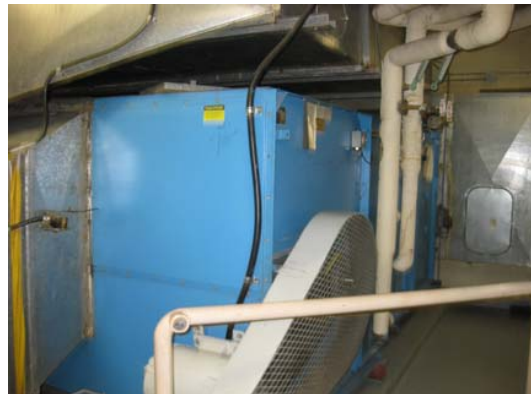
Typical Air Handling Unit – Refurbish Components

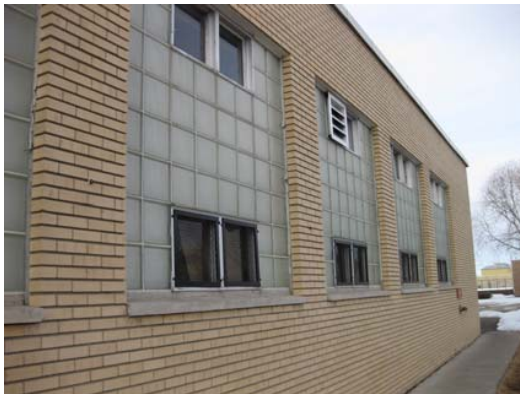
South Elevation Windows - Replace

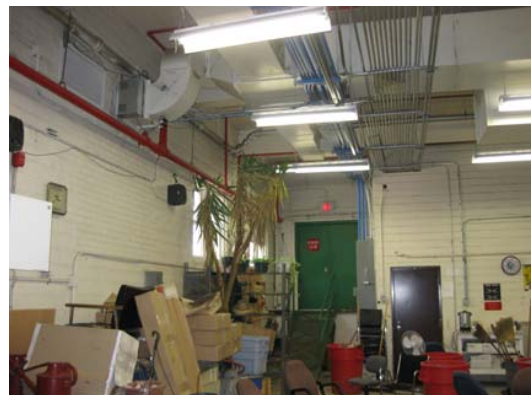
Make-Up Air Unit (High Level) - Refurbish

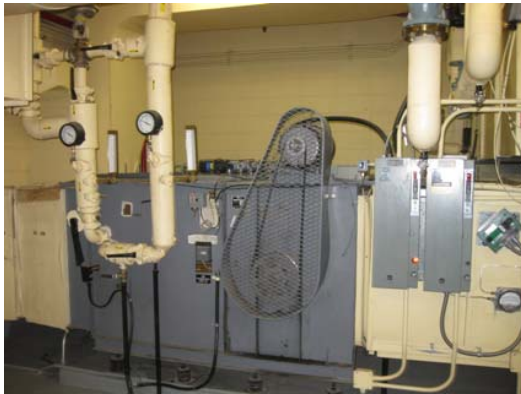
Typical Air Handling Unit – Refurbish Components

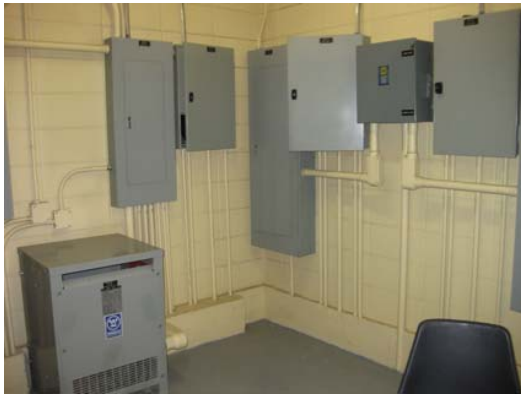
Transformer - Replace

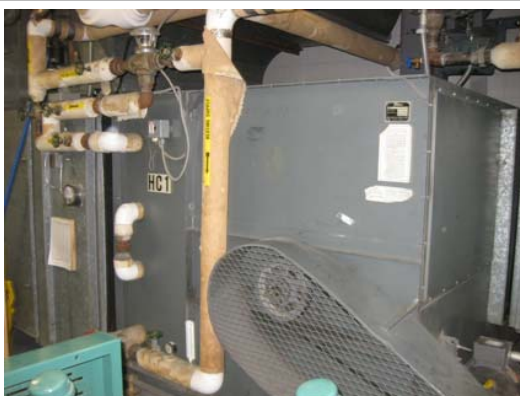
Air Handling Unit – Refurbish

The building's supply air handling units are in serviceable condition; however, they are past their useful service life and should be scheduled to be replaced or refurbished.

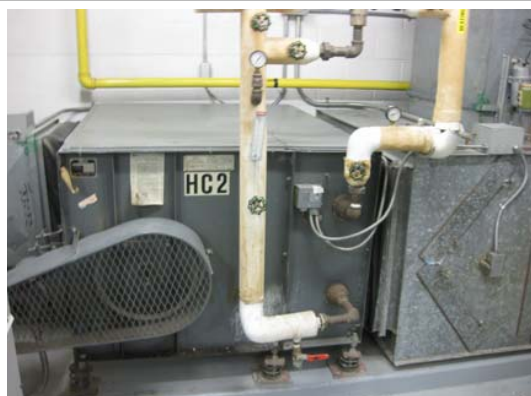
Air Handling Unit - Refurbish

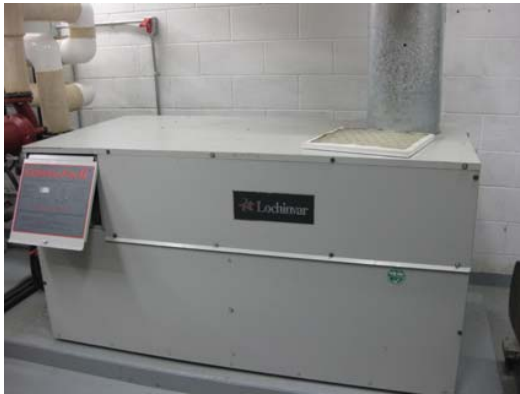
Heating Boiler - Replace

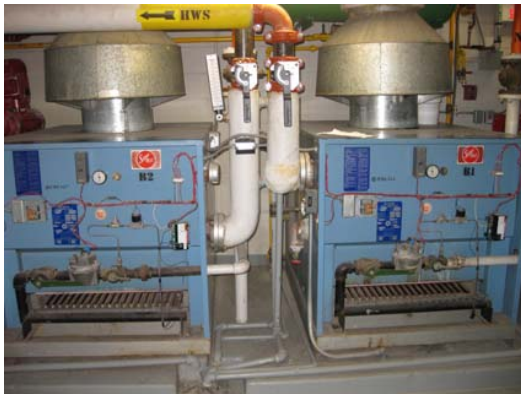
The two (2) gas fired domestic hot water heating boilers and two (2) circulation pumps are past their useful service life and should be scheduled for replacement in the near future.

Domestic Hot Water Boilers - Replace

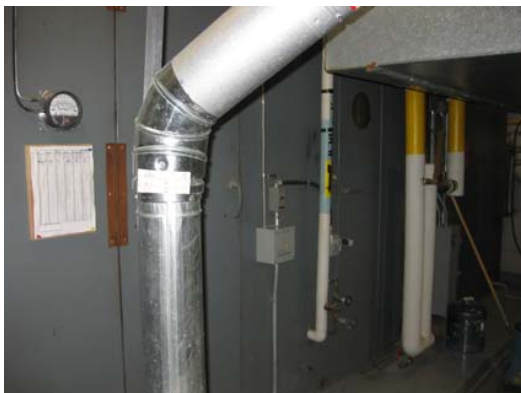
The building's supply air handling unit and kitchen make-up air units are in serviceable condition; however, they are past their useful service life and should be scheduled to be replaced or refurbished.

Air Handling Unit – Refurbish Components

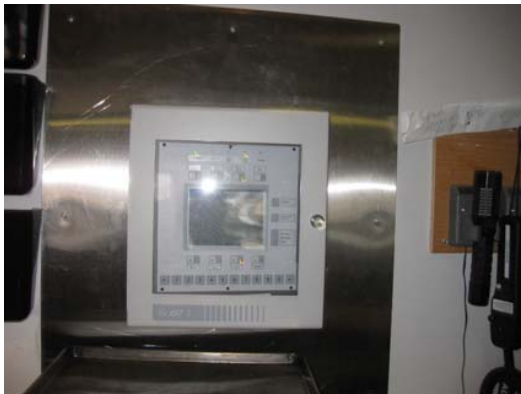
Fire Alarm Panel – Refurbish or Replace

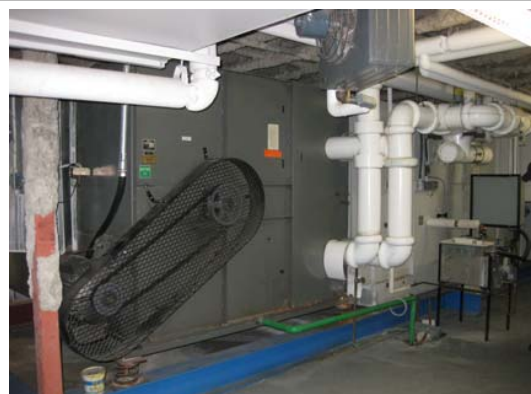
Air Handling Unit – Refurbish

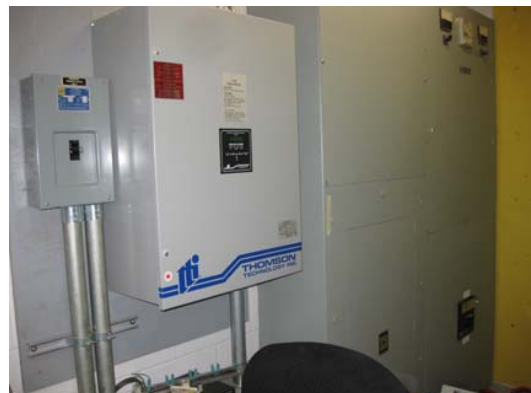
Main Breaker - Upgrade

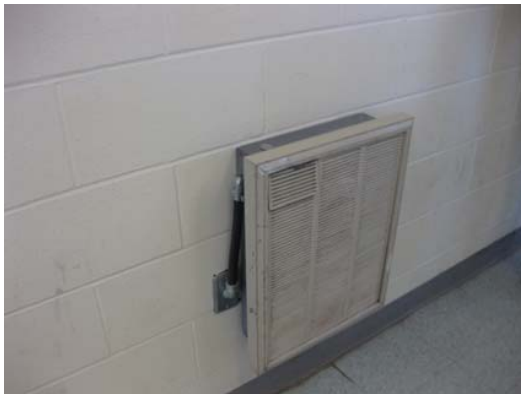
Force Flow Heater - Replace

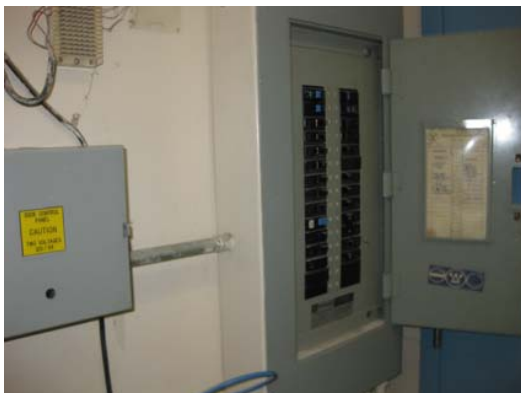
Lighting & Power Panel - Replace

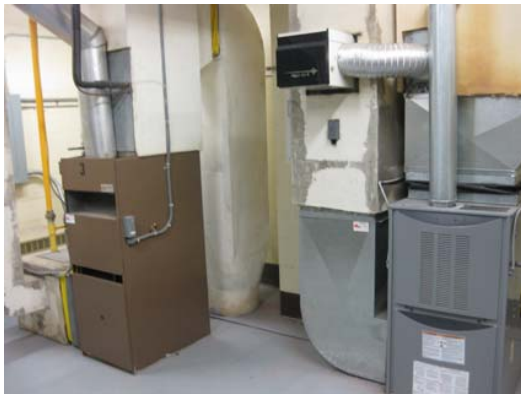
Office Furnaces – Replace Old Unit

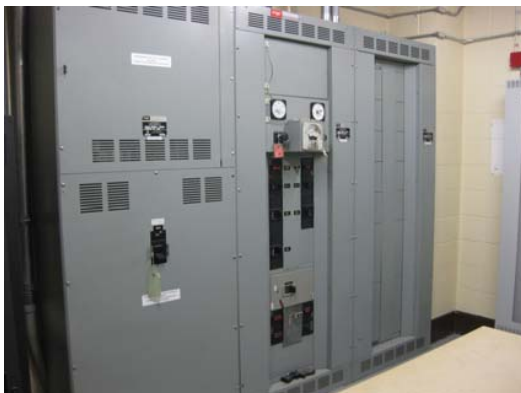
Main Electrical Breakers - Upgrade

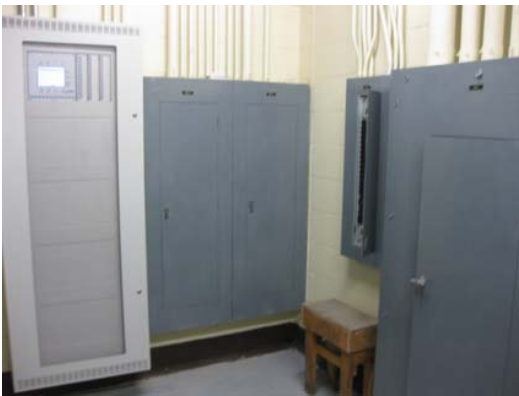
Fire Alarm Panel

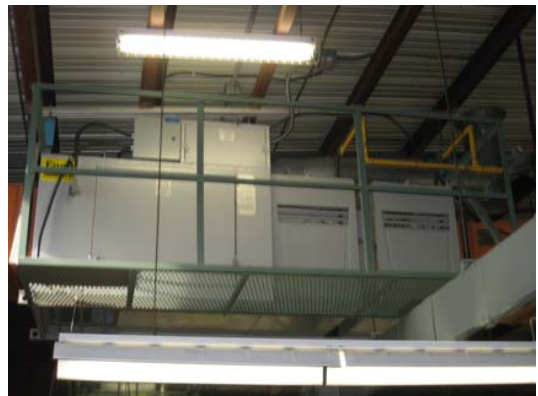
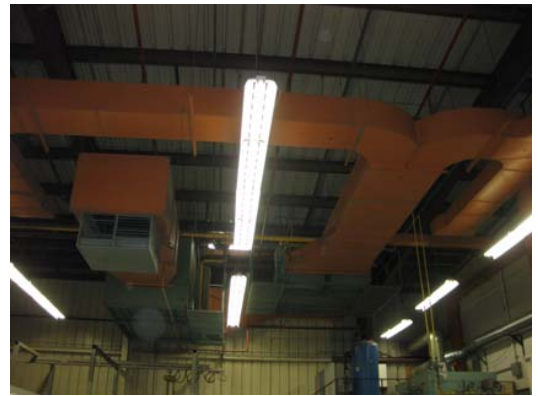
Air Handling Unit – Refurbish Components

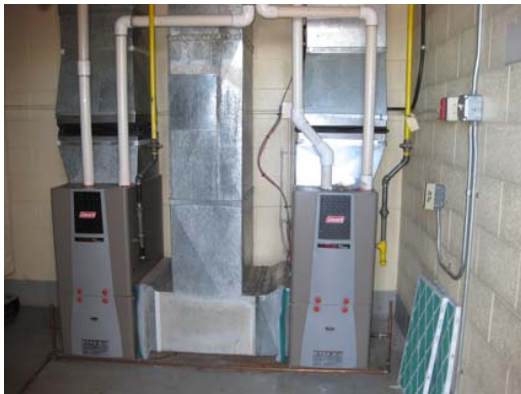
The furnaces are reportedly in good working order. All 3 of the furnaces were replaced in the past 3 years with new high efficiency gas fired furnaces.

Furnaces – High Efficiency

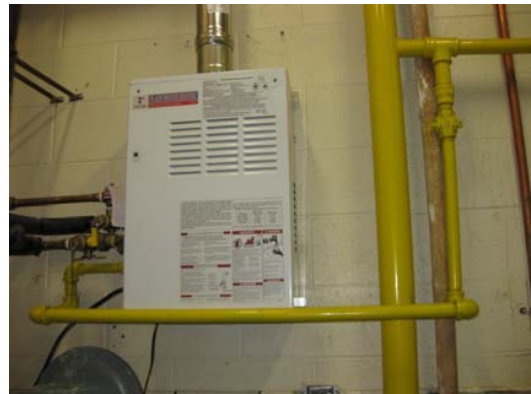
The gas fired instantaneous hot water heater was installed approximately 3 years ago and is in good condition.

Instantaneous Domestic Hot Water Heater

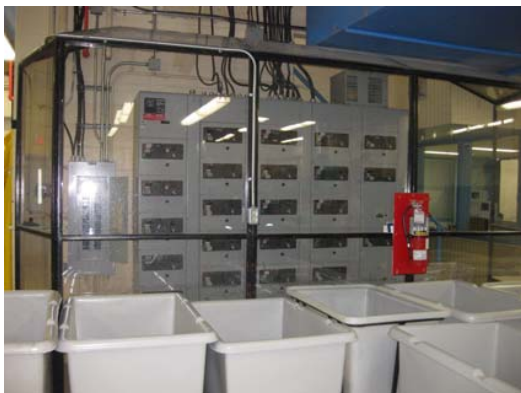
MCC - Upgrade

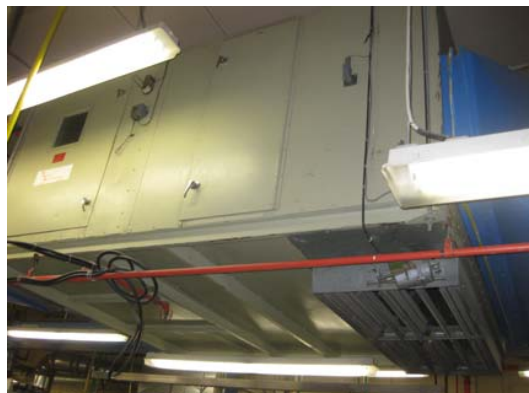
The building's supply air handling units and exhaust fans are in serviceable condition; however, they are past their useful service life and should be scheduled to have their internal components upgraded. We recommend replacing the unit motors, shafts, belts, and coils to extend the life of the equipment.

Air Handling Unit - Refurbish

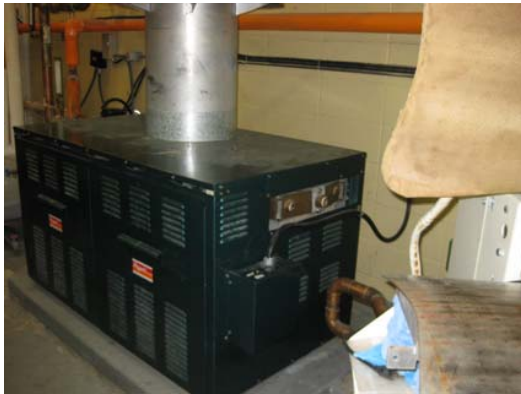
Laundry Hot Water Boiler - Replace

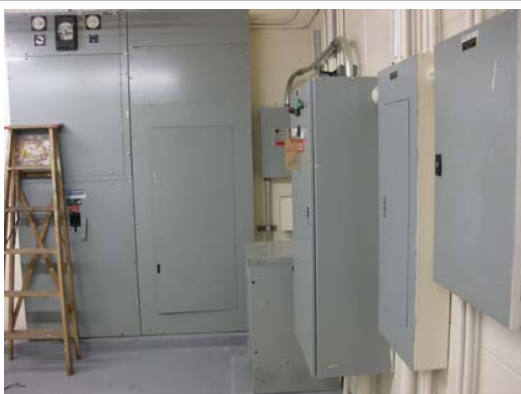
Main Electrical Disconnect – Refurbish/Replace

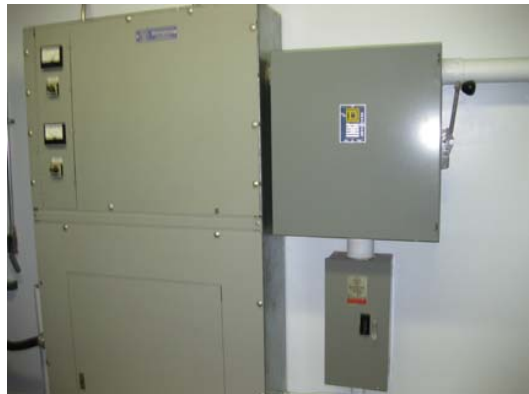
Transfer Switch & Main Breaker - Upgrade

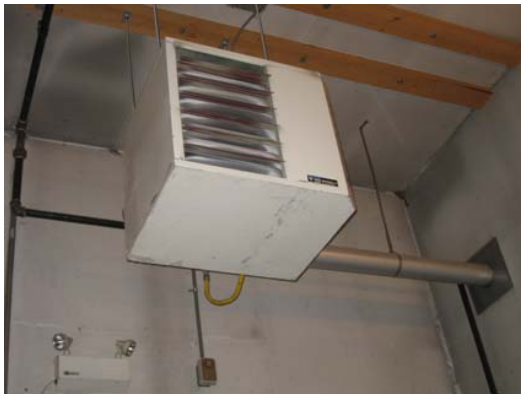
Gas Fired Unit Heater - Replace

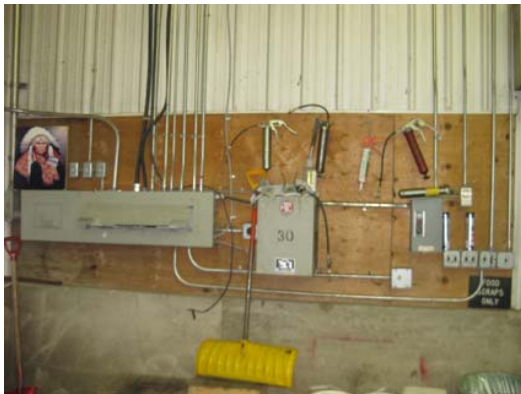
30 kVa Transformer & Distribution Panel - Replace
