**SOLICITATION AMENDMENT  
MODIFICATION DE L'INVITATION**

<b>Title - Sujet</b> Electrical Infrastructure Upgrades	
<b>Solicitation No. - N° de l'invitation</b> EP922-210870/A	<b>Amendment No. - N° modif.</b> 001
<b>Client Reference No. - N° de référence du client</b> CSC EP922-210870	<b>Date</b> 2020-09-23
<b>GETS Reference No. - N° de référence de SEAG</b> PW-\$PWU-201-11898	
<b>File No. - N° de dossier</b> PWU-0-43084 (201)	<b>CCC No./N° CCC - FMS No./N° VME</b>
<b>Solicitation Closes - L'invitation prend fin</b> <b>at - à 02:00 PM</b> <b>on - le 2020-10-13</b>	<b>Time Zone</b> Fuseau horaire Mountain Daylight Saving Time MDT
<b>F.O.B. - F.A.B.</b> <b>Plant-Usine:</b> <input type="checkbox"/> <b>Destination:</b> <input type="checkbox"/> <b>Other-Autre:</b> <input type="checkbox"/>	
<b>Address Enquiries to: - Adresser toutes questions à:</b> Ho (RPC), Hector	<b>Buyer Id - Id de l'acheteur</b> pww201
<b>Telephone No. - N° de téléphone</b> (780) 901-0989 ( )	<b>FAX No. - N° de FAX</b> (780) 497-3510

**FACILITY CONDITION ASSESSMENT  
BOWDEN INSTITUTION  
Innisfail, Alberta  
TS: 11344**

Prepared for:  
**Correctional Services Canada**

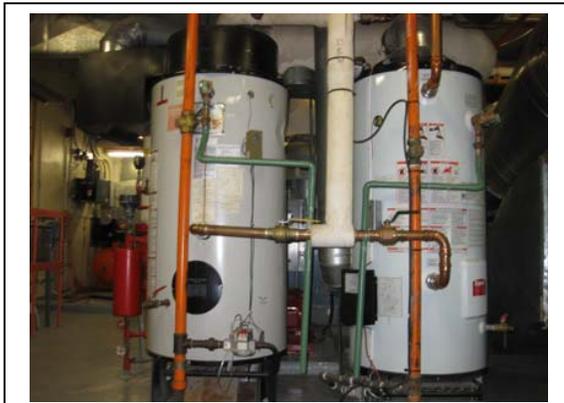
Typical Domestic Hot Water Tanks

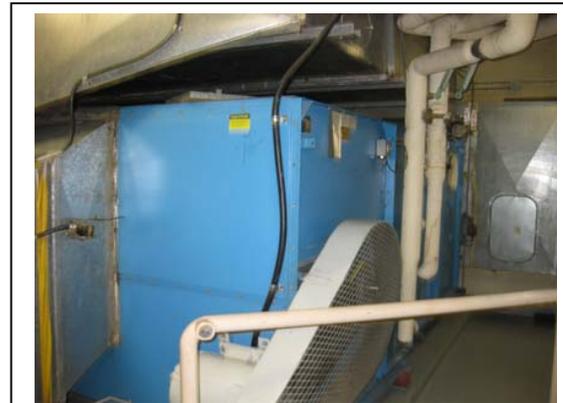
Typical Air Handling Unit - Refurbish Components

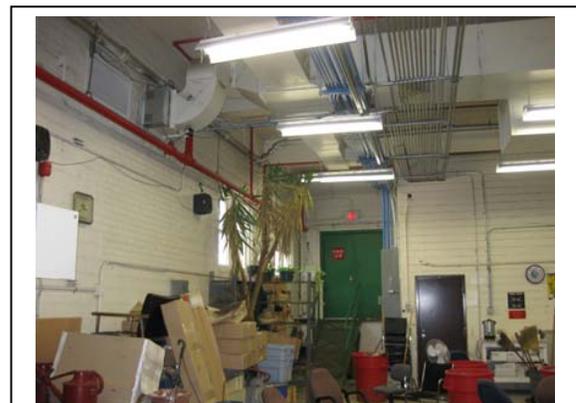
Make-Up Air Unit (High Level) - Refurbish

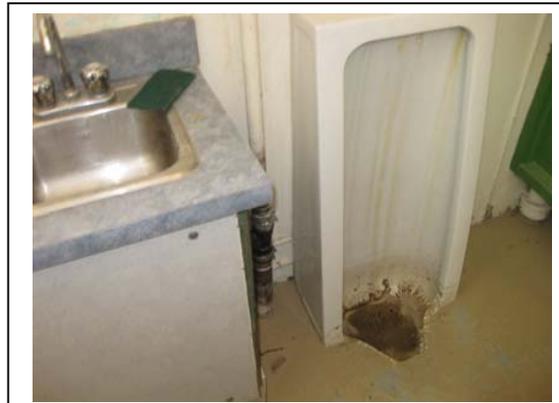
Plumbing Fixtures – Upgrade

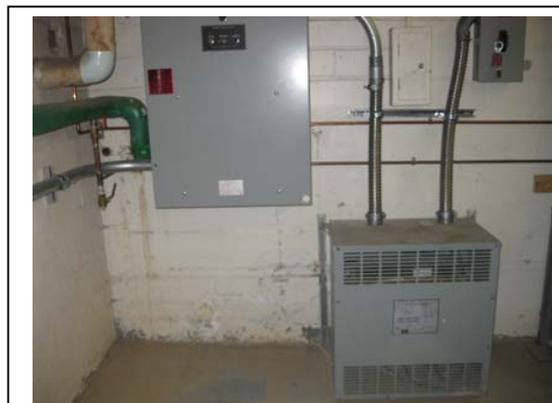
Transformer - Replace

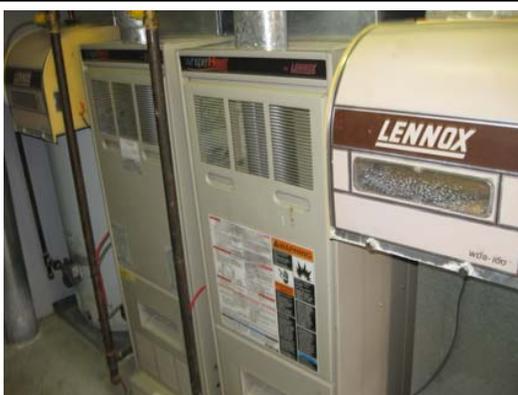
Furnaces (Typical for PFV 14 & 15) - Replace

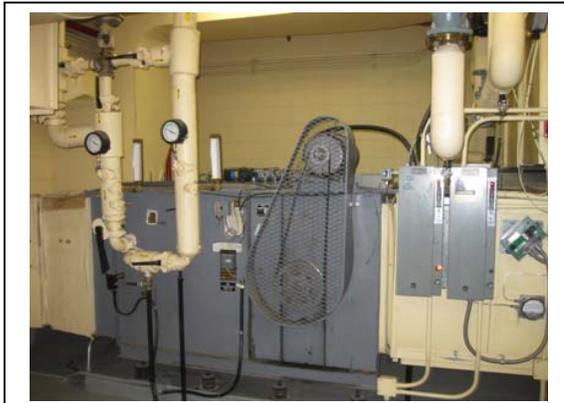
Typical Air Handling Unit – Refurbish Components

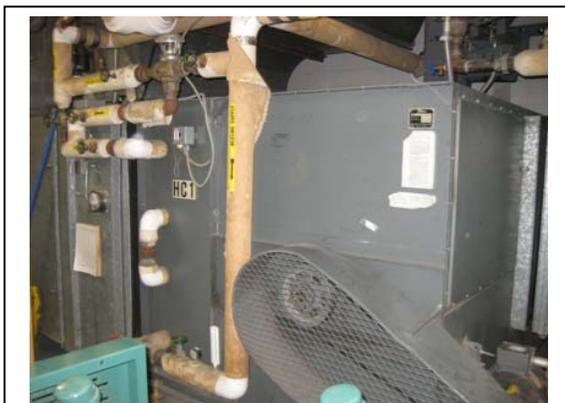
The building's supply air handling units and return air fans are in serviceable condition; however, they are past their useful service life and should be scheduled to have their internal components upgraded. We recommend replacing the unit motors, shafts, belts and coils to extend the life of the equipment.

Air Handling Unit – Refurbish

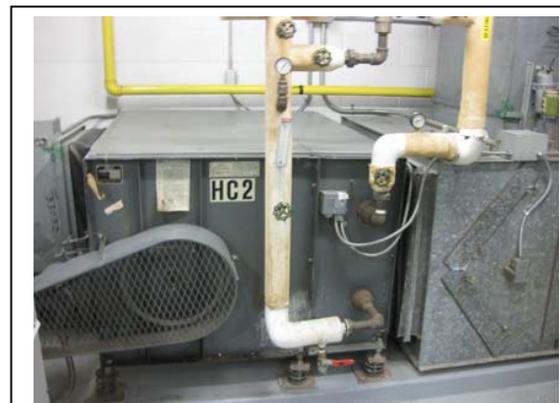
Air Handling Unit - Refurbish

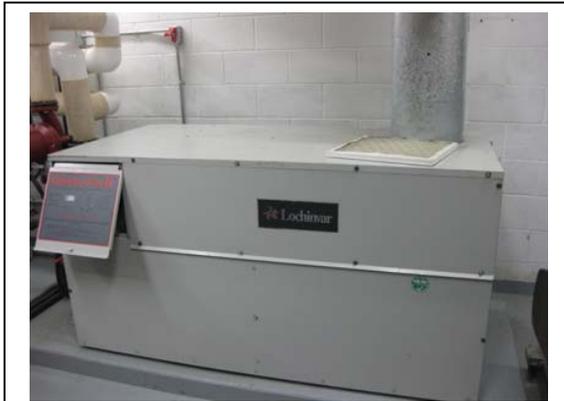
The two (2) gas fired hot water heating boilers and two (2) heating circulation pumps are past their useful service life and should be scheduled for replacement in the near future.

Heating Boiler - Replace

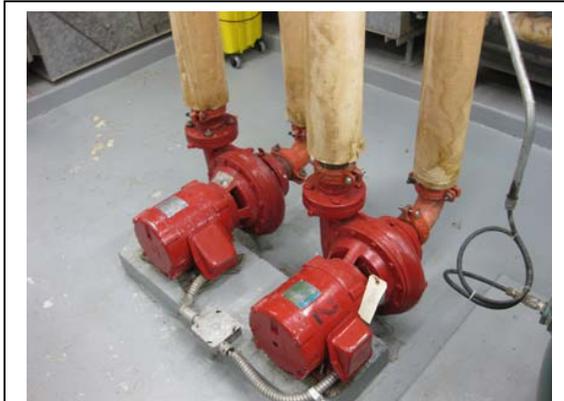
Heating Pumps - Replace

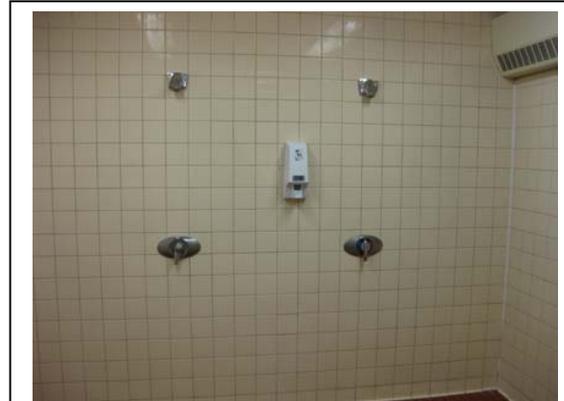
The plumbing fixtures are generally in good condition. Consideration should be given to upgrading to water efficient plumbing fixtures.

Upgrade Plumbing Fixtures

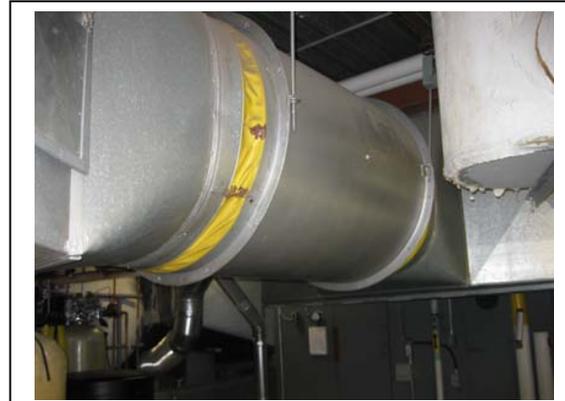
Return Air Fan (AHU-1) – Refurbish

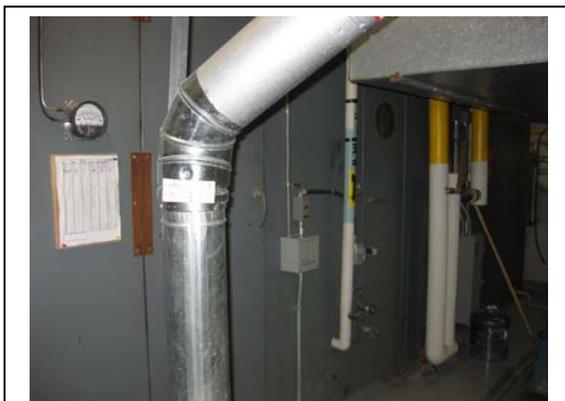
Air Handling Unit – Refurbish Components

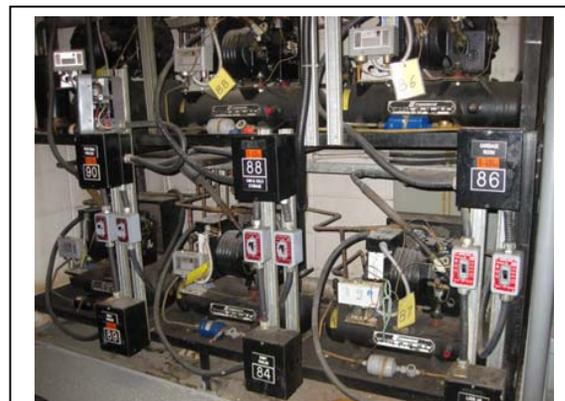
Compressors (Kitchen Equipment) - Replace

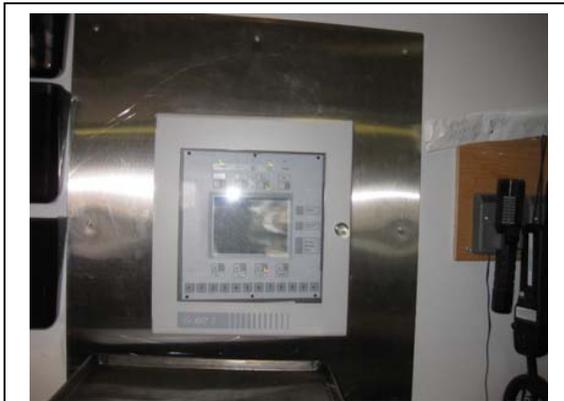
Fire Alarm Panel – Refurbish or Replace

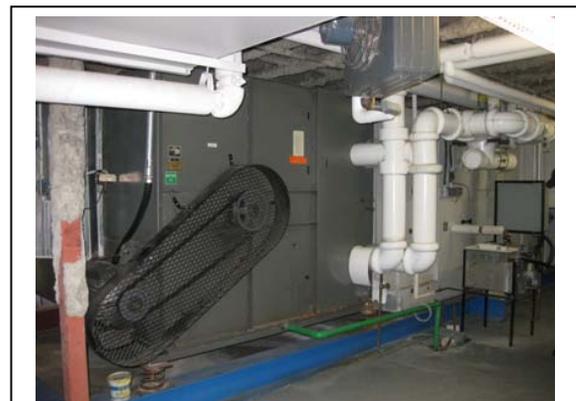
Air Handling Unit – Refurbish

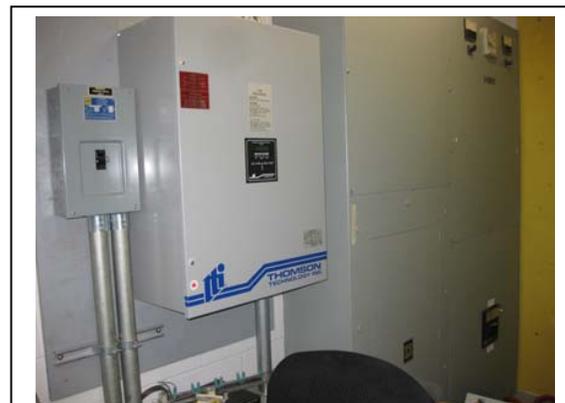
Main Breaker - Upgrade

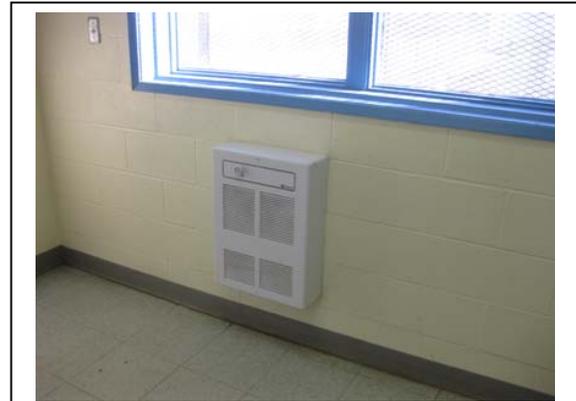
Force Flow Heater

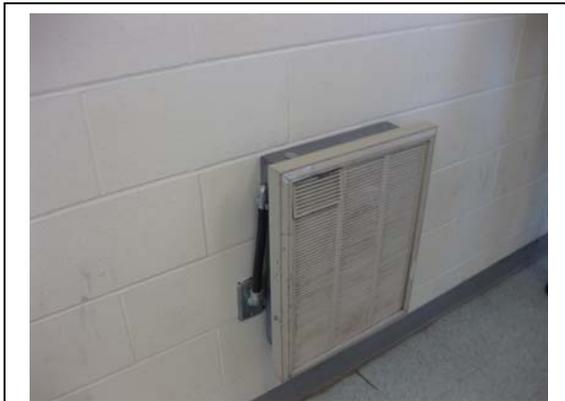
Force Flow Heater - Replace

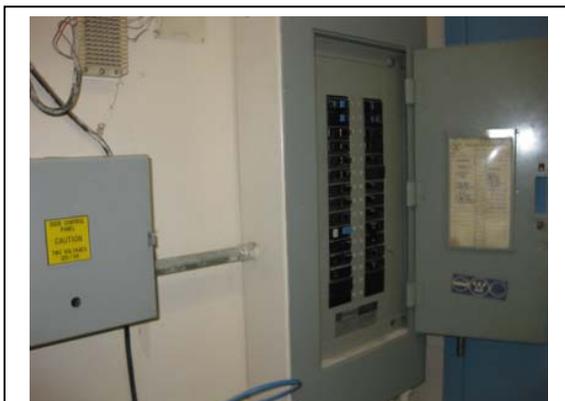
Lighting & Power Panel - Replace

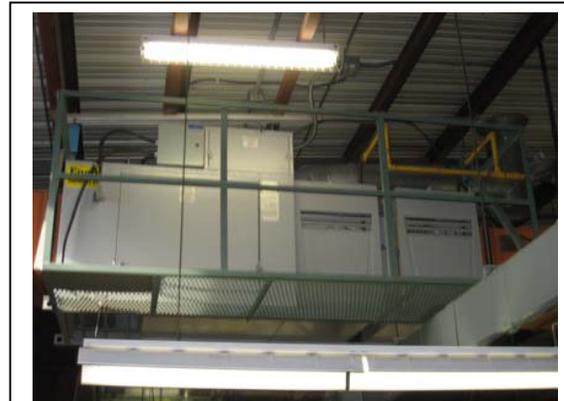
The majority of the air handling units in the warehouse/shop are original to the building's construction in 1983. The warehouse/shop supply air handling units and exhaust fans are in serviceable condition; however, they are past their useful service life and should be scheduled to have their internal components upgraded or replaced. We recommend replacing the unit motors, shafts, belts, and coils to extend the life of the equipment.

Air Handling Unit – Refurbish Components

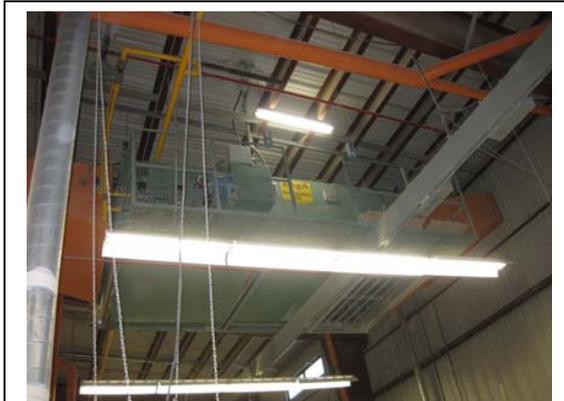
Air Handling Unit – Refurbish Components

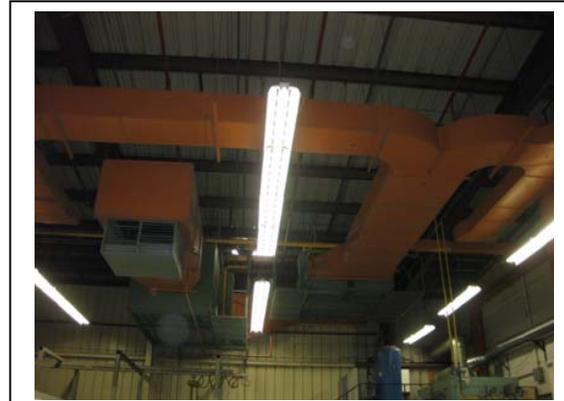
Air Handling Unit – Refurbish Components

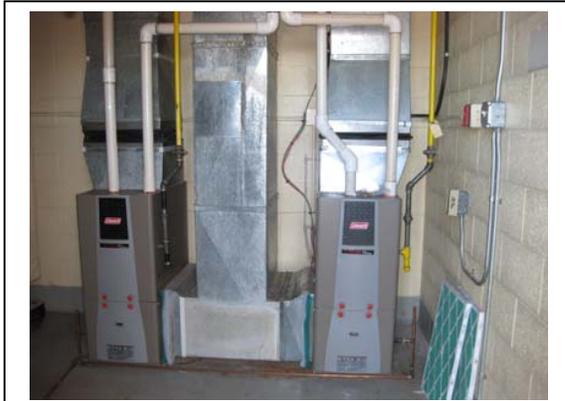
The furnaces are reportedly in good working order. All 3 of the furnaces were replaced in the past 3 years with new high efficiency gas fired furnaces.

Furnaces – High Efficiency

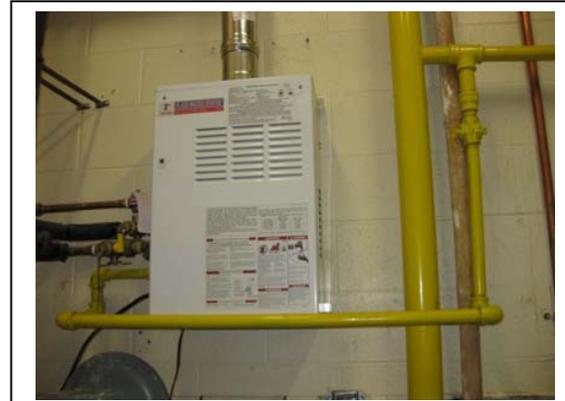
The gas fired instantaneous hot water heater was installed approximately 3 years ago and is in good condition.

Instantaneous Domestic Hot Water Heater

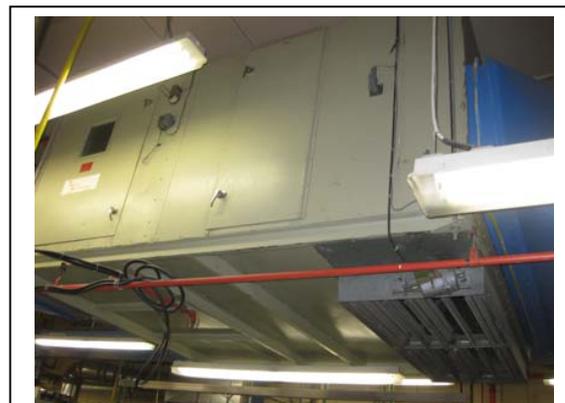
Air Handling Unit - Refurbish

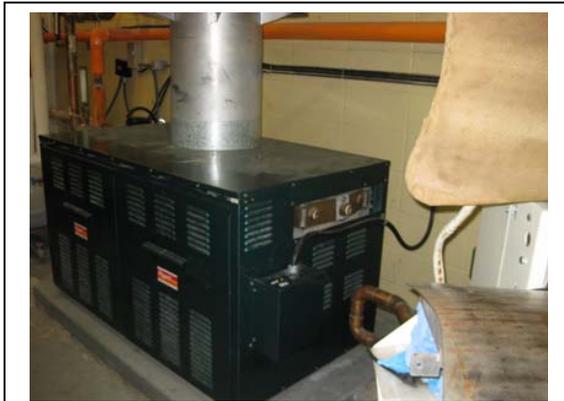
Laundry Hot Water Boiler - Replace

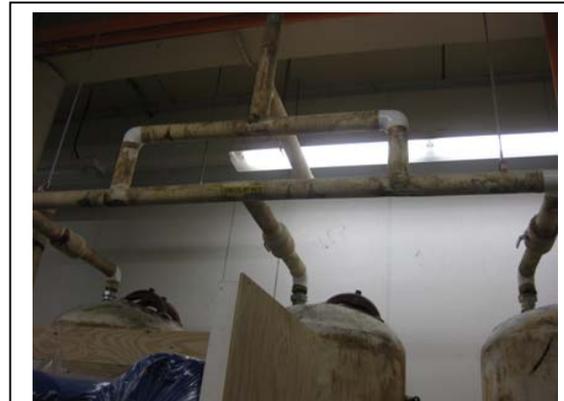
Domestic Hot Water Insulation - Replace

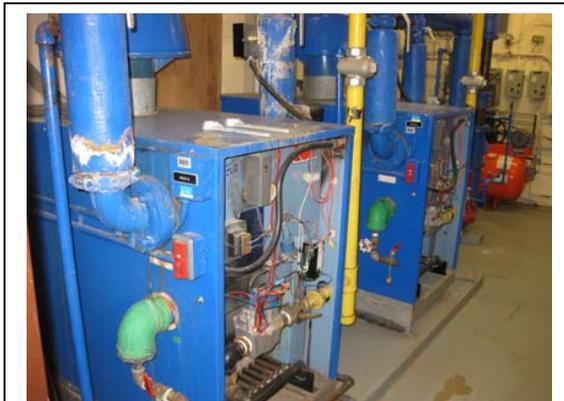
Heating Boilers - Replace

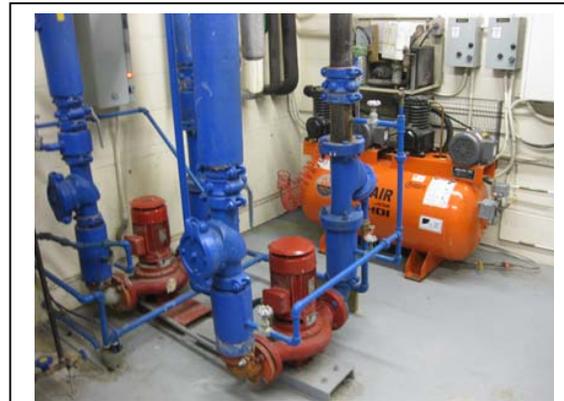
Heating Pumps - Refurbish

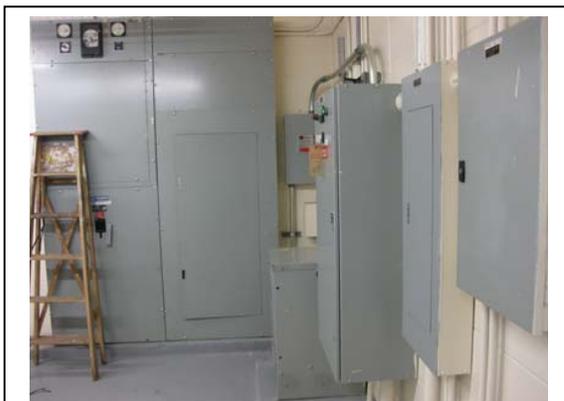
Main Electrical Disconnect – Refurbish/Replace

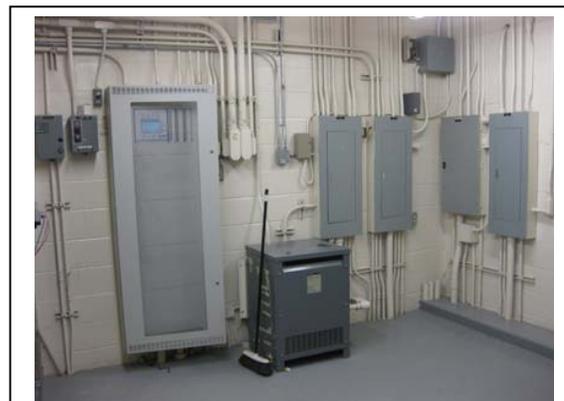
Fire Alarm Panel / Transformer - Replace

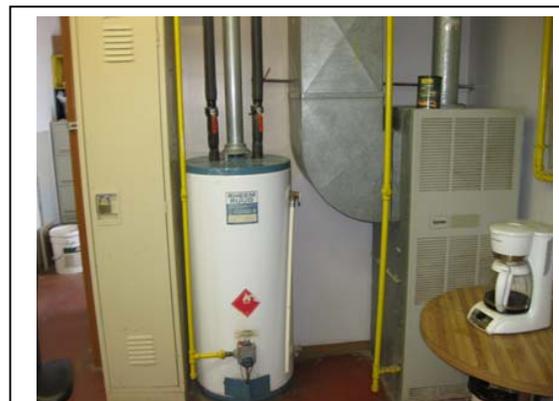
Domestic Hot Water Tank

The hot water tank was installed approximately 5 years ago and is in good condition.

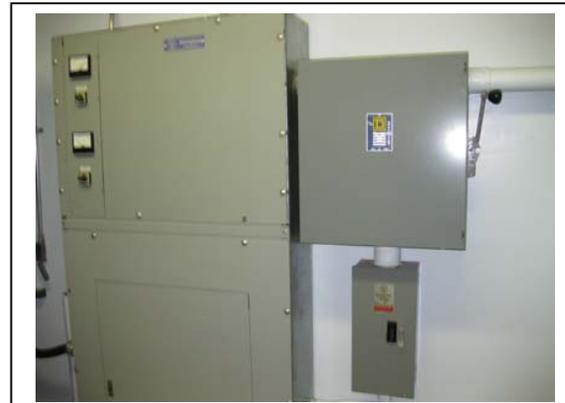
Transfer Switch & Main Breaker - Upgrade

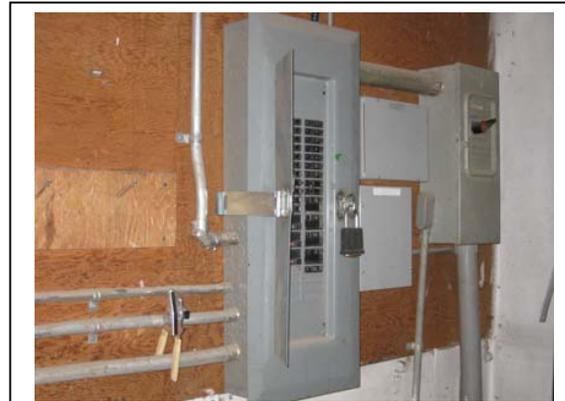
Main Disconnect & Distribution Panel - Replace

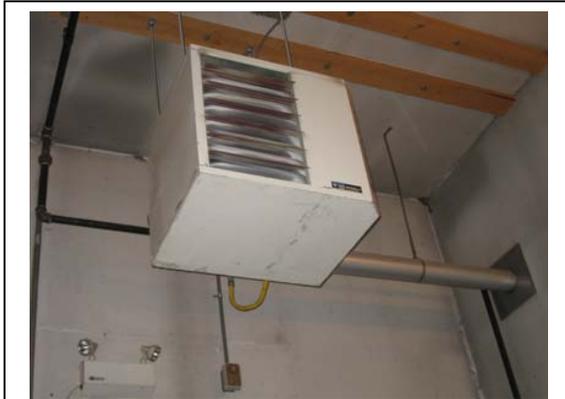
Gas Fired Unit Heater - Replace

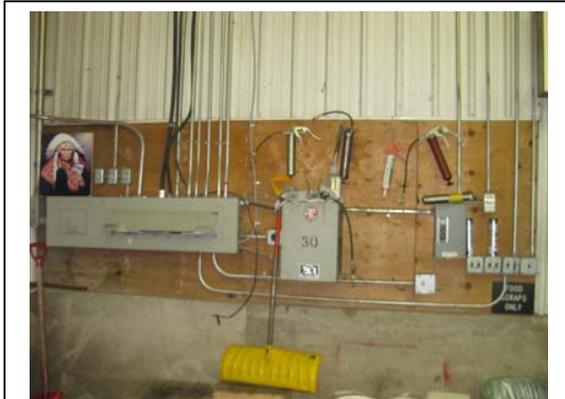
30 kVa Transformer & Distribution Panel - Replace

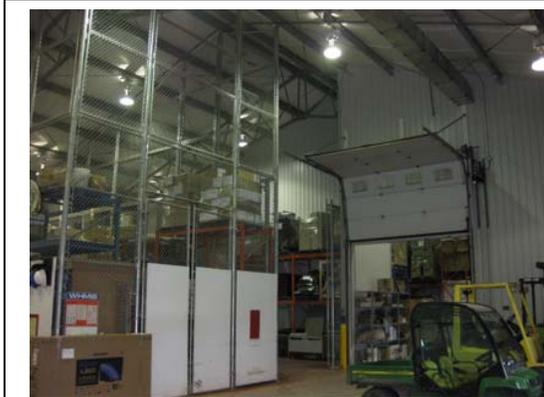
Stores Warehouse Lighting

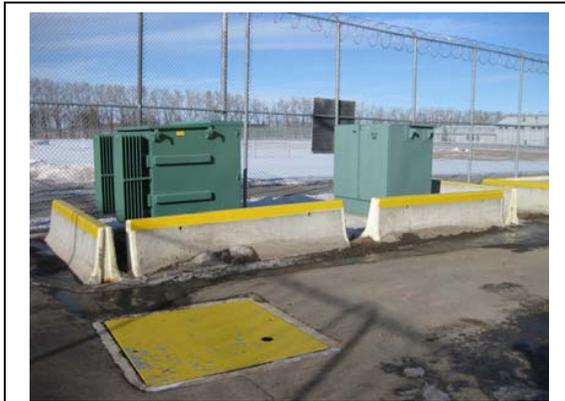
Electrical Trench Access & Building Transformers

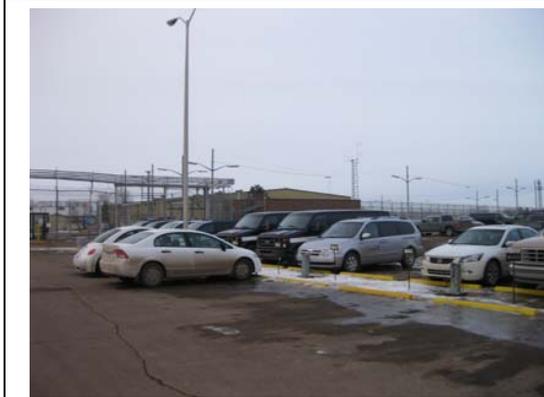
The 59 perimeter security fence light standards are of a different design than normal therefore finding components for replacement may be difficult. For the purpose of this study, we have assumed that complete replacement of the poles, double arms, and light fixtures will be required.

Double Lighting Standard (Security Fence)

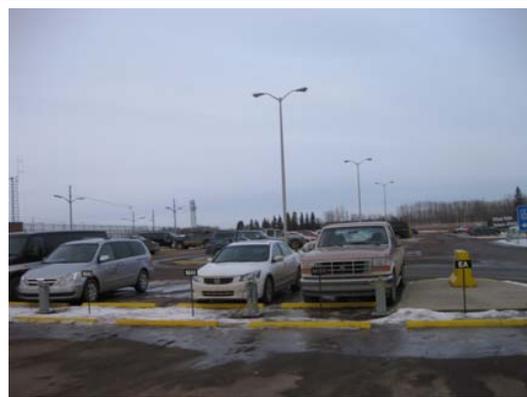
No problems were reported or observed. However, the majority of the lighting, poles, and guy wires are approaching the end of their life expectancy and should be scheduled for a replacement program.

Double Lighting Standard (Parking Areas)

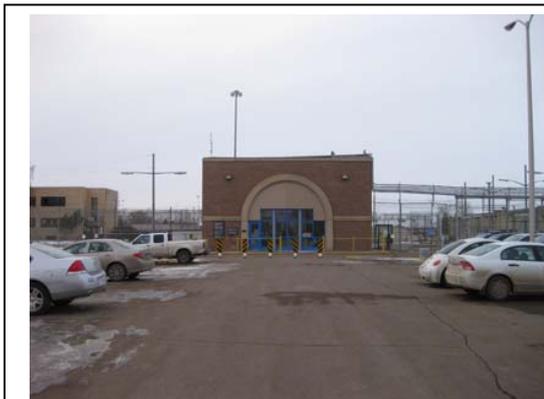
The 6 high mast light standards should be refurbished and/or replaced in the next 5 years.

Gate House & Parking Area – High Mast Lighting
