# 2018 COMPREHENSIVE DETAILED ANNUAL INSPECTION BURLINGTON CANAL LIFT BRIDGE

Contract No. EQ754-181509/001/PWL Project No. R.090046.001

**December 2019** (Rev .00)

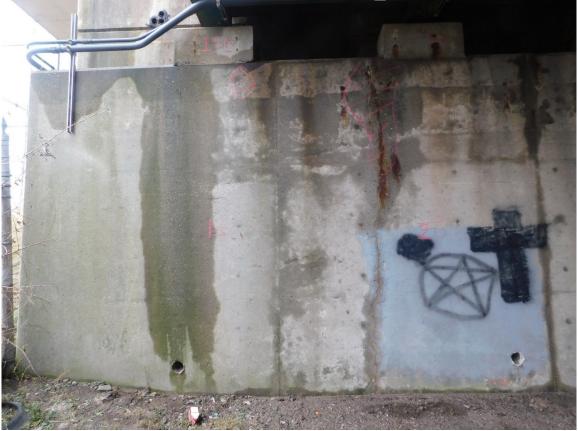
09 South Abutment, Wide Vertical Crack with Rust & Delamination on Wall between Stringers 1&2

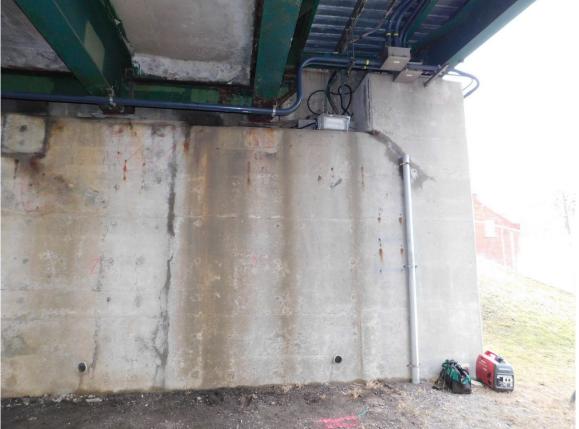
11 South Abutment, Stained Cracks & Local Delamination on Upper West Section of Wall

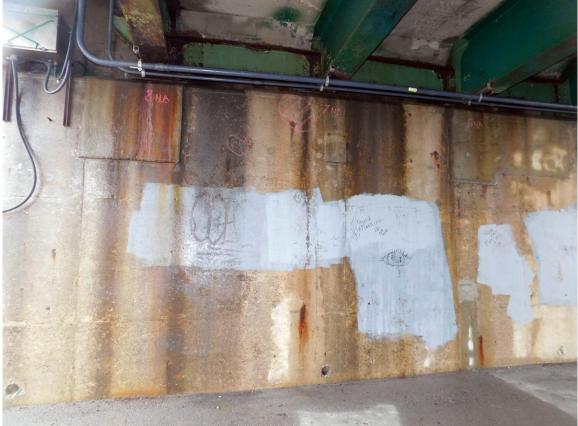
13 North Abutment, Heavy wet-Rust Stains, Medium-Wide Vertical Crack, and Local Delam on West Section of Wall

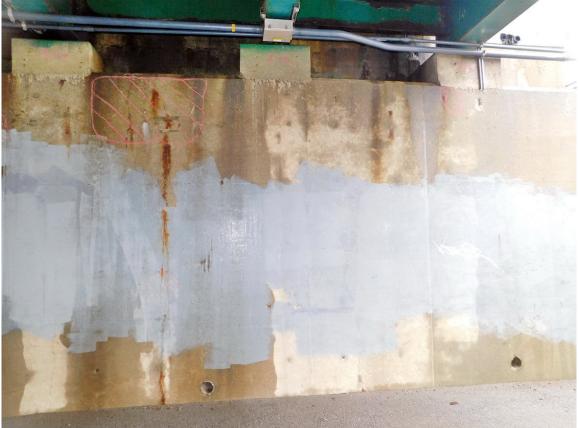
15 Local Severe Delamination Areas on Upper East Section of Wall

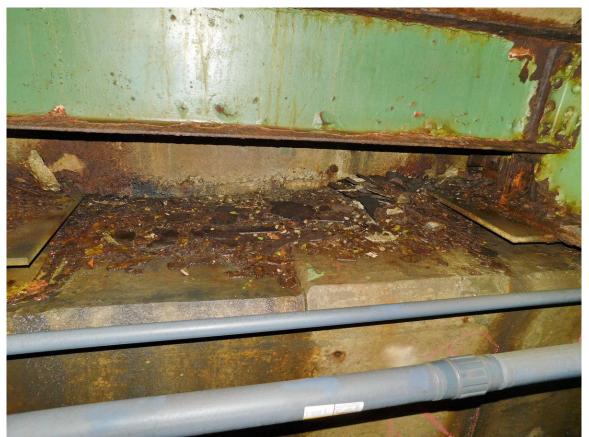
16 Typical Debris and Wet Area on Abutment Bearing Seat, North Abutment between Stringer 6&7 Shown Page A2 [8] of A2 [169]

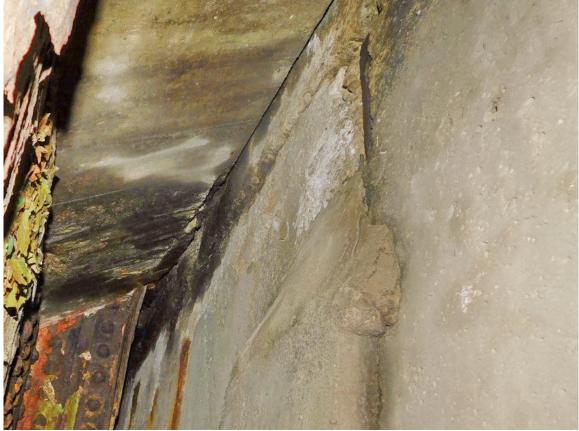
17 South Ballast Wall, Large Patch & Local Spall behind Diaphragm between Stringer 4&5

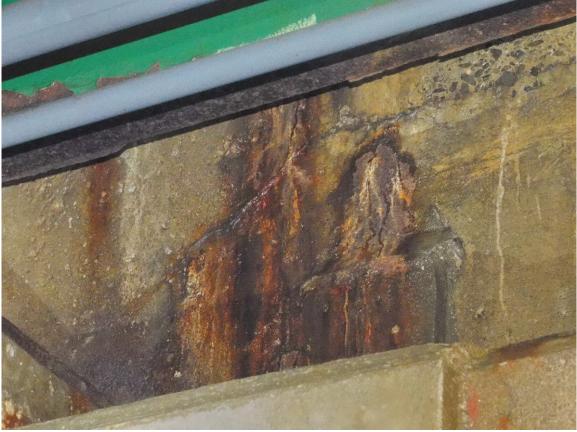
19 North Ballast Wall, Cracks with Heavy Rust Stains between Stringer 3&4

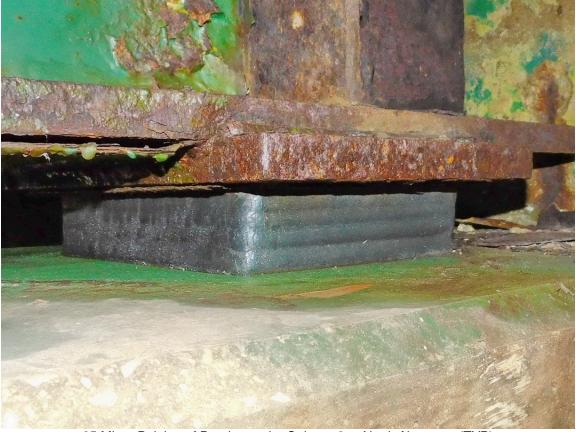
25 Minor Bulging of Bearing under Stringer 2 at North Abutment (TYP)

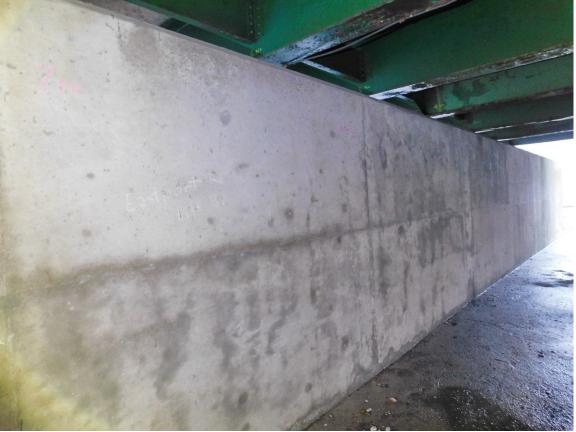
30 Typical Narrow-Medium Vertical Cracks on Curtain Wall, Central Section of North Wall Shown Page A2 [15] of A2 [169]

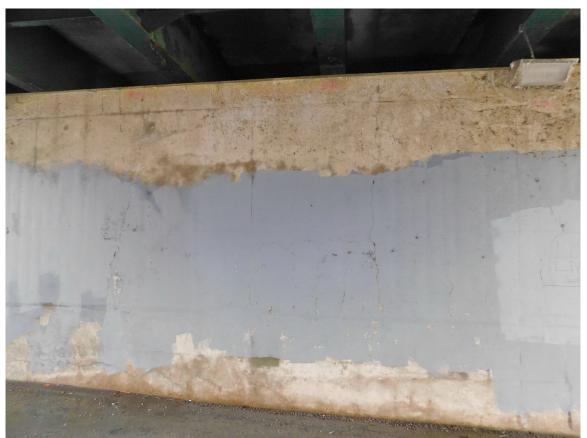
31 Local Minor Spall on East Section of South Curtain Wall

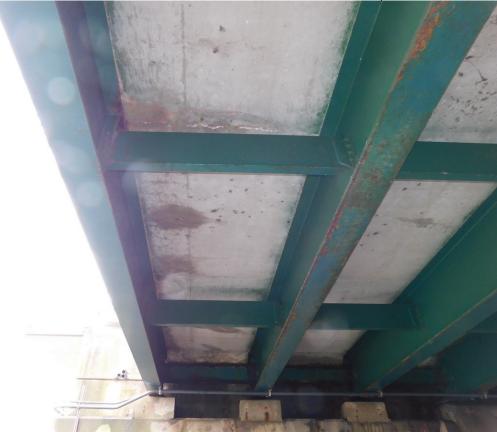
48 Large Wet Area with Stained Crack & Severe Delam on South Section of South Span between Stringers 3&4, looking Page A2 [24] of A2 [169]

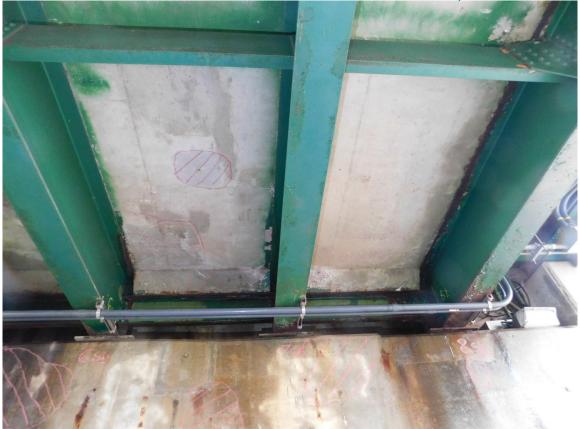
50 Wet with Rust Stains and Large Delam Areas on Central Soffit of South Span between Stringers 3&4, looking South Page A2 [25] of A2 [169]

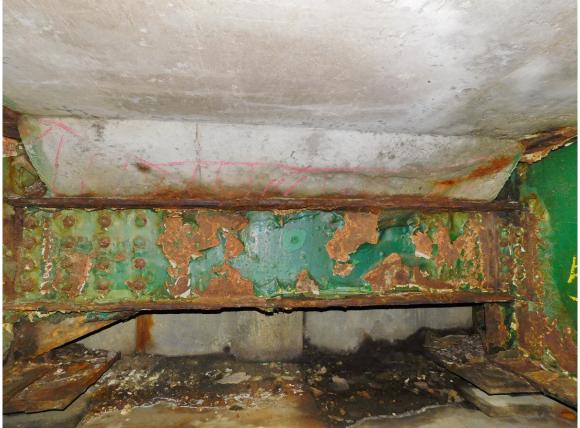
52 Heavy Wet Area with Large Delamination & Spalls at South Abutment End Soffit, East of Stringer 5 Page A2 [26] of A2 [169]

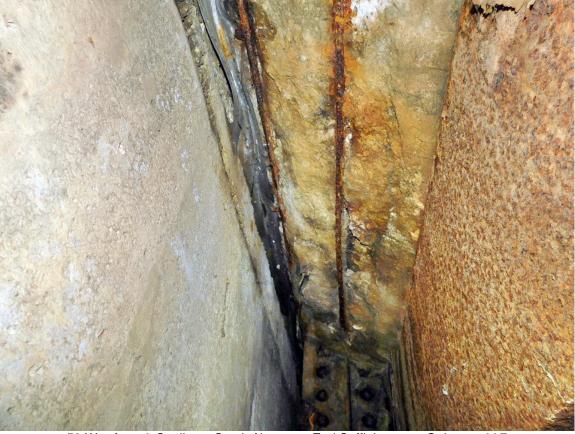
54 Large Delam with Local Severe Spall & Exposed Torn Joint Seal at South Abutment End of Soffit between Stringer 7&8 Page A2 [27] of A2 [169]

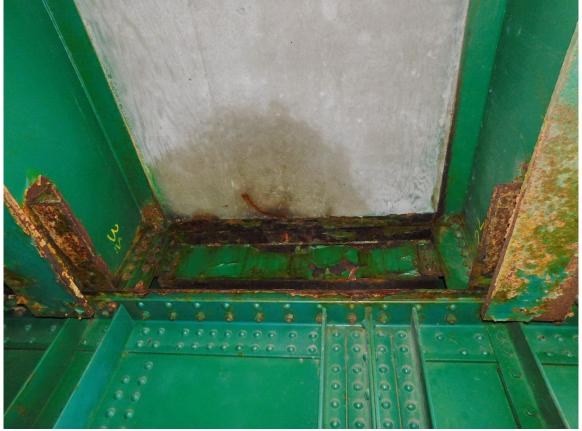
56 Large Wet Area with Stained Crack on North Section of South Approach Soffit between Stringers 3&4, looking West Page A2 [28] of A2 [169]

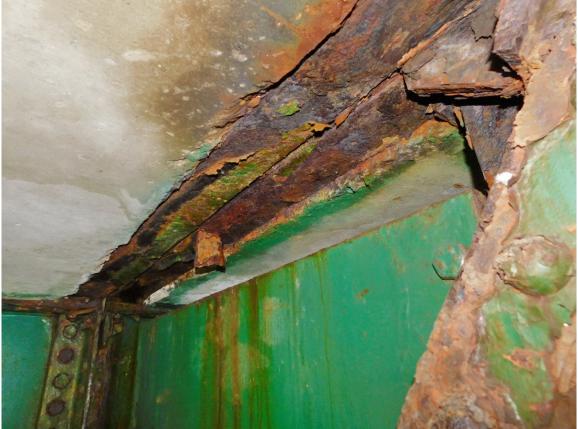
58 Local Spall on Soffit Adjacent to Expansion Joint between South Approach & South Tower Spans near Stringer 6 (TYP) Page A2 [29] of A2 [169]

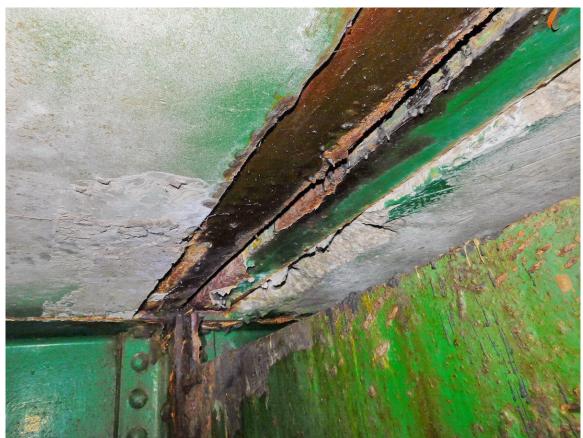
59 Local Light Surface Rust on Steel Decking under Sidewalk at NW Section of South Approach Span

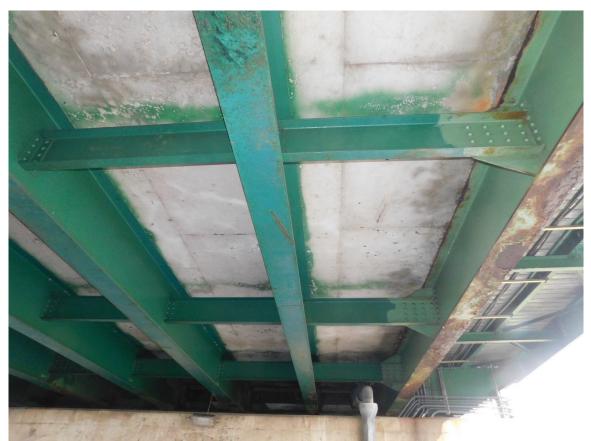
64 Large Wet Areas on West Section of North Approach Span Soffit, looking South Page A2 [32] of A2 [169]

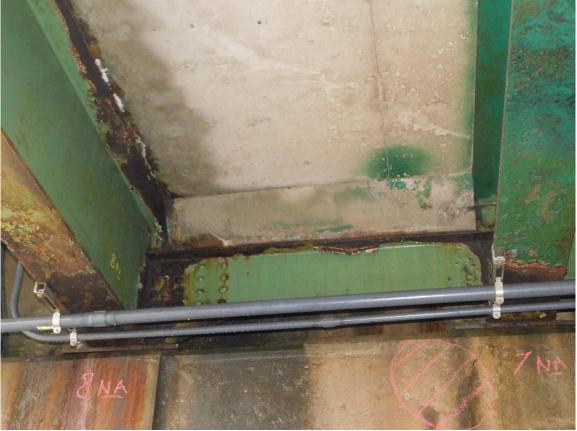
65 Heavy Wet Area on Soffit adjacent to West Stringer 8 at North Abutment (TYP)

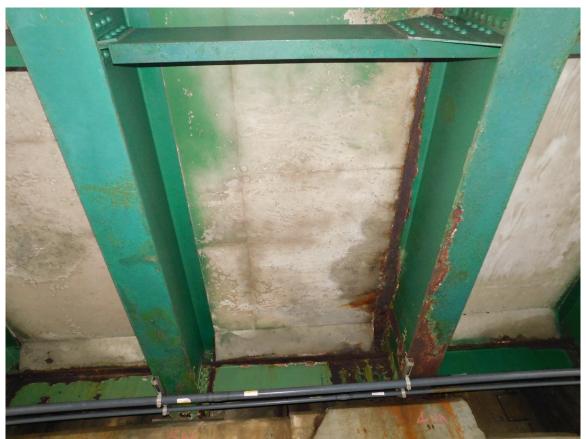
66 Wet Area on Central North End of North Approach Span Soffit

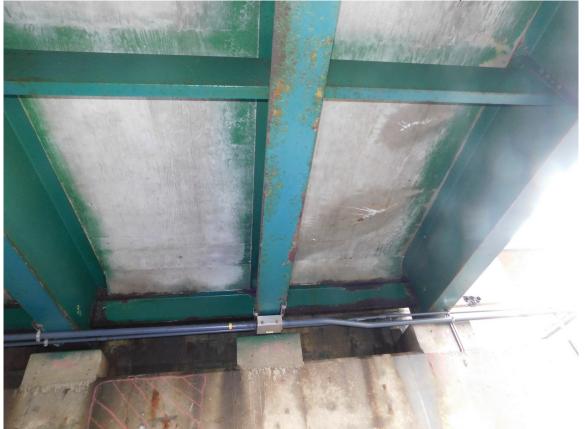
67 Cracks with Wet and Efflorescent Stains on NE Section of North Approach Span Soffit

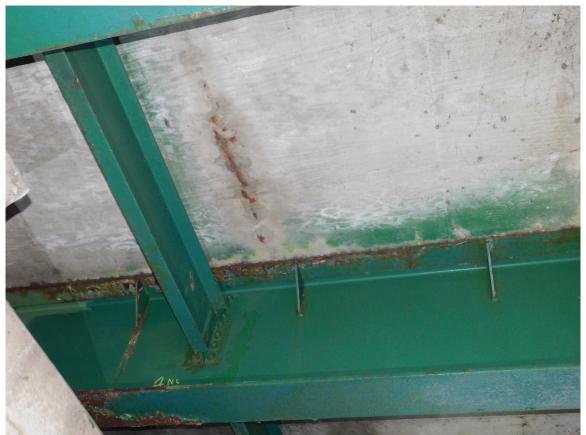
68 Crack with Wet & Rust Stains on South Central Section of North Approach Span Soffit Page A2 [34] of A2 [169]

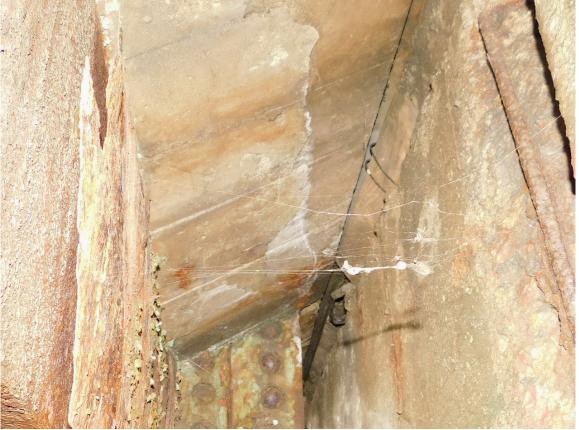
70 Heavy Wet and Large Severe Delamination on North Abutment End Soffit between Stringers 5&6 Page A2 [35] of A2 [169]

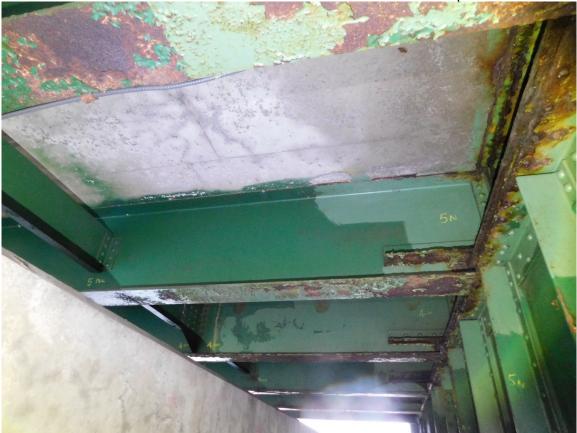
71 Large Wet Areas on South Section of North Span Soffit between Stringers 5&6, looking East

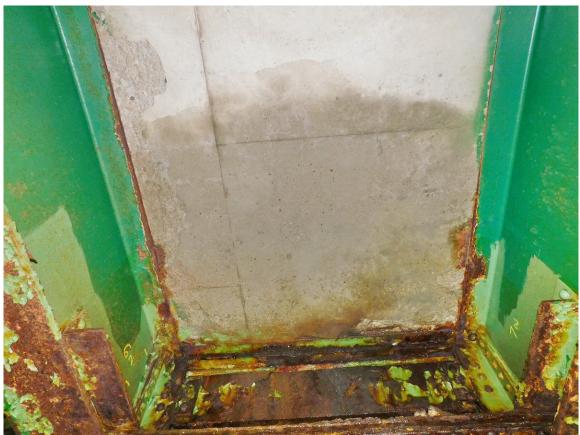
72 Heavy Wet Area on SW Section of North Span Soffit between Stringers 6&7 Page A2 [36] of A2 [169]

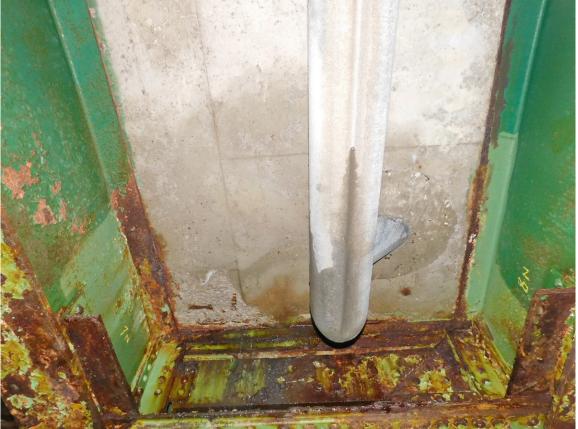
74 Severe Delamination in Wet Area at South End of North Span Soffit between Stringers 5&6 Page A2 [37] of A2 [169]

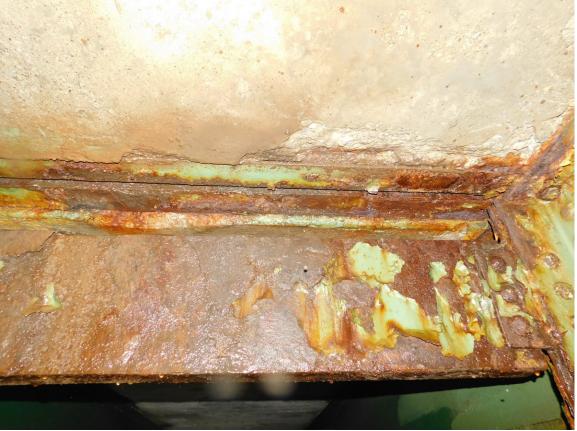
75 Local Severe Delamination on South End of North Span Soffit between Stringers 6&7

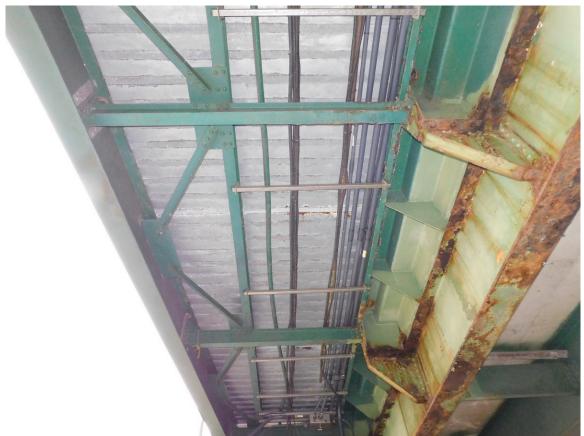
76 Local Light Rust on Steel Decking under West Sidewalk at North Approach Span, looking North Page A2 [38] of A2 [169]

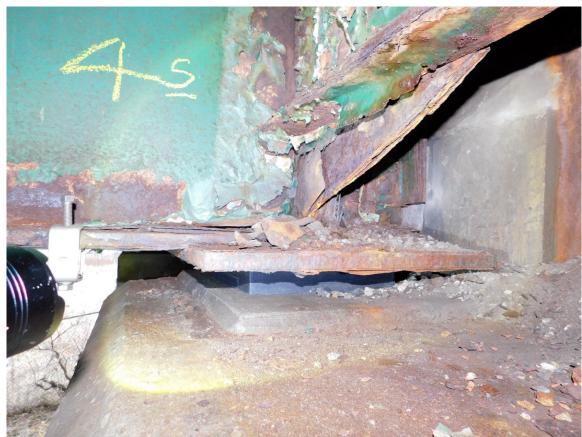
79 S Approach Span, Typical Heavy Corrosion on Interior Stringers & Diaphragm at South Abutment, Stringers 5&6 Shown

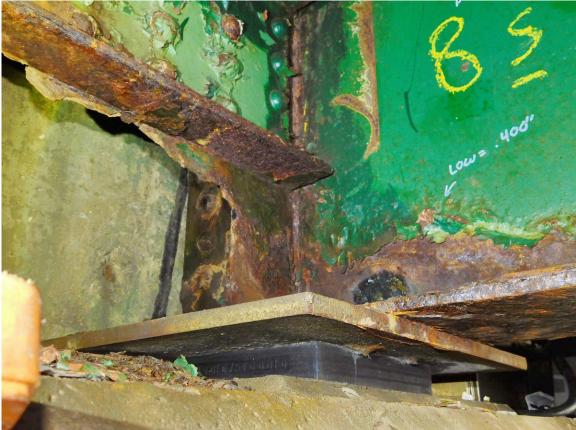
80 S Approach Span, Local Severe Corrosion on Bottom of Stringer 4, Gusset Plate, & Diaphragm at South Abutment Page A2 [40] of A2 [169]

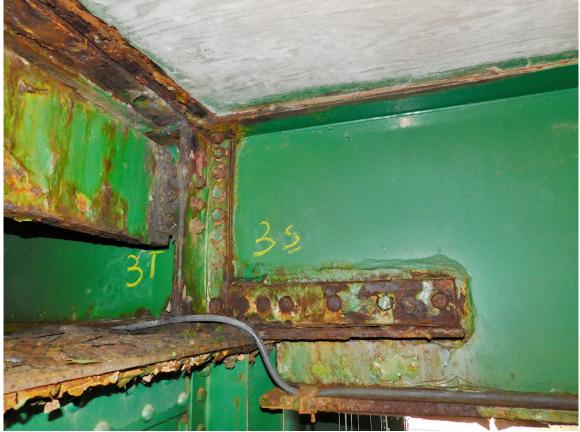
82 S Approach Span, Typical Severe Corrosion on Back Face of Diaphragm at South Abutment, Stringers 7&8 Shown Page A2 [41] of A2 [169]

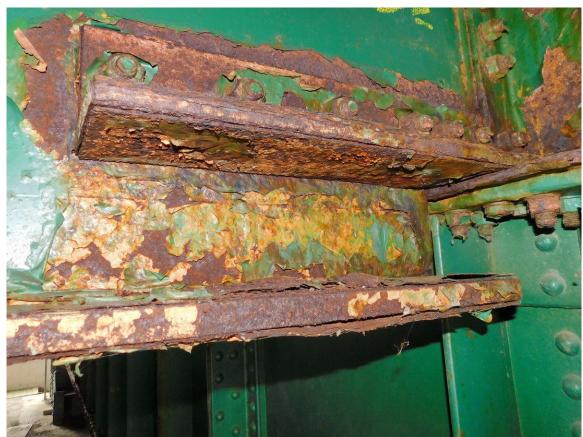
83 S Approach Span, Wet with Heavy Corrosion on Stringers & Diaphragm at North End of Span, Stringer 3 Shown

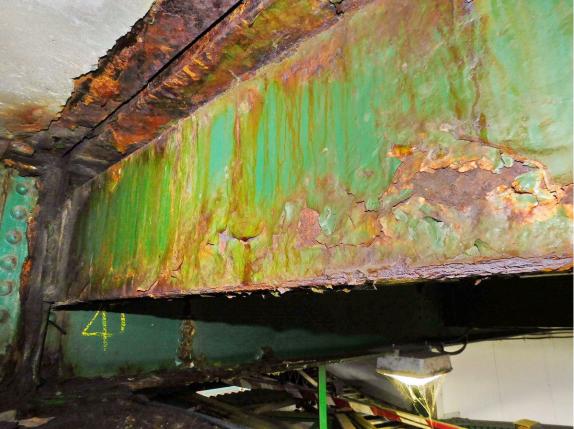
84 S Approach Span, Medium Corrosion on bottom North End of Stringer 3 (TYP) Page A2 [42] of A2 [169]

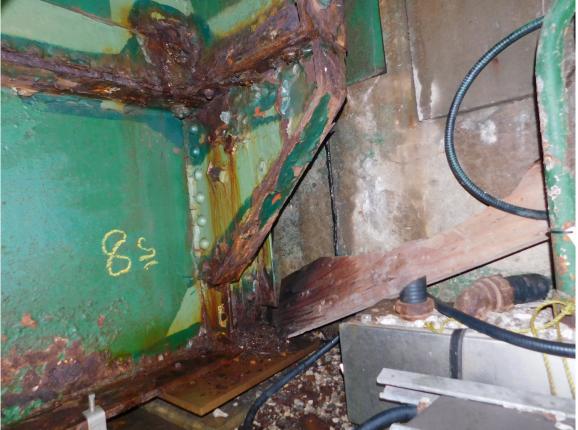
86 S Approach Span, Heavy Corrosion on Outside Face of Stringer 8 @ Central Section of Span, looking South Page A2 [43] of A2 [169]

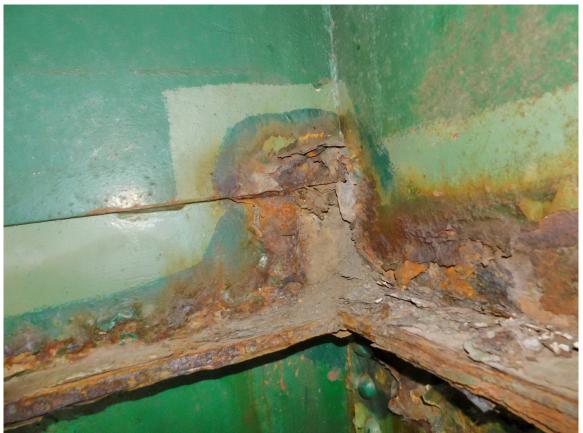
87 S Approach Span, Wet with Local Severe Corrosion on Stringer 8 at South Abutment End

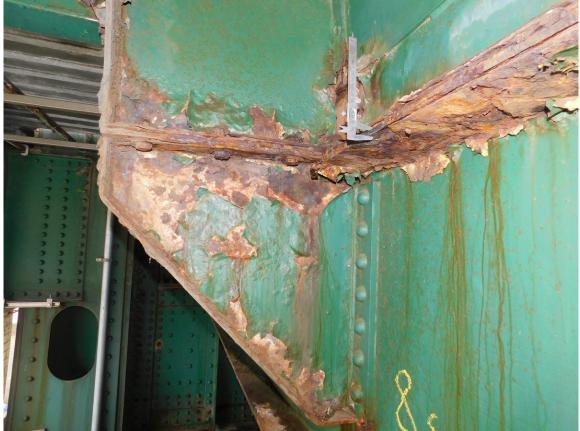
88 S Approach Span, Perforated Curb Plate atop South End of Stringer 8 Page A2 [44] of A2 [169]

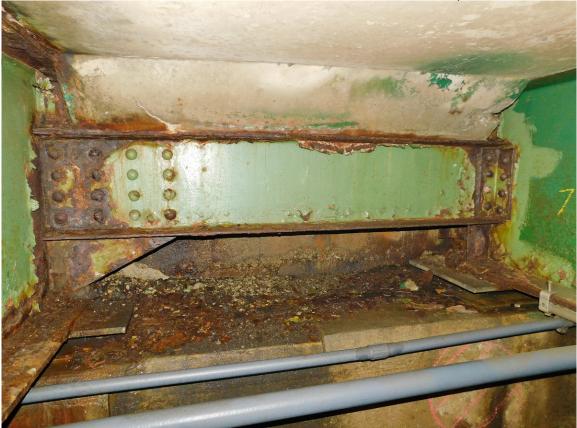
90 S Approach Span, Severe Leakage of Deck Exp Joint with Sediment Slurry on Structural Steel @ North End of Stringer Page A2 [45] of A2 [169]

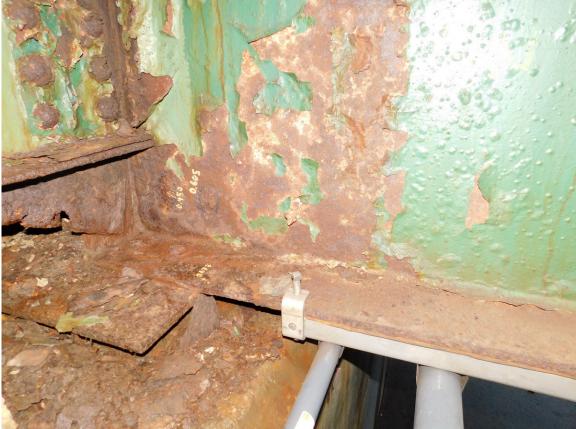
92 N Approach Span, Very Severe Corrosion on Web Section of Stringer 1 behind Bearing at North Abutment Page A2 [46] of A2 [169]

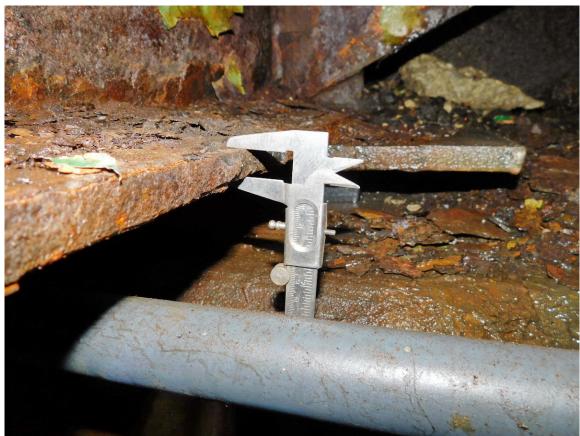
93 N Approach Span, Severe Corrosion on Lower Web and Flange at Stringer 4 & Perforated Gusset Plate at North Abut

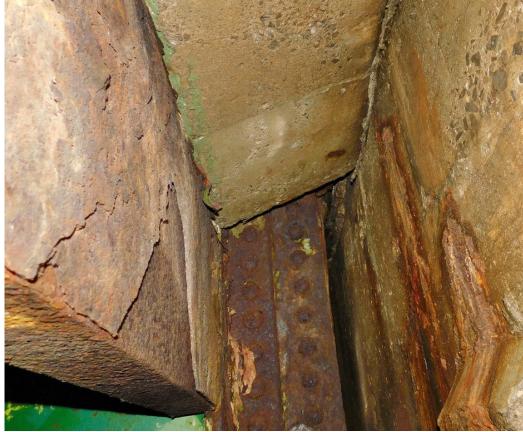
94 N Approach Span, Severe Corrosion on Bottom Flange of Stringer 8 at North Abutment End (TYP) Page A2 [47] of A2 [169]

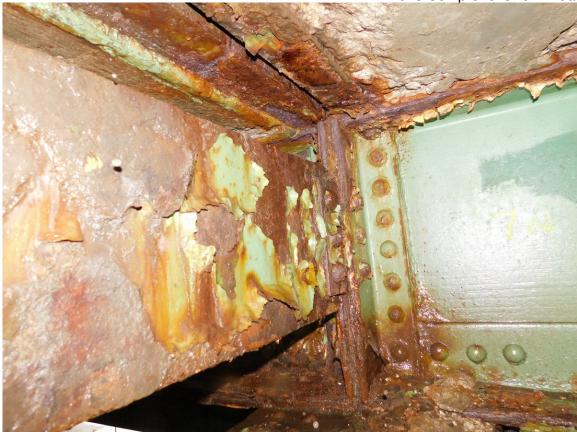
96 N Approach Span, Typical Wet with Heavy Corrosion on Stringers & Diaphragm at South End of Span, Stringer 6 Page A2 [48] of A2 [169]

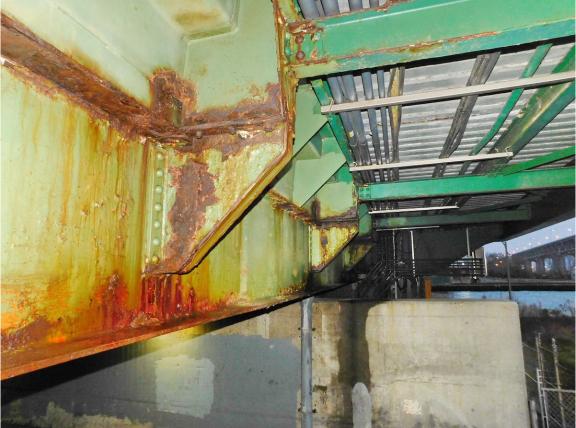
98 N Approach Span, Severe Corrosion on Bottom Flange at South End of Stringer 8 (TYP) Page A2 [49] of A2 [169]

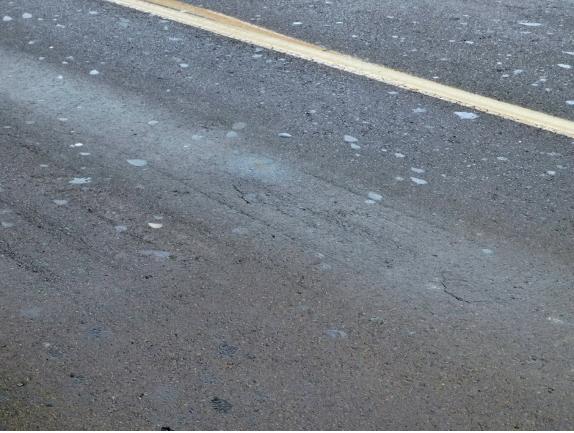
104 South Tower Span Deck from NW Corner

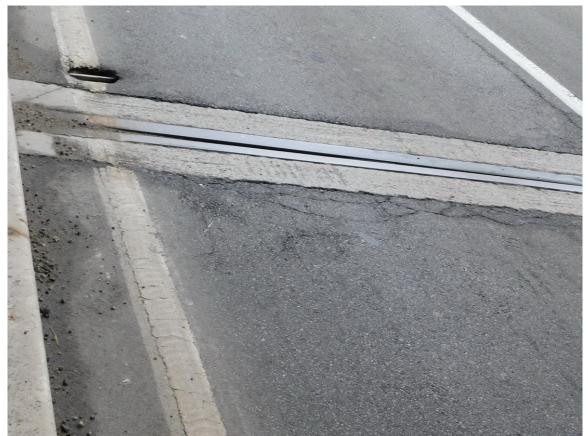
109 North Tower Span, Bridge Deck from SW Corner

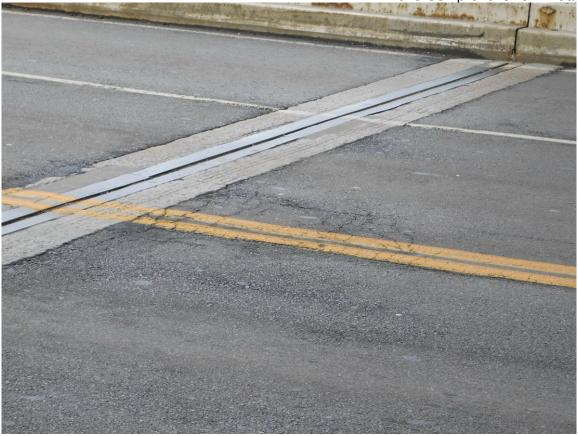
110 North Approach Span, Light Asphalt Depression with Local Unsealed Pattern Cracks on NW Corner of Deck Page A2 [55] of A2 [169]

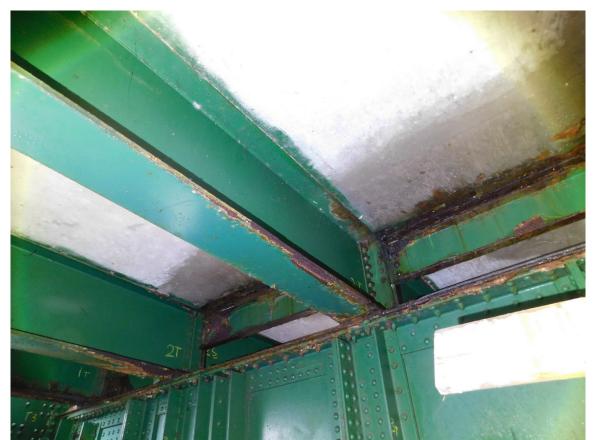
117 South Tower Span, General View of Soffit at North End of Deck looking West

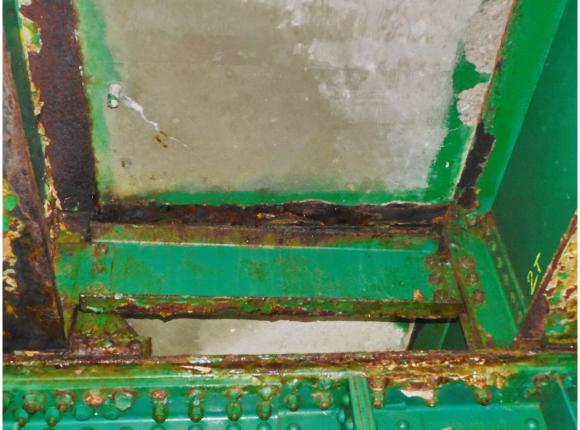
118 South Tower Span, Typical Heavy Wet Areas at South End of Soffit at Expansion Joint wth South Approach Deck Page A2 [59] of A2 [169]

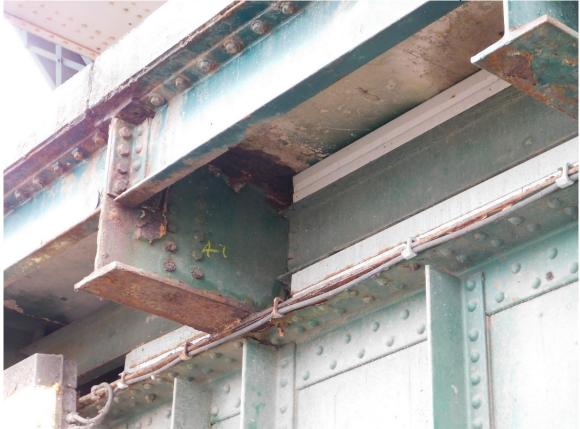
120 South Tower Span, Isolated Local Delam at South End of Stringer 4 & Exp Joint with adjacent South Approach Span Page A2 [60] of A2 [169]

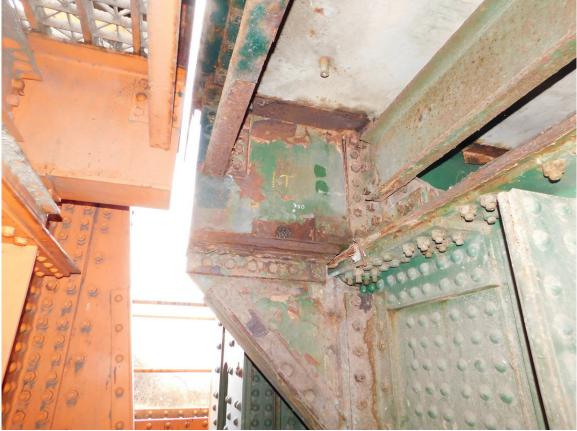
122 South Tower Span, Heavy Corrosion on Top & Bottom Section of Stringer 4 @ South End of Span (TYP) Page A2 [61] of A2 [169]

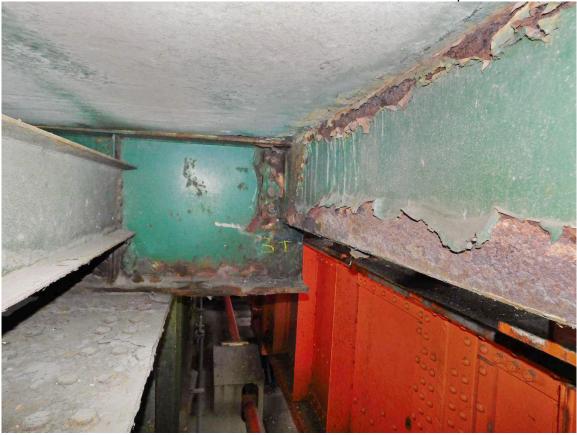
124 South Tower Span, Typical Heavy Corrosion on Linking Diaphragm with adjacent South Approach Span Page A2 [62] of A2 [169]

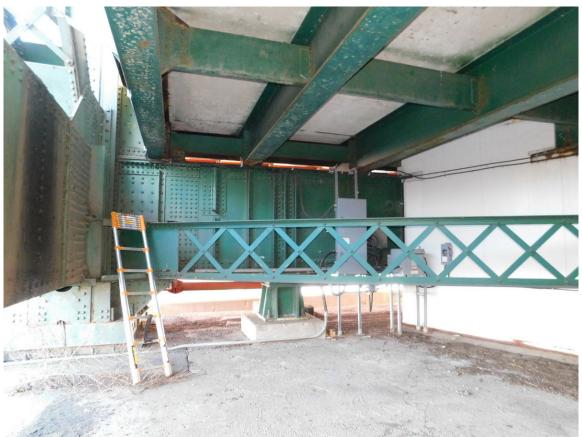
125 South Tower Span, Typical Heavy Corrosion on North Edge Diaphragm at Joint with Lift Span

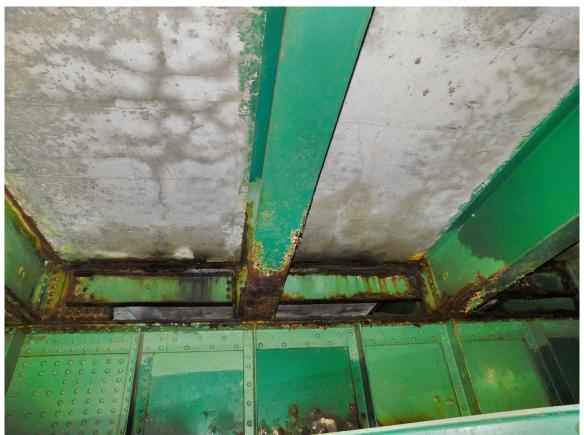
128 North Tower Span, Large Wet Areas on Soffit at NW Section of Deck, Stringers 6 to 8 Page A2 [64] of A2 [169]

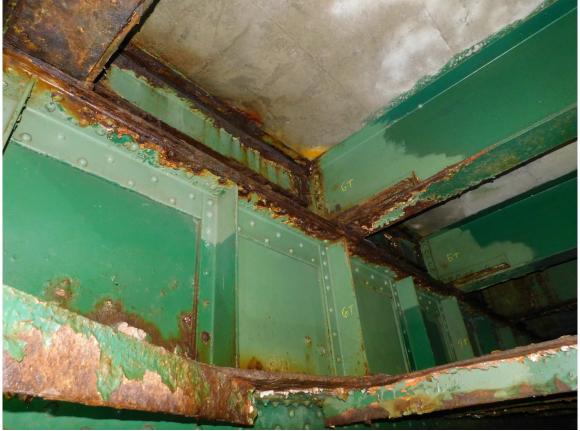
129 North Tower Span, Heavy Wet Area at north End of Deck Span, looking East

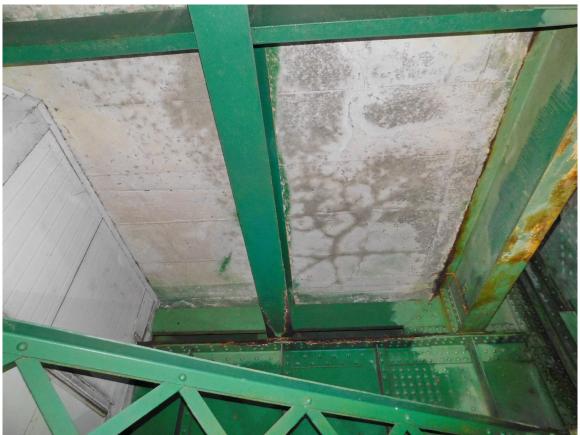
130 North Tower Span, Large Wet Area on SW Section of Soffit looking South Page A2 [65] of A2 [169]

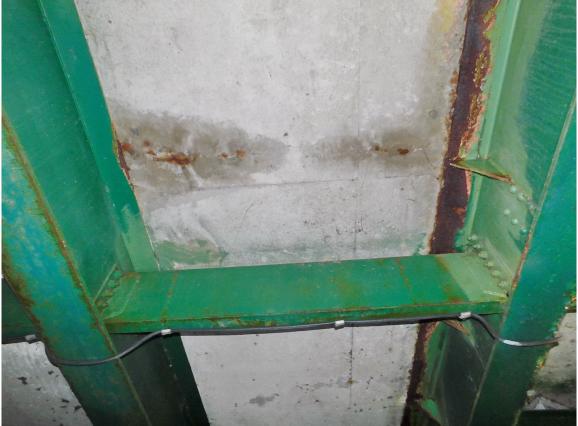
131 North Tower Span, Stained Crack with Wet and Rust Stains on North Central Section of Soffit between Stringers 3&4

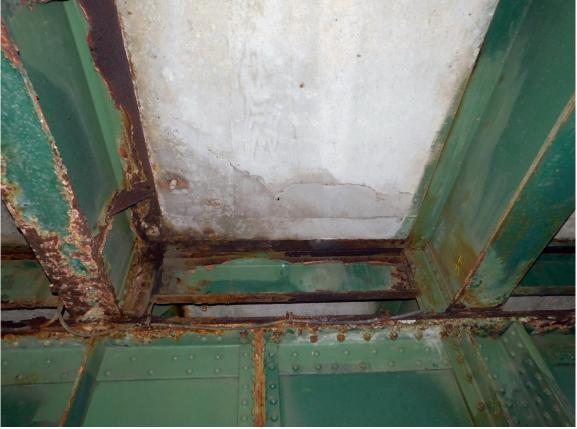
133 North Tower Span, Large Delamination Area at North End of Soffit between Stringers 3&4

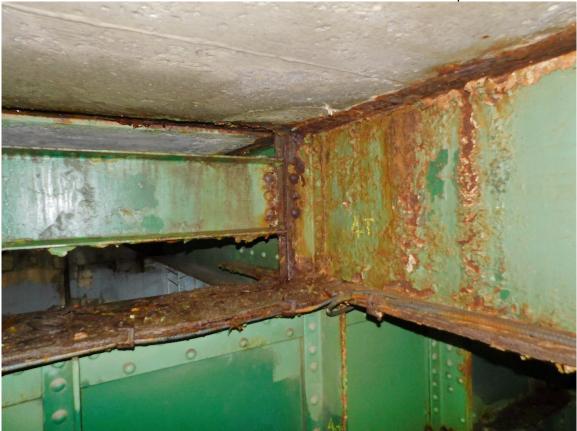
135 North Tower Span, Heavy Wet & Severe Corrosion on Stringer 4 at North End below Exp Joint with N Approach Span

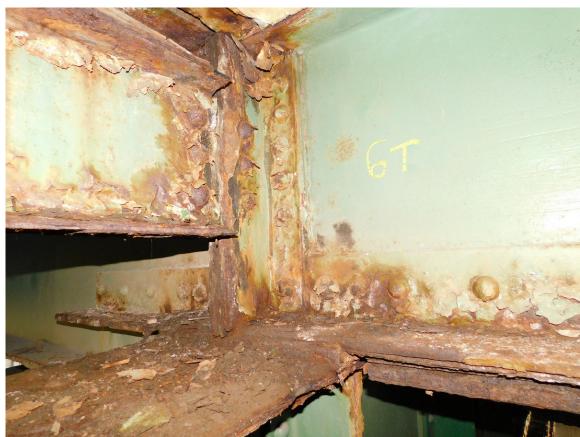
136 North Tower Span, Local Severe Corrosion on Diaphragm & Stringer 6 under Expansion Joint at North End of Span Page A2 [68] of A2 [169]

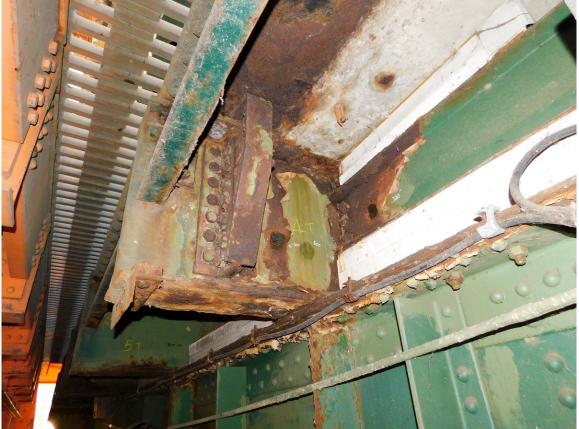
137 North Tower Span, Local Medium-Severe Corrosion on Stringer 4 and Diaphragm near Exp Joint with Lift Span

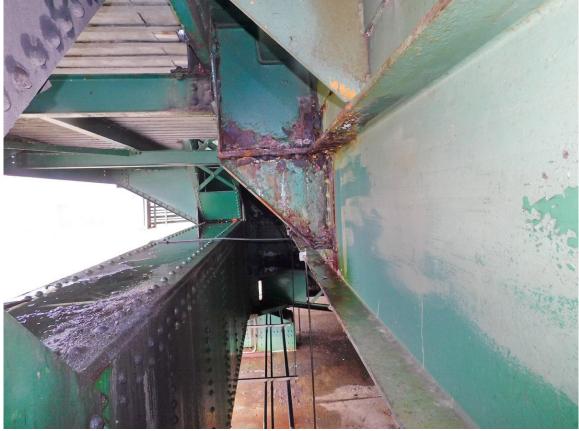
139 North Tower Span, Local Light-Medium Corrosion on Exterior Face of Stringer 8, looking North

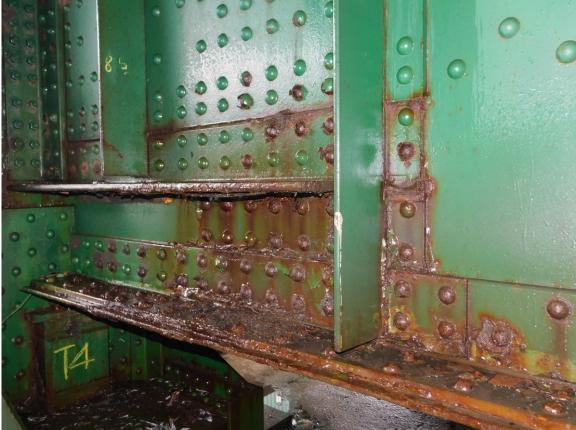
147 South Tower, Heavy Rust Stains on Bottom SW Section of Rear Floor Beam, looking West

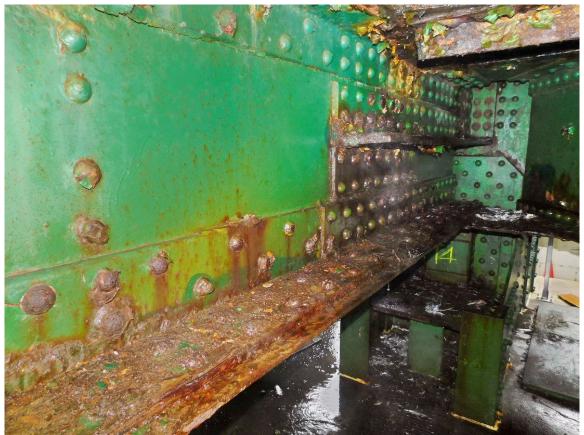
148 South Tower, Heavy Corrosion on Lower NW Section of Rear Floor Beam near SW Tower Leg T4 Page A2 [74] of A2 [169]

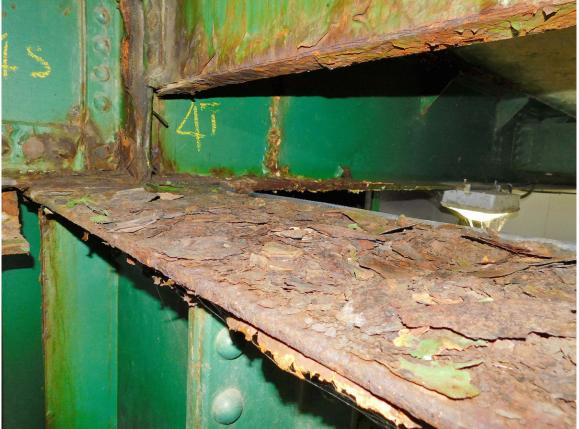
149 South Tower, Heavy Corrosion on Top Flange of Rear Floor Beam below South Exp Joint with South Approach Span

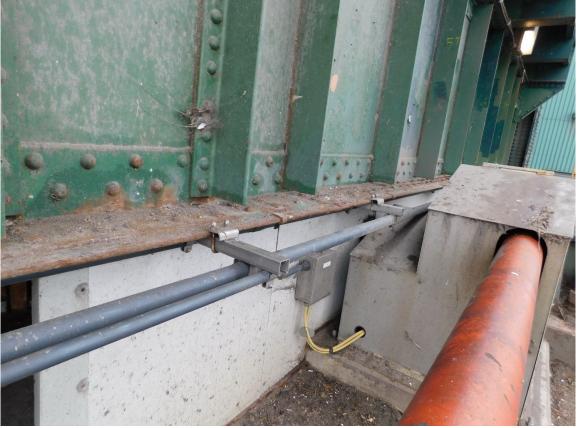
151 South Tower, Light Surface Rust on bottom Flange Section of Front Floor Beam (TYP)

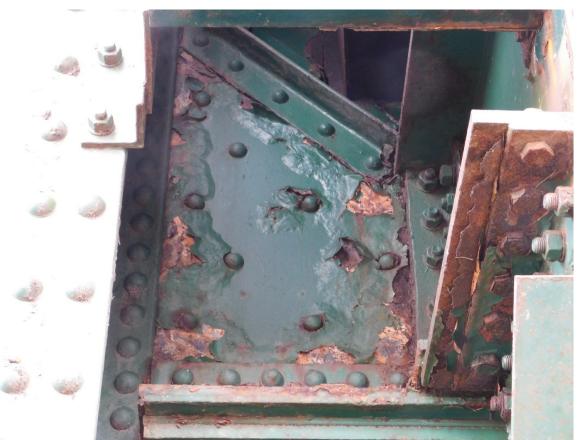
152 South Tower, Local Light-Medium Corrosion on Stiffener Plate at Top East Corner of Front Floor Beam Page A2 [76] of A2 [169]

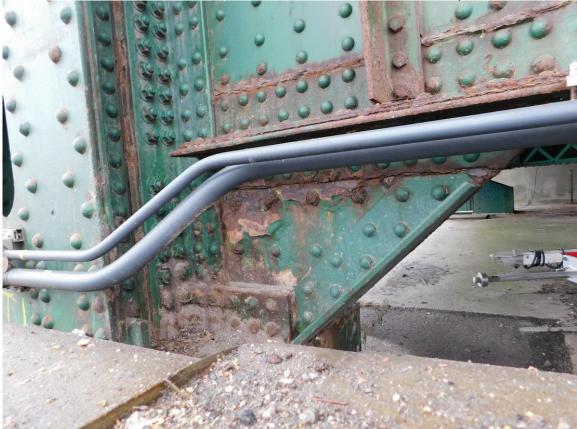
153 South Tower, Local Light-Medium- Corrosion on Stiffener Plate at Bottom East Corner of Front Floor Beam

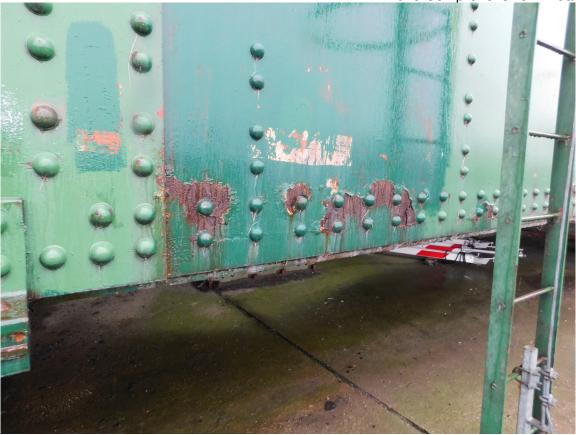
155 South Tower, Local Peeled Paint with Light Surface Rust on Bottom South Section of East Jacking Girder

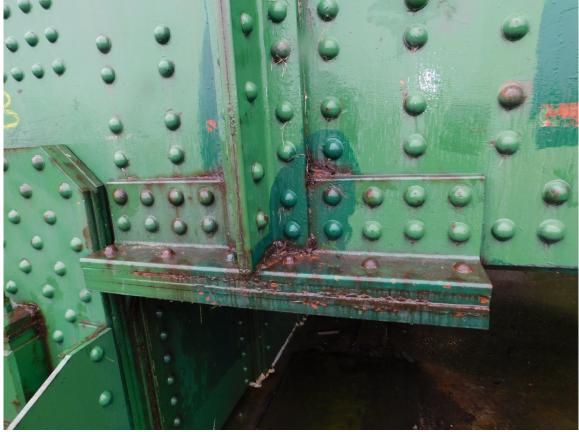
157 South Tower, Local Rust Jacking at Jacking Pad Plate at Bottom SE Section of East Jacking Girder

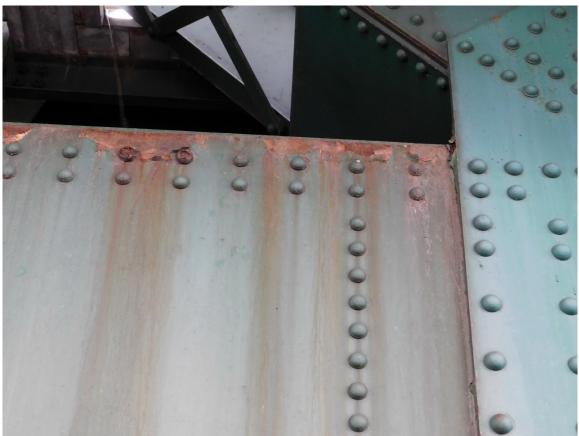
158 South Tower, Local Light Rust on top South Corner of West Jacking Girder Page A2 [79] of A2 [169]

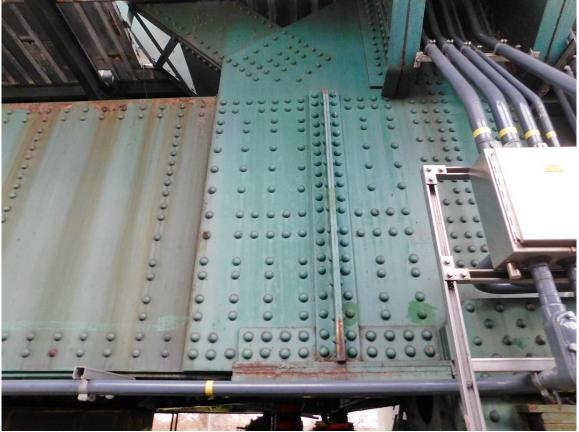
159 South Tower, Local Light Surface Rust on South End of West Jacking Girder

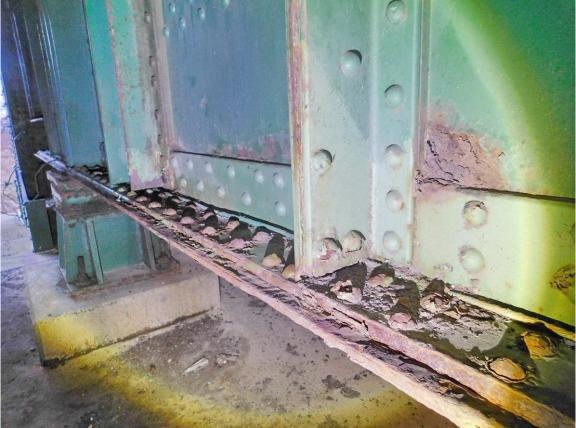
165 North Tower, Local Light-Medium Corrosion on Bottom East Section of Rear Floor Beam

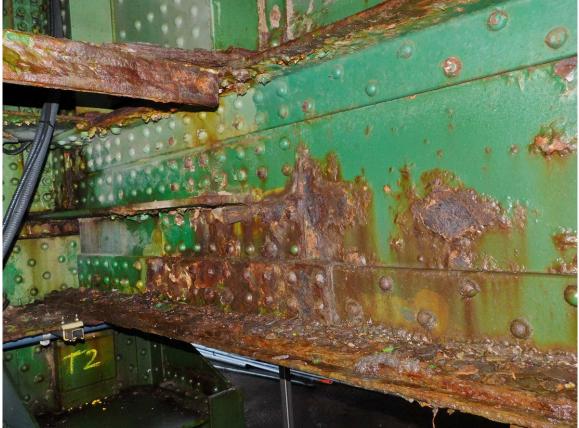
167 North Tower, Large Severe Corrosion Area on lower South Face of Rear Floor Beam below Stringers 7&8

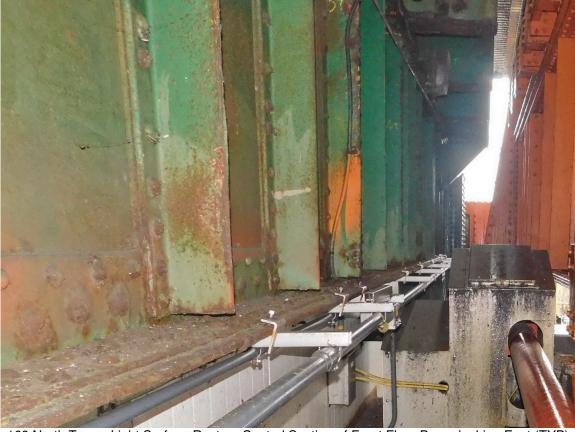
169 North Tower, Light Surface Rust on Central Section of Front Floor Beam looking East (TYP)

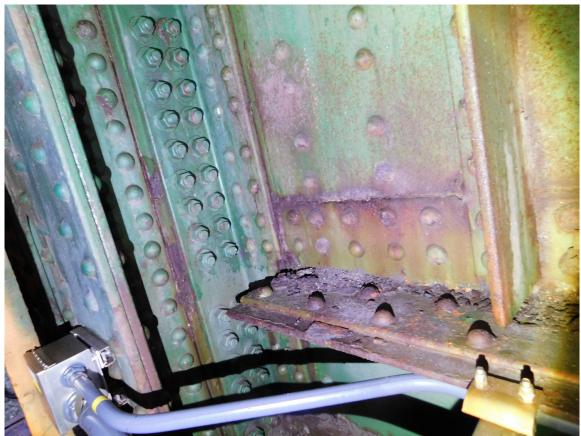
170 North Tower, Rust Stains with Local Light-Medium Rust Jacking at Bottom West Section of Front Floor Beam Page A2 [85] of A2 [169]

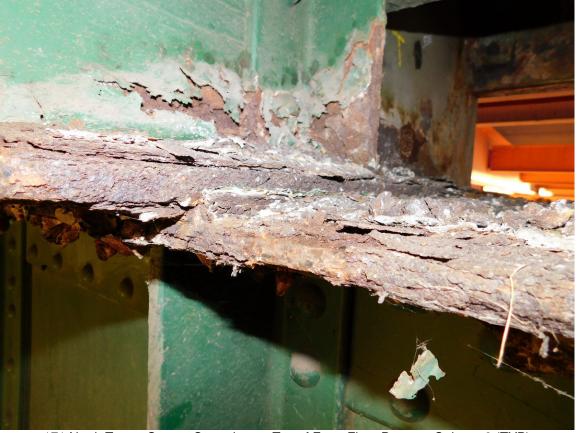
171 North Tower, Severe Corrosion on Top of Front Floor Beam at Stringer 8 (TYP)

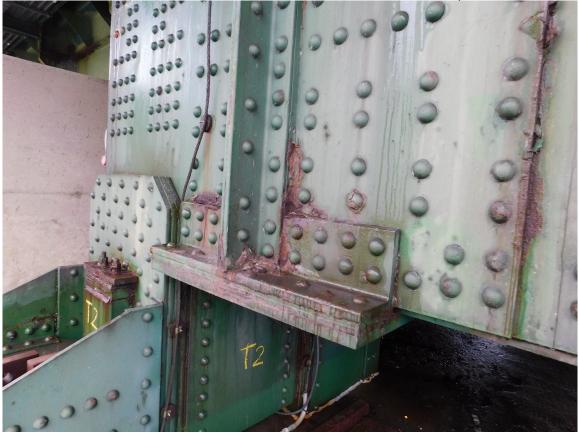
173 North Tower, Local Medium Corrosion on Bottom North Section of West Jacking Girder (TYP)

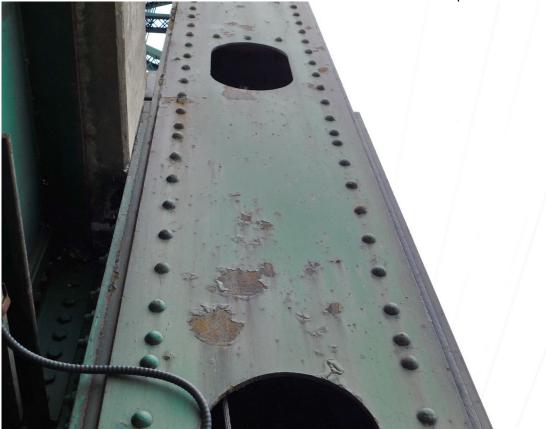
175 Typical Local Peeled Paint showing Light Rust on Tower Column, SE Column T3 at South Tower Shown

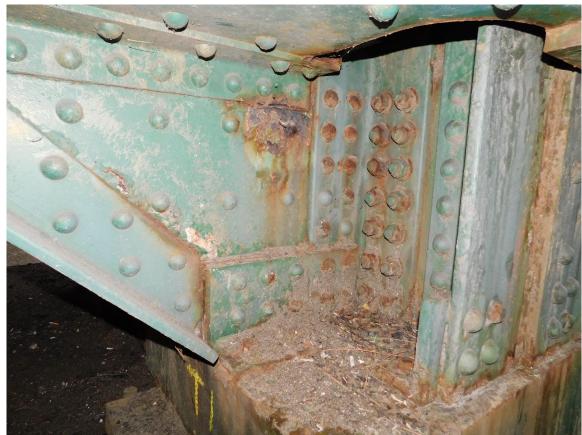
176 Typical Light Rust with Local Light-Medium Corrosion at Bottom of Tower Column, NE Column at S Tower Shown Page A2 [88] of A2 [169]

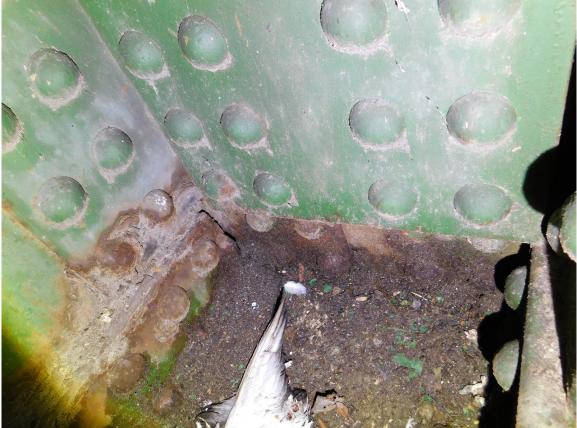
177 Typical Sediment & Local Medium Corrosion on Bottom Interior Surface of Front Columns, NE Column at S Tower

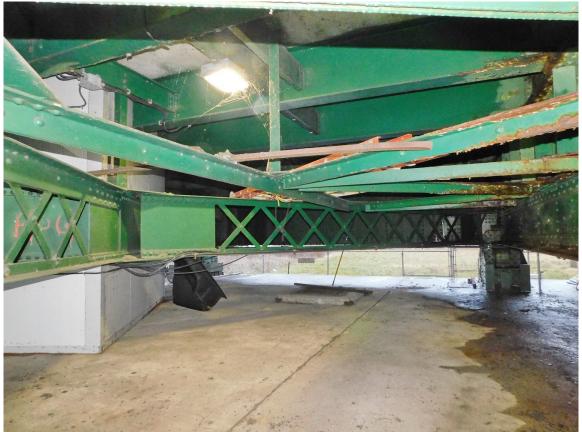
180 Wind Bracing at Bottom Rear Section of North Tower, looking West Page A2 [90] of A2 [169]

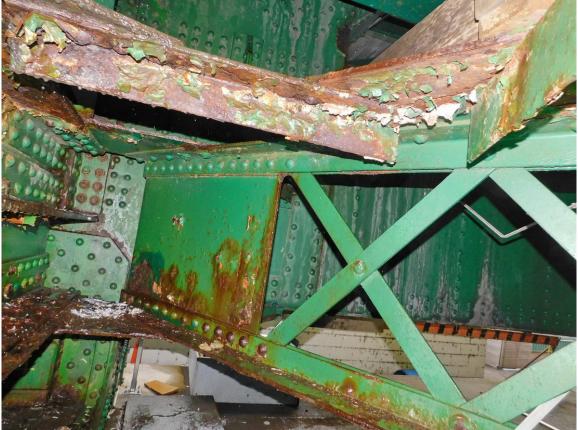
181 Typical Light Rust on Bracing Members at Connection to Tower Members, South Tower at SW Column Shown

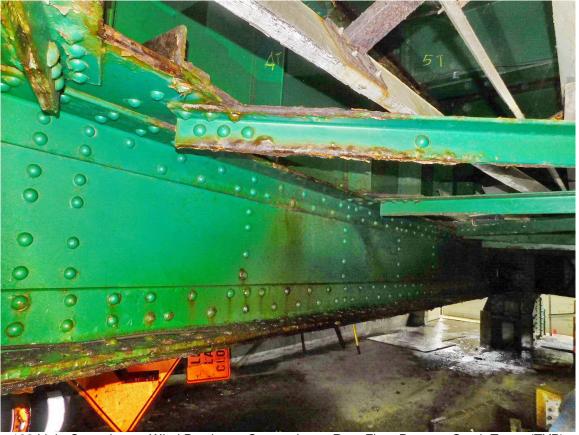
183 Light Corrosion on Wind Bracing at Connection to Rear Floor Beam at South Tower (TYP)
