# 2018 COMPREHENSIVE DETAILED ANNUAL INSPECTION BURLINGTON CANAL LIFT BRIDGE

Contract No. EQ754-181509/001/PWL Project No. R.090046.001

**December 2019** (Rev .00)

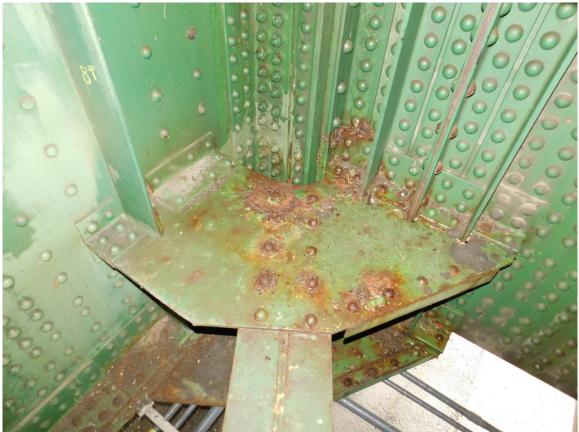
184 Typical Light Rust on Gusset Plate at Bracing Connection to Tower Column, NW Column at North Tower Shown Page A2 [92] of A2 [169]

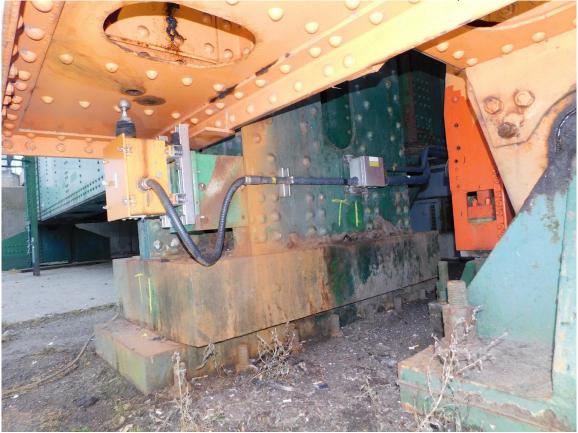
185 South Tower, Anchorage Assembly on Northeast Front Column (T1) looking South

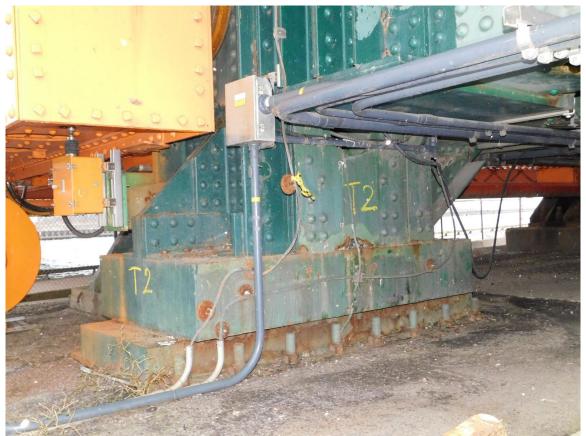
186 South Tower, Anchorage Assembly @ NW Front Tower Column (T2), looking North Page A2 [93] of A2 [169]

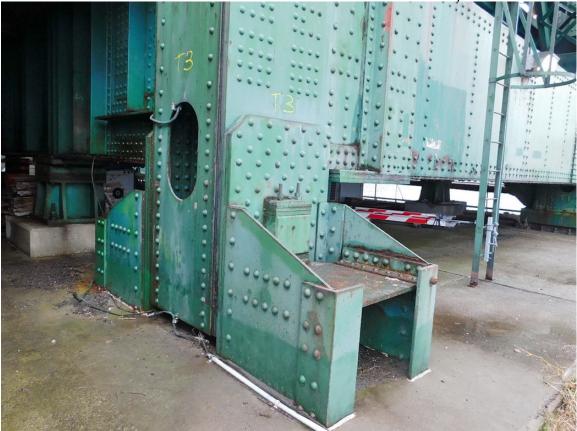
187 South Tower, Anchorage Assembly @ SE Rear Tower Column (T3) looking North

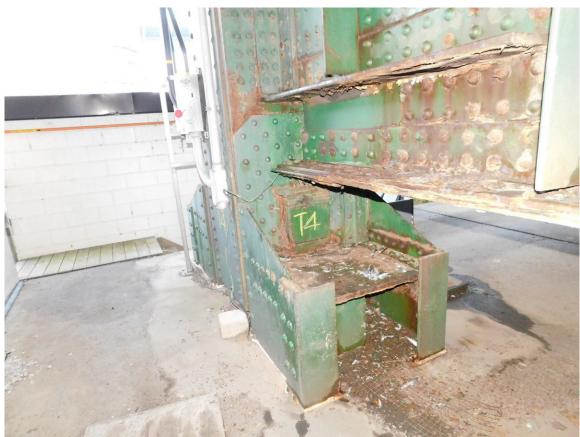
188 South Tower, Anchorage Assembly @ SW Rear Tower Column (T4) looking West Page A2 [94] of A2 [169]

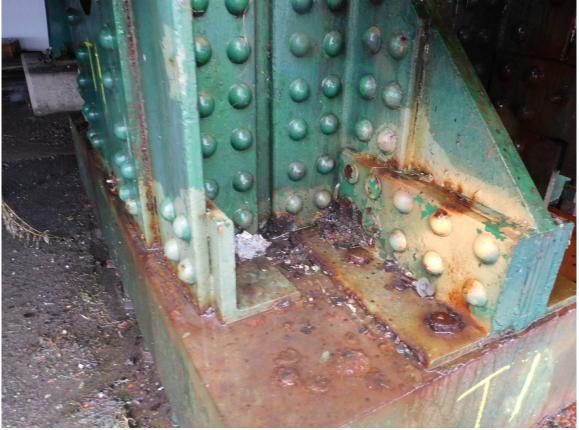
189 South Tower, Local Light Surface Rust on Top Surface of NE Column Anchorage Assembly (TYP)

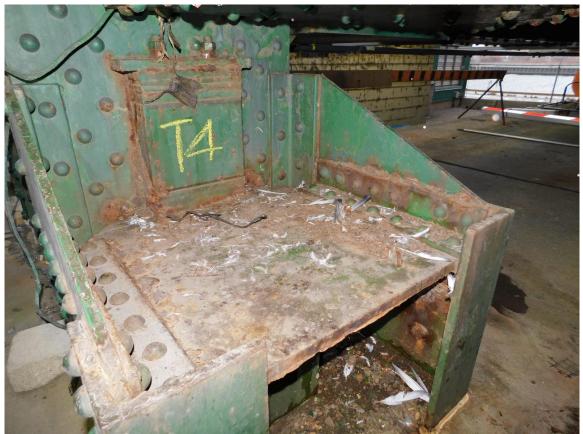
190 South Tower, Local Corrosion on Top Exposed Surface of Anchor Assembly at T4 Page A2 [95] of A2 [169]

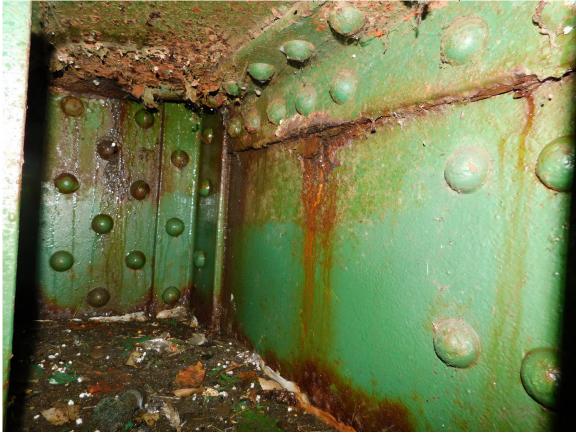
191 South Tower, Local Light Corrosion on interior Surface of T3 Anchorage Assembly

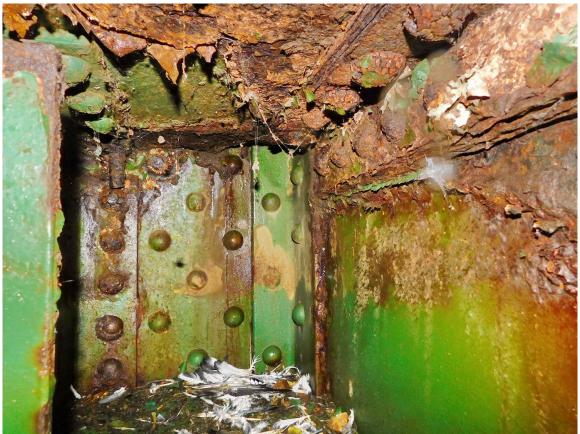
192 South Tower, Local Medium-Severe Corrosion on Interior T4 Anchorage Assembly Page A2 [96] of A2 [169]

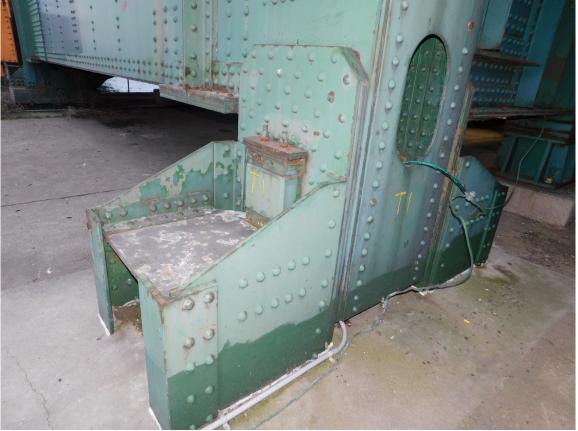
193 North Tower, Anchor Assembly @ NE Rear Column (T1) looking South

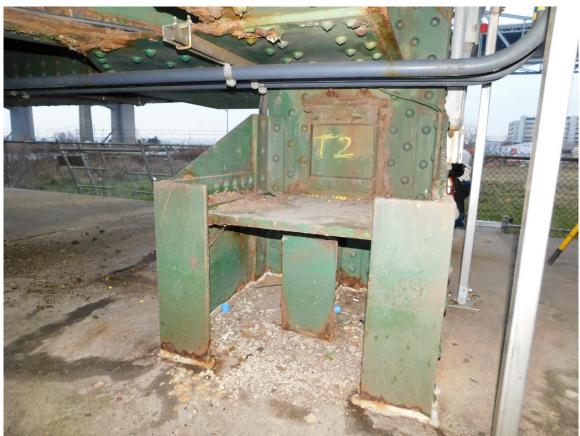
194 North Tower, Anchor Assembly @ NW Rear Column (T2) looking West Page A2 [97] of A2 [169]

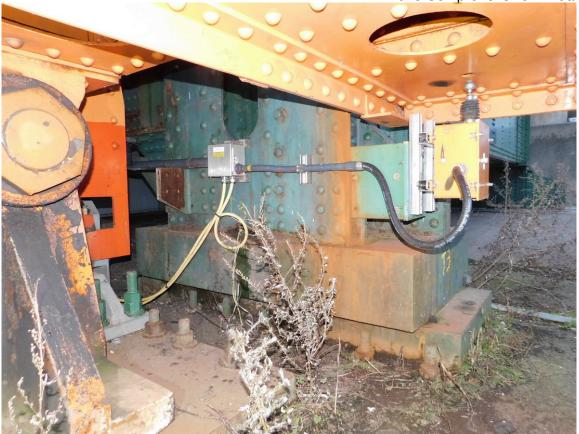
195 North Tower, Anchor Assembly @ SE Front Column (T3) looking North

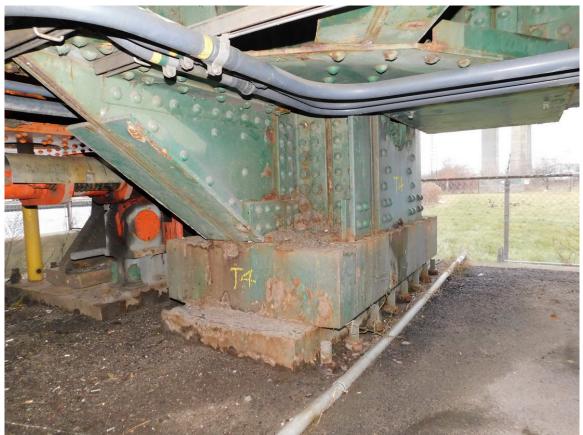
196 North Tower, Anchor Assembly @ SW Rear Column (T4) looking West Page A2 [98] of A2 [169]

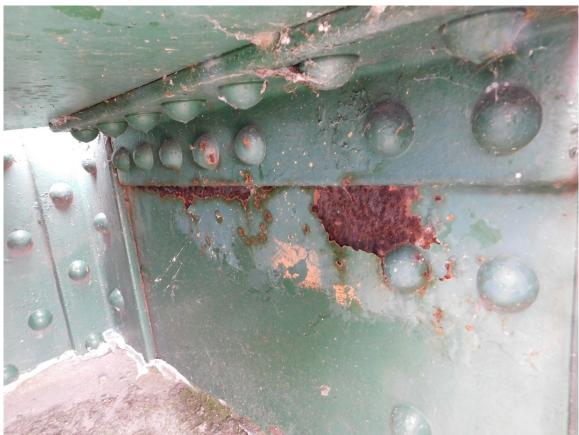
198 North Tower, Local Light Corrosion on Interior Surface of Anchor Assembly @ T1 Page A2 [99] of A2 [169]

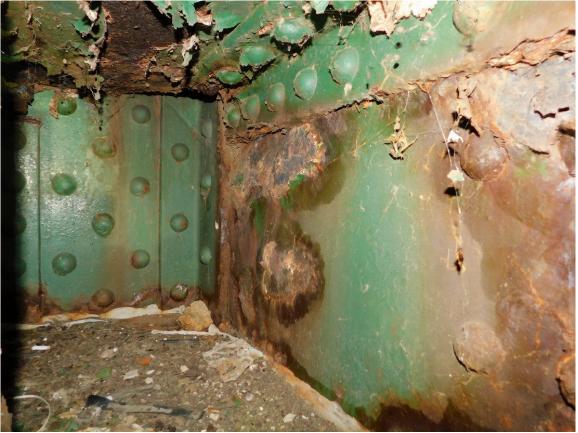
199 North Tower, Local Medium-Severe Corrosion on Interior Surface of Anchor Assembly @ T2 NW Rear Column

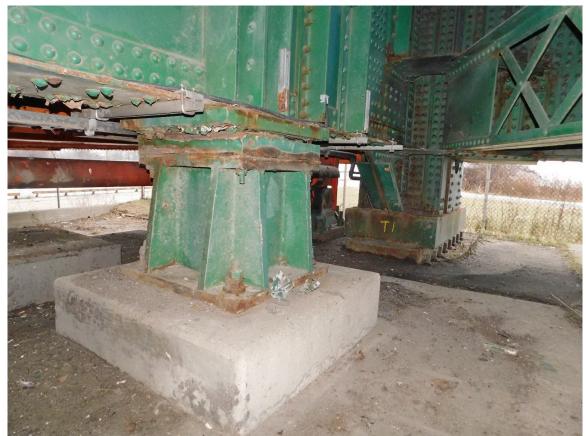
200 Typical Interior Steel Pedestal Bearing under East Section of Front Floor Beam, South Tower looking East Shown Page A2 [100] of A2 [169]

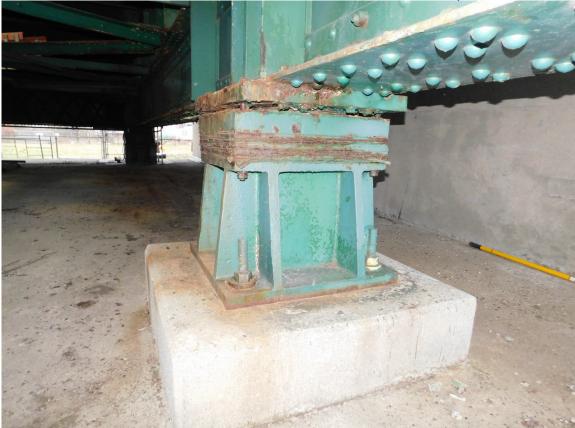
201 Typical Interior Steel Pedestal Bearing under East Section of Rear Floor Beam, North Tower looking West Shown

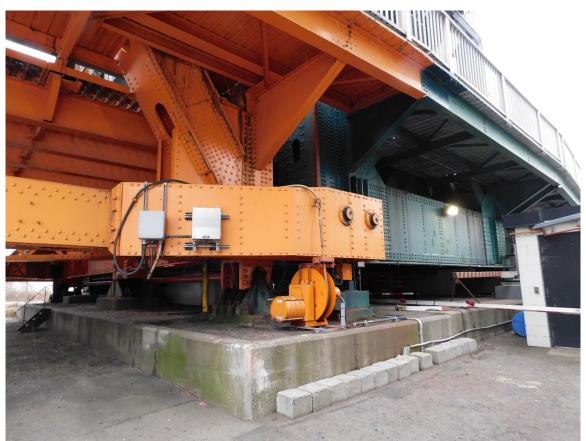
202 Concrete Pier @ South Tower (Lift Span Down) from NW

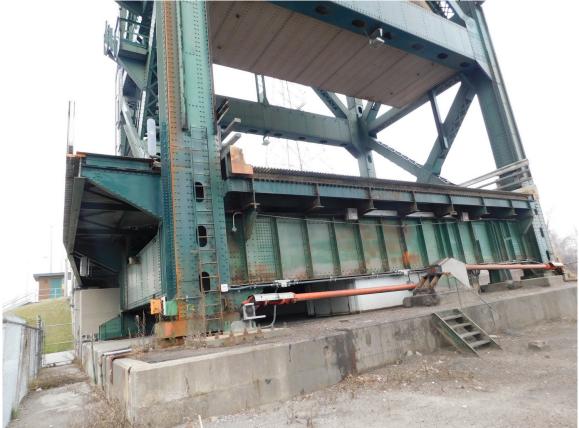
203 Concrete Pier @ North Tower (Lift Span Up) from SW Corner

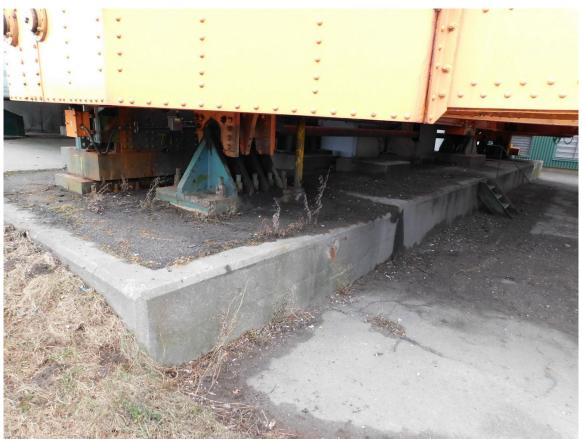
204 Typical Asphalt Paving on Pier Surface at Front Column, NE Column at South Pier Shown Page A2 [102] of A2 [169]

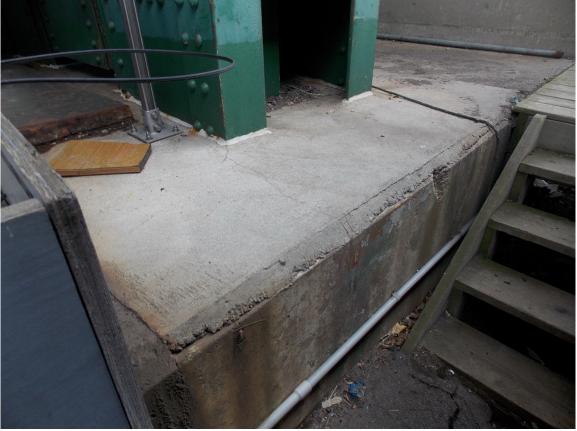
205 South Tower, Medium Crack on Resurfaced Concrete @ SW Column

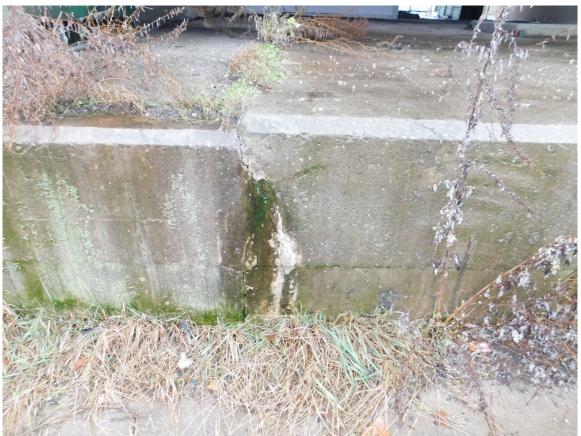
206 Wide Crack with Leakage at Construction Joint in North Concrete Pier (TYP) Page A2 [103] of A2 [169]

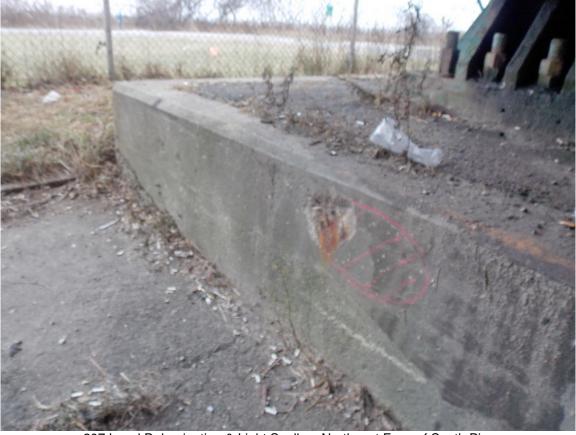
207 Local Delamination & Light Spall on Northeast Face of South Pier

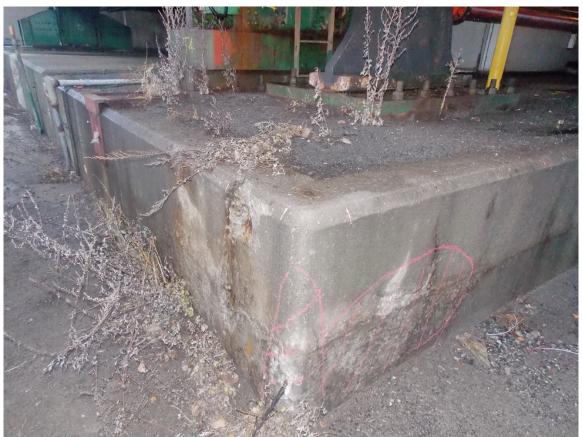
208 Large Delamination & Local Severe Spalls on SW Corner of Pier

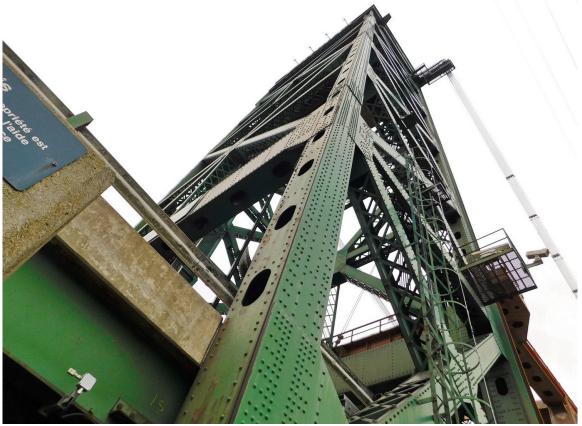
209 General View of South Tower @ Upper Section from Bottom SE Corner

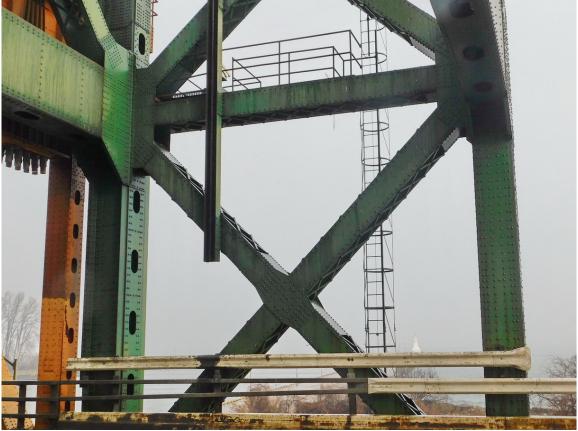
211 South Tower, East Truss @ Deck Level (Panel 1), looking East

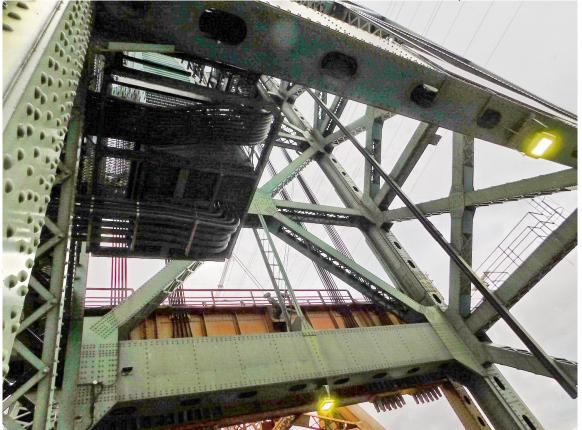
213 South Tower, Interior View from Bottom

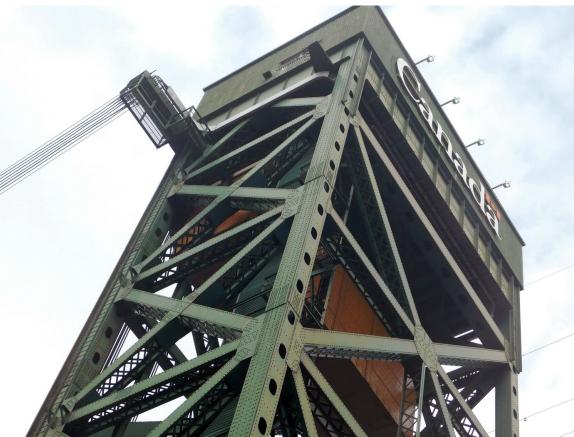
214 South Tower, Upper Panels from Bottom SW Corner

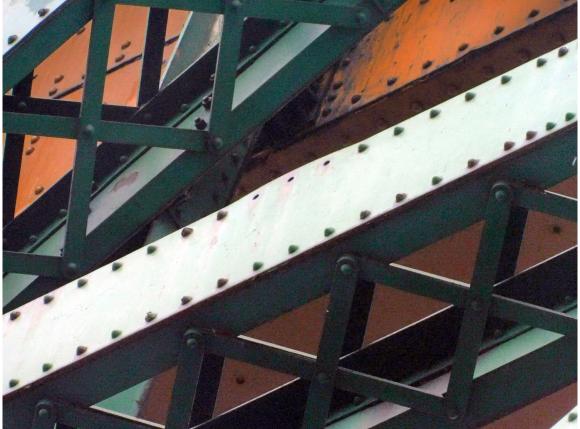
215 South Tower, Missing Rivets on Mid-Section of West Horizontal Member between Panel 5&6 West Face

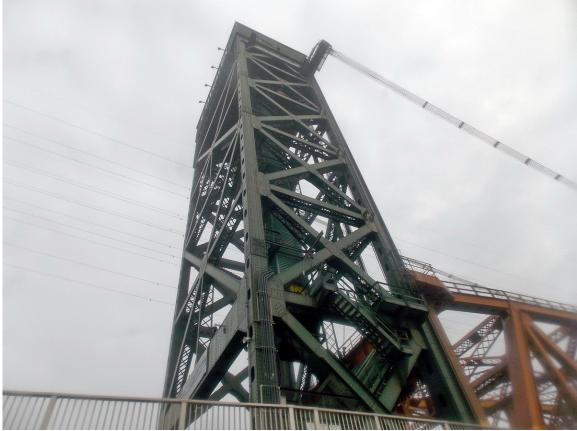
216 General View of North Tower @ Upper Panels from Bottom NW Corner

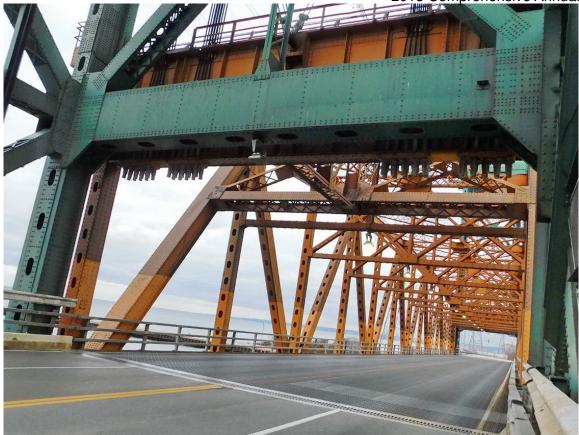
217 North Tower @ Deck Level looking South

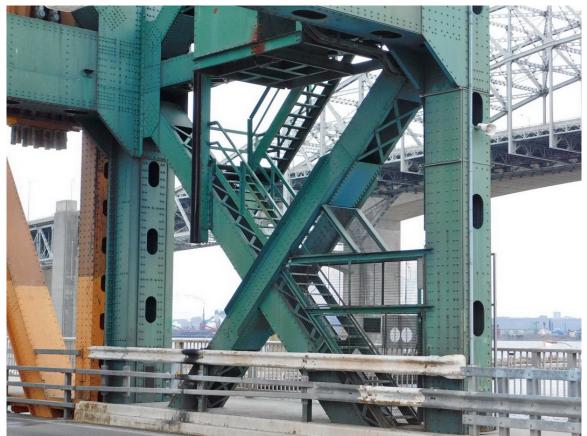
218 North Tower, West Truss @ Deck Surface looking West

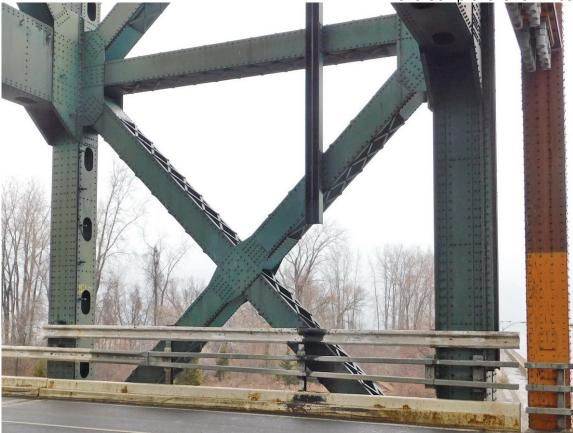
219 North Tower, East Truss @ Deck Surface (Panel 1), looking East

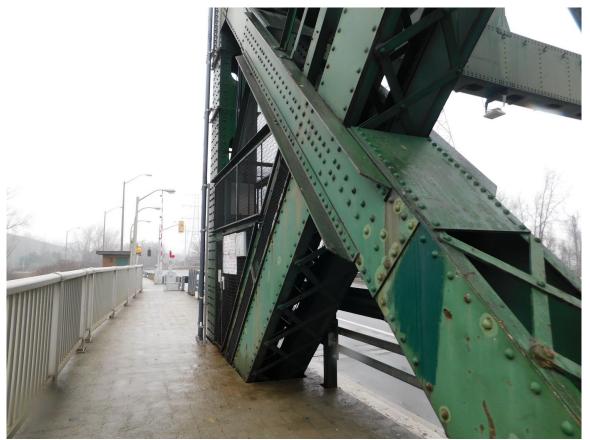
220 North Tower, West Truss @ Sidewalk level, looking North

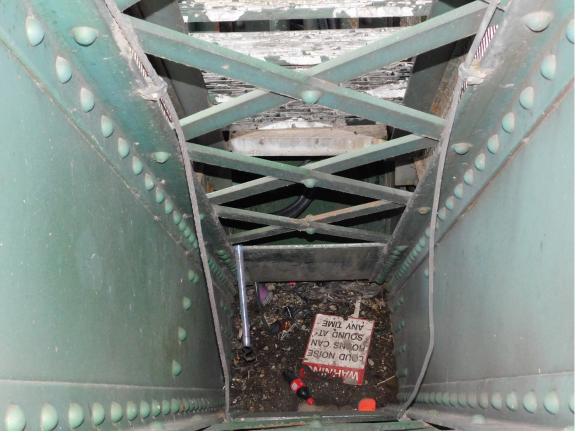
221 Typical Debris on Interior Plate below West Sidewalk at North Tower

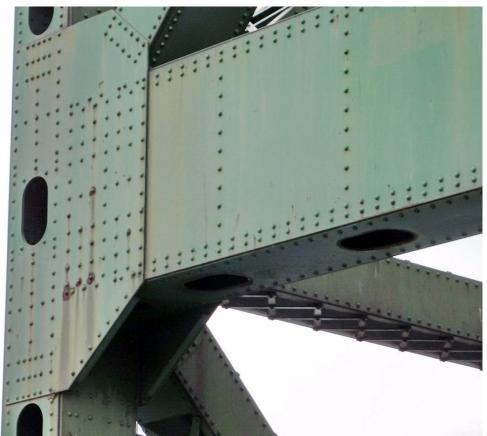
222 North Tower, Local Light Rust on Gusset Plate at top NE Corner of Panel 1, looking East Page A2 [111] of A2 [169]

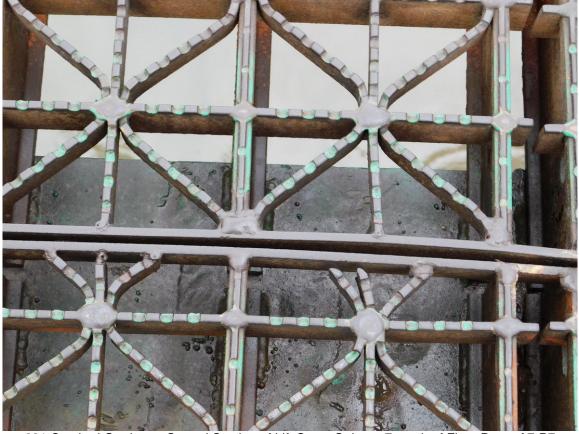
231 Cracked Grating at Central Section of Lift Span, Stringer 7 south of Floor Beam A7-B7

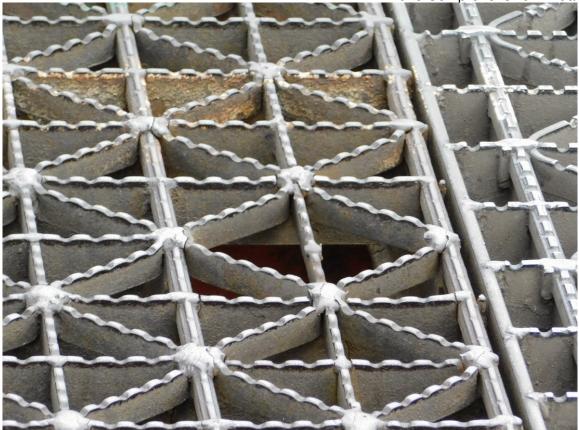
233 Several Cracked Grating & Broken Bearing Bar at North Panel near Stringer 9 and Replaced Panel, looking East

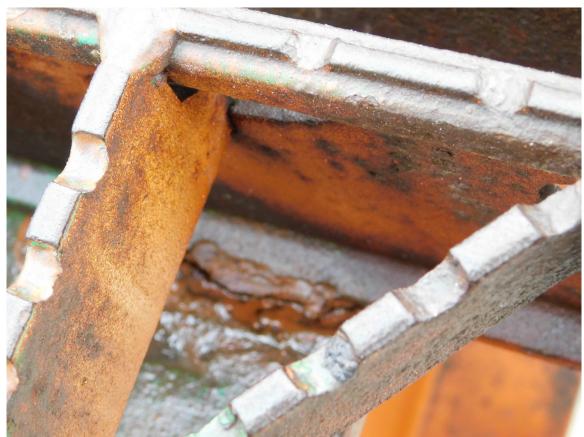
234 Cracked Hold-down Weld @ Grating to Stringer 8 South of 3rd Floor Beam from South (Beam A3-B3) Page A2 [117] of A2 [169]

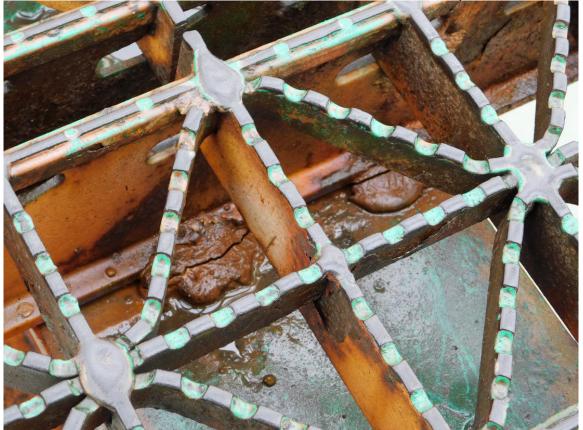
235 Cracked Hold-down Weld @ Grating to Stringer 9 South of 4th Floor Beam from South (Beam A4-B4)

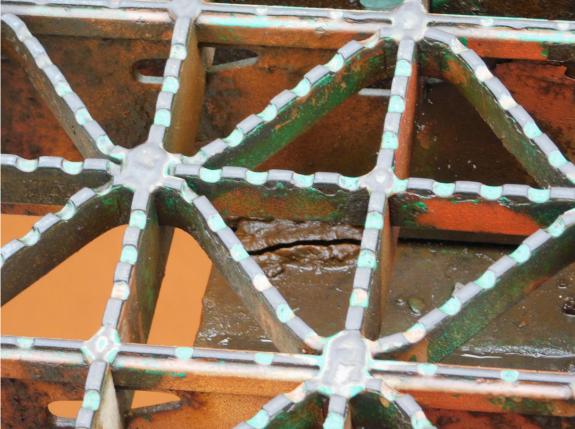
237 Cracked Hold-down Weld @ Grating to Stringer 9 in North Section of 4th Bay from South near Floor Beam A5-B5

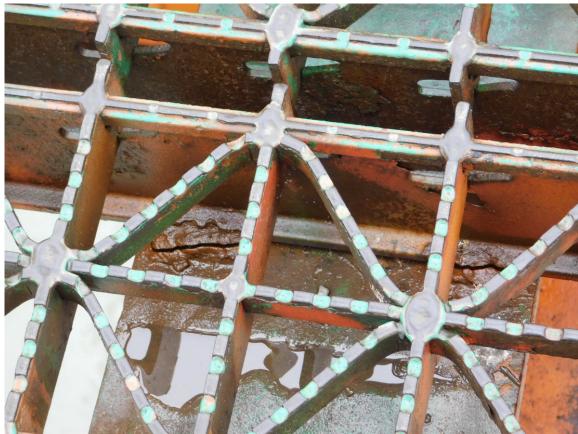
238 Cracked Hold-down Weld @ Grating to Stringer 9 South of Floor Beam A6-B6 Page A2 [119] of A2 [169]

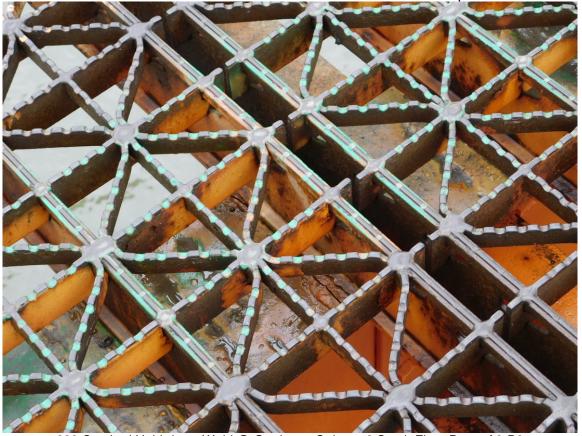
239 Cracked Hold-down Weld @ Grating to Stringer 8 South Floor Beam A8-B8

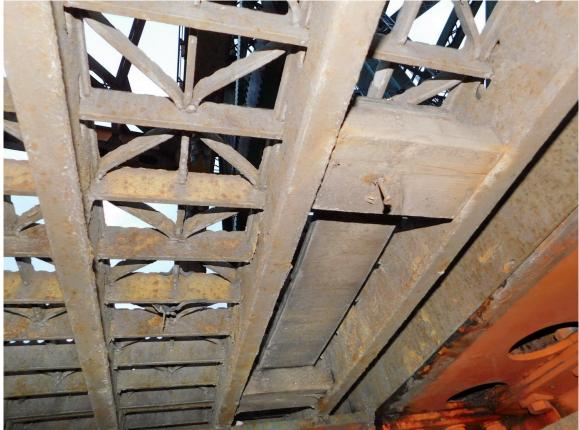
241 Wooden Blocks on Underside of Deck Grating at Central North End of Lift Span, between Stringers 6 & 7

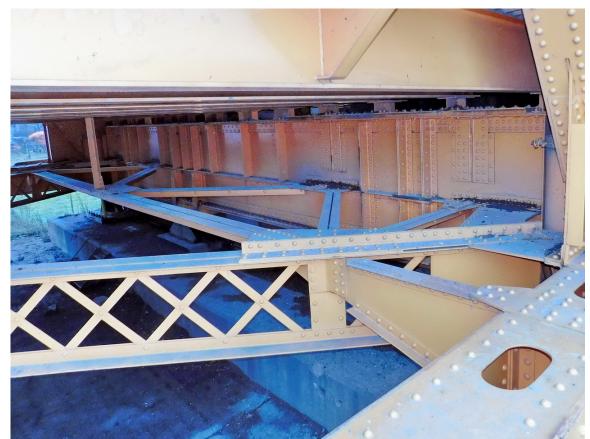
262 Typical Sway Bracing at Main Floor Beam, North Bracing at Floor Beam A13-B13 looking West Shown Page A2 [131] of A2 [169]

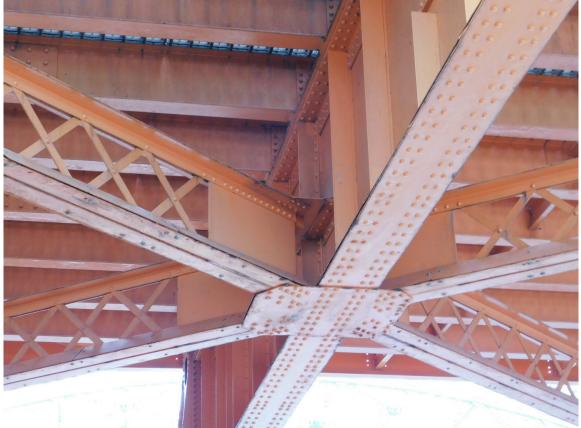
263 Typical Lateral Bracing at Intermediate Floor Beam, Beam A2-B2 looking West Shown

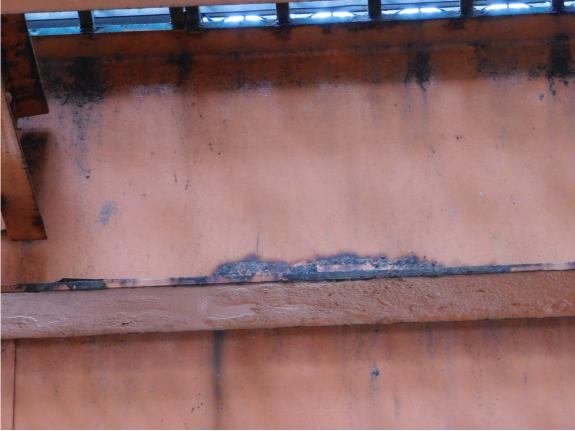
265 Local Light Surface Rust on Stringer 7 in Bay 12

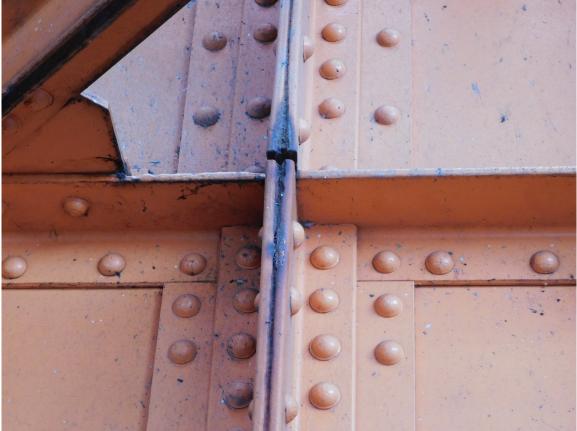
267 Localized Rust Jacking on Stiffener Angles on North Floor Beam A13-B13 (TYP)

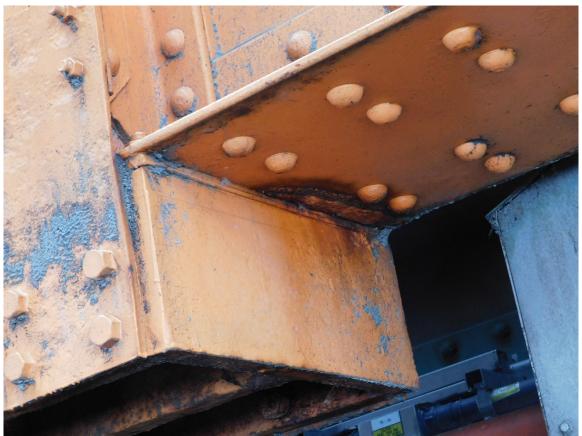
268 Local Light Surface Rust on Bottom of North Floor Beam A13-B 13 @ Centering Shoe Page A2 [134] of A2 [169]

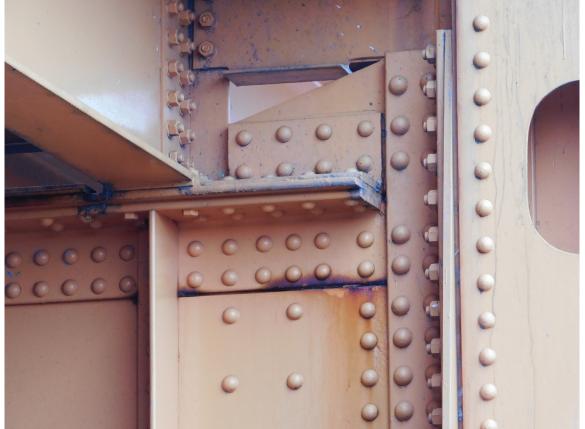
269 Typical Localized Area of Surface Rust on Steel Floor Beam, Beam A2-B2 looking North Shown

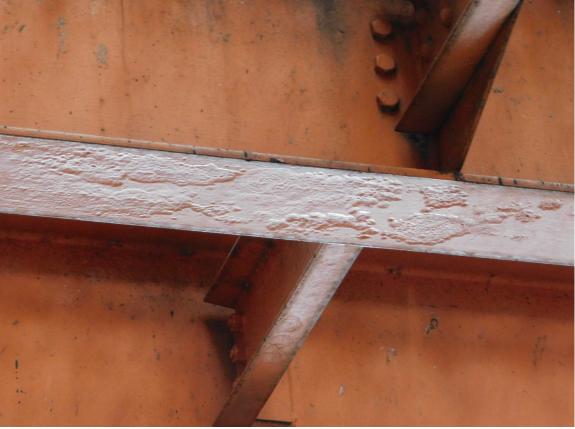
271 Typical Painted-over Pitted Stringer Surface at Lift Span, Stringer 6 in Bay 12 Shown

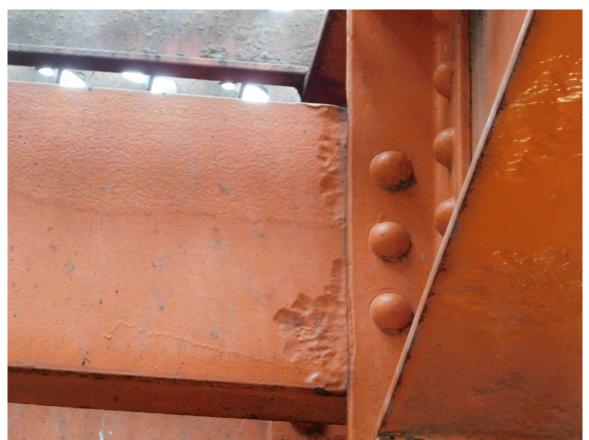
272 Typical Painted-over Pitted Diaphragm Surface at Stringer Connection, Stringer 9 at Bay 1 Shown Page A2 [136] of A2 [169]

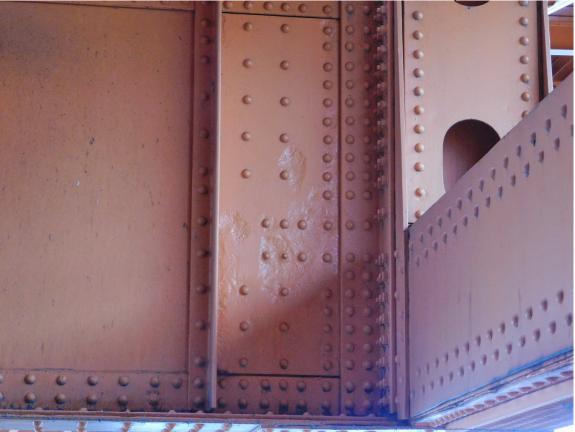
273 Painted-over Pitted West Section of Floor Beam A12-B12 Surface (TYP)

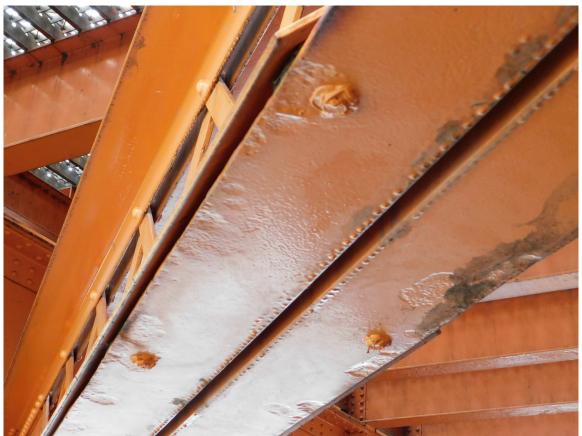
274 Painted-over Pitted Bottom Surface of Lateral Bracing in Bay 12 (TYP) Page A2 [137] of A2 [169]

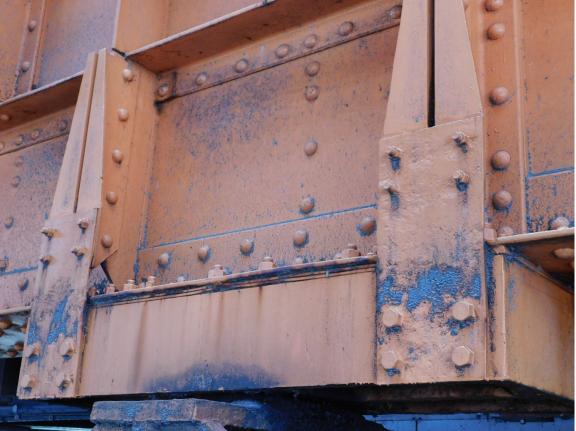
275 Painted-over Pitted Gusset Plate Surface at North Centering Shoe (TYP)

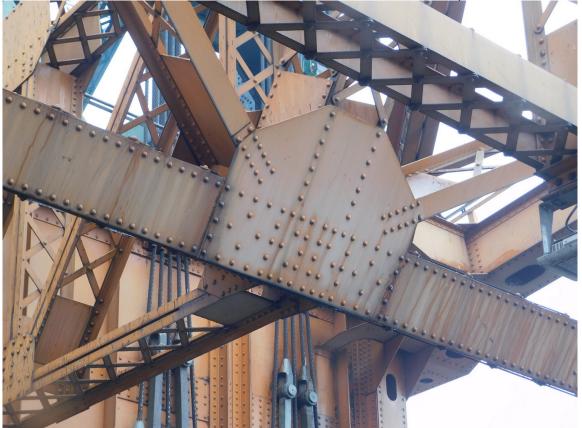
281 Typical Rust Stains & Light Corrosion on Portal Strut & Bracing, North Portal Shown

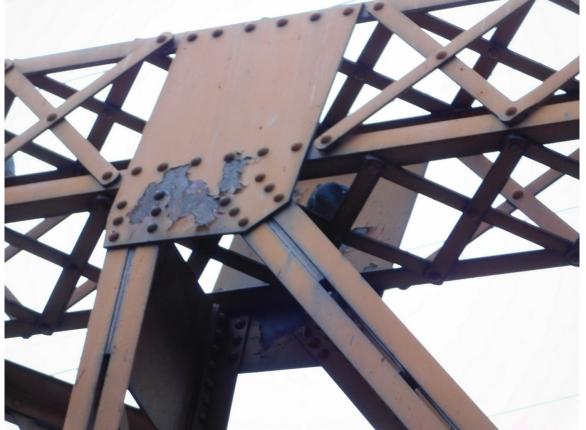
283 Peeled Coating & Light Corrosion on Gusset Plate @ South Portal Bracing (TYP)

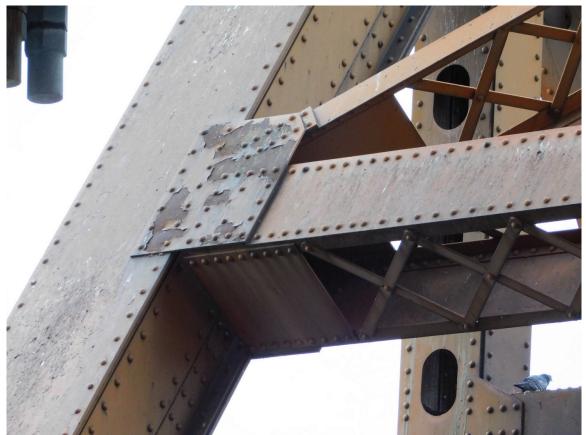
284 Peeled Coating & Light Corrosion on Lower East Gusset at North Portal Truss Page A2 [142] of A2 [169]

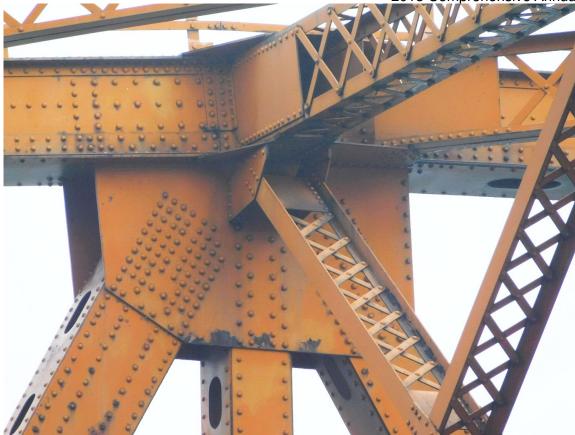
285 Typical Peeled Paint Coating at Upper Truss Connection, North BT10 Shown

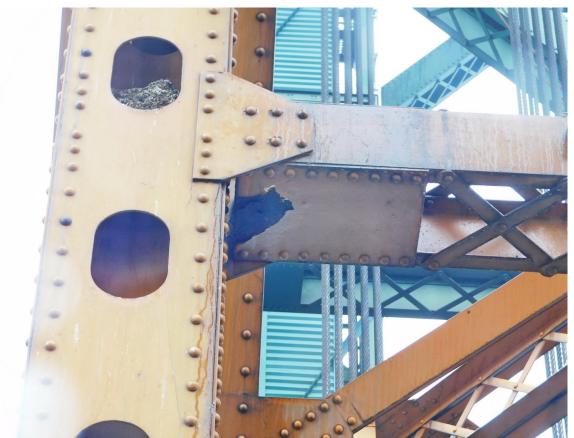
286 Large Built-up of Bird Guano in Vertical Member & Peel Coating of West Truss below Node BT12 Page A2 [143] of A2 [169]

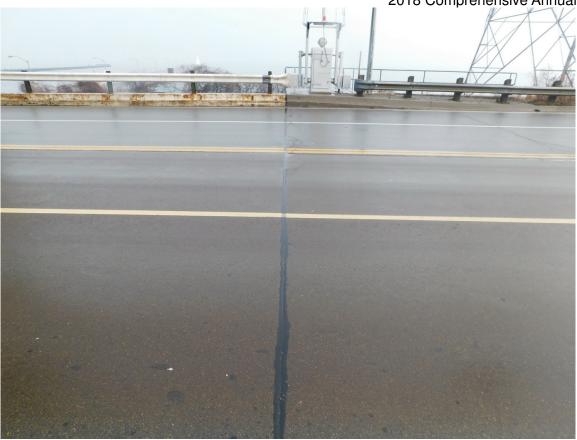
295 Paved-over South Abutment Joint, looking East

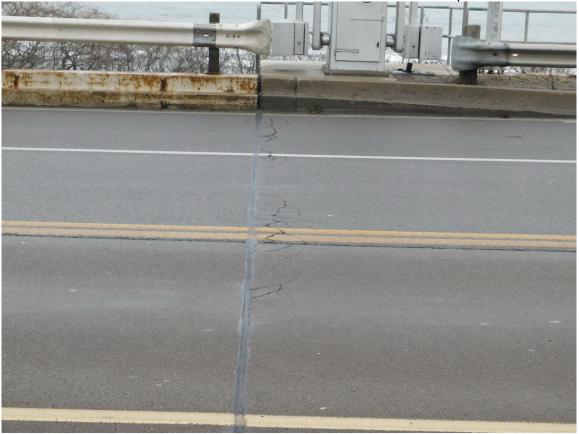
297 South Abutment Joint, Pattern Unsealed Cracks on Approach Asphalt at Joint, looking East

ELEMENT	рното	MEMBER	PREV MCR		NEW MCR		COMMENTS	PRIC	
							SOUTH APPROACH SPAN	PREV	NEW
Wearing Surface	38 TO 40, 295, 297		N/A	N/A	5		The approach is in good condition. Few isolated light transverse cracks were observed near the expansion joint between the south approach and south tower span. Few light unsealed pattern cracks were observed at the paved over joint at the south end of the approach.	N/A	D
Curb	88		N/A	N/A	4	5	The curbs were found to be in fair to good condition. The steel plates exhibited light corrosion with local areas of light to medium corrosion. A local area of severe corrosion with perforation on bent curb was noted near the deck expansion joint near the south abutment and joint between approach and tower span.	N/A	D
Sidewalk	318		N/A	N/A	5		The concrete sidewalk is in good conditicn with few isolated narrow to medium cracks. Local small areas of light surface corrosion were noted at few locations on the steel deck sheet below the sidewalk at the south approach spans.	N/A	D

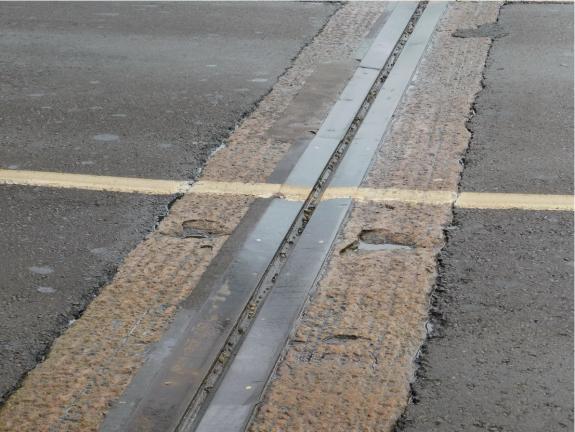
301 Typical Rough & Local Spalls on Concrete End-dams for Compression Seal Expansion Joint, South Joint Shown

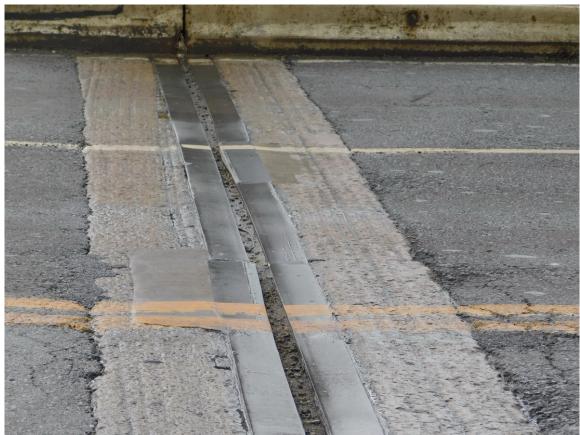
302 Typical Concrete-Asphalt Patches & Minor Spalls on End-Dams, Joint between North Approach & Tower Spans Page A2 [151] of A2 [169]

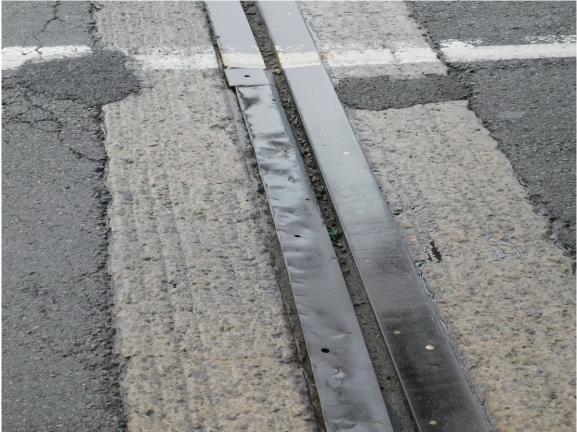
303 Deformed & Abrasion Marks on Joint Steel Angle @ Expansion Joint @ North Approach & North Tower Span

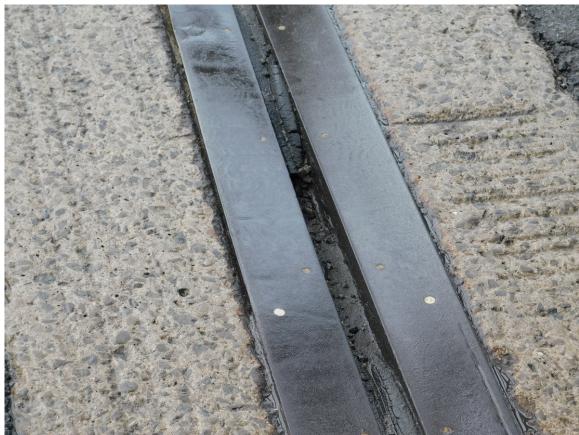
304 Loose Compression Seal in West Section of Expansion Joint between North Approach & North Tower Span Page A2 [152] of A2 [169]

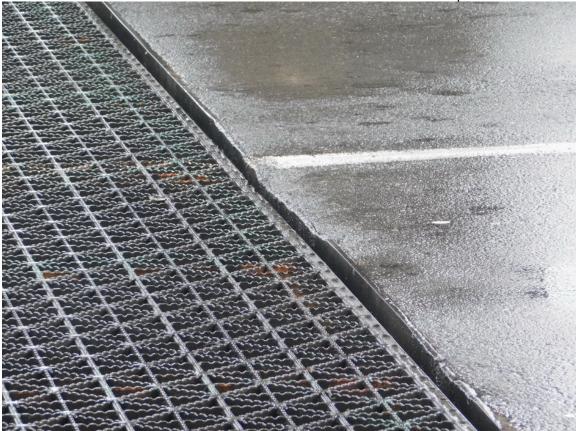
307 Severe Abrasions on Top East Section of End Plate for Open Gap Expansion Joint @ South Tower & Lift Span

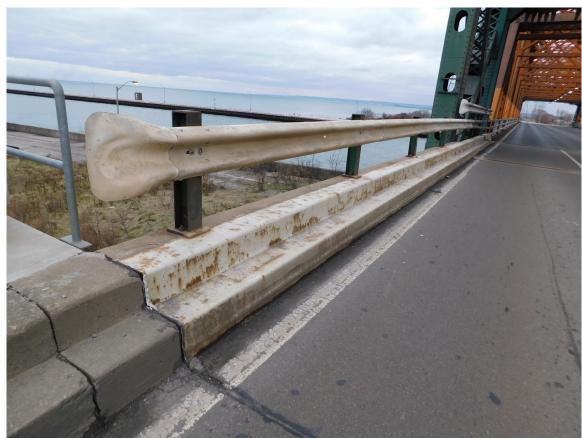
308 Typical Steel Beam Guiderail on Approach Span, East Guiderail on North Approach looking South Shown Page A2 [154] of A2 [169]

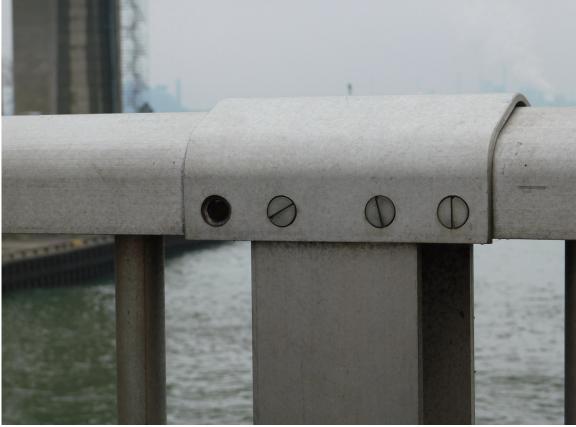
315 Missing Nut on Splice Bolt for Top Handrail @ Post near Mid Section of Lift Span

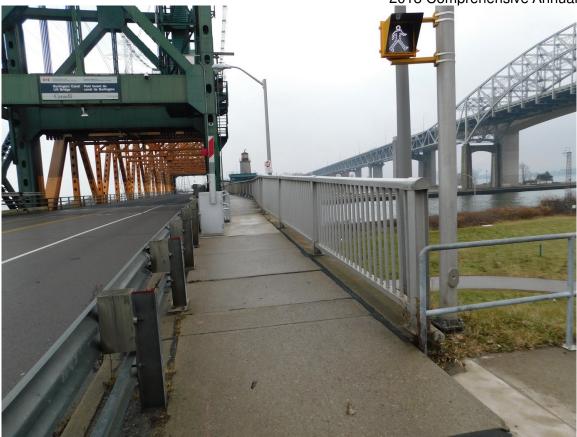
316 Typical Loose Anchor Bolts on Pedestrian Railing Post, South Post of West Railing Shown Page A2 [158] of A2 [169]

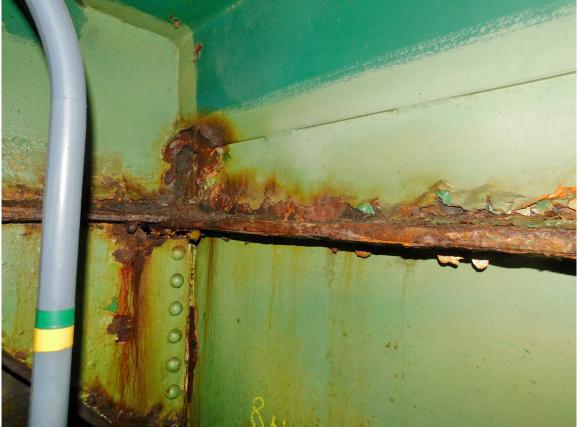
325 Typical Local Severe Corrosion on lower Section of Bent Curb Plate atop Stringer 8, North Abutment End Shown

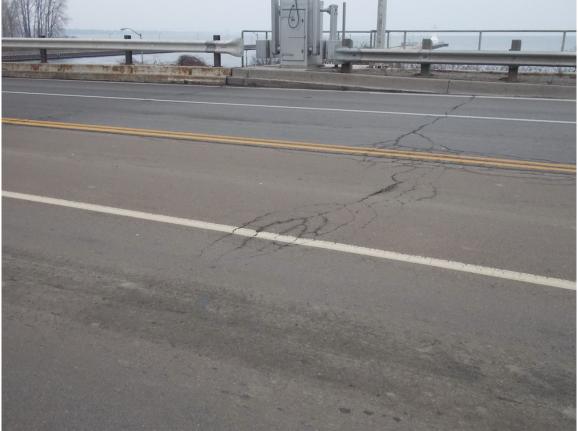
327 Typical Unsealed Pattern Cracks on Approach Road Surface, South Approach Road looking East Shown

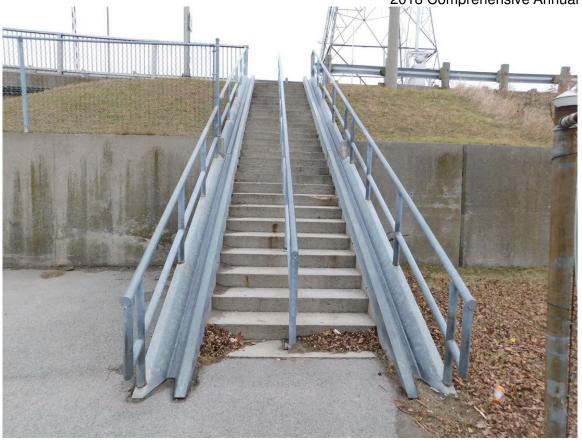
332 Local Shallow Spalls on Northwest Stairs (TYP)

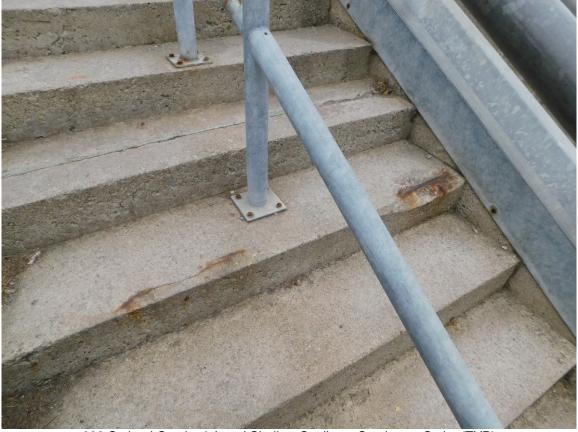
333 Stained Cracks & Local Shallow Spalls on Southwest Stairs (TYP)

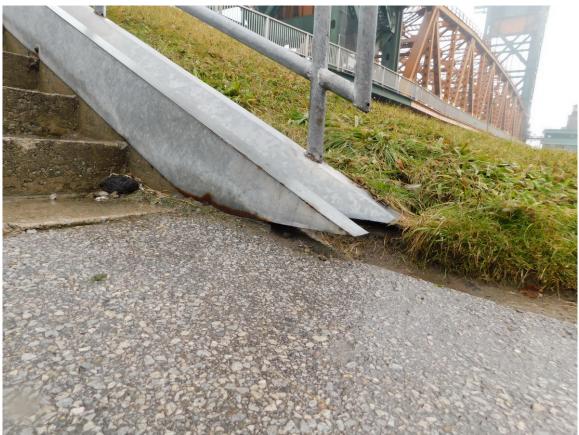
334 Puncture Hazard from Settled Walkway at bottom of Bike Rail at NW Stairs Page A2 [167] of A2 [169]

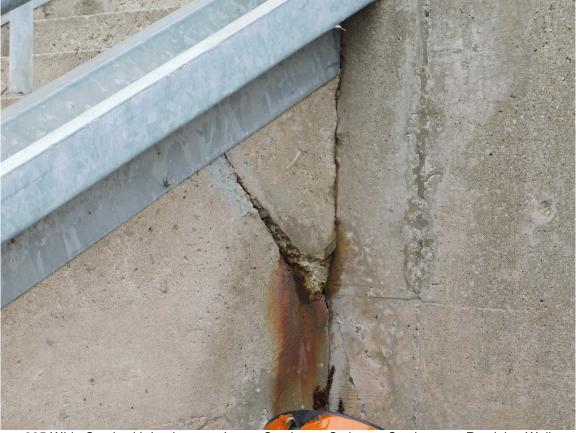
335 Wide Crack with Leakage on Lower Southwest Staircase Section near Retaining Wall

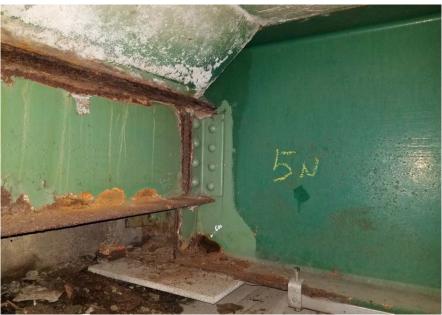
Example of a girder-to-diaphragm connection. Small patches of corrosion can be seen. The most severe locations were tested and compared against what was measured to be "nominal".

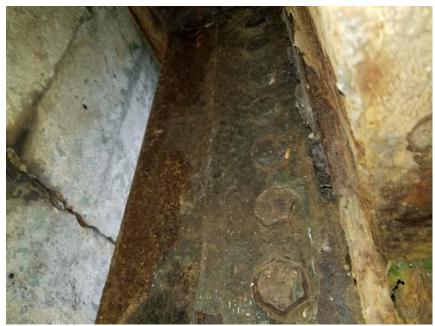
Girder web by abutment wall. Full height of the web is corroded/delaminated. This degree of corrosion is typical for all girders.

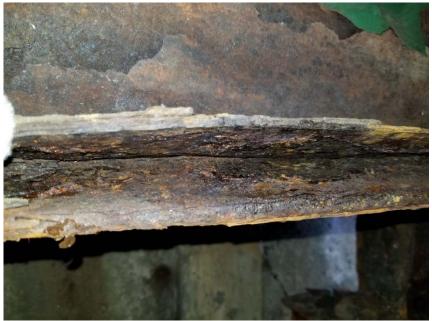
Severe delamination on diaphragm flange

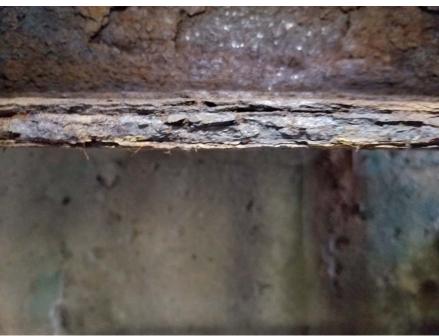
### Delamination on diaphragm

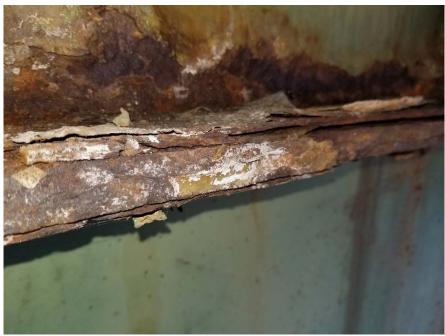
Delamination on girder flanges

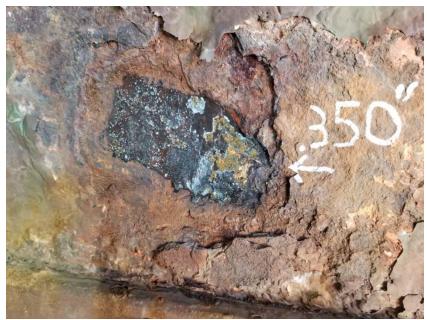
Lowest area found on the norther support beam

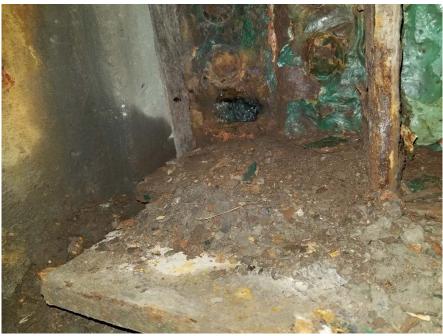
Girder 4S at the abutment wall - Severe corrosion

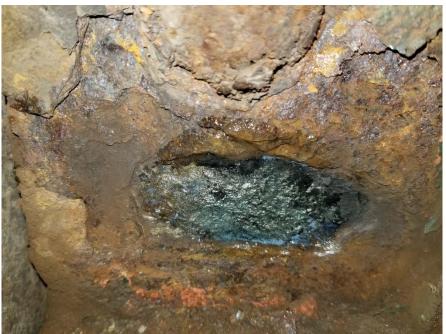
Girder 4S - Severe corrosion

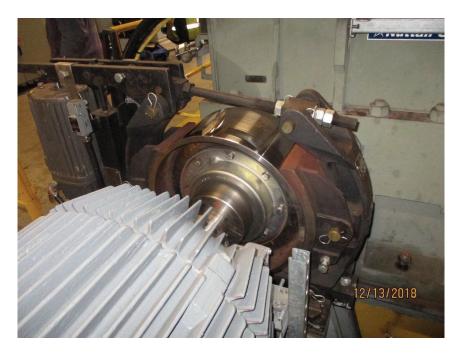
Photo M1 Machinery Brake - NW and Brake Wheel Coupling C3-NW. General view of the machinery brake assembly. Note the unpainted brake wheel coupling bolts.

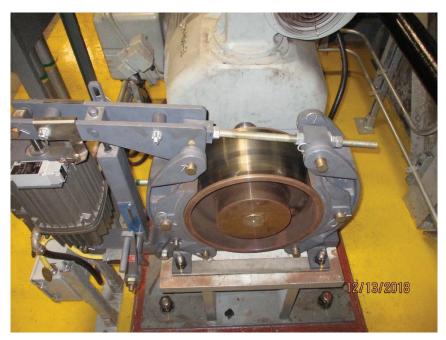
Photo M2 Motor Brake-NW. General view of a typical motor brake assembly. The brake wheel hubs and fasteners are unpainted.
