# 2018 COMPREHENSIVE DETAILED ANNUAL INSPECTION BURLINGTON CANAL LIFT BRIDGE

Contract No. EQ754-181509/001/PWL Project No. R.090046.001

**December 2019** (Rev .00)

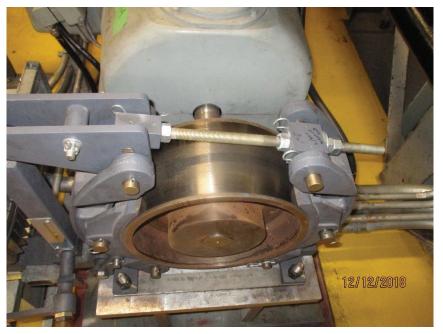
Photo M3 Motor Brake-SE. General view of the brake wheel friction surface. The brake wheel hub is unpainted.

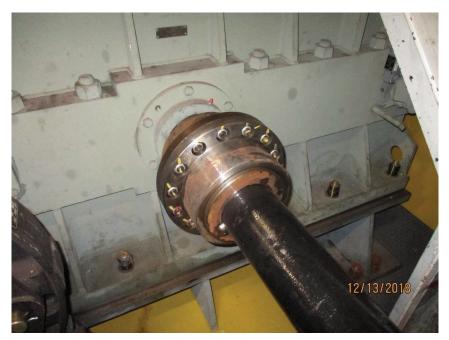
Photo M4 Coupling C2-NW. There is light corrosion on the hubs and sleeves. Corrosion was noted at all C1 and C2 couplings.

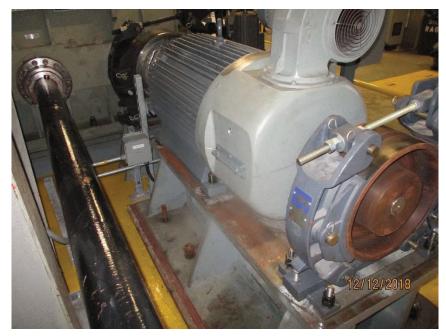
Photo M5 Motor-SW. The motor mounting bolts and support anchor bolts are unpainted with light corrosion forming. The top of the support is also unpainted with light corrosion forming.

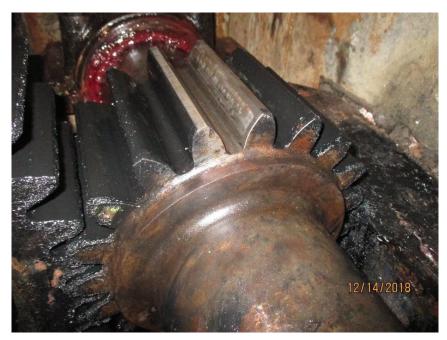
Photo M6 Pinion P2-SE-OB. The gear teeth in the acceleration zone were cleaned to bare metal for inspection.

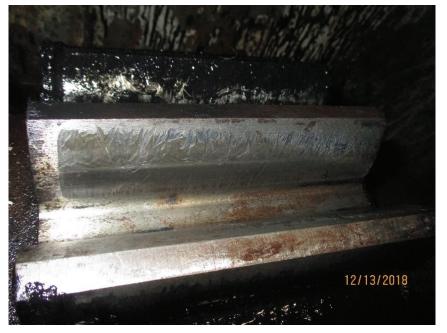
Photo M7 P1-NW-OB. Damage to the gear tooth caused by wire intrusion is wearing in.

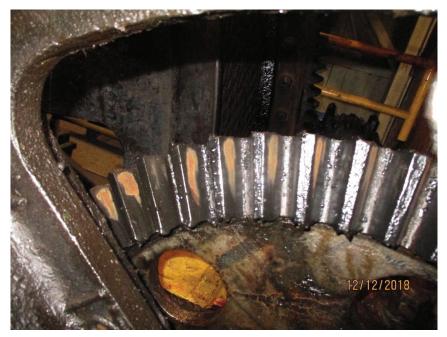
Photo M8 Gearset G2/P2-NW, Differential Gear. There was corrosion on some of the differential gear teeth due to inadequate lubricant

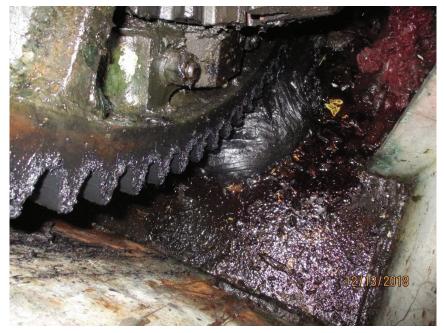
Photo M9 G2/P2-NE, Support Frame. There was an accumulation of old grease within the support frame under the G2 gear.

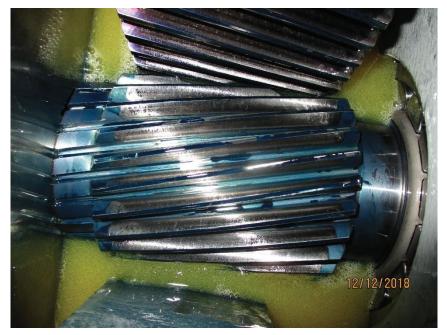
Photo M11 South Span Drive Reducer. The reducer gear teeth have minor damage that may be from particles passing through the mesh.

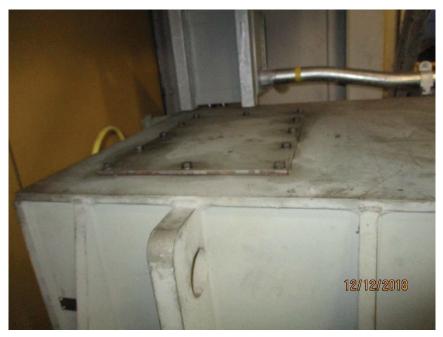
Photo M12 North Span Drive Reducer. The inspection cover screws have damaged threads.

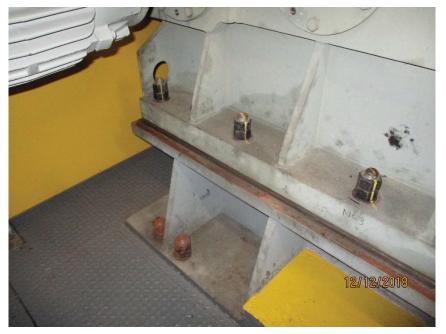
Photo M13 North Span Drive Reducer. The reducer mounting bolts and support anchor bolts are unpainted.

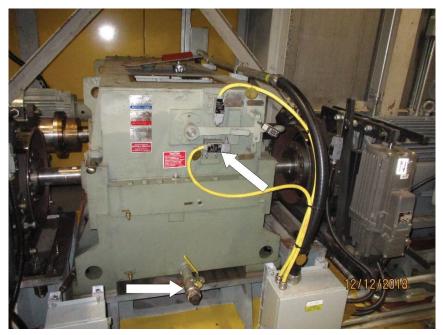
Photo M14 North Span Drive Reducer. There is evidence of a small oil leak at the north index spline lower limit switch mounting bracket (upper arrow) and the drain valve (lower arrow).

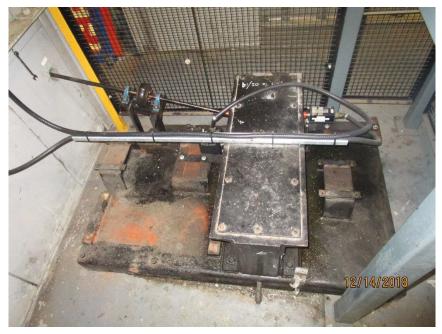
Photo M15 South Span Position Parallel Shaft Reducer. Note the light accumulation of oil around the reducer.

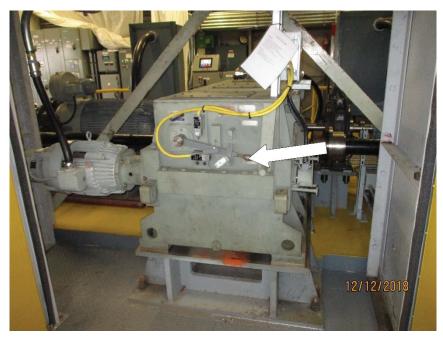
Photo M16 South Primary Reducer Auxiliary Drive Engagement Lever. Note the lever (arrow) is shown in the locked disengaged position. See Photo M17 for a close-up of the positioning bolt intended to additionally secure the lever in the disengaged position.

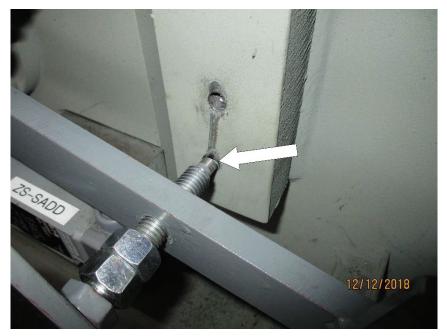
Photo M17 South Primary Reducer Auxiliary Drive Engagement Lever. Note the positioning bolt used to secure the lever in the engaged and disengaged position does not line up with the hole (arrow), preventing the bolt from being inserted in the hole with the lever locked in the disengaged position.

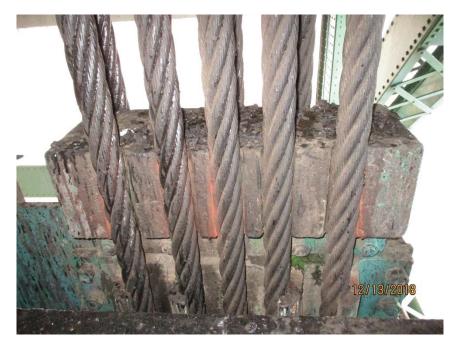
Photo M18 NE-OB Counterweight Rope Connections. Fretting corrosion is present where the counterweight ropes rub against the counterweight splay casting.

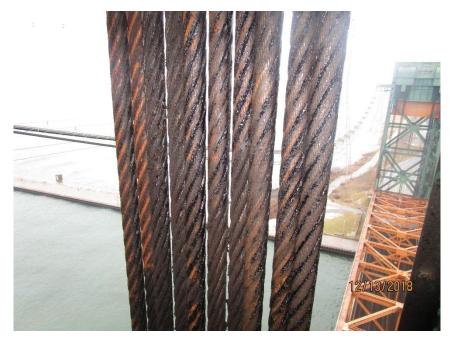
Photo M19 NE-OB Counterweight Ropes. View of the section of the ropes that contact the sheave grooves. Note the surface corrosion due to inadequate lubricant.

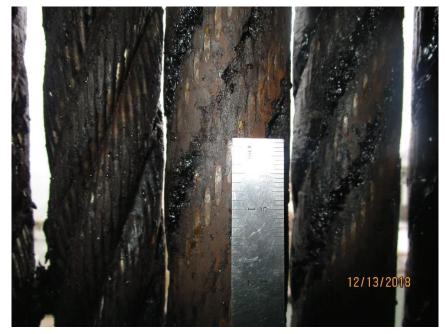
Photo M20 NE-OB Counterweight Ropes. The maximum counterweight rope wear flats were measured to be 5/8".

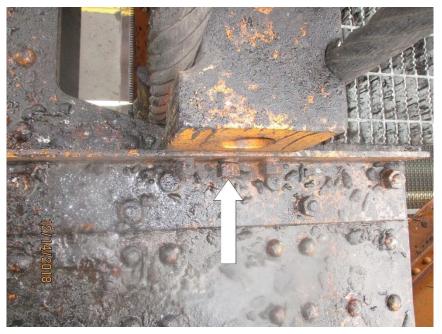
Photo M21 NW-OB Main Lift Girder Splay Casting. The middle nut is not fully seated at this location (arrow). Also note the light fretting at the rope/splay interface.

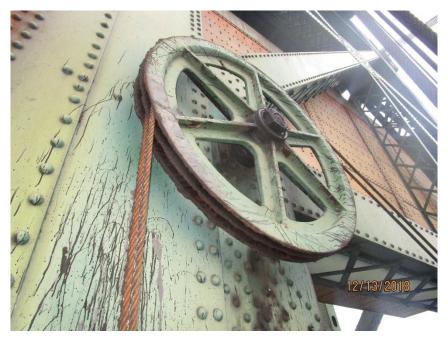
Photo M22 NW Auxiliary Counterweight Ropes. The auxiliary ropes and sheave have built up old lubricant.

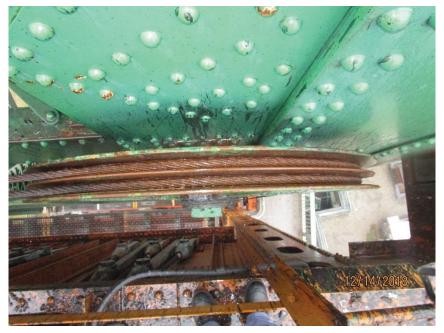
Photo M23 SW Auxiliary Counterweight Ropes. The counterweight ropes and sheave are devoid of lubricant.

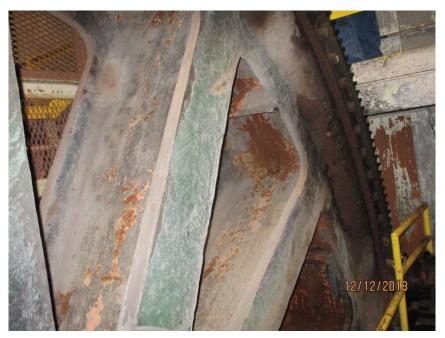
Photo M24 SW-OB Counterweight Sheave. There is paint deterioration and light corrosion on the sheave.

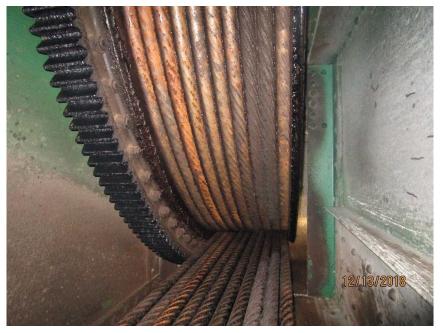
Photo M25 NE-OB Counterweight Sheave. The counterweight grooves have many sections that are devoid of lubricant and exhibit surface corrosion.

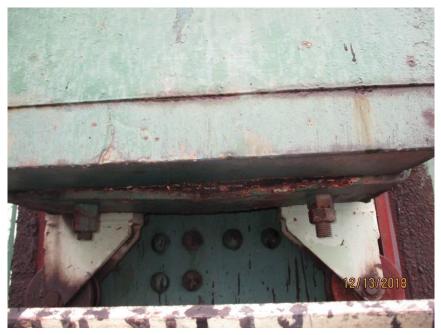
Photo M26 NE Auxiliary Counterweight. There is corrosion on the bottom support plate and bolts.

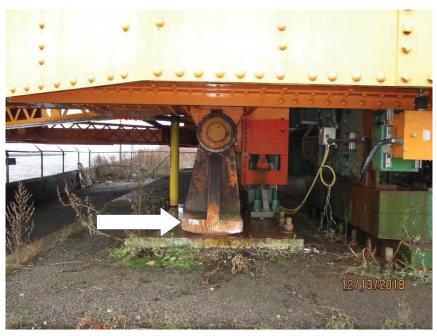
Photo M28 NW Live Load Rocker. The live load rocker was unable to be freely rotated. NE Live Load Rocker was similar.

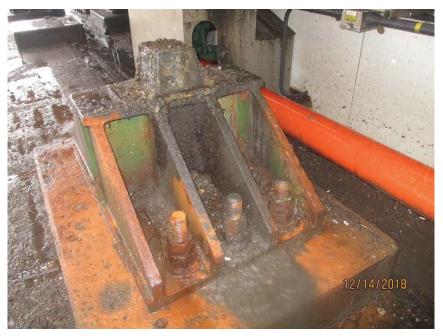
Photo M29 South Centering Device. There is minor debris accumulation on the support. The anchor bolts have paint failure and section loss.

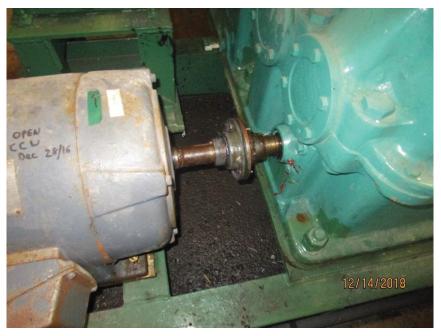
Photo M31 South Span Lock Machinery. The motor shaft, coupling hubs, and reducer input shaft is coated with a layer in rust inhibitor, which is protecting the components from corrosion.

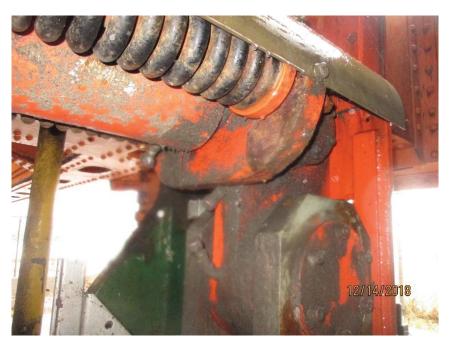
Photo M32 SE Span Lock, Spring Assembly. The springs and bolts have moderate corrosion.

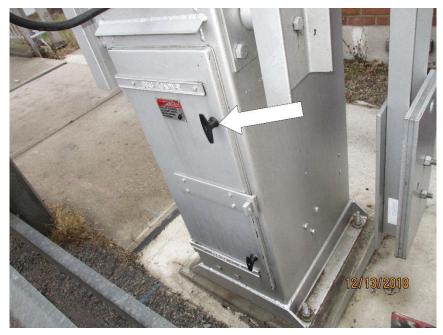
Photo M33 North Oncoming Warning Gate. The front door top latch (arrow) cannot be unlocked for inspection.

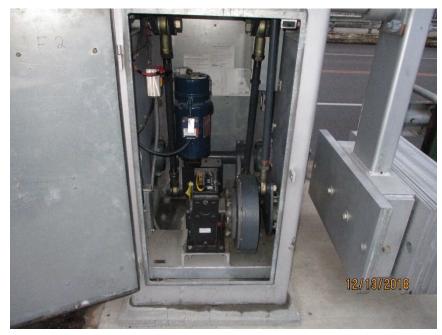
Photo M34 South Barrier Gate. The south barrier gate emitted a groaning sound during each operation.

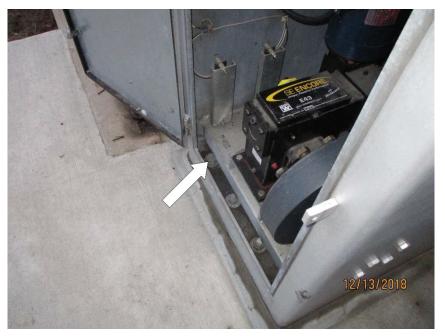
Photo M35 South Barrier Gate. The southeast anchor bolt is loose.

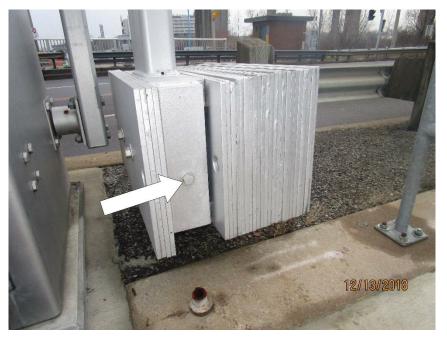
Photo M36 North Barrier Gate. The gate arm counterweight has a bolt that is not fully seated at the east side of the counterweight.

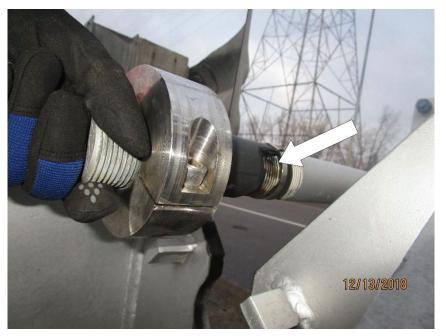
Photo M37 North Barrier Gate. The neoprene insulator (arrow) at the end of the arm is deteriorated.

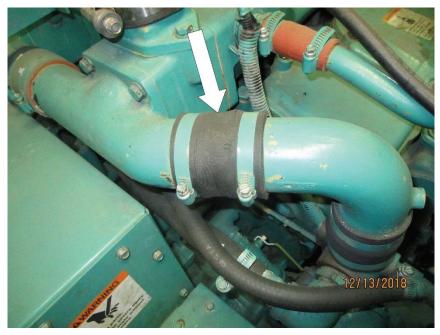
Photo M38 Main Generator. A coolant hose (arrow) exhibits dry rot and is cracked.

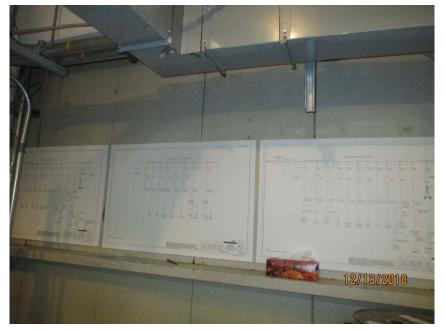
Photo E1 One Line Diagrams in Electrical Room. Note that the "As Built" one-line diagrams were updated as part of the recent motor and drive replacement project and are posted throughout the bridge.

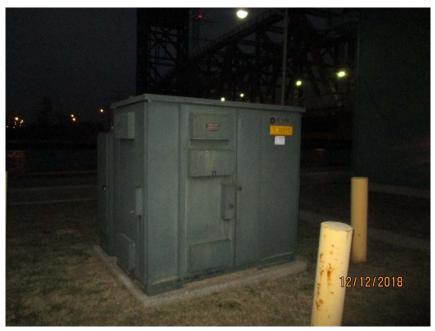
Photo E2 1,000KVA Outdoor Pad Mounted Incoming Service Transformer/Unit Substation. Note the primary service to the transformer is 13.8kV from the local utility overhead supply and the secondary of the transformer serves the bridge at 575volt, 3-phase, 60 Hz.

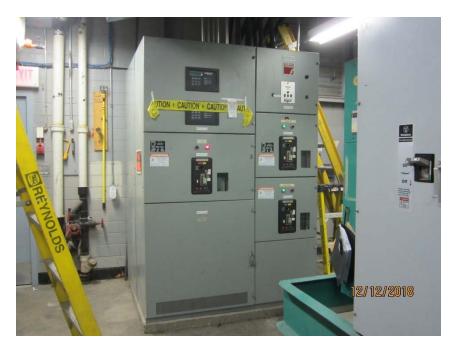
Photo E3 Switchboard #1. The switchboard was installed in approximately 1994 and is in good condition. Note the yellow tape on the metering compartment door. There are some unterminated live wires inside the metering compartment.

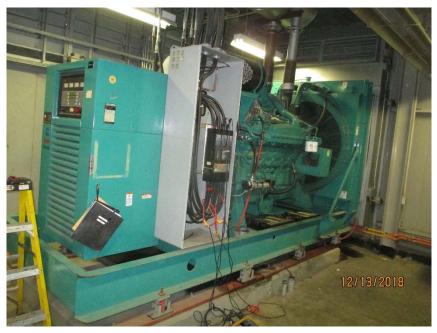
Photo E4 Main 600kW Standby Generator. Generator is used as an alternative source of power to operate the bridge. The standby generator has been well maintained and is tested monthly.

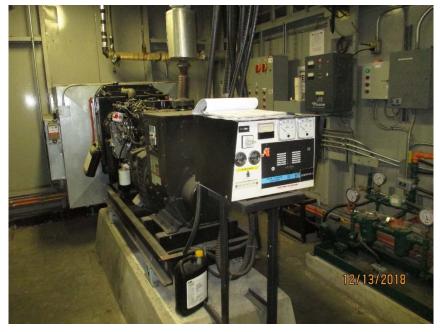
Photo E5 Auxiliary Standby Generator. Note auxiliary standby generator only provides power to bridge facility and auxiliaries in the event of a utility electric failure. It is not capable of providing power to operate the bridge. This generator is in acceptable and serviceable condition.

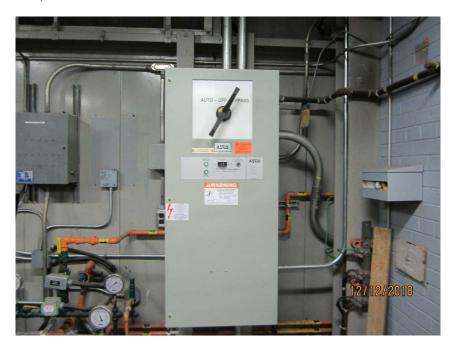
Photo E6 Automatic Transfer Switch (ATS). This ATS is used to transfer power from utility to auxiliary generator power. The ATS is configured to automatically start the auxiliary generator in the event of a power failure. The ATS is in good serviceable condition.

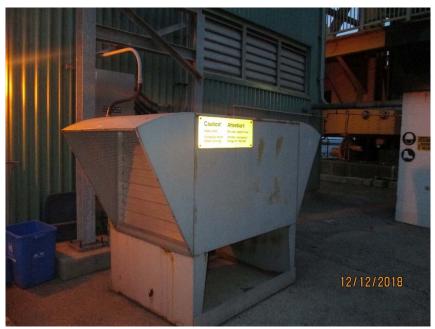
Photo E8 Main Standby Generator Load Bank. This load bank is located outside the control house and is appropriately sized to exercise the main (600kW) standby generator under load. Note the minor corrosion exhibited on the load bank enclosure.

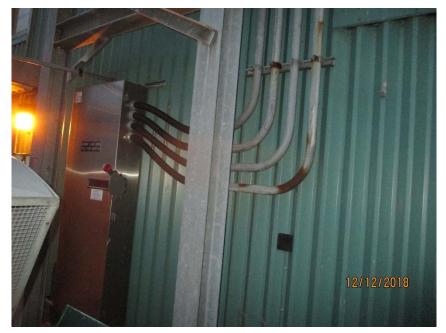
Photo E9 Load Bank Disconnect Switch. The disconnect switch is wall mounted outside the generator room facing the load bank. Note the as-new condition of the disconnect switch.

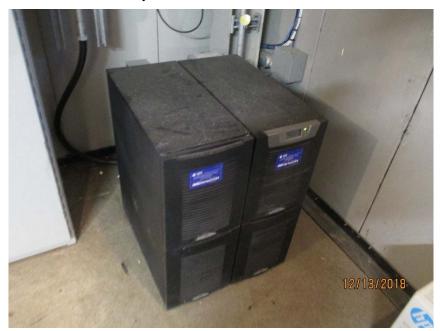
Photo E12 New UPS and UPS Distribution Panel. The UPS and its distribution panel is located next to the CP-2 and is in as new condition. Note the different type of laminated labels on the UPS distribution panel that are used to indicate the purposes of the breakers.

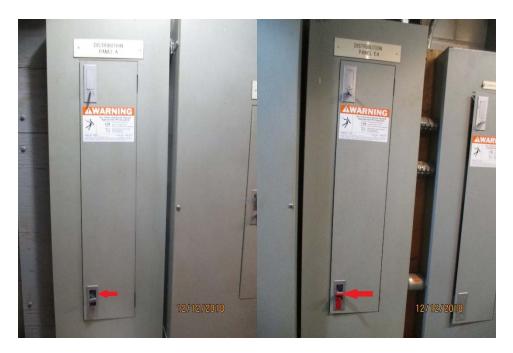
Photo E13 Broken Locks/levers on Panelboards. Note the indicated panel lock/levers were found to be broken on both Panel A and Panel EA inside the electrical room at the time of the inspection.

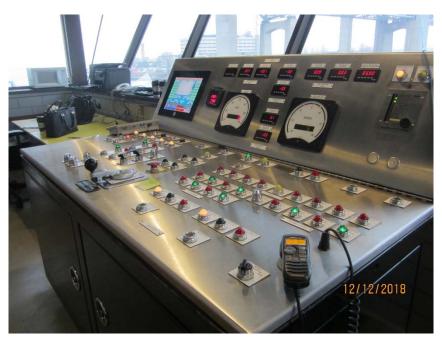
Photo E14 Main Control Console. New upgraded console top is provided during the recent motor and drive replacement project. The console is in excellent condition.

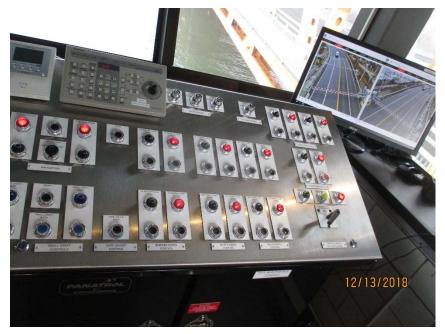
Photo E15 Traffic Control Panel. The new traffic control console top was recently installed and is in like new condition.

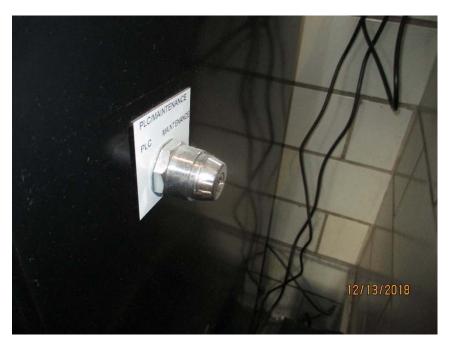
Photo E16 Traffic Control Bypass. A keyed selector switch for PLC and Maintenance select has been installed on the side of the console cabinet as part of the new control system. Note that relay mode for traffic control does not have any interlocks per the recent motor and drive replacement project design.

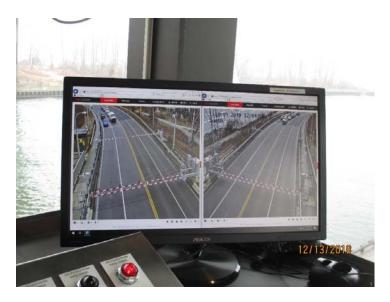
Photo E17 CCTV and Intercom. A CCTV monitor for new CCTV cameras is located next to the traffic control console. Note that both CCTV and intercom system are original and are functional. Also note that an original CCTV CRT monitor and original cameras that were installed prior to the recent motor and drive replacement project and remain in service. The intercom unit is located at the top right corner of the control console.

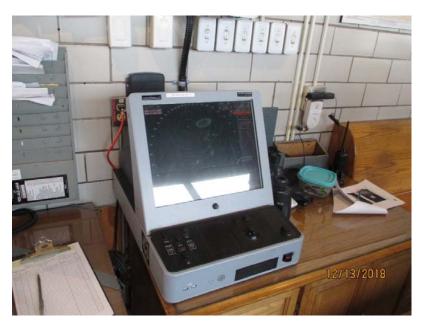
Photo E18 Bridge Radar System. A marine traffic radar system was installed to aid the bridge operation and schedule bridge openings for the boat traffic. It is also capable of displaying wind speed and direction and was found to be operational at the tie of the inspection

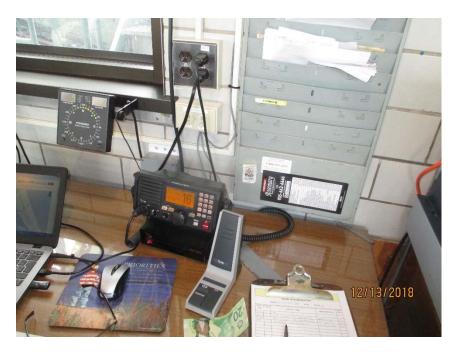
Photo E19 Wind Speed Indicator and Marine Radio. Both units were part of the bridge installation prior to the recent motor and drive replacement project and are in good serviceable condition.

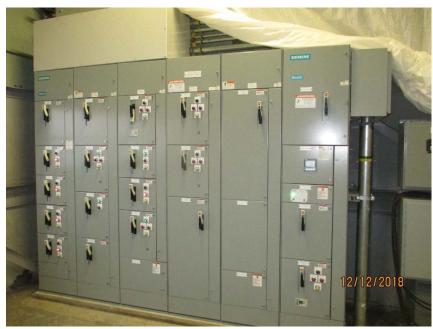
Photo E20 Typical New Motor Control Centre. Note that similar to the findings of last years inspection, the white plastic sheets that cover the MCC which are an indication of a roof leak above the MCC.

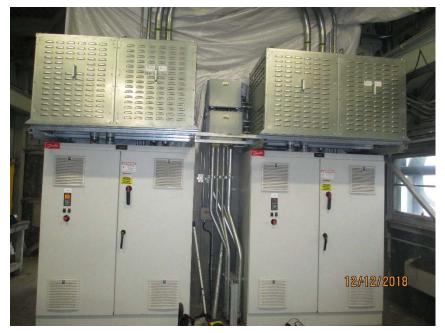
Photo E21 Typical VFD Drives Enclosure with Braking Resistors. Two new drives with resistors were installed in each tower as part of the recent recent motor and drive replacement project. Both drives are in as new condition. Note two drives are providing redundancy for the main drive operation. Operator can select drives automatically or manually.

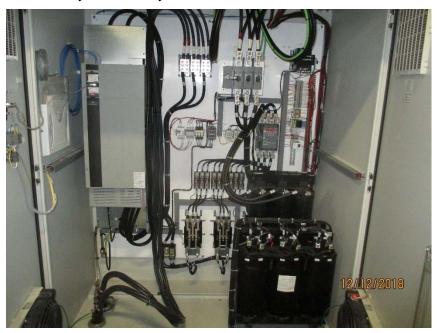
Photo E22 Typical VFD Drive System. The 200HP Danfoss VFD drive, 18 poles transformer and rectifier have been well installed inside the drive enclosure.

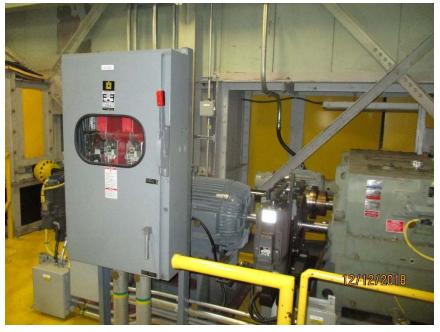
Photo E23 Typical Drive Motor Disconnect Switches. The drive motor disconnect switch was part of the original installation and have been reused to serve the new motors.

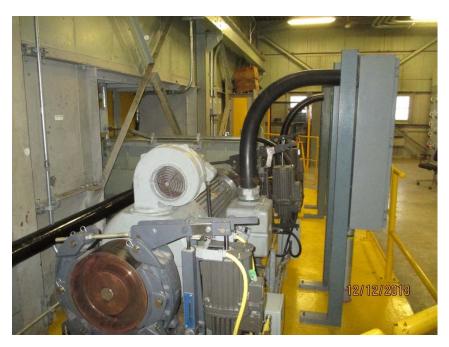
Photo E24 Typical Drive Machinery Arrangement. The span motors and motor brakes are in as-new condition. The machinery brakes were existing but have been provided with a new brake drum as part of the recent motor and drive replacement project.

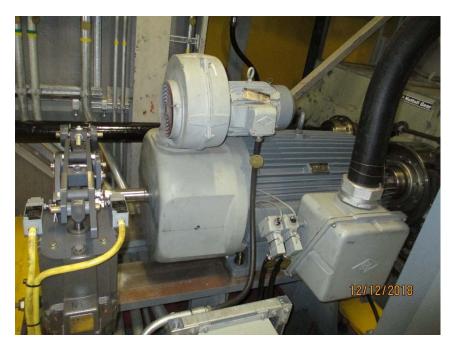
Photo E25 Northeast Motor Blower Nameplate. Similar to the last inspection, the blower nameplate was not affixed to the motor at the time of inspection.

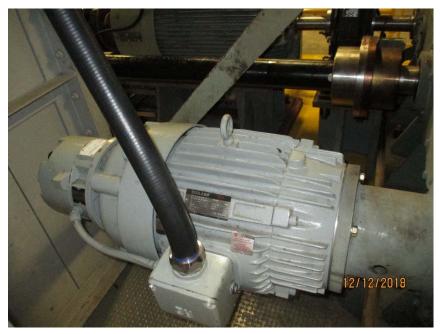
Photo E26 Typical Auxiliary Drive Motor. The new auxiliary motor with integral brake was installed during the recent motor and drive replacement project. Note that the original chain drive aux. has been changed to the direct coupling to the reducer.

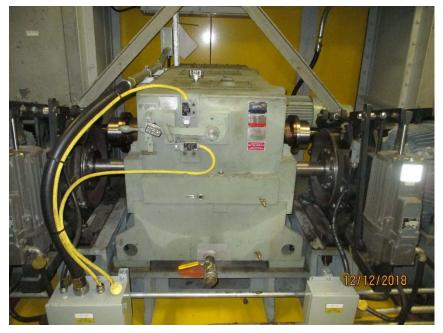
Photo E27 Lever Handle and Limit Switches on the Gear Reducer. Two handles are provided, one on each side the reducer for AUX drive operation and transverse skew adjustment. Many limit switches have been installed on the reducer box for the lever position indication and interlock.

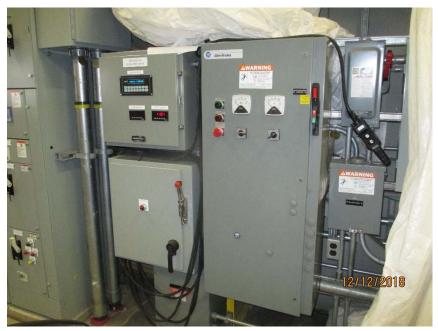
Photo E28 South Auxiliary Drive Controller and Span Height Indication Panel. The auxiliary drive was relocated along with the MTS and emergency power panelboard. They are all in good serviceable condition. Note the white plastic sheet cover over the units which is an indication of the roof leak in the area.

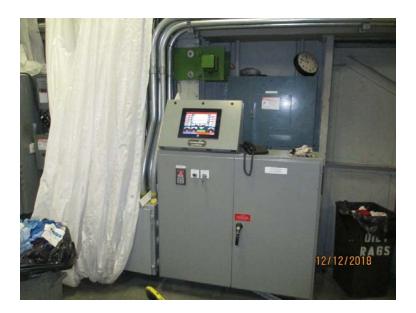
Photo E29 Typical Pull Box and Control Cabinet (CP-3) in South Tower. The control cabinet with PLC display was installed as part of the recent motor and drive replacement project.. They were in as-new condition at the time of the inspection. Note the white plastic sheet cover used to protect enclosure from a roof leak.

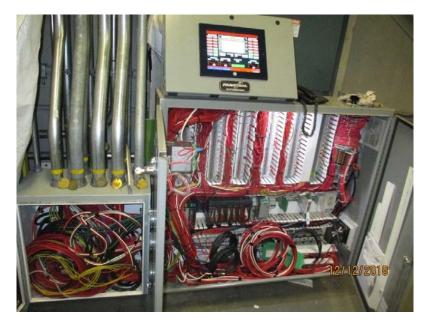
Photo E30 Inside of Pull Box and CP-3 Cabinet. Although the pull box was installed in addition to the control cabinet, both enclosures are over filled in accordance with code.

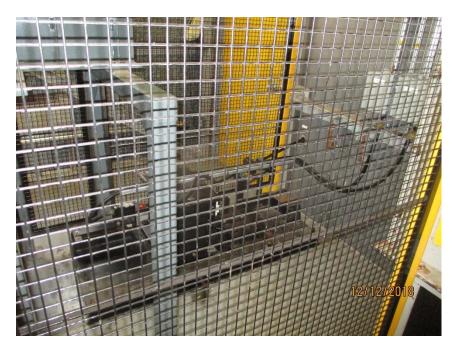
Photo E31 Span Resolvers. One single turn resolver and one multi-turn resolver have been connected to a gearbox which are attached to the tower pinion shaft. The resolvers and their junction box along with the gearbox are protected by a steel mesh cage as indicated.

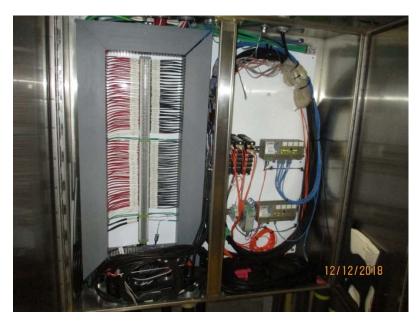
Photo E32 South Tower Aerial Cable Control Termination Box. The network switches and fiber patch boxes are also installed inside the termination box as indicated. Note the looped cables inside the box which are the spare conductors and communication cables. Their condition has not changed from the 2017 inspection.

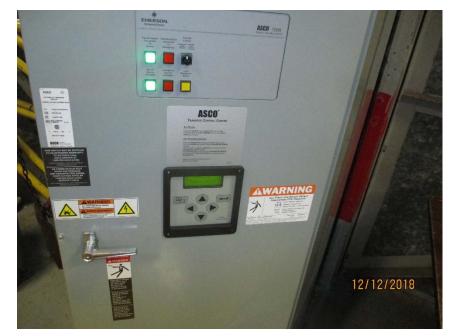
Photo E33 New Aerial Cable ATS in North Tower. The ATS was installed during the recent motor and drive replacement project.. It is used to automatically switch the aerial cable power feed between the east and west aerial installation. The ATS has been well installed and is in excellent operational condition.

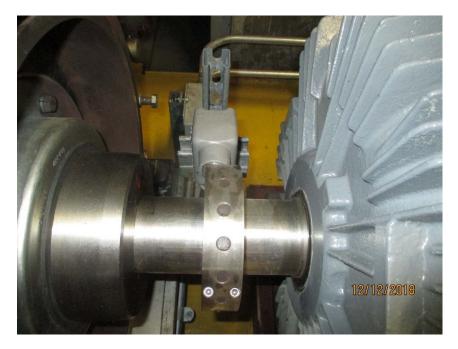
Photo E34 Typical Speed Switch Sensor. The speed switch sensor and pulse wrap have been installed between the motor and machinery brake for overspeed protection. The units are in good condition and the speed switch is operating as intended.

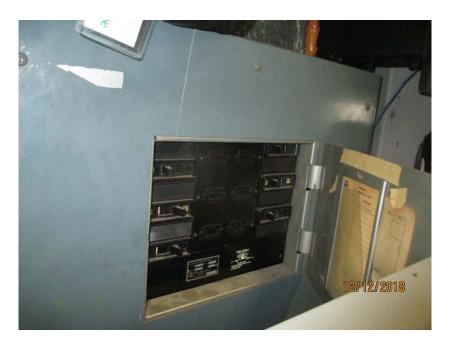
Photo E35 Typical Tower Heater Distribution Panel. This panel was part of the existing installation and was found to be in good operating condition at the time of the inspection.

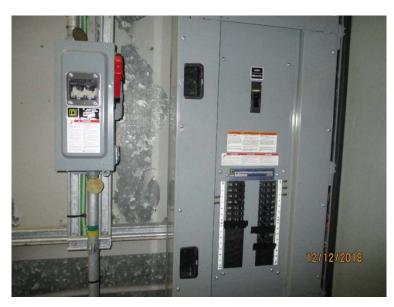
Photo E36 Typical New Lighting Panel and Disconnect. A 45kVA transformer primary disconnect switch and associated lighting panel were installed as part of the recent motor and drive replacement project.. These components are in an asnew condition. Note the black electrical tape over the empty space. Breaker space fillers should be used in place of the tape.

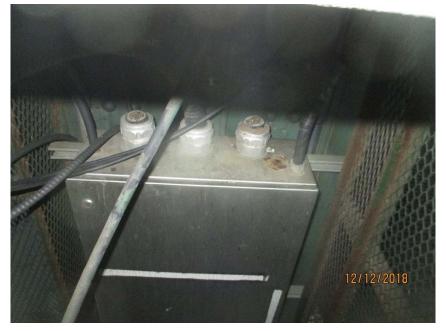
Photo E37 Abandoned Cables (typical). Abandoned cables have not been completely removed from the junction boxes/raceway system but left in place.

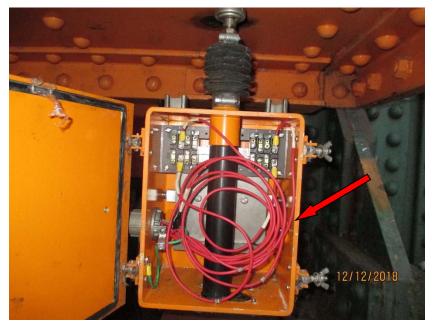
Photo E38 Typical New Span Seated Limit Switch. The switches are of the plunger type and provide indication that the span is fully seated. Note spare wires installed in the switch enclosure are missing cable ties.

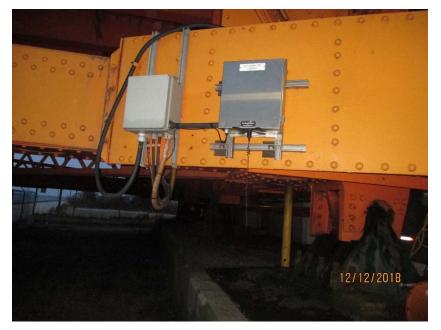
Photo E39 Span Inclinometer Enclosure. Per the recent motor and drive replacement project design, the span inclinometer was to be installed in the enclosure and to communicate wirelessly with a transmitter located inside the CP-2 enclosure. The inclinometer was to be used for the span skew control but does not presently function as intended and has been disconnected.

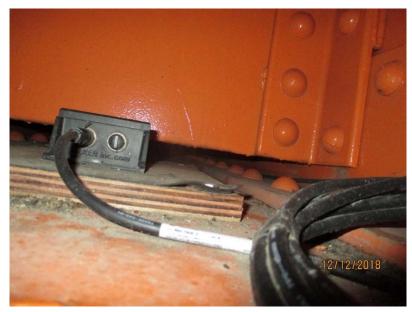
Photo E40 Inclinometer Unit. The span inclinometer was moved several times under the direction of the Engineer during its commissioning without success. The function of the inclinometer has now been disabled. The multi-turn span height resolvers, one in each tower, are presently being used in place of the inclinometers. The bridge presently has no secondary or backup means of skew detection.

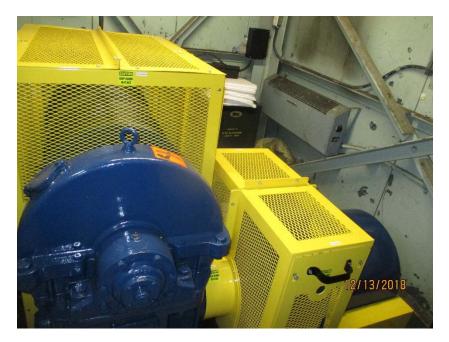
Photo E41 Typical Elevator Motor. The elevator motor is in good physical and operational condition.

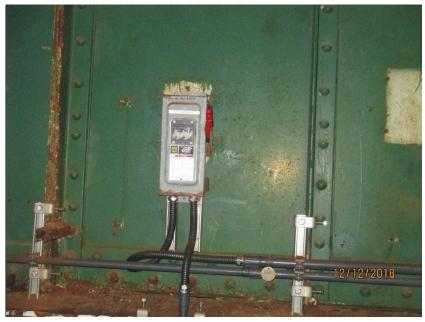
Photo E44 Typical Span Lock Motor Disconnect Switch (North Disconnect Switch Shown). The disconnect switch is rated NEMA 3R and exhibits severe corrosion on the enclosure and on disconnect handle.

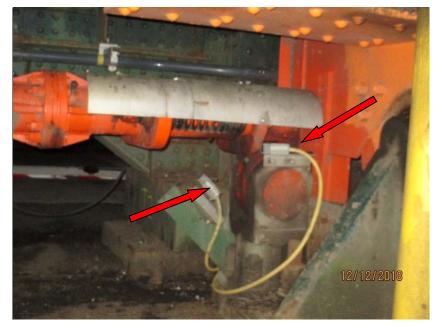
Photo E45 Typical Span Lock Limit Switches at the Lock Bar. These limit switches were installed as part of the recent motor and drive replacement project and were found to be in good physical and operational condition.

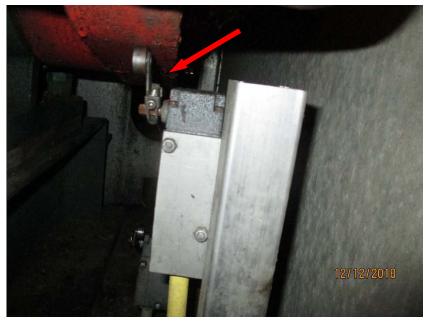
Photo E46 Typical Span Lock Limit Switches at the Center of Lock Machinery. A set of limit switches were installed at the center of the span lock rotation machinery. These limit switches were installed as part of the recent motor and drive replacement project and are now used in place of the original rotary cam limit switch installed to perform a similar function.

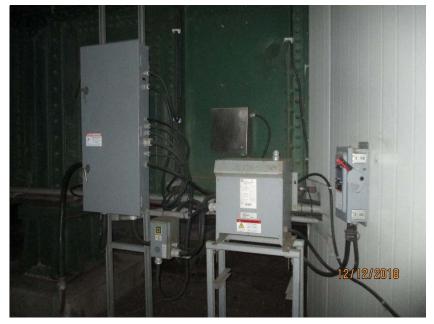
Photo E47 Lighting Panel on North Pier (LP-4). The disconnect switch, transformer, lighting panel and the lighting contactor are is in good physical condition. The lighting contactor has been modified to work with the current bridge control system.

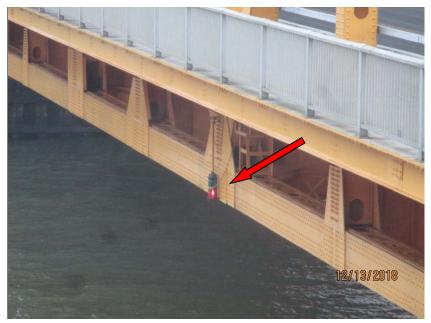
Photo E48 Typical Span Navigation Light. The bridge is provided with two span navigation lights, one facing each approaching navigable channel. These lights were found to be operational at the time of inspection and in good serviceable condition.

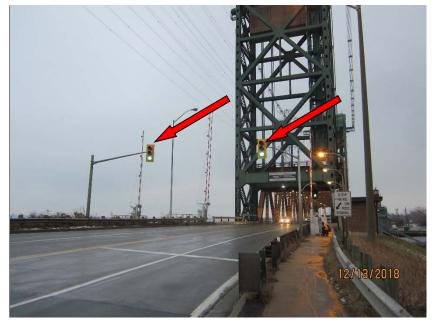
Photo E51 Traffic Signals (South Approach). Typically, traffic signals are in good physical and operational condition. The light bulbs are LED which extend the life of the bulbs.

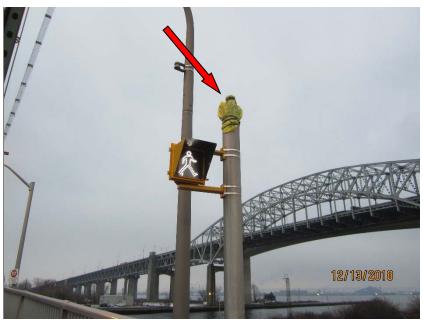
Photo E52 North Pedestrian Light. The pedestrian light is LED type Walk and Halt light. The pedestrian lights functioned properly and were found to be in good condition at the time of the inspection. The North pedestrian bell (arrow) has been completely removed from the pole.

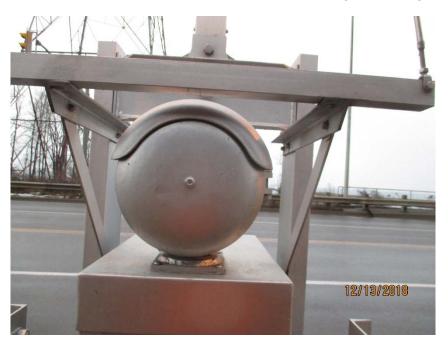
Photo E54 Typical Gong. Gongs were generally found to be in like new condition at the time of the inspection.

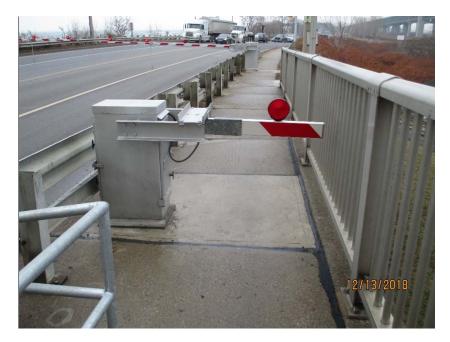
Photo E57 Typical Pedestrian Gate. The pedestrian gate is used to stop pedestrian traffic during the bridge operation. The Pedestrian gates were found to be in as-new condition. Note that the pedestrian gate and signal control are not included in the traffic control sequence. The operator is able to stop pedestrian traffic independently of bridge control system operation.

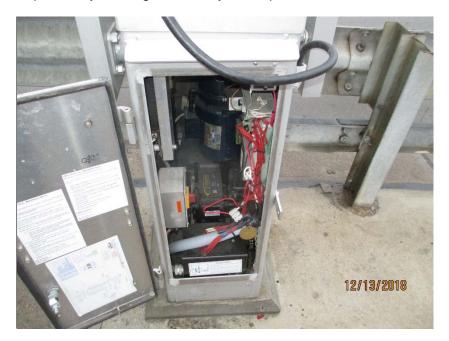
Photo E58 Typical Pedestrian Gate Enclosure. Note that the length of wires inside the gate are excessive and an improper wire splicing is used with unsecured terminal blocks at the time of inspection. Otherwise the gate is in as-new condition.

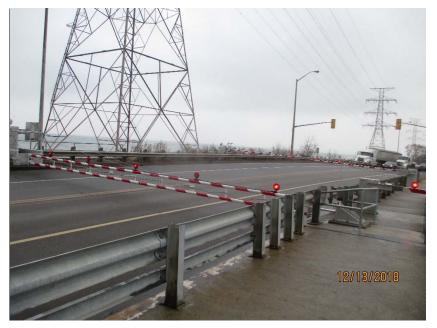
Photo E59 Typical Barrier Gate. Note the newly installed barrier gate, including arm light flasher and gong. The gate is in as-new operational condition.

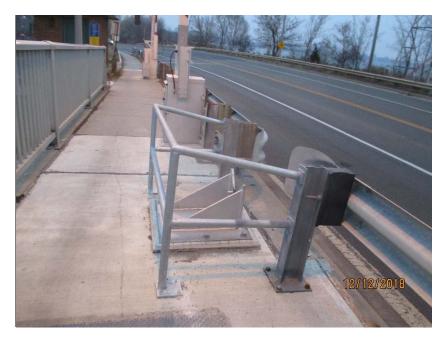
Photo E60 Barrier Gate Receiver. Note the newly installed permanent railing has been provided to keep pedestrian traffic from the barrier receiver pocket.

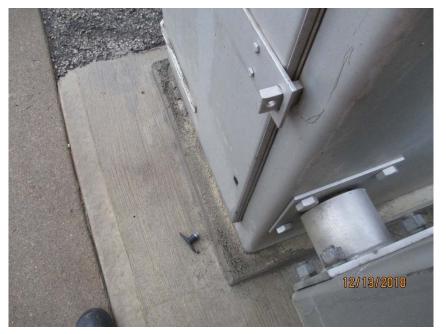
Photo E61 Broken Lock on North Barrier Gate Enclosure. North barrier gate enclosure lock was broken at the handle and left on the floor as indicated.

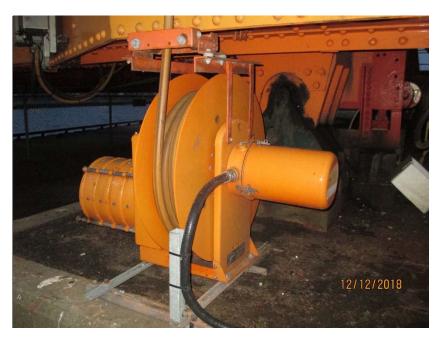
Photo E62 South Cable Reel. Note the south cable reel is in as-new condition, it provides power and control for electrical equipment on the movable span.

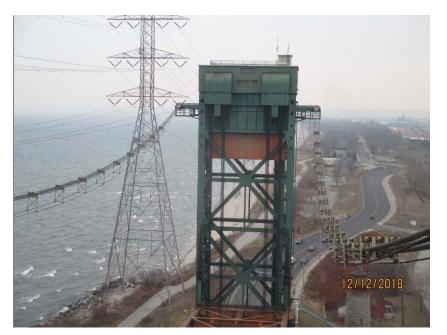
Photo E63 Typical New Aerial Cables. The aerial cables were replaced during the recent motor and drive replacement project and was found to be in good condition.

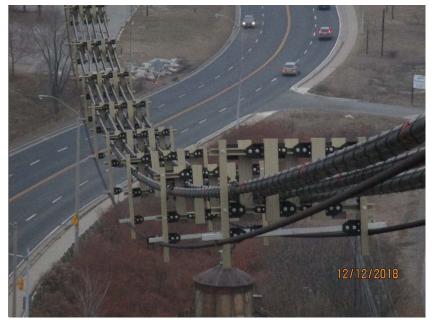
Photo E64 Typical Aerial Cable Spacer (East Shown). Note the aerial cable spacers were in as-new condition at the time of the inspection.

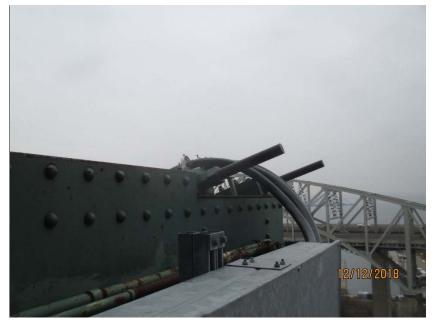
Photo E65 Typical Aerial Suspension Cables Routing. Sufficient bending radius has been created for the aerial cable before routing into the cable tray.

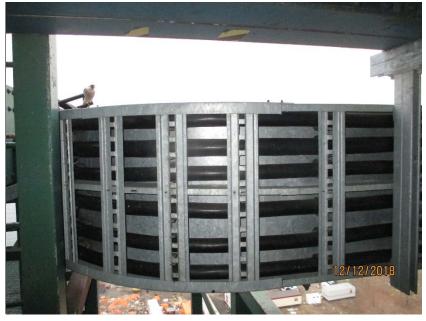
Photo E66 Typical Aerial Suspension Cables on Cable Tray. The aerial cables are well supported and spaced inside the cable tray.

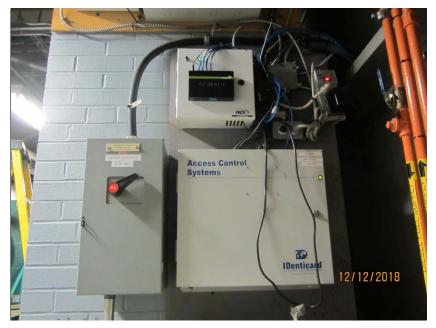
Photo E67 Bridge Access Control System. The bridge is provided with access control system to prevent unauthorized access to the bridge facilities. The access control system was operational at the time of inspection and provides an effective means of ensuring that only authorized personnel can gain access to the facility.

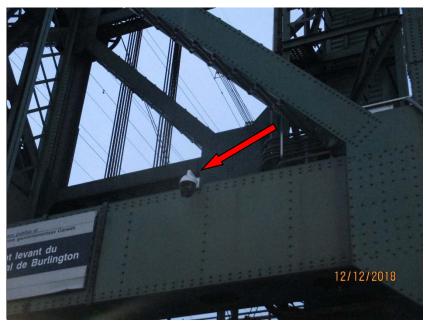
Photo E68 CCTV System. The CCTV cameras are strategically located throughout the bridge to monitor the roadway approaches, waterway approaches and main access areas to the bridge. The operation monitors all location from the operator's room via a CCTV monitor. The camera installation was found to provide good visual information and had been well installed.

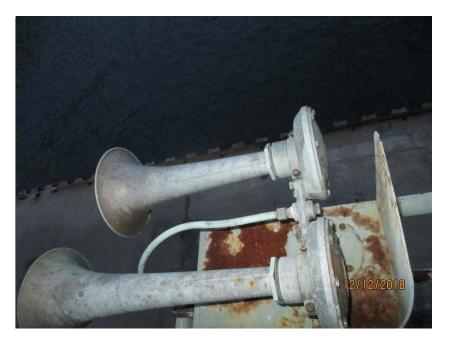
Photo E69 Typical Air Horn. The air horn is operational and is in serviceable condition. Note the moderate corrosion on the air horn housing.

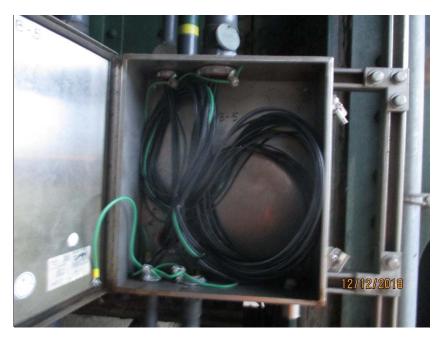
Photo E70 Typical Bonding. The raceway system bonding has been well installed and conforms to the CSA standard.

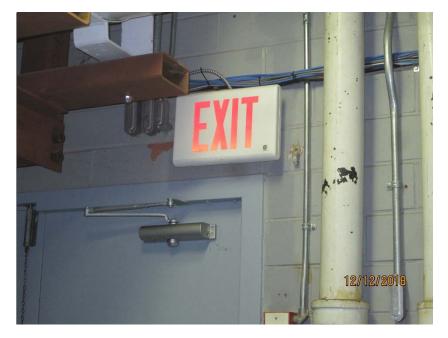
Photo E71 Exit Light. Typically, all exit lights are in working order and conform to code requirements.

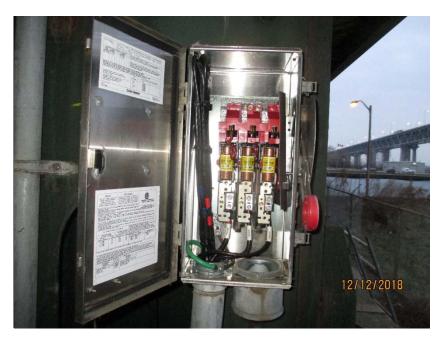
Photo E72 Existing Mobile Generator Disconnect Switch. The disconnect switch and generator receptacle are located at the foot of each tower. They have never been used but are capable of hooking up a mobile generator to operate the auxiliary drive motor in the respective tower.

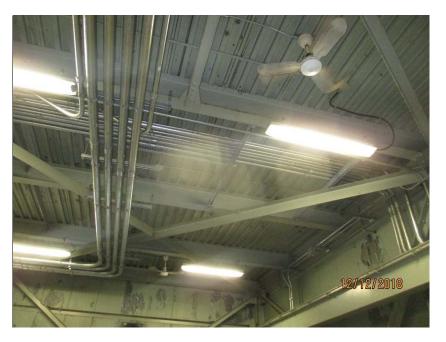
Photo E73 General Lighting and Smoke Detectors (South Tower Shown). The space lighting and fire system equipment have been adequately installed to provide a safe work place for inspection, maintenance and troubleshooting in the tower machinery spaces.

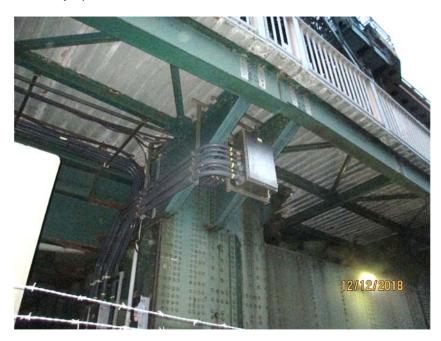
Photo E74 Typical Outdoor Raceway Installation. The newly installed conduit and stainless steel pull boxes are in as-new condition.
