# Inspection Report and Concept Repair Design

**SOLICITATION No.:**  
**PEQ754-161278/001/PWL:**  
**Burlington Canal Lift Bridge**  
**Engineering Services**

**PROJECT No.:**  
**R.081864.001**  
**Urgent Steel Deck Grating Repairs**

April, 2017

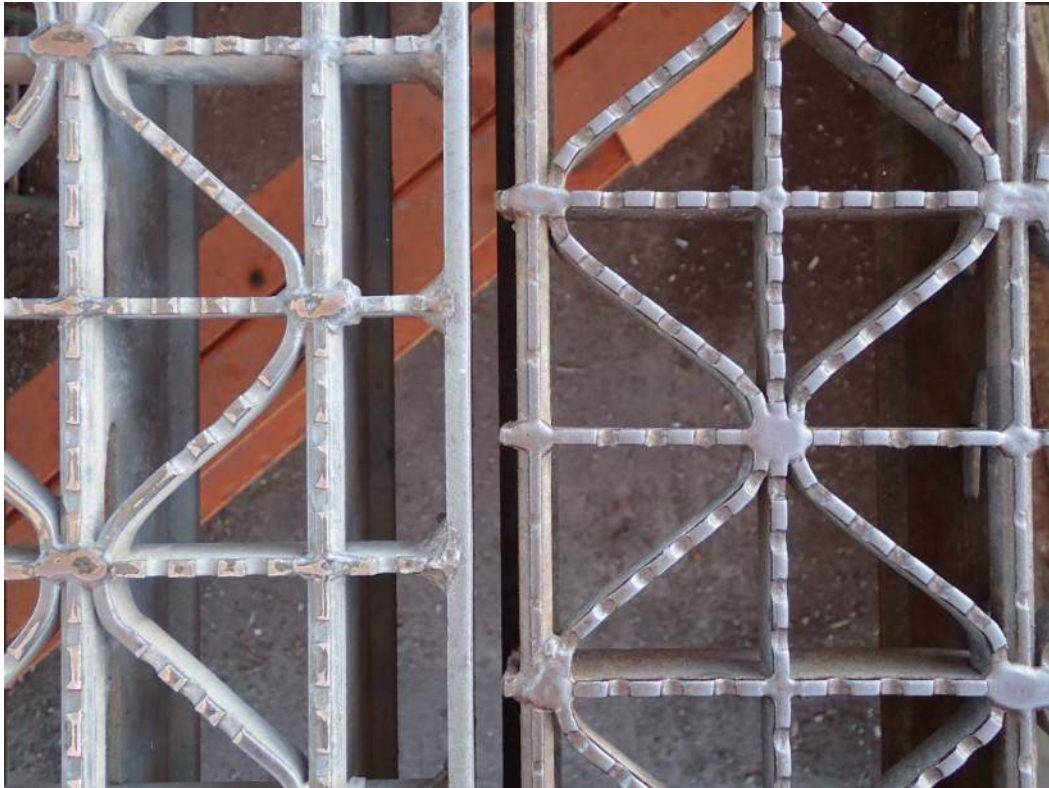
The Test Panel E1 was checked for any signs of performance deficiencies. All the structural members and connections of the panel were visually checked for, but not limited to, damages listed in point 5.1 of this Report. It was noted that the Test Panel was sturdier and less prone to vibrations than the other panels. There were no structural deficiencies noted for the Test Panel E1. (See photos 3 to 6 of **Appendix B**)

**Photo 3:** Test Panel E1 (left) and regular panel D (right)

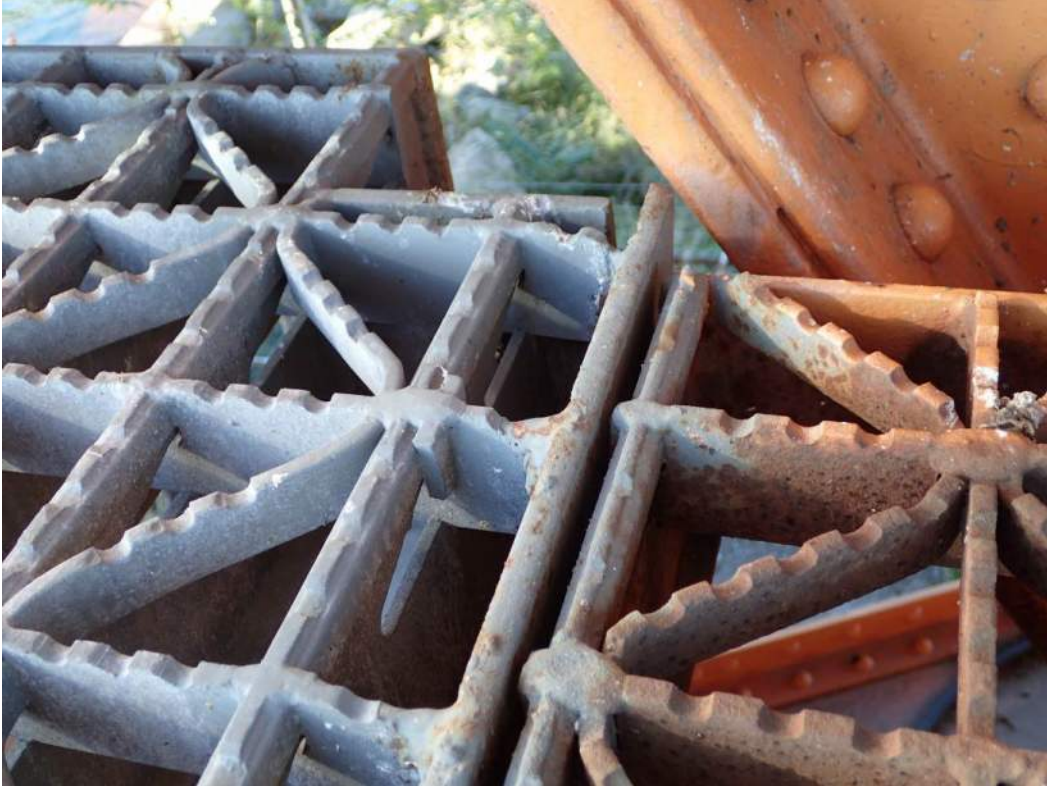
**Photo 5:** Test Panel E1 (left) and regular panel D (right)

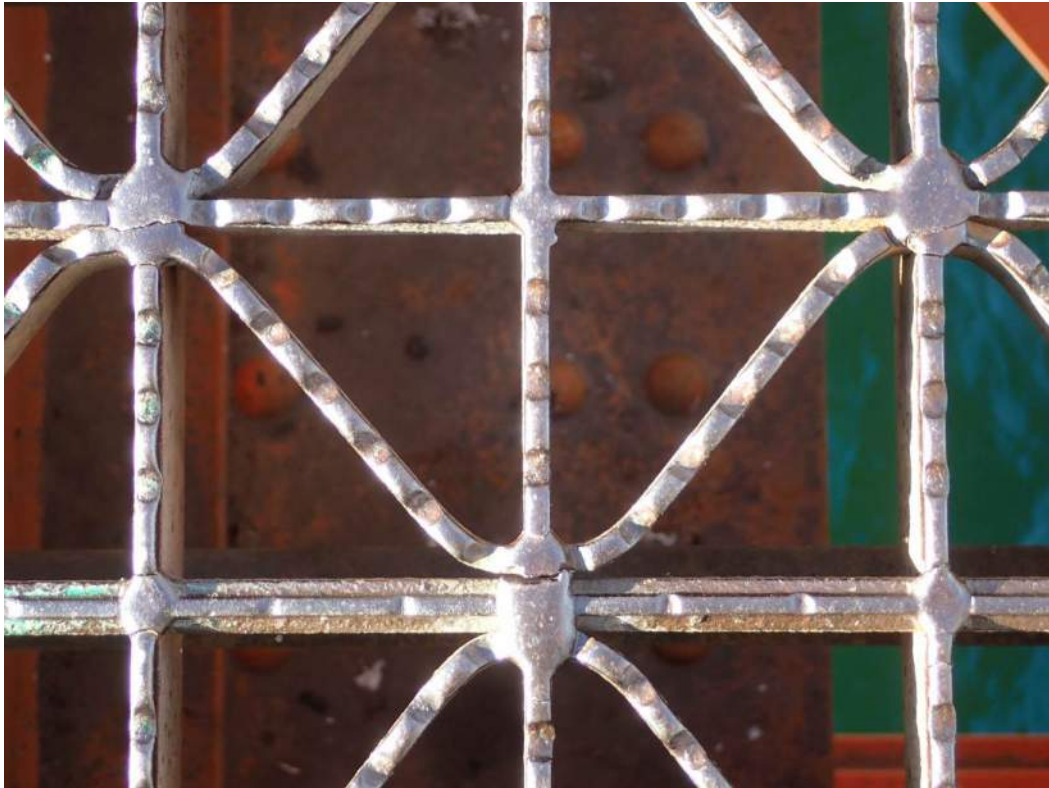
**Photo 17:** LGF – visible grating structural discontinuity along diagonal members
