2017 COMPREHENSIVE DETAILED INSPECTION BURLINGTON CANAL LIFT BRIDGE

Contract No. EQ754-181509/001/PWL Project No. R.089504.040

Revised March 29, 2018 (Rev .00)

RE: Burlington Canal Lift Bridge 2017 Comprehensive Detailed Annual Inspection Final Report

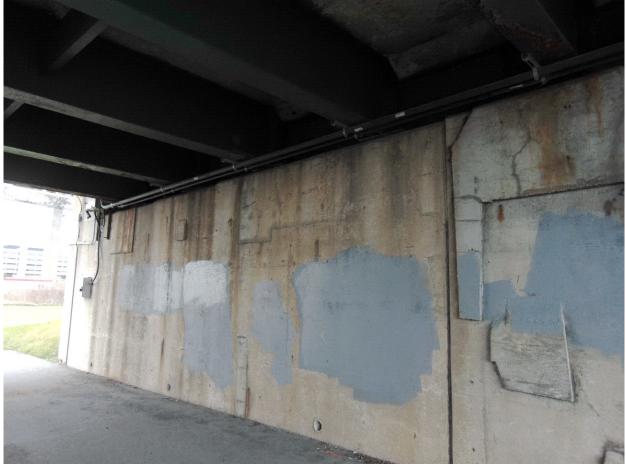
09 North Abutment, Large Patches on Upper West Section of Wall, looking West

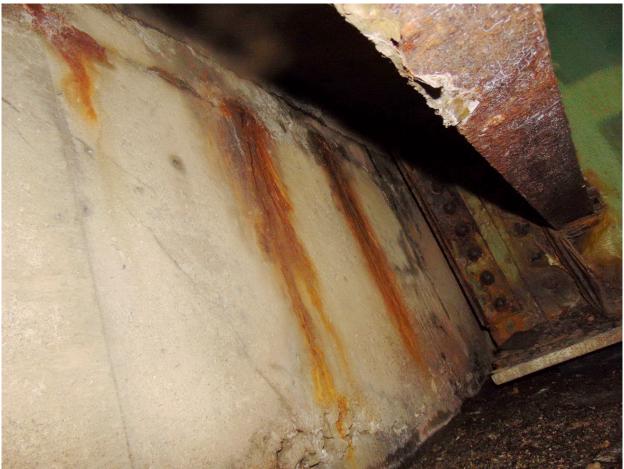
12 North Abutment, Cracks-Rust Stains-local Spalls on West Section of North Ballast Wall (YP) Page A2 [6] of A2 [153]

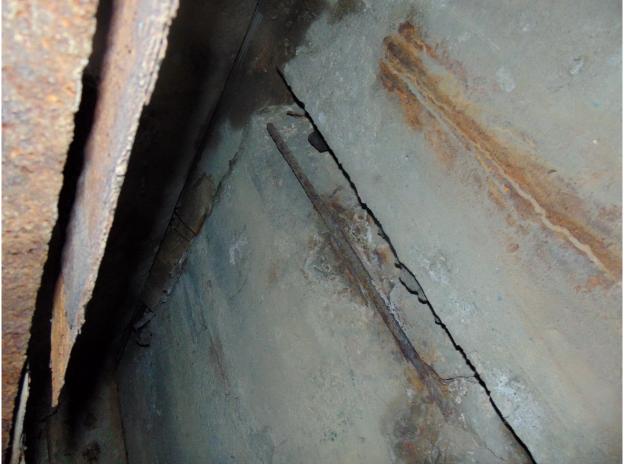
13 North Abutment, Exposed Bar in Spalls @ Central Construction Joint in North Ballast Wall

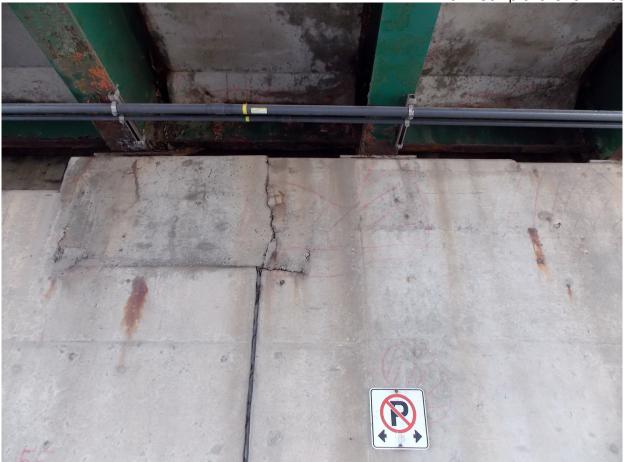
15 South Abutment, Large Concrete Patch with Wide Vertical Crack & Delamination below Stringers 4&5

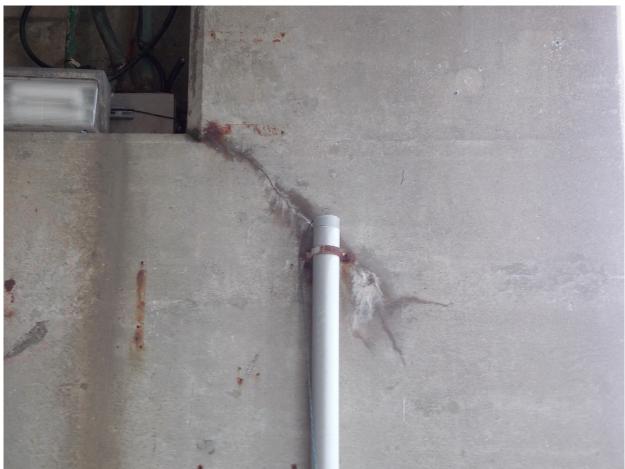
18 South Abutment, Wide Diagonal Crack with Wet & Efflorescence @ Top West Corner Area of Wall Page A2 [9] of A2 [153]

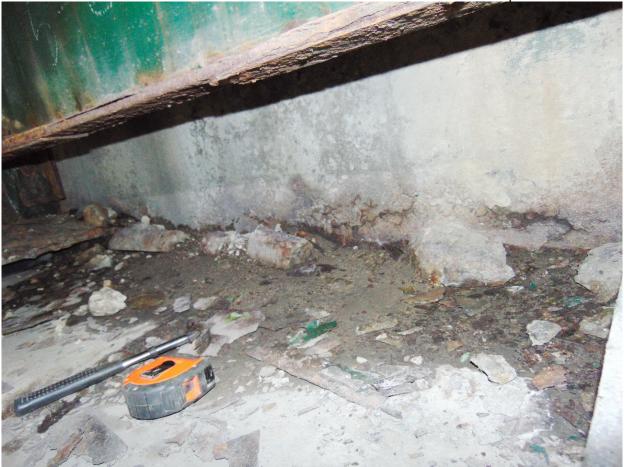
19 South Abutment, Typical Concrete Debris on Bearing Seat

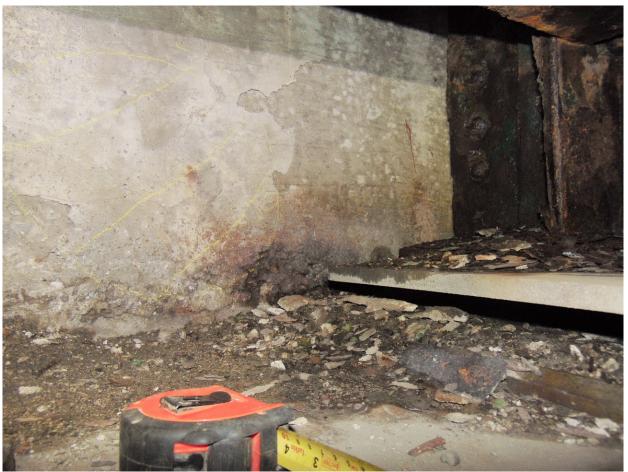
20 South Abutment, Large Delamination on South Ballast Wall near Stringer 7

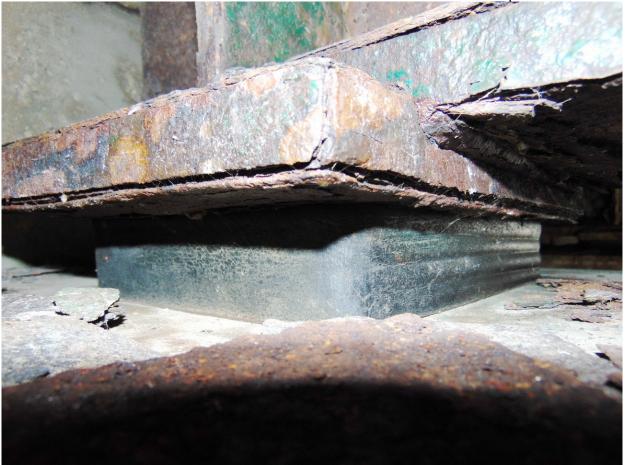
23 Minor Bulging of South Abutment Bearing under Stringer 2 (TYP)

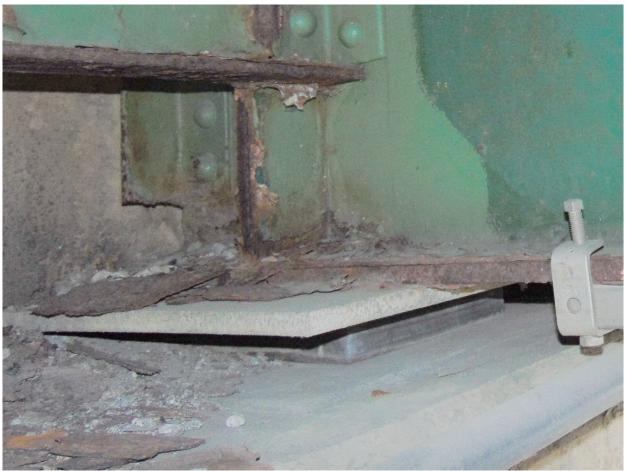
24 Typical Laminated Bearing & Oversized Shoe Plate at North Abutment, Stringer 6 Bearing Shown Page A2 [12] of A2 [153]

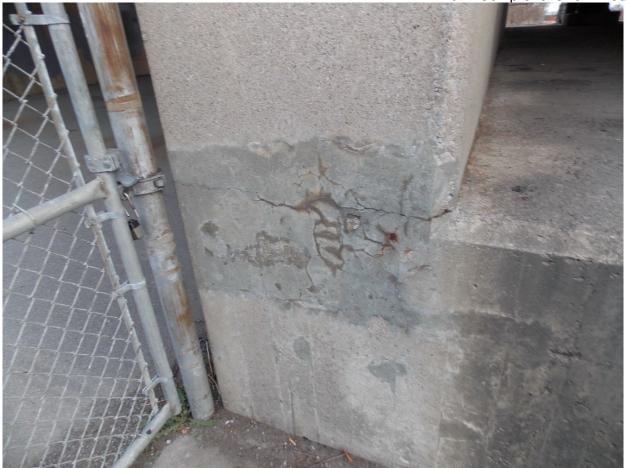
31 North Curtain Wall, Crack @ Horizontal Construction Joint on Bottom West Face of Wall

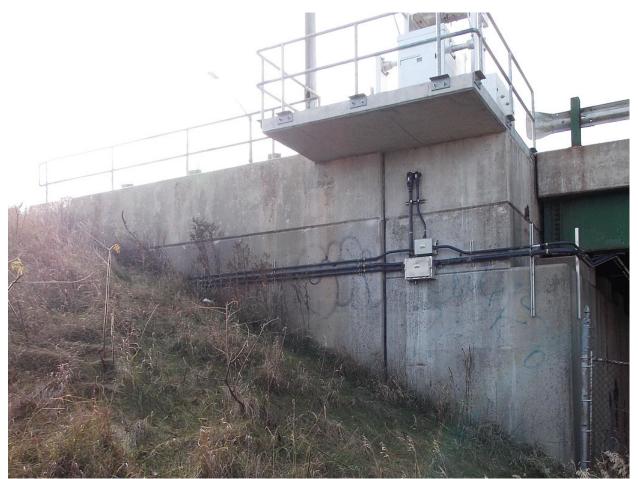
36 Southeast Wingwall

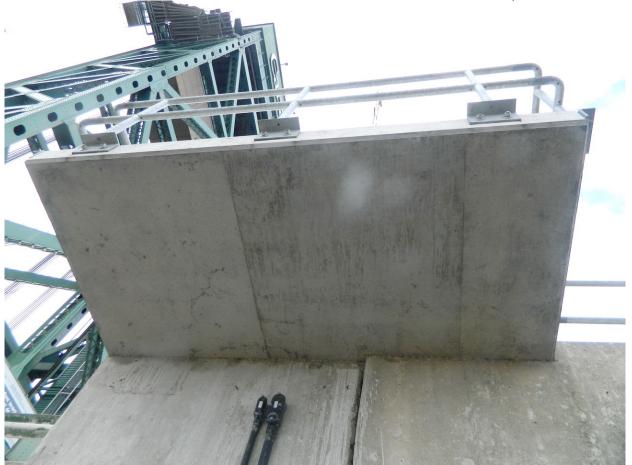
37 New Cantilever Slab for Swing Gate Support on Northeast & Southeast Retaining Walls, Northeast Wall Shown

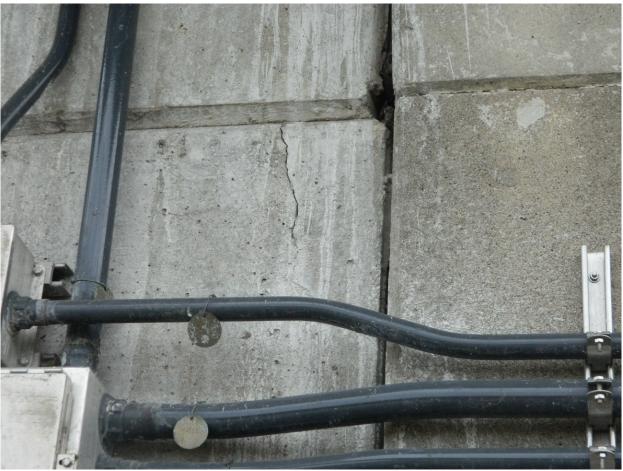
40 Medium Vertical Crack on Upper Mid Section of Northeast Retaining Wall

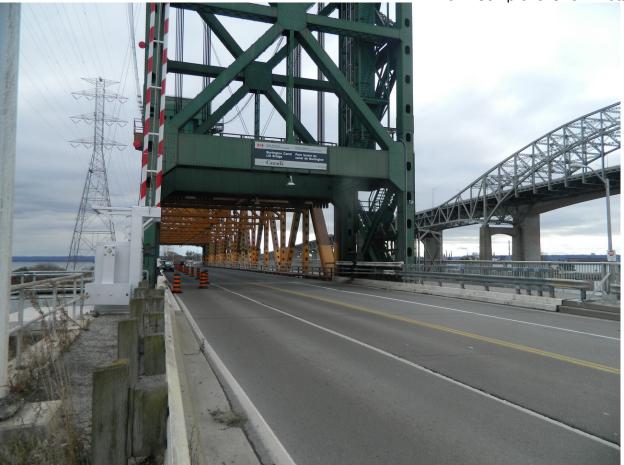
41 North Approach Span, Deck Riding Surface from NE Corner

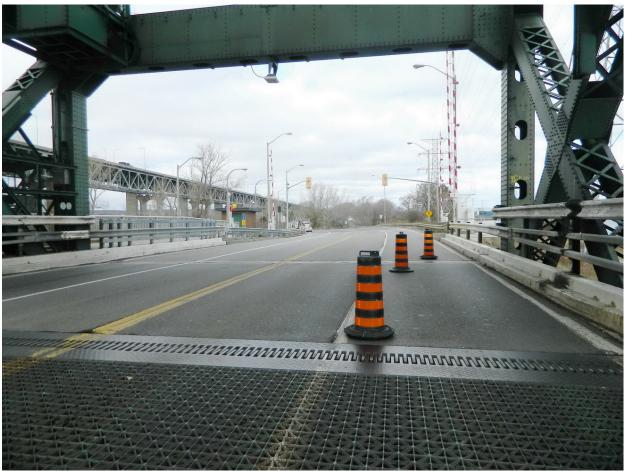
42 Deck Surface @ North Tower & North Approach Spans, looking North

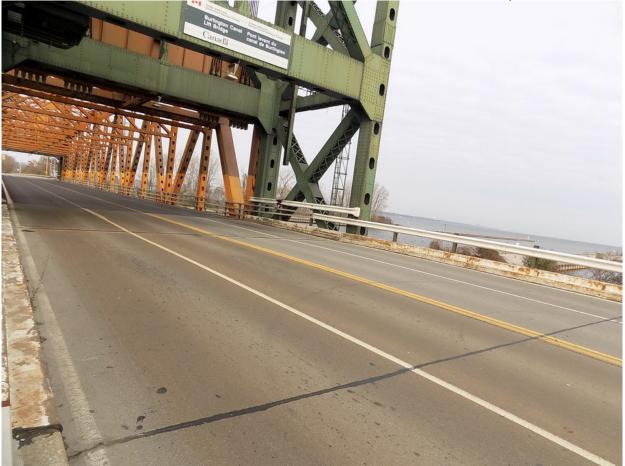
43 South Approach Span, Deck Wearing Surface from Southwest Corner (2)

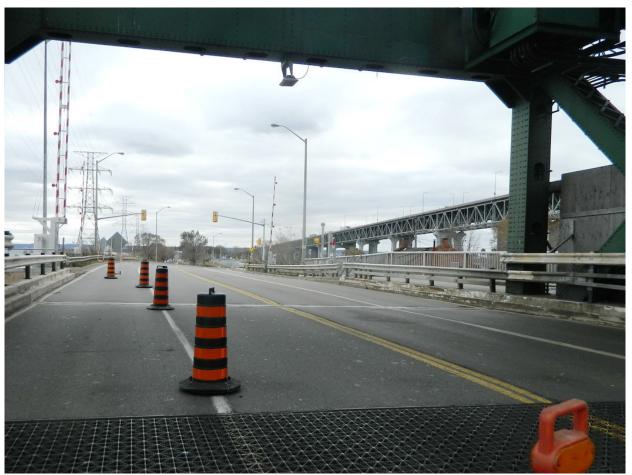
44 Deck Wearing Surface @ South Tower Span, looking South

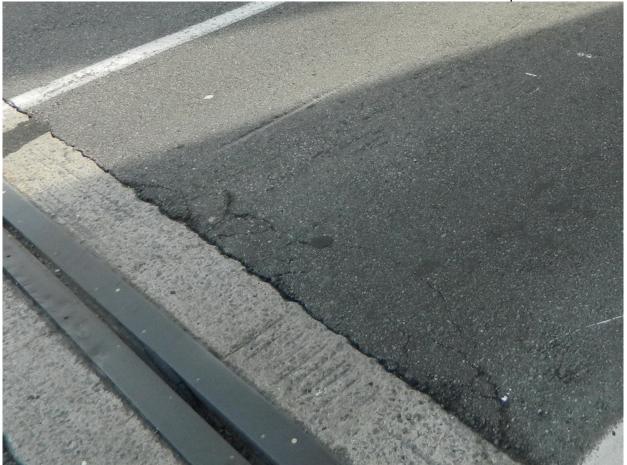
45 Unsealed Cracks & Minor Abrasions on Asphalt near Expansion Joint @ North Approach & North Tower Spans

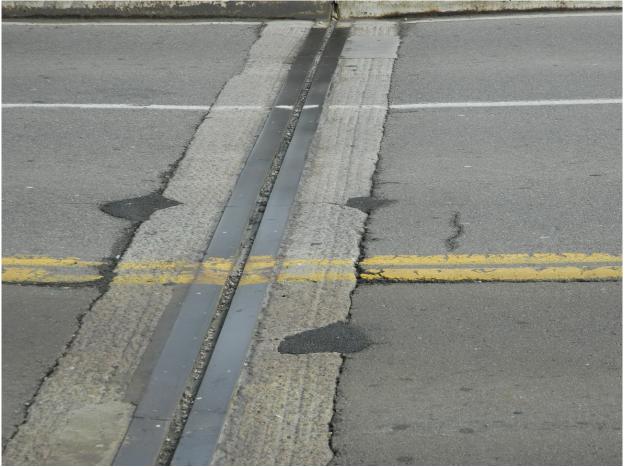
49 Cracks & Asphalt Patches at Exp Joint between South Approach & Tower Span, looking West

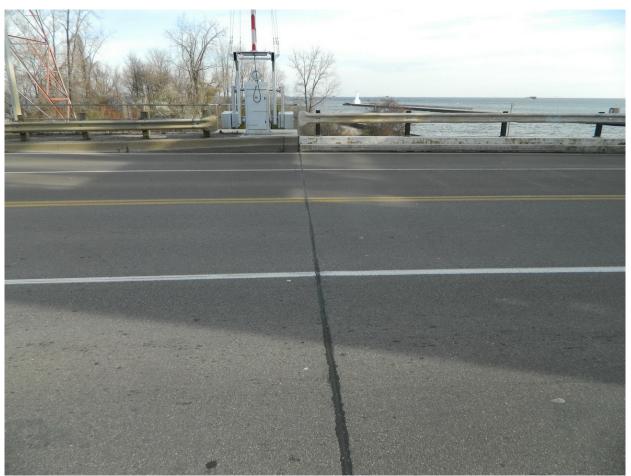
50 Paved-Over North Abutment Joint, looking East

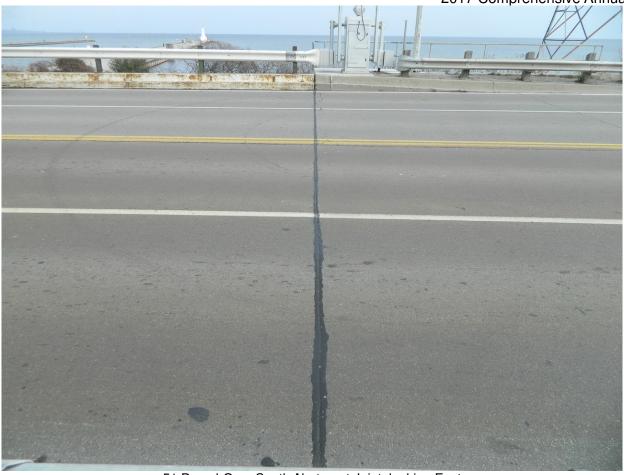
51 Paved-Over South Abutment Joint, looking East

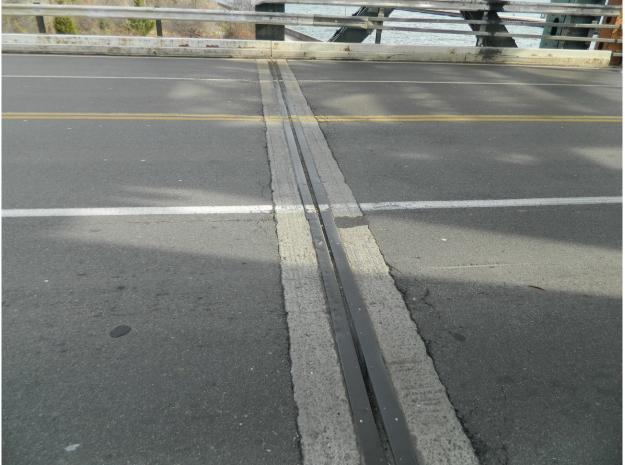
52 Compression Seal Expansion Joint @ North Approach & North Tower Span, looking East Page A2 [26] of A2 [153]

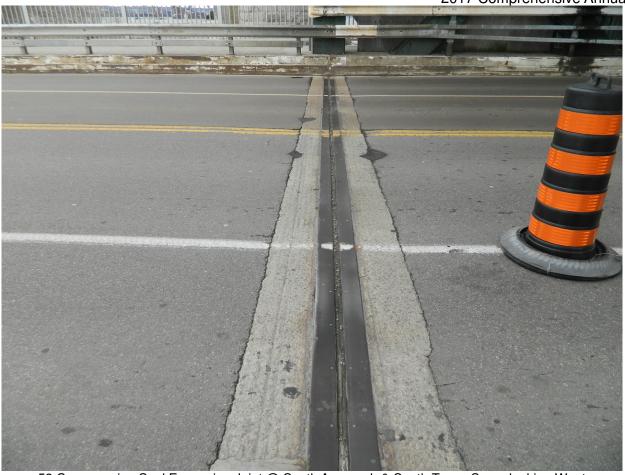
53 Compression Seal Expansion Joint @ South Approach & South Tower Span, looking West

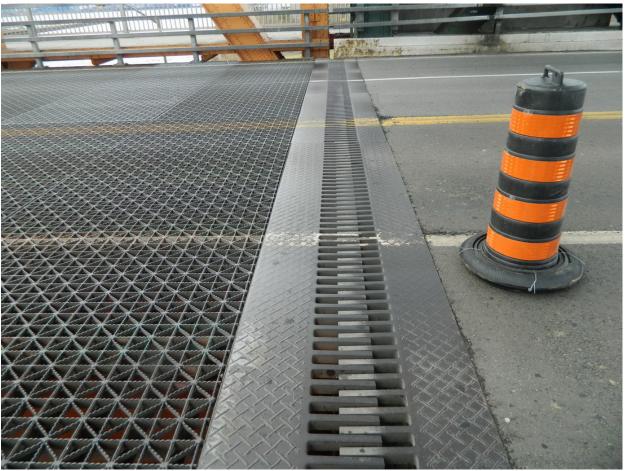
54 Open Gap Finger Plate Expansion Joint @ South Tower & Lift Span Decks, looking West Page A2 [27] of A2 [153]

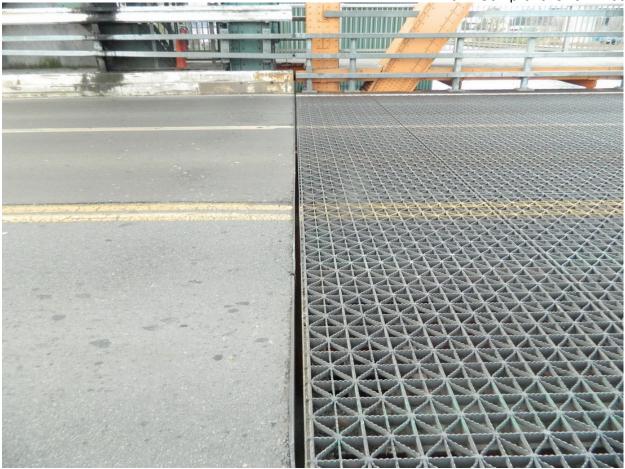
55 Open Gap Expansion Joint @ South Tower & Lift Span Decks, looking West

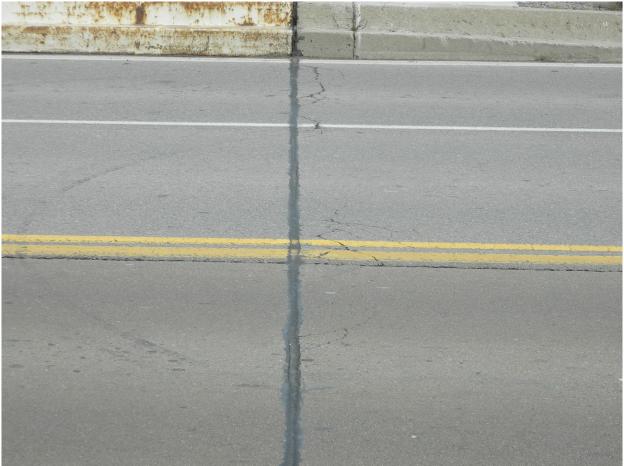
56 South Expansion Joint, Pattern Unsealed Cracks @ East Section of Paved-over South Exp Joint Page A2 [28] of A2 [153]

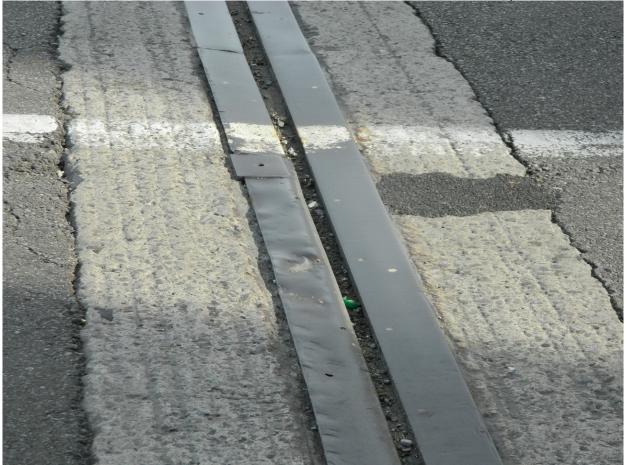
57 Deformed & Abrasion Marks on Joint Steel Angle @ Expansion Joint @ North Approach & North Tower Span

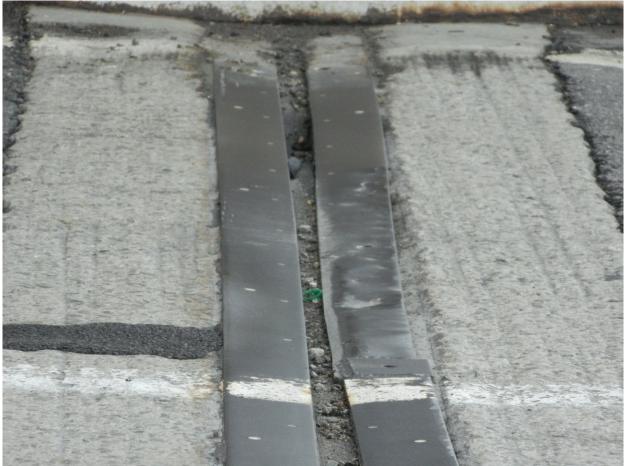
58 Loose Joint Steel Angle @ West Section of Expansion Joint between North Approach & North Tower Span Page A2 [29] of A2 [153]

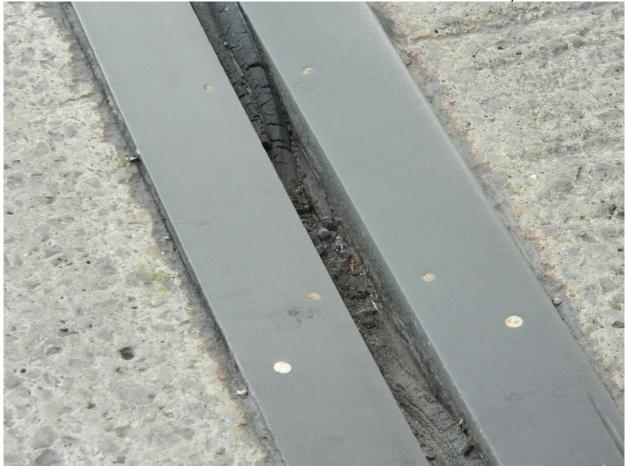
59 Loose Compression Seal in West Section of Expansion Joint between North Approach & North Tower Span

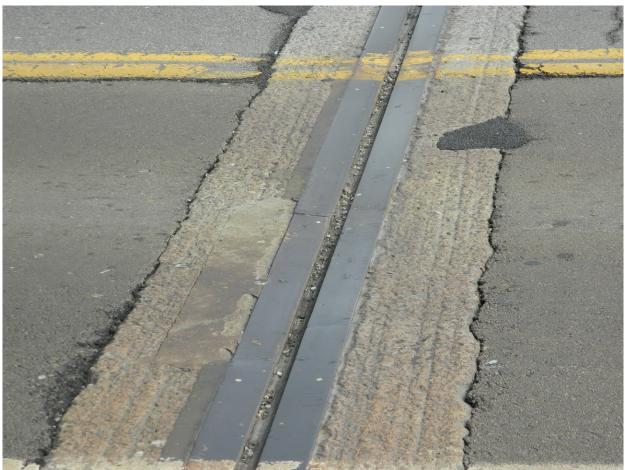
60 Concrete & Asphalt Patches and Minor Spalls on End-Dams between South Approach & Tower Spans Page A2 [30] of A2 [153]

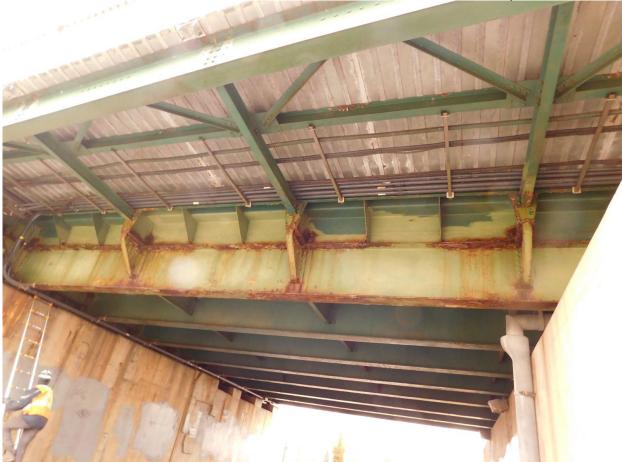
63 North Approach Span, General View of Deck Underside, looking East

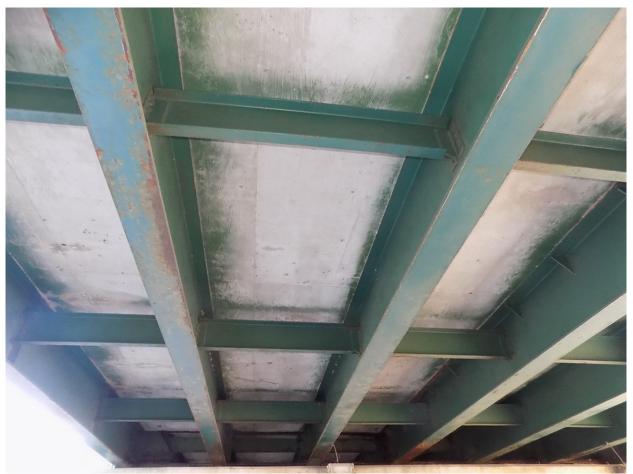
64 North Approach Span, Interior Soffit from North

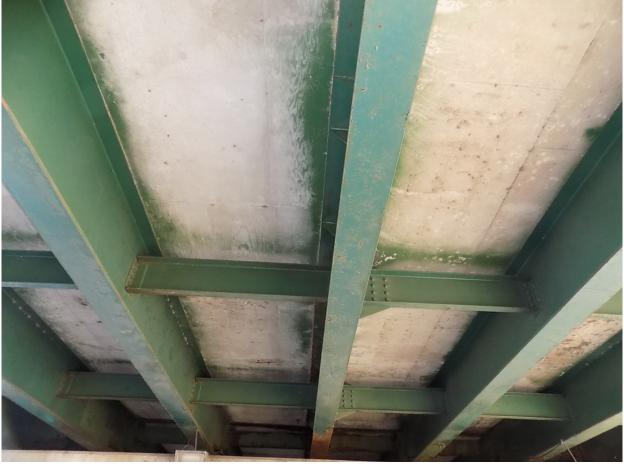
65 North Approach Span, Interior Soffit looking North

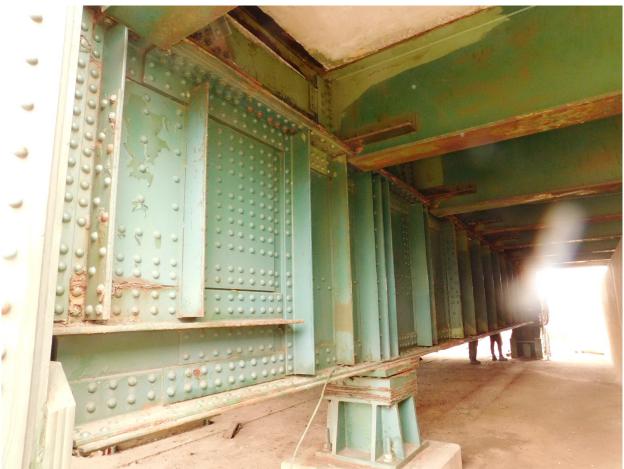
66 North Approach Span, Soffit & Stringers atop North Tower's Rear Floor Beam, looking West Page A2 [33] of A2 [153]

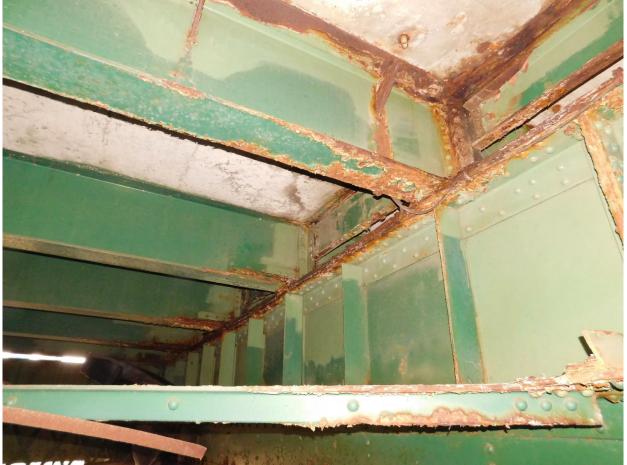
67 North Tower Span, Deck Soffit & Stringers atop Rear Floor Beam @ North Tower Span, looking West

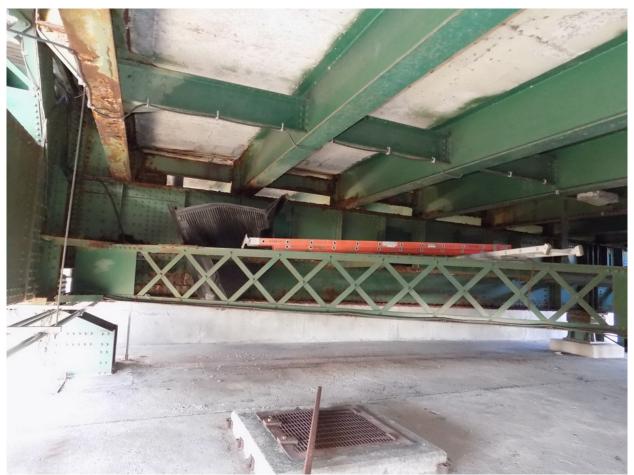
68 North Tower Span, Deck Underside @ North Tower Span, looking North

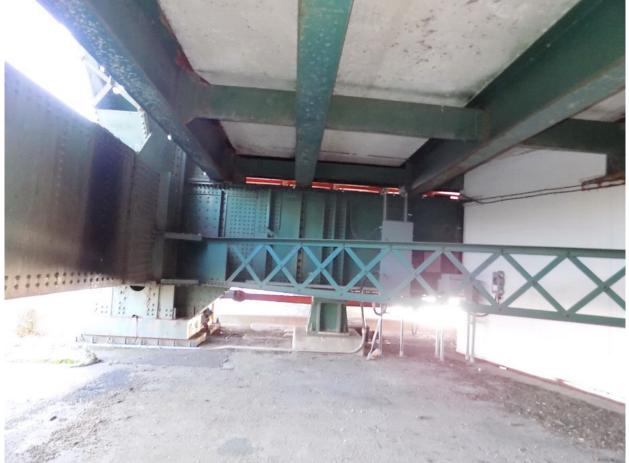
69 North Tower Span, Deck Underside @ East Side of North Tower Span, looking South

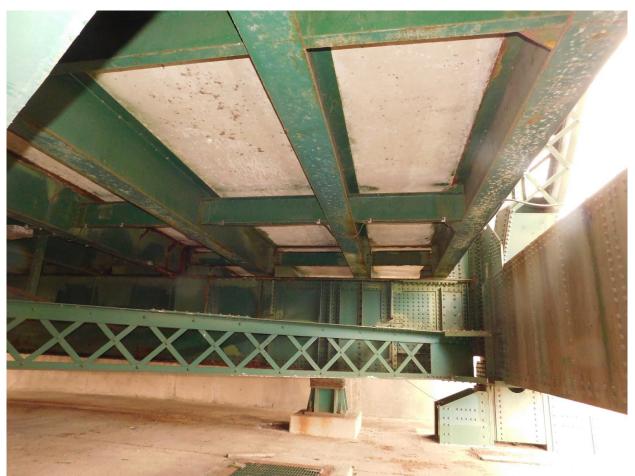
70 North Tower Span, Deck Underside @ East Side of North Tower Span, looking North Page A2 [35] of A2 [153]

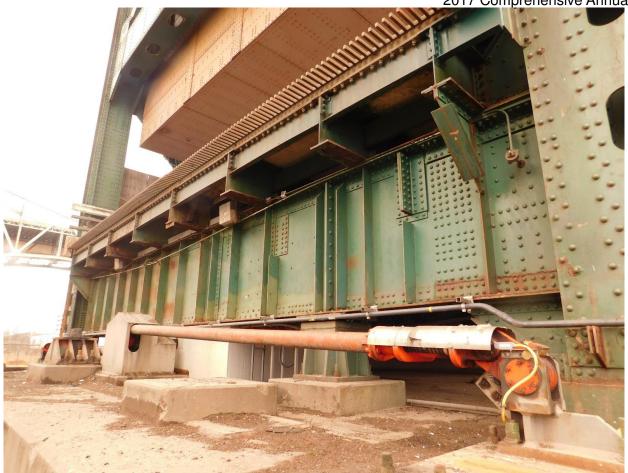
71 North Tower Span, Deck Underside @ Front Floor Beam (Lift Span Up), looking West

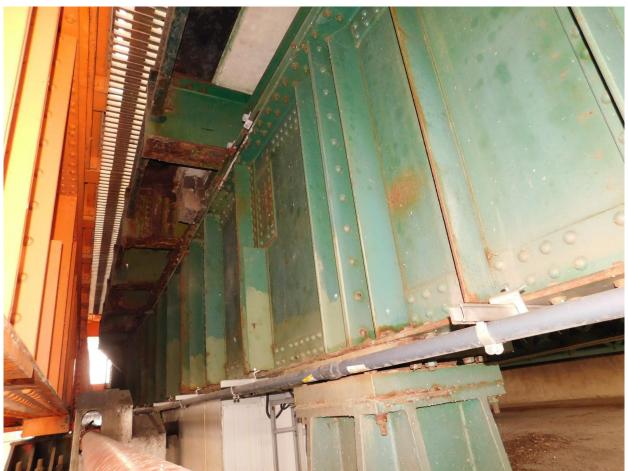
72 North Tower Span, Cantilevered Soffit & Stringers @ Front Floor Beam (Lift Span Down), looking East Page A2 [36] of A2 [153]

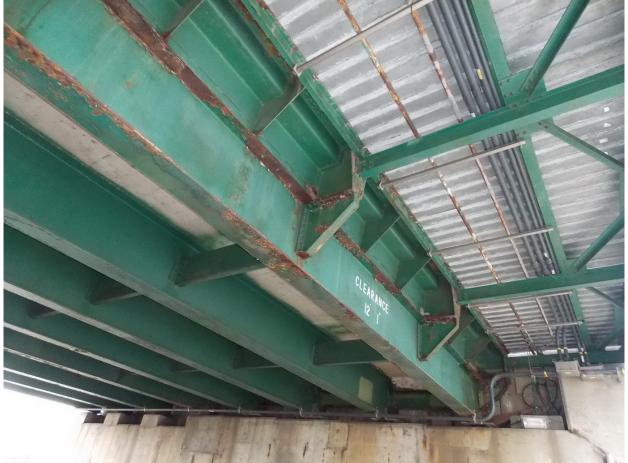
73 South Approach Span, Soffit from NW Corner

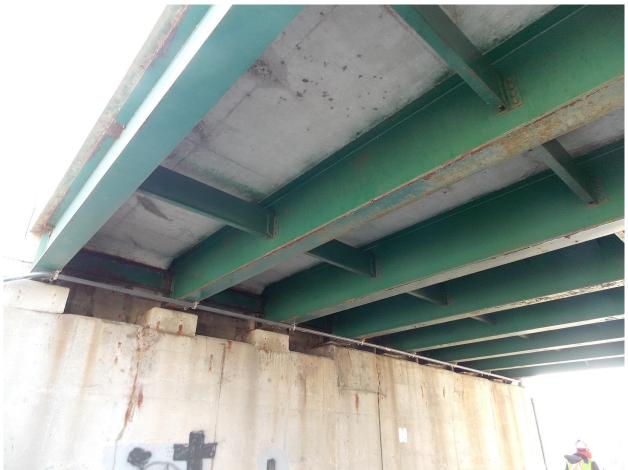
74 South Approach Span, Soffit from NE Corner

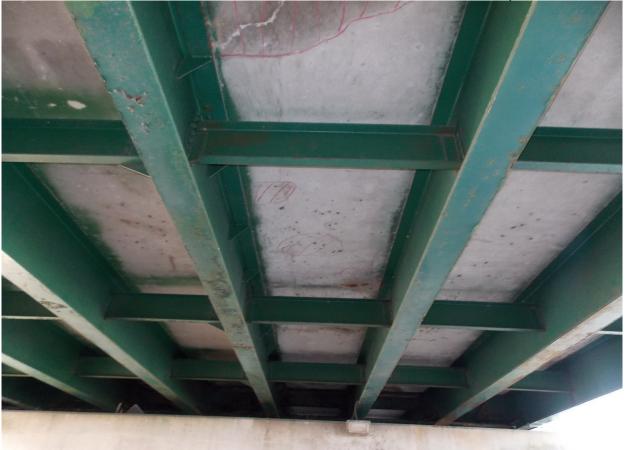
75 South Approach Span, Interior Soffit looking North

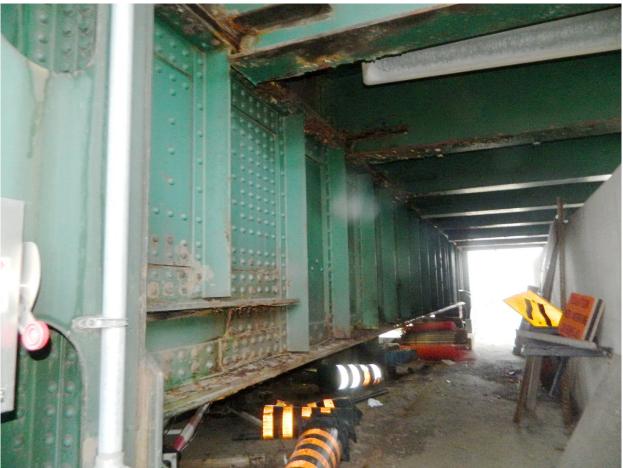
76 South Approach Span, Soffit & Stringers atop Rear Floor Beam of South Tower Span, looking East Page A2 [38] of A2 [153]

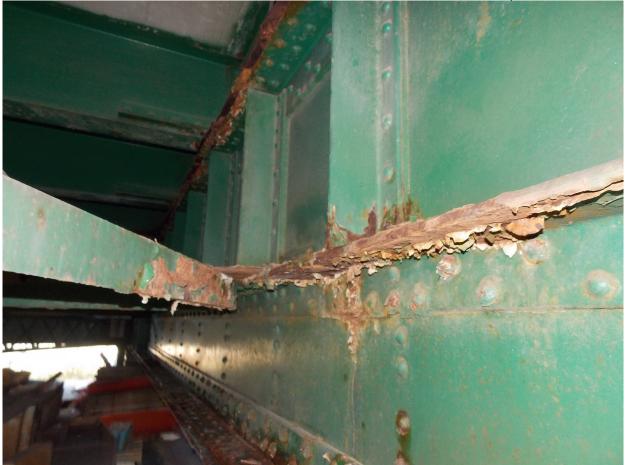
77 South Tower Span, Deck Soffit & Stringers @ Rear Floor Beam, looking East

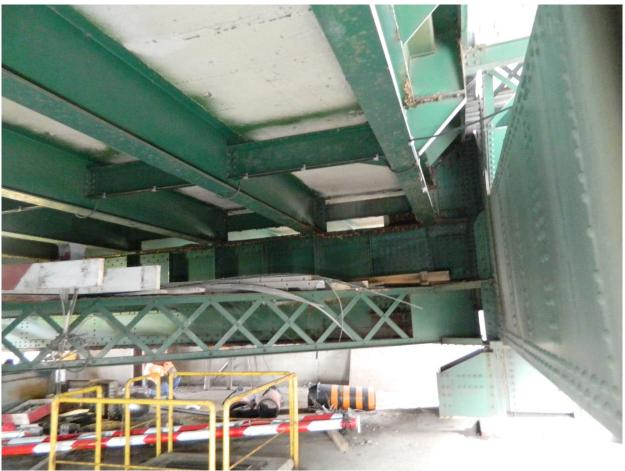
78 General View of Deck Underside @ South Tower Span, looking South

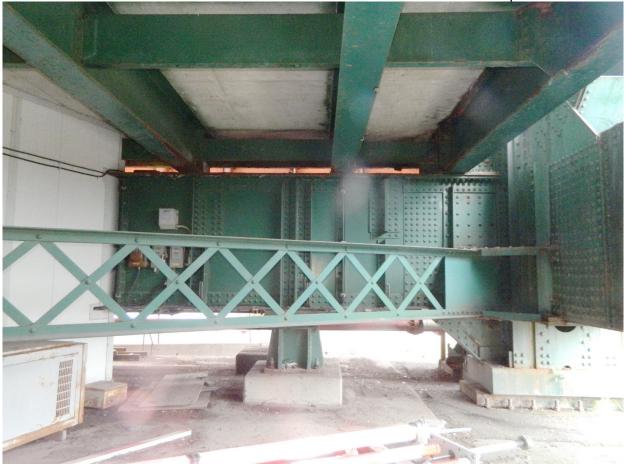
79 Deck Underside @ East Section of South Tower, looking North

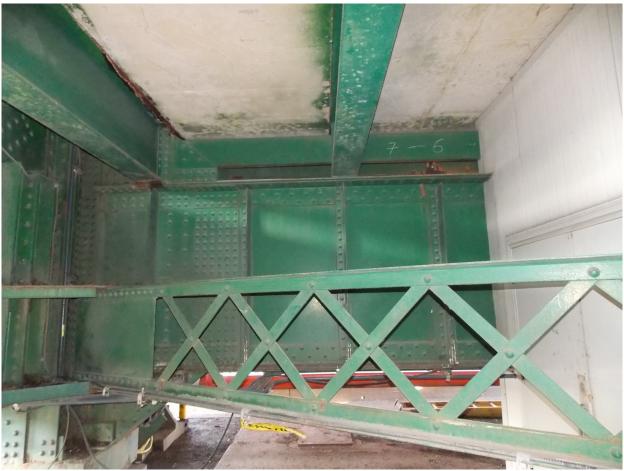
80 South Tower Span, Deck Underside @ West Section of Tower, looking North

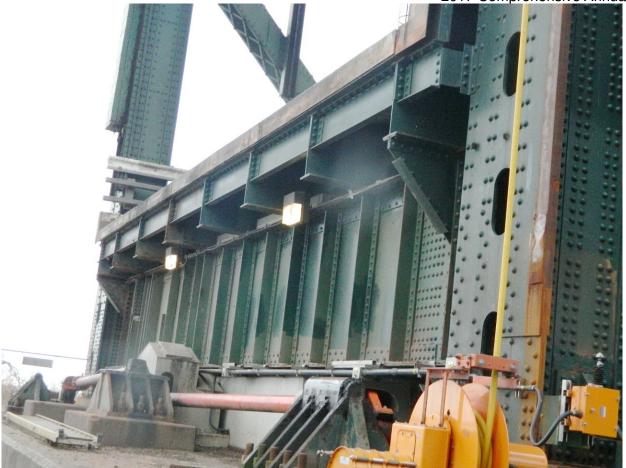
81 South Tower Span, Cantilevered Deck & Stringers @ Front Floor Beam (Lift Span Up)

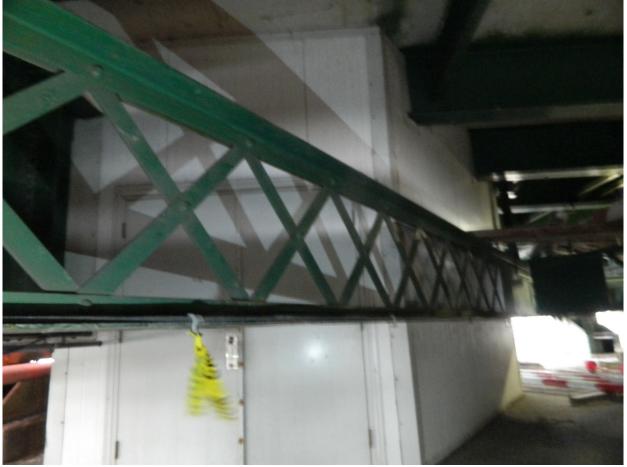
83 Typical Storage Shed @ Tower Base, South Tower Section Shown

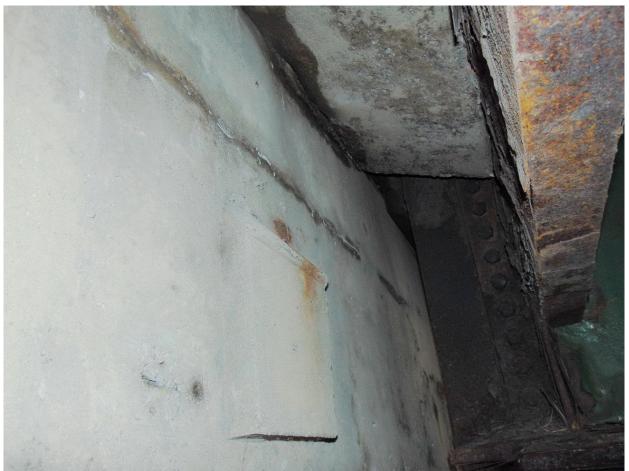
84 Typical Soffit sloping toward Stringers & Diaphragm @ North Abutment, Stringer 3 looking East Shown Page A2 [42] of A2 [153]

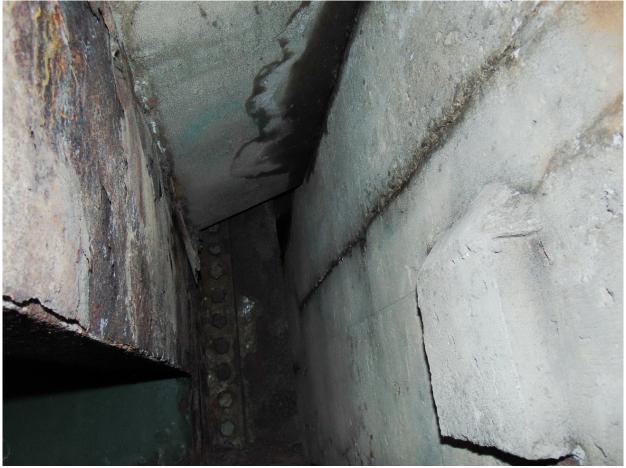
85 Typical Soffit Sloping Towards Structural Steel @ South Abutment, Stringers 3&4 Shown

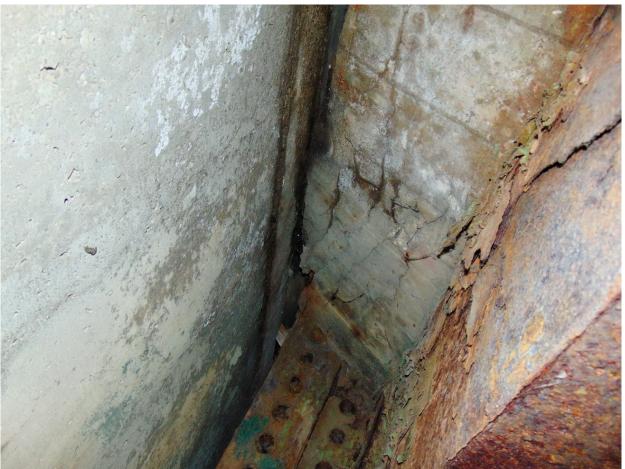
86 Typical Wet Soffit & Severe Corrosion on Steel below Abutment Joints, South End @ Stringers 5&6 Shown Page A2 [43] of A2 [153]

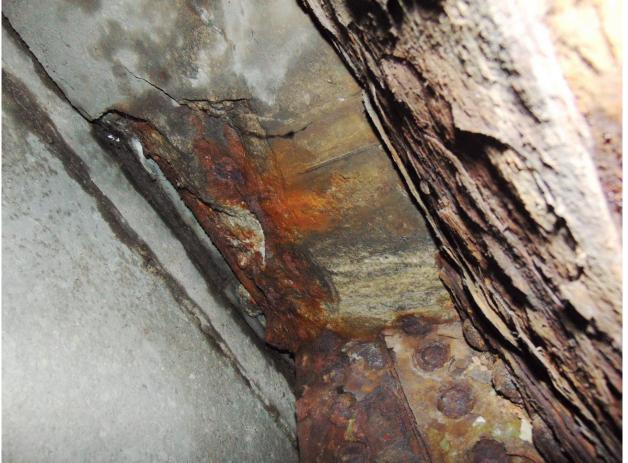
87 Heavy Wet Area with Large Delamination & Spalls at South Deck End, East of Stringer 5

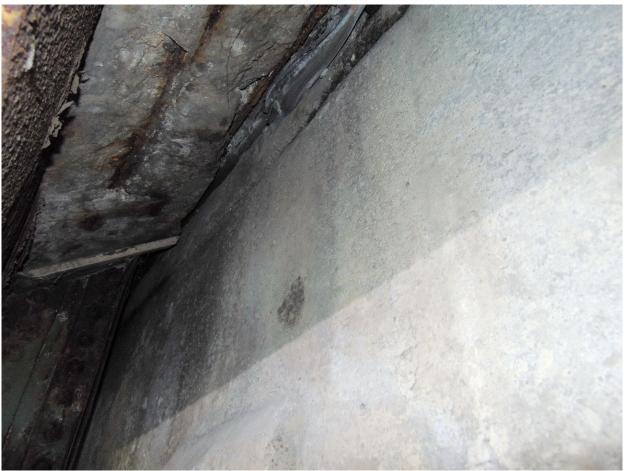
88 Wet Area & Spalls on South End Soffit between Stringers 6&7

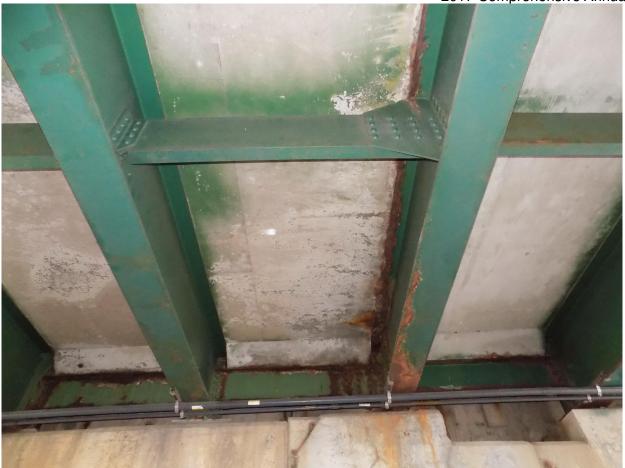
89 North Approach Span, Large Wet Areas on Soffit @ Central Interior Areas of Span

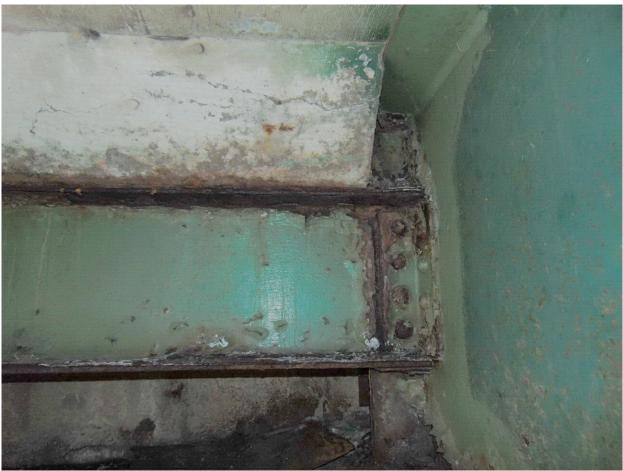
90 North Approach Span, Local Delam on Soffit atop North End Diaphragm @ Stringer 6 Page A2 [45] of A2 [153]

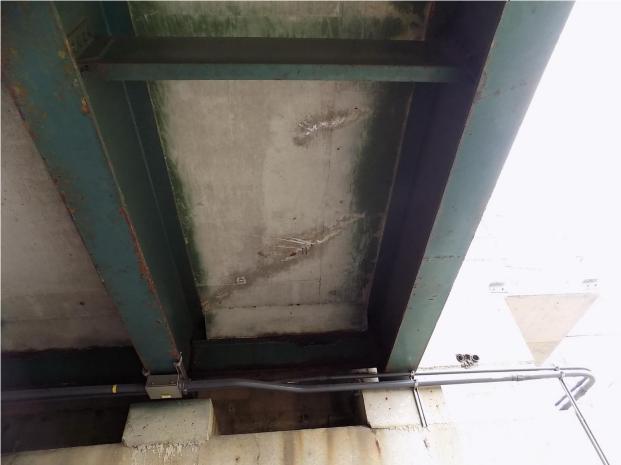
91 North Approach Span, Stained Diagonal Cracks @ Northeast Section

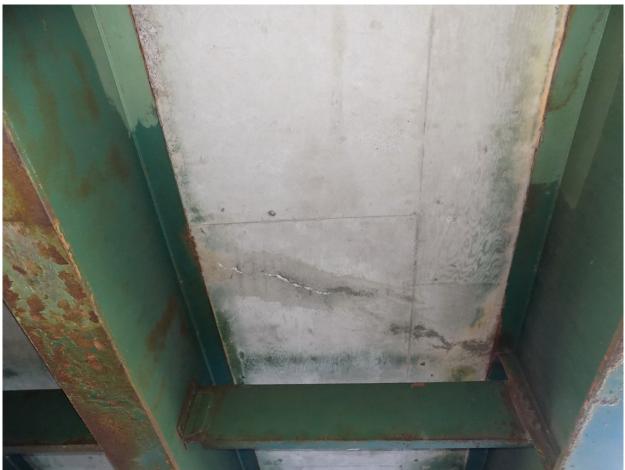
92 North Approach Span, Diagonal Stained Crack with Wet Area on East Soffit near Mid Section of Span Page A2 [46] of A2 [153]

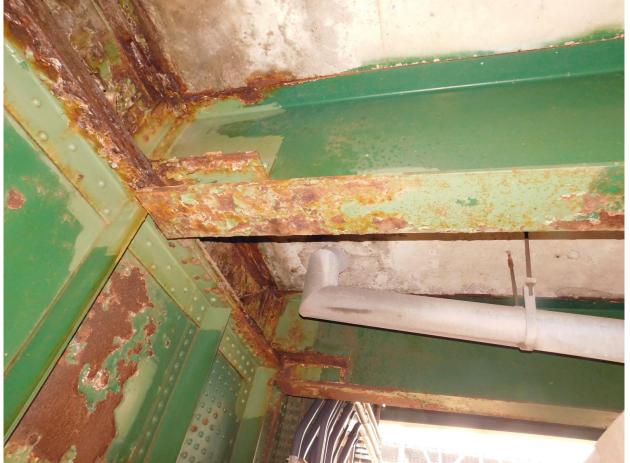
93 Wet Soffit & Heavy Corrosion on Steel below Exp Joint @ North Approach & Tower Spans, looking West

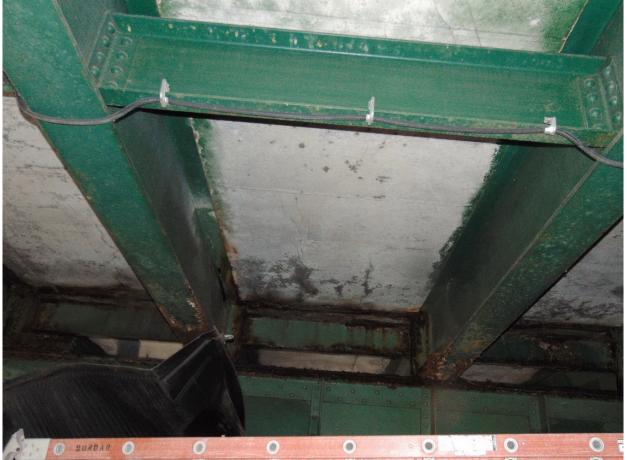
95 North Tower Span, Wet Areas on Soffit @ Northwest Section of Span

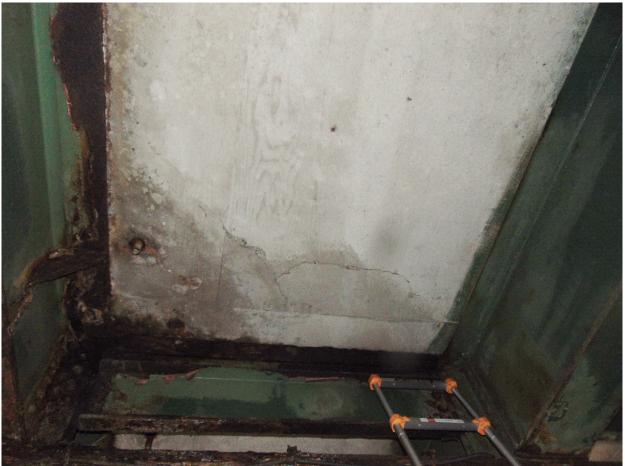
96 Wet Area & Delamination on Soffit between Stringers 3&4 near Exp Jt @ North End of North Tower Span Page A2 [48] of A2 [153]

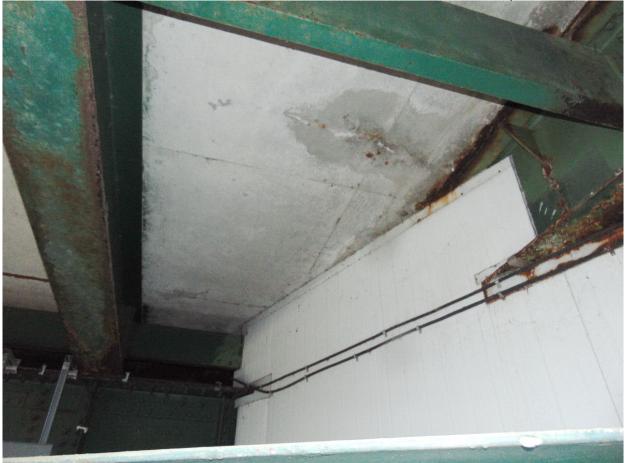
97 North Tower Span, Stained Crack with Wet Area on Interior Soffit near Mid-Span @ Stringer 4

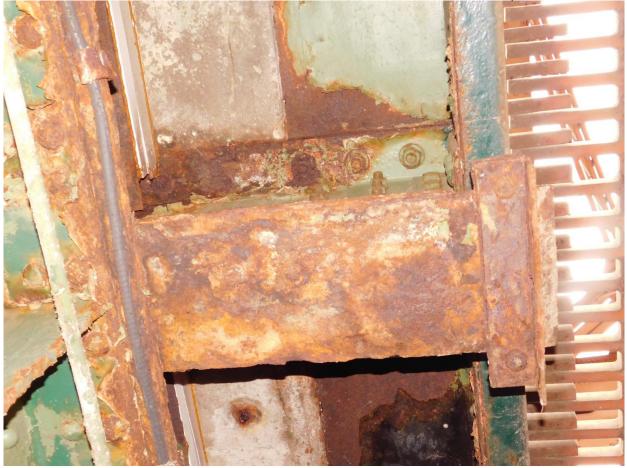
99 Wet Soffit & Heavy Corrosion on Stringer 4 below North Finger Plate Expansion Joint

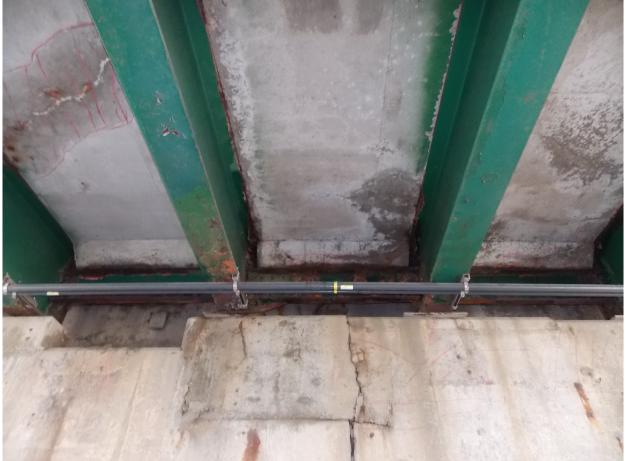
101 South Approach Span, Large Wet & Delam on Interior Soffit @ South Abutment

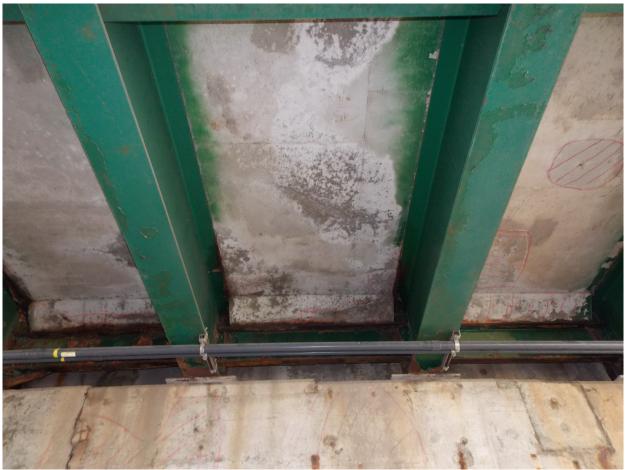
102 South Approach Span, Central Interior Soffit @ South Abutment

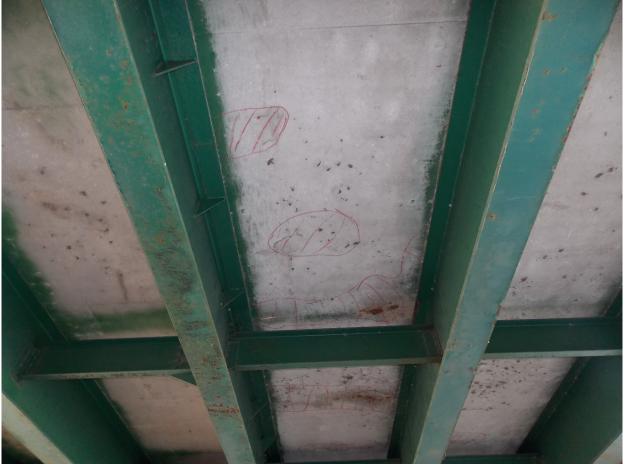
103 South Approach Span, Delam on Central Interior Soffit

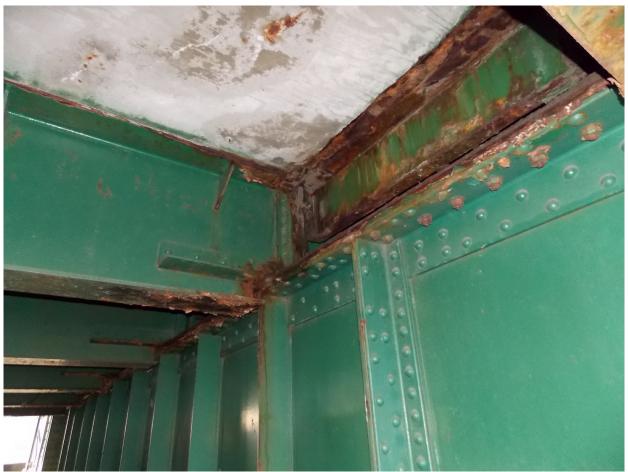
104 Wet Soffit @ North End of South Approach Span, looking West

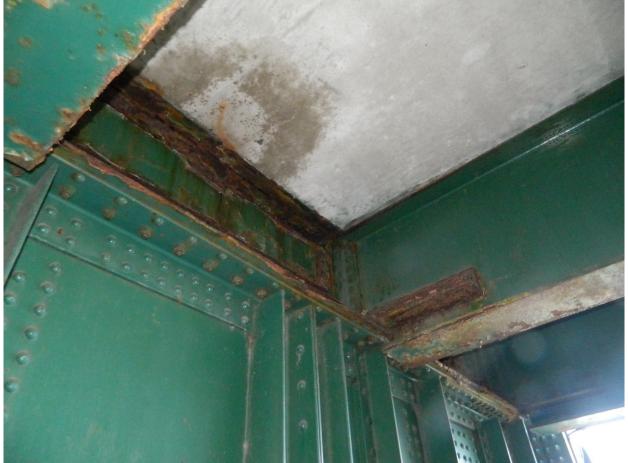
105 Wet Soffit @ Stringers 2&3 adjacent to Exp Joint @ North End of South Approach Span

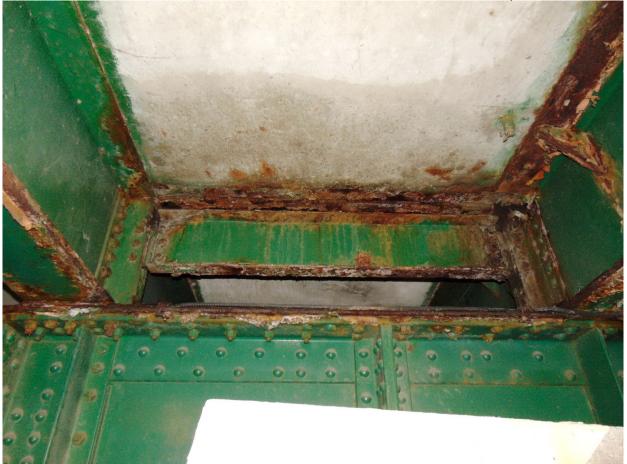
107 Wet Soffit @ Stringers 3&4 below Expansion Joint between South Approach & Tower Spans

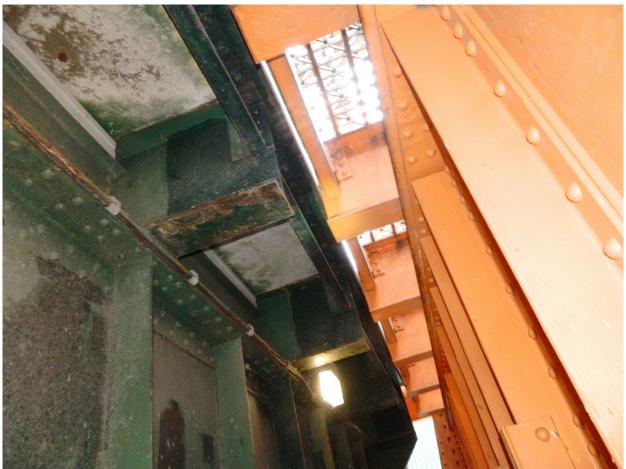
108 Overhang Soffit below Open Gap Expansion Joint @ North End of South Tower Span, looking West Page A2 [54] of A2 [153]

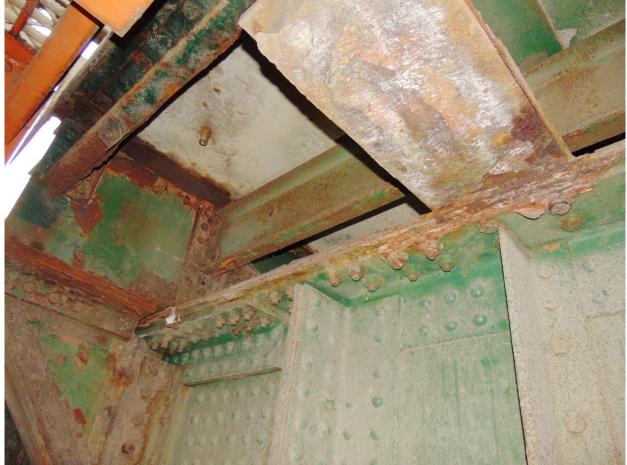
109 Wet Soffit & Heavy Corrosion on East Stringers below Open Gap Exp Joint @ NE corner of South Tower Span

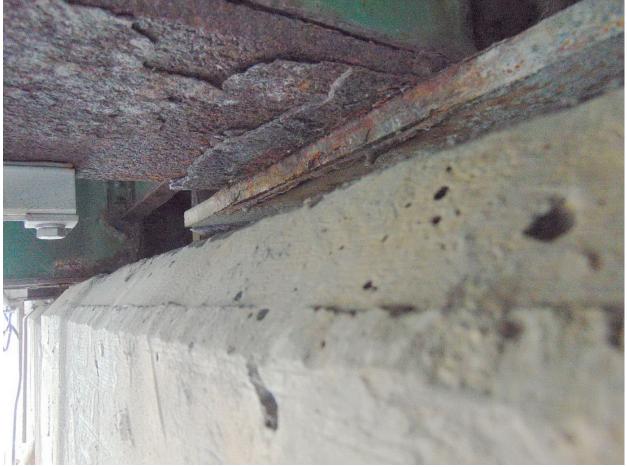
111 North Approach Span, Severe Corrosion on Bottom of Stringer 6 @ North Abutment
