2017 COMPREHENSIVE DETAILED INSPECTION BURLINGTON CANAL LIFT BRIDGE

Contract No. EQ754-181509/001/PWL Project No. R.089504.040

Revised March 29, 2018 (Rev .00)

RE: Burlington Canal Lift Bridge 2017 Comprehensive Detailed Annual Inspection Final Report

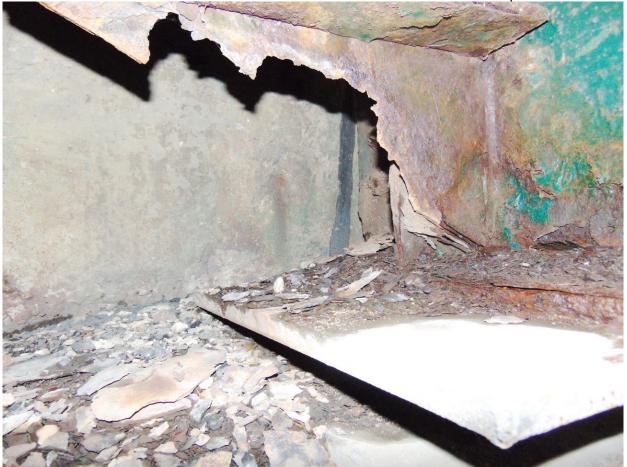
113 Severe Corrosion on Stringer 8 & Perforated Stiffener for Diaphragm @ South Abutment

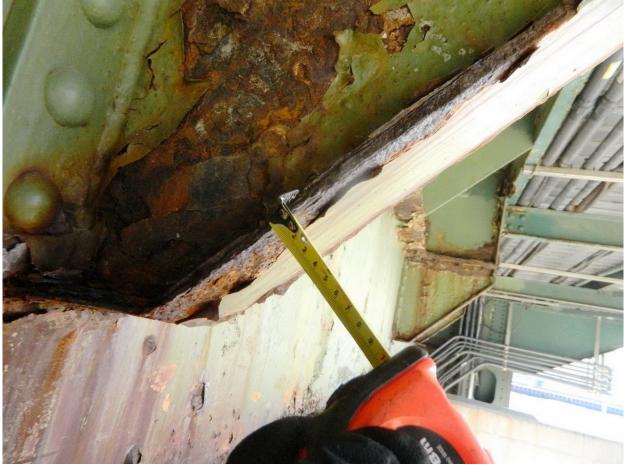
115 Local Severe Corrosion on Bracket for Cantilevered West Sidewalk @ North Approach Span

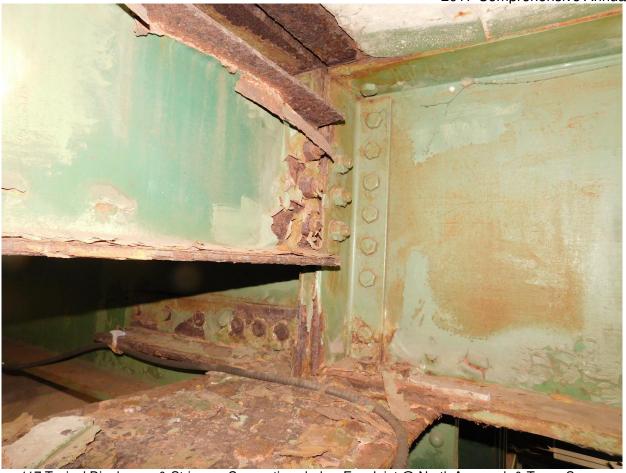
117 Typical Diaphragm & Stringers Connections below Exp Joint @ North Approach & Tower Spans

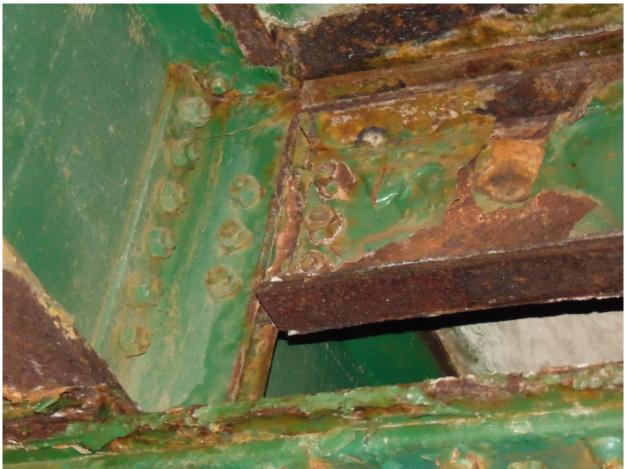
118 Typical Stringers & Diaphragm Connections below Exp Joint between South Approach & Tower Spans Page A2 [59] of A2 [153]

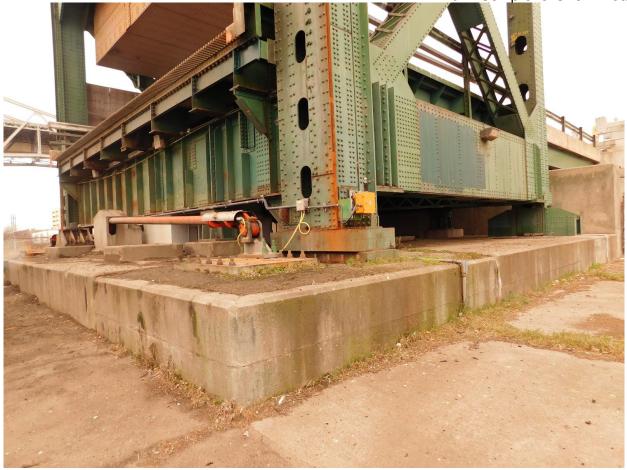
119 Concrete Pier @ North Tower Base (Lift Span Up), looking West

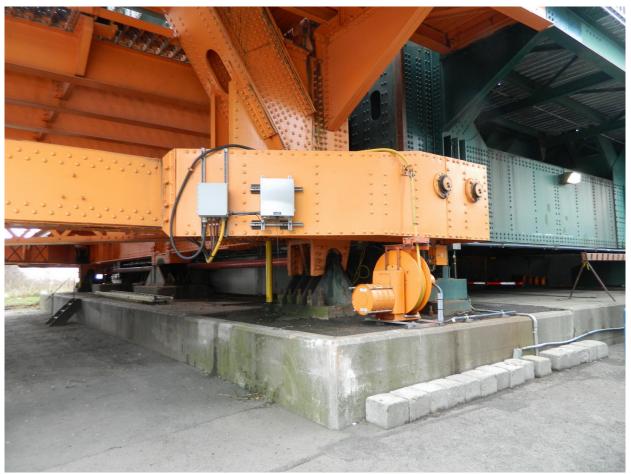
120 Concrete Pier @ South Tower Base (Lift Span Down), looking East

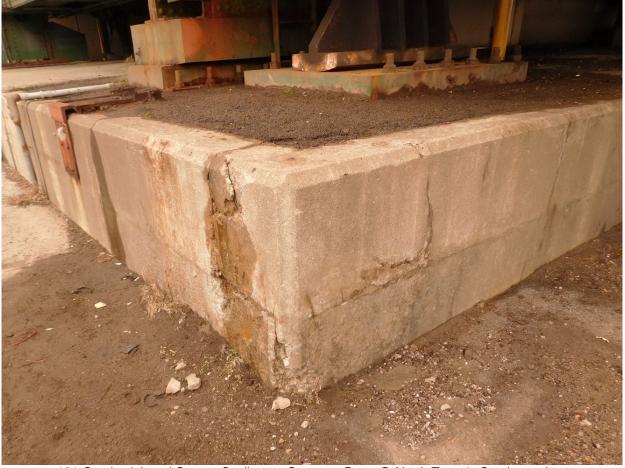
121 Cracks & Local Severe Scaling on Concrete Base @ North Tower's Southwest Leg

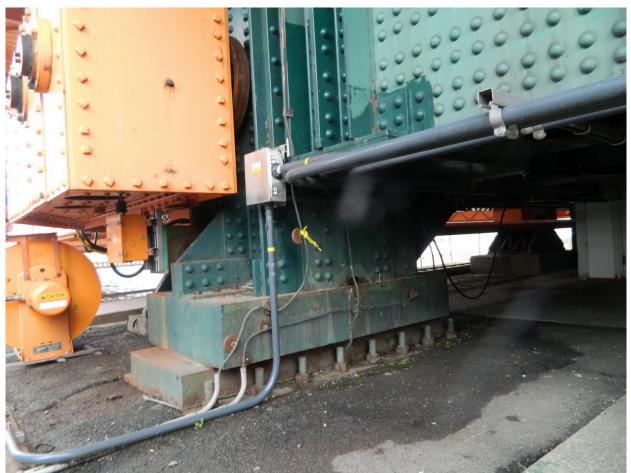
122 Typical Anchorage Assembly @ Front Tower Column, Northwest Column @ South Tower Shown Page A2 [61] of A2 [153]

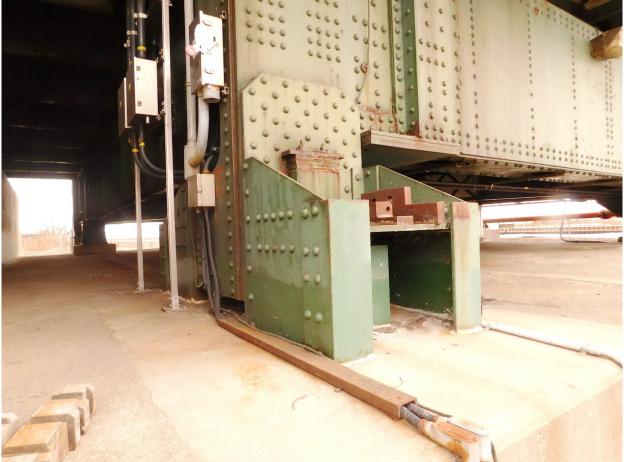
123 Typical Anchorage Assembly on Rear Tower Column, Northwest Column @ North Tower Shown

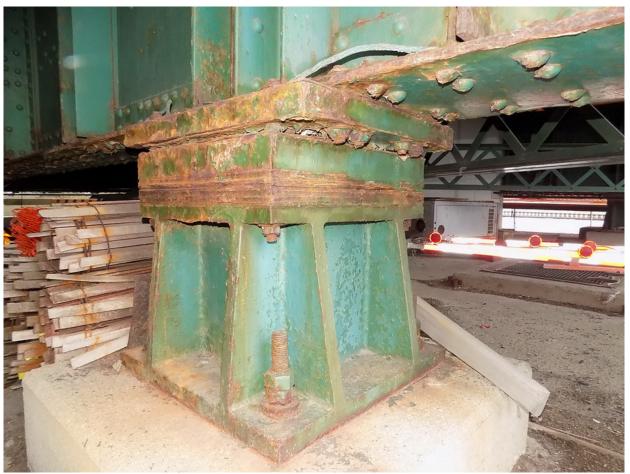
124 South Tower Base, Interior Steel Pedestal Bearing under South Floor Beam

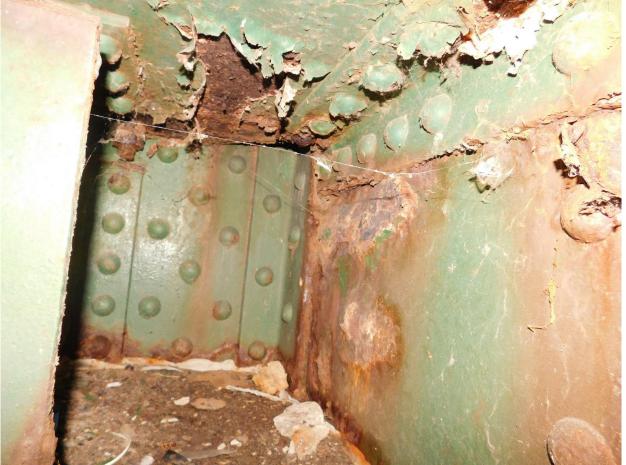
125 Local Severe Corrosion on Anchor Assembly for NW Rear Column @ North Tower

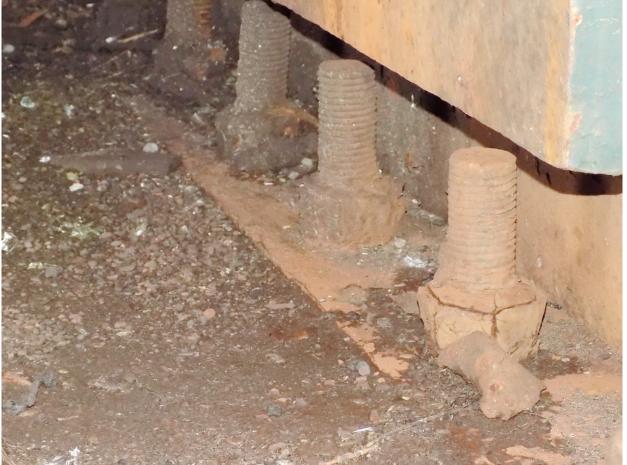
127 Severe Corrosion on Anchor Bolts for Anchorage Assembly for Front Tower Column, NW Column @ South Tower

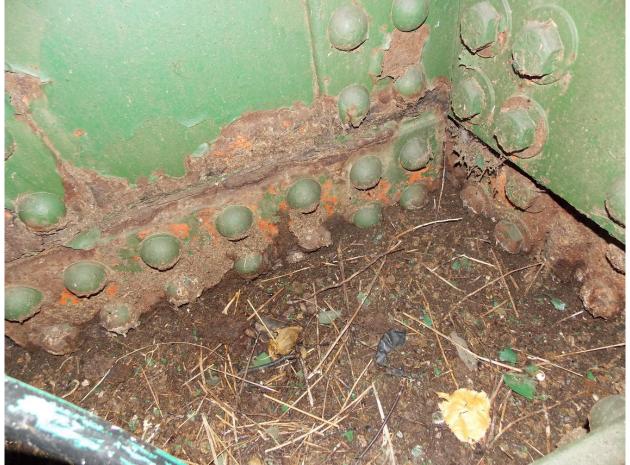
129 Sediment Accumulation @ Interior Bottom Plate of Tower Column, Northeast Column @ North Tower Shown

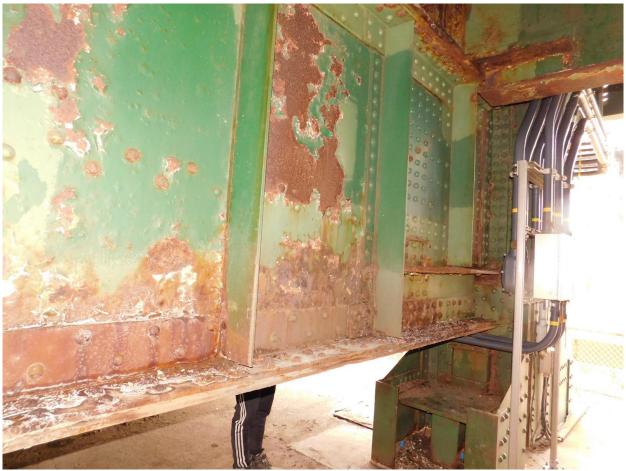
130 North Tower, Heavy Corrosion on North Face of Rear Floor Beam near NW Column Page A2 [65] of A2 [153]

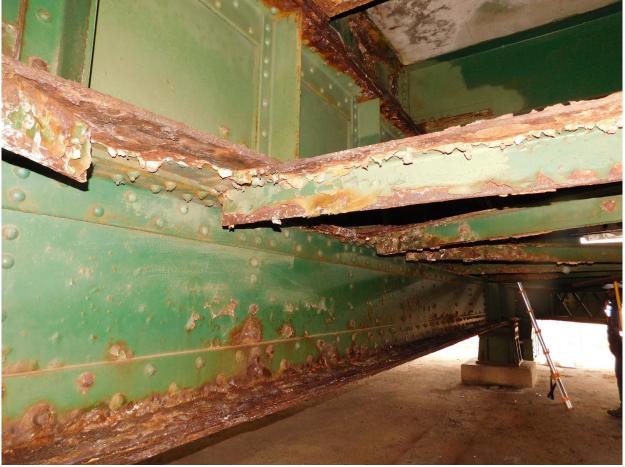
131 North Tower, Medium-Severe Corrosion on South Face of Rear Floor Beam, looking East

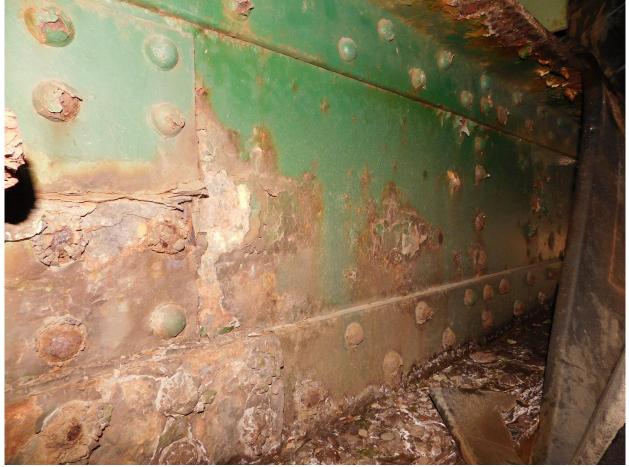
133 North Tower, Severe Corrosion on Lower South Face Section of Rear Floor Beam near NW Column

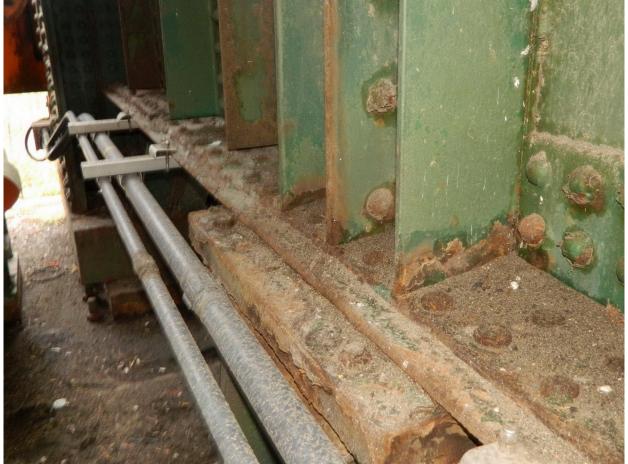
135 Typical Accumulation of Sediment on Front Floor Beam, South Tower Shown

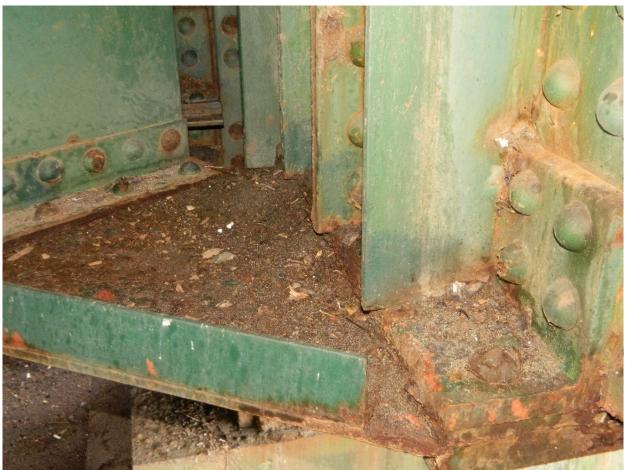
136 Sediment on Gusset Plate behind Front Tower Column, Northeast Column @ South Tower Shown Page A2 [68] of A2 [153]

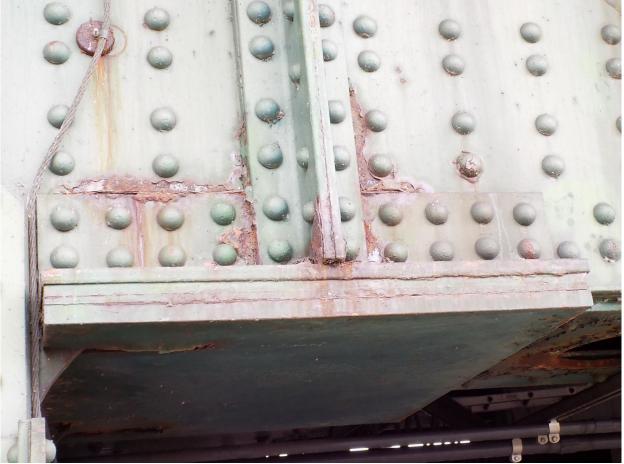
139 Local Medium Rust Jacking on Bottom North Section of West Jacking Girder @ North Tower (TYP)

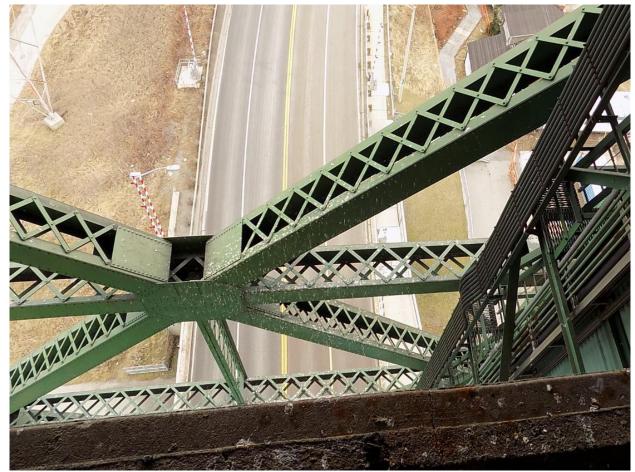
146 Typical Bird Dropping on Tower Steel, South Tower Shown

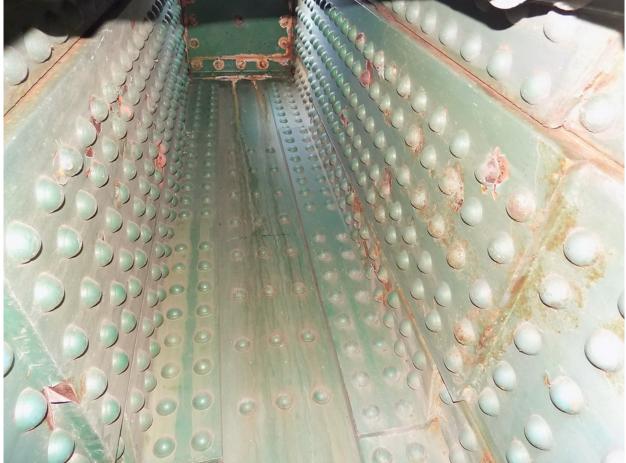
147 Typical Local Peeled Paint & Light Rust on Column Interior, Northeast Column of South Tower Shown

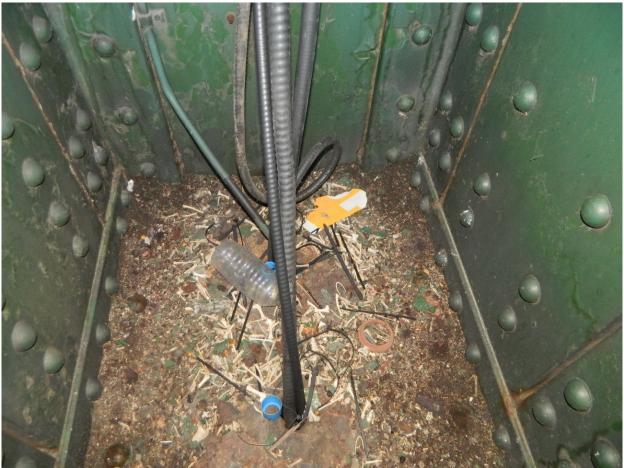
148 Debris on Interior Plate in Northwest Column of North Tower @ Sidewalk Level (TYP) Page A2 [74] of A2 [153]

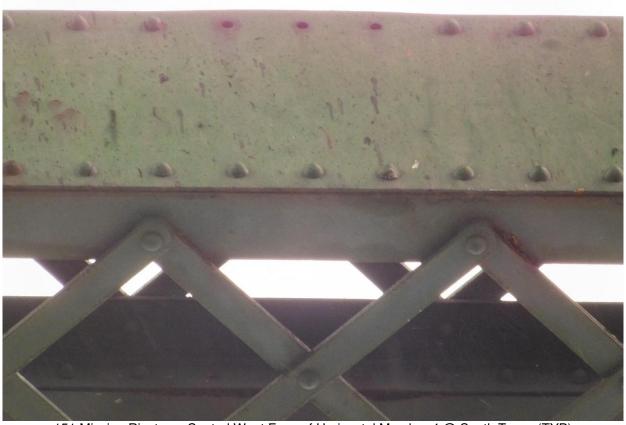
151 Missing Rivets on Central West Face of Horizontal Member 4 @ South Tower (TYP)

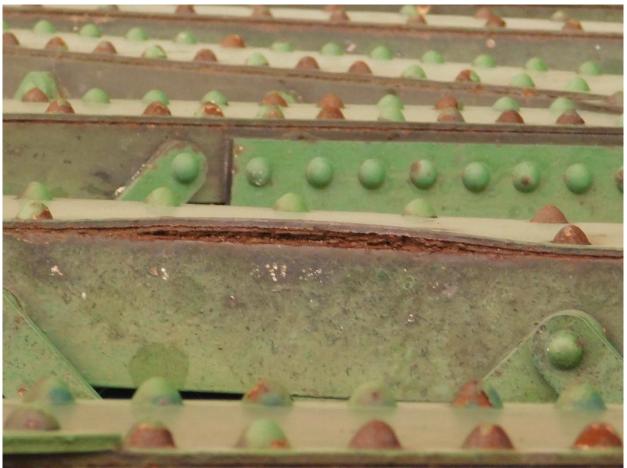
152 Severe Rust Jacking @ Missing Rivets on Horizontal Member 4 of South Tower (TYP) Page A2 [76] of A2 [153]

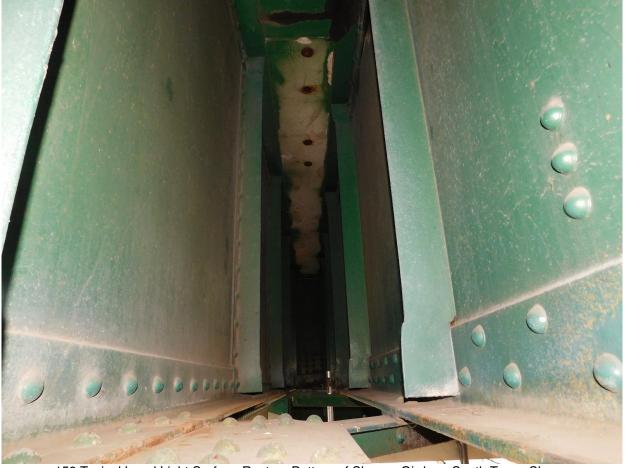
159 Typical Local Light Surface Rust on Bottom of Sheave Girders, South Tower Shown

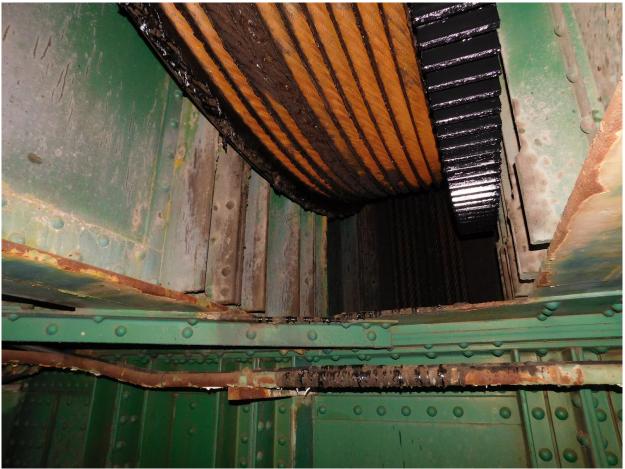
160 Typical Light Corrosion on Bottom of Sheave Girders, South Tower Shown

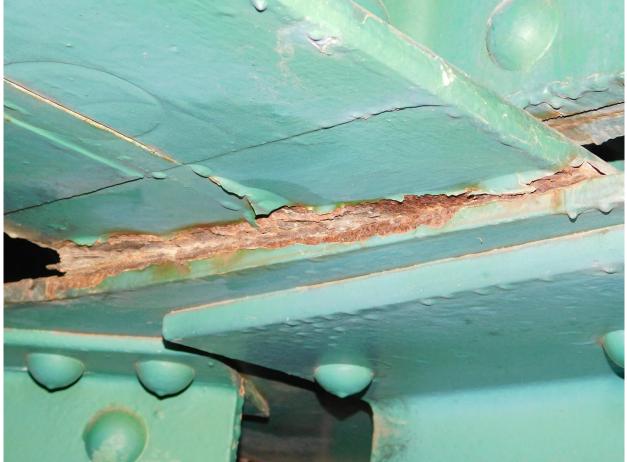
161 Severe Rust Jacking on Bottom North End of 3rd Sheave Girder from West in South Tower

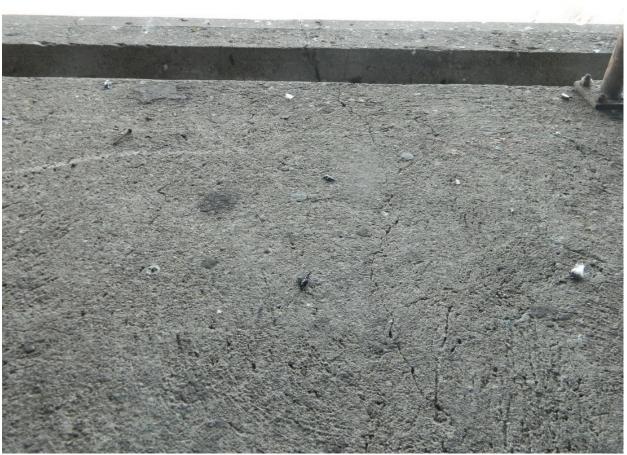
168 Typical Medium Crack on Top Surface of Concrete Counter Weight, North Tower Shown Page A2 [84] of A2 [153]

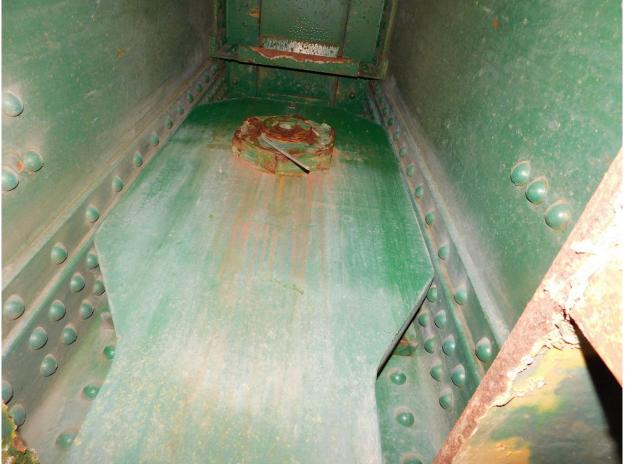
169 Light Surface Rust on Pin for Counter Weight Hanger Plates @ South Tower (TYP)

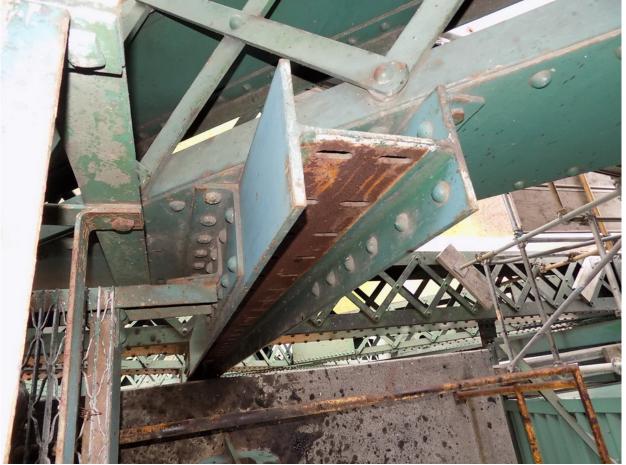
171 Missing Guide-Bar Angles @ top Section of West Guiderail for Counter Weight in North Tower

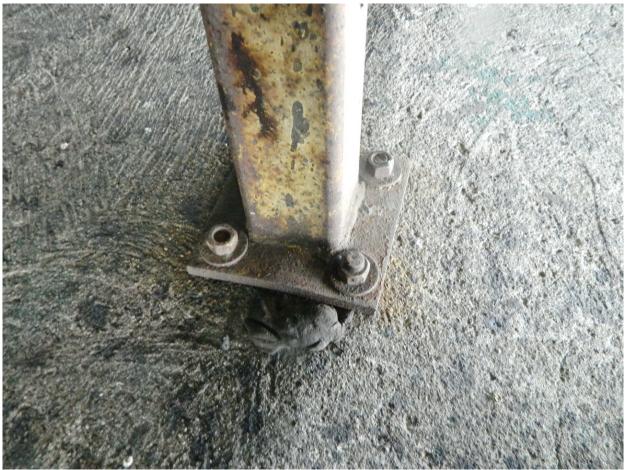
174 Loose Anchor Bolt on Central Post of Safety Rail atop South Counter Weight

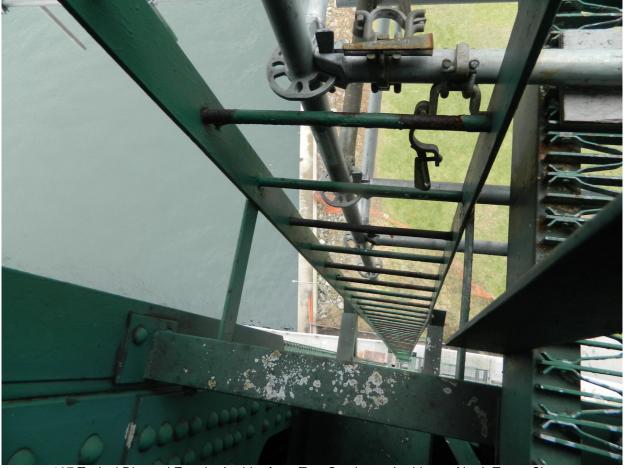
186 Typical Disconnected Lower Section of Disused Exterior Ladder, South Tower near Northwest Column Shown Page A2 [93] of A2 [153]

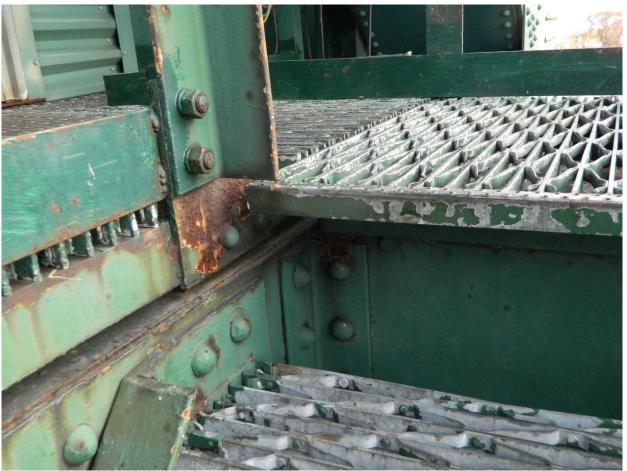
189 Severe Rust Jacking @ Top of Floor Beam for Lower Catwalk of South Tower (TYP)

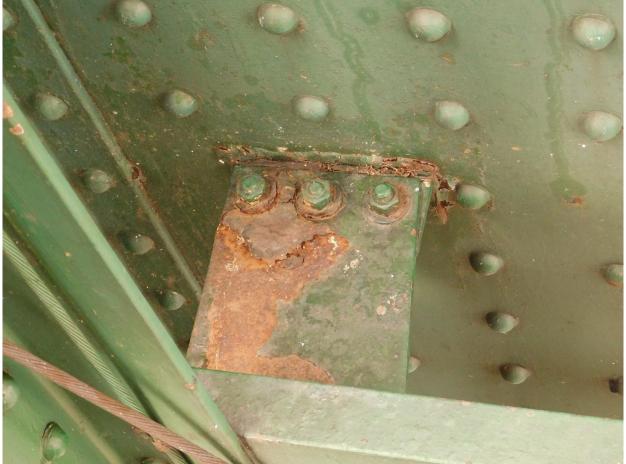
190 Light-Medium Corrosion on Anchor Plate for Catwalk Railing @ South Tower (TYP) Page A2 [95] of A2 [153]

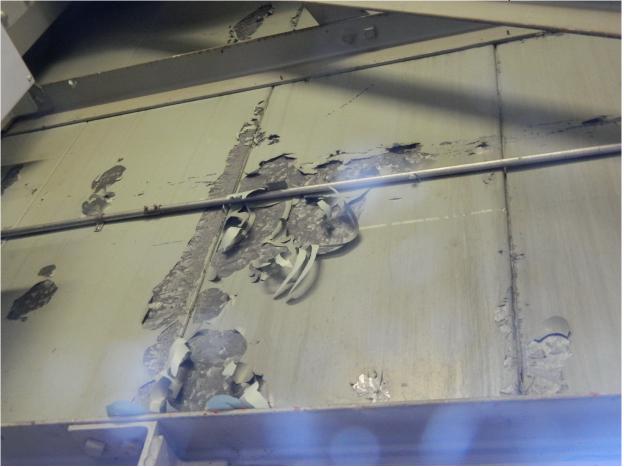
206 Typical Peeled Coating on Walls & Roof Panel in Sheave Room, North Tower Shown Page A2 [103] of A2 [153]

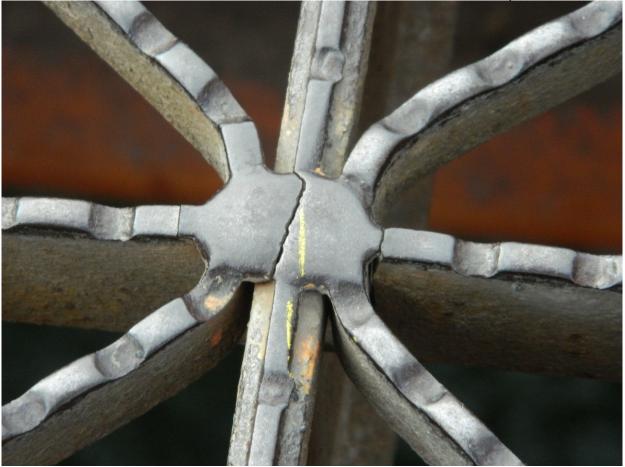
218 Typical Weld Repaired on Original Deck Grating

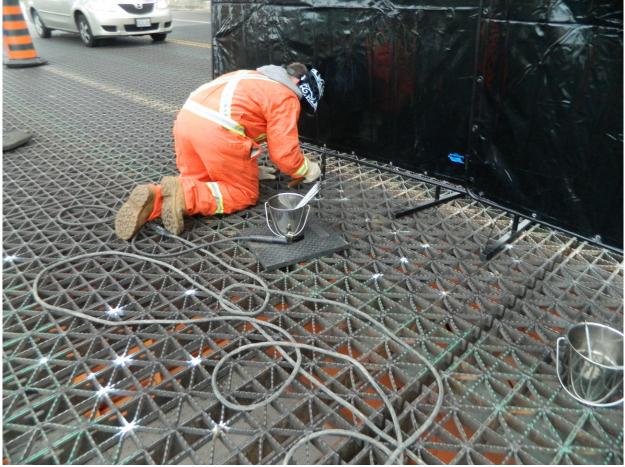
221 Emergency Welding Repairs of Severe Cracks & Broken Deck Grating (TYP)

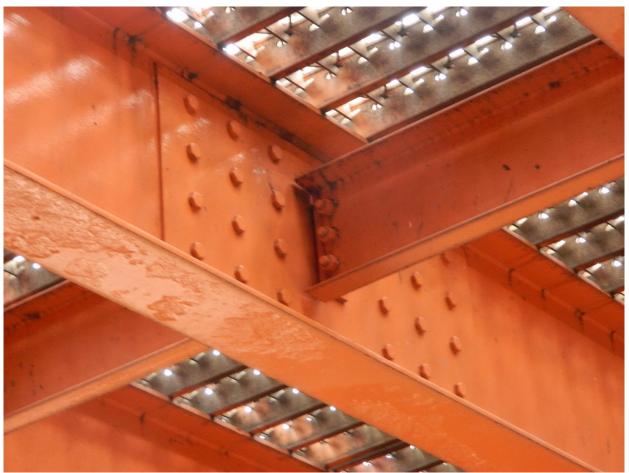
232 Typical Painted-Over Pitted Stringer Surface @ Lift Span

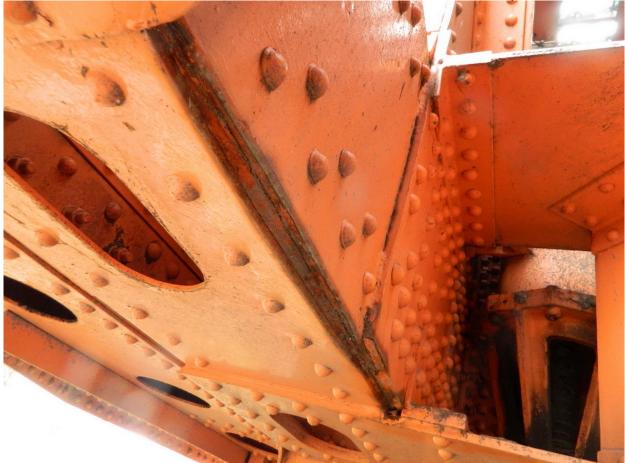
233 Typical Localized Corrosion on Truss Bottom Chord

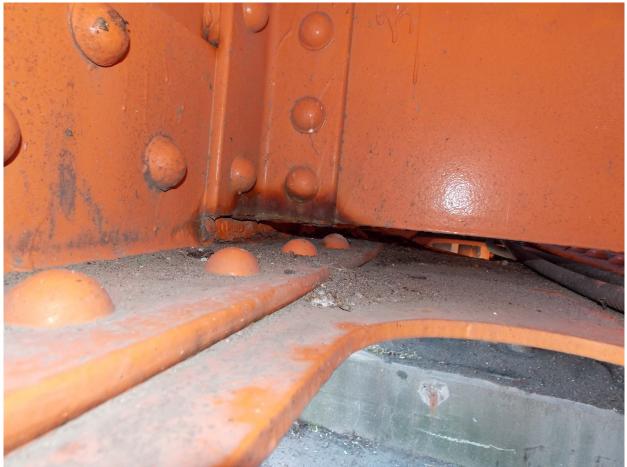
234 Local Light-Medium Corrosion on Internal Stiffener Plate near South End of East Deck Truss Page A2 [117] of A2 [153]

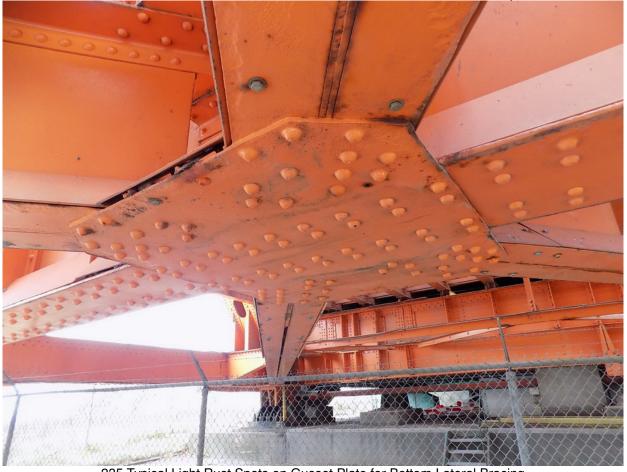
235 Typical Light Rust Spots on Gusset Plate for Bottom Lateral Bracing

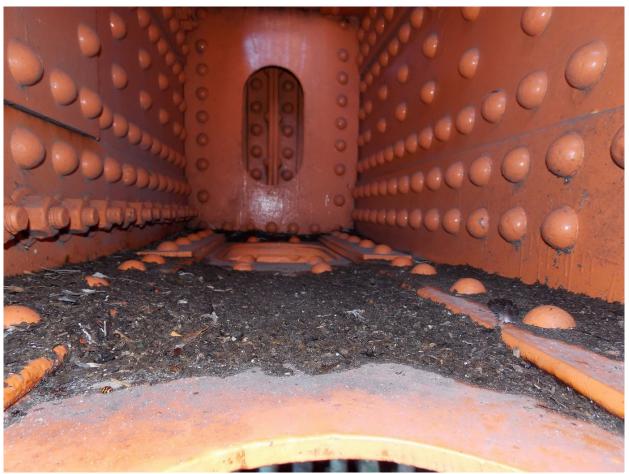
236 Bird Guano in Bottom Chord @ Southeast Corner of Lift Span

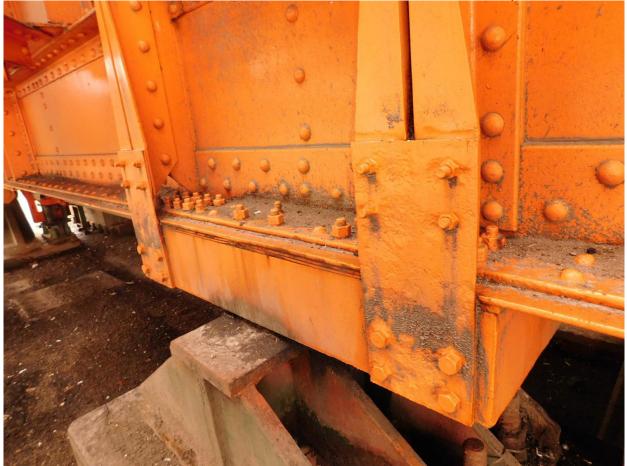
237 Typical Painted-Over Pitted Connecting Plate Surface on End Floor for Centering Shoe, North End Shown

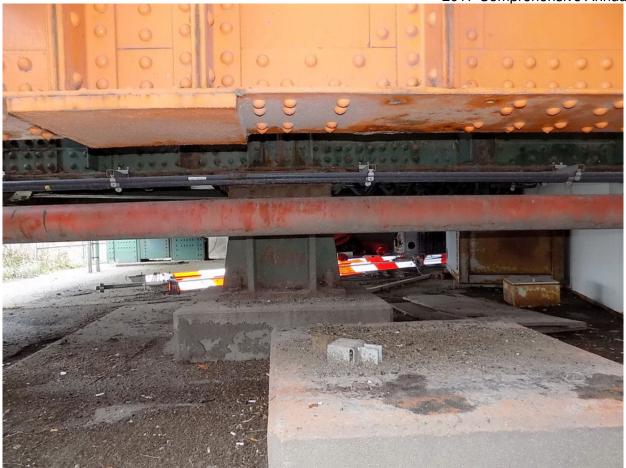
239 Removed Shoe Plate from Bottom Flange Railway Live Load Support @ South Pier (TYP)

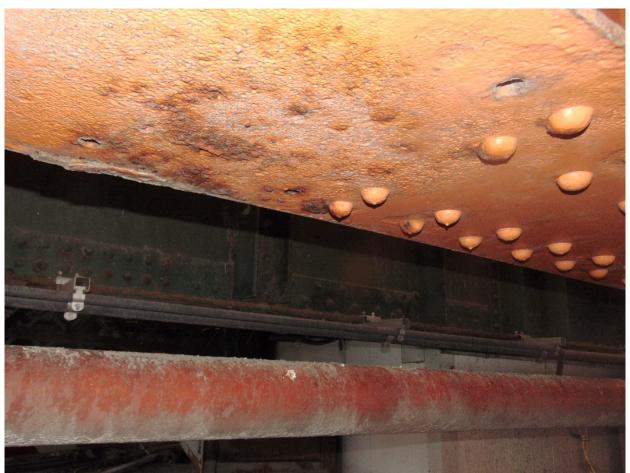
240 Light Rust Stains Bottom Flange & Rivet Holes @ Removed Shoe Plate for Rail Support(TYP) Page A2 [120] of A2 [153]

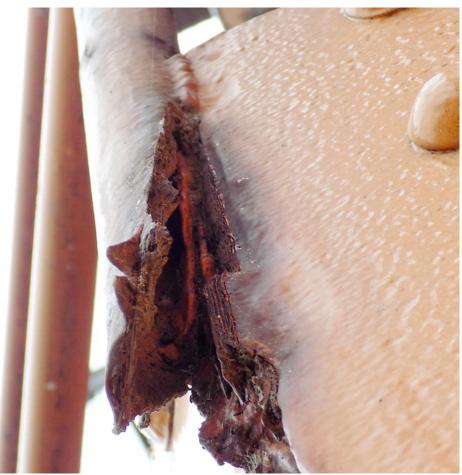
242 Typical Severe Corrosion on Railing Post @ Southeast Lower Guide Bracket

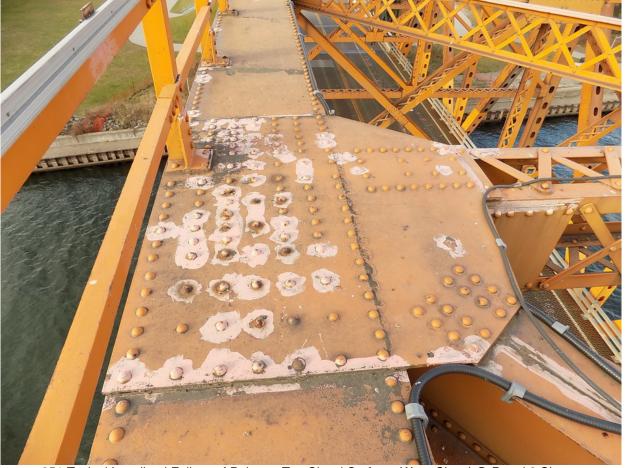
251 Typical Localized Failure of Paint on Top Chord Surface, West Chord @ Panel 3 Shown

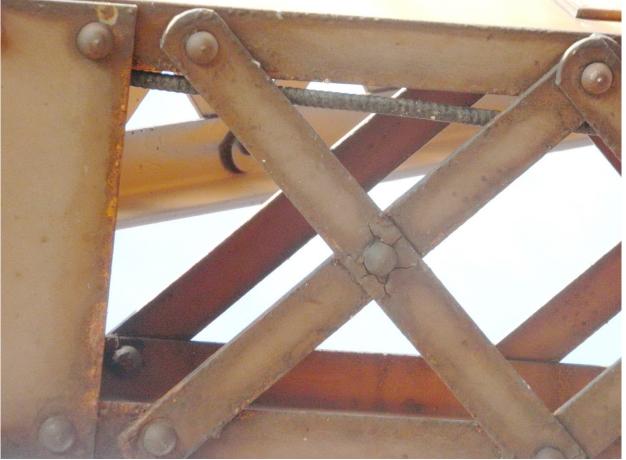
255 Typical Localized Paint Failure @ Lattice on Sway Frame Built-up Member

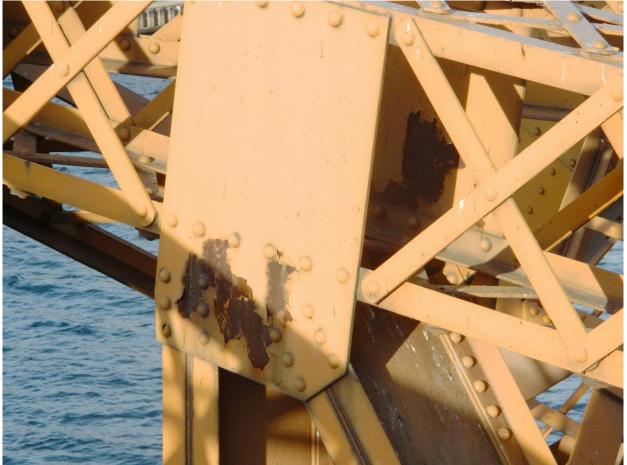
257 Peeled Paint & Light Corrosion on Gusset Plate @ South Portal Bracing

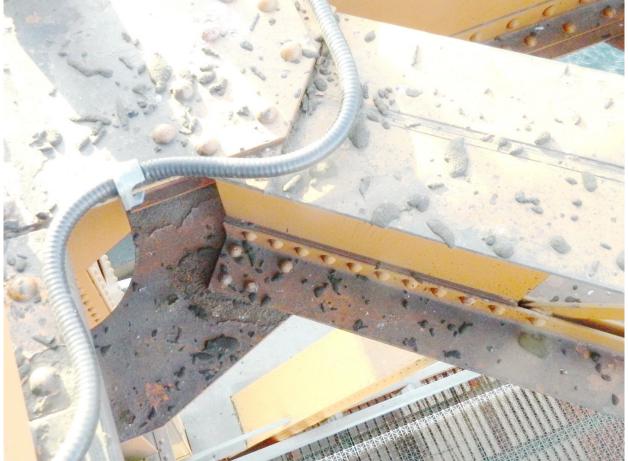
259 Light-Medium Corrosion on top of Portal Bracing Gusset Plate @ West Corner of South Lifting Girder

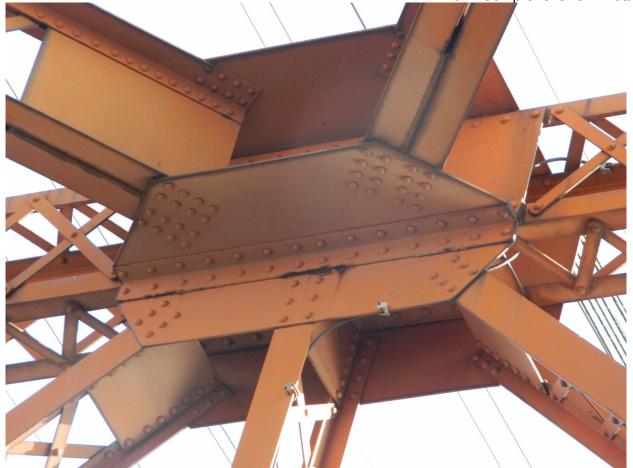
261 Light-Medium Rust Jacking on Gusset Plat @ Mid Section of Upper Horizontal of Sway Bracing @ Panel 5

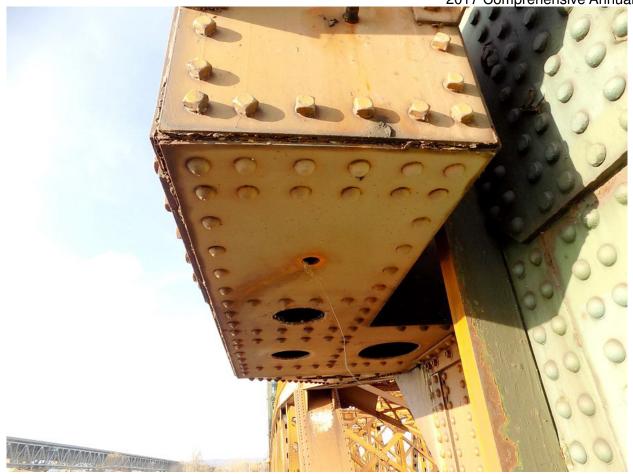
263 Light-Medium Rust Jacking on Bottom Corners of Southwest Guide Roller Assembly

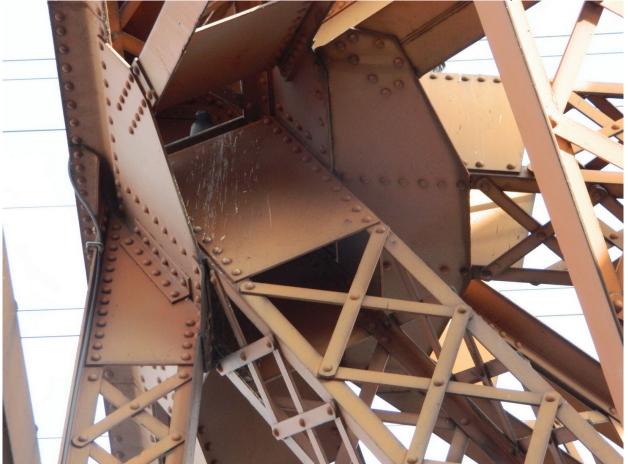
265 Bird Nesting in Mid Section of South Portal Strut

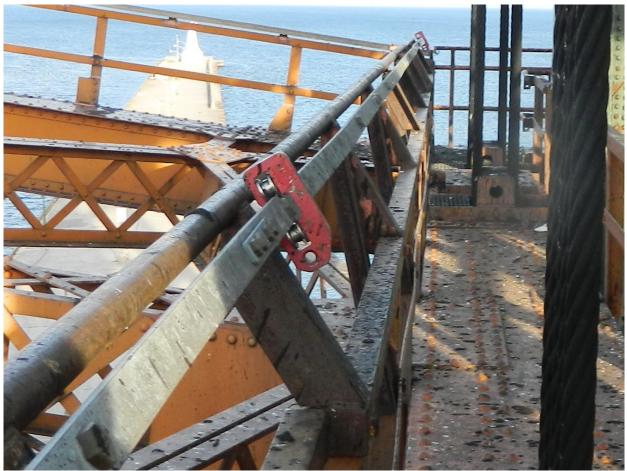
268 Sure-Rail Fall Arrest Device @ South Lifting Girder (TYP)

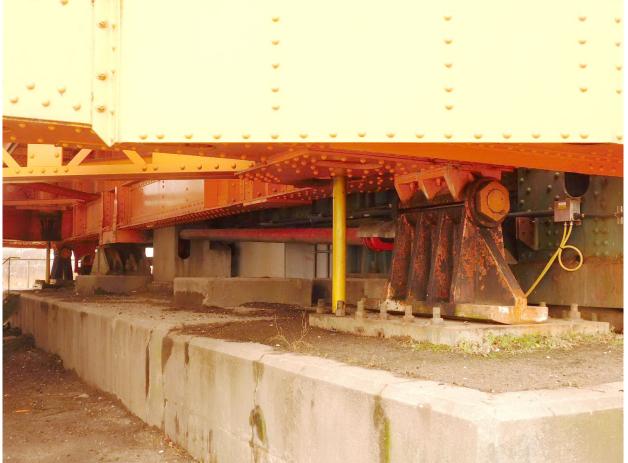
269 General View of Bearings @ North End of Lift Span, looking West

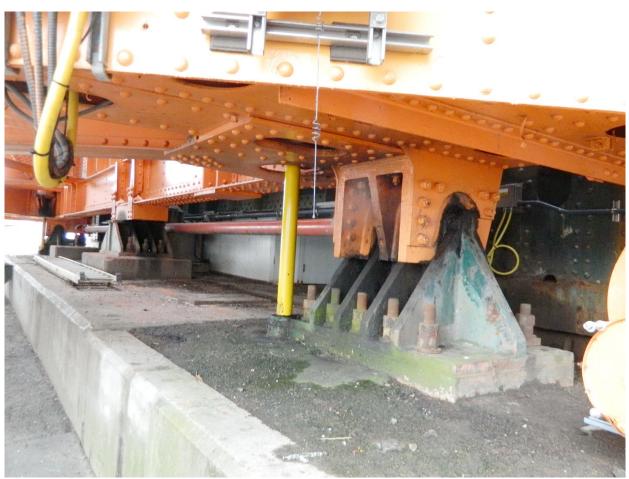
270 General View of Bearings @ South End of Lift Span, looking East

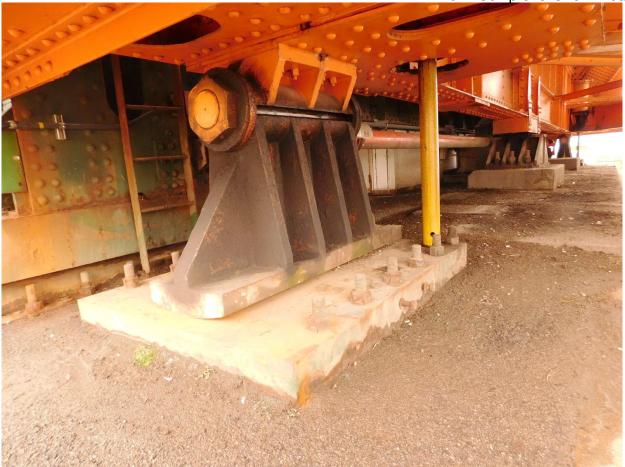
271 Rocker Bearing @ Northwest Corner of Lift Span

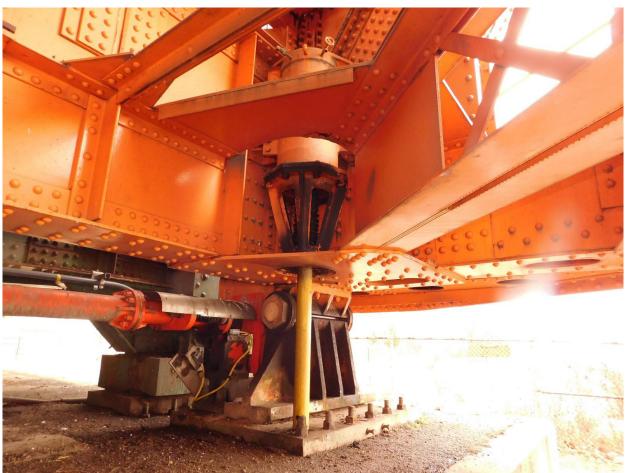
272 Roker Bearing & Air Cushion @ Northeast Corner of Lift Span (TYP)

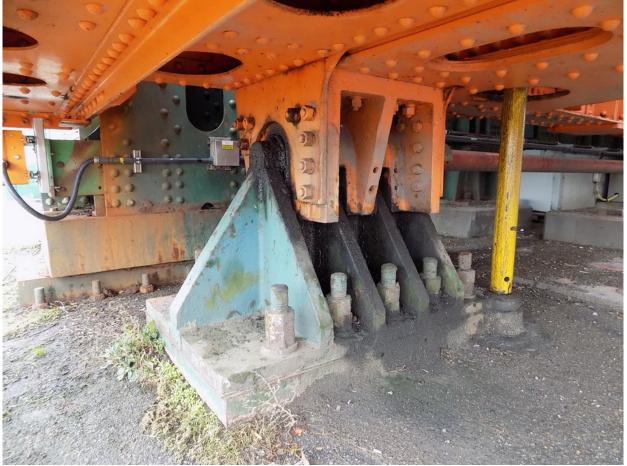
273 Steel Saddle Bearing @ Southeast Corner of Lift Span

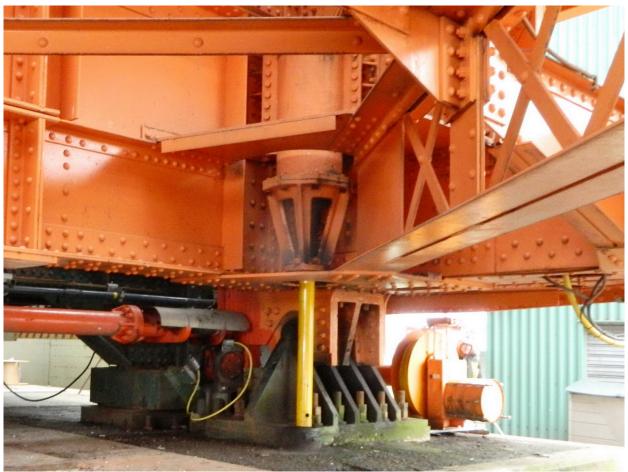
274 Saddle Bearing & Air Cushion @ Southwest Corner of Lift Span (TYP)

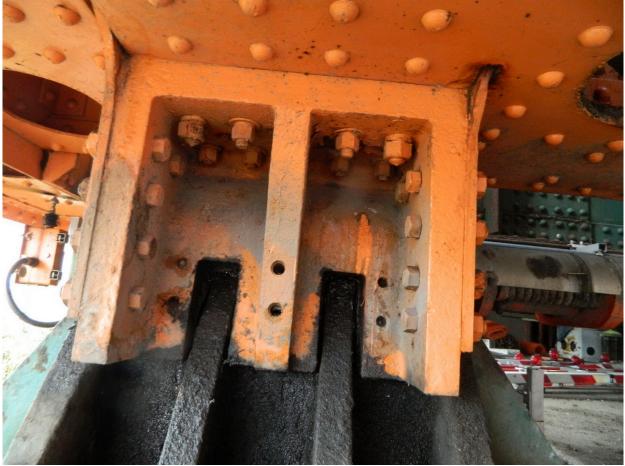
275 Bolts on Saddle Shoe Plate @ Southeast Bearing

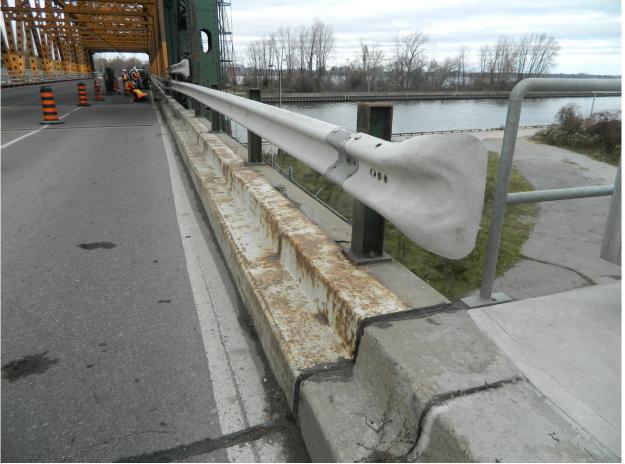
277 Steel Beam Guiderail on East Side of South Approach looking North

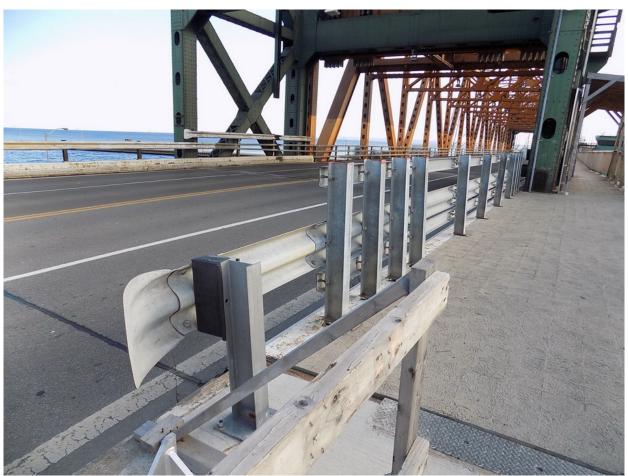
278 Steel Beam Guiderail and Channel on West Side of North Approach, looking South Page A2 [139] of A2 [153]

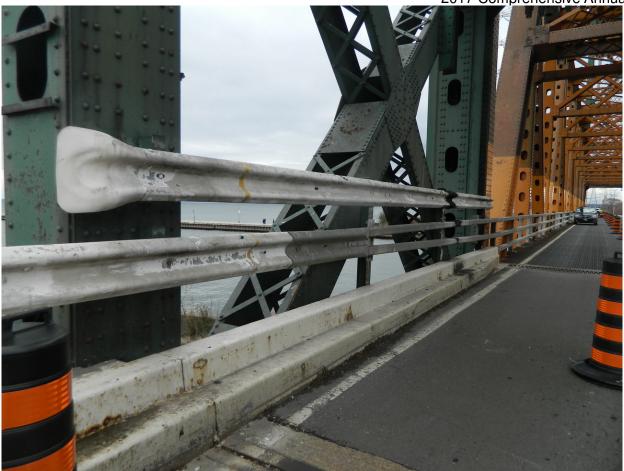
279 Typical Traffic Guiderail @ Tower Span, East Side of North Tower Shown

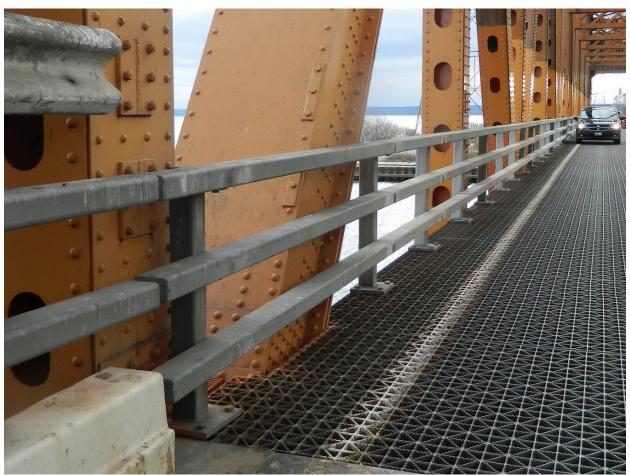
280 Typical Traffic Railing on East Side of Lift Span

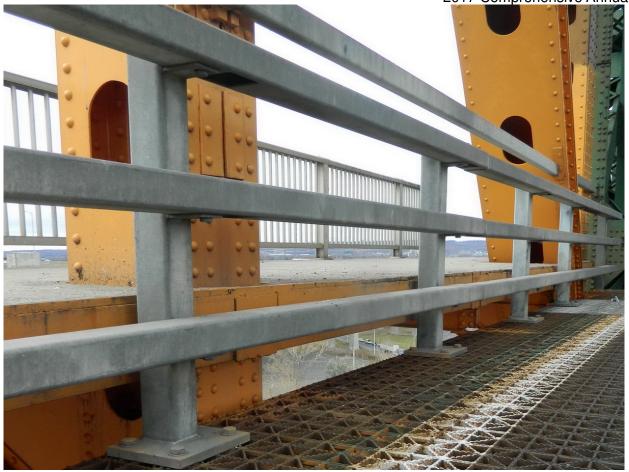
281 Typical Traffic Railing on West Side of Lift Span

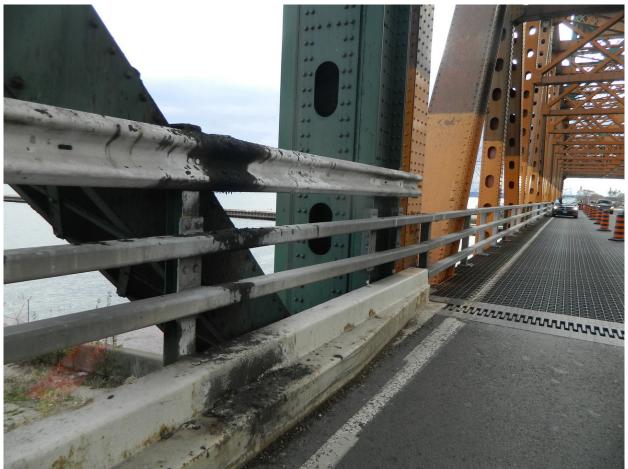
282 Typical Grease on Railings below Counterweight Guiderail @ Tower Span, East Railing @ North Tower Shown Page A2 [141] of A2 [153]

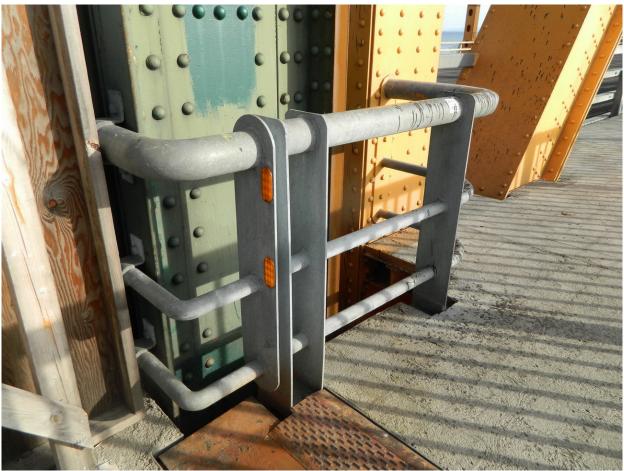
284 Pedestrian Pipe Railing on West Sidewalk @ North Tower Column and Lift Span (TYP) Page A2 [142] of A2 [153]

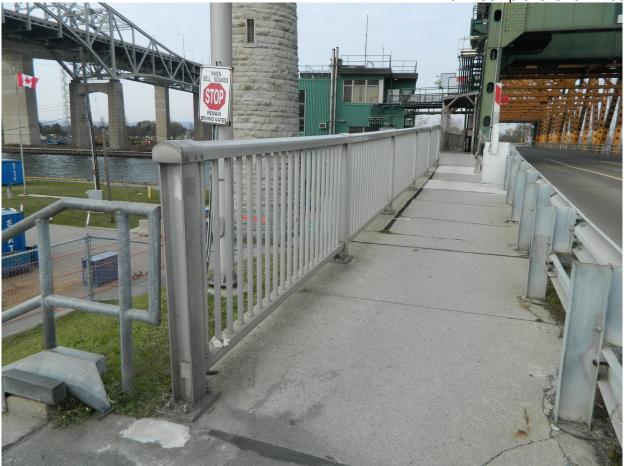
285 Pedestrian Railing on West Sidewalk from South Approach

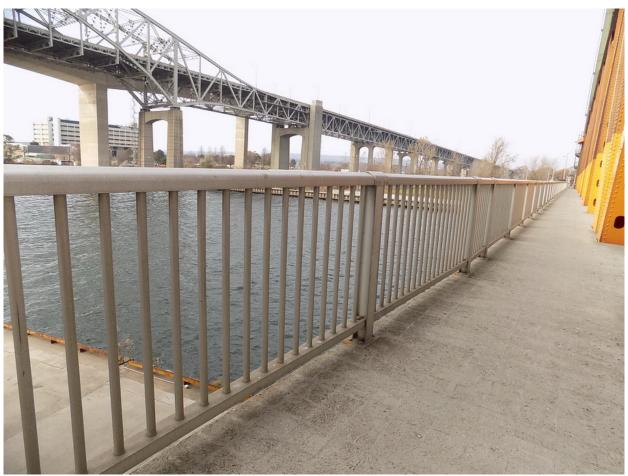
286 West Pedestrian Railing @ Lift Span, looking North

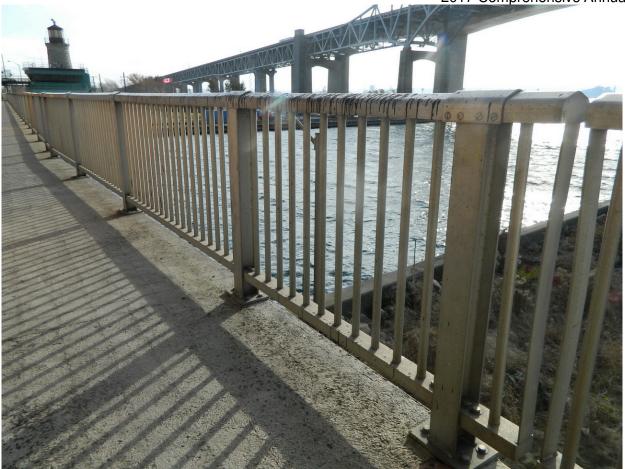
287 Grease Stains on Pedestrian Railing near North Tower, looking South

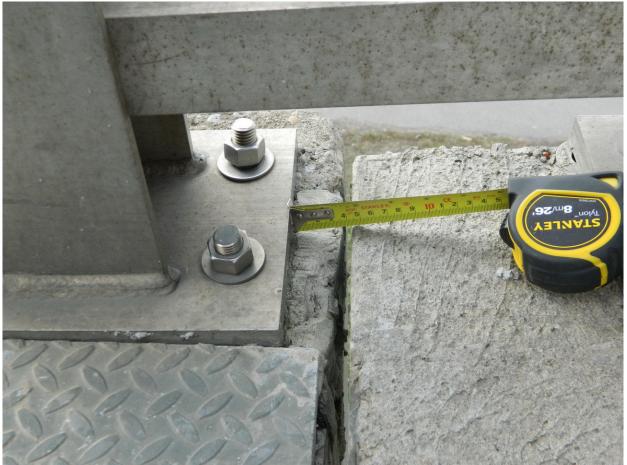
290 Typical Loose Anchor Bolt on West Railing Post adjacent to Abutment Joint, South Abutment Joint Shown Page A2 [145] of A2 [153]

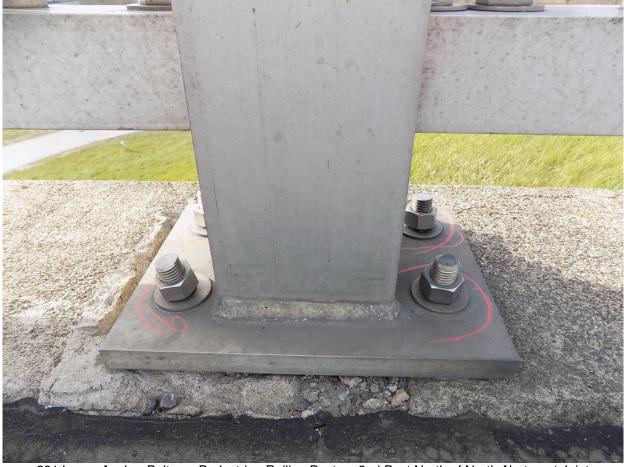
291 Loose Anchor Bolts on Pedestrian Railing Post on 2nd Post North of North Abutment Joint
