2017 COMPREHENSIVE DETAILED INSPECTION BURLINGTON CANAL LIFT BRIDGE

Contract No. EQ754-181509/001/PWL Project No. R.089504.040

Revised March 29, 2018 (Rev .00)

RE: Burlington Canal Lift Bridge 2017 Comprehensive Detailed Annual Inspection Final Report

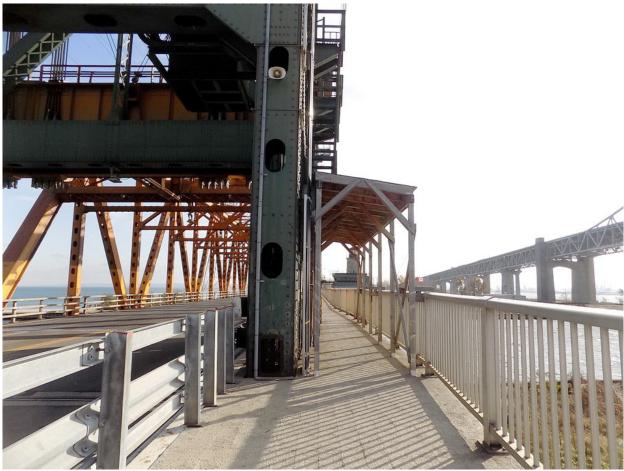
292 General View of West Sidewalk at Bridge from North Approach

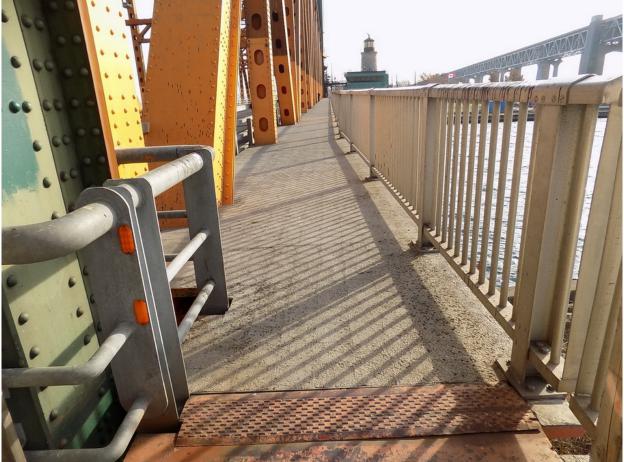
293 West Sidewalk at Lift Span, looking South

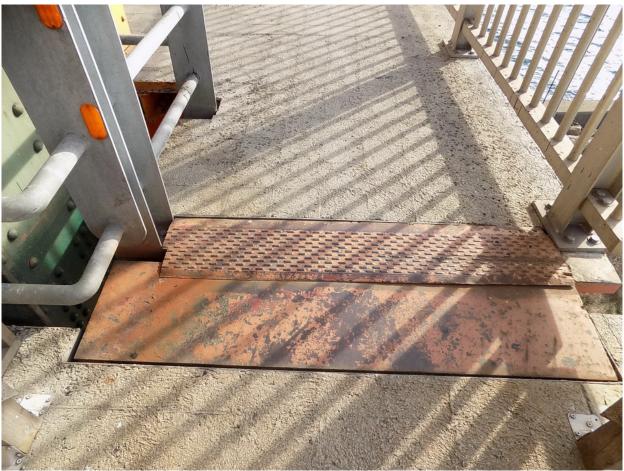
294 Steel Cover Plate on Sidewalk @ Joint between North Tower & Lift Span

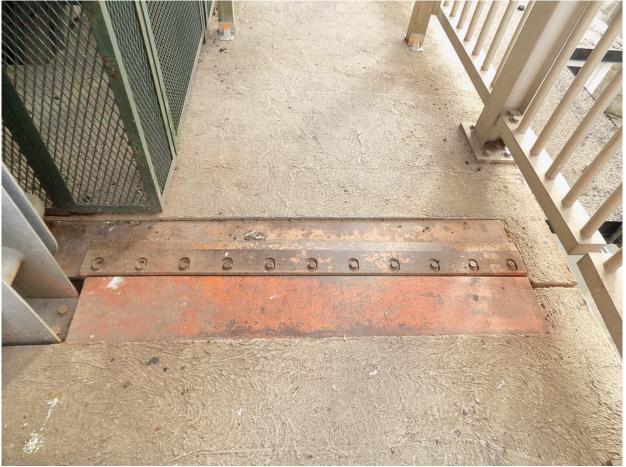
295 Steel Cover Plate @ Joint between South Tower & Lift Span

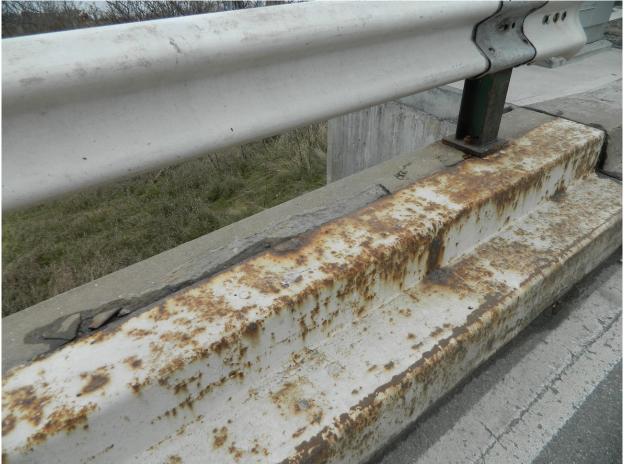
297 Typical Light with Local Medium Corrosion on Steel Curb Plate

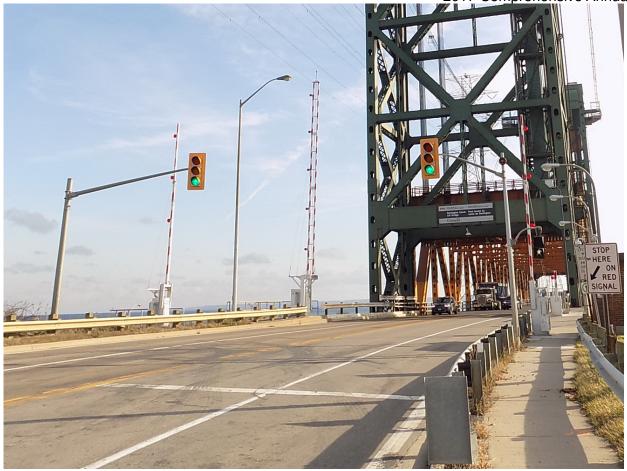
299 North Approach Road & Sidewalk, looking South

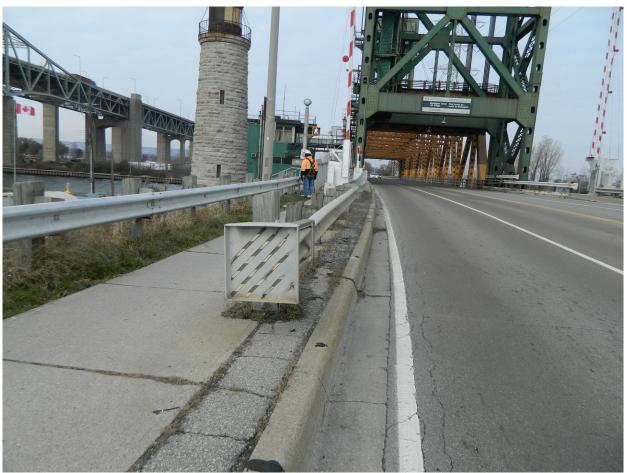
300 South Approach Road & Sidewalk, looking North

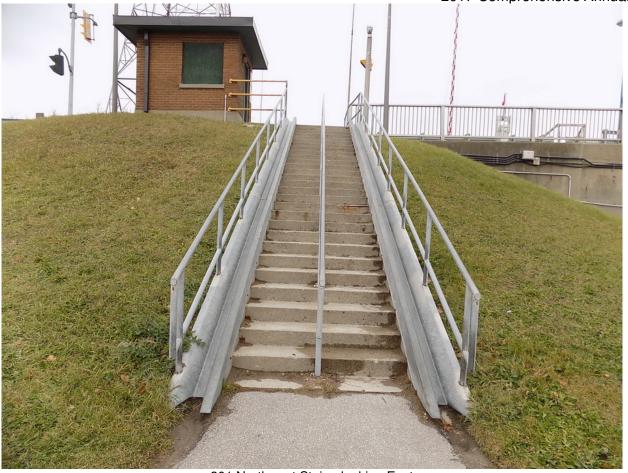
301 Northwest Stairs, looking East

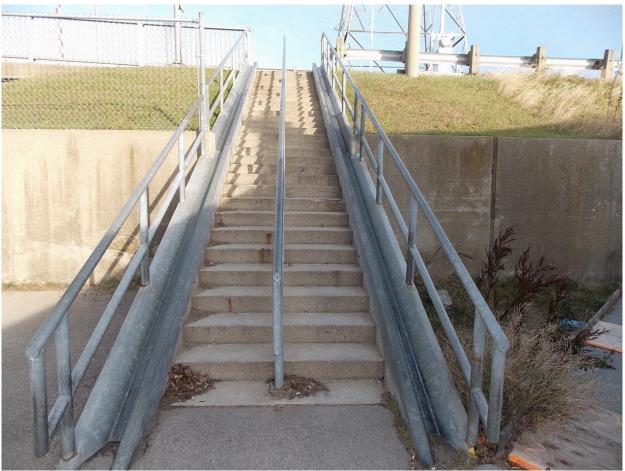
302 Southwest Stairs, looking East

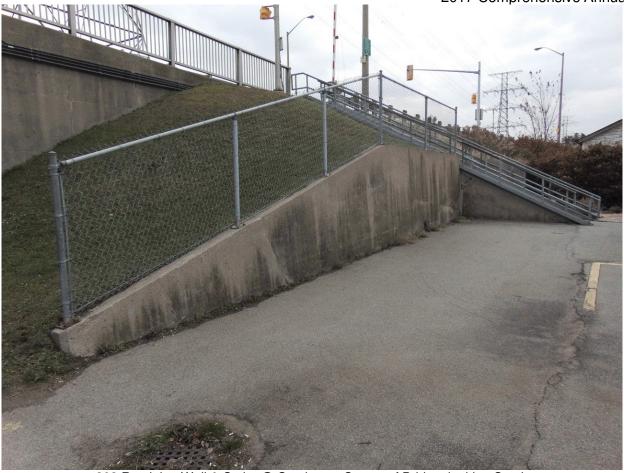
303 Retaining Wall & Stairs @ Southwest Corner of Bridge, looking South

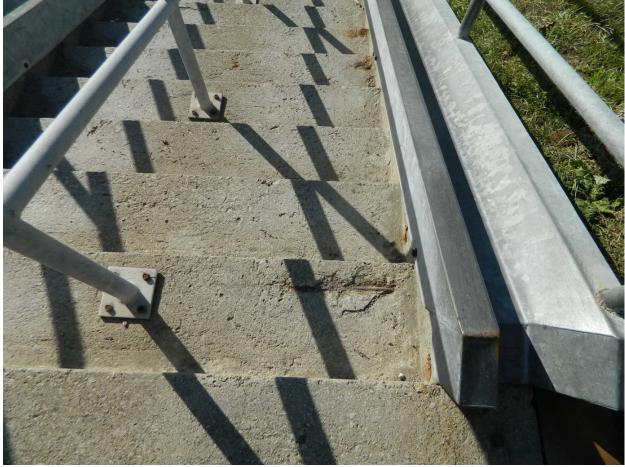
305 Local Shallow Spalls on Northwest Stairs (TYP)

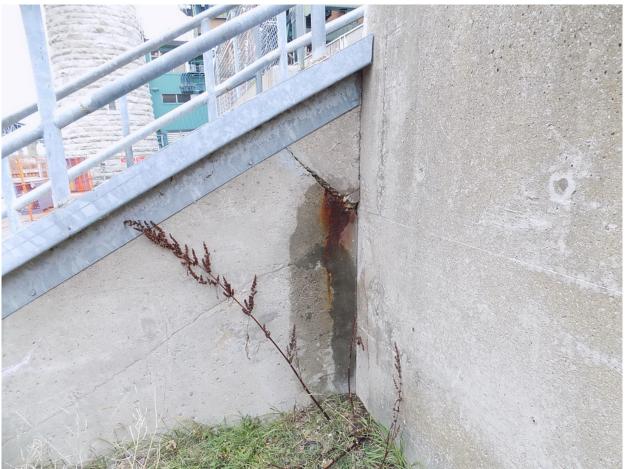
306 Wide Crack with Leakage on Lower Southwest Staircase Section near Retaining Wall Page A2 [153] of A2 [153]

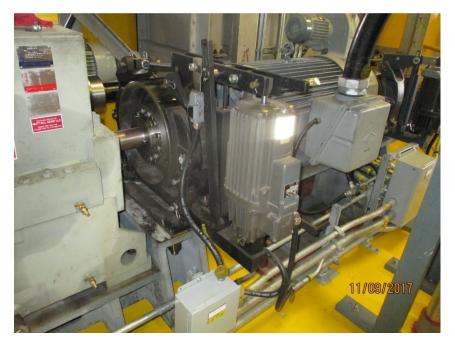
Photo M1 Machinery Brake - SE and Brake Wheel Coupling C3-SE. General view of the machinery brake assembly. Note the unpainted brake wheel coupling bolts.

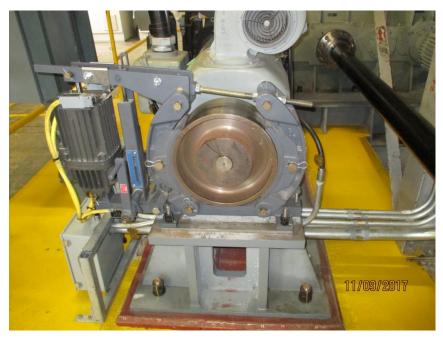
Photo M2 Motor Brake-SE. General view of a typical motor brake assembly. The brake assembly, including the brake wheel hubs and fasteners are unpainted.

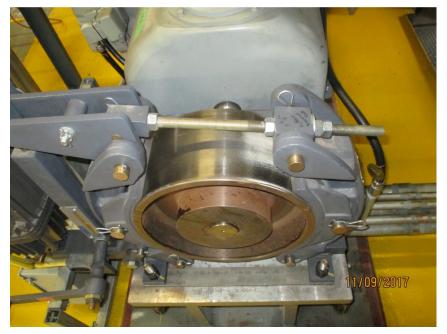
Photo M3 Motor Brake-SE. Areas of paint were found on the friction surface of the brake wheel.

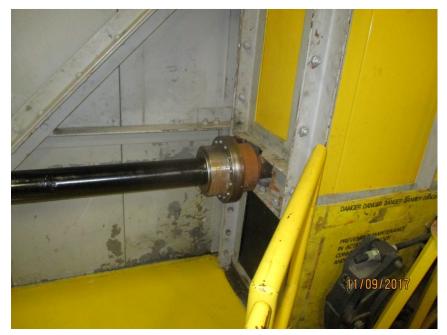
Photo M4 Coupling C1-SE. There was light corrosion on the hub. Corrosion was noted at all C1 and C2 couplings.

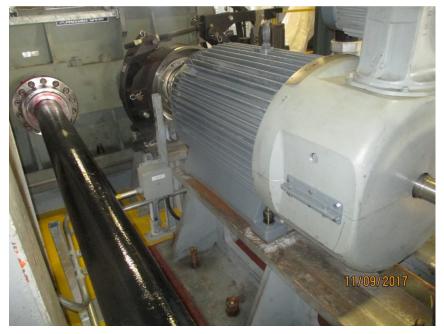
Photo M5 Motor-SW. The motor mounting bolts and support anchor bolts are unpainted with light corrosion forming. The shims and the top of the support are also unpainted.

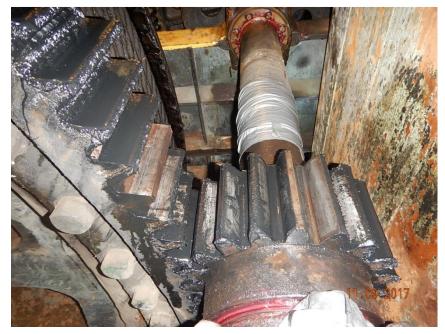
Photo M6 Pinion P1-SW-OB. The gear teeth in the acceleration zone were cleaned to bare metal for inspection. Gear tooth thickness measurements were taken at all gears.

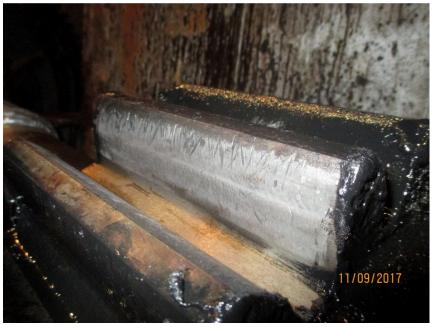
Photo M7 G1-SW-OB. Damage to the gear tooth caused by wire intrusion is wearing in.

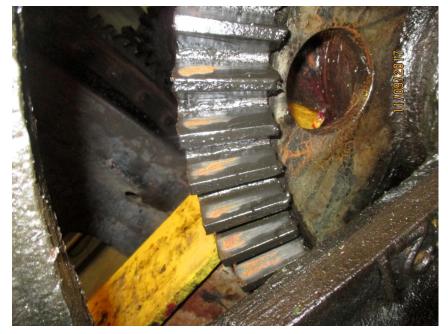
Photo M8 Gearset G2/P2-SE, Differential Gear. There was corrosion on some of the differential gear teeth due to inadequate lubricant

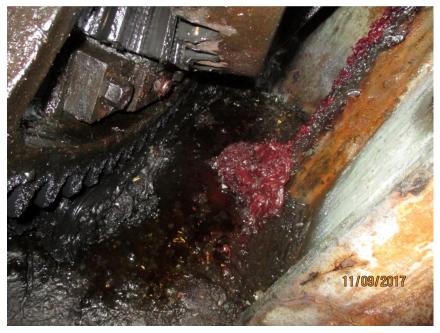
Photo M9 G2/P2-SE, Support Frame. There was an accumulation of old grease within the support frame under the G2 gear.

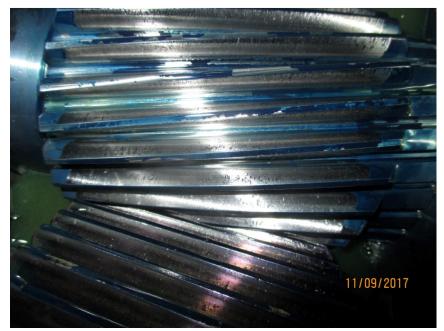
Photo M10 South Span Drive Reducer Auxiliary Gears. The reducer gear teeth have minor damage that may be from particles passing through the mesh.

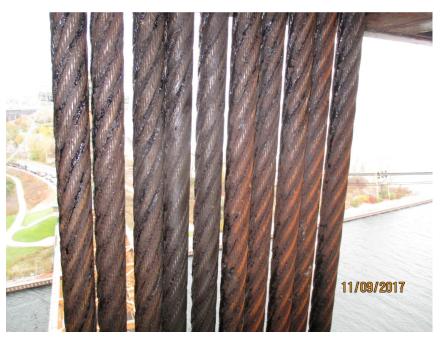
Photo M16 NW-OB Counterweight Rope Connections. There was fretting where the counterweight ropes rub against the counterweight splay casting. There was also light corrosion in spots due to inadequate lubricant.

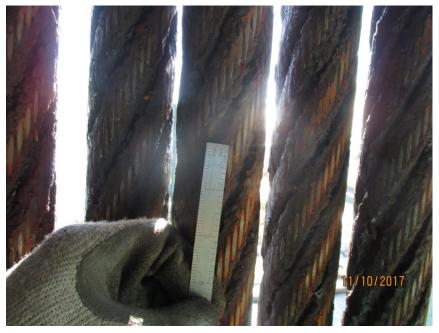
Photo M17 SW-IB Counterweight Ropes. View of the section of the ropes that contact the sheave grooves. Note the corrosion due to inadequate lubricant.

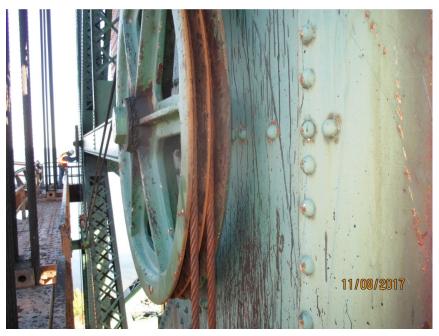
Photo M20 NW Auxiliary Counterweight Ropes. The auxiliary ropes and sheave have built up old lubricant.

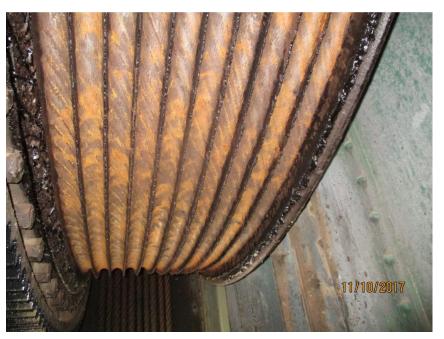
Photo M22 SW-OB Counterweight Sheave. There was paint deterioration and light corrosion on the sheave casting.

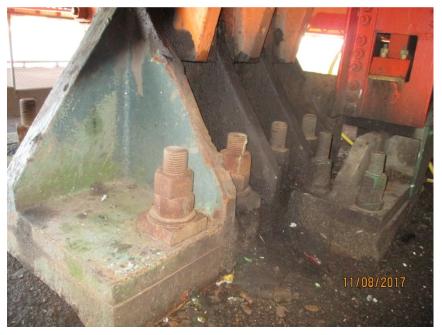
Photo M24 NE Auxiliary Counterweight. There are areas of light corrosion and paint deterioration on the counterweight blocks and frames.

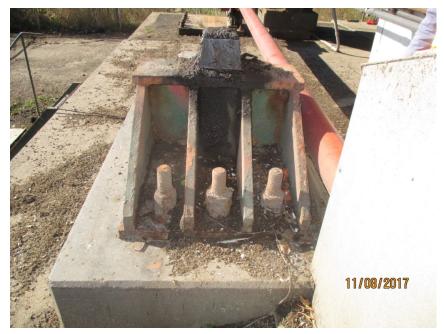
Photo M25 SW Live Load Support. The anchor bolts were corroded.

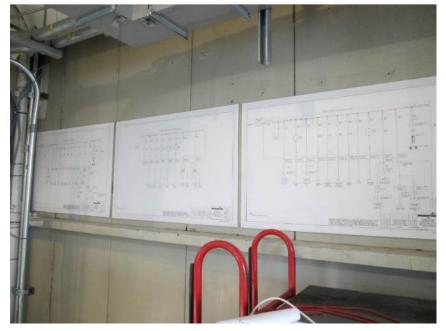
Photo E1 One Line Diagrams in Electrical Room. Note that the "As Built" one-line diagrams of the recently completed rehabilitation project are poster printed.

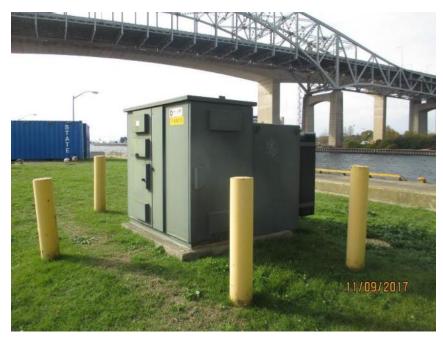
Photo E2 1,000KVA Outdoor Pad Mounted Incoming Service Transformer/Unit Substation. Note the primary service to the transformer is 13.8kV from the local utility overhead supply and secondary of the transformer serves the bridge at 575volt, 3-phase, 60 Hz.

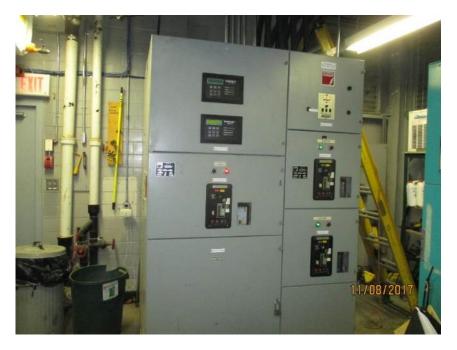
Photo E3 Switchboard #1. The switchboard is the original installation and is in good condition. Note that the utility and generator power main breakers are electrically operated and interlocked. There is no mechanical interlock for this manual transfer means.

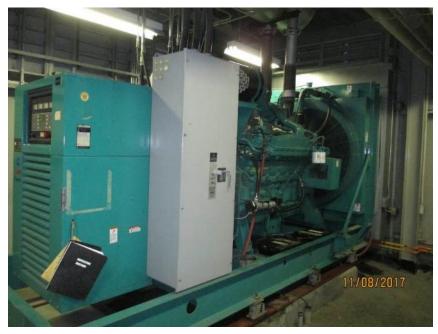
Photo E4 Main 600kW Standby Generator. Generator is used as an alternative source of power to operate the bridge. The standby generator is well maintained and been tested monthly.

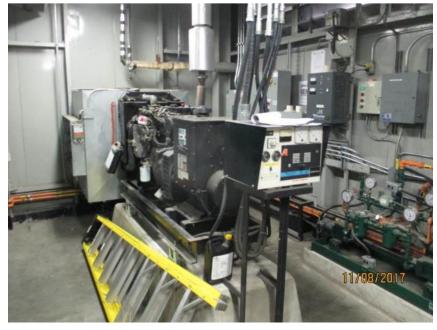
Photo E5 Auxiliary Standby Generator. Note auxiliary standby generator only provide powers the bridge facility and auxiliaries in the event of a utility electric failure but is not used or rated to operate the bridge.

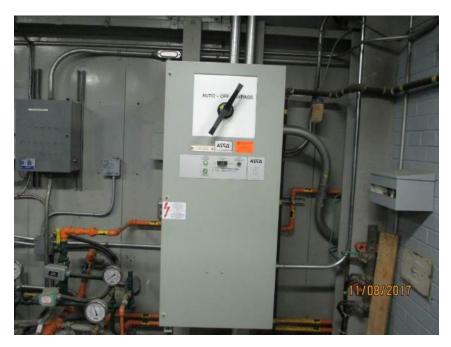
Photo E6 Automatic Transfer Switch (ATS). This ATS is used to automatically start the auxiliary generator to power the bridge facilities in the event of a power failure.

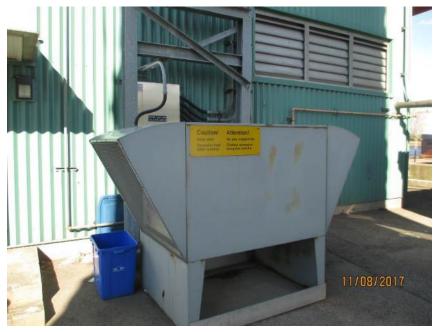
Photo E8 Main Standby Generator Load Bank. This load bank is located outside of the control house and is appropriately sized to exercise the main (600kW) standby generator under load. Note the excellent condition of the load bank enclosure with louver and protective screen.

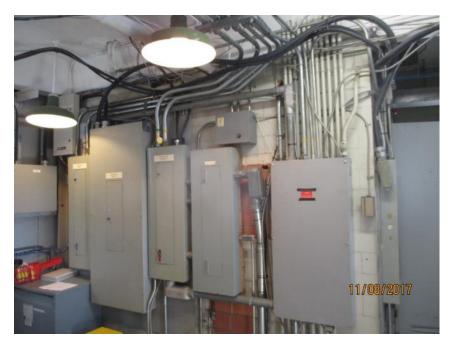
Photo E13 Electrical Room Panelboards. The transformer and the panelboards are of the existing installation. All panels are in good condition with additional circuits been added as part of the recent rehab.

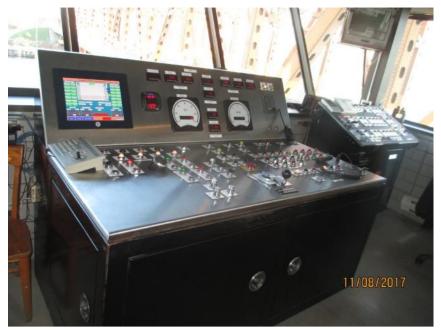
Photo E14 Main Control Desk. New upgraded console top is provided during the recent rehabilitation project. The console is in excellent condition.

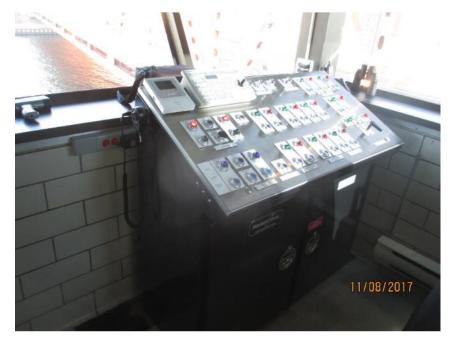
Photo E15 Traffic Control Panel. The new traffic control console top was recently installed. The layout and function of the console top is similar to the old console.

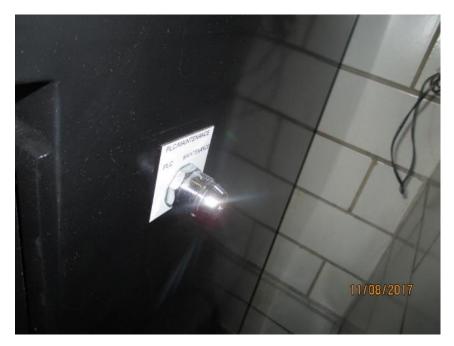
Photo E16 Traffic Control Bypass. A keyed selector switch for PLC and Maintenance select has been installed on the side of the console cabinet as part of the new control system function. Note that the relay mode of the traffic control does not have any interlocks per new logic.

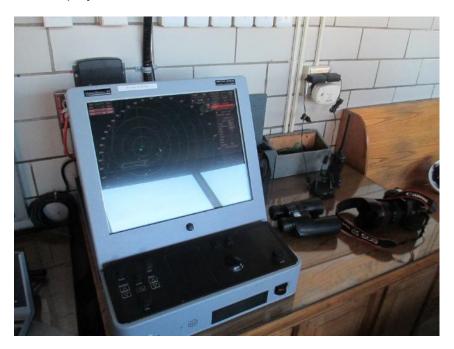
Photo E18 Bridge Radar System. The Radar system was installed to aid the bridge operation and schedule for the boat traffic. It also capable of display the wind speed and direction.

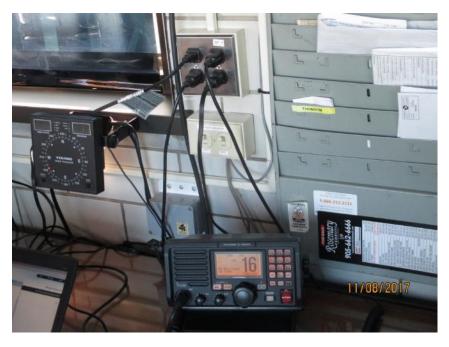
Photo E19 Wind Speed Indicator and Marine Radio. Both units are of the existing installation and are in good serviceable condition.

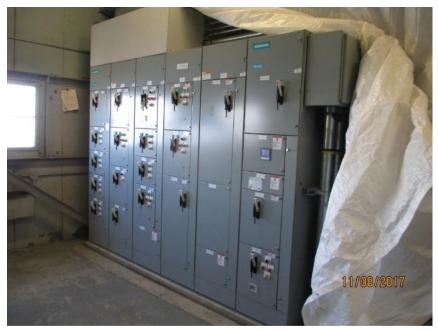
Photo E20 Typical New Motor Control Centre. Note that the white plastic that covers the MCC is the indication of the roof leak.

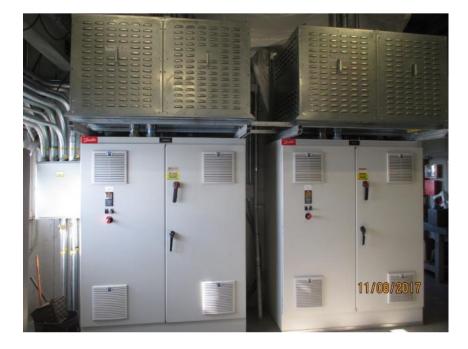
Photo E21 Typical VFD Drives Enclosure with Braking Resistors. Two new drives with resistors are installed in each tower. Both drives are in as new condition. Note two drives are providing redundancy for the main drive operation. Operator can select drives automatically or manually.

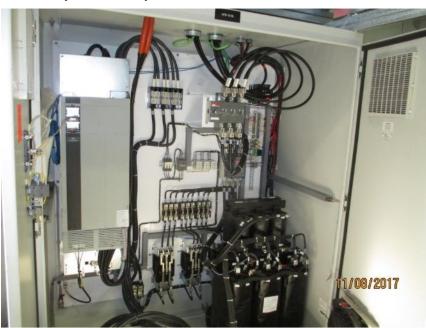
Photo E22 Typical VFD Drive System. The 200HP Danfoss VFD drive, 18 poles transformer and rectifier are well installed inside the drive enclosure.

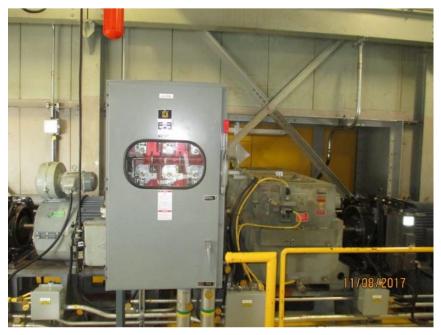
Photo E23 Typical Drive Motor Disconnect Switches. The drive motor disconnect switch is of the original installation and been reused to serve the new motor.

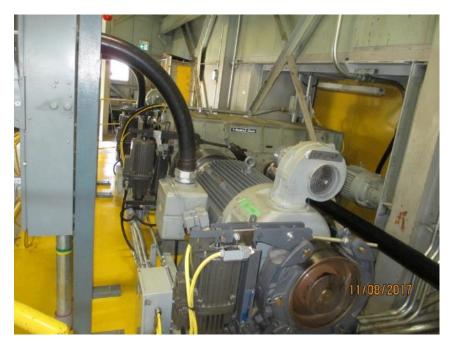
Photo E24 Typical Drive Machinery Arrangement. The span motors and motor brakes are in as-new condition. The machinery brakes are existing but are provided with a new brake drum.

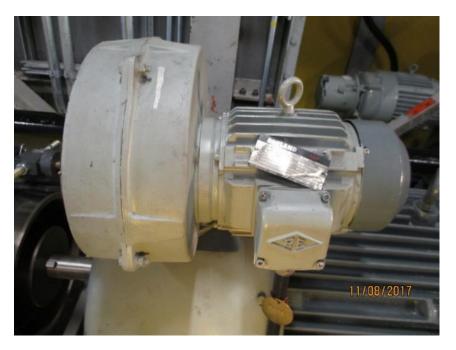
Photo E25 Northeast Motor Blower Nameplate. The blower nameplate was not affixed to the motor at the time of inspection.

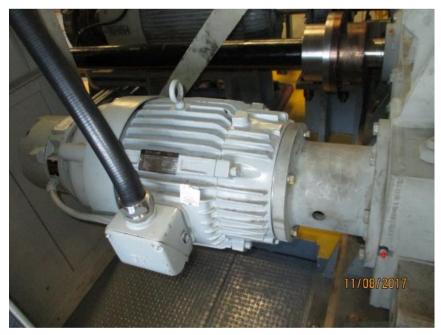
Photo E26 Typical Auxiliary Drive Motor. The new auxiliary motor with integral brake was installed during the recent rehab. Note that the original chain drive aux. has been changed to the direct coupling to the reducer.

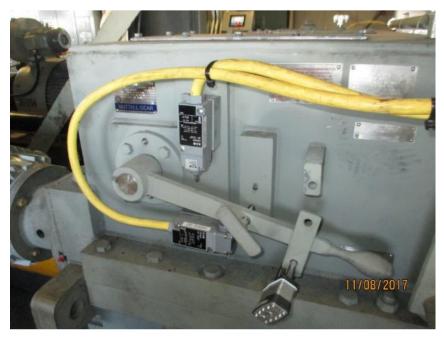
Photo E27 Lever Handle and Limit Switches on the Gear Reducer. Two handles are provided, one on each side the reducer for AUX drive operation and transverse skew adjustment. Many limit switches have been installed on the reducer box for the lever position indication and interlock.

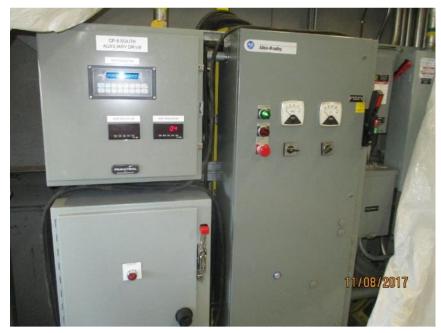
Photo E28 South Auxiliary Drive Controller and Span Height Indication Panel. The auxiliary drive was relocated along with the MTS and emergency power panelboard. They are all in good serviceable condition. Note the white plastic sheet cover over the units is the indication of the roof leak in the area. The span height indication is recently installed.

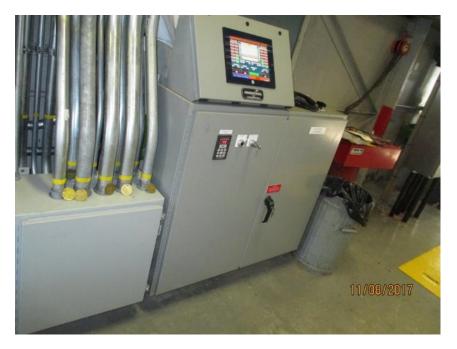
Photo E29 Typical Pull Box and Control Cabinet (CP-3) in South Tower. The control cabinet with PLC display was installed as part of recent rehab. They are in as-new condition.

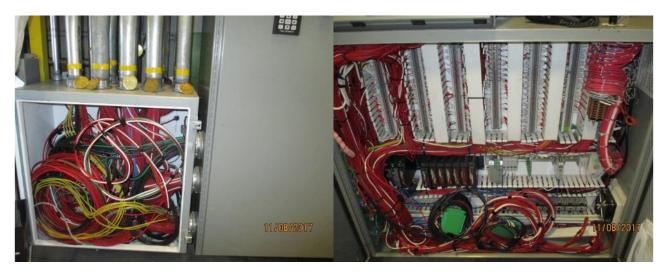
Photo E30 Inside of Pull Box and CP-3 Cabinet. Although the pull box was installed in addition to the control cabinet, both enclosures are over-congested.

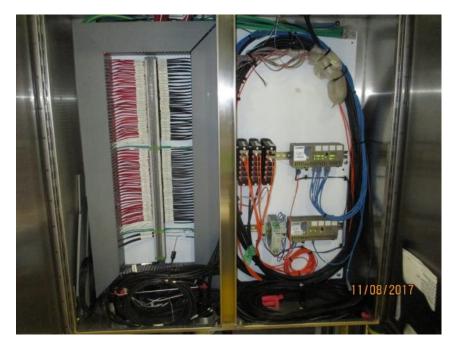
Photo E32 South Tower Aerial Cable Control Termination Box. The network switches and fiber patch boxes are also installed inside the box. Note the looped cables are the spare conductors and communication cables. All wires are well trained and installed.

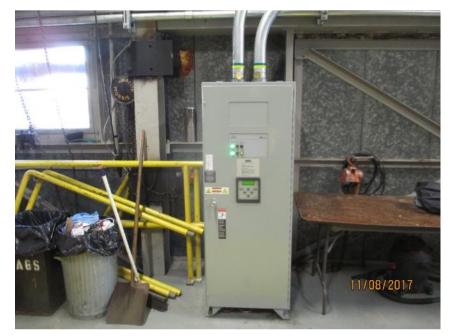
Photo E33 New Aerial Cable ATS in North Tower. The ATS was installed during the recent rehab project. It is used to automatically switch the aerial cable power feed between the east and west. The ATS is well installed.

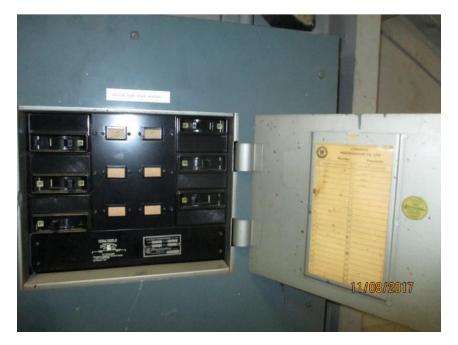
Photo E35 Typical Tower Heater Distribution Panel. This panel is of the existing installation and is in good operating condition.

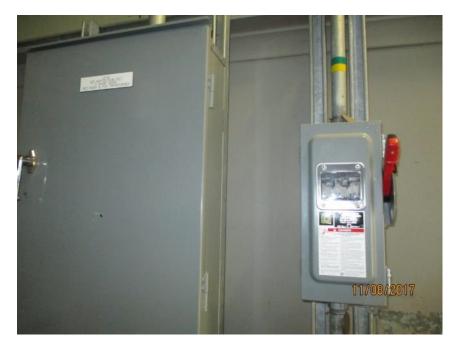
Photo E36 Typical New Lighting and Disconnect. A transformer, a disconnect switch and a lighting panel are of part of the new installation during the recent bridge rehabilitation. These components are in an as-new condition.

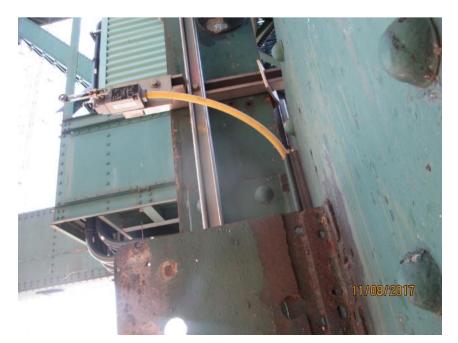
Photo E37 Typical Span Position Limit Switch. 3 span position limit switches have been installed on the south side along the counter weight traveling path: near seated, near open and full open limit. Note that these switches were configured in series with the programmable limit switch interfacing the span height resolver to create redundant/fail safe operation. However, the bridge operation is not fail safe without the positive indication from the north side of the span.

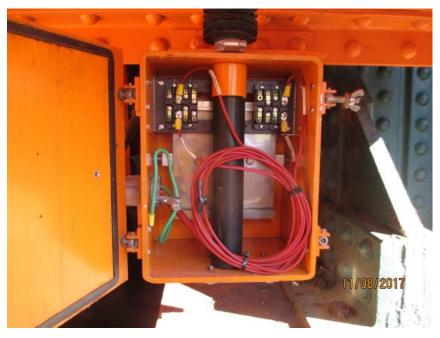
Photo E38 Typical New Span Seated Limit Switch. The switch is of the plunger type and provides indication that the span is fully seated. Note the switches were newly installed during the recent rehab project.

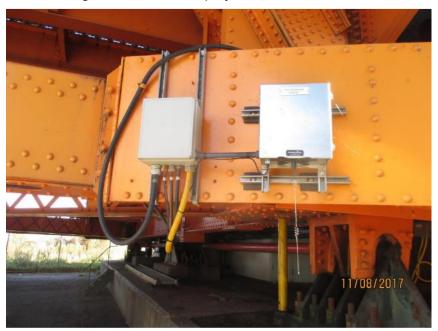
Photo E39 Span Inclinometer Enclosure. Per the rehab design, the span inclinometer was originally installed in the enclosure and communicated wirelessly with the transmitter located inside the CP-2 enclosure. The inclinometer was to be used for the span skew control but does not function.

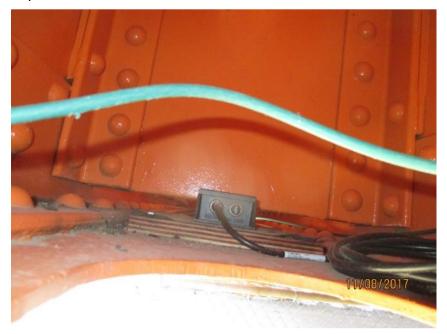
Photo E40 Inclinometer Unit. The span inclinometer had been moved several times under the direction of the Engineer during the rehab project. The function of the inclinometer

has now been disabled. The multi-turn span height resolvers, one in each tower, are being used in place of the inclinometers. The bridge has no secondary means of skew detection.

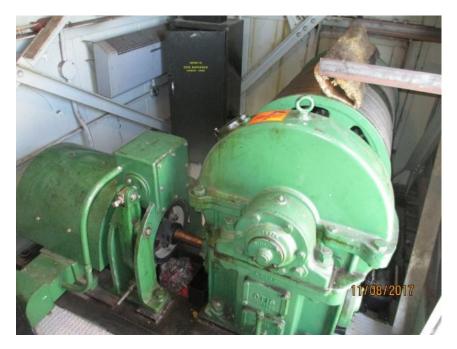
Photo E41 Typical Elevator Motor. The elevator motor is of the original installation.

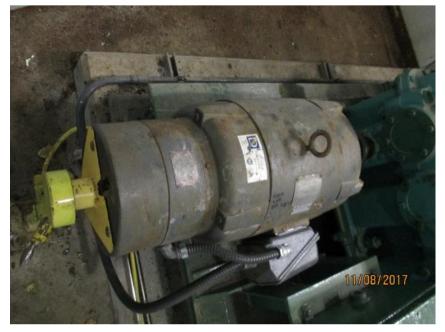
Photo E43 Typical Span Lock Motor. Note the lock motor is of original installation. A limit switch has been installed as part of the hand crank installation and used to prevent electrical operation of the lock motor when the hand crank cover is removed. The hand crank limit switch has been replaced during the recent rehab.

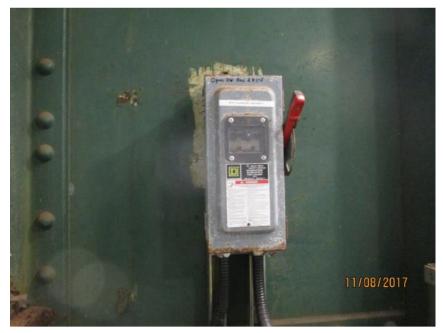
Photo E44 Typical Span Lock Motor Disconnect Switch (North Disconnect Switch Shown). The disconnect switch is rated NEMA 3R and exhibits excessive corrosion.

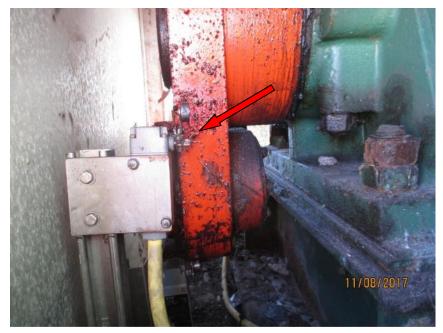
Photo E46 Typical Span Lock Limit Switches at the Center of Lock Machinery. A set of limit switches have been installed at the center of the span lock rotation machinery. These limit switches were installed as part of the recent replacement and upgrade project and are used in place of the original rotary cam limit switch.

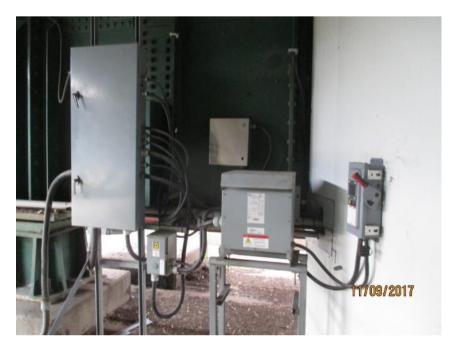
Photo E47 Lighting Panel on North Pier (LP-4). The disconnect switch, transformer, lighting panel and the lighting contactor are of the original installation. The lighting contactor has been modified to work with the current control system.

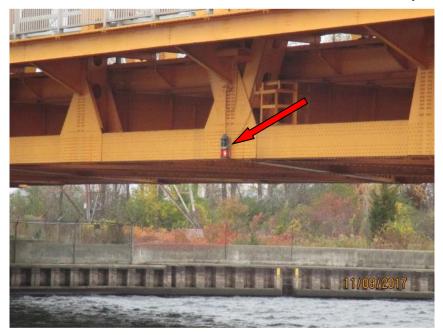
Photo E48 Typical Span Navigation Light. The bridge is provided with two span navigation lights, one facing each approaching navigable channel. These lights were found to be operational at the time of inspection and in good serviceable condition.

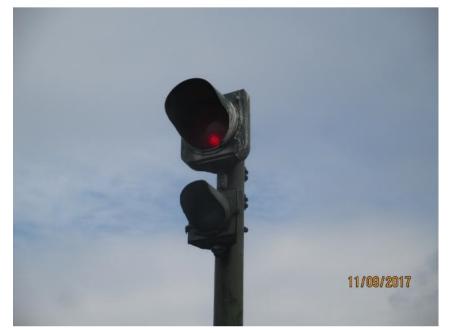
Photo E49 Typical Marine Traffic Navigation Light. The marine traffic lights are located at the tip end of the pier for signaling approaching vessels. The lights are operational but lights and poles exhibit minor signs of corrosion.

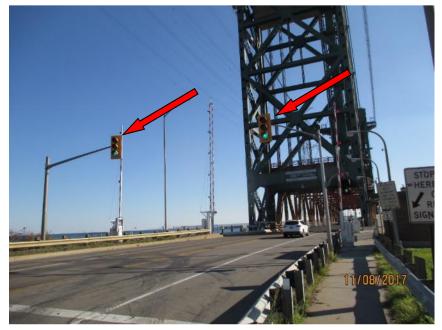
Photo E51 Traffic Signals. Note the good condition of the signals. The light bulbs are LED which extend the life of the bulbs.

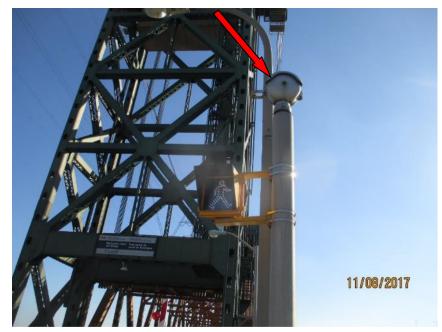
Photo E52 Typical Pedestrian Light and Pedestrian Bell. The pedestrian light is LED type Walk and Halt light. All pedestrian lights functioned properly. The North pedestrian bell (arrow) was out of service and should be fixed.

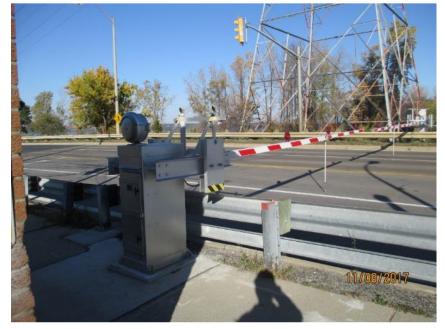
Photo E53 Typical Traffic Gate with Gong. The traffic gates of the new construction and function as expected. Note that the gong on NE traffic gate did not work at time of the inspection.

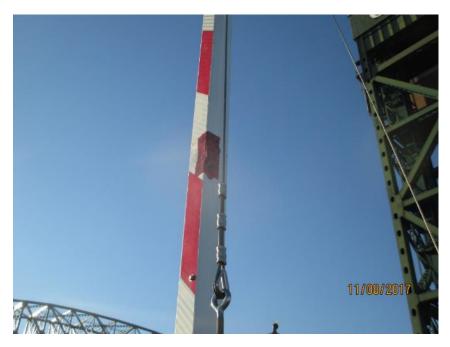
Photo E54 Damaged SE Traffic Gate Arm. Note the dent on the gate arm with a red tape is the result of the impact by a vehicle.

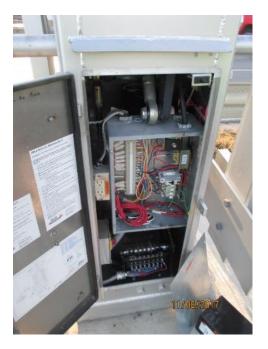
Photo E55 Typical Traffic Gate Enclosure. The equipment inside the gate enclosure is in asnew condition.

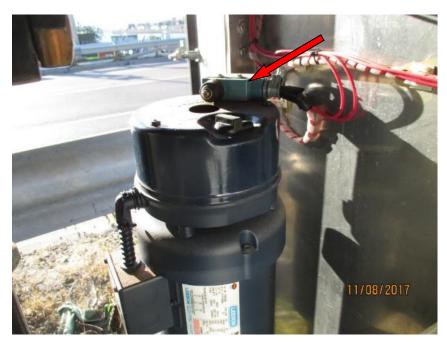
Photo E56 Typical Traffic Gate Motor and Hand Crank Limit Switch. The components are in as-new condition. Note that the gate is provided with a hand crank limit switch (arrow).

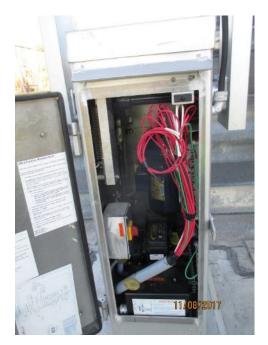
Photo E58 Typical Pedestrian Gate Enclosure. Note that the length of wires inside the gate is excessive in such a small enclosure. Otherwise the gate is in as-new condition.

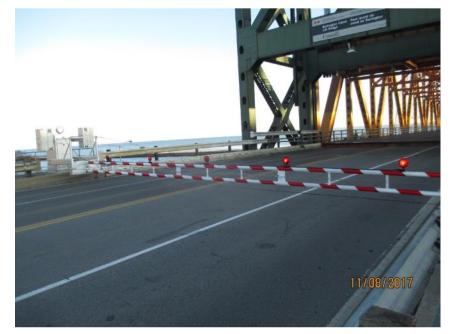
Photo E59 Typical Barrier Gate. Note the newly installed barrier gate, including arm light flasher and gong. The gate is in as-new condition.

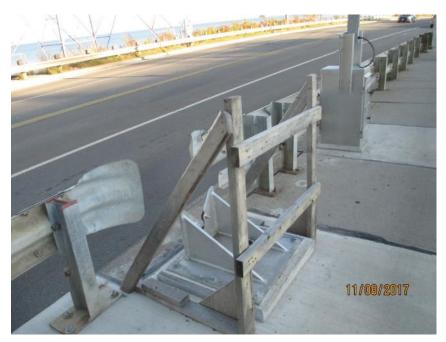
Photo E60 Barrier Gate Receiver. Note the wooden fencing around the receivers for temporary protection. Note that due to the independent of the pedestrian gate operation, the pedestrian can possibly come close to this receiver while the barrier gate is lowering. The wooden fencing was created after the barrier gate installation during the rehab but permanent railing should be provided to keep the pedestrian away from the receiver pocket.

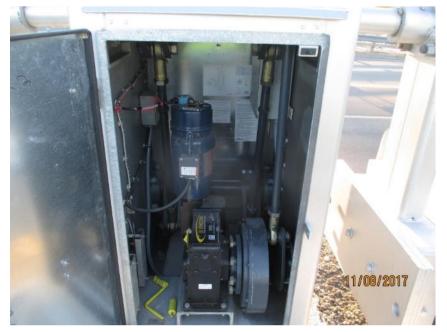
Photo E61 Typical Barrier Gate Enclosure. The barrier gate is in as-new condition. Note that the hand crank handles and drill adapter are laying on the bottom of the enclosure.

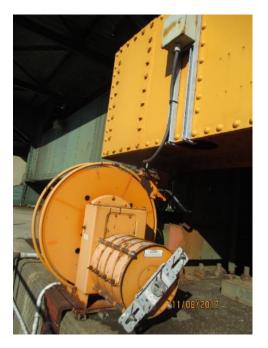
Photo E62 Typical Cable Reel (North Shown). Provides power and control for electrical equipment on the movable span. Note the corrosion throughout the cable reel body.

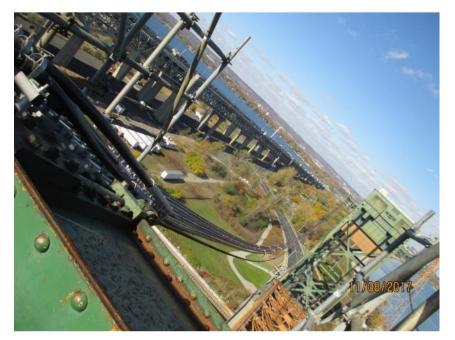
Photo E63 Typical New Aerial Cables Installation (East Shown). The aerial cables were replaced during the recent rehab project. The new aerial cable is the self-supported type and there has been some damage among the cable assemblies due to movement under the wind loads. The aerial cables have been temporary tied together with ropes to mitigate damage. A solution in the form of the installation of aerial cable spacers was underway at the time of the inspection.

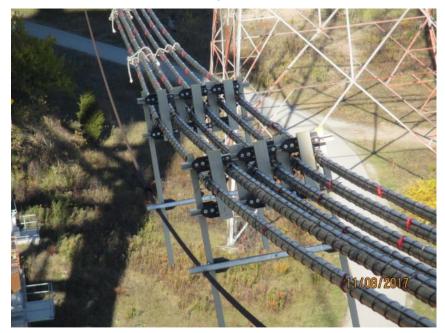
Photo E64 Typical Aerial Cable Spacer Installation (West Shown). The contractor is in the process of installing the aerial cable spacers.

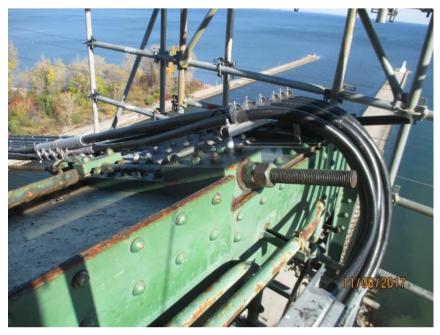
Photo E65 Typical Aerial Suspension Cables Routing. Sufficient bending radius has been created for the aerial cable before routing into the cable tray.

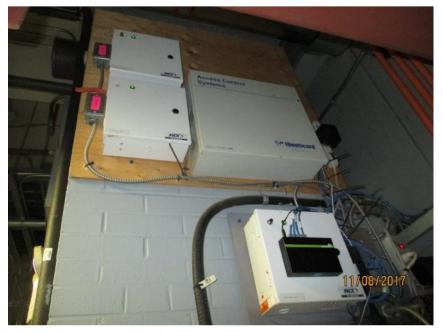
Photo E67 Bridge Access Control System. The bridge is provided with access control system to prevent unauthorized access to the bridge facilities. The access control system was operational at the time of inspection and provides an effective means of ensuring that only authorized personnel can gain access to the facility.

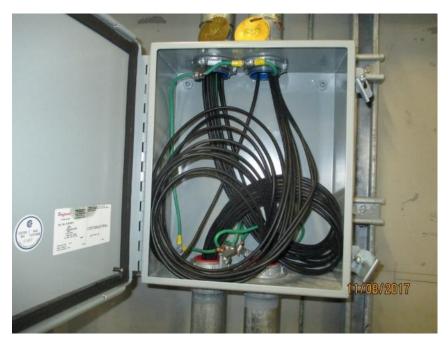
Photo E70 Typical Bonding. The raceway system bonding is well installed and conform to the CSA standard.

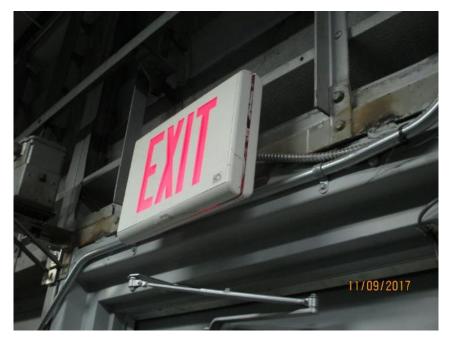
Photo E71 Exit Light. The casing of the Exit light in the generator room was damaged. Otherwise all exit lights are in working order.

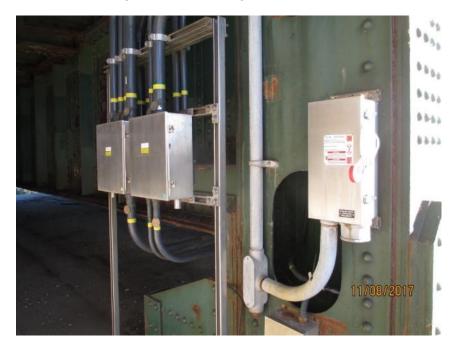
Photo E72 Existing Mobile Generator Disconnect and New Junction Boxes. Note the mobile generator disconnect with receptacle was the original installation. The disconnect switch and generator receptacle have never been used.

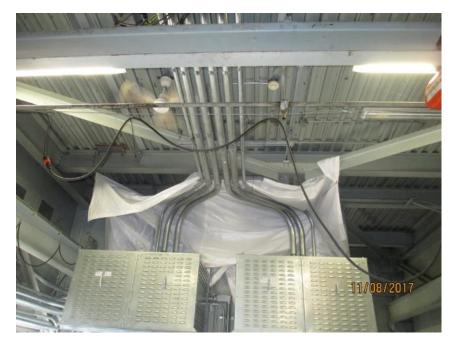
Photo E73 General Lighting and Smoke Detectors (South Tower Shown). The space lighting and fire system equipment is the original installation. They are adequately installed to provide safe work place. Note the cover over the top of the south drive/resistors is the indication of the roof leak. Immediate action should be taken to repair the roof leak in order to keep bridge operating reliably.

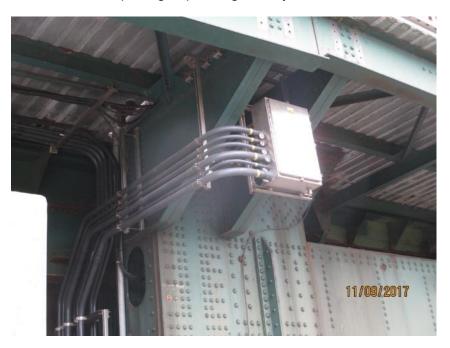
Photo E74 Typical Outdoor Raceway Installation. The newly installed conduit and stainless steel pull boxes are in as-new condition.
