**SUPPLEMENTAL
HAZARDOUS BUILDING MATERIALS ASSESSMENT**

**ADMINISTRATION BUILDING PRE-DECONSTRUCTION
CANADIAN COAST GUARD SOUTHSIDE BASE
280 SOUTHSIDE ROAD, ST. JOHN'S
NEWFOUNDLAND AND LABRADOR
DFRP 72019**

April 2020

Wood Project No. TF20076860

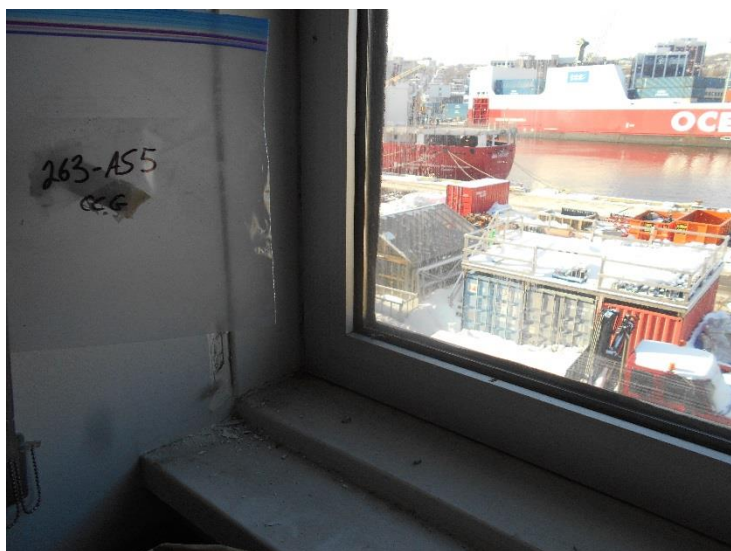
Photo 5: View of bulk material sample 20-AS-05 (renamed after sampling).

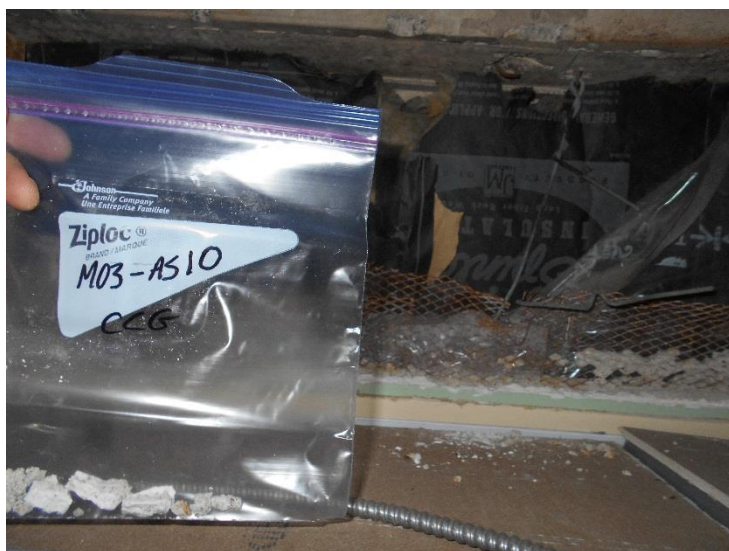
During the current HBMA, seven (7) samples of parging finish (20-AS-07, 20-AS-10, 20-AS-28, 20-AS-29, 20-AS-31, 20-AS-32 and 20-AS-33) were collected from the surfaces of walls and ceilings of the Administration Building for asbestos content analysis (refer to Photos 7, 11, 29, 30, and 32 to 34, Appendix B). It should be noted that six (6) of the parging samples were separated into layers (20-AS-07-Skim Coat, 20-AS-07-Rough Coat, 20-AS-10-Skim Coat, 20-AS-10-Rough Coat, 20-AS-28-Beige Adhesive, 20-AS-28-Parging on Gyproc, 20-AS-28-Rough Coat, 20-AS-28-Skim Coat, 20-AS-31-Skim Coat, 20-AS-31-Rough Coat, 20-AS-32-Skim Coat, 20-AS-32-Rough Coat, 20-AS-33-Skim Coat, and 20-AS-33-Rough Coat) by the laboratory prior to asbestos content analysis. Actinolite asbestos was detected in finish parging sample 20-AS-29-Rough Coat at a concentration less than 1% and is not considered to be an ACM. Asbestos was not detected in any other finish parging samples collected from the walls and ceilings of the Administration Building in the current HBMA.

Photo 11: View of bulk material sample 20-AS-10 (renamed after sampling).

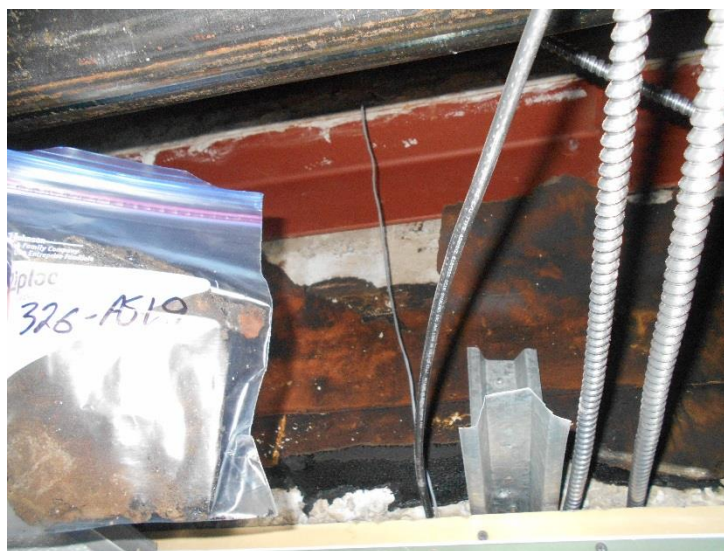
Nine (9) samples of tar paper (20-AS-18, 20-AS-19, and EX-1 to EX-7) were collected from the current and former exterior walls of the Administration Building for asbestos content analysis (refer to Photos 19, 20, and 60 to 66, Appendix B). Chrysotile asbestos was detected in tar paper samples 20-AS-18 (16.5%), 20-AS-19 (17.5%), EX-1 (19.6%), EX-2 (10.5%), EX-3 (22.4%), EX-5 (8.7%), EX-6 (13.3%) and EX-7 (13.5%) at concentrations above the applicable NL Asbestos Abatement Regulations (111/98) (i.e., >1%); and are considered to be a ACMs. Tar paper samples 20-AS-18 and 20-AS-19 were collected beneath the suspended floor tiles of the Operations Centre (Room 326) from a former exterior wall of the Administration Building. Tar paper samples EX-1 to EX-3 and EX-5 to EX-7 were collected from behind the outer layer of brick on the exterior walls of the Administration Building. Asbestos was not detected in tar paper sample EX-4.

Photo 19: View of bulk material sample 20-AS-18 (renamed after sampling).

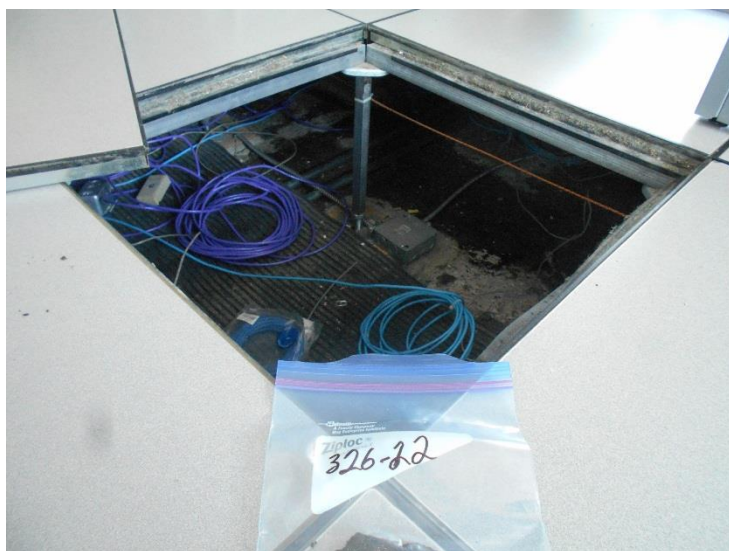
Two (2) samples of tar (20-AS-21 and 20-AS-22) were collected from beneath the suspended floor in the Operation Centre (Room 326) for asbestos content analysis (refer to Photos 22 and 23, Appendix B). Asbestos was not detected in either tar sample collected during the current HBMA.

Photo 22: View of bulk material sample 20-AS-21 (renamed after sampling).

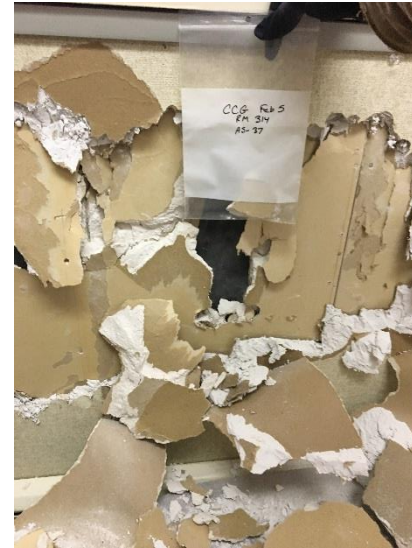
Photo 37: View of location of bulk material sample 20-AS-36.

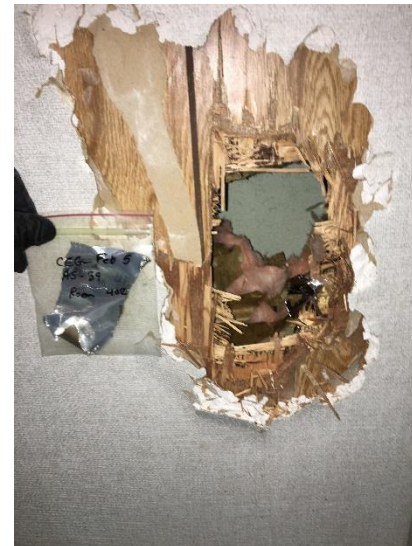
Two (2) samples of tar with foil backing (20-AS-38 and 20-AS-39) were collected during cavity inspections of the walls of Offices 305 and 402, respectively, and analyzed for asbestos content (refer to Photos 39 and 40, Appendix B). Sample 20-AS-38 was collected from behind a plywood wall underlying finished Gyproc and sample 20-AS-39 was collected from behind a wood panel wall underlying finished Gyproc. Asbestos was not detected in either tar with foil backing sample collected during the current HBMA.

Photo 39: View of bulk material sample 20-AS-38 (renamed after sampling).

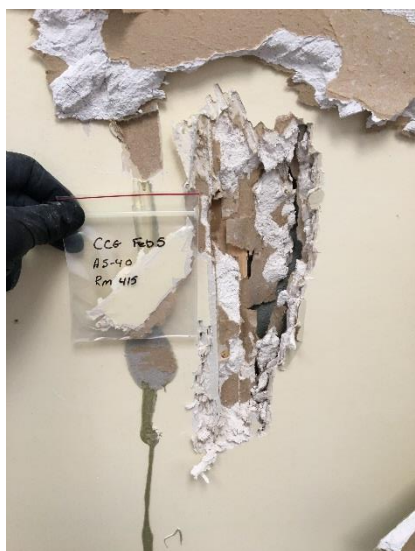
Photo 40: View of bulk material sample 20-AS-39 (renamed after sampling).

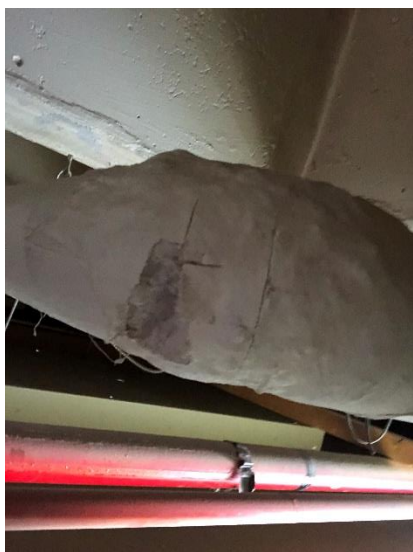
One (1) sample of wrap insulation (20-AS-49) was collected from a pipe in the stairwell for asbestos content analysis, asbestos was not detected in the pipe wrap insulation sample (refer to Photo 50, Appendix B).

Photo 50: View of bulk material sample 20-AS-49 (renamed after sampling).

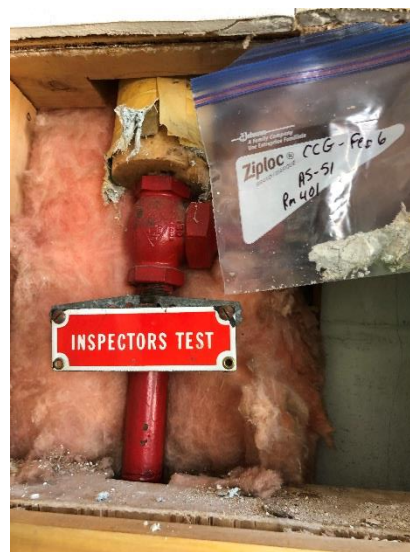
Photo 52: View of bulk material sample 20-AS-51 (renamed after sampling).

During the current HBMA, six (6) samples of parging (20-AS-50, 20-AS-51, 20-AS-52, 20-AS-53, 20-AS-54 and 20-AS-55) were collected from pipes and pipe elbows throughout the Administration Building for asbestos content analysis (refer to Photos 51 to 56, Appendix B). Chrysotile asbestos was detected in parging sample 20-AS-51 (70%) at a concentration above the applicable NL Asbestos Abatement Regulations (111/98) (i.e., >1%); and is considered to be an ACM. Parging sample 20-AS-51 was collected from a pipe valve in Room 401.

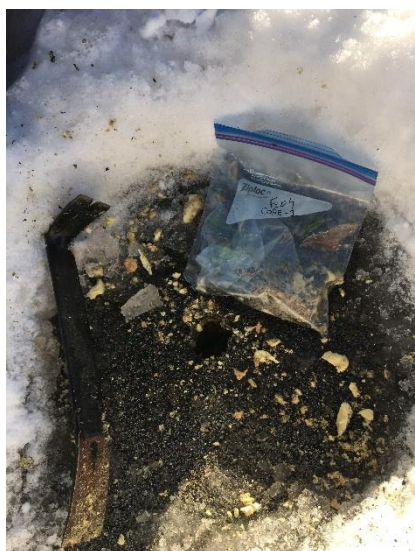
Photo 57: View of bulk material CORE-1.

During the current HBMA, three (3) roofing material core samples (CORE-1, CORE-2 and CORE-3) were collected from the roof of the Administration Building (refer to Photos 57 to 59, Appendix B). It should be noted that the core samples were split into distinct layers (CORE-1-Roof Tar, CORE-1-Particle Board, CORE-1-Foam, CORE-1-Roof Felt, CORE-2-Roof Tar, CORE-2-Foam, CORE-2-Tar Paper, CORE-3-Roof Tar, CORE-3-Particle Board, CORE-3-Foam, and CORE-3-Roof Felt) by the laboratory prior to asbestos content analyses. Asbestos was not detected in any core sample layer analyzed as part of the current HBMA.

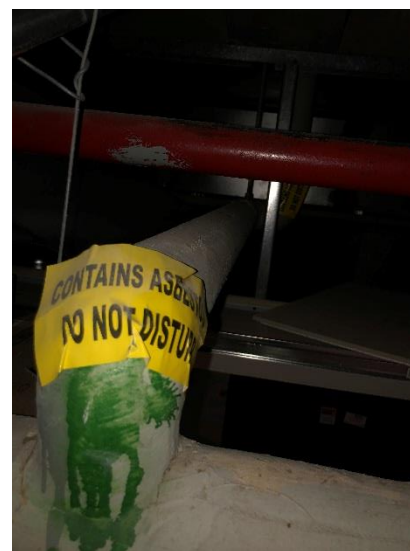
During the current HBMA a pipe elbow with signage indicating that it was an ACM was observed above the ceiling tile in Room M07 (Maritime Room) (refer to Photos 67 and 68, Appendix B). This pipe elbow was not sampled as it was already confirmed to be an ACM.

Photo 68: View of asbestos containing pipe insulation on pipe above ceiling tile in the "Maritime Unit" Room M07

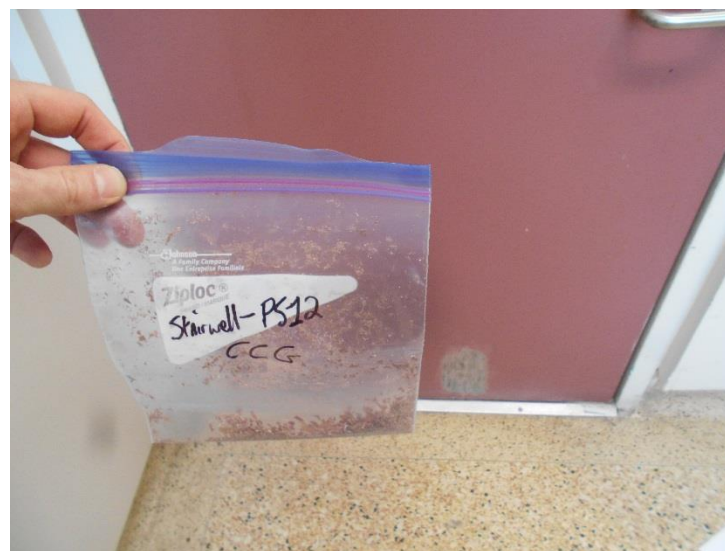
Photo 80: View of paint sample 20-PS-12 (renamed after sampling).

During the current HBMA, four (4) paint samples (20-PS-12, 20-PS-14, 20-PS-22, and 20-PS-23) were selected for asbestos content analysis in addition to lead, mercury and PCB content analyses (refer to Photos 80, 82, 90, and 91, Appendix B). Chrysotile asbestos was detected in paint sample 20-PS-23 (1-5%) at a concentration above the applicable NL Asbestos Abatement Regulations (111/98) (i.e., >1%); and is considered to be an ACM. Paint sample 20-PS-23 was beige in colour and collected from the concrete ceiling of the elevator storage room. Asbestos was not detected in any of the other paint samples analyzed as part of the current HBMA.

The concentrations of lead in the paint samples collected from the Administration Building during the 2020 additional HBMA ranged from non-detect (i.e., <10 mg/kg) to 2,230 mg/kg (refer to Table C2, Appendix C). In total 13 paint samples (20-PS-02, 20-PS-03, 20-PS-03A, 20-PS-04, 20-PS-05, 20-PS-09, 20-PS-12, 20-PS-13, 20-PS-18, 20-PS-19A, 20-PS-21, 20-PS-22, and 20-PS-24) contained lead at concentrations above the Federal HPA criterion of 90 mg/kg, but below the former Federal HPA criterion of 5,000 mg/kg (refer to Photos 70 to 74, 77, 80, 81, 86, 88, and 90, Appendix B, note that photographs of paint samples 20-PS-21 or 20-PS-24 are not available). No paint samples analyzed as part of the current HBMA contained lead at

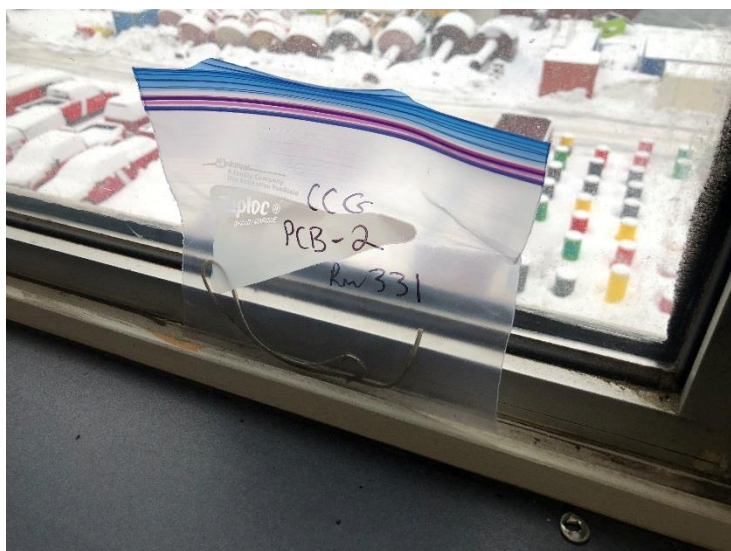
Photo 93: View of PCB sample PCB 2.

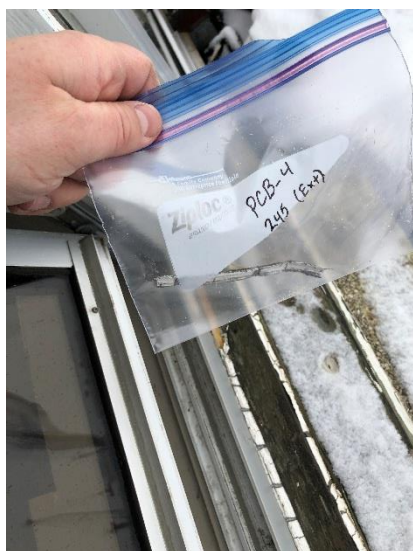
Photo 95: View of PCB sample PCB 4.

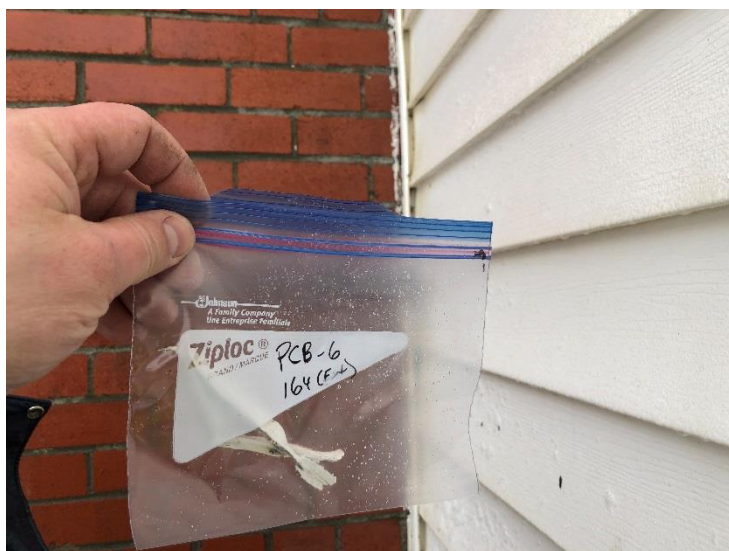
Photo 97: View of PCB sample PCB 6.

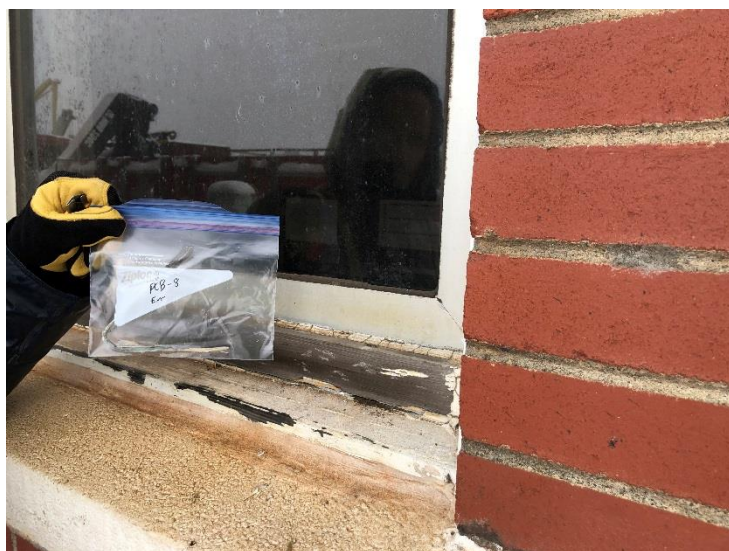
Photo 99: View of PCB sample PCB 8.

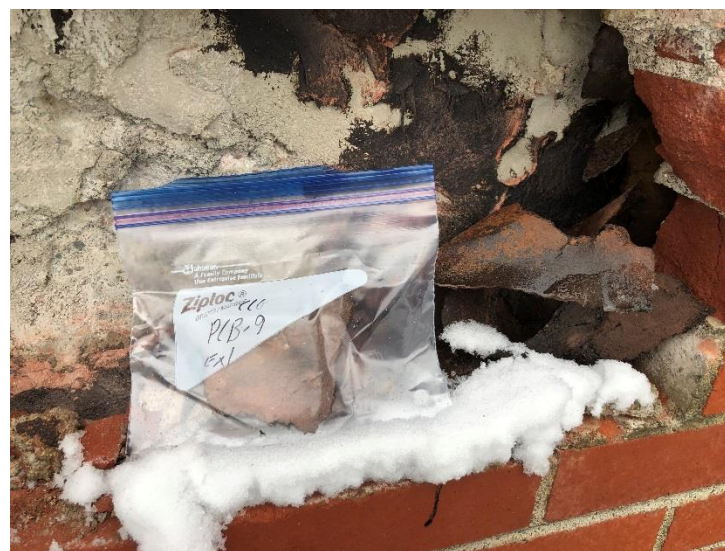
Photo 100: View of PCB sample PCB 9.

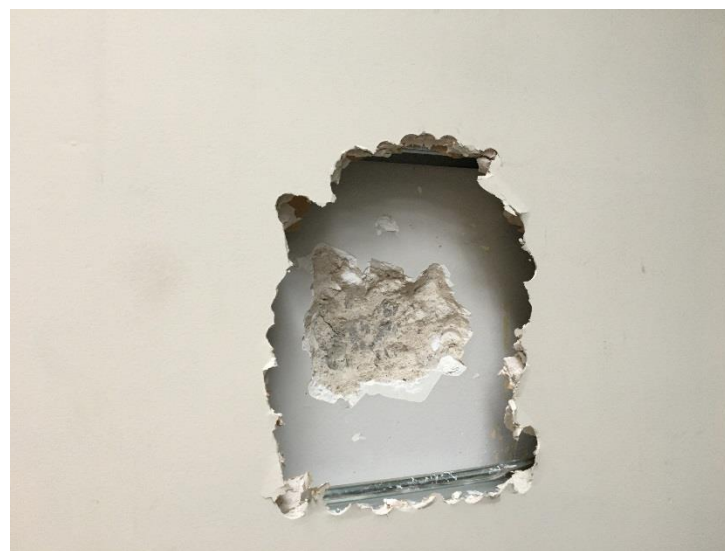
Photo 102: View of cavity inspection in Room 233.

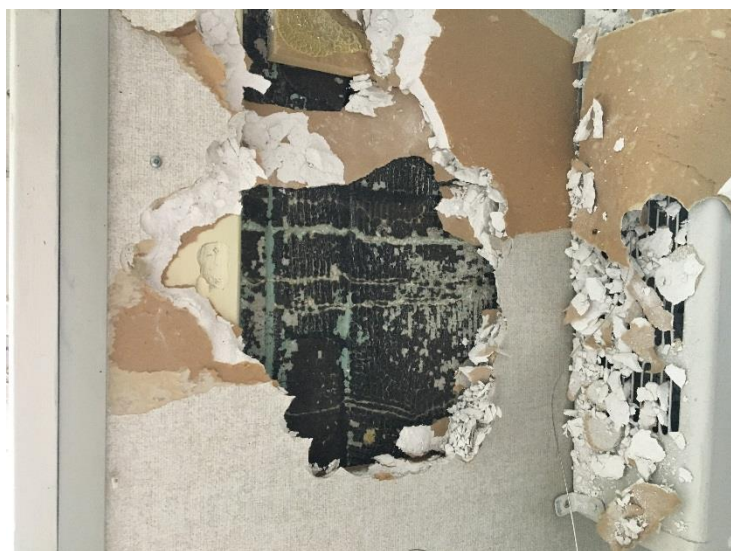
Photo 103: View of cavity inspection in Room 263.

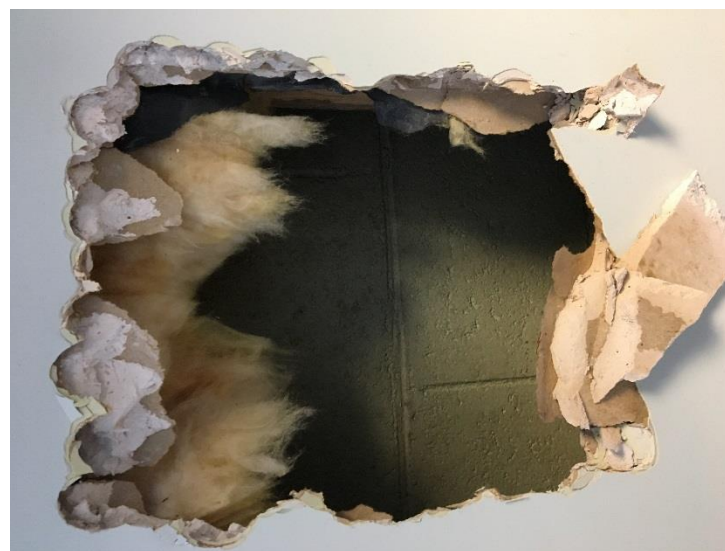
Photo 104: View of cavity inspection in Room 326.

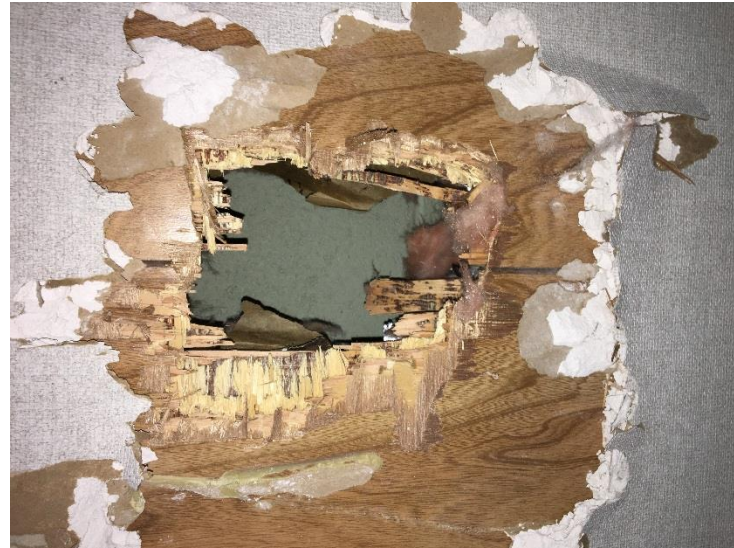
Photo 106: View of cavity inspection in Room 401.

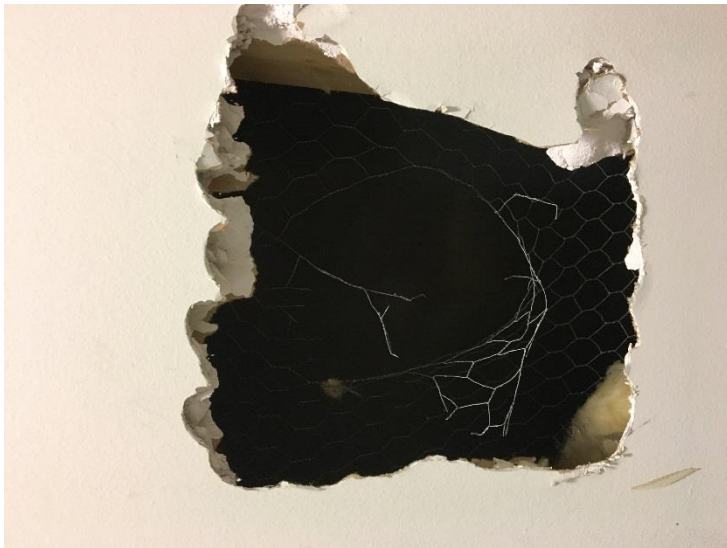
Photo 107: View of cavity inspection in Room 103.

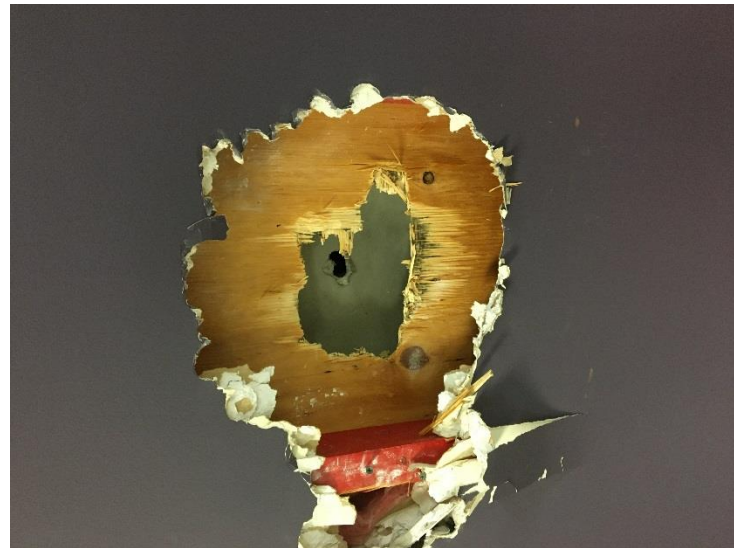
Photo 108: View of cavity inspection in John Cabot Room.
