Addendum No. 2

Project #: 20-078
Project Name: CFIA Lethbridge re-roofing

**ASBESTOS SURVEY
CFIA FACILITY: LETHBRIDGE
ALBERTA**

KGS Group 17-0006-013
March 2018

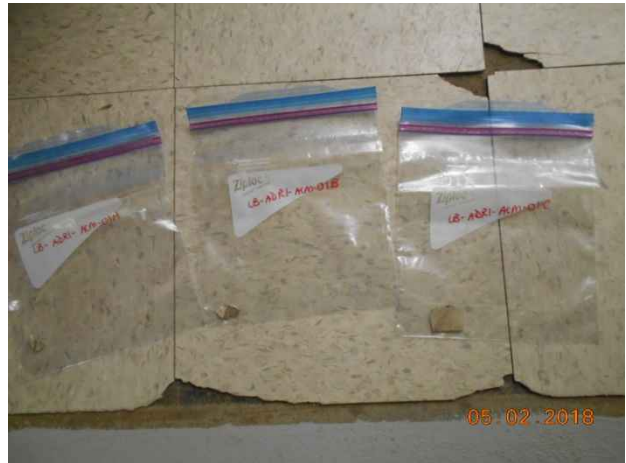
Photo 2. Sample locations LB-ADRI- ACM-01A to C; 12"12" beige/grey vinyl floor tile.

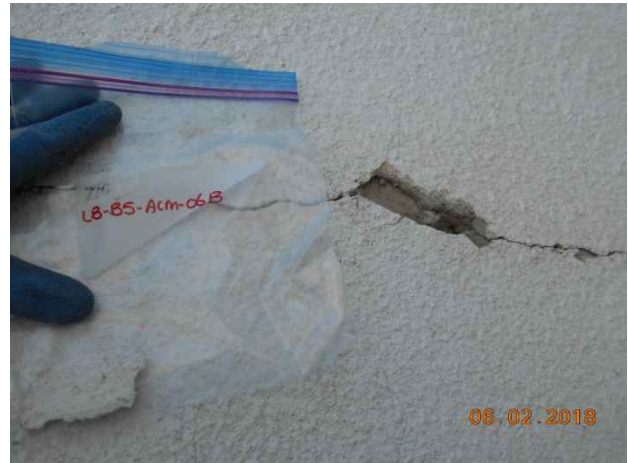
Photo 56. Sample location LB-B5-ACM-06B; exterior wall plaster.

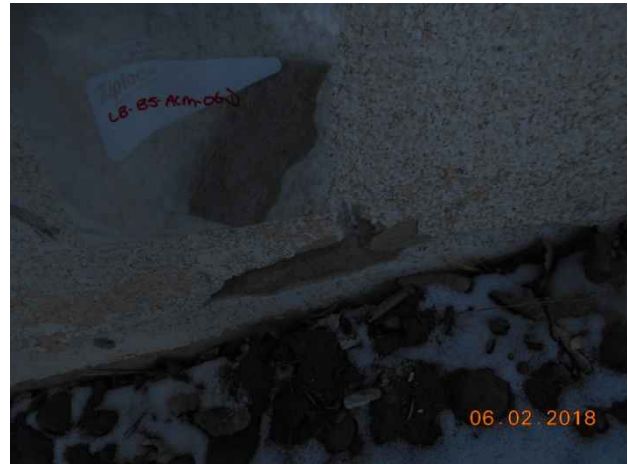
Photo 58. Sample location LB-B5-ACM-06D; exterior wall plaster.

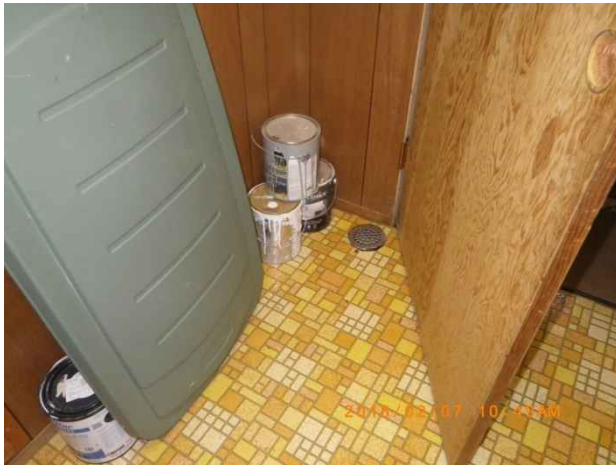
Photo 61. View of yellow brick pattern vinyl flooring in the basement.

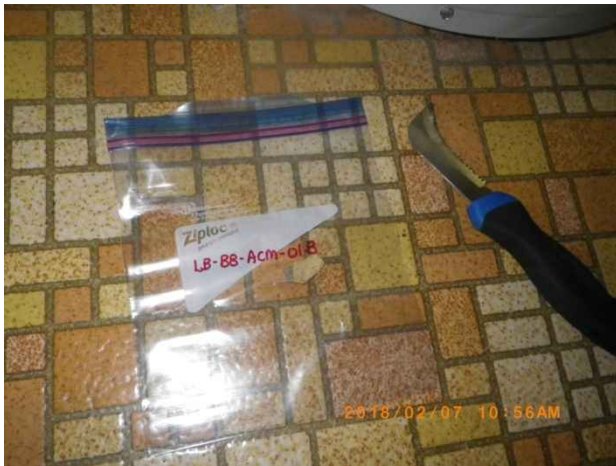
Photo 63. Sample location LB-B8-ACM-01B; yellow brick pattern vinyl flooring.

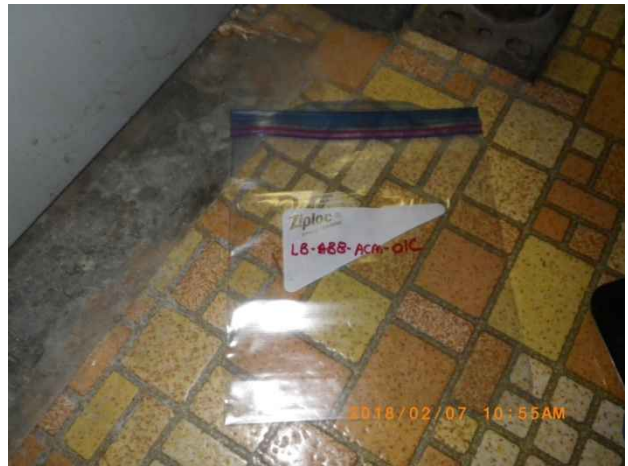
Photo 64. Sample location LB-B8-ACM-01C; yellow brick pattern vinyl flooring.

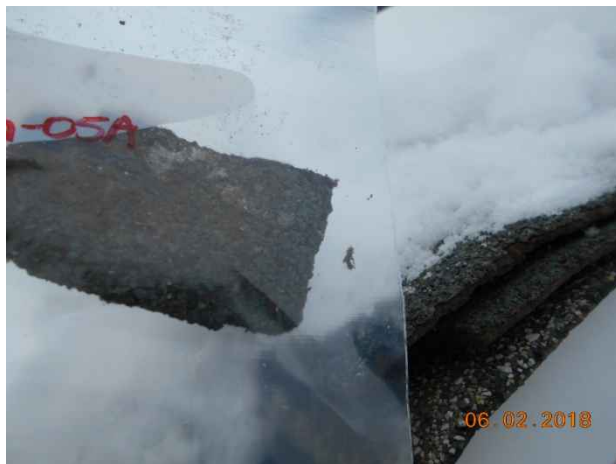
Photo 77. Sample locations LB-LB-ACM-05A to C; green roof shingles (top layer).

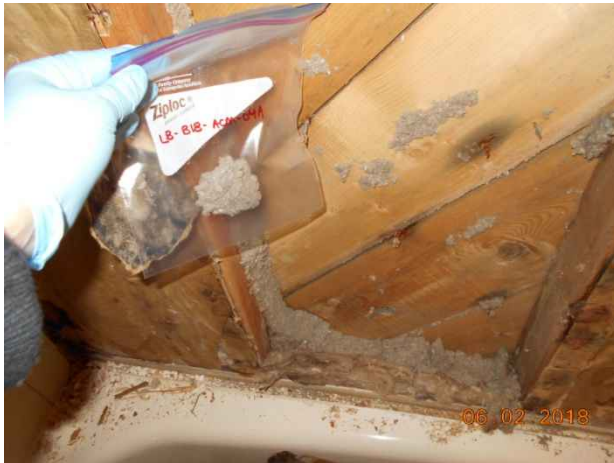
Photo 91. Sample locations LB-B18-ACM-04A to C; wall insulation from bathroom.
